Flood Damage Reduction Segment / System Inspection Report

Name of Segment / System: Bolivar, NY - Root Creek

Corps of Engineers Inspector: Dave Andreko Inspection Start Date: 11/7/2013

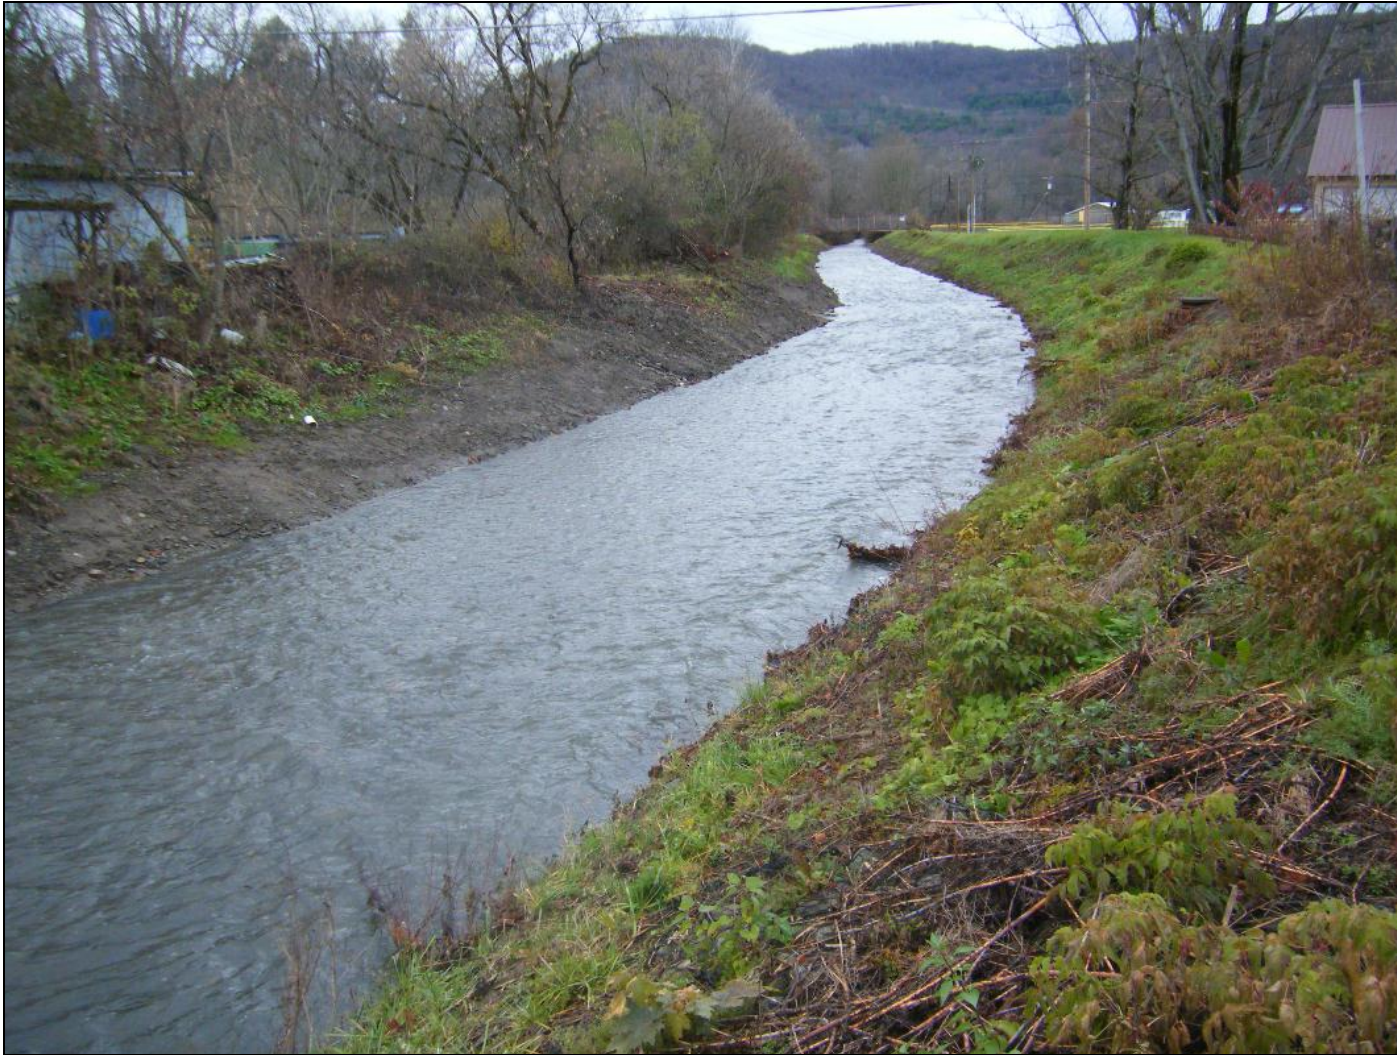
Inspect ID: BOLI_2013_a_0023 **Title:** USACE_CELRP_BOLI_2013_a_0023_1.jpg **Rated Item:** 1. Unwanted Vegetation Growth **Caption:** Rating: Acceptable; Remarks: good condition work completed in Sept; Action: NA; Station_1: NA

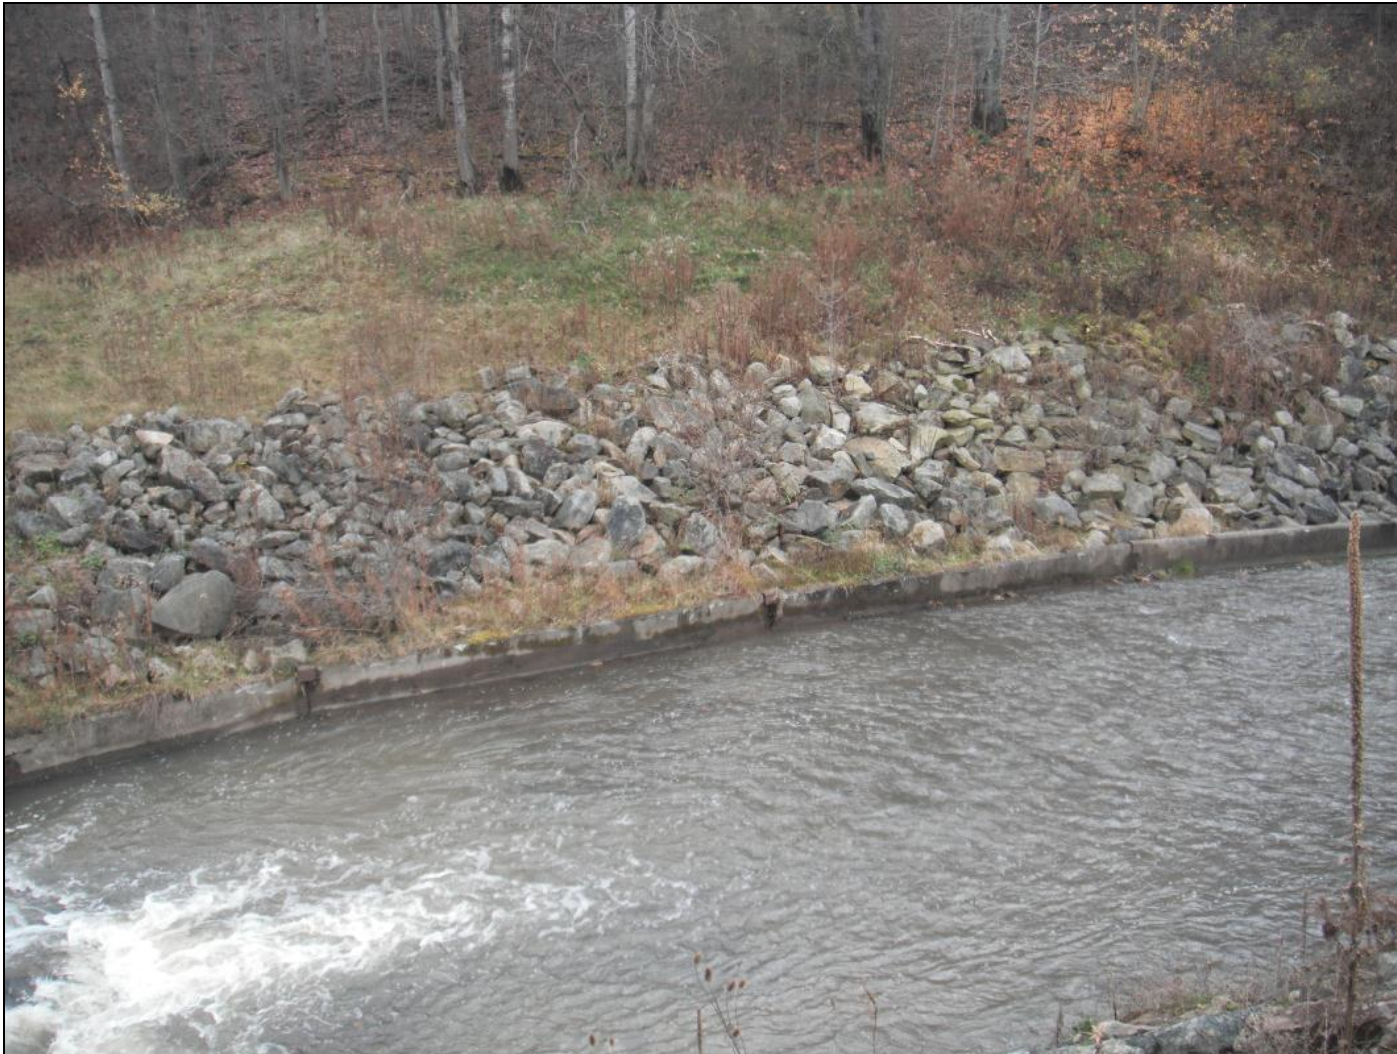
3. Ponding Areas	A	A	No trash, debris, structures, or other obstructions present within the ponding areas. Sediment deposits do not exceed 10% of capacity.	BOLI_2013_a_0011: Station_1 NA: channel clear - stone good: NA (A)
		M	Trash, debris, excavations, structures, or other obstructions present, or inappropriate activities that will not inhibit operations and maintenance. Sediment deposits do not exceed 30% of capacity.	
		U	Trash, debris, excavations, structures, or other obstructions, or other encroachments or activities noted that will inhibit operations, maintenance, or emergency work. Sediment deposits exceeds 30% of capacity.	
		N/A	There are no ponding areas associated with the interior drainage system.

Inspect ID: BOLI_2013_a_0011 **Title:** USACE_CELRP_BOLI_2013_a_0011_1.jpg **Rated Item:** 3. Ponding Areas **Caption:** Rating: Acceptable; Remarks: channel clear - stone good; Action: NA; Station_1: NA

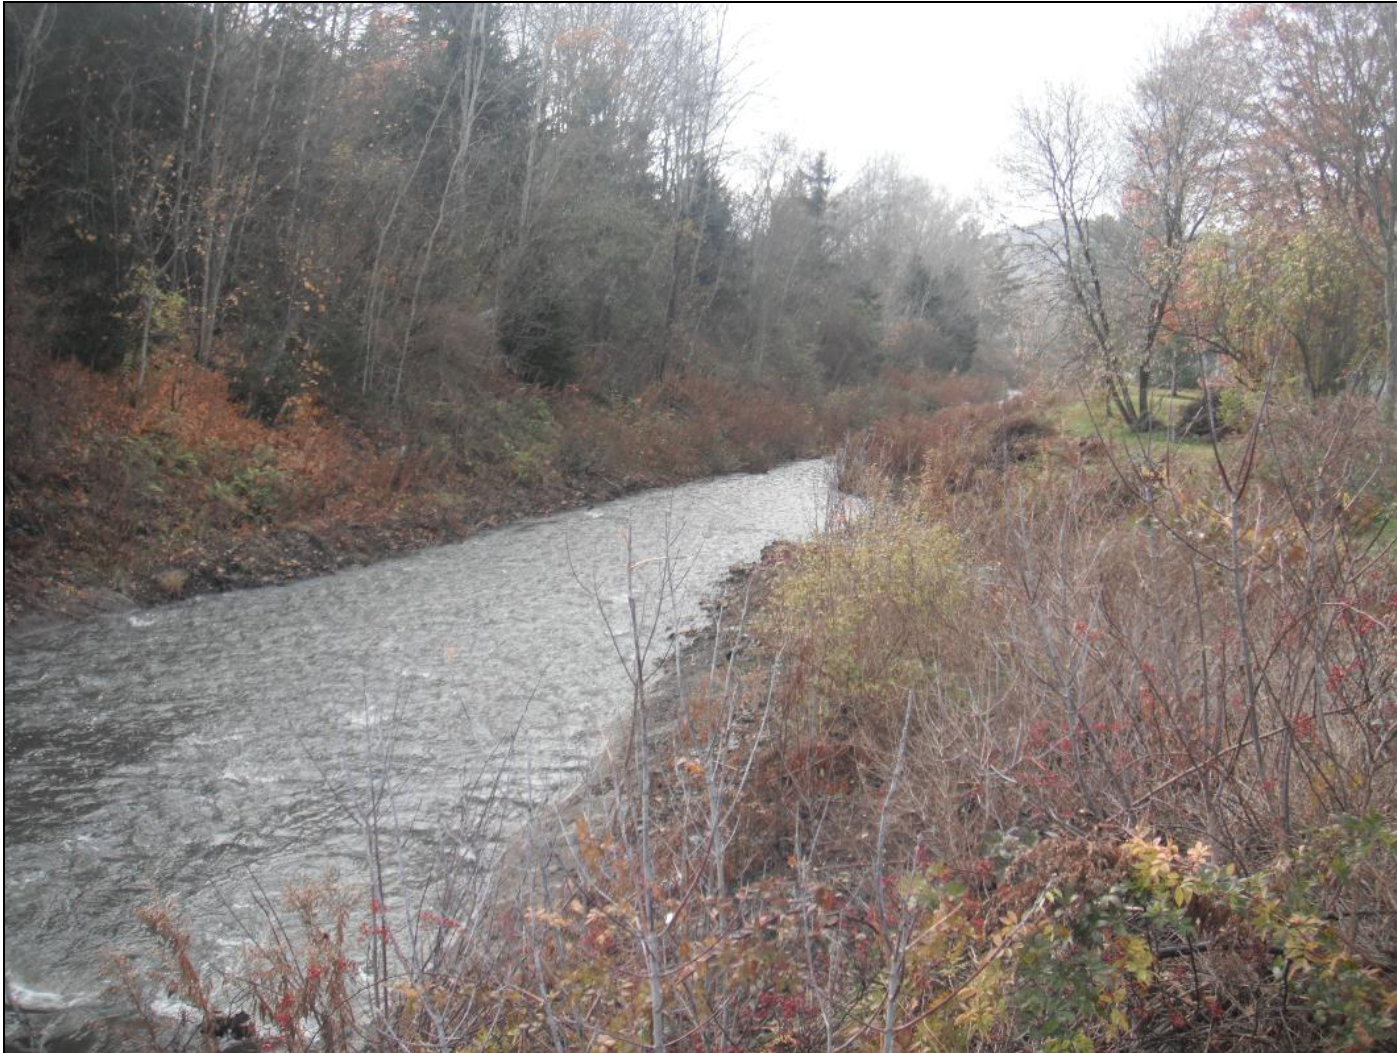
Inspect ID: BOLI_2013_a_0002 **Title:** USACE_CELRP_BOLI_2013_a_0002_1.jpg **Rated Item:** 1. Vegetation and Obstructions **Caption:** Rating: Minimally Acceptable;
Remarks: minimal need clearing of upper banks; Action: NA; Station_1: NA

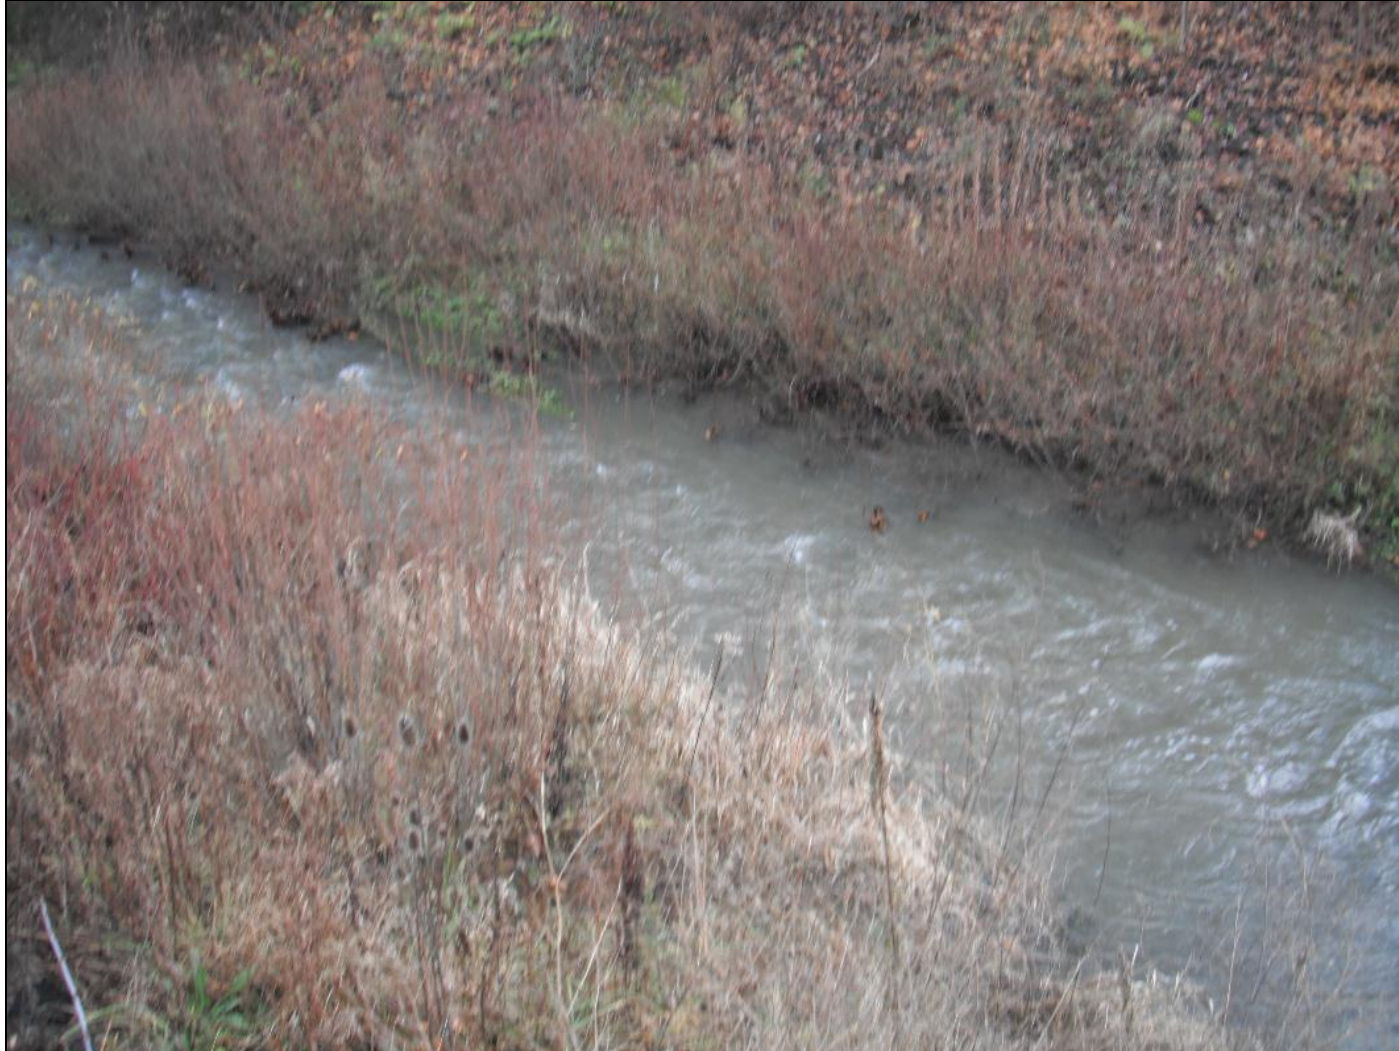
Inspect ID: BOLI_2013_a_0003 **Title:** USACE_CELRP_BOLI_2013_a_0003_1.jpg **Rated Item:** 1. Vegetation and Obstructions **Caption:** Rating: Minimally Acceptable;
Remarks: near Davis St vegetation a long banks need clearing; Action: clear banks; Station_1: NA

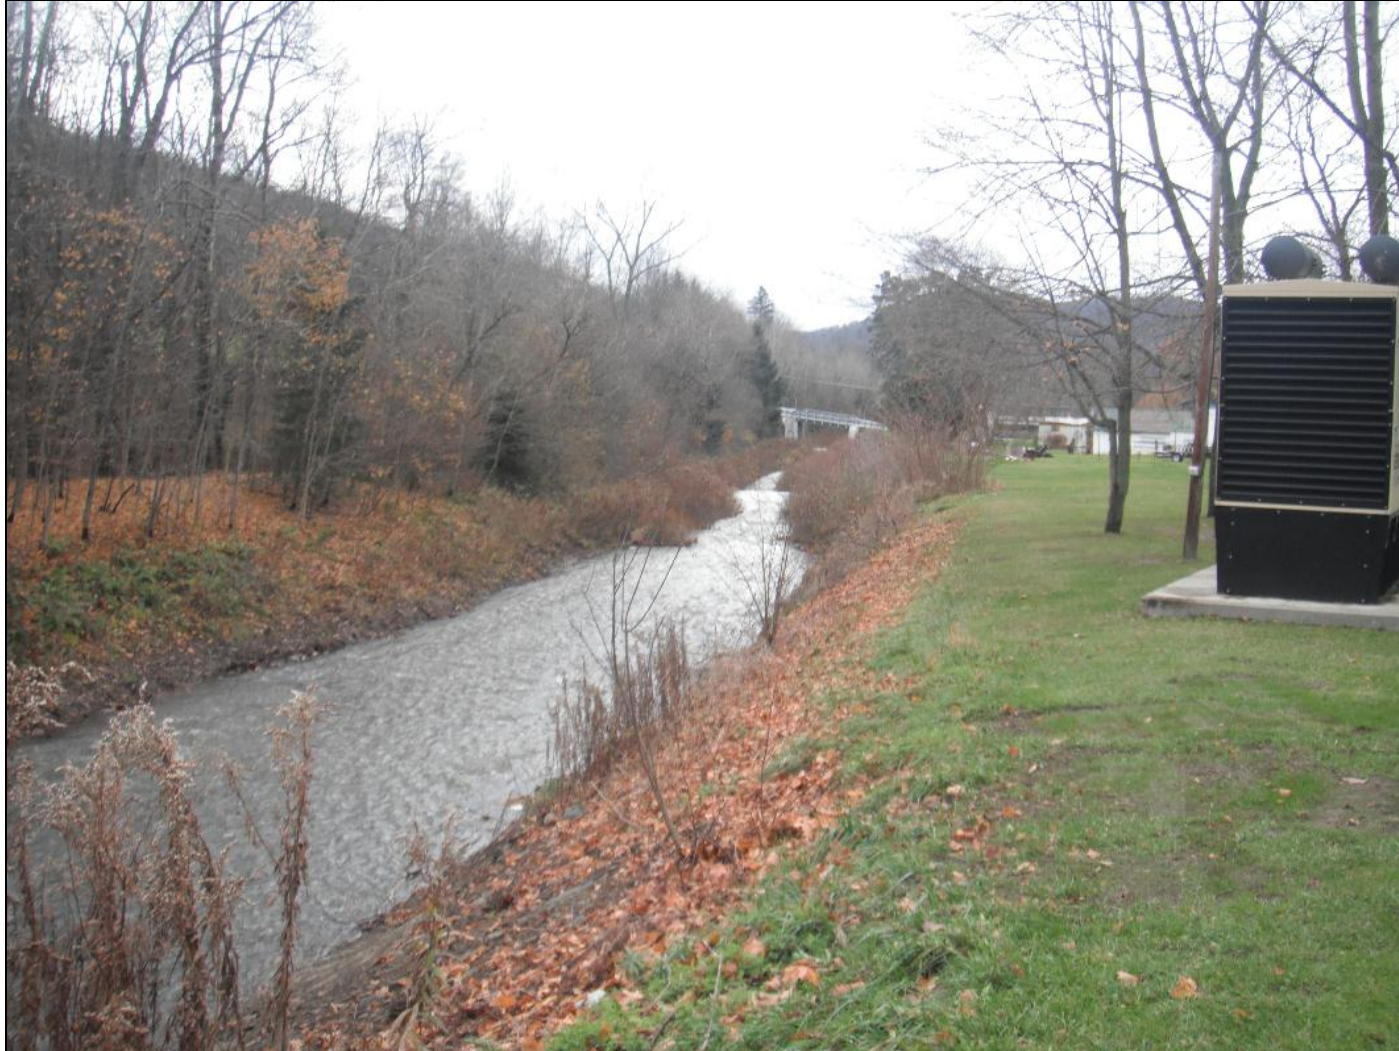
Inspect ID: BOLI_2013_a_0006 **Title:** USACE_CELRP_BOLI_2013_a_0006_1.jpg **Rated Item:** 1. Vegetation and Obstructions **Caption:** Rating: Minimally Acceptable; Remarks: NA; Action: needs maintained; Station_1: NA

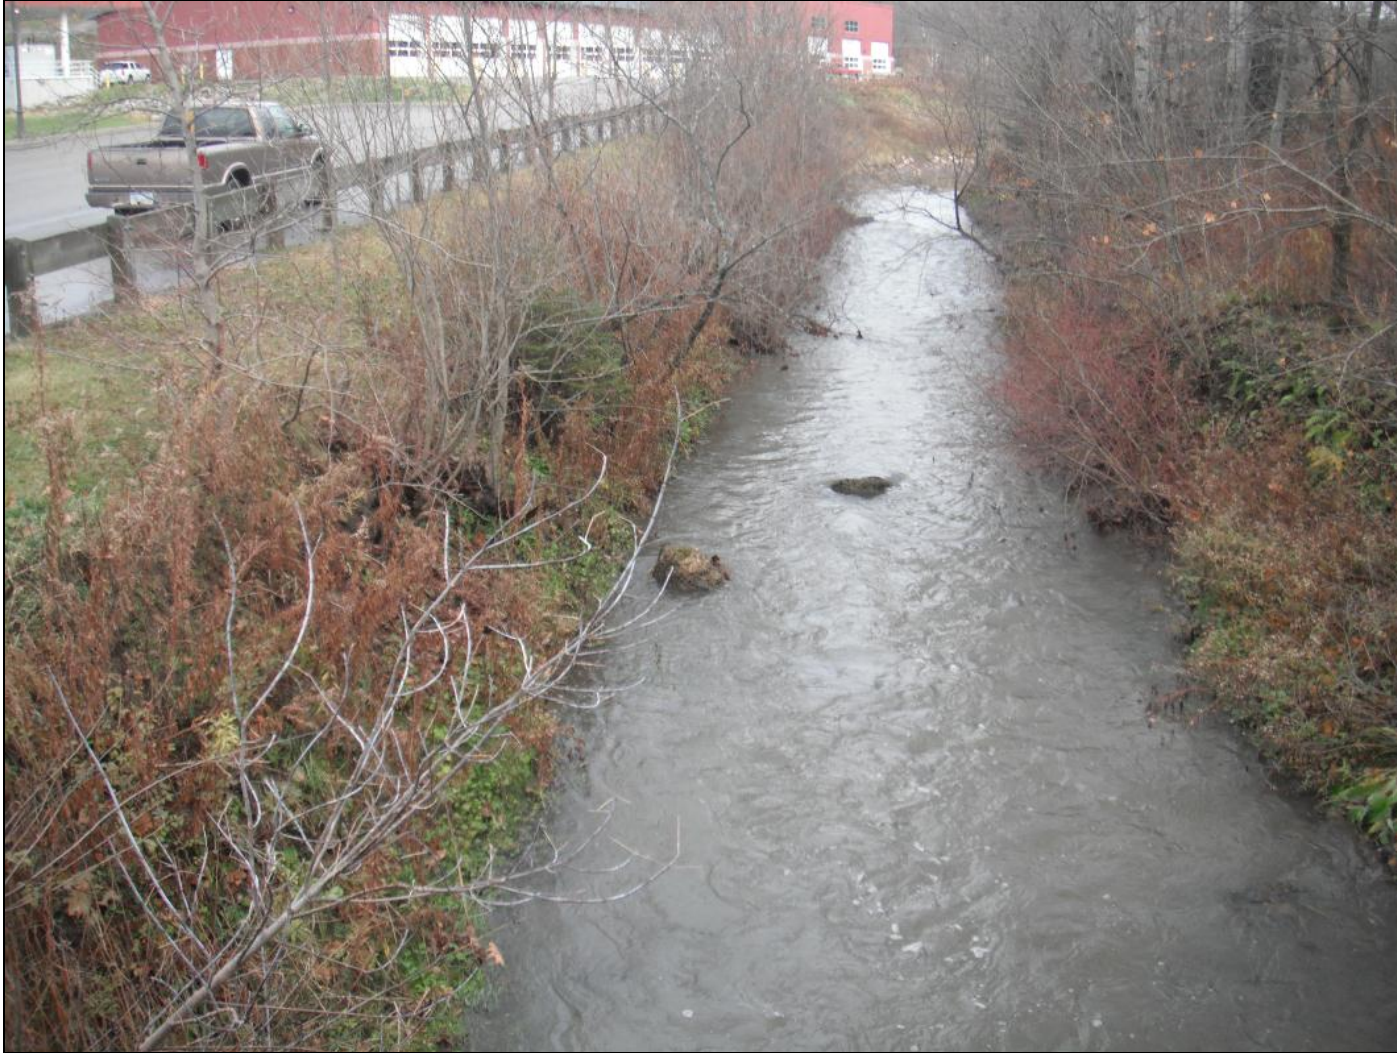
Inspect ID: BOLI_2013_a_0010 **Title:** USACE_CELRP_BOLI_2013_a_0010_1.jpg **Rated Item:** 1. Vegetation and Obstructions **Caption:** Rating: Minimally Acceptable;
Remarks: NA; **Action:** NA; **Station_1:** NA

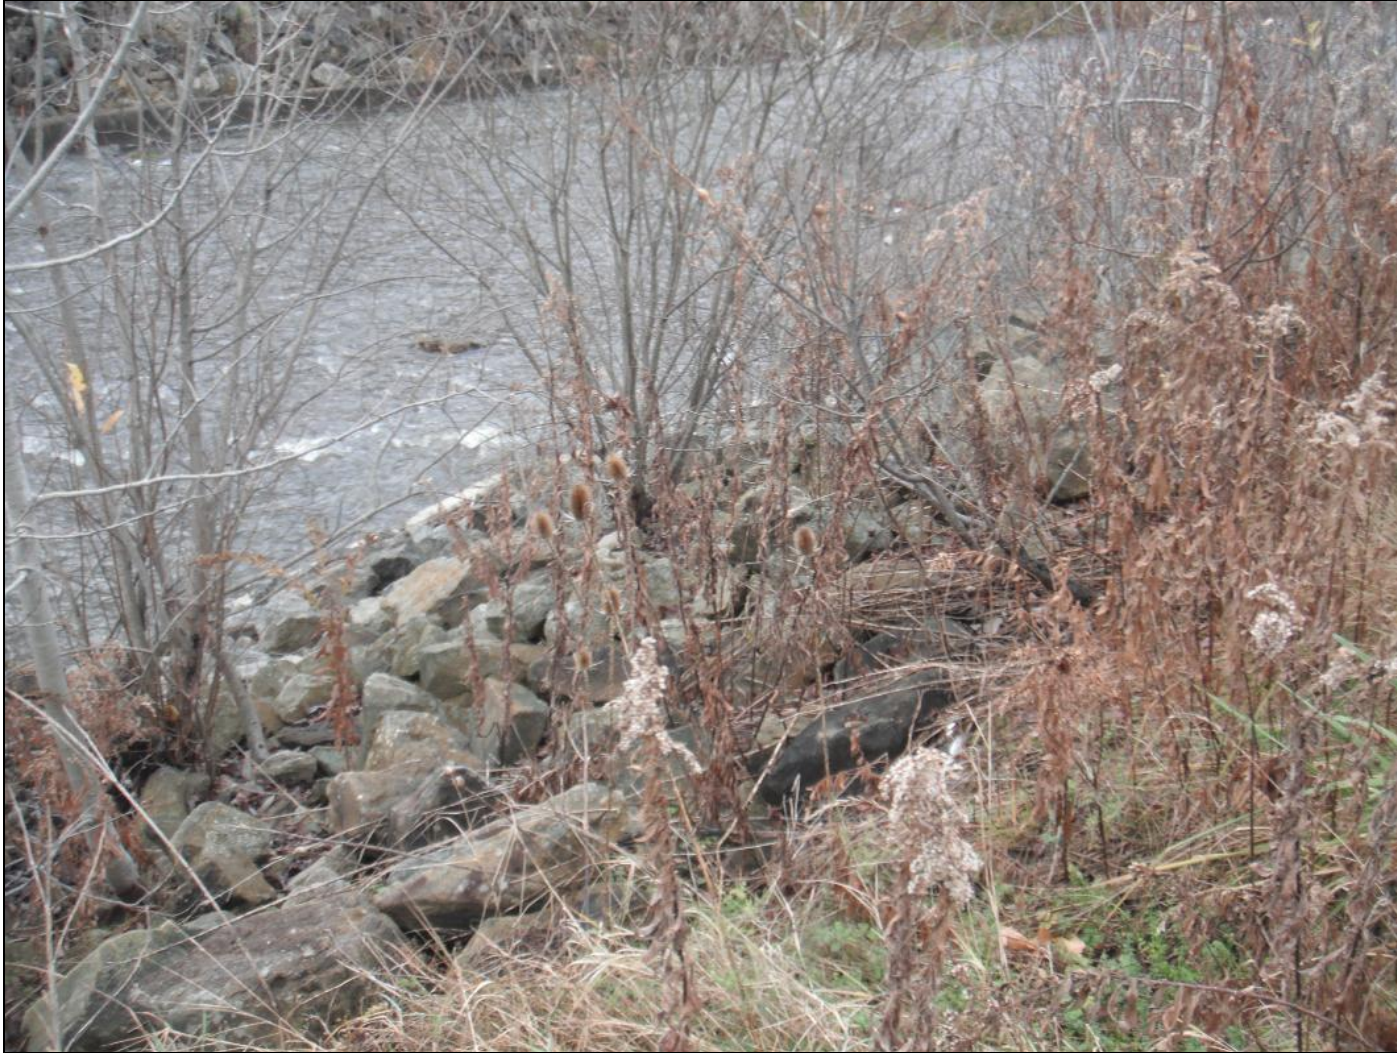
Inspect ID: BOLI_2013_a_0012 **Title:** USACE_CELRP_BOLI_2013_a_0012_1.jpg **Rated Item:** 1. Vegetation and Obstructions **Caption:** Rating: Minimally Acceptable;
Remarks: NA; **Action:** NA; **Station_1:** NA

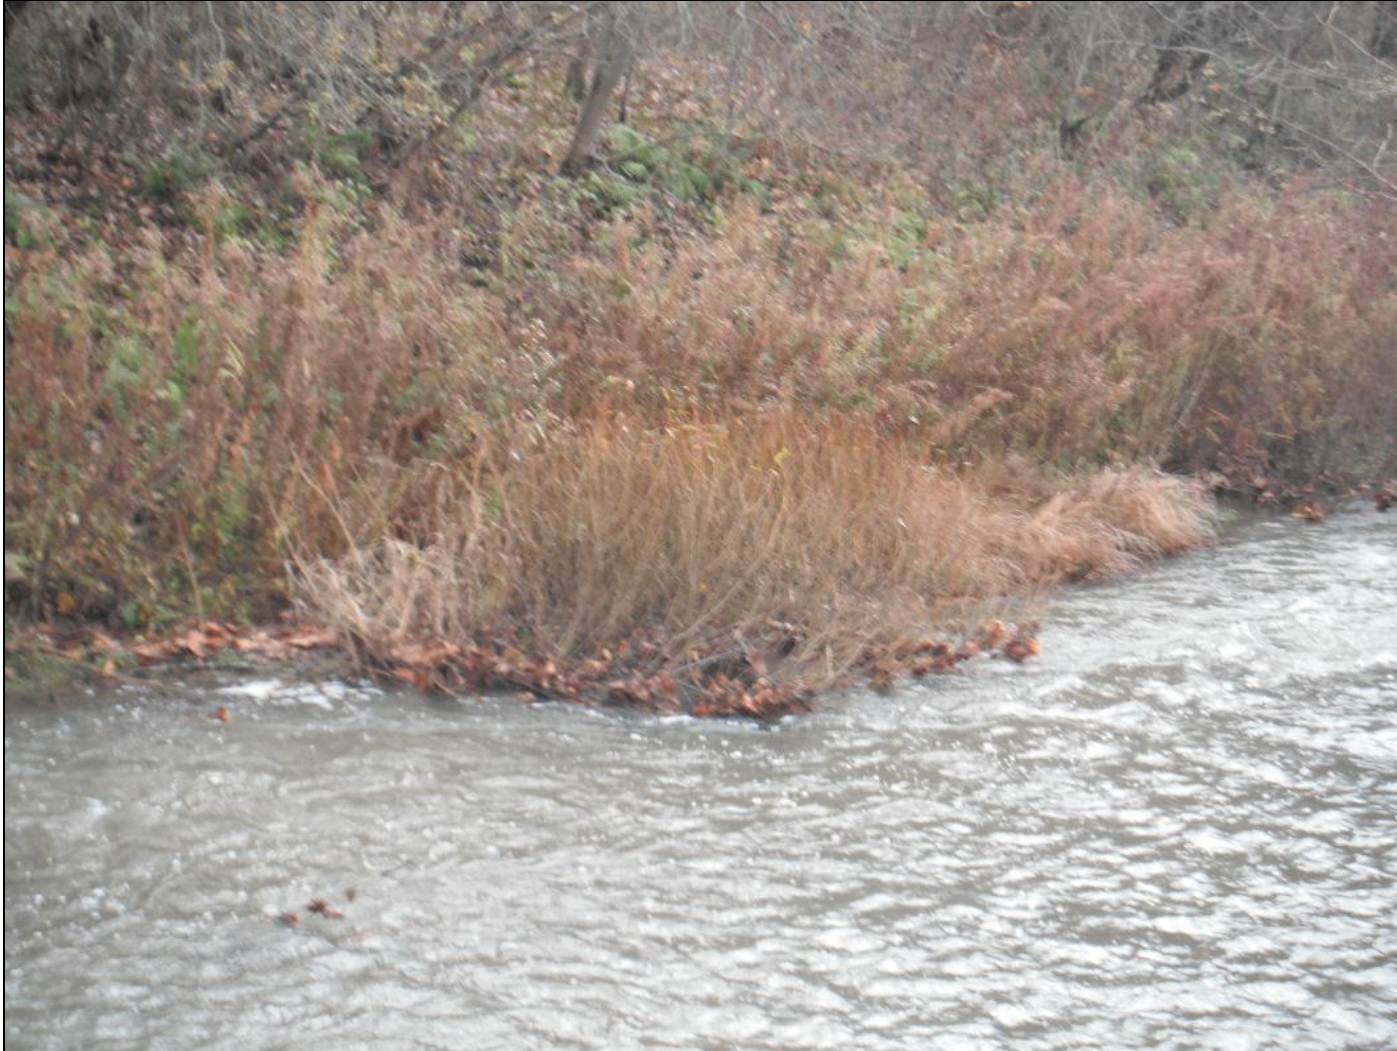
2. Shoaling ¹ (sediment deposition)	M	A	No shoaling or minor, non-vegetated shoaling is present.	BOLI_2013_a_0007: Station_1 NA: channel clearing needed: NA (M)
		M	More widespread vegetated and non-vegetated shoaling is present. Non-aquatic grasses are present on shoal. No trees or brush is present on shoal, and channel flow is not significantly reduced. Sediment and debris removal recommended.	
		U	Shoaling is well established, stabilized by saplings, brush, or other vegetation. Shoals are diverting flow to channel walls. Channel flow capacity is reduced and maintenance is required.

Inspect ID: BOLI_2013_a_0007 **Title:** USACE_CELRP_BOLI_2013_a_0007_1.jpg **Rated Item:** 2. Shoaling (sediment deposition) **Caption:** Rating: Minimally Acceptable;
Remarks: channel clearing needed; **Action:** NA; **Station_1:** NA

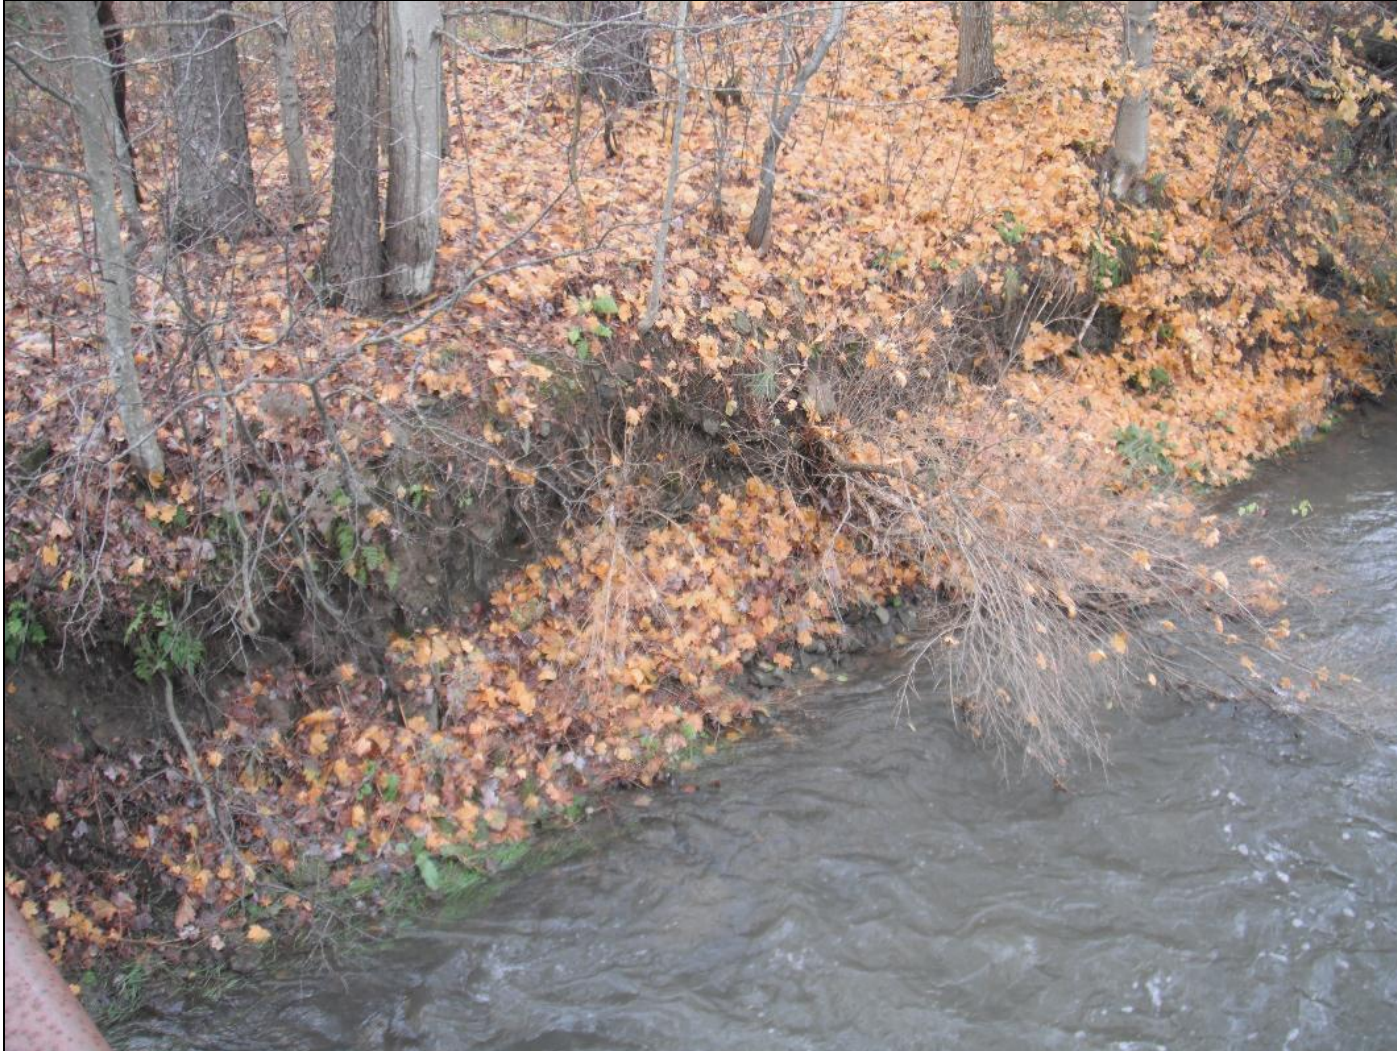
Inspect ID: BOLI_2013_a_0009 **Title:** USACE_CELRP_BOLI_2013_a_0009_1.jpg **Rated Item:** 4. Erosion **Caption:** Rating: Minimally Acceptable; Remarks: NA; Action: NA; Station_1: NA

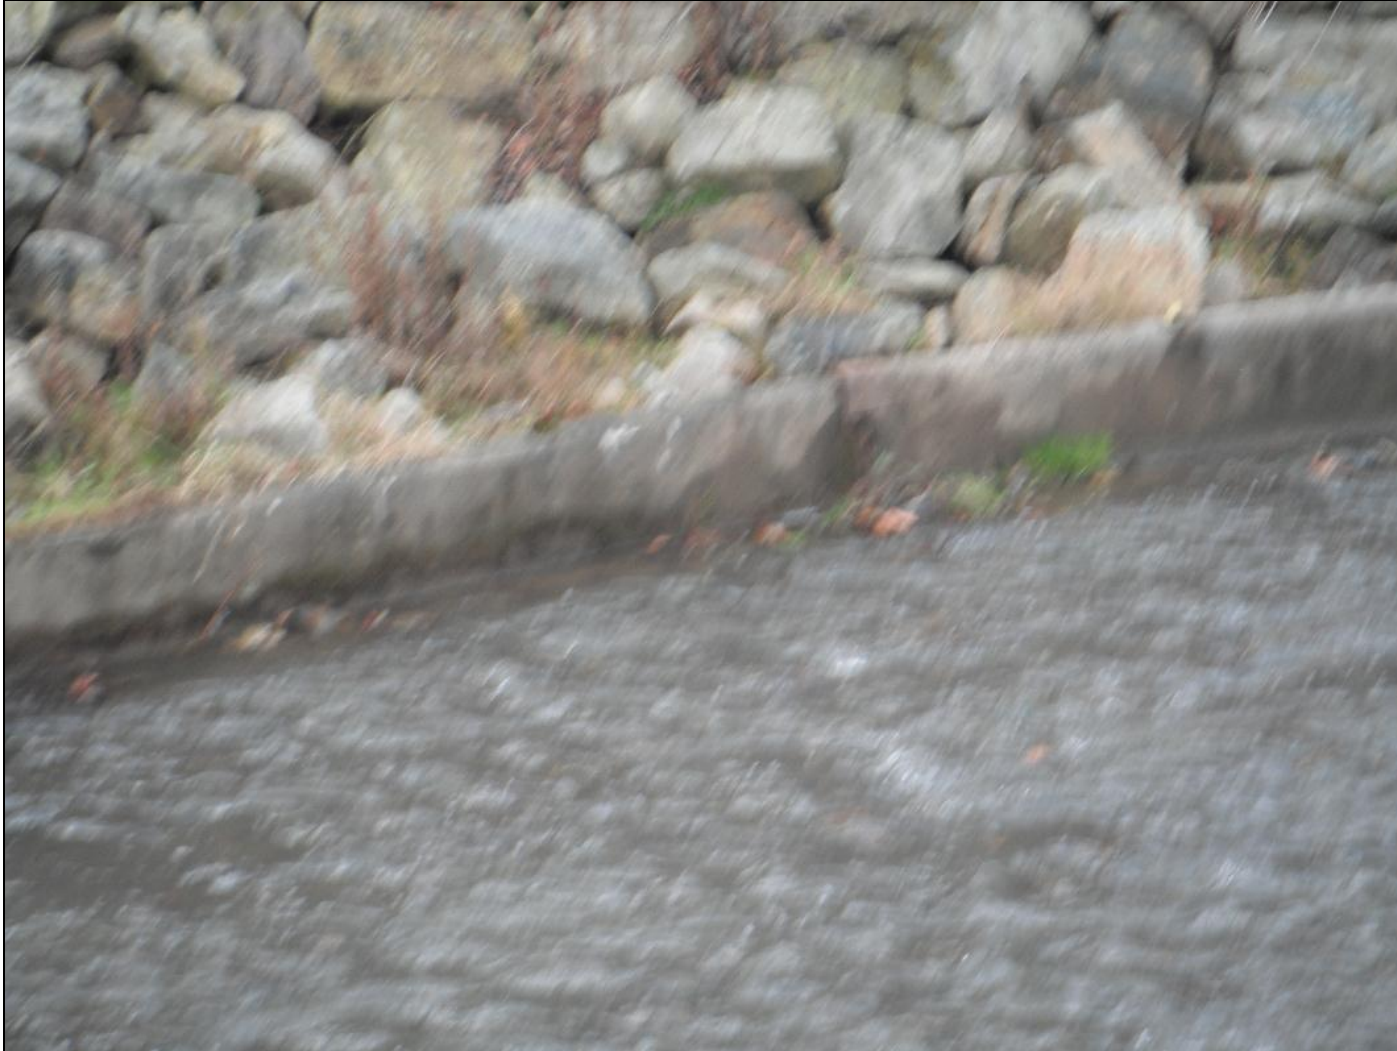
Inspect ID: BOLI_2013_a_0013 **Title:** USACE_CELRP_BOLI_2013_a_0013_1.jpg **Rated Item:** 5. Concrete Surfaces **Caption:** Rating: Acceptable; Remarks: minor; Action: NA; Station_1: NA

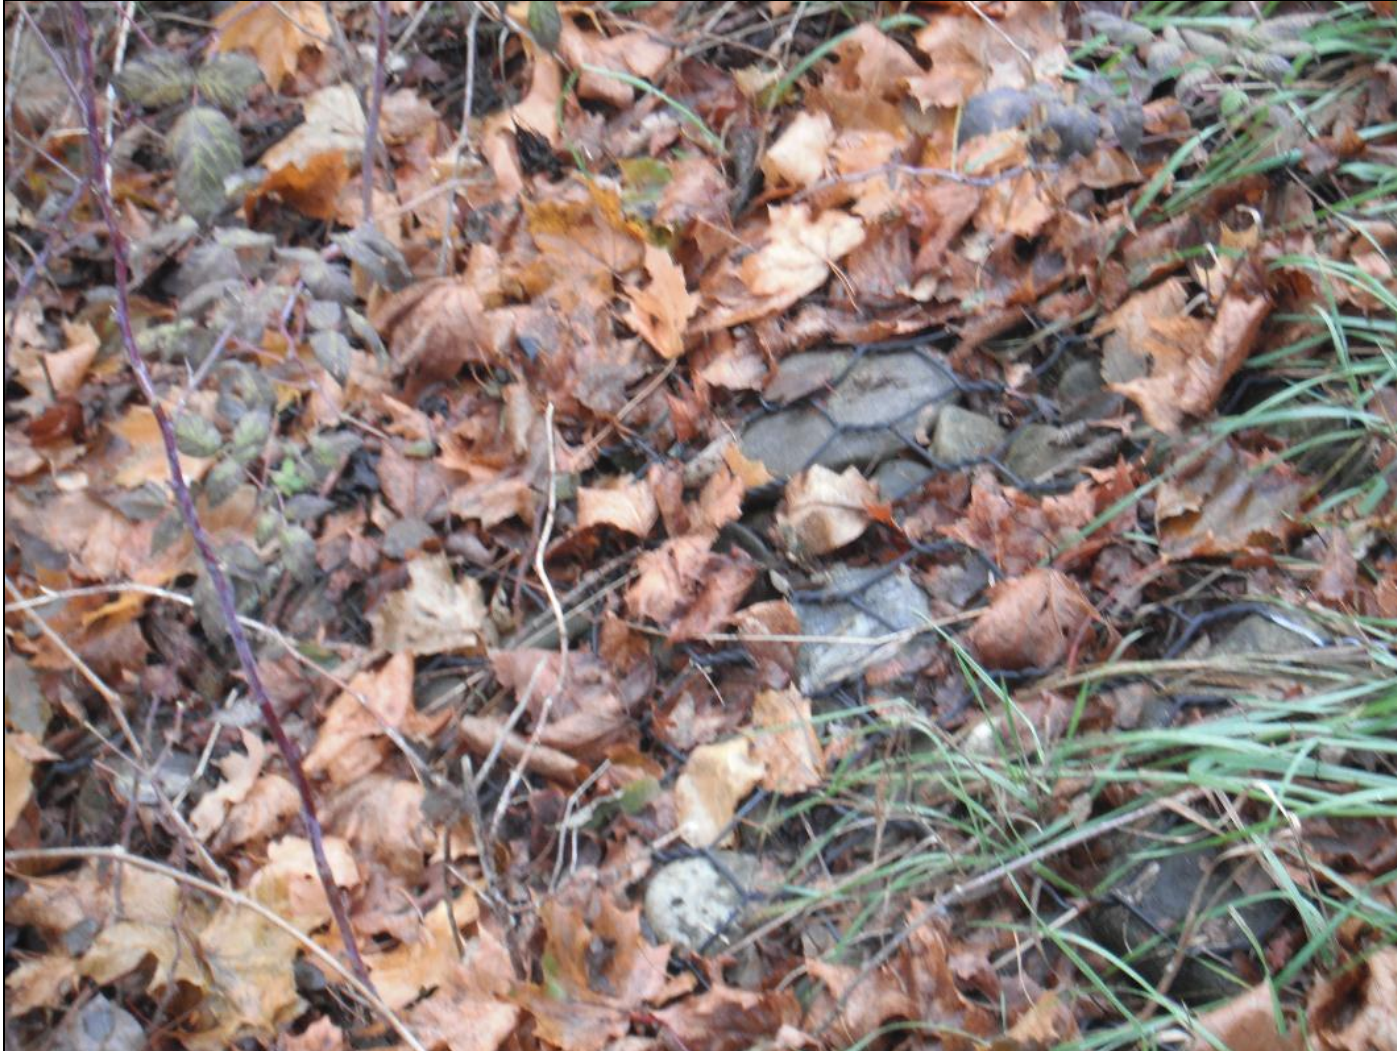
Inspect ID: BOLI_2013_a_0018 **Title:** USACE_CELRP_BOLI_2013_a_0018_1.jpg **Rated Item:** 10. Riprap Revetments & Banks **Caption:** Rating: Minimally Acceptable;
Remarks: damage to gabions for construction; **Action:** NA; **Station_1:** NA

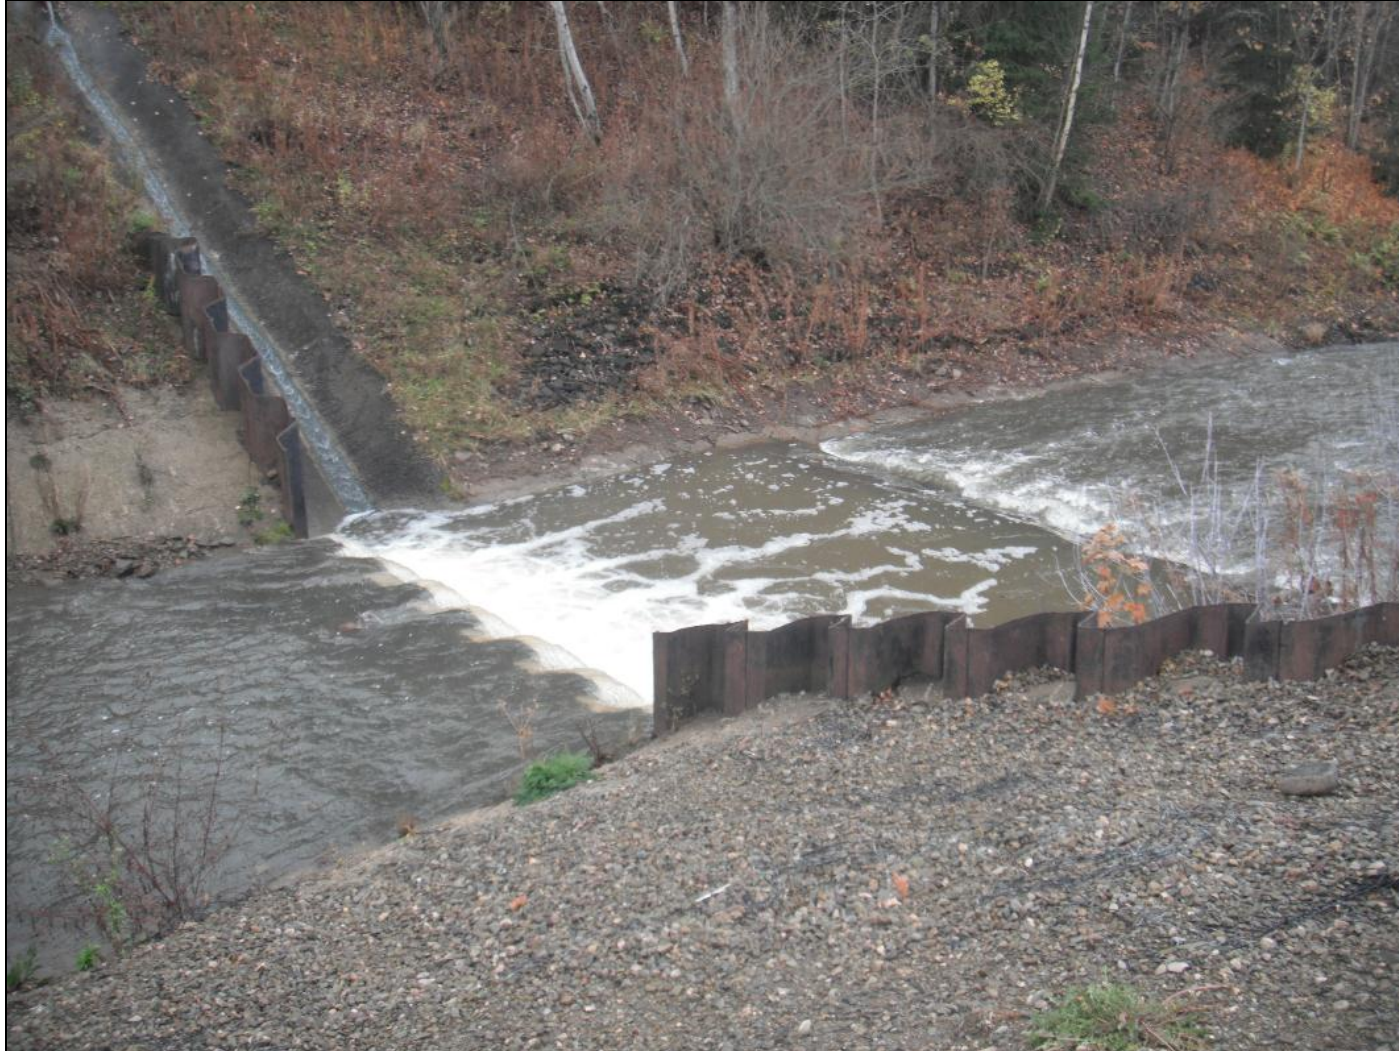
Inspect ID: BOLI_2013_a_0001 **Title:** USACE_CELRP_BOLI_2013_a_0001_1.jpg **Rated Item:** 11. Revetments other than Riprap **Caption:** Rating: Acceptable; Remarks: drop structure; Action: NA; Station_1: NA

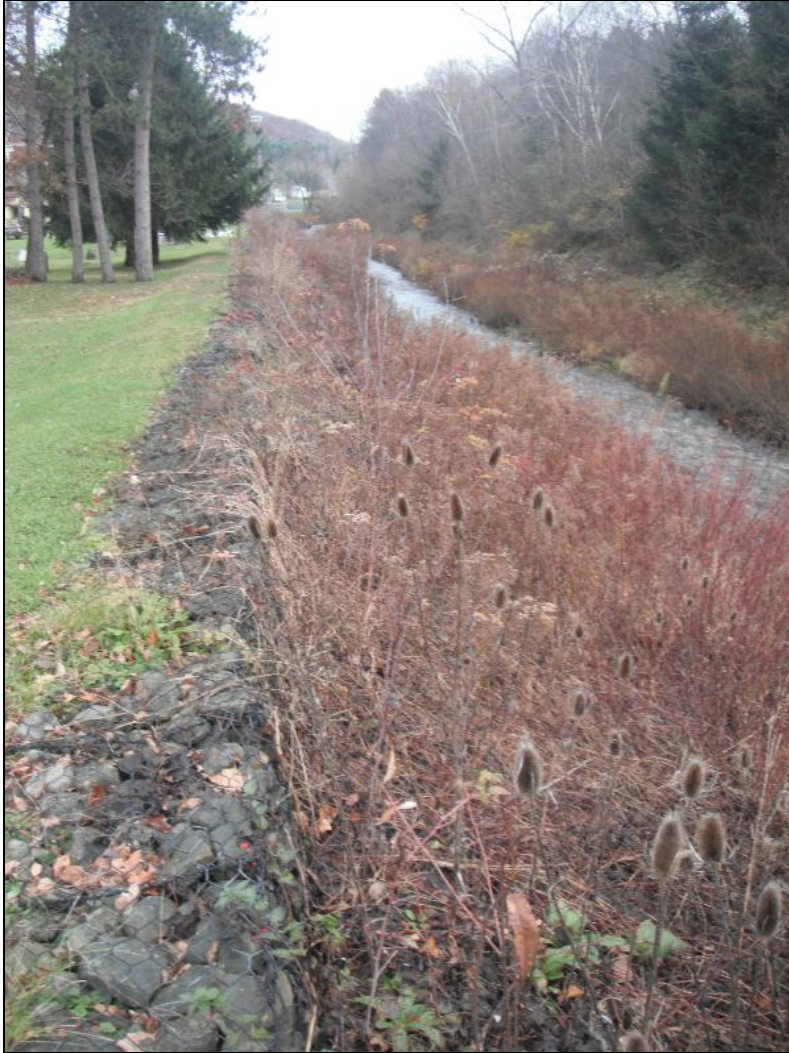
Inspect ID: BOLI_2013_a_0004 **Title:** USACE_CELRP_BOLI_2013_a_0004_1.jpg **Rated Item:** 11. Revetments other than Riprap **Caption:** Rating: Minimally Acceptable;
Remarks: gabion wall some displacement; **Action:** NA; **Station_1:** NA

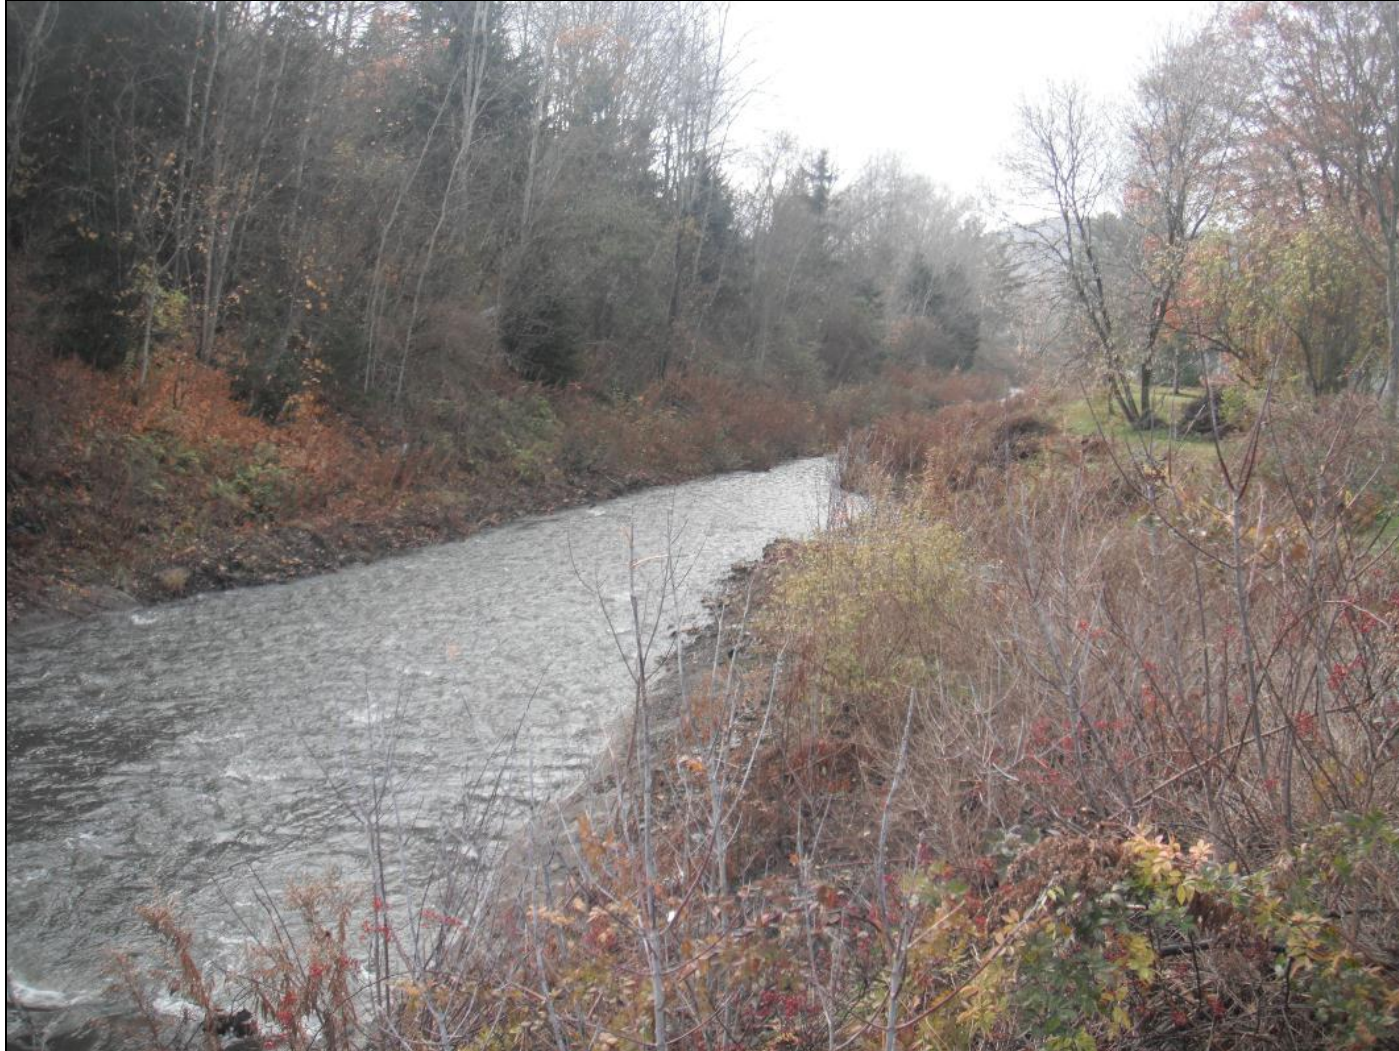
Inspect ID: BOLI_2013_a_0005 **Title:** USACE_CELRP_BOLI_2013_a_0005_1.jpg **Rated Item:** 11. Revetments other than Riprap **Caption:** Rating: Acceptable; Remarks: drop structure; Action: NA; Station_1: NA

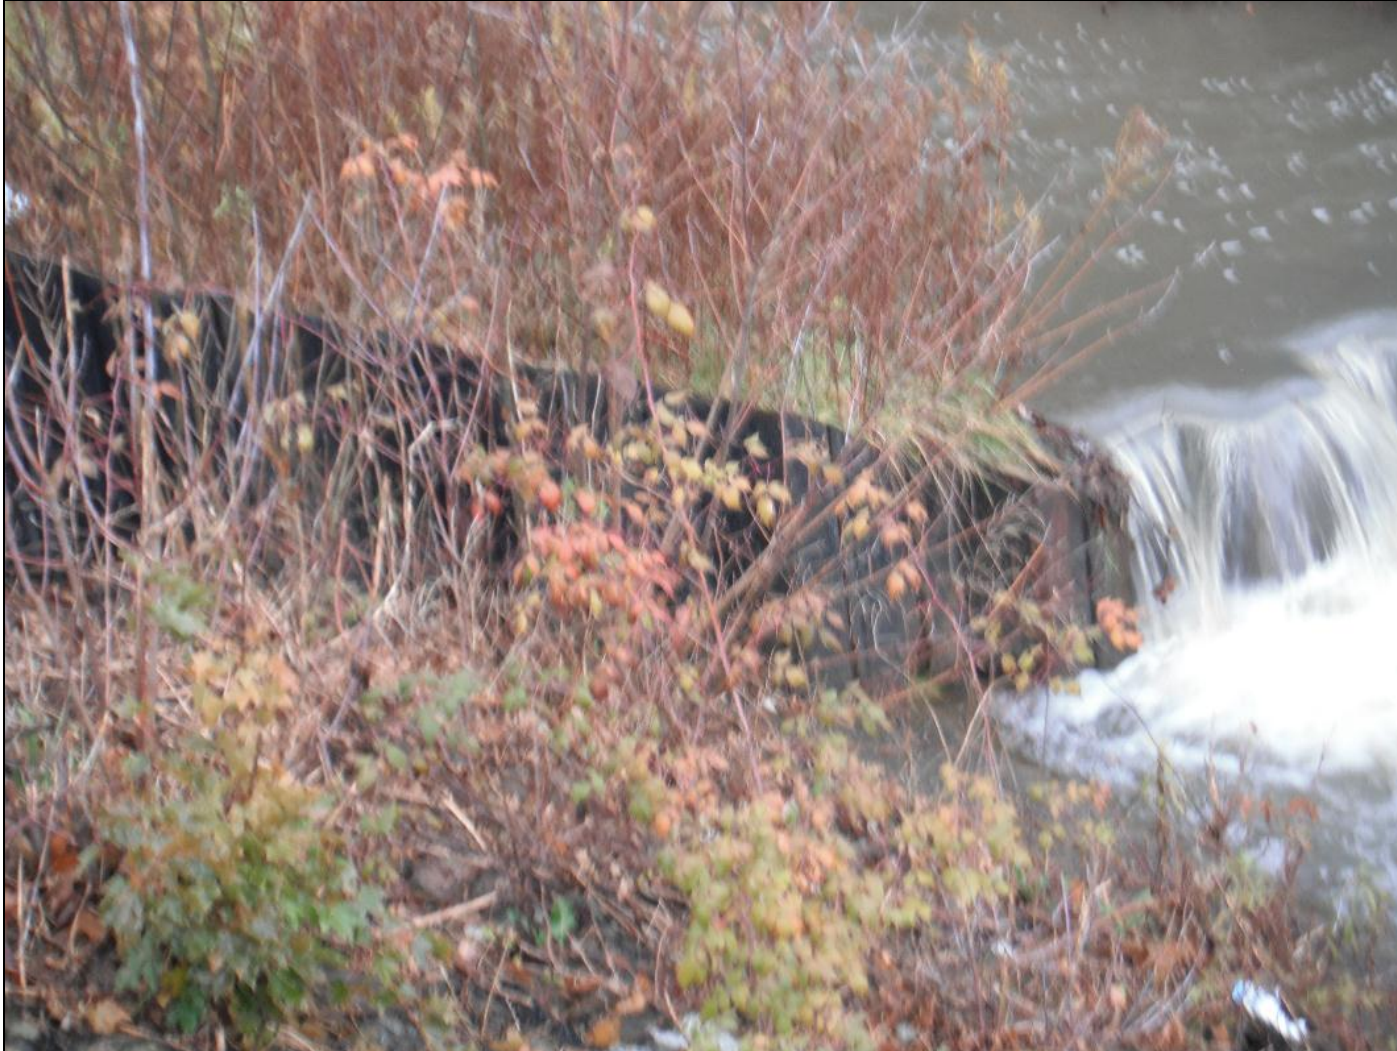
Inspect ID: BOLI_2013_a_0017 **Title:** USACE_CELRP_BOLI_2013_a_0017_1.jpg **Rated Item:** 11. Revetments other than Riprap **Caption:** Rating: Acceptable; Remarks: drop structure some rust; Action: NA; Station_1: NA
