Flood Damage Reduction Segment / System Inspection Report

Name of Segment / System: Bolivar, NY - Root Creek

Corps of Engineers Inspector: Dave Andreko Inspection Start Date: 11/7/2013

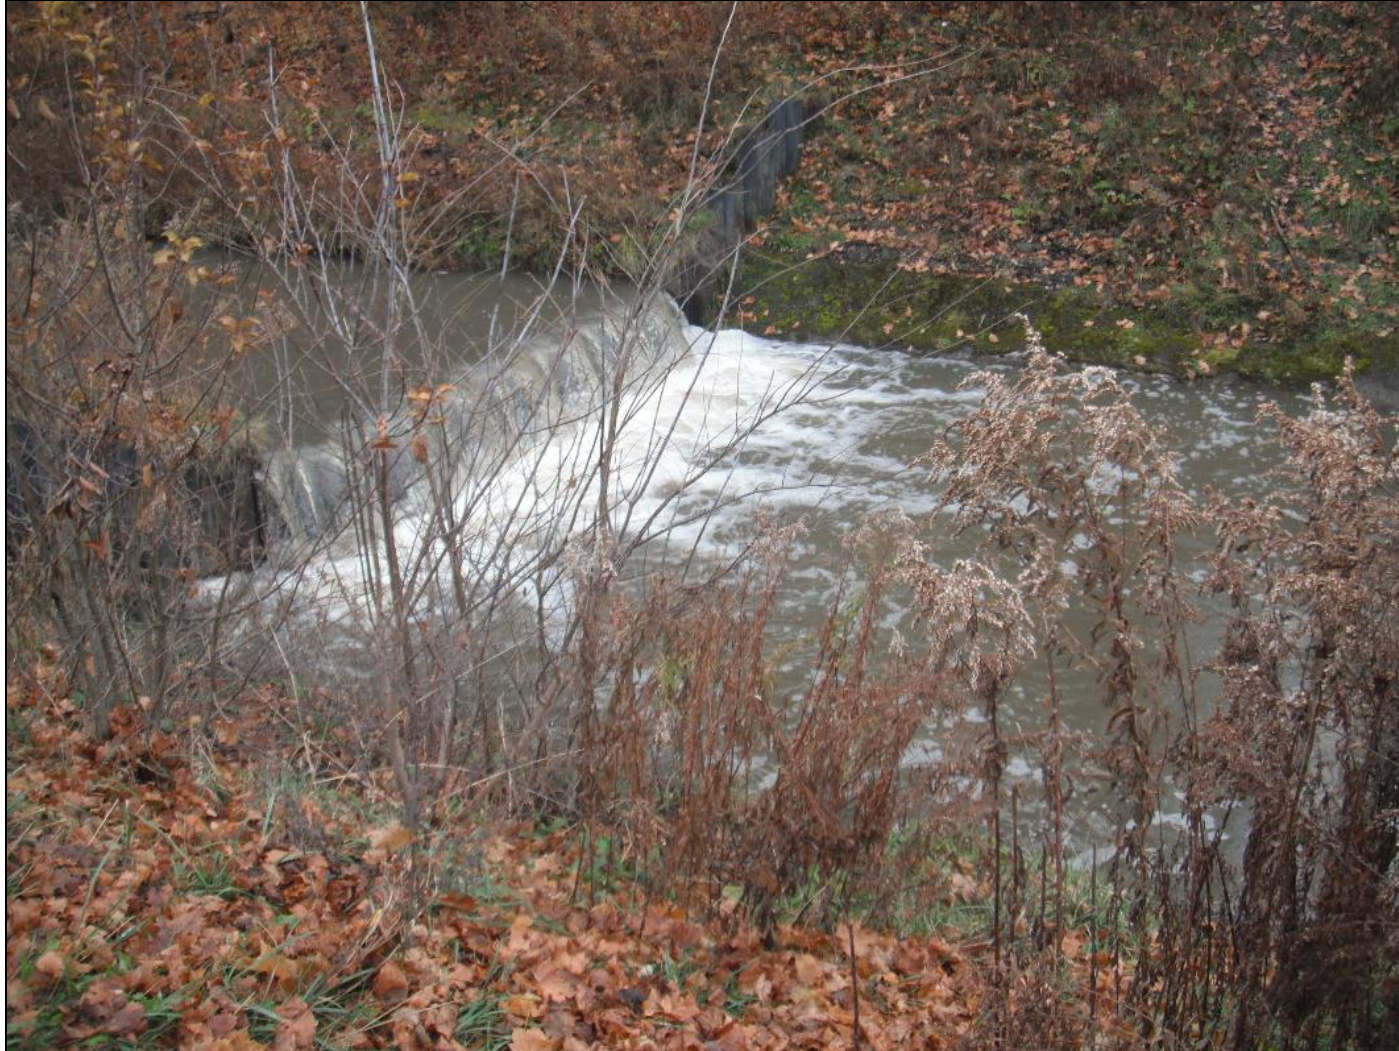
Inspect ID: BOLI_2013_a_0021 **Title:** USACE_CELRP_BOLI_2013_a_0021_1.jpg **Rated Item:** 11. Revetments other than Riprap **Caption:** Rating: Acceptable; Remarks: drop structure well maintained work completed this year; Action: NA; Station_1: NA
