**US Army Corps  
of Engineers  
Pittsburgh District**

# **Bolivar - Right Bank Root Creek**

**Bolivar, New York**

## **Periodic Inspection Report No. 1**

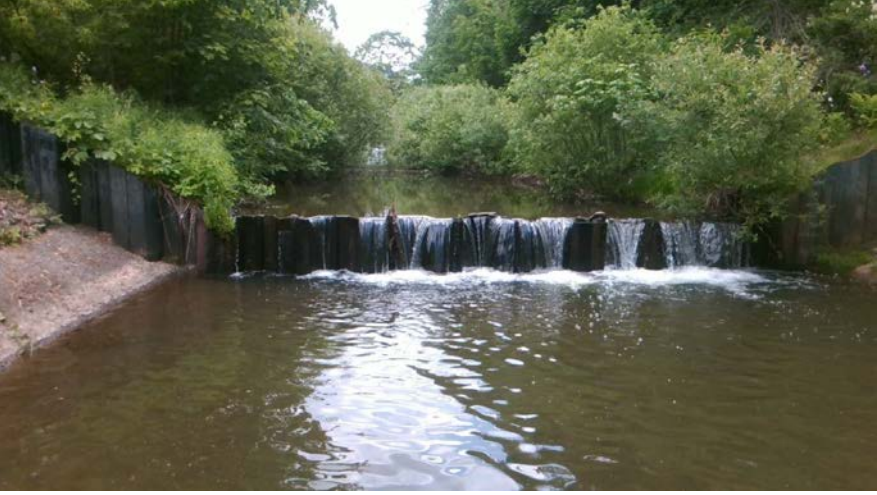
<p><b>Inspect ID:</b> BOLI_2017_p_0021 <b>Title:</b> USACE_CELRP_BOLI_2017_p_0021_1.jpg <b>Rated Item:</b> 7. Foundation of Concrete Structures <b>Caption:</b> Rating: Acceptable; <b>Remarks:</b> Drop structure at 45+25.; Action: NA</p>

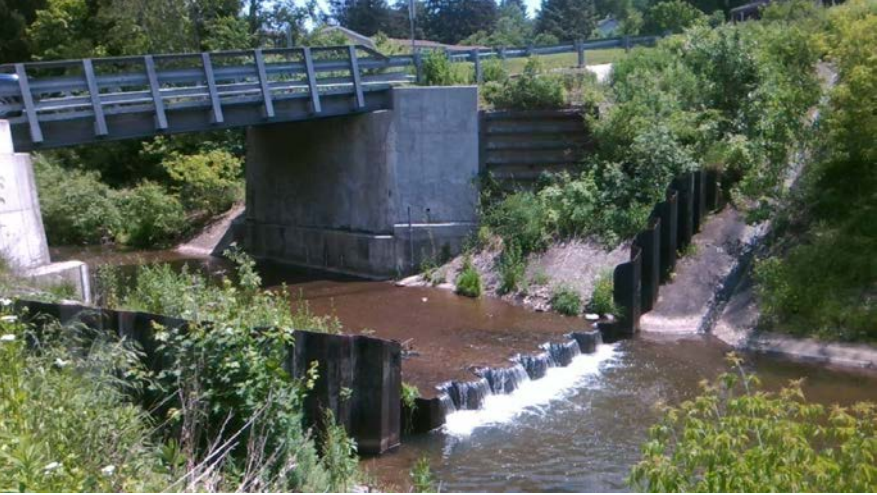
<p><b>Inspect ID:</b> BOLI_2017_p_0034 <b>Title:</b> USACE_CELRP_BOLI_2017_p_0034_1.jpg <b>Rated Item:</b> 7. Foundation of Concrete Structures <b>Caption:</b> Rating: Acceptable; <b>Remarks:</b> Drop Structure at 40+25 (Typ.); Action: NA</p>

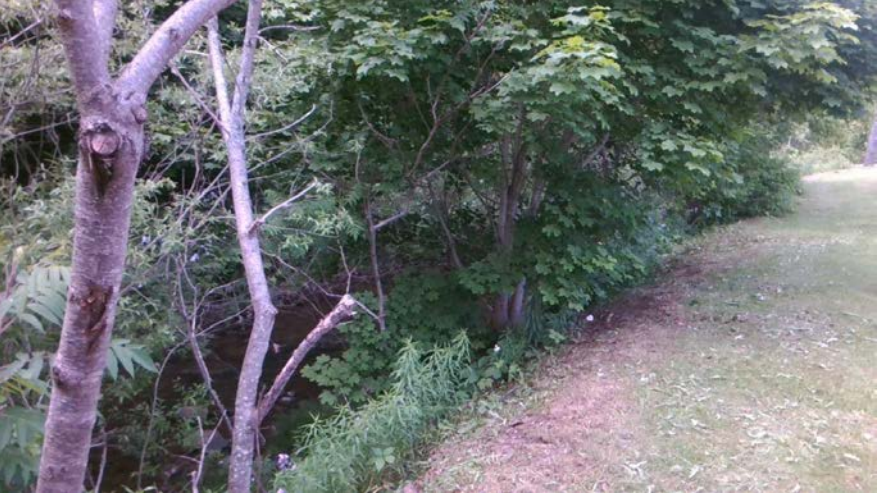
<p><b>Inspect ID:</b> BOLI_2017_p_0011 <b>Title:</b> USACE_CELRP_BOLI_2017_p_0011_1.jpg <b>Rated Item:</b> 11. Revetments other than Riprap <b>Caption:</b> Rating: Minimally Acceptable; <b>Remarks:</b> Unwanted heavy large woody vegetation in gabion channel slope protection on the right bank.; <b>Action:</b> Remove unwanted vegetation.</p>

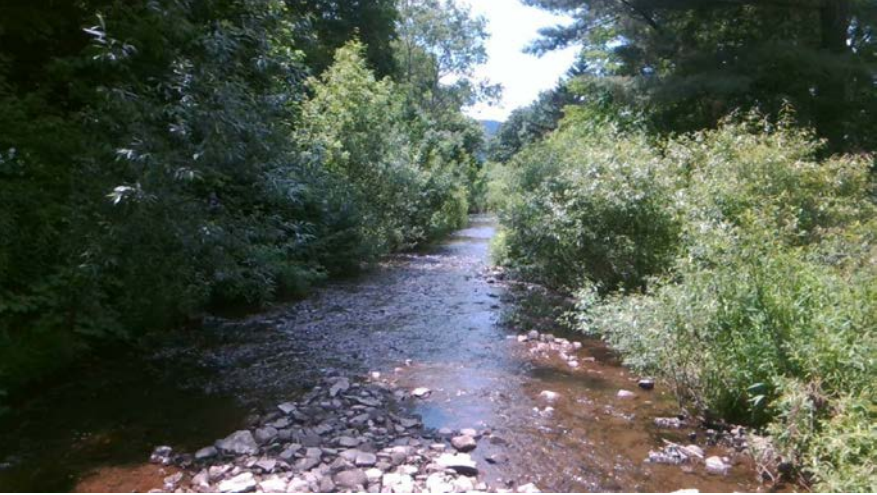
<p><b>Inspect ID:</b> BOLI_2017_p_0047 <b>Title:</b> USACE_CELRP_BOLI_2017_p_0047_1.jpg <b>Rated Item:</b> 11. Revetments other than Riprap <b>Caption:</b> Rating: Unacceptable; <b>Remarks:</b> Unwanted heavy woody vegetation in gabion channel slope protection on both banks.; <b>Action:</b> Remove unwanted vegetation.</p>
