# Flood Damage Reduction Segment / System Inspection Report

Name of Segment / System: Bolivar, NY

**Flood Damage Reduction Segment / System  
Inspection Report  
Bolivar, NY (BOLI)**

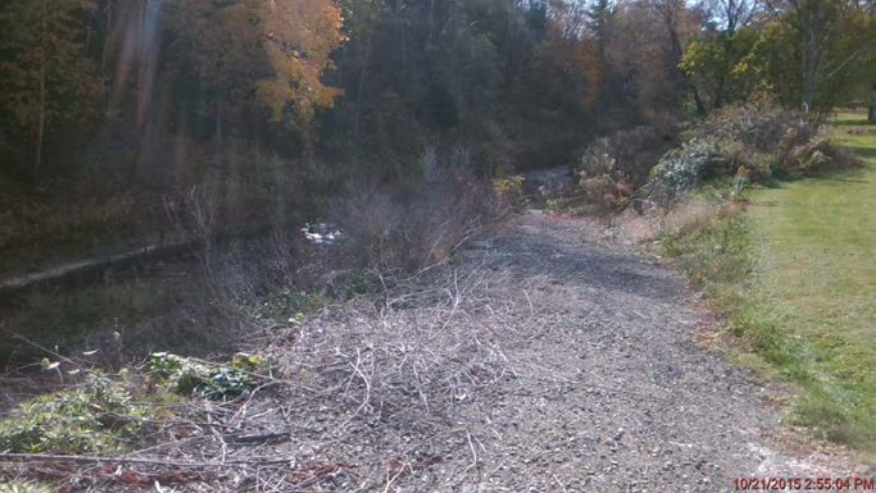
<p><b>Inspect ID:</b> BOLI_2015_a_0029 <b>Title:</b> USACE_CELRP_BOLI_2015_a_0029_1.jpg <b>Rated Item:</b> 1. Vegetation and Obstructions <b>Caption:</b> Rating: Acceptable</p>

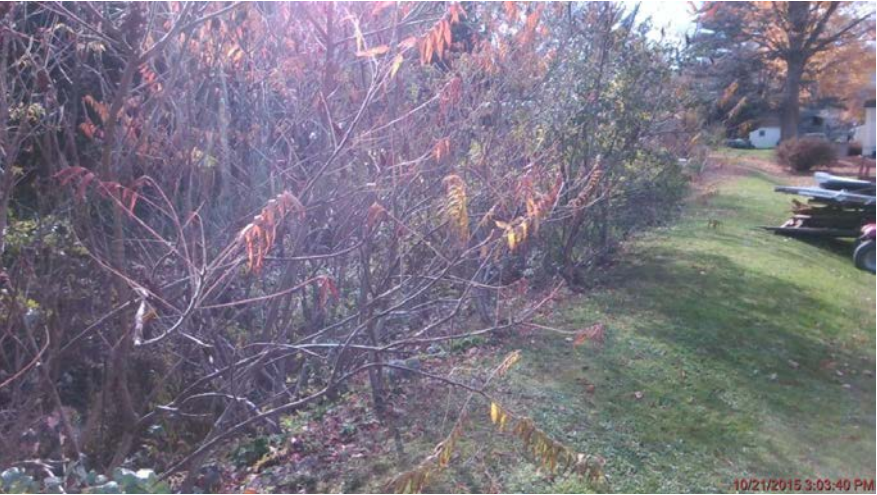
<p><b>Inspect ID:</b> BOLI_2015_a_0032 <b>Title:</b> USACE_CELRP_BOLI_2015_a_0032_1.jpg <b>Rated Item:</b> 1. Vegetation and Obstructions <b>Caption:</b> Rating: Minimally Acceptable</p>

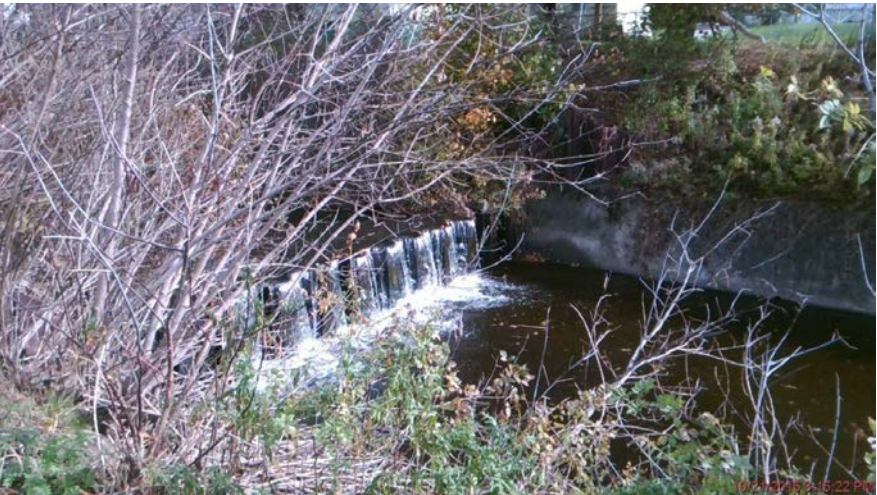
<p><b>Inspect ID:</b> BOLI_2015_a_0035 <b>Title:</b> USACE_CELRP_BOLI_2015_a_0035_1.jpg <b>Rated Item:</b> 1. Vegetation and Obstructions <b>Caption:</b> Rating: Acceptable</p>

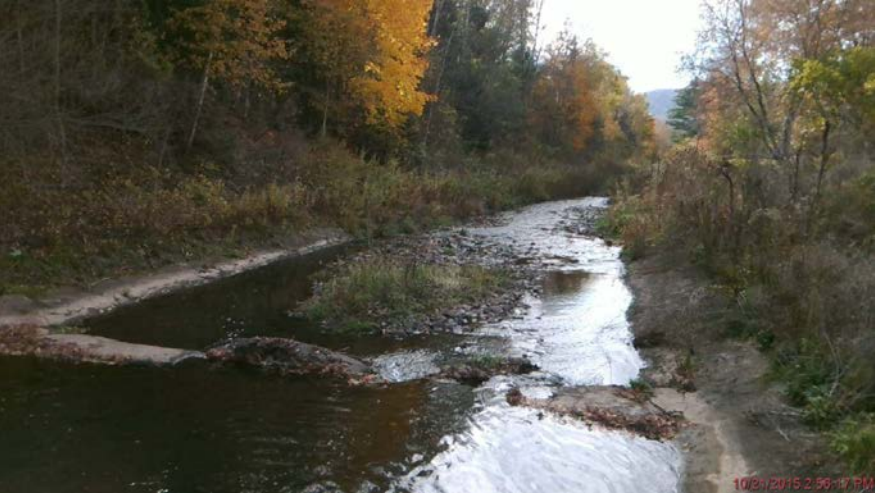
<p><b>Inspect ID:</b> BOLI_2015_a_0030 <b>Title:</b> USACE_CELRP_BOLI_2015_a_0030_1.jpg <b>Rated Item:</b> 2. Shoaling (sediment deposition) <b>Caption:</b> Rating: Minimally Acceptable</p>

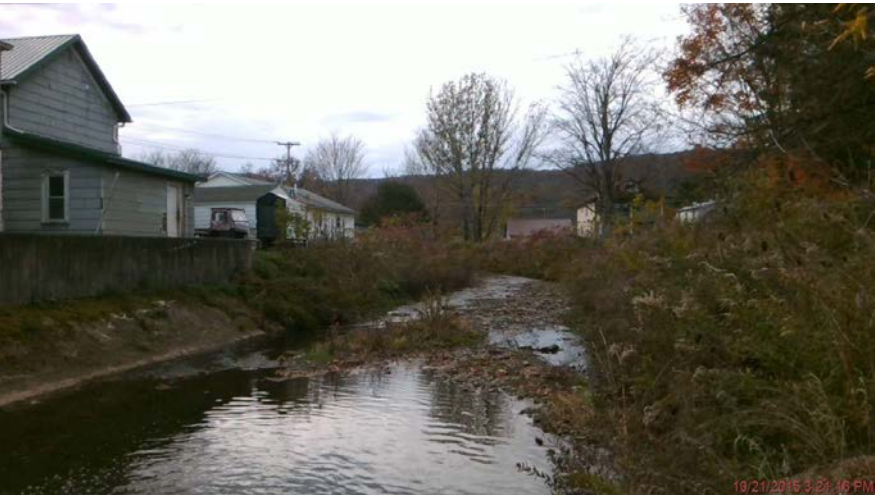
<p><b>Inspect ID:</b> BOLI_2015_a_0039 <b>Title:</b> USACE_CELRP_BOLI_2015_a_0039_1.jpg <b>Rated Item:</b> 2. Shoaling (sediment deposition) <b>Caption:</b> Rating: Unacceptable</p>

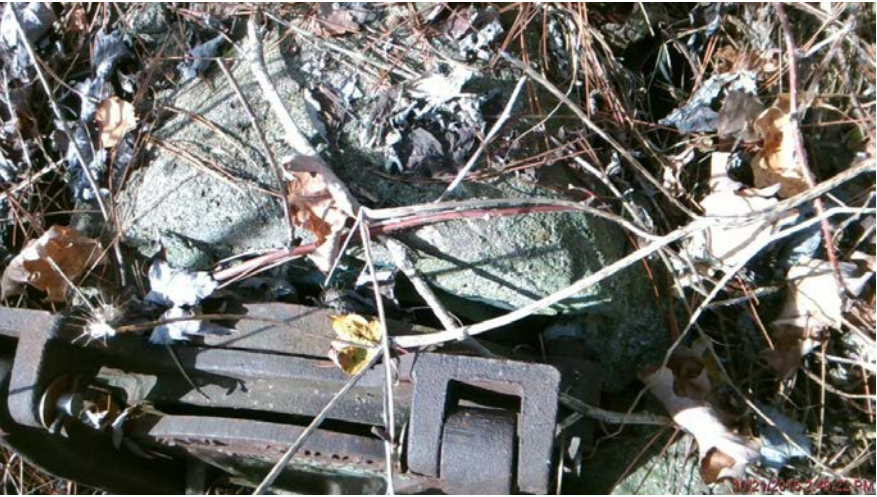
<b>Inspect ID:</b> BOLI_2015_a_0026 <b>Title:</b> USACE_CELRP_BOLI_2015_a_0026_2.jpg <b>Rated Item:</b> 9. Flap Gates/ Flap Valves/ Pinch Valves <b>Caption:</b> Rating: Unacceptable

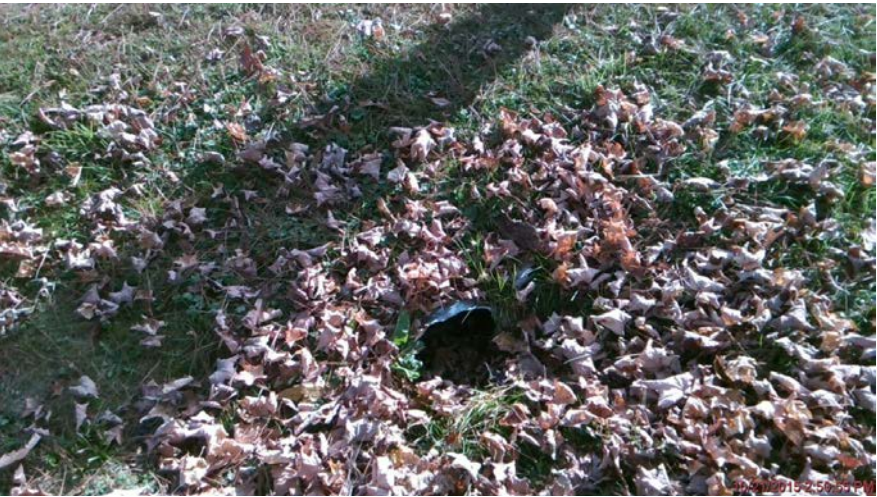
<b>Inspect ID:</b> BOLI_2015_a_0026 <b>Title:</b> USACE_CELRP_BOLI_2015_a_0026_3.jpg <b>Rated Item:</b> 9. Flap Gates/ Flap Valves/ Pinch Valves <b>Caption:</b> Rating: Unacceptable

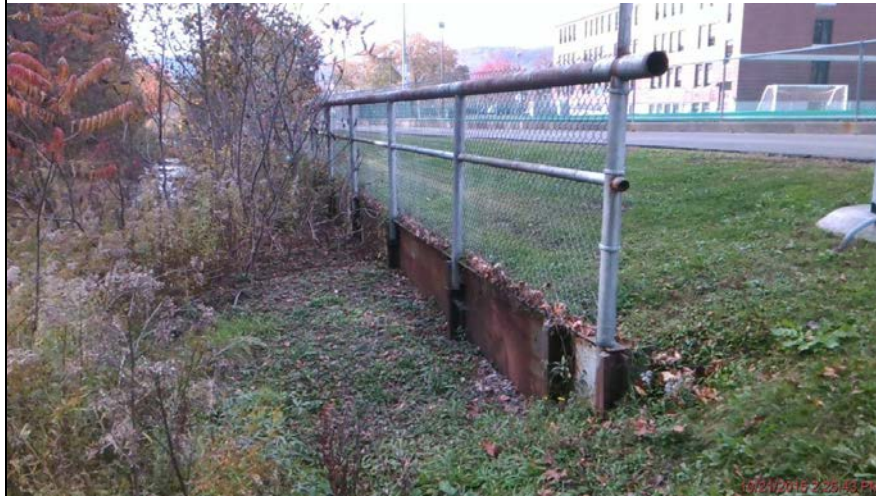
**Inspect ID:** BOLI\_2015\_a\_0015 **Title:** USACE\_CELRP\_BOLI\_2015\_a\_0015\_1.jpg  
**Rated Item:** 11. Revetments other than Riprap **Caption:** Rating: Acceptable

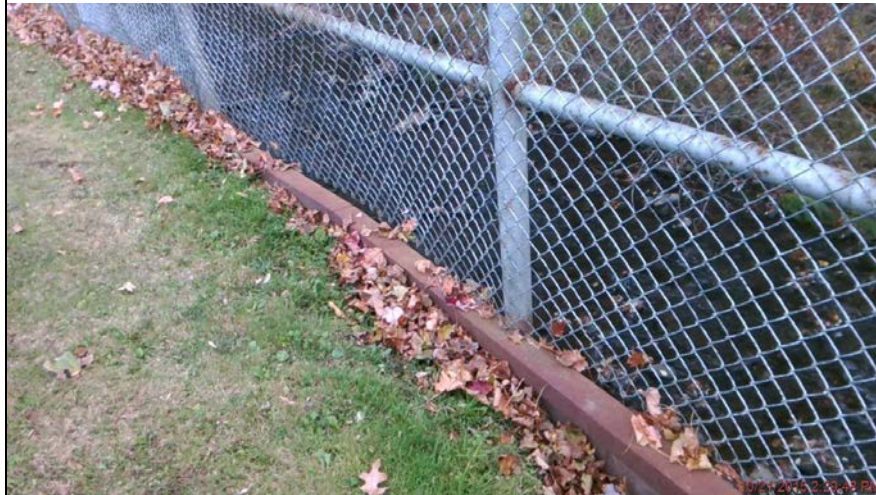
**Inspect ID:** BOLI\_2015\_a\_0019 **Title:** USACE\_CELRP\_BOLI\_2015\_a\_0019\_1.jpg  
**Rated Item:** 11. Revetments other than Riprap **Caption:** Rating: Acceptable
