## Flood Damage Reduction Segment / System Inspection Report

Name of Segment / System: Bolivar, NY

Inspection Start Date: 10/21/2015

**Flood Damage Reduction Segment / System  
Inspection Report  
Bolivar, NY (BOLI)**

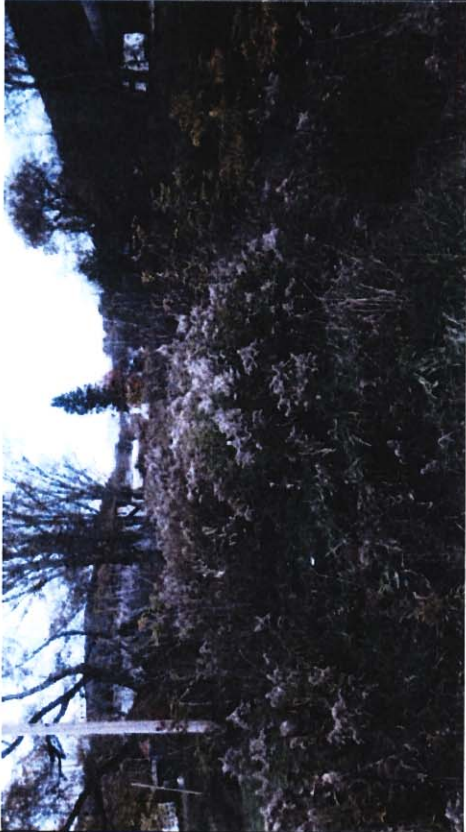
<p><b>Inspect ID:</b> BOLI_2015_a_0041 <b>Title:</b> USACE_CELRP_BOLI_2015_a_0041_3.jpg  <b>Rated Item:</b> 1. Unwanted Vegetation Growth <b>Caption:</b> Rating: Unacceptable</p>

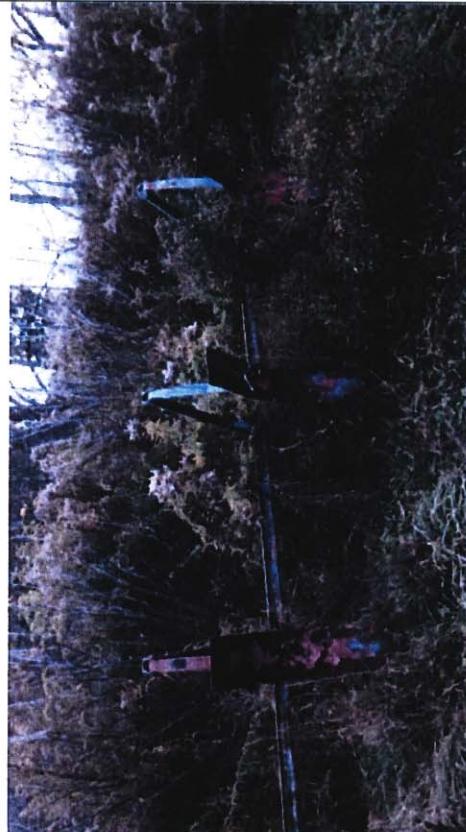
<p><b>Inspect ID:</b> BOLI_2015_a_0041 <b>Title:</b> USACE_CELRP_BOLI_2015_a_0041_4.jpg  <b>Rated Item:</b> 1. Unwanted Vegetation Growth <b>Caption:</b> Rating: Unacceptable</p>

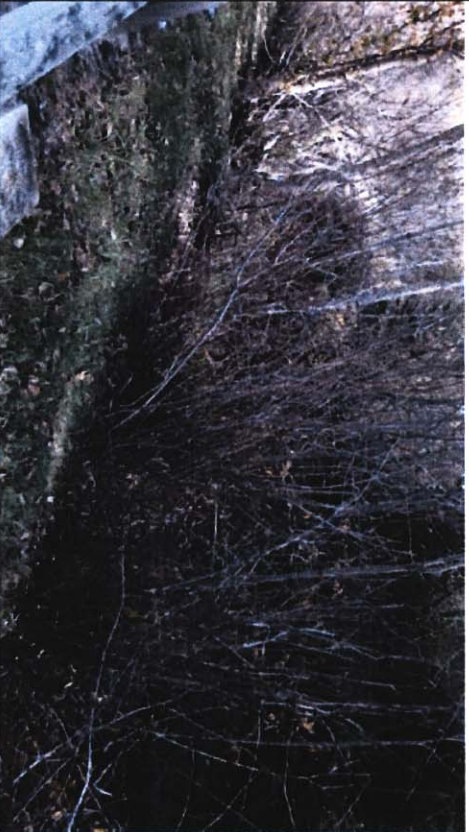
<p><b>Inspect ID:</b> BOLI_2015_a_0004 <b>Title:</b> USACE_CELRP_BOLI_2015_a_0004_1.jpg  <b>Rated Item:</b> 1. Vegetation and Obstructions <b>Caption:</b> Rating: Acceptable</p>

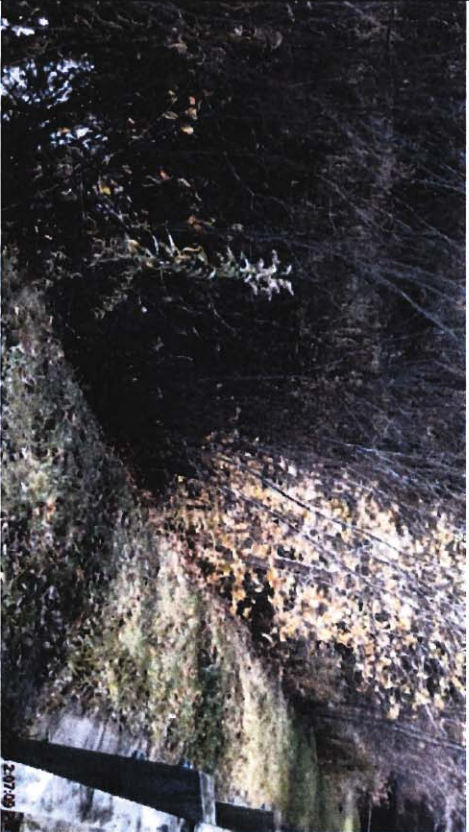
<p><b>Inspect ID:</b> BOLI_2015_a_0004 <b>Title:</b> USACE_CELRP_BOLI_2015_a_0004_2.jpg  <b>Rated Item:</b> 1. Vegetation and Obstructions <b>Caption:</b> Rating: Acceptable</p>

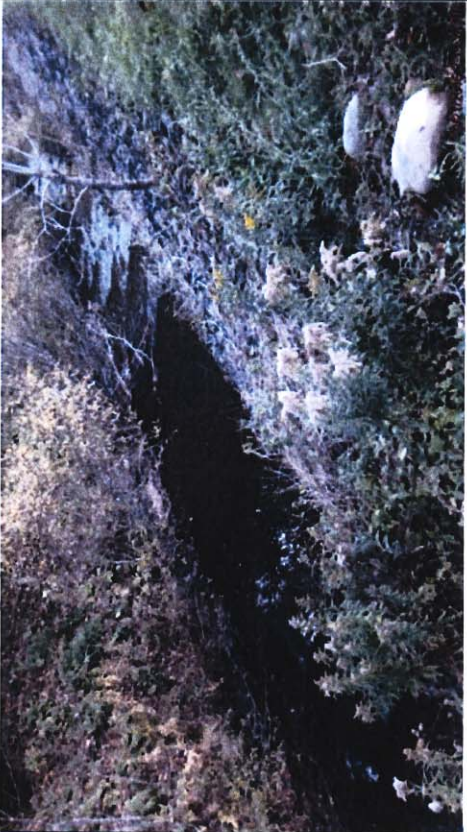
<p><b>Inspect ID:</b> BOLI_2015_a_0010 <b>Title:</b> USACE_CELRP_BOLI_2015_a_0010_2.jpg  <b>Rated Item:</b> 1. Vegetation and Obstructions <b>Caption:</b> Rating: Minimally Acceptable</p>

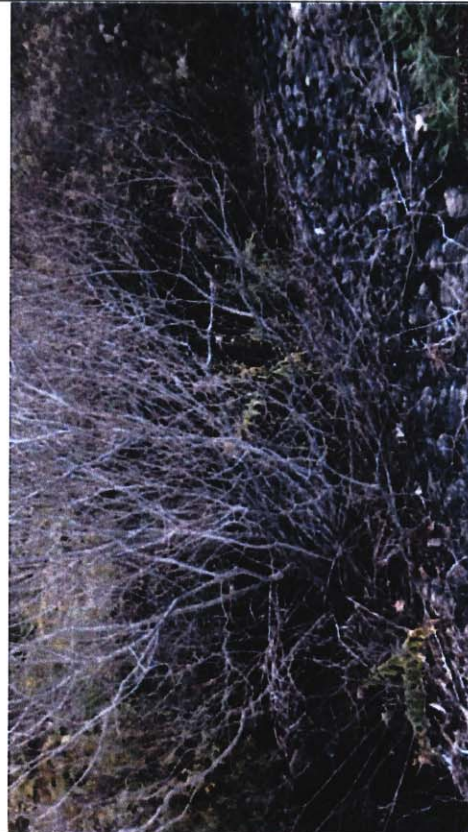
<p><b>Inspect ID:</b> BOLI_2015_a_0010 <b>Title:</b> USACE_CELRP_BOLI_2015_a_0010_1.jpg  <b>Rated Item:</b> 1. Vegetation and Obstructions <b>Caption:</b> Rating: Minimally Acceptable</p>

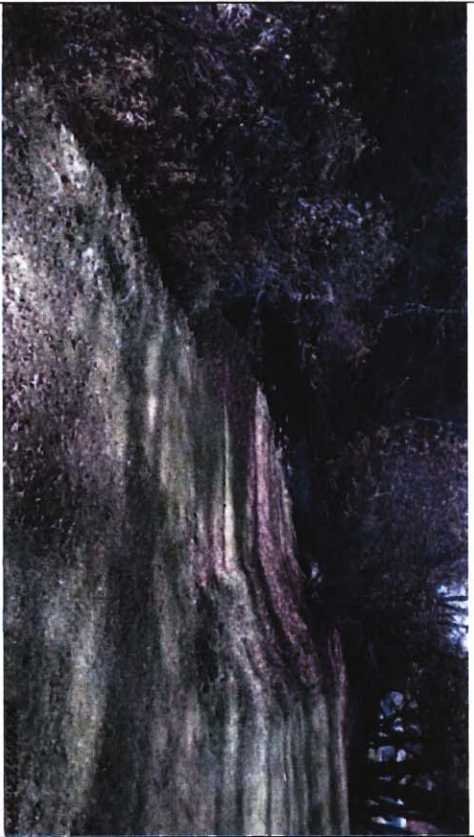
<p><b>Inspect ID:</b> BOLI_2015_a_0012 <b>Title:</b> USACE_CELRP_BOLI_2015_a_0012_1.jpg <b>Rated Item:</b> 1. Vegetation and Obstructions <b>Caption:</b> Rating: Acceptable</p>

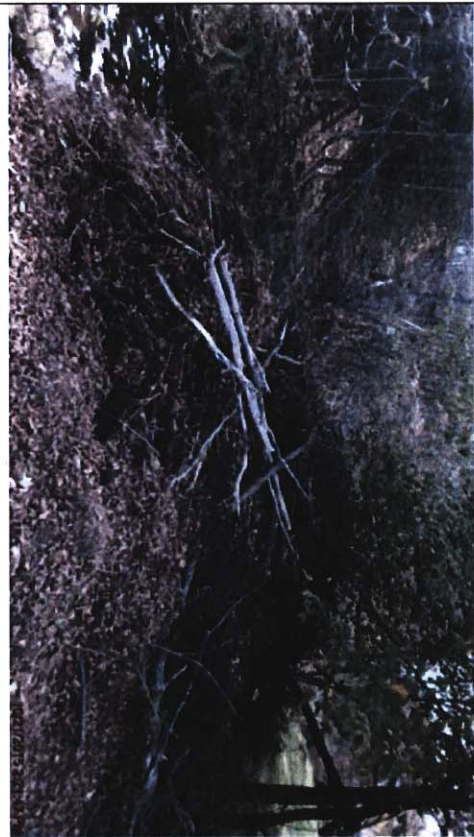
<p><b>Inspect ID:</b> BOLI_2015_a_0013 <b>Title:</b> USACE_CELRP_BOLI_2015_a_0013_1.jpg <b>Rated Item:</b> 1. Vegetation and Obstructions <b>Caption:</b> Rating: Acceptable</p>

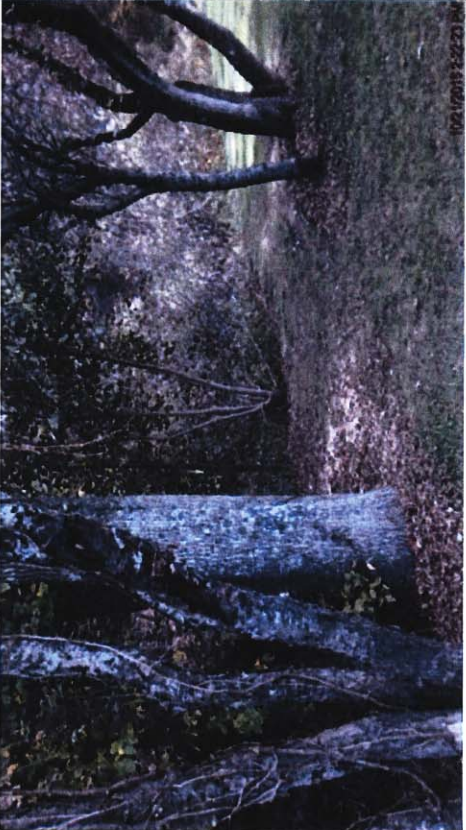
<p><b>Inspect ID:</b> BOLI_2015_a_0014 <b>Title:</b> USACE_CELRP_BOLI_2015_a_0014_1.jpg  <b>Rated Item:</b> 1. Vegetation and Obstructions <b>Caption:</b> Rating: Acceptable</p>

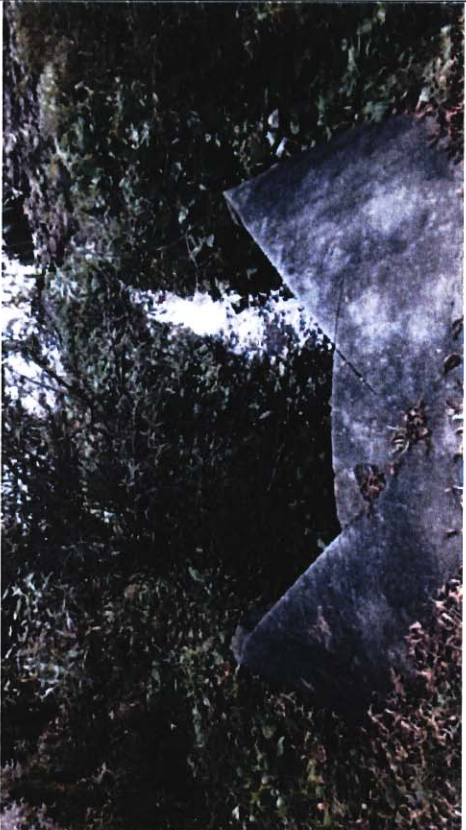
<p><b>Inspect ID:</b> BOLI_2015_a_0016 <b>Title:</b> USACE_CELRP_BOLI_2015_a_0016_1.jpg  <b>Rated Item:</b> 1. Vegetation and Obstructions <b>Caption:</b> Rating: Acceptable</p>

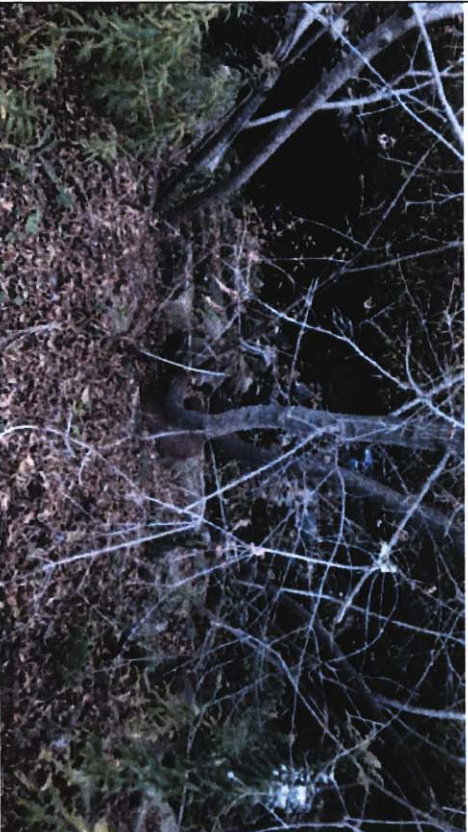
<p><b>Inspect ID:</b> BOLI_2015_a_0020 <b>Title:</b> USACE_CELRP_BOLI_2015_a_0020_1.jpg  <b>Rated Item:</b> 1. Vegetation and Obstructions <b>Caption:</b> Rating: Minimally Acceptable</p>

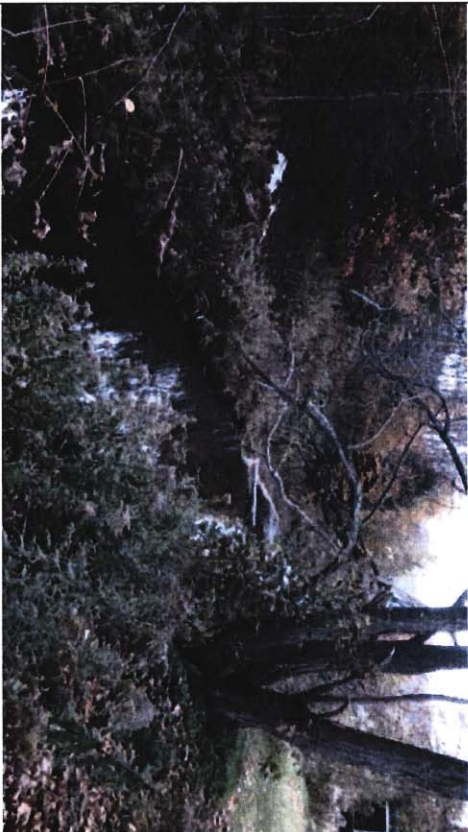
<p><b>Inspect ID:</b> BOLI_2015_a_0021 <b>Title:</b> USACE_CELRP_BOLI_2015_a_0021_1.jpg  <b>Rated Item:</b> 1. Vegetation and Obstructions <b>Caption:</b> Rating: Minimally Acceptable</p>

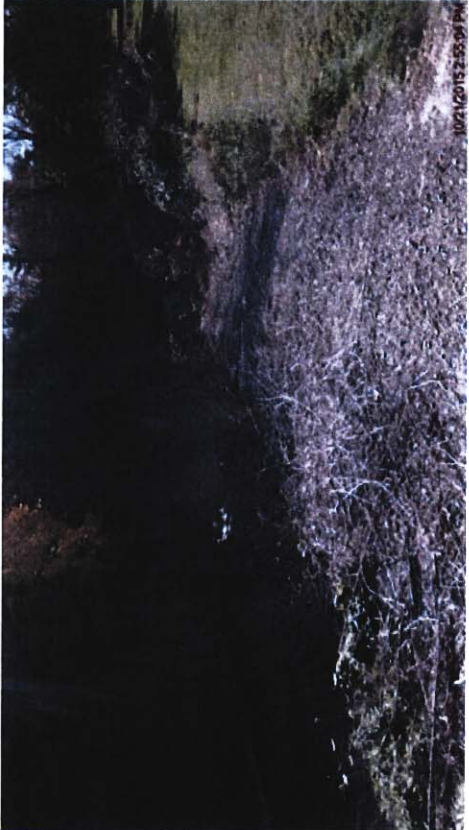
<p><b>Inspect ID:</b> BOLI_2015_a_0029 <b>Title:</b> USACE_CELRP_BOLI_2015_a_0029_1.jpg  <b>Rated Item:</b> 1. Vegetation and Obstructions <b>Caption:</b> Rating: Acceptable</p>

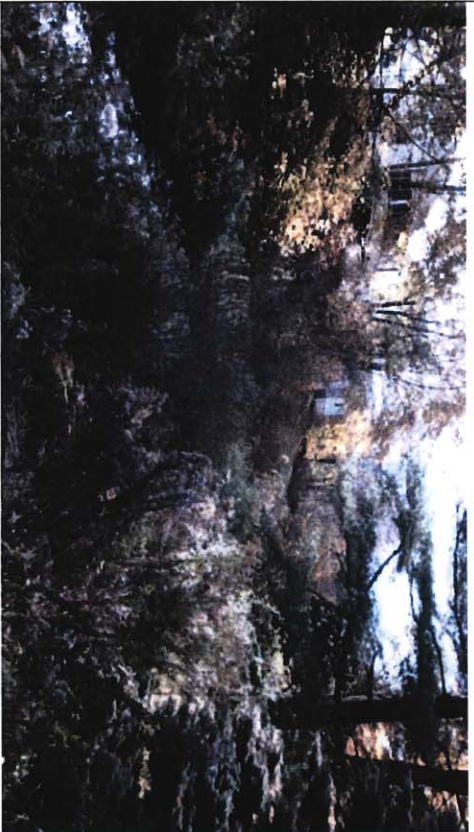
<p><b>Inspect ID:</b> BOLI_2015_a_0034 <b>Title:</b> USACE_CELRP_BOLI_2015_a_0034_1.jpg  <b>Rated Item:</b> 1. Vegetation and Obstructions <b>Caption:</b> Rating: Minimally Acceptable</p>

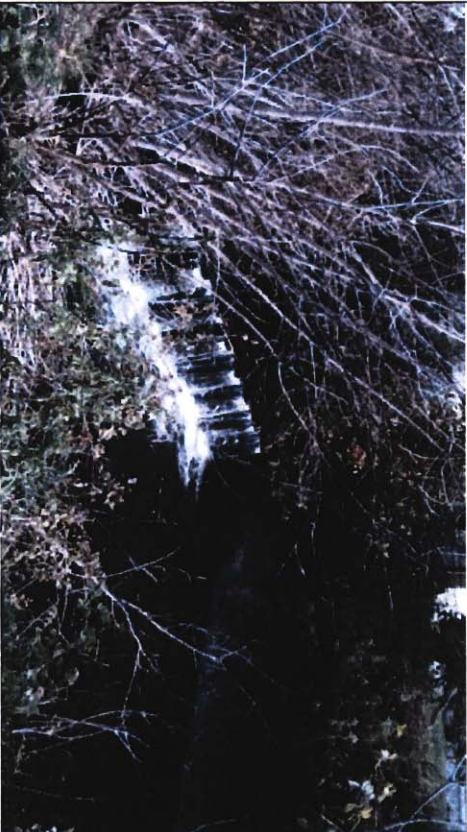
<p><b>Inspect ID:</b> BOLI_2015_a_0035 <b>Title:</b> USACE_CELRP_BOLI_2015_a_0035_1.jpg  <b>Rated Item:</b> 1. Vegetation and Obstructions <b>Caption:</b> Rating: Acceptable</p>

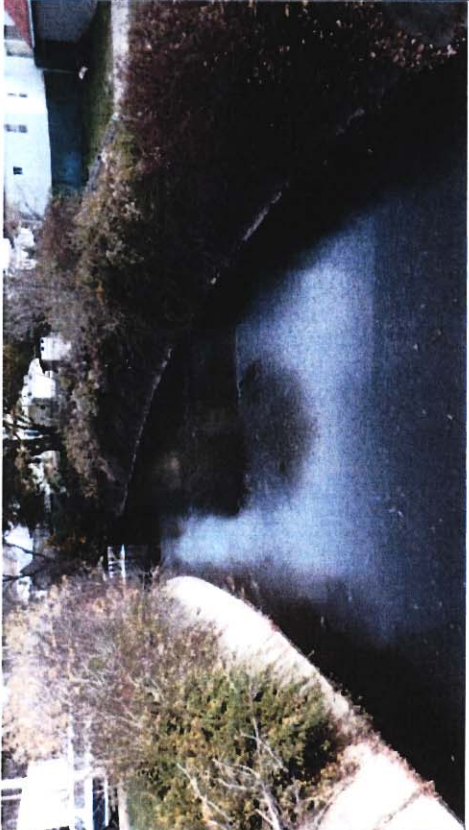
<p><b>Inspect ID:</b> BOLI_2015_a_0036 <b>Title:</b> USACE_CELRP_BOLI_2015_a_0036_1.jpg  <b>Rated Item:</b> 1. Vegetation and Obstructions <b>Caption:</b> Rating: Acceptable</p>

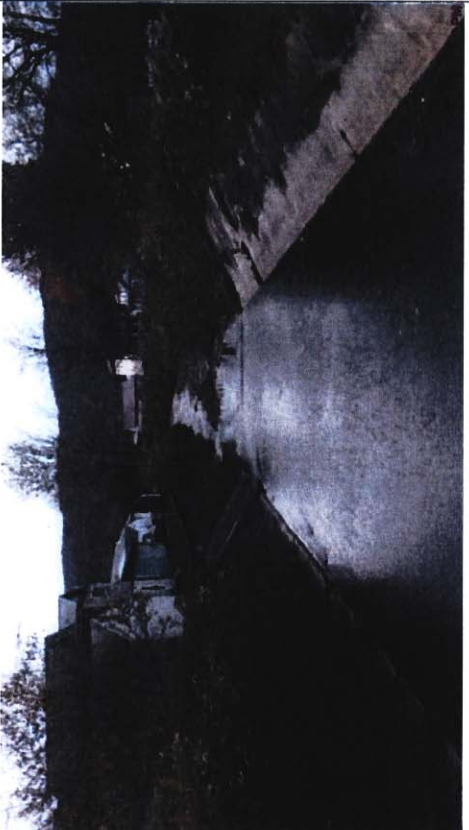
<p><b>Inspect ID:</b> BOLI_2015_a_0037 <b>Title:</b> USACE_CELRP_BOLI_2015_a_0037_1.jpg  <b>Rated Item:</b> 1. Vegetation and Obstructions <b>Caption:</b> Rating: Minimally Acceptable</p>

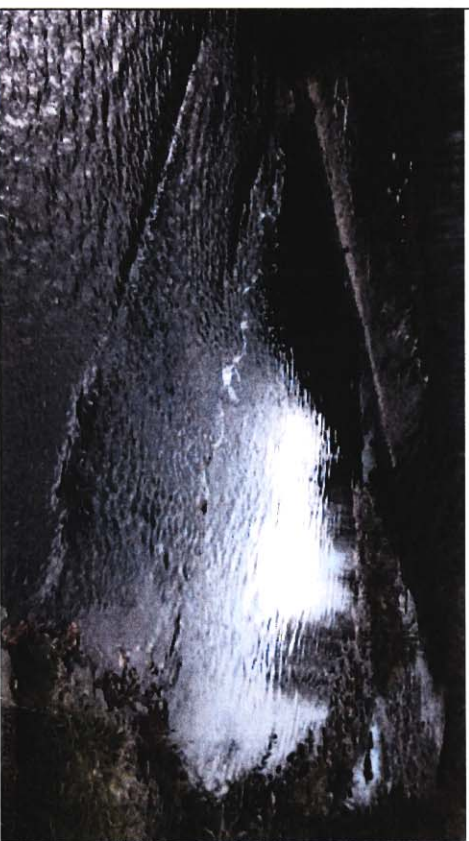
<p><b>Inspect ID:</b> BOLI_2015_a_0038 <b>Title:</b> USACE CEIRP_BOLI_2015_a_0038_1.jpg  <b>Rated Item:</b> 1. Vegetation and Obstructions <b>Caption:</b> Rating: Acceptable</p>

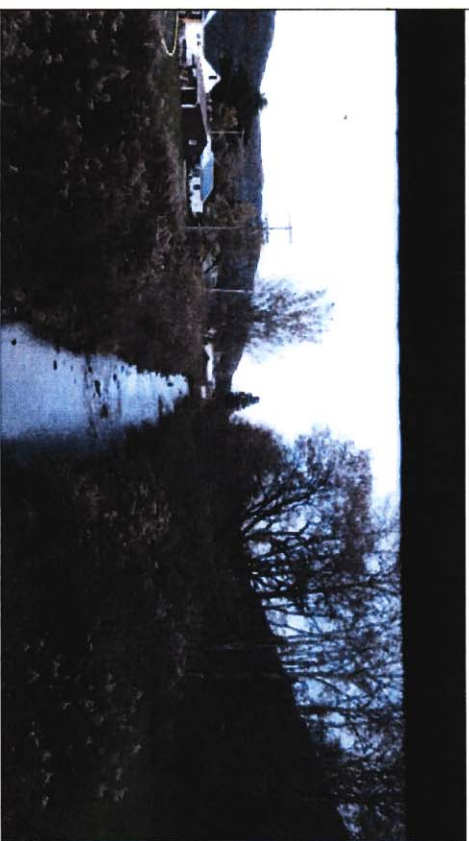
<p><b>Inspect ID:</b> BOLI_2015_a_0042 <b>Title:</b> USACE CEIRP_BOLI_2015_a_0042_1.jpg  <b>Rated Item:</b> 1. Vegetation and Obstructions <b>Caption:</b> Rating: Acceptable</p>

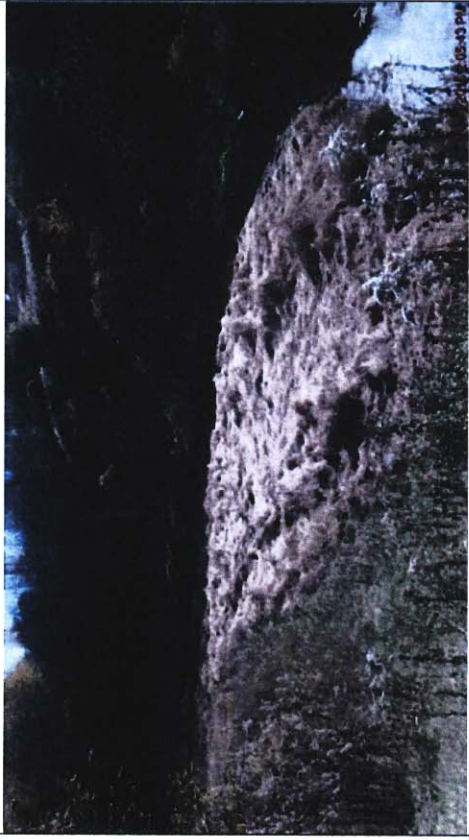
<p><b>Inspect ID:</b> BOLI_2015_a_0002 <b>Title:</b> USACE_CELRP_BOLI_2015_a_0002_4.jpg  <b>Rated Item:</b> 2. Shoaling (sediment deposition) <b>Caption:</b> Rating: Minimally Acceptable</p>

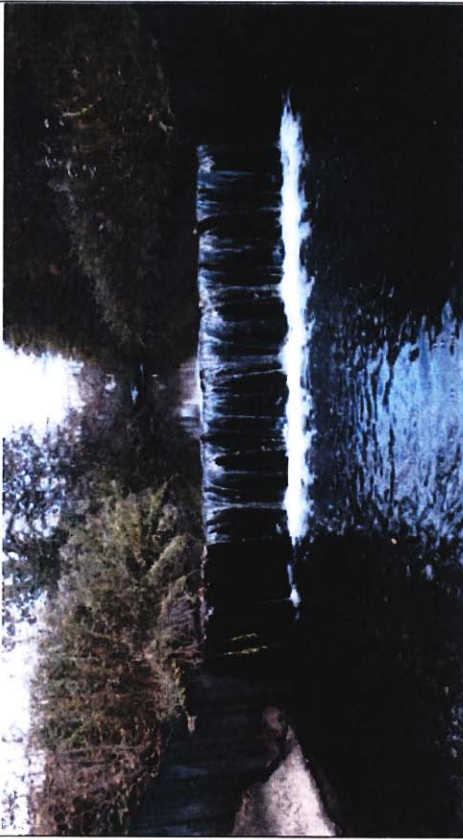
<p><b>Inspect ID:</b> BOLI_2015_a_0022 <b>Title:</b> USACE_CELRP_BOLI_2015_a_0022_1.jpg  <b>Rated Item:</b> 2. Shoaling (sediment deposition) <b>Caption:</b> Rating: Acceptable</p>

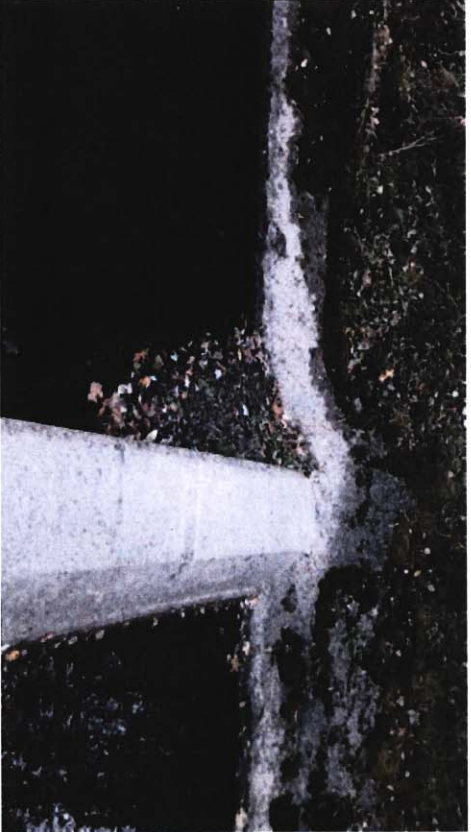
<p><b>Inspect ID:</b> BOLI_2015_a_0022 <b>Title:</b> USACE_CELRP_BOLI_2015_a_0022_2.jpg  <b>Rated Item:</b> 2. Shoaling (sediment deposition) <b>Caption:</b> Rating: Acceptable</p>

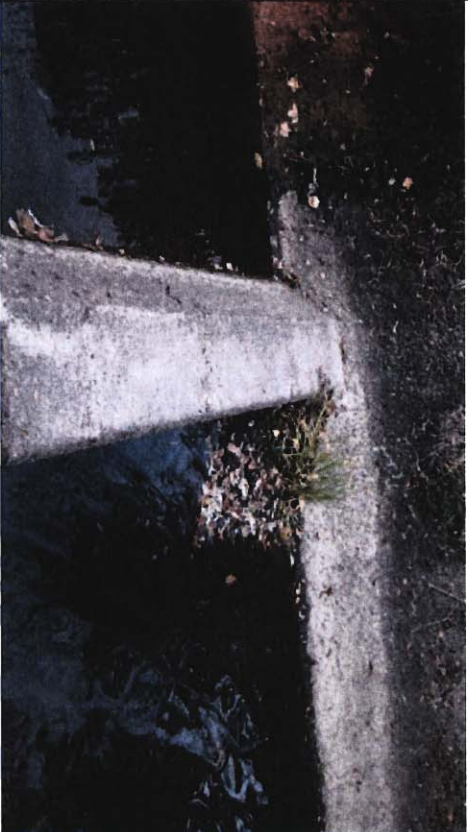
<p><b>Inspect ID:</b> BOLI_2015_a_0022 <b>Title:</b> USACE_CELRP_BOLI_2015_a_0022_3.jpg  <b>Rated Item:</b> 2. Shoaling (sediment deposition) <b>Caption:</b> Rating: Acceptable</p>

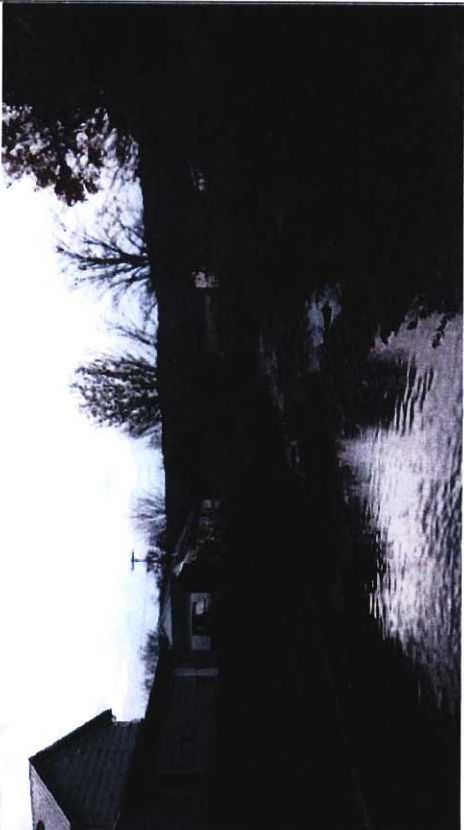
<p><b>Inspect ID:</b> BOLI_2015_a_0039 <b>Title:</b> USACE_CELRP_BOLI_2015_a_0039_1.jpg <b>Rated Item:</b> 2. Shoaling (sediment deposition) <b>Caption:</b> Rating: Unacceptable</p>

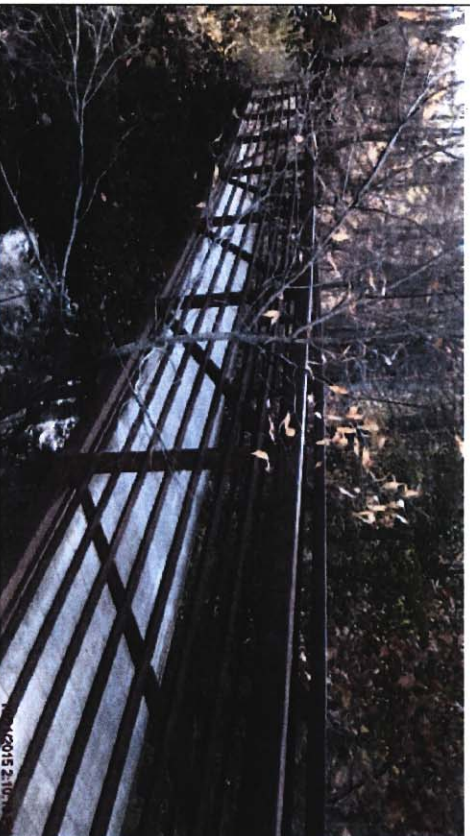
<p><b>Inspect ID:</b> BOLI_2015_a_0005 <b>Title:</b> USACE_CELRP_BOLI_2015_a_0005_1.jpg  <b>Rated Item:</b> 3. Encroachments <b>Caption:</b> Rating: Acceptable</p>

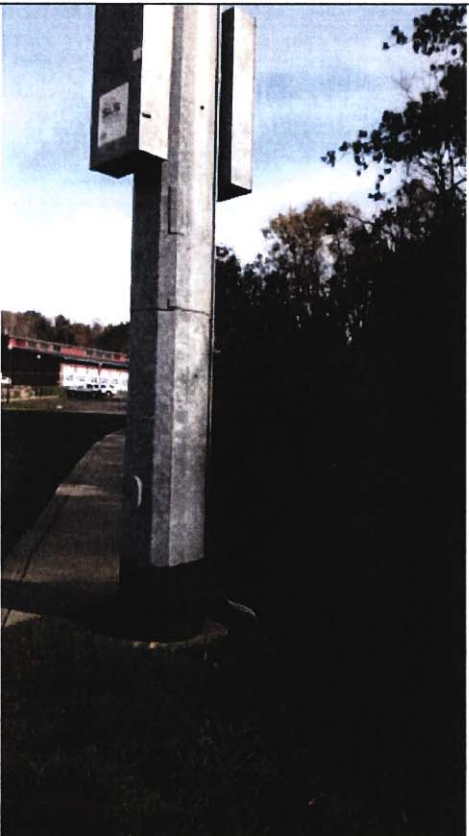
<p><b>Inspect ID:</b> BOLI_2015_a_0006 <b>Title:</b> USACE_CELRP_BOLI_2015_a_0006_1.jpg  <b>Rated Item:</b> 3. Encroachments <b>Caption:</b> Rating: Acceptable</p>

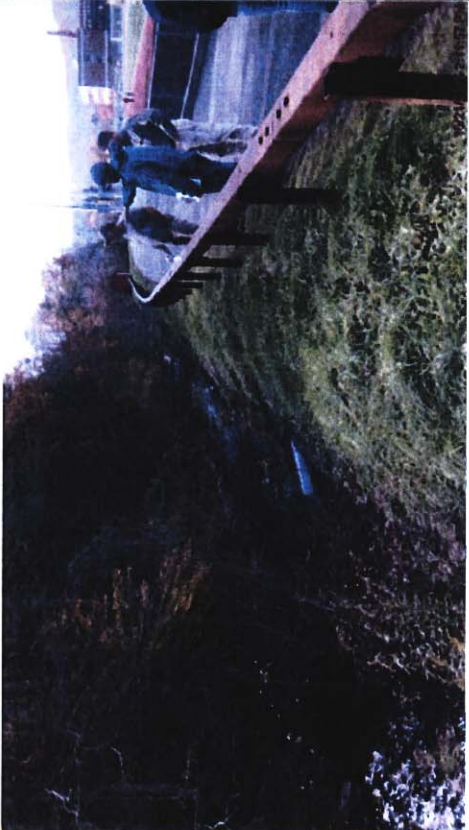
<p><b>Inspect ID:</b> BOLI_2015_a_0007 <b>Title:</b> USACE_CELRP_BOLI_2015_a_0007_1.jpg  <b>Rated Item:</b> 3. Encroachments <b>Caption:</b> Rating: Acceptable</p>

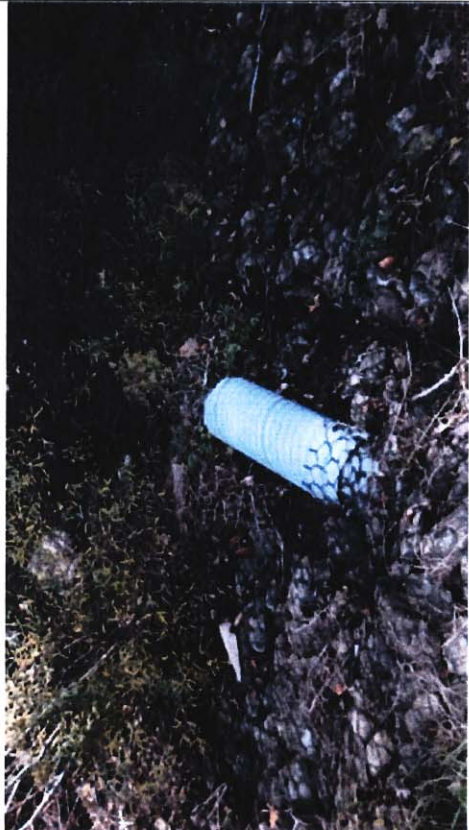
<p><b>Inspect ID:</b> BOLI_2015_a_0009 <b>Title:</b> USACE_CELRP_BOLI_2015_a_0009_1.jpg  <b>Rated Item:</b> 3. Encroachments <b>Caption:</b> Rating: Acceptable</p>

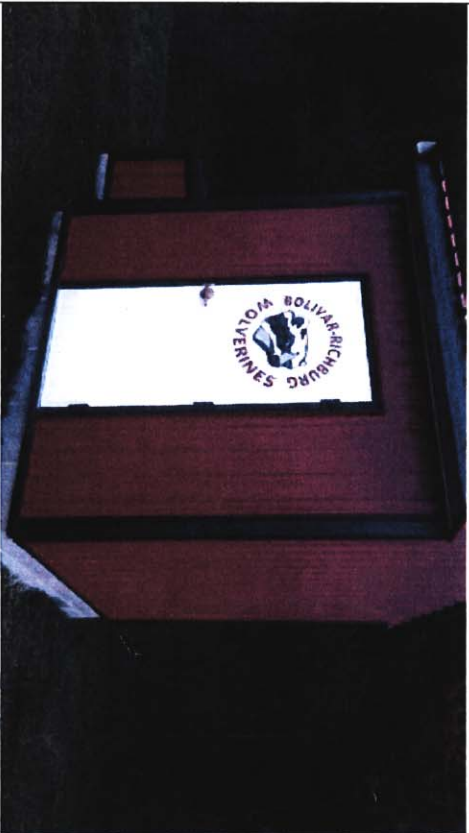
<p><b>Inspect ID:</b> BOLI_2015_a_0011 <b>Title:</b> USACE_CELRP_BOLI_2015_a_0011_1.jpg</p> <p><b>Rated Item:</b> 3. Encroachments <b>Caption:</b> Rating: Acceptable</p>

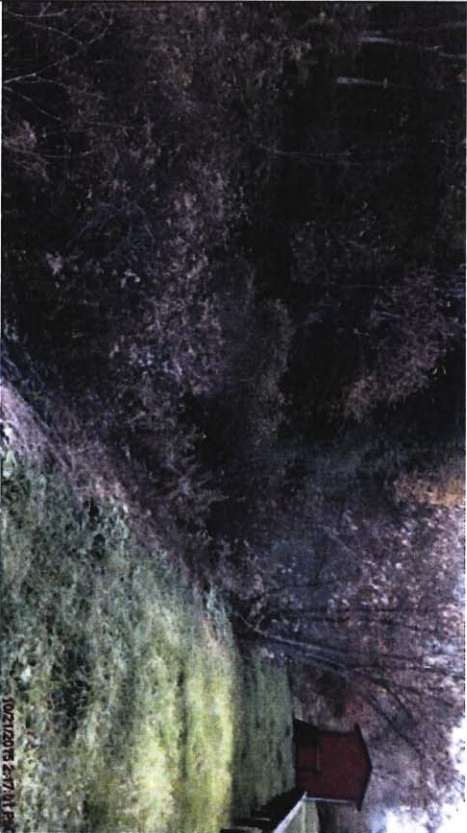
<p><b>Inspect ID:</b> BOLI_2015_a_0011 <b>Title:</b> USACE_CELRP_BOLI_2015_a_0011_2.jpg</p> <p><b>Rated Item:</b> 3. Encroachments <b>Caption:</b> Rating: Acceptable</p>

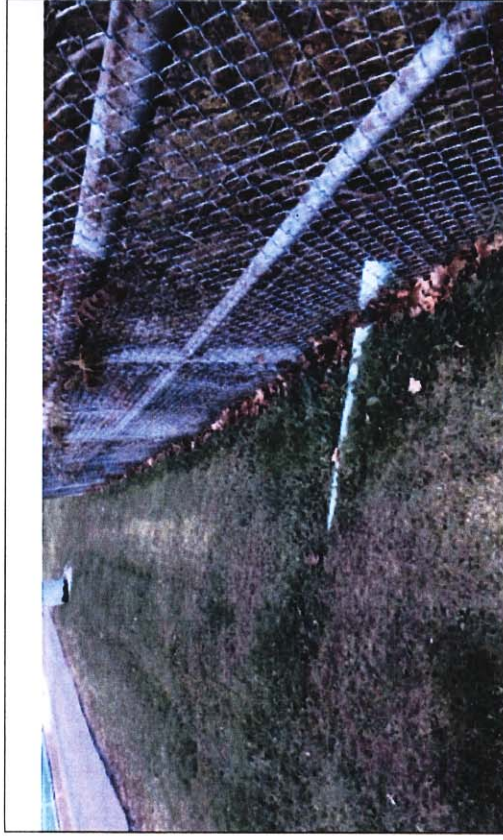
**Inspect ID:** BOLI\_2015\_a\_0017 **Title:** USACE\_CELRP\_BOLI\_2015\_a\_0017\_1.jpg  
**Rated Item:** 3. Encroachments **Caption:** Rating: Acceptable

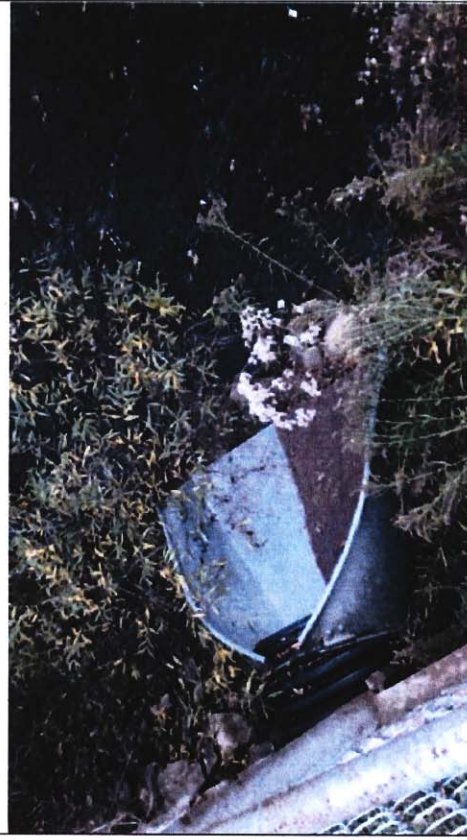
**Inspect ID:** BOLI\_2015\_a\_0018 **Title:** USACE\_CELRP\_BOLI\_2015\_a\_0018\_1.jpg  
**Rated Item:** 3. Encroachments **Caption:** Rating: Acceptable

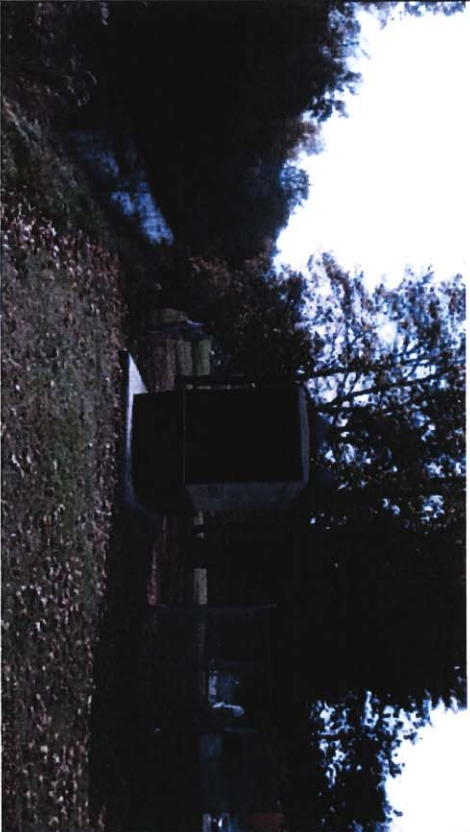
<p><b>Inspect ID:</b> BOLI_2015_a_0023 <b>Title:</b> USACE CELRP BOLI_2015_a_0023_1.jpg  <b>Rated Item:</b> 3. Encroachments <b>Caption:</b> Rating: Acceptable</p>

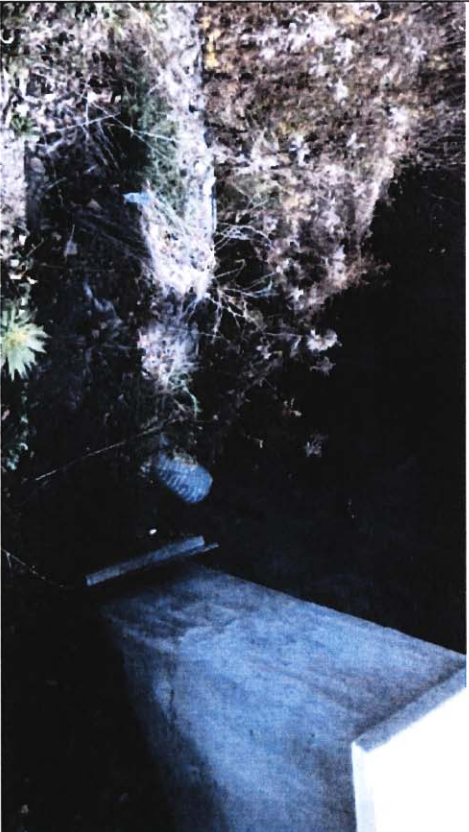
<p><b>Inspect ID:</b> BOLI_2015_a_0027 <b>Title:</b> USACE CELRP BOLI_2015_a_0027_1.jpg  <b>Rated Item:</b> 3. Encroachments <b>Caption:</b> Rating: Acceptable</p>

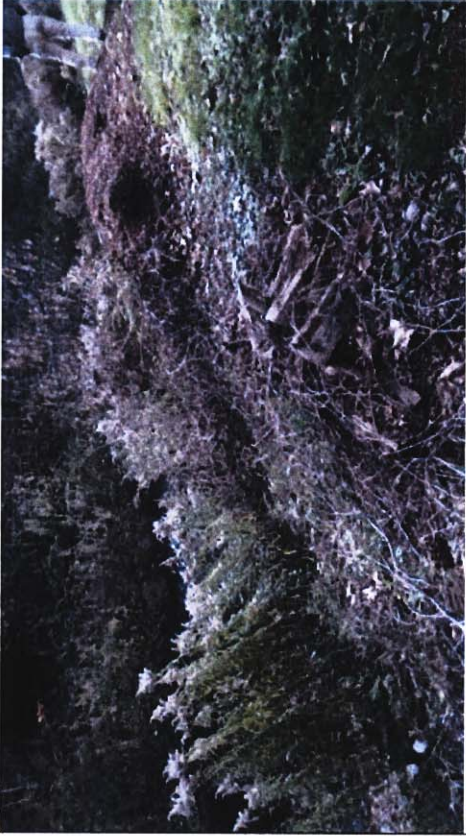
<p><b>Inspect ID:</b> BOLI_2015_a_0031 <b>Title:</b> USACE_CELRP_BOLI_2015_a_0031_1.jpg <b>Rated Item:</b> 3. Encroachments <b>Caption:</b> Rating: Minimally Acceptable</p>

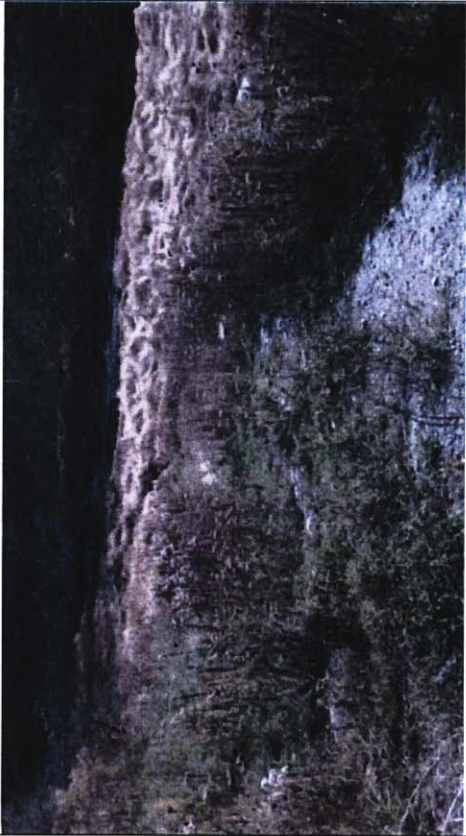
<p><b>Inspect ID:</b> BOLI_2015_a_0001 <b>Title:</b> USACE_CELRP_BOLI_2015_a_0001_1.jpg <b>Rated Item:</b> 4. Erosion <b>Caption:</b> Rating: Acceptable</p>

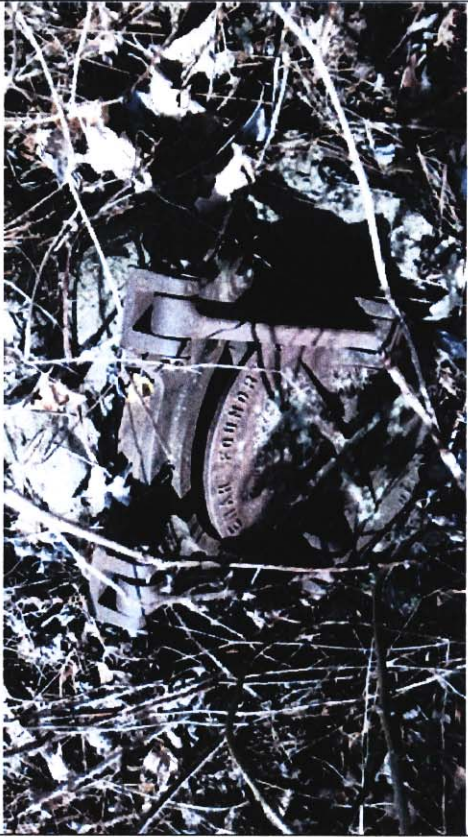
<p><b>Inspect ID:</b> BOLI_2015_a_0026 <b>Title:</b> USACE_CELRP_BOLI_2015_a_0026_1.jpg <b>Rated Item:</b> 9. Flap Gates/Flap Valves/ Pinch Valves <b>Caption:</b> Rating: Unacceptable</p>

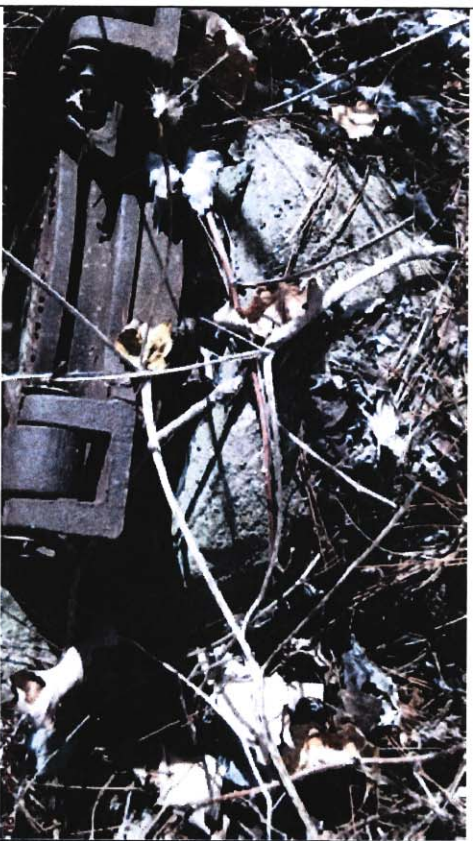
<p><b>Inspect ID:</b> BOLI 2015 a 0026 <b>Title:</b> USACE CEIRP BOLI 2015 a 0026 2.jpg  <b>Rated Item:</b> 9. Flap Gates/ Flap Valves/ Pinch Valves <b>Caption:</b> Rating: Unacceptable</p>

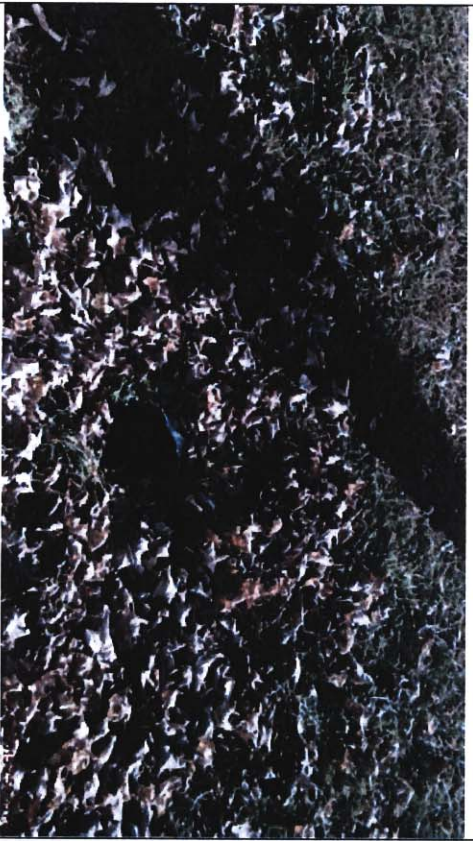
<p><b>Inspect ID:</b> BOLI 2015 a 0026 <b>Title:</b> USACE CEIRP BOLI 2015 a 0026 3.jpg  <b>Rated Item:</b> 9. Flap Gates/ Flap Valves/ Pinch Valves <b>Caption:</b> Rating: Unacceptable</p>

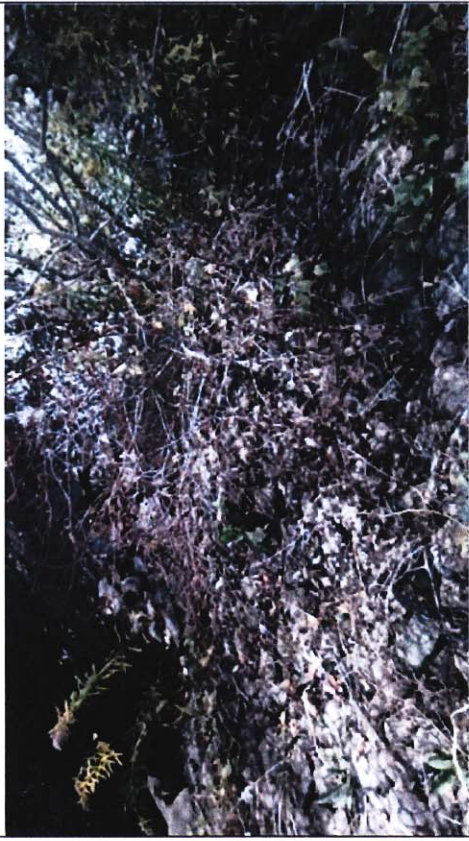
<p><b>Inspect ID:</b> BOLI_2015_a_0008 <b>Title:</b> USACE_CELRP_BOLI_2015_a_0008_1.jpg  <b>Rated Item:</b> 10. Riprap Revetments &amp; Banks <b>Caption:</b> Rating: Acceptable</p>

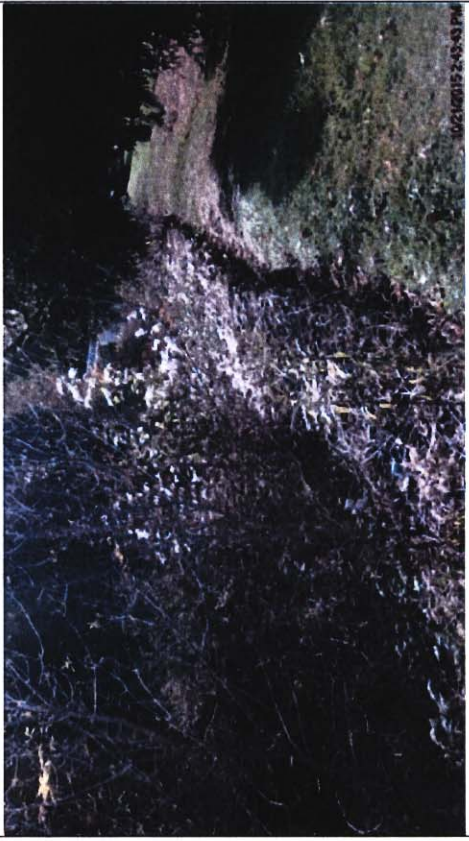
<p><b>Inspect ID:</b> BOLI_2015_a_0025 <b>Title:</b> USACE_CELRP_BOLI_2015_a_0025_1.jpg  <b>Rated Item:</b> 10. Riprap Revetments &amp; Banks <b>Caption:</b> Rating: Minimally Acceptable</p>

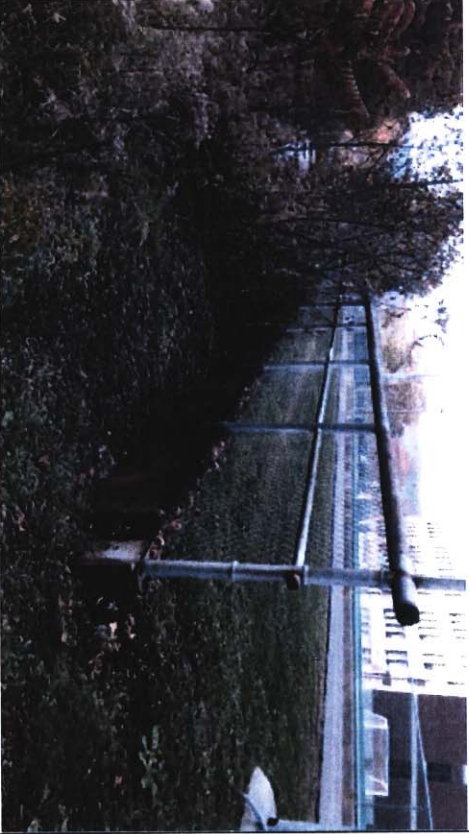
<p><b>Inspect ID:</b> BOLI_2015_a_0015 <b>Title:</b> USACE_CELRP_BOLI_2015_a_0015_1.jpg  <b>Rated Item:</b> 11. Revetments other than Riprap <b>Caption:</b> Rating: Acceptable</p>

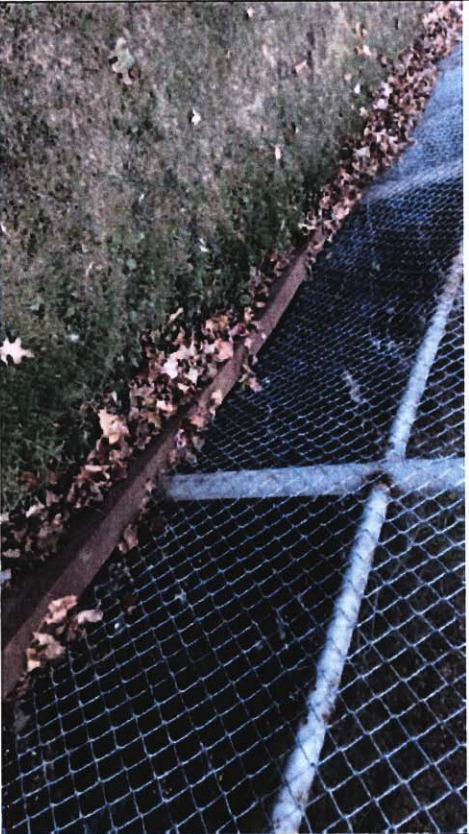
<p><b>Inspect ID:</b> BOLI_2015_a_0019 <b>Title:</b> USACE_CELRP_BOLI_2015_a_0019_1.jpg  <b>Rated Item:</b> 11. Revetments other than Riprap <b>Caption:</b> Rating: Acceptable</p>
