DEPARTMENT OF THE ARMY

BUFFALO DISTRICT, CORPS OF ENGINEERS
1776 NIAGARA STREET
BUFFALO, NEW YORK 14207-3199

SUBJECT: FY19 Joint Routine Inspection of Completed Works, Flood Risk Management Project, Genesee River and Dyke Creek, Wellsville, New York (09/23/19)

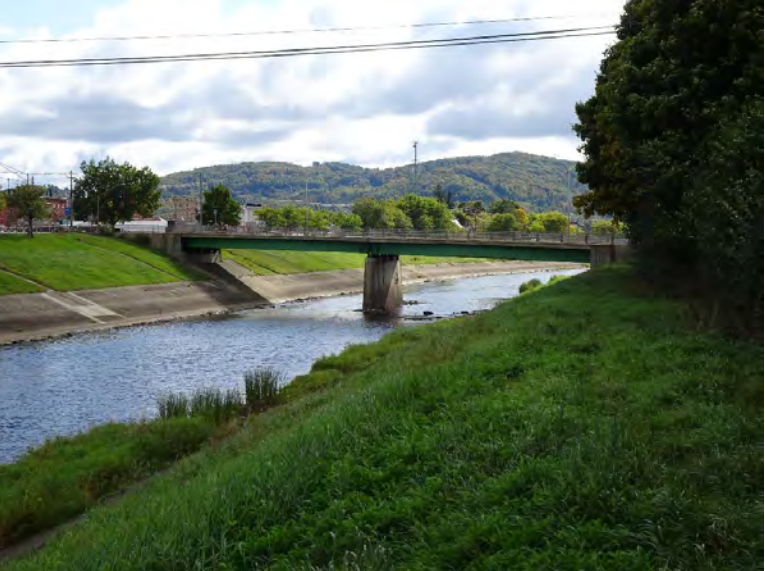
<p>Inspect ID: N21L_2019_r_0096 Title: USACE_CELRB_N21L_2019_r_0096_1.jpg Rated Item: 3. Encroachments Caption: Rating: Minimally Acceptable; Remarks: Unauthorized alteration (E-29): Madison Street (Stevens Street) bridge (replaced Pearl Street bridge). Constructed after project. NYSDEC says permitted.; Action: Submit Section 408 Alteration Request to USACE or verify USACE permission.; Station_1: 44+00</p>

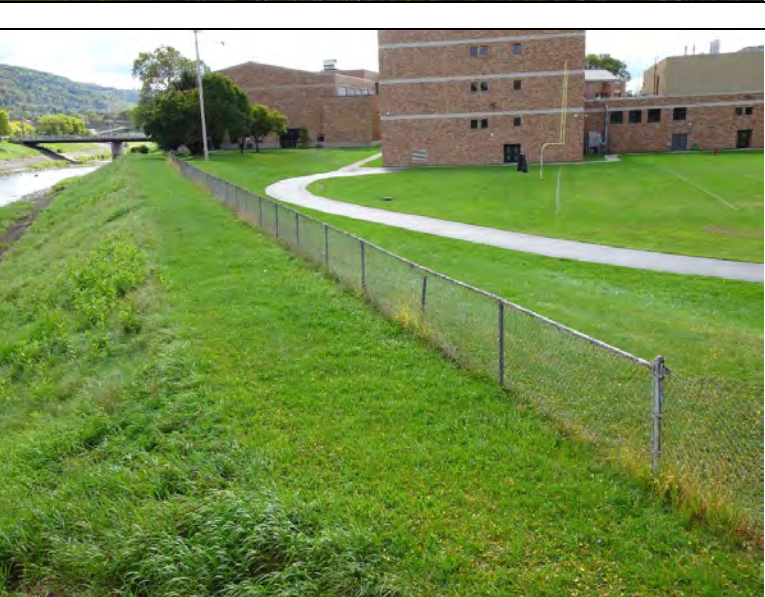
<p>Inspect ID: N21L_2019_r_0097 Title: USACE_CELRB_N21L_2019_r_0097_1.jpg Rated Item: 3. Encroachments Caption: Rating: Minimally Acceptable; Remarks: Unauthorized alteration (E-30): Fence on left bank channel crest from Madison Street (Stevens Street) bridge to school building.; Action: Remove or submit Section 408 Alteration Request to USACE.; Station_1: 34+00; Station_2: 43+00</p>

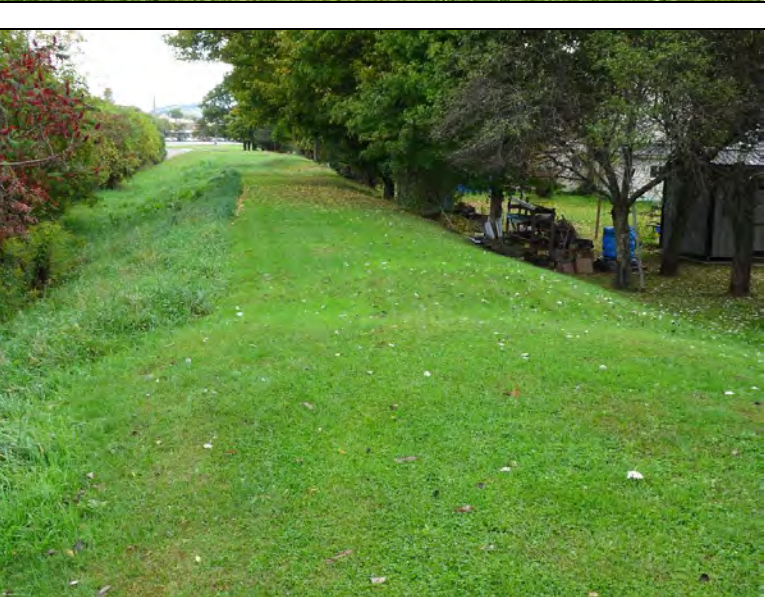
<p>Inspect ID: N21L_2019_r_0150 Title: USACE_CELRB_N21L_2019_r_0150_1.jpg Rated Item: 7. Settlement Caption: Rating: Minimally Acceptable; Remarks: Depression within levee crown over unauthorized 24" CMP outfall.; Action: Fill and repair depression in levee crown; determine cause of depression and rectify problem.; Station_1: 61+00</p>

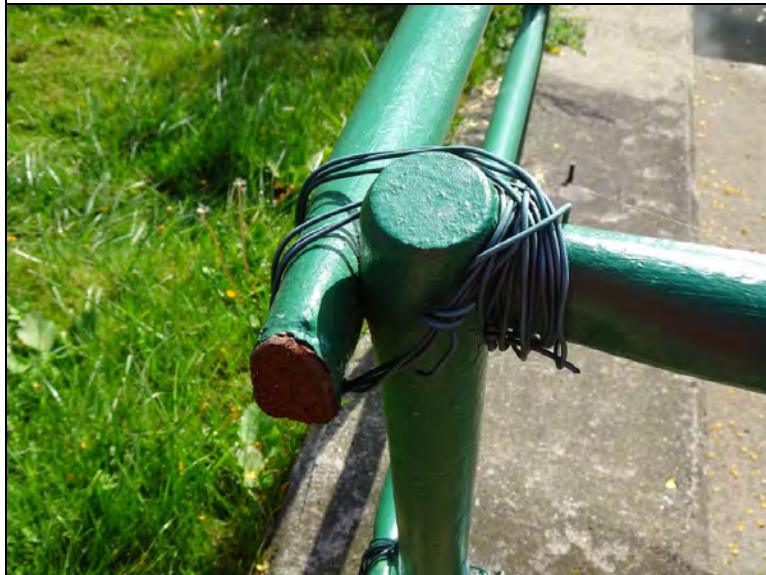
Inspect ID: N21L_2019_r_0034 **Title:** USACE_CELRB_N21L_2019_r_0034_1.jpg
Rated Item: 4. Fencing and Gates **Caption:** Rating: Minimally Acceptable; Remarks: Joint connections improperly repaired and lower support pole for handrailing is no longer anchored to headwall on left bank, 300' upstream of Bolivar Road bridge.; Action: Properly repair headwall railing.; Station_1: 88+00

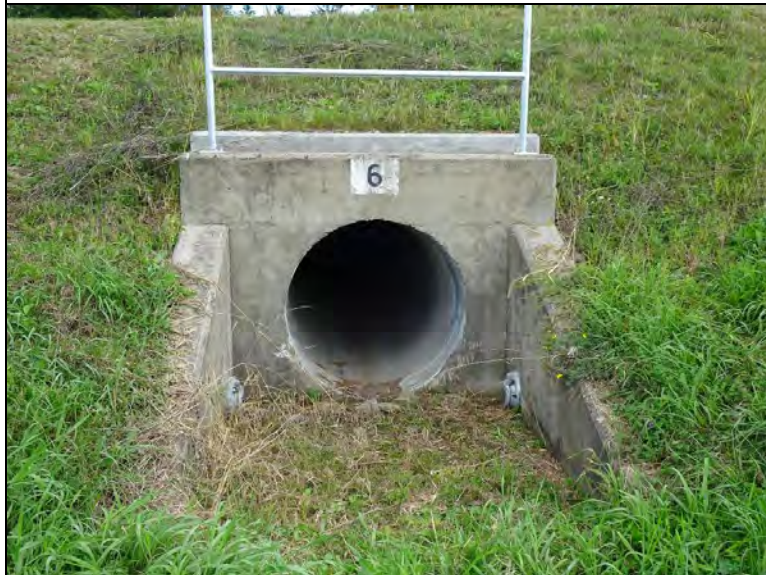
Inspect ID: N21L_2019_r_0128 **Title:** USACE_CELRB_N21L_2019_r_0128_1.jpg
Rated Item: 12. Trash Racks (non-mechanical) **Caption:** Rating: Acceptable; Remarks: Observation: 48" CMP on levee landside slope, 515' upstream of Steel Sheet Pile Weir, does not have a trash rack to prevent unauthorized access into pipe.; Action: Recommendation: installing trash rack over opening to keep out debris and unauthorized access. ; Station_1: 23+00

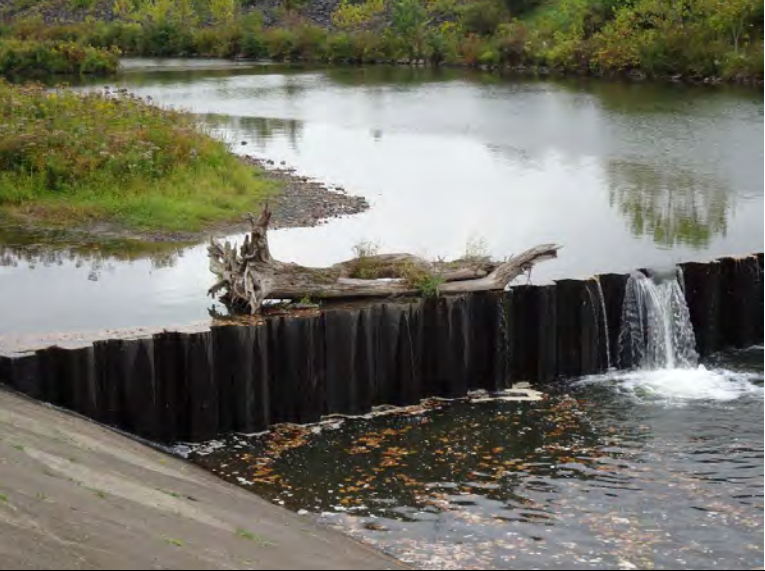
<p>Inspect ID: N21L_2019_r_0001 Title: USACE_CELRB_N21L_2019_r_0001_1.jpg Rated Item: 1. Vegetation and Obstructions Caption: Rating: Minimally Acceptable; Remarks: Tree debris on right bank at upstream limit weir.; Action: Remove tree debris.; Station_1: 0+00</p>

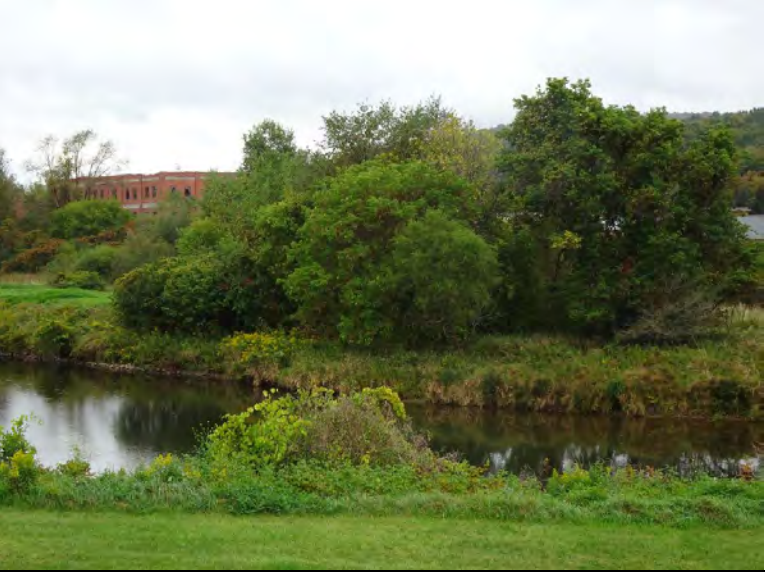
<p>Inspect ID: N21L_2019_r_0005 Title: USACE_CELRB_N21L_2019_r_0005_1.jpg Rated Item: 1. Vegetation and Obstructions Caption: Rating: Unacceptable; Remarks: Trees and vegetation on left bank 175' upstream of barrier levee weir.; Action: Remove trees and mow vegetation to 3"-6" height.; Station_1: 0+00</p>

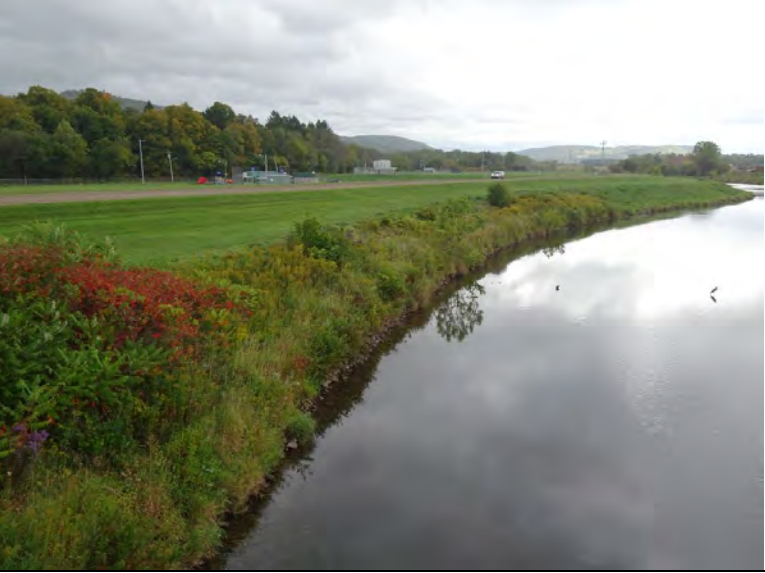
<p>Inspect ID: N21L_2019_r_0010 Title: USACE_CELRB_N21L_2019_r_0010_1.jpg Rated Item: 1. Vegetation and Obstructions Caption: Rating: Minimally Acceptable; Remarks: Trees and vegetation on right bank from Island Park to 500' upstream of Island Park pedestrian bridge.; Action: Remove trees and vegetation.; Station_1: 29+00; Station_2: 11+00</p>

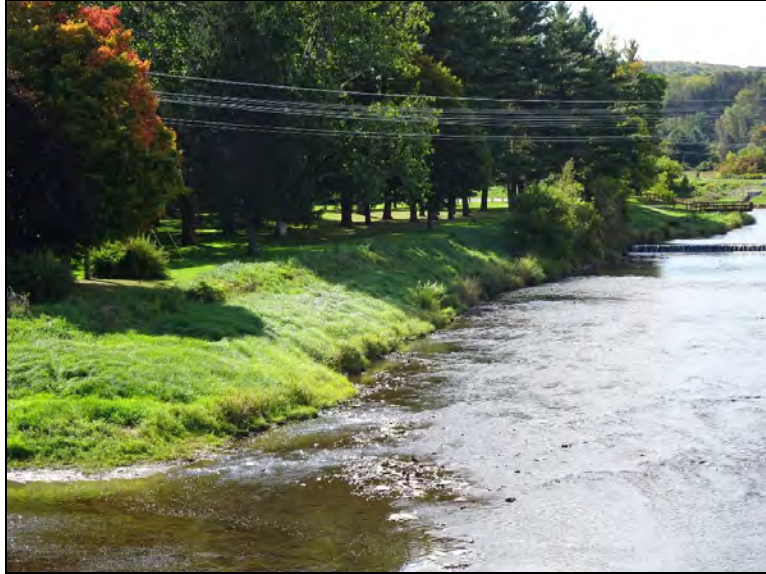
Inspect ID: N21L_2019_r_0010 **Title:** USACE_CELRB_N21L_2019_r_0010_3.jpg
Rated Item: 1. Vegetation and Obstructions **Caption:** Rating: Minimally Acceptable;
 Remarks: Trees and vegetation on right bank from Island Park to 500' upstream of Island Park pedestrian bridge.; Action: Remove trees and vegetation.; Station_1: 29+00; Station_2: 11+00

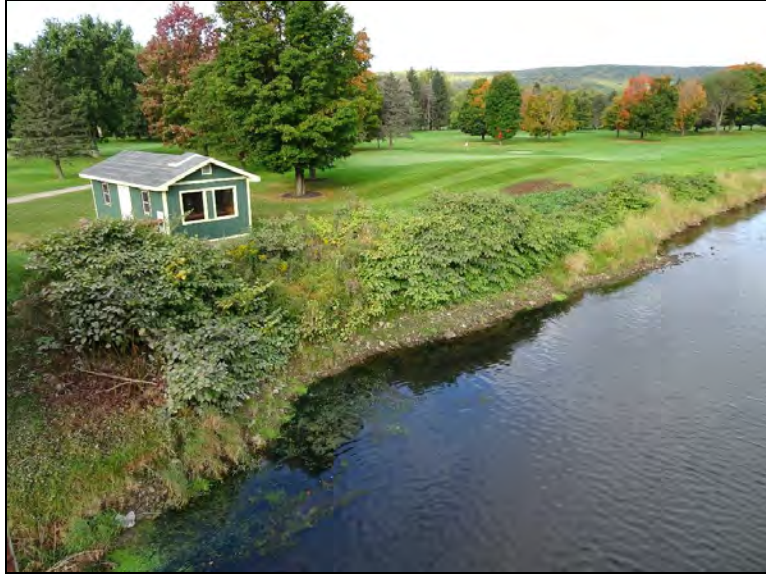
Inspect ID: N21L_2019_r_0019 **Title:** USACE_CELRB_N21L_2019_r_0019_1.jpg
Rated Item: 1. Vegetation and Obstructions **Caption:** Rating: Minimally Acceptable;
Remarks: Vegetation in excess of 12" on left bank of channel just downstream of golf course pedestrian bridge.; **Action:** Mow vegetation to 3"-6" height.; **Station_1:** 105+00;
Station_2: 104+00

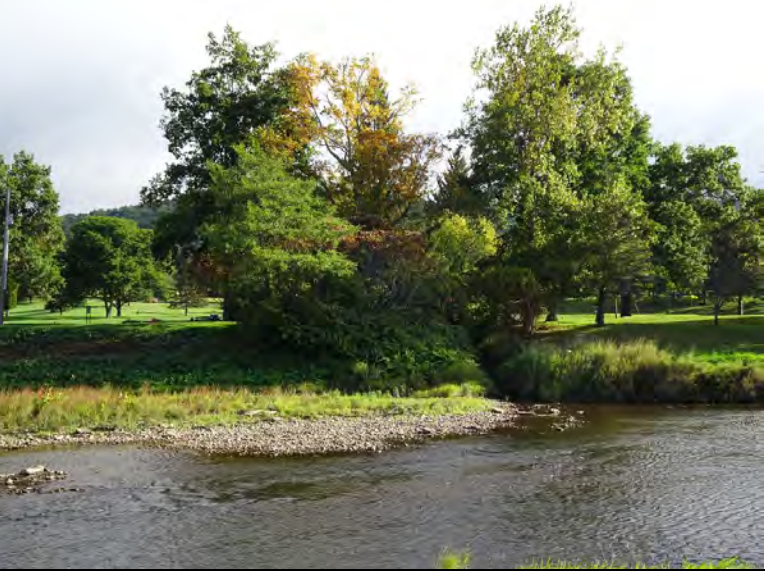
<p>Inspect ID: N21L_2019_r_0024 Title: USACE_CELRB_N21L_2019_r_0024_1.jpg Rated Item: 1. Vegetation and Obstructions Caption: Rating: Minimally Acceptable; Remarks: Trees on right bank channel sideslope 900' downstream of Bolivar Street bridge.; Action: Remove trees.; Station_1: 100+00</p>

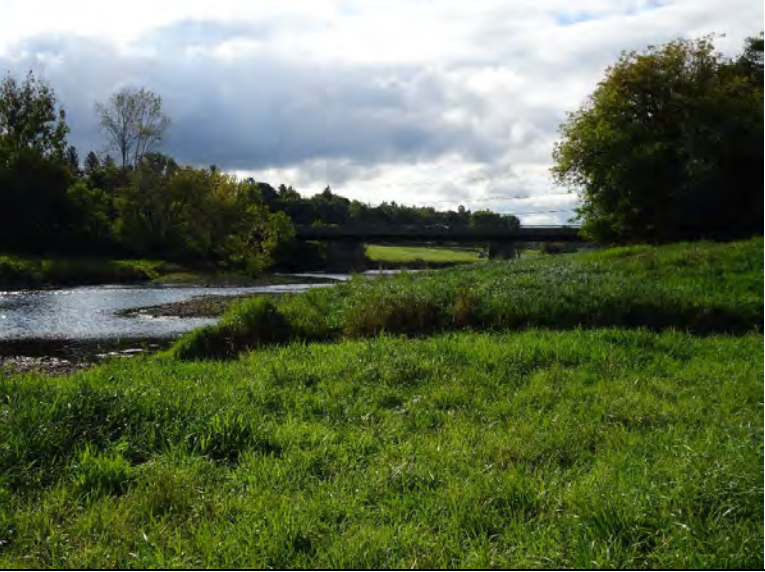
<p>Inspect ID: N21L_2019_r_0025 Title: USACE_CELRB_N21L_2019_r_0025_2.jpg Rated Item: 1. Vegetation and Obstructions Caption: Rating: Minimally Acceptable; Remarks: Vegetation in excess of 12" on left bank of channel from golf course pedestrian bridge to Bolivar Road bridge.; Action: Mow vegetation to 3"-6" height.; Station_1: 104+00; Station_2: 103+00</p>

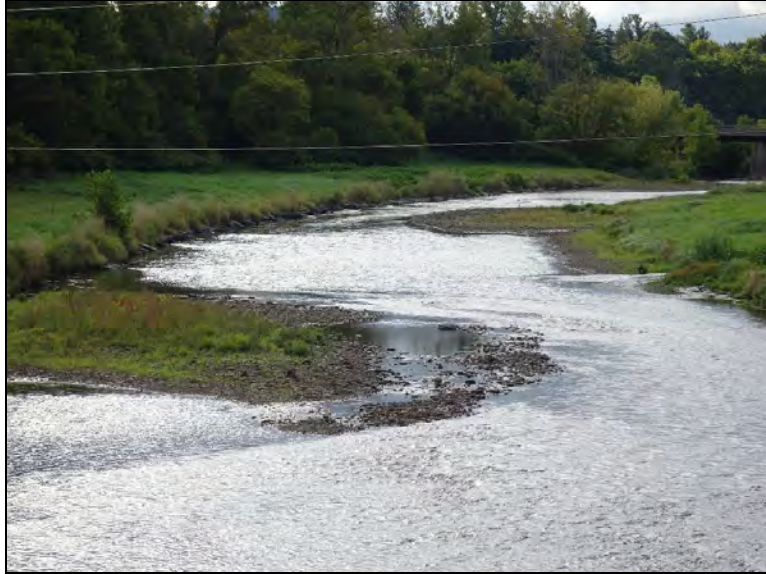
Inspect ID: N21L_2019_r_0027 **Title:** USACE_CELRB_N21L_2019_r_0027_2.jpg
Rated Item: 1. Vegetation and Obstructions **Caption:** Rating: Minimally Acceptable;
Remarks: Vegetation in excess of 12" on right bank of channel 280' downstream from Bolivar Road Bridge.; **Action:** Mow vegetation to 3"-6" height.; **Station_1:** 94+00

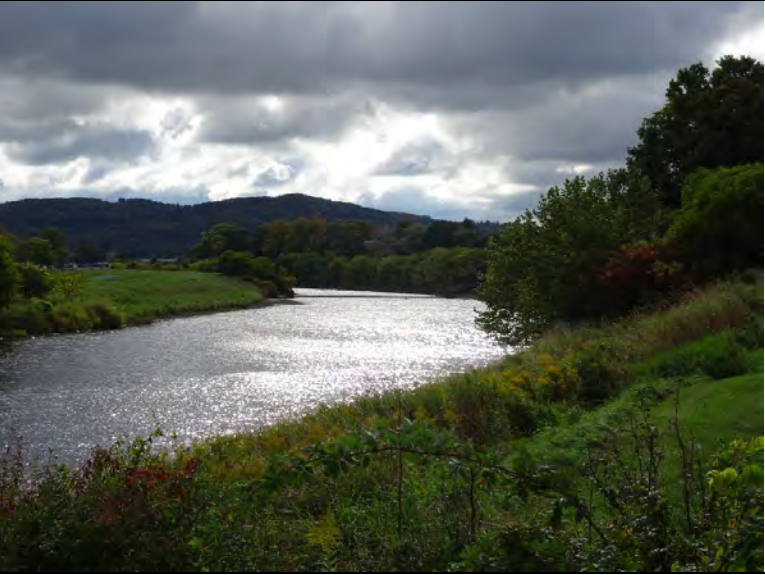
<p>Inspect ID: N21L_2019_r_0044 Title: USACE_CELRB_N21L_2019_r_0044_1.jpg Rated Item: 1. Vegetation and Obstructions Caption: Rating: Minimally Acceptable; Remarks: Unwanted vegetation on both bank sideslopes from 750' upstream of Bolivar Road bridge to Madison Street bridge.; Action: Remove unwanted vegetation.; Station_1: 84+00; Station_2: 44+00</p>

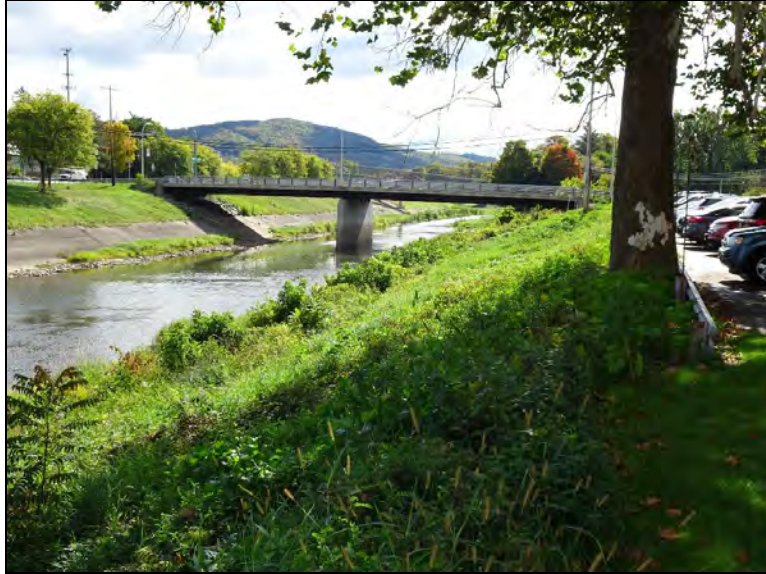
Inspect ID: N21L_2019_r_0103 **Title:** USACE_CELRB_N21L_2019_r_0103_1.jpg
Rated Item: 1. Vegetation and Obstructions **Caption:** Rating: Minimally Acceptable;
Remarks: Unwanted vegetation on left bank from State Street Bridge to 400'
downstream.; **Action:** Mow vegetation to 3"-6" height.; **Station_1:** 37+00

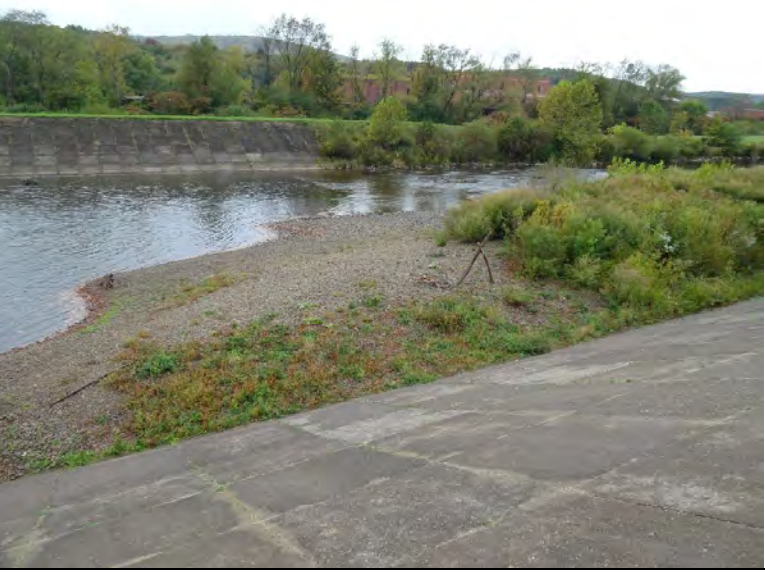
<p>Inspect ID: N21L_2019_r_0004 Title: USACE_CELRB_N21L_2019_r_0004_1.jpg Rated Item: 2. Shoaling (sediment deposition) Caption: Rating: Unacceptable; Remarks: Significant vegetated shoal (S-11) and trees in channel on right bank from 100'-700' downstream of upstream limit weir.; Action: Remove shoaling.; Station_1: 0+00</p>

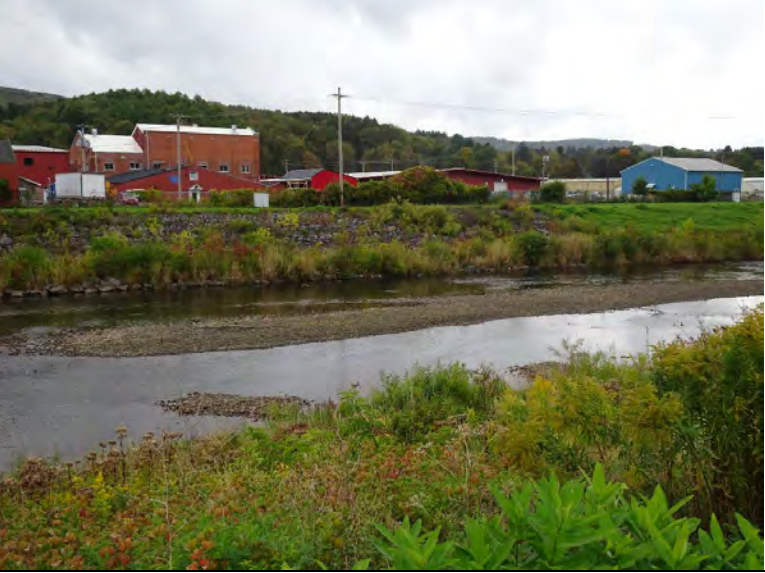
<p>Inspect ID: N21L_2019_r_0007 Title: USACE_CELRB_N21L_2019_r_0007_1.jpg Rated Item: 2. Shoaling (sediment deposition) Caption: Rating: Minimally Acceptable; Remarks: Minor shoaling (S-10) downstream of barrier levee weir.; Action: Remove shoal.; Station_1: 3+00</p>

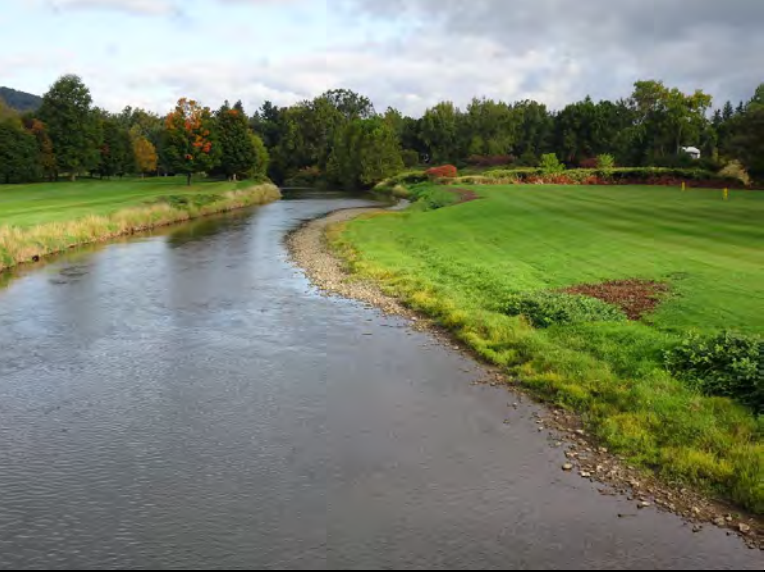
<p>Inspect ID: N21L_2019_r_0017 Title: USACE_CELRB_N21L_2019_r_0017_1.jpg Rated Item: 2. Shoaling (sediment deposition) Caption: Rating: Minimally Acceptable; Remarks: Grassy shoal (S-1) along right bank from 225' to 700' downstream of golf course pedestrian bridge.; Action: Remove shoaling.; Station_1: 111+00; Station_2: 106+00</p>

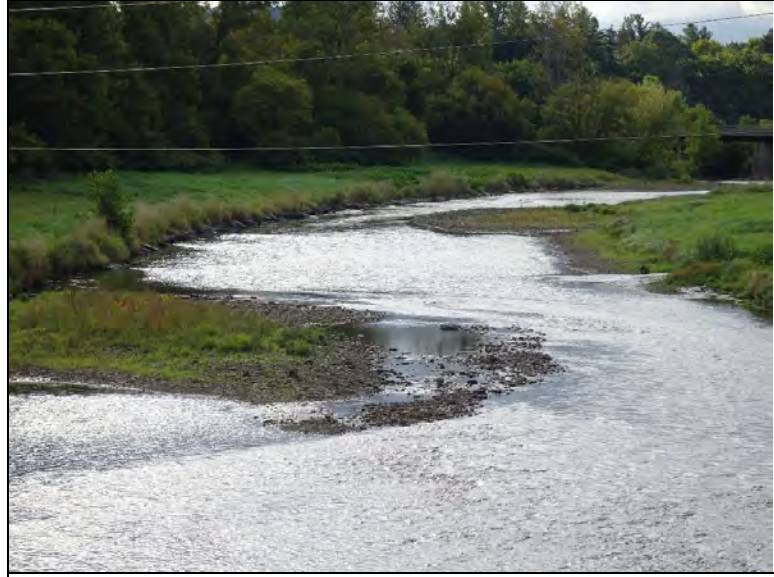
<p>Inspect ID: N21L_2019_r_0022 Title: USACE_CELRB_N21L_2019_r_0022_2.jpg Rated Item: 2. Shoaling (sediment deposition) Caption: Rating: Minimally Acceptable; Remarks: Four alternating vegetated shoals (S-2, S-3, S-4, S-5) on both banks from green golf course pedestrian bridge to Bolivar Road Bridge.; Action: Remove shoals.; Station_1: 103+00; Station_2: 92+00</p>

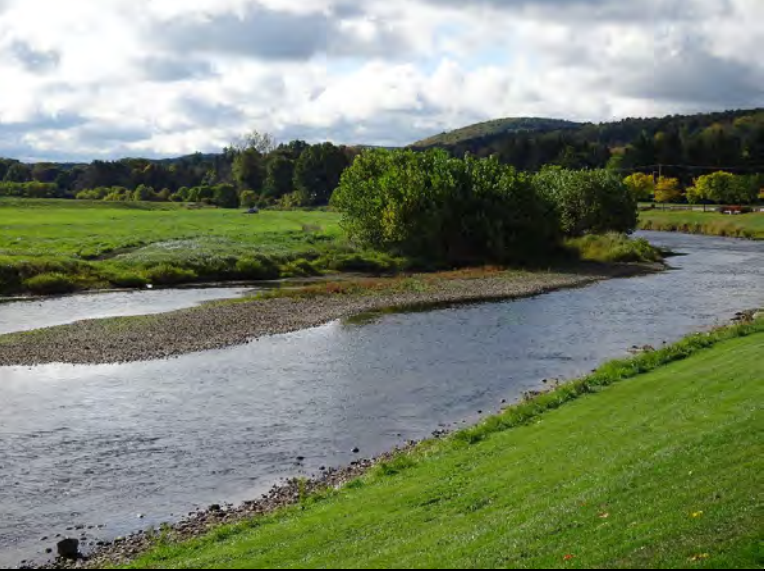
<p>Inspect ID: N21L_2019_r_0038 Title: USACE_CELRB_N21L_2019_r_0038_1.jpg Rated Item: 2. Shoaling (sediment deposition) Caption: Rating: Minimally Acceptable; Remarks: Shoaling (S-6) along right bank from 750' to 1,300' upstream of Bolivar Road bridge (near plaza).; Action: Remove shoaling.; Station_1: 83+00; Station_2: 78+00</p>

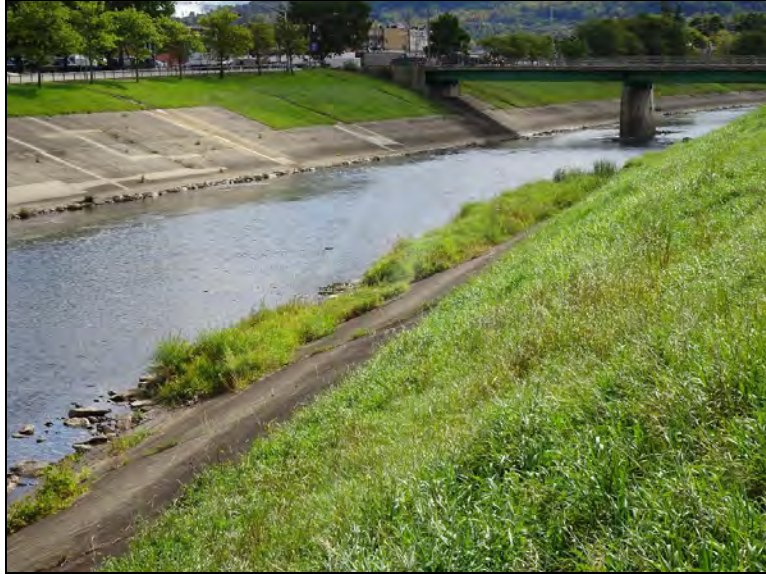
Inspect ID: N21L_2019_r_0086 **Title:** USACE_CELRB_N21L_2019_r_0086_1.jpg
Rated Item: 2. Shoaling (sediment deposition) **Caption:** Rating: Minimally Acceptable;
Remarks: Minor shoaling (S-8) along left bank channel toe from 600' downstream of Madison Street (Stevens Street) bridge to State Street bridge.; **Action:** Remove shoaling.;
Station_1: 49+00; **Station_2:** 0+00

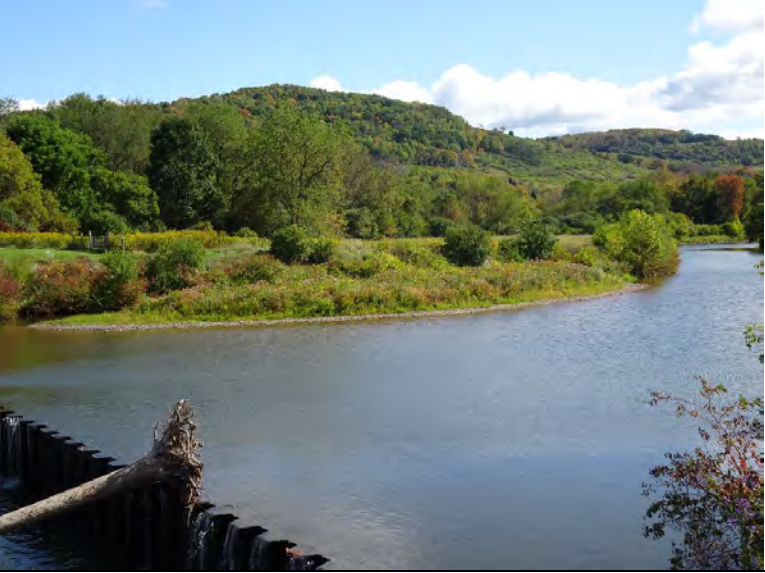
<p>Inspect ID: N21L_2019_r_0143 Title: USACE_CELRB_N21L_2019_r_0143_1.jpg Rated Item: 2. Shoaling (sediment deposition) Caption: Rating: Unacceptable; Remarks: Significant vegetated shoaling (S-12) on right bank from 50' to 225' upstream of upstream limit weir.; Action: Remove shoaling.; Station_1: 0+00; Station_2: 0+00</p>

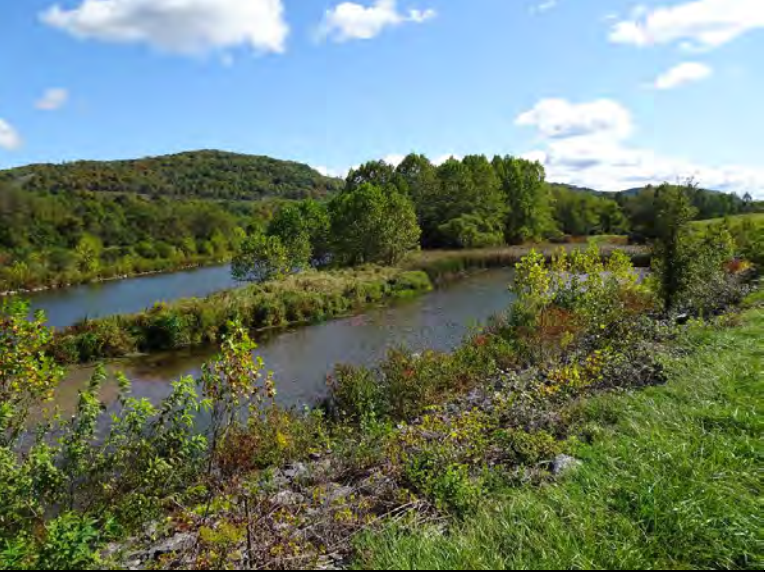
<p>Inspect ID: N21L_2019_r_0146 Title: USACE_CELRB_N21L_2019_r_0146_2.jpg Rated Item: 2. Shoaling (sediment deposition) Caption: Rating: Unacceptable; Remarks: Significant vegetated shoaling (S-13) with trees in center of channel just upstream of upstream limit weir.; Action: Remove shoaling.; Station_1: 0+00</p>

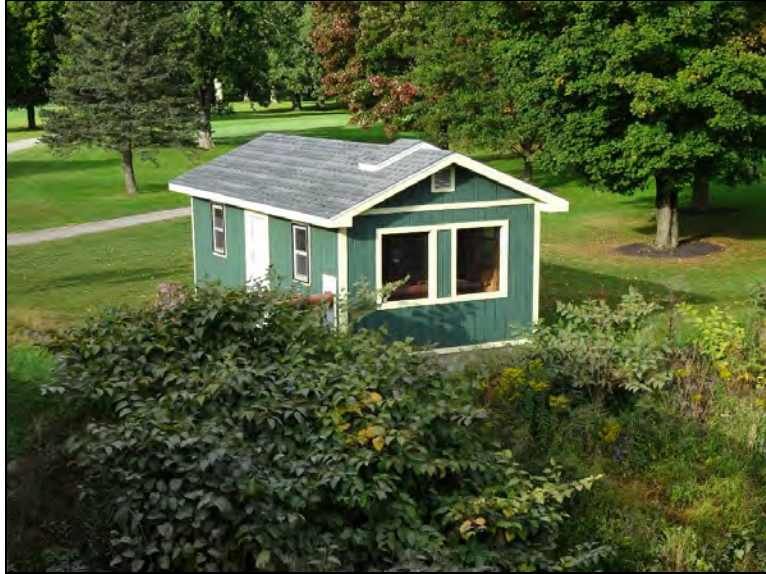
Inspect ID: N21L_2019_r_0020 **Title:** USACE_CELRB_N21L_2019_r_0020_1.jpg
Rated Item: 3. Encroachments **Caption:** Rating: Minimally Acceptable; Remarks: Unauthorized alteration (E-1): new pump station building, riprap, intake pipe to pump station, and feeder pipes for golf course water just downstream of pedestrian bridge.; Action: Submit Section 408 Alteration Request to USACE.; Station_1: 104+00

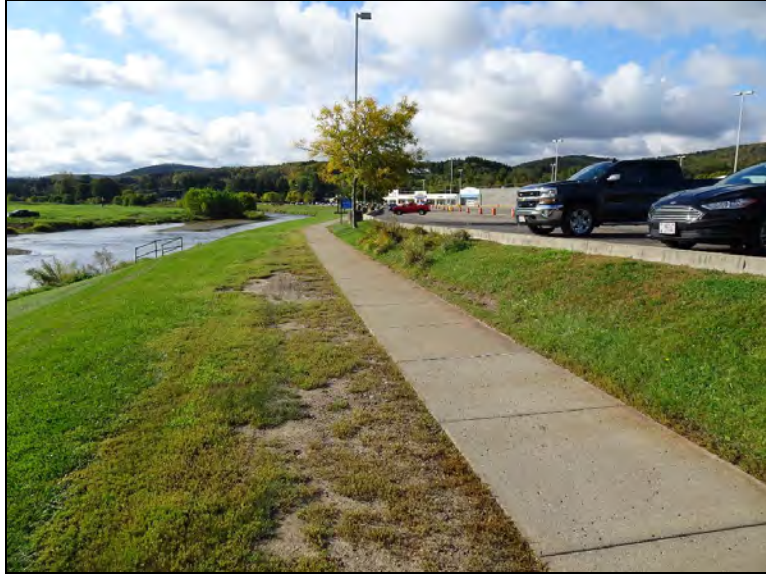
Inspect ID: N21L_2019_r_0033 **Title:** USACE_CELRB_N21L_2019_r_0033_1.jpg
Rated Item: 3. Encroachments **Caption:** Rating: Minimally Acceptable; Remarks: Unauthorized alteration (E-4): River Walk Trail encroachment (benches and lightposts are not encroachments) along left bank from Bolivar Road Bridge to 1,775 feet upstream of Bolivar Road Bridge.; Action: Submit Section 408 Alteration Request to USACE.; Station_1: 90+00; Station_2: 76+00

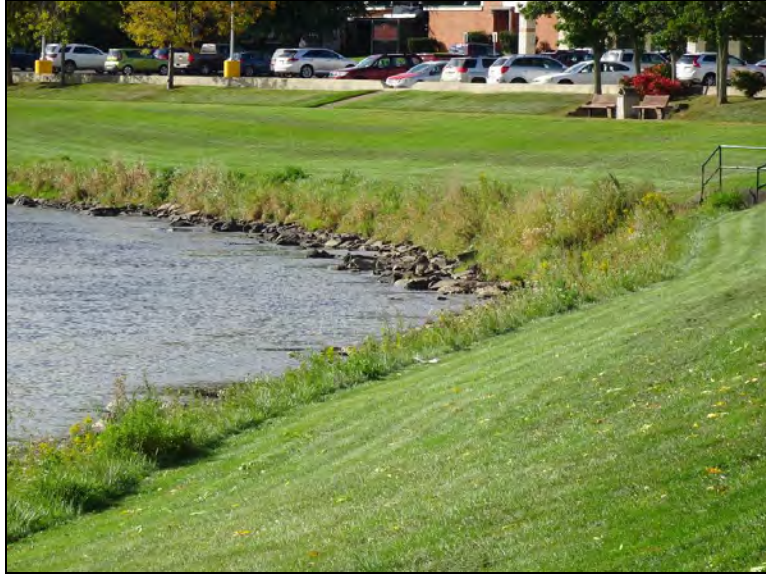
Inspect ID: N21L_2019_r_0037 **Title:** USACE_CELRB_N21L_2019_r_0037_1.jpg
Rated Item: 3. Encroachments **Caption:** Rating: Minimally Acceptable; Remarks: Unauthorized alteration (E-47a): Riprap added to left bank channel toe.; Action: Submit Section 408 Alteration Request to USACE.; Station_1: 84+00; Station_2: 68+00

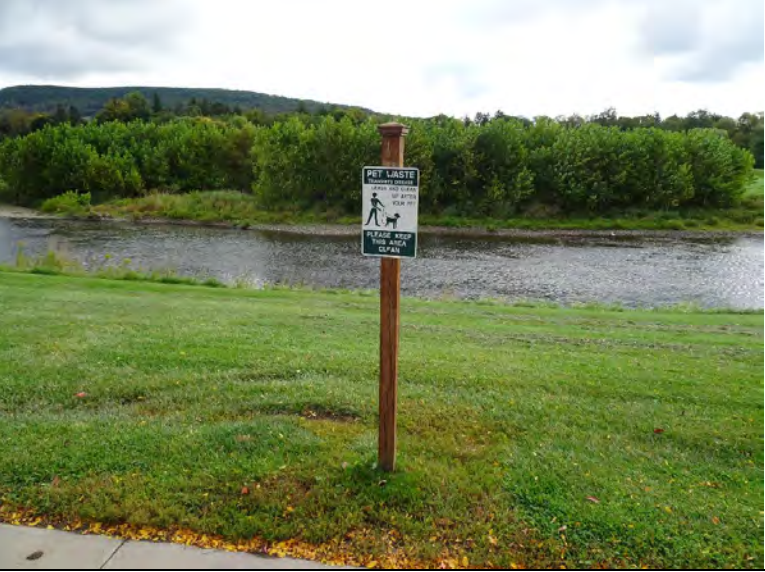
<p>Inspect ID: N21L_2019_r_0041 Title: USACE_CELRB_N21L_2019_r_0041_1.jpg Rated Item: 3. Encroachments Caption: Rating: Minimally Acceptable; Remarks: Unauthorized alteration (E-8): pet sign and post encroachment on left bank channel crest.; Action: Remove or submit Section 408 Alteration Request to USACE.; Station_1: 77+00</p>
 	<p>Inspect ID: N21L_2019_r_0042 Title: USACE_CELRB_N21L_2019_r_0042_1.jpg Rated Item: 3. Encroachments Caption: Rating: Minimally Acceptable; Remarks: Unauthorized alteration: 24" CMP encroachment on left bank 1,600' upstream of Bolivar Road bridge (just downstream of access drive).; Action: Submit Section 408 Alteration Request to USACE.; Station_1: 75+00</p>

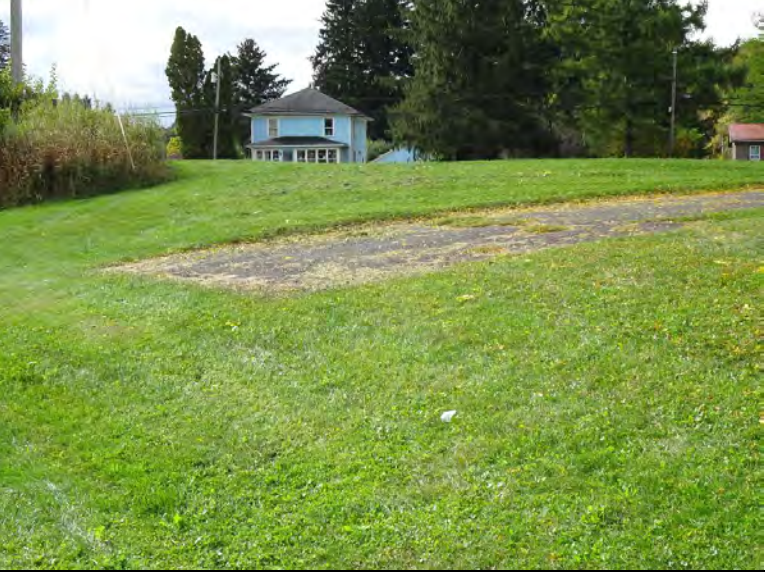
<p>Inspect ID: N21L_2019_r_0045 Title: USACE_CELRB_N21L_2019_r_0045_1.jpg Rated Item: 3. Encroachments Caption: Rating: Minimally Acceptable; Remarks: Unauthorized alteration (E-10): asphalt access drive and gate on left bank just downstream of Seneca Street.; Action: Submit Section 408 Alteration Request to USACE.; Station_1: 75+00</p>

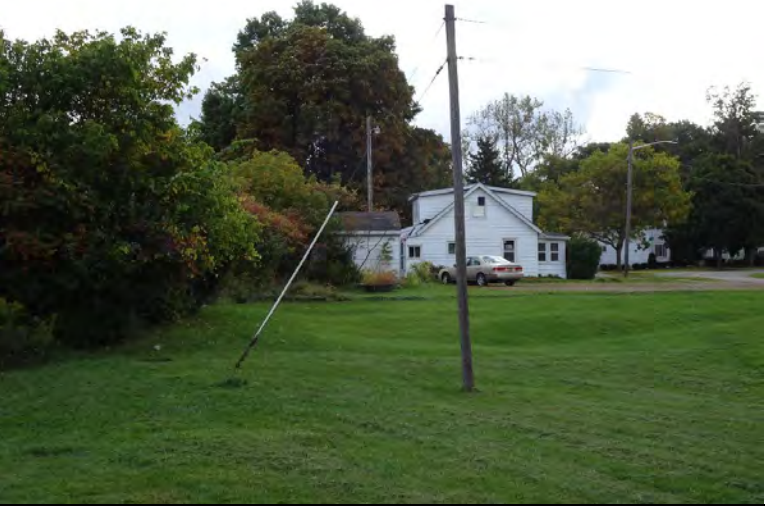
<p>Inspect ID: N21L_2019_r_0047 Title: USACE_CELRB_N21L_2019_r_0047_1.jpg Rated Item: 3. Encroachments Caption: Rating: Minimally Acceptable; Remarks: Unauthorized alteration (E-12): guy wire for utility pole on left bank channel crest at Seneca Street (utility pole not an encroachment).; Action: Submit Section 408 Alteration Request to USACE.; Station_1: 73+00</p>

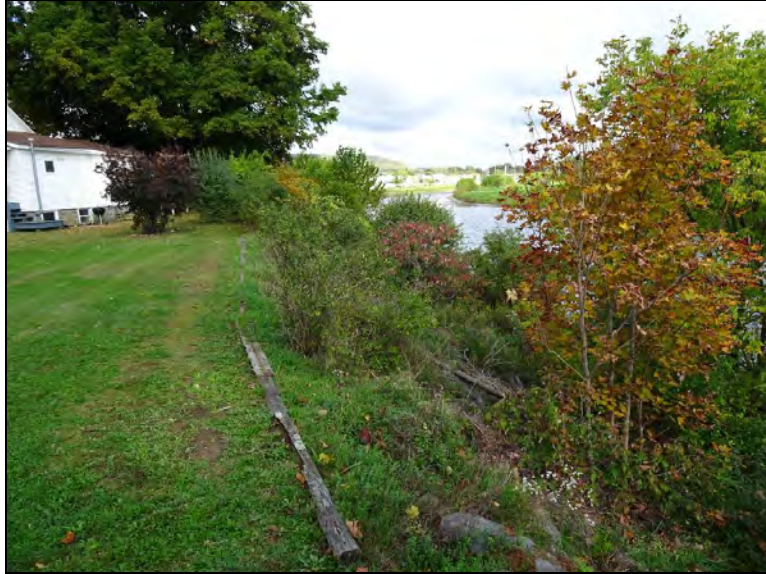
Inspect ID: N21L_2019_r_0050 **Title:** USACE_CELRB_N21L_2019_r_0050_1.jpg
Rated Item: 3. Encroachments **Caption:** Rating: Minimally Acceptable; Remarks: Unauthorized alteration (E-13): misc. landscaping timbers at 92 Seneca Street. ; Action: Remove or submit Section 408 Alteration Request to USACE.; Station_1: 72+00; Station_2: 69+00

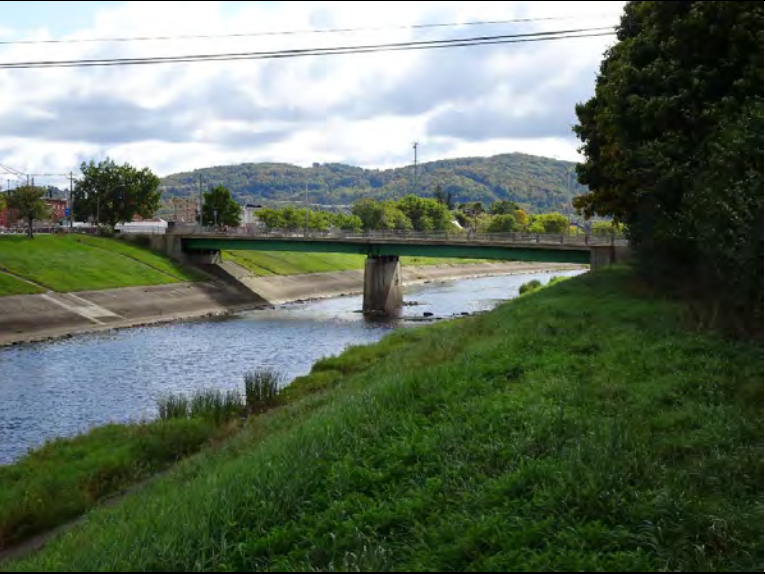
<p>Inspect ID: N21L_2019_r_0089 Title: USACE_CELRB_N21L_2019_r_0089_1.jpg Rated Item: 3. Encroachments Caption: Rating: Minimally Acceptable; Remarks: Unauthorized alteration (E-26): Pearl Street bridge removed.; Action: Submit Section 408 Alteration Request to USACE.; Station_1: 46+00</p>

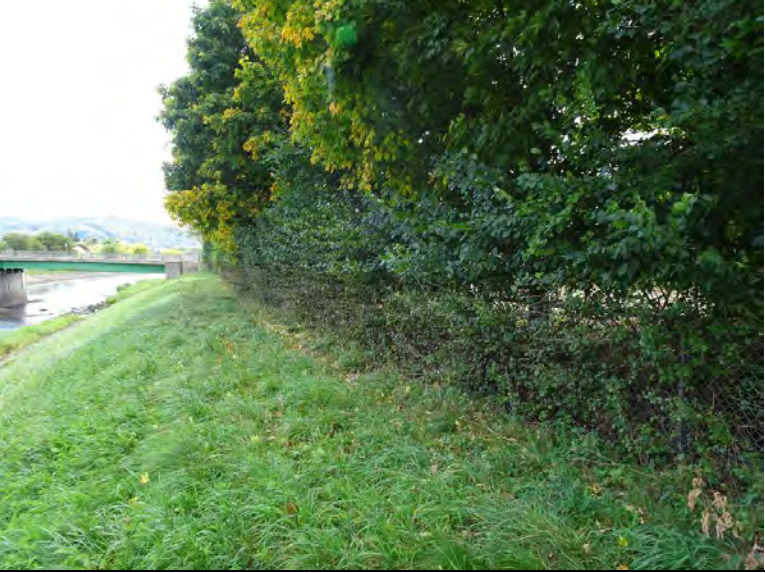
<p>Inspect ID: N21L_2019_r_0094 Title: USACE_CELRB_N21L_2019_r_0094_1.jpg Rated Item: 3. Encroachments Caption: Rating: Minimally Acceptable; Remarks: Unauthorized alteration (E-28): chain link fence on left bank channel crest from 250' downstream of Madison Street (Stevens Street) bridge to Madison Street bridge.; Action: Remove or submit Section 408 Alteration Request to USACE.; Station_1: 46+00; Station_2: 44+00</p>

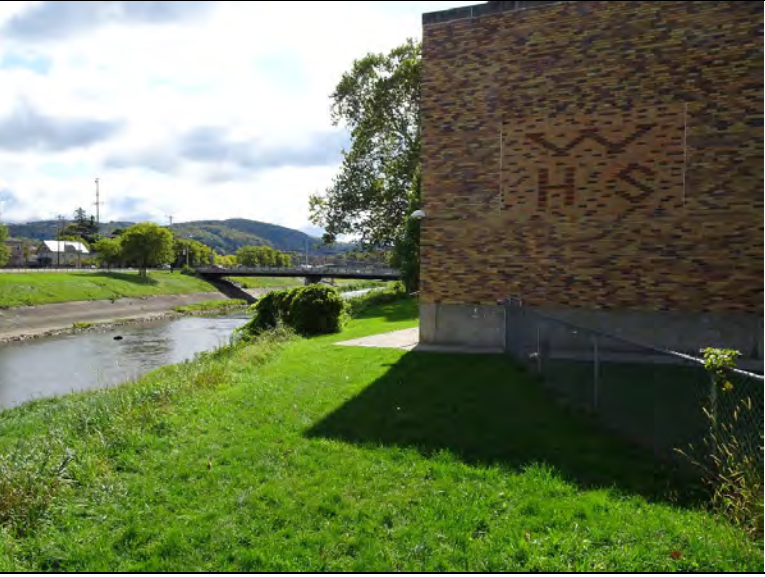
<p>Inspect ID: N21L_2019_r_0101 Title: USACE_CELRB_N21L_2019_r_0101_1.jpg Rated Item: 3. Encroachments Caption: Rating: Minimally Acceptable; Remarks: Unauthorized alteration (E-32): fence (covered in unwanted vegetation) 300' downstream of State Street bridge .; Action: Remove or submit Section 408 Alteration Request to USACE.; Station_1: 38+00</p>
 	<p>Inspect ID: N21L_2019_r_0102 Title: USACE_CELRB_N21L_2019_r_0102_1.jpg Rated Item: 3. Encroachments Caption: Rating: Minimally Acceptable; Remarks: Unauthorized alteration (E-33): Wellsville High School gaurdrail, parking lot, and 2 signs on left bank levee downstream of State Street bridge. Blocks O&M access, per NYSDEC.; Action: Remove or submit Section 408 Alteration Request to USACE.; Station_1: 37+00</p>

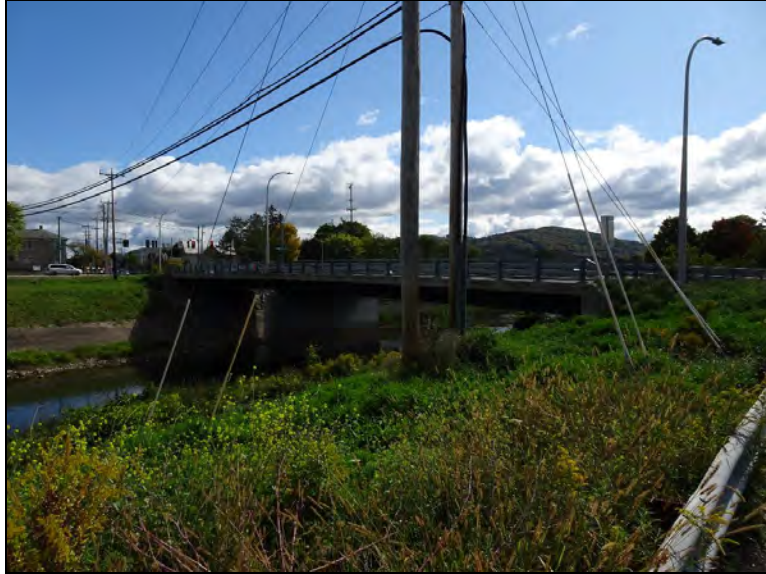
Inspect ID: N21L_2019_r_0104 **Title:** USACE_CELRB_N21L_2019_r_0104_1.jpg
Rated Item: 3. Encroachments **Caption:** Rating: Minimally Acceptable; Remarks: Unauthorized alteration (E-34): 2 utility poles 6 guy wires just downstream of State Street bridge (NYSDEC says permitted).; Action: Submit Section 408 Alteration Request to USACE.; Station_1: 35+00

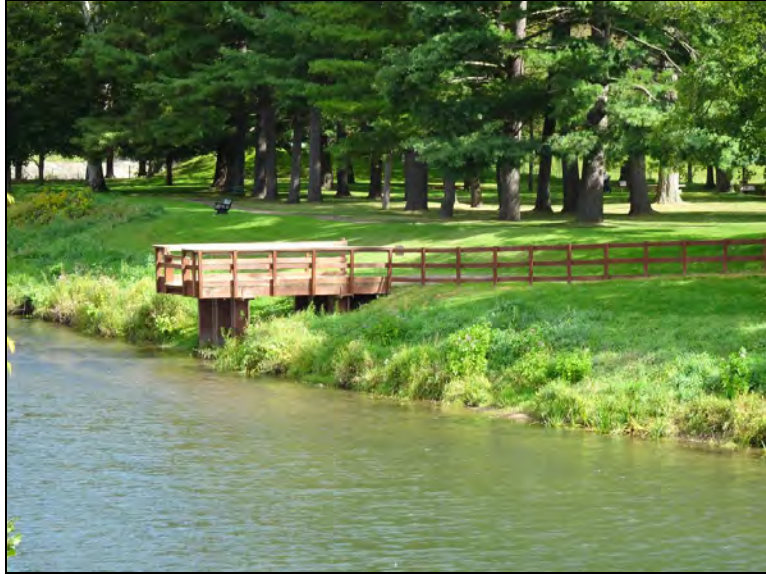
Inspect ID: N21L_2019_r_0118 **Title:** USACE_CELRB_N21L_2019_r_0118_1.jpg
Rated Item: 3. Encroachments **Caption:** Rating: Minimally Acceptable; Remarks: Unauthorized alteration (E-41): Wooden observation platform and fence on right bank 200' upstream of Steel Sheet Pile Weir.; Action: Submit Section 408 Alteration Request to USACE.; Station_1: 25+00

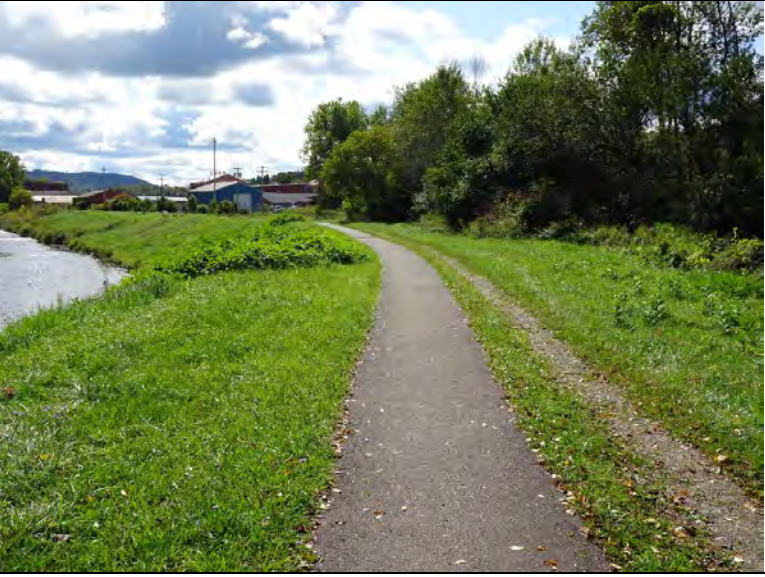
<p>Inspect ID: N21L_2019_r_0136 Title: USACE_CELRB_N21L_2019_r_0136_1.jpg Rated Item: 3. Encroachments Caption: Rating: Minimally Acceptable; Remarks: Unauthorized alteration (E-45): Wellsville, Addison, & Galetton Railroad gravel railway (from Island Park pedestrian bridge to barrier levee weir) and signs on left bank near stone blocks blocking access to channel crest.; Action: Submit Section 408 Alteration Request to USACE.; Station_1: 0+00; Station_2: 13+00</p>

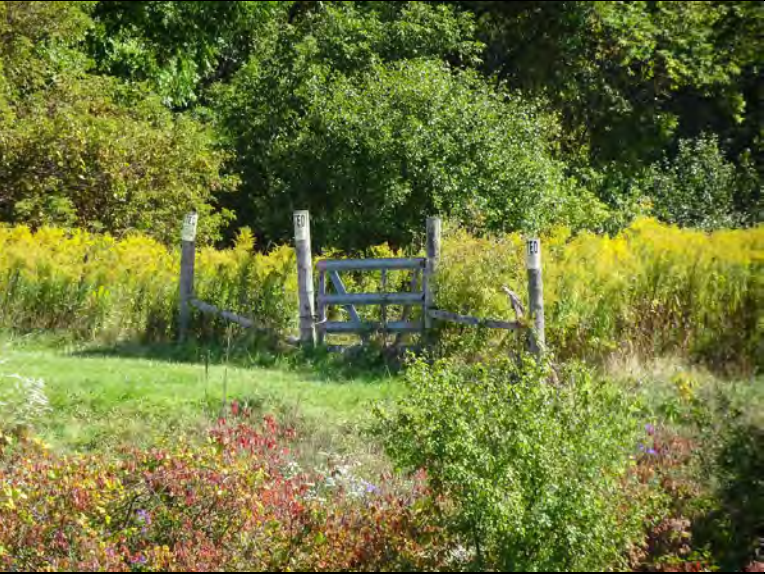
<p>Inspect ID: N21L_2019_r_0145 Title: USACE_CELRB_N21L_2019_r_0145_1.jpg Rated Item: 3. Encroachments Caption: Rating: Minimally Acceptable; Remarks: Unauthorized alteration (E-47): barbed wire fence and metal gate on right bank at upstream limit weir.; Action: Remove or submit Section 408 Alteration Request to USACE.; Station_1: 0+00</p>

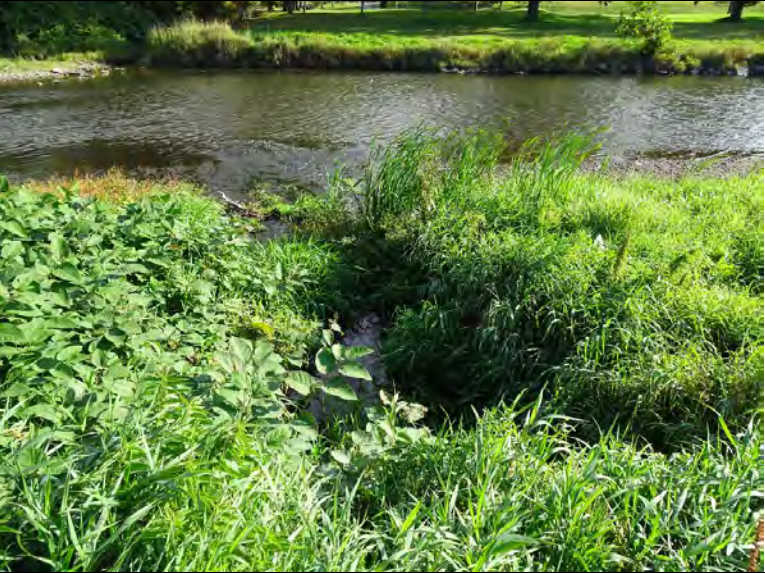
<p>Inspect ID: N21L_2019_r_0149 Title: USACE_CELRB_N21L_2019_r_0149_1.jpg Rated Item: 3. Encroachments Caption: Rating: Minimally Acceptable; Remarks: Unauthorized alteration: 36" culvert on left bank, 400' upstream of pedestrian bridge.; Action: Submit Section 408 Alteration Request to USACE.; Station_1: 100+00</p>

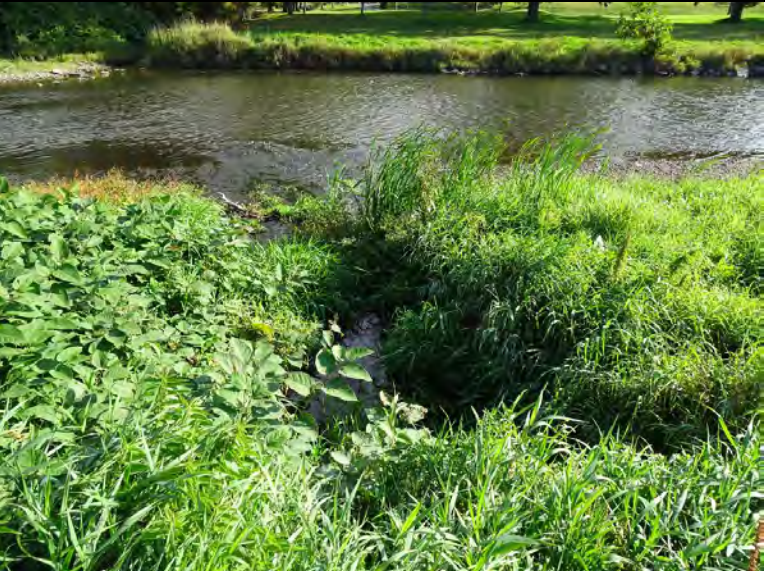
<p>Inspect ID: N21L_2019_r_0023 Title: USACE_CELRB_N21L_2019_r_0023_1.jpg Rated Item: 4. Erosion Caption: Rating: Minimally Acceptable; Remarks: Erosion at two outfalls on left bank, 400' upstream of pedestrian bridge.; Action: Repair erosion.; Station_1: 100+00</p>

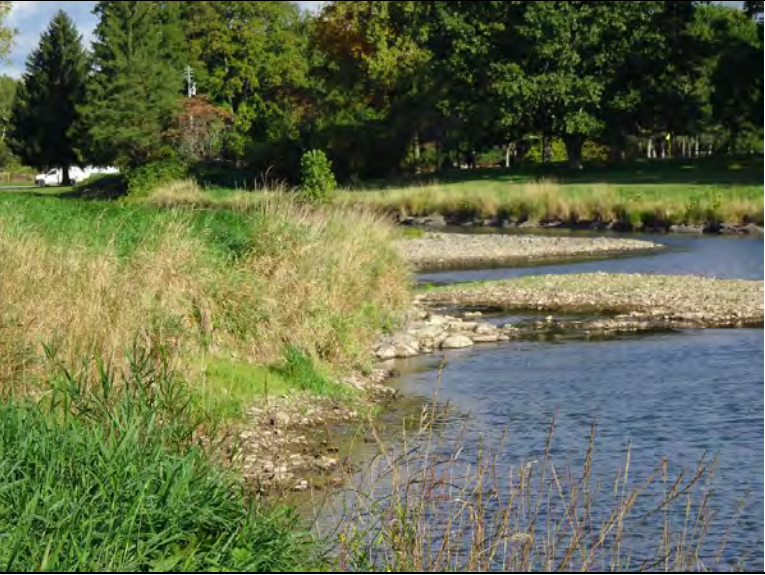
<p>Inspect ID: N21L_2019_r_0029 Title: USACE_CELRB_N21L_2019_r_0029_1.jpg Rated Item: 4. Erosion Caption: Rating: Minimally Acceptable; Remarks: Side slope erosion along left bank toe starting at Bolivar Road bridge and continuing 425' downstream.; Action: Repair erosion.; Station_1: 96+00; Station_2: 91+00</p>

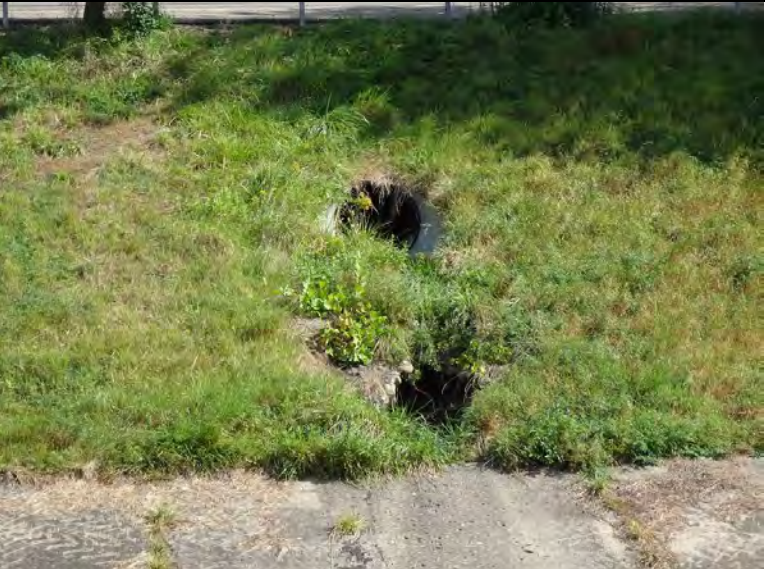
<p>Inspect ID: N21L_2019_r_0098 Title: USACE_CELRB_N21L_2019_r_0098_1.jpg Rated Item: 4. Erosion Caption: Rating: Minimally Acceptable; Remarks: Culvert on right bank, 280' upstream of the Madison Street Bridge, is causing an erosion pocket at the top of the concrete line channel.; Action: Repair erosion pocket and protect channel side slope from culvert discharge.; Station_1: 39+00</p>

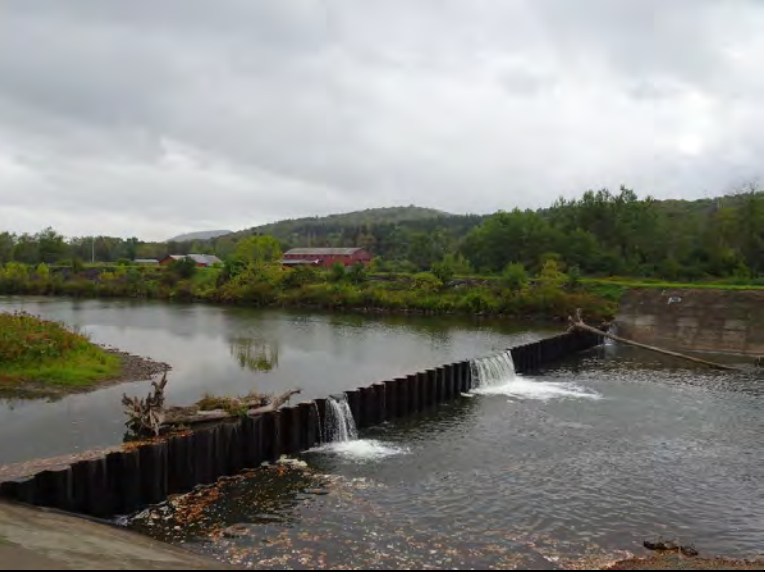
<p>Inspect ID: N21L_2019_r_0002 Title: USACE_CELRB_N21L_2019_r_0002_1.jpg Rated Item: 10. Riprap Revetments & Banks Caption: Rating: Unacceptable; Remarks: Trees and vegetation in riprap on left bank upstream and downstream of upstream limit weir.; Action: Remove trees and vegetation from riprap.; Station_1: 0+00; Station_2: 0+00</p>
