DEPARTMENT OF THE ARMY

BUFFALO DISTRICT, CORPS OF ENGINEERS
1776 NIAGARA STREET
BUFFALO, NEW YORK 14207-3199

SUBJECT: FY19 Joint Routine Inspection of Completed Works, Flood Risk Management Project, Genesee River and Dyke Creek, Wellsville, New York (09/23/19)

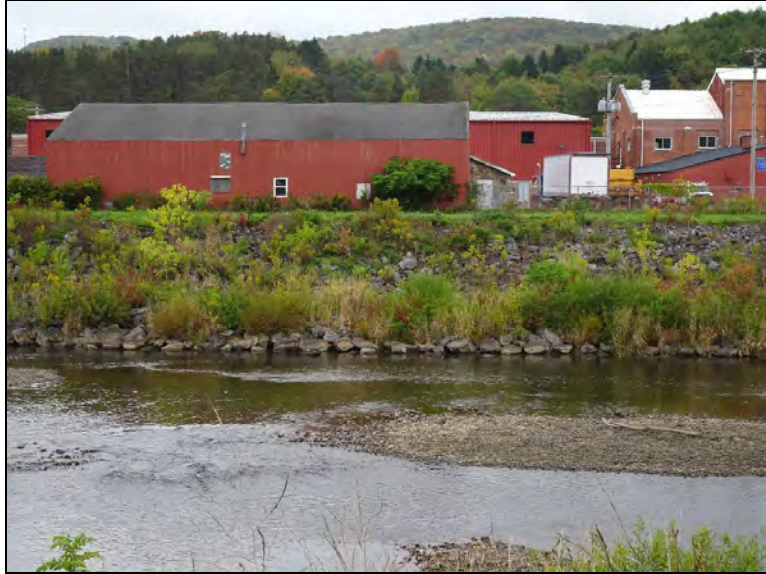
Inspect ID: N21L_2019_r_0006 **Title:** USACE_CELRB_N21L_2019_r_0006_1.jpg
Rated Item: 10. Riprap Revetments & Banks **Caption:** Rating: Minimally Acceptable;
Remarks: Woody vegetation in riprap on left bank from barrier levee weir to 550'
downstream.; **Action:** Remove woody vegetation from riprap.; **Station_1:** 6+00;
Station_2: 0+00

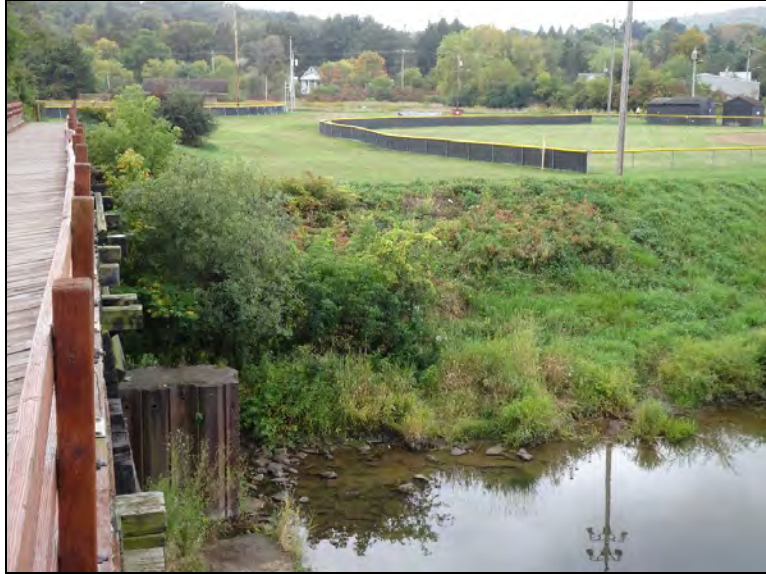
Inspect ID: N21L_2019_r_0011 **Title:** USACE_CELRB_N21L_2019_r_0011_2.jpg
Rated Item: 10. Riprap Revetments & Banks **Caption:** Rating: Minimally Acceptable;
Remarks: Trees and vegetation in riprap on left bank around both sides of Island Park Pedestrian Walkway Bridge; **Action:** Remove trees and vegetation from riprap.;
Station_1: 17+00; **Station_2:** 16+00

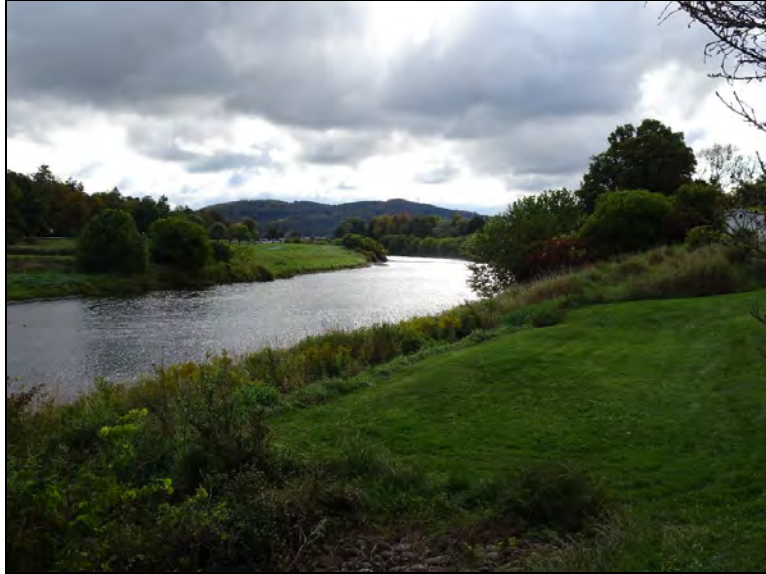
Inspect ID: N21L_2019_r_0049 **Title:** USACE_CELRB_N21L_2019_r_0049_1.jpg
Rated Item: 10. Riprap Revetments & Banks **Caption:** Rating: Unacceptable; Remarks: Vegetation in left bank riprap from Drop Structure to 500' downstream.; Action: Remove vegetation from riprap.; Station_1: 72+00; Station_2: 66+00

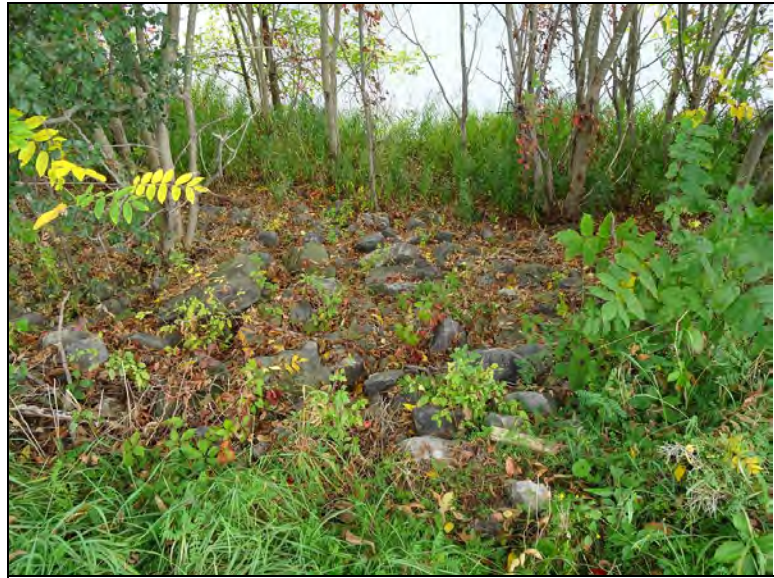
<p>Inspect ID: N21L_2019_r_0057 Title: USACE_CELRB_N21L_2019_r_0057_1.jpg Rated Item: 10. Riprap Revetments & Banks Caption: Rating: Unacceptable; Remarks: Trees and vegetation in riprap on left bank channel side slope from Drop Structure to 1,000' upstream.; Action: Remove trees and vegetation from riprap.; Station_1: 65+00; Station_2: 52+00</p>

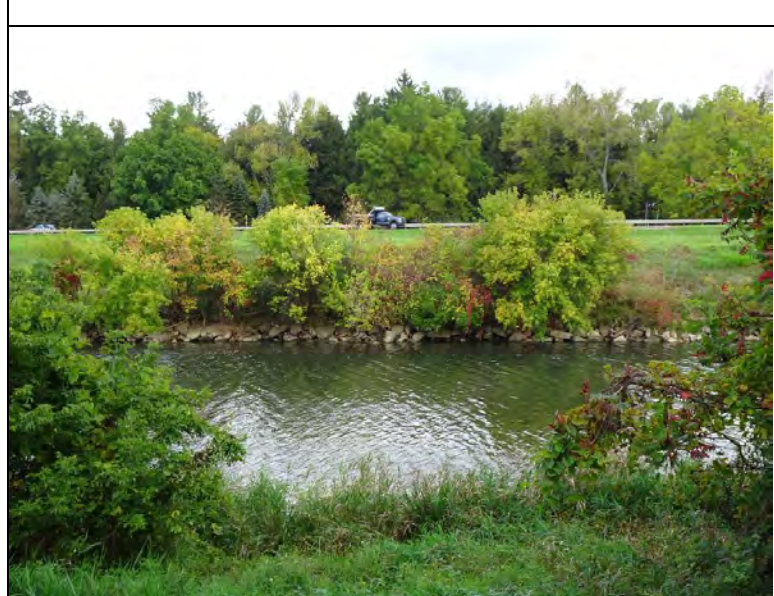
<p>Inspect ID: N21L_2019_r_0063 Title: USACE_CELRB_N21L_2019_r_0063_1.jpg Rated Item: 10. Riprap Revetments & Banks Caption: Rating: Minimally Acceptable; Remarks: Trees and vegetation in riprap on right bank from 1,600' to 1,300' downstream of Madison Street (Stevens Street) bridge.; Action: Remove trees and vegetation from riprap.; Station_1: 59+00; Station_2: 56+00</p>

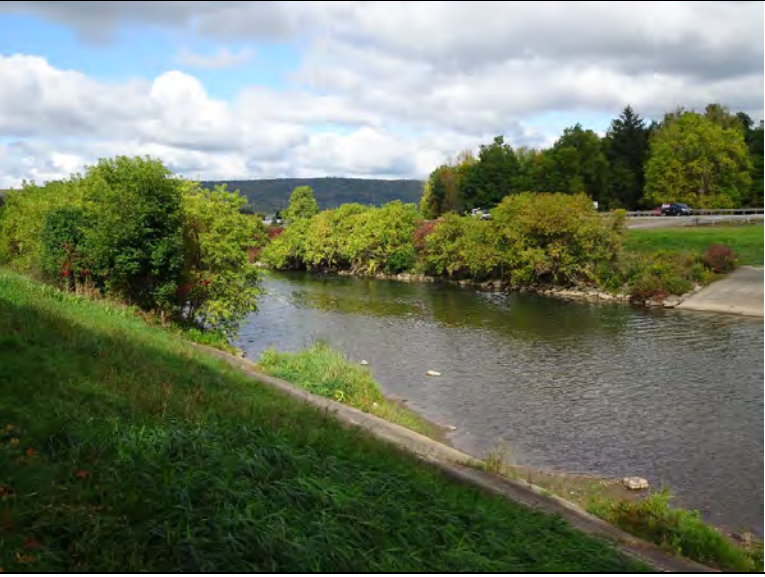
<p>Inspect ID: N21L_2019_r_0063 Title: USACE_CELRB_N21L_2019_r_0063_2.jpg Rated Item: 10. Riprap Revetments & Banks Caption: Rating: Minimally Acceptable; Remarks: Trees and vegetation in riprap on right bank from 1,600' to 1,300' downstream of Madison Street (Stevens Street) bridge.; Action: Remove trees and vegetation from riprap.; Station_1: 59+00; Station_2: 56+00</p>
