DEPARTMENT OF THE ARMY

BUFFALO DISTRICT, CORPS OF ENGINEERS
1776 NIAGARA STREET
BUFFALO, NEW YORK 14207-3199

SUBJECT: FY15 Joint Routine Inspection of Completed Works, Flood Damage Reduction Project, Genesee River and Dyke Creek, Wellsville, New York (09/10/15)

Attachment A –
Genesee River - Left Bank and Channel, Wellsville
Summary of Deficiencies and Recommendations

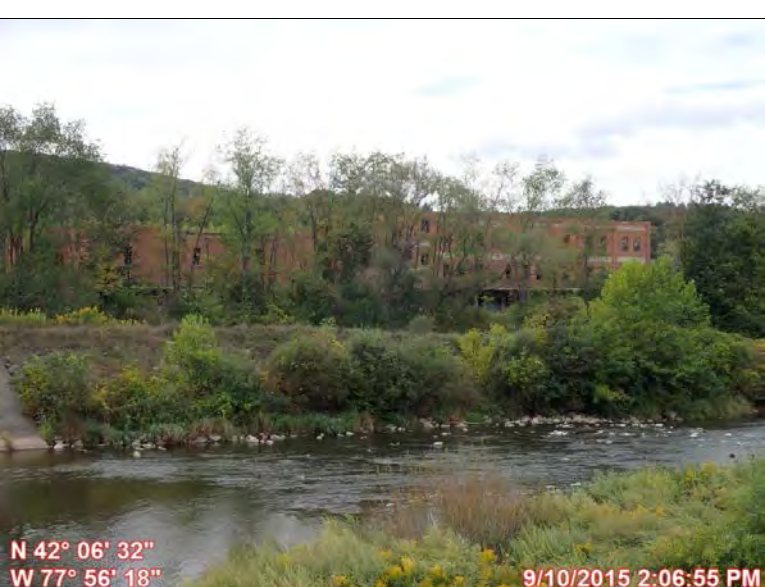
<p>N 42° 06' 32" W 77° 56' 18" 9/10/2015 2:06:55 PM</p>	<p>Inspect ID: N21L_2015_a_0118 Title: USACE_CELRB_N21L_2015_a_0118_2.jpg Rated Item: 1. Unwanted Vegetation Growth Caption: Rating: Unacceptable; Remarks: Significant vegetation in riprap on left bank upstream and downstream of 1976 Weir.; Action: Remove vegetation from riprap.; Station_1: 0+00; Station_2: 0+00</p>

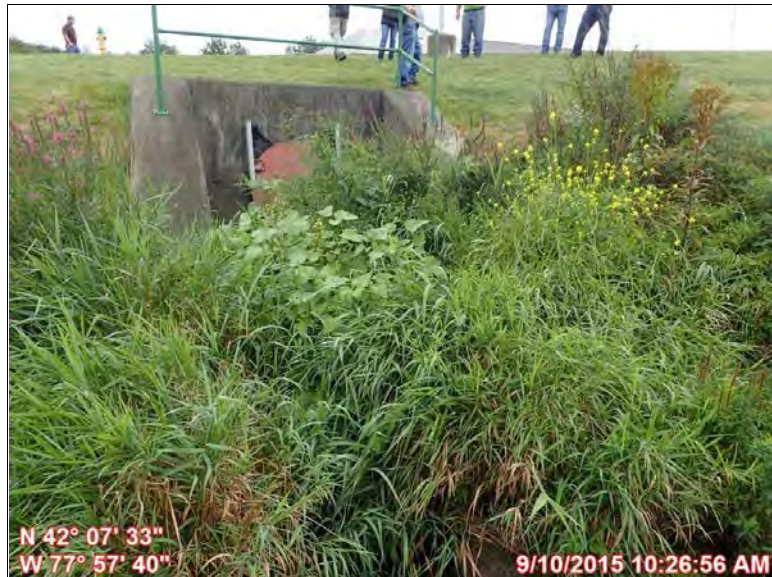
Inspect ID: N21L_2015_a_0021 **Title:** USACE_CELRB_N21L_2015_a_0021_1.jpg
Rated Item: 1. Vegetation and Obstructions **Caption:** Rating: Minimally Acceptable;
Remarks: Soft unwanted vegetation obstructing outfall on left bank 900' upstream of Bolivar Road bridge.; Action: Remove unwanted vegetation.; Station_1: 82+00

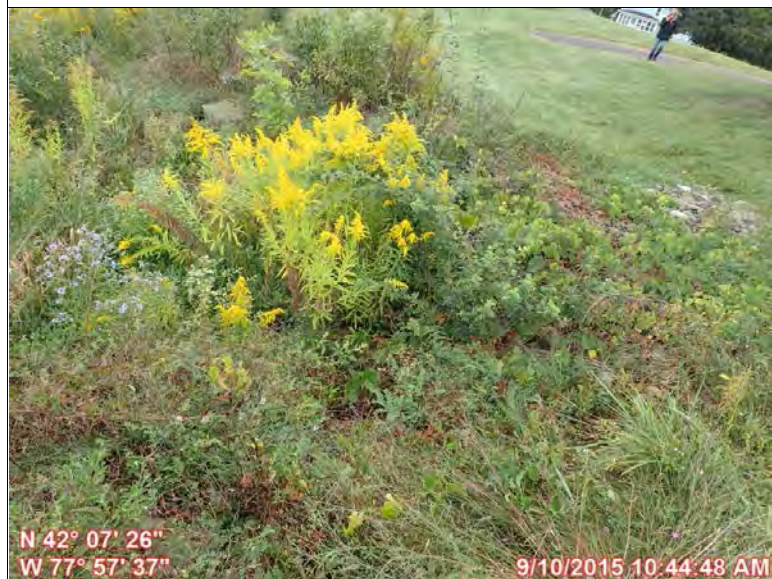
Inspect ID: N21L_2015_a_0023 **Title:** USACE_CELRB_N21L_2015_a_0023_1.jpg
Rated Item: 1. Vegetation and Obstructions **Caption:** Rating: Minimally Acceptable;
Remarks: 30" CMP outfall on left bank 1,600' upstream of Bolivar Road bridge is 20% obstructed by minor sediment.; Action: Remove sediment obstruction.; Station_1: 75+00

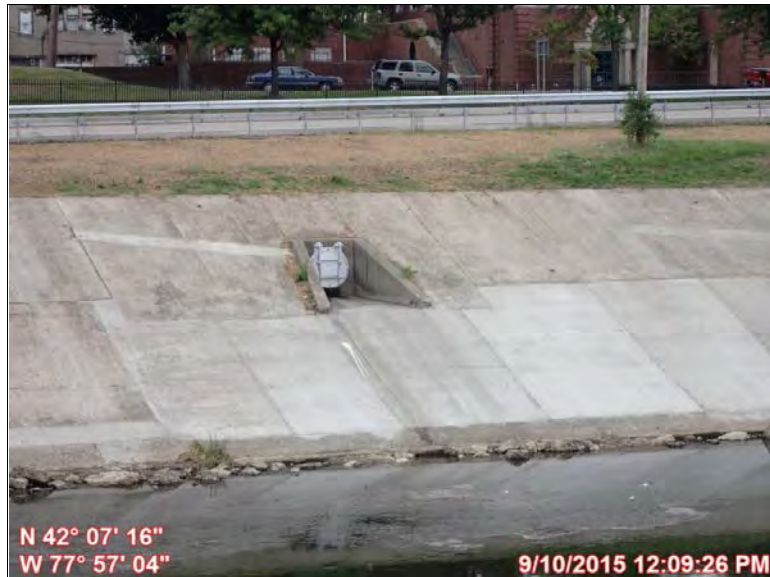
Inspect ID: N21L_2015_a_0063 **Title:** USACE_CELRB_N21L_2015_a_0063_1.jpg
Rated Item: 5. Concrete Surfaces (Such as gate wells, outfalls, intakes, or culverts)
Caption: Rating: Acceptable; Remarks: Large erosion hole under concrete slope @ 36" outfall on right bank repaired on right bank 400' downstream of Madison Street (Stevens Street) bridge.; Action: NA; Station_1: 47+00

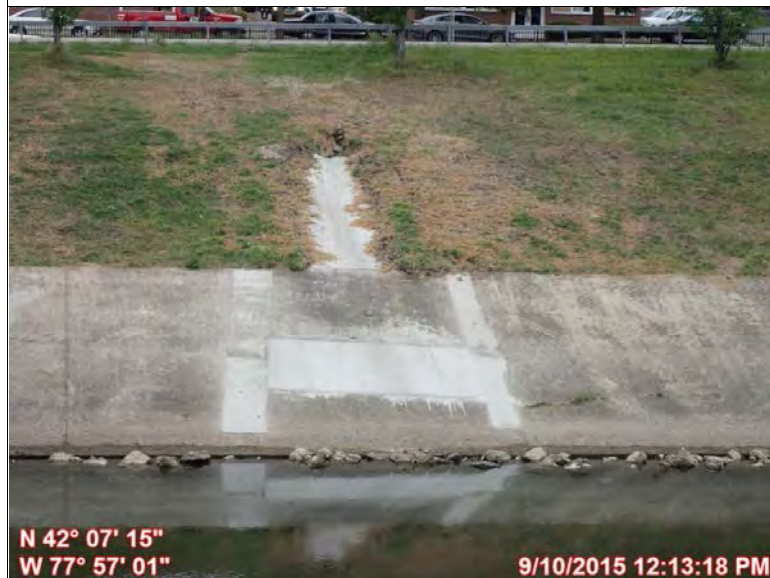
Inspect ID: N21L_2015_a_0068 **Title:** USACE_CELRB_N21L_2015_a_0068_1.jpg
Rated Item: 9. Culverts/ Discharge Pipes **Caption:** Rating: Acceptable; Remarks: 12" CMP repaired on right bank 250' downstream of Madison Street (Stevens Street) bridge.; Action: NA; Station_1: 44+00

(4) Replaced rusted 12” CMP outfall and repaired eroded outfall channel (Photos 68 & 69).

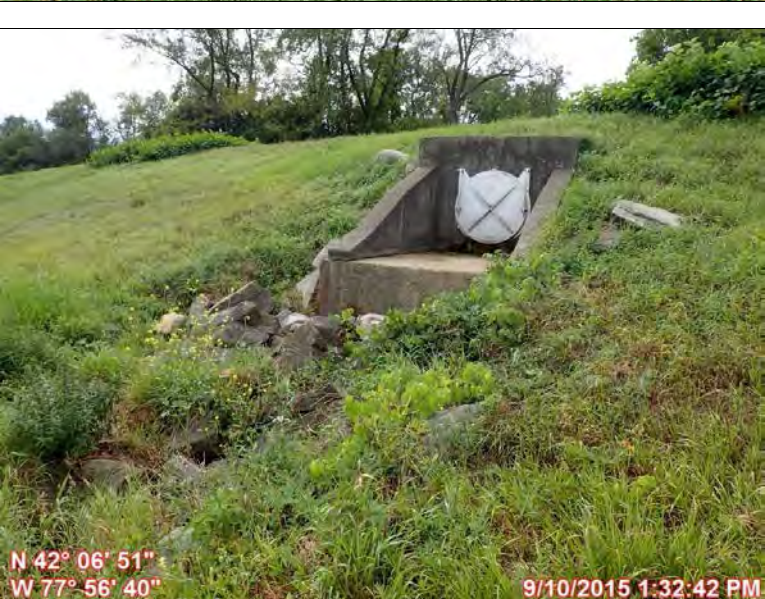
<p>N 42° 06' 51" W 77° 56' 40" 9/10/2015 1:32:42 PM</p>	<p>Inspect ID: N21L_2015_a_0100 Title: USACE_CELRB_N21L_2015_a_0100_1.jpg Rated Item: 9. Culverts/ Discharge Pipes Caption: Rating: Acceptable; Remarks: 42" CMP outfall on left bank 325' upstream of Island Park Pedestrian Walkway Bridge (rated A in NYSDEC 19DEC13 pipe inspection).; Action: Maintain pipe and videotape inspect by 19DEC18.; Station_1: 13+00</p>

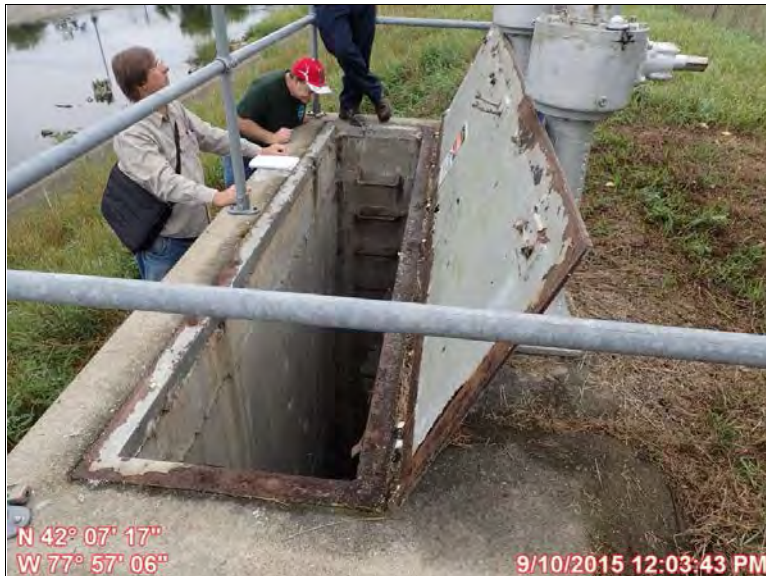
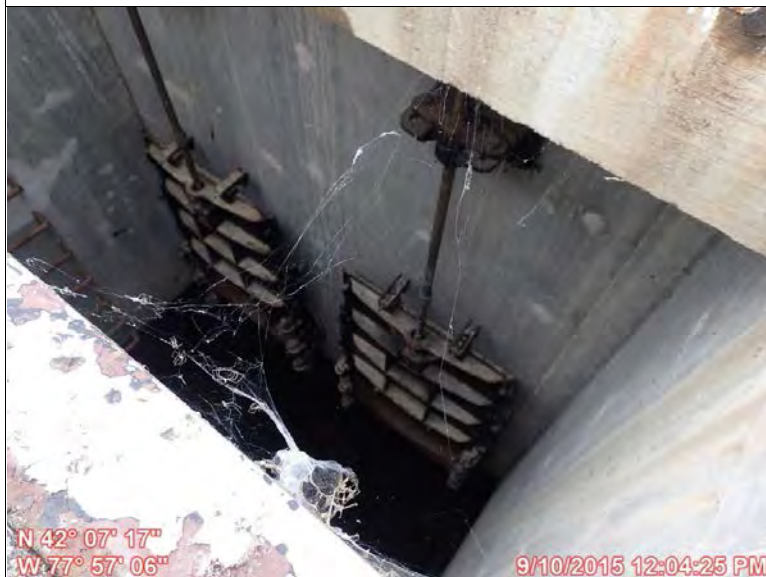
Inspect ID: N21L_2015_a_0059 **Title:** USACE_CELRB_N21L_2015_a_0059_1.jpg
Rated Item: 10. Sluice/ Slide Gates **Caption:** Rating: Acceptable; Remarks: Sluice gate on left bank 550' downstream of Madison Street (Stevens Street) bridge in good condition.; Action: NA; Station_1: 49+00

Inspect ID: N21L_2015_a_0059 **Title:** USACE_CELRB_N21L_2015_a_0059_2.jpg
Rated Item: 10. Sluice/ Slide Gates **Caption:** Rating: Acceptable; Remarks: Sluice gate on left bank 550' downstream of Madison Street (Stevens Street) bridge in good condition.; Action: NA; Station_1: 49+00

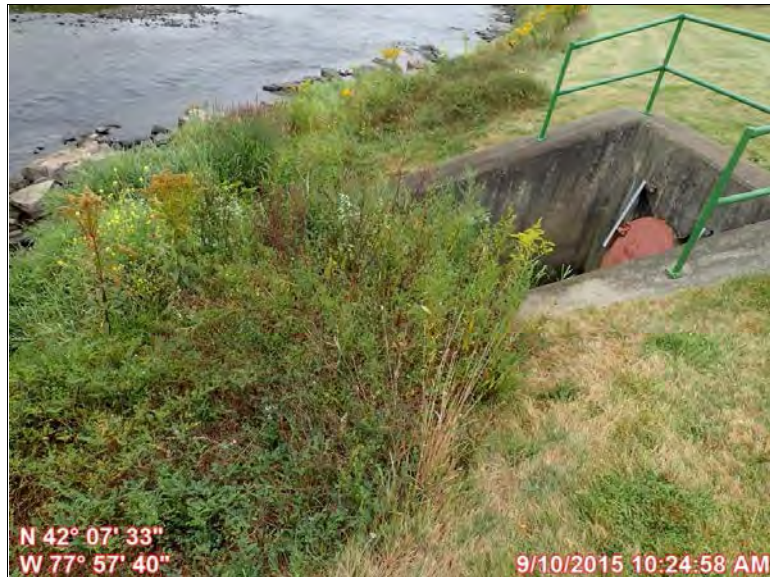
Inspect ID: N21L_2015_a_0019 **Title:** USACE_CELRB_N21L_2015_a_0019_1.jpg
Rated Item: 11. Flap Gates/ Flap Valves/ Pinch Valves **Caption:** Rating: Acceptable;
Remarks: 42" flap gate on left bank 900' upstream of Bolivar Road bridge exercised.;
Action: NA; Station_1: 82+00

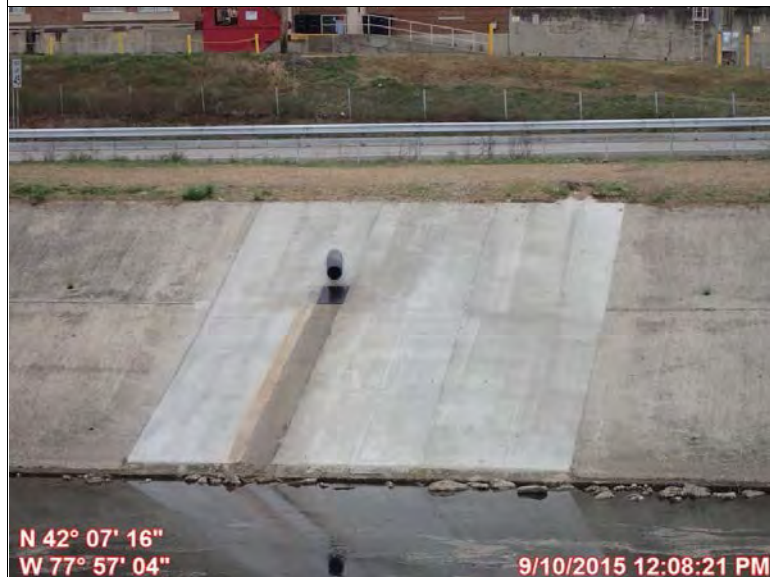
Inspect ID: N21L_2015_a_0061 **Title:** USACE_CELRB_N21L_2015_a_0061_1.jpg
Rated Item: 14. Riprap Revetments of Inlet/ Discharge Areas **Caption:** Rating:
Acceptable; Remarks: Rusty 12" CMP and eroded concrete repaired on right bank 475'
downstream of Madison Street (Stevens Street) bridge.; Action: NA; Station_1: 48+00

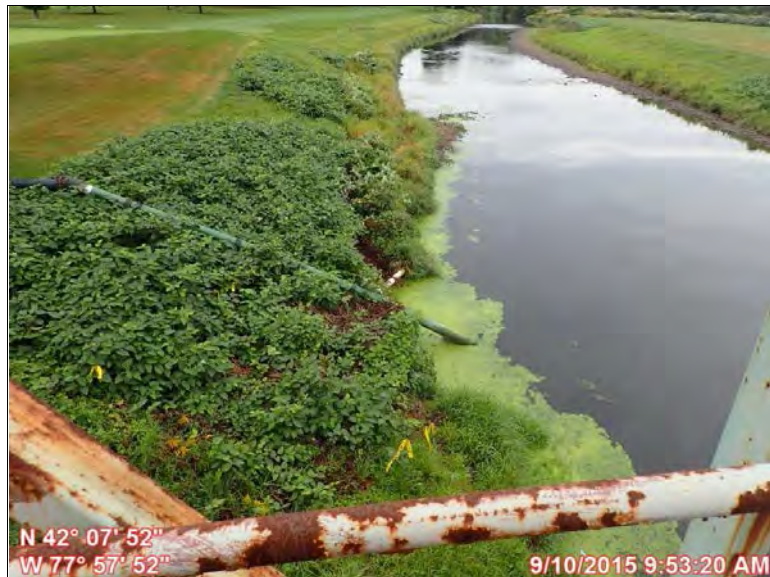
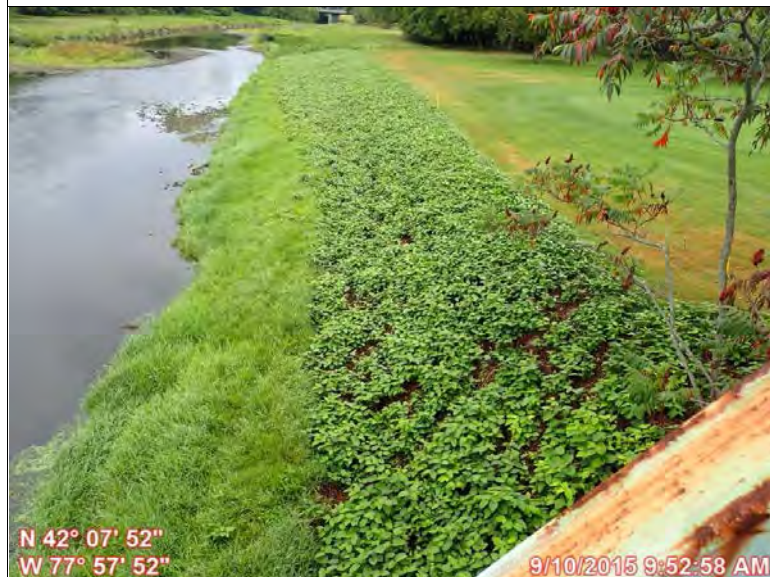
Inspect ID: N21L_2015_a_0005 **Title:** USACE_CELRB_N21L_2015_a_0005_1.jpg
Rated Item: 1. Vegetation and Obstructions **Caption:** Rating: Minimally Acceptable;
Remarks: Soft vegetation on both banks upstream and downstream of the golf course pedestrian bridge.; Action: Remove unwanted vegetation.; Station_1: 116+00; Station_2: 92+00

Inspect ID: N21L_2015_a_0005 **Title:** USACE_CELRB_N21L_2015_a_0005_2.jpg
Rated Item: 1. Vegetation and Obstructions **Caption:** Rating: Minimally Acceptable;
Remarks: Soft vegetation on both banks upstream and downstream of the golf course pedestrian bridge.; Action: Remove unwanted vegetation.; Station_1: 116+00; Station_2: 92+00

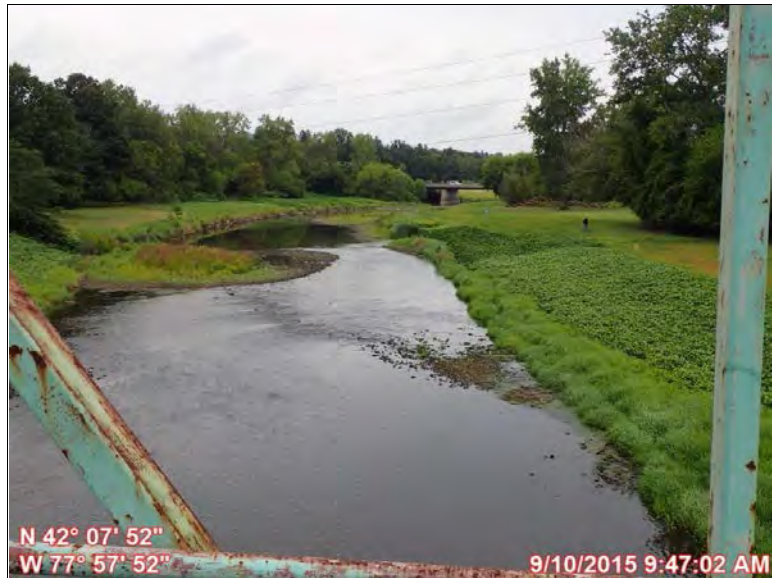
Inspect ID: N21L_2015_a_0008 **Title:** USACE_CELRB_N21L_2015_a_0008_1.jpg
Rated Item: 1. Vegetation and Obstructions **Caption:** Rating: Minimally Acceptable;
Remarks: Soft vegetation and woody growth on right bank from 300' upstream of golf course pedestrian bridge to Bolivar Road bridge.; Action: Remove unwanted vegetation.;
Station_1: 100+00; Station_2: 92+00

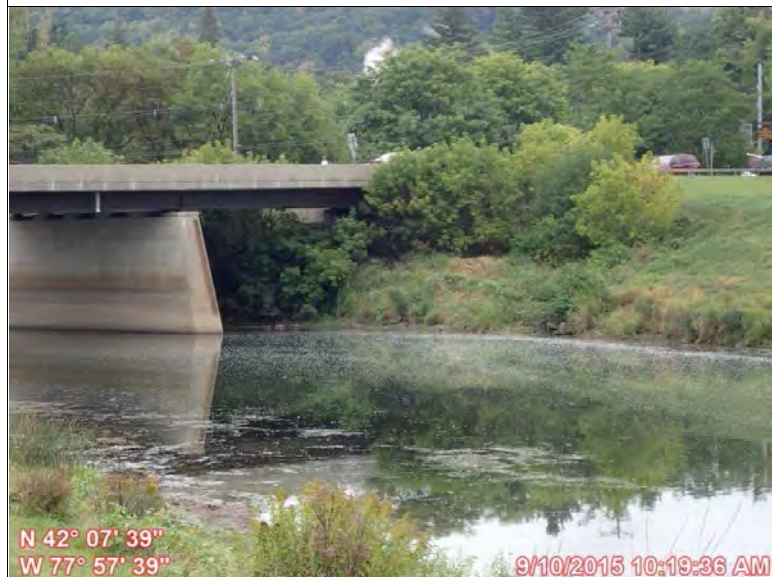
Inspect ID: N21L_2015_a_0015 **Title:** USACE_CELRB_N21L_2015_a_0015_1.jpg
Rated Item: 1. Vegetation and Obstructions **Caption:** Rating: Minimally Acceptable;
Remarks: Unwanted heavy wooded vegetation on both banks around Bolivar Road bridge.; Action: Remove unwanted vegetation.; Station_1: 91+00

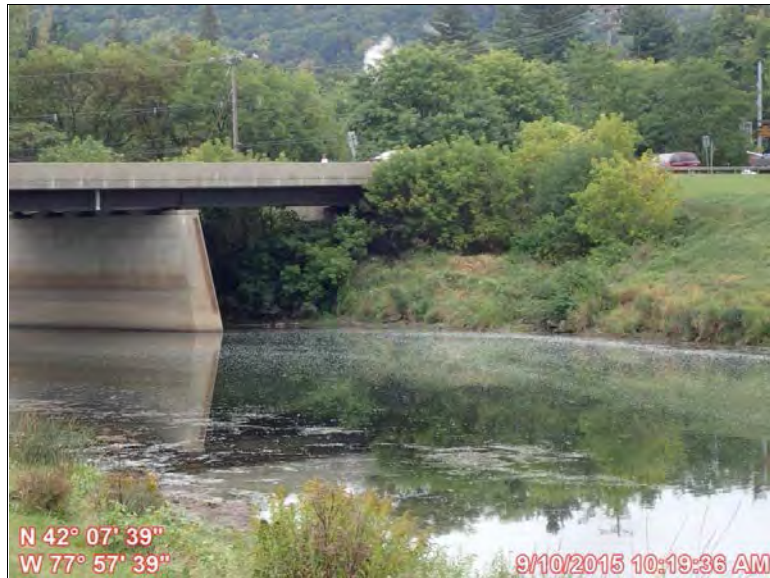
Inspect ID: N21L_2015_a_0016 **Title:** USACE_CELRB_N21L_2015_a_0016_1.jpg
Rated Item: 1. Vegetation and Obstructions **Caption:** Rating: Minimally Acceptable;
Remarks: Vegetation in riprap on right bank around Bolivar Road bridge.; **Action:** Remove vegetation from riprap.; **Station_1:** 91+00

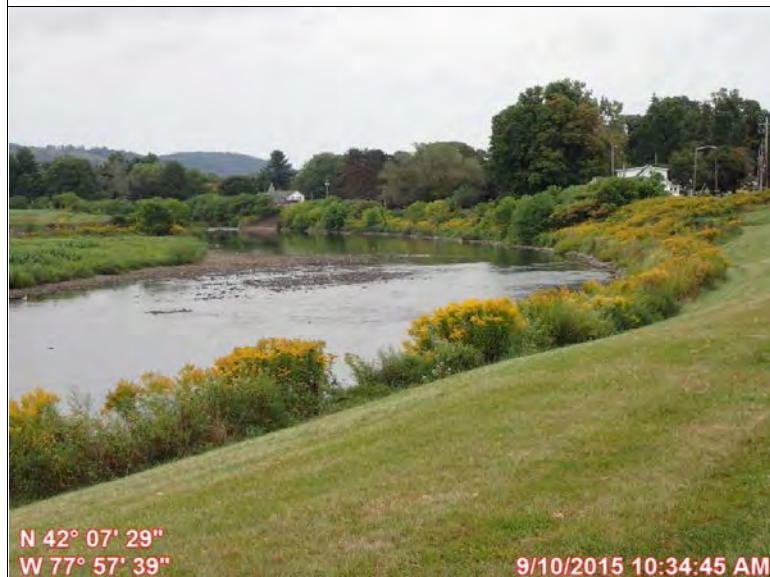
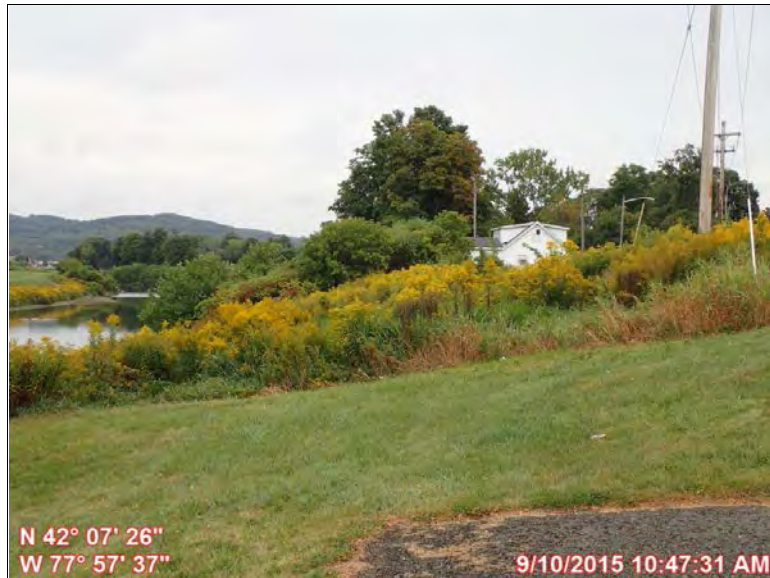
Inspect ID: N21L_2015_a_0022 **Title:** USACE_CELRB_N21L_2015_a_0022_1.jpg
Rated Item: 1. Vegetation and Obstructions **Caption:** Rating: Minimally Acceptable;
Remarks: Unwanted vegetation on both bank sideslopes from 750' upstream of Bolivar Road bridge to Madison Street bridge.; **Action:** Remove unwanted vegetation.; **Station_1:** 84+00; **Station_2:** 44+00

Inspect ID: N21L_2015_a_0022 **Title:** USACE_CELRB_N21L_2015_a_0022_2.jpg
Rated Item: 1. Vegetation and Obstructions **Caption:** Rating: Minimally Acceptable;
Remarks: Unwanted vegetation on both bank sideslopes from 750' upstream of Bolivar Road bridge to Madison Street bridge.; Action: Remove unwanted vegetation.; Station_1: 84+00; Station_2: 44+00

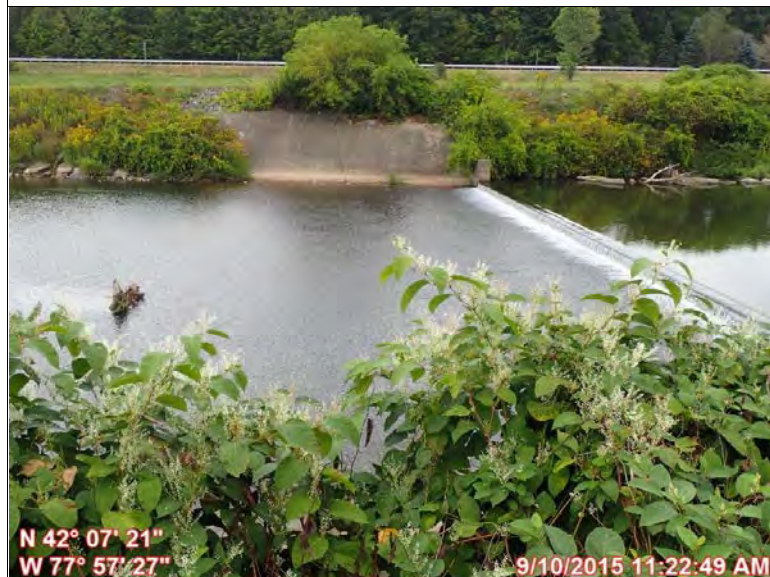
Inspect ID: N21L_2015_a_0032 **Title:** USACE_CELRB_N21L_2015_a_0032_1.jpg
Rated Item: 1. Vegetation and Obstructions **Caption:** Rating: Minimally Acceptable;
Remarks: Tree debris in channel just downstream of Drop Structure.; Action: Remove tree debris.; Station_1: 66+00

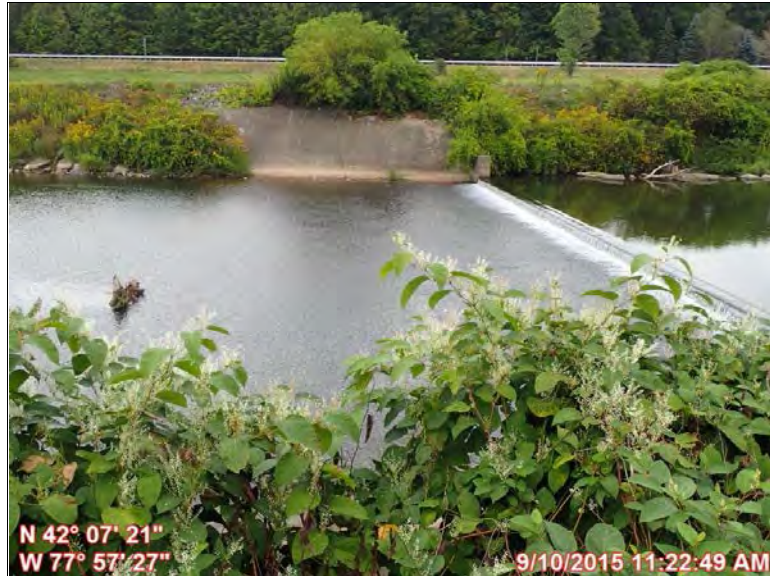
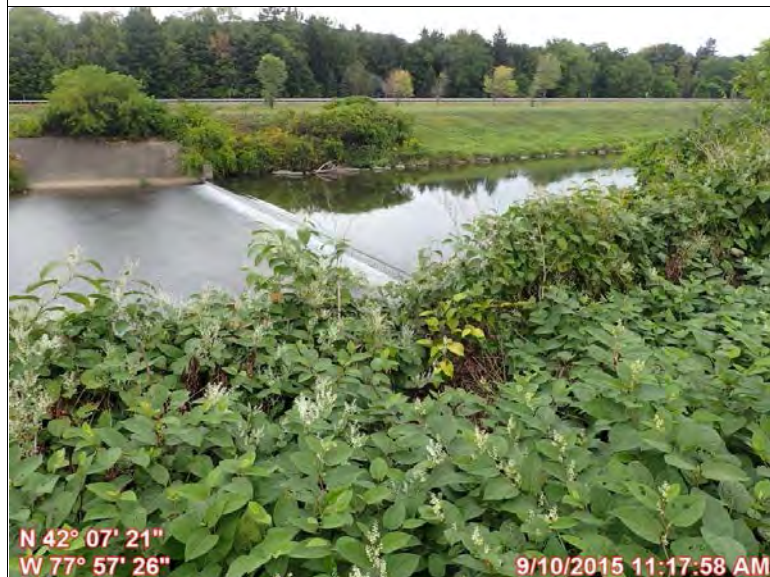
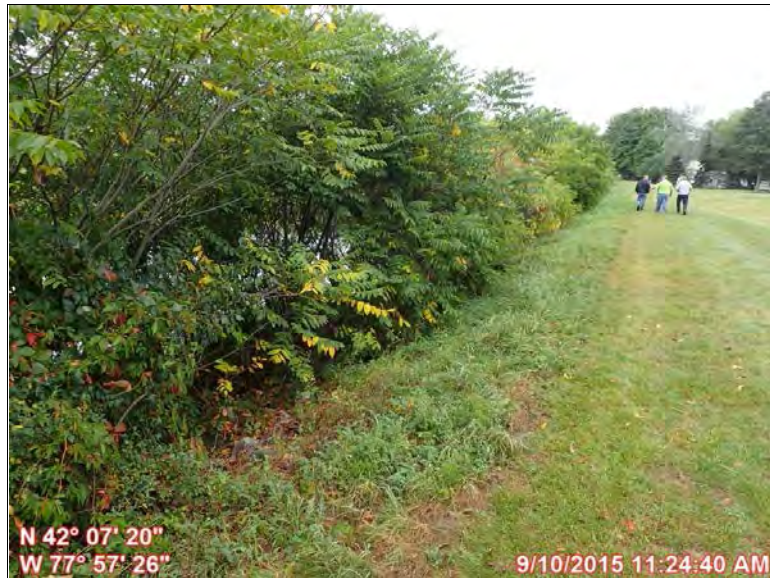
Inspect ID: N21L_2015_a_0033 **Title:** USACE_CELRB_N21L_2015_a_0033_1.jpg
Rated Item: 1. Vegetation and Obstructions **Caption:** Rating: Minimally Acceptable;
Remarks: Vegetation in riprap on both banks around Drop Structure.; **Action:** Remove vegetation from riprap.; Station_1: 66+00; Station_2: 72+00

Inspect ID: N21L_2015_a_0033 **Title:** USACE_CELRB_N21L_2015_a_0033_2.jpg
Rated Item: 1. Vegetation and Obstructions **Caption:** Rating: Minimally Acceptable;
Remarks: Vegetation in riprap on both banks around Drop Structure.; **Action:** Remove vegetation from riprap.; Station_1: 66+00; Station_2: 72+00

Inspect ID: N21L_2015_a_0033 **Title:** USACE_CELRB_N21L_2015_a_0033_3.jpg
Rated Item: 1. Vegetation and Obstructions **Caption:** Rating: Minimally Acceptable;
Remarks: Vegetation in riprap on both banks around Drop Structure.; **Action:** Remove vegetation from riprap.; **Station_1:** 66+00; **Station_2:** 72+00

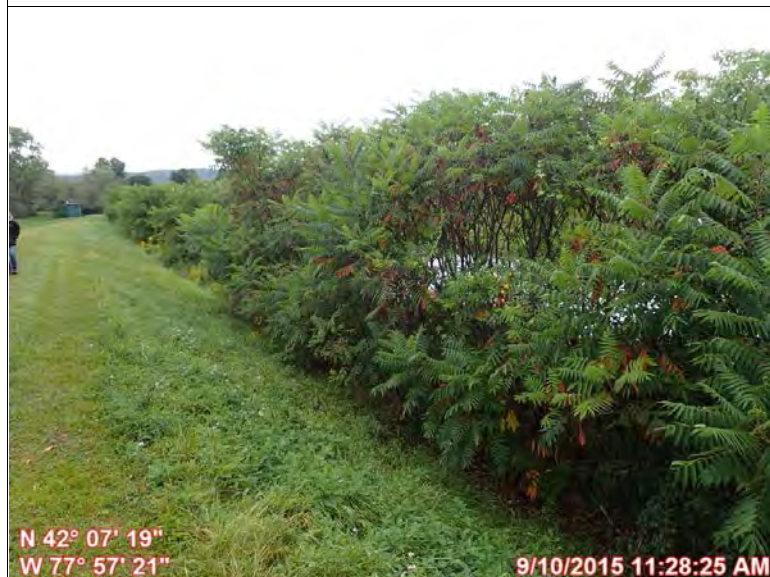
Inspect ID: N21L_2015_a_0036 **Title:** USACE_CELRB_N21L_2015_a_0036_1.jpg
Rated Item: 1. Vegetation and Obstructions **Caption:** Rating: Unacceptable; **Remarks:** Vegetation in riprap on left bank 2,200' to 900' downstream of Madison Street (Stevens Street) bridge.; **Action:** Remove vegetation from riprap.; **Station_1:** 65+00; **Station_2:** 52+00

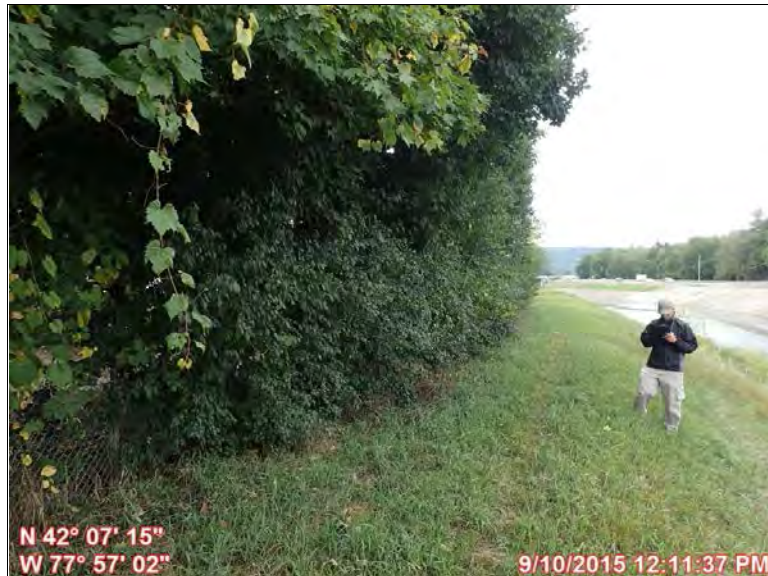
Inspect ID: N21L_2015_a_0065 **Title:** USACE_CELRB_N21L_2015_a_0065_1.jpg
Rated Item: 1. Vegetation and Obstructions **Caption:** Rating: Minimally Acceptable;
Remarks: Trees on left bank channel crest from 250' downstream of Madison Street (Stevens Street) bridge to Madison Street bridge.; **Action:** Remove trees.; **Station_1:** 46+00; **Station_2:** 44+00

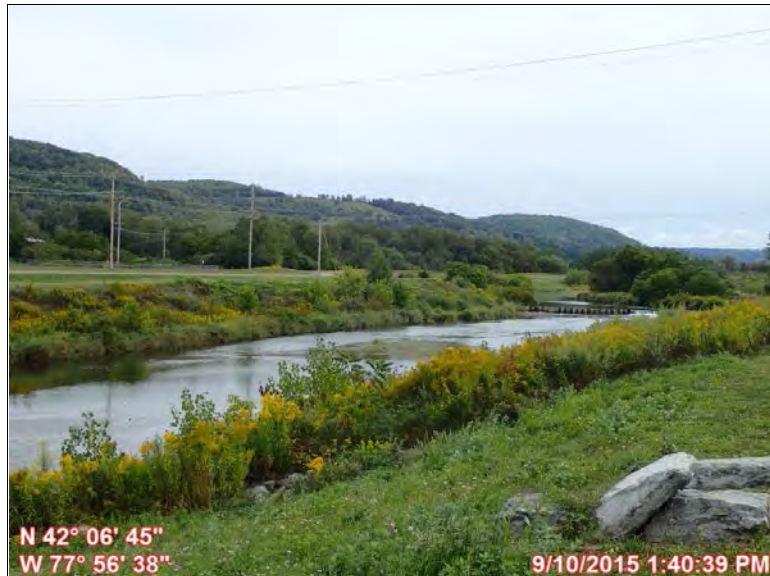
Inspect ID: N21L_2015_a_0104 **Title:** USACE_CELRB_N21L_2015_a_0104_1.jpg
Rated Item: 1. Vegetation and Obstructions **Caption:** Rating: Unacceptable; Remarks: Significant vegetation in riprap on right bank from 400' downstream of 1957 Weir to 1957 Weir.; Action: Remove vegetation from riprap.; Station_1: 4+00; Station_2: 0+00

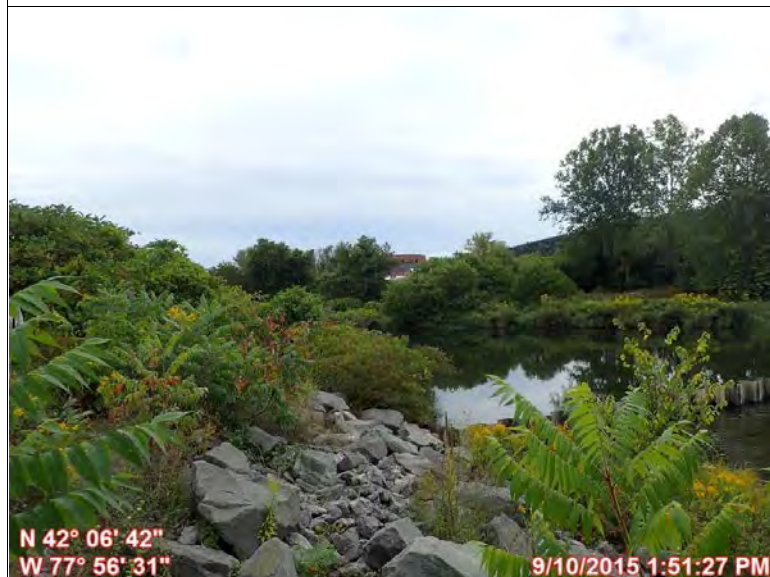
Inspect ID: N21L_2015_a_0107 **Title:** USACE_CELRB_N21L_2015_a_0107_1.jpg
Rated Item: 1. Vegetation and Obstructions **Caption:** Rating: Unacceptable; Remarks: Significant woody vegetation in riprap on right bank from Upstream Weir to 500' upstream of 1957 Weir.; Action: Remove vegetation from riprap.; Station_1: 0+00; Station_2: 0+00

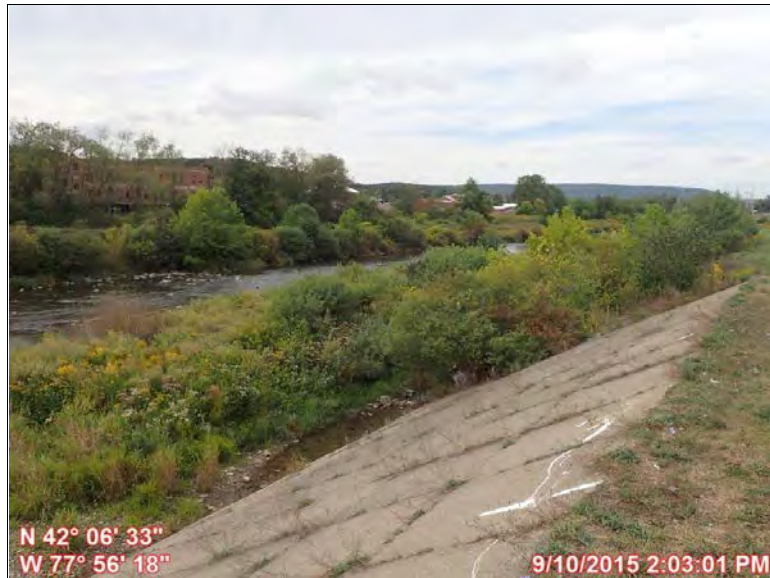
Inspect ID: N21L_2015_a_0112 **Title:** USACE_CELRB_N21L_2015_a_0112_1.jpg
Rated Item: 1. Vegetation and Obstructions **Caption:** Rating: Unacceptable; Remarks: Significant unwanted vegetation on right bank sideslope from 400' downstream of 1976 Weir to 1976 Weir.; Action: Remove unwanted vegetation.; Station_1: 0+00; Station_2: 0+00

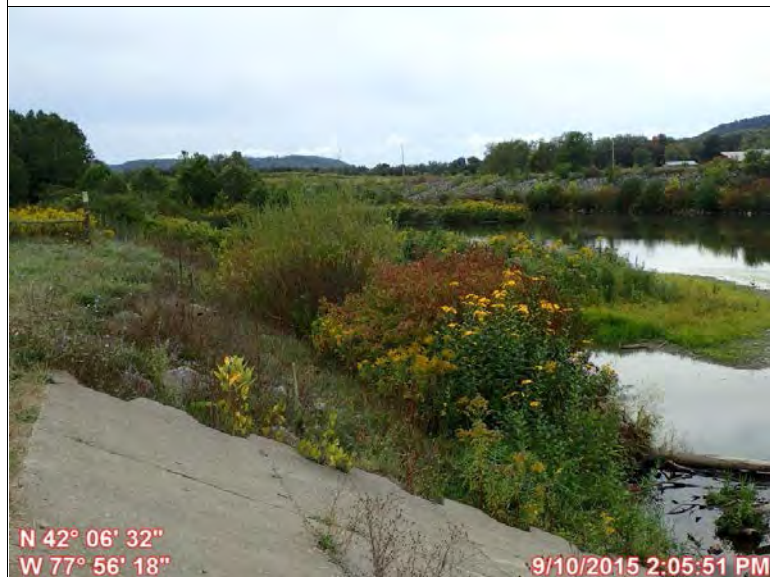
Inspect ID: N21L_2015_a_0116 **Title:** USACE_CELRB_N21L_2015_a_0116_1.jpg
Rated Item: 1. Vegetation and Obstructions **Caption:** Rating: Unacceptable; Remarks: Significant vegetation in riprap on right bank from 1976 Weir to 350' upstream of 1976 Weir.; Action: Remove vegetation from riprap.; Station_1: 0+00; Station_2: 0+00

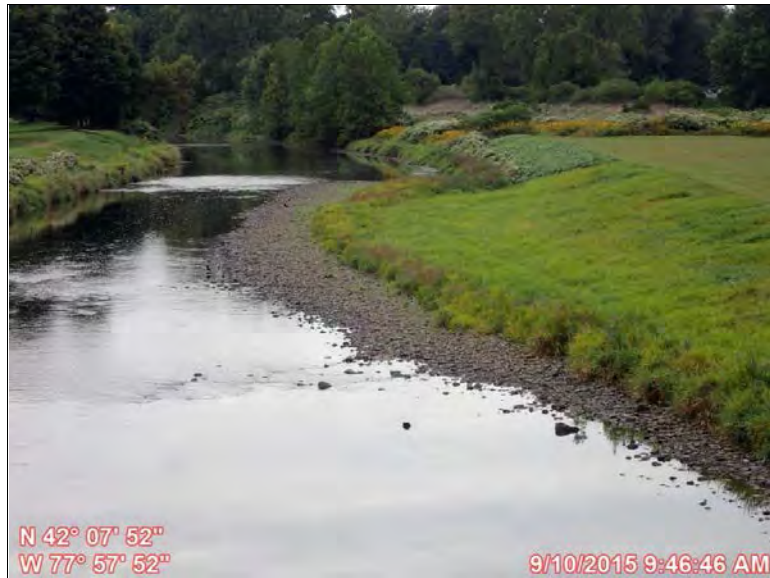
Inspect ID: N21L_2015_a_0004 **Title:** USACE_CELRB_N21L_2015_a_0004_1.jpg
Rated Item: 2. Shoaling (sediment deposition) **Caption:** Rating: Minimally Acceptable;
Remarks: Shoaling along right bank from 225' to 700' downstream of golf course pedestrian bridge.; **Action:** Remove shoaling.; **Station_1:** 111+00; **Station_2:** 106+00

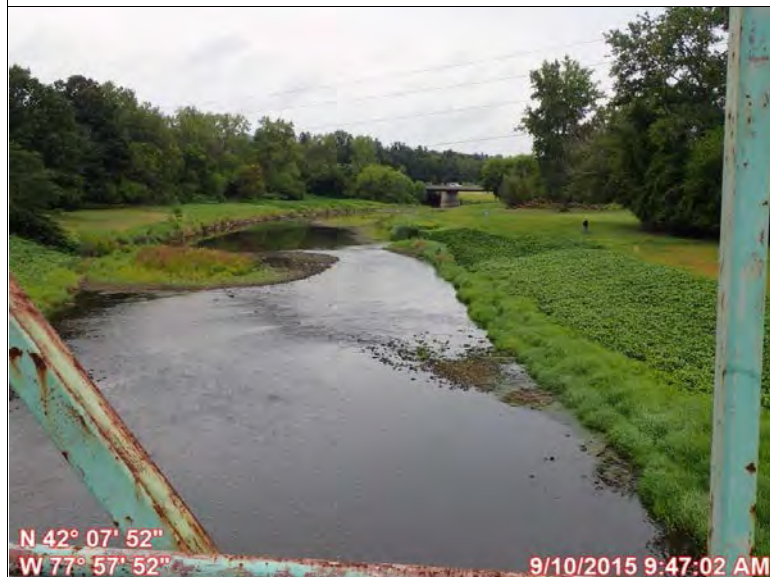
Inspect ID: N21L_2015_a_0006 **Title:** USACE_CELRB_N21L_2015_a_0006_1.jpg
Rated Item: 2. Shoaling (sediment deposition) **Caption:** Rating: Minimally Acceptable;
Remarks: 3 alternating shoals on both banks from 150' upstream of golf course pedestrian bridge to Bolivar Road bridge.; **Action:** Remove shoals.; **Station_1:** 103+00; **Station_2:** 92+00

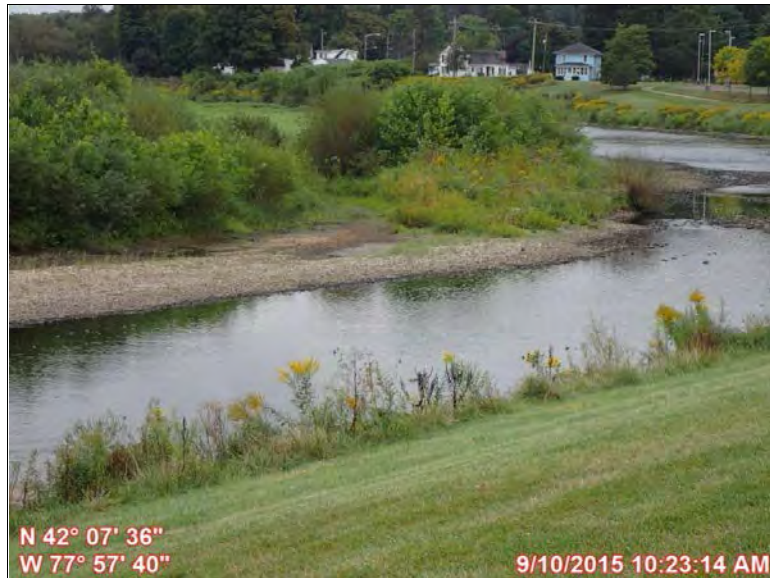
Inspect ID: N21L_2015_a_0018 **Title:** USACE_CELRB_N21L_2015_a_0018_1.jpg
Rated Item: 2. Shoaling (sediment deposition) **Caption:** Rating: Minimally Acceptable;
Remarks: Shoaling along right bank from 750' to 1,300' upstream of Bolivar Road bridge.; **Action:** Remove shoaling.; **Station_1:** 83+00; **Station_2:** 78+00

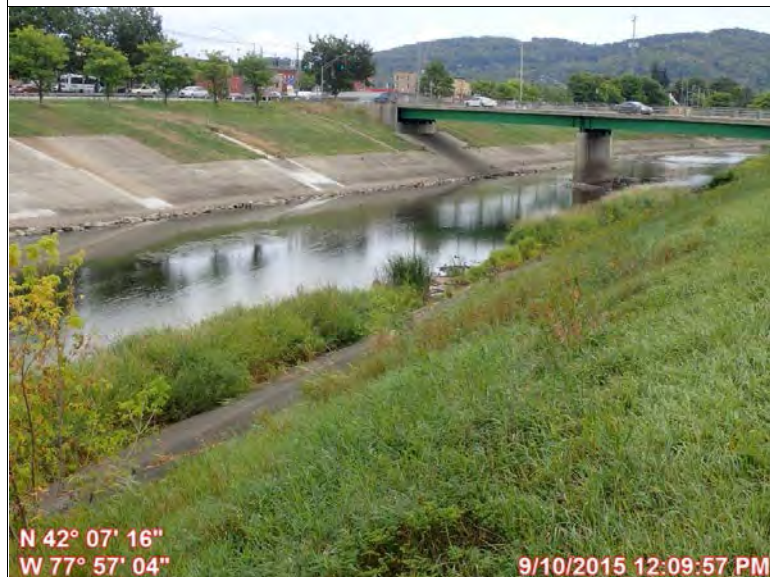
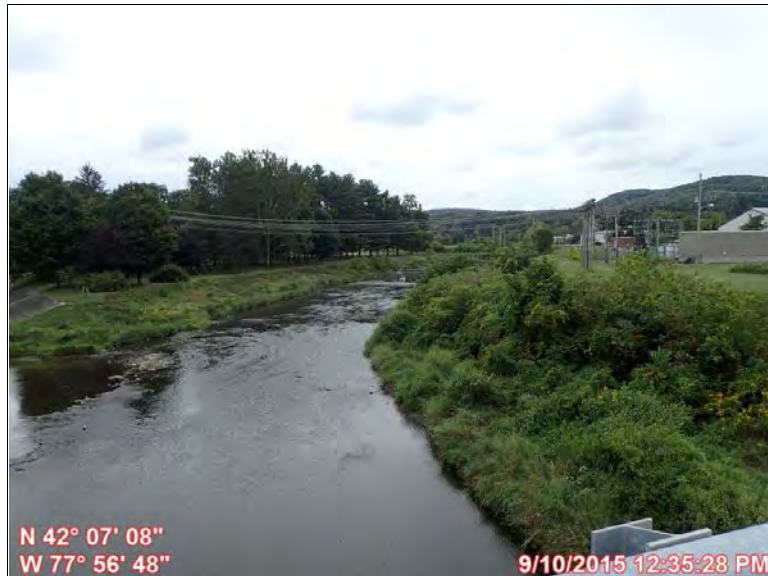
Inspect ID: N21L_2015_a_0060 **Title:** USACE_CELRB_N21L_2015_a_0060_1.jpg
Rated Item: 2. Shoaling (sediment deposition) **Caption:** Rating: Minimally Acceptable;
Remarks: Minor shoaling on left bank from 600' downstream of Madison Street (Stevens Street) bridge to State Street bridge.; **Action:** Remove shoaling.; **Station_1:** 49+00; **Station_2:** 0+00

Inspect ID: N21L_2015_a_0060 **Title:** USACE_CELRB_N21L_2015_a_0060_2.jpg
Rated Item: 2. Shoaling (sediment deposition) **Caption:** Rating: Minimally Acceptable;
Remarks: Minor shoaling on left bank from 600' downstream of Madison Street (Stevens Street) bridge to State Street bridge.; **Action:** Remove shoaling.; **Station_1:** 49+00;
Station_2: 0+00

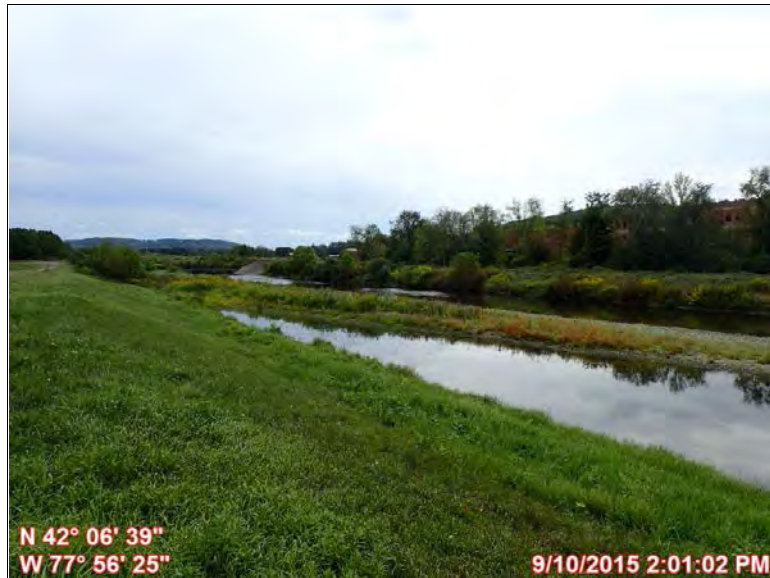
Inspect ID: N21L_2015_a_0111 **Title:** USACE_CELRB_N21L_2015_a_0111_1.jpg
Rated Item: 2. Shoaling (sediment deposition) **Caption:** Rating: Unacceptable;
Remarks: Significant shoaling in channel on right bank from 100'-700' downstream of 1976 Weir.; Action: Remove shoaling.; Station_1: 0+00

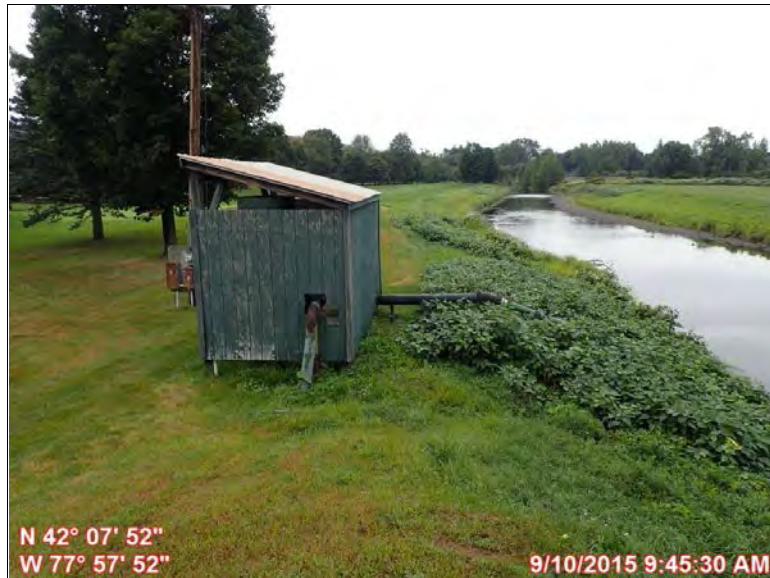
Inspect ID: N21L_2015_a_0003 **Title:** USACE_CELRB_N21L_2015_a_0003_1.jpg
Rated Item: 3. Encroachments **Caption:** Rating: Minimally Acceptable; Remarks: Unauthorized Alteration: Pump station, intake pipe to pump station for golf course water, and feeder pipes.; Action: Remove unauthorized alteration or submit a Section 408 Alteration Request Form.; Station_1: 104+00

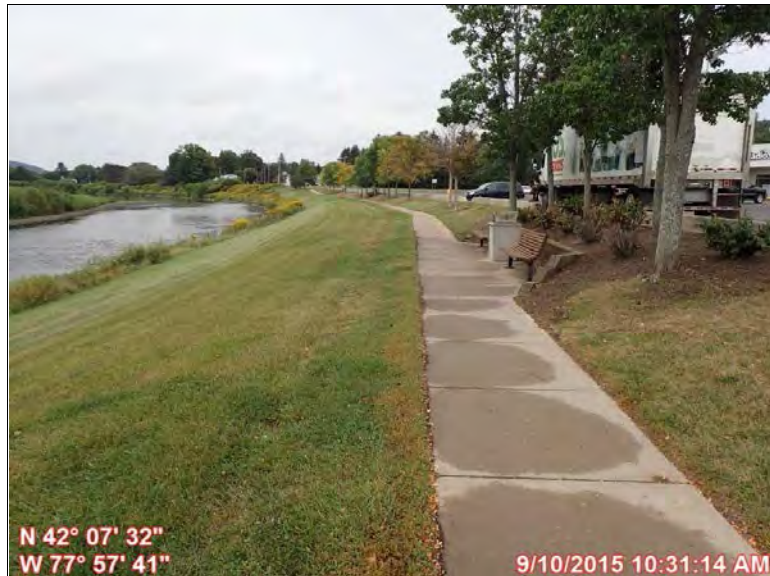
Inspect ID: N21L_2015_a_0013 **Title:** USACE_CELRB_N21L_2015_a_0013_1.jpg
Rated Item: 3. Encroachments **Caption:** Rating: Minimally Acceptable; Remarks: Unauthorized Alteration: Sidewalk and benches along left bank from Bolivar Road bridge to 1,775' upstream of Bolivar Road bridge.; Action: Remove unauthorized alteration or submit a Section 408 Alteration Request Form.; Station_1: 90+00; Station_2: 75+00

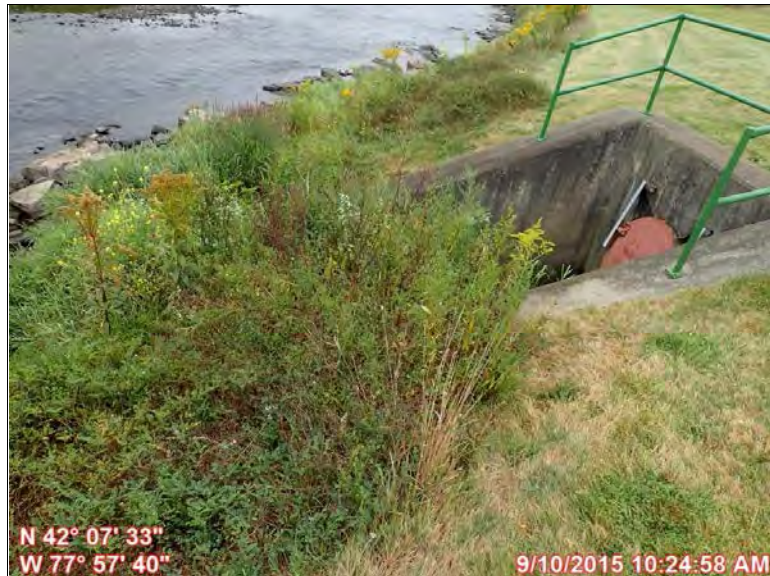
Inspect ID: N21L_2015_a_0020 **Title:** USACE_CELRB_N21L_2015_a_0020_1.jpg
Rated Item: 3. Encroachments **Caption:** Rating: Minimally Acceptable; Remarks: Unauthorized Alteration - 42" outfall on left bank 900' upstream of Bolivar Road bridge.; Action: Remove unauthorized alteration or submit a Section 408 Alteration Request Form.; Station_1: 82+00

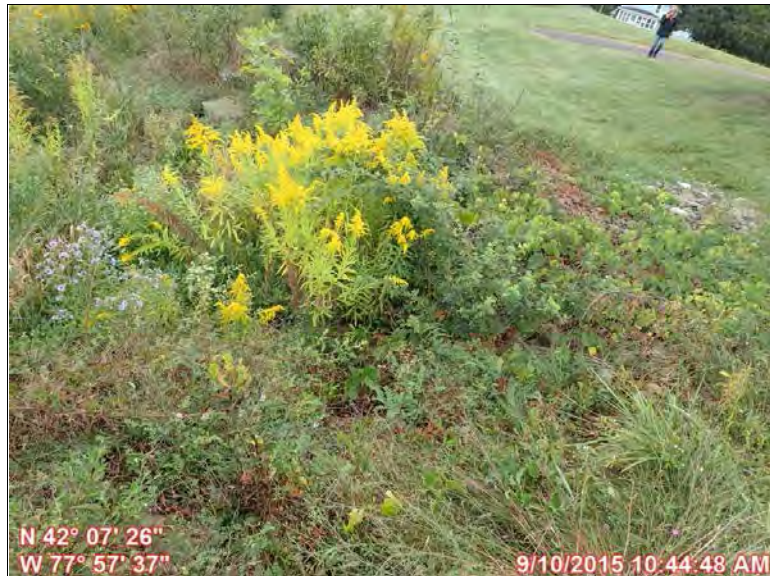
Inspect ID: N21L_2015_a_0025 **Title:** USACE_CELRB_N21L_2015_a_0025_1.jpg
Rated Item: 3. Encroachments **Caption:** Rating: Minimally Acceptable; Remarks: Unauthorized Alteration - 30" CMP outfall on left bank 1,600' upstream of Bolivar Road bridge.; Action: Remove unauthorized alteration or submit a Section 408 Alteration Request Form.; Station_1: 75+00

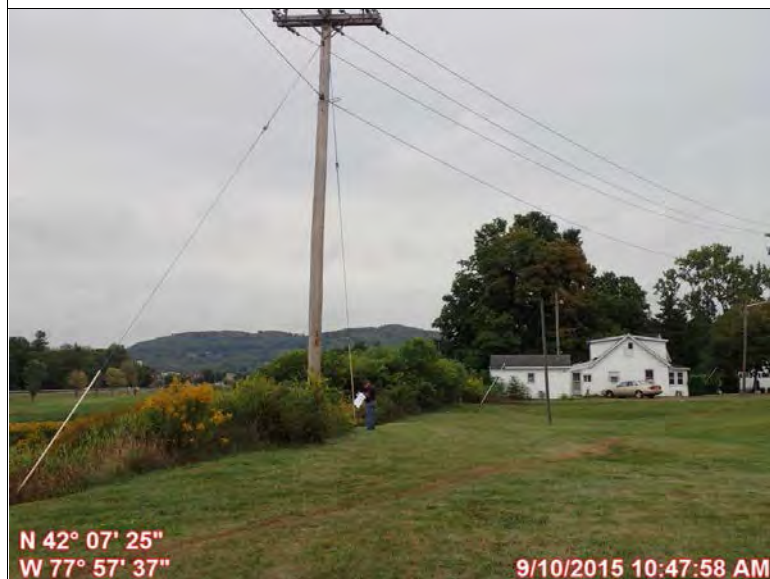
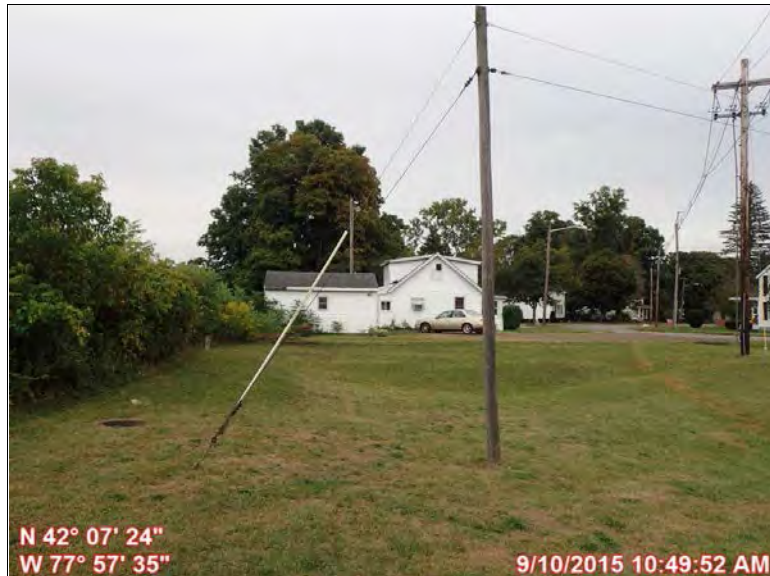
Inspect ID: N21L_2015_a_0026 **Title:** USACE_CELRB_N21L_2015_a_0026_1.jpg
Rated Item: 3. Encroachments **Caption:** Rating: Minimally Acceptable; Remarks: Unauthorized Alteration - One utility pole and 3 guy wires 1,700' upstream of Boliver Road bridge.; Action: Remove unauthorized alteration or submit a Section 408 Alteration Request Form.; Station_1: 74+00

Inspect ID: N21L_2015_a_0026 **Title:** USACE_CELRB_N21L_2015_a_0026_2.jpg
Rated Item: 3. Encroachments **Caption:** Rating: Minimally Acceptable; Remarks: Unauthorized Alteration - One utility pole and 3 guy wires 1,700' upstream of Bolivar Road bridge.; Action: Remove unauthorized alteration or submit a Section 408 Alteration Request Form.; Station_1: 74+00

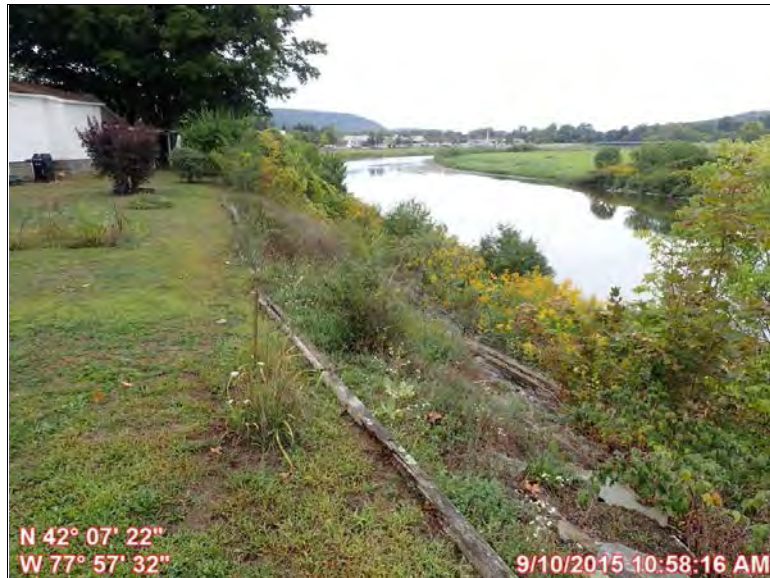
Inspect ID: N21L_2015_a_0028 **Title:** USACE_CELRB_N21L_2015_a_0028_2.jpg
Rated Item: 3. Encroachments **Caption:** Rating: Minimally Acceptable; Remarks: Unauthorized Alteration - Misc. landscaping encroachments 1,900' to 2,200' upstream of Bolivar Road bridge.; Action: Remove unauthorized alteration or submit a Section 408 Alteration Request Form.; Station_1: 72+00; Station_2: 69+00

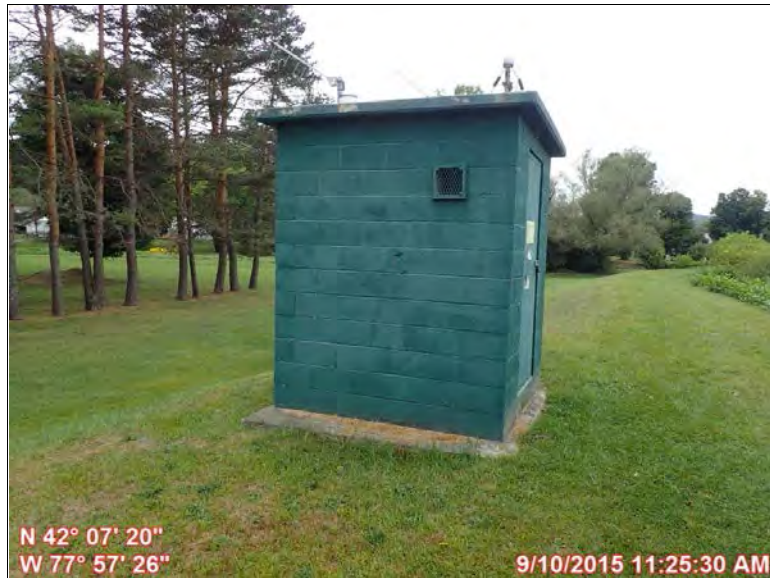
Inspect ID: N21L_2015_a_0034 **Title:** USACE_CELRB_N21L_2015_a_0034_1.jpg
Rated Item: 3. Encroachments **Caption:** Rating: Minimally Acceptable; Remarks: Unauthorized Alteration - Gage house on left bank 2,230' downstream of Madison Street (Stevens Street) bridge is in acceptable condition.; Action: Remove unauthorized alteration or submit Section 408 Alteration Request Form.; Station_1: 65+00

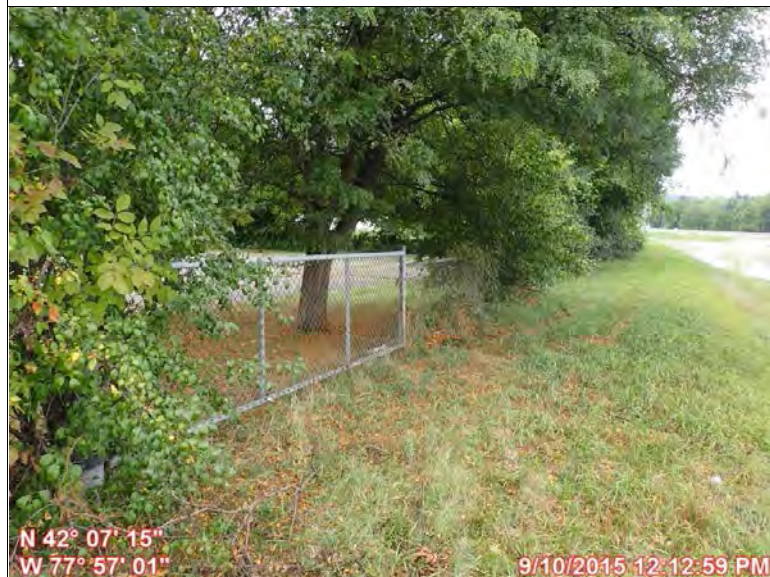
Inspect ID: N21L_2015_a_0064 **Title:** USACE_CELRB_N21L_2015_a_0064_1.jpg
Rated Item: 3. Encroachments **Caption:** Rating: Minimally Acceptable; Remarks: Unauthorized Alteration - Fence on left bank channel crest from 250' downstream of Madison Street (Stevens Street) bridge to Madison Street bridge.; Action: Remove unauthorized alteration or submit a Section 408 Alteration Request Form.; Station_1: 46+00; Station_2: 44+00
