DEPARTMENT OF THE ARMY

BUFFALO DISTRICT, CORPS OF ENGINEERS
1776 NIAGARA STREET
BUFFALO, NEW YORK 14207-3199

SUBJECT: FY15 Joint Routine Inspection of Completed Works, Flood Damage Reduction Project, Genesee River and Dyke Creek, Wellsville, New York (09/10/15)

Attachment A –
Genesee River - Left Bank and Channel, Wellsville
Summary of Deficiencies and Recommendations

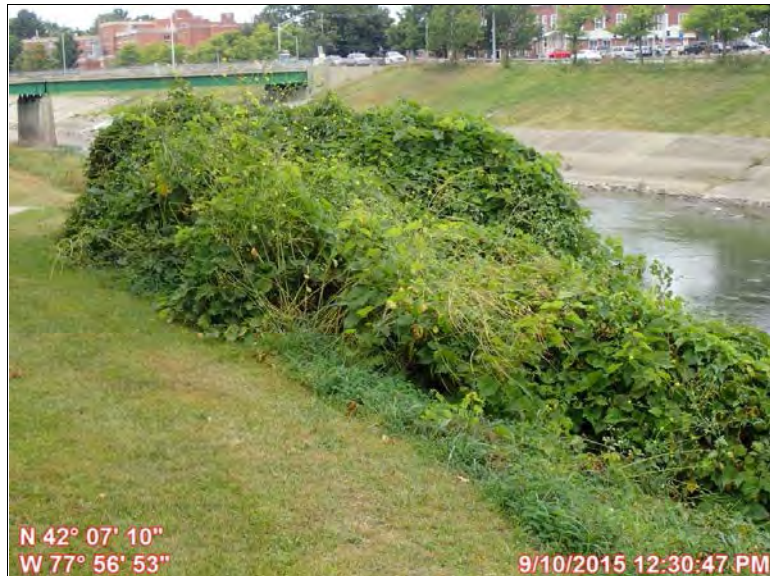
Inspect ID: N21L_2015_a_0076 **Title:** USACE_CELRB_N21L_2015_a_0076_1.jpg
Rated Item: 3. Encroachments **Caption:** Rating: Minimally Acceptable; Remarks: Unauthorized Alteration - Fence (covered in unwanted vegetation) 300' downstream of State Street bridge.; Action: Remove unauthorized alteration or submit a Section 408 Alteration Request Form.; Station_1: 38+00

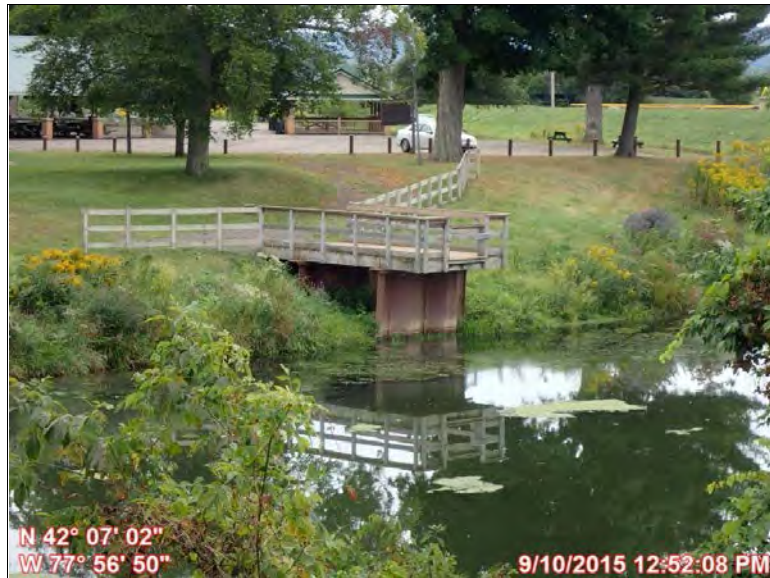
Inspect ID: N21L_2015_a_0088 **Title:** USACE_CELRB_N21L_2015_a_0088_1.jpg
Rated Item: 3. Encroachments **Caption:** Rating: Minimally Acceptable; Remarks: Unauthorized Alteration - Fishing access platform and fence on right bank 200' upstream of Steel Sheet Pile Weir.; Action: Remove unauthorized alteration or submit a Section 408 Alteration Request Form.; Station_1: 25+00

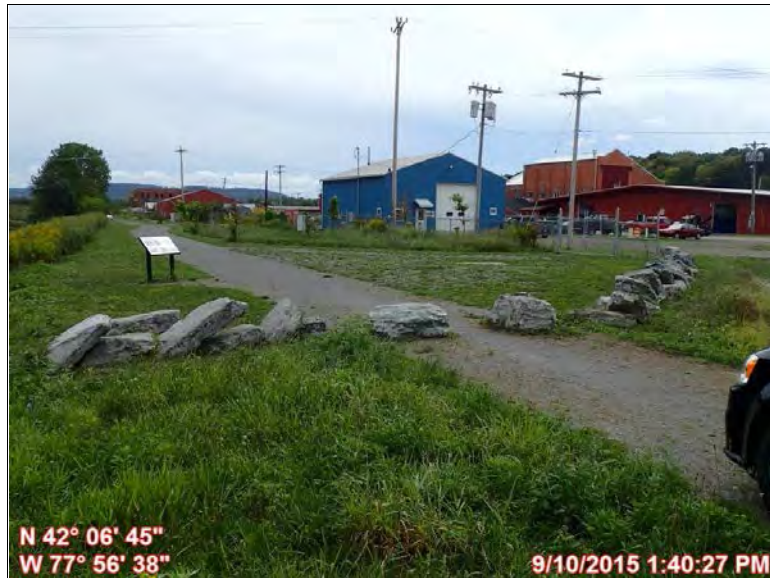
Inspect ID: N21L_2015_a_0102 **Title:** USACE_CELRB_N21L_2015_a_0102_1.jpg
Rated Item: 3. Encroachments **Caption:** Rating: Minimally Acceptable; Remarks: Unauthorized Alteration - Wellsville, Addison, & Galetton Railroad trailway rocks obstructing access 575' downstream of 1957 Weir.; Action: Remove unauthorized alteration or submit a Section 408 Alteration Request Form.; Station_1: 6+00

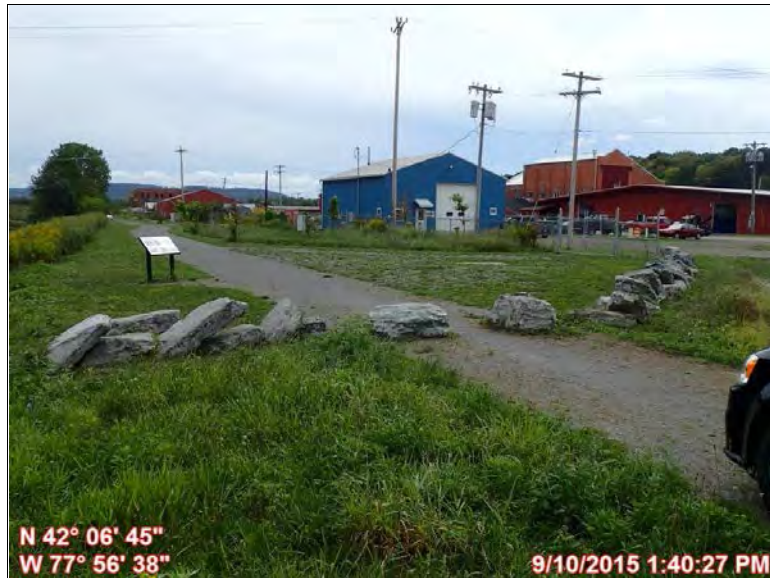
Inspect ID: N21L_2015_a_0126 **Title:** USACE_CELRB_N21L_2015_a_0126_1.jpg
Rated Item: 3. Encroachments **Caption:** Rating: Minimally Acceptable; Remarks: Unauthorized Alteration - Wellsville, Addison, & Galetton Railroad railway and signs on left bank newar 1957 Weir.; Action: Remove unauthorized alteration or submit Section 408 Alteration Request Form.; Station_1: 0+00; Station_2: 7+00
