## DEPARTMENT OF THE ARMY

BUFFALO DISTRICT, CORPS OF ENGINEERS  
1776 NIAGARA STREET  
BUFFALO, NEW YORK 14207-3199

September 30, 2014

SUBJECT: FY13 Joint Routine Inspection of Completed Works, Flood Damage Reduction Project, Genesee River and Dyke Creek, Wellsville, New York (09/24/13)

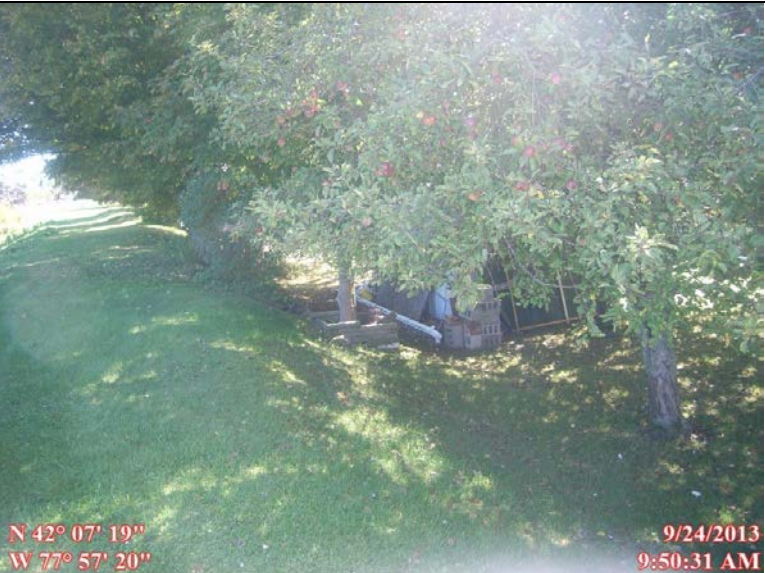
<p>N 42° 07' 19" W 77° 57' 20"</p> <p>9/24/2013 9:50:31 AM</p>	<p><b>Inspect ID:</b> N21L_2013_a_0060 <b>Title:</b> USACE_CELRB_N21L_2013_a_0060_1.jpg <b>Rated Item:</b> 1. Unwanted Vegetation Growth <b>Caption:</b> Rating: Minimally Acceptable; <b>Remarks:</b> Multiple trees on landside slope and within 15' of the toe; Station_1: 61+00; Station_2: 58+00</p>

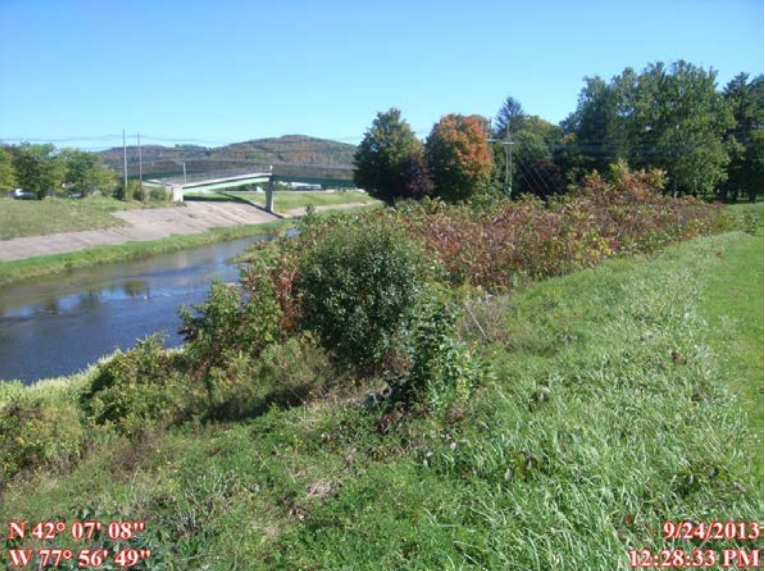
<p>N 42° 07' 08" W 77° 56' 49"</p> <p>9/24/2013 12:28:33 PM</p>	<p><b>Inspect ID:</b> N21L_2013_a_0156 <b>Title:</b> USACE_CELRB_N21L_2013_a_0156_1.jpg <b>Rated Item:</b> 1. Unwanted Vegetation Growth <b>Caption:</b> Rating: Unacceptable; Remarks: Unwanted vegetation in riprap; Station_1: 33+00; Station_2: 24+00</p>

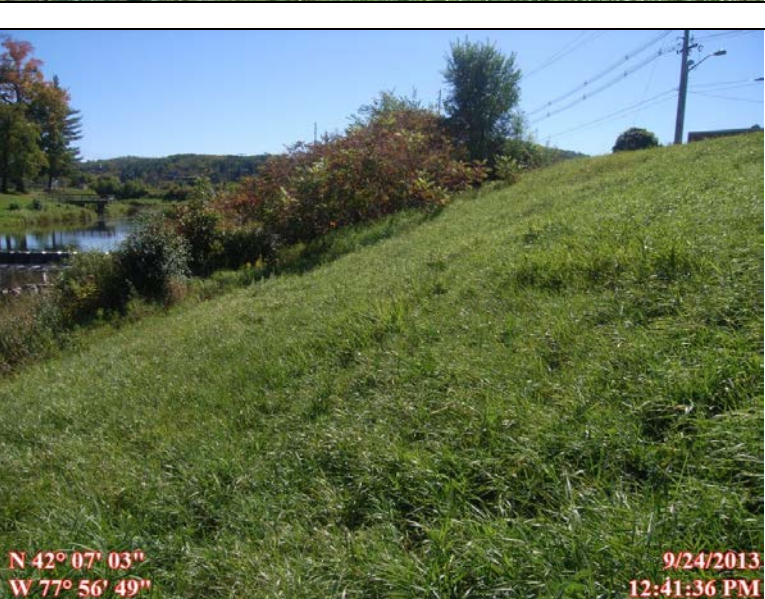
<p>N 42° 07' 03" W 77° 56' 49"</p> <p>9/24/2013 12:41:36 PM</p>	<p><b>Inspect ID:</b> N21L_2013_a_0156 <b>Title:</b> USACE_CELRB_N21L_2013_a_0156_2.jpg <b>Rated Item:</b> 1. Unwanted Vegetation Growth <b>Caption:</b> Rating: Unacceptable; Remarks: Unwanted vegetation in riprap; Station_1: 33+00; Station_2: 24+00</p>

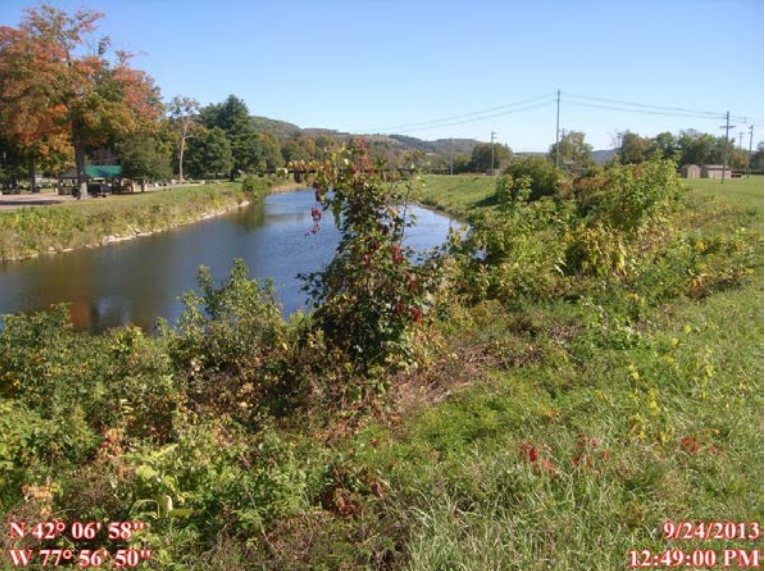
<p>N 42° 06' 58" W 77° 56' 50" 9/24/2013 12:49:00 PM</p>	<p><b>Inspect ID:</b> N21L_2013_a_0173 <b>Title:</b> USACE_CELRB_N21L_2013_a_0173_1.jpg <b>Rated Item:</b> 1. Unwanted Vegetation Growth <b>Caption:</b> Rating: Unacceptable; Remarks: Unwanted vegetation in riprap; Station_1: 21+00; Station_2: 24+00</p>

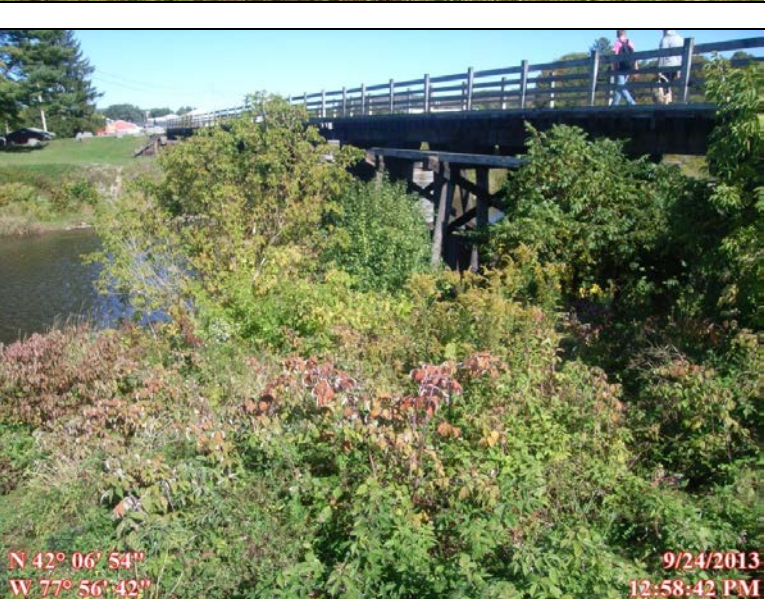
<p>N 42° 06' 54" W 77° 56' 42" 9/24/2013 12:58:42 PM</p>	<p><b>Inspect ID:</b> N21L_2013_a_0181 <b>Title:</b> USACE_CELRB_N21L_2013_a_0181_1.jpg <b>Rated Item:</b> 1. Unwanted Vegetation Growth <b>Caption:</b> Rating: Unacceptable; Remarks: Unwanted vegetation in riprap; Station_1: 17+00</p>

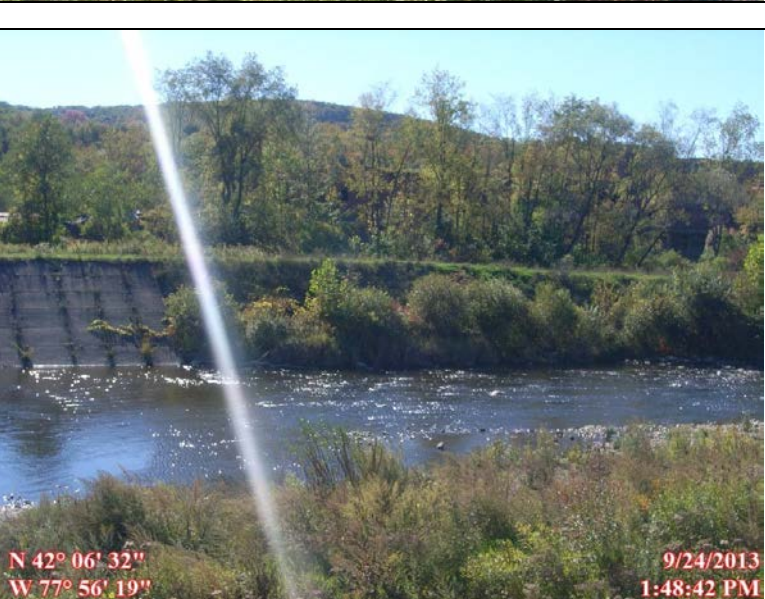
<p><b>Inspect ID:</b> N21L_2013_a_0222 <b>Title:</b> USACE_CELRB_N21L_2013_a_0222_1.jpg  <b>Rated Item:</b> 1. Unwanted Vegetation Growth <b>Caption:</b> Rating: Unacceptable; Remarks: Unwanted vegetation in riprap on LB; Station_1: 0+00; Station_2: 0+00</p>

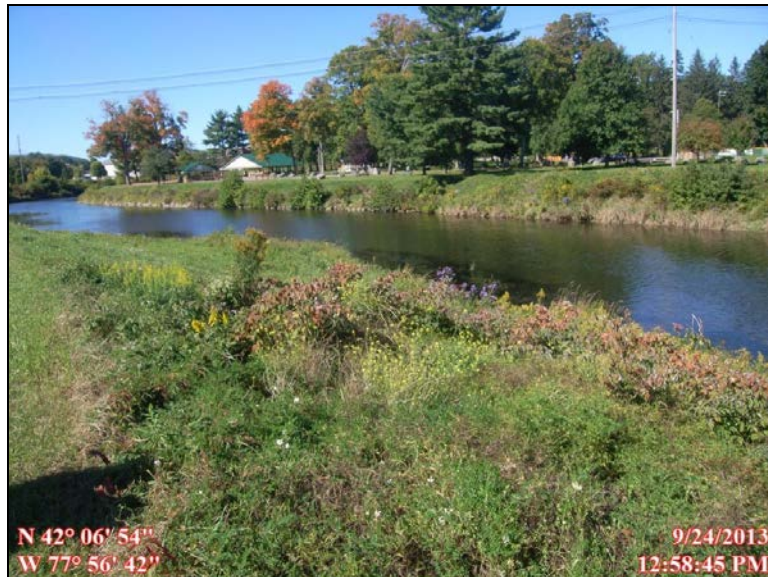
**Inspect ID:** N21L\_2013\_a\_0179 **Title:** USACE\_CELRB\_N21L\_2013\_a\_0179\_1.jpg  
**Rated Item:** 3. Encroachments **Caption:** Rating: Minimally Acceptable; Remarks: Shoaling along toe; Station\_1: 17+00; Station\_2: 21+00

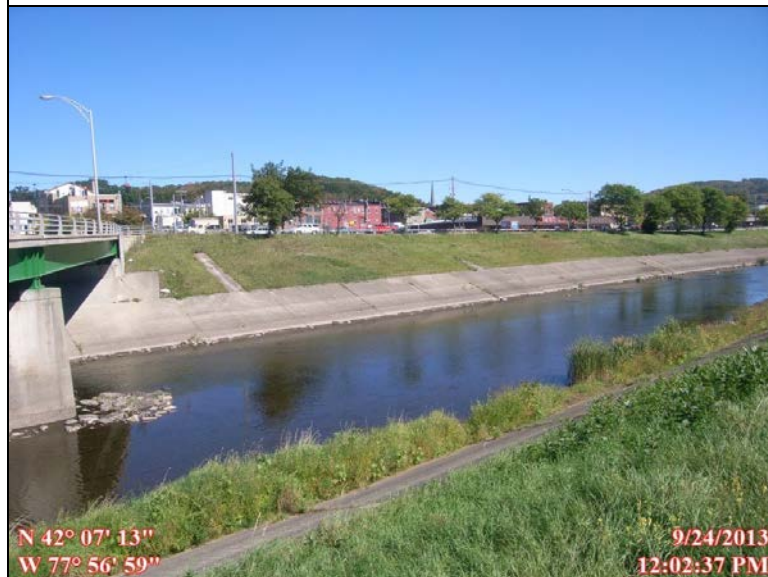
**Inspect ID:** N21L\_2013\_a\_0122 **Title:** USACE\_CELRB\_N21L\_2013\_a\_0122\_1.jpg  
**Rated Item:** 6. Erosion/ Bank Caving **Caption:** Rating: Minimally Acceptable; Remarks: Erosion in riprap along concrete; Station\_1: 43+00

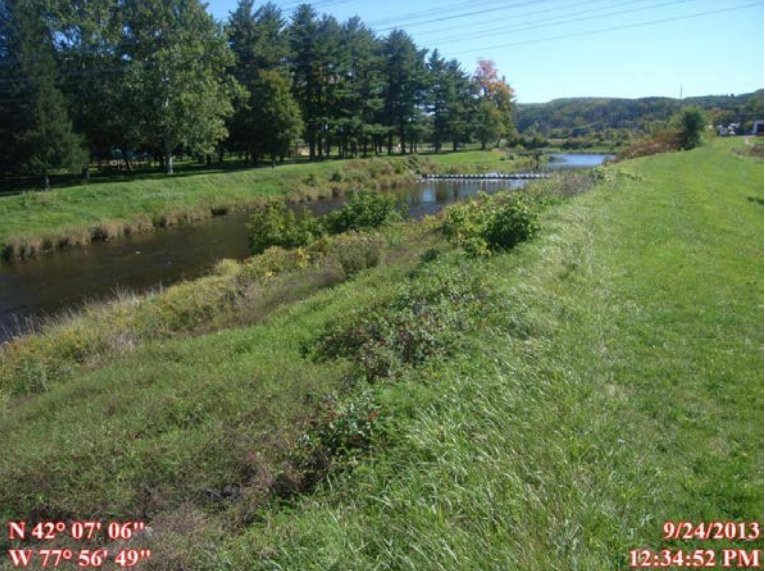
<p>N 42° 07' 06" W 77° 56' 49"</p> <p>9/24/2013 12:34:52 PM</p>	<p><b>Inspect ID:</b> N21L_2013_a_0157 <b>Title:</b> USACE_CELRB_N21L_2013_a_0157_1.jpg <b>Rated Item:</b> 12. Riprap Revetments &amp; Bank Protection <b>Caption:</b> Rating: Minimally Acceptable; Remarks: Buried or missing riprap; Station_1: 30+00; Station_2: 28+00</p>

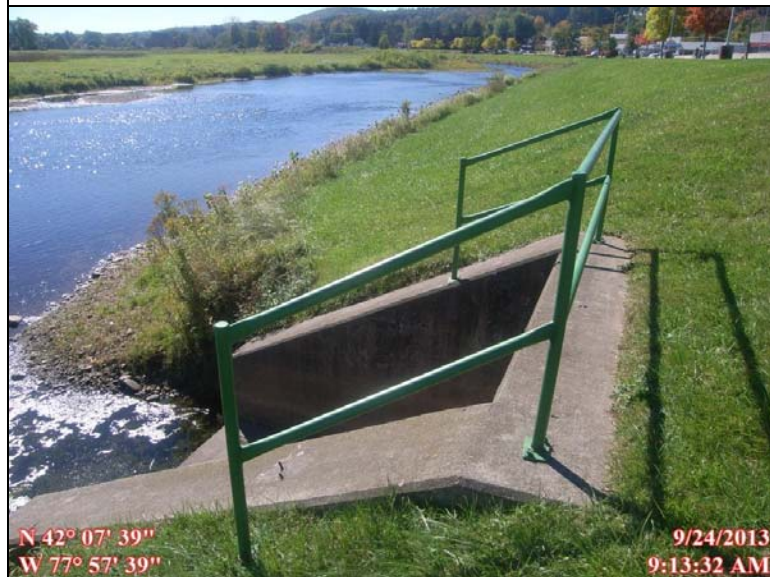
**Inspect ID:** N21L\_2013\_a\_0034 **Title:** USACE\_CELRB\_N21L\_2013\_a\_0034\_1.jpg  
**Rated Item:** 4. Fencing and Gates **Caption:** Rating: Minimally Acceptable; Remarks:  
Fence on head wall is dislodged at both ends from headwall; Station\_1: 88+00

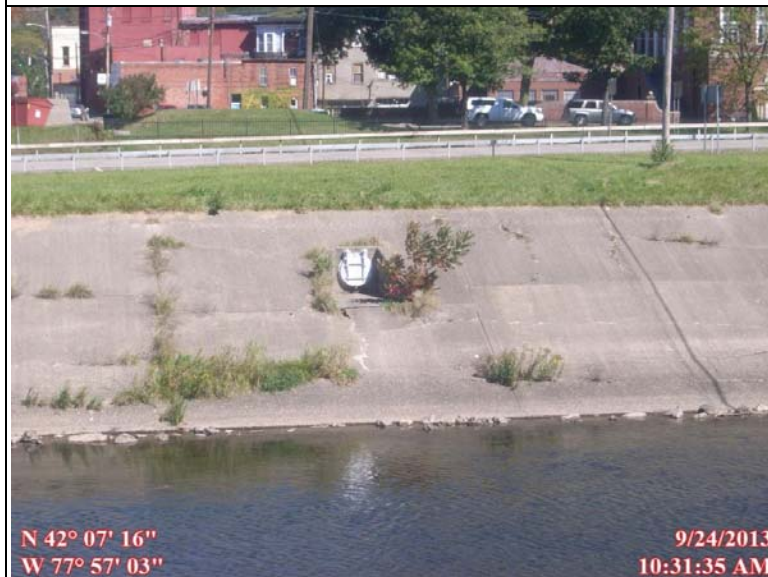
**Inspect ID:** N21L\_2013\_a\_0107 **Title:** USACE\_CELRB\_N21L\_2013\_a\_0107\_1.jpg  
**Rated Item:** 5. Concrete Surfaces **Caption:** Rating: Minimally Acceptable; Remarks: Headwall broken rebar exposed; Station\_1: 47+00

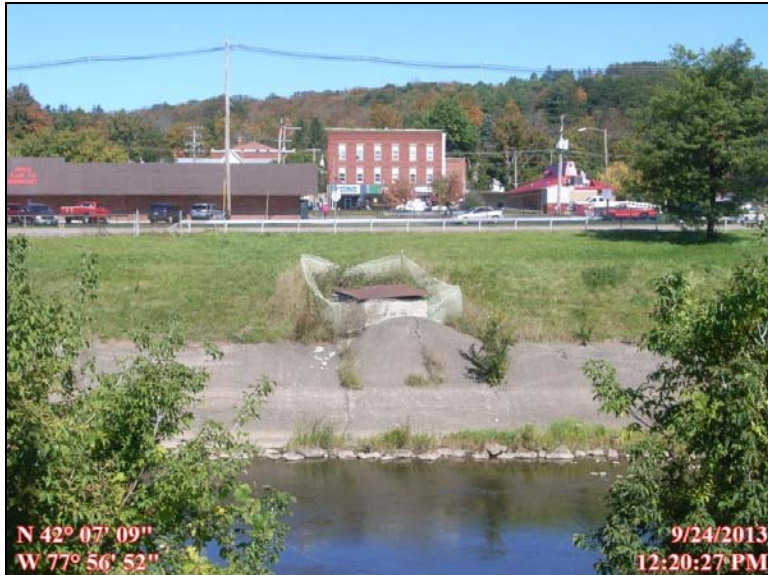
**Inspect ID:** N21L\_2013\_a\_0143 **Title:** USACE\_CELRB\_N21L\_2013\_a\_0143\_1.jpg  
**Rated Item:** 5. Concrete Surfaces **Caption:** Rating: Unacceptable; Remarks: Sanitary sewer structure - severely damaged; Station\_1: 36+00

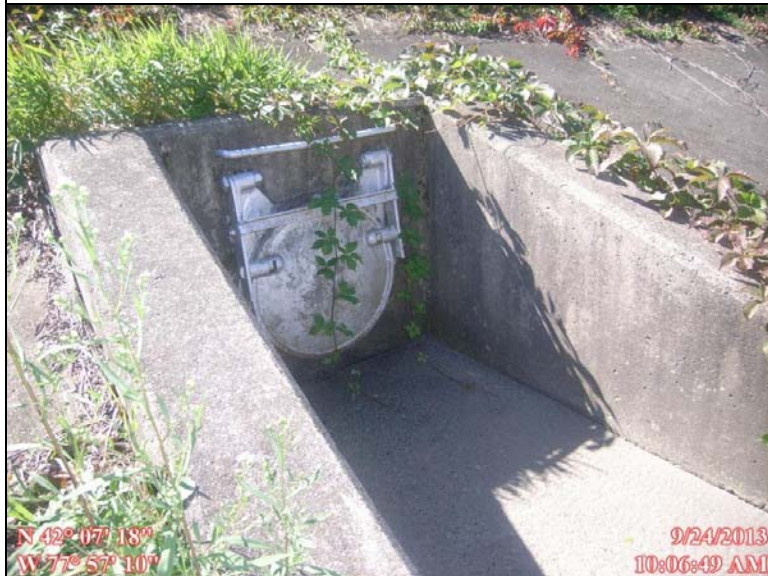
**Inspect ID:** N21L\_2013\_a\_0069 **Title:** USACE\_CELRB\_N21L\_2013\_a\_0069\_1.jpg  
**Rated Item:** 9. Culverts/Discharge Pipes **Caption:** Rating: Unacceptable; Remarks: 24" RCP, pipe not videotape inspected; videotape inspect pipe; Station\_1: 53+00

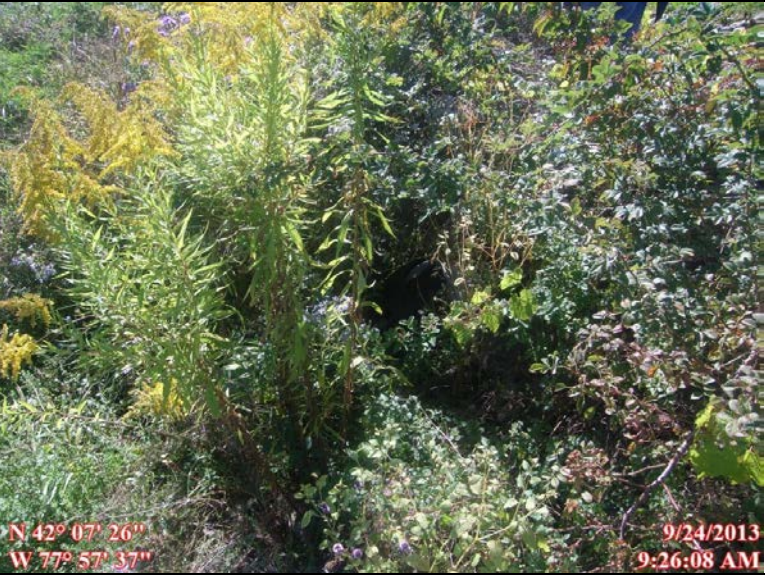
<p>N 42° 07' 26" W 77° 57' 37" 9/24/2013 9:26:08 AM</p>	<p><b>Inspect ID:</b> N21L_2013_a_0046 <b>Title:</b> USACE_CELRB_N21L_2013_a_0046_1.jpg <b>Rated Item:</b> 1. Vegetation and Obstructions <b>Caption:</b> Rating: Minimally Acceptable; <b>Remarks:</b> 30" CMP 20% silted. Sediment in riprap; Station_1: 75+00</p>

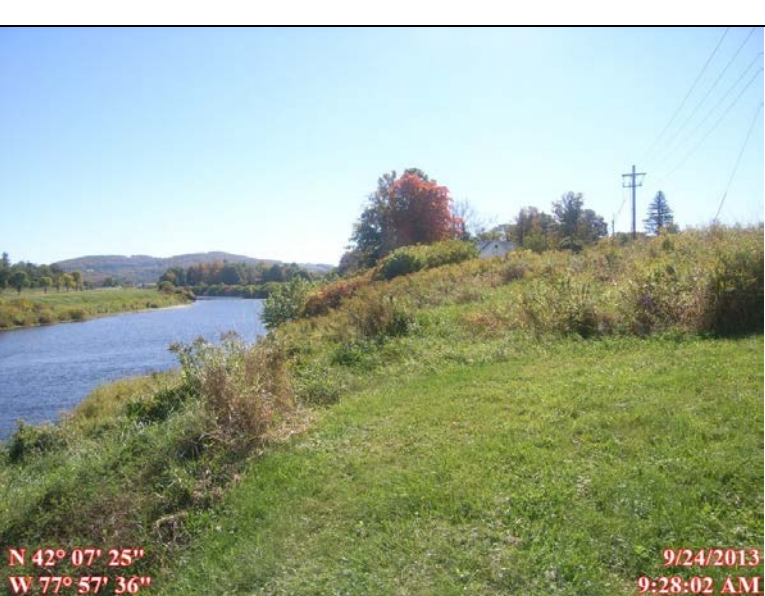
<p>N 42° 07' 25" W 77° 57' 36" 9/24/2013 9:28:02 AM</p>	<p><b>Inspect ID:</b> N21L_2013_a_0047 <b>Title:</b> USACE_CELRB_N21L_2013_a_0047_1.jpg <b>Rated Item:</b> 1. Vegetation and Obstructions <b>Caption:</b> Rating: Minimally Acceptable; <b>Remarks:</b> Unwanted vegetation on LB; Station_1: 72+00; Station_2: 74+00</p>

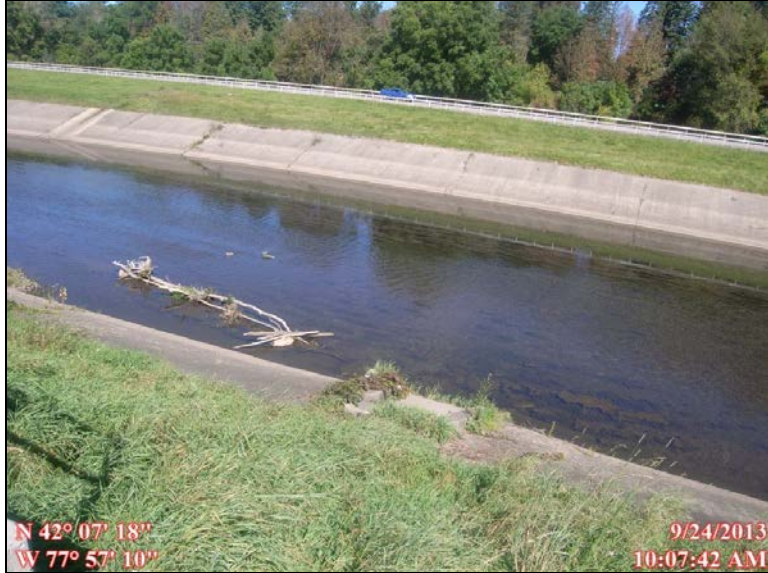
**Inspect ID:** N21L\_2013\_a\_0073 **Title:** USACE\_CELRB\_N21L\_2013\_a\_0073\_1.jpg  
**Rated Item:** 1. Vegetation and Obstructions **Caption:** Rating: Minimally Acceptable;  
**Remarks:** Debris in channel; Station\_1: 54+00

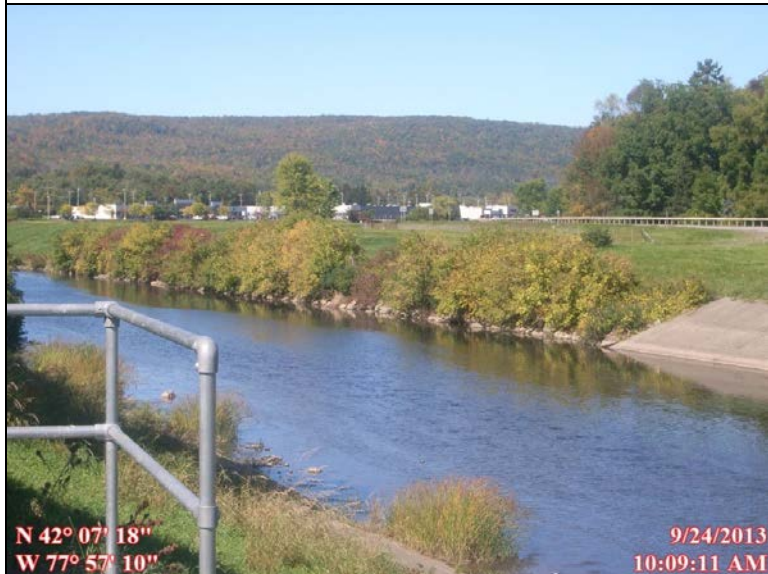
**Inspect ID:** N21L\_2013\_a\_0077 **Title:** USACE\_CELRB\_N21L\_2013\_a\_0077\_1.jpg  
**Rated Item:** 1. Vegetation and Obstructions **Caption:** Rating: Minimally Acceptable;  
**Remarks:** Unwanted vegetation in riprap on RB; Station\_1: 59+00; Station\_2: 53+00

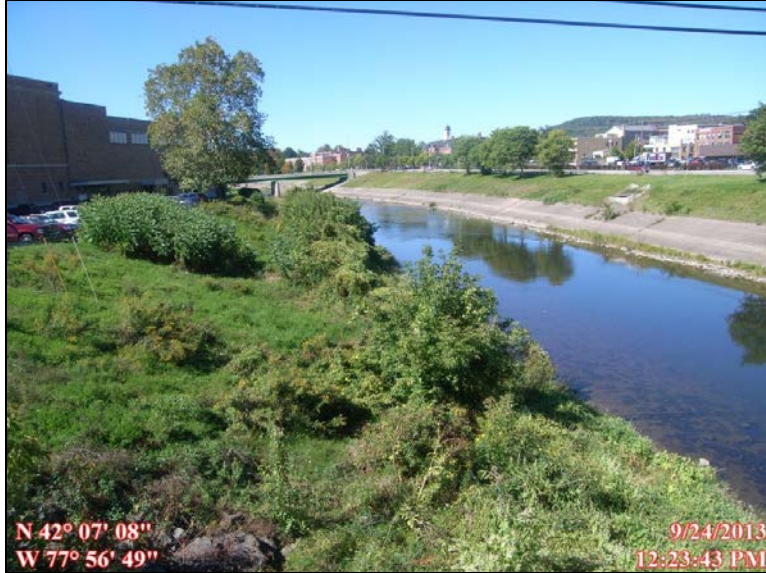
**Inspect ID:** N21L\_2013\_a\_0123 **Title:** USACE\_CELRB\_N21L\_2013\_a\_0123\_2.jpg  
**Rated Item:** 1. Vegetation and Obstructions **Caption:** Rating: Minimally Acceptable;  
**Remarks:** Vegetated shoal along LB toe; Station\_1: 34+00; Station\_2: 43+00

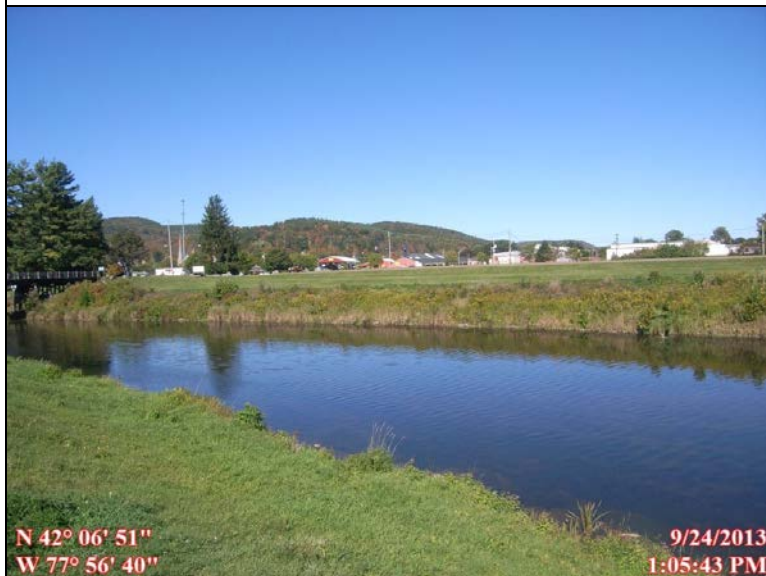
**Inspect ID:** N21L\_2013\_a\_0188 **Title:** USACE\_CELRB\_N21L\_2013\_a\_0188\_1.jpg  
**Rated Item:** 1. Vegetation and Obstructions **Caption:** Rating: Minimally Acceptable;  
**Remarks:** Unwanted vegetation in riprap on RB; Station\_1: 12+00; Station\_2: 16+00

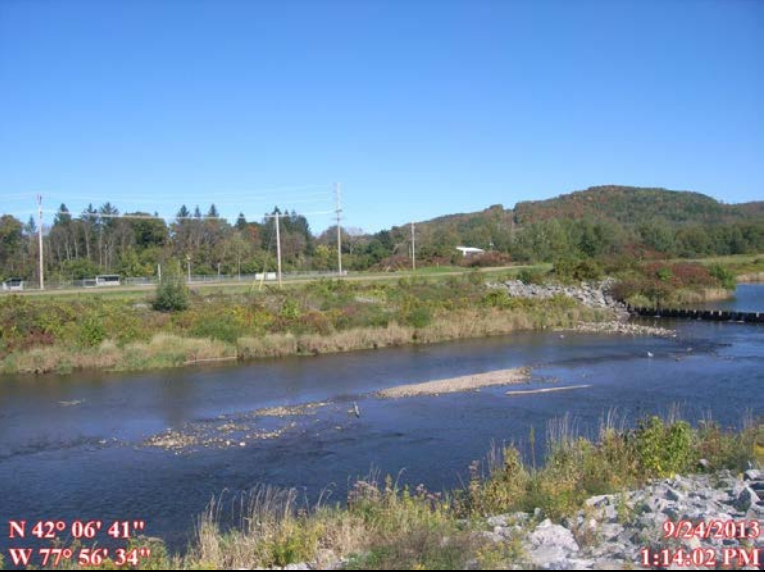
<p>N 42° 06' 41" W 77° 56' 34" 9/24/2013 1:14:02 PM</p>	<p><b>Inspect ID:</b> N21L_2013_a_0198 <b>Title:</b> USACE_CELRB_N21L_2013_a_0198_1.jpg <b>Rated Item:</b> 1. Vegetation and Obstructions <b>Caption:</b> Rating: Unacceptable; Remarks: Unwanted vegetation in riprap; Station_1: 4+00; Station_2: 0+00</p>

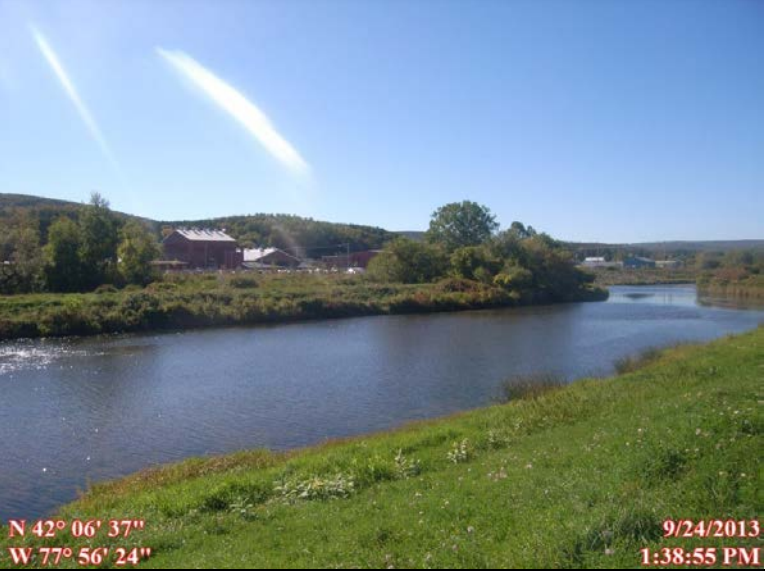
<p>N 42° 06' 37" W 77° 56' 24" 9/24/2013 1:38:55 PM</p>	<p><b>Inspect ID:</b> N21L_2013_a_0203 <b>Title:</b> USACE_CELRB_N21L_2013_a_0203_1.jpg <b>Rated Item:</b> 1. Vegetation and Obstructions <b>Caption:</b> Rating: Minimally Acceptable; Remarks: Unwanted vegetation on left bank from weir to weir; Station_1: 0+00</p>

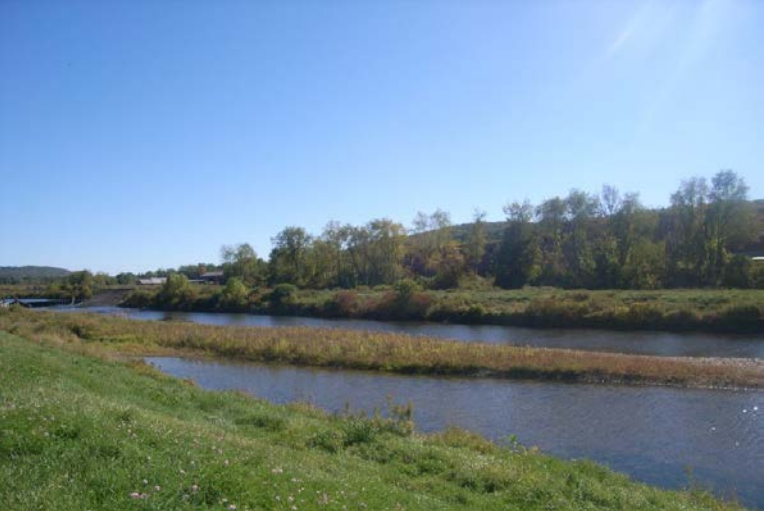
<p>N 42° 06' 37" W 77° 56' 24" 9/24/2013 1:38:55 PM</p>	<p><b>Inspect ID:</b> N21L_2013_a_0209 <b>Title:</b> USACE_CELRB_N21L_2013_a_0209_2.jpg <b>Rated Item:</b> 1. Vegetation and Obstructions <b>Caption:</b> Rating: Unacceptable; Remarks: Unwanted vegetation in riprap; Station_1: 0+00; Station_2: 0+00</p>

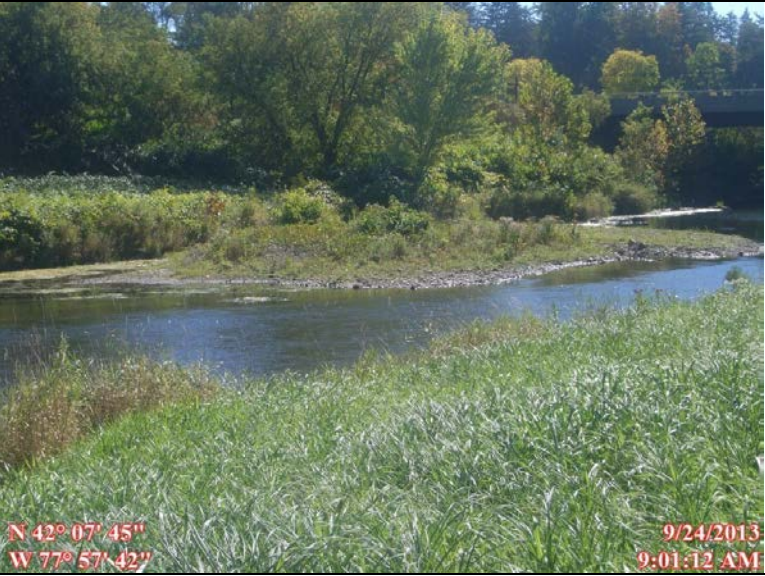
<p>N 42° 07' 45" W 77° 57' 42" 9/24/2013 9:01:12 AM</p>	<p><b>Inspect ID:</b> N21L_2013_a_0025 <b>Title:</b> USACE_CELRB_N21L_2013_a_0025_1.jpg <b>Rated Item:</b> 2. Shoaling (sediment deposition) <b>Caption:</b> Rating: Minimally Acceptable; <b>Remarks:</b> Shoaling from drainage outlet channel into channel; Station_1: 93+00</p>

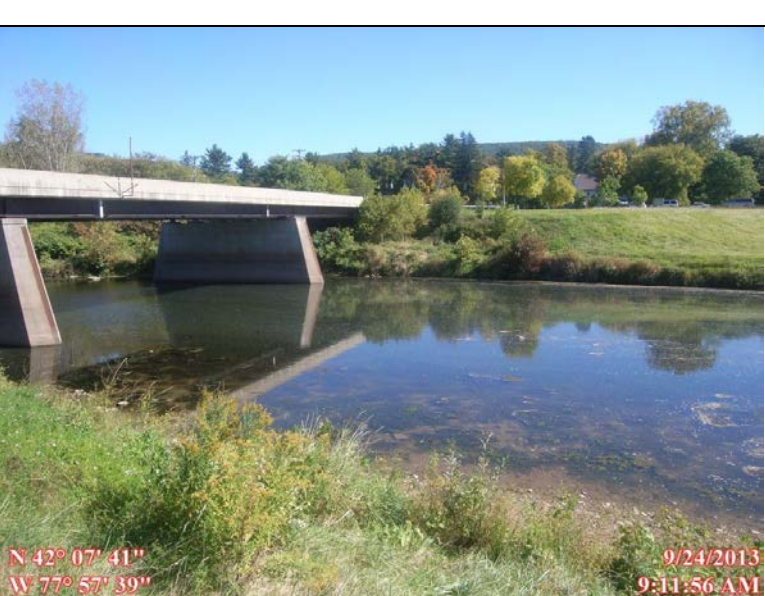
<p>N 42° 07' 41" W 77° 57' 39" 9/24/2013 9:11:56 AM</p>	<p><b>Inspect ID:</b> N21L_2013_a_0032 <b>Title:</b> USACE_CELRB_N21L_2013_a_0032_1.jpg <b>Rated Item:</b> 2. Shoaling (sediment deposition) <b>Caption:</b> Rating: Minimally Acceptable; <b>Remarks:</b> Shoaling under bridge; Station_1: 91+00</p>

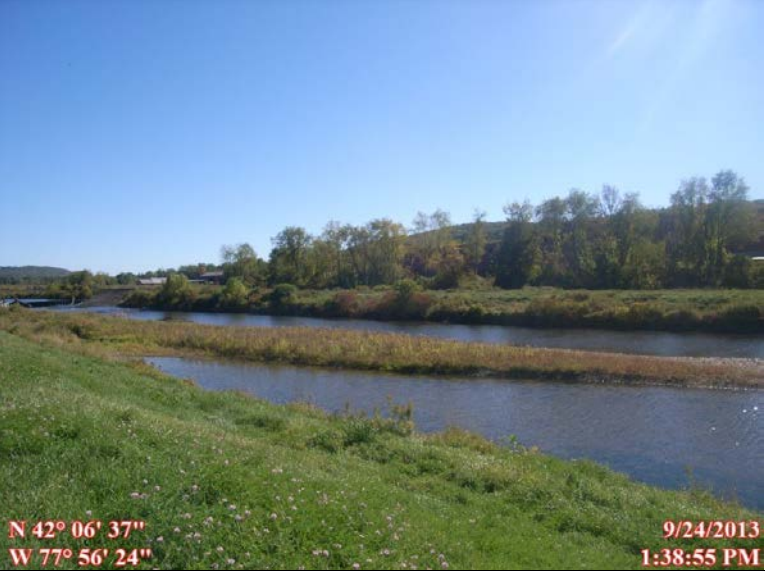
<p>N 42° 06' 37" W 77° 56' 24" 9/24/2013 1:38:55 PM</p>	<p><b>Inspect ID:</b> N21L_2013_a_0211 <b>Title:</b> USACE_CELRB_N21L_2013_a_0211_1.jpg <b>Rated Item:</b> 2. Shoaling (sediment deposition) <b>Caption:</b> Rating: Unacceptable; Remarks: Shoaling in channel; Station_1: 0+00</p>

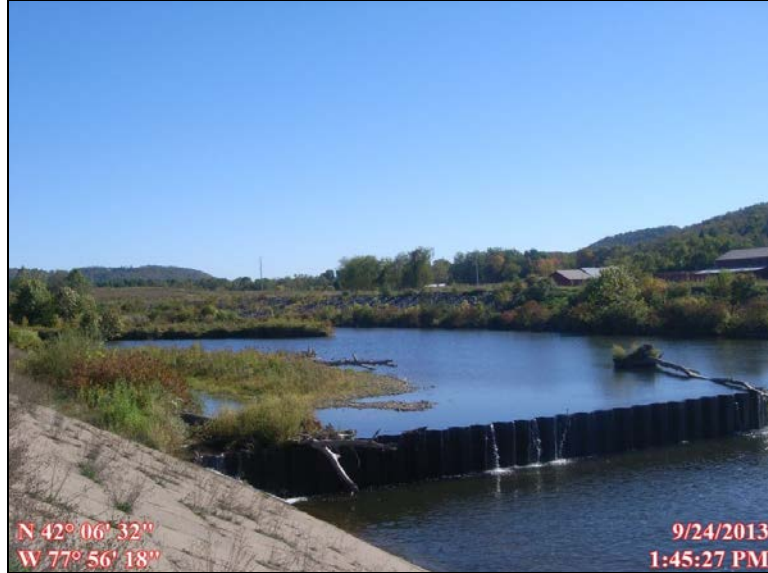
**Inspect ID:** N21L\_2013\_a\_0217 **Title:** USACE\_CELRB\_N21L\_2013\_a\_0217\_1.jpg  
**Rated Item:** 2. Shoaling (sediment deposition) **Caption:** Rating: Unacceptable;  
Remarks: Shoaling; Station\_1: 0+00; Station\_2: 0+00

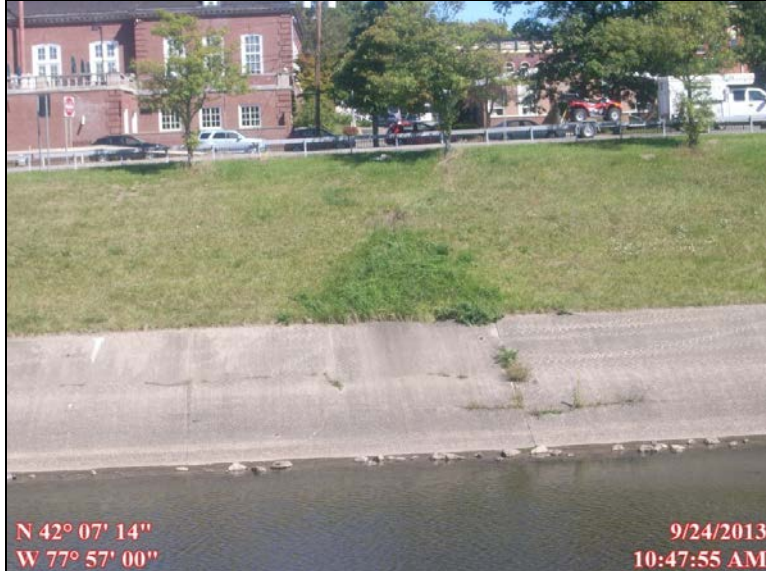
**Inspect ID:** N21L\_2013\_a\_0114 **Title:** USACE\_CELRB\_N21L\_2013\_a\_0114\_1.jpg  
**Rated Item:** 4. Erosion **Caption:** Rating: Minimally Acceptable; Remarks: 15 x 3' erosion; Station\_1: 44+00

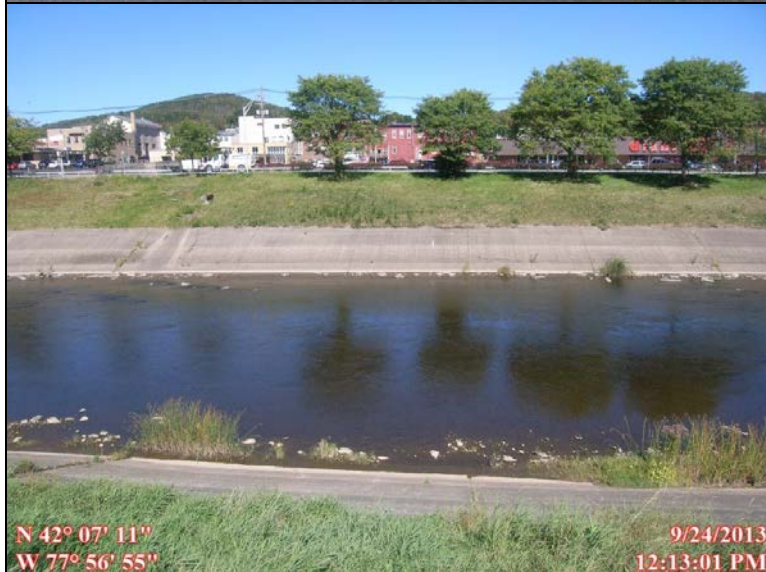
**Inspect ID:** N21L\_2013\_a\_0137 **Title:** USACE\_CELRB\_N21L\_2013\_a\_0137\_1.jpg  
**Rated Item:** 4. Erosion **Caption:** Rating: Minimally Acceptable; Remarks: Erosion, lack of riprap; Station\_1: 39+00

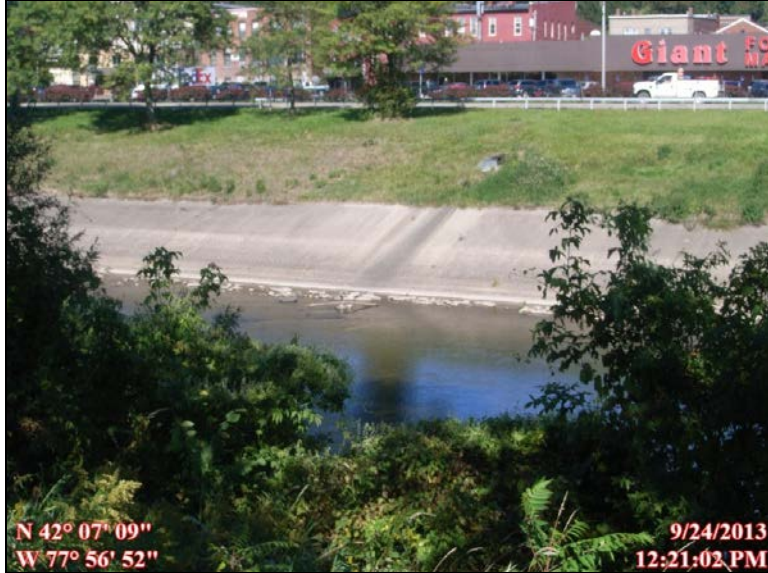
**Inspect ID:** N21L\_2013\_a\_0142 **Title:** USACE\_CELRB\_N21L\_2013\_a\_0142\_1.jpg  
**Rated Item:** 4. Erosion **Caption:** Rating: Minimally Acceptable; Remarks: Erosion lack of riprap; Station\_1: 37+00

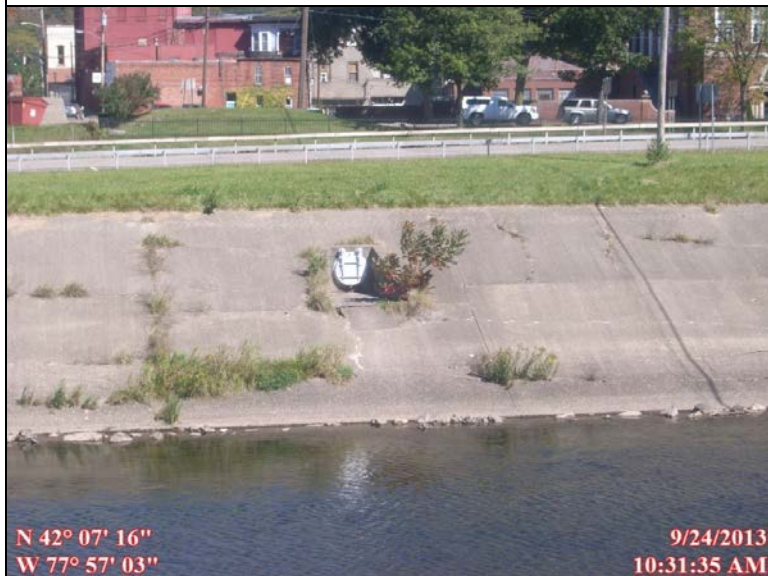
**Inspect ID:** N21L\_2013\_a\_0100 **Title:** USACE\_CELRB\_N21L\_2013\_a\_0100\_1.jpg  
**Rated Item:** 5. Concrete Surfaces **Caption:** Rating: Minimally Acceptable; Remarks: 1' x 10' x 18" erosion in concrete; Station\_1: 48+00

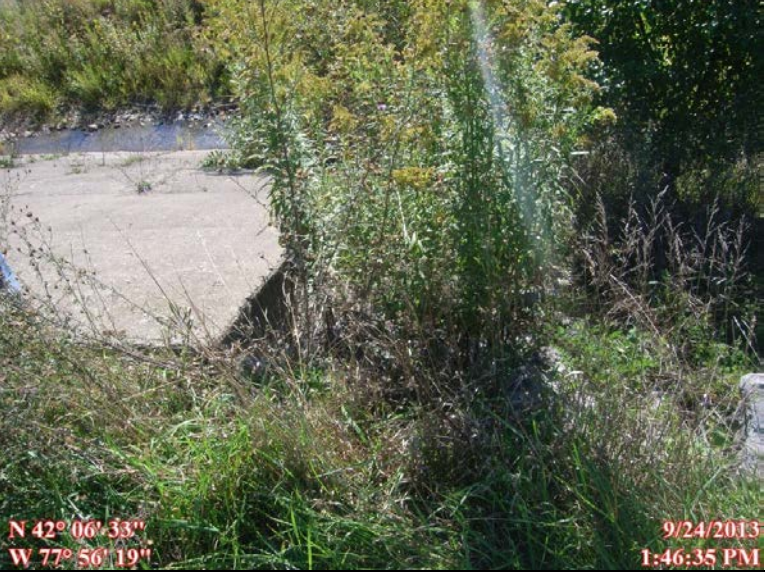
<p>N 42° 06' 33" W 77° 56' 19" 9/24/2013 1:46:35 PM</p>	<p><b>Inspect ID:</b> N21L_2013_a_0216 <b>Title:</b> USACE_CELRB_N21L_2013_a_0216_1.jpg <b>Rated Item:</b> 10. Riprap Revetments &amp; Banks <b>Caption:</b> Rating: Minimally Acceptable; Remarks: Displacement of riprap along concrete; Station_1: 0+00</p>

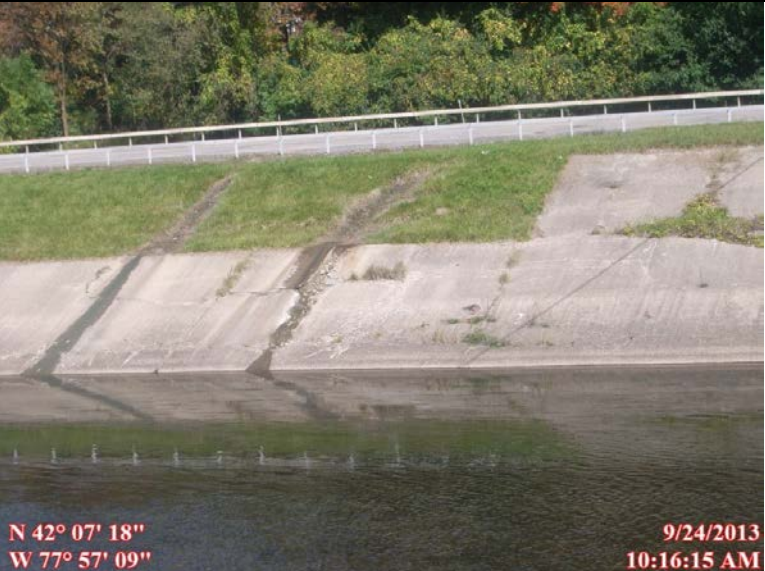
<p>N 42° 07' 18" W 77° 57' 09" 9/24/2013 10:16:15 AM</p>	<p><b>Inspect ID:</b> N21L_2013_a_0083 <b>Title:</b> USACE_CELRB_N21L_2013_a_0083_1.jpg <b>Rated Item:</b> 11. Revetments other than Riprap <b>Caption:</b> Rating: Minimally Acceptable; Remarks: 15' x 3' concrete spalling; Station_1: 52+00</p>

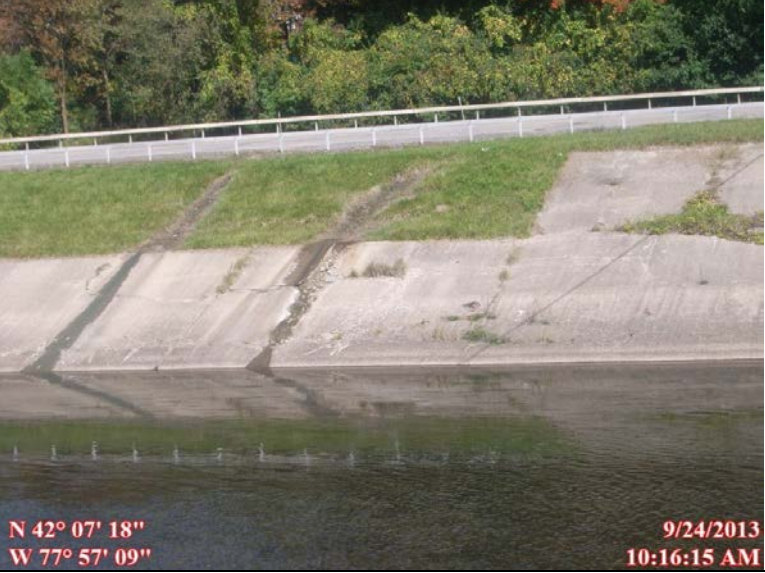
<p>N 42° 07' 18" W 77° 57' 09"</p> <p>9/24/2013 10:16:15 AM</p>	<p><b>Inspect ID:</b> N21L_2013_a_0085 <b>Title:</b> USACE_CELRB_N21L_2013_a_0085_1.jpg <b>Rated Item:</b> 11. Revetments other than Riprap <b>Caption:</b> Rating: Acceptable; Remarks: Typical spalling; Station_1: 52+00</p>

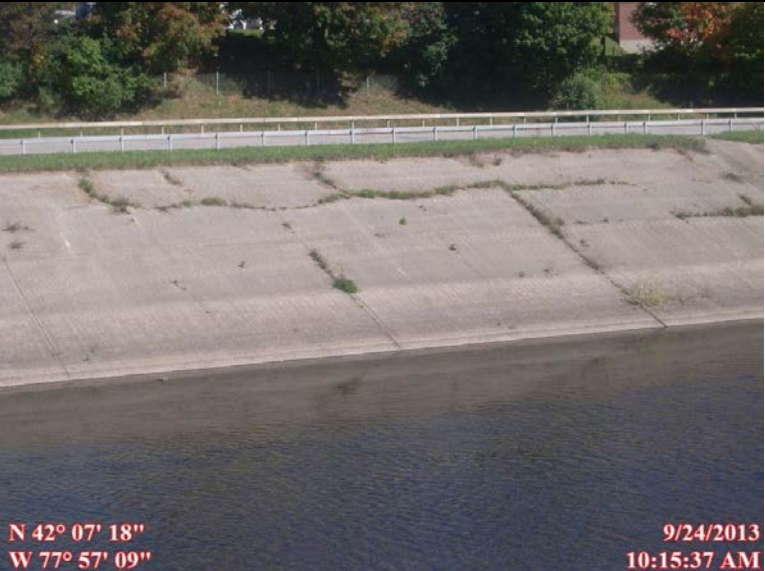
<p>N 42° 07' 18" W 77° 57' 09"</p> <p>9/24/2013 10:15:37 AM</p>	<p><b>Inspect ID:</b> N21L_2013_a_0086 <b>Title:</b> USACE_CELRB_N21L_2013_a_0086_1.jpg <b>Rated Item:</b> 11. Revetments other than Riprap <b>Caption:</b> Rating: Minimally Acceptable; Remarks: Minor unwanted vegetation at concrete joints; Station_1: 52+00; Station_2: 43+00</p>

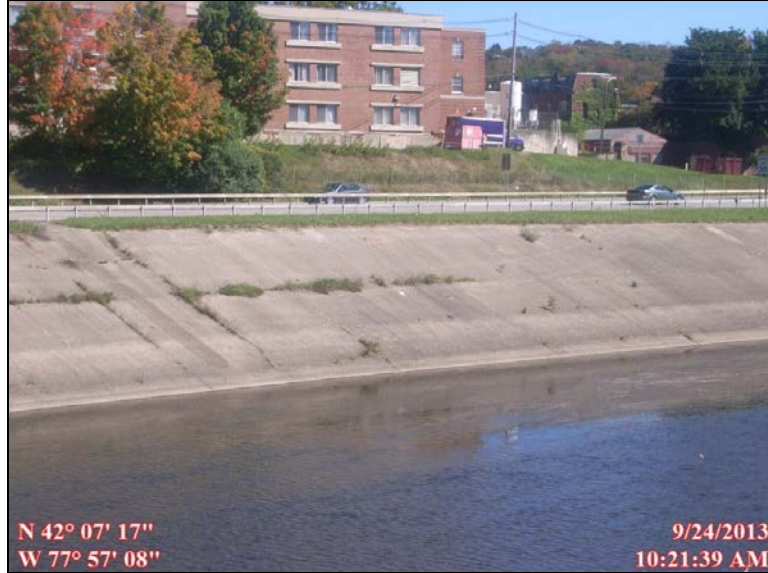
**Inspect ID:** N21L\_2013\_a\_0088 **Title:** USACE\_CELRB\_N21L\_2013\_a\_0088\_1.jpg  
**Rated Item:** 11. Revetments other than Riprap **Caption:** Rating: Minimally Acceptable;  
Remarks: Typical cracking in concrete; Station\_1: 51+00

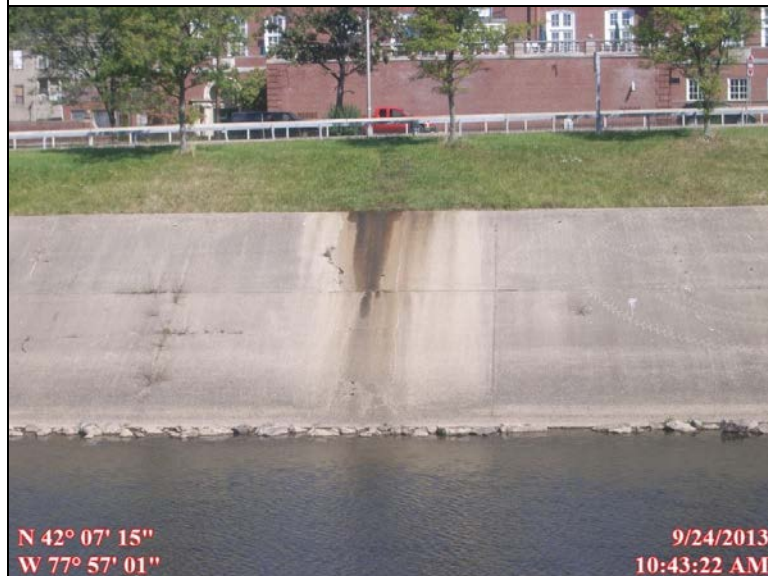
**Inspect ID:** N21L\_2013\_a\_0111 **Title:** USACE\_CELRB\_N21L\_2013\_a\_0111\_1.jpg  
**Rated Item:** 11. Revetments other than Riprap **Caption:** Rating: Minimally Acceptable;  
Remarks: Cracking in concrete; Station\_1: 45+00

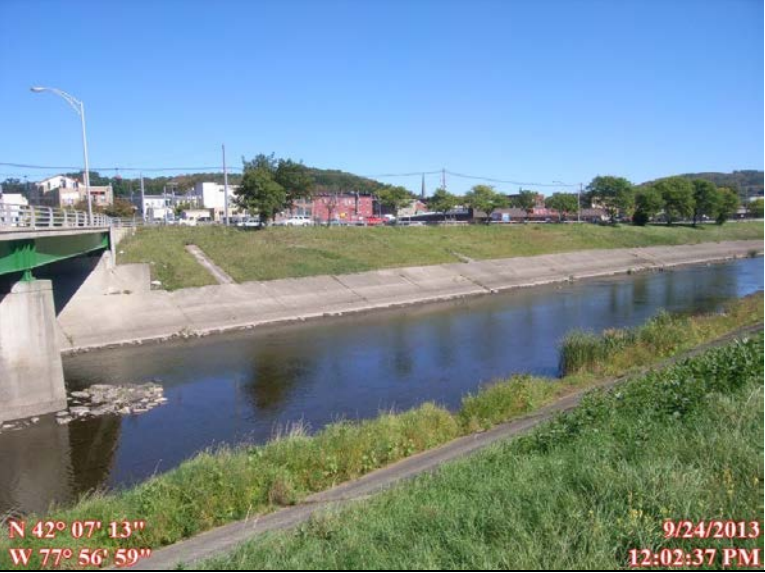
<p><b>Inspect ID:</b> N21L_2013_a_0127 <b>Title:</b> USACE_CELRB_N21L_2013_a_0127_1.jpg <b>Rated Item:</b> 11. Revetments other than Riprap <b>Caption:</b> Rating: Minimally Acceptable; <b>Remarks:</b> Spalling on bank; Station_1: 41+00</p>

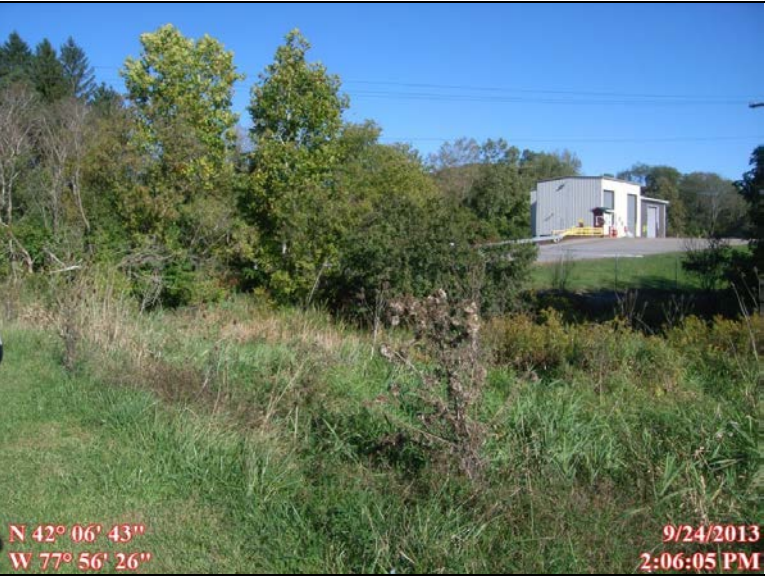
<p>N 42° 06' 43" W 77° 56' 26"</p> <p>9/24/2013 2:06:05 PM</p>	<p><b>Inspect ID:</b> N21R_2013_a_0007 <b>Title:</b> USACE_CELRB_N21R_2013_a_0007_1.jpg <b>Rated Item:</b> 1. Unwanted Vegetation Growth <b>Caption:</b> Rating: Minimally Acceptable; <b>Remarks:</b> Unwanted vegetation on the riverside; Station_1: 0+00; Station_2: 0+00</p>
