DEPARTMENT OF THE ARMY

SUBJECT: FY17 Periodic Inspection of Completed Works, Flood Risk Management Project,
Genesee River, Wellsville, New York (09/27/17)

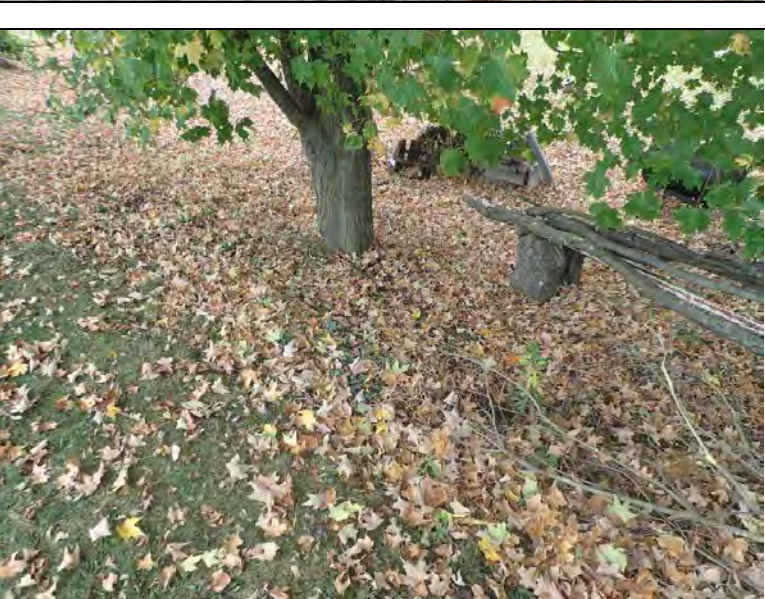
<p>Inspect ID: N21L_2017_p_0047 Title: USACE_CELRB_N21L_2017_p_0047_1.jpg Rated Item: 2. Sod Cover Caption: Rating: Minimally Acceptable; Remarks: Inadequate sod cover at 70 Chamberlain Street on iandside slope.; Action: Re-establish sod cover.; Station_1: 60+00</p>

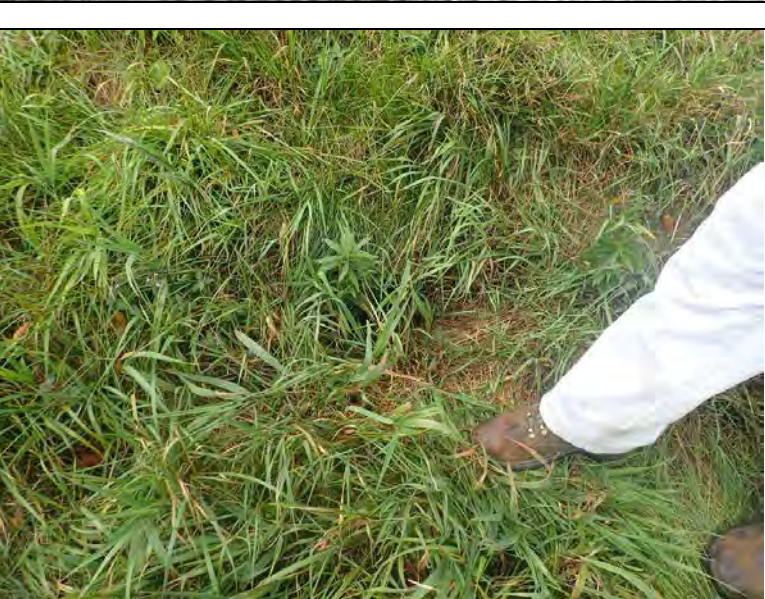
<p>Inspect ID: N21L_2017_p_0114 Title: USACE_CELRB_N21L_2017_p_0114_1.jpg Rated Item: 10. Animal Control Caption: Rating: Minimally Acceptable; Remarks: Erosion and animal burrow on left bank 350' upstream of the pedestrain bridge.; Action: Repair erosion and animal burrow.; Station_1: 13+00</p>

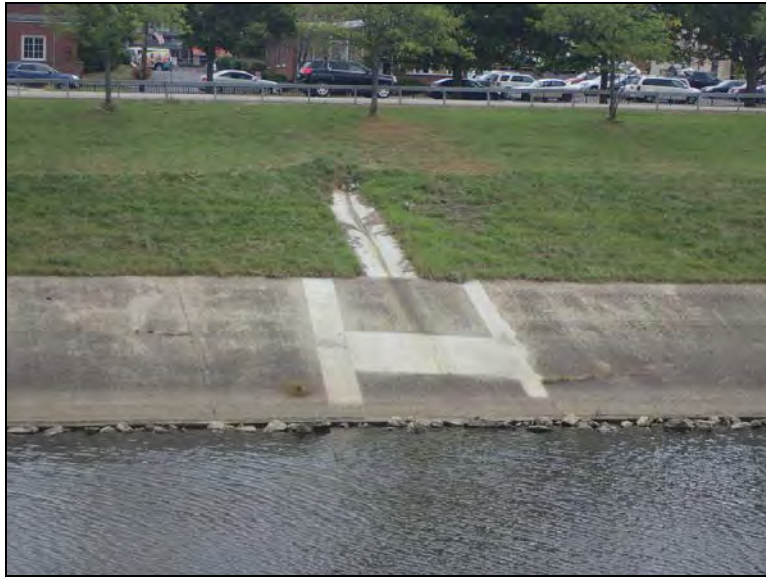
Inspect ID: N21L_2017_p_0079 **Title:** USACE_CELRB_N21L_2017_p_0079_1.jpg
Rated Item: 9. Culverts/ Discharge Pipes **Caption:** Rating: Acceptable; Remarks: 12" CMP repaired on right bank 250' downstream of Madison Street (Stevens Street) bridge.; Action: NA; Station_1: 44+00

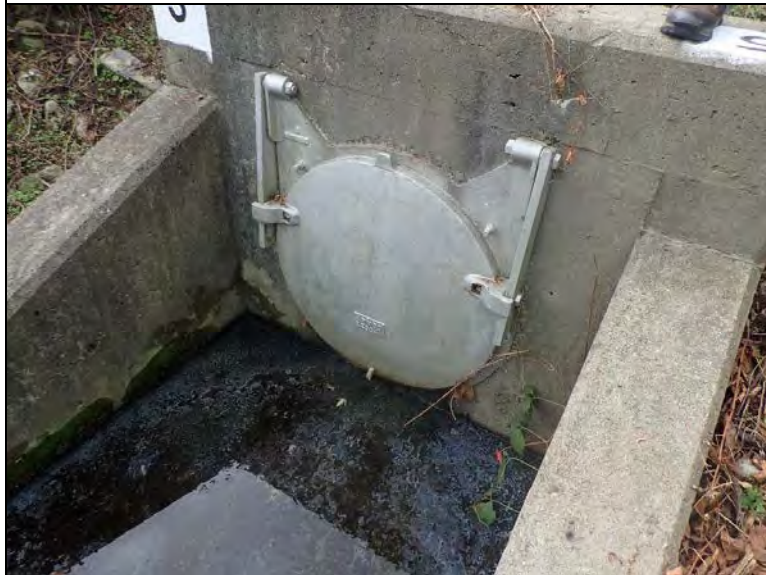
Inspect ID: N21L_2017_p_0101 **Title:** USACE_CELRB_N21L_2017_p_0101_1.jpg
Rated Item: 9. Culverts/ Discharge Pipes **Caption:** Rating: Acceptable; Remarks: 36" CMP on left bank 475' upstream of Steel Sheet Pile Weir (rated A in NYSDEC 19DEC13 pipe inspection).; Action: Maintain pipe and videotape inspect by 19DEC18.; Station_1: 23+00

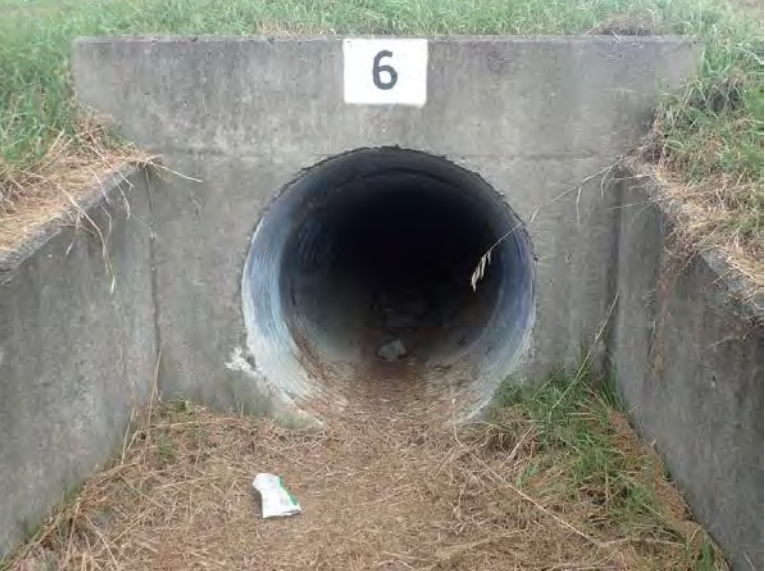
<p>Inspect ID: N21L_2017_p_0104 Title: USACE_CELRB_N21L_2017_p_0104_1.jpg Rated Item: 9. Culverts/ Discharge Pipes Caption: Rating: Acceptable; Remarks: 48" CMP on left bank landside slope 515' upstream of Steel Sheet Pile Weir (rated A in NYSDEC 19DEC13 pipe inspection). Pipet does not have a trash rack to prevent obstructions from entering the pipe. ; Action: Maintain pipe and videotape inspect by 19DEC18. Recommend installing trash rack over opening to keep out debris and unauthorized access. ; Station_1: 23+00</p>

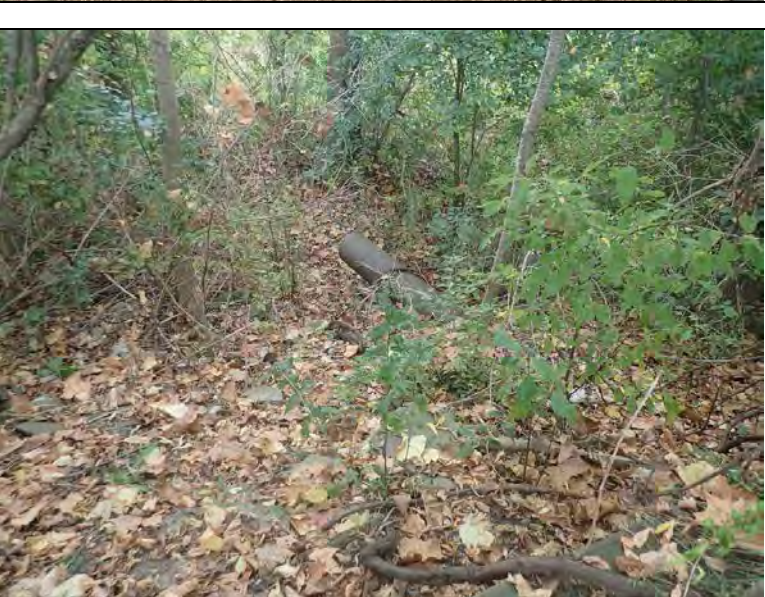
<p>Inspect ID: N21L_2017_p_0123 Title: USACE_CELRB_N21L_2017_p_0123_1.jpg Rated Item: 9. Culverts/ Discharge Pipes Caption: Rating: Minimally Acceptable; Remarks: Unauthorized Alteration (A-NEW) - 12" cast iron pipe on left bank 125' upstream of barrier levee weir.; Action: Submit Section 408 Alteration Request to USACE or remove unauthorized alteration.; Station_1: 0+00</p>

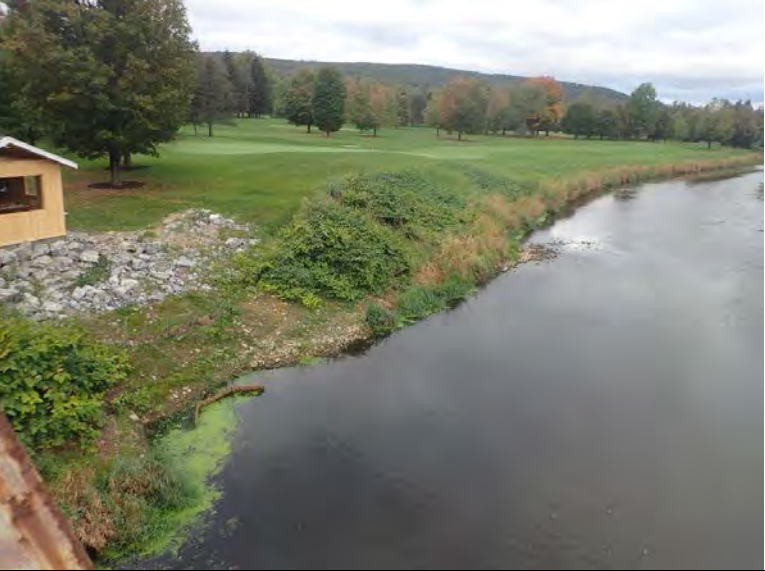
<p>Inspect ID: N21L_2017_p_0002 Title: USACE_CELRB_N21L_2017_p_0002_1.jpg Rated Item: 1. Vegetation and Obstructions Caption: Rating: Minimally Acceptable; Remarks: Unwanted vegetation on left bank channel sideslope just downstream of golf course pedestrian bridge.; Action: Remove unwanted vegetation.; Station_1: 105+00; Station_2: 104+00</p>

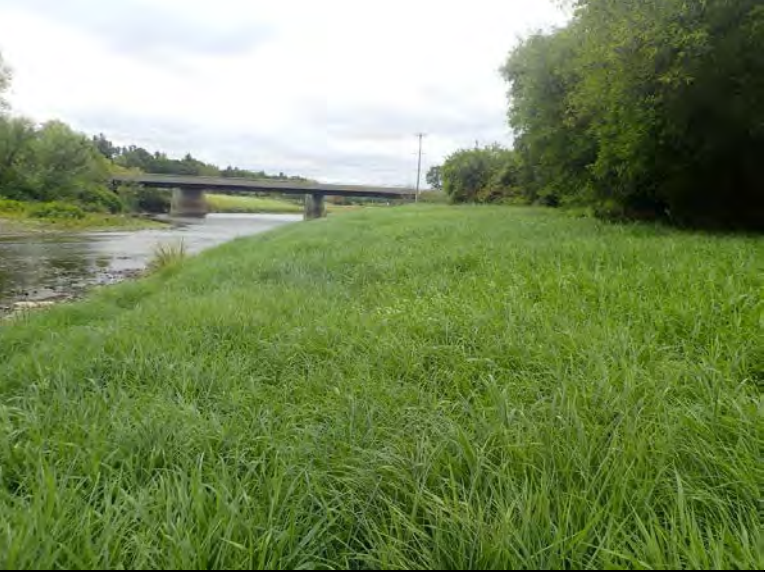
<p>Inspect ID: N21L_2017_p_0009 Title: USACE_CELRB_N21L_2017_p_0009_1.jpg Rated Item: 1. Vegetation and Obstructions Caption: Rating: Minimally Acceptable; Remarks: Unwanted vegetation on left bank channel sideslope upstream of Bolivar Road bridge.; Action: Remove unwanted vegetation.; Station_1: 96+00; Station_2: 91+00</p>

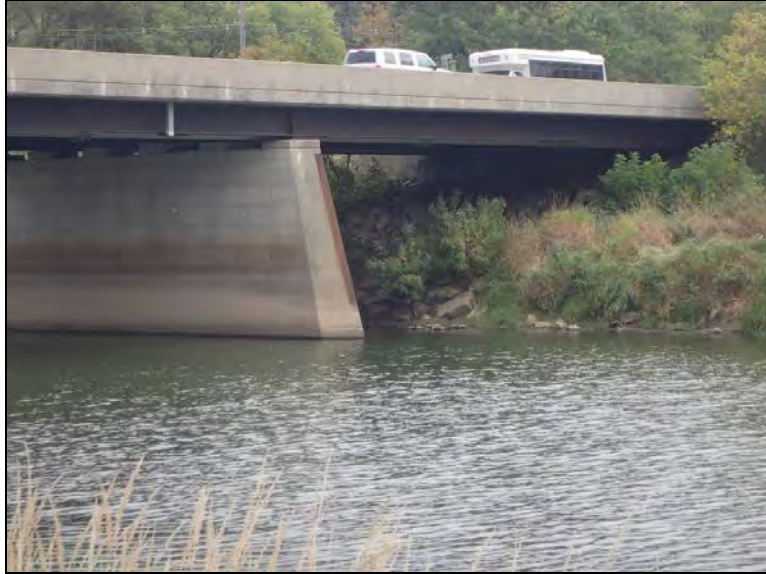
Inspect ID: N21L_2017_p_0010 **Title:** USACE_CELRB_N21L_2017_p_0010_2.jpg
Rated Item: 1. Vegetation and Obstructions **Caption:** Rating: Minimally Acceptable;
Remarks: Vegetation in riprap on right bank around Bolivar Road bridge.; **Action:** Remove vegetation from riprap.; **Station_1:** 91+00

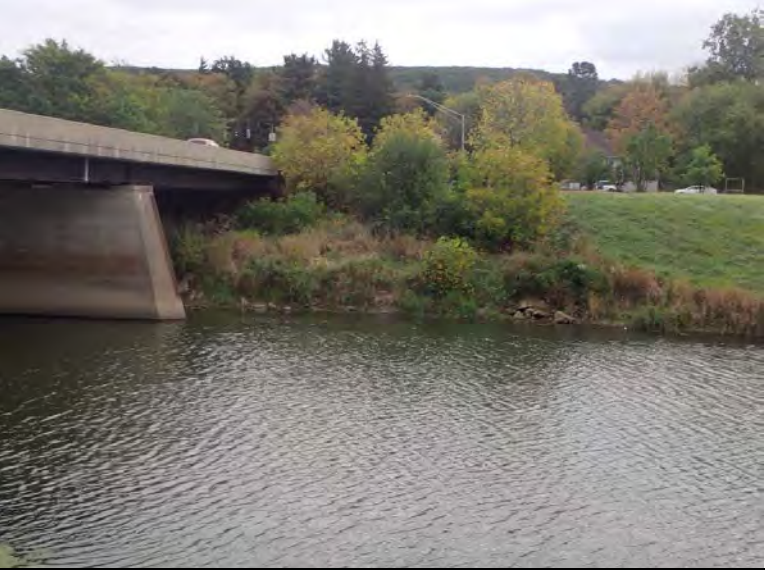
<p>Inspect ID: N21L_2017_p_0011 Title: USACE_CELRB_N21L_2017_p_0011_2.jpg Rated Item: 1. Vegetation and Obstructions Caption: Rating: Minimally Acceptable; Remarks: Unwanted heavy woody vegetation on right bank around Bolivar Road bridge.; Action: Remove vegetation.; Station_1: 91+00</p>

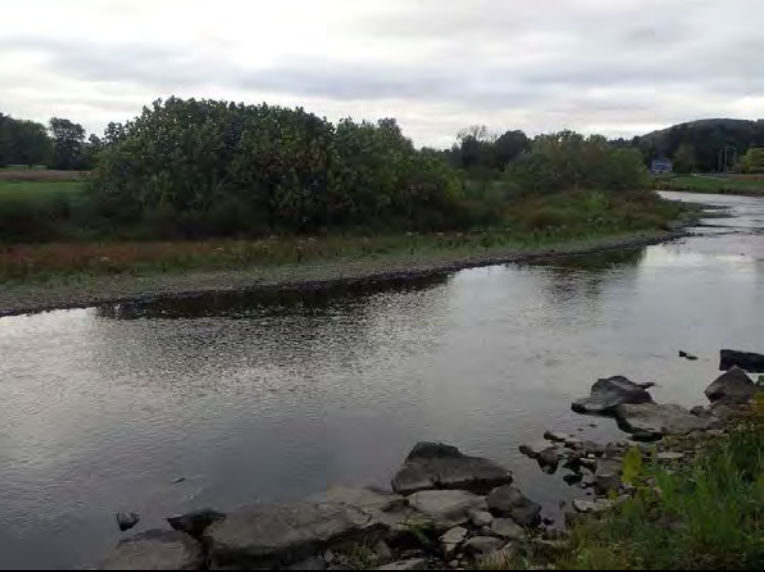
<p>Inspect ID: N21L_2017_p_0022 Title: USACE_CELRB_N21L_2017_p_0022_1.jpg Rated Item: 1. Vegetation and Obstructions Caption: Rating: Minimally Acceptable; Remarks: Unwanted vegetation on both bank sideslopes from 750' upstream of Bolivar Road bridge to Madison Street bridge.; Action: Remove unwanted vegetation.; Station_1: 84+00; Station_2: 44+00</p>

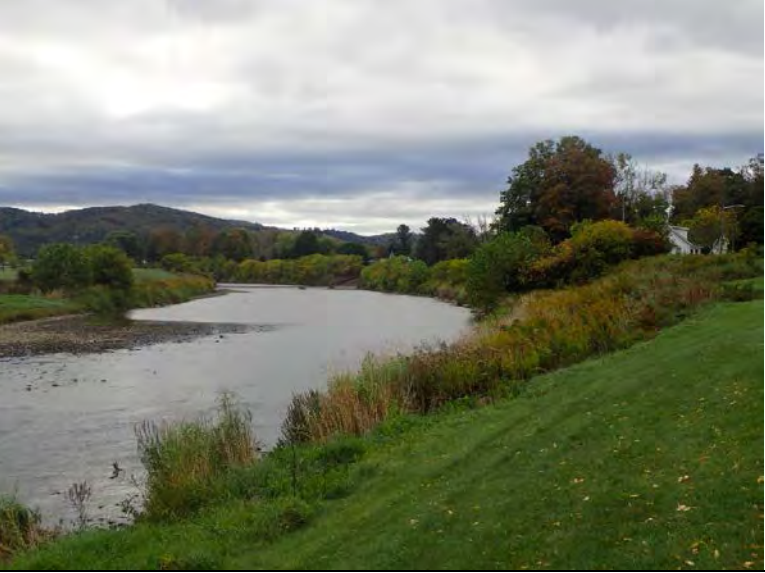
<p>Inspect ID: N21L_2017_p_0022 Title: USACE_CELRB_N21L_2017_p_0022_3.jpg Rated Item: 1. Vegetation and Obstructions Caption: Rating: Minimally Acceptable; Remarks: Unwanted vegetation on both bank sideslopes from 750' upstream of Bolivar Road bridge to Madison Street bridge.; Action: Remove unwanted vegetation.; Station_1: 84+00; Station_2: 44+00</p>

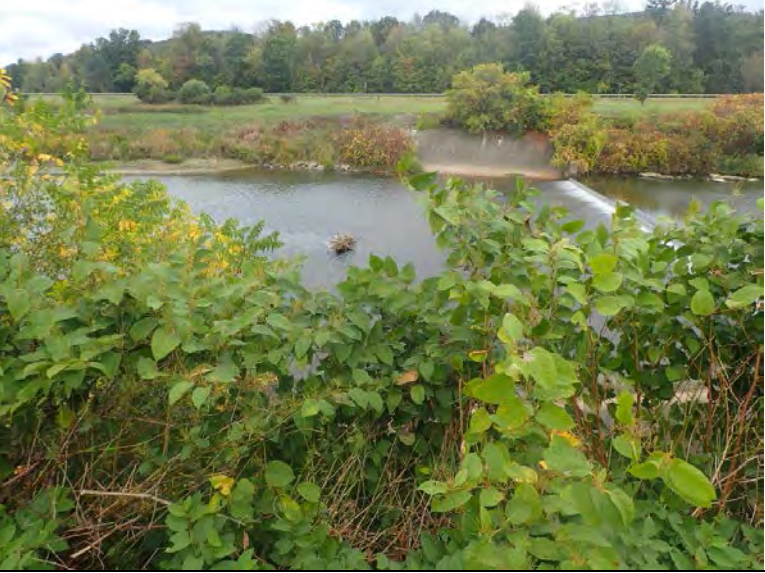
<p>Inspect ID: N21L_2017_p_0039 Title: USACE_CELRB_N21L_2017_p_0039_1.jpg Rated Item: 1. Vegetation and Obstructions Caption: Rating: Minimally Acceptable; Remarks: Tree debris in channel just downstream of Drop Structure.; Action: Remove tree debris.; Station_1: 66+00</p>

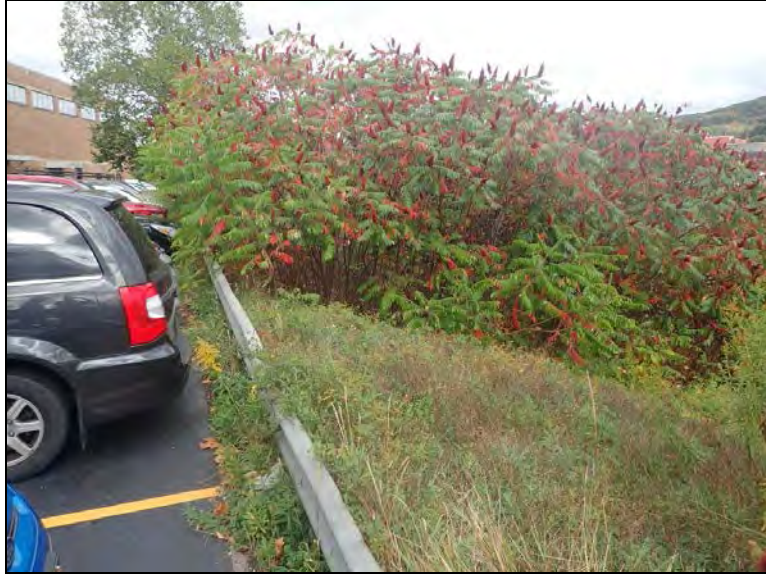
Inspect ID: N21L_2017_p_0087 **Title:** USACE_CELRB_N21L_2017_p_0087_2.jpg
Rated Item: 1. Vegetation and Obstructions **Caption:** Rating: Unacceptable; Remarks: Significant unwanted vegetation and trees on left bank 400' downstream of State Street bridge.; Action: Remove unwanted vegetation and trees.; Station_1: 37+00

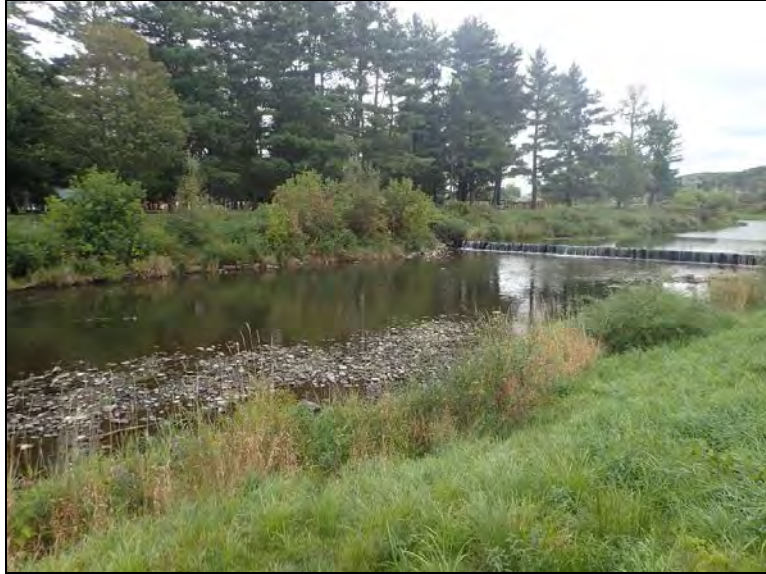
Inspect ID: N21L_2017_p_0095 **Title:** USACE_CELRB_N21L_2017_p_0095_1.jpg
Rated Item: 1. Vegetation and Obstructions **Caption:** Rating: Minimally Acceptable;
Remarks: Soft vegetation on right bank from Island Park to 500 feet upstream of Island Park pedestrian bridge.; **Action:** Remove soft vegetation.; **Station_1:** 29+00; **Station_2:** 11+00

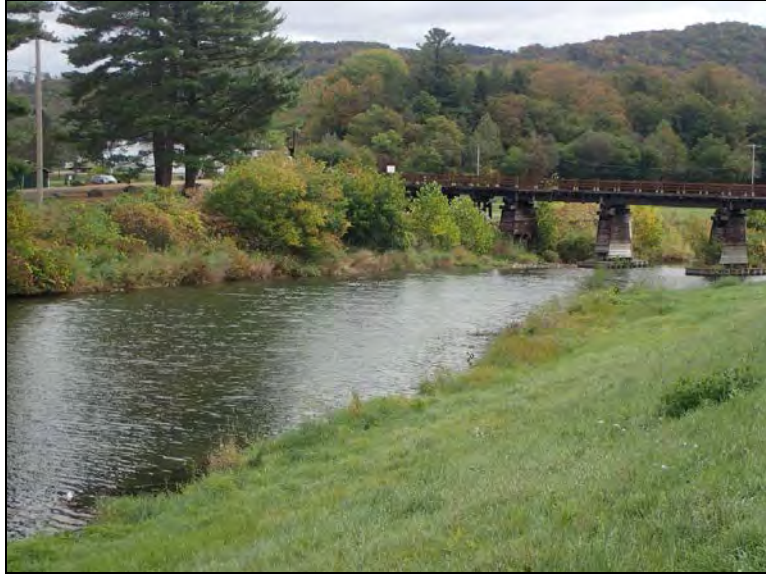
Inspect ID: N21L_2017_p_0095 **Title:** USACE_CELRB_N21L_2017_p_0095_3.jpg
Rated Item: 1. Vegetation and Obstructions **Caption:** Rating: Minimally Acceptable;
Remarks: Soft vegetation on right bank from Island Park to 500 feet upstream of Island Park pedestrian bridge.; **Action:** Remove soft vegetation.; **Station_1:** 29+00; **Station_2:** 11+00

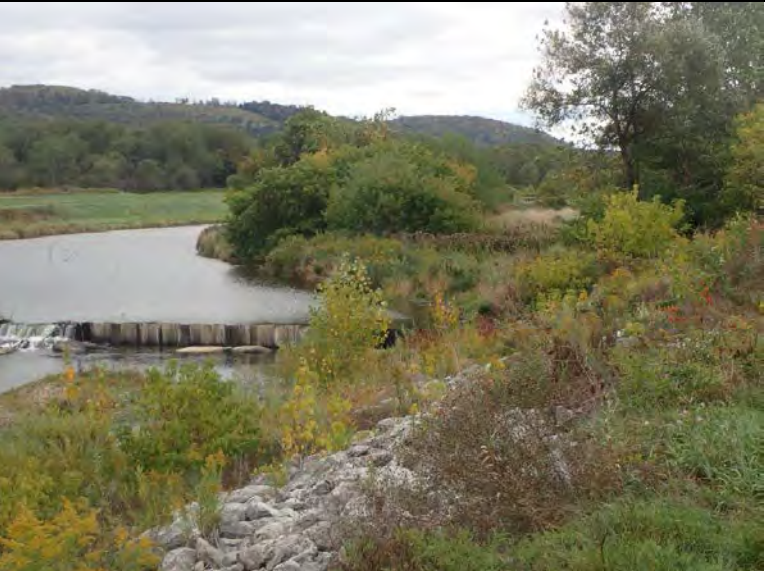
<p>Inspect ID: N21L_2017_p_0121 Title: USACE_CELRB_N21L_2017_p_0121_1.jpg Rated Item: 1. Vegetation and Obstructions Caption: Rating: Unacceptable; Remarks: Significant unwanted vegetation and trees on left bank 175' upstream of barrier levee weir.; Action: Remove unwanted vegetation.; Station_1: 0+00</p>

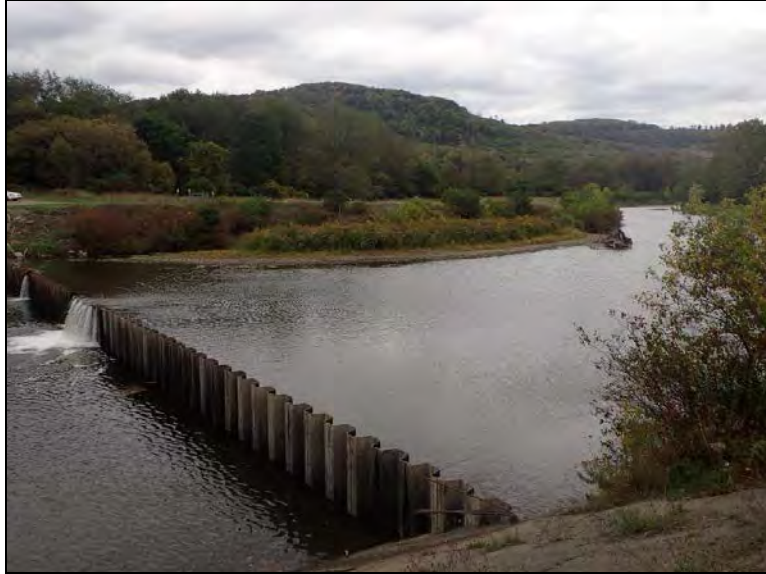
Inspect ID: N21L_2017_p_0122 **Title:** USACE_CELRB_N21L_2017_p_0122_1.jpg
Rated Item: 1. Vegetation and Obstructions **Caption:** Rating: Minimally Acceptable;
Remarks: Large tree debris in channel at downstream end of large shoal.; **Action:** Remove tree debris.; **Station_1:** 0+00

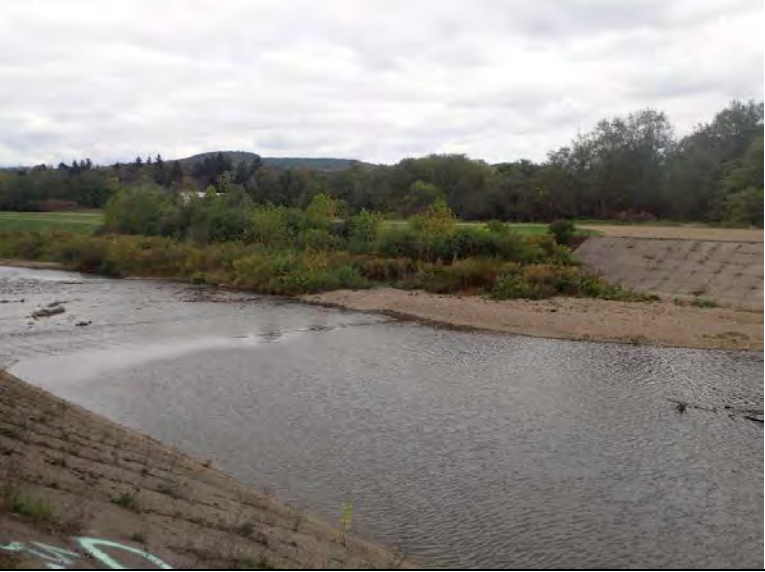
<p>Inspect ID: N21L_2017_p_0130 Title: USACE_CELRB_N21L_2017_p_0130_1.jpg Rated Item: 1. Vegetation and Obstructions Caption: Rating: Unacceptable; Remarks: Significant unwanted vegetation on right bank sideslope from 400' downstream of upstream limit weir to upstream limit weir.; Action: Remove unwanted vegetation.; Station_1: 0+00; Station_2: 0+00</p>

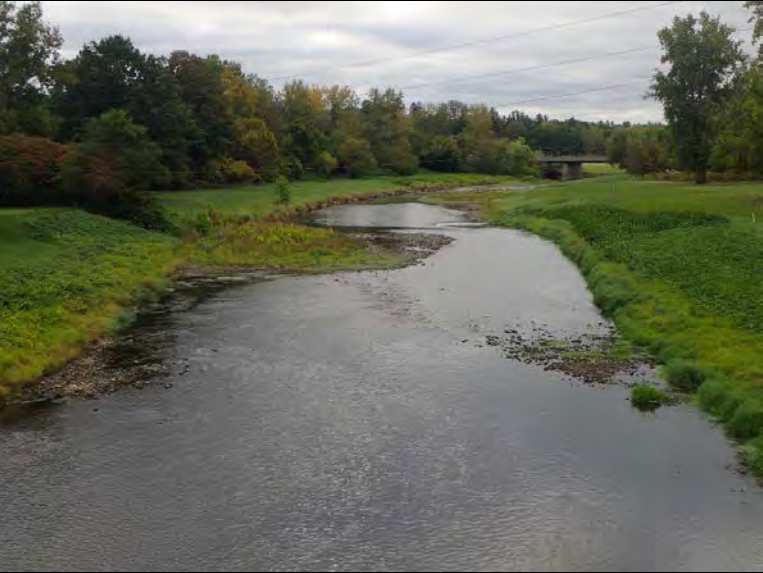
<p>Inspect ID: N21L_2017_p_0005 Title: USACE_CELRB_N21L_2017_p_0005_1.jpg Rated Item: 2. Shoaling (sediment deposition) Caption: Rating: Minimally Acceptable; Remarks: Four alternating vegetated shoals (S-2, S-3, S-4, S-5) on both banks from green golf course pedestrian bridge to Bolivar Road bridge.; Action: Remove shoals.; Station_1: 103+00; Station_2: 92+00</p>

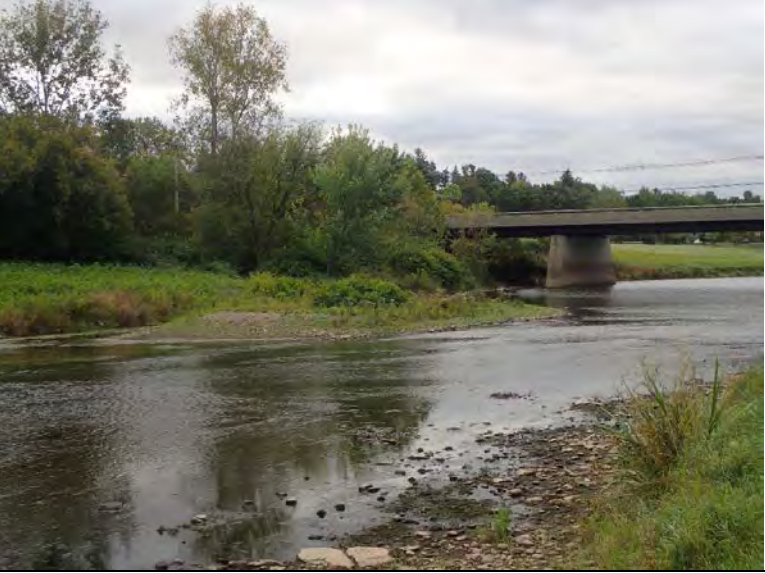
<p>Inspect ID: N21L_2017_p_0005 Title: USACE_CELRB_N21L_2017_p_0005_3.jpg Rated Item: 2. Shoaling (sediment deposition) Caption: Rating: Minimally Acceptable; Remarks: Four alternating vegetated shoals (S-2, S-3, S-4, S-5) on both banks from green golf course pedestrian bridge to Bolivar Road bridge.; Action: Remove shoals.; Station_1: 103+00; Station_2: 92+00</p>

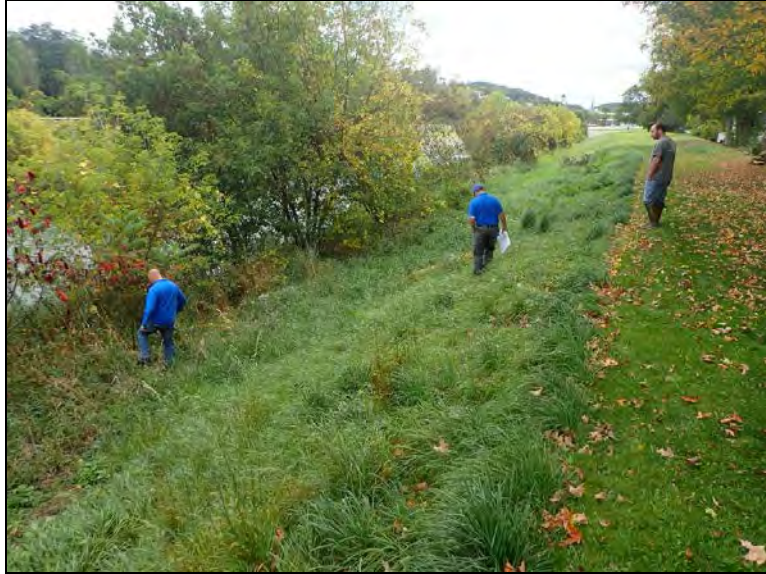
Inspect ID: N21L_2017_p_0050 **Title:** USACE_CELRB_N21L_2017_p_0050_1.jpg
Rated Item: 2. Shoaling (sediment deposition) **Caption:** Rating: Minimally Acceptable;
Remarks: Shoal (S-7) on left bank toe, not part of as-built project (189-WEL-2/5).;
Action: Remove Shoal.; Station_1: 60+00; Station_2: 56+00

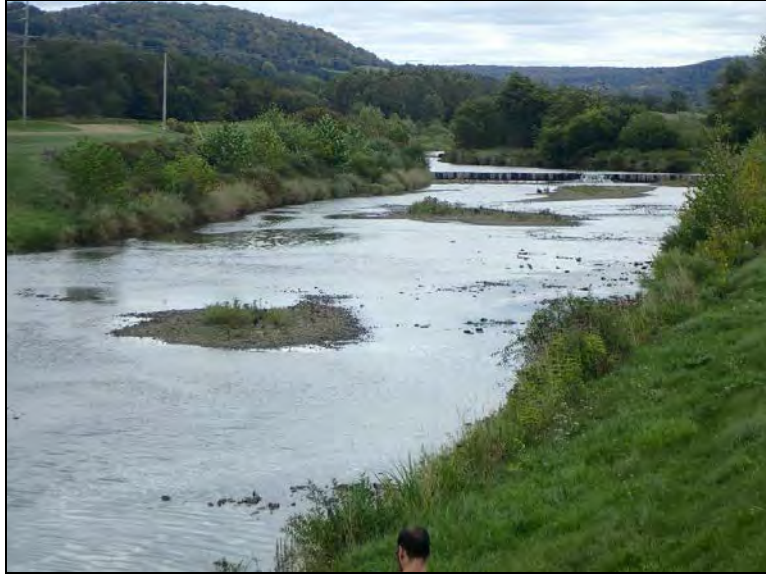
Inspect ID: N21L_2017_p_0116 **Title:** USACE_CELRB_N21L_2017_p_0116_1.jpg
Rated Item: 2. Shoaling (sediment deposition) **Caption:** Rating: Minimally Acceptable;
Remarks: Minor shoaling (S-10) downstream of barrier levee weir.limits to approx 600ft
ds; **Action:** Remove shoal.; **Station_1:** 3+00

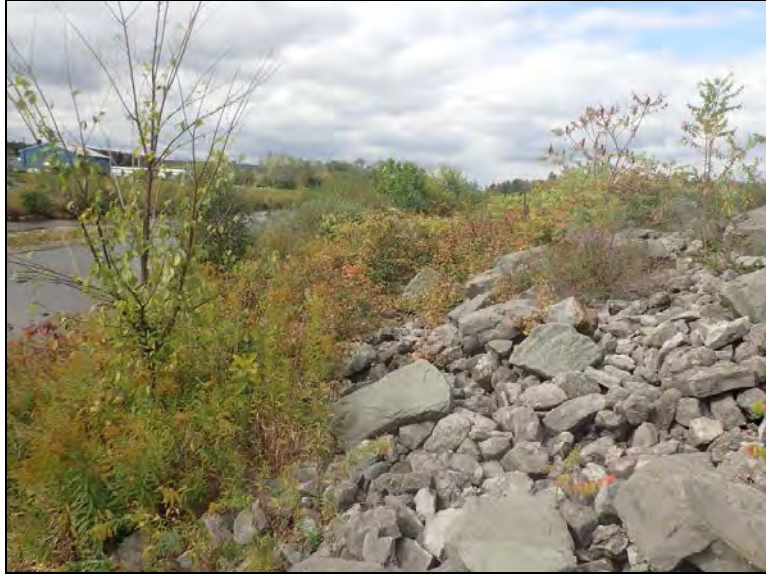
Inspect ID: N21L_2017_p_0127 **Title:** USACE_CELRB_N21L_2017_p_0127_2.jpg
Rated Item: 2. Shoaling (sediment deposition) **Caption:** Rating: Unacceptable;
Remarks: Significant vegetated shoal (S-11) and trees in channel on right bank from 100'-700' downstream of upstream limit weir.; **Action:** Remove shoaling.; **Station_1:** 0+00

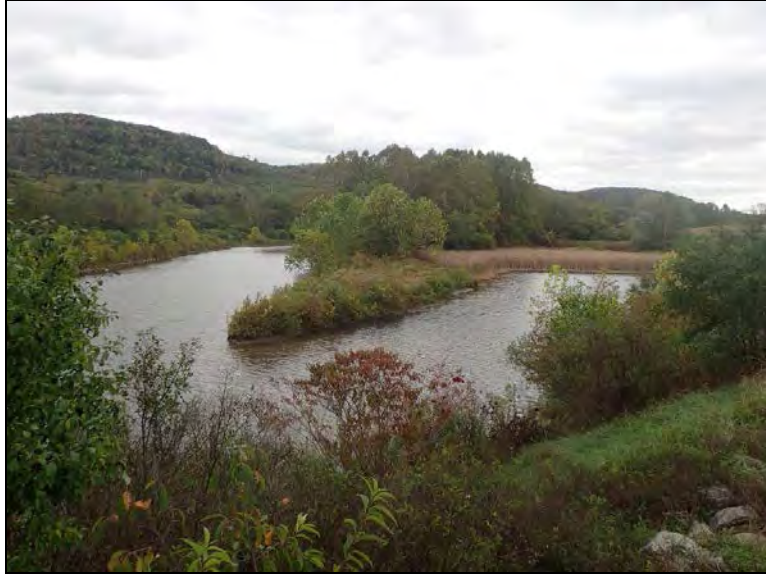
Inspect ID: N21L_2017_p_0131 **Title:** USACE_CELRB_N21L_2017_p_0131_1.jpg
Rated Item: 2. Shoaling (sediment deposition) **Caption:** Rating: Unacceptable;
Remarks: Significant vegetated shoaling (S-13) with trees in center of channel just upstream of upstream limit weir.; **Action:** Remove shoaling.; **Station_1:** 0+00

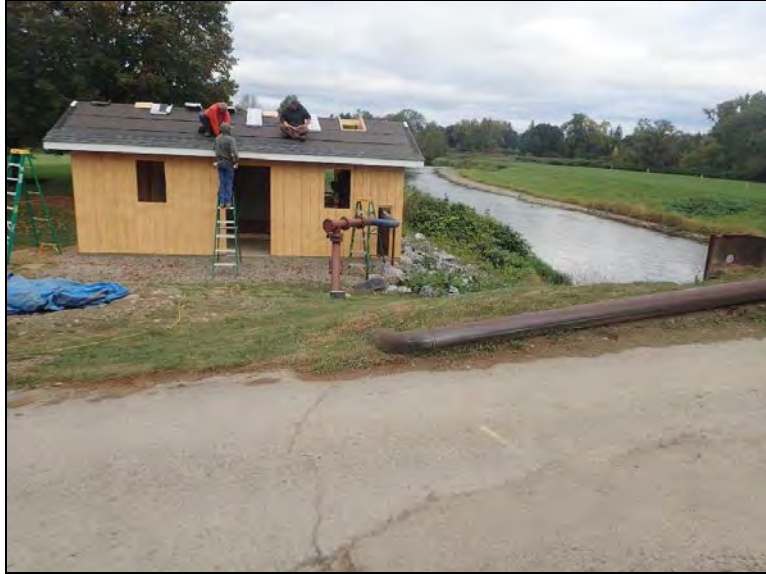
Inspect ID: N21L_2017_p_0003 **Title:** USACE_CELRB_N21L_2017_p_0003_2.jpg
Rated Item: 3. Encroachments **Caption:** Rating: Minimally Acceptable; Remarks: Unauthorized Alteration (A-1) - New pump station building, riprap, intake pipe to pump station, and feeder pipes for golf course water just downstream of pedestrian bridge.; Action: Submit Section 408 Alteration Request to USACE or remove unauthorized alteration.; Station_1: 104+00

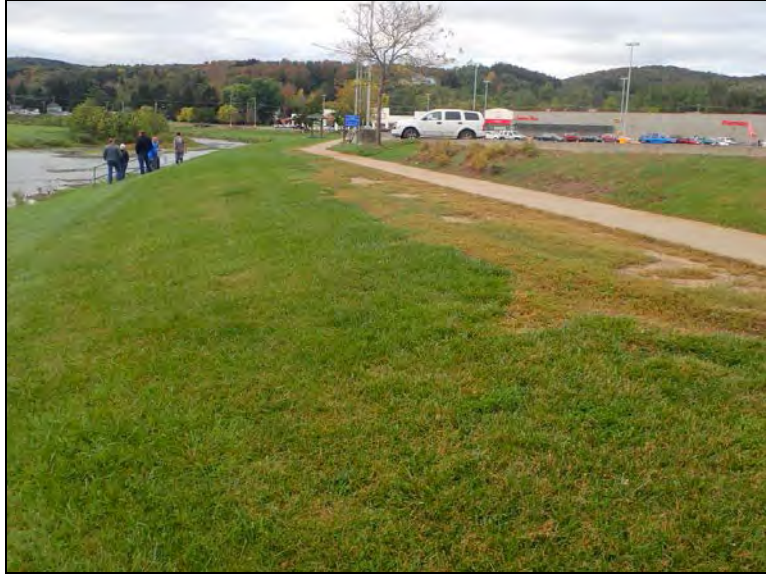
Inspect ID: N21L_2017_p_0018 **Title:** USACE_CELRB_N21L_2017_p_0018_1.jpg
Rated Item: 3. Encroachments **Caption:** Rating: Minimally Acceptable; Remarks: Unauthorized Alteration (A-4) - Sidewalk encroachment (benches and lightposts are not encroachments) along left bank from Bolivar road bridge to 1,775 feet upstream of Bolivar Road bridge.; Action: Submit Section 408 Alteration Request to USACE or remove unauthorized alteration.; Station_1: 90+00; Station_2: 76+00

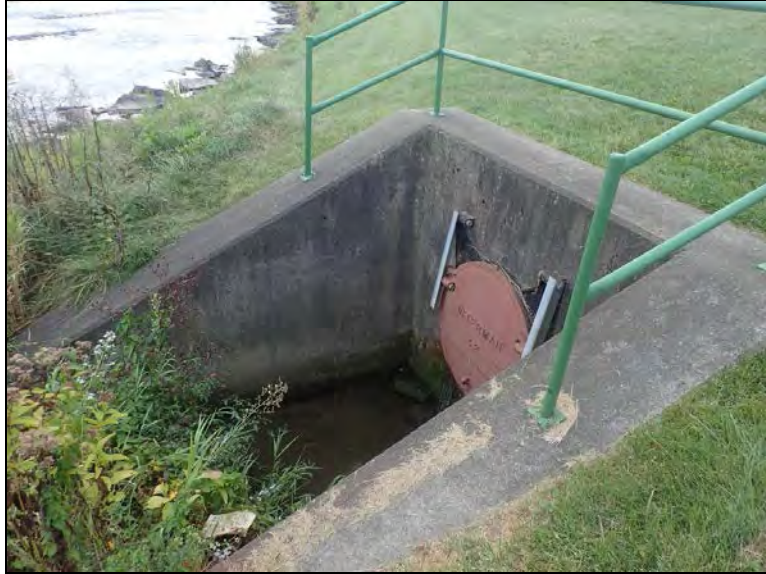
Inspect ID: N21L_2017_p_0024 **Title:** USACE_CELRB_N21L_2017_p_0024_1.jpg
Rated Item: 3. Encroachments **Caption:** Rating: Minimally Acceptable; Remarks: Unauthorized Alteration (A-7) - 42" outfall on left bank 900' upstream of Bolivar Road bridge at K-Mart. NYSDEC says permitted.; Action: Submit Section 408 Alteration Request to USACE or remove unauthorized alteration.; Station_1: 82+00

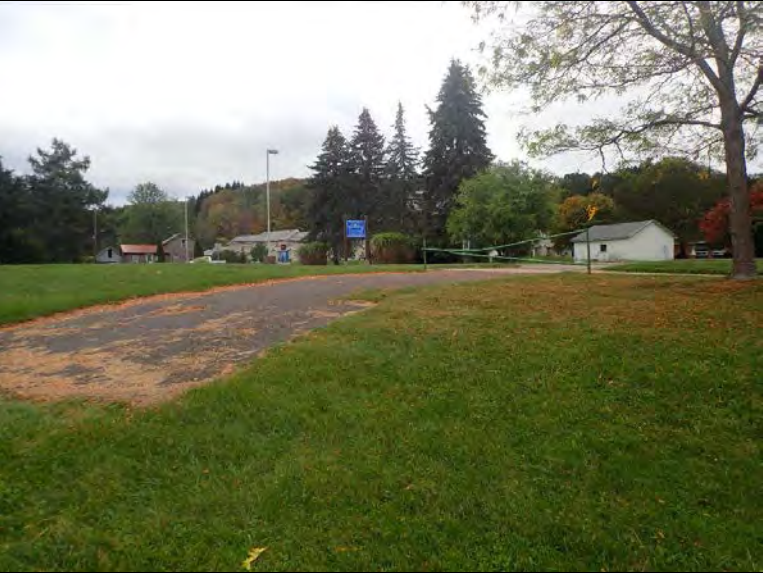
<p>Inspect ID: N21L_2017_p_0030 Title: USACE_CELRB_N21L_2017_p_0030_1.jpg Rated Item: 3. Encroachments Caption: Rating: Minimally Acceptable; Remarks: Unauthorized Alteration (A-10) - Asphalt access drive and gate on left bank just downstream of Seneca Street.; Action: Submit Section 408 Alteration Request to USACE or remove unauthorized alteration.; Station_1: 75+00</p>

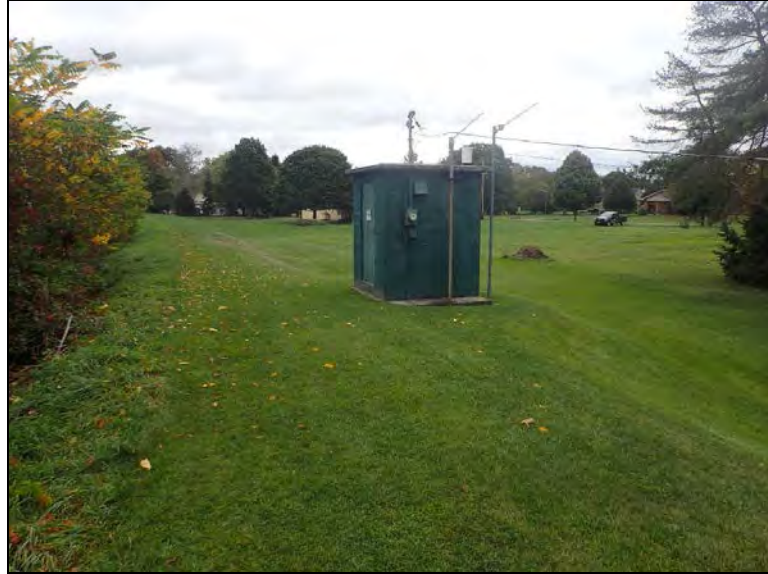
Inspect ID: N21L_2017_p_0040 **Title:** USACE_CELRB_N21L_2017_p_0040_1.jpg
Rated Item: 3. Encroachments **Caption:** Rating: Minimally Acceptable; Remarks: Unauthorized Alteration (A-14) - Gage house on left bank 2,230' downstream of Madison Street (Stevens Street) bridge is in acceptable condition (NYSDEC says part of project, need to verify).; Action: Submit Section 408 Alteration Request to USACE or remove unauthorized alteration.; Station_1: 65+00

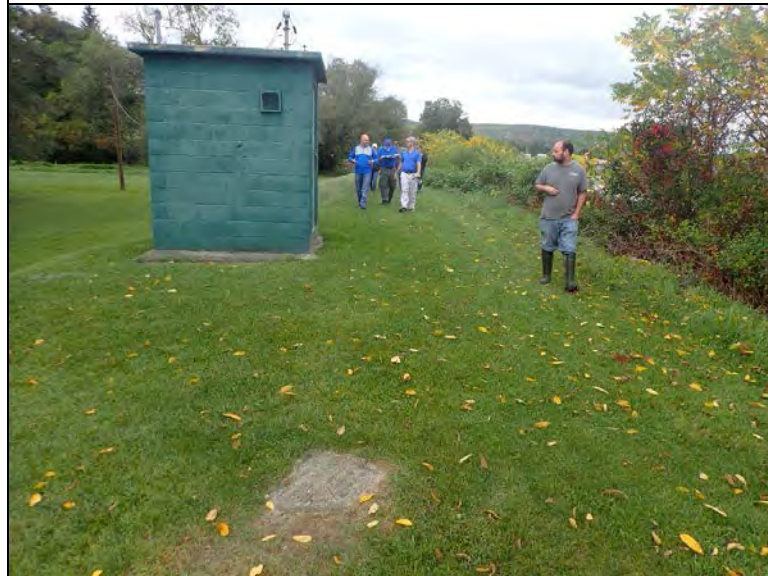
Inspect ID: N21L_2017_p_0040 **Title:** USACE_CELRB_N21L_2017_p_0040_2.jpg
Rated Item: 3. Encroachments **Caption:** Rating: Minimally Acceptable; Remarks: Unauthorized Alteration (A-14) - Gage house on left bank 2,230' downstream of Madison Street (Stevens Street) bridge is in acceptable condition (NYSDEC says part of project, need to verify).; Action: Submit Section 408 Alteration Request to USACE or remove unauthorized alteration.; Station_1: 65+00

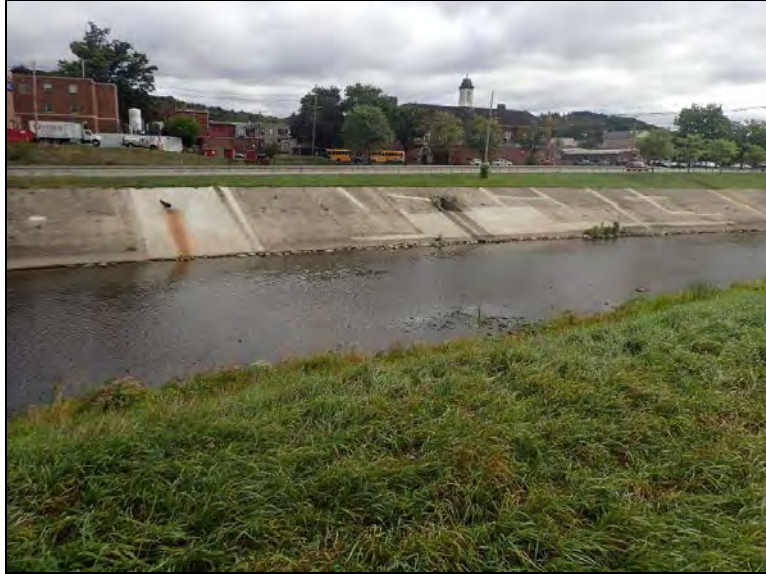
Inspect ID: N21L_2017_p_0074 **Title:** USACE_CELRB_N21L_2017_p_0074_1.jpg
Rated Item: 3. Encroachments **Caption:** Rating: Minimally Acceptable; Remarks:
Unauthorized Aleteration (A-26) - Pearl Street bridge removed.; Action: Submit Section
408 Alteration Request to USACE.; Station_1: 46+00

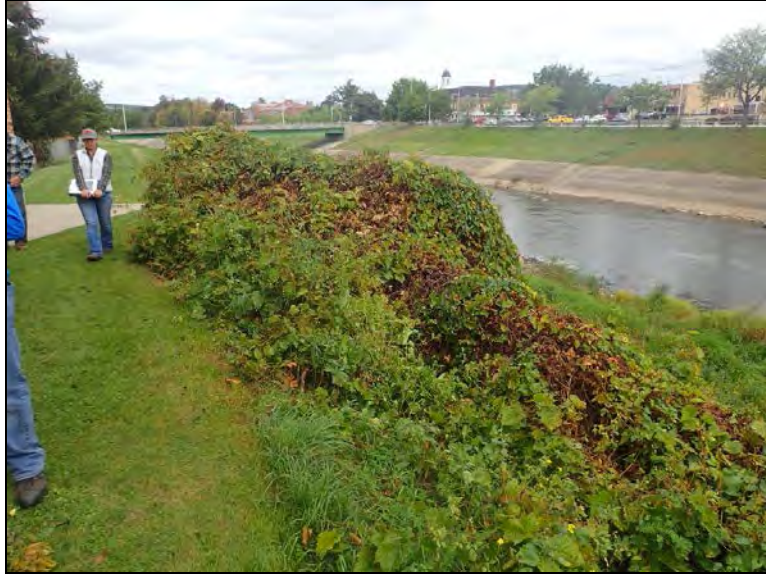
Inspect ID: N21L_2017_p_0085 **Title:** USACE_CELRB_N21L_2017_p_0085_1.jpg
Rated Item: 3. Encroachments **Caption:** Rating: Minimally Acceptable; Remarks: Unauthorized Alteration (A-32) - Fence (covered in unwanted vegetation) 300' downstream of State Street bridge .; Action: Submit Section 408 Alteration Request to USACE or remove unauthorized alteration.; Station_1: 38+00

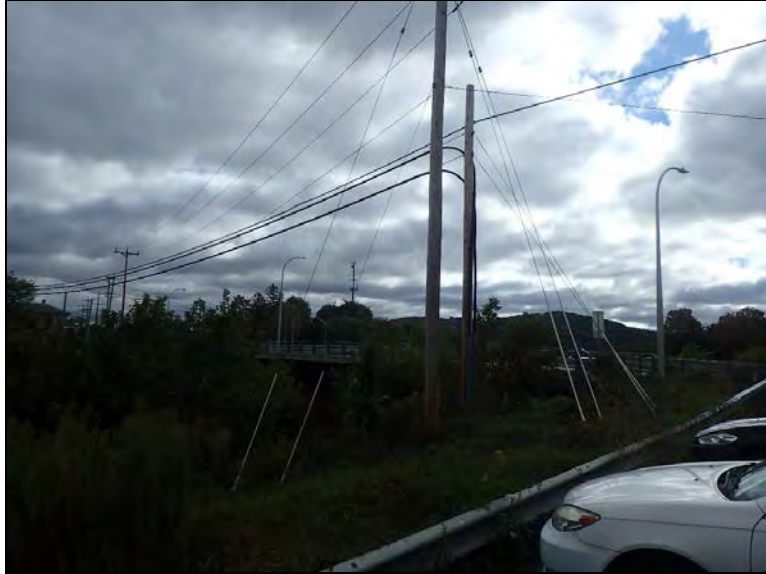
Inspect ID: N21L_2017_p_0088 **Title:** USACE_CELRB_N21L_2017_p_0088_1.jpg
Rated Item: 3. Encroachments **Caption:** Rating: Minimally Acceptable; Remarks: Unauthorized Alteration (A-34) - 2 utility poles 6 guy wires just downstream of State Street bridge (NYSDEC says permitted).; Action: Submit Section 408 Alteration Request to USACE or remove unauthorized alteration.; Station_1: 35+00

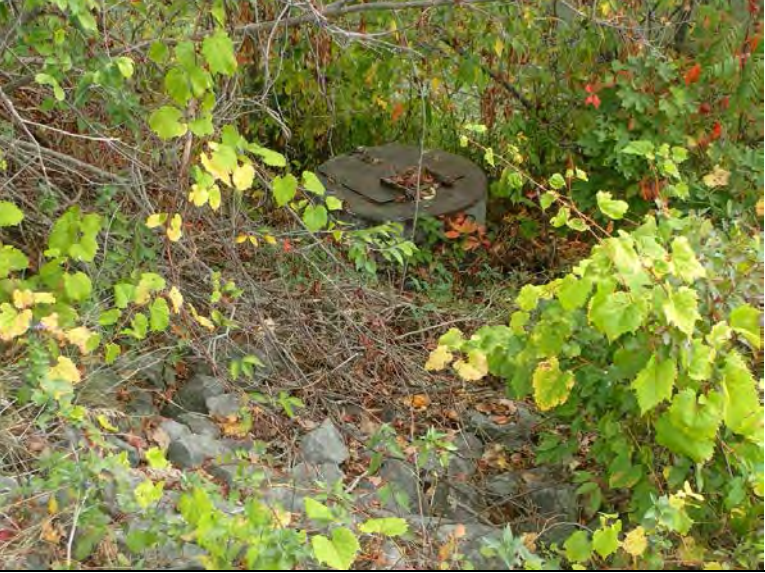
<p>Inspect ID: N21L_2017_p_0098 Title: USACE_CELRB_N21L_2017_p_0098_1.jpg Rated Item: 3. Encroachments Caption: Rating: Minimally Acceptable; Remarks: Unauthorized Alteration (A-40) - Unidentified drainage structure (metal man hole) on channel side slope on left bank, just upstream of Steel Sheet Pile Weir.; Action: Submit Section 408 Alteration Request to USACE or remove unauthorized alteration.; Station_1: 26+00</p>

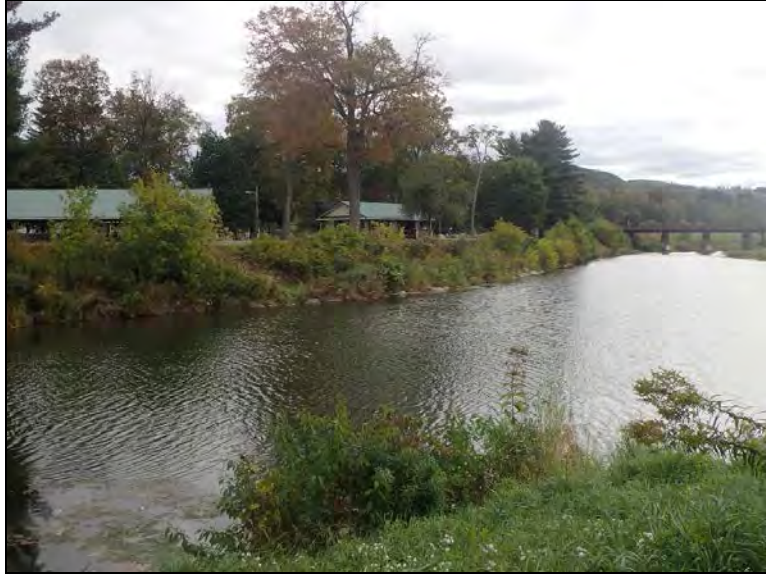
Inspect ID: N21L_2017_p_0106 **Title:** USACE_CELRB_N21L_2017_p_0106_1.jpg
Rated Item: 3. Encroachments **Caption:** Rating: Minimally Acceptable; Remarks: Unauthorized Alteration (A-44) - Riprap added on right bank toe at island park adjacent to parking area.; Action: Submit Section 408 Alteration Request to USACE or remove unauthorized alteration.; Station_1: 21+00; Station_2: 17+00

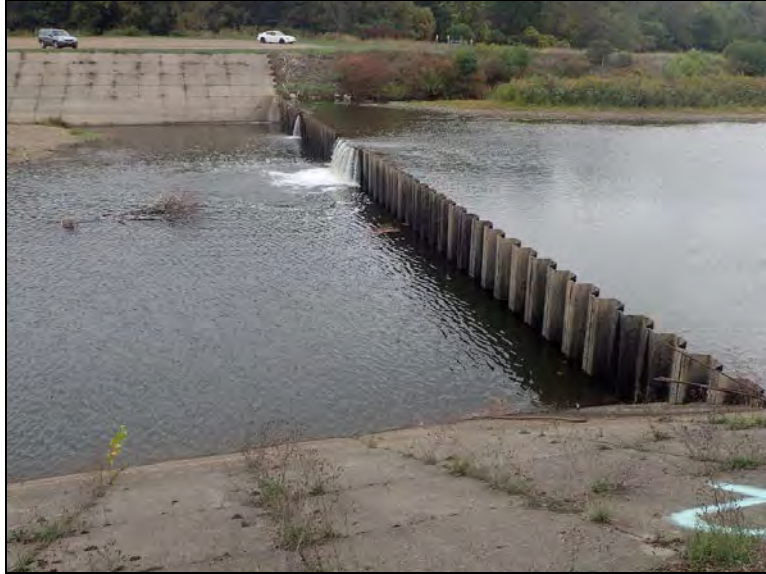
Inspect ID: N21L_2017_p_0125 **Title:** USACE_CELRB_N21L_2017_p_0125_1.jpg
Rated Item: 3. Encroachments **Caption:** Rating: Minimally Acceptable; Remarks: Minor debris on right bank at upstream limit weir.; Action: Remove debris.; Station_1: 0+00

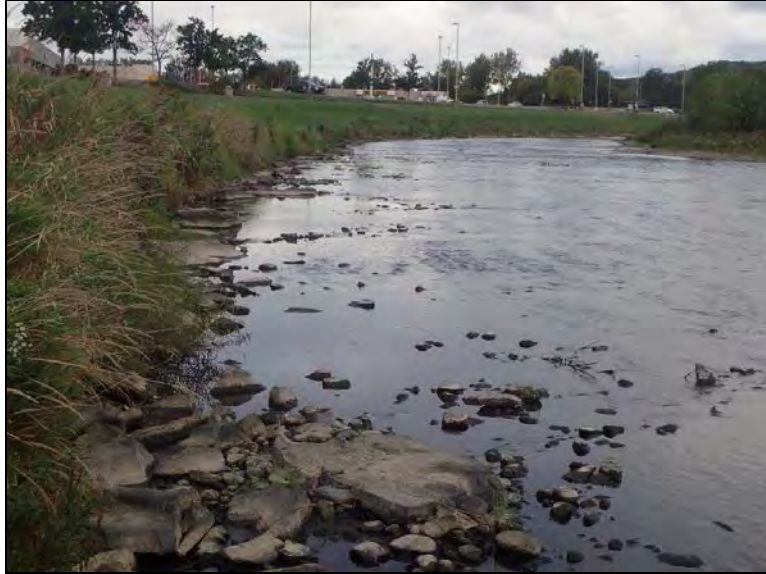
Inspect ID: N21L_2017_p_0141 **Title:** USACE_CELRB_N21L_2017_p_0141_1.jpg
Rated Item: 3. Encroachments **Caption:** Rating: Minimally Acceptable; Remarks: Unauthorized Alteration (A-NEW) - Riprap added to left bank channel toe.; Action: Submit Section 408 Alteration Request to USACE or remove unauthorized alteration.; Station_1: 84+00; Station_2: 68+00

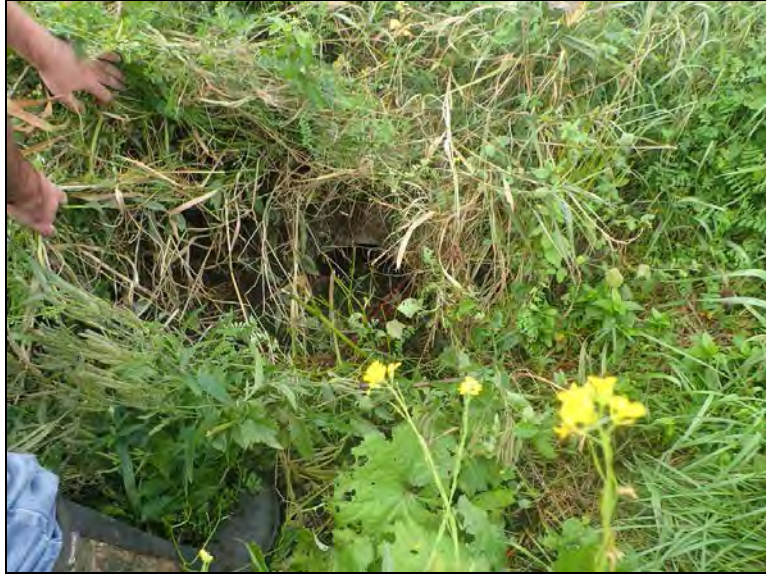
Inspect ID: N21L_2017_p_0007 **Title:** USACE_CELRB_N21L_2017_p_0007_3.jpg
Rated Item: 4. Erosion **Caption:** Rating: Minimally Acceptable; Remarks: Erosion at two outfalls (36" and 24" diameter) on left bank 400' upstream of pedestrian bridge. Outfalls are not on plans-possible encroachment.; Action: Repair erosion and modify pipe.; Station_1: 100+00

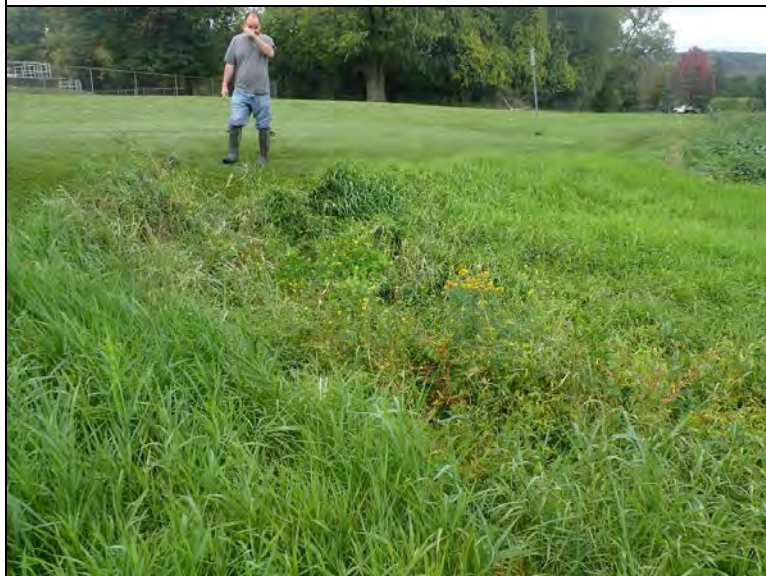
Inspect ID: N21L_2017_p_0007 **Title:** USACE_CELRB_N21L_2017_p_0007_4.jpg
Rated Item: 4. Erosion **Caption:** Rating: Minimally Acceptable; Remarks: Erosion at two outfalls (36" and 24" diameter) on left bank 400' upstream of pedestrian bridge. Outfalls are not on plans-possible encroachment.; Action: Repair erosion and modify pipe.; Station_1: 100+00

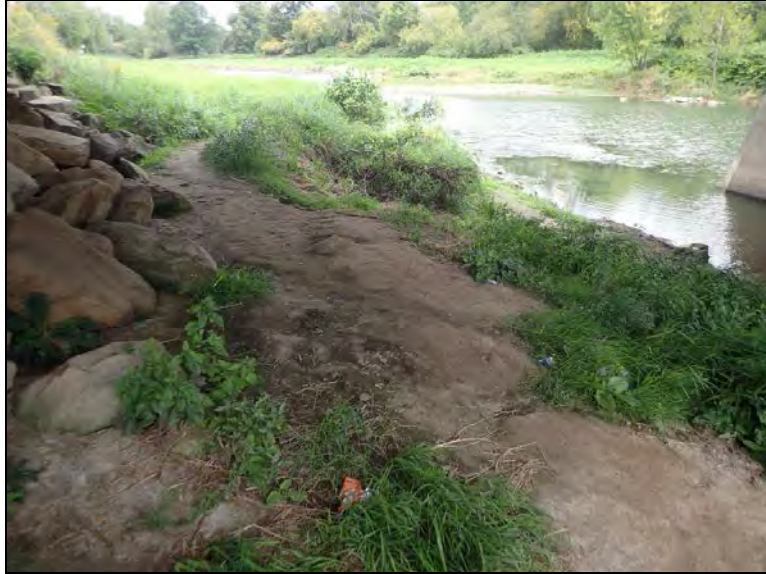
Inspect ID: N21L_2017_p_0014 **Title:** USACE_CELRB_N21L_2017_p_0014_1.jpg
Rated Item: 10. Riprap Revetments & Banks **Caption:** Rating: Unacceptable; Remarks: no rr on as built - Riprap missing or covered on left bank underneath Bolivar Road bridge.; Action: Replace or uncover missing riprap.; Station_1: 91+00

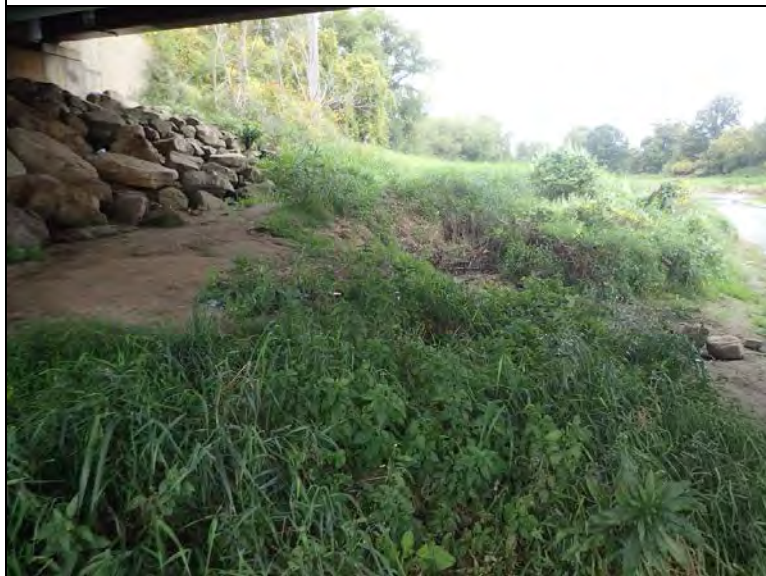
Inspect ID: N21L_2017_p_0014 **Title:** USACE_CELRB_N21L_2017_p_0014_2.jpg
Rated Item: 10. Riprap Revetments & Banks **Caption:** Rating: Unacceptable; Remarks: no rr on as built - Riprap missing or covered on left bank underneath Bolivar Road bridge.; Action: Replace or uncover missing riprap.; Station_1: 91+00
