DEPARTMENT OF THE ARMY

SUBJECT: FY17 Periodic Inspection of Completed Works, Flood Risk Management Project,
Genesee River, Wellsville, New York (09/27/17)

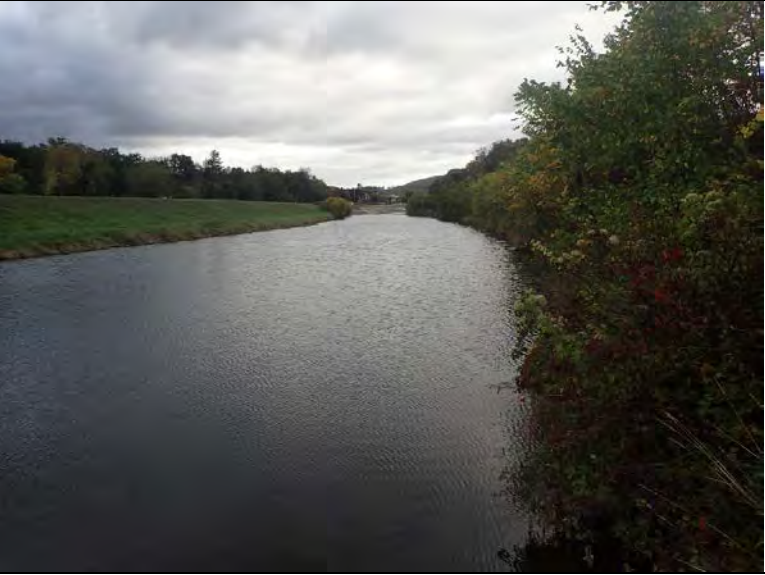
<p>Inspect ID: N21L_2017_p_0042 Title: USACE_CELRB_N21L_2017_p_0042_1.jpg Rated Item: 10. Riprap Revetments & Banks Caption: Rating: Unacceptable; Remarks: Significant unwanted woody vegetation on left bank channel sideslopes from 2,200' downstream of the Madison Street (Stevens Street) bridge to the Madison Street bridge.; Action: Remove unwanted vegetation.; Station_1: 44+00; Station_2: 64+00</p>

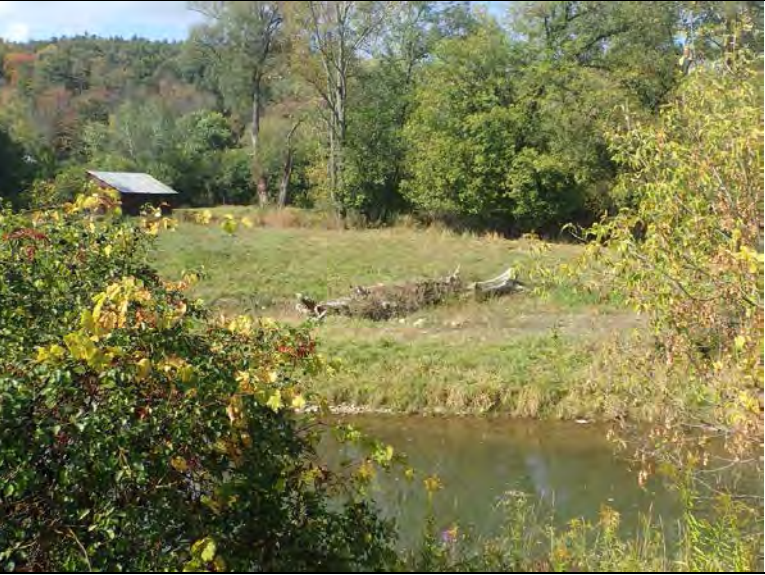
<p>Inspect ID: N21R_2017_p_0004 Title: USACE_CELRB_N21R_2017_p_0004_1.jpg Rated Item: 1. Vegetation and Obstructions Caption: Rating: Minimally Acceptable; Remarks: Log debris in channel on right bank shoal 500' upstream of drop structure. (Dyke Creek); Action: Remove debris.; Station_1: 35+00</p>

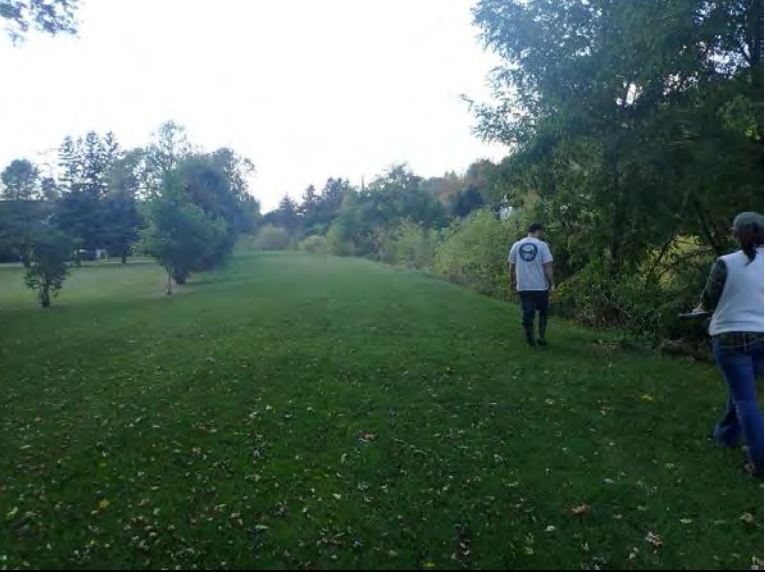
<p>Inspect ID: N21R_2017_p_0016 Title: USACE_CELRB_N21R_2017_p_0016_1.jpg Rated Item: 1. Vegetation and Obstructions Caption: Rating: Unacceptable; Remarks: Significant unwanted vegetation on left bank from Broad Street bridge to Drop Structure. (Dyke Creek); Action: Remove unwanted vegetation.; Station_1: 35+00; Station_2: 24+00</p>
 	<p>Inspect ID: N21R_2017_p_0016 Title: USACE_CELRB_N21R_2017_p_0016_2.jpg Rated Item: 1. Vegetation and Obstructions Caption: Rating: Unacceptable; Remarks: Significant unwanted vegetation on left bank from Broad Street bridge to Drop Structure. (Dyke Creek); Action: Remove unwanted vegetation.; Station_1: 35+00; Station_2: 24+00</p>

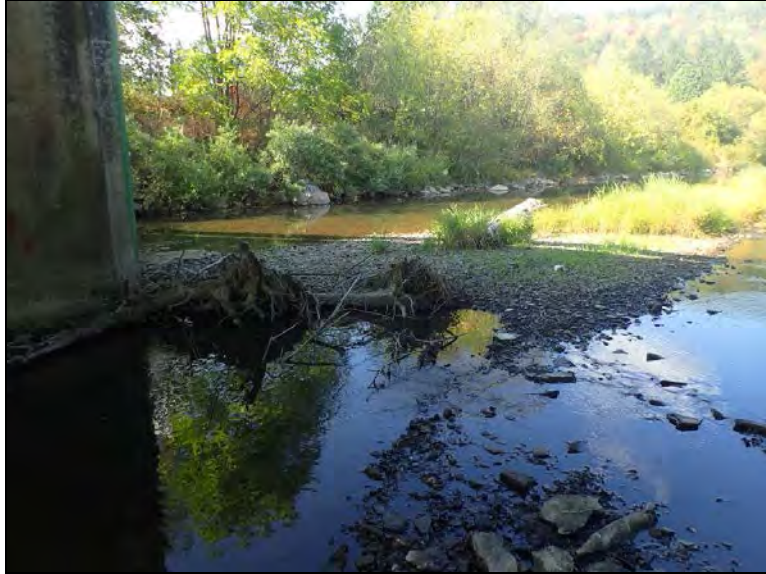
Inspect ID: N21R_2017_p_0023 **Title:** USACE_CELRB_N21R_2017_p_0023_1.jpg
Rated Item: 1. Vegetation and Obstructions **Caption:** Rating: Minimally Acceptable;
 Remarks: Large tree debris in channel just upstream of Broad Street bridge. (Dyke Creek); Action: Remove tree debris.; Station_1: D 24+00

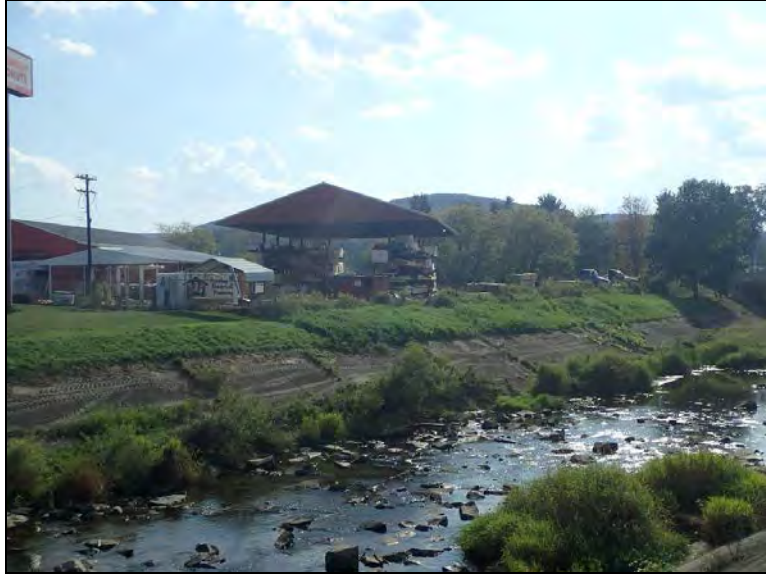
Inspect ID: N21R_2017_p_0039 **Title:** USACE_CELRB_N21R_2017_p_0039_2.jpg
Rated Item: 1. Vegetation and Obstructions **Caption:** Rating: Minimally Acceptable;
Remarks: Unwanted vegetation in left and right bank concrete channel sideslopes.;
Action: Remove unwanted vegetation from concrete channel sideslopes.; **Station_1:** D 18+00; **Station_2:** D 12+00
