Wellsville, New York  
Genesee River  
Right Bank Levee and Dyke Creek  
Flood Damage Reduction Project  
Levee Periodic Inspection 2010  
System 12 of 13  
Contract No. W912QR-10-D-0003  
Task Order No. DN01

February 16, 2011

**FOR OFFICIAL USE ONLY**  
**Wellsville, New York**  
**Genesee River**  
**Right Bank Levee and Dyke Creek**  
**Flood Damage Reduction Project**  
**Levee Periodic Inspection 2010**  
**System 12 of 13**  
**Contract No. W912QR-10-D-0003**  
**Task Order No. DN01**

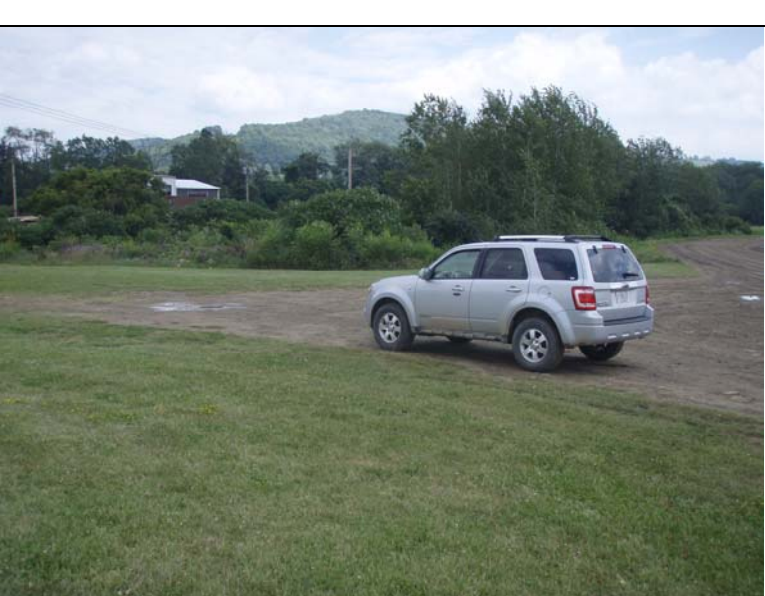
<p><b>Inspect ID:</b> N21R_2010_a_0002 <b>Title:</b> USACE_CELRB_N21R_2010_a_0002_1.jpg <b>Caption:</b> Lack of vegetation L/S</p>

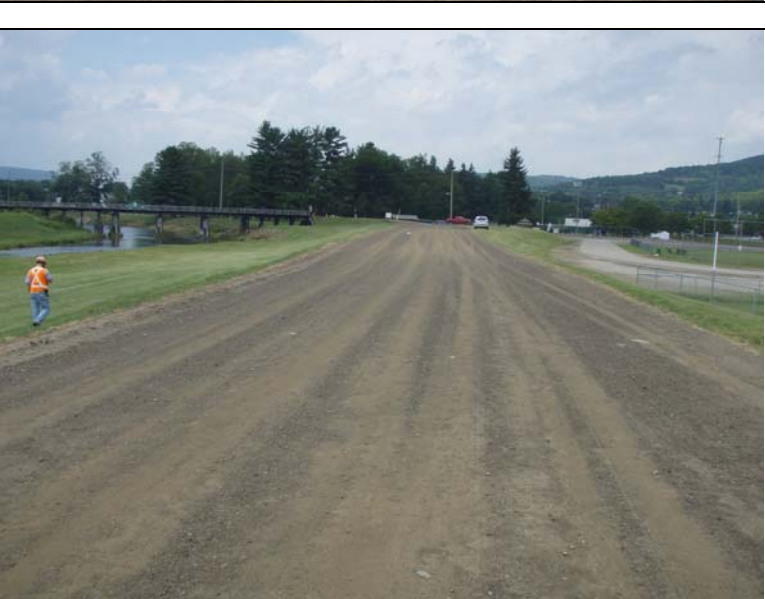
<p><b>Inspect ID:</b> N21R_2010_a_0016   <b>Title:</b> USACE_CELRB_N21R_2010_a_0016_1.jpg <b>Caption:</b> Gravel drive</p>

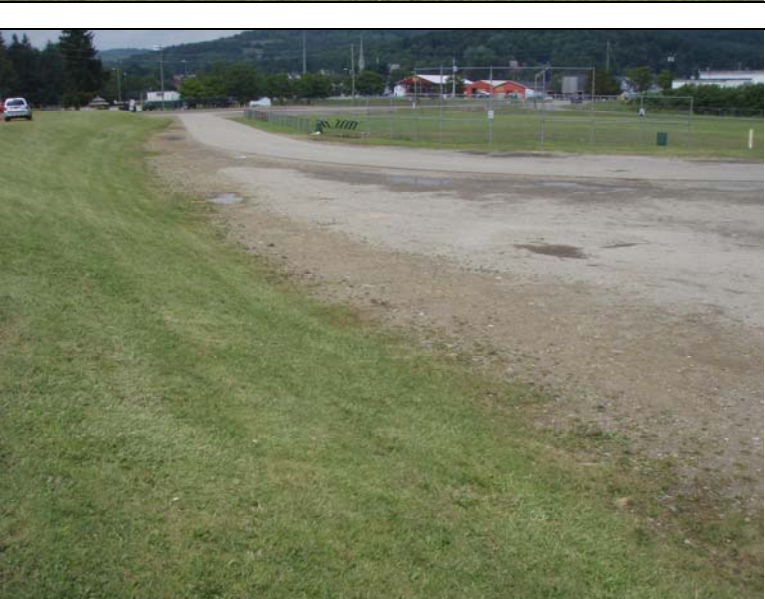
<p><b>Inspect ID:</b> N21R_2010_a_0018 <b>Title:</b> USACE_CELRB_N21R_2010_a_0018_1.jpg <b>Caption:</b> Lack of vegetation L/S</p>

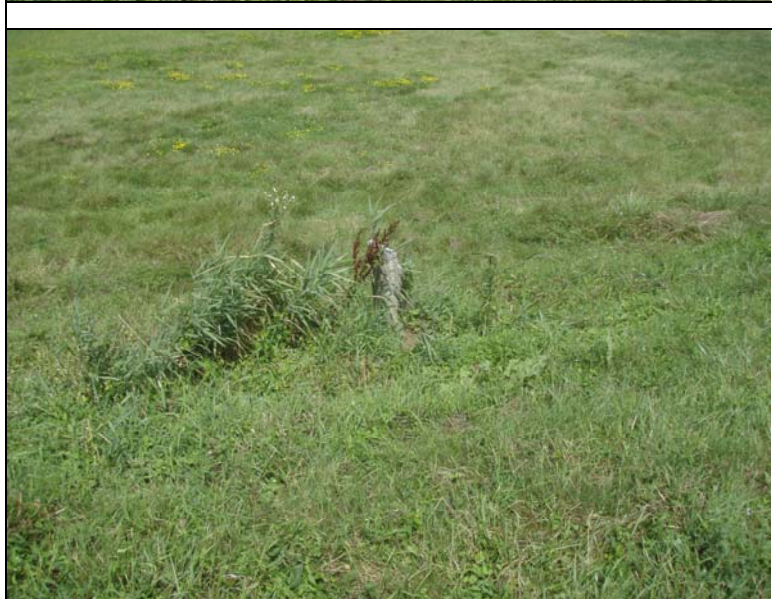
<p><b>Inspect ID:</b> N21R_2010_a_0036 <b>Title:</b> USACE_CELRB_N21R_2010_a_0036_1.jpg <b>Caption:</b> Burrow hole L/S</p>

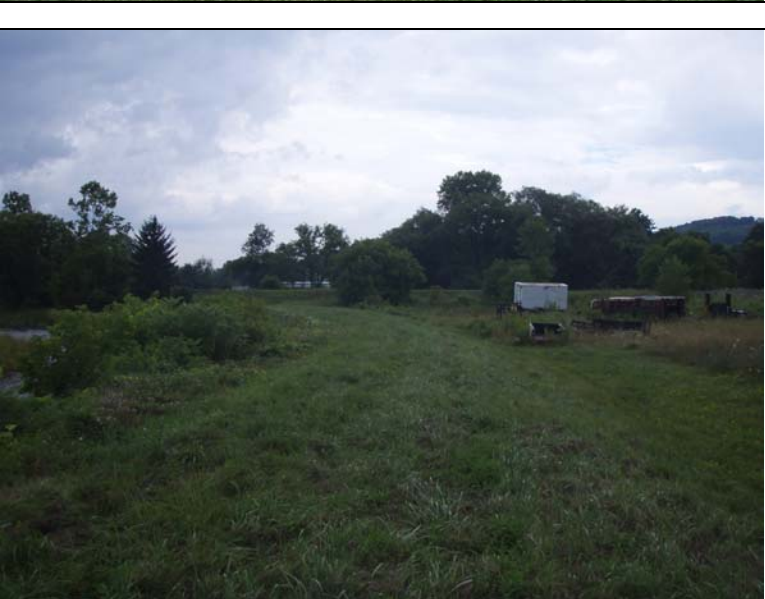
<p><b>Inspect ID:</b> N21R_2010_a_0087 <b>Title:</b> USACE_CELRB_N21R_2010_a_0087_1.jpg <b>Caption:</b> Miscellaneous encroachments</p>

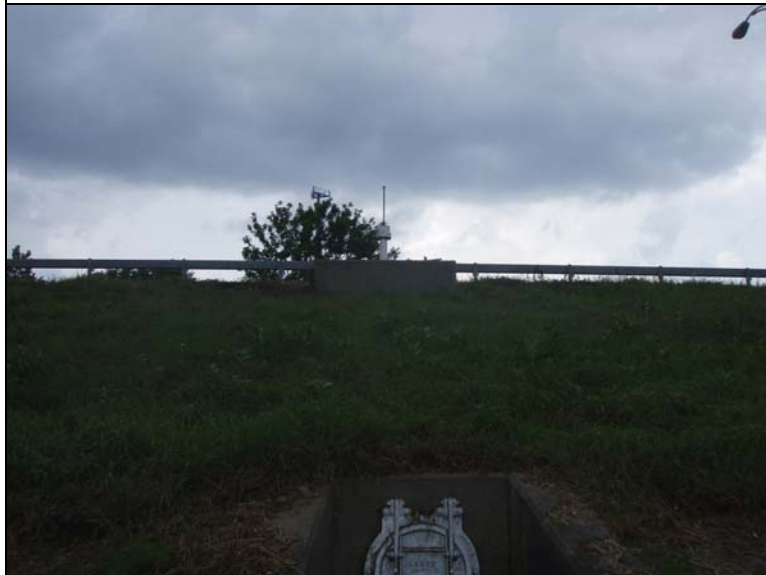
**Inspect ID:** N21R\_2010\_a\_0045 **Title:** USACE\_CELRB\_N21R\_2010\_a\_0045\_1.jpg  
**Caption:** Slide gate above flap gate, exterior good condition

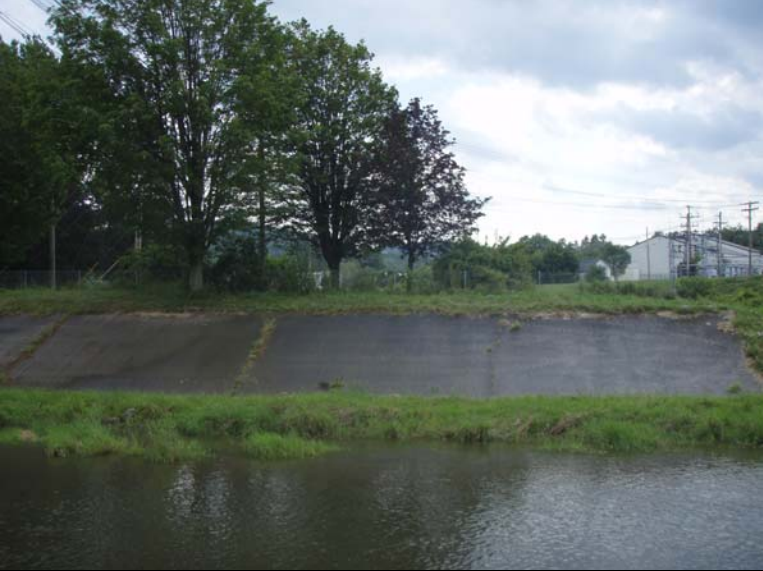
<p><b>Inspect ID:</b> N21R_2010_a_0039 <b>Title:</b> USACE_CELRB_N21R_2010_a_0039_1.jpg <b>Caption:</b> Multiple trees, fence, vegetation</p>

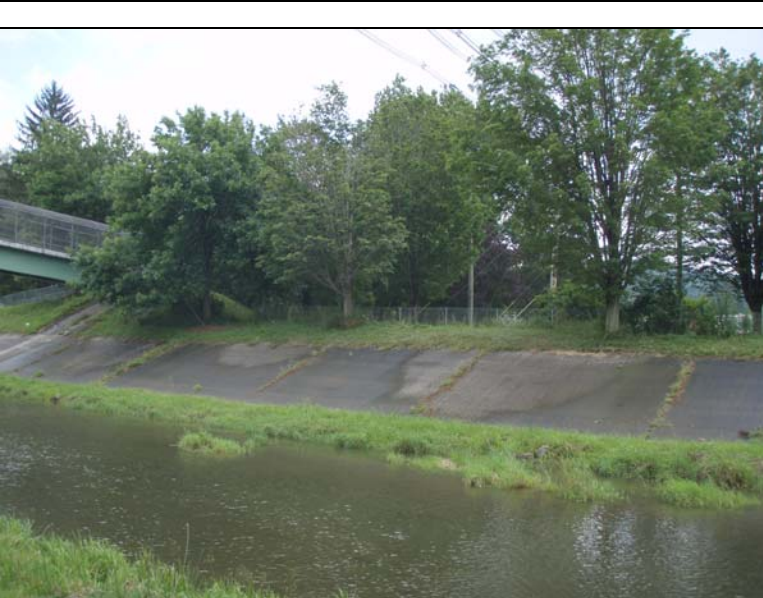
<p><b>Inspect ID:</b> N21R_2010_a_0039 <b>Title:</b> USACE_CELRB_N21R_2010_a_0039_2.jpg <b>Caption:</b> Multiple trees, fence, vegetation</p>

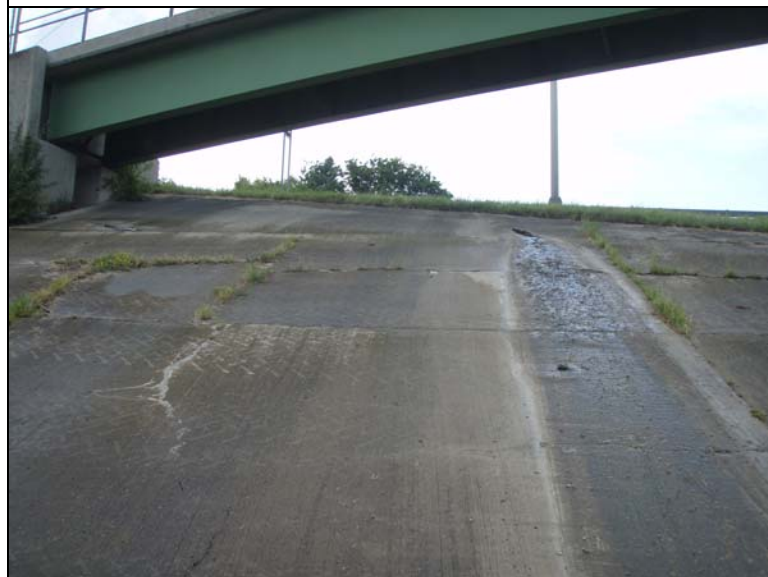
**Inspect ID:** N21R\_2010\_a\_0041 **Title:** USACE\_CELRB\_N21R\_2010\_a\_0041\_1.jpg  
**Caption:** Two 12" CMP, one is corroded

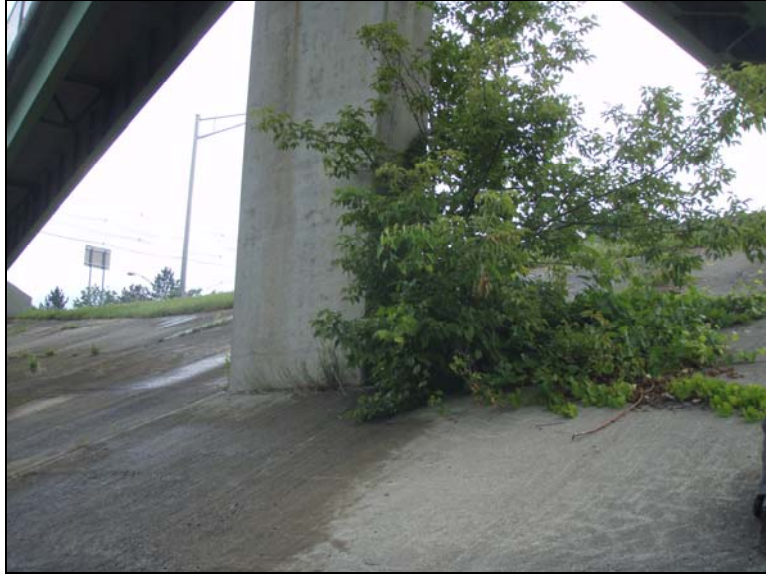
**Inspect ID:** N21R\_2010\_a\_0042 **Title:** USACE\_CELRB\_N21R\_2010\_a\_0042\_1.jpg  
**Caption:** Tree at bridge support

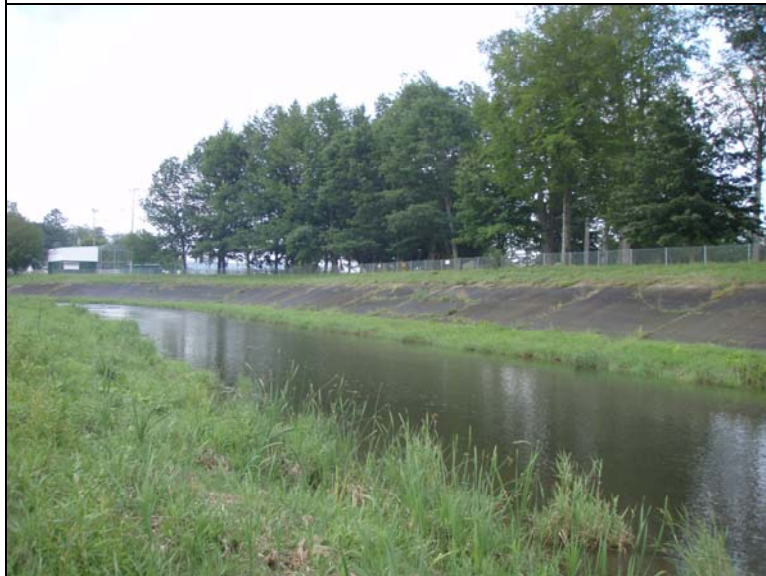
**Inspect ID:** N21R\_2010\_a\_0043 **Title:** USACE\_CELRB\_N21R\_2010\_a\_0043\_1.jpg  
**Caption:** Concrete cracking, vegetation, both banks

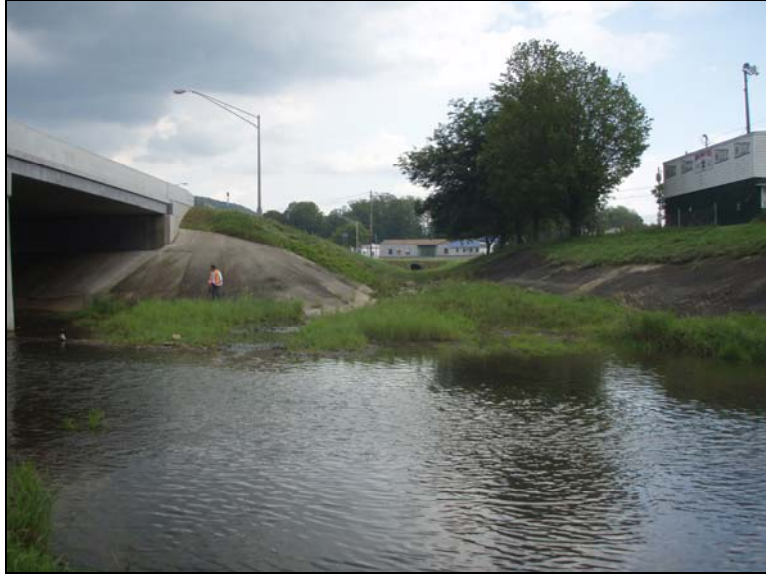
**Inspect ID:** N21R\_2010\_a\_0046 **Title:** USACE\_CELRB\_N21R\_2010\_a\_0046\_1.jpg  
**Caption:** Shoaling in drainage channel to Dyke creek

- 0046: Shoaling is well established (U)
- Near Sta. 10+00

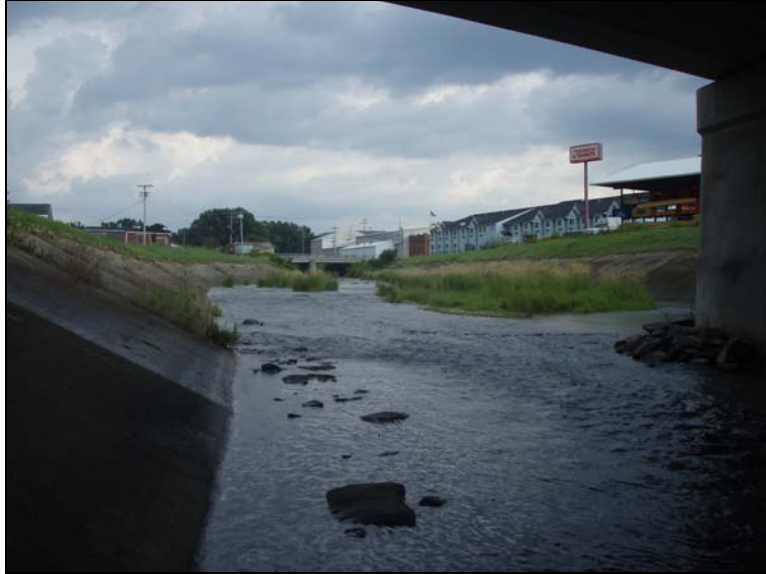
**Inspect ID:** N21R\_2010\_a\_0048 **Title:** USACE\_CELRB\_N21R\_2010\_a\_0048\_1.jpg  
**Caption:** Shoaling in channel

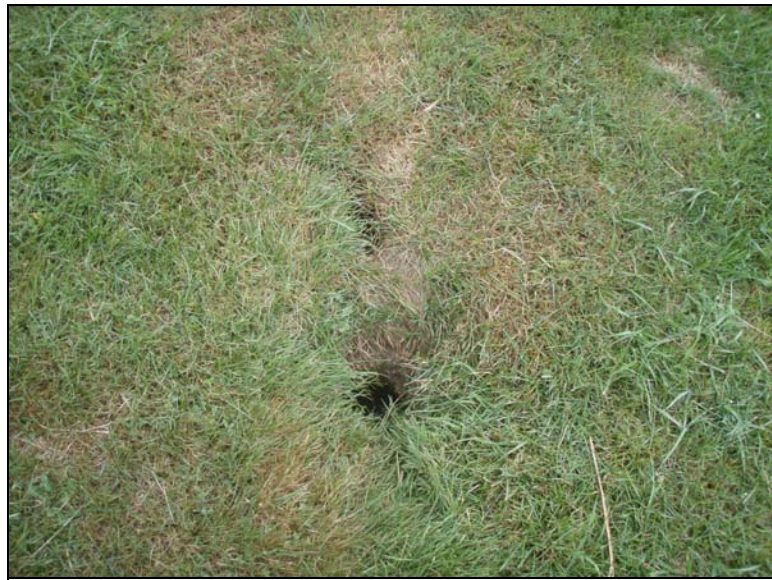
<p><b>Inspect ID:</b> N21R_2010_a_0052 <b>Title:</b> USACE_CELRB_N21R_2010_a_0052_1.jpg <b>Caption:</b> Burrow hole on top of bank</p>

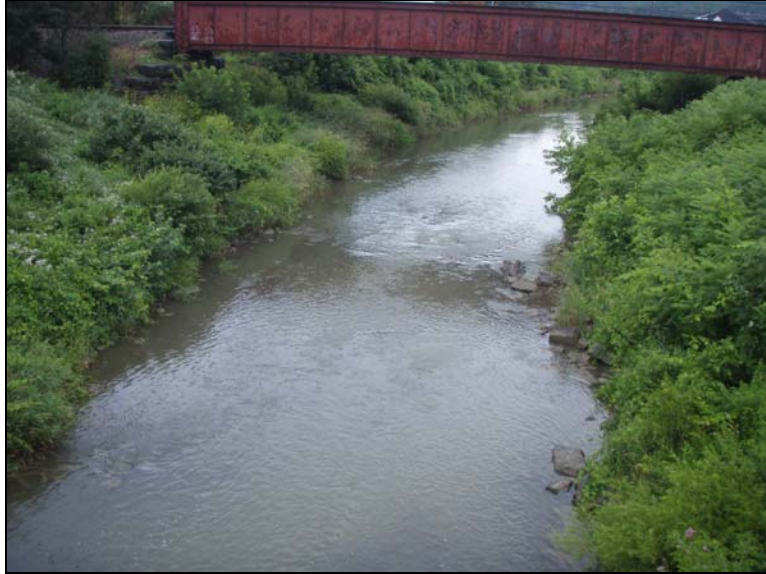
**Inspect ID:** N21R\_2010\_a\_0058 **Title:** USACE\_CELRB\_N21R\_2010\_a\_0058\_1.jpg  
**Caption:** Vegetation along channel

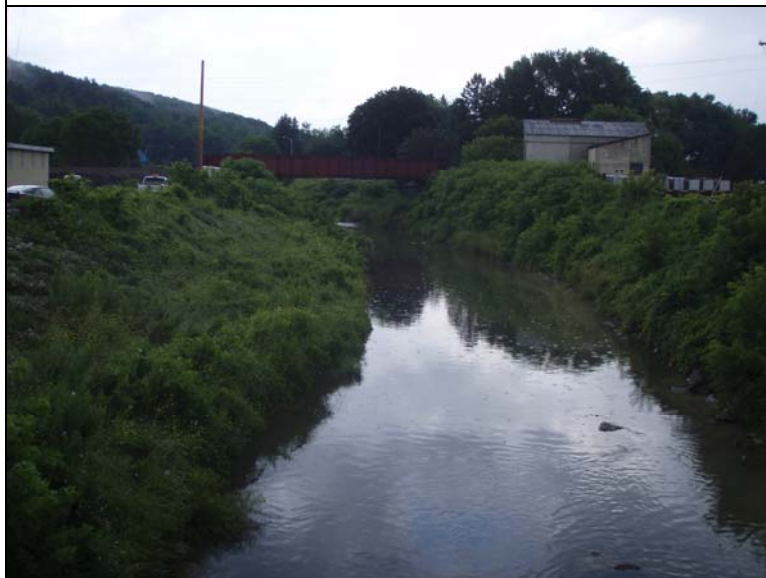
**Inspect ID:** N21R\_2010\_a\_0061 **Title:** USACE\_CELRB\_N21R\_2010\_a\_0061\_1.jpg  
**Caption:** Heavy vegetation both banks

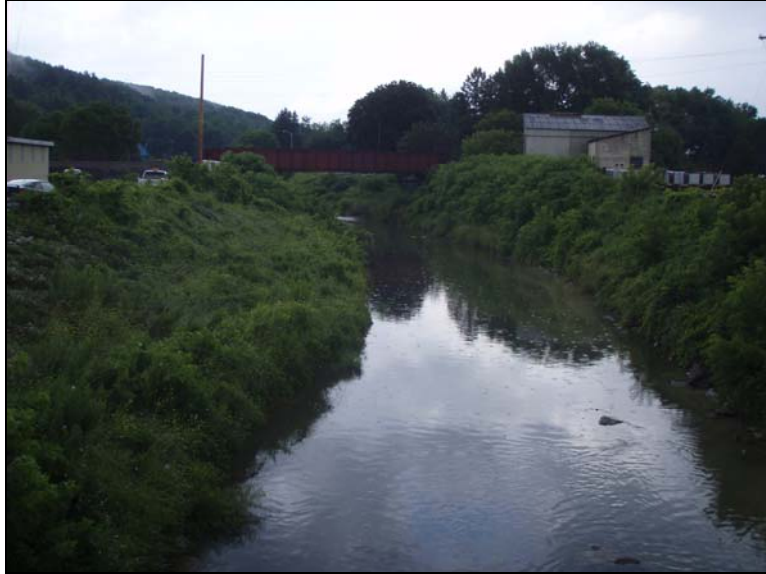
**Inspect ID:** N21R\_2010\_a\_0062 **Title:** USACE\_CELRB\_N21R\_2010\_a\_0062\_1.jpg  
**Caption:** Heavy vegetation both banks

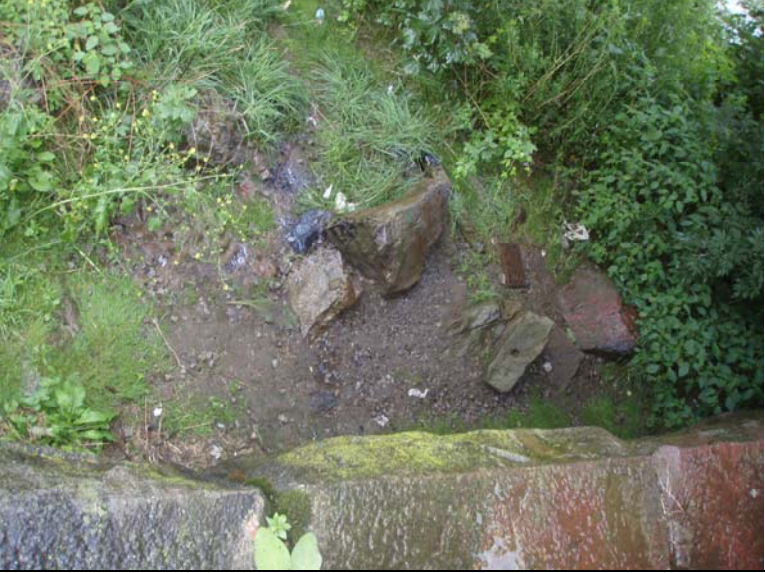
<p><b>Inspect ID:</b> N21R_2010_a_0067 <b>Title:</b> USACE_CELRB_N21R_2010_a_0067_1.jpg <b>Caption:</b> Lack of riprap</p>

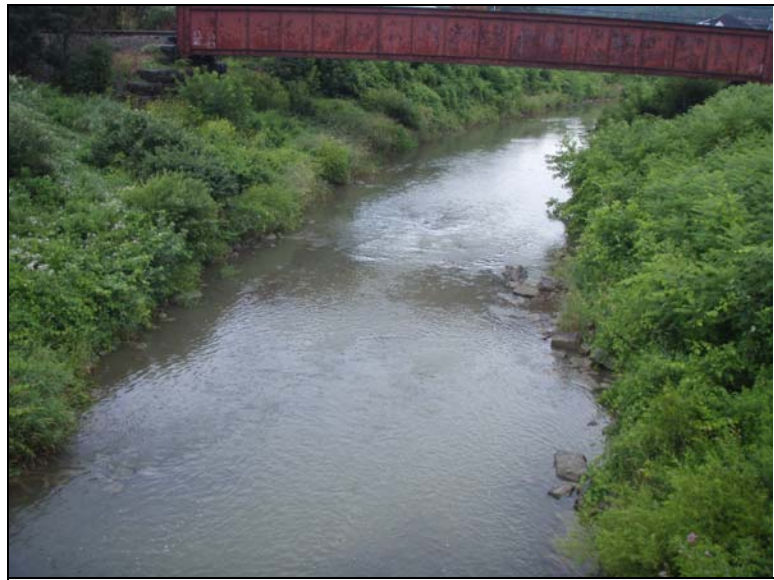
<p><b>Inspect ID:</b> N21R_2010_a_0071 <b>Title:</b> USACE_CELRB_N21R_2010_a_0071_1.jpg <b>Caption:</b> Vegetation on both banks</p>

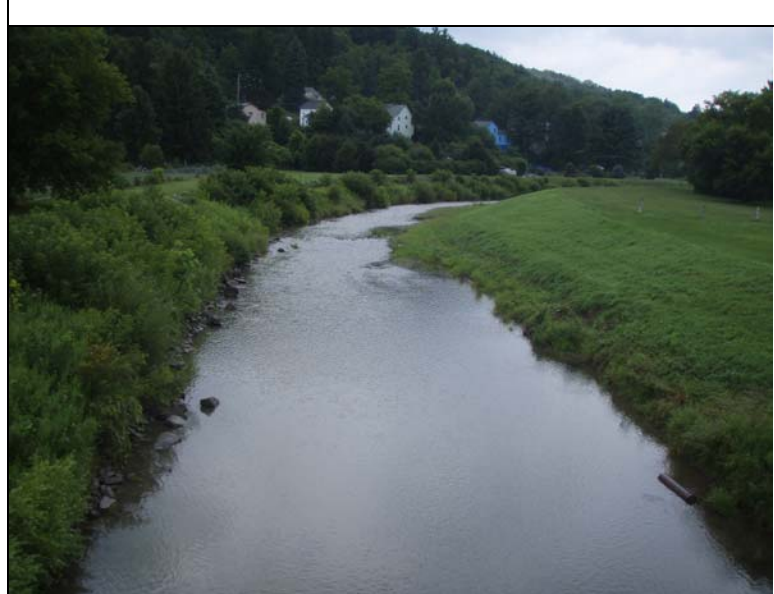
<p><b>Inspect ID:</b> N21R_2010_a_0072 <b>Title:</b> USACE_CELRB_N21R_2010_a_0072_1.jpg <b>Caption:</b> Vegetation on bank</p>

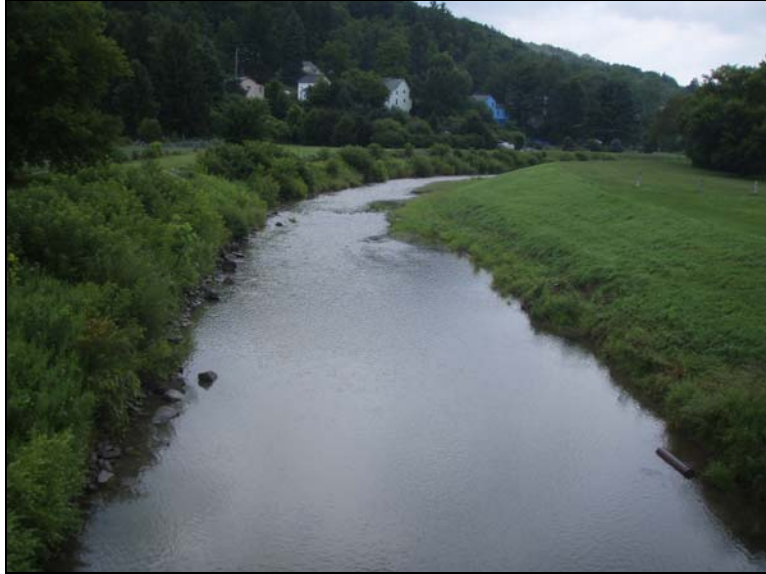
**Inspect ID:** N21R\_2010\_a\_0073 **Title:** USACE\_CELRB\_N21R\_2010\_a\_0073\_1.jpg  
**Caption:** Shoaling in channel

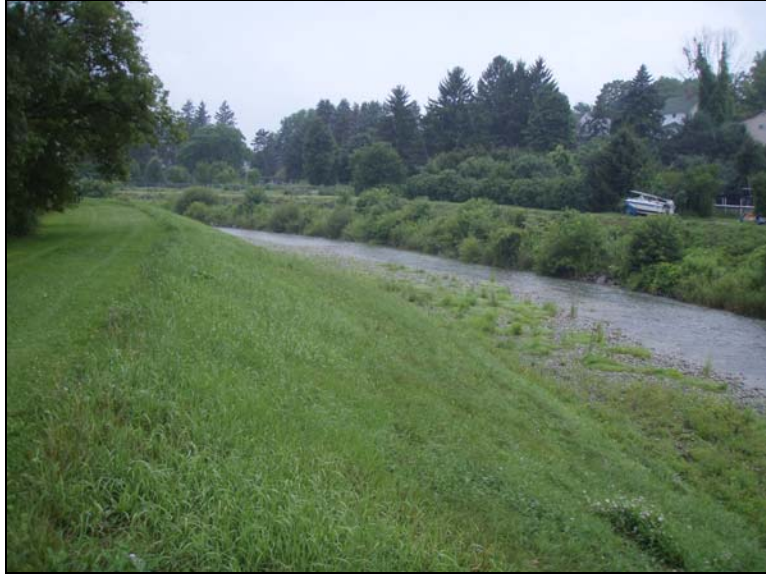
**Inspect ID:** N21R\_2010\_a\_0076 **Title:** USACE\_CELRB\_N21R\_2010\_a\_0076\_1.jpg  
**Caption:** Shoaling on bank side

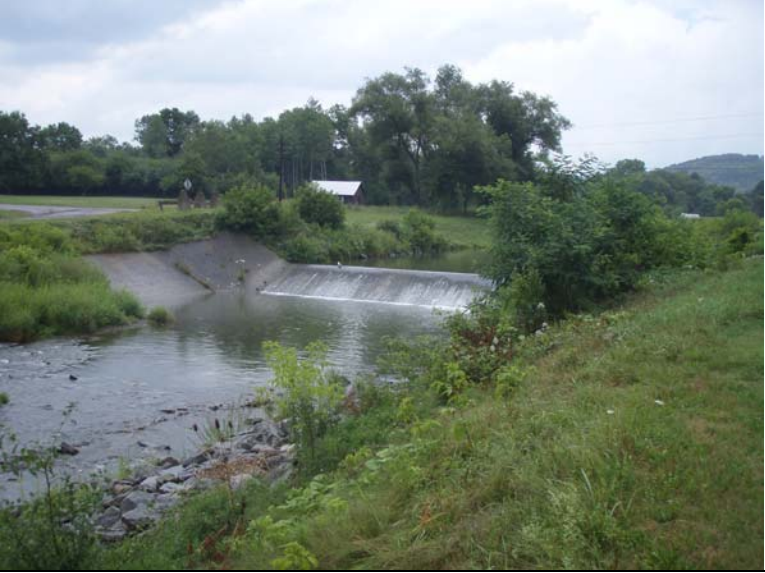
<p><b>Inspect ID:</b> N21R_2010_a_0077 <b>Title:</b> USACE_CELRB_N21R_2010_a_0077_2.jpg <b>Caption:</b> Vegetation on bank</p>

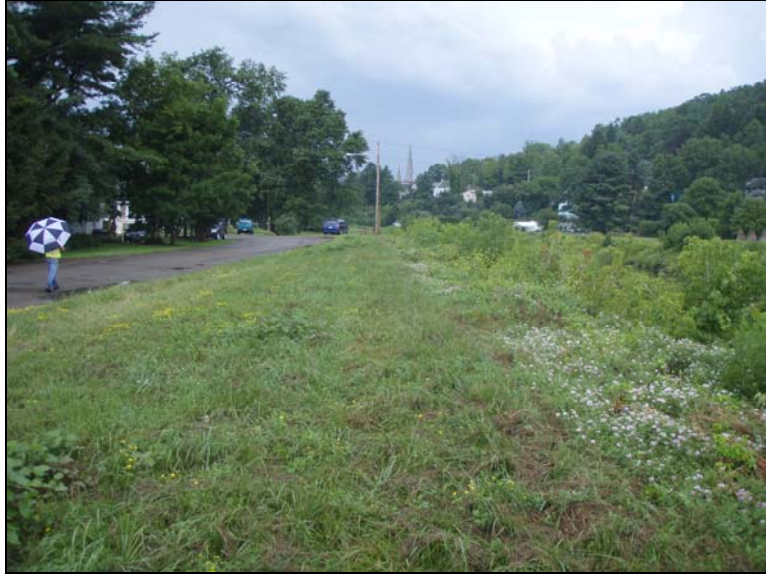
**Inspect ID:** N21R\_2010\_a\_0083 **Title:** USACE\_CELRB\_N21R\_2010\_a\_0083\_1.jpg  
**Caption:** Vegetation, trees on levee bank

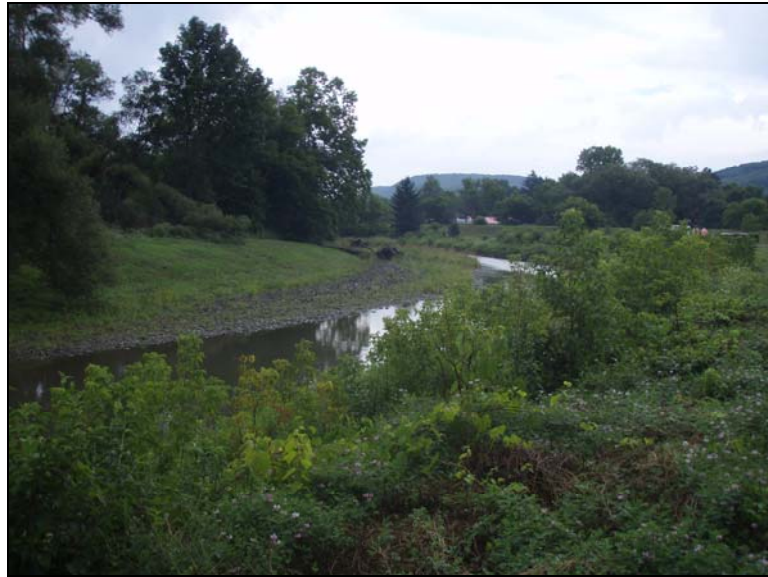
**Inspect ID:** N21R\_2010\_a\_0085 **Title:** USACE\_CELRB\_N21R\_2010\_a\_0085\_1.jpg  
**Caption:** Shoaling bank side

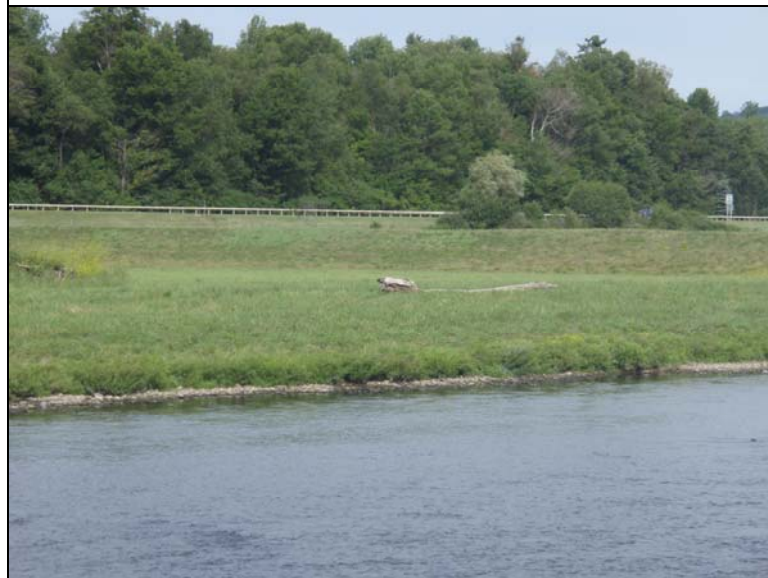
**Inspect ID:** N21R\_2010\_a\_0090 **Title:** USACE\_CELRB\_N21R\_2010\_a\_0090\_1.jpg  
**Caption:** Log on bank

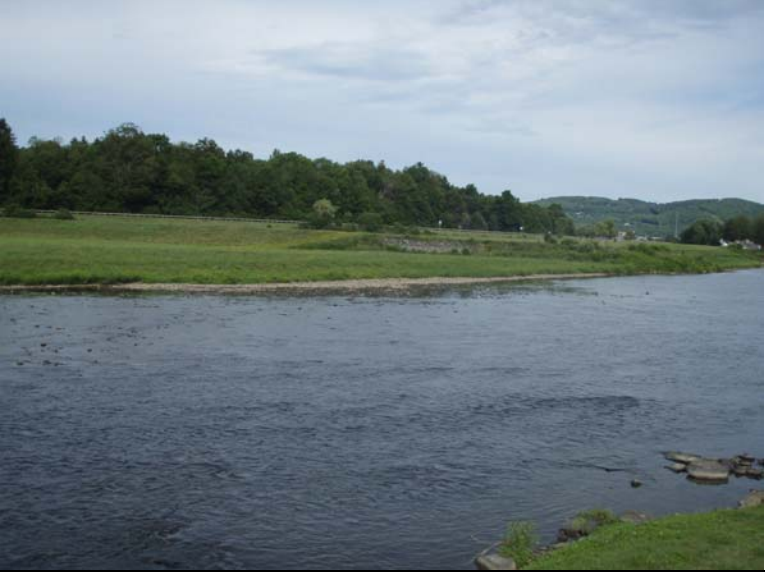
<p><b>Inspect ID:</b> N21R_2010_a_0091 <b>Title:</b> USACE_CELRB_N21R_2010_a_0091_1.jpg <b>Caption:</b> Shoaling in channel</p>

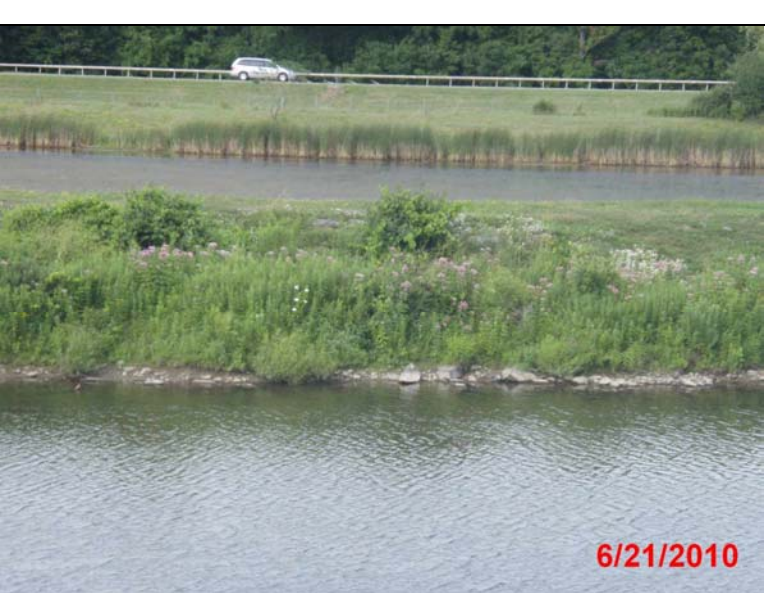
<p><b>Inspect ID:</b> N21R_2010_a_0092 <b>Title:</b> USACE_CELRB_N21R_2010_a_0092_1.jpg <b>Caption:</b> Vegetation in riprap</p>

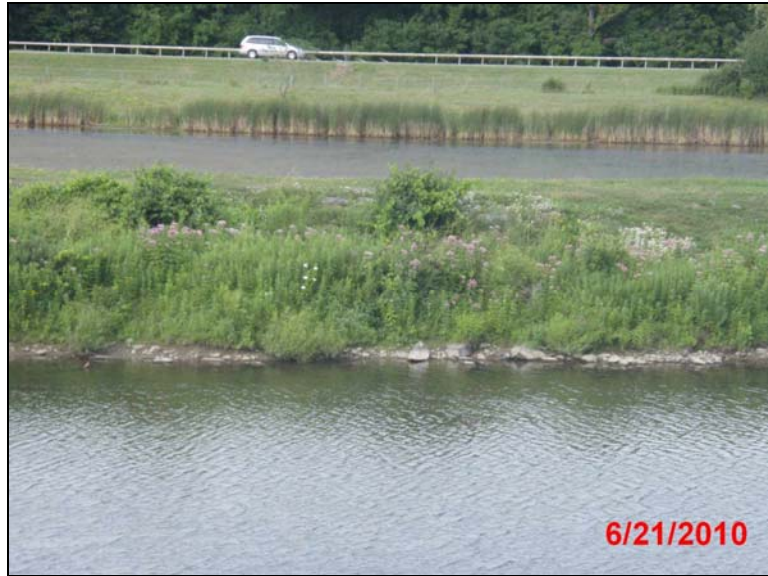
**Inspect ID:** N21R\_2010\_a\_0093 **Title:** USACE\_CELRB\_N21R\_2010\_a\_0093\_1.jpg  
**Caption:** Erosion

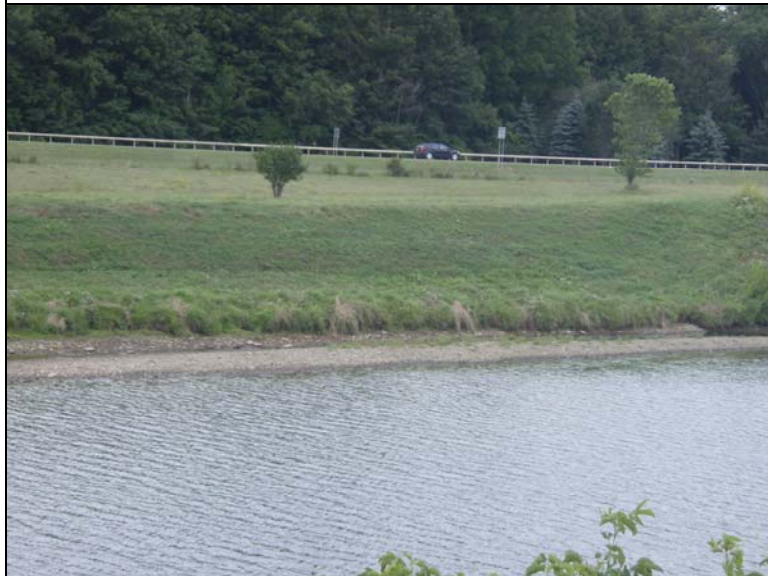
**Inspect ID:** N21R\_2010\_a\_0094 **Title:** USACE\_CELRB\_N21R\_2010\_a\_0094\_1.jpg  
**Caption:** Shoaling in channel

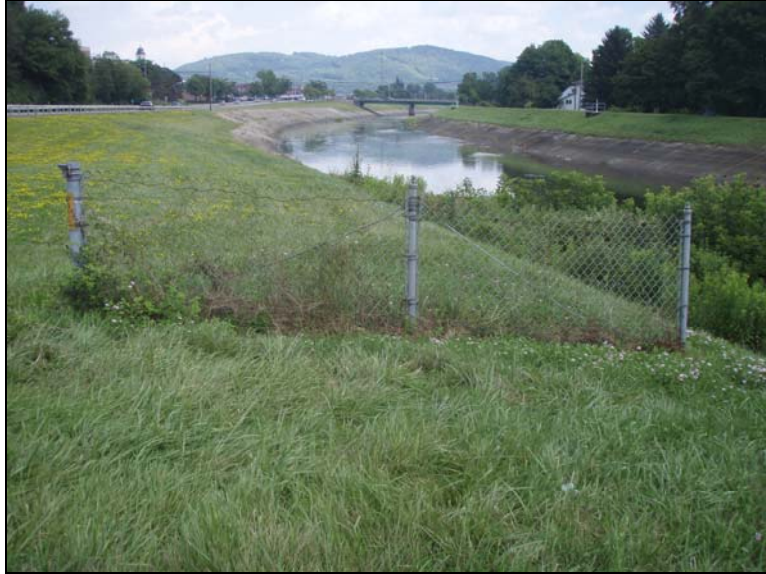
**Inspect ID:** N21R\_2010\_a\_0097 **Title:** USACE\_CELRB\_N21R\_2010\_a\_0097\_1.jpg  
**Caption:** Vegetation in riprap to the right of fence

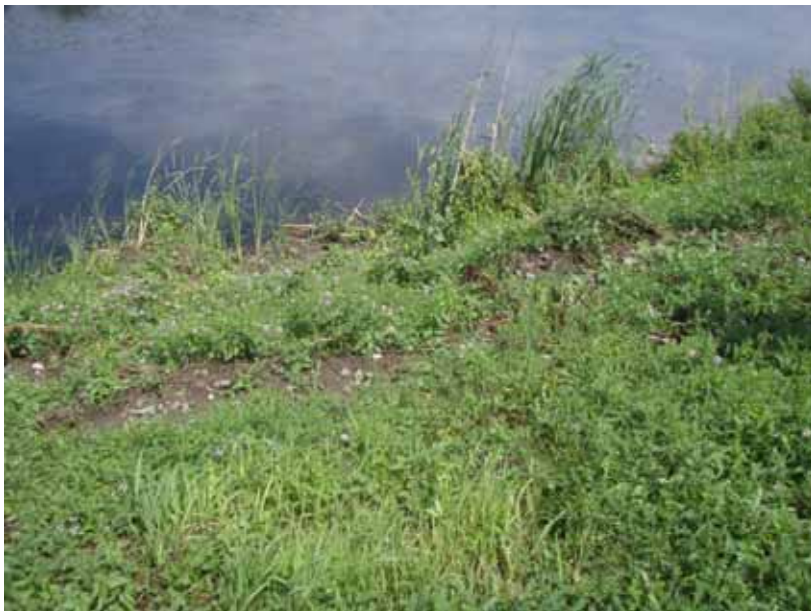
- 0033: Erosion noted (M)
- Near Sta. 70+00

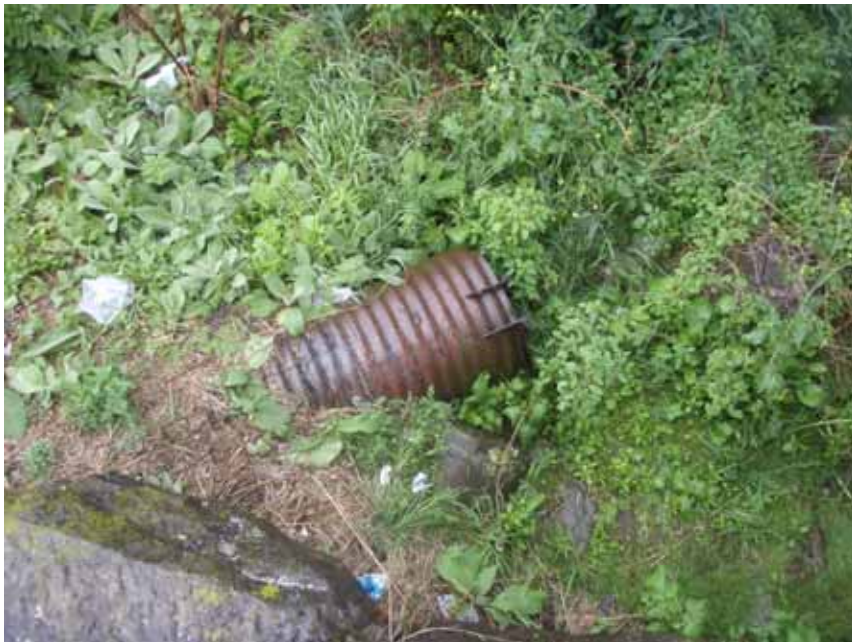
- 0066: Unwanted vegetation: remove vegetation (U)
- Near Sta. 22+00

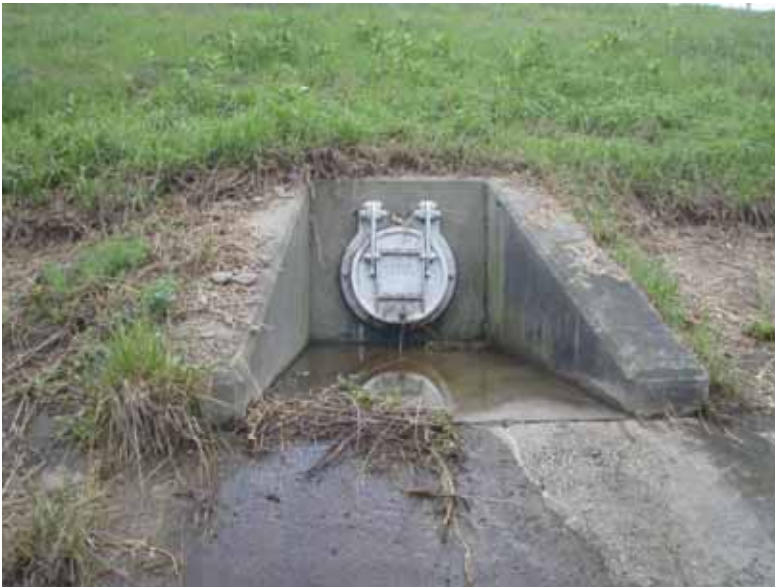
- 0044: Flap gate hinge loose from 18 inch CMP through the levee (M)
- Near Sta. 8+00

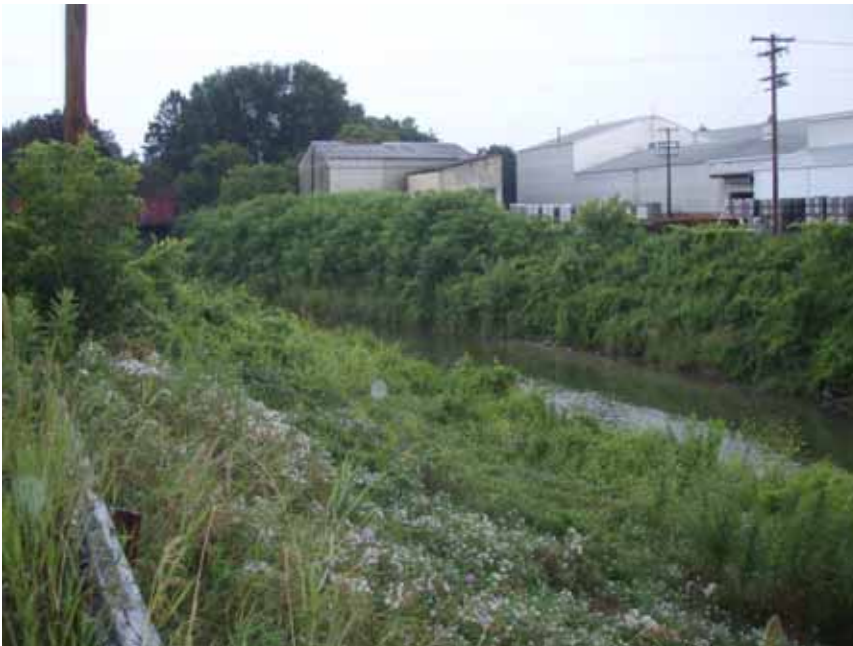
- 0077: Unwanted vegetation along Dyke Creek channel : remove vegetation (U)
- Near Sta. 31+00

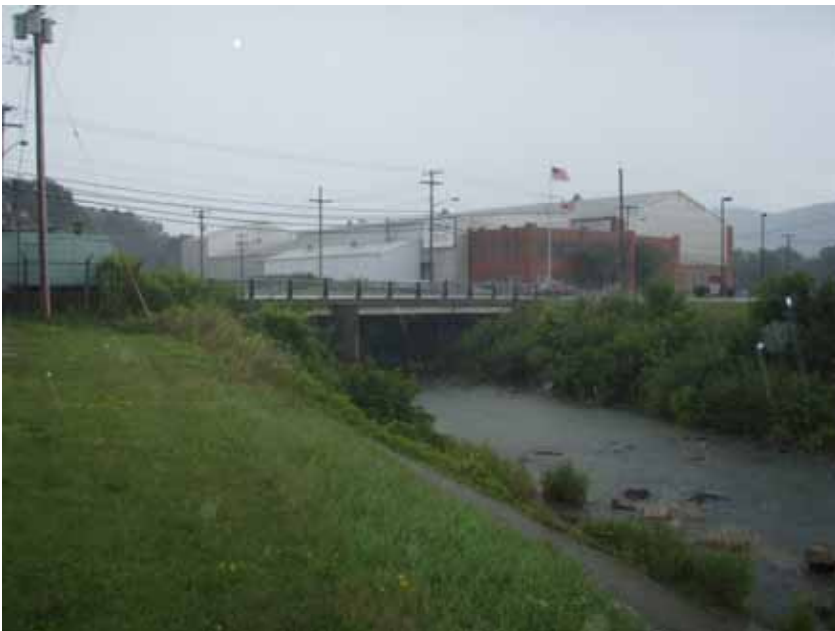
- 0059: Multiple encroachments (U)
- Near Sta. 18+00

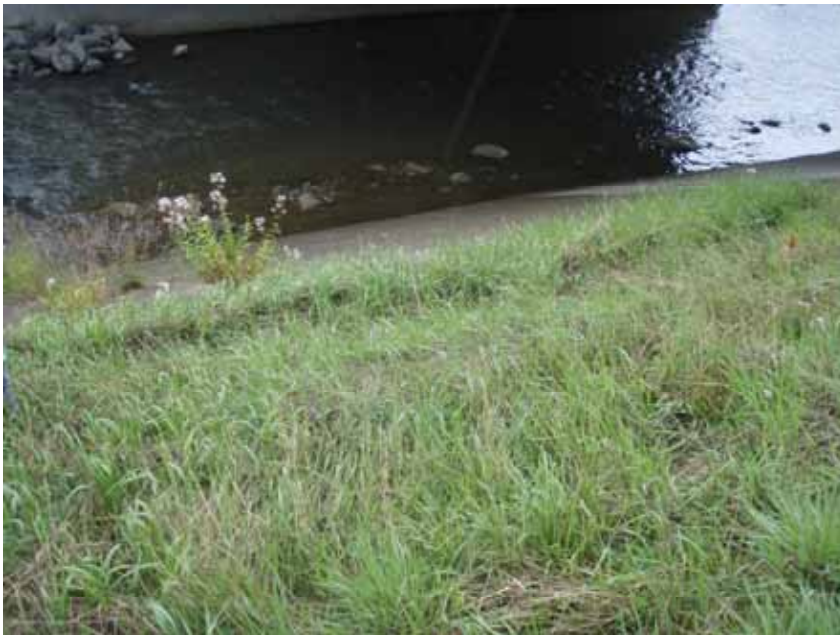
- 0050: Erosion noted: (M)
- Near Sta. 12+00

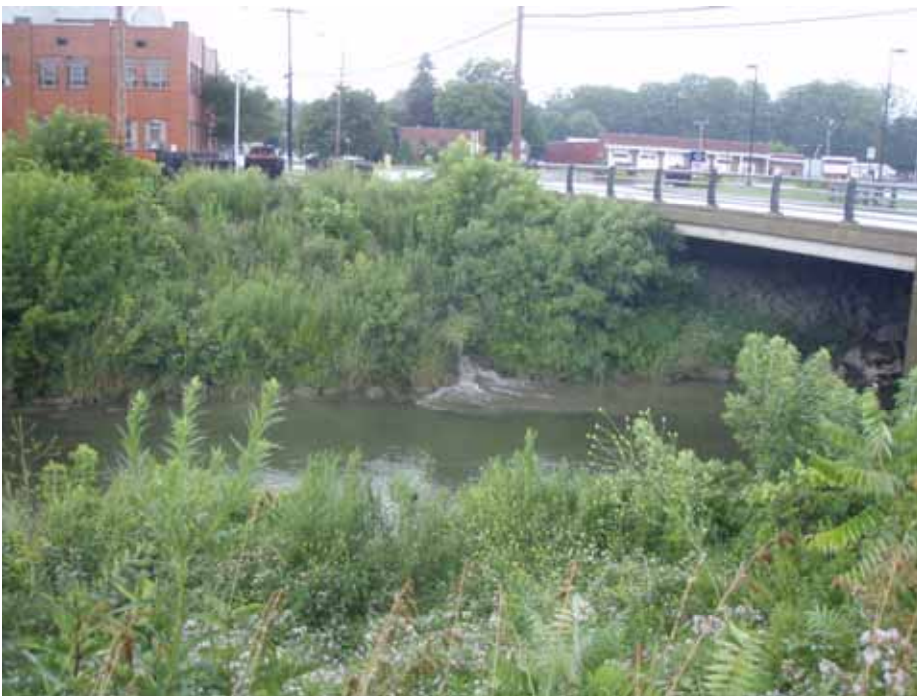
- 0068: Vegetation in riprap noted: (U)
- Near Sta. 22+00

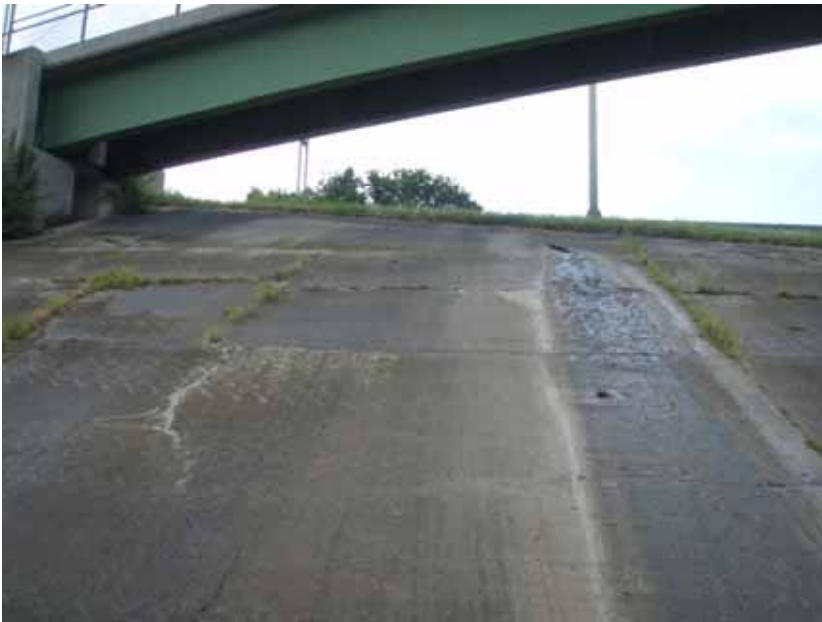
- 0043: Cracking in concrete noted: (M)
- Near Sta. 5+00
