Wellsville, New York

Genesee River

Left Bank Levee and Entire
Channel

Levee Periodic Inspection 2010

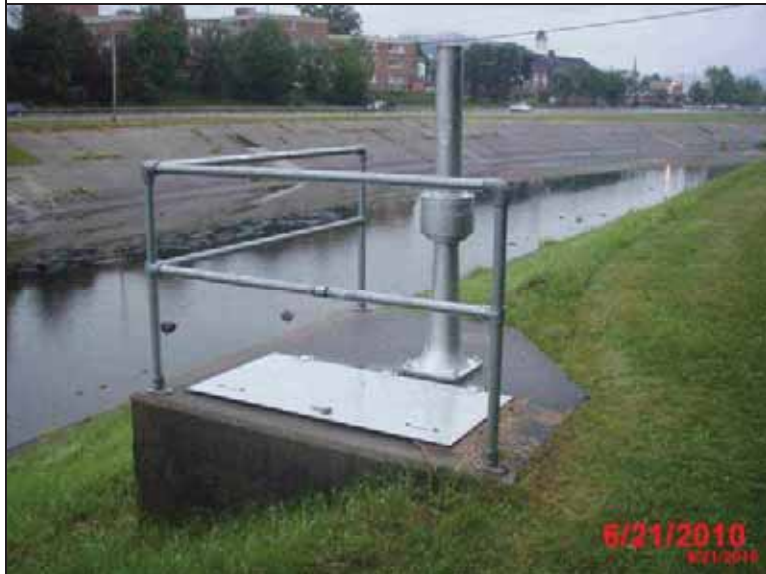
Inspect ID: N21L_2010_a_0087 **Title:** USACE_CELRB_N21L_2010_a_0087_1.jpg
Caption: Minor cracking, spalling

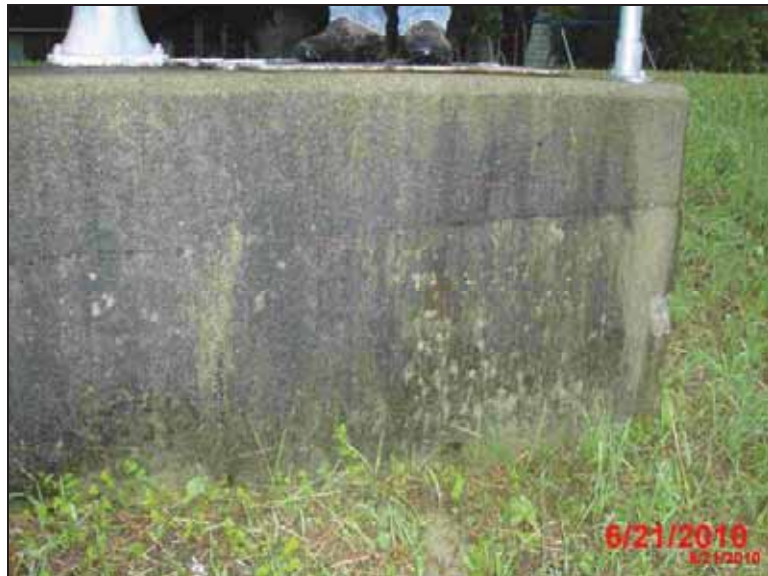
Inspect ID: N21L_2010_a_0087 **Title:** USACE_CELRB_N21L_2010_a_0087_2.jpg
Caption: Minor cracking, spalling

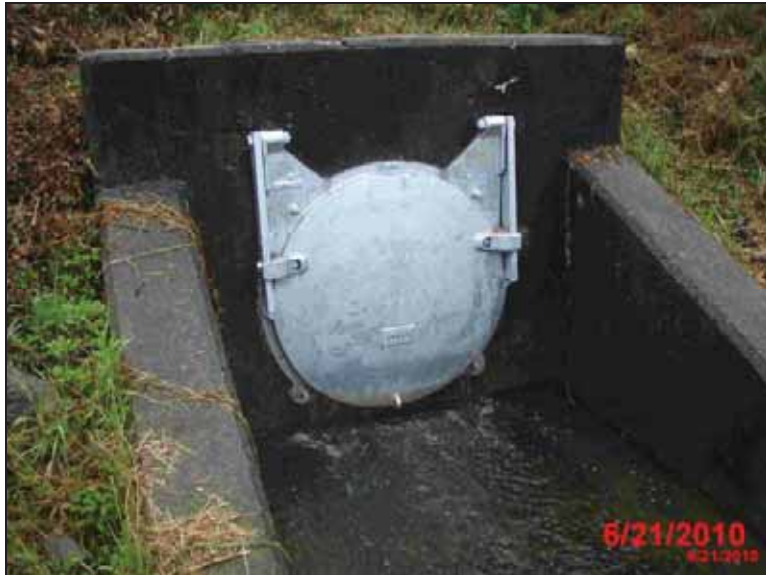
Inspect ID: N21L_2010_a_0144 **Title:** USACE_CELRB_N21L_2010_a_0144_1.jpg
Caption: 36" CMP, spalling, cracking on concrete

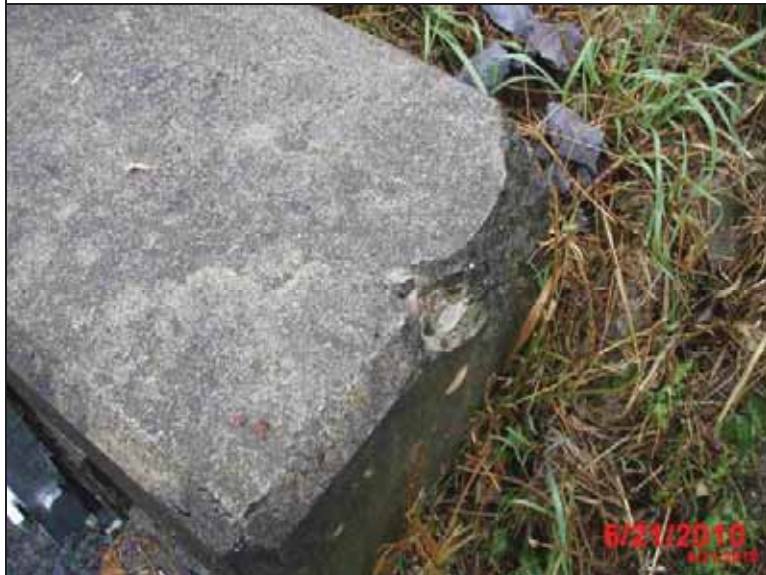
Inspect ID: N21L_2010_a_0144 **Title:** USACE_CELRB_N21L_2010_a_0144_2.jpg
Caption: 36" CMP, spalling, cracking on concrete

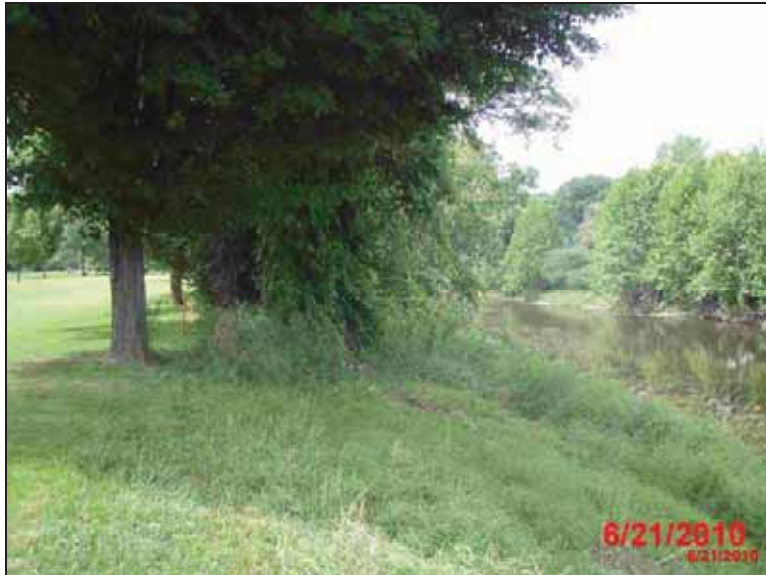
Inspect ID: N21L_2010_a_0001 **Title:** USACE_CELRB_N21L_2010_a_0001_1.jpg
Caption: Vegetation, trees along both banks

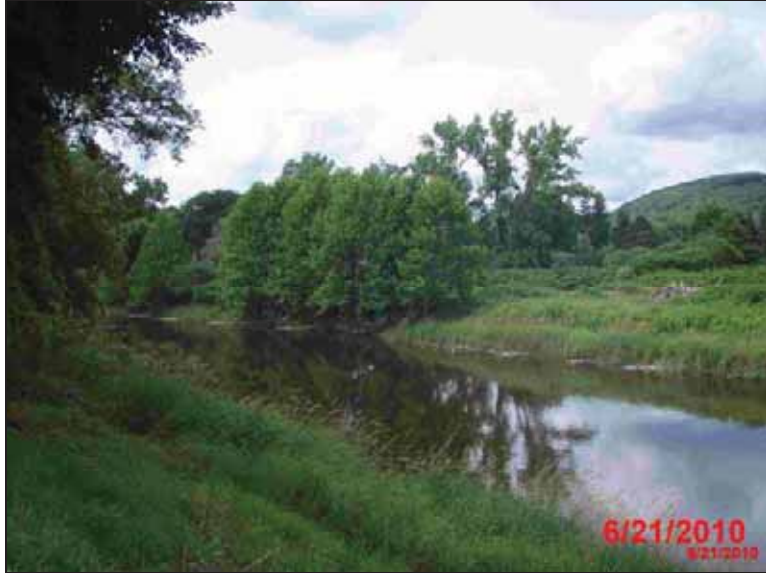
Inspect ID: N21L_2010_a_0003 **Title:** USACE_CELRB_N21L_2010_a_0003_1.jpg
Caption: Shoaling, debris along bank

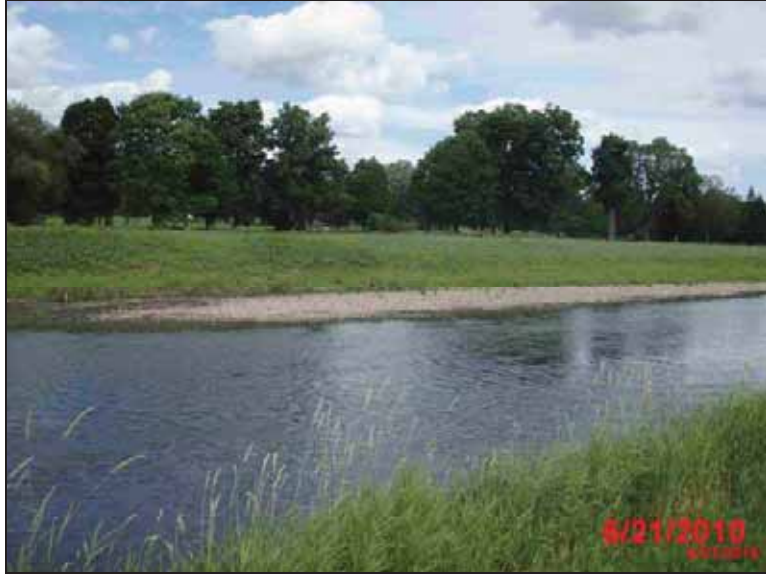
Inspect ID: N21L_2010_a_0007 **Title:** USACE_CELRB_N21L_2010_a_0007_1.jpg
Caption: Shoaling along bank

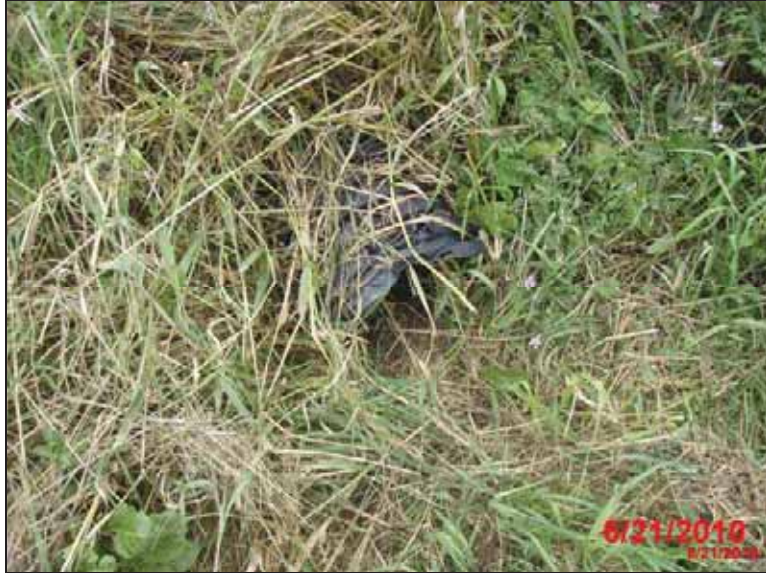
Inspect ID: N21L_2010_a_0009 **Title:** USACE_CELRB_N21L_2010_a_0009_1.jpg
Caption: 12" HDPE drainage pipe from golf course, 25% silted

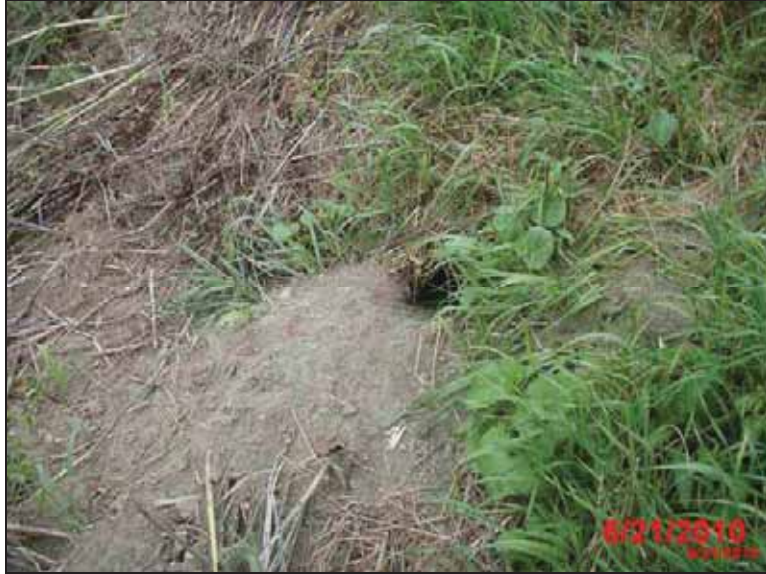
Inspect ID: N21L_2010_a_0011 **Title:** USACE_CELRB_N21L_2010_a_0011_1.jpg
Caption: Multiple burrow holes along bank

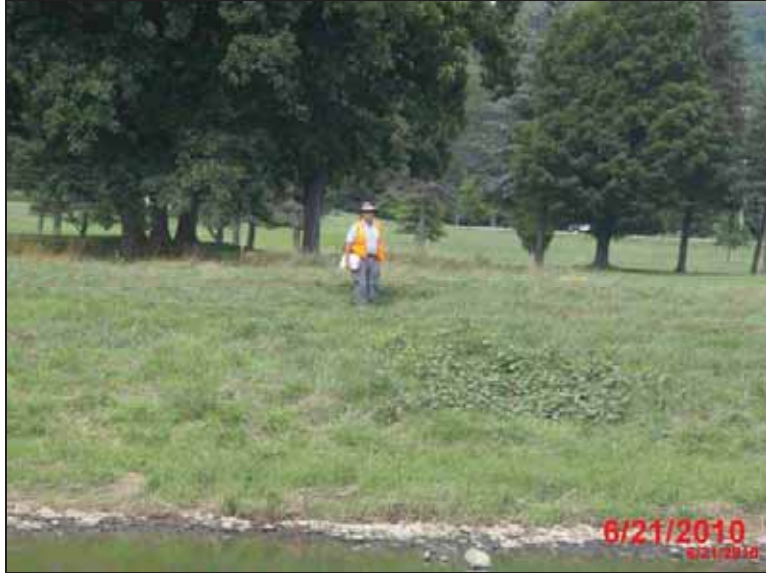
Inspect ID: N21L_2010_a_0012 **Title:** USACE_CELRB_N21L_2010_a_0012_1.jpg
Caption: Erosion along bank

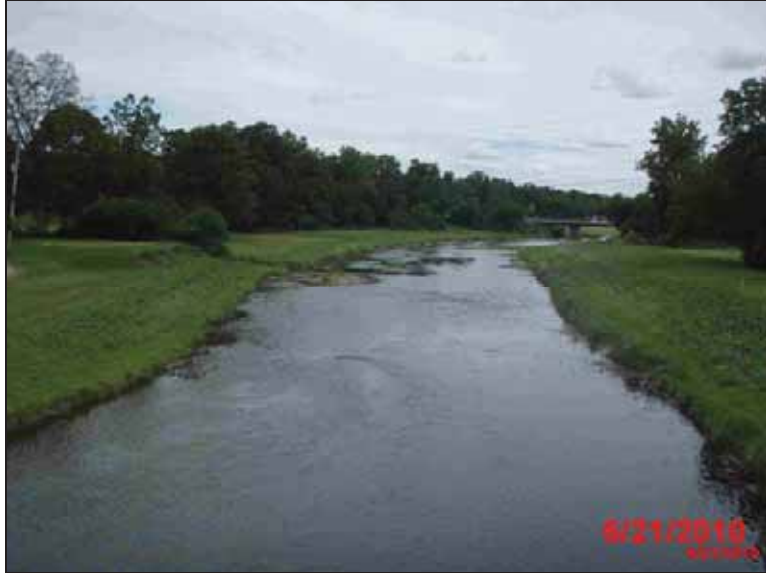
Inspect ID: N21L_2010_a_0018 **Title:** USACE_CELRB_N21L_2010_a_0018_1.jpg
Caption: Vegetation along both banks

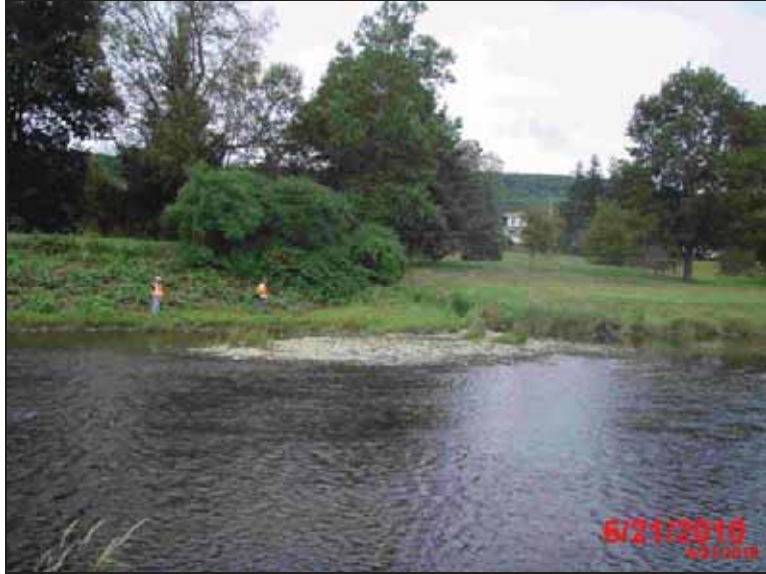
Inspect ID: N21L_2010_a_0020 **Title:** USACE_CELRB_N21L_2010_a_0020_1.jpg
Caption: Shoaling in channel

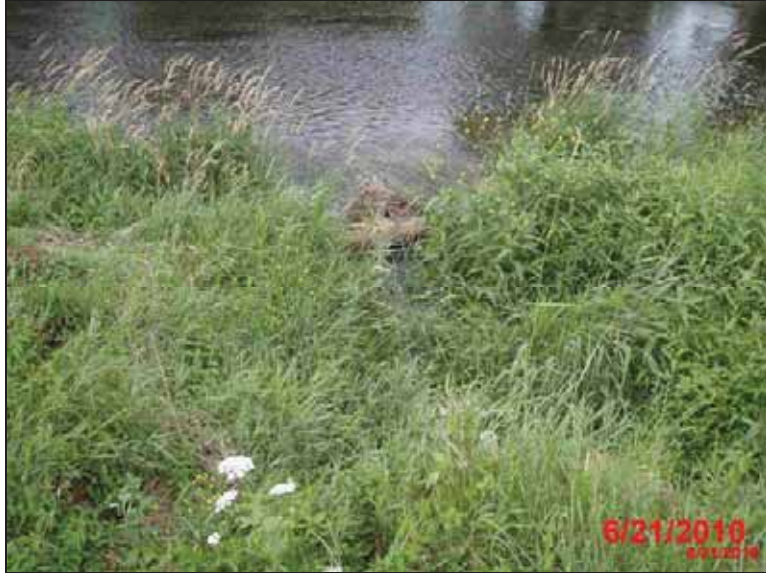
Inspect ID: N21L_2010_a_0024 **Title:** USACE_CELRB_N21L_2010_a_0024_1.jpg
Caption: Vegetation, debris in drainage ditch to channel

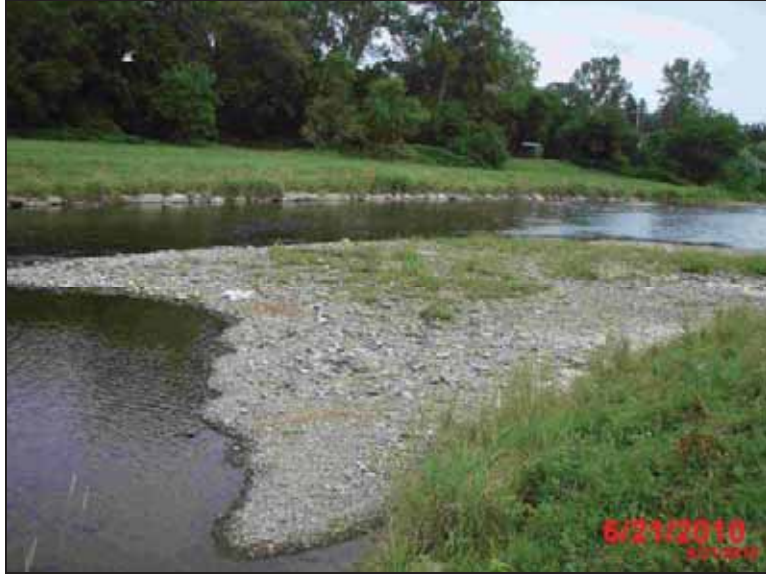
Inspect ID: N21L_2010_a_0028 **Title:** USACE_CELRB_N21L_2010_a_0028_1.jpg
Caption: Shoaling in channel

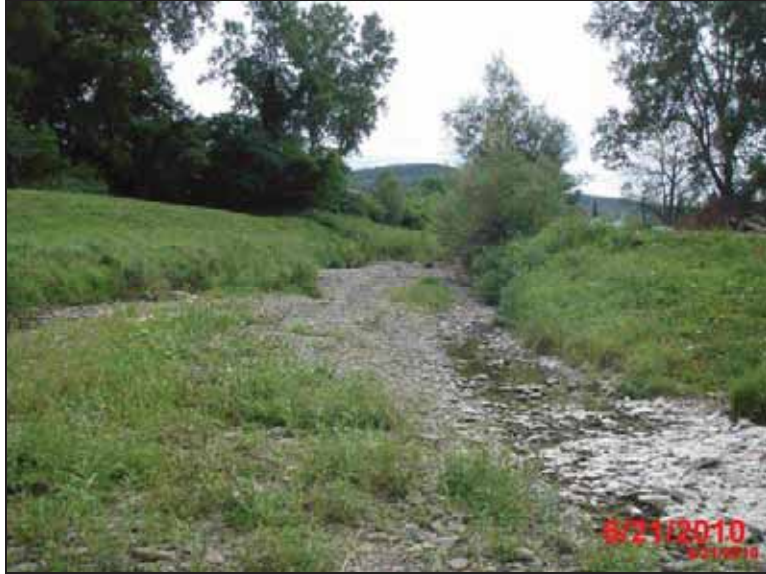
Inspect ID: N21L_2010_a_0030 **Title:** USACE_CELRB_N21L_2010_a_0030_1.jpg
Caption: Vegetation on banks

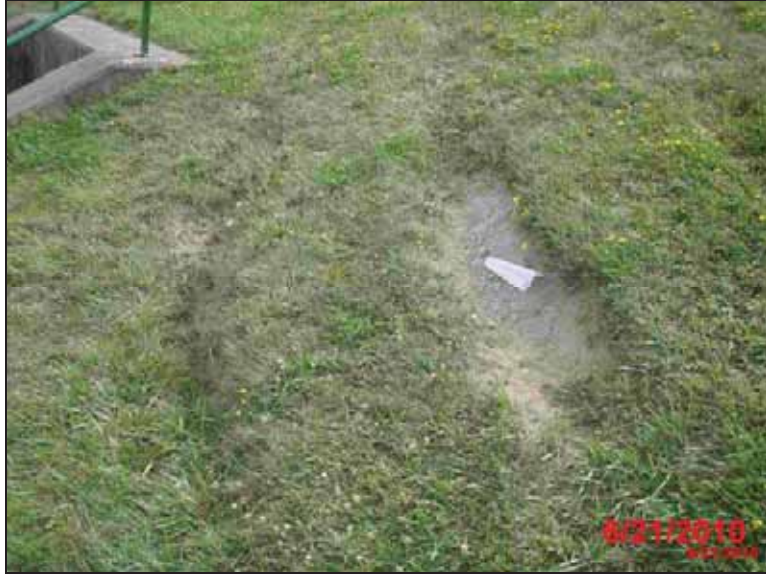
Inspect ID: N21L_2010_a_0041 **Title:** USACE_CELRB_N21L_2010_a_0041_1.jpg
Caption: Rutting from mower

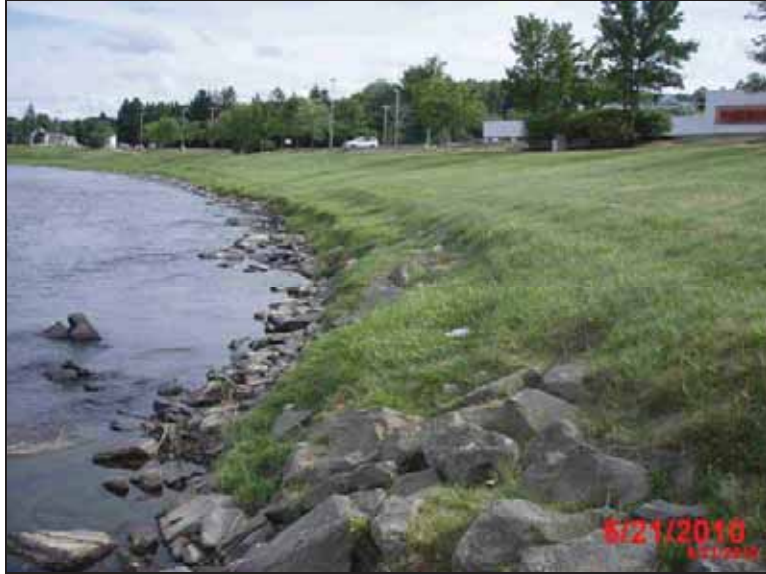
Inspect ID: N21L_2010_a_0050 **Title:** USACE_CELRB_N21L_2010_a_0050_1.jpg
Caption: Erosion along bank

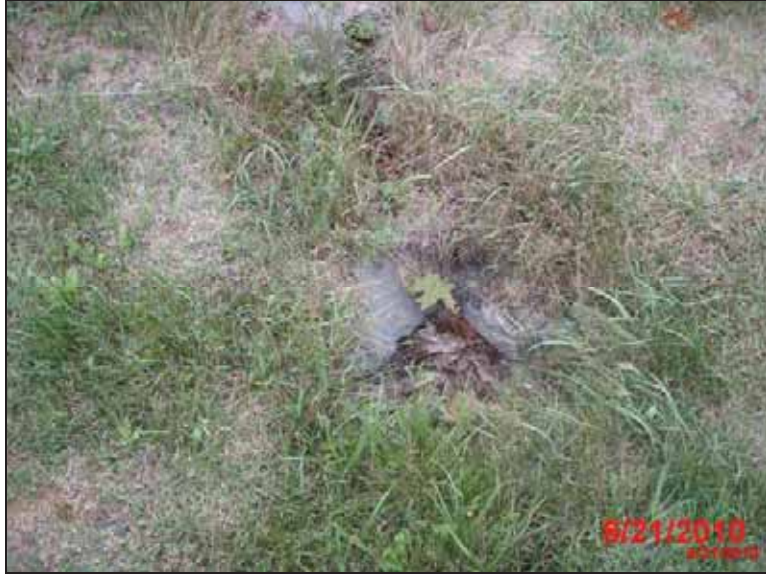
Inspect ID: N21L_2010_a_0058 **Title:** USACE_CELRB_N21L_2010_a_0058_1.jpg
Caption: Burrow hole

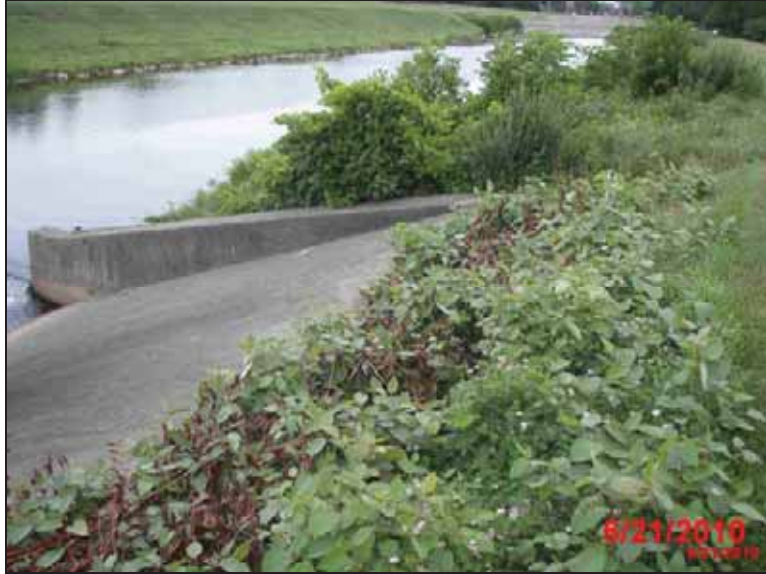
Inspect ID: N21L_2010_a_0065 **Title:** USACE_CELRB_N21L_2010_a_0065_1.jpg
Caption: Vegetation in riprap

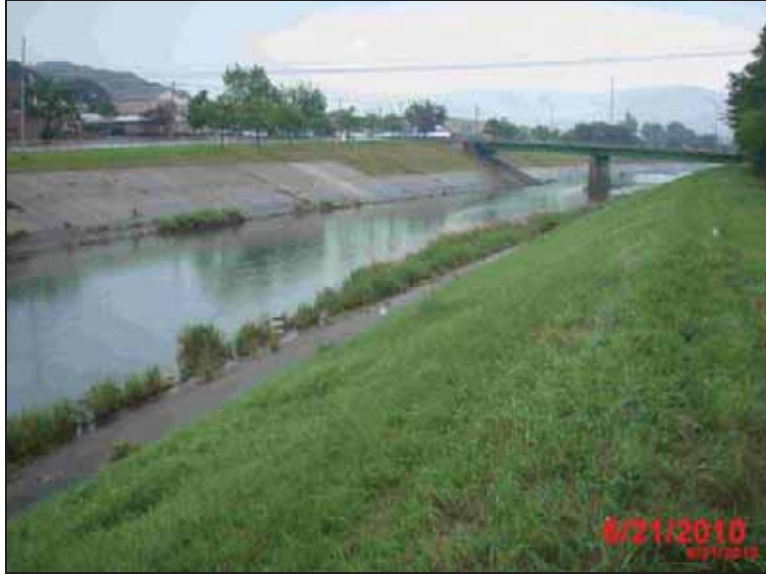
Inspect ID: N21L_2010_a_0102 **Title:** USACE_CELRB_N21L_2010_a_0102_1.jpg
Caption: Shoaling, vegetation

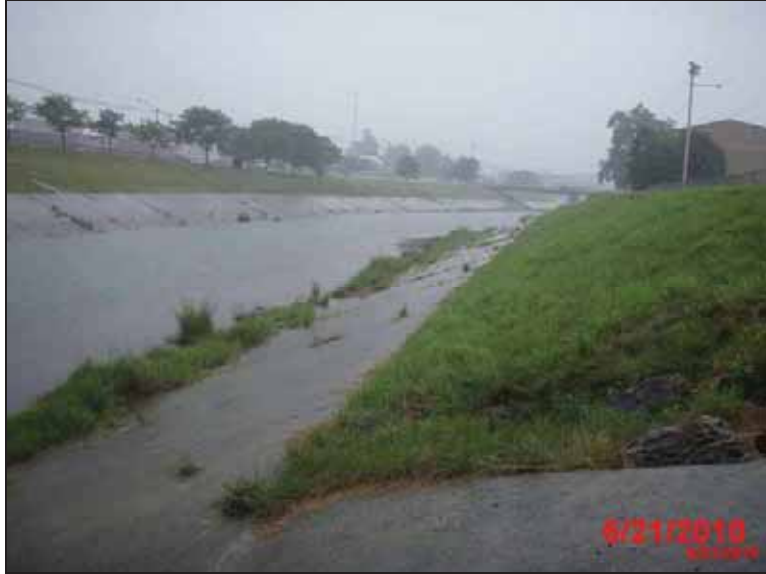
Inspect ID: N21L_2010_a_0110 **Title:** USACE_CELRB_N21L_2010_a_0110_1.jpg
Caption: Shoaling, vegetation

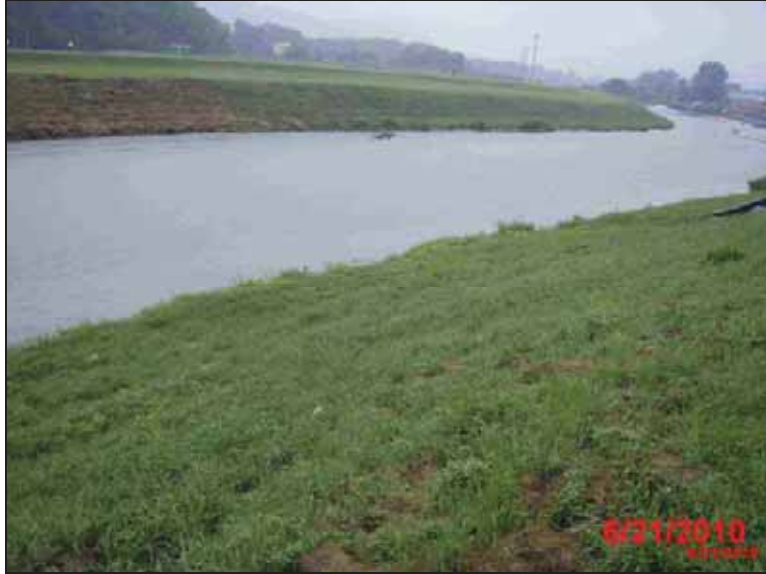
Inspect ID: N21L_2010_a_0157 **Title:** USACE_CELRB_N21L_2010_a_0157_1.jpg
Caption: Shoaling at bank

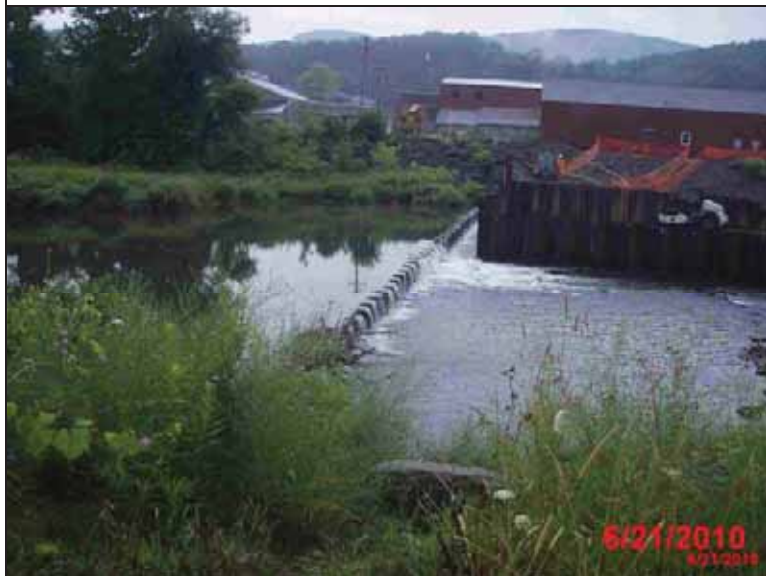
Inspect ID: N21L_2010_a_0175 **Title:** USACE_CELRB_N21L_2010_a_0175_1.jpg
Caption: Possible damage, low spot on weir

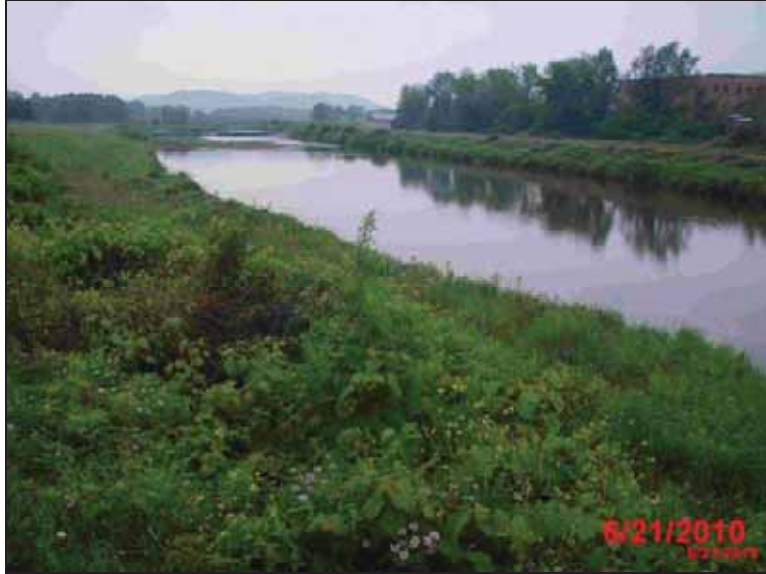
Inspect ID: N21L_2010_a_0178 **Title:** USACE_CELRB_N21L_2010_a_0178_1.jpg
Caption: Shoaling in channel near bank

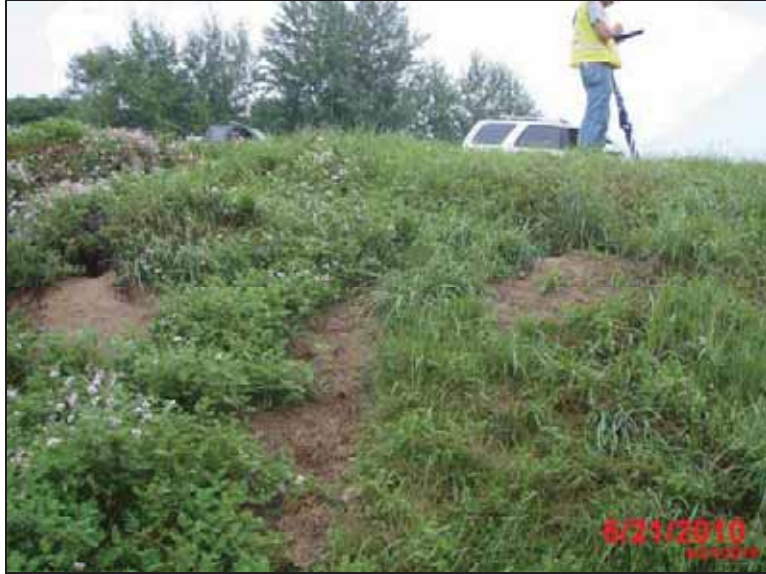
Inspect ID: N21L_2010_a_0180 **Title:** USACE_CELRB_N21L_2010_a_0180_1.jpg
Caption: Multiple burrow holes

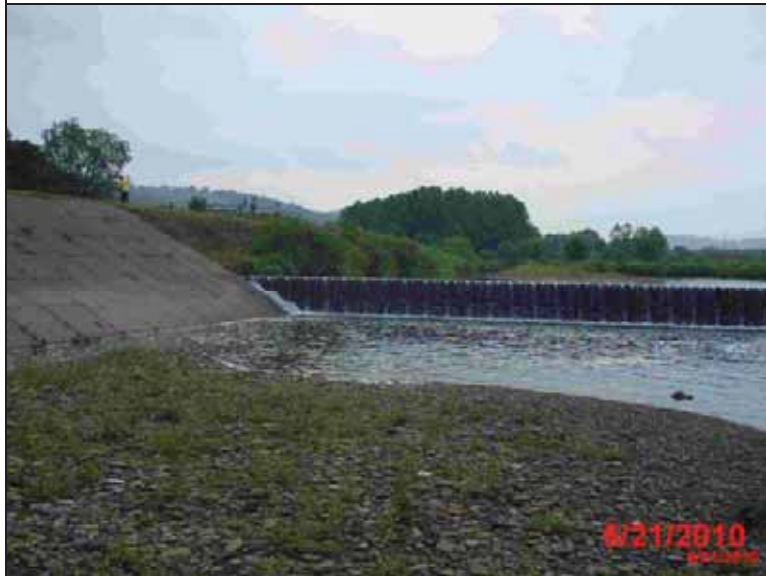
Inspect ID: N21L_2010_a_0190 **Title:** USACE_CELRB_N21L_2010_a_0190_1.jpg
Caption: Upper weir, possible damage, low spot in weir

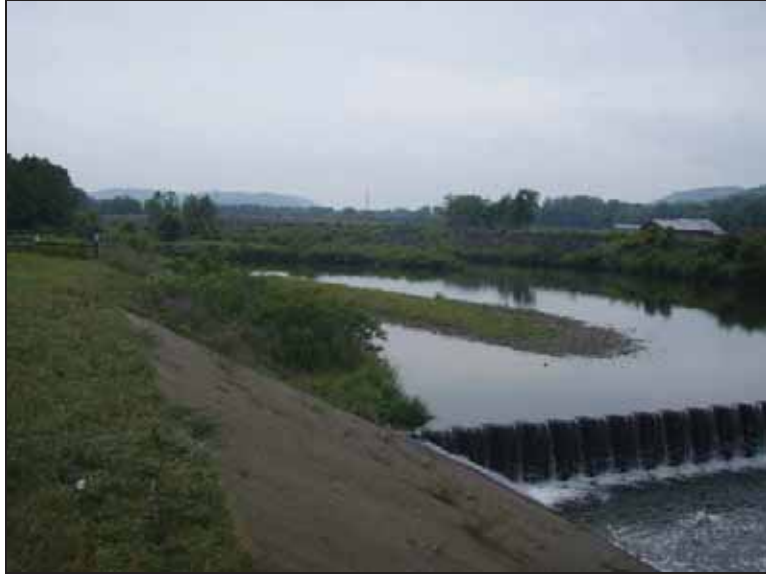
Inspect ID: N21L_2010_a_0191 **Title:** USACE_CELRB_N21L_2010_a_0191_1.jpg
Caption: Shoaling

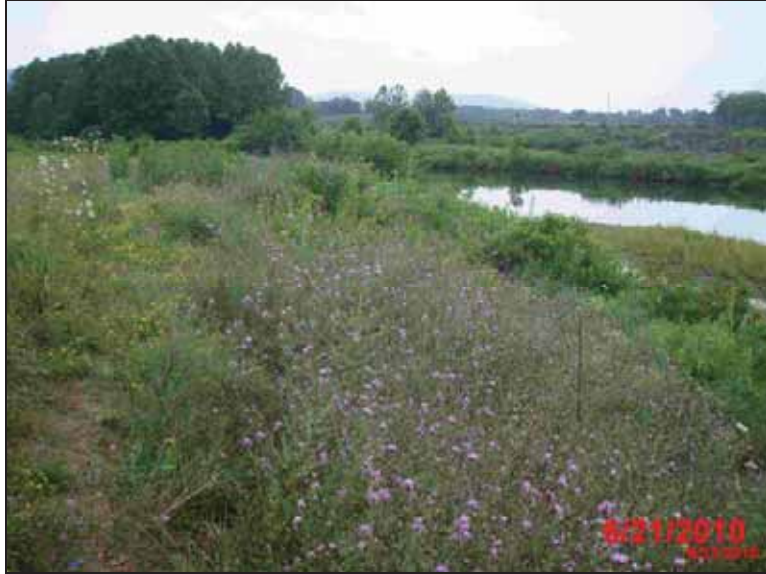
Inspect ID: N21L_2010_a_0194 **Title:** USACE_CELRB_N21L_2010_a_0194_1.jpg
Caption: Vegetation in riprap

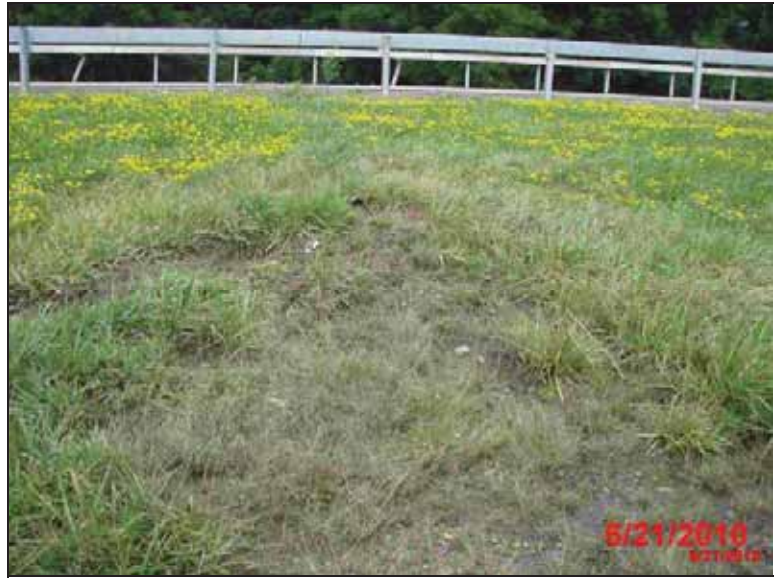
<p>Inspect ID: N21L_2010_a_0209 Title: USACE_CELRB_N21L_2010_a_0209_1.jpg Caption: 4" perforated pipe 25% silted</p>

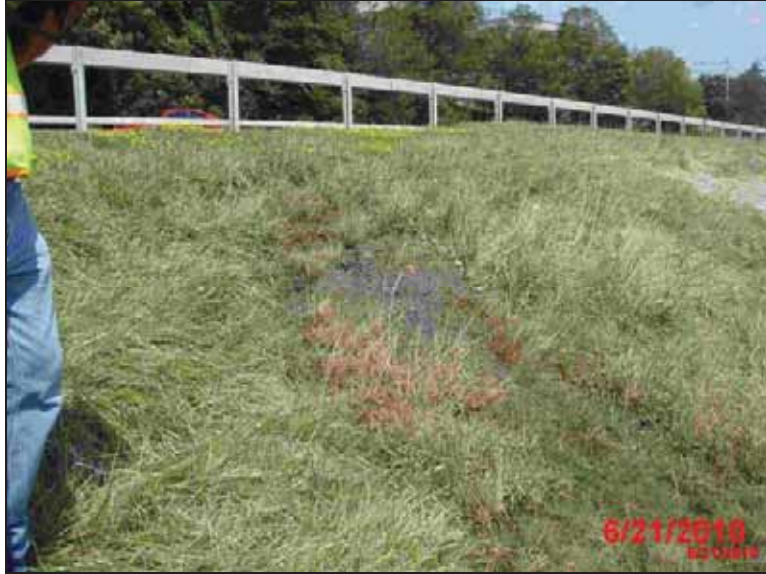
Inspect ID: N21L_2010_a_0212 **Title:** USACE_CELRB_N21L_2010_a_0212_1.jpg
Caption: Seepage

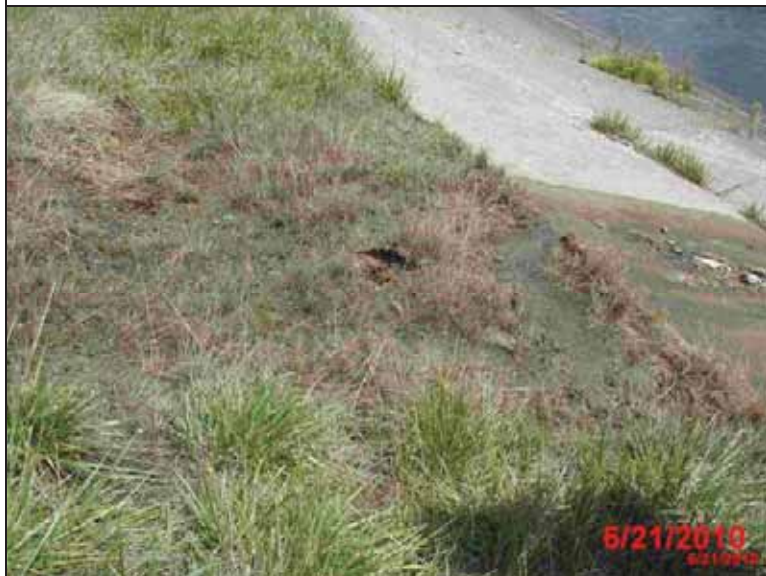
Inspect ID: N21L_2010_a_0213 **Title:** USACE_CELRB_N21L_2010_a_0213_1.jpg
Caption: 6" CMP, rusted

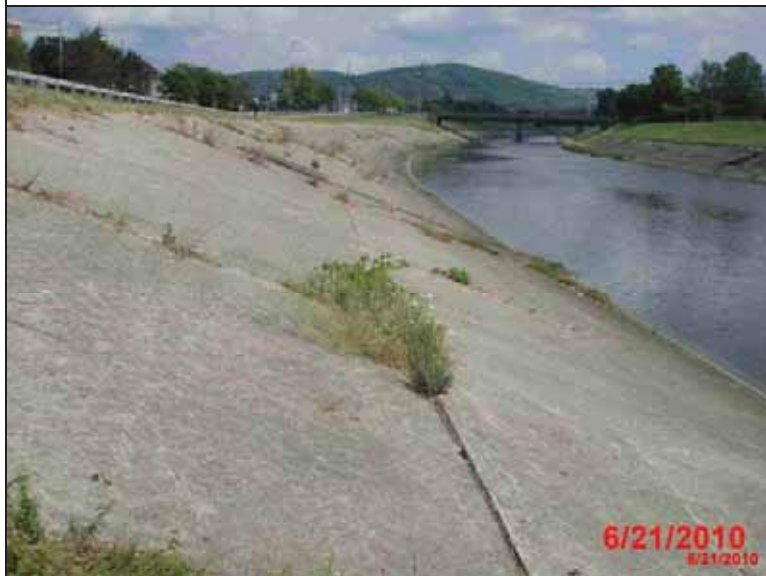
Inspect ID: N21L_2010_a_0215 **Title:** USACE_CELRB_N21L_2010_a_0215_1.jpg
Caption: Vegetation at concrete joints

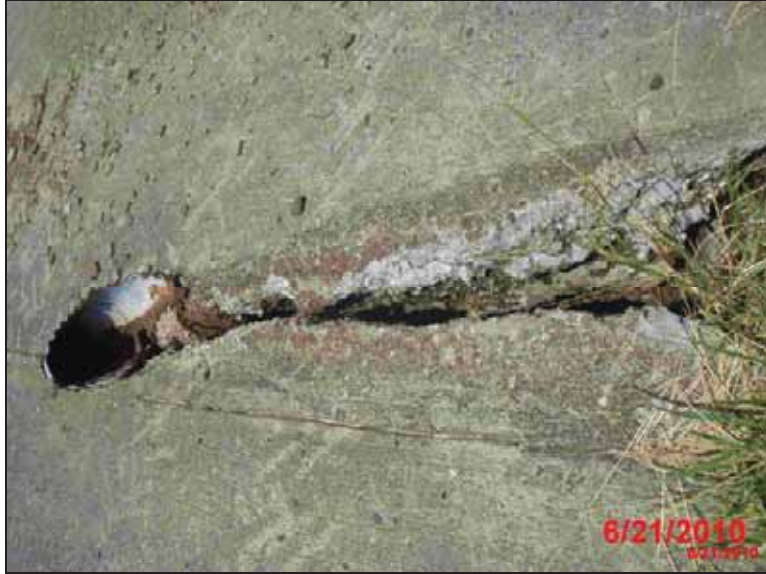
Inspect ID: N21L_2010_a_0223 **Title:** USACE_CELRB_N21L_2010_a_0223_1.jpg
Caption: 1' x 10' x 18" deep erosion in concrete

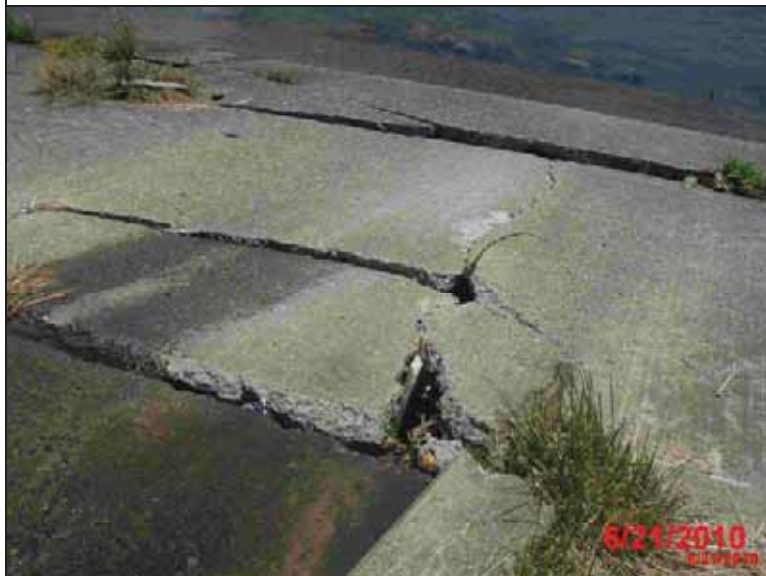
Inspect ID: N21L_2010_a_0224 **Title:** USACE_CELRB_N21L_2010_a_0224_1.jpg
Caption: 30' x 15' broken concrete, erosion below

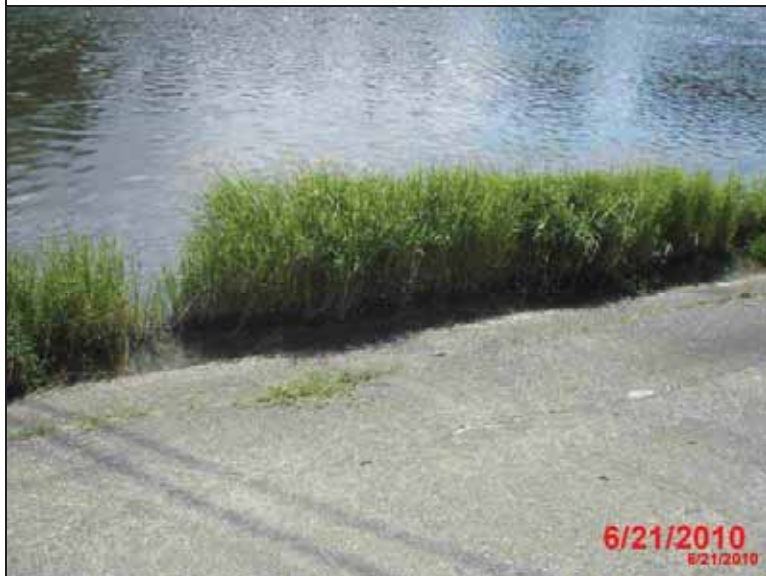
Inspect ID: N21L_2010_a_0227 **Title:** USACE_CELRB_N21L_2010_a_0227_1.jpg
Caption: Vegetation on bank

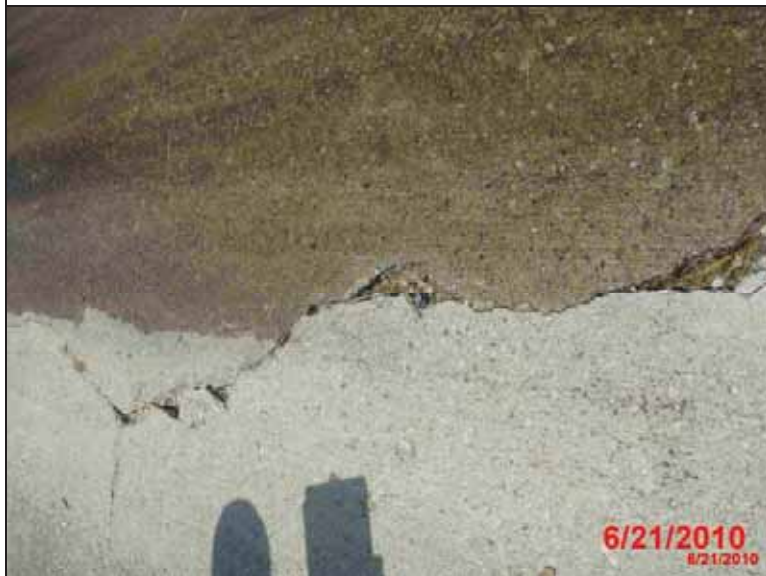
Inspect ID: N21L_2010_a_0229 **Title:** USACE_CELRB_N21L_2010_a_0229_1.jpg
Caption: Cracking in concrete

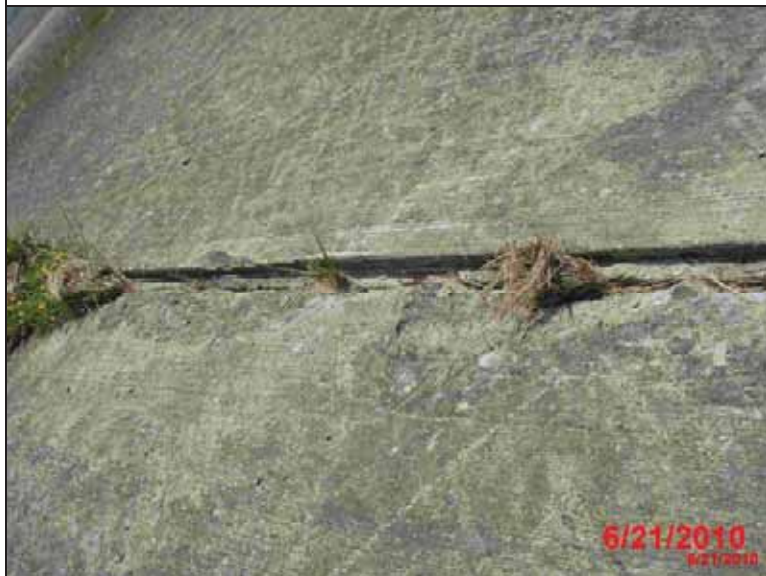
Inspect ID: N21L_2010_a_0241 **Title:** USACE_CELRB_N21L_2010_a_0241_1.jpg
Caption: Spalling at concrete joint

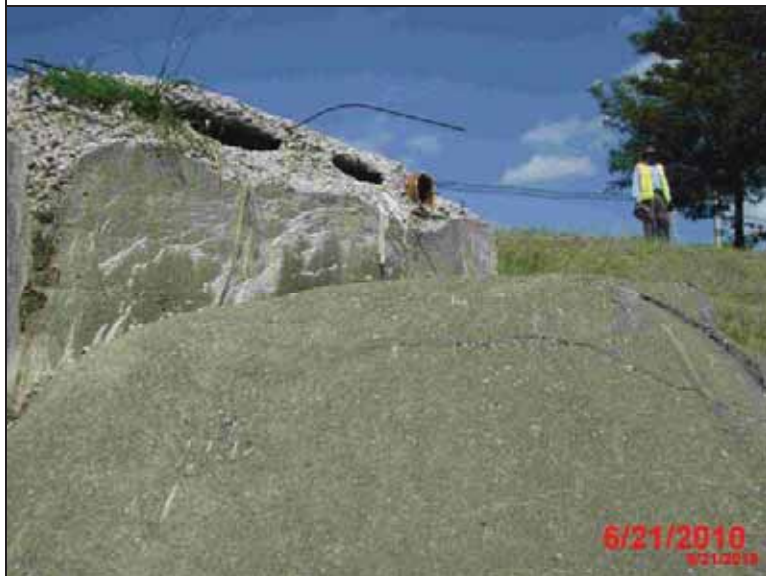
Inspect ID: N21L_2010_a_0245 **Title:** USACE_CELRB_N21L_2010_a_0245_2.jpg
Caption: Sanitary sewer structure, severely damaged

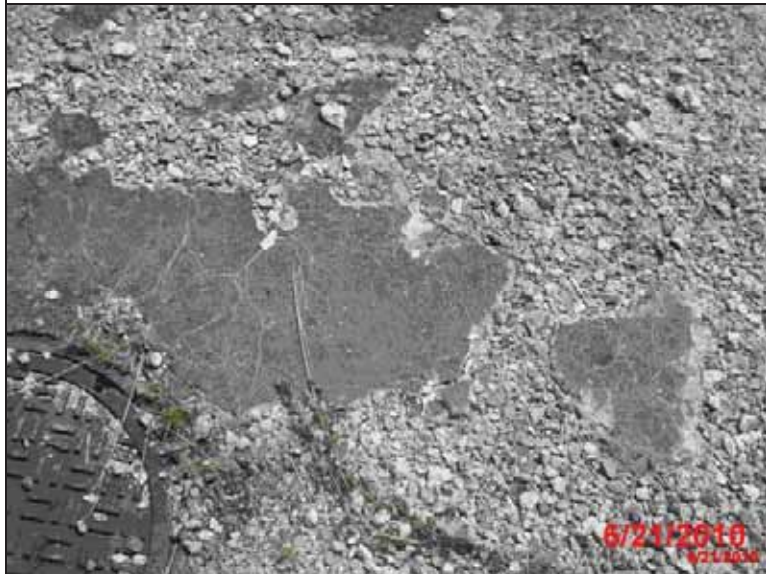
Inspect ID: N21L_2010_a_0245 **Title:** USACE_CELRB_N21L_2010_a_0245_4.jpg
Caption: Sanitary sewer structure, severely damaged

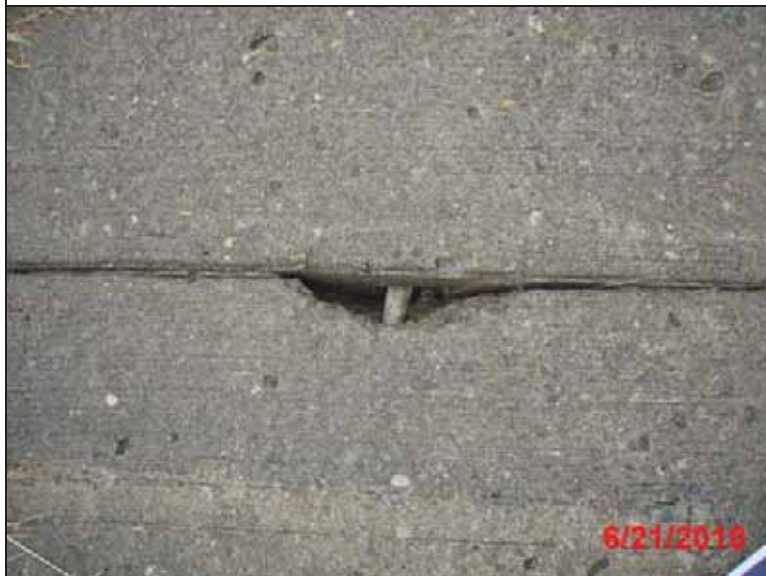
Inspect ID: N21L_2010_a_0252 **Title:** USACE_CELRB_N21L_2010_a_0252_1.jpg
Caption: Spalling at concrete joint

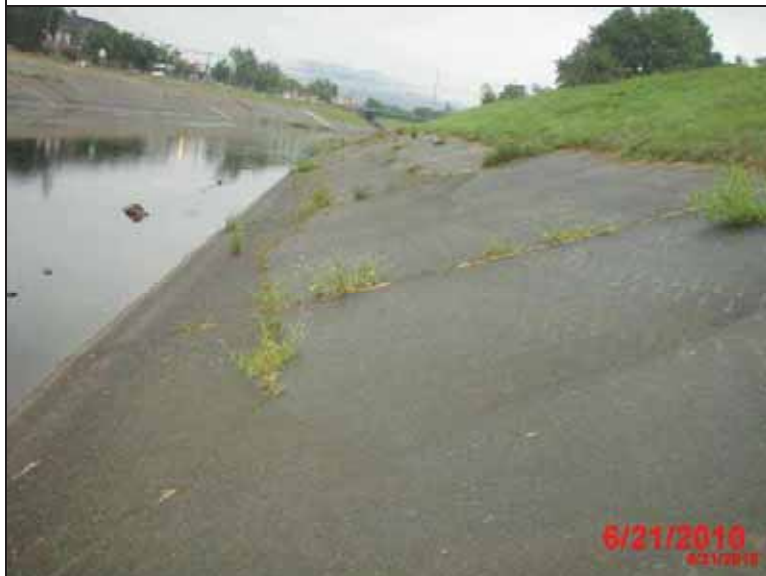
Inspect ID: N21L_2010_a_0265 **Title:** USACE_CELRB_N21L_2010_a_0265_1.jpg
Caption: Cracking in concrete

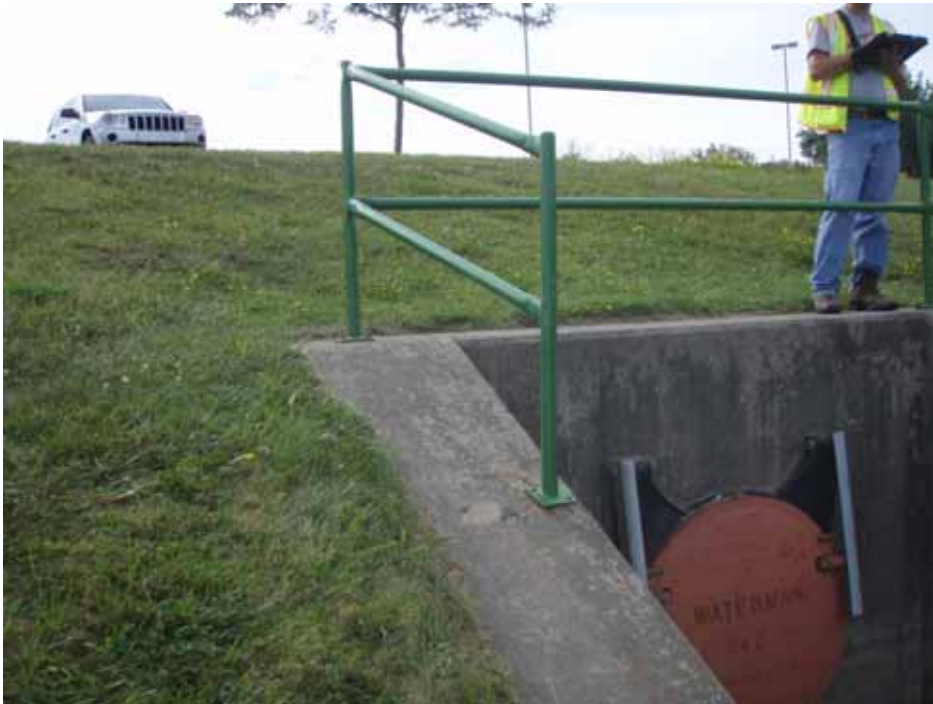
- 0042: Fence at headwall is dislodged: repair fence (U)
- Near Sta. 88+00

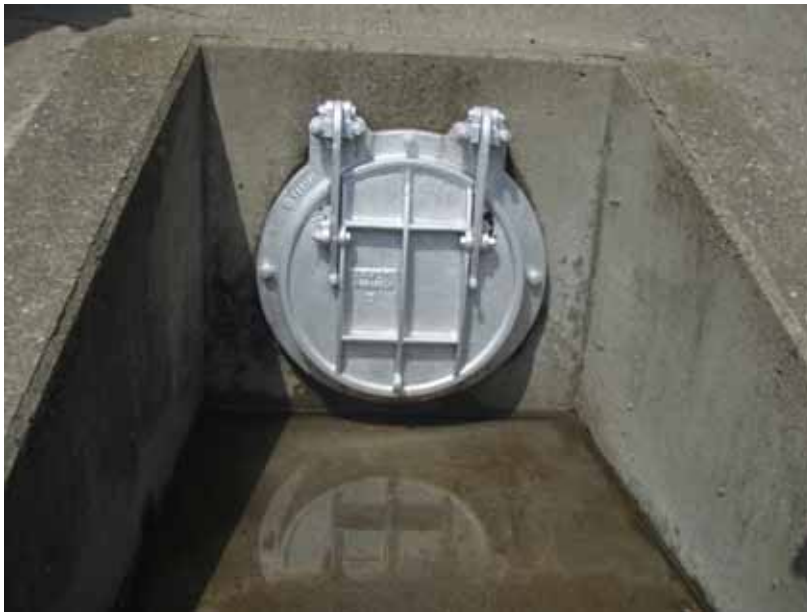
- 0218: Flap gate hinge loose from 24 inch CMP through the levee (U)
- Near Sta. 51+00

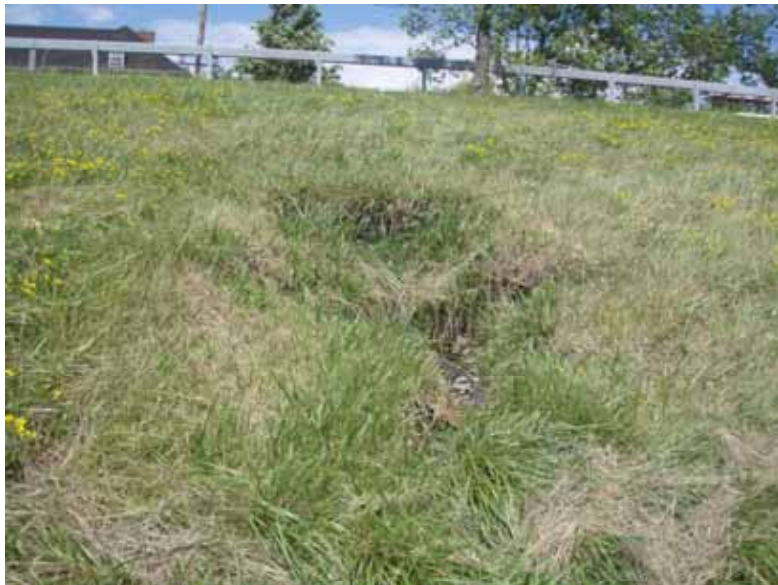
- 0150: Lack of riprap: (M)
- Near Sta. 22+00

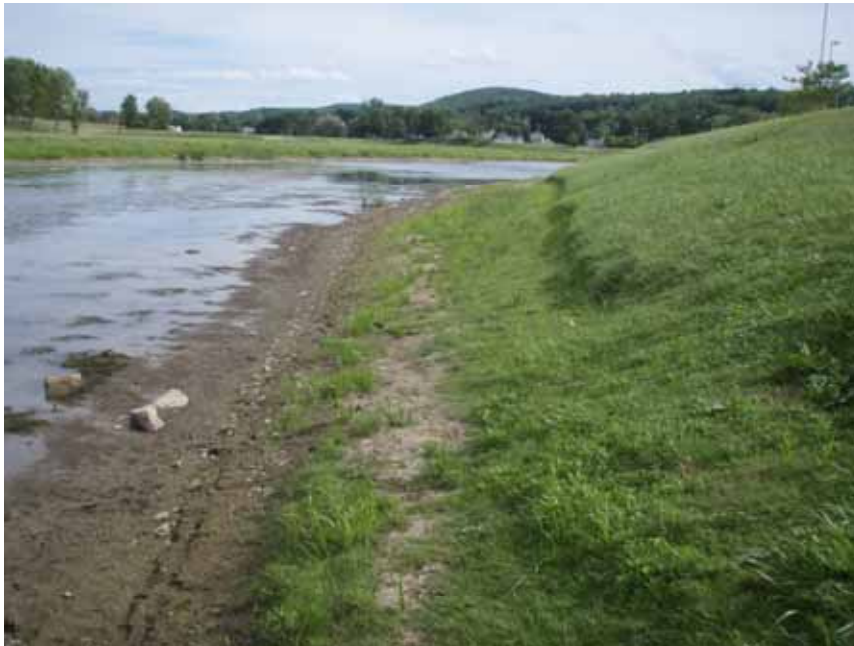
- 0038: Erosion noted along bank: (U)
- Near Sta. 89+00

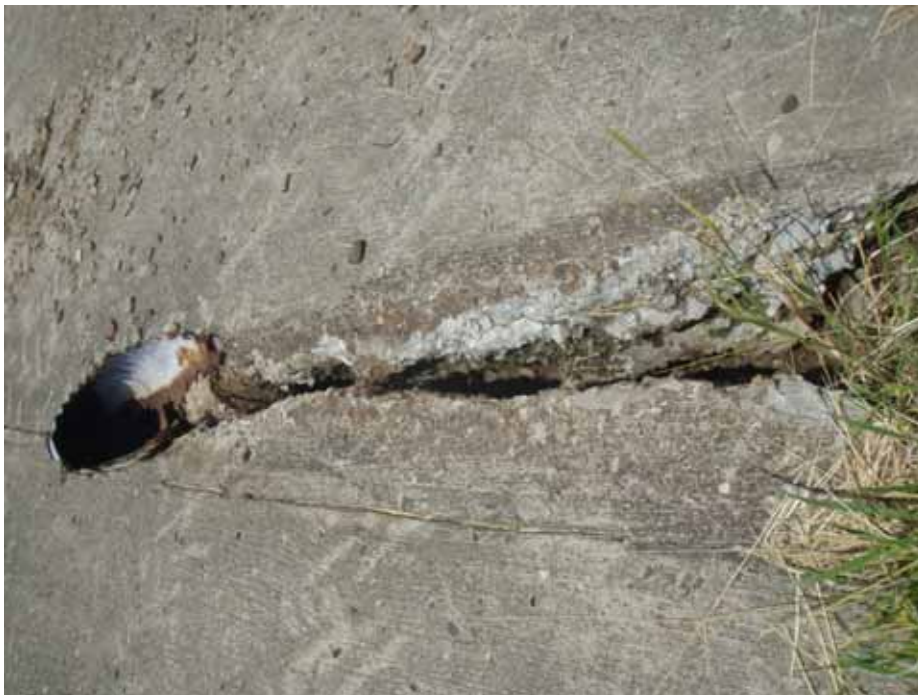
0223: Deep cracks in concrete (U)
Near Sta. 47+00

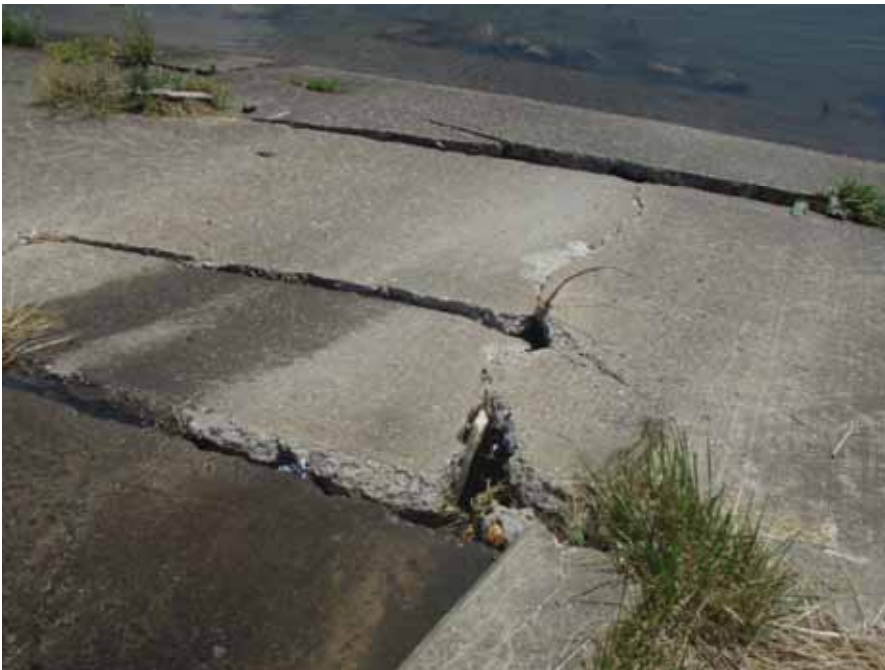
- 0224: Cracking in concrete noted: (U)
- Near Sta. 47+00
