## DEPARTMENT OF THE ARMY

BUFFALO DISTRICT, CORPS OF ENGINEERS  
1776 NIAGARA STREET  
BUFFALO, NEW YORK 14207-3199

September 19, 2017

SUBJECT: FY16 Joint Routine Inspection of Completed Works, Flood Risk Management Project, Genesee River and Dyke Creek, Wellsville, New York (09/23/16)

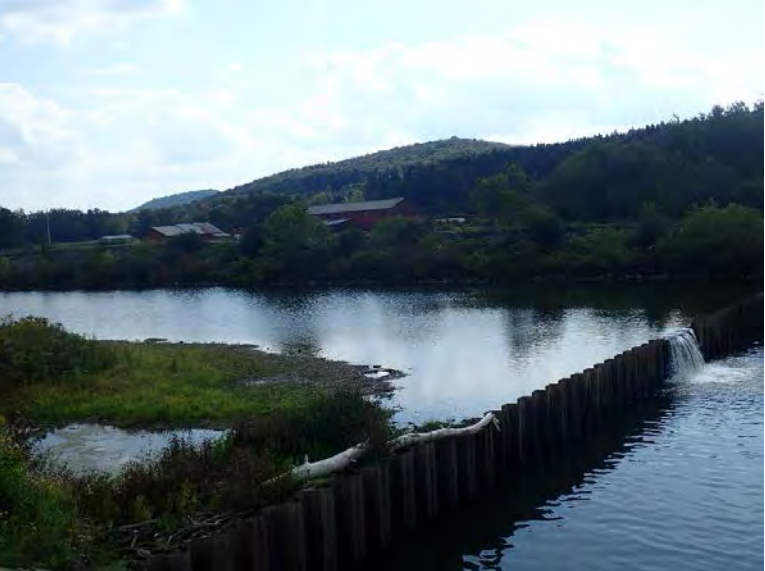
<p><b>Inspect ID:</b> N21L_2016_r_0129 <b>Title:</b> USACE_CELRB_N21L_2016_r_0129_1.jpg  <b>Rated Item:</b> 3. Encroachments <b>Caption:</b> Rating: Minimally Acceptable; Remarks: Unauthorized Alteration (A-48) - USACE levee on left bank at upstream end of project has been removed and replaced by a new levee (constructed by BP &amp; Sinclair Refinery during landfill remediation). NYSDEC says approved.; Action: Submit Section 408 Alteration Request to USACE or remove unauthorized alteration.; Station_1: 0+00</p>

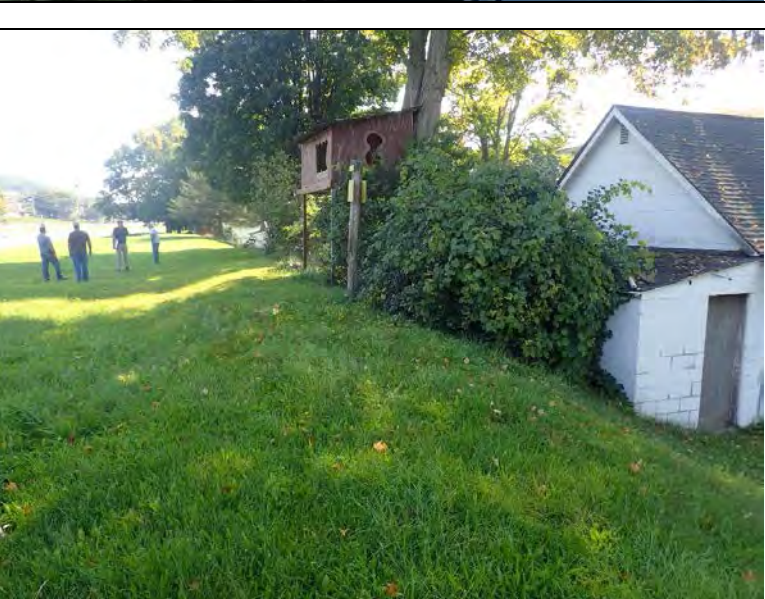
<p><b>Inspect ID:</b> N21L_2016_r_0135 <b>Title:</b> USACE_CELRB_N21L_2016_r_0135_1.jpg  <b>Rated Item:</b> 3. Encroachments <b>Caption:</b> Rating: Minimally Acceptable; Remarks: Unauthorized Alteration (A-18) - white concrete block shed, utility marker, and tree house on left bank levee landside slope at 52 and 48 Seneca Street. Note: levee is overbuilt at this location (approx. 42 feet wide).; Action: Submit Section 408 Alteration Request to USACE or remove unauthorized alteration.; Station_1: 57+00</p>

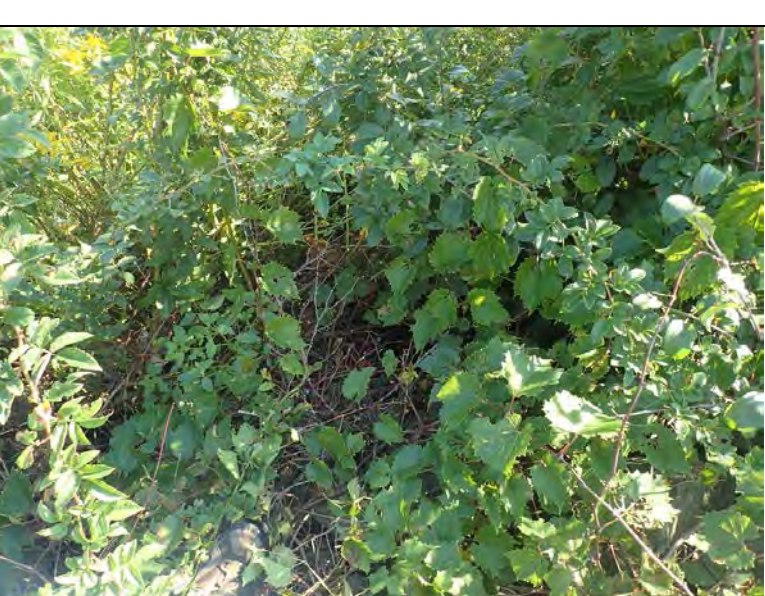
<p><b>Inspect ID:</b> N21L_2016_r_0029 <b>Title:</b> USACE_CELRB_N21L_2016_r_0029_1.jpg <b>Rated Item:</b> 1. Vegetation and Obstructions <b>Caption:</b> Rating: Minimally Acceptable; <b>Remarks:</b> 30" CMP outfall on left bank 1,600' upstream of Bolivar Road bridge is approx. 20% obstructed by minor sediment.; <b>Action:</b> Remove sediment obstruction.; <b>Station_1:</b> 75+00</p>

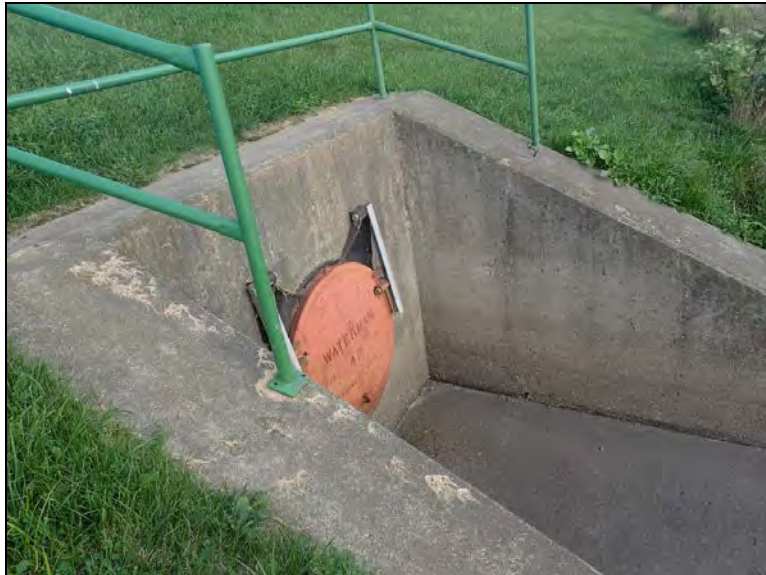
**Inspect ID:** N21L\_2016\_r\_0015 **Title:** USACE\_CELRB\_N21L\_2016\_r\_0015\_1.jpg  
**Rated Item:** 4. Fencing and Gates **Caption:** Rating: Minimally Acceptable; Remarks: Lower supports of headwall railing are dislodged on left bank outfall 300' upstream of Bolivar Road bridge.; Action: Repair headwall railing.; Station\_1: 88+00

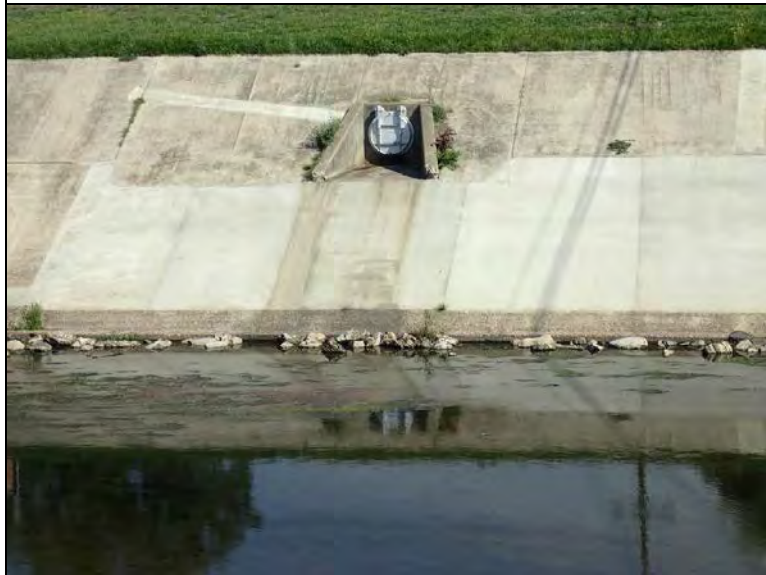
**Inspect ID:** N21L\_2016\_r\_0065 **Title:** USACE\_CELRB\_N21L\_2016\_r\_0065\_1.jpg  
**Rated Item:** 5. Concrete Surfaces (Such as gate wells, outfalls, intakes, or culverts)  
**Caption:** Rating: Acceptable; Remarks: Large erosion hole under concrete slope @ 36" outfall on right bank repaired on right bank 400' downstream of Madison Street (Stevens Street) bridge.; Action: NA; Station\_1: 47+00

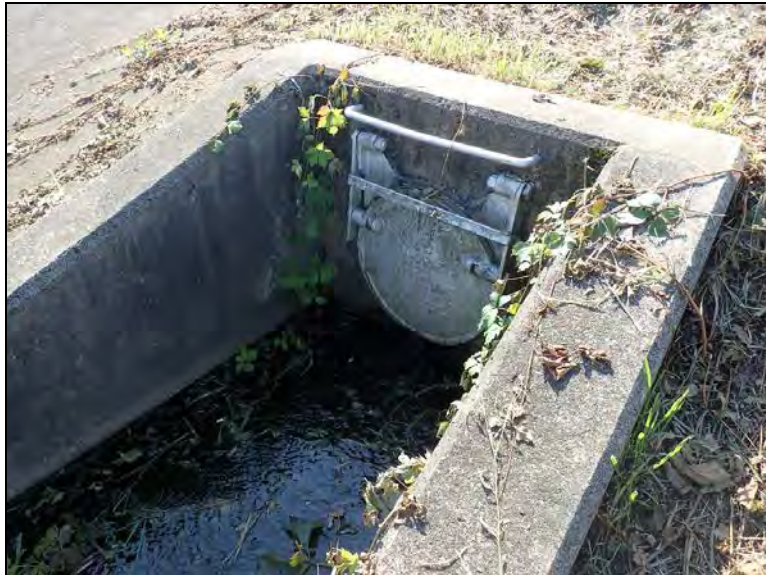
**Inspect ID:** N21L\_2016\_r\_0054 **Title:** USACE\_CELRB\_N21L\_2016\_r\_0054\_1.jpg  
**Rated Item:** 9. Culverts/ Discharge Pipes **Caption:** Rating: Minimally Acceptable;  
Remarks: 24" RCP on left bank 900' downstream of Madison Street (Stevens Street)  
bridge (rated M in NYSDEC 19DEC13 pipe inspection).; Action: Repair pipe to  
acceptable condition.; Station\_1: 53+00

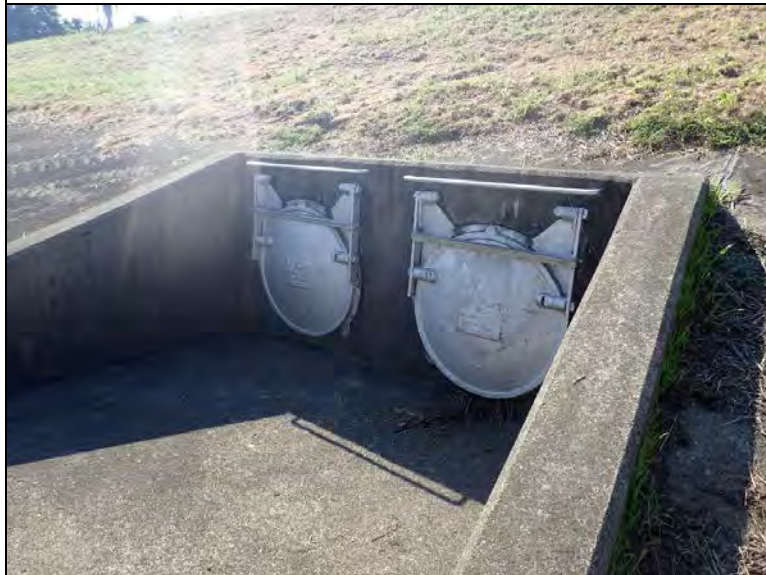
**Inspect ID:** N21L\_2016\_r\_0063 **Title:** USACE\_CELRB\_N21L\_2016\_r\_0063\_1.jpg  
**Rated Item:** 9. Culverts/ Discharge Pipes **Caption:** Rating: Acceptable; Remarks: Two  
36" outfalls with flap gates.; Action: NA; Station\_1: 50+00

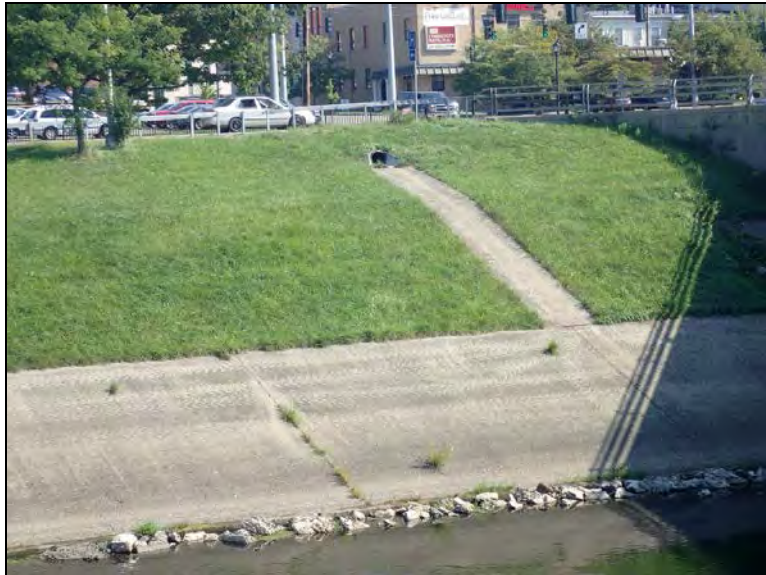
**Inspect ID:** N21L\_2016\_r\_0070 **Title:** USACE\_CELRB\_N21L\_2016\_r\_0070\_1.jpg  
**Rated Item:** 9. Culverts/ Discharge Pipes **Caption:** Rating: Acceptable; Remarks: Outfall on right bank in acceptable condition.; Action: NA; Station\_1: 43+00

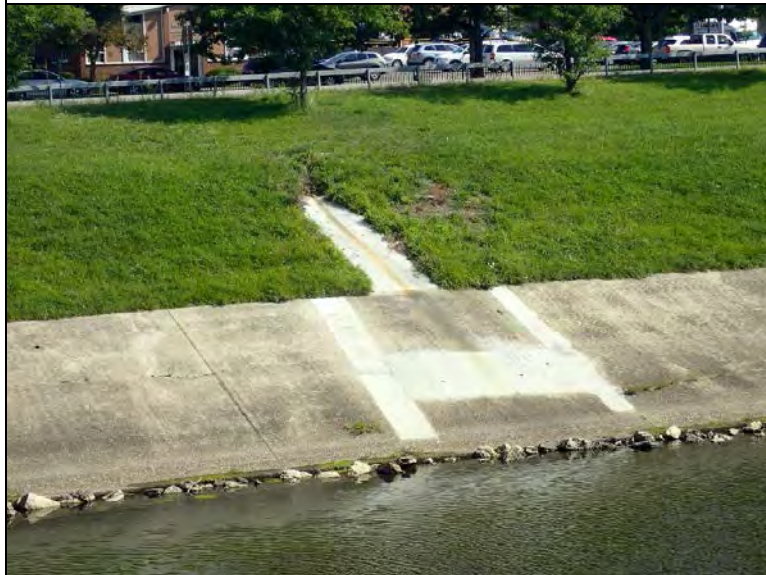
**Inspect ID:** N21L\_2016\_r\_0071 **Title:** USACE\_CELRB\_N21L\_2016\_r\_0071\_1.jpg  
**Rated Item:** 9. Culverts/ Discharge Pipes **Caption:** Rating: Acceptable; Remarks: 12" CMP repaired on right bank 250' downstream of Madison Street (Stevens Street) bridge.; Action: NA; Station\_1: 44+00

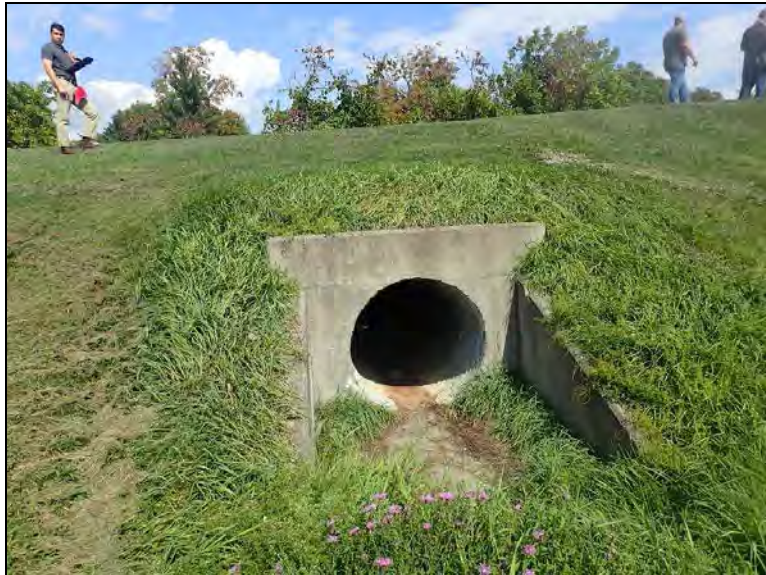
**Inspect ID:** N21L\_2016\_r\_0100 **Title:** USACE\_CELRB\_N21L\_2016\_r\_0100\_1.jpg  
**Rated Item:** 9. Culverts/ Discharge Pipes **Caption:** Rating: Acceptable; Remarks: 48"  
CMP on left bank landside slope 515' upstream of Steel Sheet Pile Weir (rated A in  
NYSDEC 19DEC13 pipe inspection). Pipet does not have a trash rack to prevent  
obstructions from entering the pipe. ; Action: Maintain pipe and videotape inspect by  
19DEC18. Recommend installing trash rack over opening to keep out debris and  
unauthorized access. ; Station\_1: 23+00

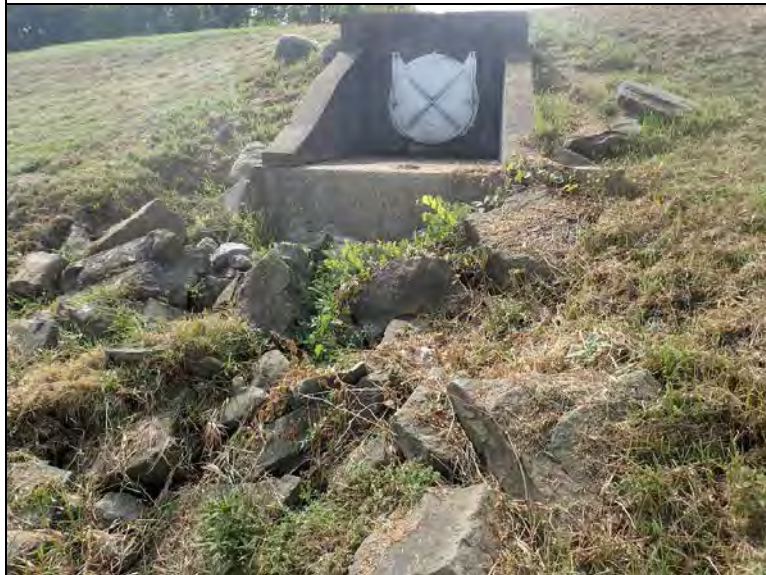
**Inspect ID:** N21L\_2016\_r\_0107 **Title:** USACE\_CELRB\_N21L\_2016\_r\_0107\_1.jpg  
**Rated Item:** 9. Culverts/ Discharge Pipes **Caption:** Rating: Acceptable; Remarks: 42"  
CMP outfall on left bank 325' upstream of Island Park Pedestrian Walkway Bridge (rated  
A in NYSDCE 19DEC13 pipe inspection).; Action: Maintain pipe and videotape inspect  
by 19DEC18.; Station\_1: 13+00

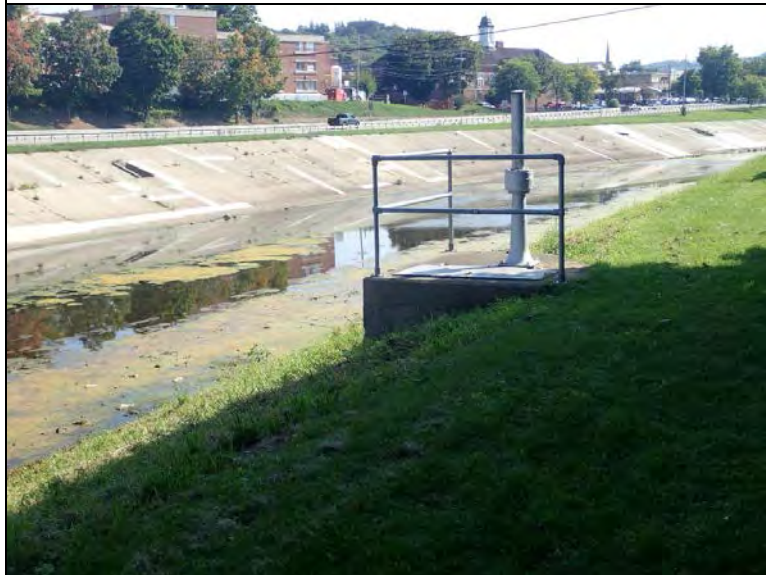
**Inspect ID:** N21L\_2016\_r\_0052 **Title:** USACE\_CELRB\_N21L\_2016\_r\_0052\_1.jpg  
**Rated Item:** 10. Sluice/ Slide Gates **Caption:** Rating: Acceptable; Remarks: Sluice gate on left bank 1,000' downstream of Madison Street (Stevens Street) bridge appears to be in acceptable condition, not operated at the time of the FY15 Inspection.; Action: NA; Station\_1: 53+00

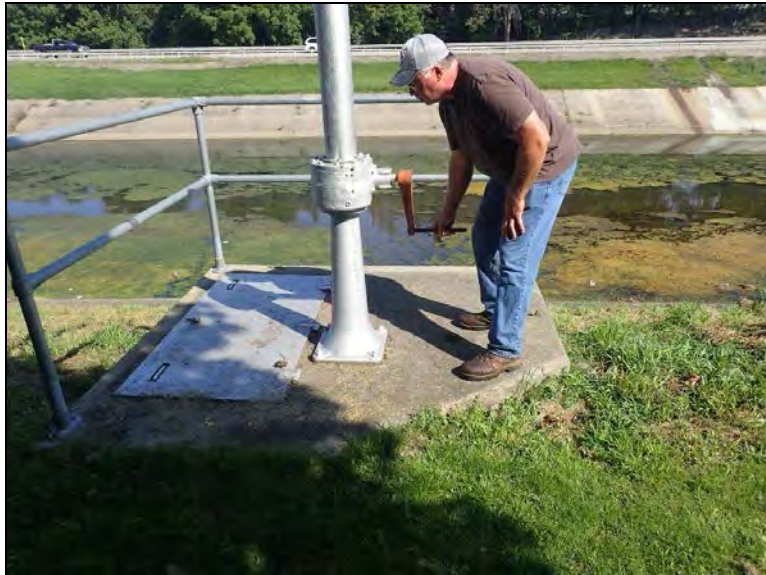
**Inspect ID:** N21L\_2016\_r\_0052 **Title:** USACE\_CELRB\_N21L\_2016\_r\_0052\_2.jpg  
**Rated Item:** 10. Sluice/ Slide Gates **Caption:** Rating: Acceptable; Remarks: Sluice gate on left bank 1,000' downstream of Madison Street (Stevens Street) bridge appears to be in acceptable condition, not operated at the time of the FY15 Inspection.; Action: NA; Station\_1: 53+00

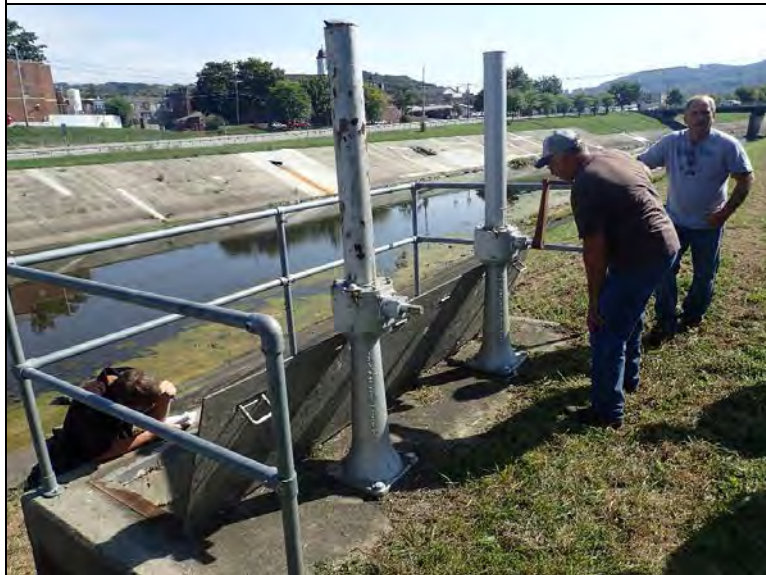
**Inspect ID:** N21L\_2016\_r\_0059 **Title:** USACE\_CELRB\_N21L\_2016\_r\_0059\_1.jpg  
**Rated Item:** 10. Sluice/ Slide Gates **Caption:** Rating: Acceptable; Remarks: Sluice gate on left bank 550' downstream of Madison Street (Stevens Street) bridge in good condition.; Action: NA; Station\_1: 49+00

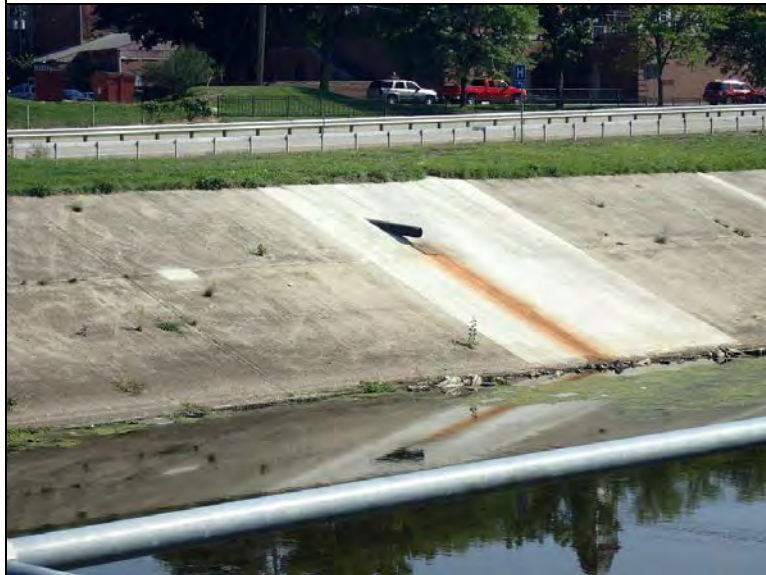
**Inspect ID:** N21L\_2016\_r\_0064 **Title:** USACE\_CELRB\_N21L\_2016\_r\_0064\_1.jpg  
**Rated Item:** 14. Riprap Revetments of Inlet/ Discharge Areas **Caption:** Rating:  
Acceptable; Remarks: Rusty 12" CMP and eroded concrete repaired with HDPE pipe on  
right bank 475' downstream of Madison Street (Stevens Street) bridge.; Action: NA;  
Station\_1: 48+00

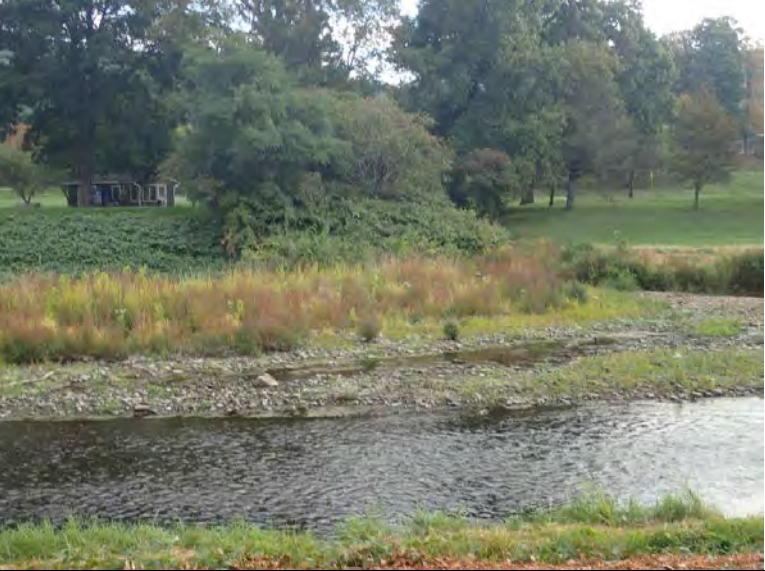
<p><b>Inspect ID:</b> N21L_2016_r_0007 <b>Title:</b> USACE_CELRB_N21L_2016_r_0007_1.jpg <b>Rated Item:</b> 1. Vegetation and Obstructions <b>Caption:</b> Rating: Minimally Acceptable; <b>Remarks:</b> Trees on right bank channel sideslope 900 feet downstream of Bolivar Street bridge.; <b>Action:</b> Remove trees.; <b>Station_1:</b> 100+00</p>

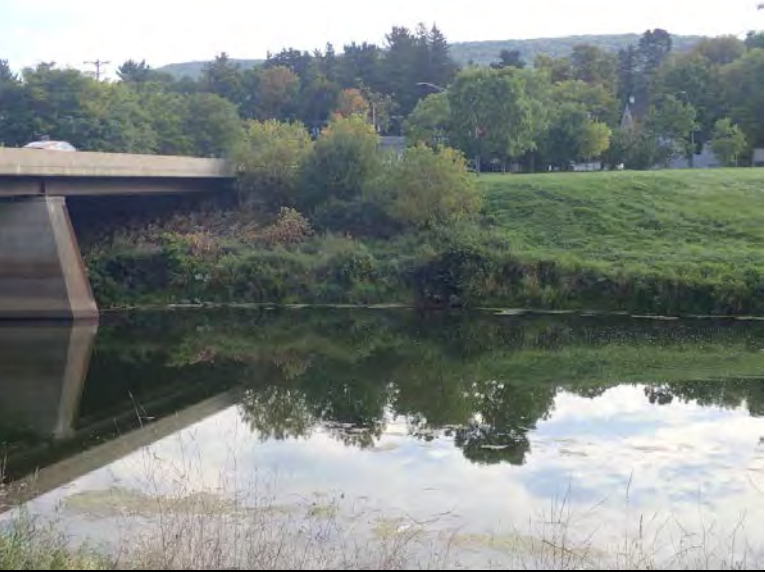
<p><b>Inspect ID:</b> N21L_2016_r_0013 <b>Title:</b> USACE_CELRB_N21L_2016_r_0013_2.jpg <b>Rated Item:</b> 1. Vegetation and Obstructions <b>Caption:</b> Rating: Minimally Acceptable; <b>Remarks:</b> Unwanted heavy woody vegetation on both banks around Bolivar Road bridge.; <b>Action:</b> Remove vegetation.; Station_1: 91+00</p>

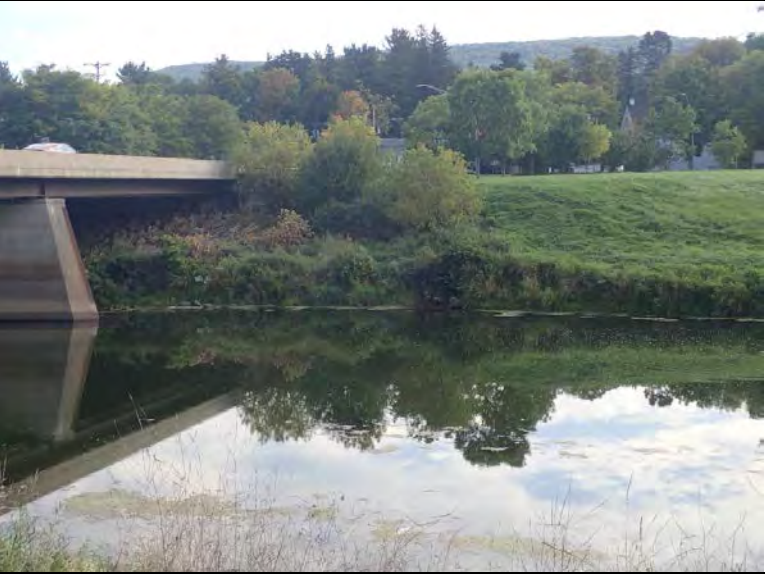
<p><b>Inspect ID:</b> N21L_2016_r_0014 <b>Title:</b> USACE_CELRB_N21L_2016_r_0014_2.jpg <b>Rated Item:</b> 1. Vegetation and Obstructions <b>Caption:</b> Rating: Minimally Acceptable; <b>Remarks:</b> Vegetation in riprap on right bank around Bolivar Road bridge.; <b>Action:</b> Remove vegetation from riprap.; <b>Station_1:</b> 91+00</p>

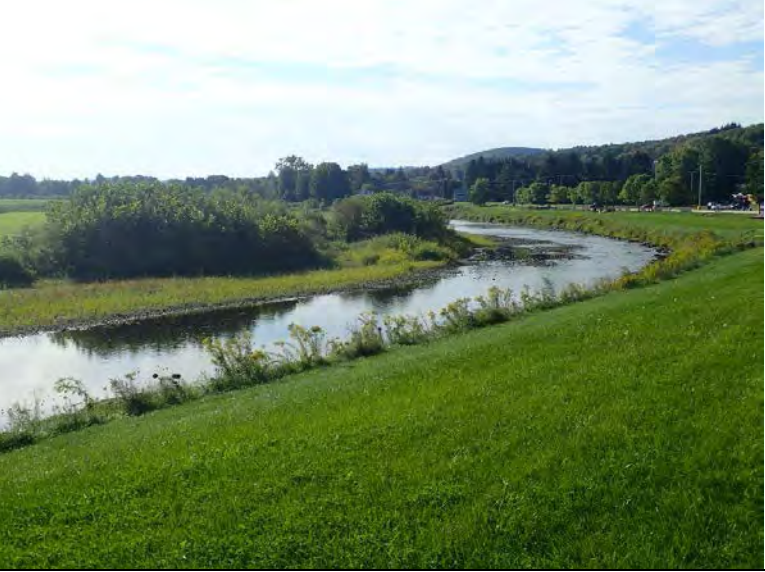
<p><b>Inspect ID:</b> N21L_2016_r_0023 <b>Title:</b> USACE_CELRB_N21L_2016_r_0023_1.jpg <b>Rated Item:</b> 1. Vegetation and Obstructions <b>Caption:</b> Rating: Minimally Acceptable; <b>Remarks:</b> Unwanted vegetation on both bank sideslopes from 750' upstream of Bolivar Road bridge to Madison Street bridge.; <b>Action:</b> Remove unwanted vegetation.; <b>Station_1:</b> 84+00; <b>Station_2:</b> 44+00</p>

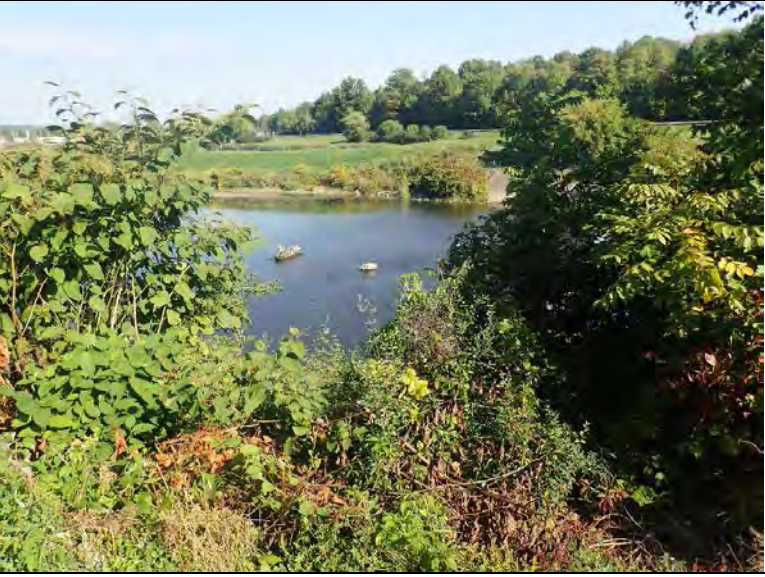
<p><b>Inspect ID:</b> N21L_2016_r_0035 <b>Title:</b> USACE_CELRB_N21L_2016_r_0035_1.jpg <b>Rated Item:</b> 1. Vegetation and Obstructions <b>Caption:</b> Rating: Minimally Acceptable; <b>Remarks:</b> Vegetation in riprap on both banks around Drop Structure; <b>Action:</b> Remove vegetation in riprap.; Station_1: 66+00</p>

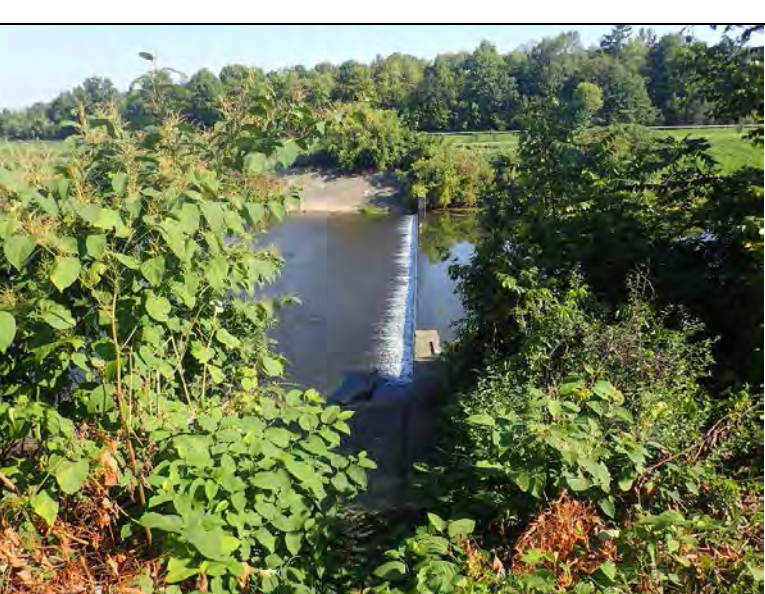
<p><b>Inspect ID:</b> N21L_2016_r_0035 <b>Title:</b> USACE_CELRB_N21L_2016_r_0035_2.jpg <b>Rated Item:</b> 1. Vegetation and Obstructions <b>Caption:</b> Rating: Minimally Acceptable; <b>Remarks:</b> Vegetation in riprap on both banks around Drop Structure; <b>Action:</b> Remove vegetation in riprap.; Station_1: 66+00</p>

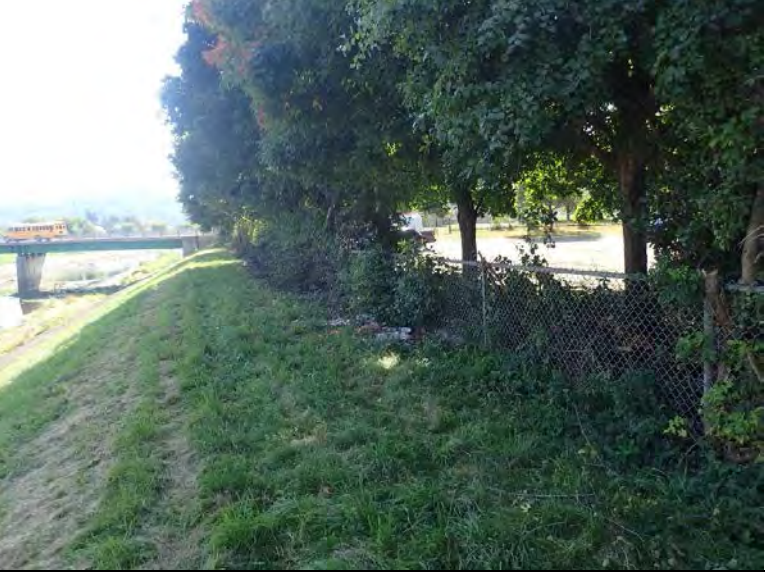
<p><b>Inspect ID:</b> N21L_2016_r_0069 <b>Title:</b> USACE_CELRB_N21L_2016_r_0069_1.jpg <b>Rated Item:</b> 1. Vegetation and Obstructions <b>Caption:</b> Rating: Minimally Acceptable; <b>Remarks:</b> Trees on left bank channel crest from 250' downstream of Madison Street (Stevens Street) bridge to Madison Street bridge.; <b>Action:</b> Remove trees.; <b>Station_1:</b> 46+00; <b>Station_2:</b> 44+00</p>

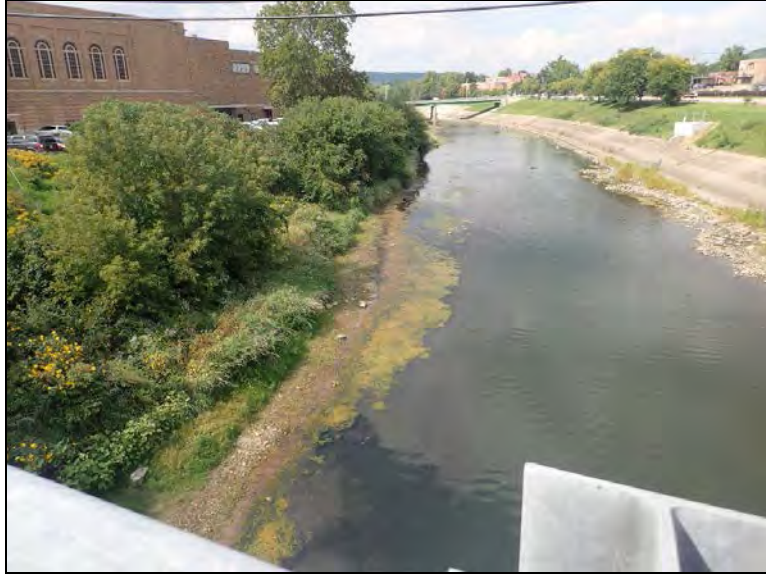
**Inspect ID:** N21L\_2016\_r\_0080 **Title:** USACE\_CELRB\_N21L\_2016\_r\_0080\_2.jpg  
**Rated Item:** 1. Vegetation and Obstructions **Caption:** Rating: Unacceptable; Remarks: Significant unwanted vegetation and trees on left bank 400' downstream of State Street bridge.; Action: Remove unwanted vegetation and trees.; Station\_1: 37+00

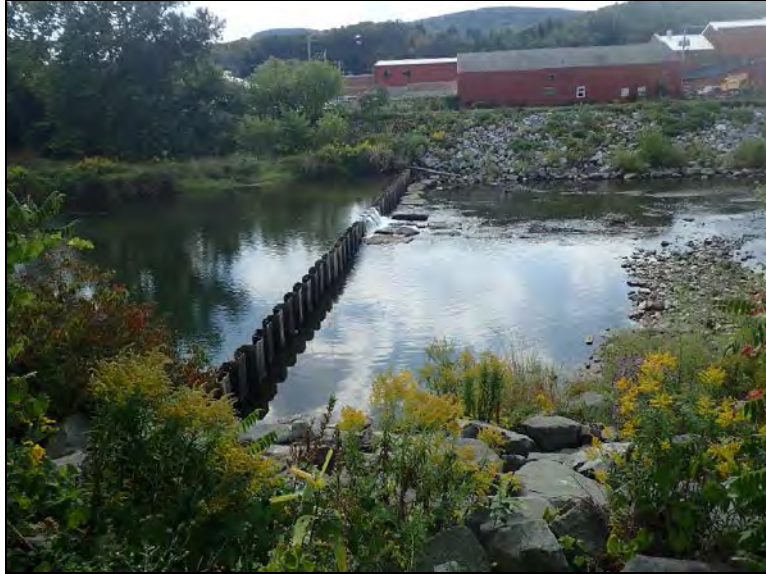
**Inspect ID:** N21L\_2016\_r\_0115 **Title:** USACE\_CELRB\_N21L\_2016\_r\_0115\_1.jpg  
**Rated Item:** 1. Vegetation and Obstructions **Caption:** Rated Item: 1. Public Sponsor (A or U only); Rating: Acceptable; Remarks: Weir structure at barrier levee ("barrier levee weir") at upstream end of project, clear of debris; Action: NA; Station\_1: 0+00

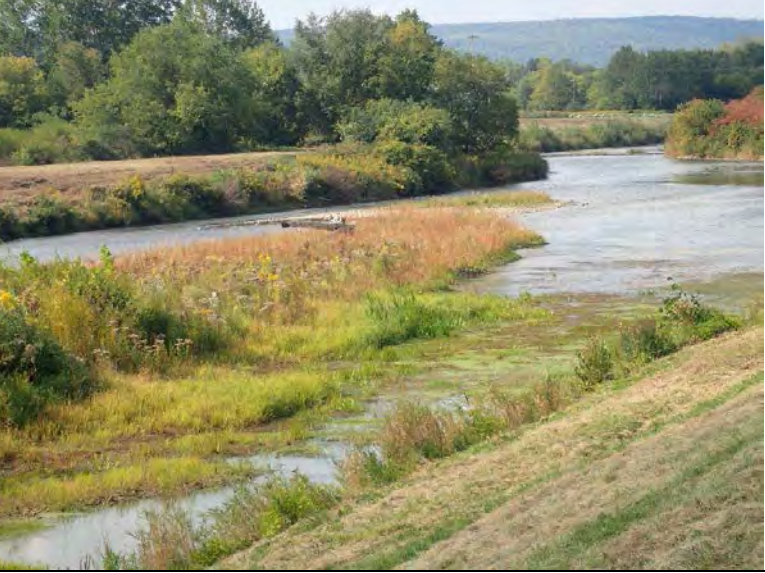
<p><b>Inspect ID:</b> N21L_2016_r_0123 <b>Title:</b> USACE_CELRB_N21L_2016_r_0123_1.jpg <b>Rated Item:</b> 1. Vegetation and Obstructions <b>Caption:</b> Rating: Minimally Acceptable; <b>Remarks:</b> Large tree debris in channel at downstream end of large shoal.; <b>Action:</b> Remove tree debris.; <b>Station_1:</b> 0+00</p>

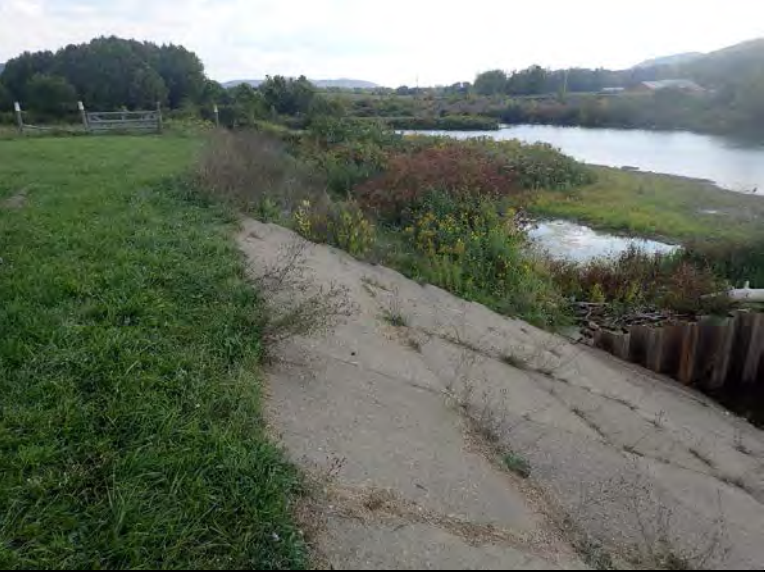
<p><b>Inspect ID:</b> N21L_2016_r_0126 <b>Title:</b> USACE_CELRB_N21L_2016_r_0126_1.jpg <b>Rated Item:</b> 1. Vegetation and Obstructions <b>Caption:</b> Rating: Unacceptable; Remarks: Significant vegetation in riprap on right bank from upstream limit weir to 350' upstream of upstream limit weir.; Action: Remove vegetation from riprap.; Station_1: 0+00; Station_2: 0+00</p>

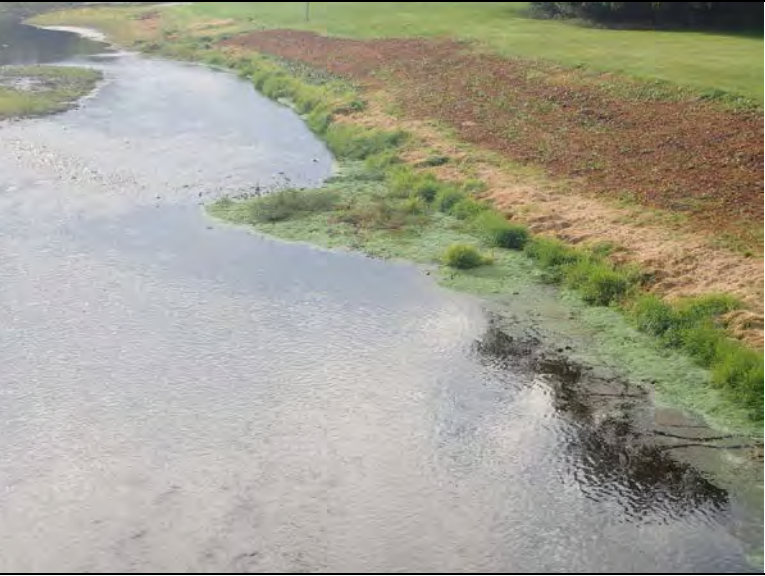
<p><b>Inspect ID:</b> N21L_2016_r_0005 <b>Title:</b> USACE_CELRB_N21L_2016_r_0005_2.jpg <b>Rated Item:</b> 2. Shoaling (sediment deposition) <b>Caption:</b> Rating: Minimally Acceptable; <b>Remarks:</b> Four alternating vegetated shoals (S-2, S-3, S-4, S-5) on both banks from green golf course pedestrian bridge to Bolivar Road bridge.; <b>Action:</b> Remove shoals.; <b>Station_1:</b> 103+00; <b>Station_2:</b> 92+00</p>

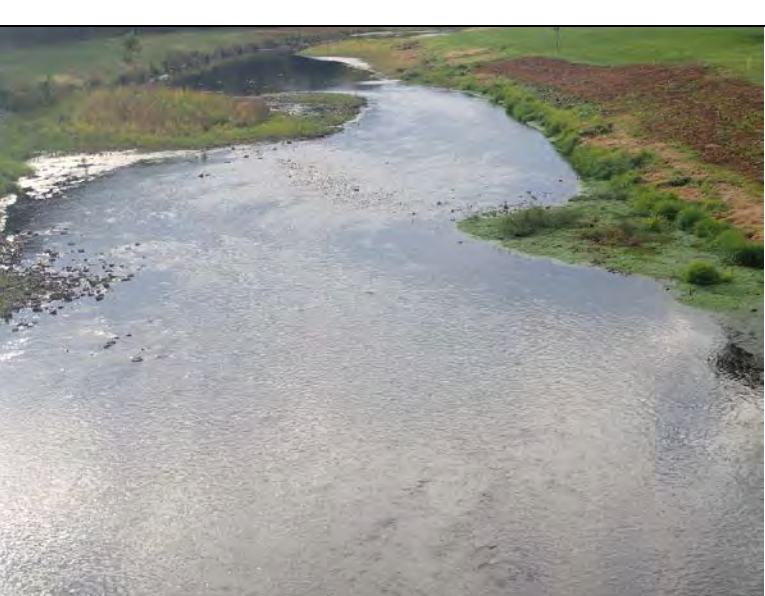
<p><b>Inspect ID:</b> N21L_2016_r_0005 <b>Title:</b> USACE_CELRB_N21L_2016_r_0005_3.jpg <b>Rated Item:</b> 2. Shoaling (sediment deposition) <b>Caption:</b> Rating: Minimally Acceptable; <b>Remarks:</b> Four alternating vegetated shoals (S-2, S-3, S-4, S-5) on both banks from green golf course pedestrian bridge to Bolivar Road bridge.; <b>Action:</b> Remove shoals.; <b>Station_1:</b> 103+00; <b>Station_2:</b> 92+00</p>

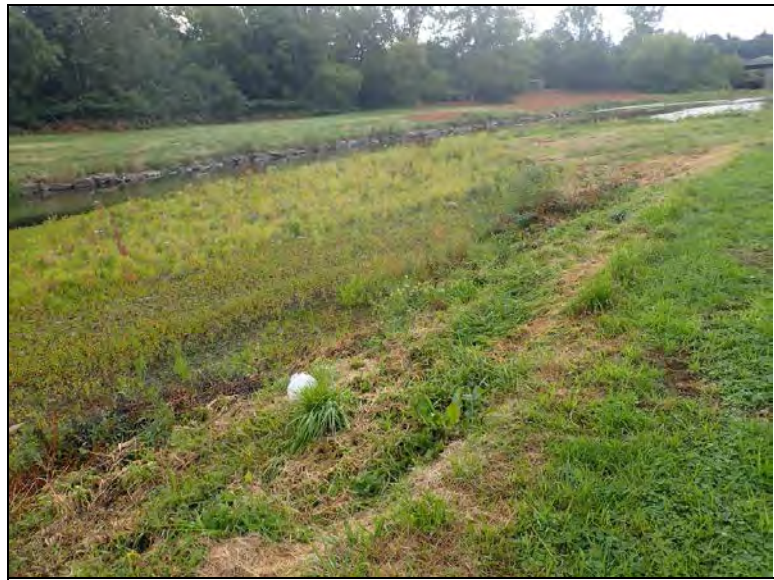
<p><b>Inspect ID:</b> N21L_2016_r_0005 <b>Title:</b> USACE_CELRB_N21L_2016_r_0005_4.jpg <b>Rated Item:</b> 2. Shoaling (sediment deposition) <b>Caption:</b> Rating: Minimally Acceptable; <b>Remarks:</b> Four alternating vegetated shoals (S-2, S-3, S-4, S-5) on both banks from green golf course pedestrian bridge to Bolivar Road bridge.; <b>Action:</b> Remove shoals.; <b>Station_1:</b> 103+00; <b>Station_2:</b> 92+00</p>

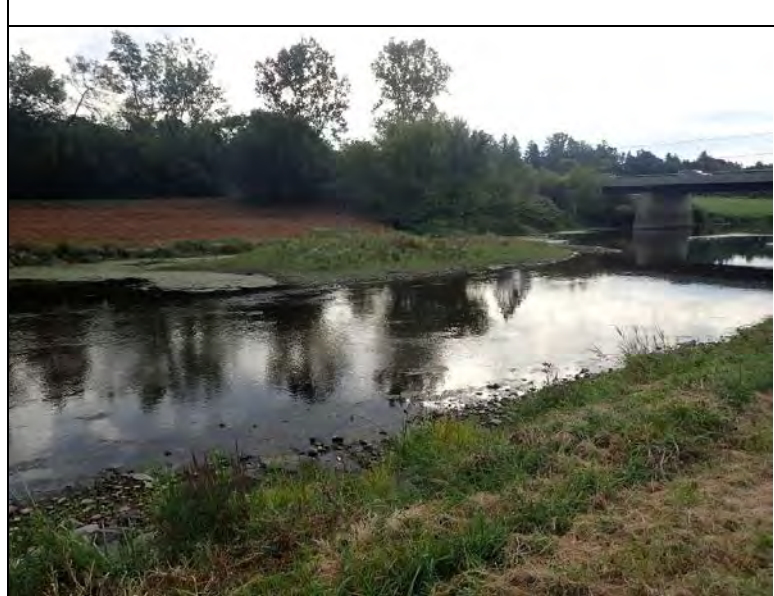
<p><b>Inspect ID:</b> N21L_2016_r_0005 <b>Title:</b> USACE_CELRB_N21L_2016_r_0005_5.jpg <b>Rated Item:</b> 2. Shoaling (sediment deposition) <b>Caption:</b> Rating: Minimally Acceptable; <b>Remarks:</b> Four alternating vegetated shoals (S-2, S-3, S-4, S-5) on both banks from green golf course pedestrian bridge to Bolivar Road bridge.; <b>Action:</b> Remove shoals.; <b>Station_1:</b> 103+00; <b>Station_2:</b> 92+00</p>

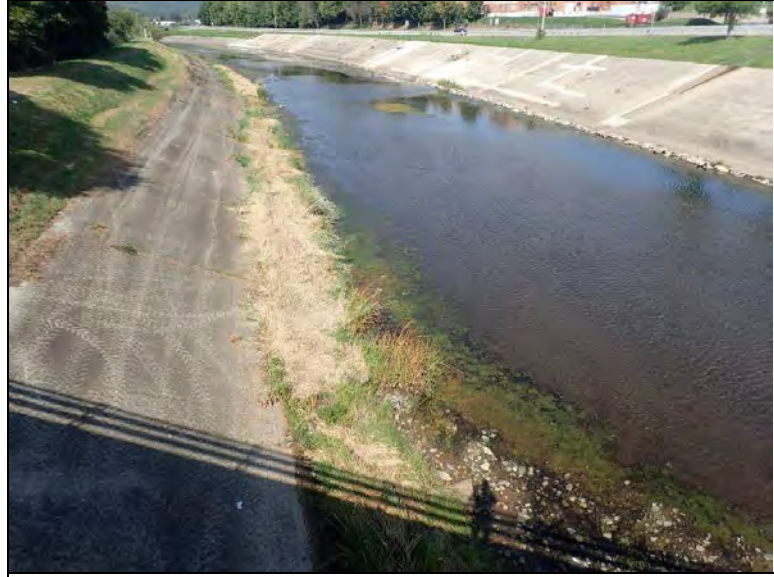
<p><b>Inspect ID:</b> N21L_2016_r_0073 <b>Title:</b> USACE_CELRB_N21L_2016_r_0073_1.jpg <b>Rated Item:</b> 2. Shoaling (sediment deposition) <b>Caption:</b> Rating: Minimally Acceptable; <b>Remarks:</b> Minor shoaling (S-8) on left bank from 600' downstream of Madison Street (Stevens Street) bridge to State Street bridge.; <b>Action:</b> Remove shoaling.; <b>Station_1:</b> 49+00; <b>Station_2:</b> 0+00</p>

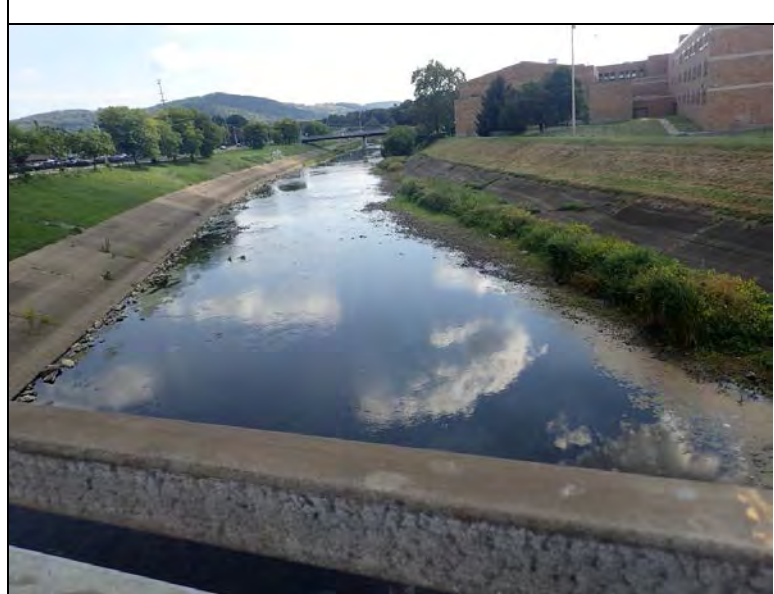
<p><b>Inspect ID:</b> N21L_2016_r_0073 <b>Title:</b> USACE_CELRB_N21L_2016_r_0073_2.jpg <b>Rated Item:</b> 2. Shoaling (sediment deposition) <b>Caption:</b> Rating: Minimally Acceptable; <b>Remarks:</b> Minor shoaling (S-8) on left bank from 600' downstream of Madison Street (Stevens Street) bridge to State Street bridge.; <b>Action:</b> Remove shoaling.; <b>Station_1:</b> 49+00; <b>Station_2:</b> 0+00</p>

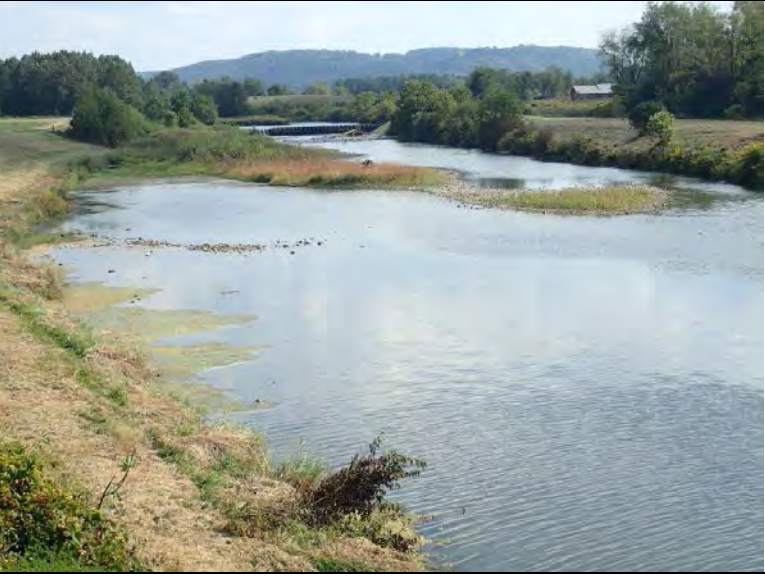
<p><b>Inspect ID:</b> N21L_2016_r_0118 <b>Title:</b> USACE_CELRB_N21L_2016_r_0118_1.jpg <b>Rated Item:</b> 2. Shoaling (sediment deposition) <b>Caption:</b> Rating: Unacceptable; <b>Remarks:</b> Significant vegetated shoal (S-11) and trees in channel on right bank from 100'-700' downstream of upstream limit weir.; <b>Action:</b> Remove shoaling.; <b>Station_1:</b> 0+00</p>

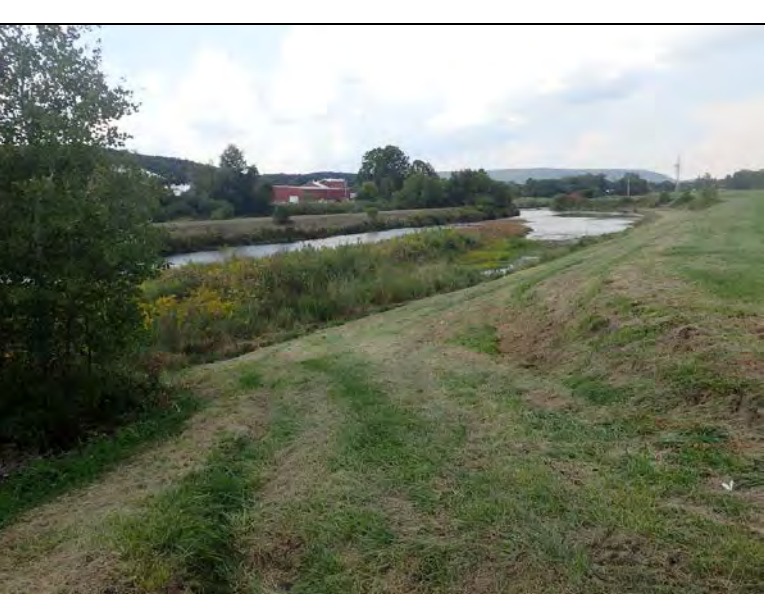
<p><b>Inspect ID:</b> N21L_2016_r_0118 <b>Title:</b> USACE_CELRB_N21L_2016_r_0118_2.jpg <b>Rated Item:</b> 2. Shoaling (sediment deposition) <b>Caption:</b> Rating: Unacceptable; <b>Remarks:</b> Significant vegetated shoal (S-11) and trees in channel on right bank from 100'-700' downstream of upstream limit weir.; <b>Action:</b> Remove shoaling.; <b>Station_1:</b> 0+00</p>

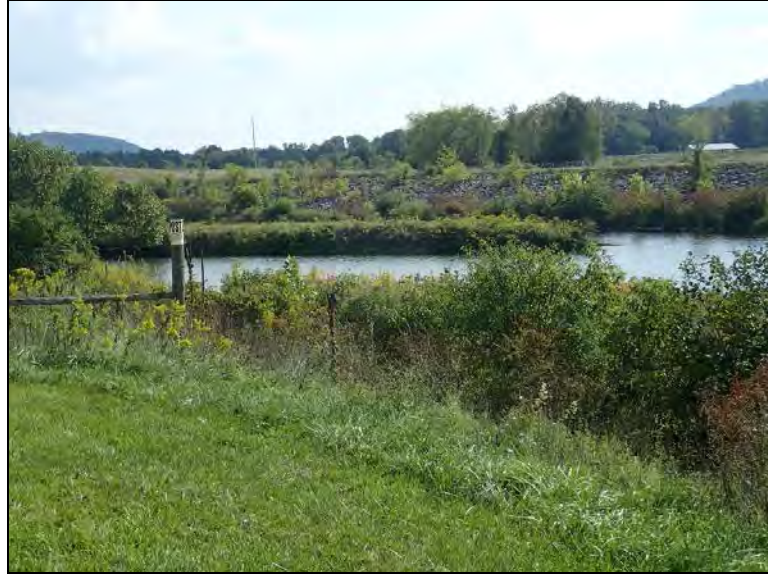
**Inspect ID:** N21L\_2016\_r\_0130 **Title:** USACE\_CELRB\_N21L\_2016\_r\_0130\_1.jpg  
**Rated Item:** 2. Shoaling (sediment deposition) **Caption:** Rating: Unacceptable;  
**Remarks:** Significant vegetated shoaling (S-13) with trees in center of channel just upstream of upstream limit weir.; **Action:** Remove shoaling.; **Station\_1:** 0+00

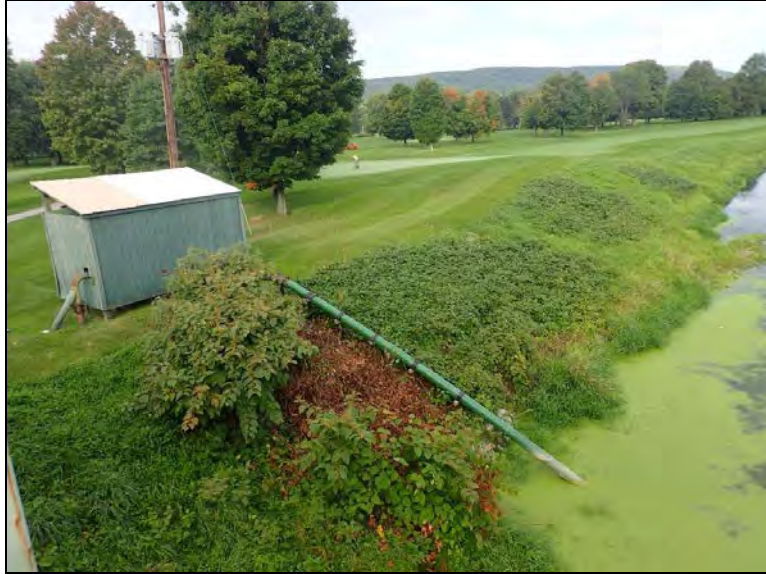
**Inspect ID:** N21L\_2016\_r\_0003 **Title:** USACE\_CELRB\_N21L\_2016\_r\_0003\_2.jpg  
**Rated Item:** 3. Encroachments **Caption:** Rating: Minimally Acceptable; Remarks: Unauthorized Alteration (A-1) - Pump station, intake pipe to pump station, and feeder pipes for golf course water.; Action: Submit Section 408 Alteration Request to USACE or remove unauthorized alteration.; Station\_1: 104+00

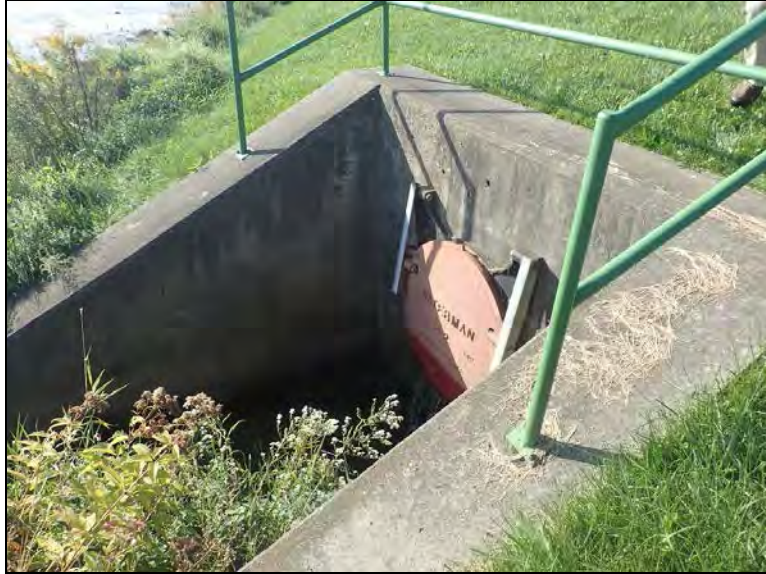
**Inspect ID:** N21L\_2016\_r\_0025 **Title:** USACE\_CELRB\_N21L\_2016\_r\_0025\_1.jpg  
**Rated Item:** 3. Encroachments **Caption:** Rating: Minimally Acceptable; Remarks:  
Unauthorized Alteration (A-7) - 42" outfall on left bank 900' upstream of Bolivar Road  
bridge at K-Mart.; Action: Submit Section 408 Alteration Request to USACE or remove  
unauthorized alteration.; Station\_1: 82+00

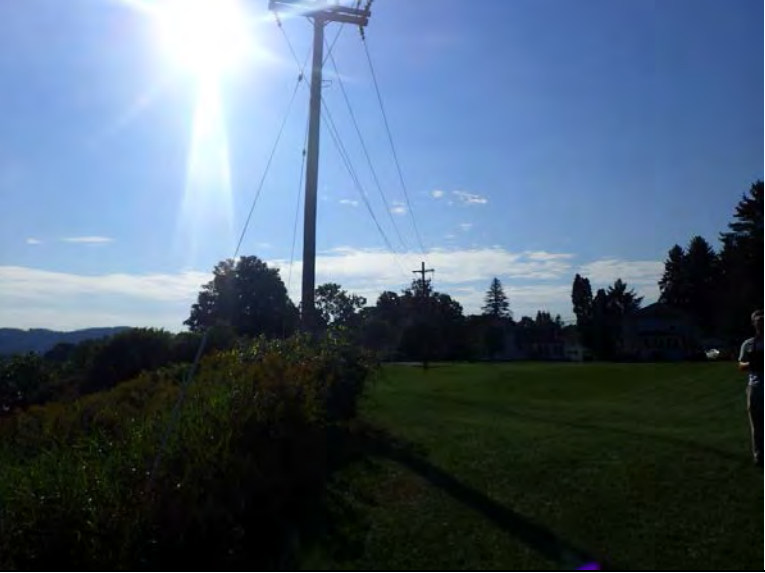
<p><b>Inspect ID:</b> N21L_2016_r_0030 <b>Title:</b> USACE_CELRB_N21L_2016_r_0030_1.jpg <b>Rated Item:</b> 3. Encroachments <b>Caption:</b> Rating: Minimally Acceptable; Remarks: Unauthorized Alteration (A-10) - Asphalt access drive and gate on left bank 1,600' upstream of Bolivar Road bridge.; Action: Submit Section 408 Alteration Request to USACE or remove unauthorized alteration.; Station_1: 75+00</p>

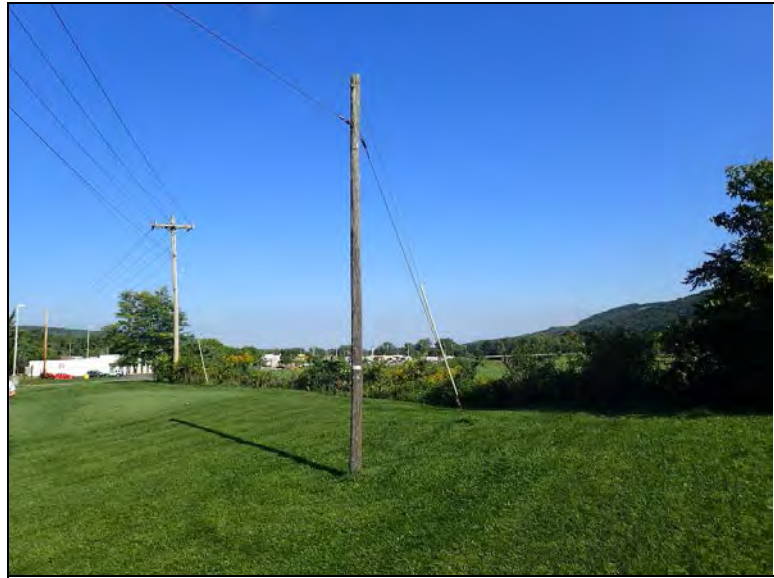
<p><b>Inspect ID:</b> N21L_2016_r_0030 <b>Title:</b> USACE_CELRB_N21L_2016_r_0030_3.jpg <b>Rated Item:</b> 3. Encroachments <b>Caption:</b> Rating: Minimally Acceptable; Remarks: Unauthorized Alteration (A-10) - Asphalt access drive and gate on left bank 1,600' upstream of Bolivar Road bridge.; Action: Submit Section 408 Alteration Request to USACE or remove unauthorized alteration.; Station_1: 75+00</p>

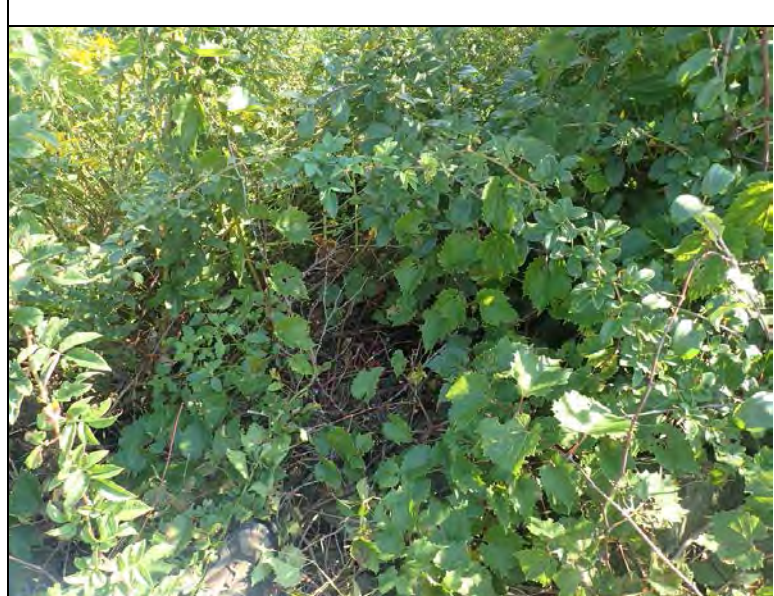
<p><b>Inspect ID:</b> N21L_2016_r_0031 <b>Title:</b> USACE_CELRB_N21L_2016_r_0031_1.jpg <b>Rated Item:</b> 3. Encroachments <b>Caption:</b> Rating: Minimally Acceptable; Remarks: Unauthorized Alteration (A-9) - 30" CMP outfall on left bank 1,600' upstream of Bolivar Road bridge (just downstream of gravel access drive).; Action: Submit Section 408 Alteration Request to USACE or remove unauthorized alteration.; Station_1: 75+00</p>

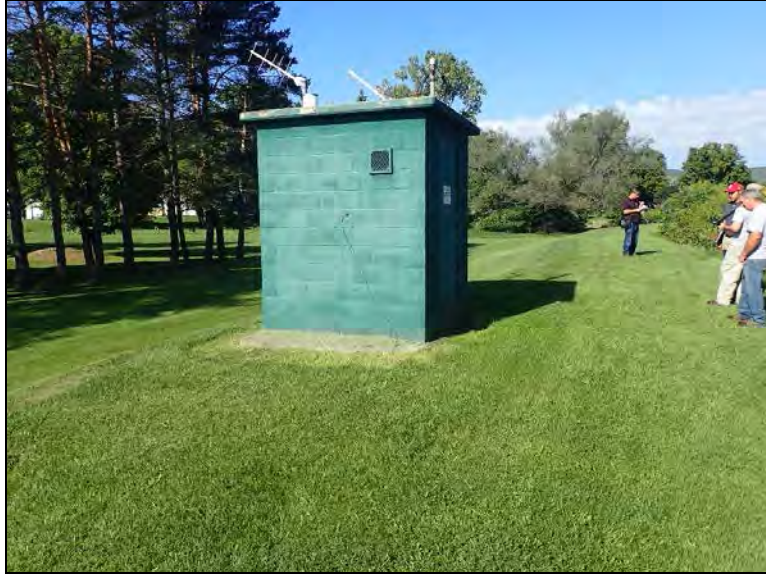
**Inspect ID:** N21L\_2016\_r\_0040 **Title:** USACE\_CELRB\_N21L\_2016\_r\_0040\_1.jpg  
**Rated Item:** 3. Encroachments **Caption:** Rating: Minimally Acceptable; Remarks: Unauthorized Alteration - Gage house on left bank 2,230' downstream of Madison Street (Stevens Street) bridge is in acceptable condition (NYSDEC says part of project, need to verify).; Action: Submit Section 408 Alteration Request to USACE or remove unauthorized alteration.; Station\_1: 65+00
