## DEPARTMENT OF THE ARMY

BUFFALO DISTRICT, CORPS OF ENGINEERS  
1776 NIAGARA STREET  
BUFFALO, NEW YORK 14207-3199

September 19, 2017

SUBJECT: FY16 Joint Routine Inspection of Completed Works, Flood Risk Management Project, Genesee River and Dyke Creek, Wellsville, New York (09/23/16)

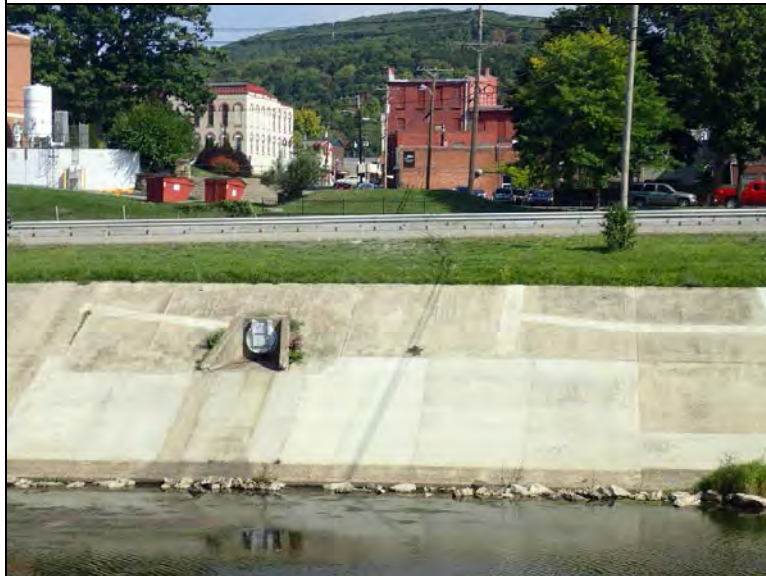
**Inspect ID:** N21L\_2016\_r\_0066 **Title:** USACE\_CELRB\_N21L\_2016\_r\_0066\_1.jpg  
**Rated Item:** 3. Encroachments **Caption:** Rating: Minimally Acceptable; Remarks: Unauthorized Aleteration (A-26) - Pearl Street bridge removed.; Action: Submit Section 408 Alteration Request to USACE.; Station\_1: 46+00

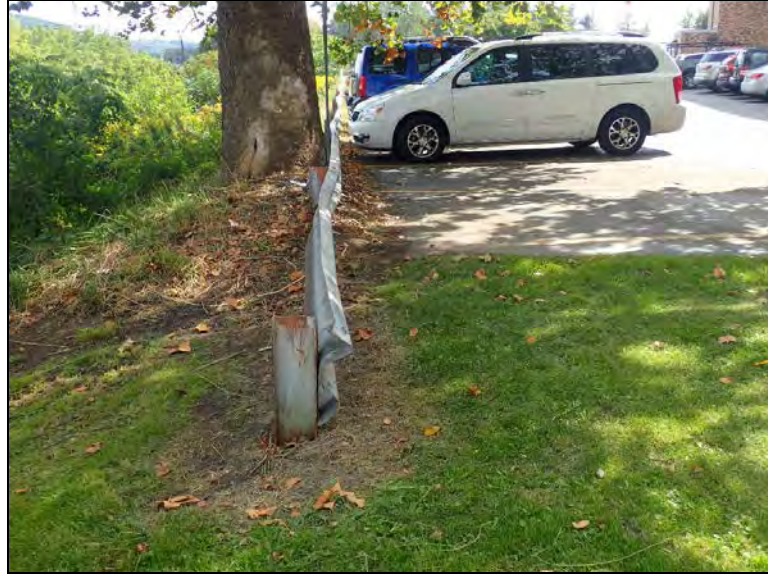
**Inspect ID:** N21L\_2016\_r\_0079 **Title:** USACE\_CELRB\_N21L\_2016\_r\_0079\_1.jpg  
**Rated Item:** 3. Encroachments **Caption:** Rating: Minimally Acceptable; Remarks: Unauthorized Alteration (A-33) - Wellsville High School rail, parking lot, and 2 signs on left bank levee downstream of State Street bridge.; Action: Submit Section 408 Alteration Request Form to USACE.; Station\_1: 37+00

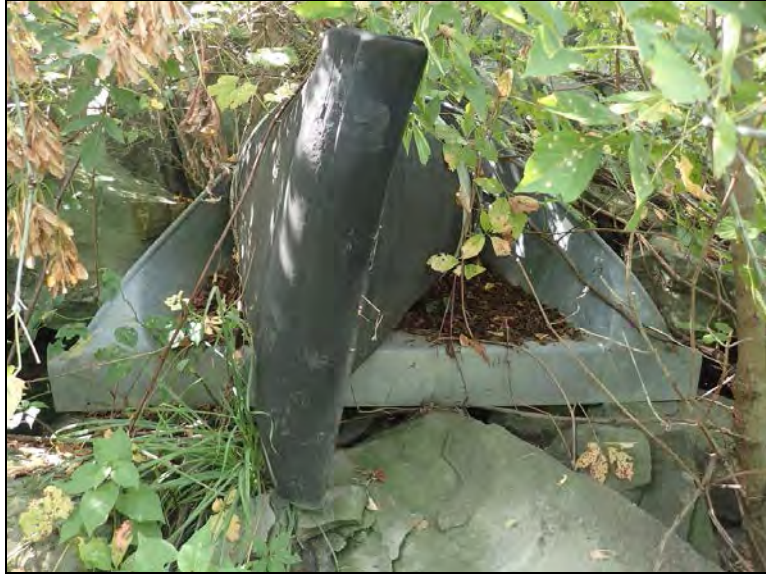
**Inspect ID:** N21L\_2016\_r\_0081 **Title:** USACE\_CELRB\_N21L\_2016\_r\_0081\_1.jpg  
**Rated Item:** 3. Encroachments **Caption:** Rating: Minimally Acceptable; Remarks: Unauthorized Alteration (A-36) - 18" HDPE outfall and duck bill valve on left bank side slope just downstream of State Street bridge owned by NYSDOT. (NYSDEC says permitted); Action: Submit Section 408 Alteration Request to USACE; Station\_1: 34+00

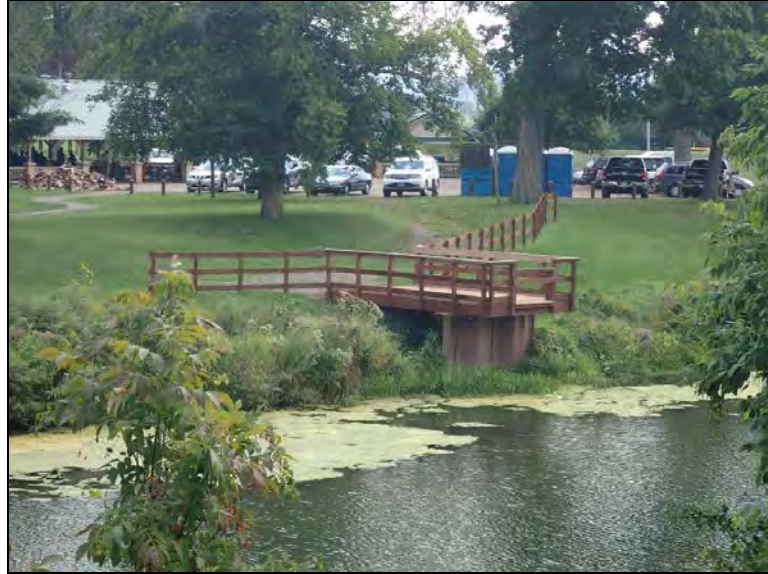
**Inspect ID:** N21L\_2016\_r\_0091 **Title:** USACE\_CELRB\_N21L\_2016\_r\_0091\_1.jpg  
**Rated Item:** 3. Encroachments **Caption:** Rating: Minimally Acceptable; Remarks: Unauthorized Alteration (A-39) - Fishing access platform and fence on right bank 200' upstream of Steel Sheet Pile Weir.; Action: Submit Section 408 Alteration Request to USACE or remove unauthorized alteration.; Station\_1: 25+00

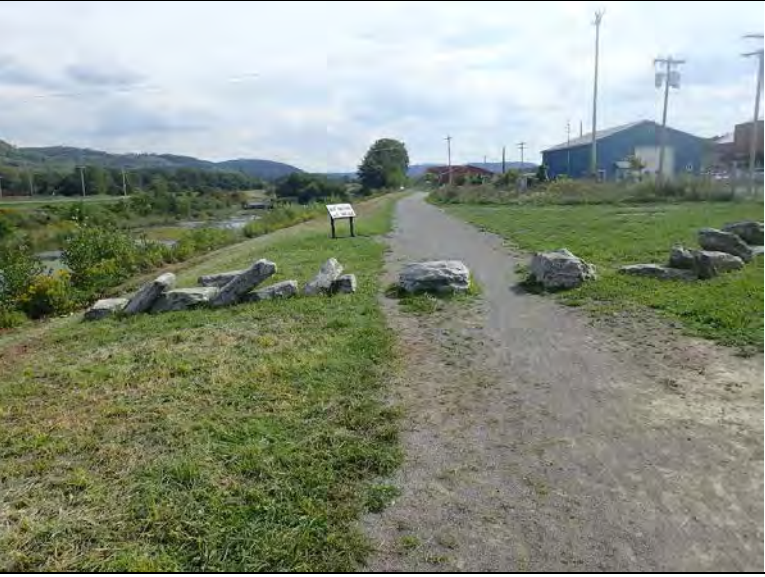
<p><b>Inspect ID:</b> N21L_2016_r_0110 <b>Title:</b> USACE_CELRB_N21L_2016_r_0110_1.jpg <b>Rated Item:</b> 3. Encroachments <b>Caption:</b> Rating: Unacceptable; Remarks: Unauthorized Alteration (A-46) - Wellsville, Addison, &amp; Galetton Railroad trailway rocks obstructing access 575' downstream of barrier levee weir.; Action: Submit Section 408 Alteration Request to USACE or remove unauthorized alteration.; Station_1: 6+00</p>
 	<p><b>Inspect ID:</b> N21L_2016_r_0125 <b>Title:</b> USACE_CELRB_N21L_2016_r_0125_1.jpg <b>Rated Item:</b> 3. Encroachments <b>Caption:</b> Rating: Minimally Acceptable; Remarks: Minor debris on right bank at upstream limit weir.; Action: Remove debris.; Station_1: 0+00</p>

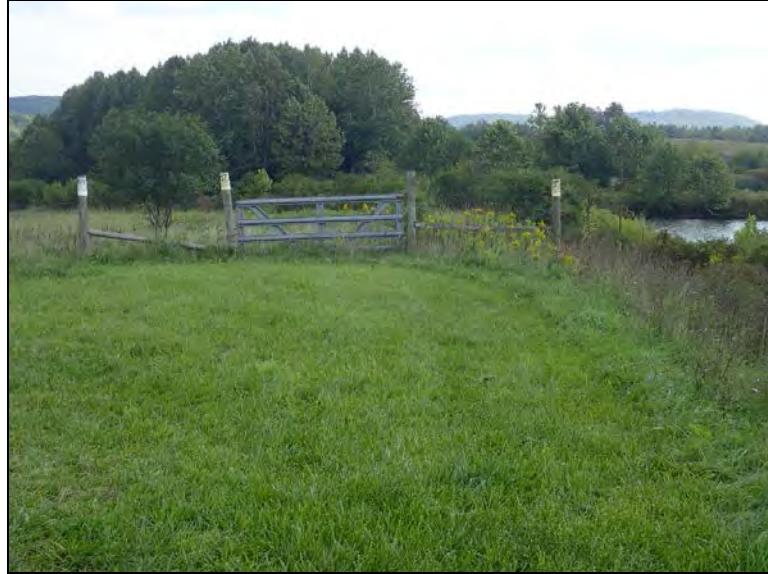
**Inspect ID:** N21L\_2016\_r\_0128 **Title:** USACE\_CELRB\_N21L\_2016\_r\_0128\_1.jpg  
**Rated Item:** 3. Encroachments **Caption:** Rating: Minimally Acceptable; Remarks: Unauthorized Alteration (A-47) - Barbed wire fence and metal gate on right bank at upstream limit.; Action: Submit Section 408 Alteration Request to USACE or remove unauthorized alteration.; Station\_1: 0+00
