## DEPARTMENT OF THE ARMY

BUFFALO DISTRICT, CORPS OF ENGINEERS  
1776 NIAGARA STREET  
BUFFALO, NEW YORK 14207-3199

SUBJECT: FY18 Joint Routine Inspection of Completed Works, Flood Risk Management Project, Genesee River and Dyke Creek, Wellsville, New York (09/24/18)

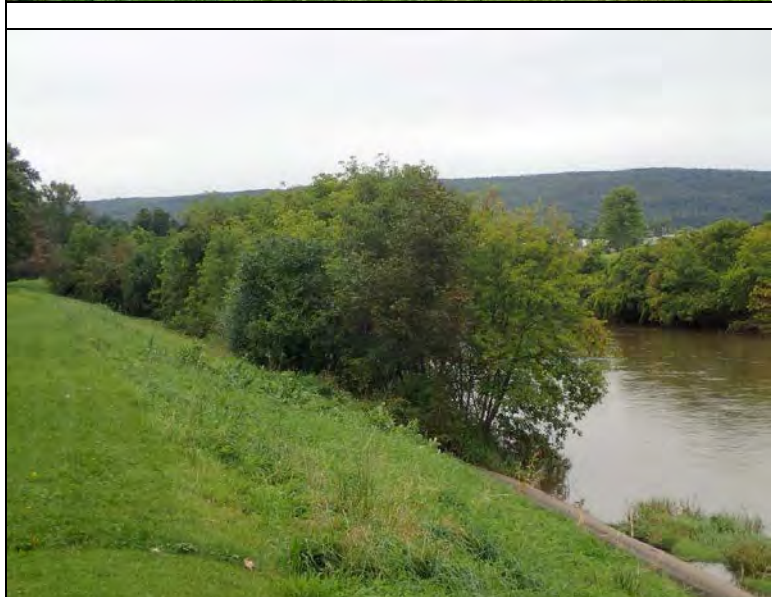
<p><b>Inspect ID:</b> N21L_2018_r_0049 <b>Title:</b> USACE_CELRB_N21L_2018_r_0049_3.jpg <b>Rated Item:</b> 1. Unwanted Vegetation Growth <b>Caption:</b> Rating: Minimally Acceptable; Remarks: Vegetation in excess of 12" on left bank levee waterside slope from Chamberland Street drainage channel to Madison Street bridge.; Action: Mow vegetation to 3"-6" height.; Station_1: 67+00; Station_2: 66+00</p>

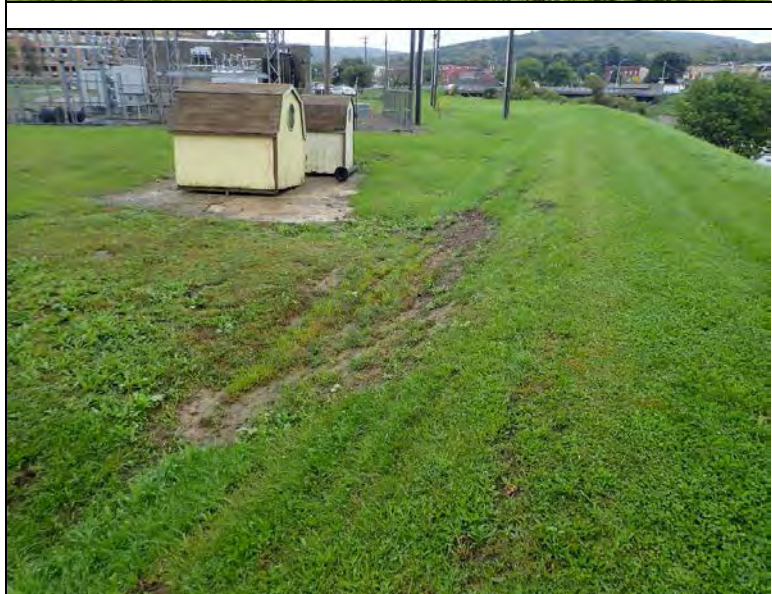
<p><b>Inspect ID:</b> N21L_2018_r_0113 <b>Title:</b> USACE_CELRB_N21L_2018_r_0113_1.jpg <b>Rated Item:</b> 2. Sod Cover <b>Caption:</b> Rating: Minimally Acceptable; Remarks: Lack of sod cover on left bank levee landside slope, 400' upstream of State Street bridge.; Action: Repair sod cover on levee.; Station_1: 28+00</p>

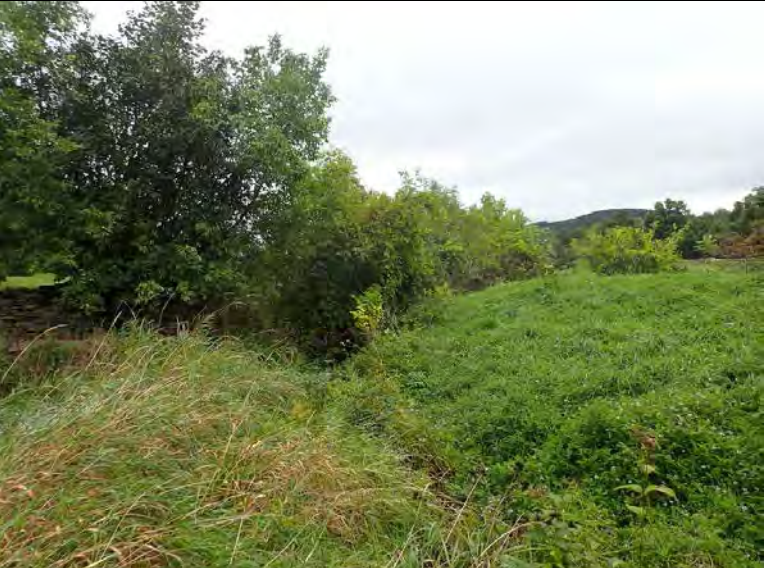
<p><b>Inspect ID:</b> N21L_2018_r_0045 <b>Title:</b> USACE_CELRB_N21L_2018_r_0045_1.jpg  <b>Rated Item:</b> 8. Depressions/ Rutting <b>Caption:</b> Rating: Acceptable; Remarks: Observation: Chamberland Street drainage channel creates apparent gap in line of protection on left bank levee.; Action: Recommendation: evaluate the possibility of altering the project to improve a continuous line of protection; potentially include a pipe and flapgate.; Station_1: 69+00; potentially include a pipe and flapgate.;</p>

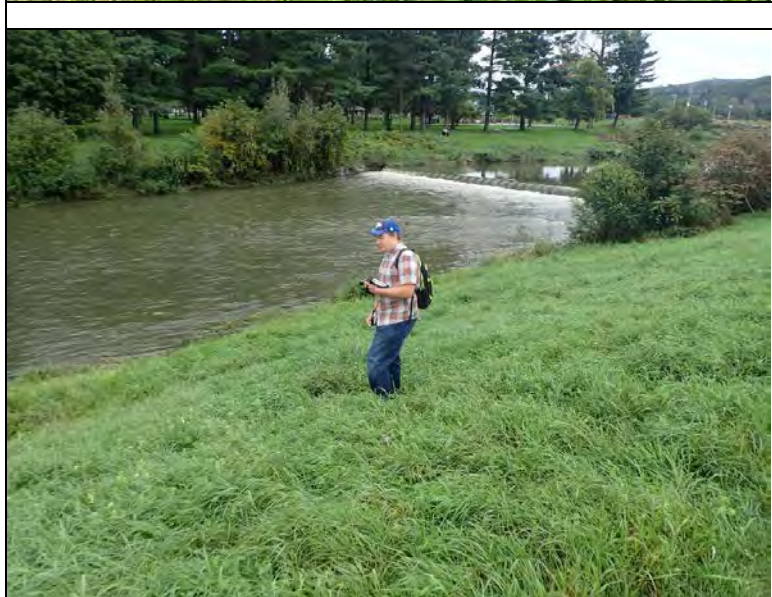
<p><b>Inspect ID:</b> N21L_2018_r_0110 <b>Title:</b> USACE_CELRB_N21L_2018_r_0110_1.jpg <b>Rated Item:</b> 10. Animal Control <b>Caption:</b> Rating: Minimally Acceptable; Remarks: Multiple animal burrows (approx. half dozen) on left bank waterside slope 450' upstream of State Street bridge.; Action: Fill animal burrows and improve animal control program.; Station_1: 28+00</p>

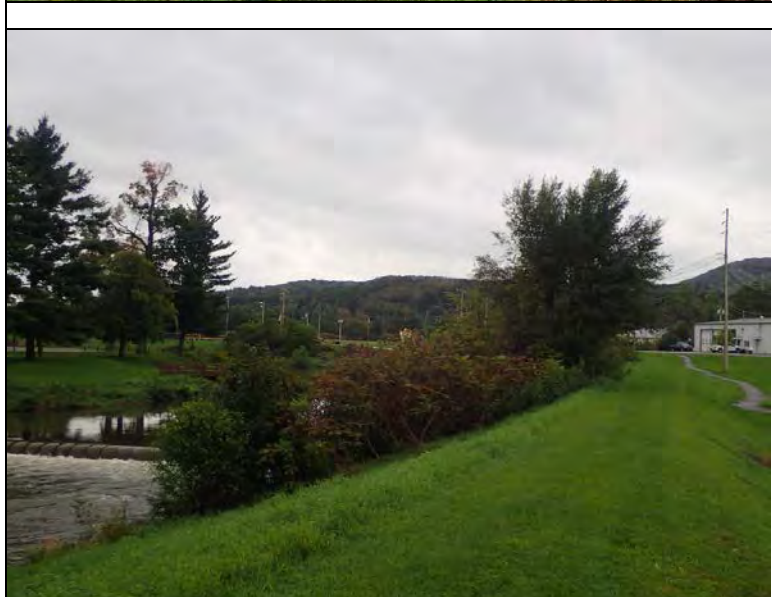
<p><b>Inspect ID:</b> N21L_2018_r_0107 <b>Title:</b> USACE_CELRB_N21L_2018_r_0107_2.jpg <b>Rated Item:</b> 12. Riprap Revetments &amp; Bank Protection <b>Caption:</b> Rated Item: 1. Unwanted Vegetation Growth; Rating: Unacceptable; Remarks: Trees and vegetation in riprap on left bank channel side slope from State Street bridge to 1,250' upstream.; Action: Remove trees and vegetation from riprap.; Station_1: 33+00; Station_2: 24+00</p>

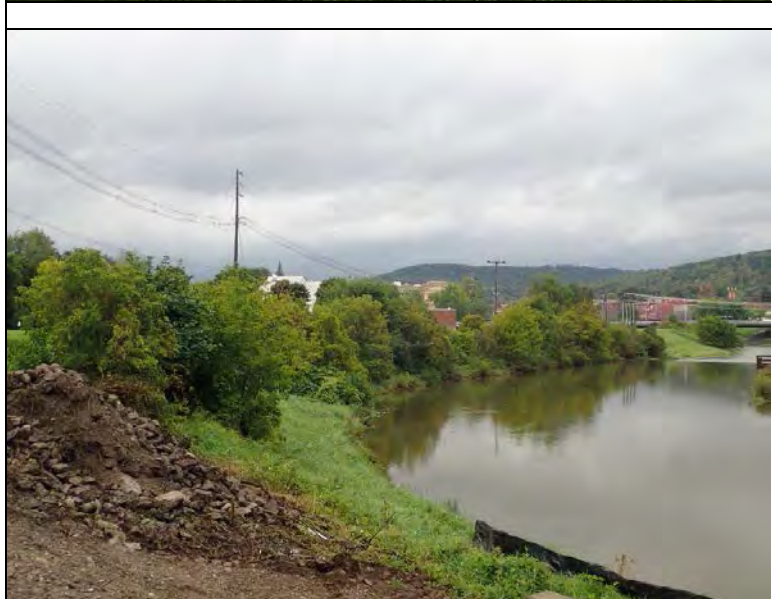
<p><b>Inspect ID:</b> N21L_2018_r_0107 <b>Title:</b> USACE_CELRB_N21L_2018_r_0107_4.jpg  <b>Rated Item:</b> 12. Riprap Revetments &amp; Bank Protection <b>Caption:</b> Rated Item: 1.  Unwanted Vegetation Growth; Rating: Unacceptable; Remarks: Trees and vegetation in riprap on left bank channel side slope from State Street bridge to 1,250' upstream.;  Action: Remove trees and vegetation from riprap.; Station_1: 33+00; Station_2: 24+00</p>

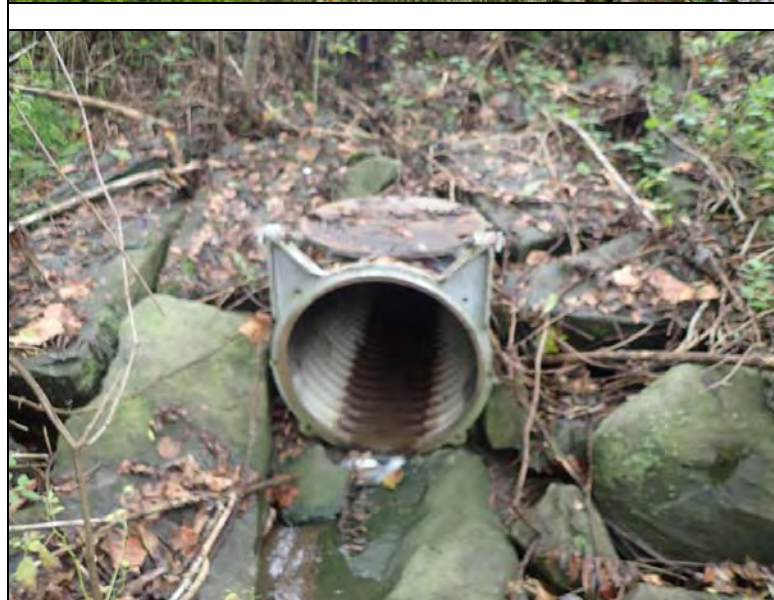
<p><b>Inspect ID:</b> N21L_2018_r_0055 <b>Title:</b> USACE_CELRB_N21L_2018_r_0055_1.jpg <b>Rated Item:</b> 2. Encroachments <b>Caption:</b> Rating: Minimally Acceptable; Remarks: Unauthorized alteration (E-15a): 24" CMP encroachment on left bank channel side slope with flap gate. Pipe has not been videotaped. Potentially causing 2" depression on levee crown.; Action: Remove or submit Section 408 Alteration Request to USACE. Videotape pipe.; Station_1: 61+00</p>

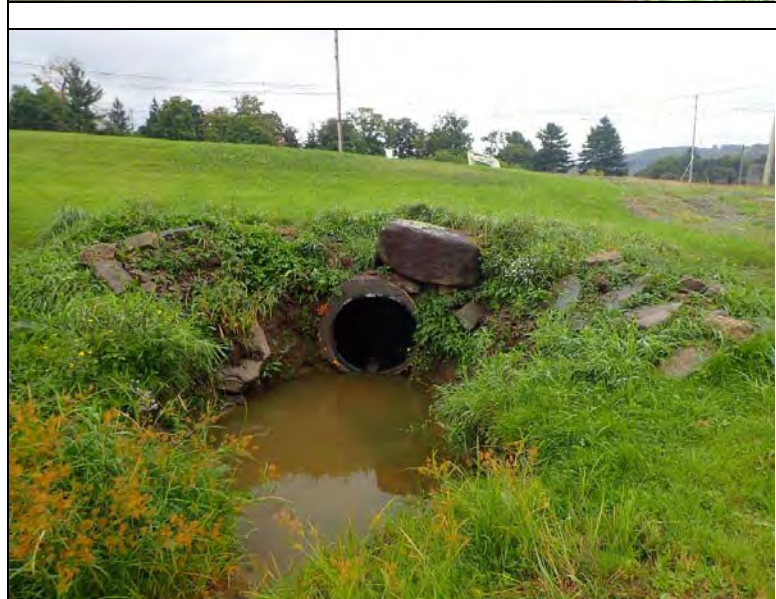
<p><b>Inspect ID:</b> N21L_2018_r_0124 <b>Title:</b> USACE_CELRB_N21L_2018_r_0124_2.jpg <b>Rated Item:</b> 2. Encroachments <b>Caption:</b> Rating: Acceptable; Remarks: Approved alteration: HDPE slipline inserted into 48" CMP under Dyke Street access road on left bank.; Action: NA; Station_1: 23+00</p>

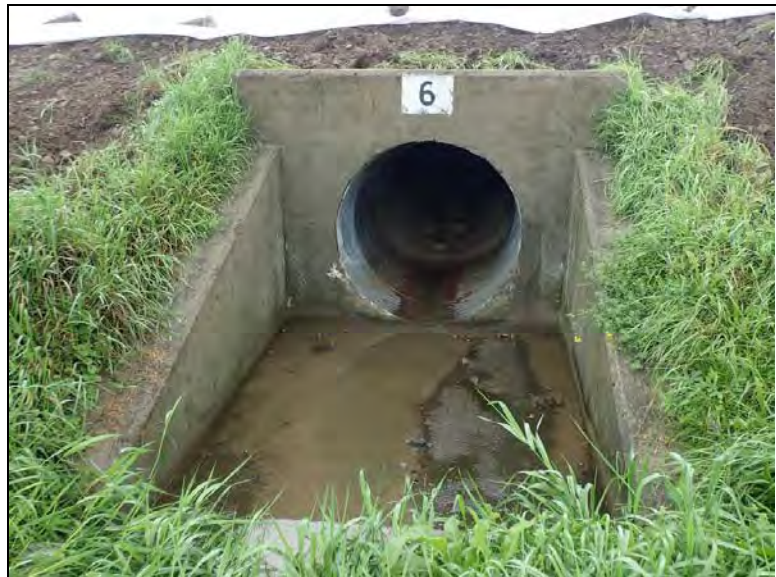
<p><b>Inspect ID:</b> N21L_2018_r_0120 <b>Title:</b> USACE_CELRB_N21L_2018_r_0120_1.jpg <b>Rated Item:</b> 12. Trash Racks (non-mechanical) <b>Caption:</b> Rating: Acceptable; Remarks: Observation: 48" CMP on levee landside slope, 515' upstream of Steel Sheet Pile Weir, does not have a trash rack to prevent obstructions from entering the pipe. ; Action: Recommendation: installing trash rack over opening to keep out debris and unauthorized access. ; Station_1: 23+00; ; ;</p>

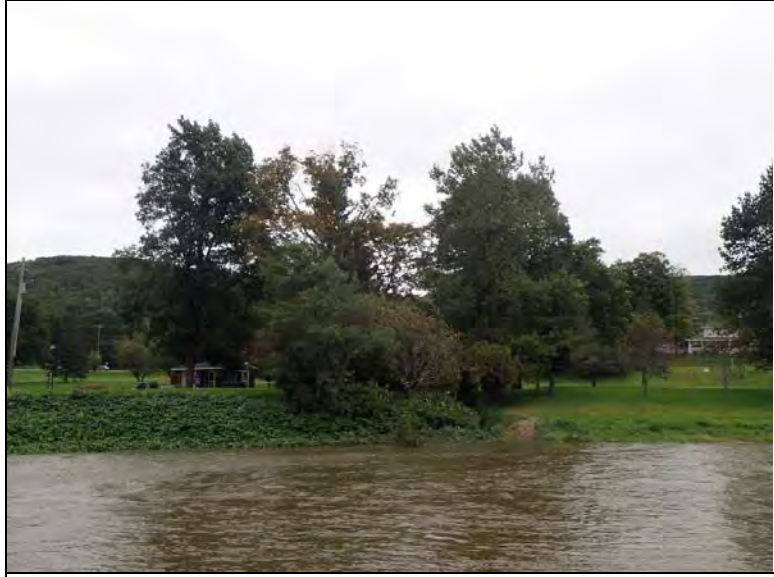
<p><b>Inspect ID:</b> N21L_2018_r_0012 <b>Title:</b> USACE_CELRB_N21L_2018_r_0012_1.jpg <b>Rated Item:</b> 1. Vegetation and Obstructions <b>Caption:</b> Rating: Minimally Acceptable; <b>Remarks:</b> Trees on right bank channel sideslope 900' downstream of Bolivar Street bridge.; <b>Action:</b> Remove trees.; <b>Station_1:</b> 100+00</p>

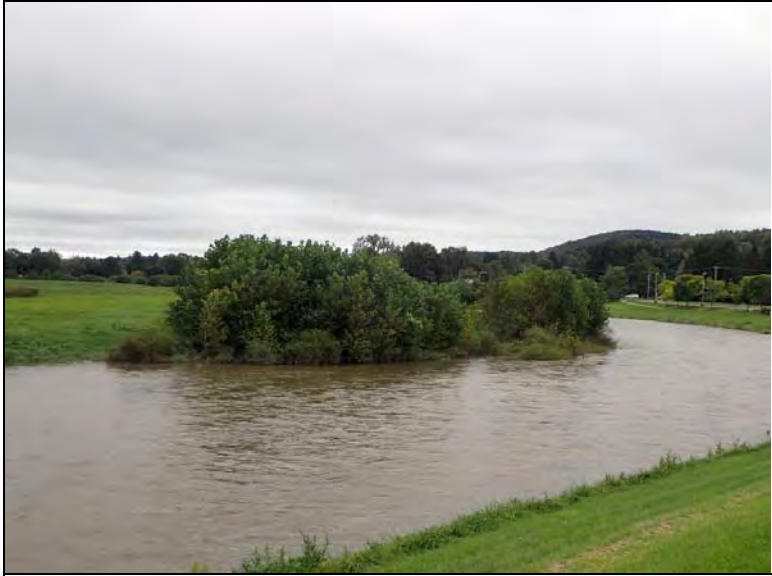
<p><b>Inspect ID:</b> N21L_2018_r_0030 <b>Title:</b> USACE_CELRB_N21L_2018_r_0030_1.jpg <b>Rated Item:</b> 1. Vegetation and Obstructions <b>Caption:</b> Rating: Minimally Acceptable; <b>Remarks:</b> Unwanted vegetation on both bank sideslopes from 750' upstream of Bolivar Road bridge to Madison Street bridge.; <b>Action:</b> Remove unwanted vegetation.; <b>Station_1:</b> 84+00; <b>Station_2:</b> 44+00</p>

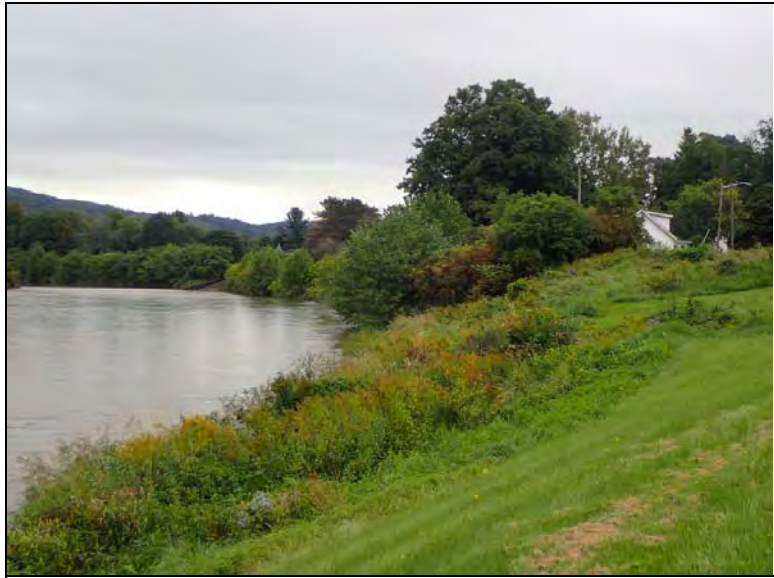
<p><b>Inspect ID:</b> N21L_2018_r_0030 <b>Title:</b> USACE_CELRB_N21L_2018_r_0030_3.jpg <b>Rated Item:</b> 1. Vegetation and Obstructions <b>Caption:</b> Rating: Minimally Acceptable; <b>Remarks:</b> Unwanted vegetation on both bank sideslopes from 750' upstream of Bolivar Road bridge to Madison Street bridge.; <b>Action:</b> Remove unwanted vegetation.; <b>Station_1:</b> 84+00; <b>Station_2:</b> 44+00</p>

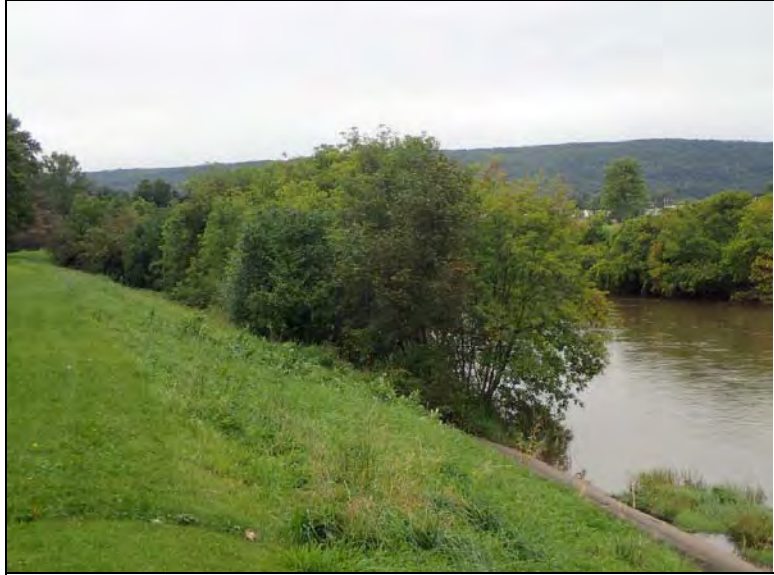
<p><b>Inspect ID:</b> N21L_2018_r_0030 <b>Title:</b> USACE_CELRB_N21L_2018_r_0030_5.jpg <b>Rated Item:</b> 1. Vegetation and Obstructions <b>Caption:</b> Rating: Minimally Acceptable; Remarks: Unwanted vegetation on both bank sideslopes from 750' upstream of Bolivar Road bridge to Madison Street bridge.; Action: Remove unwanted vegetation.; Station_1: 84+00; Station_2: 44+00</p>

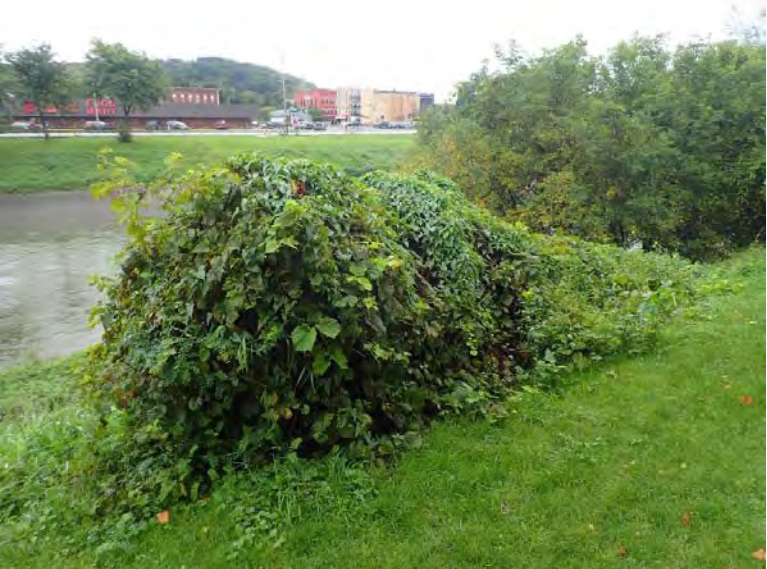
<p><b>Inspect ID:</b> N21L_2018_r_0104 <b>Title:</b> USACE_CELRB_N21L_2018_r_0104_1.jpg <b>Rated Item:</b> 1. Vegetation and Obstructions <b>Caption:</b> Rating: Unacceptable; Remarks: Unwanted vegetation and trees on left bank 400' downstream of State Street bridge.; <b>Action:</b> Remove unwanted vegetation and trees.; Station_1: 37+00</p>

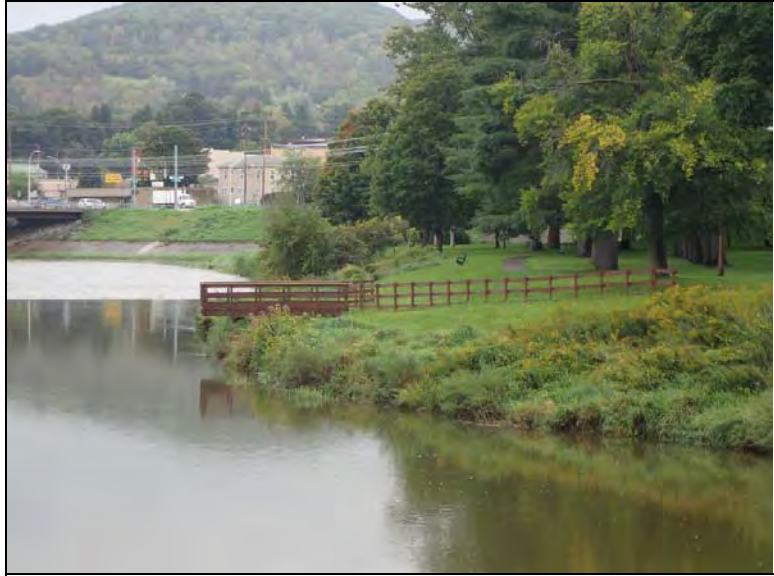
<p><b>Inspect ID:</b> N21L_2018_r_0109 <b>Title:</b> USACE_CELRB_N21L_2018_r_0109_3.jpg <b>Rated Item:</b> 1. Vegetation and Obstructions <b>Caption:</b> Rating: Minimally Acceptable; <b>Remarks:</b> Trees and vegetation on right bank from Island Park to 500' upstream of Island Park pedestrian bridge.; <b>Action:</b> Remove vegetation.; <b>Station_1:</b> 29+00; <b>Station_2:</b> 11+00</p>

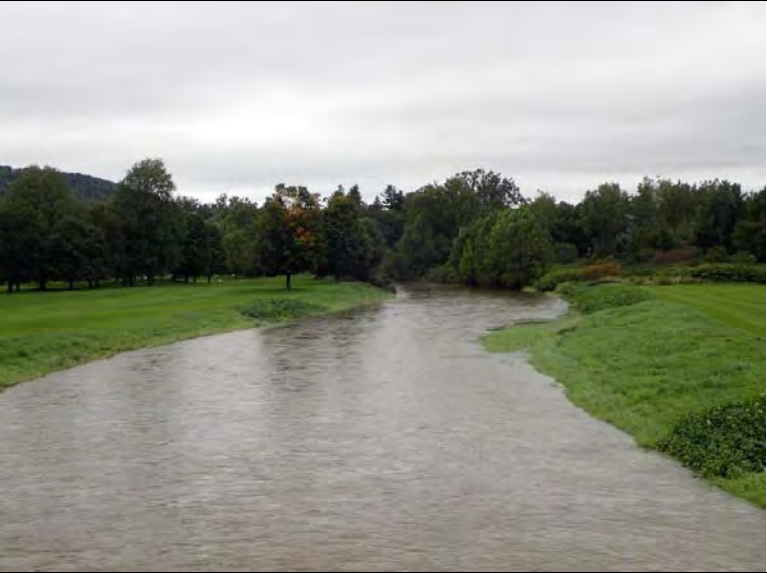
<p><b>Inspect ID:</b> N21L_2018_r_0004 <b>Title:</b> USACE_CELRB_N21L_2018_r_0004_1.jpg <b>Rated Item:</b> 2. Shoaling (sediment deposition) <b>Caption:</b> Rating: Minimally Acceptable; Remarks: Grassy shoal (S-1) along right bank from 225' to 700' downstream of golf course pedestrian bridge.; Action: Remove shoaling.; Station_1: 111+00; Station_2: 106+00</p>

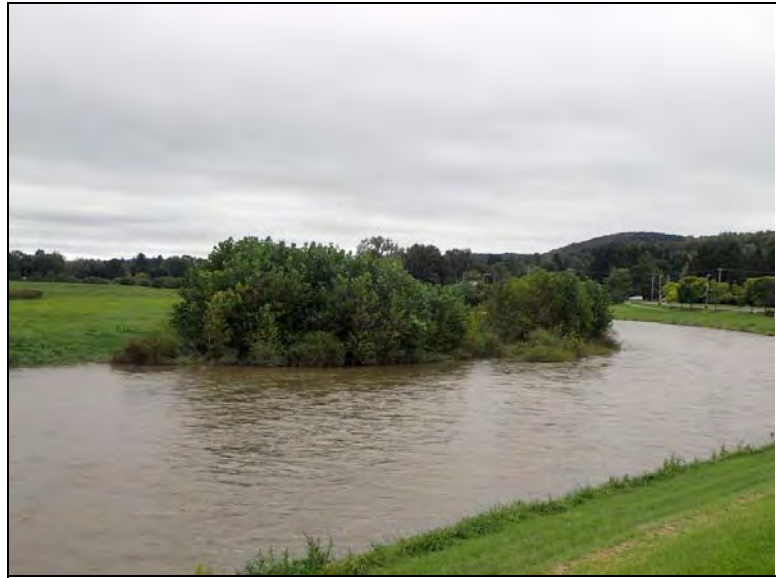
<p><b>Inspect ID:</b> N21L_2018_r_0028 <b>Title:</b> USACE_CELRB_N21L_2018_r_0028_1.jpg <b>Rated Item:</b> 2. Shoaling (sediment deposition) <b>Caption:</b> Rating: Minimally Acceptable; <b>Remarks:</b> Shoaling (S-6) along right bank from 750' to 1,300' upstream of Bolivar Road bridge (near K-mart Plaza).; <b>Action:</b> Remove shoaling.; <b>Station_1:</b> 83+00; <b>Station_2:</b> 78+00</p>

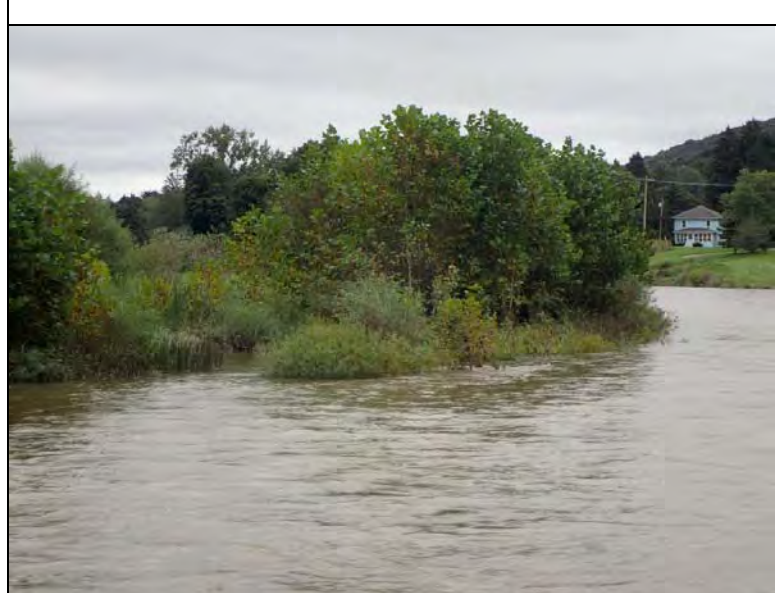
<p><b>Inspect ID:</b> N21L_2018_r_0028 <b>Title:</b> USACE_CELRB_N21L_2018_r_0028_2.jpg <b>Rated Item:</b> 2. Shoaling (sediment deposition) <b>Caption:</b> Rating: Minimally Acceptable; <b>Remarks:</b> Shoaling (S-6) along right bank from 750' to 1,300' upstream of Bolivar Road bridge (near K-mart Plaza).; <b>Action:</b> Remove shoaling.; <b>Station_1:</b> 83+00; <b>Station_2:</b> 78+00</p>

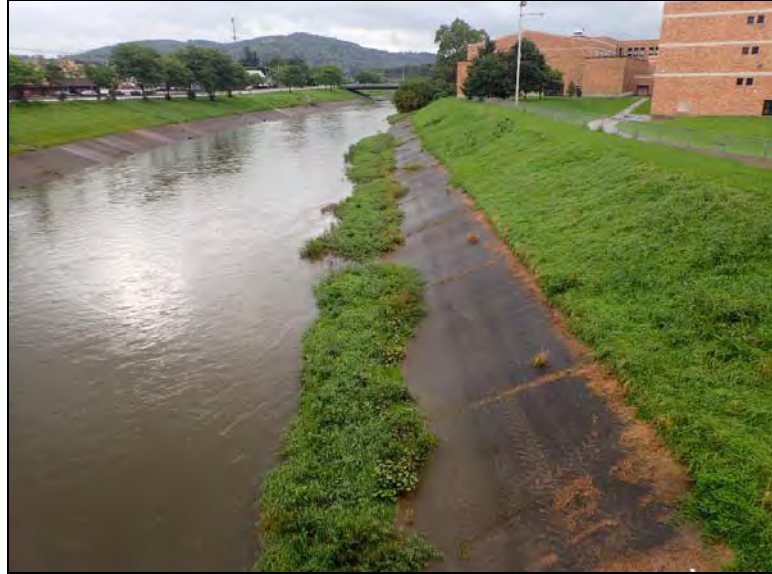
**Inspect ID:** N21L\_2018\_r\_0088 **Title:** USACE\_CELRB\_N21L\_2018\_r\_0088\_2.jpg  
**Rated Item:** 2. Shoaling (sediment deposition) **Caption:** Rating: Minimally Acceptable;  
**Remarks:** Minor shoaling (S-8) on left bank from 600' downstream of Madison Street  
(Stevens Street) bridge to State Street bridge.; **Action:** Remove shoaling.; **Station\_1:**  
49+00; **Station\_2:** 0+00

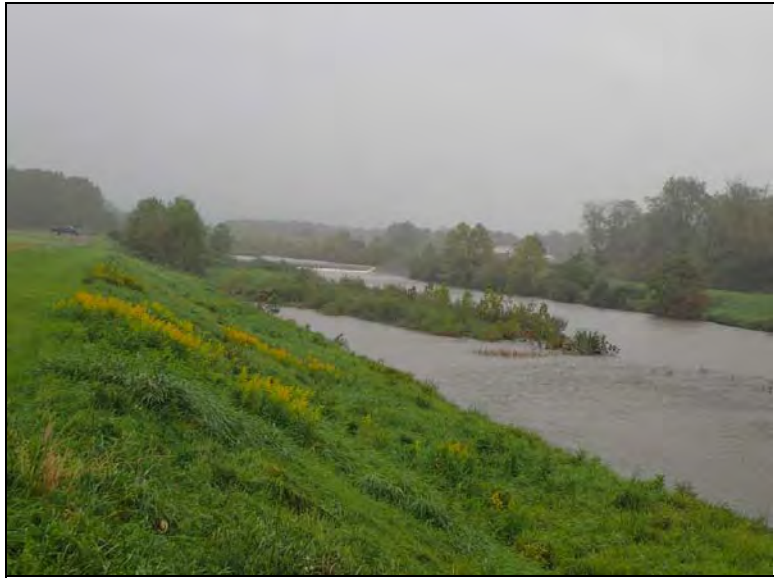
<p><b>Inspect ID:</b> N21L_2018_r_0142 <b>Title:</b> USACE_CELRB_N21L_2018_r_0142_1.jpg <b>Rated Item:</b> 2. Shoaling (sediment deposition) <b>Caption:</b> Rating: Unacceptable; <b>Remarks:</b> Significant vegetated shoal (S-11) and trees in channel on right bank from 100'-700' downstream of upstream limit weir.; <b>Action:</b> Remove shoaling.; <b>Station_1:</b> 0+00</p>

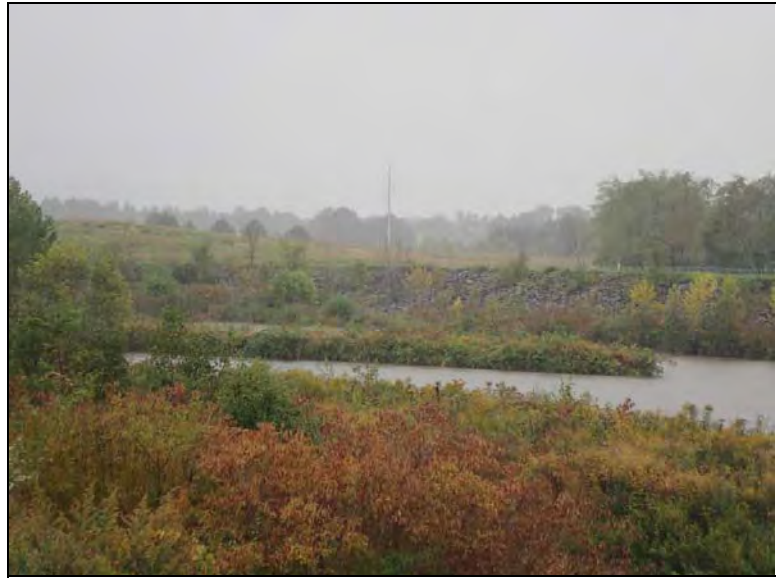
<p><b>Inspect ID:</b> N21L_2018_r_0147 <b>Title:</b> USACE_CELRB_N21L_2018_r_0147_1.jpg <b>Rated Item:</b> 2. Shoaling (sediment deposition) <b>Caption:</b> Rating: Unacceptable; Remarks: Significant vegetated shoaling (S-13) with trees in center of channel just upstream of upstream limit weir.; Action: Remove shoaling.; Station_1: 0+00</p>

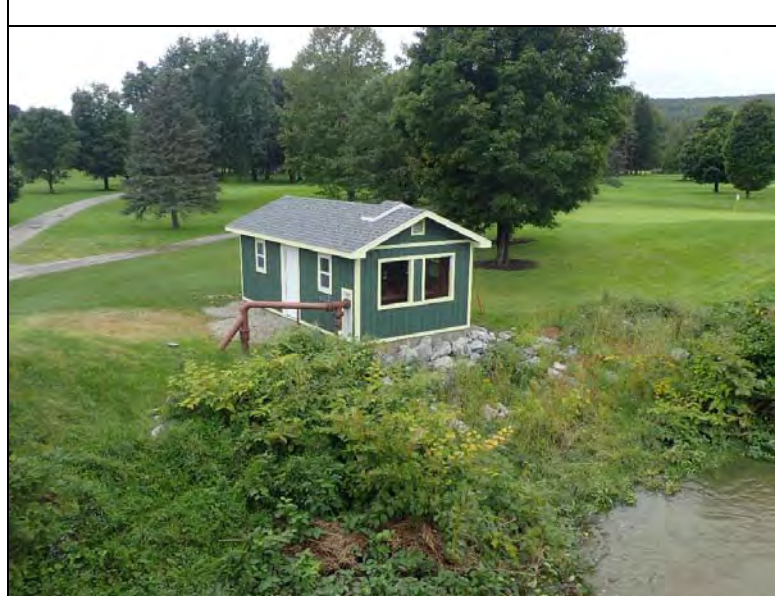
<p><b>Inspect ID:</b> N21L_2018_r_0007 <b>Title:</b> USACE_CELRB_N21L_2018_r_0007_1.jpg <b>Rated Item:</b> 3. Encroachments <b>Caption:</b> Rating: Minimally Acceptable; Remarks: Unauthorized alteration (E-1): New pump station building, riprap, intake pipe to pump station, and feeder pipes for golf course water just downstream of pedestrian bridge.; Action: Submit Section 408 Alteration Request to USACE.; Station_1: 104+00</p>

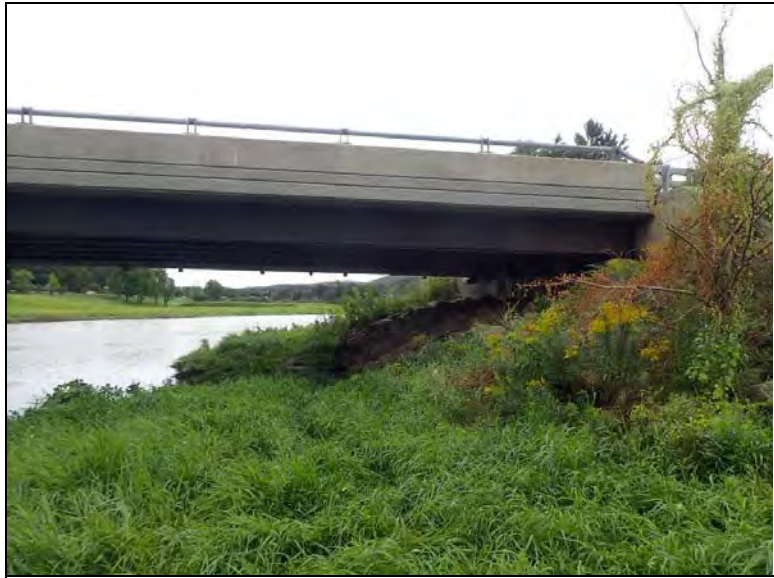
<p><b>Inspect ID:</b> N21L_2018_r_0018 <b>Title:</b> USACE_CELRB_N21L_2018_r_0018_1.jpg <b>Rated Item:</b> 3. Encroachments <b>Caption:</b> Rating: Acceptable; Remarks: Pending alteration: proposed recreational trail on right bank under bridge connecting Riverwalk trail to Bolivar Road. Currently processing Section 408 paperwork (as of 2/28/18); Action: USACE is processing Section 408 Alteration Request.; Station_1: 92+00</p>

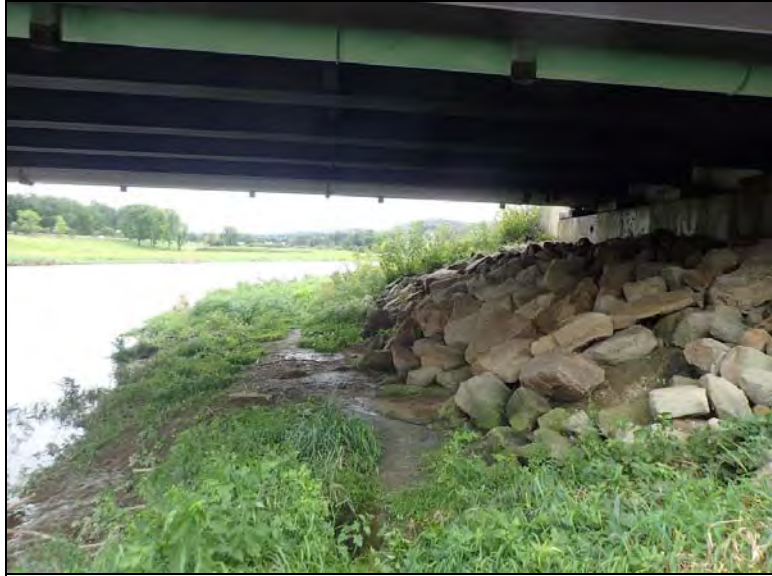
<p><b>Inspect ID:</b> N21L_2018_r_0018 <b>Title:</b> USACE_CELRB_N21L_2018_r_0018_3.jpg <b>Rated Item:</b> 3. Encroachments <b>Caption:</b> Rating: Acceptable; Remarks: Pending alteration: proposed recreational trail on right bank under bridge connecting Riverwalk trail to Bolivar Road. Currently processing Section 408 paperwork (as of 2/28/18); Action: USACE is processing Section 408 Alteration Request.; Station_1: 92+00</p>

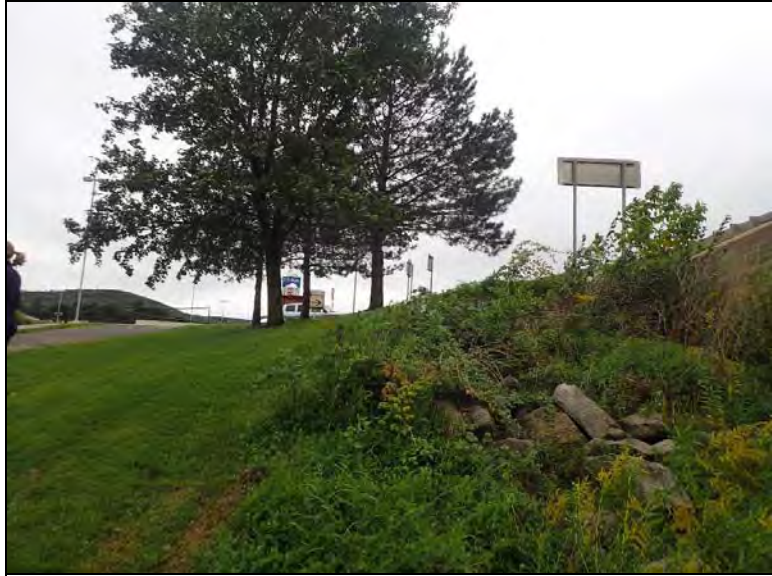
<p><b>Inspect ID:</b> N21L_2018_r_0018 <b>Title:</b> USACE_CELRB_N21L_2018_r_0018_5.jpg <b>Rated Item:</b> 3. Encroachments <b>Caption:</b> Rating: Acceptable; Remarks: Pending alteration: proposed recreational trail on right bank under bridge connecting Riverwalk trail to Bolivar Road. Currently processing Section 408 paperwork (as of 2/28/18); Action: USACE is processing Section 408 Alteration Request.; Station_1: 92+00</p>

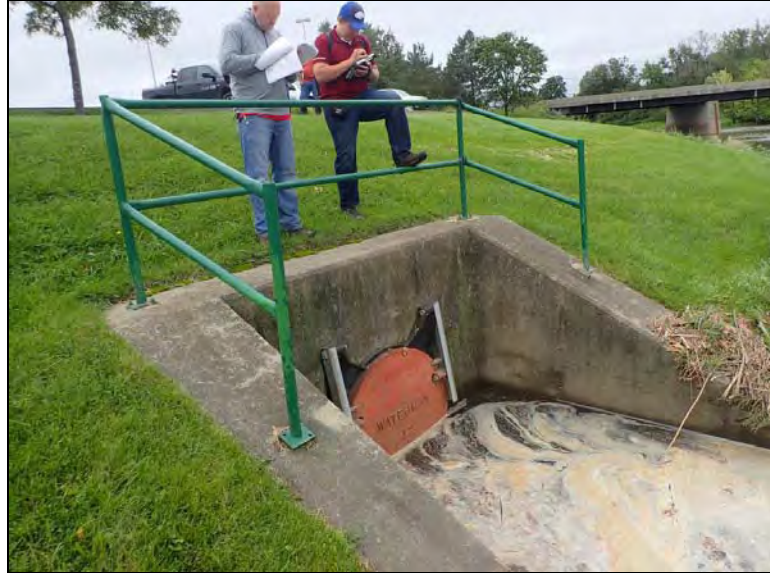
**Inspect ID:** N21L\_2018\_r\_0025 **Title:** USACE\_CELRB\_N21L\_2018\_r\_0025\_1.jpg  
**Rated Item:** 3. Encroachments **Caption:** Rating: Minimally Acceptable; Remarks:  
Unauthorized alteration (E-6): 42" outfall on left bank 300' upstream of Bolivar Road  
bridge. NYSDEC says permitted.; Action: Submit Section 408 Alteration Request to  
USACE.; Station\_1: 88+00

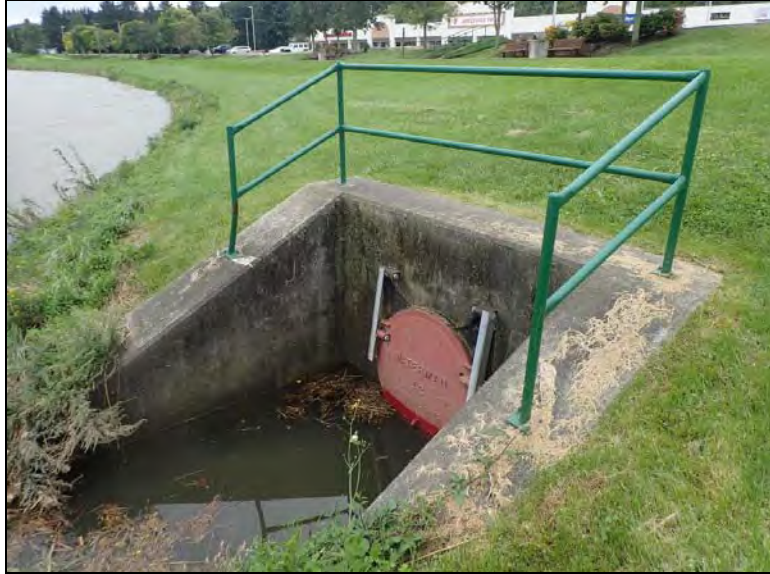
**Inspect ID:** N21L\_2018\_r\_0032 **Title:** USACE\_CELRB\_N21L\_2018\_r\_0032\_1.jpg  
**Rated Item:** 3. Encroachments **Caption:** Rating: Minimally Acceptable; Remarks:  
Unauthorized alteration (E-7): 42" outfall on left bank 900' upstream of Bolivar Road  
bridge at K-Mart. NYSDEC says permitted.; Action: Submit Section 408 Alteration  
Request to USACE.; Station\_1: 82+00

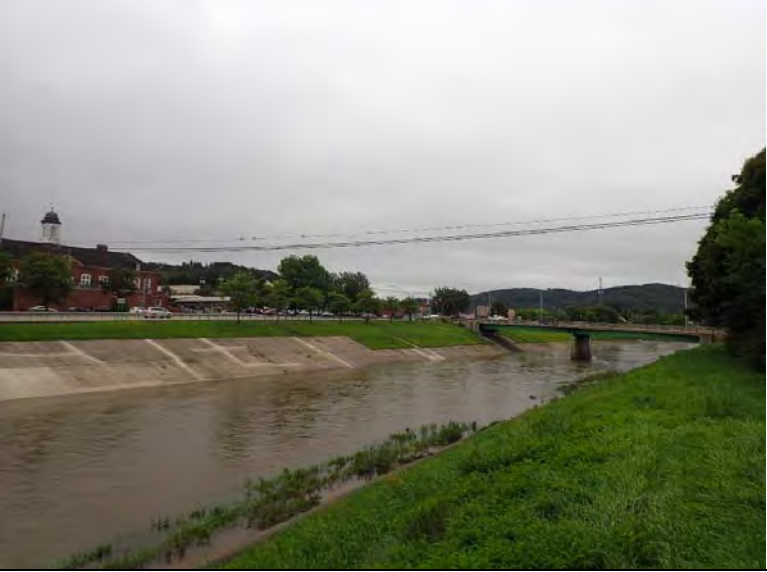
<p><b>Inspect ID:</b> N21L_2018_r_0089 <b>Title:</b> USACE_CELRB_N21L_2018_r_0089_1.jpg <b>Rated Item:</b> 3. Encroachments <b>Caption:</b> Rating: Minimally Acceptable; Remarks: Unauthorized alteration (E-26): Pearl Street bridge removed.; Action: Submit Section 408 Alteration Request to USACE.; Station_1: 46+00</p>

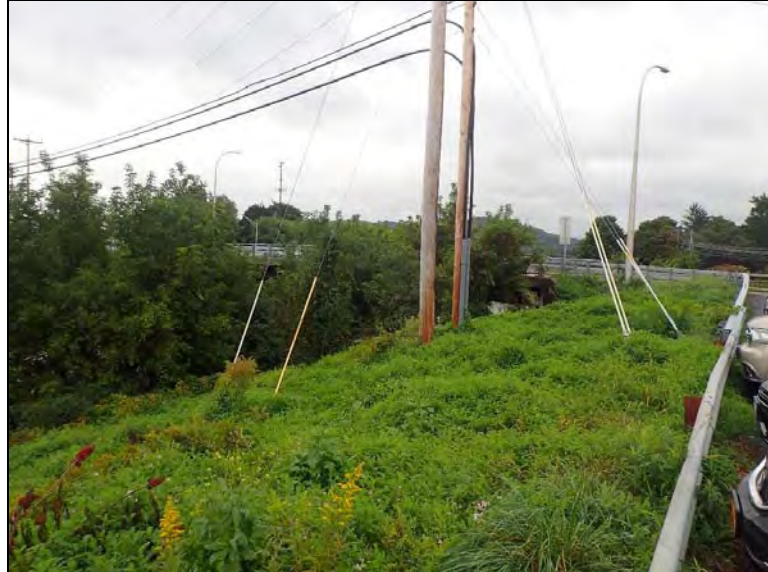
<p><b>Inspect ID:</b> N21L_2018_r_0105 <b>Title:</b> USACE_CELRB_N21L_2018_r_0105_1.jpg  <b>Rated Item:</b> 3. Encroachments <b>Caption:</b> Rating: Minimally Acceptable; Remarks:  Unauthorized alteration (E-34): 2 utility poles 6 guy wires just downstream of State Street  bridge (NYSDEC says permitted).; Action: Submit Section 408 Alteration Request to  USACE.; Station_1: 35+00</p>

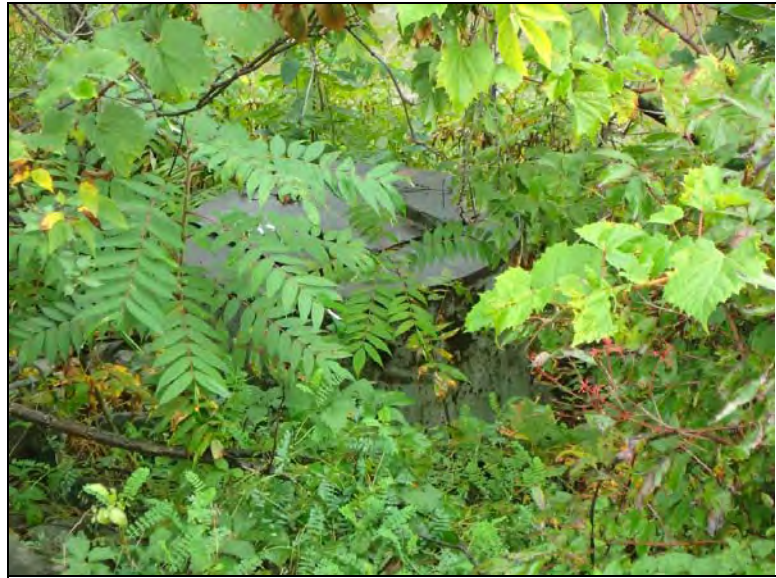
<p><b>Inspect ID:</b> N21L_2018_r_0117 <b>Title:</b> USACE_CELRB_N21L_2018_r_0117_1.jpg <b>Rated Item:</b> 3. Encroachments <b>Caption:</b> Rating: Minimally Acceptable; Remarks: Unauthorized alteration (E-40): unidentified drainage structure (metal man hole) on channel side slope on left bank, just upstream of Steel Sheet Pile Weir.; Action: Remove or submit Section 408 Alteration Request to USACE.; Station_1: 26+00</p>

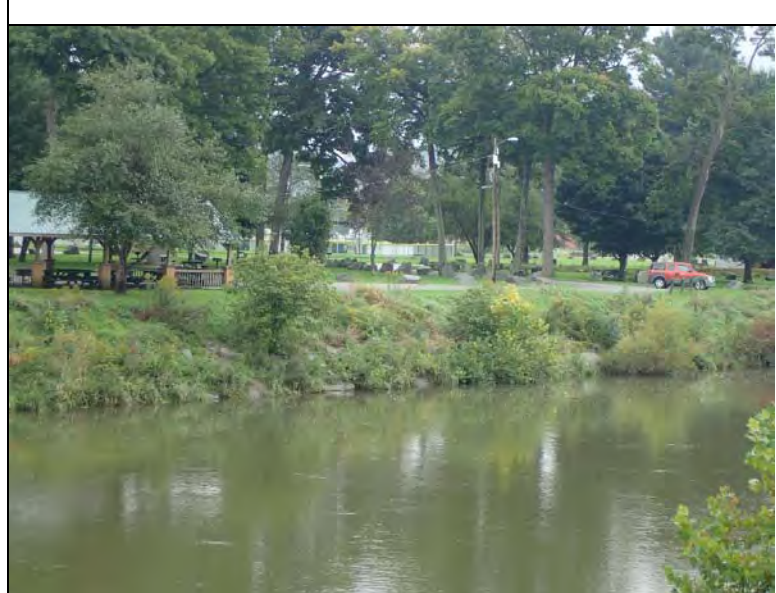
<p><b>Inspect ID:</b> N21L_2018_r_0121 <b>Title:</b> USACE_CELRB_N21L_2018_r_0121_1.jpg <b>Rated Item:</b> 3. Encroachments <b>Caption:</b> Rating: Minimally Acceptable; Remarks: Unauthorized alteration (E-44): riprap added on right bank toe at island park adjacent to parking area.; Action: Remove or submit Section 408 Alteration Request to USACE.; Station_1: 21+00; Station_2: 17+00</p>

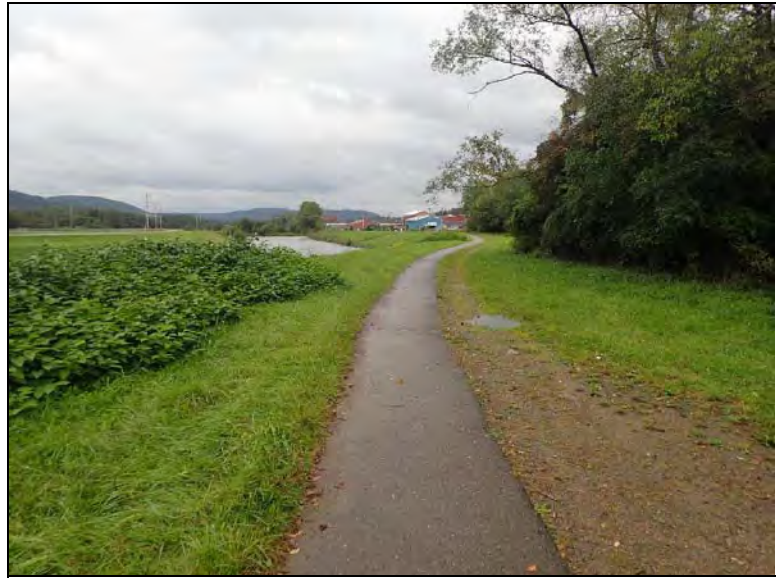
<p><b>Inspect ID:</b> N21L_2018_r_0132 <b>Title:</b> USACE_CELRB_N21L_2018_r_0132_1.jpg <b>Rated Item:</b> 3. Encroachments <b>Caption:</b> Rating: Minimally Acceptable; Remarks: Unauthorized alteration (E-45): Wellsville, Addison, &amp; Galetton Railroad gravel trailway (from Island Park pedestrian bridge to barrier levee weir) and signs on left bank near boulders blocking all access to channel crest.; Action: Submit Section 408 Alteration Request to USACE.; Station_1: 0+00; Station_2: 13+00</p>
 	<p><b>Inspect ID:</b> N21L_2018_r_0133 <b>Title:</b> USACE_CELRB_N21L_2018_r_0133_1.jpg <b>Rated Item:</b> 3. Encroachments <b>Caption:</b> Rating: Unacceptable; Remarks: Unauthorized alteration (E-46): Wellsville, Addison, &amp; Galetton Railroad trailway rocks obstructing access 575' downstream of barrier levee weir.; Action: Remove or submit Section 408 Alteration Request to USACE.; Station_1: 6+00</p>

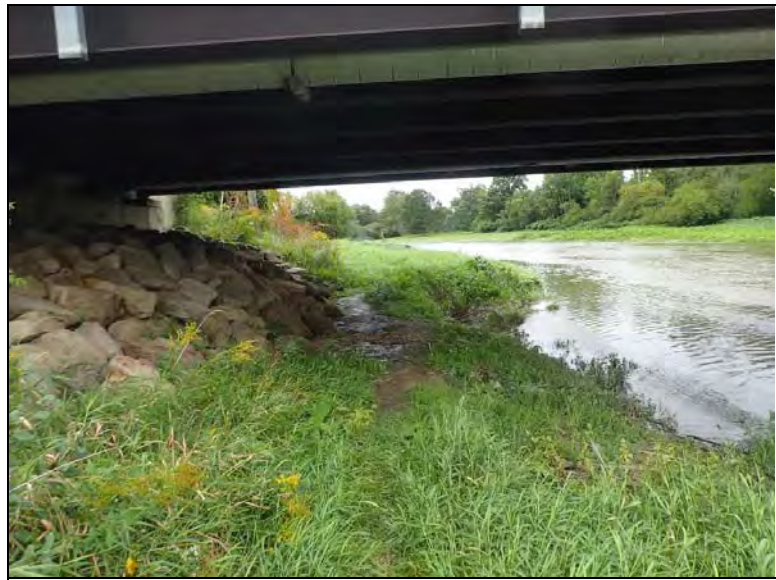
<p><b>Inspect ID:</b> N21L_2018_r_0155 <b>Title:</b> USACE_CELRB_N21L_2018_r_0155_1.jpg <b>Rated Item:</b> 3. Encroachments <b>Caption:</b> Rating: Minimally Acceptable; Remarks: Unauthorized alteration: riprap on left bank around both sides of Bolivar Road bridge.; Action: Submit Section 408 Alteration Request to USACE.; Station_1: 92+00; Station_2: 91+00</p>

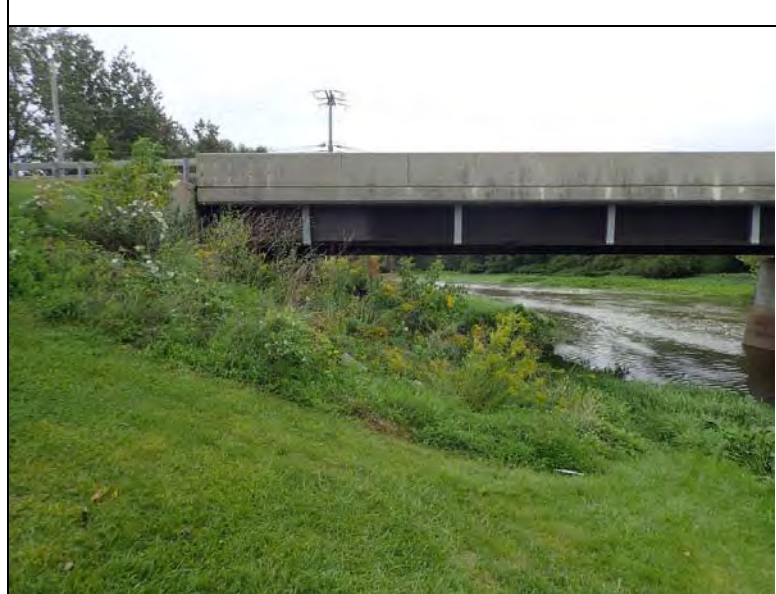
<p><b>Inspect ID:</b> N21L_2018_r_0155 <b>Title:</b> USACE_CELRB_N21L_2018_r_0155_2.jpg <b>Rated Item:</b> 3. Encroachments <b>Caption:</b> Rating: Minimally Acceptable; Remarks: Unauthorized alteration: riprap on left bank around both sides of Bolivar Road bridge.; Action: Submit Section 408 Alteration Request to USACE.; Station_1: 92+00; Station_2: 91+00</p>

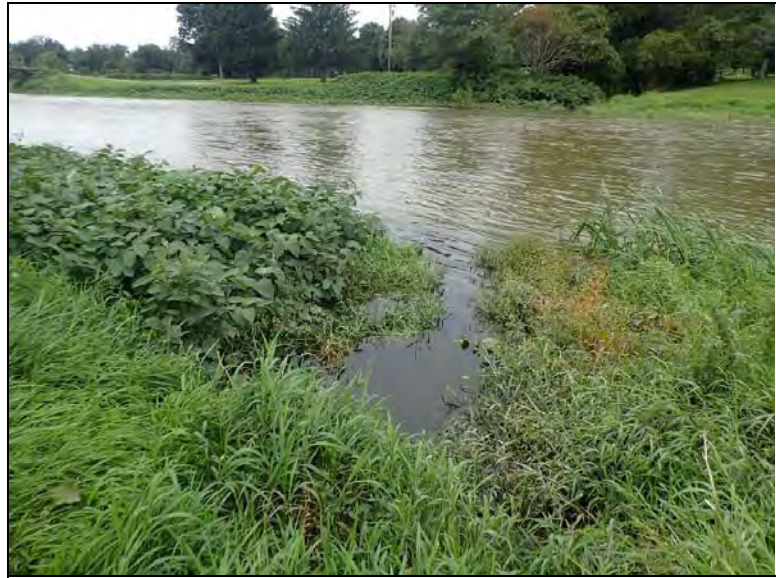
<p><b>Inspect ID:</b> N21L_2018_r_0013 <b>Title:</b> USACE_CELRB_N21L_2018_r_0013_1.jpg <b>Rated Item:</b> 4. Erosion <b>Caption:</b> Rating: Minimally Acceptable; Remarks: Erosion at two outfalls (36" and 24" diameter) on left bank 400' upstream of pedestrian bridge. Outfalls are not on plans-possible encroachment.; Action: Repair erosion and modify pipe.; Station_1: 100+00</p>

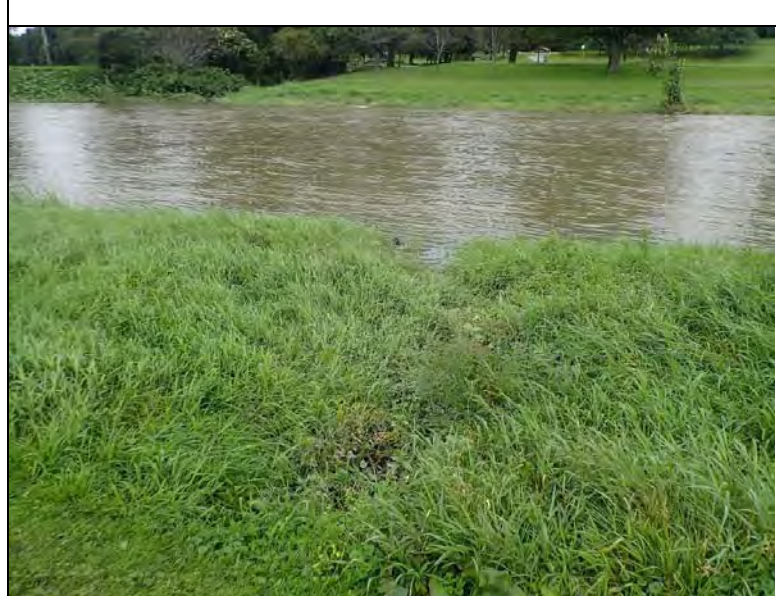
<p><b>Inspect ID:</b> N21L_2018_r_0013 <b>Title:</b> USACE_CELRB_N21L_2018_r_0013_2.jpg <b>Rated Item:</b> 4. Erosion <b>Caption:</b> Rating: Minimally Acceptable; Remarks: Erosion at two outfalls (36" and 24" diameter) on left bank 400' upstream of pedestrian bridge. Outfalls are not on plans-possible encroachment.; Action: Repair erosion and modify pipe.; Station_1: 100+00</p>

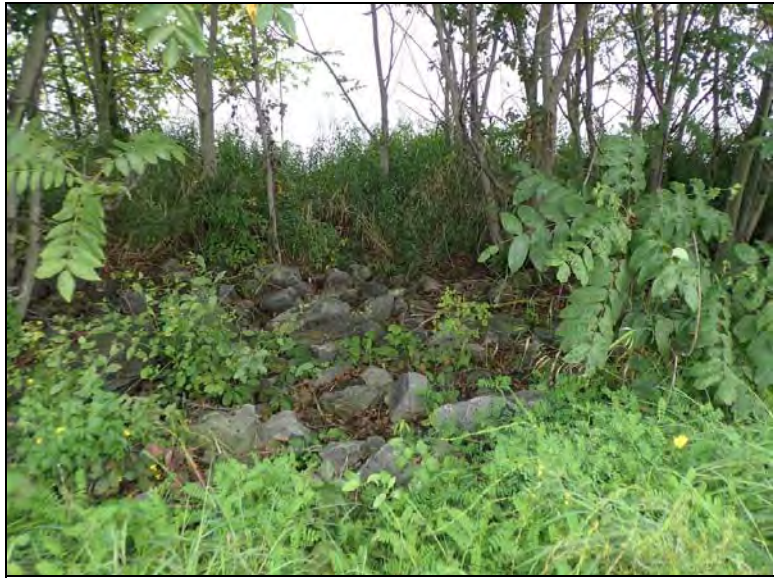
<p><b>Inspect ID:</b> N21L_2018_r_0053 <b>Title:</b> USACE_CELRB_N21L_2018_r_0053_2.jpg  <b>Rated Item:</b> 10. Riprap Revetments &amp; Banks <b>Caption:</b> Rating: Unacceptable; Remarks: Trees and vegetation in riprap on left bank channel side slope from Drop Structure to 1,000' upstream.; Action: Remove trees and vegetation from riprap.; Station_1: 65+00; Station_2: 52+00</p>

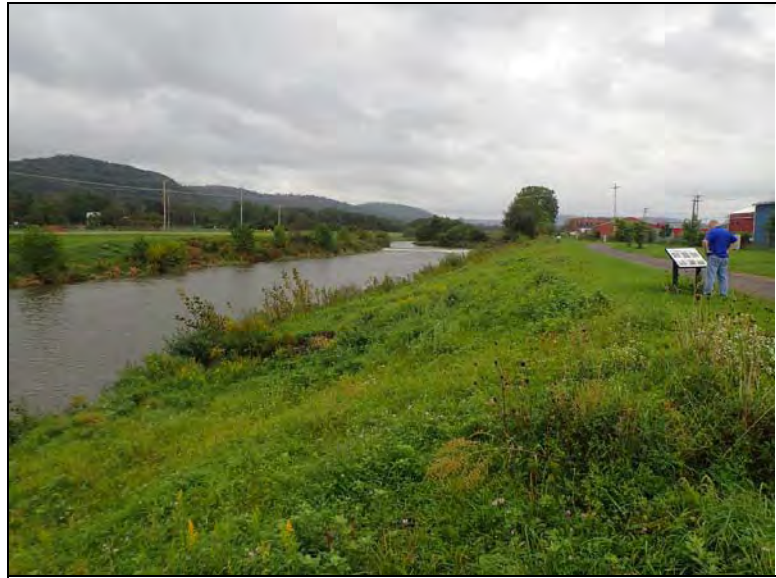
<p><b>Inspect ID:</b> N21L_2018_r_0134 <b>Title:</b> USACE_CELRB_N21L_2018_r_0134_1.jpg <b>Rated Item:</b> 10. Riprap Revetments &amp; Banks <b>Caption:</b> Rating: Minimally Acceptable; Remarks: Unwanted vegetation in riprap on left bank from barrier levee weir to 550' downstream.; Action: Remove unwanted woody vegetation.; Station_1: 6+00; Station_2: 0+00</p>

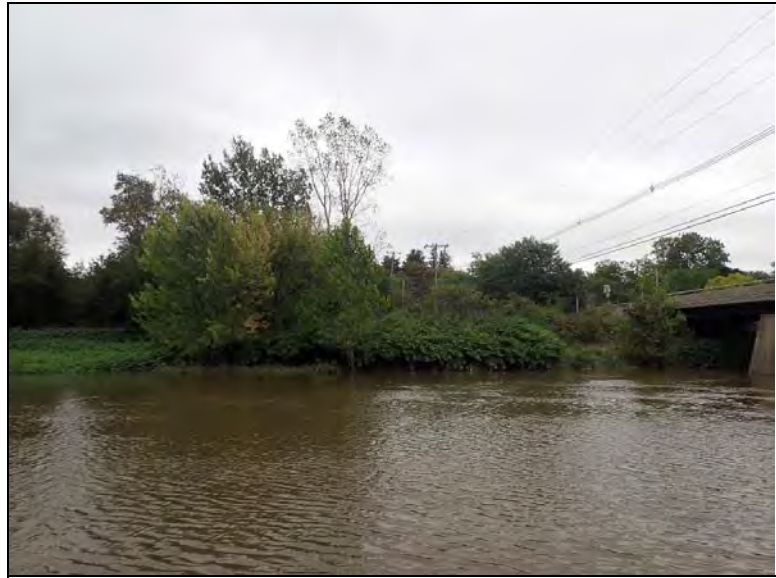
<p><b>Inspect ID:</b> N21L_2018_r_0153 <b>Title:</b> USACE_CELRB_N21L_2018_r_0153_1.jpg <b>Rated Item:</b> 10. Riprap Revetments &amp; Banks <b>Caption:</b> Rating: Minimally Acceptable; Remarks: Trees and vegetation in riprap on right bank around both sides of Bolivar Road bridge.; Action: Remove trees and vegetation from riprap.; Station_1: 91+00; Station_2: 91+00</p>

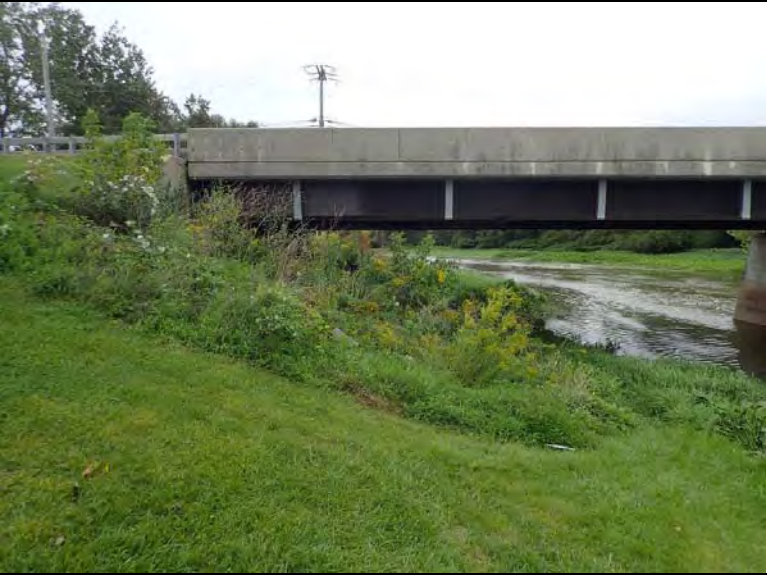
<p><b>Inspect ID:</b> N21L_2018_r_0154 <b>Title:</b> USACE_CELRB_N21L_2018_r_0154_1.jpg <b>Rated Item:</b> 10. Riprap Revetments &amp; Banks <b>Caption:</b> Rating: Minimally Acceptable; <b>Remarks:</b> Vegetation in unauthorized riprap on left bank around both sides of Bolivar Road bridge.; <b>Action:</b> Remove vegetation from riprap.; <b>Station_1:</b> 92+00; <b>Station_2:</b> 91+00</p>
