## DEPARTMENT OF THE ARMY

BUFFALO DISTRICT, CORPS OF ENGINEERS  
1776 NIAGARA STREET  
BUFFALO, NEW YORK 14207-3199

SUBJECT: FY18 Joint Routine Inspection of Completed Works, Flood Risk Management Project, Genesee River and Dyke Creek, Wellsville, New York (09/24/18)

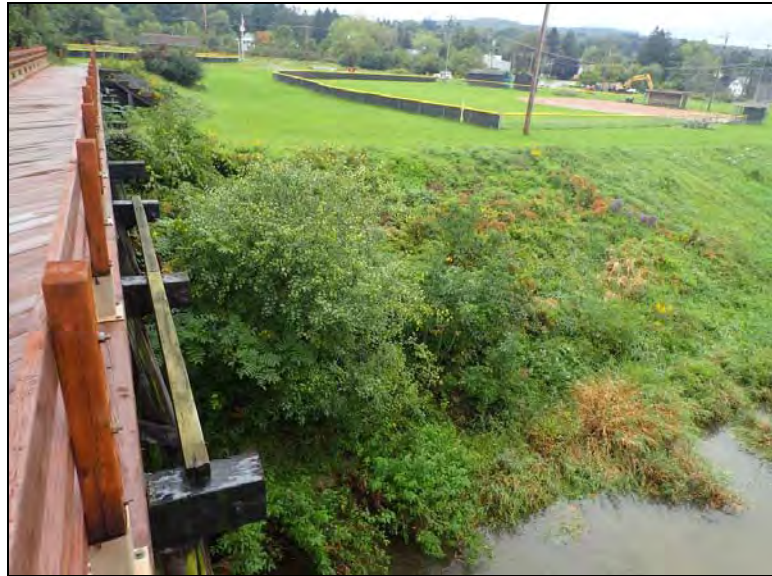
**Inspect ID:** N21L\_2018\_r\_0165 **Title:** USACE\_CELRB\_N21L\_2018\_r\_0165\_1.jpg  
**Rated Item:** 10. Riprap Revetments & Banks **Caption:** Rating: Minimally Acceptable;  
Remarks: Trees and vegetation in riprap on left bank around both sides of Island Park  
Pedestrian Walkway Bridge; Action: Remove trees and vegetation from riprap.;  
Station\_1: 17+00; Station\_2: 16+00

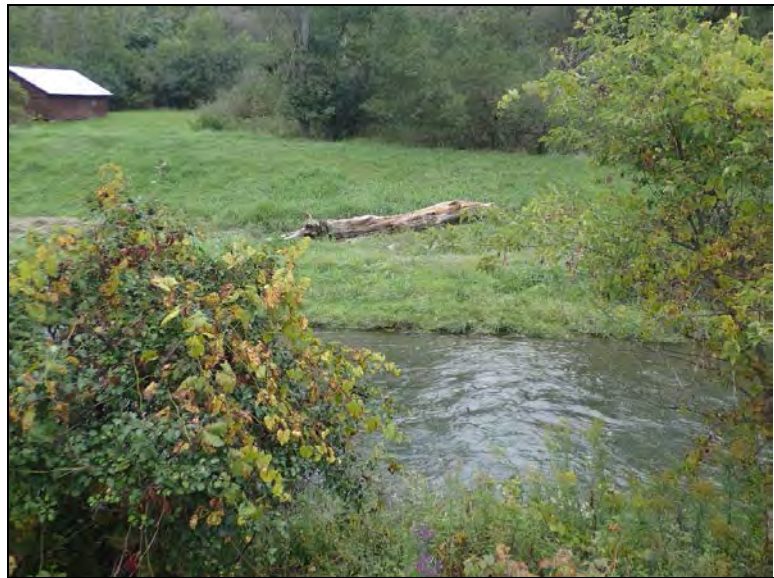
<p><b>Inspect ID:</b> N21R_2018_r_0005 <b>Title:</b> USACE_CELRB_N21R_2018_r_0005_1.jpg <b>Rated Item:</b> 1. Vegetation and Obstructions <b>Caption:</b> Rating: Minimally Acceptable; <b>Remarks:</b> Log debris in channel on right bank shoal 500' upstream of drop structure. (Dyke Creek); <b>Action:</b> Remove debris.; <b>Station_1:</b> 35+00</p>

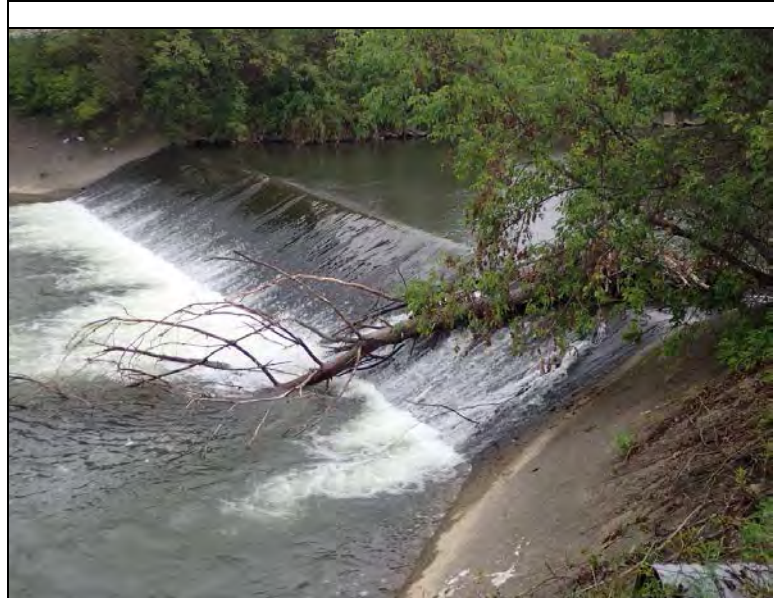
<p><b>Inspect ID:</b> N21R_2018_r_0011 <b>Title:</b> USACE_CELRB_N21R_2018_r_0011_1.jpg <b>Rated Item:</b> 1. Vegetation and Obstructions <b>Caption:</b> Rating: Minimally Acceptable; <b>Remarks:</b> Fallen tree on drop structure.; <b>Action:</b> Remove fallen tree from drop structure.; <b>Station_1:</b> D 35+00</p>

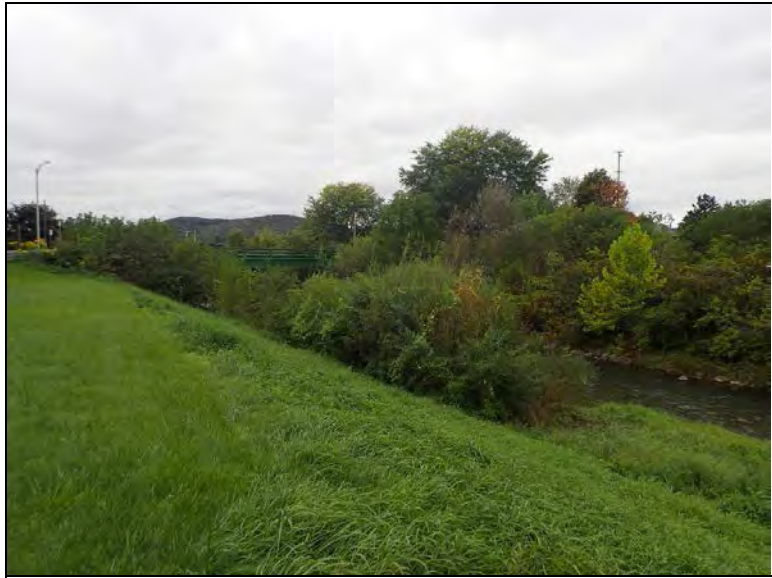
<p><b>Inspect ID:</b> N21R_2018_r_0019 <b>Title:</b> USACE_CELRB_N21R_2018_r_0019_1.jpg <b>Rated Item:</b> 1. Vegetation and Obstructions <b>Caption:</b> Rating: Unacceptable; Remarks: Trees and vegetation on left bank channel side slope from Broad Street bridge to 125' upstream.; Action: Remove trees and vegetation.; Station_1: D 24+00; Station_2: D 26+00</p>

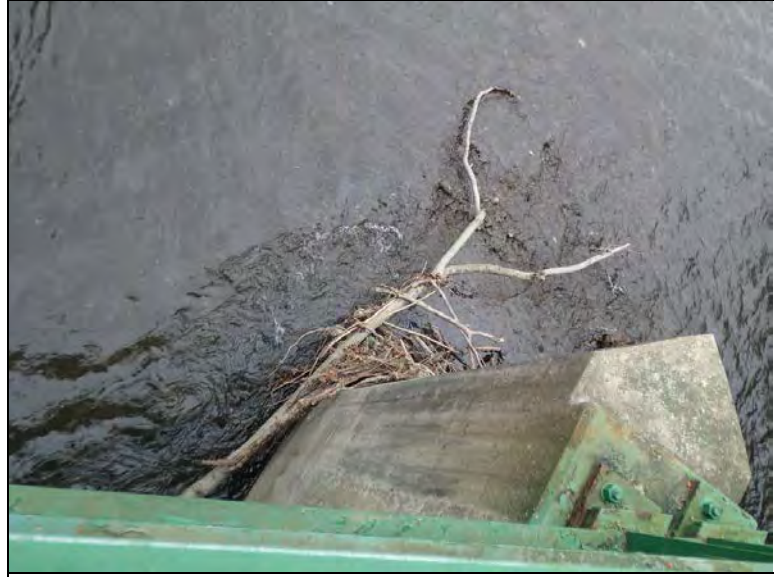
<p><b>Inspect ID:</b> N21R_2018_r_0020 <b>Title:</b> USACE_CELRB_N21R_2018_r_0020_2.jpg <b>Rated Item:</b> 1. Vegetation and Obstructions <b>Caption:</b> Rating: Minimally Acceptable; <b>Remarks:</b> Tree debris in channel on pier of Broad Street bridge. (Dyke Creek); <b>Action:</b> Remove tree debris.; <b>Station_1:</b> D 24+00</p>

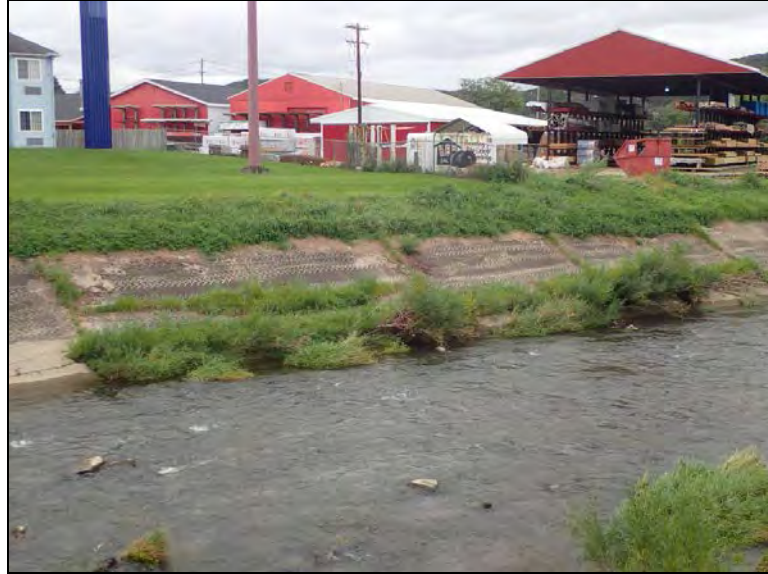
**Inspect ID:** N21R\_2018\_r\_0034 **Title:** USACE\_CELRB\_N21R\_2018\_r\_0034\_2.jpg  
**Rated Item:** 1. Vegetation and Obstructions **Caption:** Rating: Minimally Acceptable;  
Remarks: Unwanted vegetation in left and right bank concrete channel sideslopes.;  
Action: Remove unwanted vegetation from concrete channel sideslopes.; Station\_1: D  
18+00; Station\_2: D 12+00

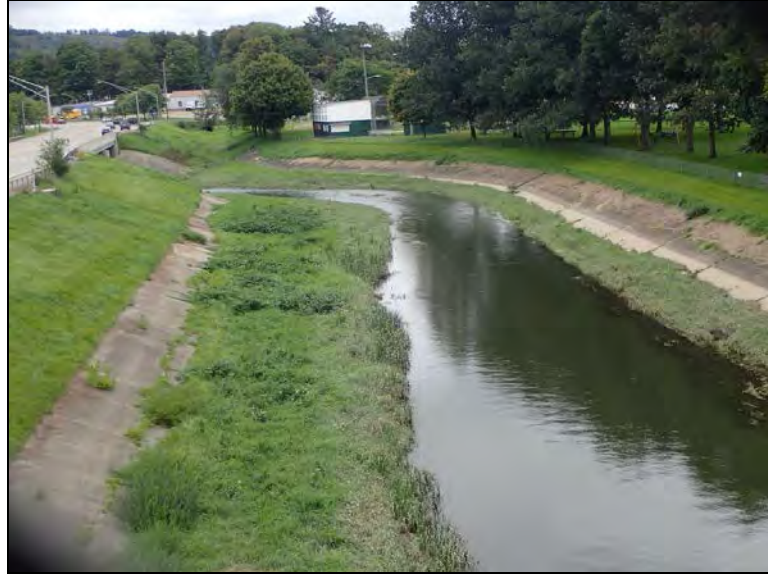
**Inspect ID:** N21R\_2018\_r\_0039 **Title:** USACE\_CELRB\_N21R\_2018\_r\_0039\_1.jpg  
**Rated Item:** 1. Vegetation and Obstructions **Caption:** Rating: Minimally Acceptable;  
**Remarks:** Unwanted vegetation in left and right bank concrete channel sideslopes.;  
**Action:** Remove unwanted vegetation from concrete channel sideslopes.; **Station\_1:** D  
11+00; **Station\_2:** D 2+00
