MEMORANDUM FOR CENAP-EM

SUBJECT: Initial Eligibility Inspection of Local Flood Risk Management Project, Deposit, New York, 8 June 2016

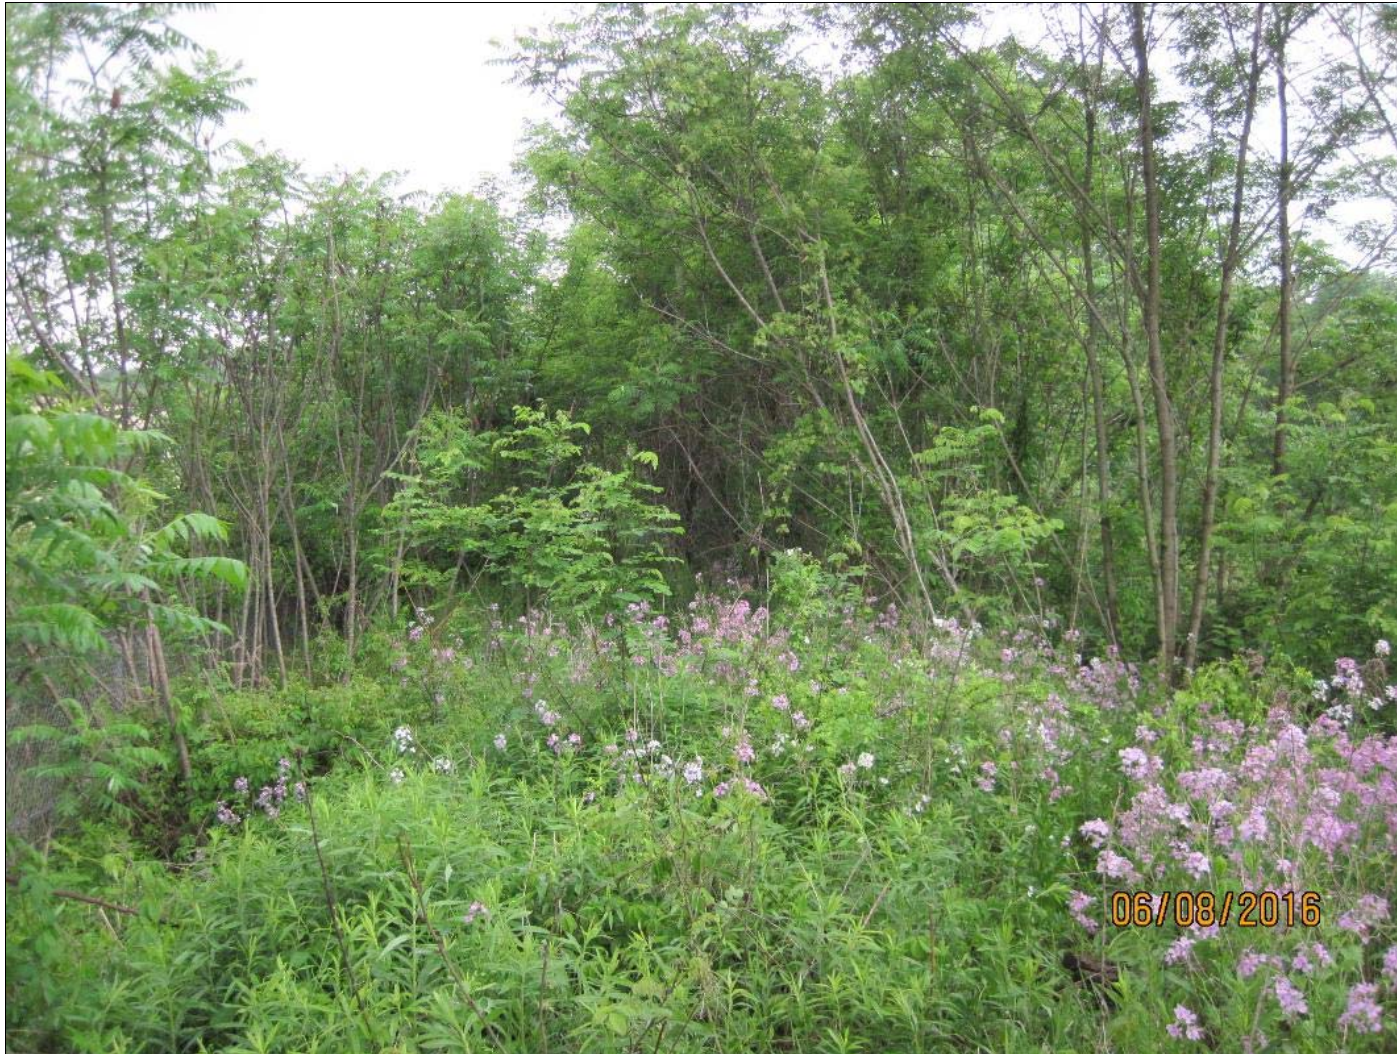
a. **Big Hollow Creek Levee and Sheetpile Floodwall.** Although Broome County personnel performed maintenance along the 1100-foot long Big Hollow Creek section earlier in 2016, vegetation had grown back on the levee and on the riprap on the creek side of the sheetpile floodwall by the date of this inspection (see Photos 1, 2, 8, 9, and 10). In addition, removal of excessive vegetation from a short section of the levee was completely missed (see Photo 2). The levee should have the remaining bushes cleared and then be seeded with grass cover on the crest and both slopes (except where there is riprap slope protection). If evidence of slope erosion is apparent upon removal of the remaining vegetation, then the eroded areas should be repaired. The riprap along the sheetpile floodwall should be sprayed with an appropriate water-safe herbicide. The riprap will likely require herbicidal spraying at least every two years. In addition, all trees and bushes should be removed out to 15 feet of either levee toe or as far as the existing easement distance, whichever is less.

Photo 1. Inspect ID: DEPO_2016_a_0001 **Title:** USACE_CENAP_DEPO_2016_a_0001_1.jpg **Rated Item:** 1. Unwanted Vegetation Growth. **Caption:** Excessive vegetation on the Big Hollow Creek Levee.

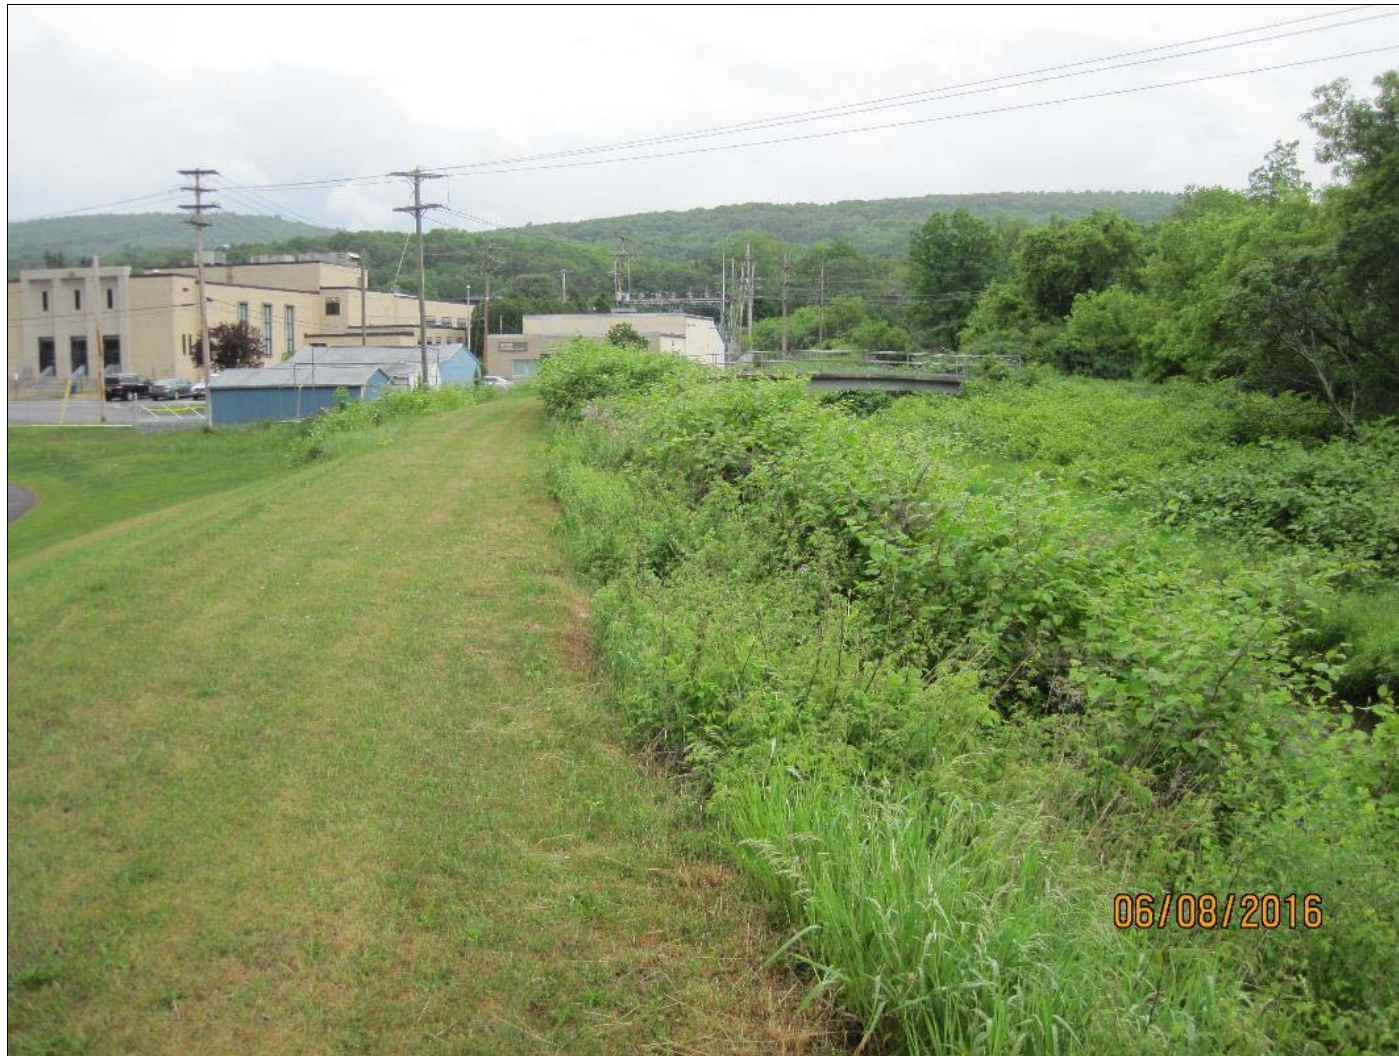
Rated Item	Rating	Rating Guidelines		Location/Remarks/Recommendations
1. Unwanted Vegetation Growth ¹	M	A	The levee has little or no unwanted vegetation (trees, bush, or undesirable weeds), except for vegetation that is properly contained and/or situated on overbuilt sections, such that the mandatory 3-foot root-free zone is preserved around the levee profile. The levee has been recently mowed. The vegetation-free zone extends 15 feet from both the landside and riverside toes of the levee to the centerline of the tree. If the levee access easement doesn't extend to the described limits, then the vegetation-free zone must be maintained to the easement limits. Reference EM 1110-2-301 or Corps policy for regional vegetation variance.	DEPO_2016_a_0001: Station_1 NA: More clearing to do (see Photo 1).: Remove vegetation/ (U) DEPO_2016_a_0003: Station_1 NA: Station_2 NA: Vegetation prevents inspection (see Photo 2).: Remove vegetation (U)

Photo 2. Inspect ID: DEPO_2016_a_0003 **Title:** USACE_CENAP_DEPO_2016_a_0003_1.jpg **Rated Item:** 1. Unwanted Vegetation Growth. **Caption:** Looking upstream along the Big Hollow Creek Levee. Excessive vegetation on the riverside slope.

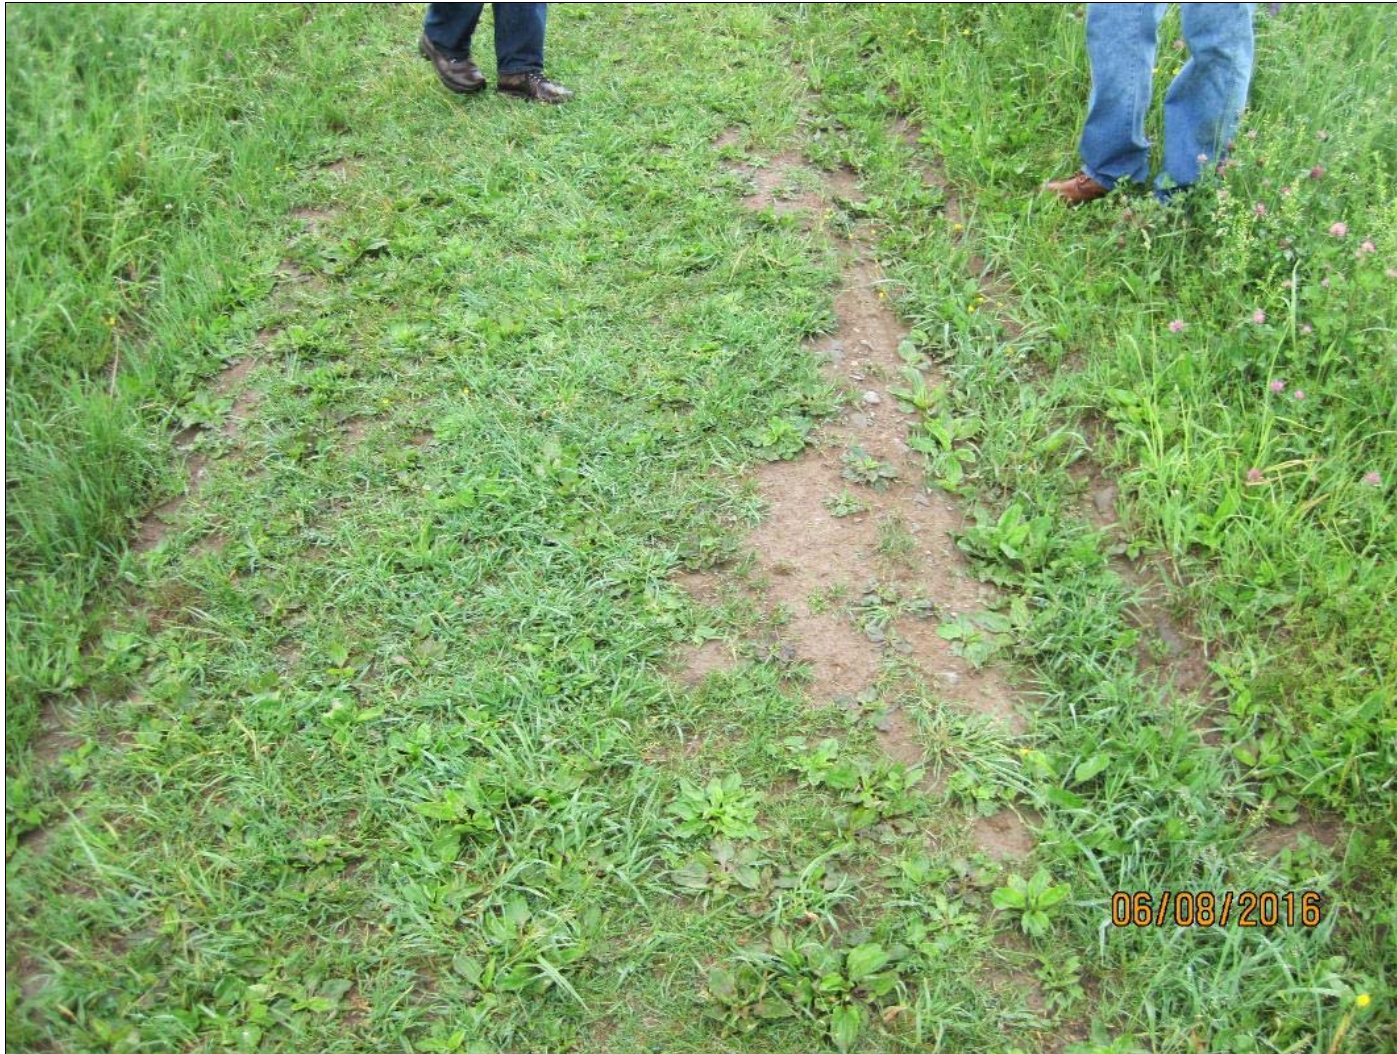
b. **Butler Brook Levee.** The 3000-foot long Butler Brook levee was mostly in very good condition (see Photos 12 through 15). Rutting was observed at one small area on the levee crest (see Photo 3). This area should be repaired. Other rutted areas on the levee crest had been filled in, but were inadequately compacted. These areas should be re-compacted; additional fill material will likely be required. One location on the riverside slope of the Butler Brook Levee is rutted due to foot traffic and ATV use (see Photo 4). Recommend installing articulated concrete mat (ACM) at this location. The material that had been dumped near the upstream end of the Butler Brook Levee has been removed. No new encroachments were observed. The eroded scarp just upstream from the transition structure has been repaired, including the addition of large riprap (see Photo 11).

Photo 3. Inspect ID: DEPO_2016_a_0005 **Title:** USACE_CENAP_DEPO_2016_a_0005_1.jpg **Rated Item:** 8. Depressions/ Rutting. **Caption:** Rutting on the Butler Brook Levee crest that was not repaired.

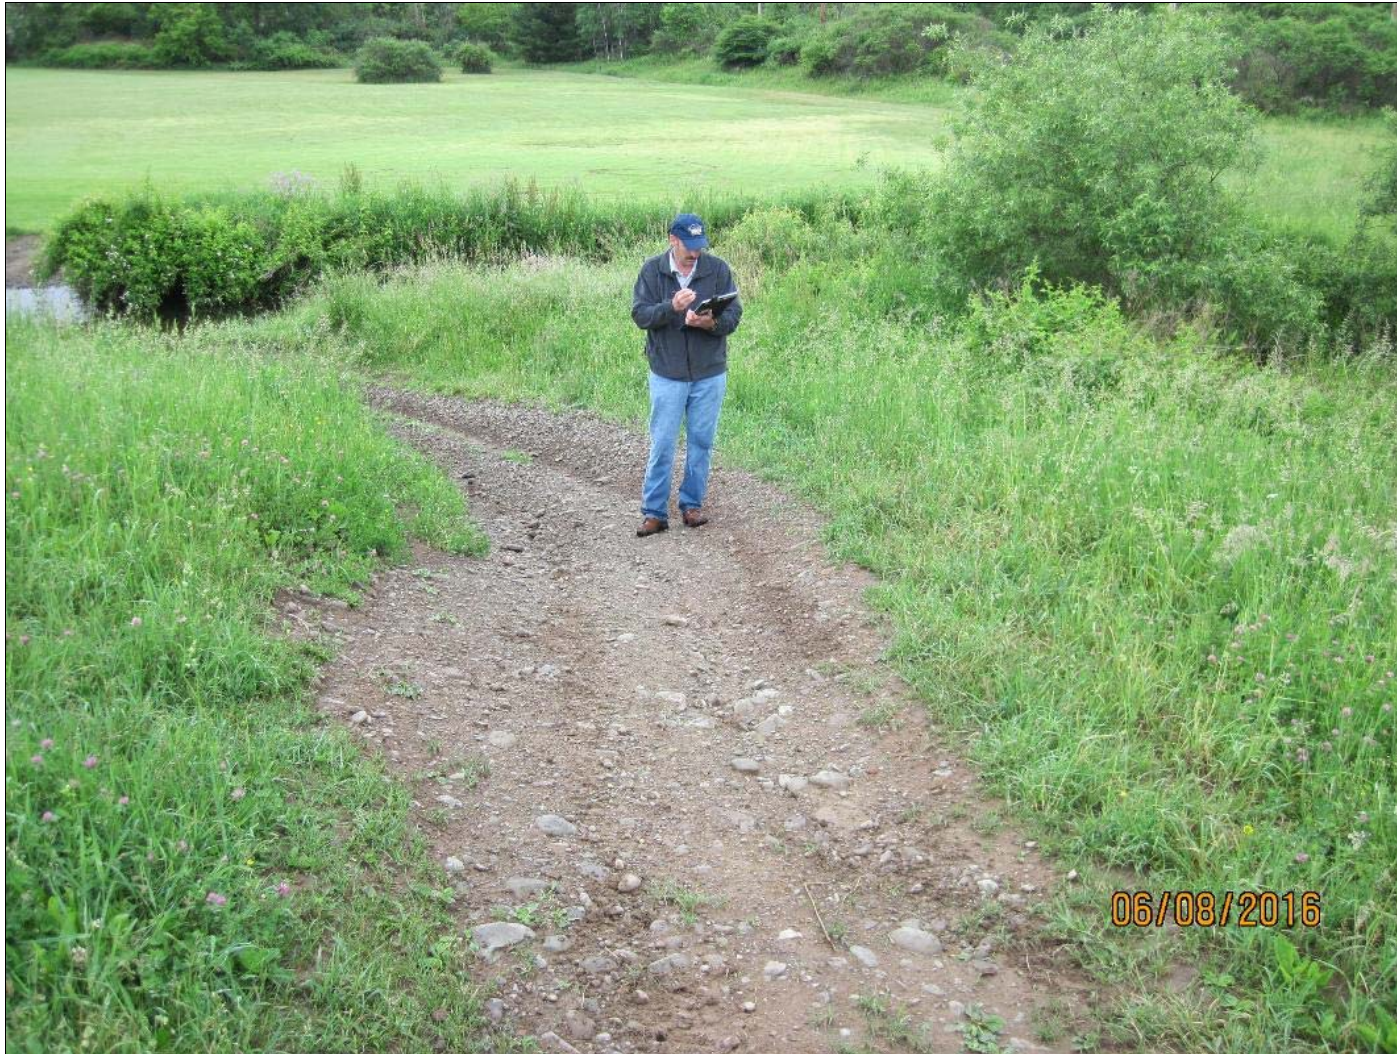
Photo 4. Inspect ID: DEPO_2016_a_0006 **Title:** USACE_CENAP_DEPO_2016_a_0006_1.jpg **Rated Item:** 8. Depressions/ Rutting. **Caption:** Rutting of the riverside slope of the Butler Brook Levee where foot traffic and ATVs pass through.

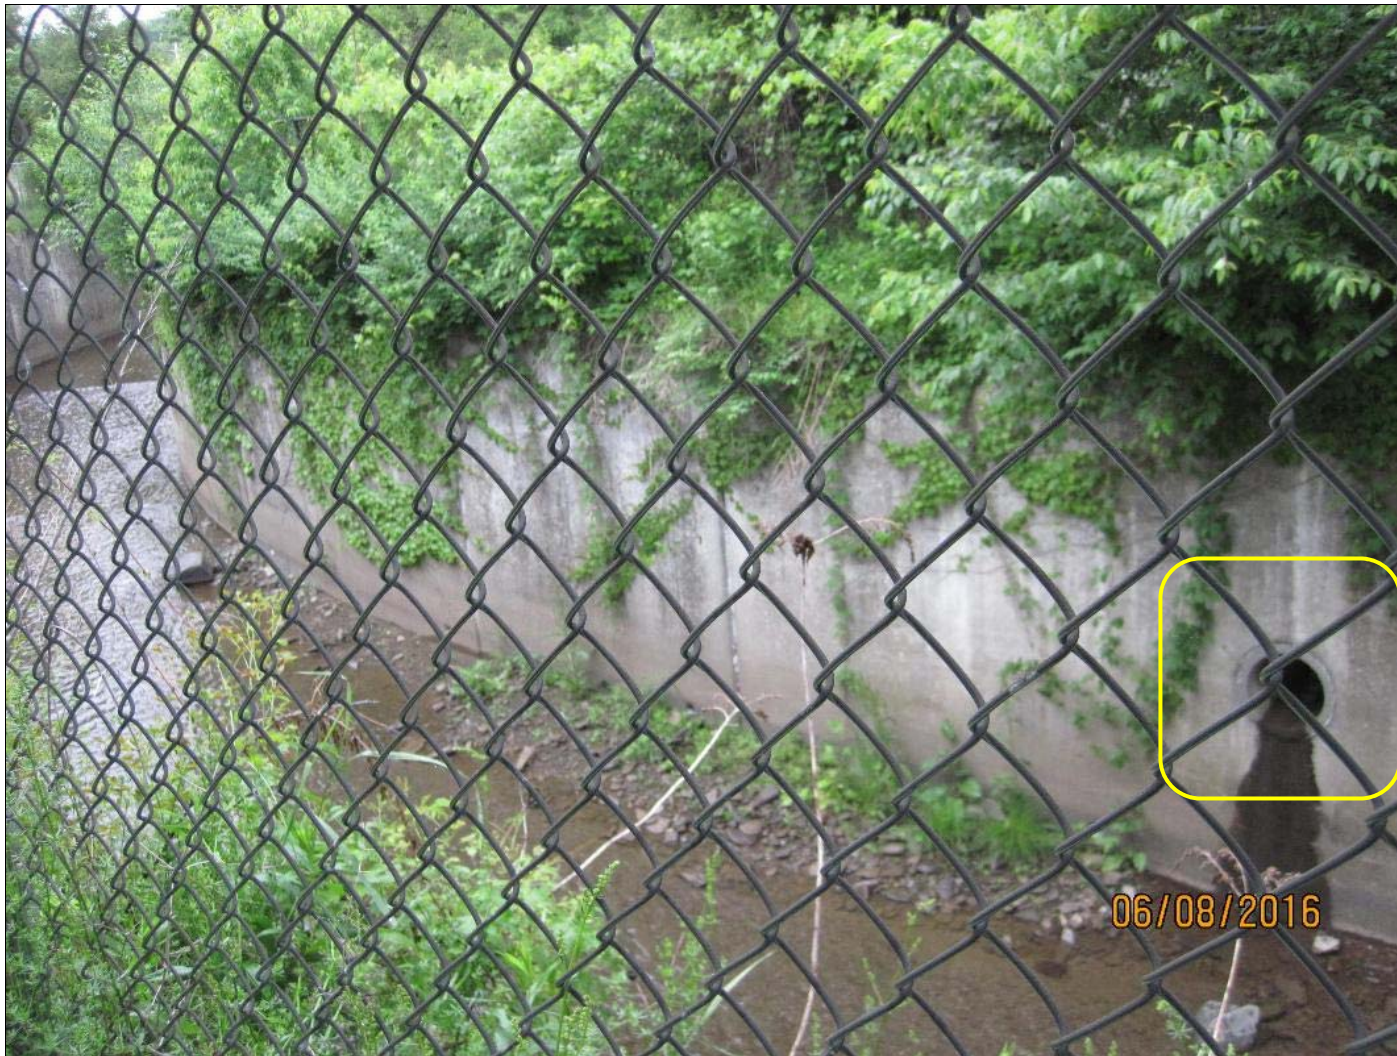
e. **Concrete Diversion Channel.** The concrete U-channel was in good overall condition (see Photos 17 and 19). Vegetation overhanging the walls should be removed, especially prior to project inspections. The 18" drainage pipe that enters the concrete U-channel at Station 98+00 (seen in Photo 33) was apparently designed without a flap gate to prevent flood water from backing up the pipe and flowing out of the catch basins into the protected area. Previous assessments of this situation indicate that the highest expected flood water level in the diversion channel would indeed back up the pipe and drop structure, and flow out of the catch basin (see the 2012 inspection report). It is recommended that a flap gate is acquired and installed.

Photo 5. Inspect ID: DEPO_2016_a_0008 **Title:** USACE_CENAP_DEPO_2016_a_0008_1.jpg **Rated Item:** 9. Flap Gates/ Flap Valves/ Pinch Valves. **Caption:** Drainage pipe exiting into the diversion channel.

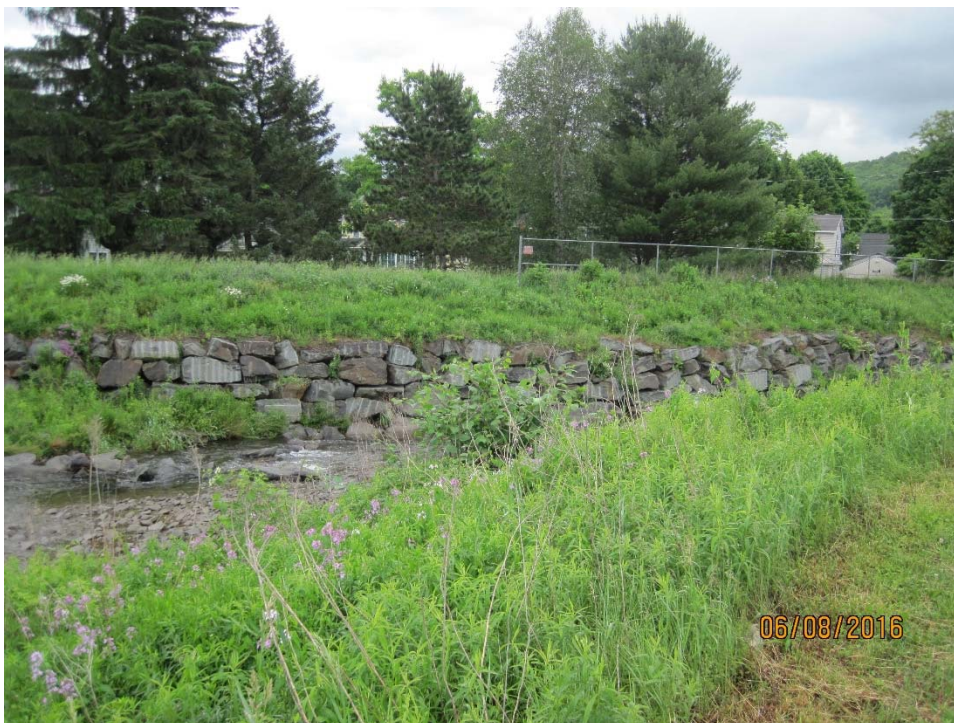
6. Erosion/ Bank Caving	A	A	No erosion or bank caving is observed on the landward or riverward sides of the levee that might endanger its stability.	The eroded scarp just upstream from the transition structure has been repaired, including the addition of large riprap (see Photo 11).
		M	There are areas where minor erosion is occurring or has occurred on or near the levee embankment, but levee integrity is not threatened.	
		U	Erosion or caving is occurring or has occurred that threatens the stability and integrity of the levee. The erosion or caving has progressed into the levee section or into the extended footprint of the levee foundation and has compromised the levee foundation stability.

Photo 11: Repaired scarp area on the Butler Brook Levee just upstream from the transition structure.

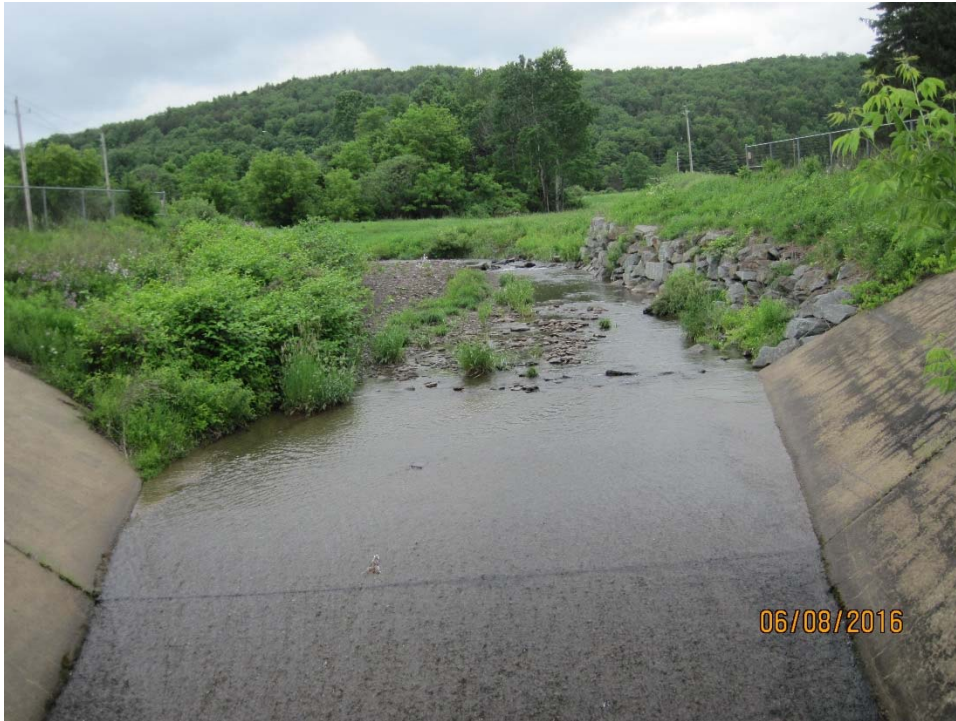
c. **Earthen Channels.** The channels along the levees were in good overall condition. It was noted that the shoal on the right side of the channel immediately upstream from the transition structure continues to build (see Photo 16). The shoaling should be removed periodically in order to maintain the design channel capacity.

Photo 16: Looking upstream through the transition structure.

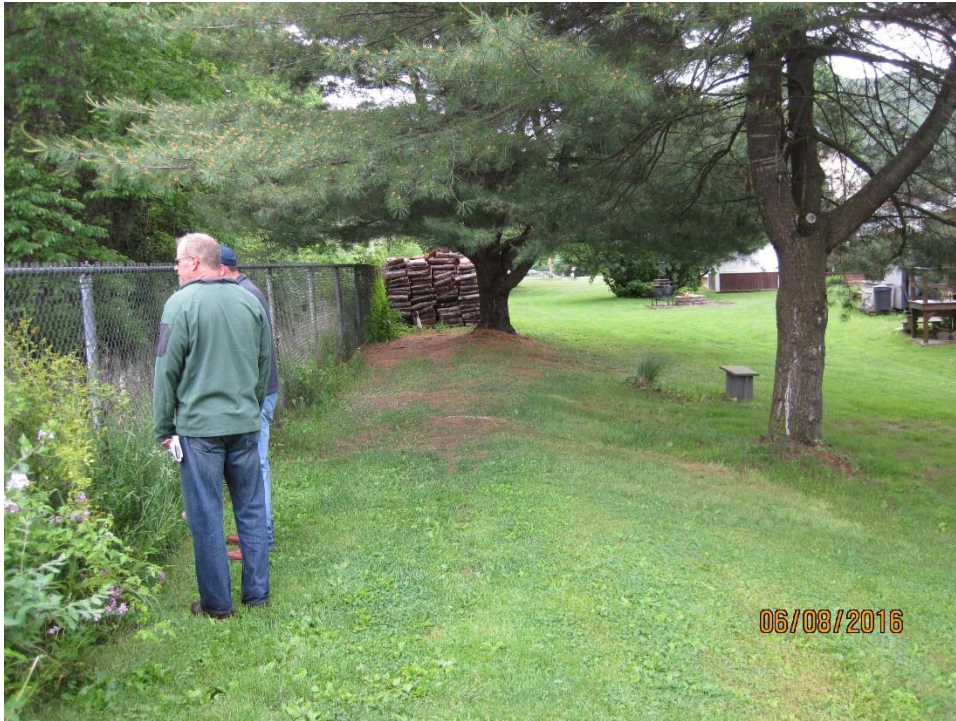
Photo 18: Firewood stacked immediately against the diversion channel.
