**US Army Corps  
of Engineers  
Pittsburgh District**

# **Bolivar - Right Bank Root Creek**

**Bolivar, New York**

## **Periodic Inspection Report No. 1**

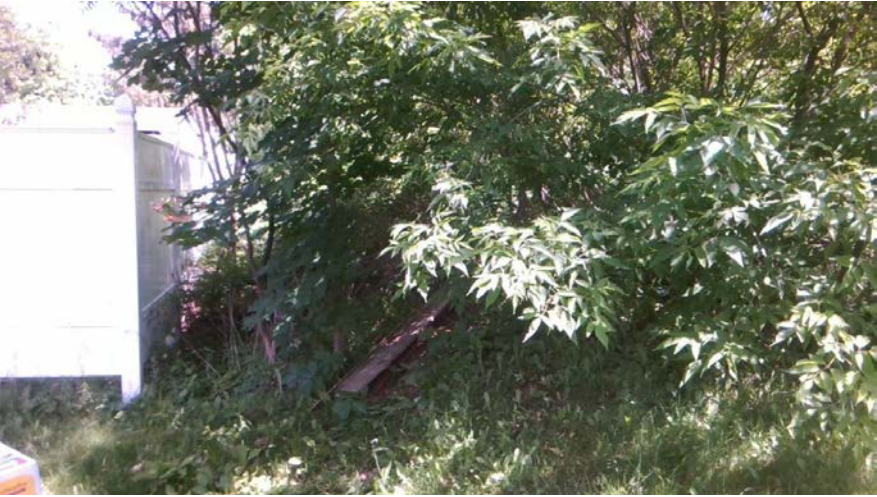
<p><b>Inspect ID:</b> BOLI_2017_p_0055 <b>Title:</b> USACE_CELRP_BOLI_2017_p_0055_1.jpg <b>Rated Item:</b> 1. Unwanted Vegetation Growth <b>Caption:</b> Rating: Unacceptable; Remarks: Unwanted heavy woody vegetation on both levee side slopes and crest.; Action: Remove unwanted vegetation.</p>

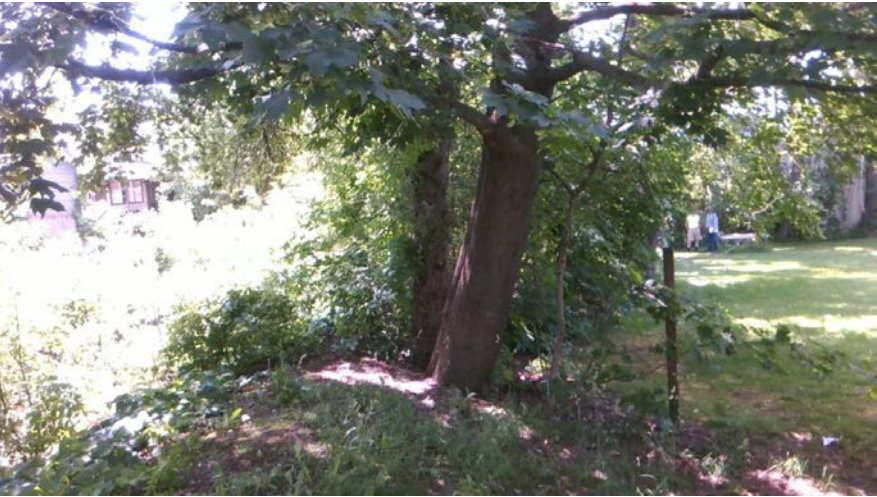
<p><b>Inspect ID:</b> BOLI_2017_p_0057 <b>Title:</b> USACE_CELRP_BOLI_2017_p_0057_1.jpg <b>Rated Item:</b> 1. Unwanted Vegetation Growth <b>Caption:</b> Rating: Unacceptable; Remarks: Large trees in levee crest and LS slope.; Action: Remove trees.</p>

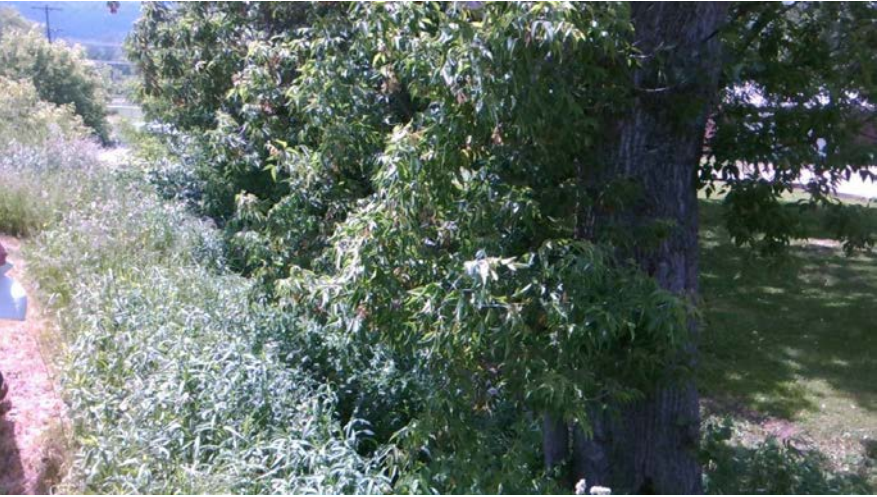
<p><b>Inspect ID:</b> BOLI_2017_p_0078 <b>Title:</b> USACE_CELRP_BOLI_2017_p_0078_1.jpg <b>Rated Item:</b> 1. Unwanted Vegetation Growth <b>Caption:</b> Rating: Unacceptable; Remarks: Unwanted large tree on levee LS toe within permanent easement.; Action: Remove tree.</p>

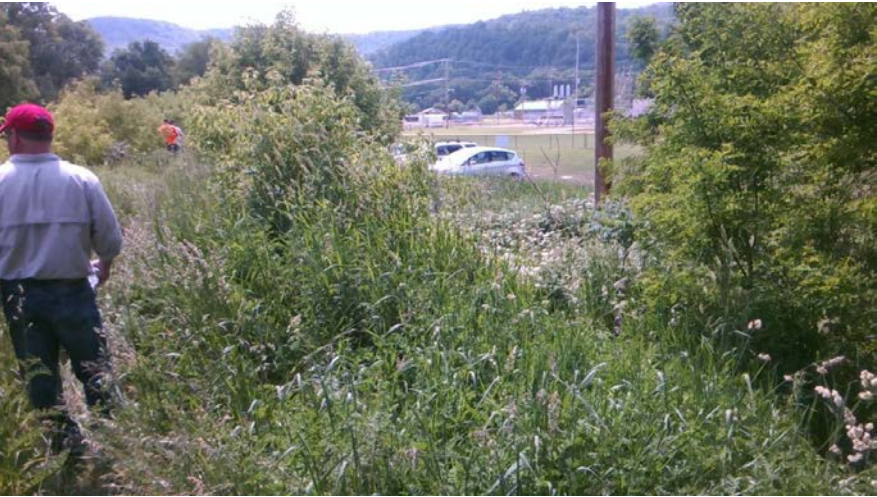
<p><b>Inspect ID:</b> BOLI_2017_p_0079 <b>Title:</b> USACE_CELRP_BOLI_2017_p_0079_1.jpg <b>Rated Item:</b> 1. Unwanted Vegetation Growth <b>Caption:</b> Rating: Unacceptable; Remarks: Unwanted woody vegetation LS slope.; Action: Remove unwanted vegetation.</p>

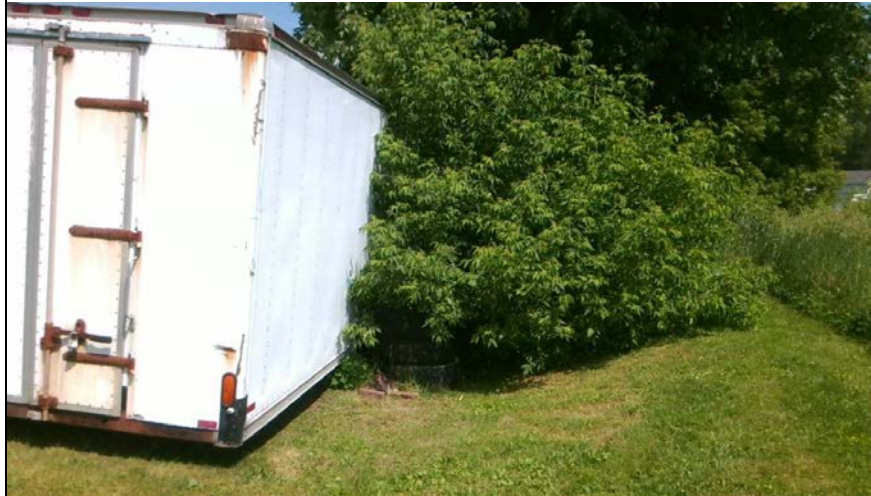
**Inspect ID:** BOLI\_2017\_p\_0070 **Title:** USACE\_CELRP\_BOLI\_2017\_p\_0070\_1.jpg  
**Rated Item:** 3. Encroachments **Caption:** Rating: Minimally Acceptable; Remarks: Trailer and tires within permanent easement of levee LS toe.; Action: Remove trailer and tires.

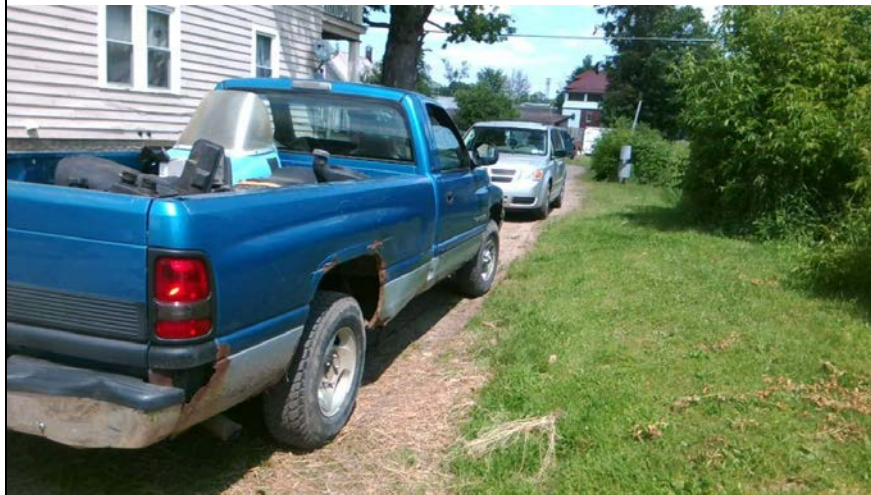
**Inspect ID:** BOLI\_2017\_p\_0073 **Title:** USACE\_CELRP\_BOLI\_2017\_p\_0073\_1.jpg  
**Rated Item:** 3. Encroachments **Caption:** Rating: Minimally Acceptable; Remarks: 2 vehicles within 15 feet of levee LS toe and within the easement.; Action: Remove vehicles.

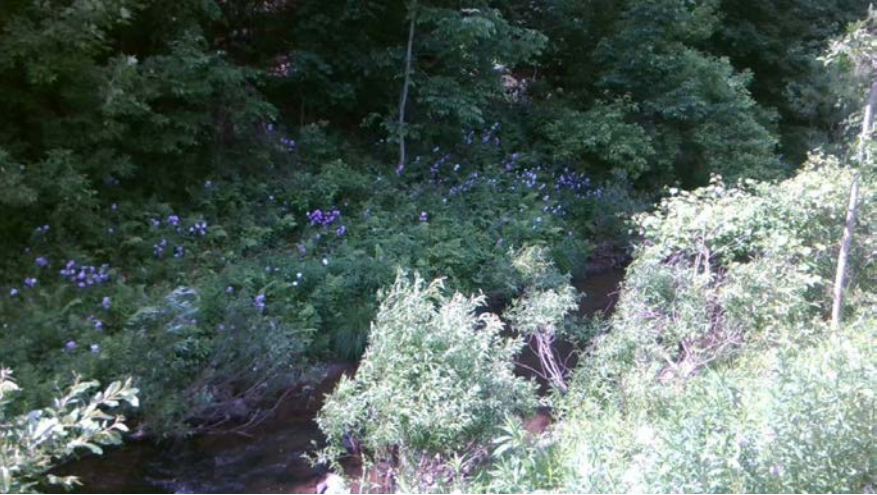
<p><b>Inspect ID:</b> BOLI_2017_p_0012 <b>Title:</b> USACE_CELRP_BOLI_2017_p_0012_1.jpg <b>Rated Item:</b> 11. Revetments other than Riprap <b>Caption:</b> Rating: Minimally Acceptable; <b>Remarks:</b> Unwanted vegetation in gabion channel slope protection on the left bank.; <b>Action:</b> Remove unwanted vegetation.</p>

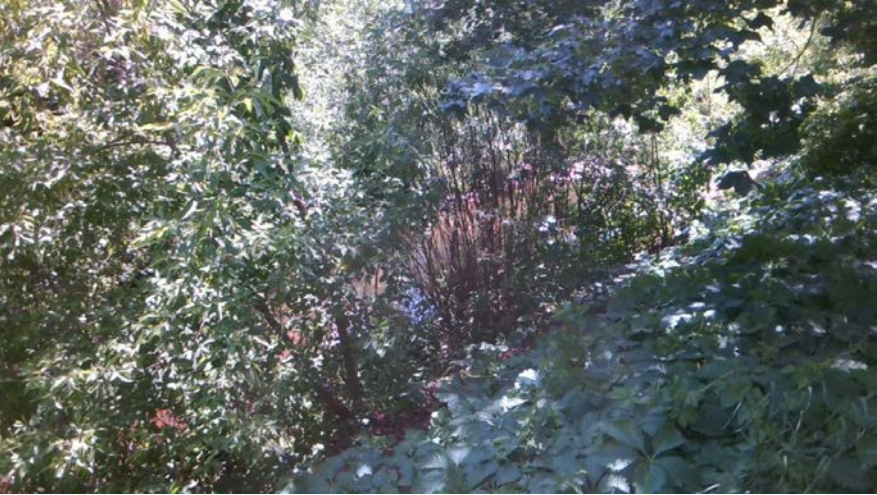
<p><b>Inspect ID:</b> BOLI_2017_p_0056 <b>Title:</b> USACE_CELRP_BOLI_2017_p_0056_1.jpg <b>Rated Item:</b> 11. Revetments other than Riprap <b>Caption:</b> Rating: Unacceptable; <b>Remarks:</b> Unwanted heavy woody vegetation in gabion channel slope protection on both banks.; <b>Action:</b> Remove unwanted vegetation.</p>

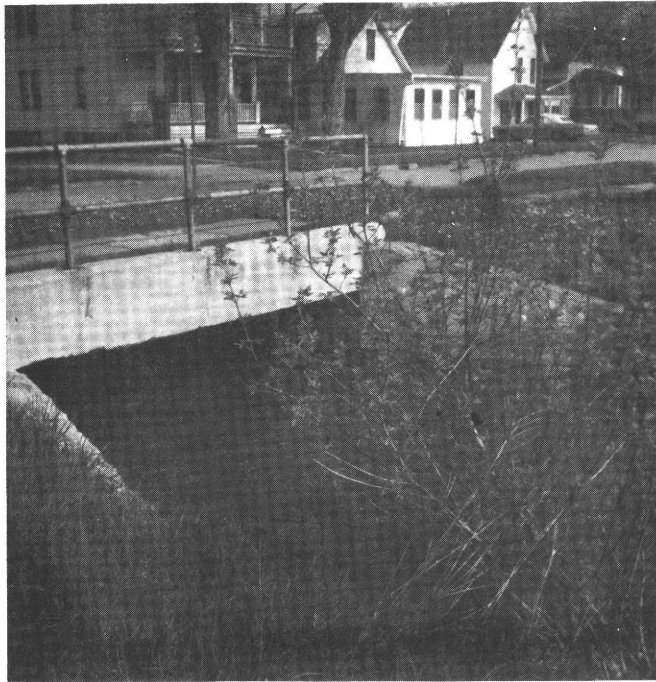
Station 22+00, First Street Bridge which is  
to be removed by NYDOT

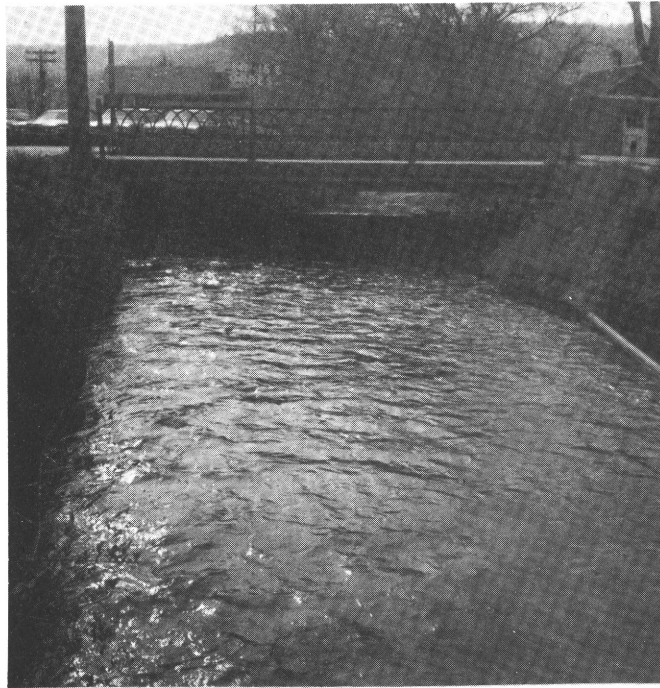
.Station 28+00 to 24+00 - looking downstream  
and the Main Street Bridge which is to be  
replaced by NYDOT
