DEPARTMENT OF THE ARMY

BUFFALO DISTRICT, CORPS OF ENGINEERS
1776 NIAGARA STREET
BUFFALO, NEW YORK 14207-3199

SUBJECT: FY19 Joint Routine Inspection of Completed Works, Flood Risk Management Project, Genesee River and Dyke Creek, Wellsville, New York (09/23/19)

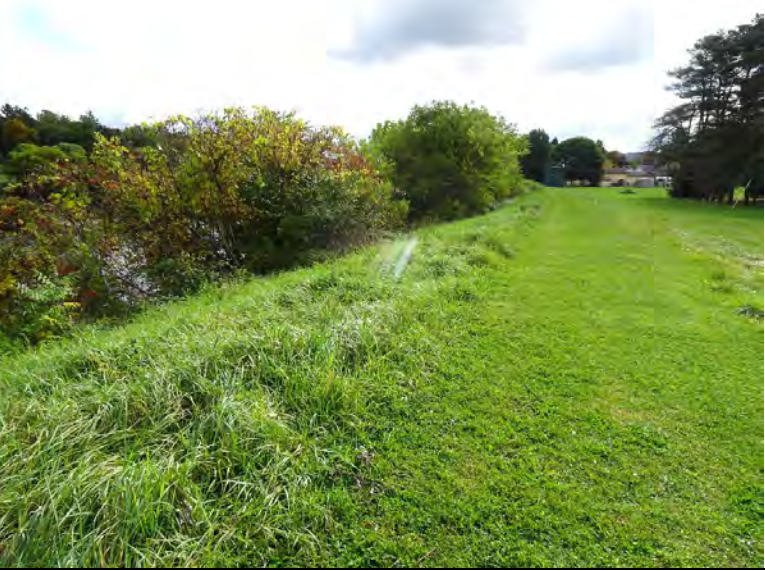
<p>Inspect ID: N21L_2019_r_0055 Title: USACE_CELRB_N21L_2019_r_0055_1.jpg Rated Item: 1. Unwanted Vegetation Growth Caption: Rating: Minimally Acceptable; Remarks: Vegetation in excess of 12" on left bank levee waterside slope from Chamberland Street drainage channel to Madison Street bridge.; Action: Mow vegetation to 3"-6" height.; Station_1: 67+00; Station_2: 66+00</p>

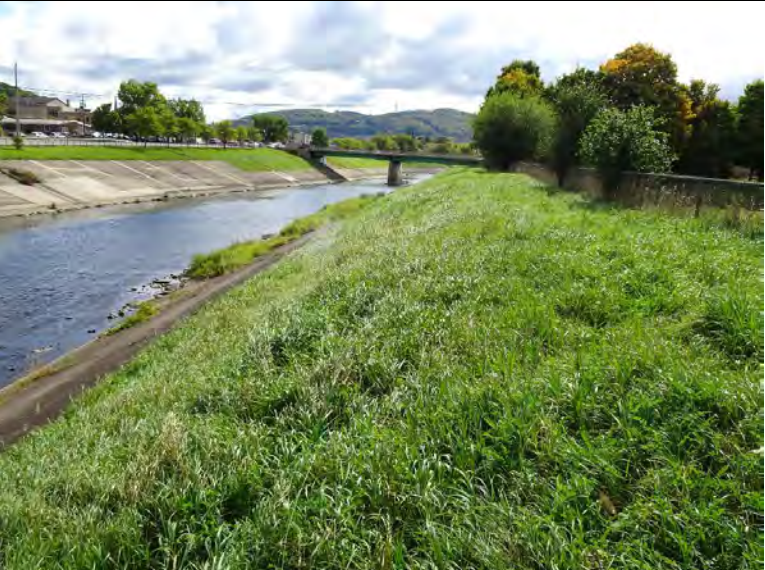
<p>Inspect ID: N21L_2019_r_0055 Title: USACE_CELRB_N21L_2019_r_0055_2.jpg Rated Item: 1. Unwanted Vegetation Growth Caption: Rating: Minimally Acceptable; Remarks: Vegetation in excess of 12" on left bank levee waterside slope from Chamberland Street drainage channel to Madison Street bridge.; Action: Mow vegetation to 3"-6" height.; Station_1: 67+00; Station_2: 66+00</p>

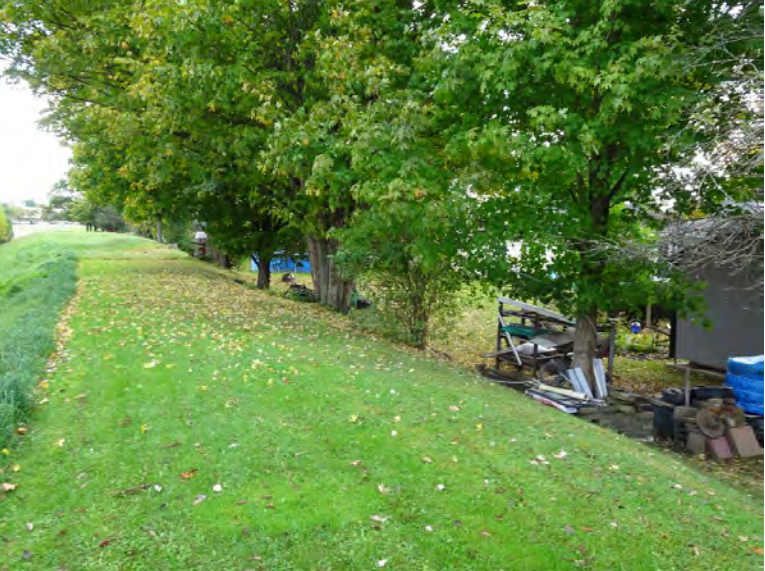
<p>Inspect ID: N21L_2019_r_0060 Title: USACE_CELRB_N21L_2019_r_0060_1.jpg Rated Item: 1. Unwanted Vegetation Growth Caption: Rating: Minimally Acceptable; Remarks: 9 trees and 1 tree stump within 15' of levee landside toe 1,600' downstream of Madison Street (Stevens Street) bridge (60, 68, & 70 Seneca Street).; Action: Remove trees and tree stump.; Station_1: 61+00; Station_2: 58+00</p>

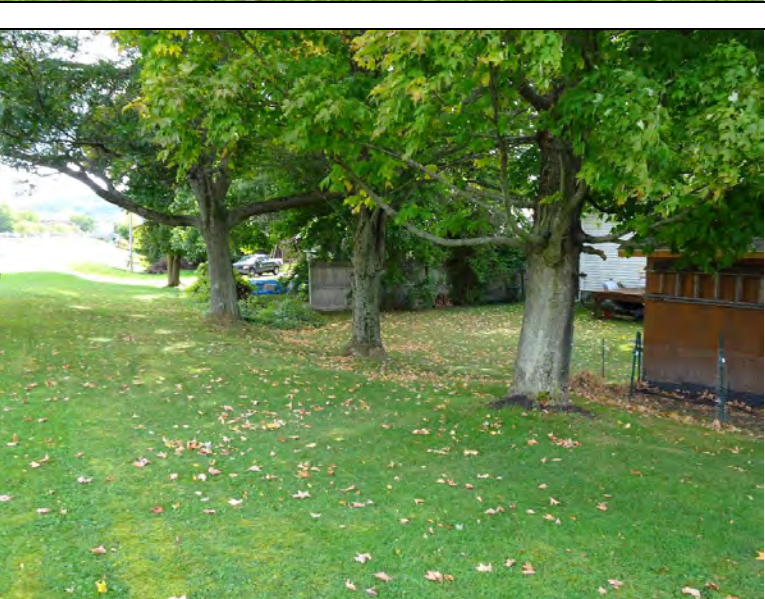
<p>Inspect ID: N21L_2019_r_0072 Title: USACE_CELRB_N21L_2019_r_0072_1.jpg Rated Item: 1. Unwanted Vegetation Growth Caption: Rating: Minimally Acceptable; Remarks: Trees on left bank landside slope and within 15' of landside toe from 1,200' downstream of Madison Street (Stevens Street) bridge to Ponding Area fence.; Action: Remove trees.; Station_1: 54+00; Station_2: 46+00</p>

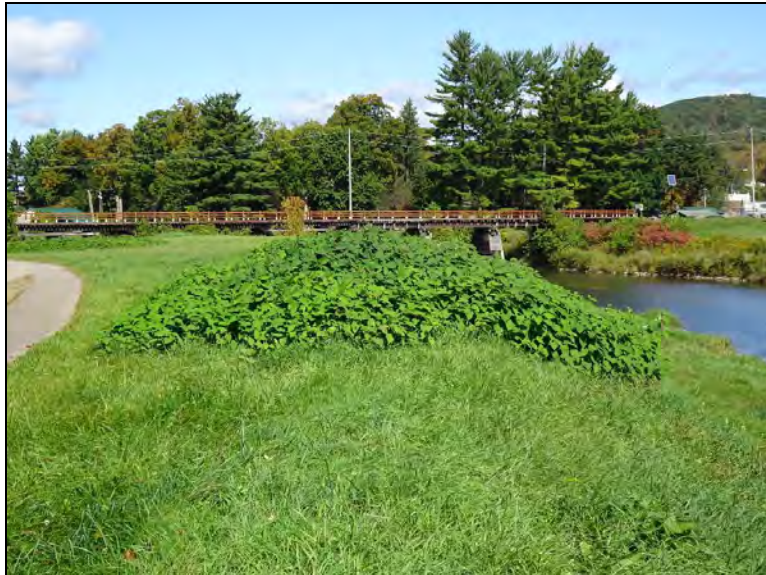
Inspect ID: N21L_2019_r_0133 **Title:** USACE_CELRB_N21L_2019_r_0133_2.jpg
Rated Item: 1. Unwanted Vegetation Growth **Caption:** Rating: Minimally Acceptable;
 Remarks: Vegetation in excess of 12" on left bank of levee, 400' upstream of pedestrian bridge.; Action: Mow vegetation to 3"-6" height.; Station_1: 13+00

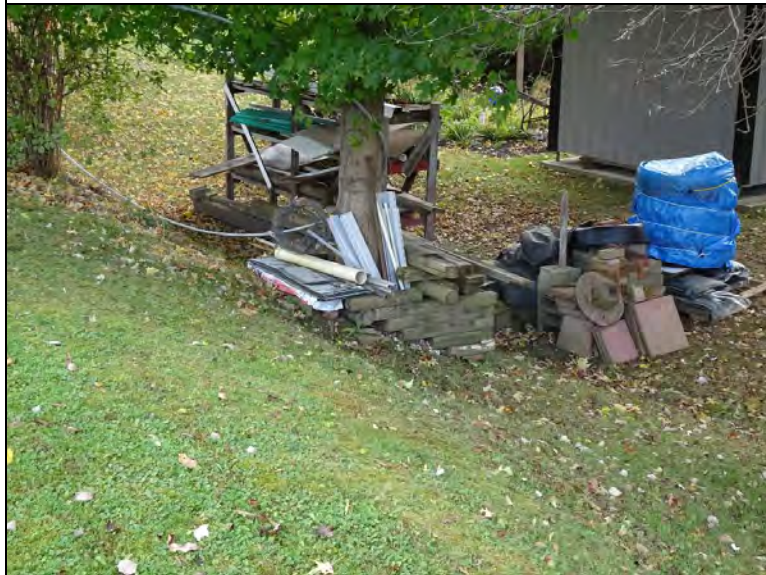
Inspect ID: N21L_2019_r_0061 **Title:** USACE_CELRB_N21L_2019_r_0061_1.jpg
Rated Item: 3. Encroachments **Caption:** Rating: Minimally Acceptable; Remarks:
 Unauthorized alteration (E-15): landscaping timbers and debris on landside slope at 70 Chamberlain Street on left bank 1,700' downstream of Madison Street (Stevens Street) bridge.; Action: Remove or submit Section 408 Alteration Request to USACE.; Station_1: 60+00

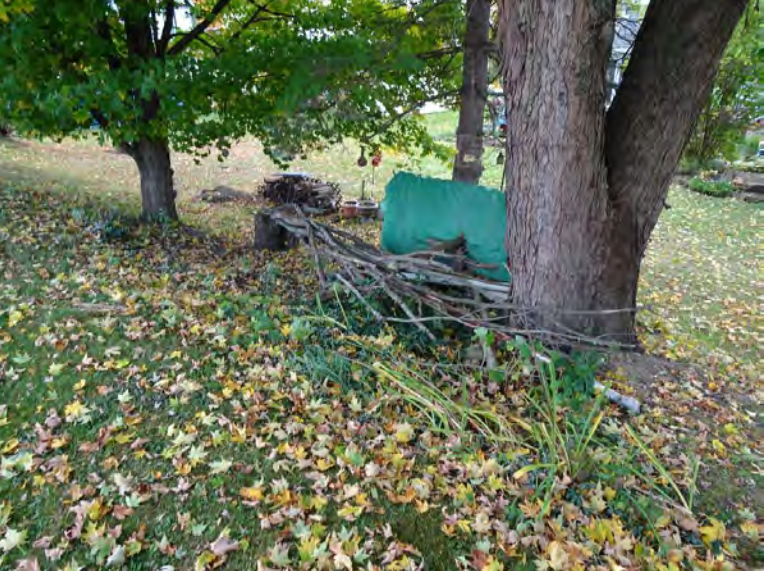
<p>Inspect ID: N21L_2019_r_0061 Title: USACE_CELRB_N21L_2019_r_0061_2.jpg Rated Item: 3. Encroachments Caption: Rating: Minimally Acceptable; Remarks: Unauthorized alteration (E-15): landscaping timbers and debris on landside slope at 70 Chamberlain Street on left bank 1,700' downstream of Madison Street (Stevens Street) bridge.; Action: Remove or submit Section 408 Alteration Request to USACE.; Station_1: 60+00</p>

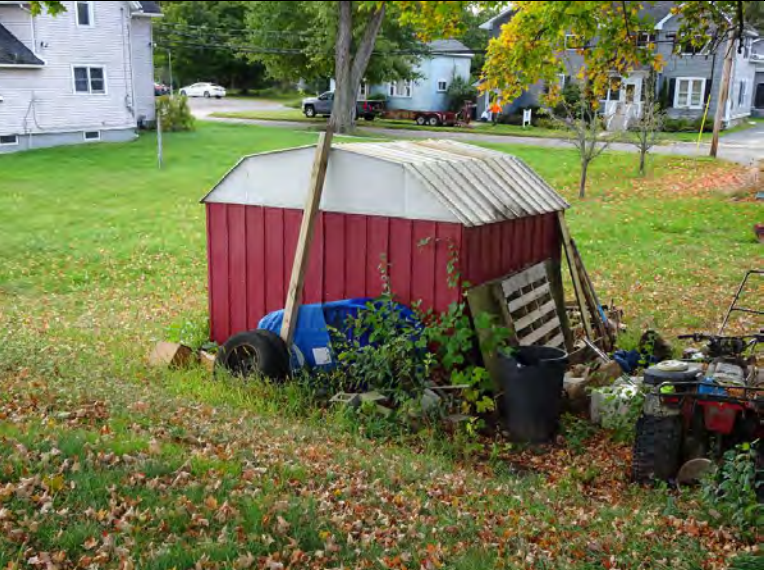
<p>Inspect ID: N21L_2019_r_0062 Title: USACE_CELRB_N21L_2019_r_0062_1.jpg Rated Item: 3. Encroachments Caption: Rating: Minimally Acceptable; Remarks: Unauthorized alteration (E-17): red metal shed and debris at 60 Chamberlain Street on left bank 1,600' downstream of Madison Street (Stevens Street) bridge (60 Chamberlain Street).; Action: Remove or submit Section 408 Alteration Request to USACE.; Station_1: 59+00</p>

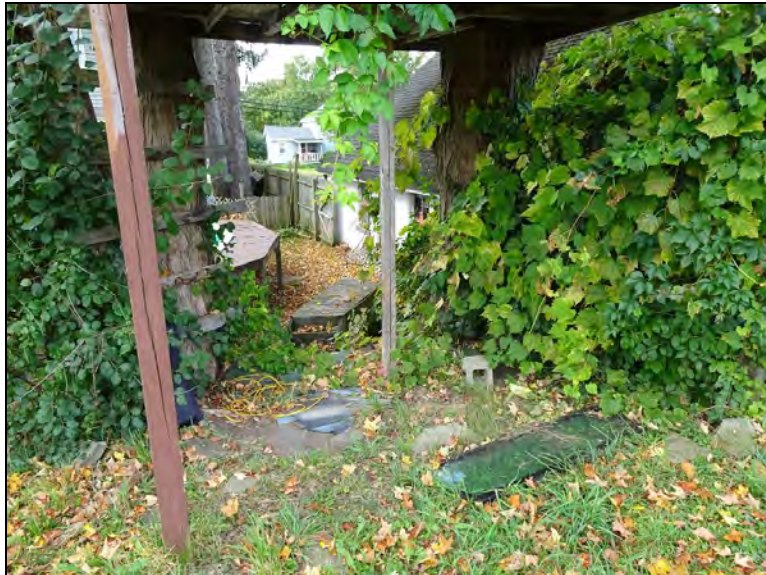
Inspect ID: N21L_2019_r_0069 **Title:** USACE_CELRB_N21L_2019_r_0069_2.jpg
Rated Item: 3. Encroachments **Caption:** Rating: Minimally Acceptable; Remarks: Unauthorized alteration (E-20): stone landscaping on left bank levee landside slope; pool within 15 feet of landside toe; tree fort on levee crown at 48 Chamberlain Street. Note: levee is overbuilt at this location (approx. 42 feet wide).; Action: Remove or submit Section 408 Alteration Request to USACE.; Station_1: 56+00

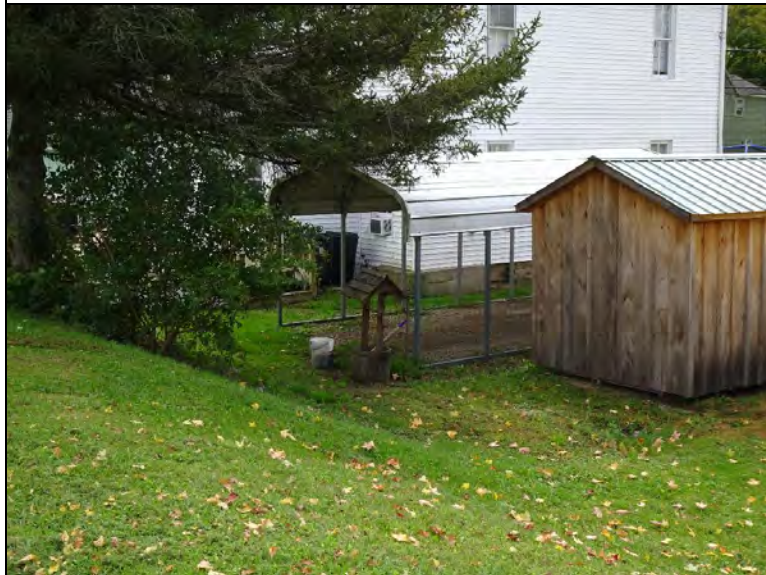
Inspect ID: N21L_2019_r_0070 **Title:** USACE_CELRB_N21L_2019_r_0070_1.jpg
Rated Item: 3. Encroachments **Caption:** Rating: Minimally Acceptable; Remarks: Unauthorized alteration (E-22): carport and patio deck at left bank levee landside toe; clothesline and metal pole on landside slope at 38 Chamberlain Street. Note: levee is overbuilt at this location (approx. 42 feet wide).; Action: Remove or submit Section 408 Alteration Request to USACE.; Station_1: 55+00

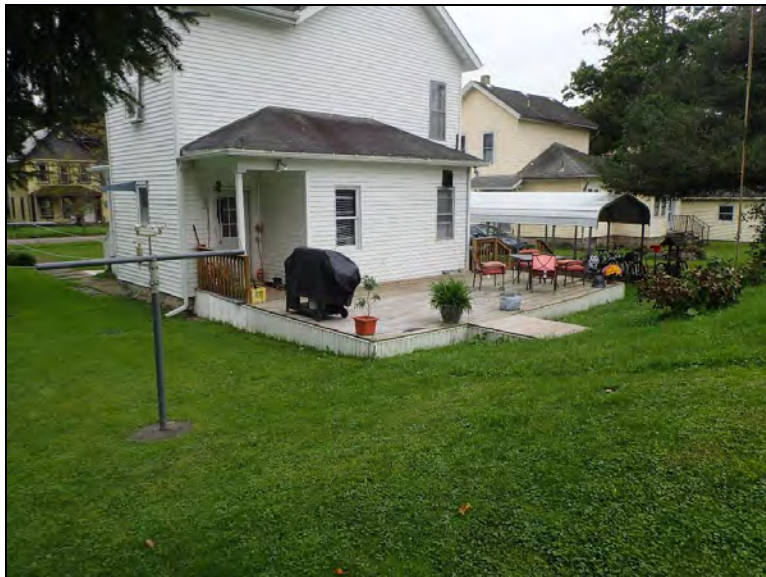
Inspect ID: N21L_2019_r_0070 **Title:** USACE_CELRB_N21L_2019_r_0070_2.jpg
Rated Item: 3. Encroachments **Caption:** Rating: Minimally Acceptable; Remarks: Unauthorized alteration (E-22): carport and patio deck at left bank levee landside toe; clothesline and metal pole on landside slope at 38 Chamberlain Street. Note: levee is overbuilt at this location (approx. 42 feet wide).; Action: Remove or submit Section 408 Alteration Request to USACE.; Station_1: 55+00

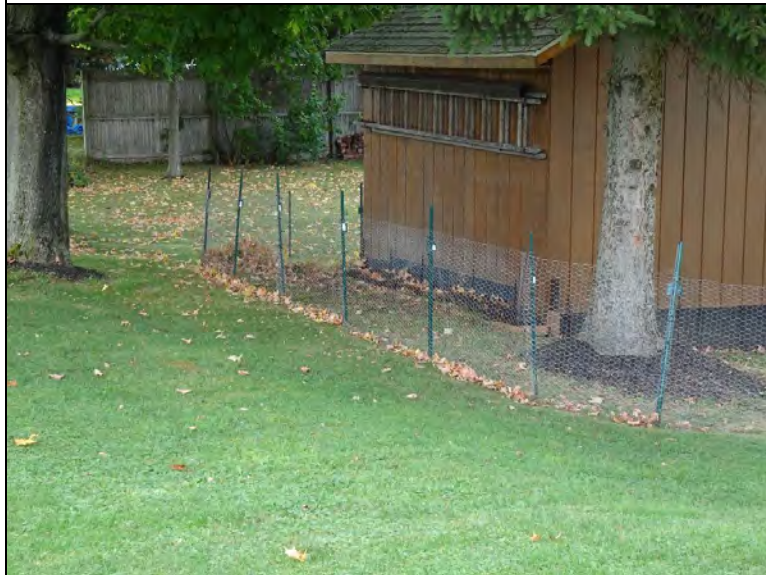
Inspect ID: N21L_2019_r_0071 **Title:** USACE_CELRB_N21L_2019_r_0071_1.jpg
Rated Item: 3. Encroachments **Caption:** Rating: Minimally Acceptable; Remarks: Unauthorized alteration (E-23): chicken wire fence on left bank levee landside toe at 20 Chamberlain Street. Note: levee is overbuilt at this location (approx. 42 feet wide).; Action: Remove or submit Section 408 Alteration Request to USACE.; Station_1: 55+00

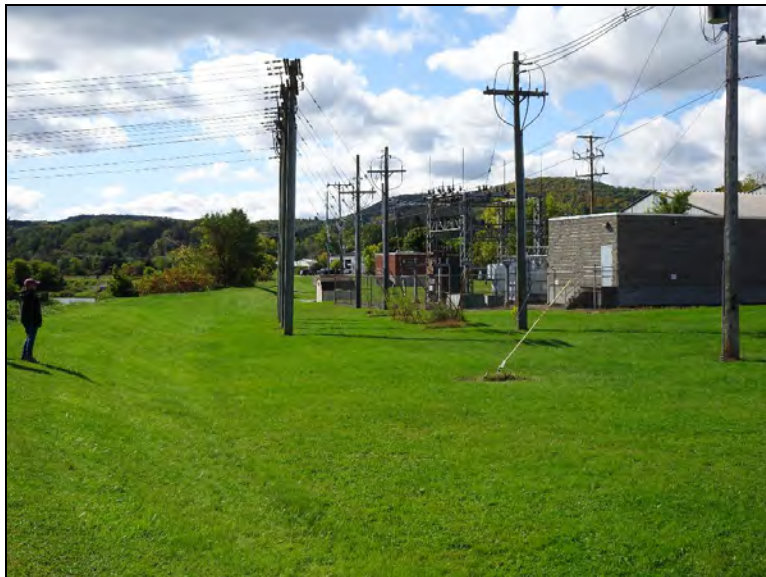
Inspect ID: N21L_2019_r_0110 **Title:** USACE_CELRB_N21L_2019_r_0110_1.jpg
Rated Item: 3. Encroachments **Caption:** Rating: Minimally Acceptable; Remarks: Unauthorized alteration (E-37): 4 utility poles within 15' of landside toe on left bank 250' upstream of State Street bridge.; Action: Submit Section 408 Alteration Request to USACE.; Station_1: 30+00

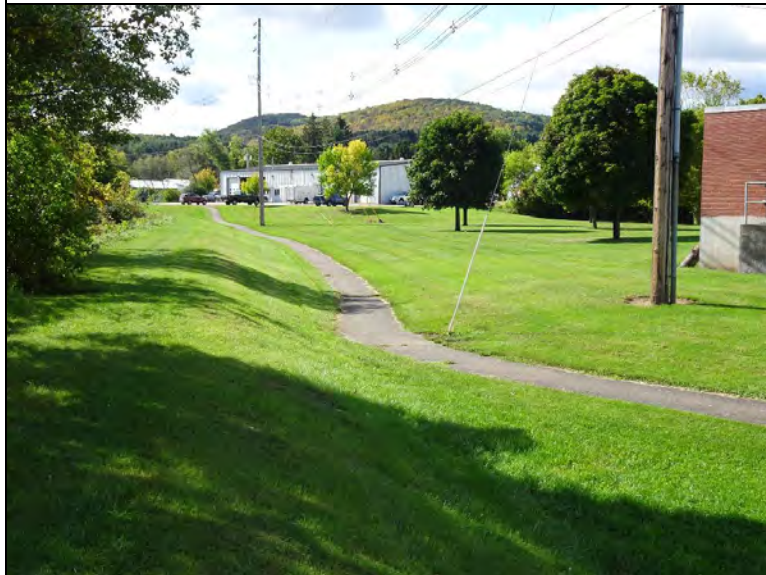
Inspect ID: N21L_2019_r_0114 **Title:** USACE_CELRB_N21L_2019_r_0114_1.jpg
Rated Item: 3. Encroachments **Caption:** Rating: Minimally Acceptable; Remarks: Unauthorized alteration (E-39): asphalt sidewalk and guy wire at left bank levee landside toe.; Action: Submit Section 408 Alteration Request to USACE.; Station_1: 24+00; Station_2: 28+00

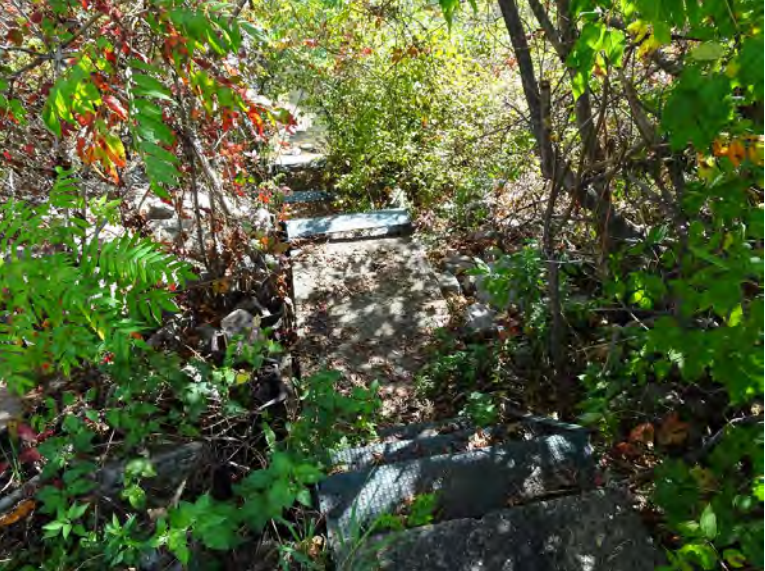
<p>Inspect ID: N21L_2019_r_0115 Title: USACE_CELRB_N21L_2019_r_0115_1.jpg Rated Item: 3. Encroachments Caption: Rating: Minimally Acceptable; Remarks: Unauthorized alteration (E-38): Green metal stairs and concrete pad for access to Water Intake Unit in left bank riverside slope at Steel Sheet Pile Weir (Water Intake Unit is part of project as shown on As-Constructed drawing 189-WEL-2/4).; Action: Remove or submit Section 408 Alteration Request to USACE.; Station_1: 27+00</p>

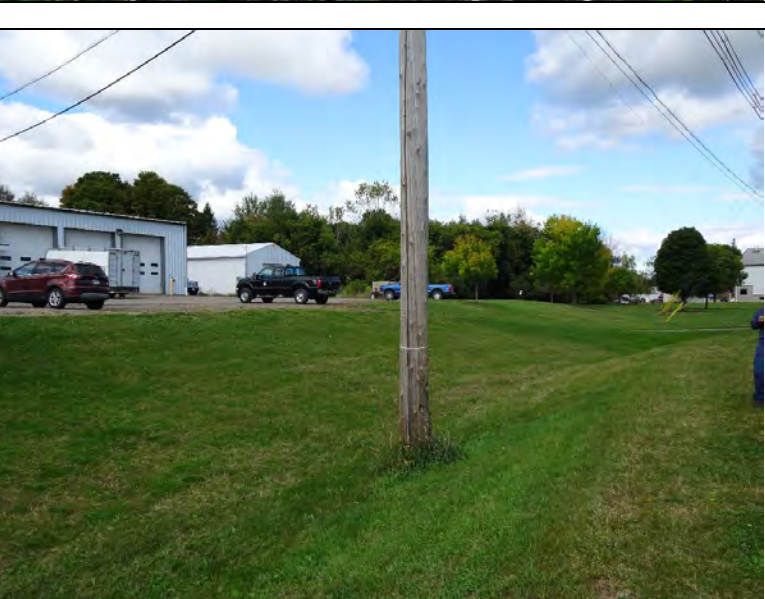
<p>Inspect ID: N21L_2019_r_0122 Title: USACE_CELRB_N21L_2019_r_0122_1.jpg Rated Item: 3. Encroachments Caption: Rating: Minimally Acceptable; Remarks: Unauthorized alteration (E-42): utility pole on left bank landside slope 475' upstream of Steel Sheet Pile Weir (across from maintenance garage).; Action: Submit Section 408 Alteration Request to USACE.; Station_1: 23+00</p>

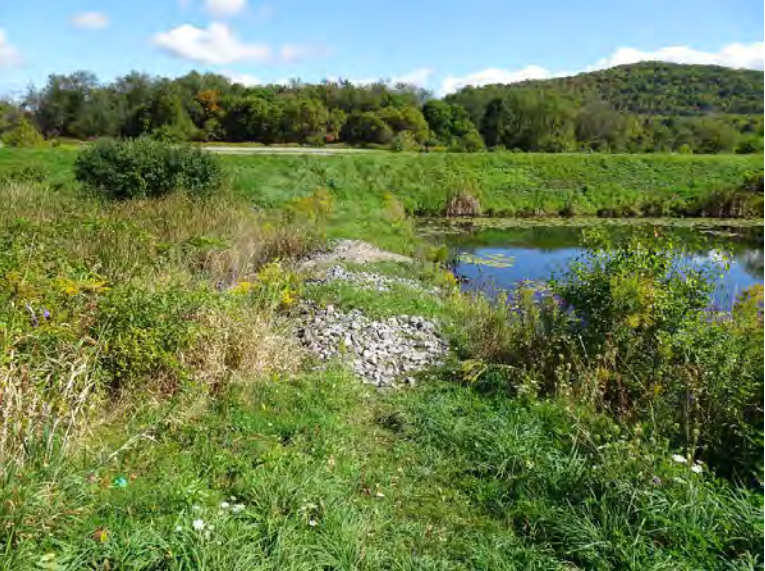
<p>Inspect ID: N21L_2019_r_0142 Title: USACE_CELRB_N21L_2019_r_0142_1.jpg Rated Item: 3. Encroachments Caption: Rating: Acceptable; Remarks: Approved alteration: drainage swale berm at left bank lagoon between barrier levee weir and upstream limit weir.; Action: NA; Station_1: 0+00; Station_2: 0+00</p>

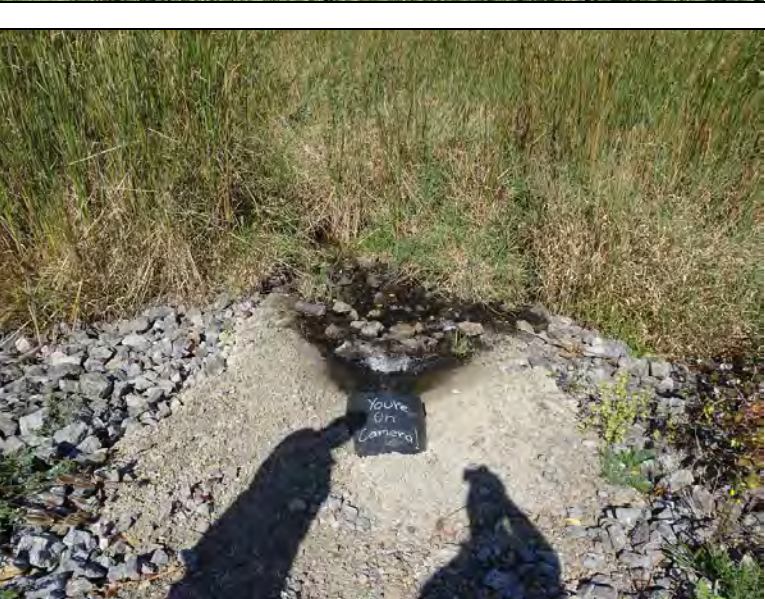
<p>Inspect ID: N21L_2019_r_0142 Title: USACE_CELRB_N21L_2019_r_0142_3.jpg Rated Item: 3. Encroachments Caption: Rating: Acceptable; Remarks: Approved alteration: drainage swale berm at left bank lagoon between barrier levee weir and upstream limit weir.; Action: NA; Station_1: 0+00; Station_2: 0+00</p>

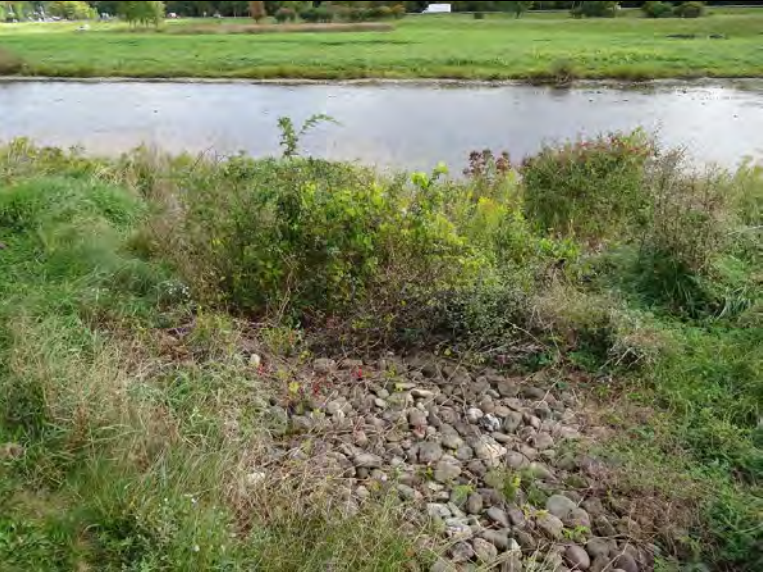
<p>Inspect ID: N21L_2019_r_0043 Title: USACE_CELRB_N21L_2019_r_0043_1.jpg Rated Item: 1. Vegetation and Obstructions Caption: Rating: Minimally Acceptable; Remarks: 24" CMP outfall on left bank 1,600' upstream of Bolivar Road bridge is approx. 20% obstructed by vegetation and sediment.; Action: Remove vegetation and sediment obstructions.; Station_1: 75+00</p>

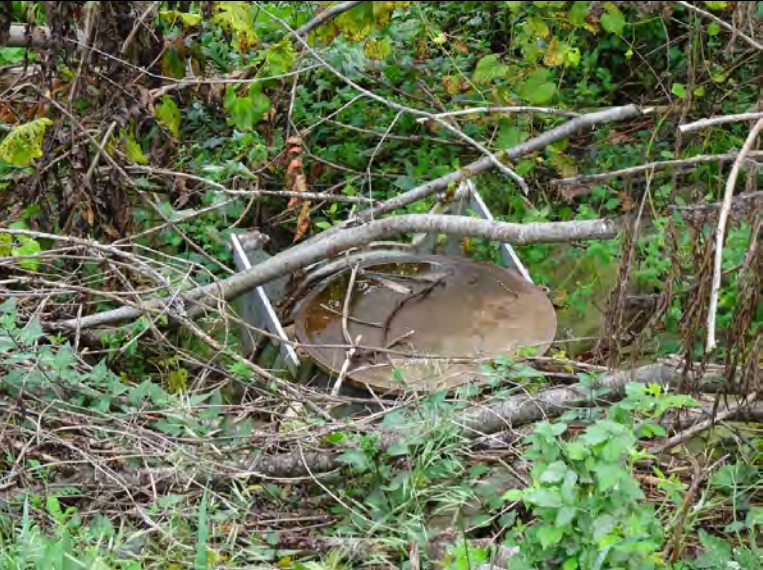
<p>Inspect ID: N21L_2019_r_0059 Title: USACE_CELRB_N21L_2019_r_0059_1.jpg Rated Item: 2. Encroachments Caption: Rating: Unacceptable; Remarks: Unauthorized alteration (E-15a): 24" CMP outfall with flap gate encroachment through levee. Flap gate stuck in open position. Pipe has not been videotaped. ; Action: Remove or submit Section 408 Alteration Request to USACE. Videotape pipe. Close flap gate and check seal.; Station_1: 61+00</p>

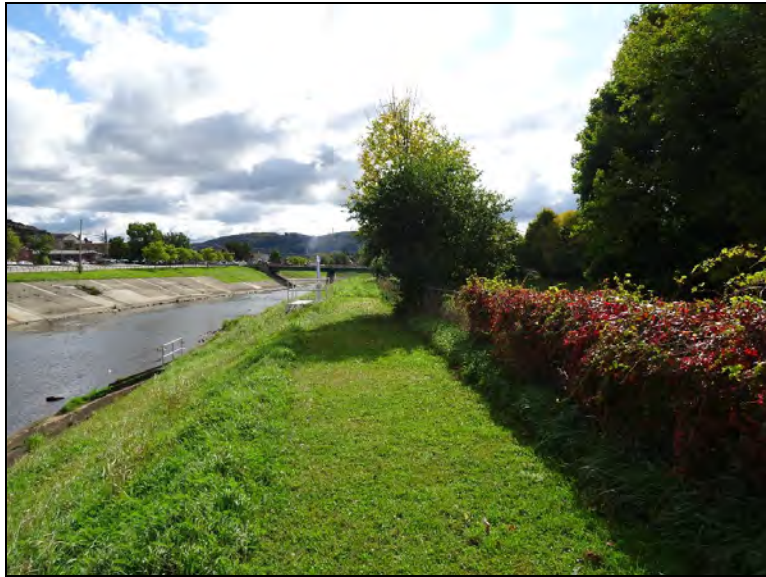
Rated Item	Rating	Rating Guidelines		Location/Remarks/Recommendations
		N/A	There are no features noted that require safety fencing.	on left bank, 900' upstream of Bolivar Road bridge.: Properly repair headwall railing. (M) N21L_2019_r_0081: Station_1 50+00: Station_2 47+00: Trees and vegetation on ponding area fence.: Remove trees and vegetation. (M)

Inspect ID: N21L_2019_r_0081 **Title:** USACE_CELRB_N21L_2019_r_0081_1.jpg
Rated Item: 4. Fencing and Gates **Caption:** Rating: Minimally Acceptable; Remarks: Trees and vegetation on ponding area fence.; Action: Remove trees and vegetation.; Station_1: 50+00; Station_2: 47+00

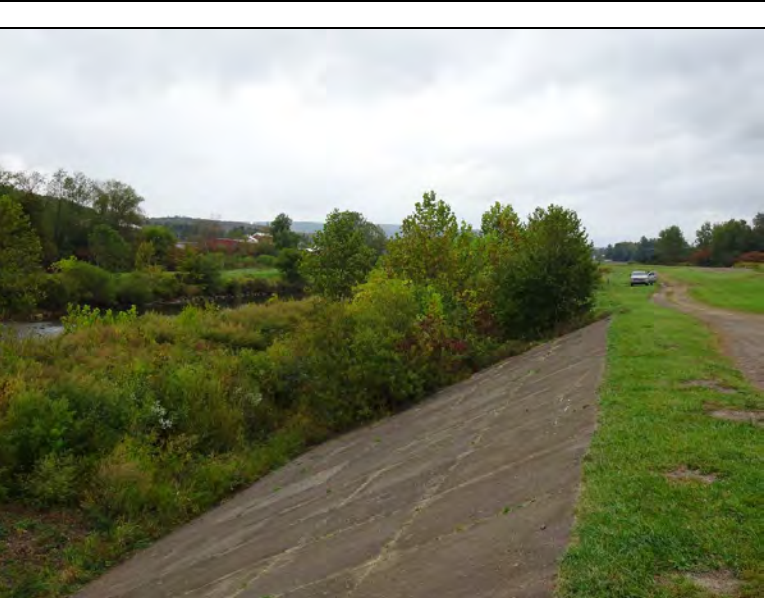
<p>Inspect ID: N21L_2019_r_0003 Title: USACE_CELRB_N21L_2019_r_0003_1.jpg Rated Item: 1. Vegetation and Obstructions Caption: Rating: Unacceptable; Remarks: Trees and vegetation on right bank sideslope from 400' downstream of upstream limit weir to upstream limit weir.; Action: Remove vegetation.; Station_1: 0+00; Station_2: 0+00</p>

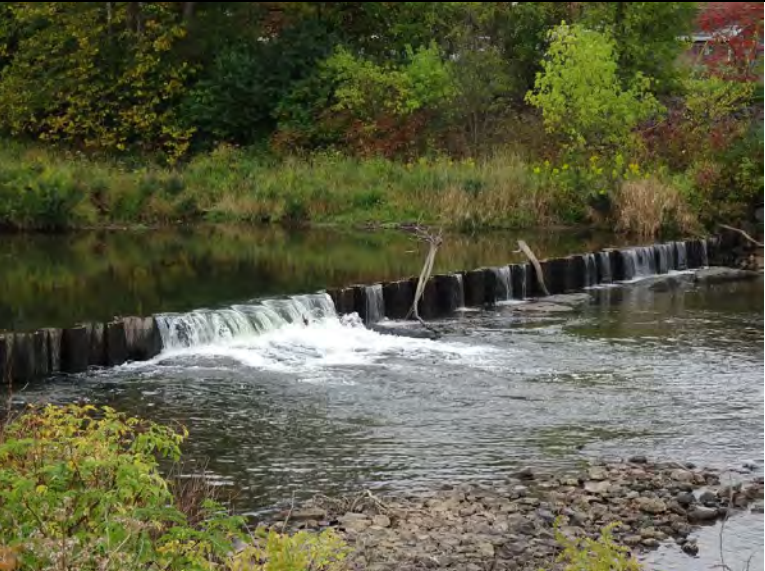
<p>Inspect ID: N21L_2019_r_0008 Title: USACE_CELRB_N21L_2019_r_0008_1.jpg Rated Item: 1. Vegetation and Obstructions Caption: Rating: Acceptable; Remarks: Weir structure at barrier levee ("barrier levee weir") at upstream end of project, clear of debris; Action: NA; Station_1: 0+00</p>

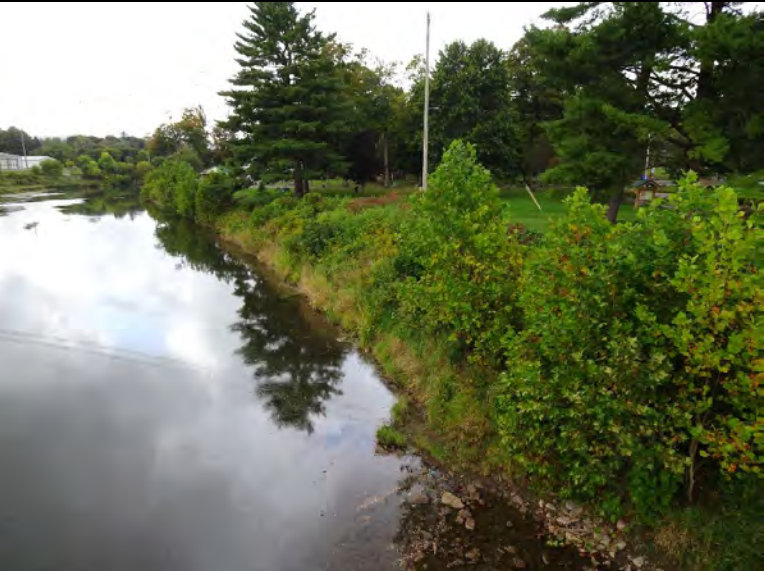
<p>Inspect ID: N21L_2019_r_0010 Title: USACE_CELRB_N21L_2019_r_0010_2.jpg Rated Item: 1. Vegetation and Obstructions Caption: Rating: Minimally Acceptable; Remarks: Trees and vegetation on right bank from Island Park to 500' upstream of Island Park pedestrian bridge.; Action: Remove trees and vegetation.; Station_1: 29+00; Station_2: 11+00</p>

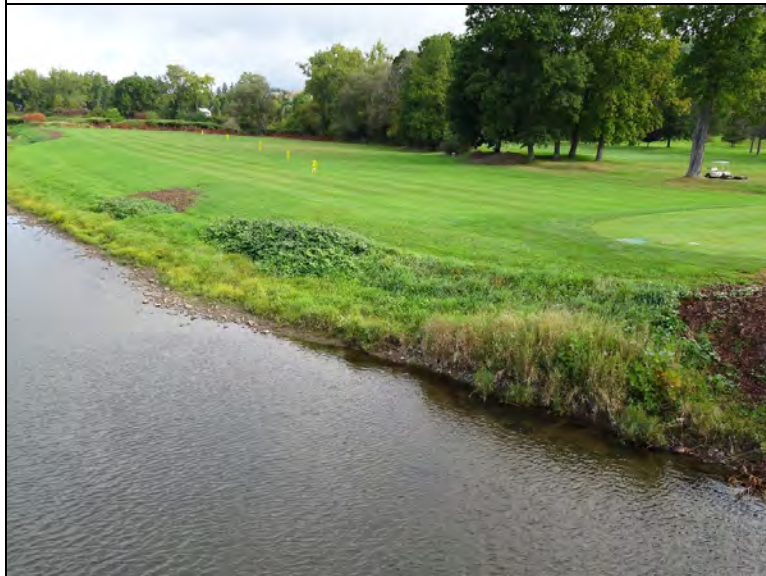
Inspect ID: N21L_2019_r_0018 **Title:** USACE_CELRB_N21L_2019_r_0018_1.jpg
Rated Item: 1. Vegetation and Obstructions **Caption:** Rating: Minimally Acceptable;
 Remarks: Vegetation in excess of 12" on right bank of channel just downstream of golf course pedestrian bridge.; Action: Mow vegetation to 3"-6" height.; Station_1: 104+00; Station_2: 106+00

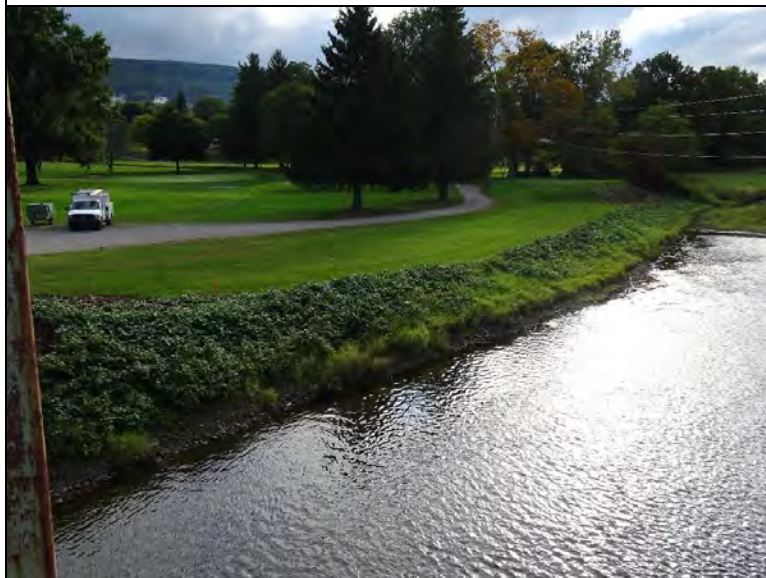
Inspect ID: N21L_2019_r_0021 **Title:** USACE_CELRB_N21L_2019_r_0021_1.jpg
Rated Item: 1. Vegetation and Obstructions **Caption:** Rating: Minimally Acceptable;
Remarks: Vegetation in excess of 12" on right bank of channel from golf course pedestrian bridge to Bolivar Road bridge.; **Action:** Mow vegetation to 3"-6" height.;
Station_1: 103+00; **Station_2:** 101+00

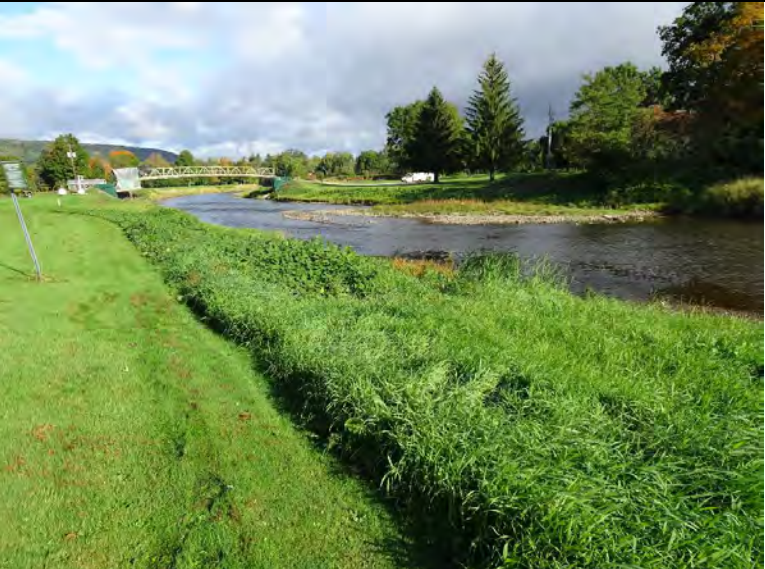
<p>Inspect ID: N21L_2019_r_0025 Title: USACE_CELRB_N21L_2019_r_0025_1.jpg Rated Item: 1. Vegetation and Obstructions Caption: Rating: Minimally Acceptable; Remarks: Vegetation in excess of 12" on left bank of channel from golf course pedestrian bridge to Bolivar Road bridge.; Action: Mow vegetation to 3"-6" height.; Station_1: 104+00; Station_2: 103+00</p>

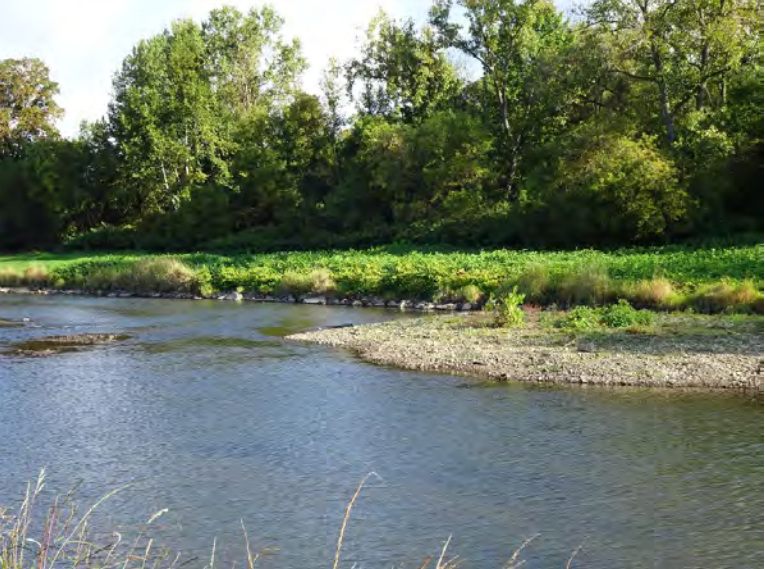
<p>Inspect ID: N21L_2019_r_0027 Title: USACE_CELRB_N21L_2019_r_0027_1.jpg Rated Item: 1. Vegetation and Obstructions Caption: Rating: Minimally Acceptable; Remarks: Vegetation in excess of 12" on right bank of channel 280' downstream from Bolivar Road Bridge.; Action: Mow vegetation to 3"-6" height.; Station_1: 94+00</p>

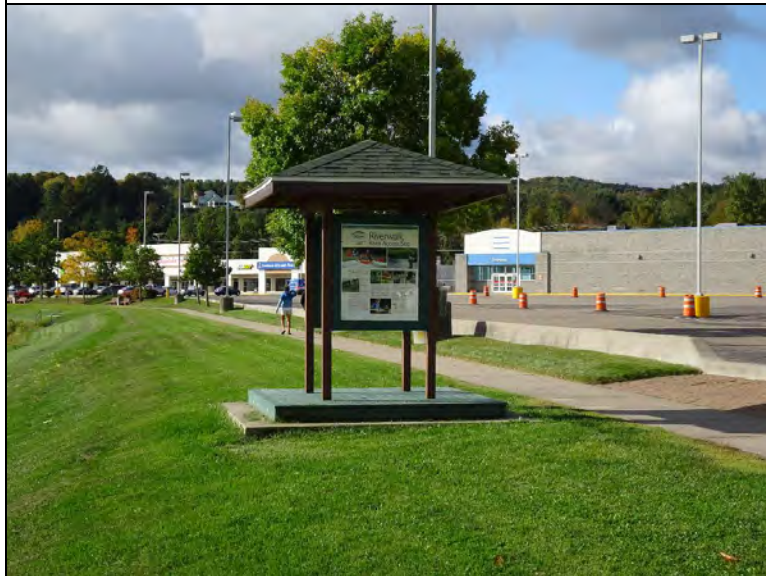
Inspect ID: N21L_2019_r_0036 **Title:** USACE_CELRB_N21L_2019_r_0036_1.jpg
Rated Item: 1. Vegetation and Obstructions **Caption:** Rating: Minimally Acceptable;
Remarks: Unauthorized alteration (E-5): River Walk Trail kiosk on left bank channel crest.; **Action:** Submit Section 408 Alteration Request to USACE.; **Station_1:** 85+00

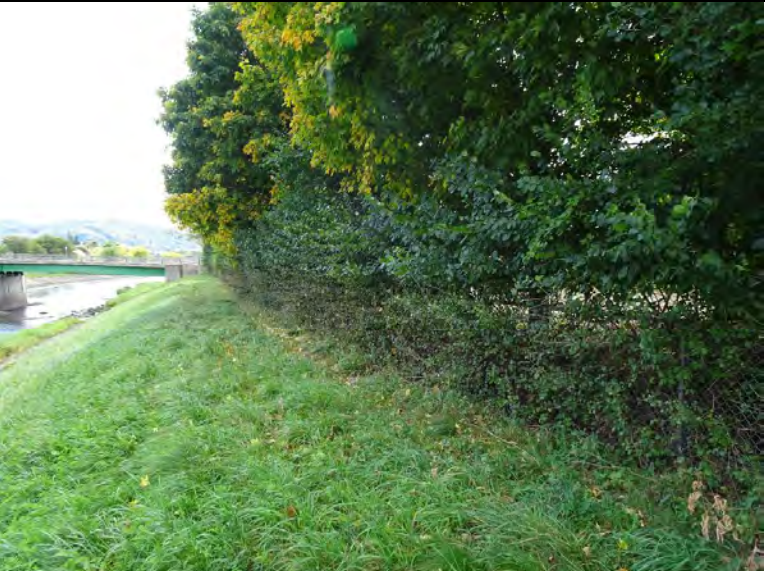
<p>Inspect ID: N21L_2019_r_0095 Title: USACE_CELRB_N21L_2019_r_0095_1.jpg Rated Item: 1. Vegetation and Obstructions Caption: Rating: Minimally Acceptable; Remarks: Trees on left bank channel crest from 250' downstream of Madison Street (Stevens Street) bridge to Madison Street bridge.; Action: Remove trees.; Station_1: 46+00; Station_2: 44+00</p>

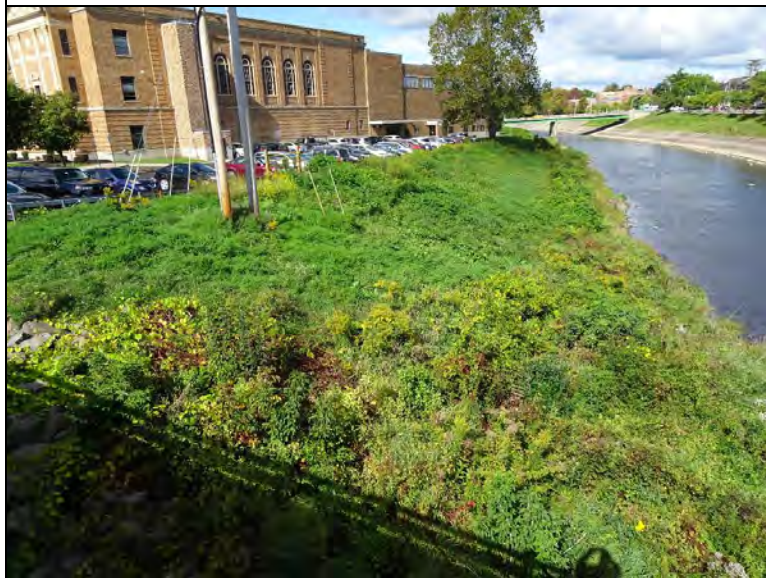
Inspect ID: N21L_2019_r_0103 **Title:** USACE_CELRB_N21L_2019_r_0103_2.jpg
Rated Item: 1. Vegetation and Obstructions **Caption:** Rating: Minimally Acceptable;
Remarks: Unwanted vegetation on left bank from State Street Bridge to 400'
downstream.; **Action:** Mow vegetation to 3"-6" height.; **Station_1:** 37+00

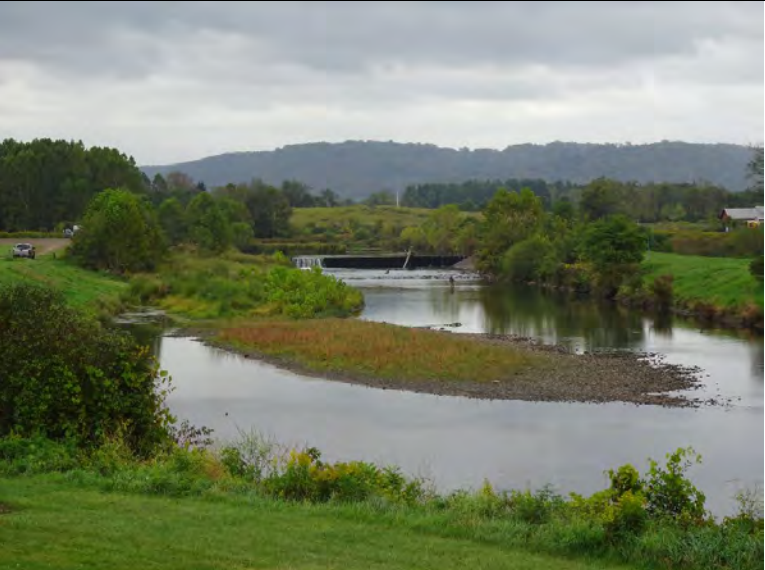
<p>Inspect ID: N21L_2019_r_0004 Title: USACE_CELRB_N21L_2019_r_0004_2.jpg Rated Item: 2. Shoaling (sediment deposition) Caption: Rating: Unacceptable; Remarks: Significant vegetated shoal (S-11) and trees in channel on right bank from 100'-700' downstream of upstream limit weir.; Action: Remove shoaling.; Station_1: 0+00</p>

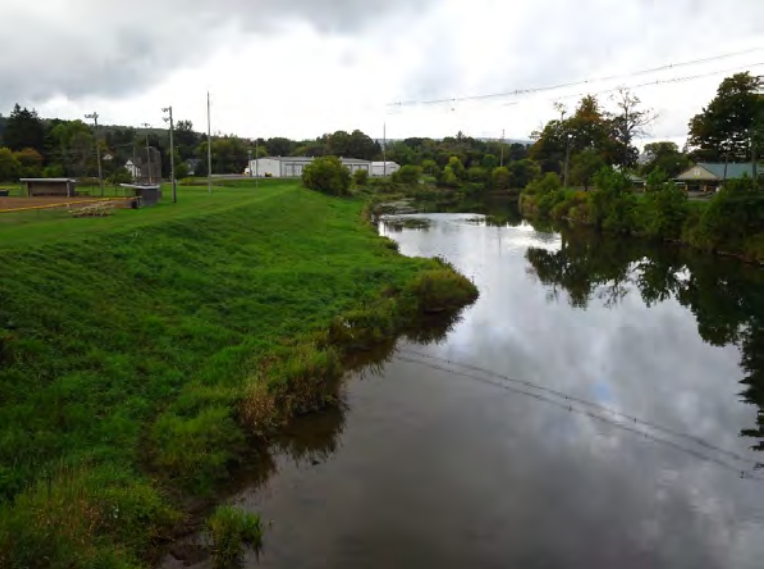
<p>Inspect ID: N21L_2019_r_0012 Title: USACE_CELRB_N21L_2019_r_0012_1.jpg Rated Item: 2. Shoaling (sediment deposition) Caption: Rating: Minimally Acceptable; Remarks: Shoal (S-9) along left bank toe from 450' downstream of Island Park pedestrian walkway bridge to Island Park Pedestrian Walkway Bridge.; Action: Remove shoaling.; Station_1: 17+00; Station_2: 21+00</p>

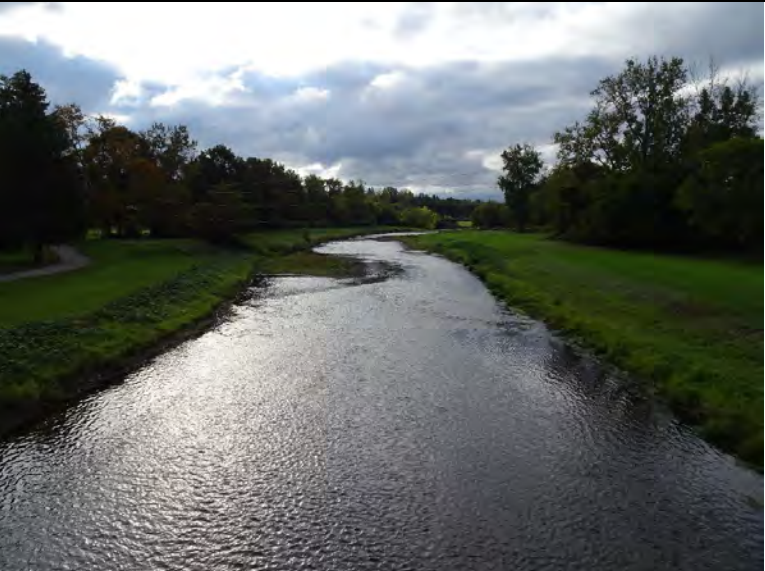
<p>Inspect ID: N21L_2019_r_0022 Title: USACE_CELRB_N21L_2019_r_0022_1.jpg Rated Item: 2. Shoaling (sediment deposition) Caption: Rating: Minimally Acceptable; Remarks: Four alternating vegetated shoals (S-2, S-3, S-4, S-5) on both banks from green golf course pedestrian bridge to Bolivar Road Bridge.; Action: Remove shoals.; Station_1: 103+00; Station_2: 92+00</p>

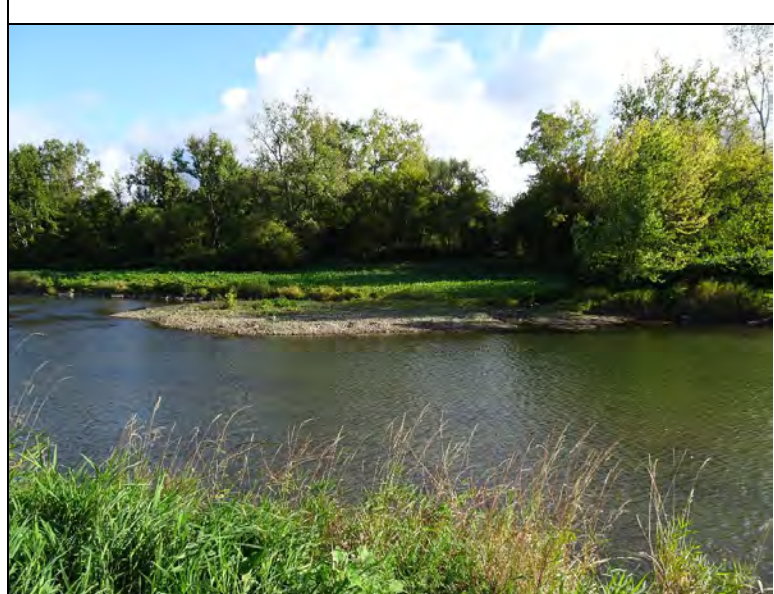
<p>Inspect ID: N21L_2019_r_0022 Title: USACE_CELRB_N21L_2019_r_0022_3.jpg Rated Item: 2. Shoaling (sediment deposition) Caption: Rating: Minimally Acceptable; Remarks: Four alternating vegetated shoals (S-2, S-3, S-4, S-5) on both banks from green golf course pedestrian bridge to Bolivar Road Bridge.; Action: Remove shoals.; Station_1: 103+00; Station_2: 92+00</p>

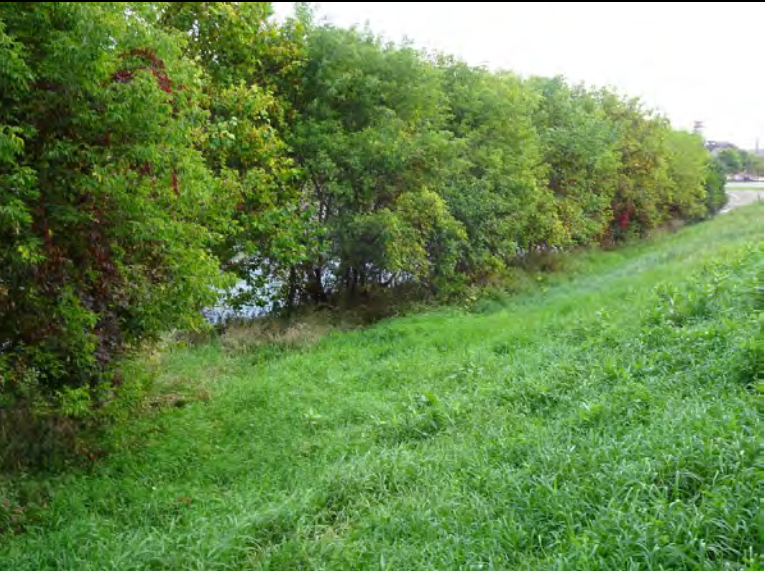
<p>Inspect ID: N21L_2019_r_0064 Title: USACE_CELRB_N21L_2019_r_0064_1.jpg Rated Item: 2. Shoaling (sediment deposition) Caption: Rating: Minimally Acceptable; Remarks: Shoal (S-7) on left bank toe, not part of as-built project (189-WEL-2/5).; Action: Remove Shoal.; Station_1: 60+00; Station_2: 56+00</p>

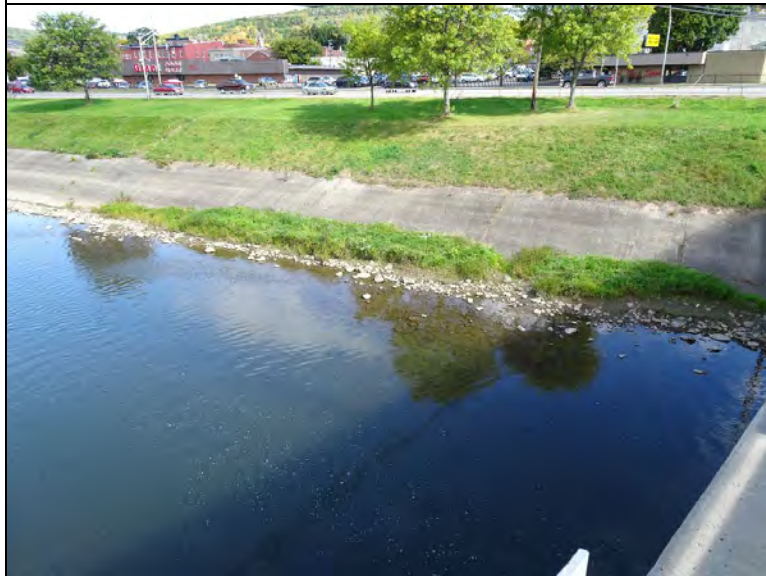
Inspect ID: N21L_2019_r_0106 **Title:** USACE_CELRB_N21L_2019_r_0106_1.jpg
Rated Item: 2. Shoaling (sediment deposition) **Caption:** Rating: Minimally Acceptable;
Remarks: Minor shoal along right bank channel toe just downstream of State Street Bridge.; **Action:** Remove shoal.; **Station_1:** D 0+00; **Station_2:** 35+00

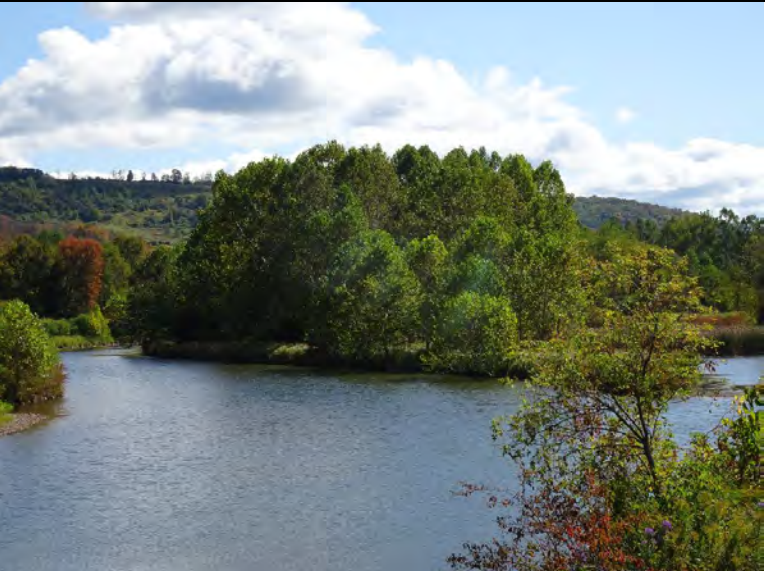
<p>Inspect ID: N21L_2019_r_0146 Title: USACE_CELRB_N21L_2019_r_0146_1.jpg Rated Item: 2. Shoaling (sediment deposition) Caption: Rating: Unacceptable; Remarks: Significant vegetated shoaling (S-13) with trees in center of channel just upstream of upstream limit weir.; Action: Remove shoaling.; Station_1: 0+00</p>

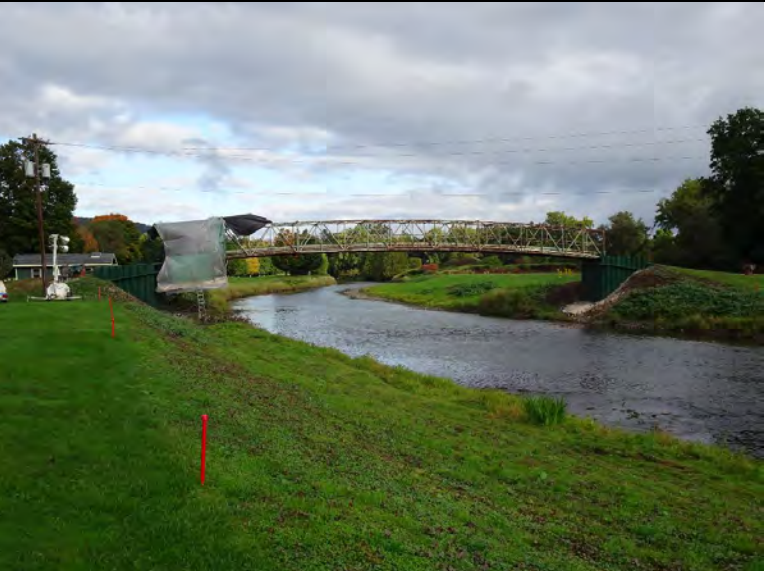
<p>Inspect ID: N21L_2019_r_0016 Title: USACE_CELRB_N21L_2019_r_0016_1.jpg Rated Item: 3. Encroachments Caption: Rating: Minimally Acceptable; Remarks: Unauthorized alteration (E-2): Green golf course pedestrian bridge 1,250' downstream of Boliver Road bridge. NYSDEC says permitted (need to verify).; Action: Submit Section 408 Alteration Request to USACE.; Station_1: 104+00</p>

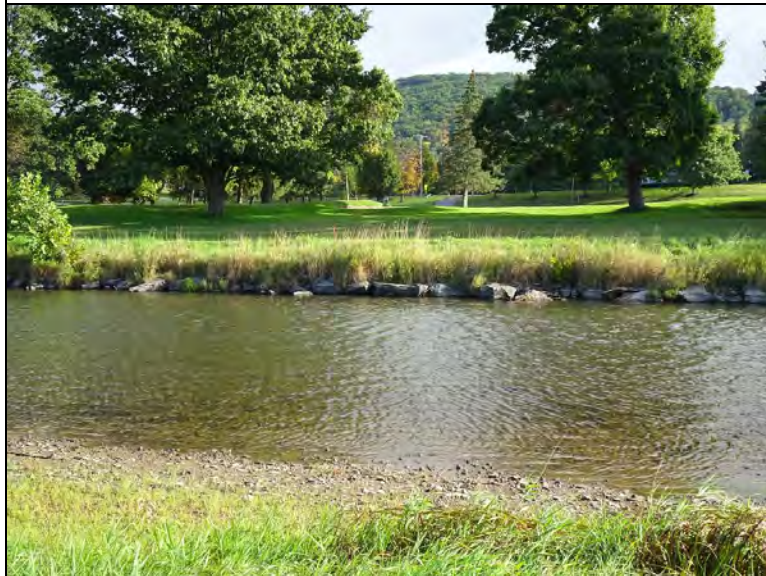
Inspect ID: N21L_2019_r_0026 **Title:** USACE_CELRB_N21L_2019_r_0026_1.jpg
Rated Item: 3. Encroachments **Caption:** Rating: Minimally Acceptable; Remarks: Unauthorized alteration (E-3): riprap on right bank toe from 300' upstream of pedestrian bridge to 300 feet downstream of Bolivar Street bridge.; Action: Submit Section 408 Alteration Request to USACE.; Station_1: 100+00; Station_2: 93+00

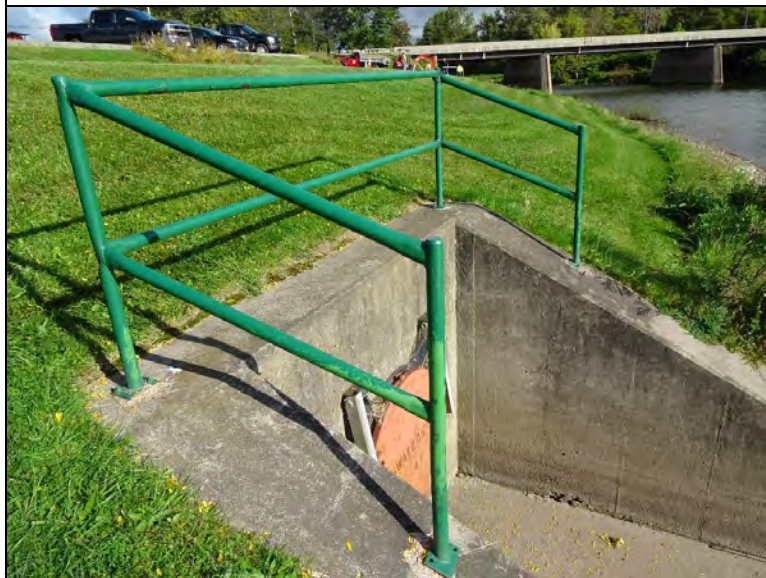
Inspect ID: N21L_2019_r_0035 **Title:** USACE_CELRB_N21L_2019_r_0035_1.jpg
Rated Item: 3. Encroachments **Caption:** Rating: Minimally Acceptable; Remarks: Unauthorized alteration (E-6): 42" outfall on left bank 300' upstream of Bolivar Road bridge. NYSDEC says permitted.; Action: Submit Section 408 Alteration Request to USACE or verify USACE permission.; Station_1: 88+00
