DEPARTMENT OF THE ARMY

BUFFALO DISTRICT, CORPS OF ENGINEERS
1776 NIAGARA STREET
BUFFALO, NEW YORK 14207-3199

SUBJECT: FY19 Joint Routine Inspection of Completed Works, Flood Risk Management Project, Genesee River and Dyke Creek, Wellsville, New York (09/23/19)

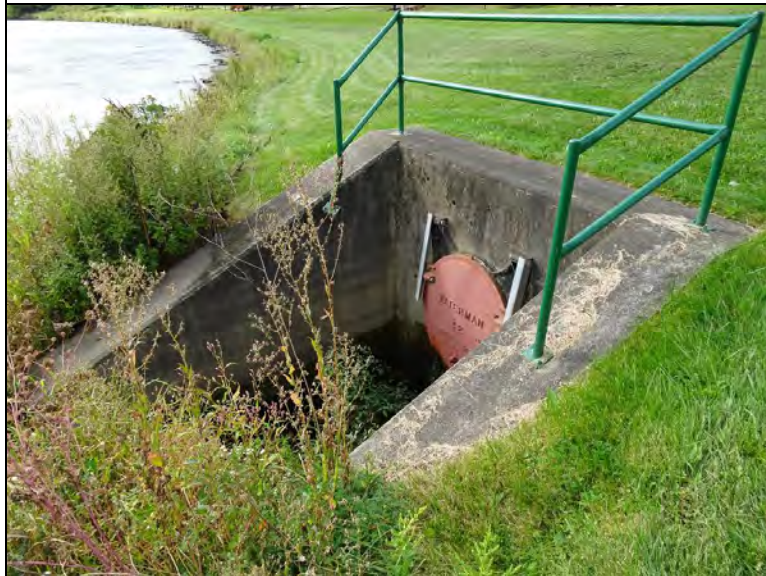
Inspect ID: N21L_2019_r_0039 **Title:** USACE_CELRB_N21L_2019_r_0039_1.jpg
Rated Item: 3. Encroachments **Caption:** Rating: Minimally Acceptable; Remarks: Unauthorized alteration (E-7): 42" outfall on left bank 900' upstream of Bolivar Road Bridge at plaza. NYSDEC says permitted.; Action: Submit Section 408 Alteration Request to USACE or verify USACE permission.; Station_1: 82+00

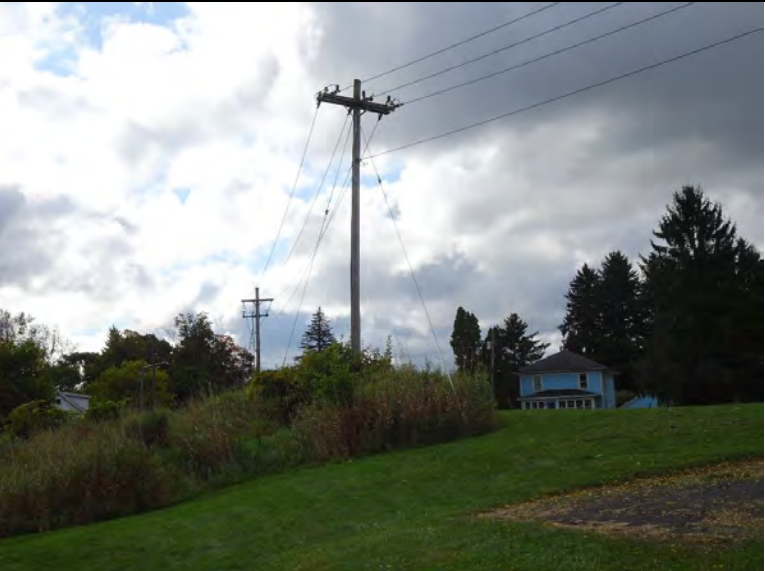
<p>Inspect ID: N21L_2019_r_0046 Title: USACE_CELRB_N21L_2019_r_0046_1.jpg Rated Item: 3. Encroachments Caption: Rating: Acceptable; Remarks: Project infrastructure: utility pole and 2 guy wires on left bank channel crest 1,700' upstream of Boliver Road bridge (just upstream of asphalt drive).; Action: NA; Station_1: 74+00</p>

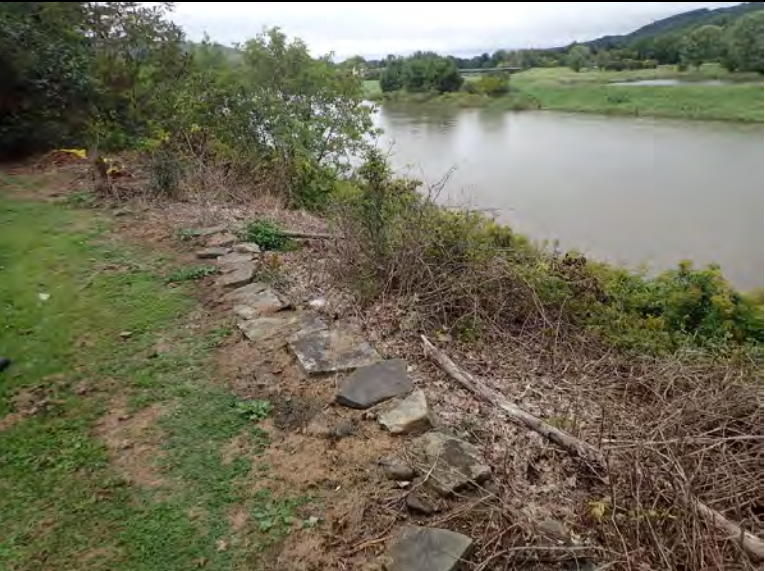
<p>Inspect ID: N21L_2019_r_0048 Title: USACE_CELRB_N21L_2019_r_0048_1.jpg Rated Item: 3. Encroachments Caption: Rating: Minimally Acceptable; Remarks: Unauthorized alteration (E-9): stone along left bank channel crest at 82 Seneca Street.; Action: Remove or submit Section 408 Alteration Request to USACE.; Station_1: 71+00</p>

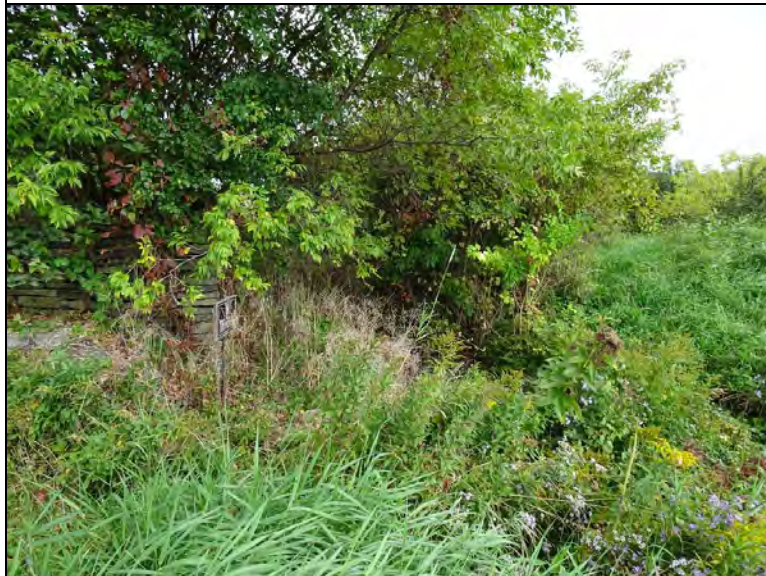
Inspect ID: N21L_2019_r_0051 **Title:** USACE_CELRB_N21L_2019_r_0051_1.jpg
Rated Item: 3. Encroachments **Caption:** Rating: Minimally Acceptable; Remarks: Vegetation obstructions in Chamberlain Street drainage ditch to river.; Action: Remove vegetation obstructions.; Station_1: 69+00

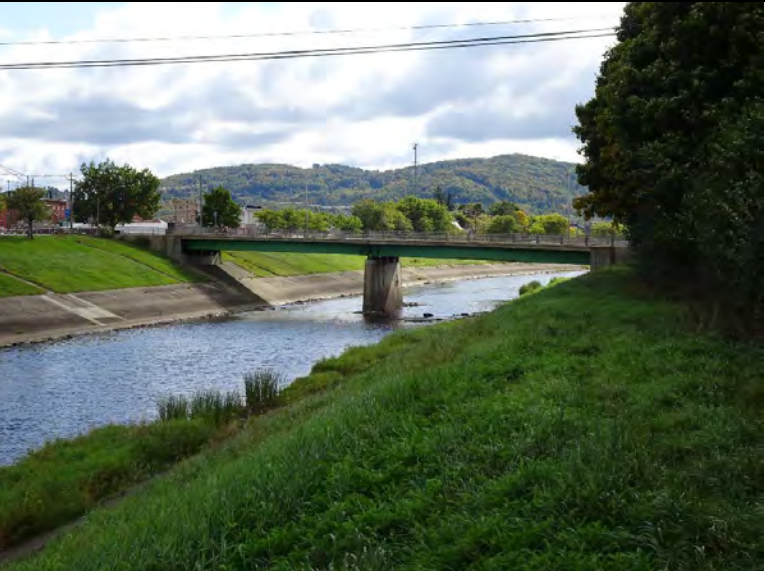
<p>Inspect ID: N21L_2019_r_0091 Title: USACE_CELRB_N21L_2019_r_0091_1.jpg Rated Item: 3. Encroachments Caption: Rating: Minimally Acceptable; Remarks: Unauthorized alteration (E-27): pipe line bridge just downstream of Steven Street bridge has been removed.; Action: Submit Section 408 Alteration Request to USACE.; Station_1: 46+00</p>

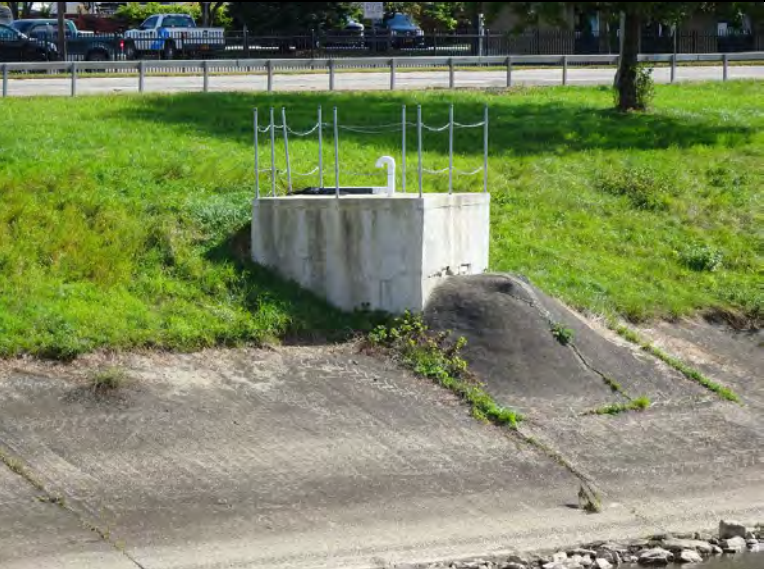
<p>Inspect ID: N21L_2019_r_0099 Title: USACE_CELRB_N21L_2019_r_0099_1.jpg Rated Item: 3. Encroachments Caption: Rating: Minimally Acceptable; Remarks: Unauthorized alteration (E-35): concrete siphon gatewell on right bank channel sideslope (across from school). NYSDEC says permitted.; Action: Submit Section 408 Alteration Request to USACE or verify USACE permission.; Station_1: 36+00</p>

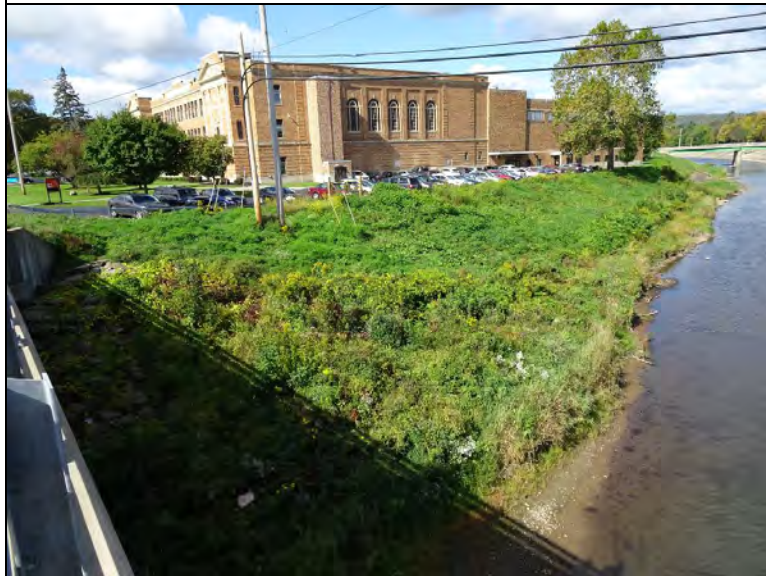
Inspect ID: N21L_2019_r_0105 **Title:** USACE_CELRB_N21L_2019_r_0105_1.jpg
Rated Item: 3. Encroachments **Caption:** Rating: Minimally Acceptable; Remarks: Unauthorized alteration (E-36): 18" HDPE outfall and duck bill valve on left bank side slope just downstream of State Street bridge owned by NYSDOT. (NYSDEC says permitted); Action: Submit Section 408 Alteration Request to USACE or verify USACE permission.; Station_1: 34+00

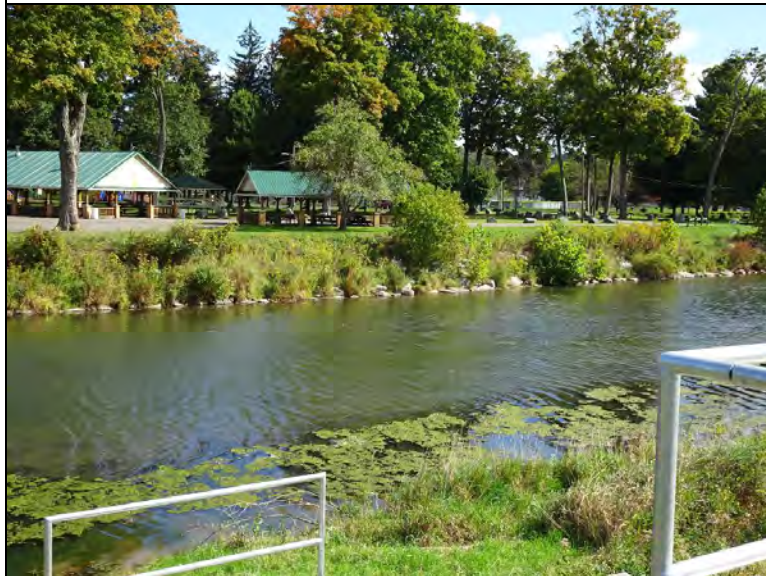
Inspect ID: N21L_2019_r_0131 **Title:** USACE_CELRB_N21L_2019_r_0131_1.jpg
Rated Item: 3. Encroachments **Caption:** Rating: Minimally Acceptable; Remarks: Unauthorized alteration (E-44): riprap added on right bank toe at island park adjacent to parking area.; Action: Remove or submit Section 408 Alteration Request to USACE.; Station_1: 21+00; Station_2: 17+00

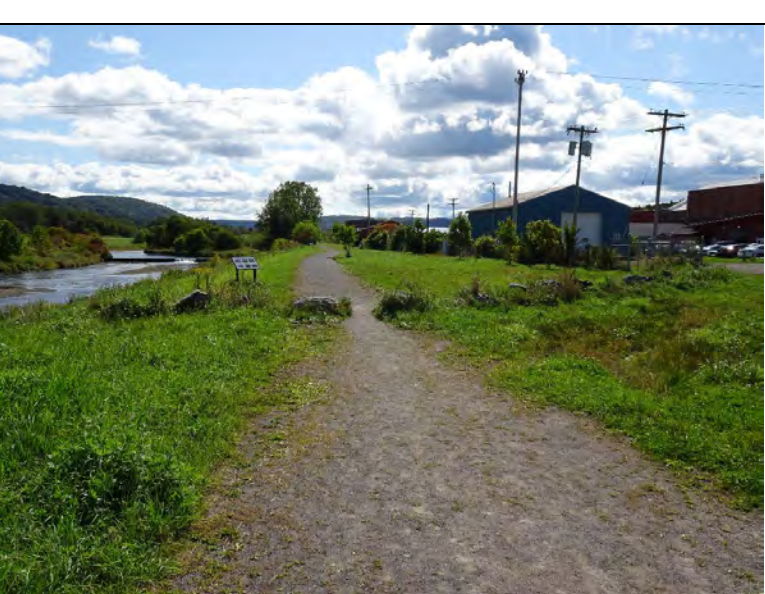
<p>Inspect ID: N21L_2019_r_0137 Title: USACE_CELRB_N21L_2019_r_0137_1.jpg Rated Item: 3. Encroachments Caption: Rating: Unacceptable; Remarks: Unauthorized alteration (E-46): Wellsville, Addison, & Galetton Railroad railway stone blocks obstructing access 575' downstream of barrier levee weir.; Action: Remove or submit Section 408 Alteration Request to USACE.; Station_1: 6+00</p>

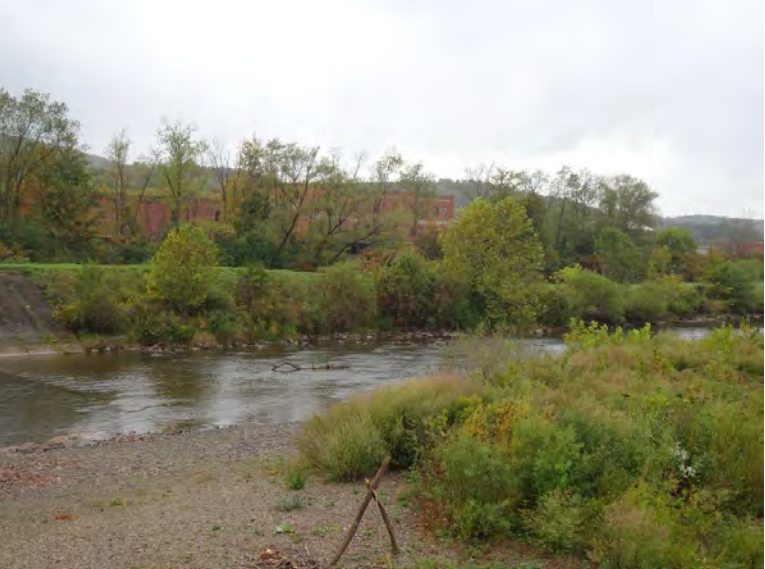
<p>Inspect ID: N21L_2019_r_0002 Title: USACE_CELRB_N21L_2019_r_0002_2.jpg Rated Item: 10. Riprap Revetments & Banks Caption: Rating: Unacceptable; Remarks: Trees and vegetation in riprap on left bank upstream and downstream of upstream limit weir.; Action: Remove trees and vegetation from riprap.; Station_1: 0+00; Station_2: 0+00</p>

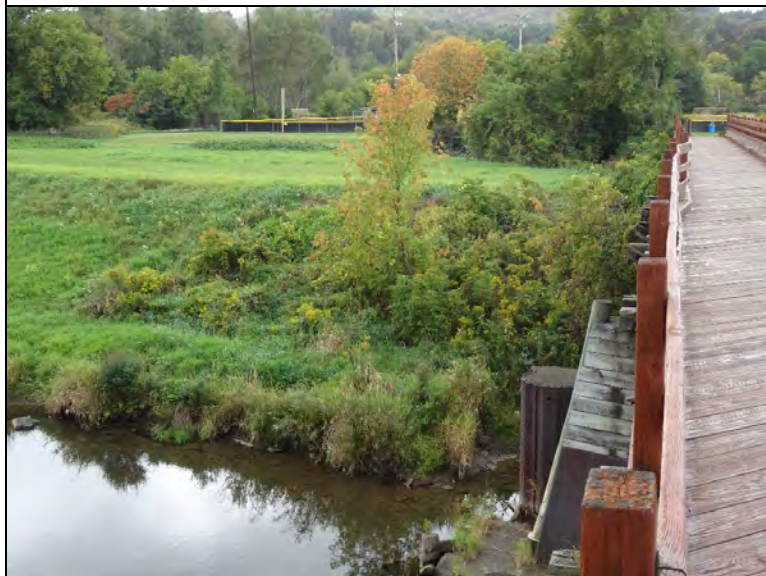
Inspect ID: N21L_2019_r_0011 **Title:** USACE_CELRB_N21L_2019_r_0011_1.jpg
Rated Item: 10. Riprap Revetments & Banks **Caption:** Rating: Minimally Acceptable;
Remarks: Trees and vegetation in riprap on left bank around both sides of Island Park
Pedestrian Walkway Bridge; **Action:** Remove trees and vegetation from riprap.;
Station_1: 17+00; **Station_2:** 16+00

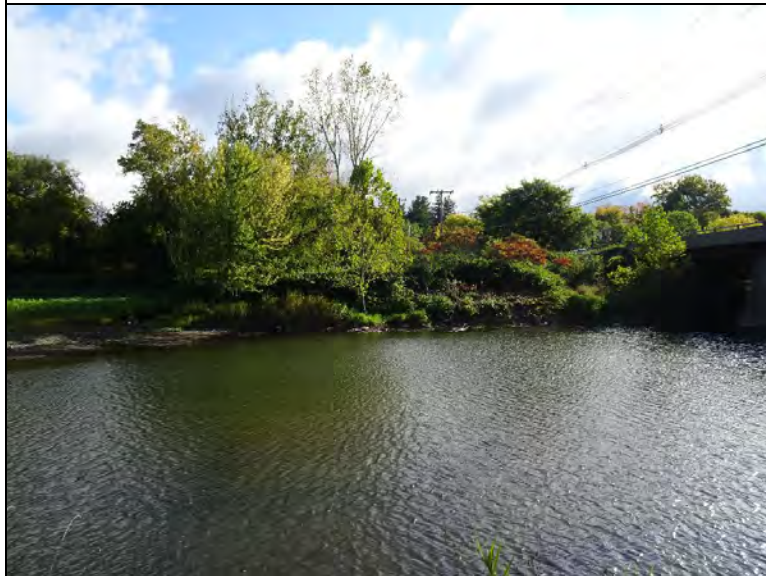
Inspect ID: N21L_2019_r_0028 **Title:** USACE_CELRB_N21L_2019_r_0028_1.jpg
Rated Item: 10. Riprap Revetments & Banks **Caption:** Rating: Minimally Acceptable;
Remarks: Trees and vegetation in riprap on right bank around both sides of Bolivar Road bridge.; **Action:** Remove trees and vegetation from riprap.; **Station_1:** 91+00; **Station_2:** 91+00

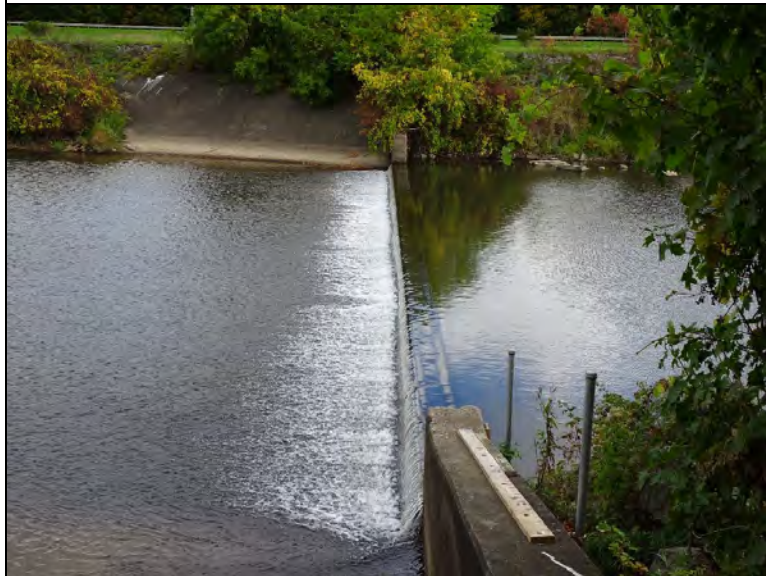
Inspect ID: N21L_2019_r_0056 **Title:** USACE_CELRB_N21L_2019_r_0056_1.jpg
Rated Item: 10. Riprap Revetments & Banks **Caption:** Rating: Minimally Acceptable; Remarks: Vegetation in riprap on both banks around drop structure.; Action: Remove vegetation in riprap.; Station_1: 66+00

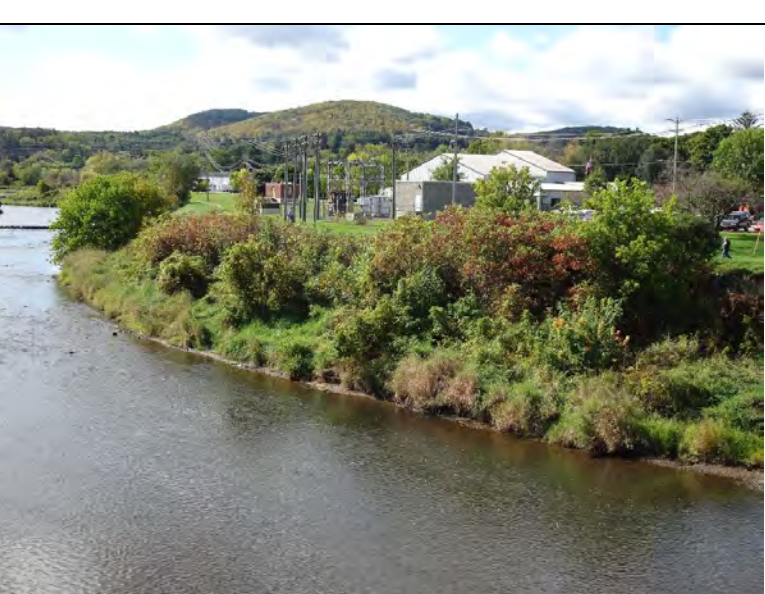
<p>Inspect ID: N21L_2019_r_0108 Title: USACE_CELRB_N21L_2019_r_0108_1.jpg Rated Item: 10. Riprap Revetments & Banks Caption: Rated Item: 12. Riprap Revetments & Bank Protection; Rating: Unacceptable; Remarks: Trees and vegetation in riprap on left bank channel side slope from State Street bridge to 1,250' upstream.; Action: Remove trees and vegetation from riprap.; Station_1: 33+00; Station_2: 24+00</p>

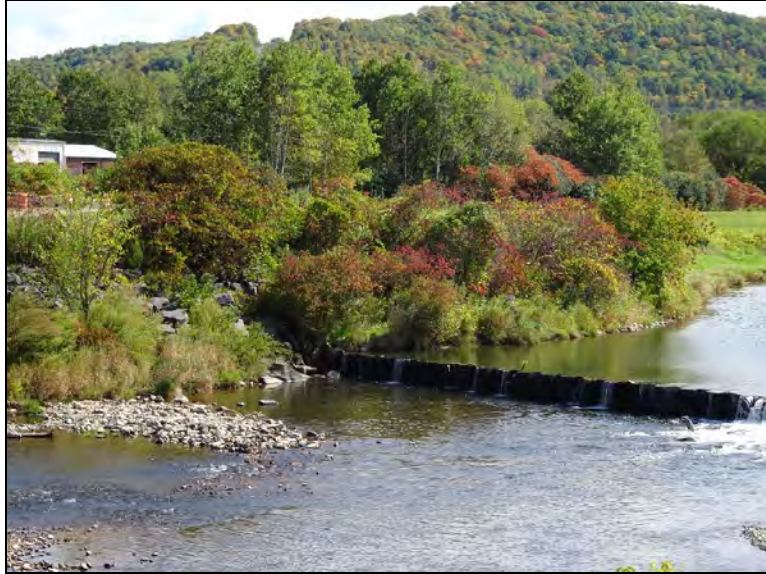
Inspect ID: N21L_2019_r_0139 **Title:** USACE_CELRB_N21L_2019_r_0139_1.jpg
Rated Item: 10. Riprap Revetments & Banks **Caption:** Rating: Unacceptable; Remarks: Trees and vegetation in riprap on right bank from barrier levee weir to 500' upstream of barrier levee weir.; Action: Remove trees and vegetation from riprap.; Station_1: 0+00; Station_2: 0+00

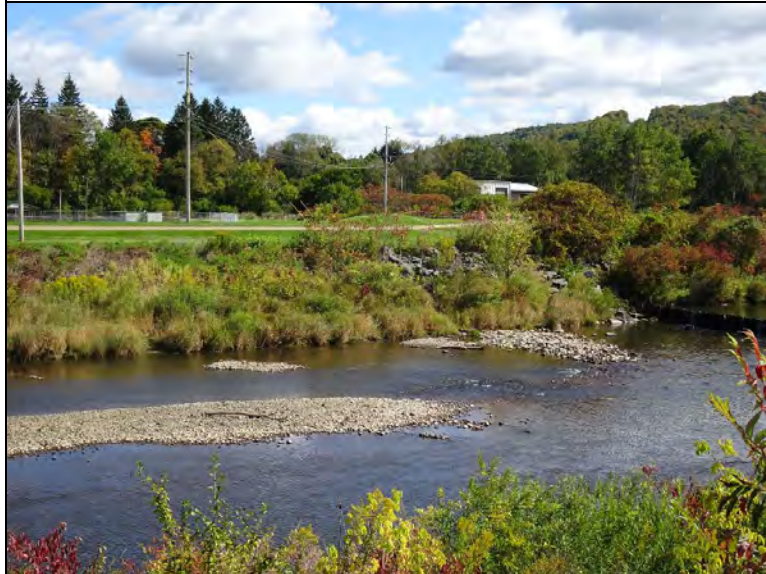
Inspect ID: N21L_2019_r_0140 **Title:** USACE_CELRB_N21L_2019_r_0140_1.jpg
Rated Item: 10. Riprap Revetments & Banks **Caption:** Rating: Unacceptable; Remarks: Vegetation in riprap on right bank from 400' downstream of upstream limit weir to barrier levee weir.; Action: Remove vegetation from riprap.; Station_1: 4+00; Station_2: 0+00

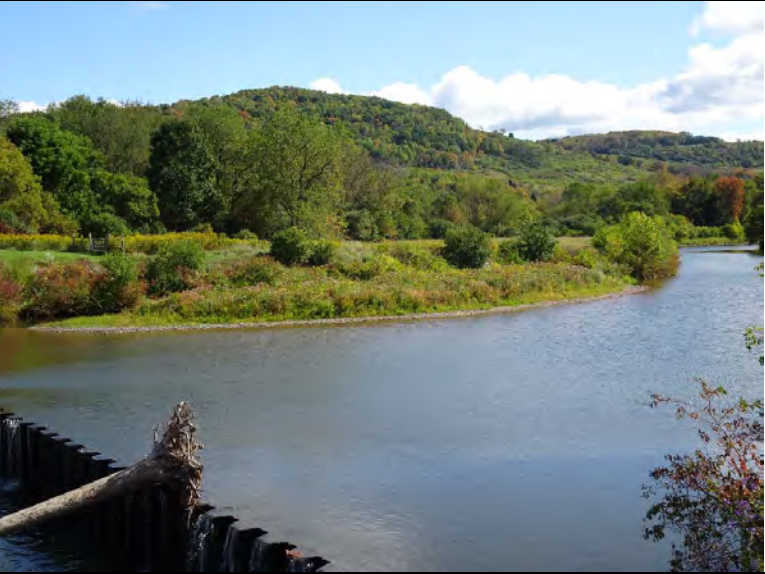
<p>Inspect ID: N21L_2019_r_0144 Title: USACE_CELRB_N21L_2019_r_0144_1.jpg Rated Item: 10. Riprap Revetments & Banks Caption: Rating: Unacceptable; Remarks: Trees and vegetation in riprap on right bank from upstream limit weir to 300' upstream.; Action: Remove trees and vegetation from riprap.; Station_1: 0+00; Station_2: 0+00</p>

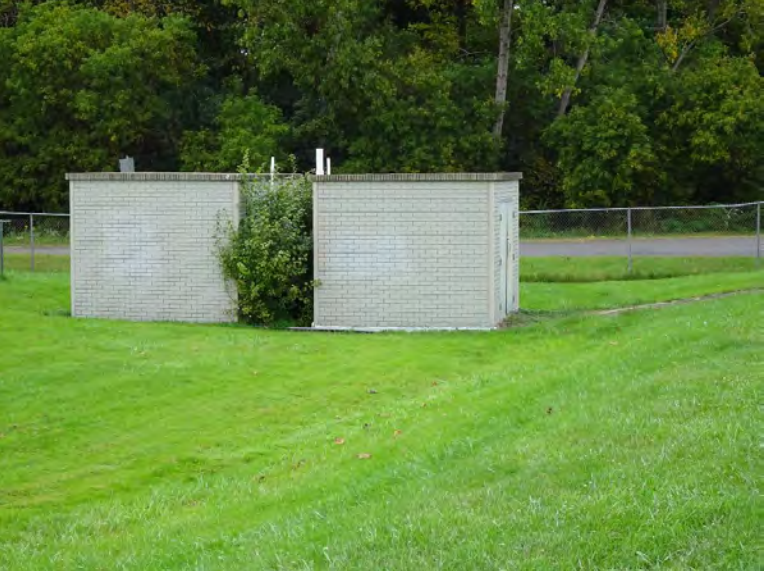
<p>Inspect ID: N21R_2019_r_0004 Title: USACE_CELRB_N21R_2019_r_0004_1.jpg Rated Item: 3. Encroachments Caption: Rating: Minimally Acceptable; Remarks: Unauthorized alteration (E-57): Gray brick utility building and sidewalk within 15' of right bank barrier levee landside toe.; Action: Submit Section 408 Alteration Request to USACE.; Station_1: NA</p>

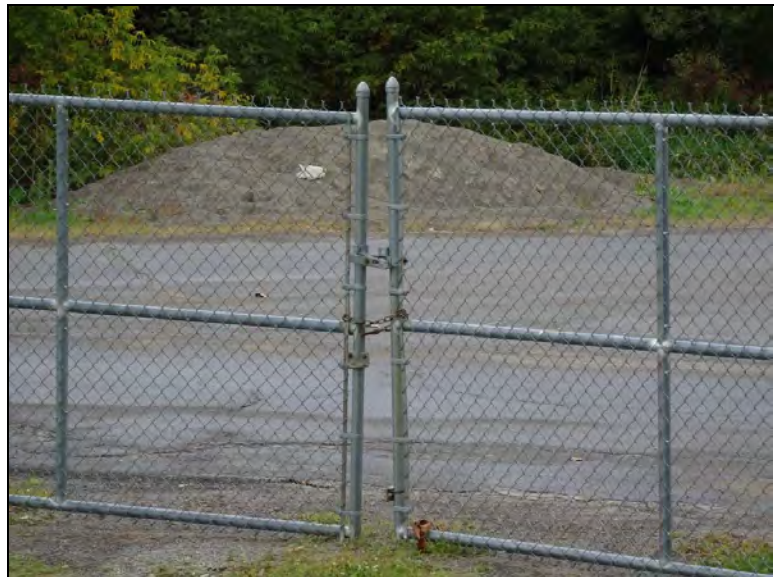
<p>Inspect ID: N21R_2019_r_0009 Title: USACE_CELRB_N21R_2019_r_0009_1.jpg Rated Item: 3. Encroachments Caption: Rating: Minimally Acceptable; Remarks: Locked gate on right bank barrier levee - NYSDEC did not have keys during inspection.; Action: NYSDEC should obtain keys to lock.; Station_1: NA</p>

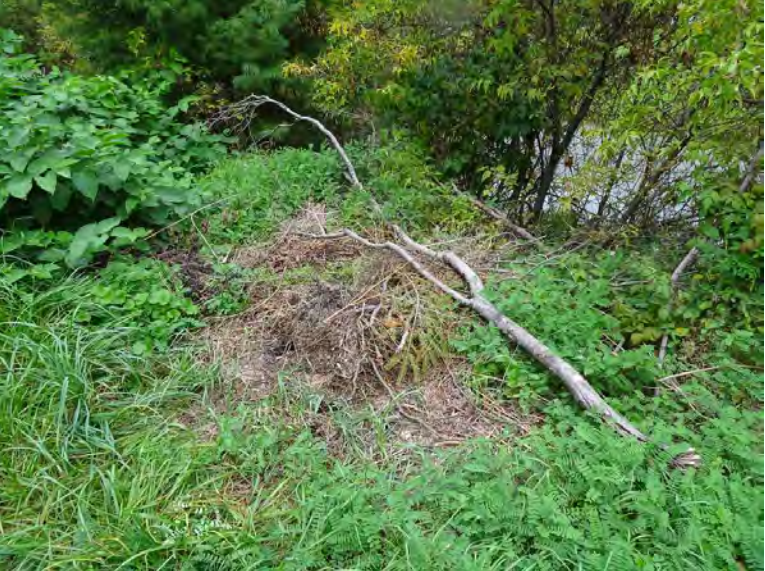
<p>Inspect ID: N21D_2019_r_0008 Title: USACE_CELRB_N21D_2019_r_0008_1.jpg Rated Item: 3. Encroachments Caption: Rating: Minimally Acceptable; Remarks: Tree debris on levee waterside slope, 550' downstream from upstream limit of Dyke Creek.; Action: Remove tree debris.; Station_1: D 35+00</p>

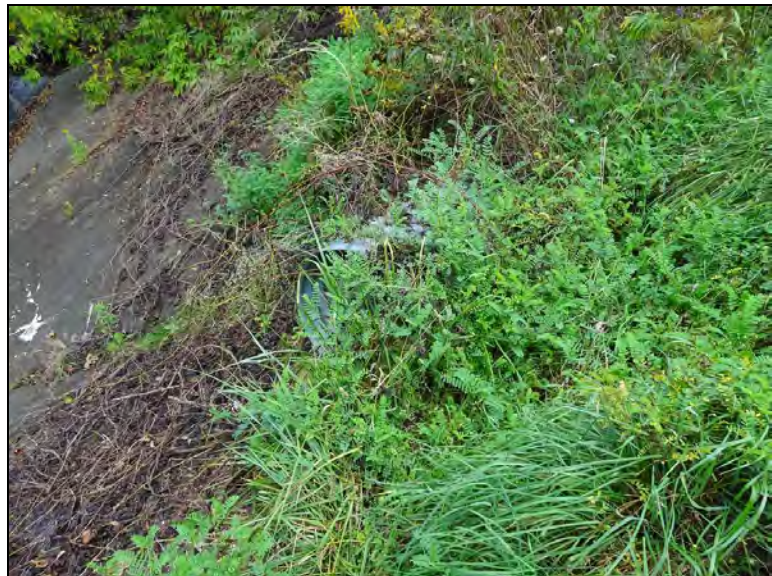
<p>Inspect ID: N21D_2019_r_0052 Title: USACE_CELRB_N21D_2019_r_0052_1.jpg Rated Item: 1. Vegetation and Obstructions Caption: Rating: Acceptable; Remarks: 24" CMP on left bank with inlet upstream of Dyke Creek drop structure and outlet just downstream of Dyke Creek drop structure. Pipe does not go under or through levee.; Action: NA; Station_1: D 35+00; Station_2: D 35+00</p>

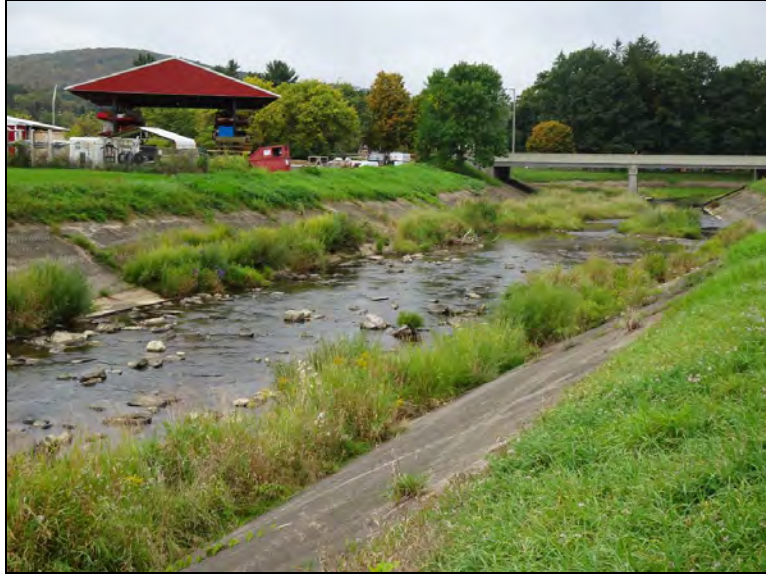
Inspect ID: N21D_2019_r_0034 **Title:** USACE_CELRB_N21D_2019_r_0034_2.jpg
Rated Item: 1. Vegetation and Obstructions **Caption:** Rating: Minimally Acceptable;
 Remarks: Vegetation in excess of 12" on tops both banks of channel from State Route 417 Bridge to Main Street Bridge. ; Action: Mow vegetation to 3"-6" height.; Station_1: D 17+00; Station_2: D 11+00; ; ; ; ; ; ;

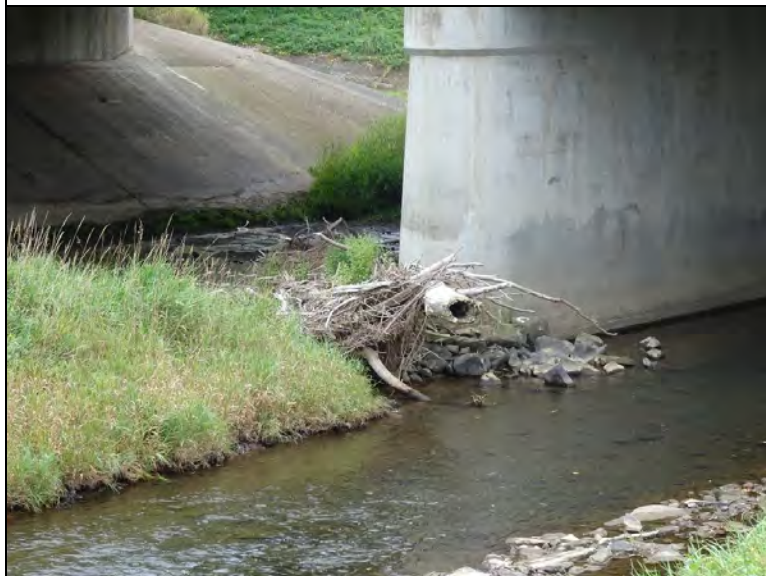
Inspect ID: N21D_2019_r_0038 **Title:** USACE_CELRB_N21D_2019_r_0038_1.jpg
Rated Item: 1. Vegetation and Obstructions **Caption:** Rating: Minimally Acceptable;
 Remarks: Tree debris in channel on pier of State Route 417 Bridge.; Action: Remove tree debris.; Station_1: D 12+00

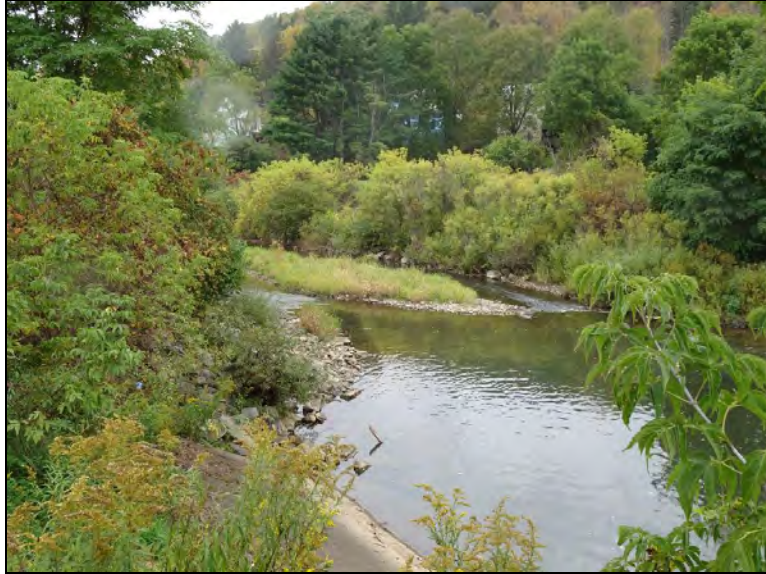
Inspect ID: N21D_2019_r_0015 **Title:** USACE_CELRB_N21D_2019_r_0015_1.jpg
Rated Item: 2. Shoaling (sediment deposition) **Caption:** Rating: Minimally Acceptable;
Remarks: Vegetated shoal (S-15) in center of channel 100' downstream of Dyke Creek drop structure to 200' downstream of drop structure.; **Action:** Remove shoal.; **Station_1:** 34+00

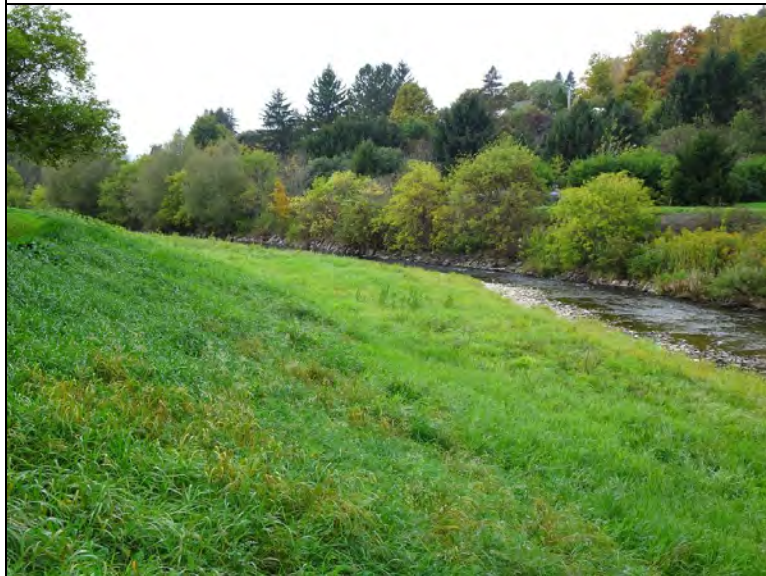
Inspect ID: N21D_2019_r_0018 **Title:** USACE_CELRB_N21D_2019_r_0018_1.jpg
Rated Item: 2. Shoaling (sediment deposition) **Caption:** Rating: Minimally Acceptable;
Remarks: Shoaling (S-16) on left bank and in center of channel from Dyke Creek drop structure to Broadway Street Bridge.; **Action:** Remove shoal.; **Station_1:** 24+00; **Station_2:** 33+00

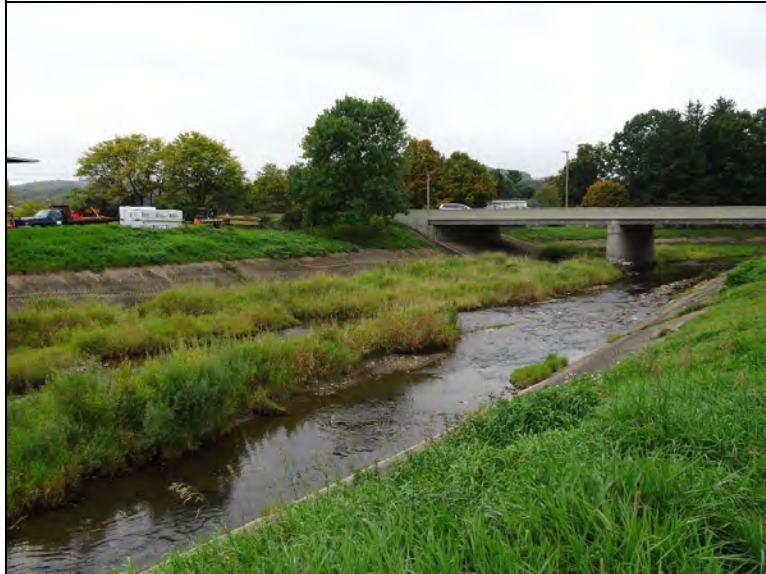
Inspect ID: N21D_2019_r_0035 **Title:** USACE_CELRB_N21D_2019_r_0035_2.jpg
Rated Item: 2. Shoaling (sediment deposition) **Caption:** Rating: Unacceptable;
Remarks: Vegetated shoals (S-17) on concrete side slopes on both banks and in channel from State Route 417 Bridge to Main Street Bridge.; Action: Remove vegetated shoal from concrete side slopes.; Station_1: 12+00; Station_2: 18+00

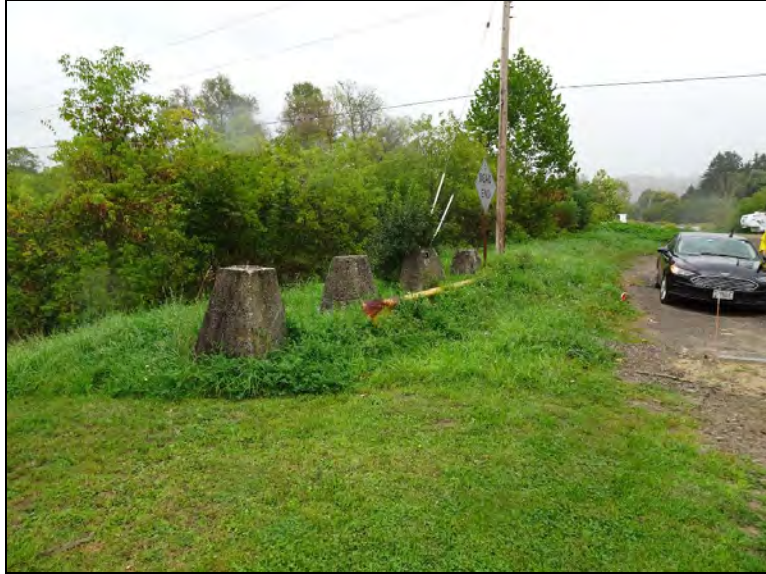
Inspect ID: N21D_2019_r_0009 **Title:** USACE_CELRB_N21D_2019_r_0009_1.jpg
Rated Item: 3. Encroachments **Caption:** Rating: Minimally Acceptable; Remarks: Unauthorized alteration (E-50): Concrete blocks, guardrail, utility pole, guy wire, and dead end sign encroachments on left bank at end of Miller Street just upstream of drop structure. (Dyke Creek); Action: Remove or submit Section 408 Alteration Request to USACE.; Station_1: 35+00

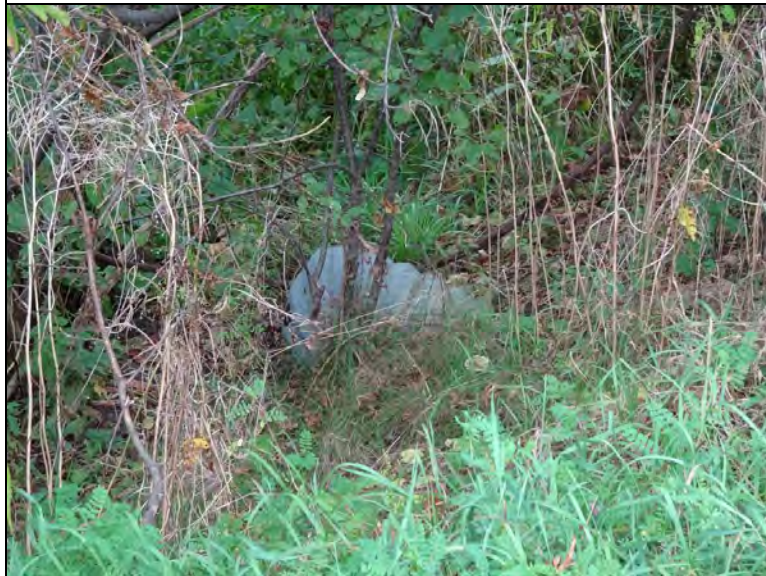
Inspect ID: N21D_2019_r_0017 **Title:** USACE_CELRB_N21D_2019_r_0017_1.jpg
Rated Item: 3. Encroachments **Caption:** Rating: Minimally Acceptable; Remarks: Unauthorized alteration (E-50a): 18" CMP encroachment on left bank, at Loring Ave.; Action: Remove or submit Section 408 Alteration Request to USACE.; Station_1: D 32+00

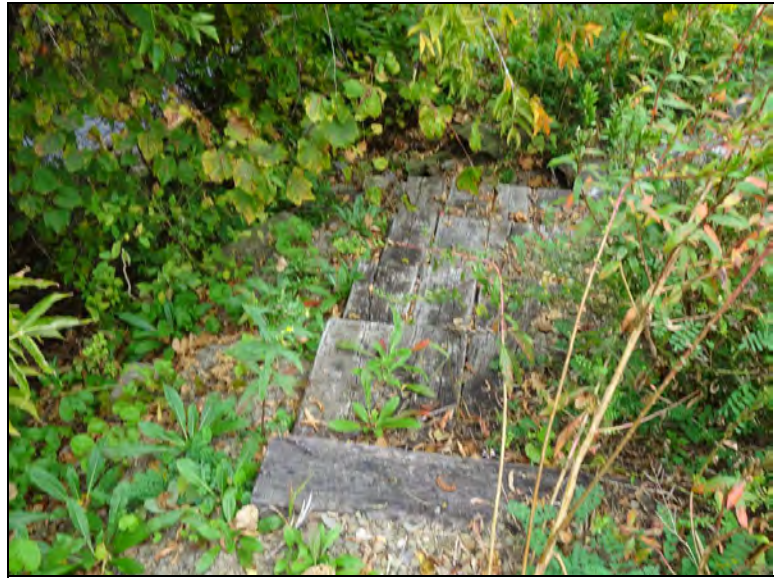
<p>Inspect ID: N21D_2019_r_0029 Title: USACE_CELRB_N21D_2019_r_0029_1.jpg Rated Item: 3. Encroachments Caption: Rating: Minimally Acceptable; Remarks: Unauthorized alteration (E-53): wood stairs left bank channel slope. ; Action: Remove or submit Section 408 Alteration Request to USACE.; Station_1: 20+00; ; ; ; ;</p>

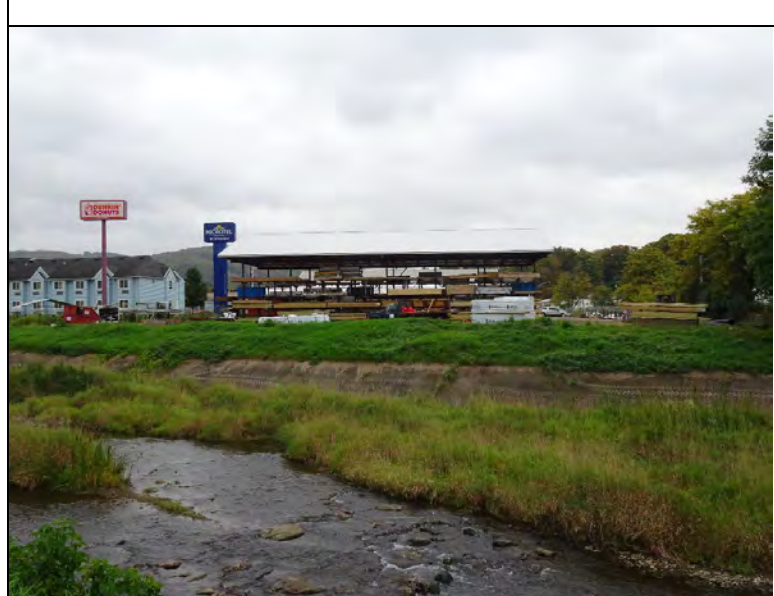
<p>Inspect ID: N21D_2019_r_0039 Title: USACE_CELRB_N21D_2019_r_0039_1.jpg Rated Item: 3. Encroachments Caption: Rating: Minimally Acceptable; Remarks: Unauthorized alteration (E-55): Heating, electrical, and plumbing yard on Dyke Creek left bank just upstream of State Route 417 Bridge.; Action: Remove or submit Section 408 Alteration Request to USACE.; Station_1: 15+00; Station_2: 13+00</p>

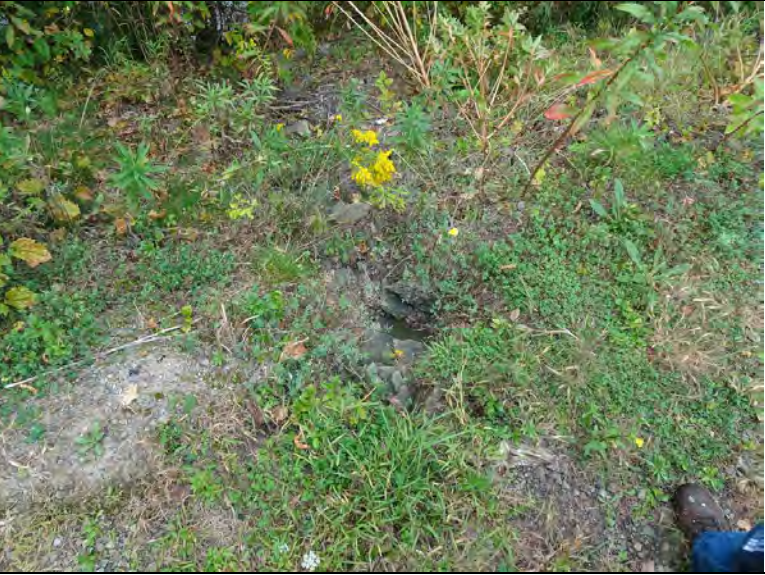
<p>Inspect ID: N21D_2019_r_0030 Title: USACE_CELRB_N21D_2019_r_0030_1.jpg Rated Item: 4. Erosion Caption: Rating: Minimally Acceptable; Remarks: Erosion on left bank upstream of Main Street. ; Action: Repair erosion.; Station_1: 19+00; ; ; ; ;</p>

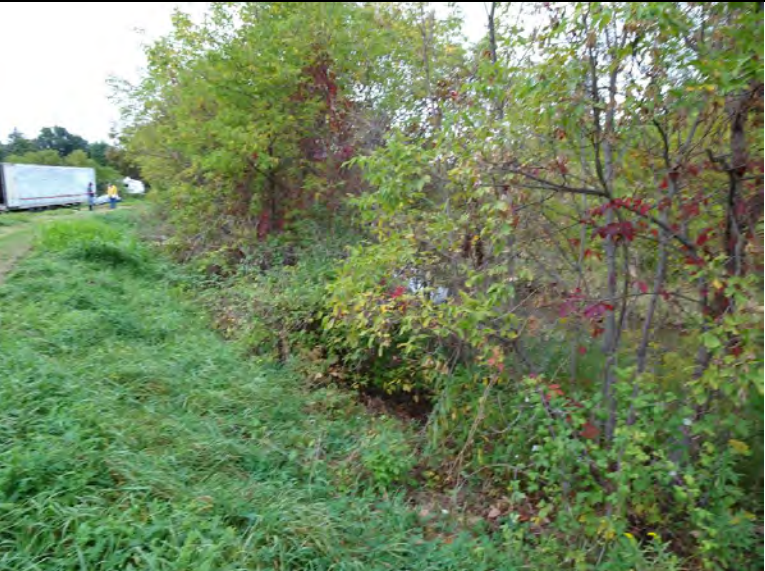
<p>Inspect ID: N21D_2019_r_0003 Title: USACE_CELRB_N21D_2019_r_0003_1.jpg Rated Item: 10. Riprap Revetments & Banks Caption: Rating: Unacceptable; Remarks: Trees and unwanted vegetation in riprap on left bank waterside slope from upstream limit of Dyke Creek to 300' downstream of the Drop Structure. (Dyke Creek).; Action: Remove trees and unwanted vegetation.; Station_1: 35+00; Station_2: 35+00</p>

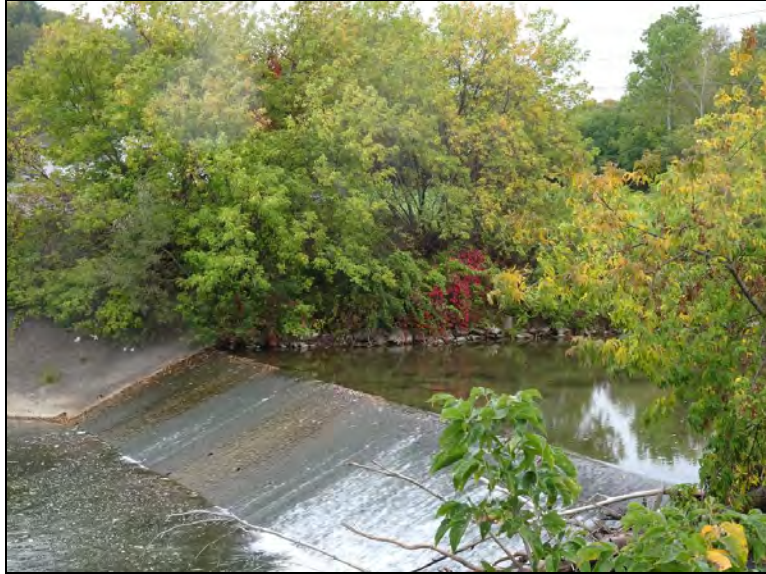
Inspect ID: N21D_2019_r_0010 **Title:** USACE_CELRB_N21D_2019_r_0010_1.jpg
Rated Item: 10. Riprap Revetments & Banks **Caption:** Rating: Unacceptable; Remarks: Trees and vegetation in riprap on right bank upstream of Dyke Creek drop structure.; Action: Remove vegetation and trees.; Station_1: 35+00

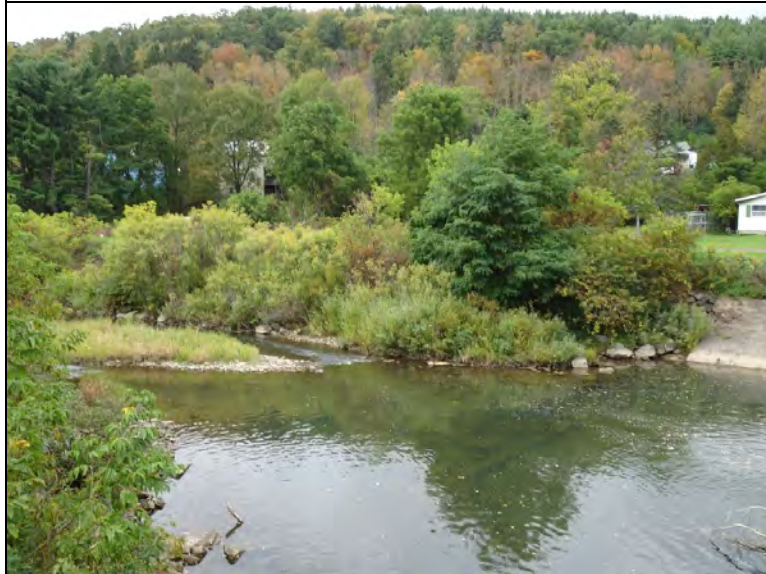
Inspect ID: N21D_2019_r_0016 **Title:** USACE_CELRB_N21D_2019_r_0016_1.jpg
Rated Item: 10. Riprap Revetments & Banks **Caption:** Rating: Unacceptable; Remarks: Trees and vegetation in riprap on right bank from Broad Street bridge to Dyke Creek drop structure.; Action: Remove unwanted vegetation.; Station_1: 35+00; Station_2: 28+00

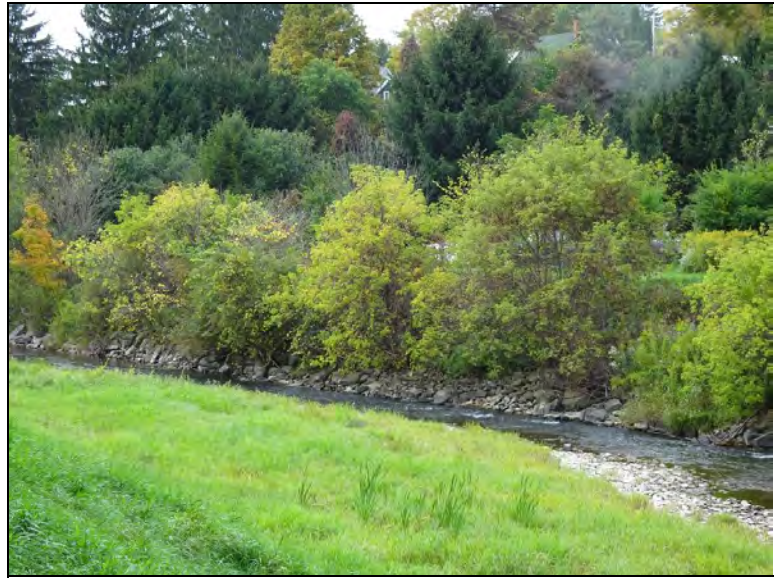
<p>Inspect ID: N21D_2019_r_0016 Title: USACE_CELRB_N21D_2019_r_0016_2.jpg Rated Item: 10. Riprap Revetments & Banks Caption: Rating: Unacceptable; Remarks: Trees and vegetation in riprap on right bank from Broad Street bridge to Dyke Creek drop structure.; Action: Remove unwanted vegetation.; Station_1: 35+00; Station_2: 28+00</p>

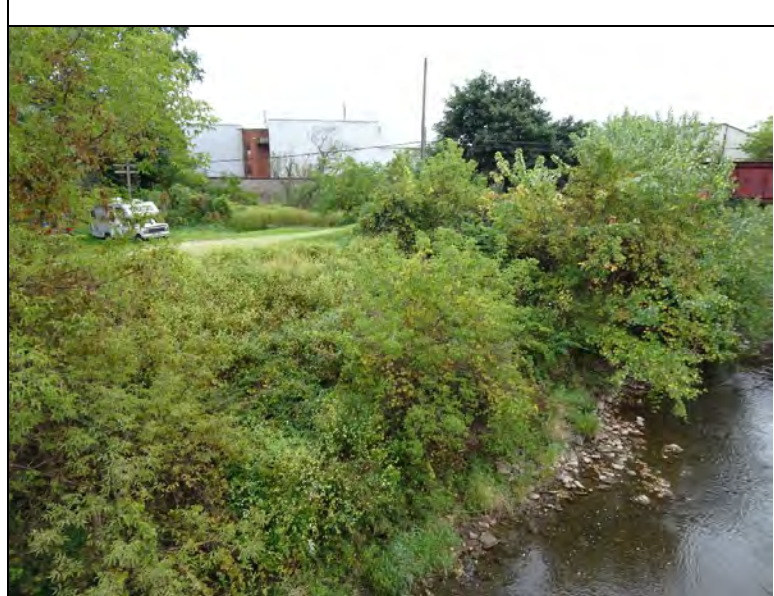
<p>Inspect ID: N21D_2019_r_0022 Title: USACE_CELRB_N21D_2019_r_0022_1.jpg Rated Item: 10. Riprap Revetments & Banks Caption: Rating: Unacceptable; Remarks: Significant vegetation and trees in riprap on both banks between Railroad bridge and Broad Street bridge. (Dyke Creek); Action: Remove trees and vegetation from riprap.; Station_1: 24+00; Station_2: 22+00</p>

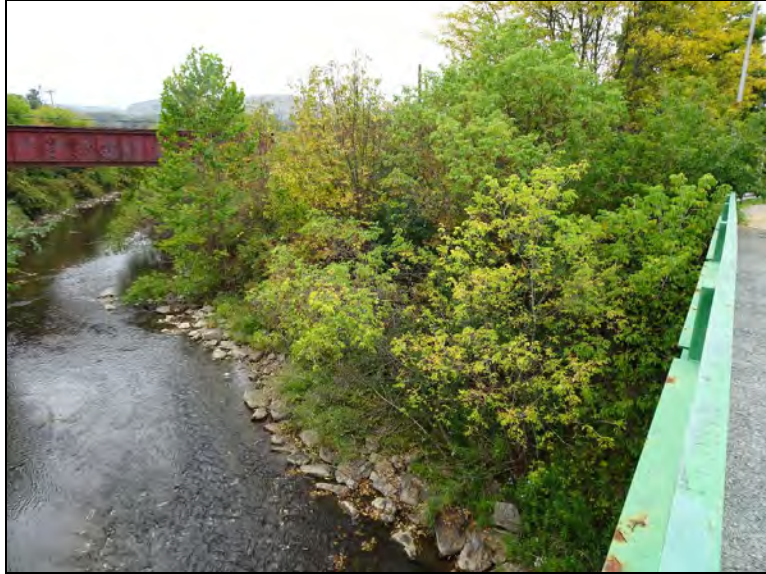
Inspect ID: N21D_2019_r_0022 **Title:** USACE_CELRB_N21D_2019_r_0022_2.jpg
Rated Item: 10. Riprap Revetments & Banks **Caption:** Rating: Unacceptable; Remarks: Significant vegetation and trees in riprap on both banks between Railroad bridge and Broad Street bridge. (Dyke Creek); Action: Remove trees and vegetation from riprap.; Station_1: 24+00; Station_2: 22+00

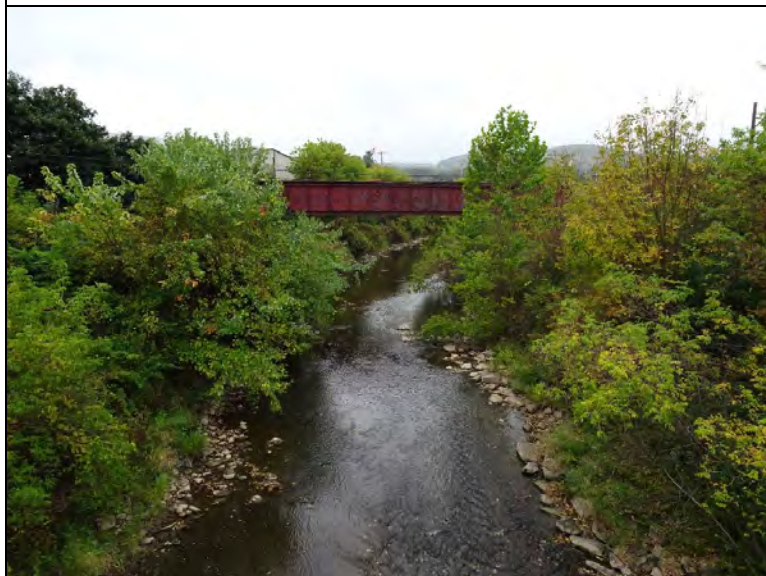
Inspect ID: N21D_2019_r_0022 **Title:** USACE_CELRB_N21D_2019_r_0022_3.jpg
Rated Item: 10. Riprap Revetments & Banks **Caption:** Rating: Unacceptable; Remarks: Significant vegetation and trees in riprap on both banks between Railroad bridge and Broad Street bridge. (Dyke Creek); Action: Remove trees and vegetation from riprap.; Station_1: 24+00; Station_2: 22+00

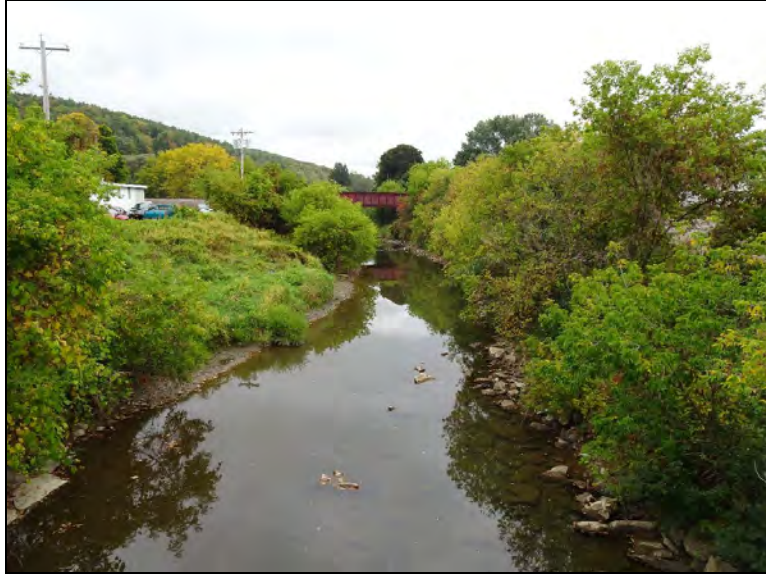
Inspect ID: N21D_2019_r_0032 **Title:** USACE_CELRB_N21D_2019_r_0032_1.jpg
Rated Item: 10. Riprap Revetments & Banks **Caption:** Rating: Unacceptable; Remarks: Trees and significant vegetation in riprap on both banks between Main Street Bridge and Railroad Bridge.; Action: Remove trees and vegetation from riprap.; Station_1: 22+00; Station_2: 18+00

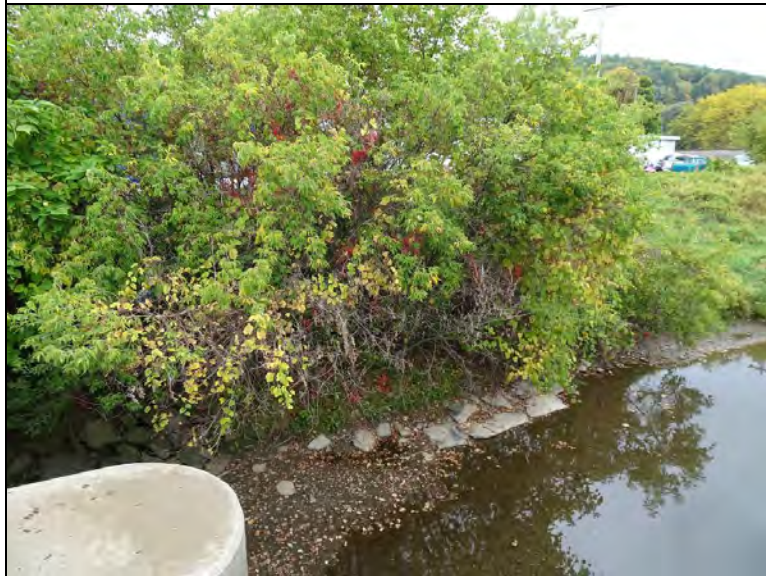
Inspect ID: N21D_2019_r_0032 **Title:** USACE_CELRB_N21D_2019_r_0032_2.jpg
Rated Item: 10. Riprap Revetments & Banks **Caption:** Rating: Unacceptable; Remarks: Trees and significant vegetation in riprap on both banks between Main Street Bridge and Railroad Bridge.; Action: Remove trees and vegetation from riprap.; Station_1: 22+00; Station_2: 18+00

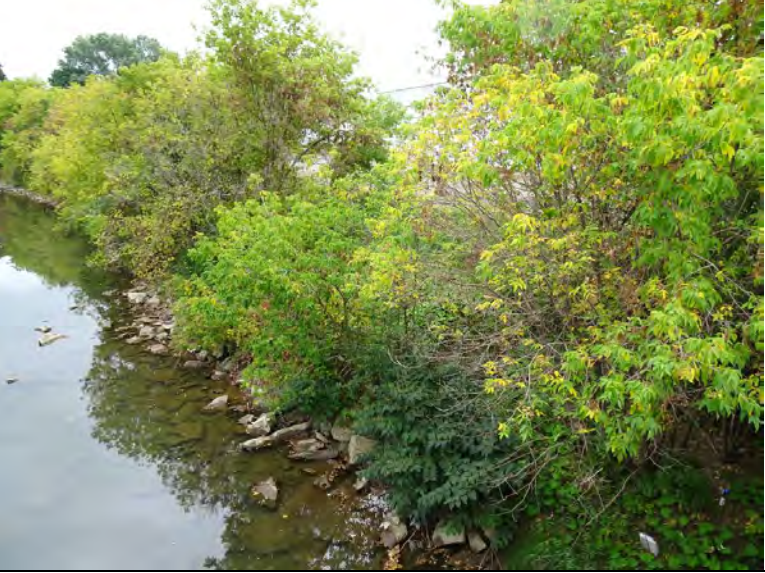
<p>Inspect ID: N21D_2019_r_0032 Title: USACE_CELRB_N21D_2019_r_0032_3.jpg Rated Item: 10. Riprap Revetments & Banks Caption: Rating: Unacceptable; Remarks: Trees and significant vegetation in riprap on both banks between Main Street Bridge and Railroad Bridge.; Action: Remove trees and vegetation from riprap.; Station_1: 22+00; Station_2: 18+00</p>

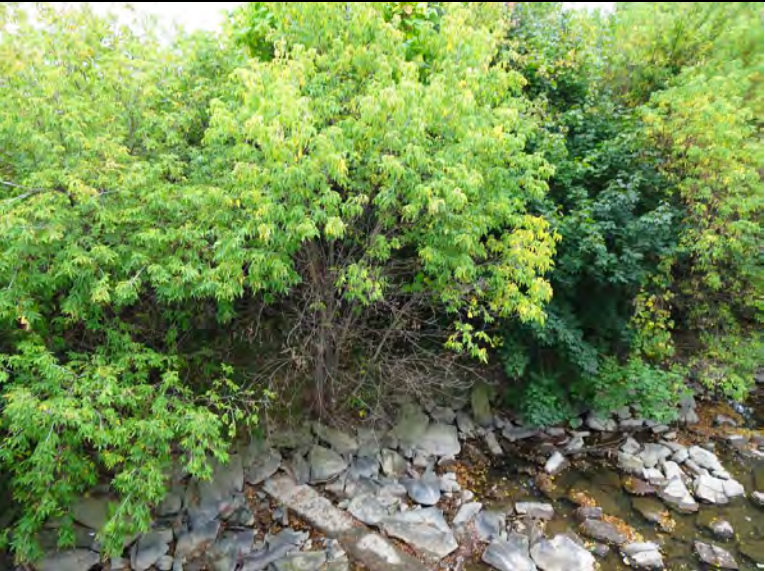
<p>Inspect ID: N21D_2019_r_0033 Title: USACE_CELRB_N21D_2019_r_0033_1.jpg Rated Item: 10. Riprap Revetments & Banks Caption: Rating: Unacceptable; Remarks: Significant trees and vegetation in riprap on both banks just 100' of bridgedownstream of Main Street bridge.; Action: Remove trees and vegetation from riprap.; Station_1: 17+00</p>
