DEPARTMENT OF THE ARMY

BUFFALO DISTRICT, CORPS OF ENGINEERS
1776 NIAGARA STREET
BUFFALO, NEW YORK 14207-3199

SUBJECT: FY19 Joint Routine Inspection of Completed Works, Flood Risk Management Project, Genesee River and Dyke Creek, Wellsville, New York (09/23/19)

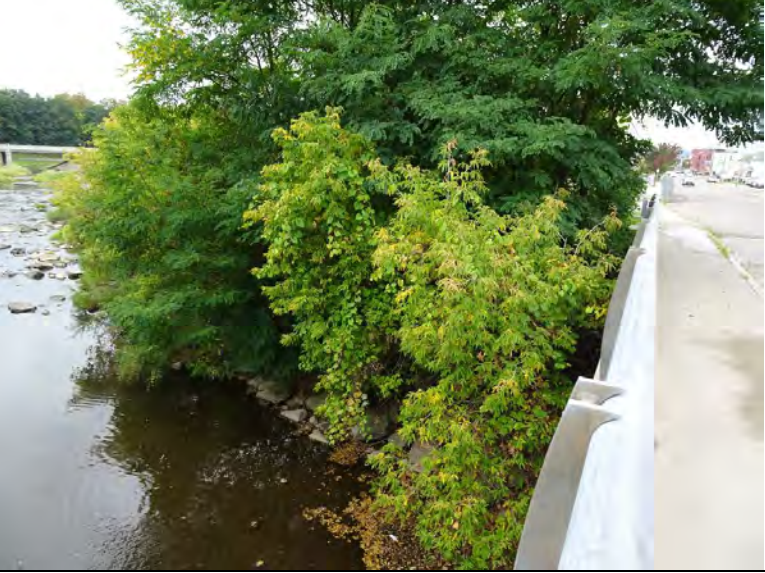
<p>Inspect ID: N21D_2019_r_0033 Title: USACE_CELRB_N21D_2019_r_0033_2.jpg Rated Item: 10. Riprap Revetments & Banks Caption: Rating: Unacceptable; Remarks: Significant trees and vegetation in riprap on both banks just 100' of bridgedownstream of Main Street bridge.; Action: Remove trees and vegetation from riprap.; Station_1: 17+00</p>

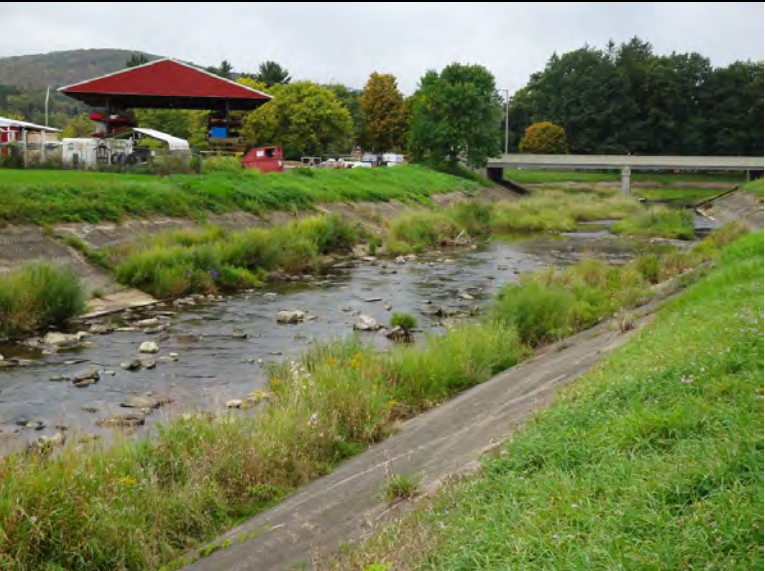
11. Revetments other than Riprap	M	A	Existing revetment protection is properly maintained, undamaged, and clearly visible.	N21D_2019_r_0036: Station_1 D 18+00: Station_2 D 12+00: Vegetation growing within left and right bank concrete channel side slopes from Main Street Bridge to State Route 417 Bridge.: Remove vegetation from concrete channel side slopes. (M)
		M	Minor revetment displacement or deterioration that does not pose an immediate threat to the integrity of the levee. Unwanted vegetation must be cleared or sprayed with an appropriate herbicide.	
		U	Significant revetment displacement, deterioration, or exposure of bedding observed. Scour activity is undercutting banks, eroding embankments, or impairing channel flows by causing turbulence or shoaling. Revetment protection is hidden by dense brush and trees.	
		N/A	There are no such revetments protecting this feature of the segment / system.

<p>Inspect ID: N21D_2019_r_0036 Title: USACE_CELRB_N21D_2019_r_0036_1.jpg Rated Item: 11. Revetments other than Riprap Caption: Rating: Minimally Acceptable; Remarks: Vegetation growing within left and right bank concrete channel side slopes from Main Street Bridge to State Route 417 Bridge.; Action: Remove vegetation from concrete channel side slopes.; Station_1: D 18+00; Station_2: D 12+00</p>
