DEPARTMENT OF THE ARMY

BUFFALO DISTRICT, CORPS OF ENGINEERS
1776 NIAGARA STREET
BUFFALO, NEW YORK 14207-3199

SUBJECT: FY15 Joint Routine Inspection of Completed Works, Flood Damage Reduction Project, Genesee River and Dyke Creek, Wellsville, New York (09/10/15)

Attachment A –
Genesee River - Left Bank and Channel, Wellsville
Summary of Deficiencies and Recommendations

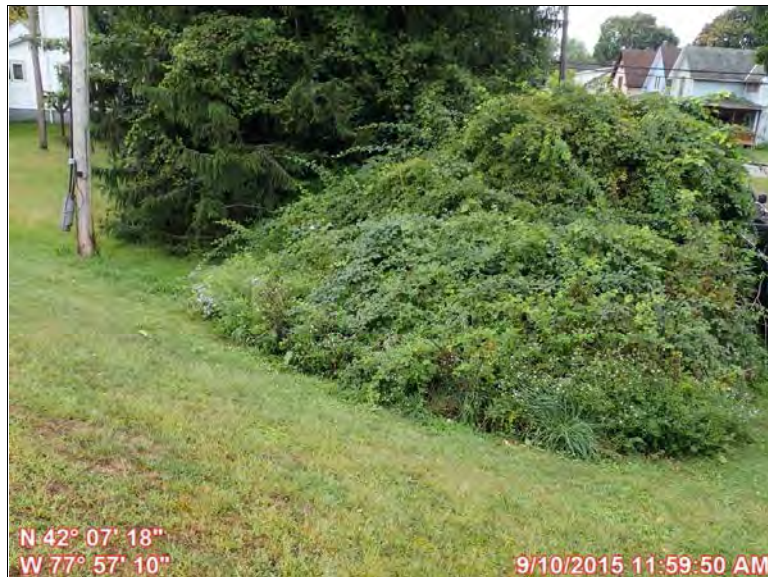
Inspect ID: N21L_2015_a_0044 **Title:** USACE_CELRB_N21L_2015_a_0044_3.jpg
Rated Item: 1. Unwanted Vegetation Growth **Caption:** Rating: Minimally Acceptable; Remarks: Trees on left bank landside slope and w/in 15' of landside toe from 1,200' downstream of Madison Street (Stevens Street) bridge to Madison Street bridge.; Action: Remove trees.; Station_1: 54+00; Station_2: 46+00

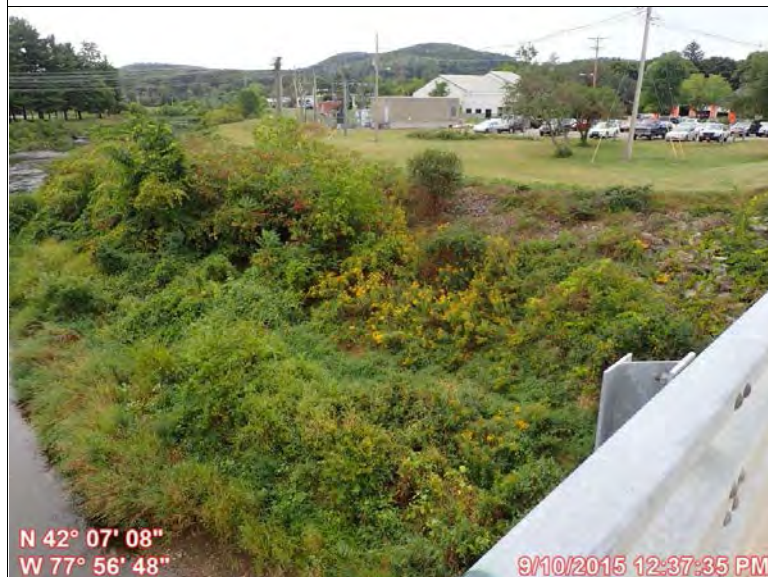
Inspect ID: N21L_2015_a_0081 **Title:** USACE_CELRB_N21L_2015_a_0081_1.jpg
Rated Item: 1. Unwanted Vegetation Growth **Caption:** Rating: Unacceptable; Remarks: Vegetation and woody growth in left bank riprap from State Street bridge to 950' upstream of State Street bridge.; Action: Remove vegetation and woody growth from riprap.; Station_1: 33+00; Station_2: 24+00

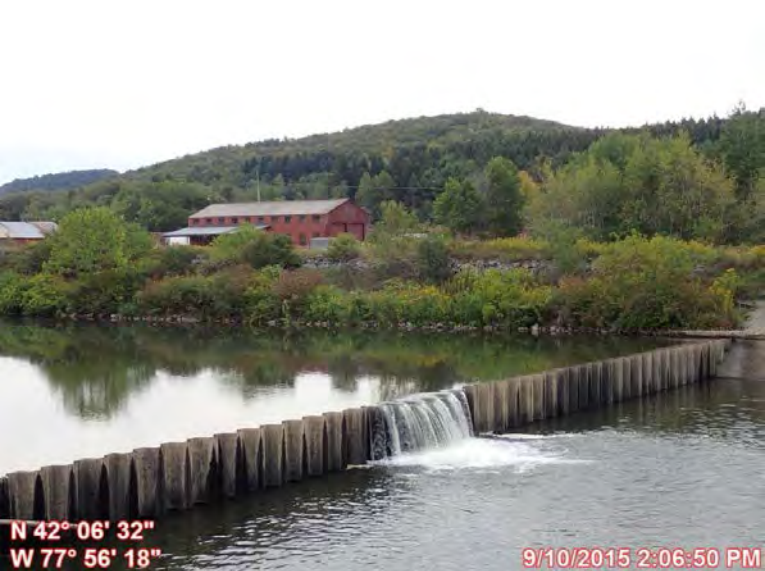
<p>N 42° 06' 32" W 77° 56' 18" 9/10/2015 2:06:50 PM</p>	<p>Inspect ID: N21L_2015_a_0118 Title: USACE_CELRB_N21L_2015_a_0118_1.jpg Rated Item: 1. Unwanted Vegetation Growth Caption: Rating: Unacceptable; Remarks: Significant vegetation in riprap on left bank upstream and downstream of 1976 Weir.; Action: Remove vegetation from riprap.; Station_1: 0+00; Station_2: 0+00</p>

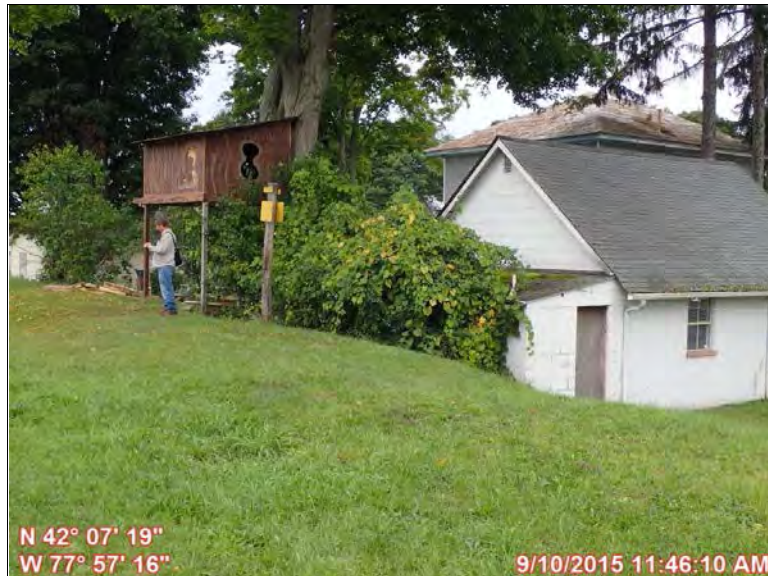
Inspect ID: N21L_2015_a_0043 **Title:** USACE_CELRB_N21L_2015_a_0043_1.jpg
Rated Item: 3. Encroachments **Caption:** Rating: Minimally Acceptable; Remarks: Unauthorized Alteration - Misc. encroachments (tree house, deck, and shed) on left bank 1,400' to 1,000' downstream of Madison Street bridge. Table, signs post, and NY telephone cable in overbuilt section of levee.; Action: Remove unauthorized alteration or submit a Section 408 Alteration Request Form.; Station_1: 57+00; Station_2: 53+00

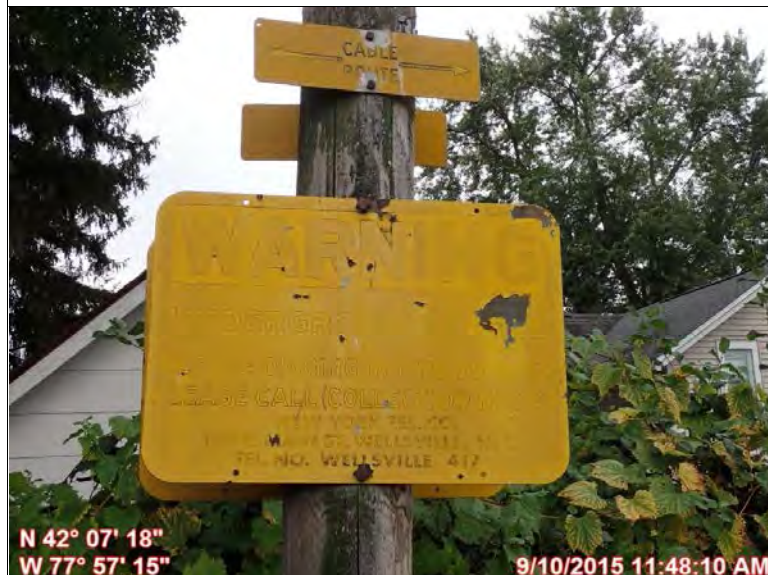
Inspect ID: N21L_2015_a_0043 **Title:** USACE_CELRB_N21L_2015_a_0043_2.jpg
Rated Item: 3. Encroachments **Caption:** Rating: Minimally Acceptable; Remarks: Unauthorized Alteration - Misc. encroachments (tree house, deck, and shed) on left bank 1,400' to 1,000' downstream of Madison Street bridge. Table, signs post, and NY telephone cable in overbuilt section of levee.; Action: Remove unauthorized alteration or submit a Section 408 Alteration Request Form.; Station_1: 57+00; Station_2: 53+00

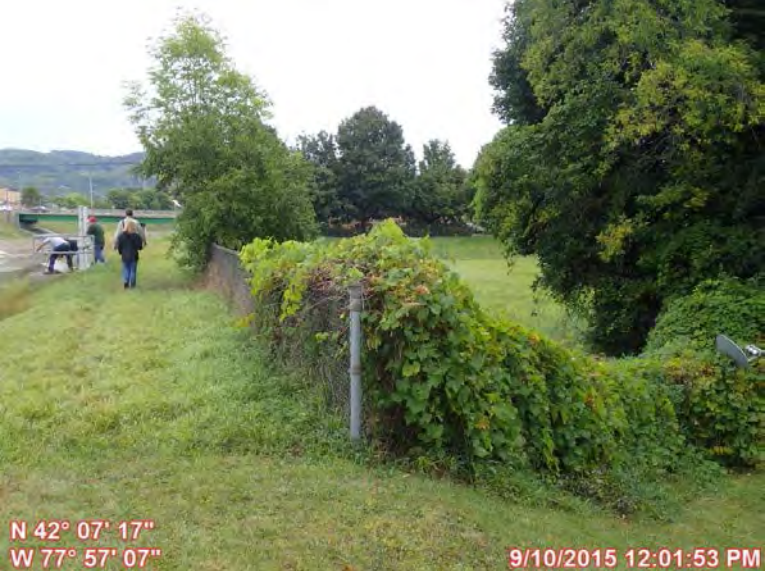
<p>N 42° 07' 17" W 77° 57' 07"</p> <p>9/10/2015 12:01:53 PM</p>	<p>Inspect ID: N21L_2015_a_0056 Title: USACE_CELRB_N21L_2015_a_0056_1.jpg Rated Item: 3. Encroachments Caption: Rating: Acceptable; Remarks: Ponding Area fence is part of the project.; Action: NA; Station_1: 47+00; Station_2: 50+00</p>

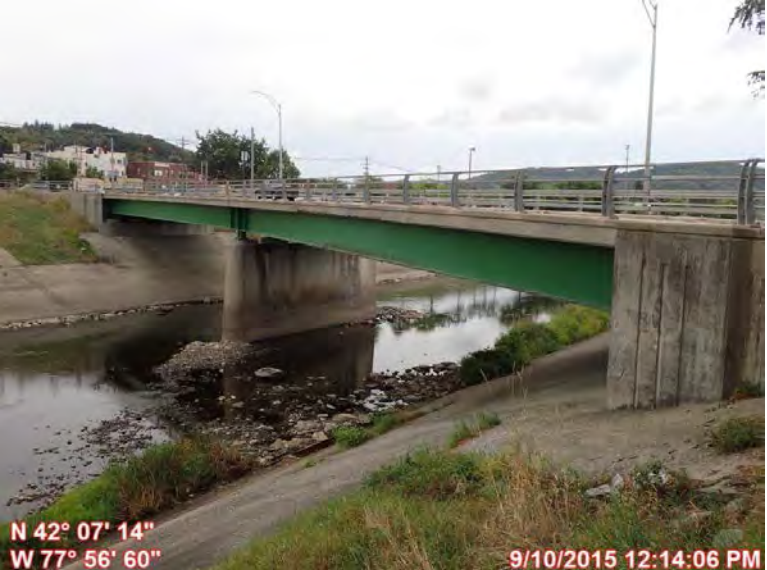
<p>N 42° 07' 14" W 77° 56' 60"</p> <p>9/10/2015 12:14:06 PM</p>	<p>Inspect ID: N21L_2015_a_0067 Title: USACE_CELRB_N21L_2015_a_0067_1.jpg Rated Item: 3. Encroachments Caption: Rating: Minimally Acceptable; Remarks: Unauthorized Alteration - Madison Street (Stevens Street) bridge.; Action: Remove unauthorized alteration or submit Section 408 Alteration Request Form.; Station_1: 44+00</p>

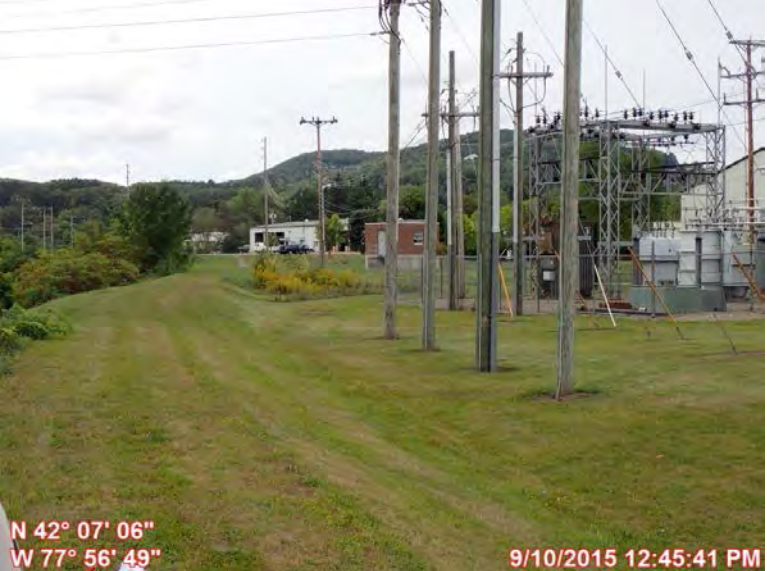
<p>N 42° 07' 06" W 77° 56' 49"</p> <p>9/10/2015 12:45:41 PM</p>	<p>Inspect ID: N21L_2015_a_0083 Title: USACE_CELRB_N21L_2015_a_0083_1.jpg Rated Item: 3. Encroachments Caption: Rating: Minimally Acceptable; Remarks: Unauthorized Alteration - 4 Utility Poles on left bank 250' upstream of State Street bridge.; Action: Remove unauthorized alteration or submit a Section 408 Alteration Request Form.; Station_1: 30+00</p>

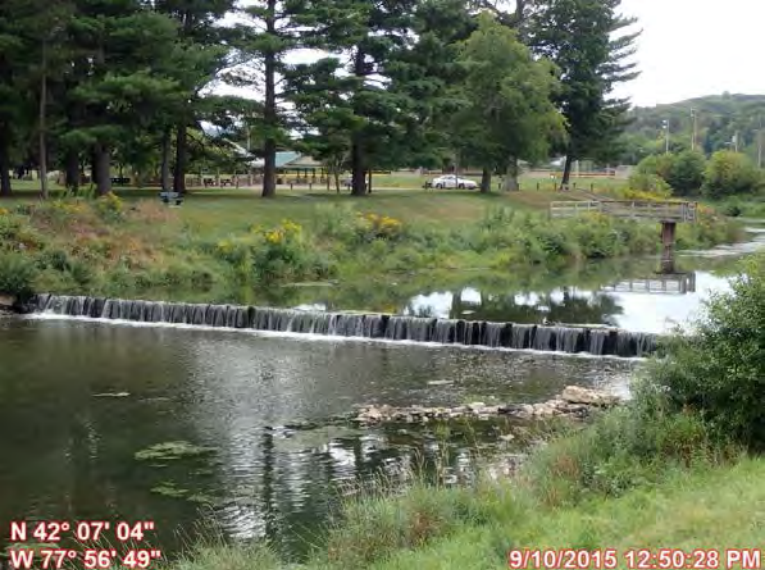
<p>N 42° 07' 04" W 77° 56' 49"</p> <p>9/10/2015 12:50:28 PM</p>	<p>Inspect ID: N21L_2015_a_0086 Title: USACE_CELRB_N21L_2015_a_0086_1.jpg Rated Item: 3. Encroachments Caption: Rating: Acceptable; Remarks: 1974 Steel Sheet Pile Weir by Others - shown on AS-CONSTRUCTED drawing 189-WEL-2/4 (approved by USACE).; Action: NA; Station_1: 27+00</p>

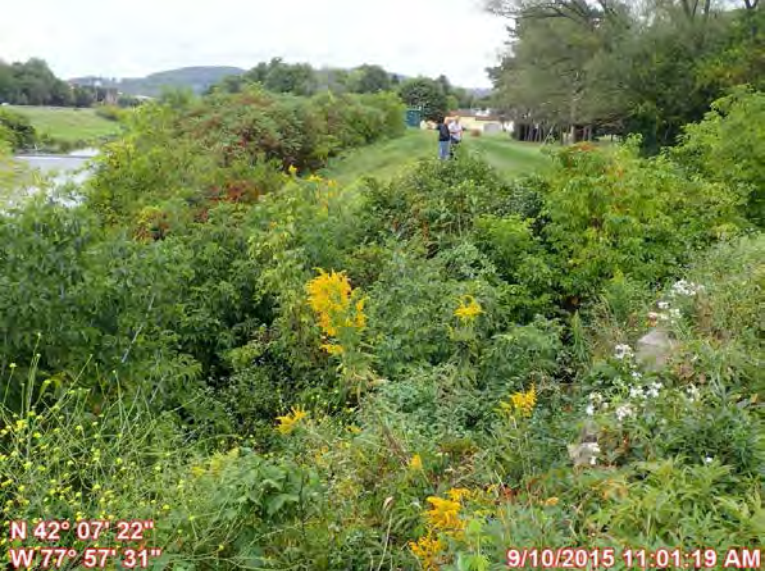
<p>Inspect ID: N21L_2015_a_0031 Title: USACE_CELRB_N21L_2015_a_0031_1.jpg Rated Item: 8. Depressions/ Rutting Caption: Rating: Minimally Acceptable; Remarks: Chamberland Street drainage channel creates apparent gap in line of protection on left bank levee.; Action: Evaluate the possibility of altering the project to improve a continuous line of protection; potentially include a pipe and flapgate.; Station_1: 69+00</p>

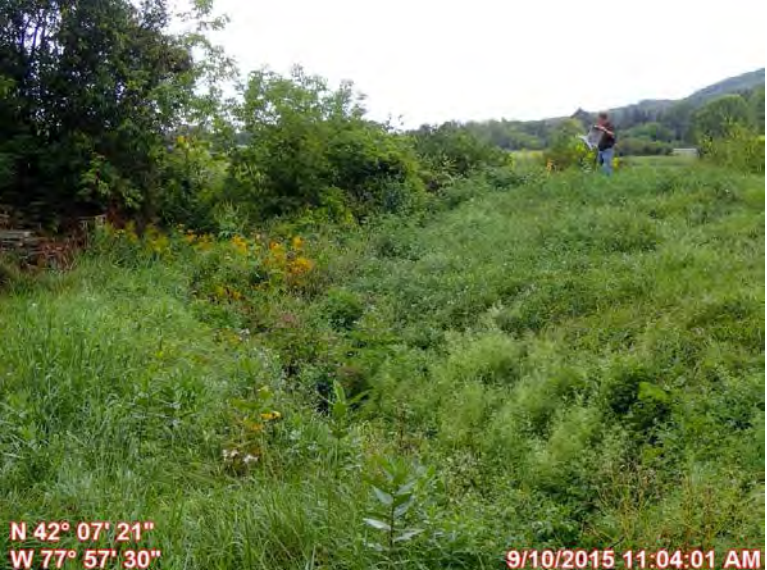
<p>Inspect ID: N21L_2015_a_0031 Title: USACE_CELRB_N21L_2015_a_0031_2.jpg Rated Item: 8. Depressions/ Rutting Caption: Rating: Minimally Acceptable; Remarks: Chamberland Street drainage channel creates apparent gap in line of protection on left bank levee.; Action: Evaluate the possibility of altering the project to improve a continuous line of protection; potentially include a pipe and flapgate.; Station_1: 69+00</p>

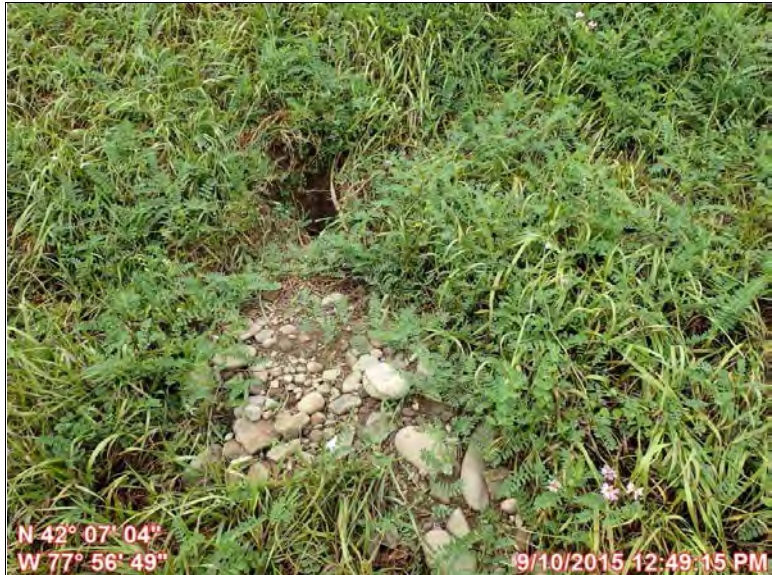
<p>Inspect ID: N21L_2015_a_0084 Title: USACE_CELRB_N21L_2015_a_0084_1.jpg Rated Item: 10. Animal Control Caption: Rating: Minimally Acceptable; Remarks: Multiple animal burrows (approx. half dozen) on left bank riverside slope 450' upstream of State Street bridge.; Action: Fill animal burrows and improve animal control program.; Station_1: 28+00</p>

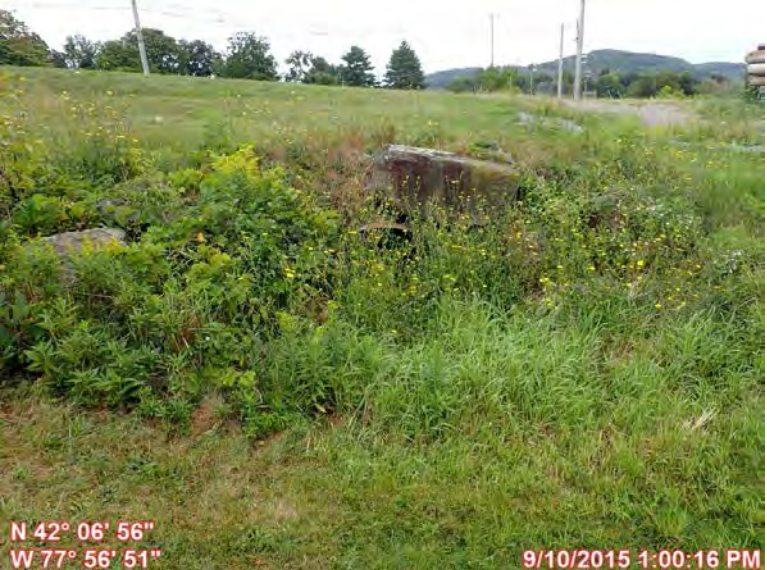
<p>Inspect ID: N21L_2015_a_0094 Title: USACE_CELRB_N21L_2015_a_0094_1.jpg Rated Item: 1. Vegetation and Obstructions Caption: Rating: Minimally Acceptable; Remarks: 48" CMP inlet to culvert under Dyke Street access road on left bank obstructed by vegetation 500' upstream of Steel Sheet Pile Weir.; Action: Remove vegetation obstruction.; Station_1: 23+00</p>

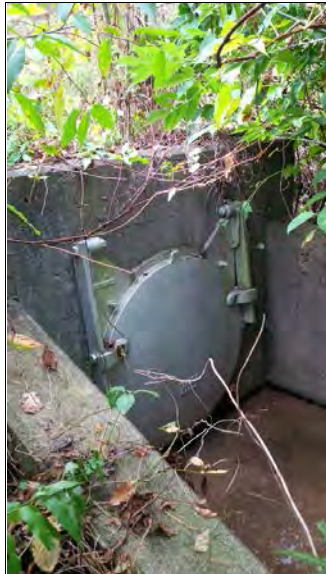
Inspect ID: N21L_2015_a_0090 **Title:** USACE_CELRB_N21L_2015_a_0090_1.jpg
Rated Item: 9. Culverts/ Discharge Pipes **Caption:** Rating: Acceptable; Remarks: 36" CMP on left bank 475' upstream of Steel Sheet Pile Weir (rated A in NYSDEC 19DEC13 pipe inspection).; Action: Maintain pipe and videotape inspect by 19DEC18.; Station_1: 23+00

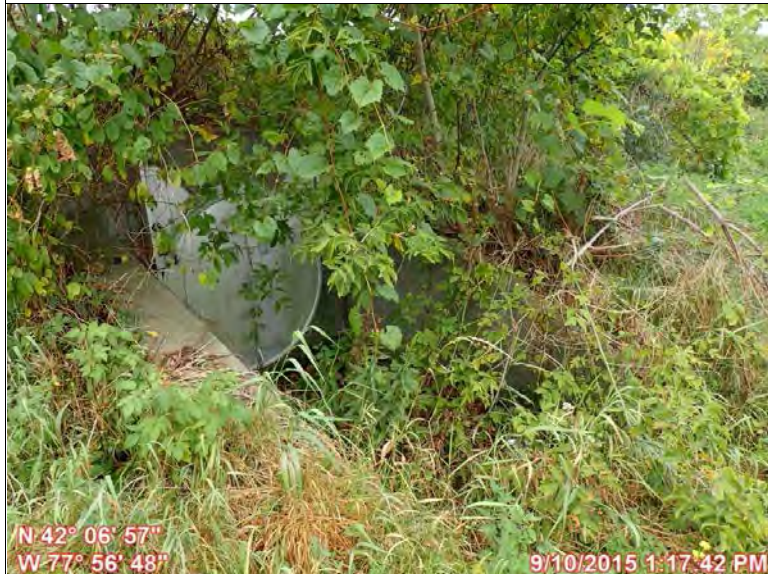
Inspect ID: N21L_2015_a_0091 **Title:** USACE_CELRB_N21L_2015_a_0091_1.jpg
Rated Item: 9. Culverts/ Discharge Pipes **Caption:** Rating: Acceptable; Remarks: 48" CMP outlet on left bank riverside slope 515' upstream of Steel Sheet Pile Weir (rated A in NYSDEC 19DEC13 pipe inspection).; Action: Maintain pipe and videotape inspect by 19DEC18.; Station_1: 23+00

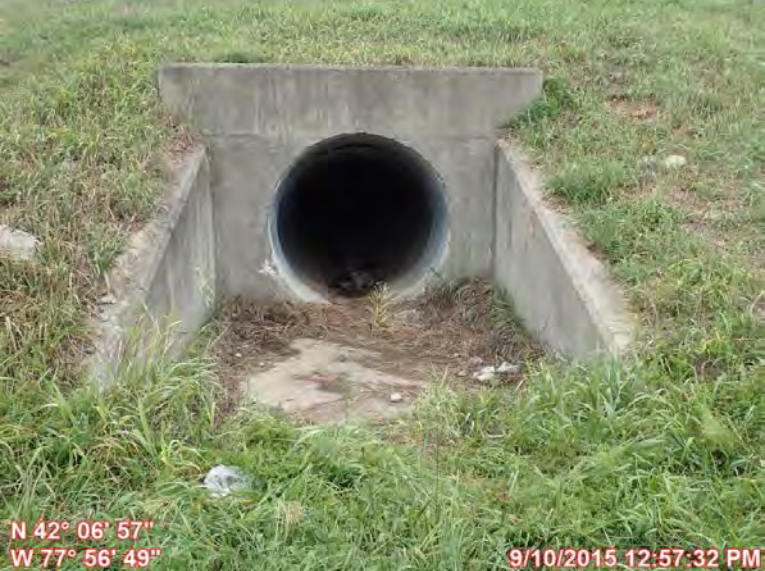
<p>N 42° 06' 57" W 77° 56' 49" 9/10/2015 12:57:32 PM</p>	<p>Inspect ID: N21L_2015_a_0093 Title: USACE_CELRB_N21L_2015_a_0093_1.jpg Rated Item: 9. Culverts/ Discharge Pipes Caption: Rating: Minimally Acceptable; Remarks: 48" CMP on left bank landside slope 515' upstream of Steel Sheet Pile Weir is not currently obstructed, however, it does not have a trash rack to prevent obstructions from entering the pipe (rated A in NYSDEC 19DEC13 pipe inspection). ; Action: Install trash rack over opening to keep out debris and unauthorized access. Maintain pipe and videotape inspect by 19DEC18.; Station_1: 23+00</p>

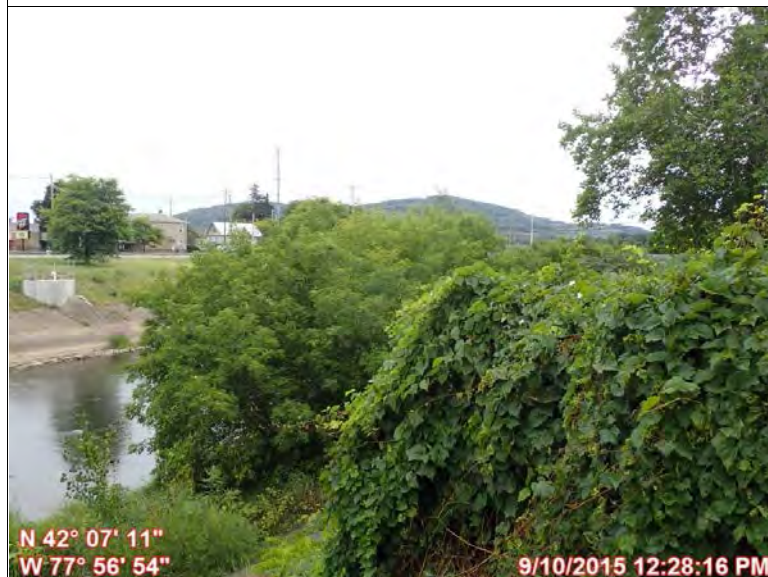
Inspect ID: N21L_2015_a_0078 **Title:** USACE_CELRB_N21L_2015_a_0078_1.jpg
Rated Item: 1. Vegetation and Obstructions **Caption:** Rating: Unacceptable; **Remarks:** Significant unwanted vegetation and trees on left bank 400' downstream of State Street bridge.; **Action:** Remove unwanted vegetation and trees.; **Station_1:** 37+00

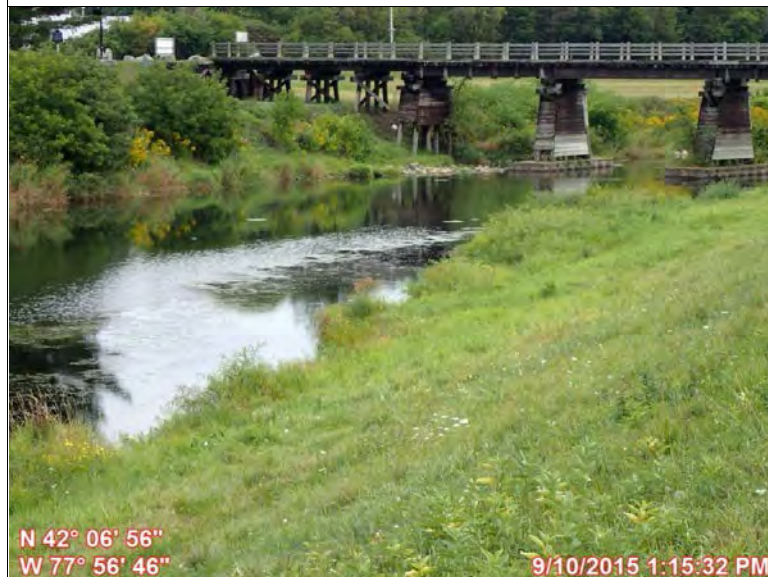
Inspect ID: N21L_2015_a_0096 **Title:** USACE_CELRB_N21L_2015_a_0096_1.jpg
Rated Item: 2. Shoaling (sediment deposition) **Caption:** Rating: Minimally Acceptable;
Remarks: Shoaling along left bank toe from 450' downstream of Island Park pedestrian walkway bridge to Island Park Pedestrian Walkway Bridge.; **Action:** Remove shoaling.;
Station_1: 17+00; **Station_2:** 21+00

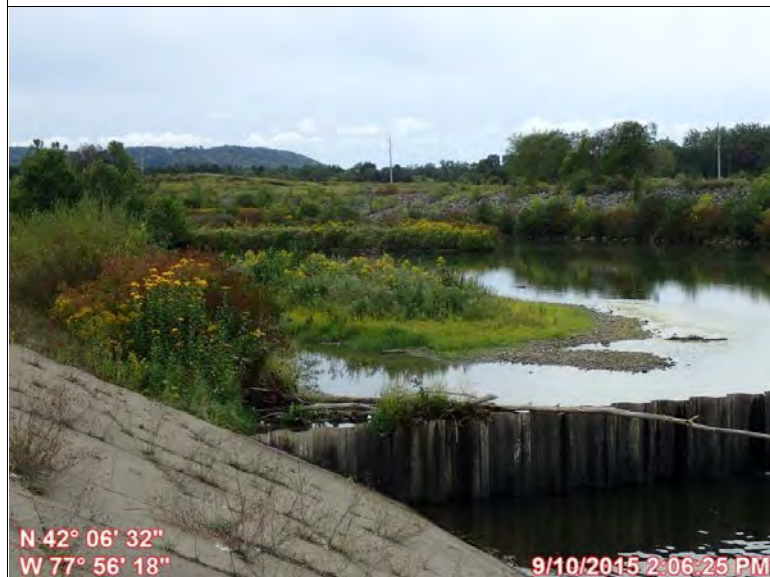
Inspect ID: N21L_2015_a_0117 **Title:** USACE_CELRB_N21L_2015_a_0117_1.jpg
Rated Item: 2. Shoaling (sediment deposition) **Caption:** Rating: Unacceptable;
Remarks: Significant shoaling on right bank from 50' to 225' upstream of 1976 Weir.; Action: Remove shoaling.; Station_1: 0+00; Station_2: 0+00

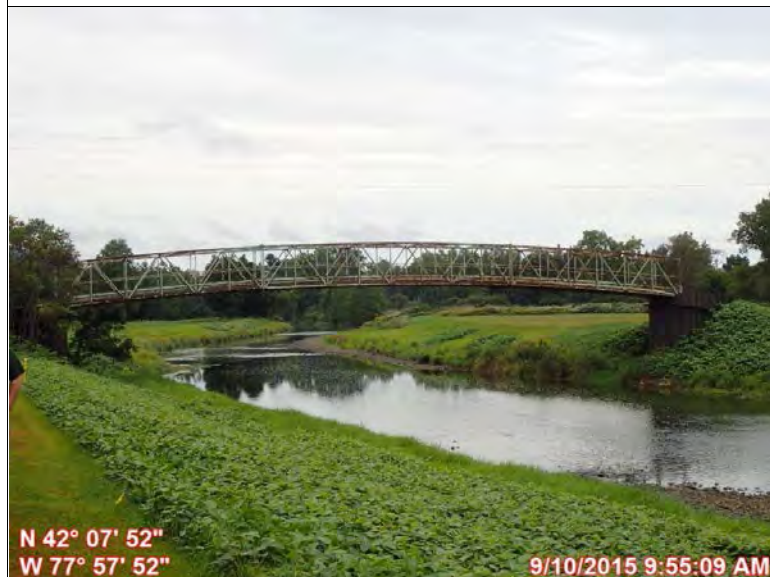
Inspect ID: N21L_2015_a_0007 **Title:** USACE_CELRB_N21L_2015_a_0007_1.jpg
Rated Item: 3. Encroachments **Caption:** Rating: Minimally Acceptable; Remarks: Unauthorized Alteration - Golf course pedestrian bridge 1,250' downstream of Boliver Road bridge.; Action: Remove unauthorized alteration or submit Section 408 Alteration Request Form.; Station_1: 104+00

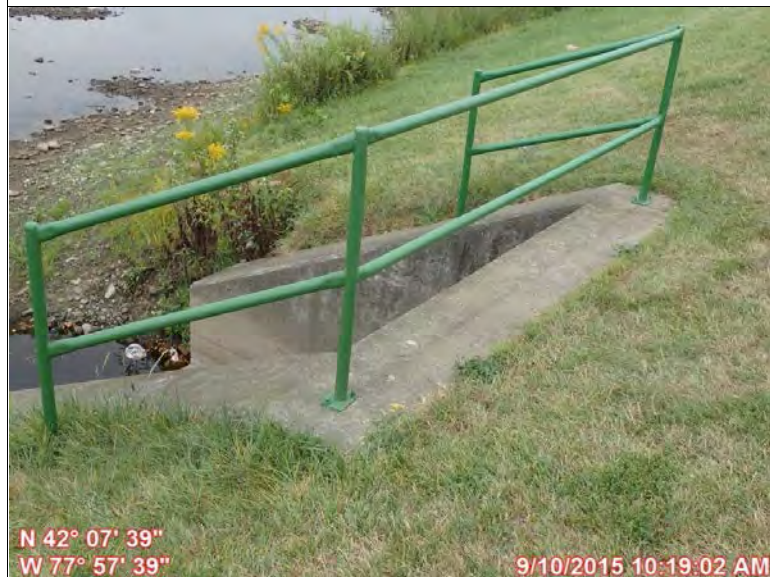
Inspect ID: N21L_2015_a_0017 **Title:** USACE_CELRB_N21L_2015_a_0017_1.jpg
Rated Item: 3. Encroachments **Caption:** Rating: Minimally Acceptable; Remarks: Unauthorized Alteration - Outfall on left bank 300' upstream of Bolivar Road bridge.; Action: Remove unauthorized alteration or submit a Section 408 Alteration Request Form.; Station_1: 88+00

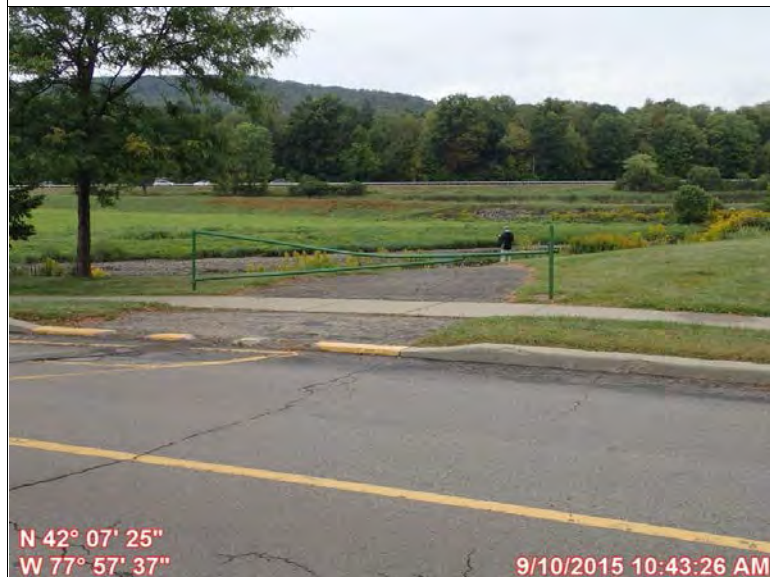
Inspect ID: N21L_2015_a_0024 **Title:** USACE_CELRB_N21L_2015_a_0024_1.jpg
Rated Item: 3. Encroachments **Caption:** Rating: Minimally Acceptable; Remarks: Unauthorized Alteration - Asphalt drive and access gate on left bank 1,600' upstream of Bolivar Road bridge.; Action: Remove unauthorized alteration or submit a Section 408 Alteration Request Form.; Station_1: 75+00

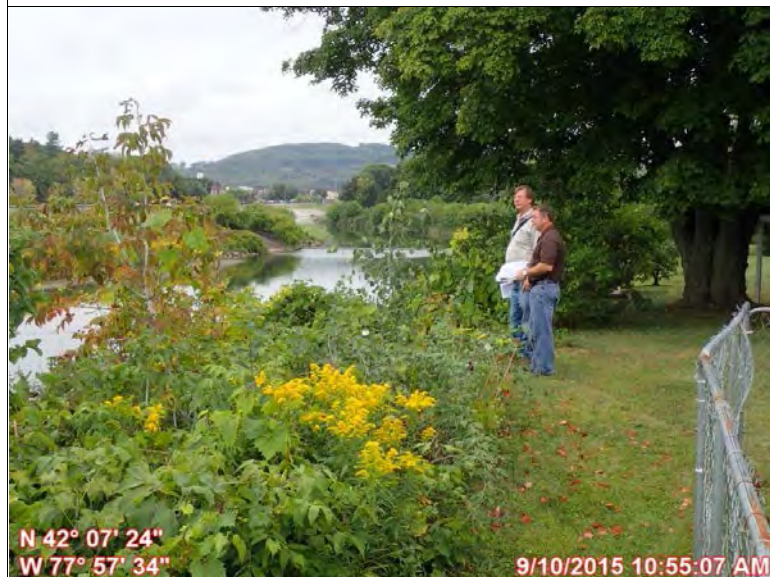
Inspect ID: N21L_2015_a_0028 **Title:** USACE_CELRB_N21L_2015_a_0028_1.jpg
Rated Item: 3. Encroachments **Caption:** Rating: Minimally Acceptable; Remarks: Unauthorized Alteration - Misc. landscaping encroachments 1,900' to 2,200' upstream of Bolivar Road bridge.; Action: Remove unauthorized alteration or submit a Section 408 Alteration Request Form.; Station_1: 72+00; Station_2: 69+00

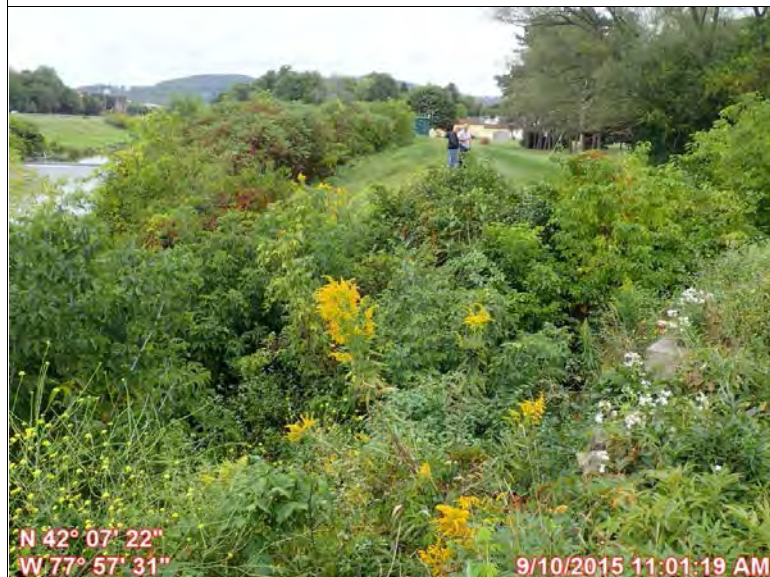
Inspect ID: N21L_2015_a_0030 **Title:** USACE_CELRB_N21L_2015_a_0030_1.jpg
Rated Item: 3. Encroachments **Caption:** Rating: Minimally Acceptable; Remarks: Vegetation and beaver dam obstructions in Chamberlain Street drainage channel to river.; Action: Remove vegetation and beaver dam obstructions.; Station_1: 69+00

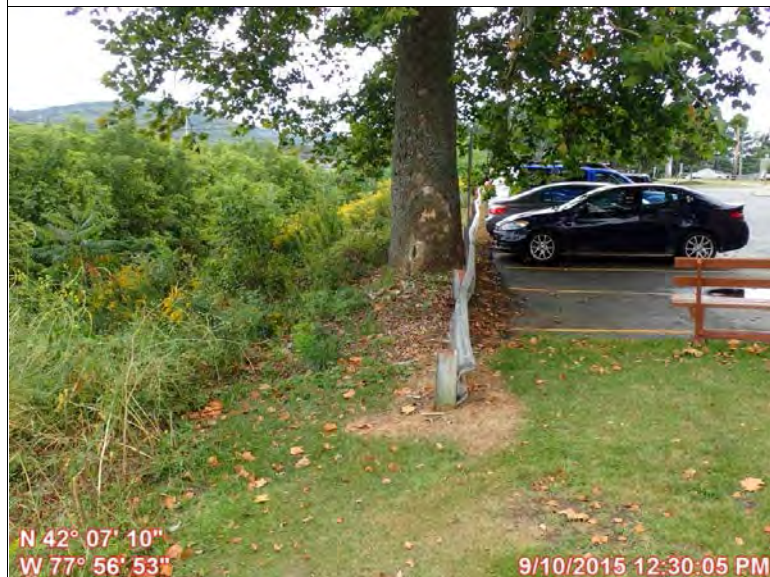
Inspect ID: N21L_2015_a_0077 **Title:** USACE_CELRB_N21L_2015_a_0077_1.jpg
Rated Item: 3. Encroachments **Caption:** Rating: Minimally Acceptable; Remarks: Unauthorized Alteration - Wellsville High School Rail and parking lot on left bank levee downstream of State Street bridge.; Action: Remove unauthorized alteration or submit a Section 408 Alteration Request Form.; Station_1: 37+00

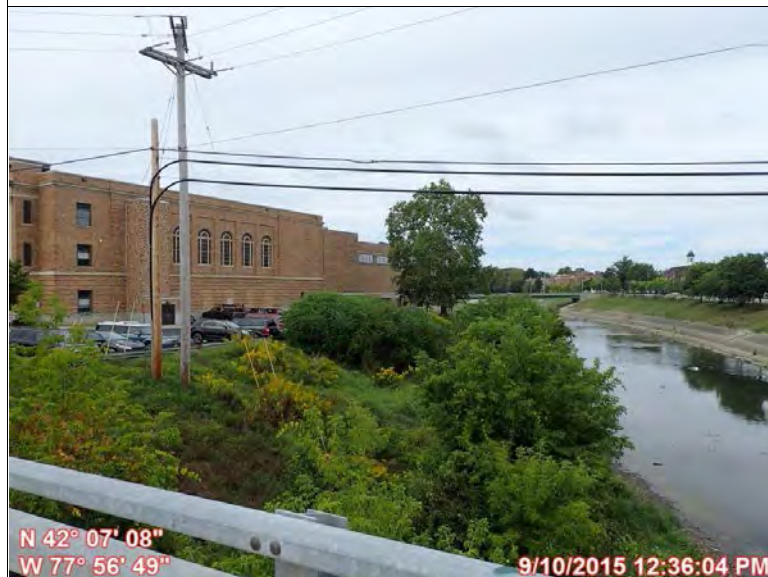
Inspect ID: N21L_2015_a_0080 **Title:** USACE_CELRB_N21L_2015_a_0080_1.jpg
Rated Item: 3. Encroachments **Caption:** Rating: Minimally Acceptable; Remarks: Unauthorized Alteration - 2 utility poles and associated guy wires 75' downstream of State Street bridge.; Action: Remove unauthorized alteration or submit a Section 408 Alteration Request Form.; Station_1: 35+00

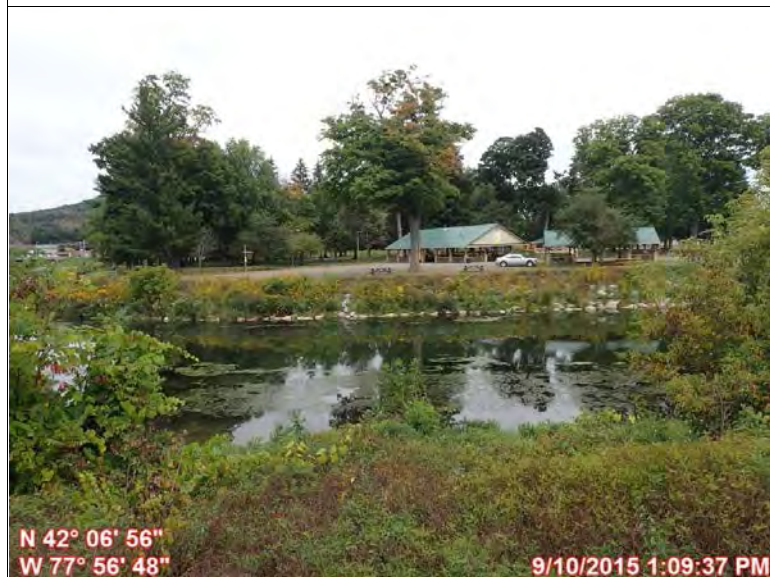
Inspect ID: N21L_2015_a_0095 **Title:** USACE_CELRB_N21L_2015_a_0095_1.jpg
Rated Item: 3. Encroachments **Caption:** Rating: Minimally Acceptable; Remarks: Unauthorized Alteration - Parking lot and wooden posts on right bank in Island Park 500' upstream of Steel Sheet Pile Weir.; Action: Remove unauthorized alteration or submit a Section 408 Alteration Request Form.; Station_1: 22+00

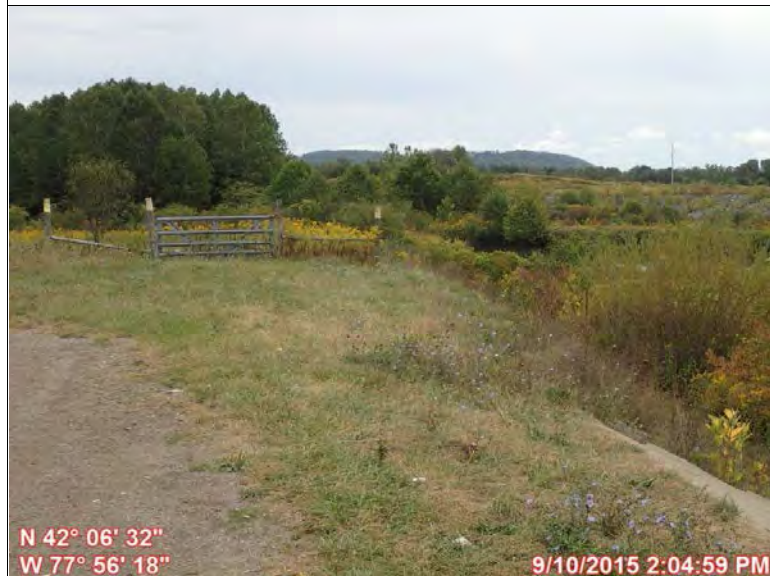
Inspect ID: N21L_2015_a_0114 **Title:** USACE_CELRB_N21L_2015_a_0114_1.jpg
Rated Item: 3. Encroachments **Caption:** Rating: Minimally Acceptable; Remarks: Unauthorized Alteration - Barbed wire fence and metal gate on right bank at 1976 Weir.; Action: Remove unauthorized alteration or submit a Section 408 Alteration Request Form.; Station_1: 0+00

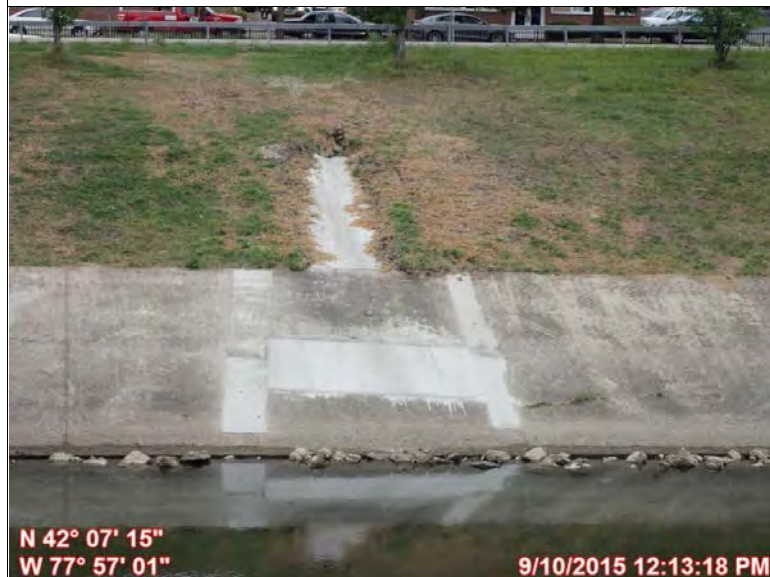
Inspect ID: N21L_2015_a_0069 **Title:** USACE_CELRB_N21L_2015_a_0069_1.jpg
Rated Item: 4. Erosion **Caption:** Rating: Acceptable; Remarks: Repaired 3' x 15' eroded outfall channel on right bank 250' downstream of Madison Street (Stevens Street) bridge.; Action: NA; Station_1: 44+00

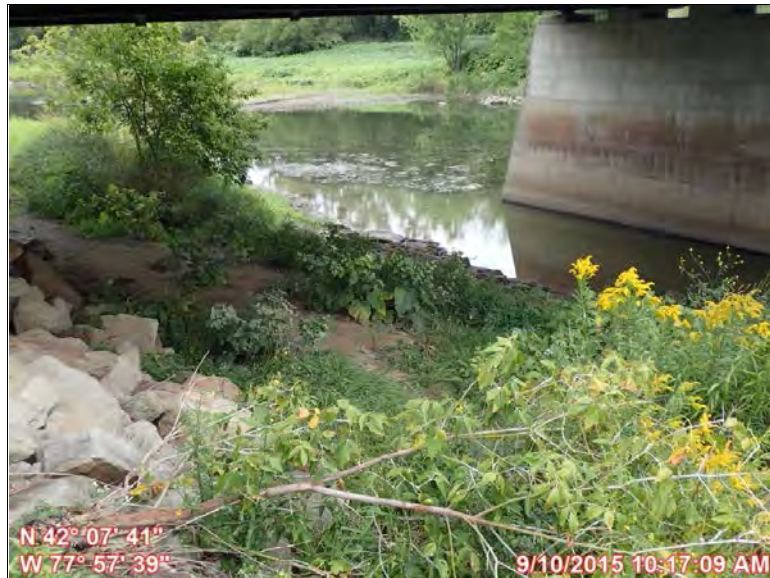
Inspect ID: N21L_2015_a_0010 **Title:** USACE_CELRB_N21L_2015_a_0010_1.jpg
Rated Item: 10. Riprap Revetments & Banks **Caption:** Rating: Unacceptable; Remarks: Riprap missing or covered on left bank underneath Bolivar Road bridge.; Action: Replace or uncover missing riprap.; Station_1: 91+00

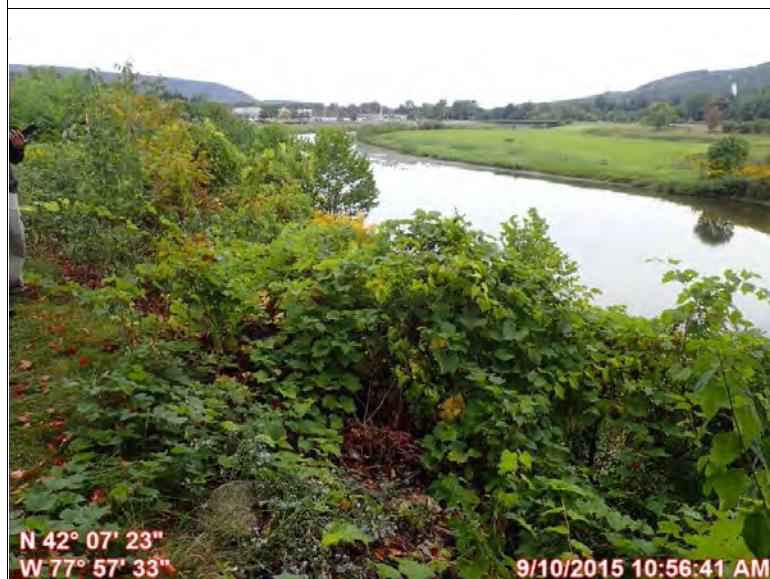
Inspect ID: N21L_2015_a_0029 **Title:** USACE_CELRB_N21L_2015_a_0029_1.jpg
Rated Item: 10. Riprap Revetments & Banks **Caption:** Rating: Minimally Acceptable; Remarks: Vegetation in left bank riprap from 1,900' to 2,500' upstream of Bolivar Road bridge.; Action: Remove vegetation from riprap.; Station_1: 72+00; Station_2: 66+00

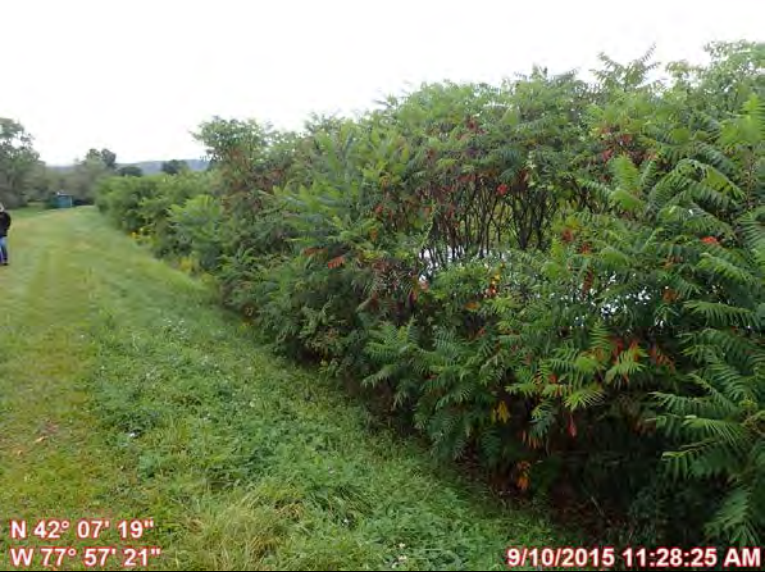
<p>N 42° 07' 19" W 77° 57' 21" 9/10/2015 11:28:25 AM</p>	<p>Inspect ID: N21L_2015_a_0037 Title: USACE_CELRB_N21L_2015_a_0037_1.jpg Rated Item: 10. Riprap Revetments & Banks Caption: Rating: Unacceptable; Remarks: Significant woody unwanted vegetation on left bank channel sideslopes from 2,200' downstream of the Madison Street (Stevens Street) bridge to the Madison Street bridge.; Action: Remove unwanted vegetation.; Station_1: 44+00; Station_2: 64+00</p>

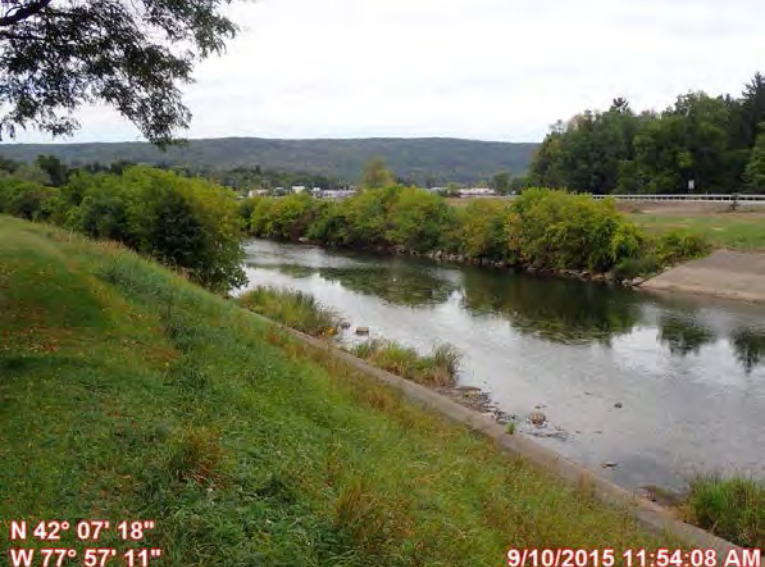
<p>N 42° 07' 18" W 77° 57' 11" 9/10/2015 11:54:08 AM</p>	<p>Inspect ID: N21L_2015_a_0048 Title: USACE_CELRB_N21L_2015_a_0048_1.jpg Rated Item: 10. Riprap Revetments & Banks Caption: Rating: Minimally Acceptable; Remarks: Vegetation in riprap on right bank from 1,600' to 1,300' downstream of Madison Street (Stevens Street) bridge.; Action: Remove vegetation from riprap.; Station_1: 59+00; Station_2: 56+00</p>

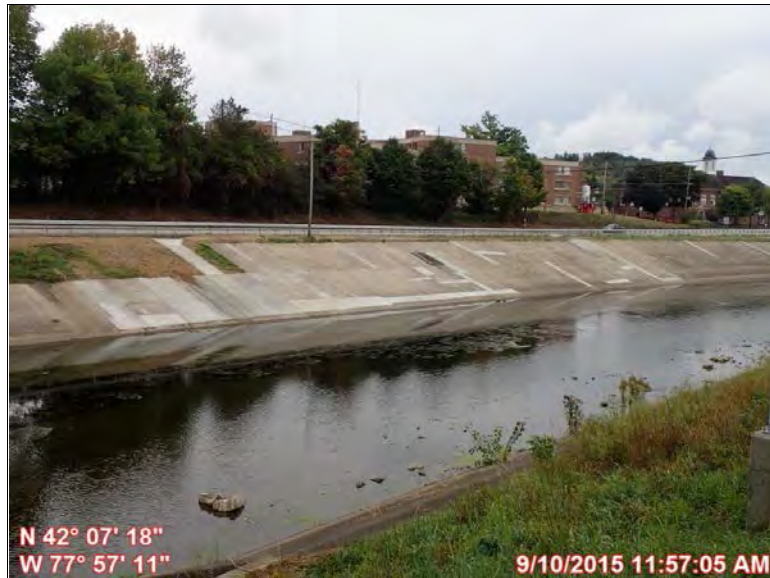
Inspect ID: N21L_2015_a_0051 **Title:** USACE_CELRB_N21L_2015_a_0051_1.jpg
Rated Item: 11. Revetments other than Riprap **Caption:** Rating: Acceptable; Remarks: 15' x 3' concrete spalling repaired on right bank 975' downstream of Madison Street (Stevens Street) bridge.; Action: NA; Station_1: 52+00

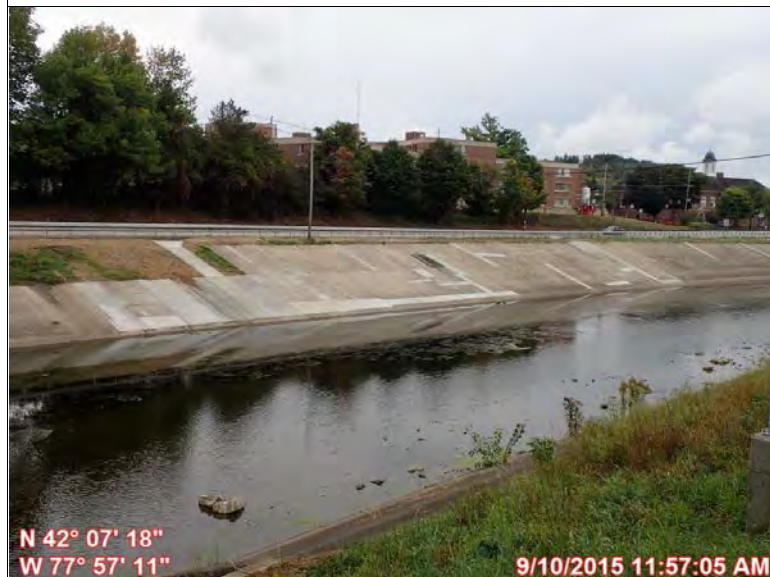
Inspect ID: N21L_2015_a_0052 **Title:** USACE_CELRB_N21L_2015_a_0052_1.jpg
Rated Item: 11. Revetments other than Riprap **Caption:** Rating: Minimally Acceptable; Remarks: Minor unwanted vegetation in joints of right bank concrete channel surface from 900' downstream of Madison Street (Stevens Street) bridge to Madison Street bridge.; Action: Remove unwanted vegetation.; Station_1: 52+00; Station_2: 43+00

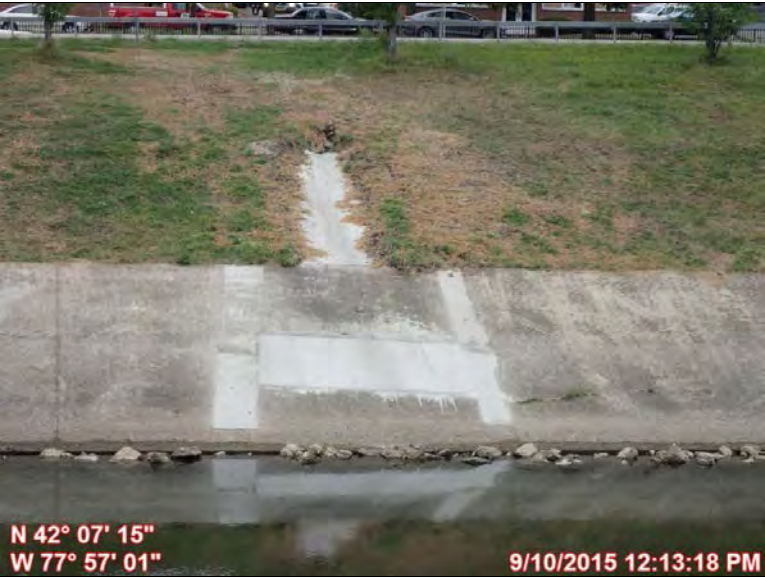
<p>Inspect ID: N21L_2015_a_0066 Title: USACE_CELRB_N21L_2015_a_0066_1.jpg Rated Item: 11. Revetments other than Riprap Caption: Rating: Acceptable; Remarks: Cracking in concrete sideslope repaired on right bank 250' downstream of Madison Street (Stevens Street) bridge.; Action: NA; Station_1: 45+00</p>

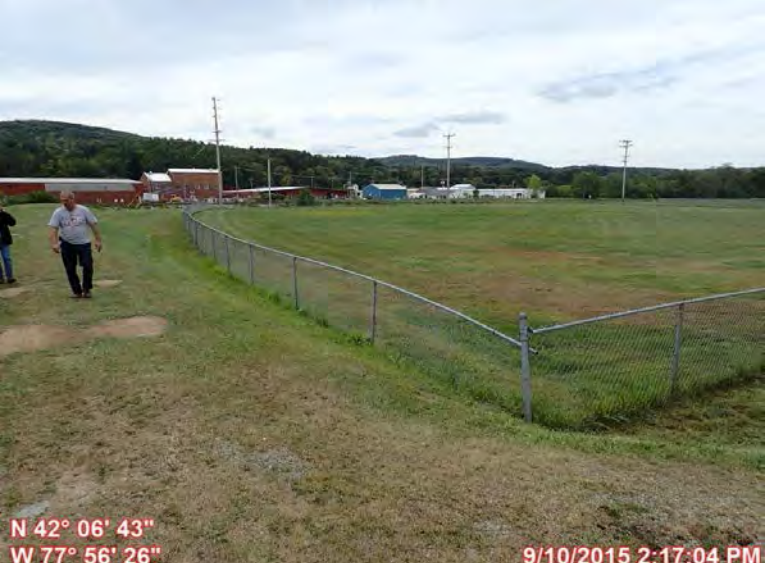
<p>N 42° 06' 43" W 77° 56' 26" 9/10/2015 2:17:04 PM</p>	<p>Inspect ID: N21R_2015_a_0002 Title: USACE_CELRB_N21R_2015_a_0002_1.jpg Rated Item: 3. Encroachments Caption: Rating: Minimally Acceptable; Remarks: Unauthorized Alteration - Fence along right bank levee adjacent to 1957 Weir landside toe.; Action: Remove unauthorized alteration or submit a Section 408 Alteration Request Form.; Station_1: 0+00; Station_2: 0+00</p>

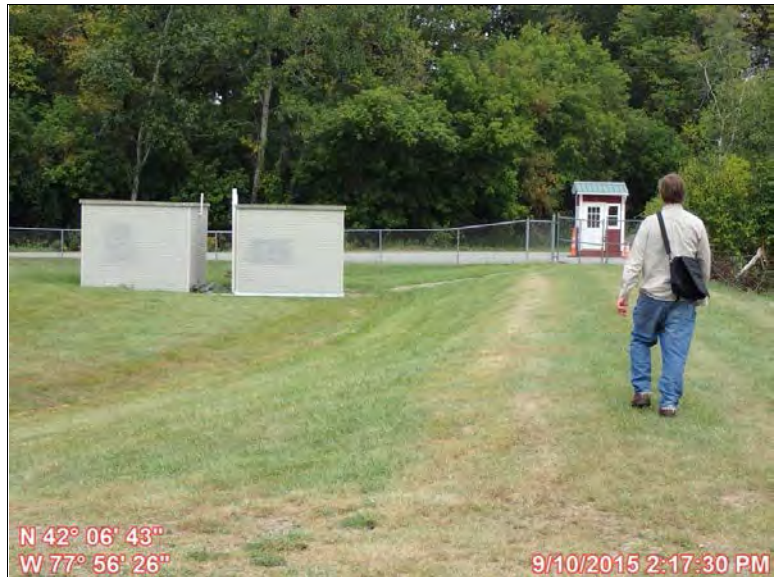
<p>N 42° 06' 43" W 77° 56' 26"</p> <p>9/10/2015 2:17:30 PM</p>	<p>Inspect ID: N21R_2015_a_0005 Title: USACE_CELRB_N21R_2015_a_0005_1.jpg Rated Item: 3. Encroachments Caption: Rating: Minimally Acceptable; Remarks: Unauthorized Alteration - Gray brick building and sidewalk within 15' of right bank levee adjacent to 1957 Weir landside toe.; Action: Remove unauthorized alteration or submit a Section 408 Alteration Request Form.; Station_1: 0+00</p>
  <p>N 42° 06' 44" W 77° 56' 25"</p> <p>9/10/2015 2:19:28 PM</p>	<p>Inspect ID: N21R_2015_a_0006 Title: USACE_CELRB_N21R_2015_a_0006_1.jpg Rated Item: 3. Encroachments Caption: Rating: Minimally Acceptable; Remarks: Unauthorized Alteration - Right bank levee adjacent to 1957 Weir removed for access road.; Action: Remove unauthorized alteration (repair levee to As-Built conditions) or submit a Section 408 Alteration Request Form.; Station_1: 0+00</p>

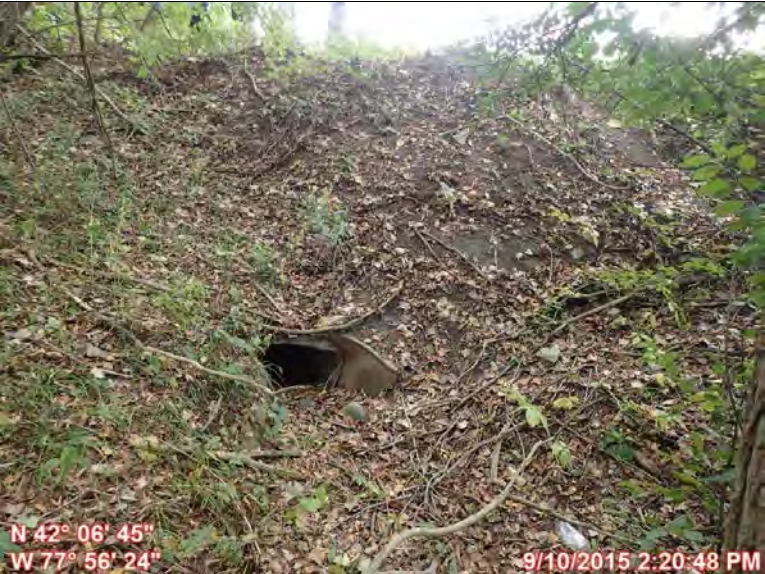
<p>N 42° 06' 45" W 77° 56' 24" 9/10/2015 2:20:48 PM</p>	<p>Inspect ID: N21R_2015_a_0008 Title: USACE_CELRB_N21R_2015_a_0008_1.jpg Rated Item: 9. Culverts/ Discharge Pipes Caption: Rating: Minimally Acceptable; Remarks: 24" CMP at terminus of right bank levee adjacent to 1957 Weir is 80% obstructed by sediment and does not have a flapgate.; Action: Clear obstructed outfall and install flapgate.; Station_1: 0+00</p>

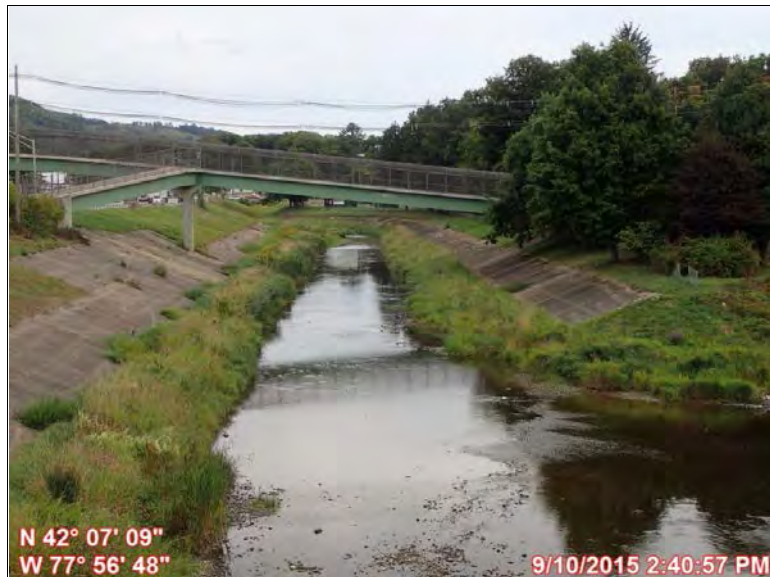
Inspect ID: N21R_2015_a_0009 **Title:** USACE_CELRB_N21R_2015_a_0009_1.jpg
Rated Item: 2. Shoaling (sediment deposition) **Caption:** Rating: Minimally Acceptable;
Remarks: Vegetated shoaling on both banks from convergence of Dyke Creek to the State Route 417 bridge.; Action: Remove shoaling.; Station_1: 11+00; Station_2: 2+00

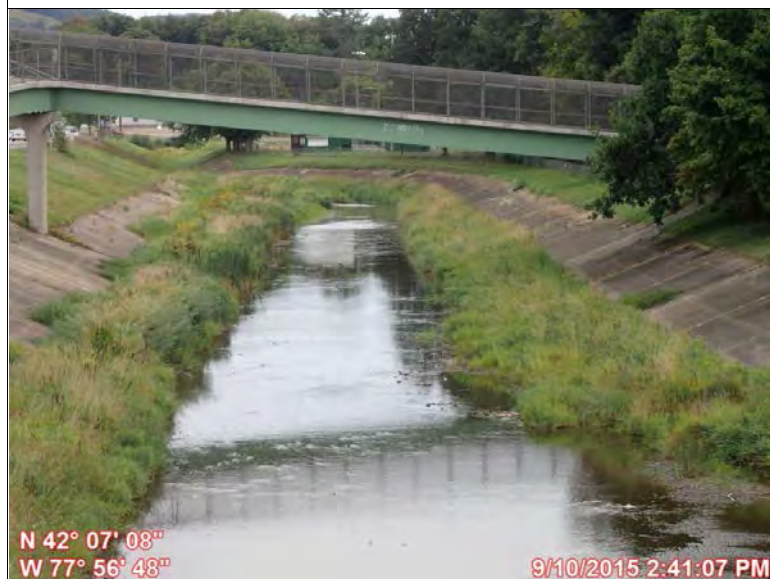
Inspect ID: N21R_2015_a_0009 **Title:** USACE_CELRB_N21R_2015_a_0009_2.jpg
Rated Item: 2. Shoaling (sediment deposition) **Caption:** Rating: Minimally Acceptable;
Remarks: Vegetated shoaling on both banks from convergence of Dyke Creek to the State Route 417 bridge.; Action: Remove shoaling.; Station_1: 11+00; Station_2: 2+00
