DEPARTMENT OF THE ARMY

BUFFALO DISTRICT, CORPS OF ENGINEERS
1776 NIAGARA STREET
BUFFALO, NEW YORK 14207-3199

SUBJECT: FY15 Joint Routine Inspection of Completed Works, Flood Damage Reduction Project, Genesee River and Dyke Creek, Wellsville, New York (09/10/15)

Attachment A –
Genesee River - Left Bank and Channel, Wellsville
Summary of Deficiencies and Recommendations

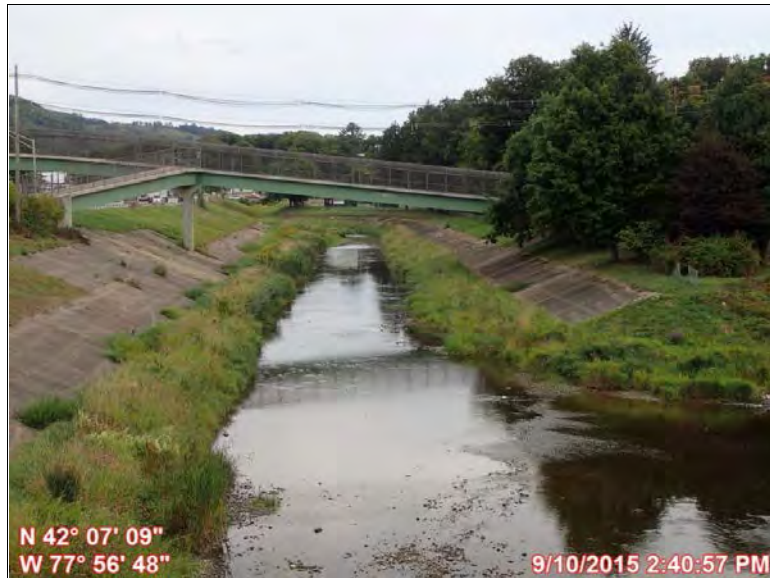
Inspect ID: N21R_2015_a_0010 **Title:** USACE_CELRB_N21R_2015_a_0010_1.jpg
Rated Item: 11. Revetments other than Riprap **Caption:** Rating: Minimally Acceptable;
Remarks: Cracking with unwanted vegetation on concrete channel sideslopes and deteriorating weep holes from Dyke Creek convergence to State Route 417 bridge.;
Action: Repair cracking, remove vegetation, clean out, and weep roles.; **Station_1:** 1+00;
Station_2: 9+00

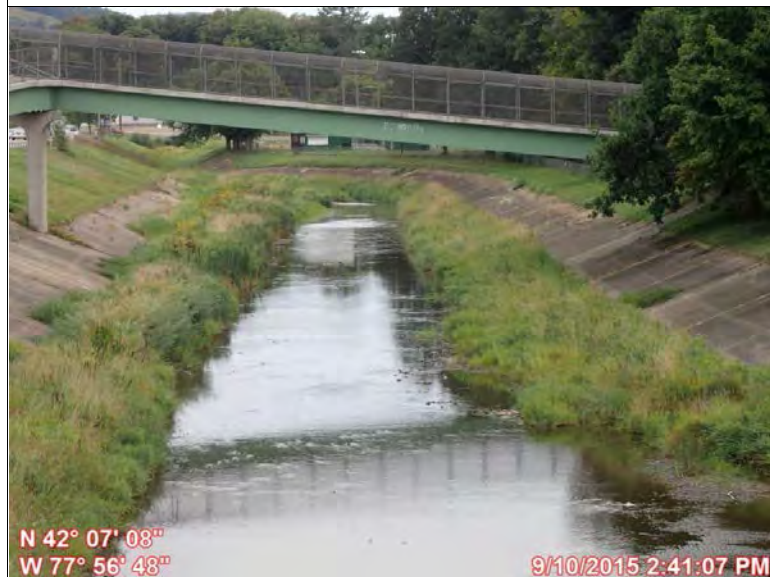
Inspect ID: N21R_2015_a_0010 **Title:** USACE_CELRB_N21R_2015_a_0010_2.jpg
Rated Item: 11. Revetments other than Riprap **Caption:** Rating: Minimally Acceptable;
Remarks: Cracking with unwanted vegetation on concrete channel sideslopes and deteriorating weep holes from Dyke Creek convergence to State Route 417 bridge.;
Action: Repair cracking, remove vegetation, clean out, and weep roles.; **Station_1:** 1+00;
Station_2: 9+00
