## DEPARTMENT OF THE ARMY

BUFFALO DISTRICT, CORPS OF ENGINEERS  
1776 NIAGARA STREET  
BUFFALO, NEW YORK 14207-3199

September 30, 2014

SUBJECT: FY13 Joint Routine Inspection of Completed Works, Flood Damage Reduction Project, Genesee River and Dyke Creek, Wellsville, New York (09/24/13)

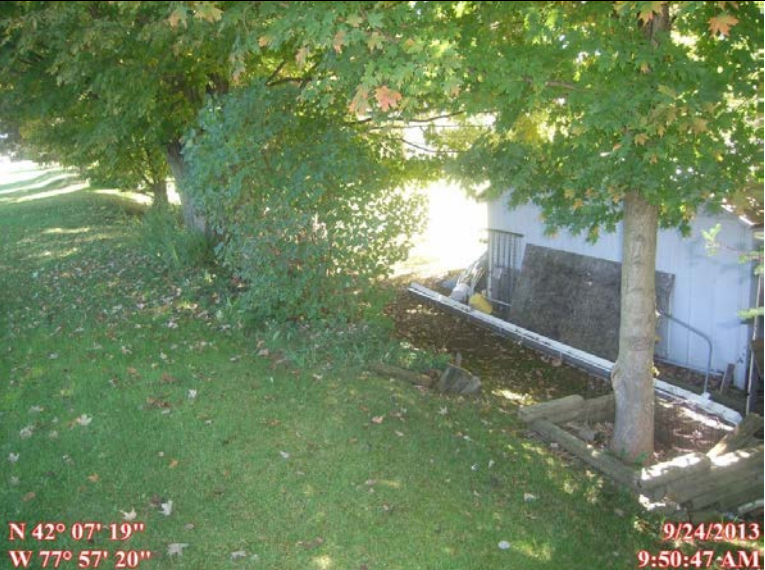
<p>N 42° 07' 19" W 77° 57' 20"</p> <p>9/24/2013 9:50:47 AM</p>	<p><b>Inspect ID:</b> N21L_2013_a_0060 <b>Title:</b> USACE_CELRB_N21L_2013_a_0060_2.jpg <b>Rated Item:</b> 1. Unwanted Vegetation Growth <b>Caption:</b> Rating: Minimally Acceptable; <b>Remarks:</b> Multiple trees on landside slope and within 15' of the toe; Station_1: 61+00; Station_2: 58+00</p>

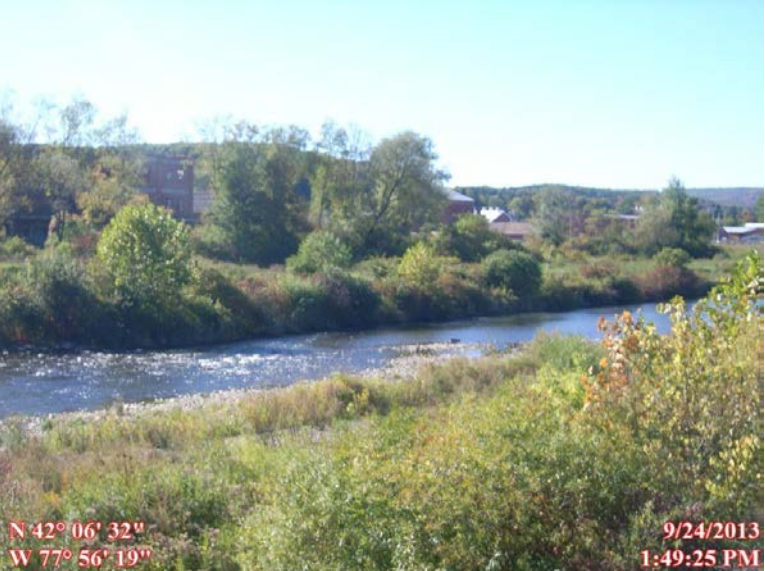
<p><b>Inspect ID:</b> N21L_2013_a_0221 <b>Title:</b> USACE_CELRB_N21L_2013_a_0221_1.jpg  <b>Rated Item:</b> 1. Unwanted Vegetation Growth <b>Caption:</b> Rating: Unacceptable; Remarks: Trees on bank on LB; Station_1: 0+00</p>

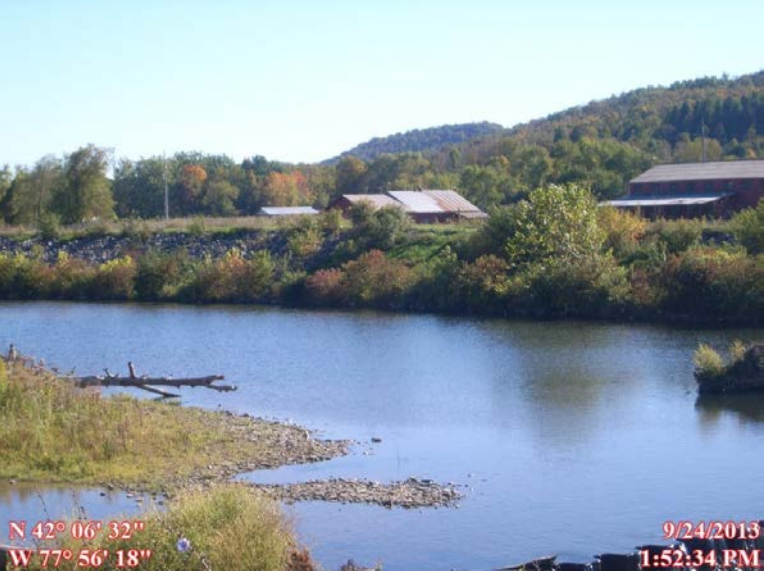
<p>N 42° 06' 32" W 77° 56' 18"</p> <p>9/24/2013 1:52:34 PM</p>	<p><b>Inspect ID:</b> N21L_2013_a_0230 <b>Title:</b> USACE_CELRB_N21L_2013_a_0230_1.jpg  <b>Rated Item:</b> 1. Unwanted Vegetation Growth <b>Caption:</b> Rating: Unacceptable; Remarks: Unwanted vegetation in riprap; Station_1: 0+00</p>

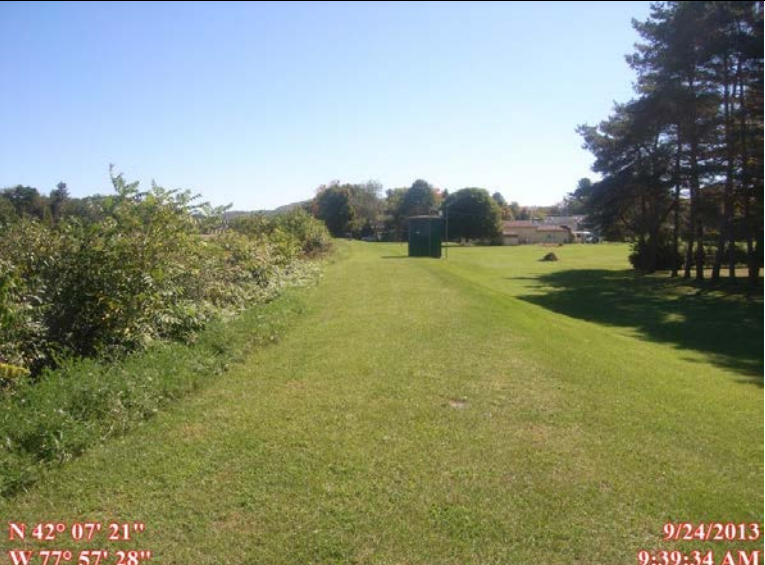
<p>N 42° 07' 21" W 77° 57' 28"</p> <p>9/24/2013 9:39:34 AM</p>	<p><b>Inspect ID:</b> N21L_2013_a_0053 <b>Title:</b> USACE_CELRB_N21L_2013_a_0053_1.jpg  <b>Rated Item:</b> 2. Sod Cover <b>Caption:</b> Rating: Acceptable; Remarks: Levee in good condition; Station_1: 67+00</p>

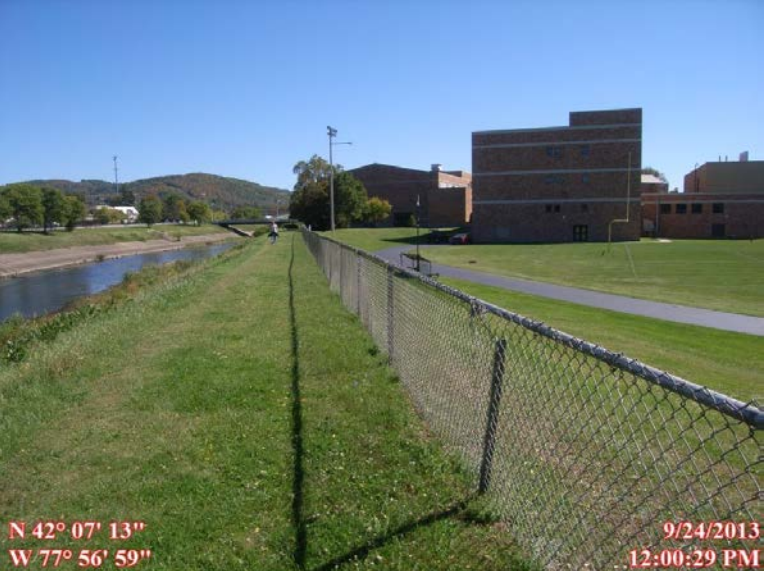
<p>N 42° 07' 13" W 77° 56' 59"</p> <p>9/24/2013 12:00:29 PM</p>	<p><b>Inspect ID:</b> N21L_2013_a_0124 <b>Title:</b> USACE_CELRB_N21L_2013_a_0124_1.jpg <b>Rated Item:</b> 3. Encroachments <b>Caption:</b> Rating: Minimally Acceptable; Remarks: Fence; Remove fence or submit modification request; Station_1: 34+00; Station_2: 43+00</p>

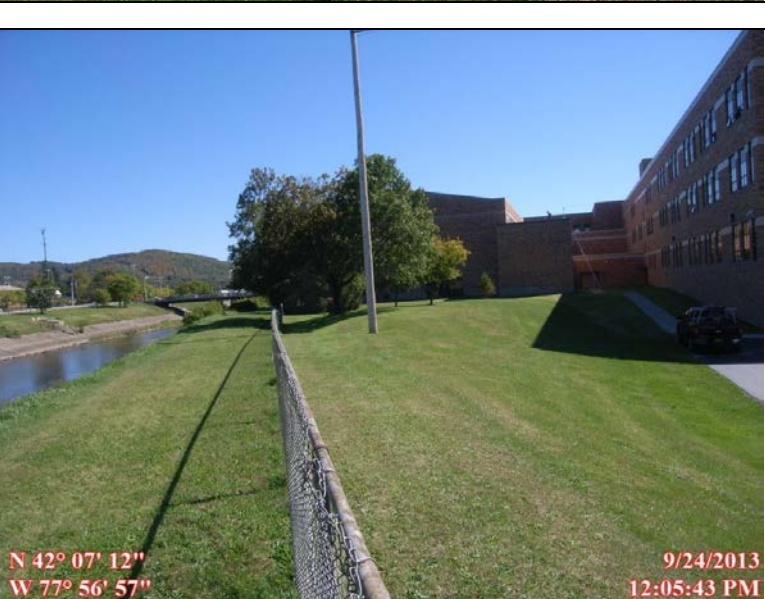
<p>N 42° 07' 12" W 77° 56' 57"</p> <p>9/24/2013 12:05:43 PM</p>	<p><b>Inspect ID:</b> N21L_2013_a_0128 <b>Title:</b> USACE_CELRB_N21L_2013_a_0128_1.jpg <b>Rated Item:</b> 3. Encroachments <b>Caption:</b> Rating: Acceptable; Remarks: Utility pole; Station_1: 40+00</p>

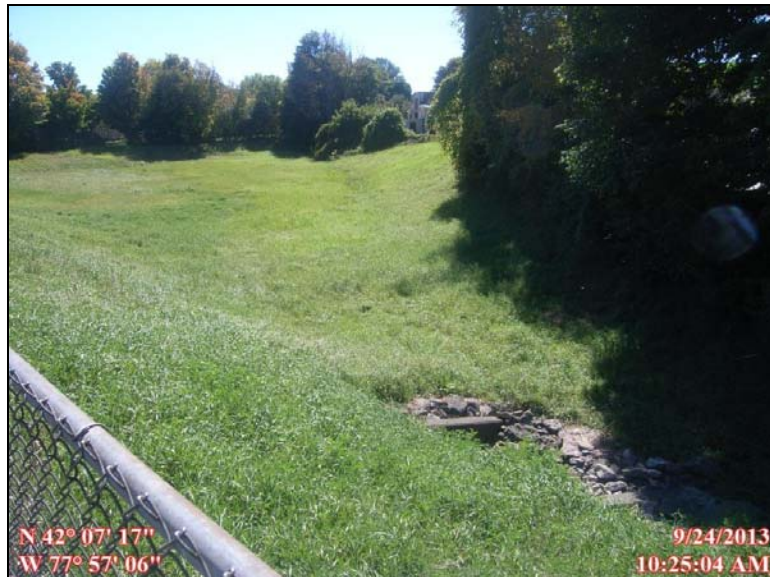
**Inspect ID:** N21L\_2013\_a\_0097 **Title:** USACE\_CELRB\_N21L\_2013\_a\_0097\_1.jpg  
**Rated Item:** 3. Ponding Areas **Caption:** Rating: Acceptable; Remarks: Ponding Area;  
Station\_1: 49+00

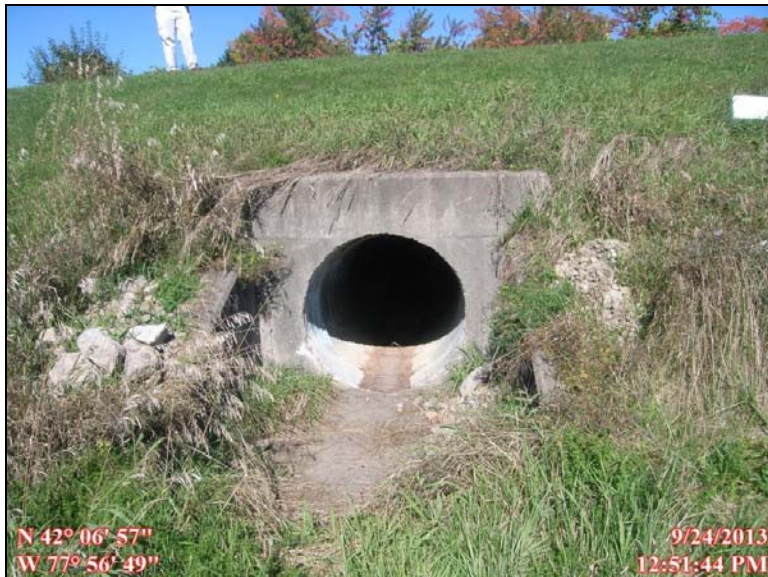
**Inspect ID:** N21L\_2013\_a\_0176 **Title:** USACE\_CELRB\_N21L\_2013\_a\_0176\_1.jpg  
**Rated Item:** 5. Concrete Surfaces (Such as gate wells, outfalls, intakes, or culverts)  
**Caption:** Rating: Acceptable; Remarks: 48" CMP inlet; Station\_1: 23+00

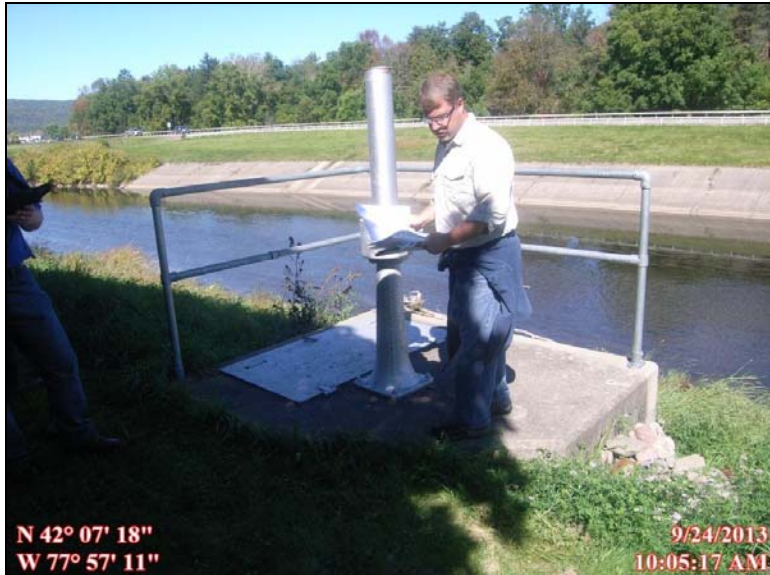
**Inspect ID:** N21L\_2013\_a\_0068 **Title:** USACE\_CELRB\_N21L\_2013\_a\_0068\_1.jpg  
**Rated Item:** 10. Sluice/ Slide Gates **Caption:** Rating: Acceptable; Remarks: Not operated; Station\_1: 53+00

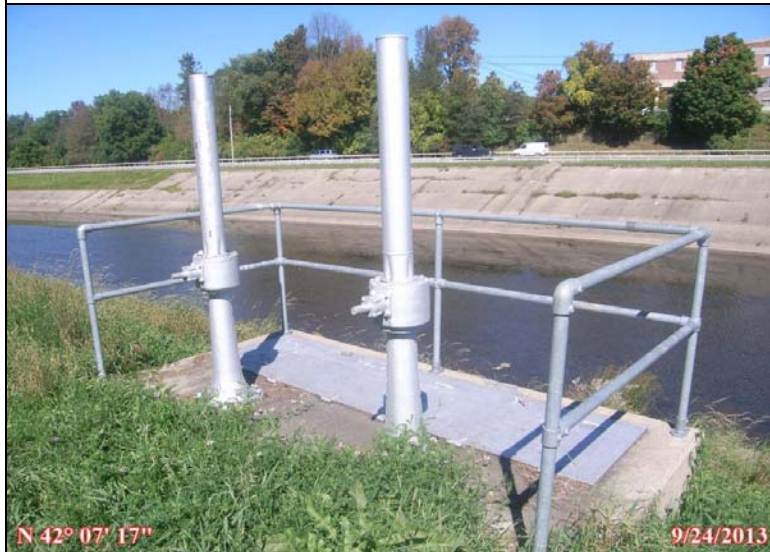
**Inspect ID:** N21L\_2013\_a\_0094 **Title:** USACE\_CELRB\_N21L\_2013\_a\_0094\_1.jpg  
**Rated Item:** 10. Sluice/ Slide Gates **Caption:** Rating: Acceptable; Remarks: Sluice gate good condition; Station\_1: 49+00

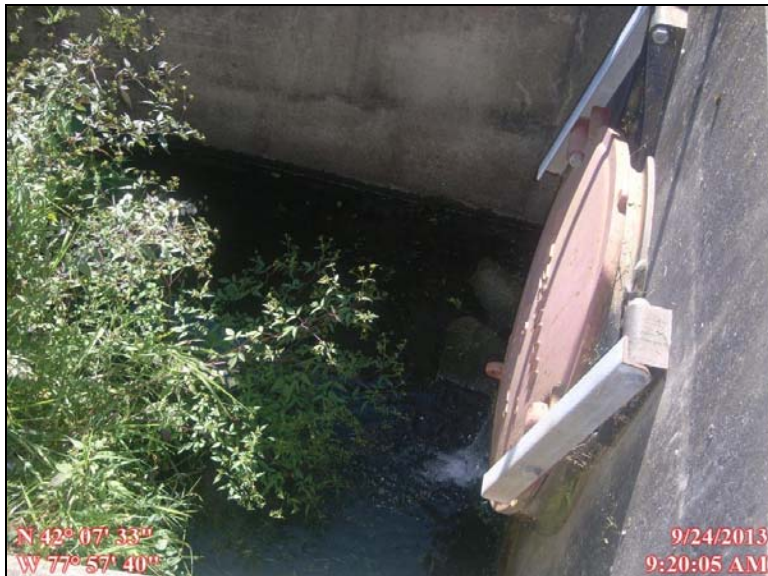
**Inspect ID:** N21L\_2013\_a\_0043 **Title:** USACE\_CELRB\_N21L\_2013\_a\_0043\_1.jpg  
**Rated Item:** 11. Flap Gates/ Flap Valves/ Pinch Valves **Caption:** Rating: Acceptable;  
**Remarks:** 42" Flap gate; Station\_1: 82+00

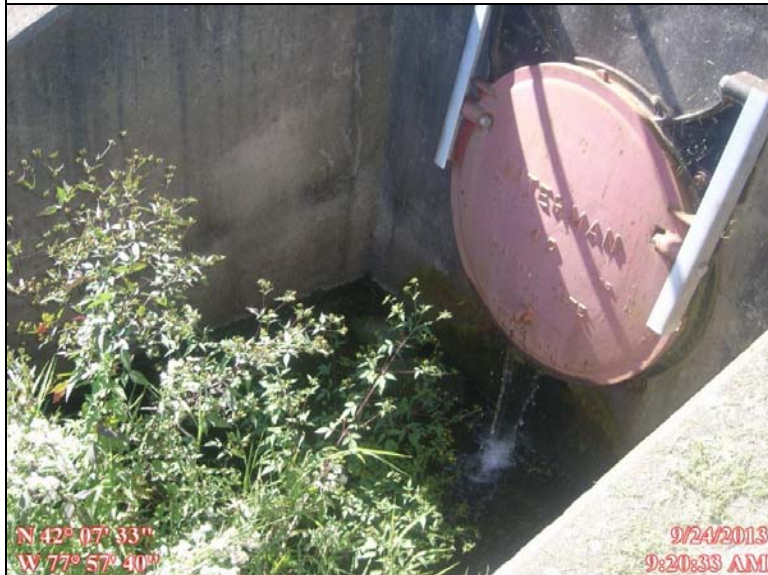
**Inspect ID:** N21L\_2013\_a\_0043 **Title:** USACE\_CELRB\_N21L\_2013\_a\_0043\_2.jpg  
**Rated Item:** 11. Flap Gates/ Flap Valves/ Pinch Valves **Caption:** Rating: Acceptable;  
**Remarks:** 42" Flap gate; Station\_1: 82+00

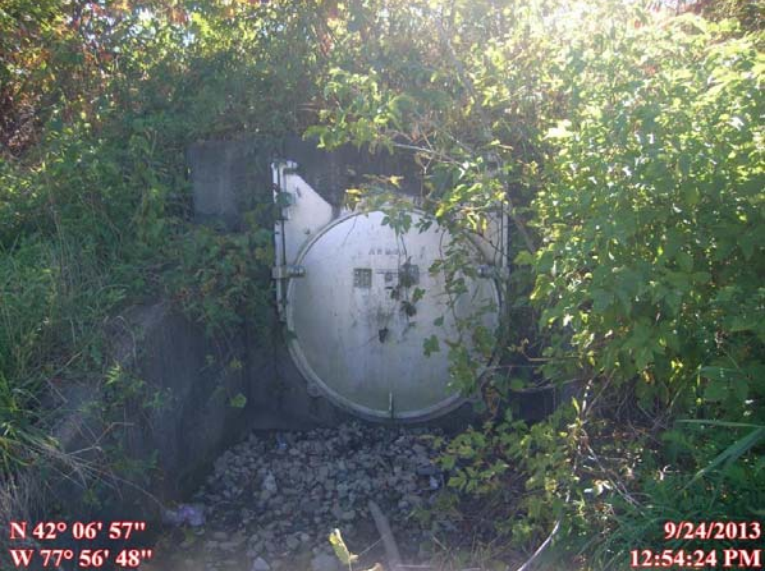
<p><b>Inspect ID:</b> N21L_2013_a_0175 <b>Title:</b> USACE_CELRB_N21L_2013_a_0175_1.jpg <b>Rated Item:</b> 11. Flap Gates/ Flap Valves/ Pinch Valves <b>Caption:</b> Rating: Acceptable; <b>Remarks:</b> 48" CMP outlet, flap gate exercised; Station_1: 23+00</p>

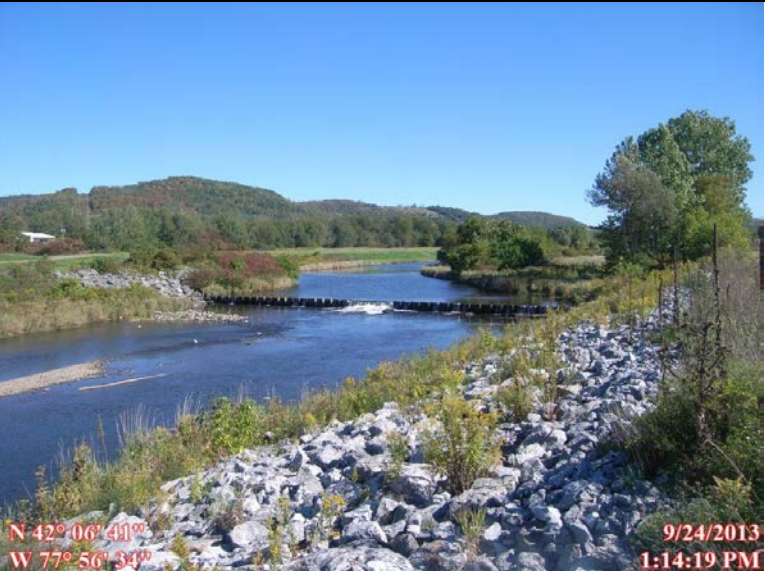
<p>N 42° 06' 41" W 77° 56' 34" 9/24/2013 1:14:19 PM</p>	<p><b>Inspect ID:</b> N21L_2013_a_0201 <b>Title:</b> USACE_CELRB_N21L_2013_a_0201_1.jpg <b>Rated Item:</b> 1. Vegetation and Obstructions <b>Caption:</b> Rating: Acceptable; Remarks: Weir; Station_1: 0+00</p>

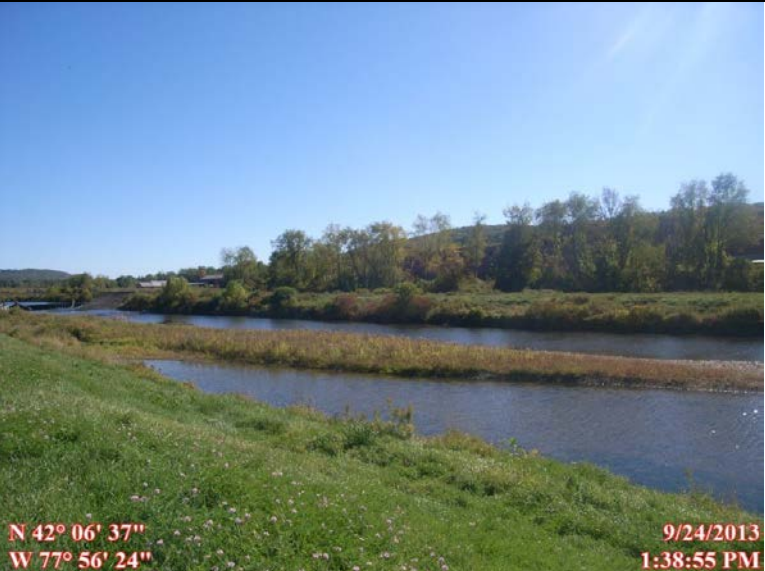
<p>N 42° 06' 37" W 77° 56' 24" 9/24/2013 1:38:55 PM</p>	<p><b>Inspect ID:</b> N21L_2013_a_0203 <b>Title:</b> USACE_CELRB_N21L_2013_a_0203_2.jpg <b>Rated Item:</b> 1. Vegetation and Obstructions <b>Caption:</b> Rating: Minimally Acceptable; Remarks: Unwanted vegetation on left bank from weir to weir; Station_1: 0+00</p>

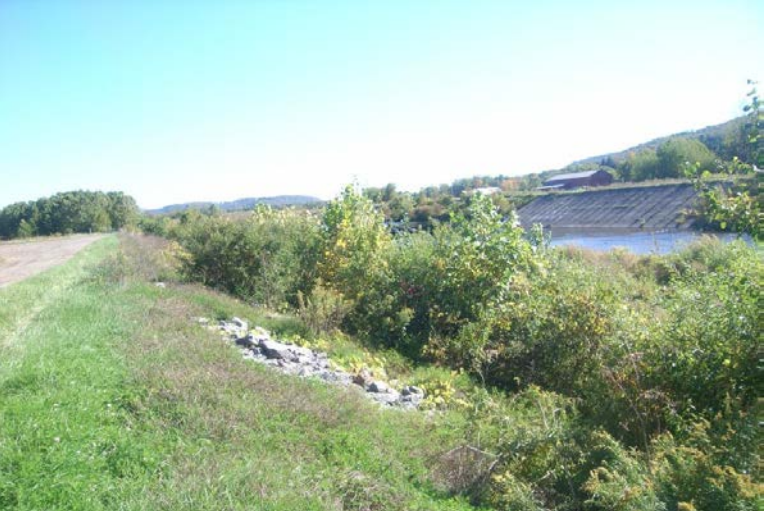
<p>N 42° 06' 34" W 77° 56' 20" 9/24/2013 1:43:37 PM</p>	<p><b>Inspect ID:</b> N21L_2013_a_0213 <b>Title:</b> USACE_CELRB_N21L_2013_a_0213_1.jpg <b>Rated Item:</b> 1. Vegetation and Obstructions <b>Caption:</b> Rating: Unacceptable; Remarks: Unwanted vegetation in riprap; Station_1: 0+00; Station_2: 0+00</p>

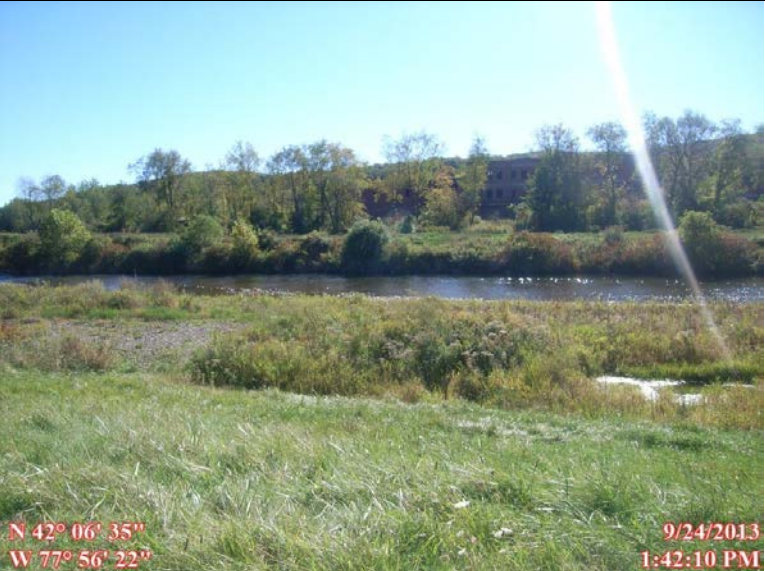
<p>N 42° 06' 35" W 77° 56' 22" 9/24/2013 1:42:10 PM</p>	<p><b>Inspect ID:</b> N21L_2013_a_0211 <b>Title:</b> USACE_CELRB_N21L_2013_a_0211_2.jpg <b>Rated Item:</b> 2. Shoaling (sediment deposition) <b>Caption:</b> Rating: Unacceptable; Remarks: Shoaling in channel; Station_1: 0+00</p>

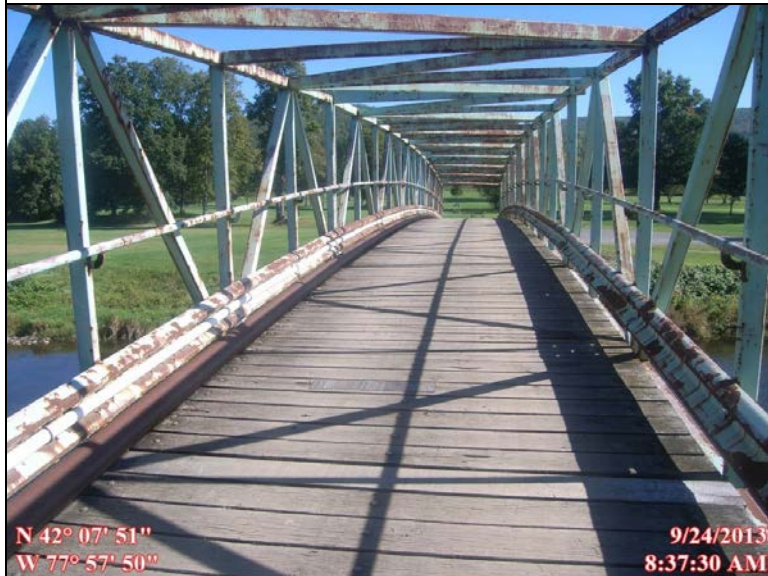
**Inspect ID:** N21L\_2013\_a\_0003 **Title:** USACE\_CELRB\_N21L\_2013\_a\_0003\_1.jpg  
**Rated Item:** 3. Encroachments **Caption:** Rating: Acceptable; Remarks: Pedestrian  
bridge; Station\_1: 104+00

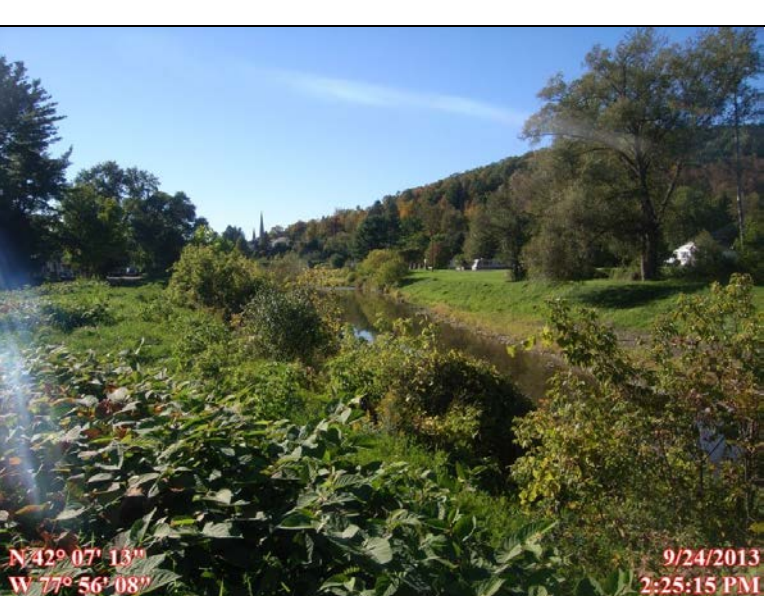
<p>N 42° 07' 13" W 77° 56' 08"</p> <p>9/24/2013 2:25:15 PM</p>	<p><b>Inspect ID:</b> N21R_2013_a_0027 <b>Title:</b> USACE_CELRB_N21R_2013_a_0027_1.jpg <b>Rated Item:</b> 1. Unwanted Vegetation Growth <b>Caption:</b> Rating: Unacceptable; <b>Remarks:</b> Unwanted vegetation trees on levee bank; Station_1: 35+00; Station_2: 35+00</p>

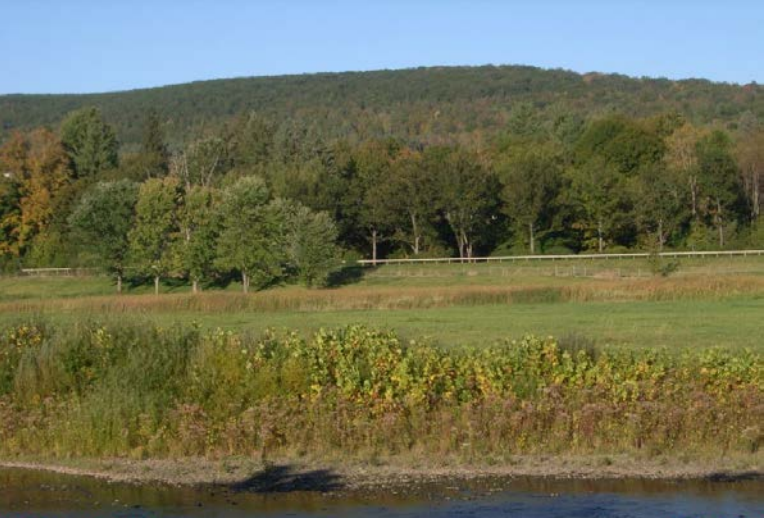
<p>N 42° 07' 31" W 77° 57' 41" 9/24/2013 3:33:57 PM</p>	<p><b>Inspect ID:</b> N21R_2013_a_0083 <b>Title:</b> USACE_CELRB_N21R_2013_a_0083_1.jpg <b>Rated Item:</b> 3. Encroachments <b>Caption:</b> Rating: Minimally Acceptable; Remarks: Fence with vegetation; Station_1: 74+00</p>

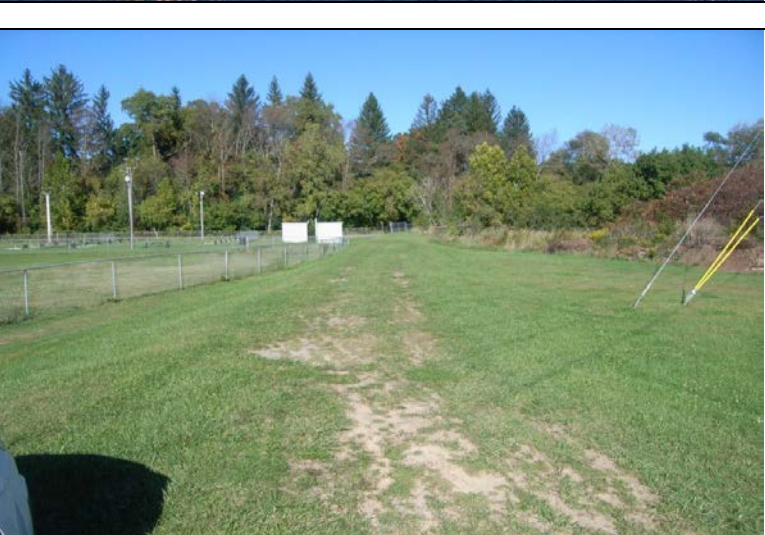
<p>N 42° 06' 42" W 77° 56' 28" 9/24/2013 2:03:58 PM</p>	<p><b>Inspect ID:</b> N21R_2013_a_0003 <b>Title:</b> USACE_CELRB_N21R_2013_a_0003_1.jpg <b>Rated Item:</b> 8. Depressions/ Rutting <b>Caption:</b> Rating: Minimally Acceptable; Remarks: 6' x 4' depression.; Station_1: 0+00</p>

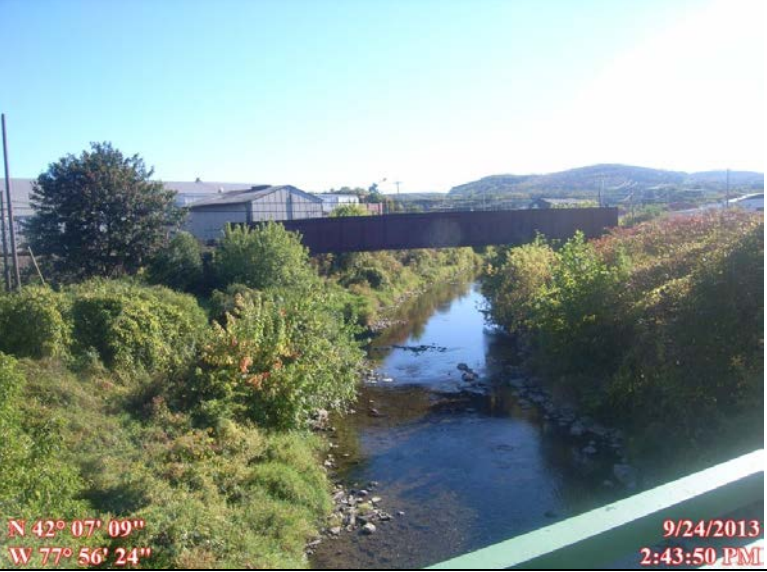
<p>N 42° 07' 09" W 77° 56' 24"</p> <p>9/24/2013 2:43:50 PM</p>	<p><b>Inspect ID:</b> N21R_2013_a_0043 <b>Title:</b> USACE_CELRB_N21R_2013_a_0043_1.jpg <b>Rated Item:</b> 1. Vegetation and Obstructions <b>Caption:</b> Rating: Unacceptable; Remarks: Unwanted vegetation on both banks; Station_1: 24+00; Station_2: 22+00</p>

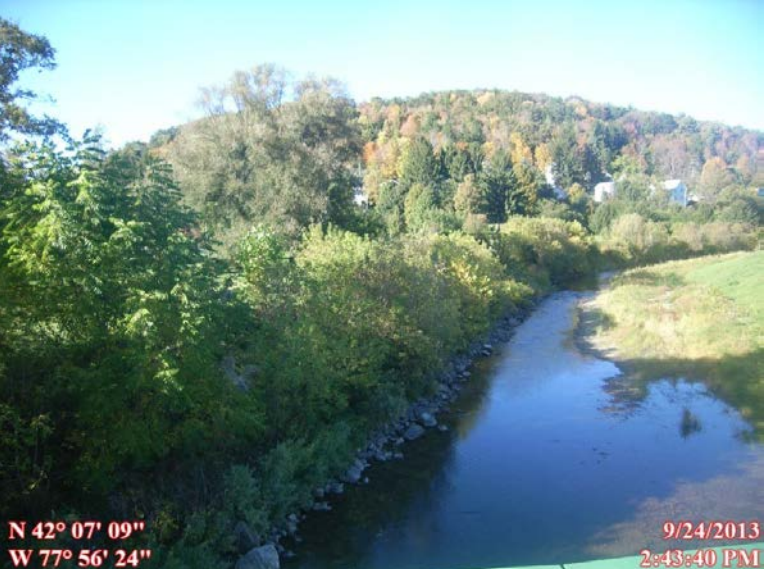
<p>N 42° 07' 09" W 77° 56' 24"</p> <p>9/24/2013 2:43:40 PM</p>	<p><b>Inspect ID:</b> N21R_2013_a_0044 <b>Title:</b> USACE_CELRB_N21R_2013_a_0044_1.jpg <b>Rated Item:</b> 1. Vegetation and Obstructions <b>Caption:</b> Rating: Unacceptable; Remarks: Unwanted vegetation on right bank; Station_1: 27+00; Station_2: 24+00</p>

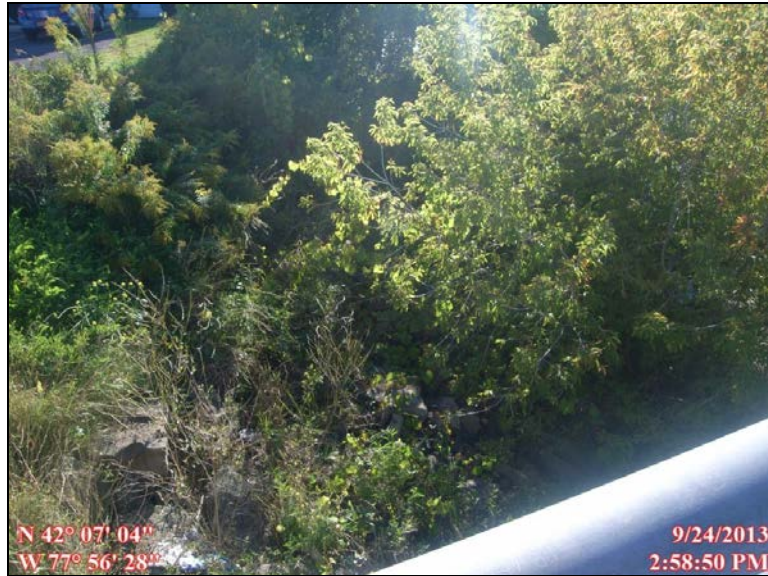
**Inspect ID:** N21R\_2013\_a\_0058 **Title:** USACE\_CELRB\_N21R\_2013\_a\_0058\_1.jpg  
**Rated Item:** 1. Vegetation and Obstructions **Caption:** Rating: Unacceptable; Remarks: Unwanted vegetation in riprap on LB; Station\_1: 17+00

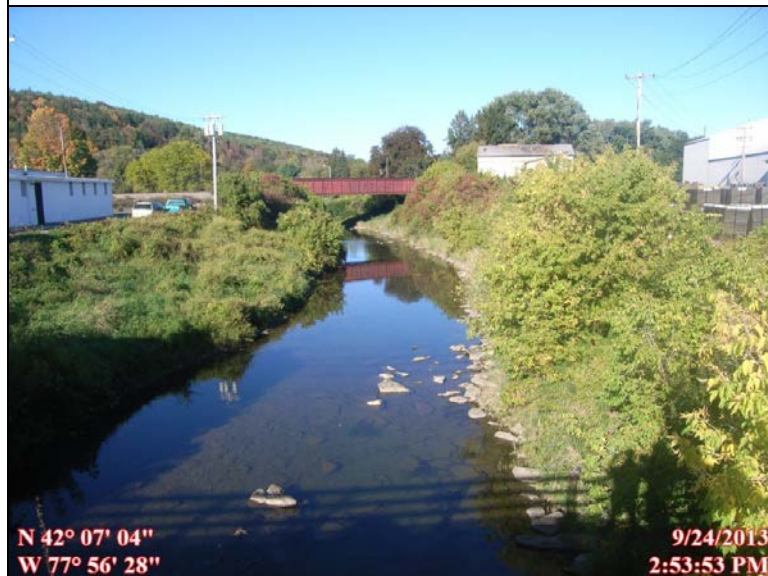
**Inspect ID:** N21R\_2013\_a\_0060 **Title:** USACE\_CELRB\_N21R\_2013\_a\_0060\_1.jpg  
**Rated Item:** 1. Vegetation and Obstructions **Caption:** Rating: Unacceptable; Remarks: Heavy unwanted vegetation both banks; Station\_1: 22+00; Station\_2: 18+00

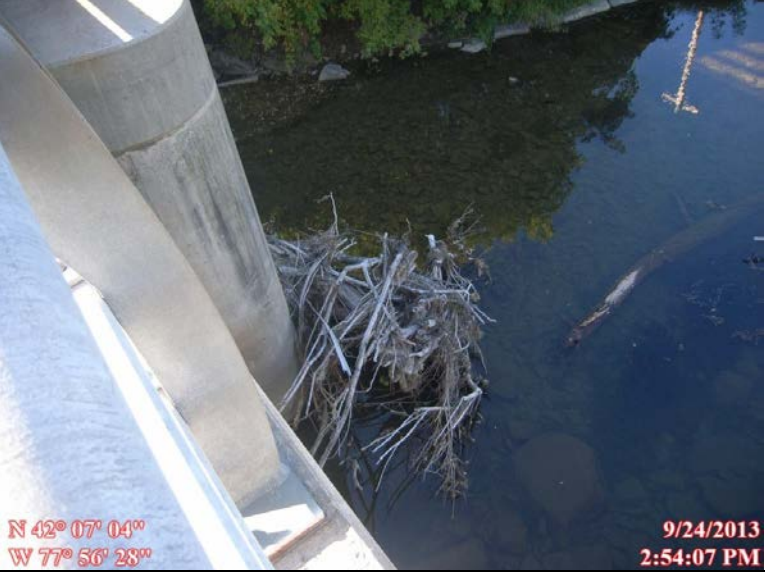
<p>N 42° 07' 04" W 77° 56' 28" 9/24/2013 2:54:07 PM</p>	<p><b>Inspect ID:</b> N21R_2013_a_0066 <b>Title:</b> USACE_CELRB_N21R_2013_a_0066_1.jpg <b>Rated Item:</b> 1. Vegetation and Obstructions <b>Caption:</b> Rating: Minimally Acceptable; <b>Remarks:</b> Debris on upstream face of bridge abutment.; Station_1: 18+00</p>

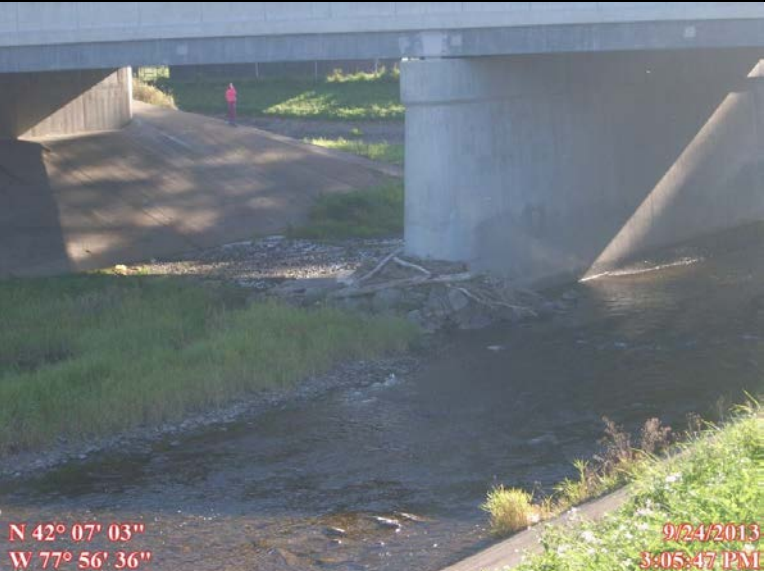
<p>N 42° 07' 03" W 77° 56' 36" 9/24/2013 3:05:47 PM</p>	<p><b>Inspect ID:</b> N21R_2013_a_0071 <b>Title:</b> USACE_CELRB_N21R_2013_a_0071_1.jpg <b>Rated Item:</b> 1. Vegetation and Obstructions <b>Caption:</b> Rating: Minimally Acceptable; <b>Remarks:</b> Debris on upstream face of bridge abutment.; Station_1: 11+00</p>

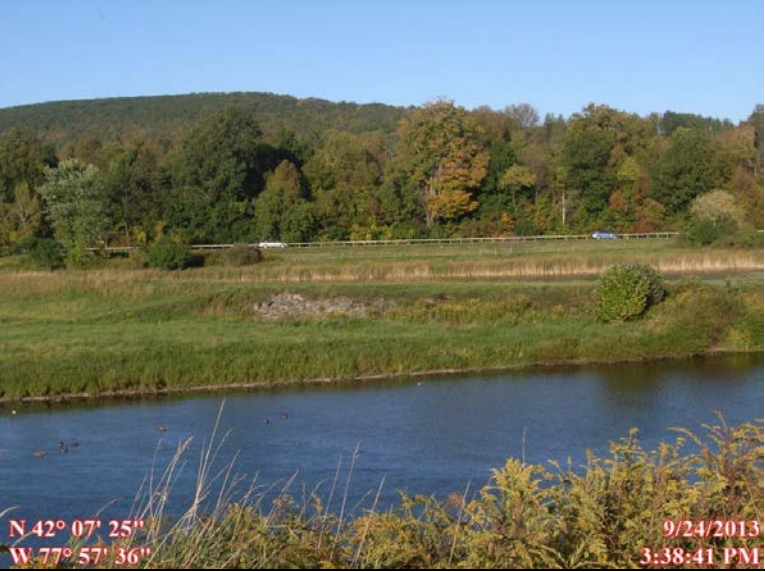
<p><b>Inspect ID:</b> N21R_2013_a_0092 <b>Title:</b> USACE_CELRB_N21R_2013_a_0092_1.jpg <b>Rated Item:</b> 1. Vegetation and Obstructions <b>Caption:</b> Rating: Unacceptable; Remarks: Unwanted vegetation in riprap; Station_1: 71+00; Station_2: 68+00</p>

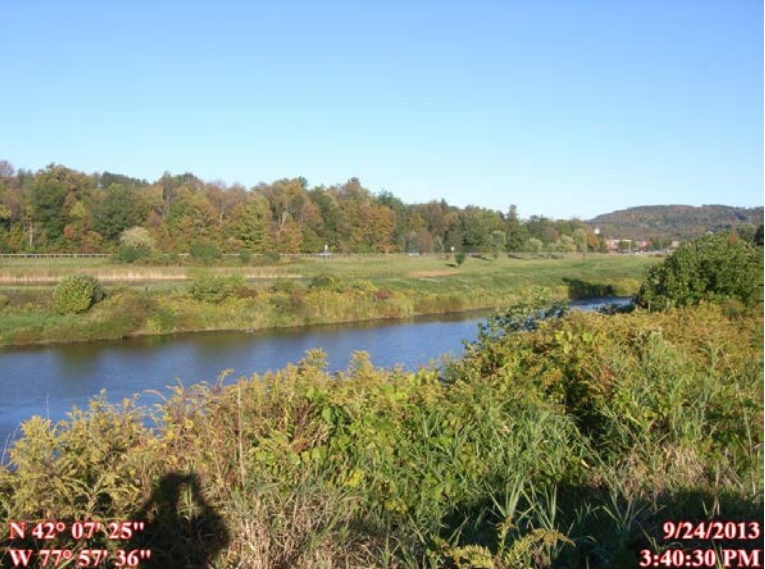
<p><b>Inspect ID:</b> N21R_2013_a_0097 <b>Title:</b> USACE_CELRB_N21R_2013_a_0097_1.jpg <b>Rated Item:</b> 1. Vegetation and Obstructions <b>Caption:</b> Rating: Minimally Acceptable; Remarks: Unwanted vegetation in riprap; Station_1: 66+00</p>

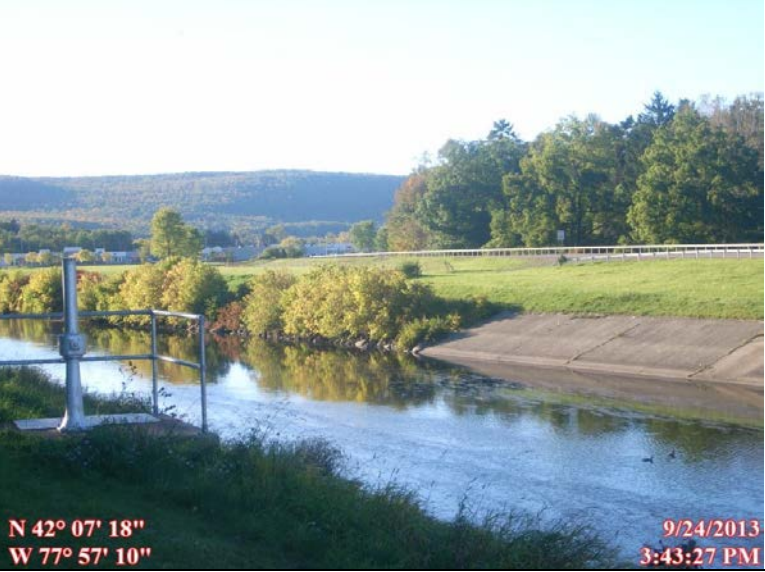
<p>N 42° 07' 18" W 77° 57' 10" 9/24/2013 3:43:27 PM</p>	<p><b>Inspect ID:</b> N21R_2013_a_0100 <b>Title:</b> USACE_CELRB_N21R_2013_a_0100_1.jpg <b>Rated Item:</b> 1. Vegetation and Obstructions <b>Caption:</b> Rating: Unacceptable; Remarks: Unwanted vegetation in riprap on RB; Station_1: 65+00</p>

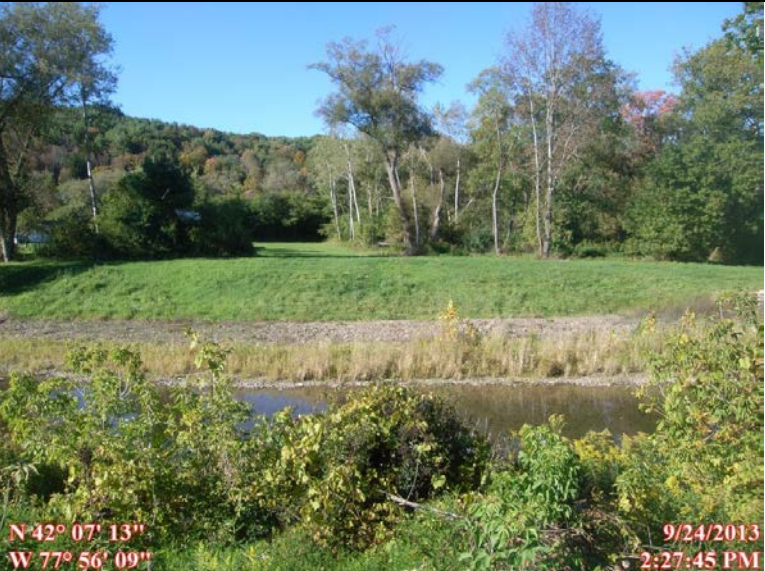
<p>N 42° 07' 13" W 77° 56' 09" 9/24/2013 2:27:45 PM</p>	<p><b>Inspect ID:</b> N21R_2013_a_0029 <b>Title:</b> USACE_CELRB_N21R_2013_a_0029_1.jpg <b>Rated Item:</b> 2. Shoaling (sediment deposition) <b>Caption:</b> Rating: Minimally Acceptable; Remarks: Shoaling along right bank; Station_1: 35+00; Station_2: 35+00</p>

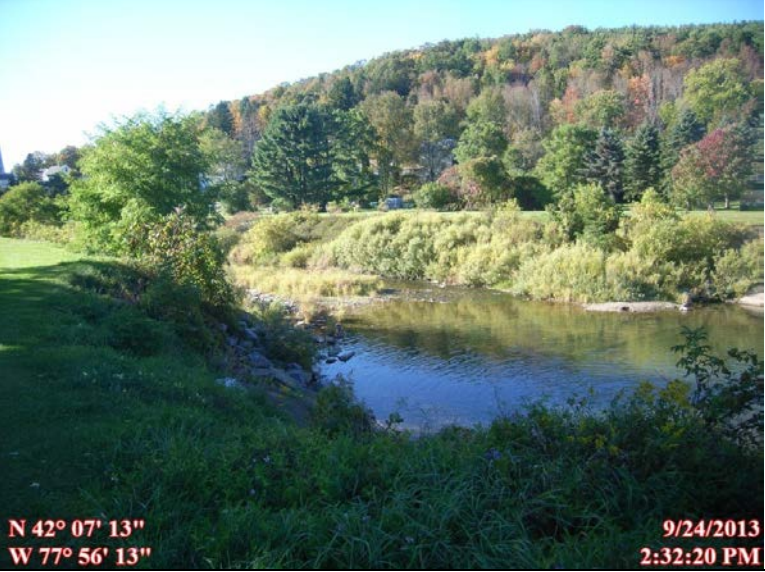
<p>N 42° 07' 13" W 77° 56' 13" 9/24/2013 2:32:20 PM</p>	<p><b>Inspect ID:</b> N21R_2013_a_0036 <b>Title:</b> USACE_CELRB_N21R_2013_a_0036_1.jpg <b>Rated Item:</b> 2. Shoaling (sediment deposition) <b>Caption:</b> Rating: Minimally Acceptable; Remarks: Shoal in channel; Station_1: 34+00</p>

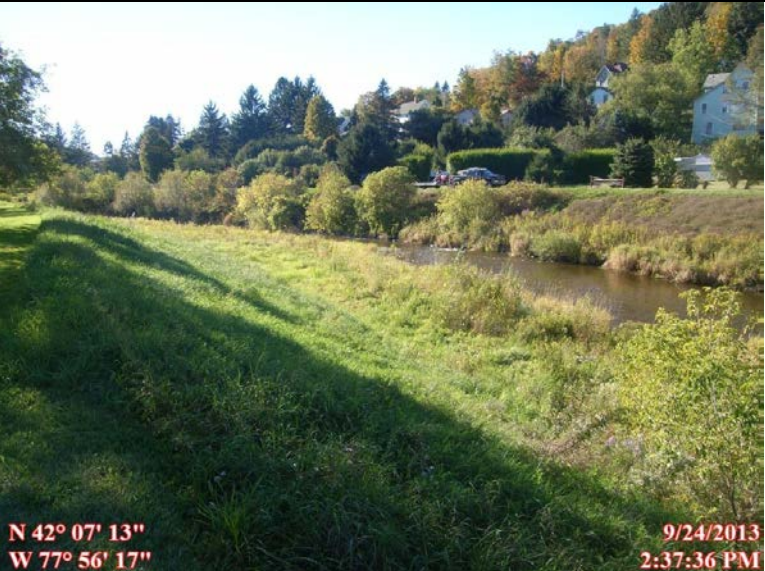
<p>N 42° 07' 13" W 77° 56' 17" 9/24/2013 2:37:36 PM</p>	<p><b>Inspect ID:</b> N21R_2013_a_0038 <b>Title:</b> USACE_CELRB_N21R_2013_a_0038_1.jpg <b>Rated Item:</b> 2. Shoaling (sediment deposition) <b>Caption:</b> Rating: Minimally Acceptable; Remarks: Shoaling along left bank; Station_1: 29+00; Station_2: 32+00</p>

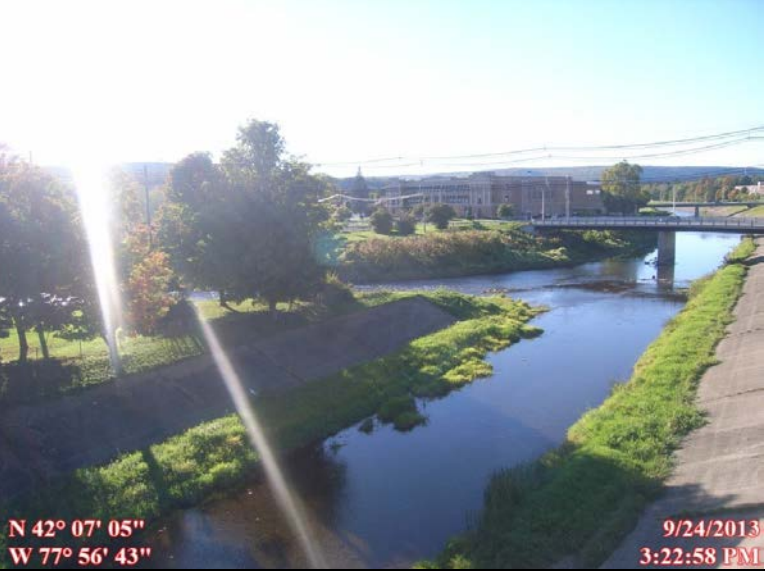
<p>N 42° 07' 05" W 77° 56' 43" 9/24/2013 3:22:58 PM</p>	<p><b>Inspect ID:</b> N21R_2013_a_0080 <b>Title:</b> USACE_CELRB_N21R_2013_a_0080_2.jpg <b>Rated Item:</b> 2. Shoaling (sediment deposition) <b>Caption:</b> Rating: Minimally Acceptable; Remarks: Shoaling on both banks; Station_1: 11+00; Station_2: 2+00</p>

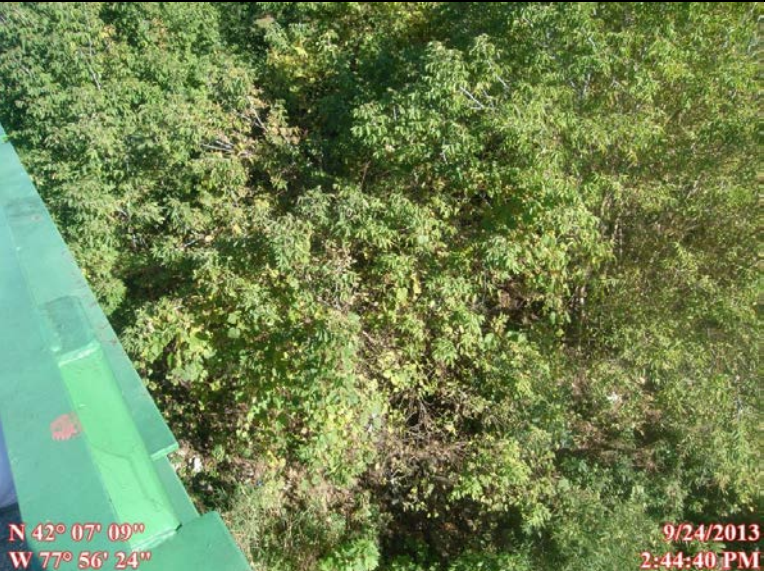
<p>N 42° 07' 09" W 77° 56' 24" 9/24/2013 2:44:40 PM</p>	<p><b>Inspect ID:</b> N21R_2013_a_0041 <b>Title:</b> USACE_CELRB_N21R_2013_a_0041_1.jpg <b>Rated Item:</b> 3. Encroachments <b>Caption:</b> Rating: Unacceptable; Remarks: Outfall covered with vegetation; Station_1: 24+00</p>

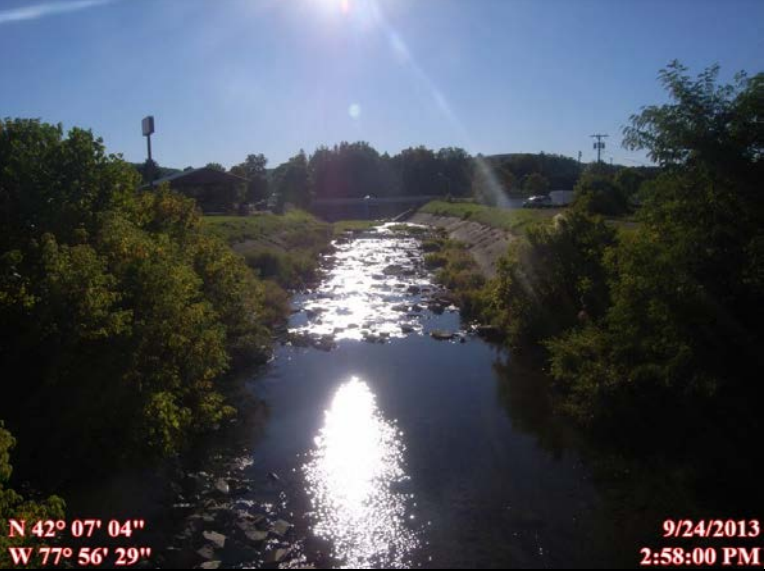
11. Revetments other than Riprap	<b>M</b>	<b>A</b>	Existing revetment protection is properly maintained, undamaged, and clearly visible.	N21R_2013_a_0057: Station_1 12+00: Station_2 18+00: Unwanted vegetation in concrete: Remove unwanted vegetation (U) N21R_2013_a_0077: Station_1 6+00: Unwanted vegetation between concrete joints both banks: Remove unwanted vegetation (M)
		<b>M</b>	Minor revetment displacement or deterioration that does not pose an immediate threat to the integrity of the levee. Unwanted vegetation must be cleared or sprayed with an appropriate herbicide.	
		<b>U</b>	Significant revetment displacement, deterioration, or exposure of bedding observed. Scour activity is undercutting banks, eroding embankments, or impairing channel flows by causing turbulence or shoaling. Revetment protection is hidden by dense brush and trees.	
		<b>N/A</b>	There are no such revetments protecting this feature of the segment / system.

<p>N 42° 07' 04" W 77° 56' 29" 9/24/2013 2:58:00 PM</p>	<p><b>Inspect ID:</b> N21R_2013_a_0057 <b>Title:</b> USACE_CELRB_N21R_2013_a_0057_1.jpg <b>Rated Item:</b> 11. Revetments other than Riprap <b>Caption:</b> Rating: Unacceptable; Remarks: Unwanted vegetation in concrete; Station_1: 12+00; Station_2: 18+00</p>

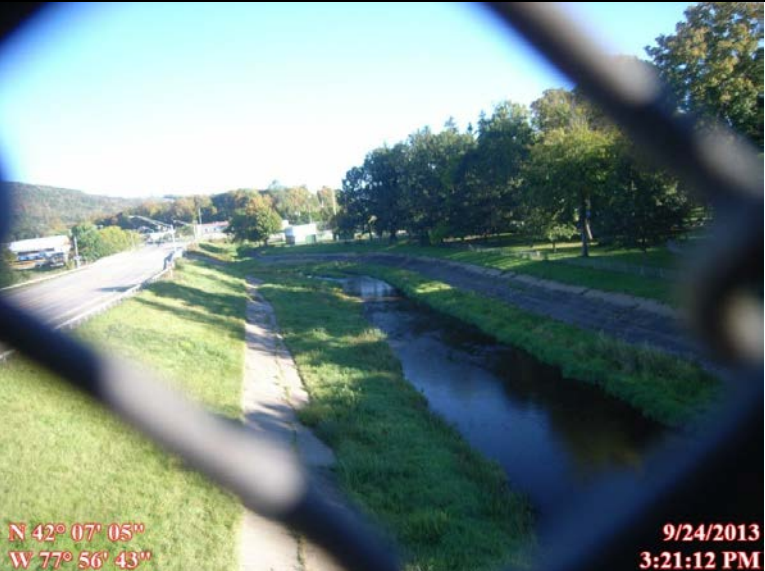
<p>N 42° 07' 05" W 77° 56' 43" 9/24/2013 3:21:12 PM</p>	<p><b>Inspect ID:</b> N21R_2013_a_0077 <b>Title:</b> USACE_CELRB_N21R_2013_a_0077_1.jpg <b>Rated Item:</b> 11. Revetments other than Riprap <b>Caption:</b> Rating: Minimally Acceptable; Remarks: Unwanted vegetation between concrete joints both banks; Station_1: 6+00</p>
