DEPARTMENT OF THE ARMY

SUBJECT: FY17 Periodic Inspection of Completed Works, Flood Risk Management Project,
Genesee River, Wellsville, New York (09/27/17)

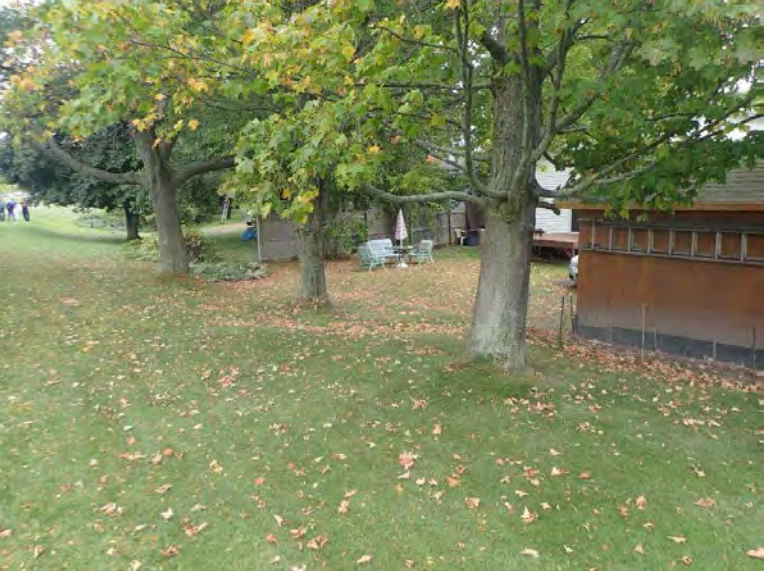
<p>Inspect ID: N21L_2017_p_0061 Title: USACE_CELRB_N21L_2017_p_0061_1.jpg Rated Item: 1. Unwanted Vegetation Growth Caption: Rating: Minimally Acceptable; Remarks: Trees on left bank landside slope and within 15' of landside toe from 1,200' downstream of Madison Street (Stevens Street) bridge to Ponding Area fence.; Action: Remove trees.; Station_1: 54+00; Station_2: 46+00</p>

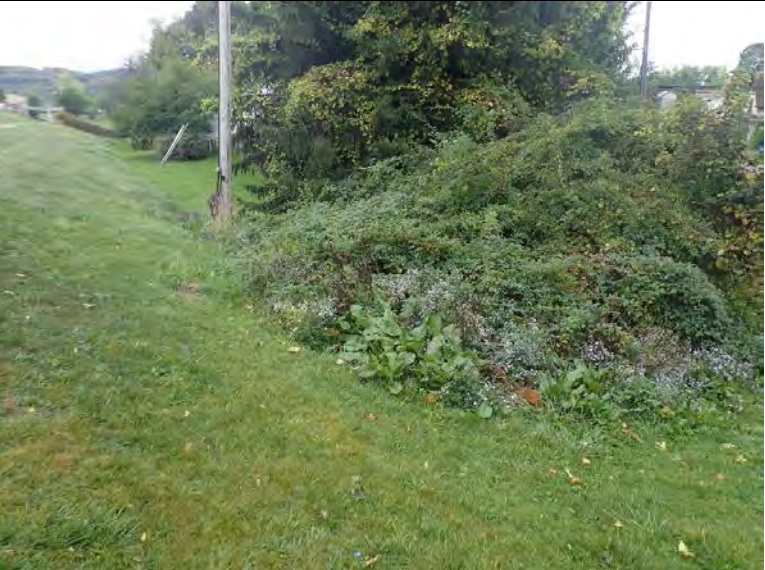
<p>Inspect ID: N21L_2017_p_0066 Title: USACE_CELRB_N21L_2017_p_0066_1.jpg Rated Item: 1. Unwanted Vegetation Growth Caption: Rating: Minimally Acceptable; Remarks: Unwanted heavy vegetation within 15' of levee landside toe.; Action: Remove unwanted vegetation.; Station_1: 53+00</p>

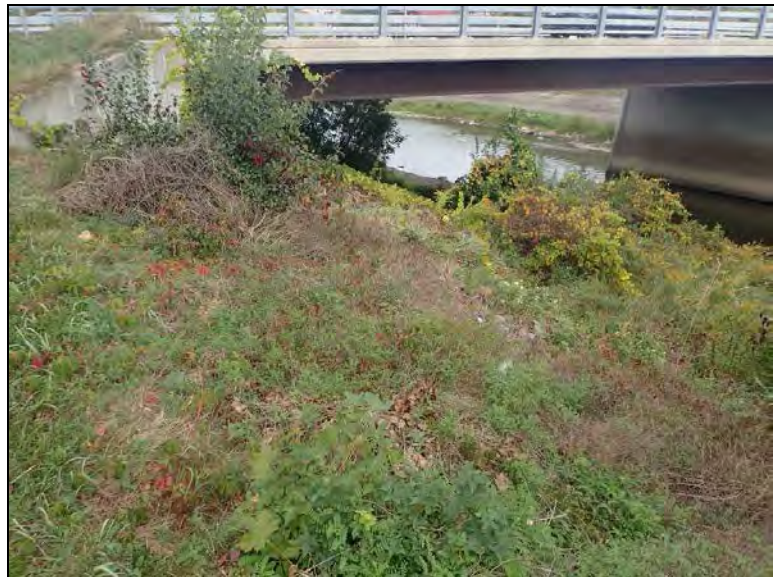
<p>Inspect ID: N21L_2017_p_0090 Title: USACE_CELRB_N21L_2017_p_0090_1.jpg Rated Item: 1. Unwanted Vegetation Growth Caption: Rating: Unacceptable; Remarks: Vegetation and woody growth in left bank riprap from State Street bridge to 1250' upstream of State Street bridge. Not much vegetation from Sta. 29+00 to 27+00.; Action: Remove vegetation and woody growth from riprap.; Station_1: 33+00; Station_2: 24+00</p>

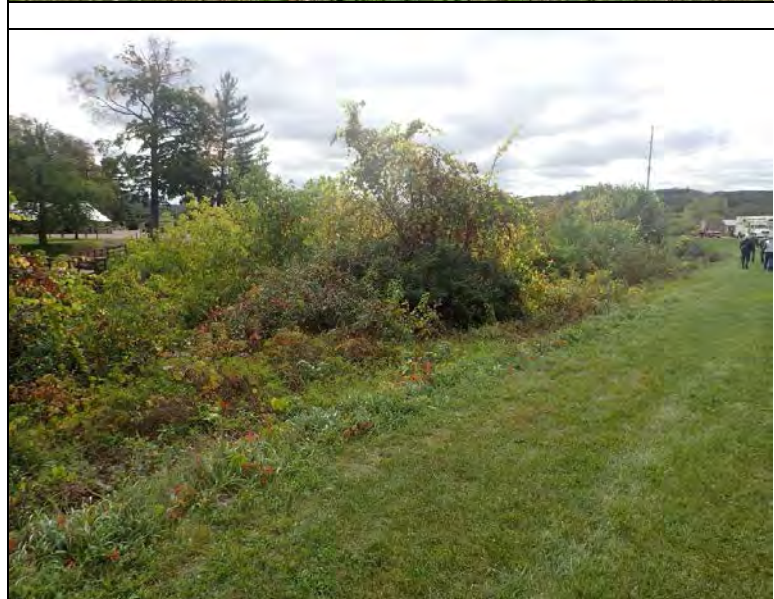
<p>Inspect ID: N21L_2017_p_0090 Title: USACE_CELRB_N21L_2017_p_0090_2.jpg Rated Item: 1. Unwanted Vegetation Growth Caption: Rating: Unacceptable; Remarks: Vegetation and woody growth in left bank riprap from State Street bridge to 1250' upstream of State Street bridge. Not much vegetation from Sta. 29+00 to 27+00.; Action: Remove vegetation and woody growth from riprap.; Station_1: 33+00; Station_2: 24+00</p>

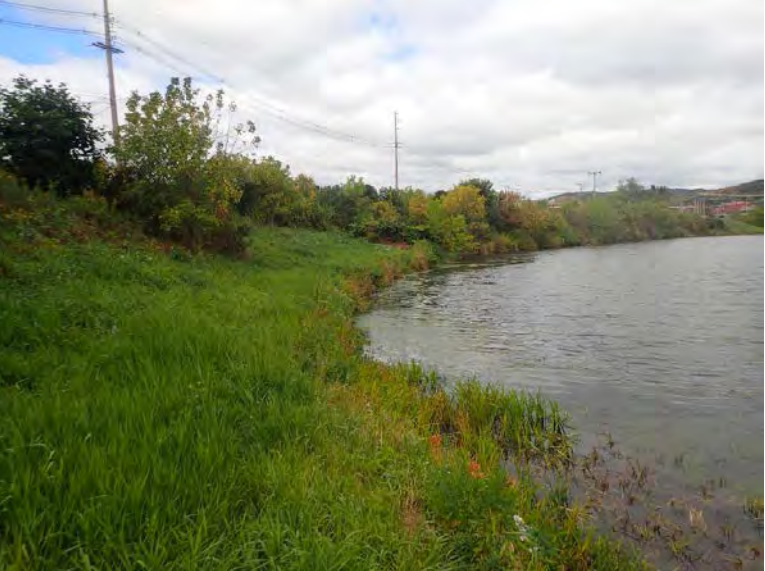
<p>Inspect ID: N21L_2017_p_0090 Title: USACE_CELRB_N21L_2017_p_0090_3.jpg Rated Item: 1. Unwanted Vegetation Growth Caption: Rating: Unacceptable; Remarks: Vegetation and woody growth in left bank riprap from State Street bridge to 1250' upstream of State Street bridge. Not much vegetation from Sta. 29+00 to 27+00.; Action: Remove vegetation and woody growth from riprap.; Station_1: 33+00; Station_2: 24+00</p>

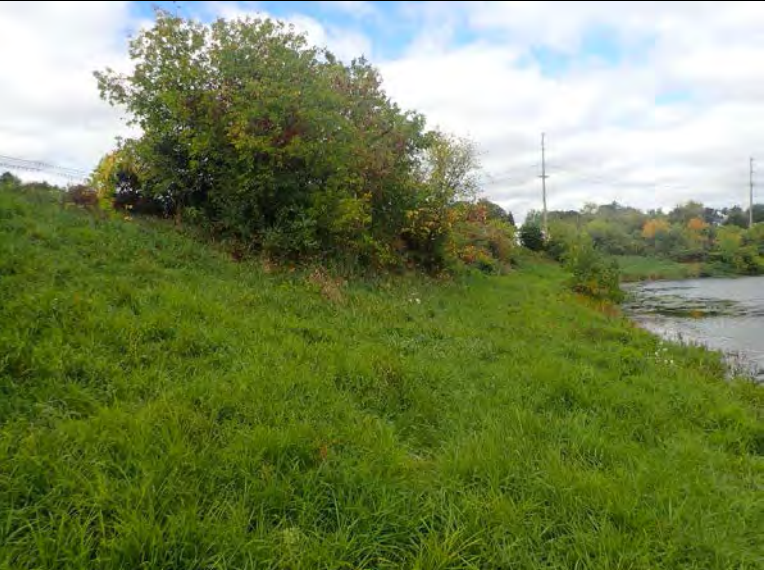
<p>Inspect ID: N21L_2017_p_0090 Title: USACE_CELRB_N21L_2017_p_0090_4.jpg Rated Item: 1. Unwanted Vegetation Growth Caption: Rating: Unacceptable; Remarks: Vegetation and woody growth in left bank riprap from State Street bridge to 1250' upstream of State Street bridge. Not much vegetation from Sta. 29+00 to 27+00.; Action: Remove vegetation and woody growth from riprap.; Station_1: 33+00; Station_2: 24+00</p>

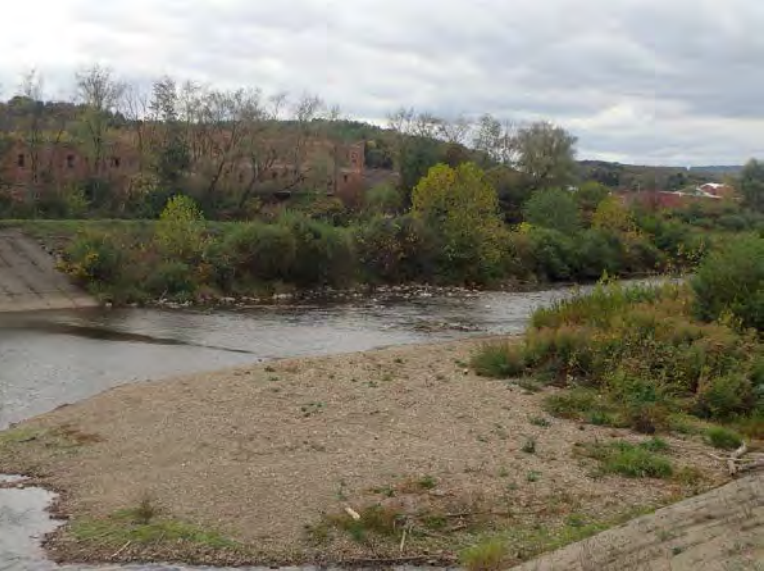
<p>Inspect ID: N21L_2017_p_0135 Title: USACE_CELRB_N21L_2017_p_0135_1.jpg Rated Item: 1. Unwanted Vegetation Growth Caption: Rating: Unacceptable; Remarks: Significant vegetation in riprap on left bank upstream and downstream of upstream limit weir.; Action: Remove vegetation from riprap.; Station_1: 0+00; Station_2: 0+00</p>

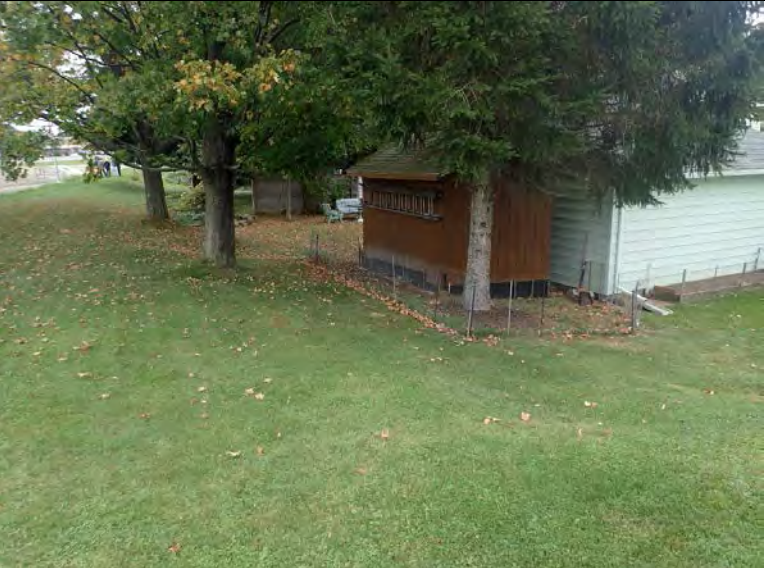
<p>Inspect ID: N21L_2017_p_0058 Title: USACE_CELRB_N21L_2017_p_0058_1.jpg Rated Item: 3. Encroachments Caption: Rating: Minimally Acceptable; Remarks: Unauthorized Alteration (A-23) - Chicken wire fence on left bank levee landside toe at 20 Chamberlain Street. Note: levee is overbuilt at this location (approx. 42 feet wide).; Action: Submit Section 408 Alteration Request to USACE or remove unauthorized alteration.; Station_1: 55+00</p>

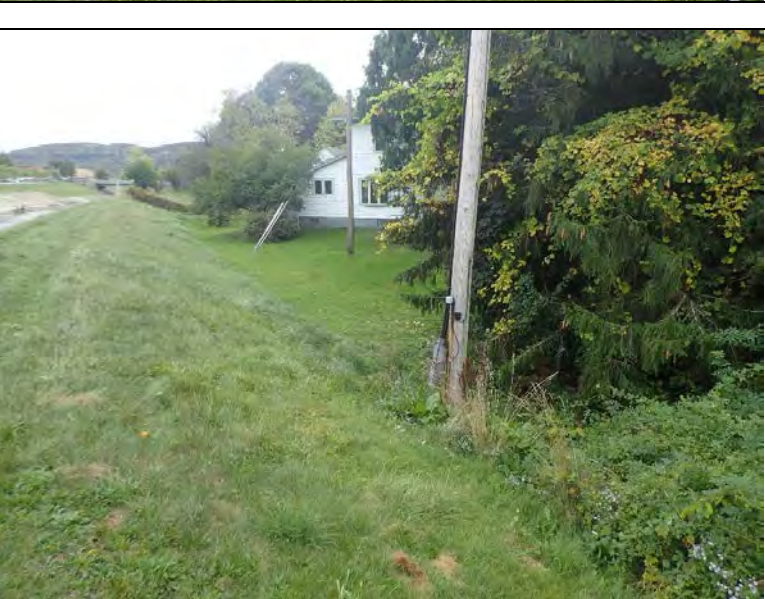
<p>Inspect ID: N21L_2017_p_0065 Title: USACE_CELRB_N21L_2017_p_0065_1.jpg Rated Item: 3. Encroachments Caption: Rating: Minimally Acceptable; Remarks: Unauthorized Alteration (A-25) - Guy wire w/in 15' of landside toe on left bank 850' downstream of Madison Street (Stevens Street) bridge(just upstream of gatewell # 3).; Action: Submit Section 408 Alteration Request to USACE or remove unauthorized alteration.; Station_1: 52+00</p>

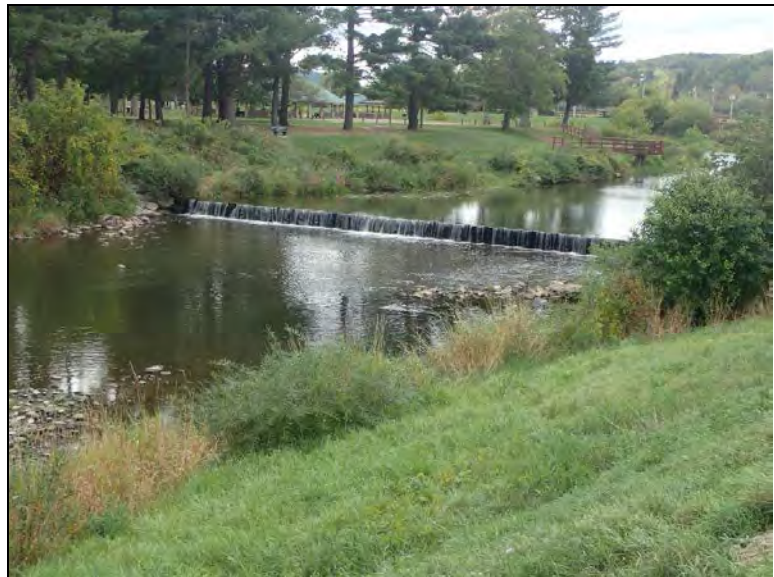
<p>Inspect ID: N21L_2017_p_0094 Title: USACE_CELRB_N21L_2017_p_0094_1.jpg Rated Item: 3. Encroachments Caption: Rating: Acceptable; Remarks: 1974 Steel Sheet Pile Weir by Others - shown on AS-CONSTRUCTED drawing 189-WEL-2/4 (approved by USACE).; Action: NA; Station_1: 27+00</p>

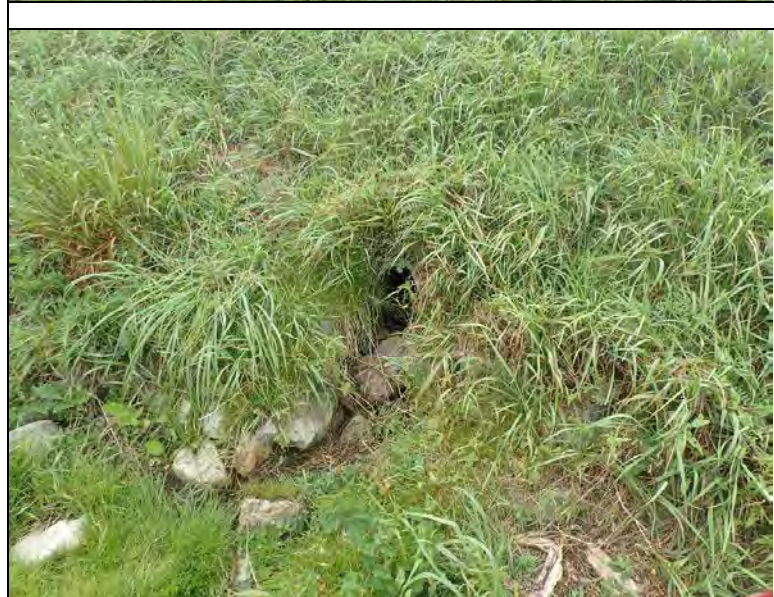
<p>Inspect ID: N21L_2017_p_0096 Title: USACE_CELRB_N21L_2017_p_0096_1.jpg Rated Item: 3. Encroachments Caption: Rated Item: 1. Public Sponsor (A or U only); Rating: Acceptable; Remarks: 6" cast iron pipe on left bank waterside slope 450' upstream of State Street bridge.; Action: Submit Section 408 Alteration Request to USACE or remove unauthorized alteration.; Station_1: 29+00</p>

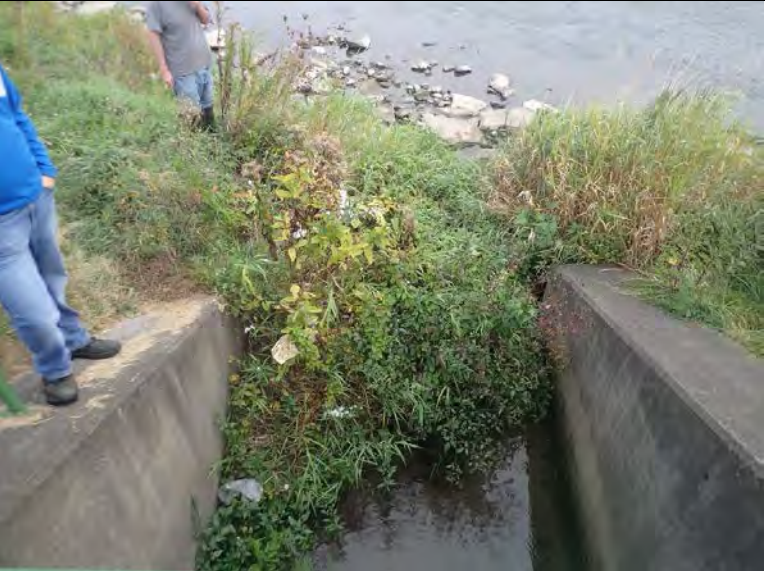
<p>Inspect ID: N21L_2017_p_0025 Title: USACE_CELRB_N21L_2017_p_0025_1.jpg Rated Item: 1. Vegetation and Obstructions Caption: Rating: Minimally Acceptable; Remarks: Soft unwanted vegetation obstructing outfall on left bank 900' upstream of Bolivar Road bridge.; Action: Remove unwanted vegetation.; Station_1: 82+00</p>

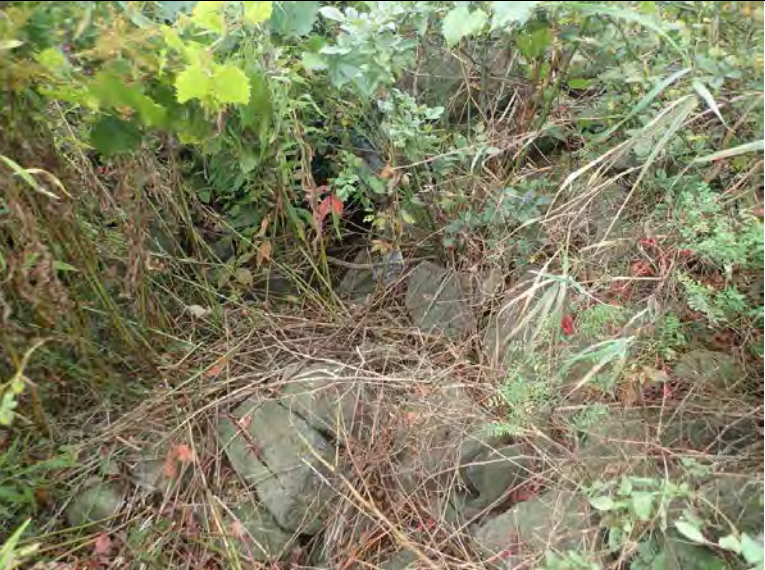
<p>Inspect ID: N21L_2017_p_0028 Title: USACE_CELRB_N21L_2017_p_0028_1.jpg Rated Item: 1. Vegetation and Obstructions Caption: Rating: Minimally Acceptable; Remarks: 24" CMP outfall on left bank 1,600' upstream of Bolivar Road bridge is approx. 20% obstructed by minor sediment.; Action: Remove sediment obstruction.; Station_1: 75+00</p>

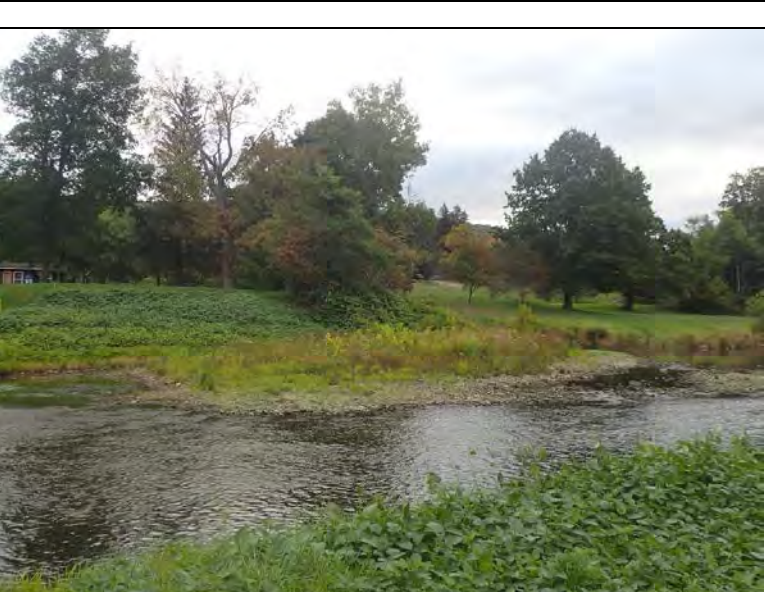
<p>Inspect ID: N21L_2017_p_0006 Title: USACE_CELRB_N21L_2017_p_0006_1.jpg Rated Item: 1. Vegetation and Obstructions Caption: Rating: Minimally Acceptable; Remarks: Trees on right bank channel sideslope 900 feet downstream of Bolivar Street bridge.; Action: Remove trees.; Station_1: 100+00</p>

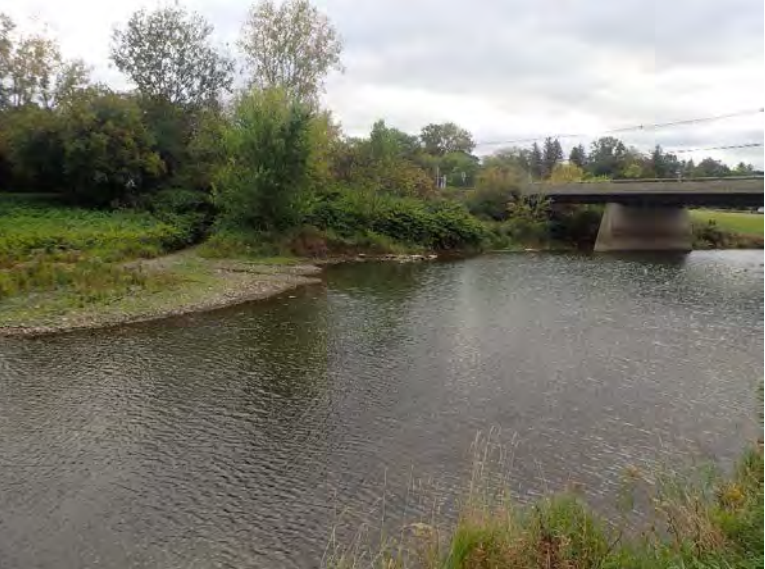
<p>Inspect ID: N21L_2017_p_0010 Title: USACE_CELRB_N21L_2017_p_0010_1.jpg Rated Item: 1. Vegetation and Obstructions Caption: Rating: Minimally Acceptable; Remarks: Vegetation in riprap on right bank around Bolivar Road bridge.; Action: Remove vegetation from riprap.; Station_1: 91+00</p>

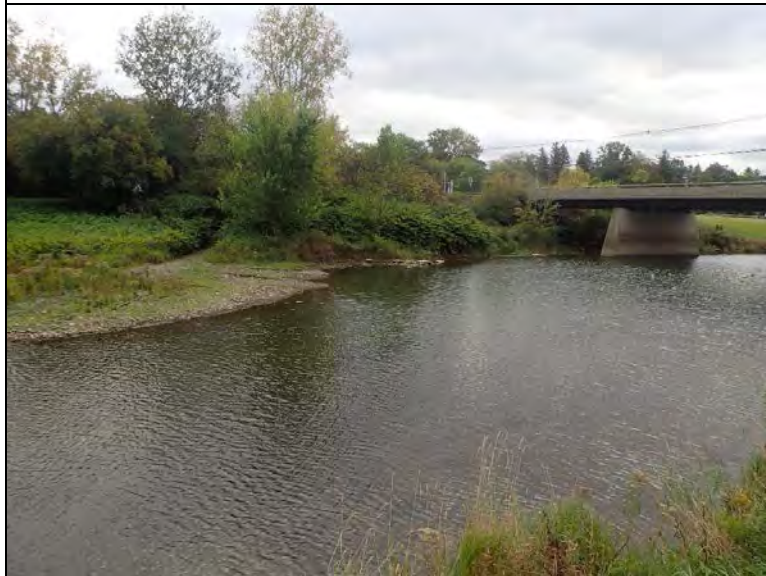
Inspect ID: N21L_2017_p_0011 **Title:** USACE_CELRB_N21L_2017_p_0011_1.jpg
Rated Item: 1. Vegetation and Obstructions **Caption:** Rating: Minimally Acceptable;
Remarks: Unwanted heavy woody vegetation on right bank around Bolivar Road bridge.; **Action:** Remove vegetation.; **Station_1:** 91+00

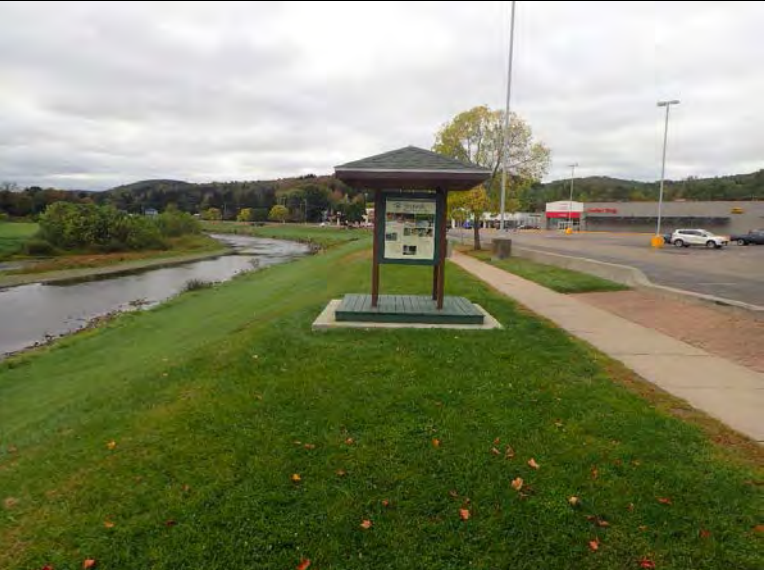
<p>Inspect ID: N21L_2017_p_0020 Title: USACE_CELRB_N21L_2017_p_0020_1.jpg Rated Item: 1. Vegetation and Obstructions Caption: Rating: Minimally Acceptable; Remarks: Unauthorized Alteration (A-5) - Riverwalk kiosk on left bank channel crest.; Action: Submit Section 408 Alteration Request to USACE or remove unauthorized alteration.; Station_1: 85+00</p>

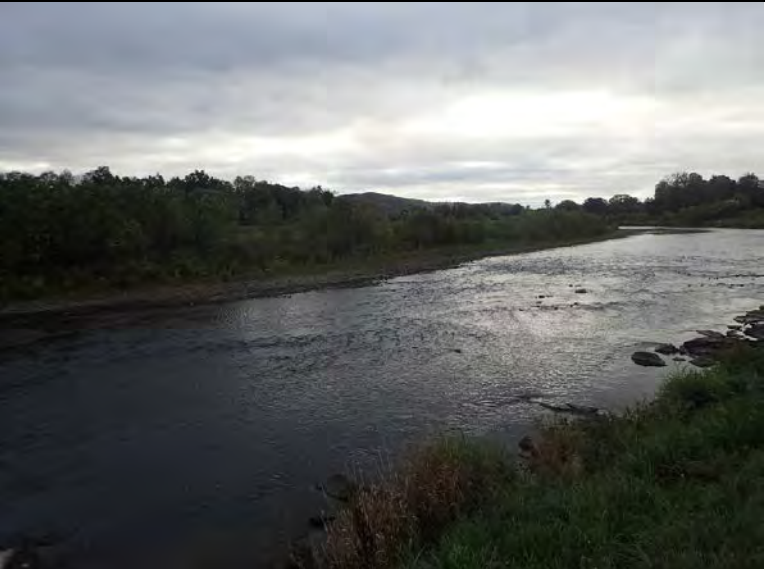
<p>Inspect ID: N21L_2017_p_0022 Title: USACE_CELRB_N21L_2017_p_0022_2.jpg Rated Item: 1. Vegetation and Obstructions Caption: Rating: Minimally Acceptable; Remarks: Unwanted vegetation on both bank sideslopes from 750' upstream of Bolivar Road bridge to Madison Street bridge.; Action: Remove unwanted vegetation.; Station_1: 84+00; Station_2: 44+00</p>

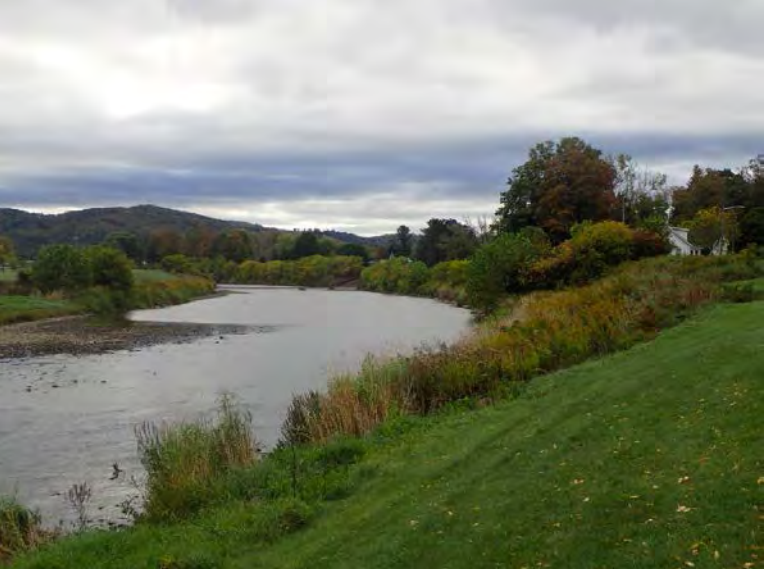
<p>Inspect ID: N21L_2017_p_0038 Title: USACE_CELRB_N21L_2017_p_0038_1.jpg Rated Item: 1. Vegetation and Obstructions Caption: Rating: Minimally Acceptable; Remarks: Vegetation in riprap on both banks around Drop Structure; Action: Remove vegetation in riprap.; Station_1: 66+00</p>

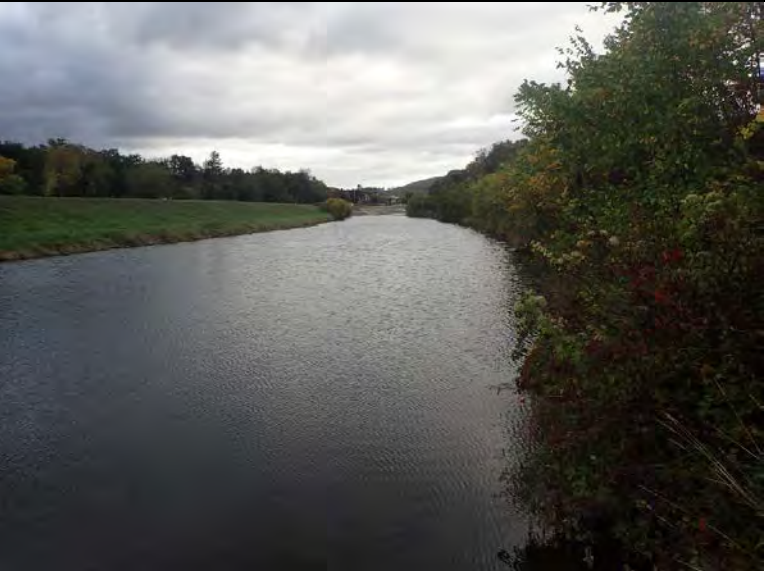
<p>Inspect ID: N21L_2017_p_0041 Title: USACE_CELRB_N21L_2017_p_0041_1.jpg Rated Item: 1. Vegetation and Obstructions Caption: Rating: Unacceptable; Remarks: Vegetation in riprap on left bank 2,200' to 1,200' downstream of Madison Street (Stevens Street) bridge.; Action: Remove vegetation from riprap.; Station_1: 65+00; Station_2: 52+00</p>

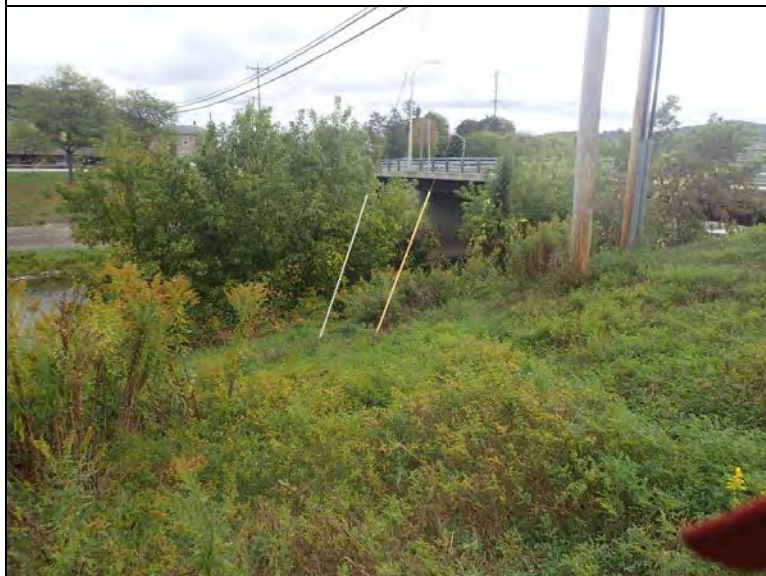
Inspect ID: N21L_2017_p_0087 **Title:** USACE_CELRB_N21L_2017_p_0087_3.jpg
Rated Item: 1. Vegetation and Obstructions **Caption:** Rating: Unacceptable; Remarks: Significant unwanted vegetation and trees on left bank 400' downstream of State Street bridge.; Action: Remove unwanted vegetation and trees.; Station_1: 37+00

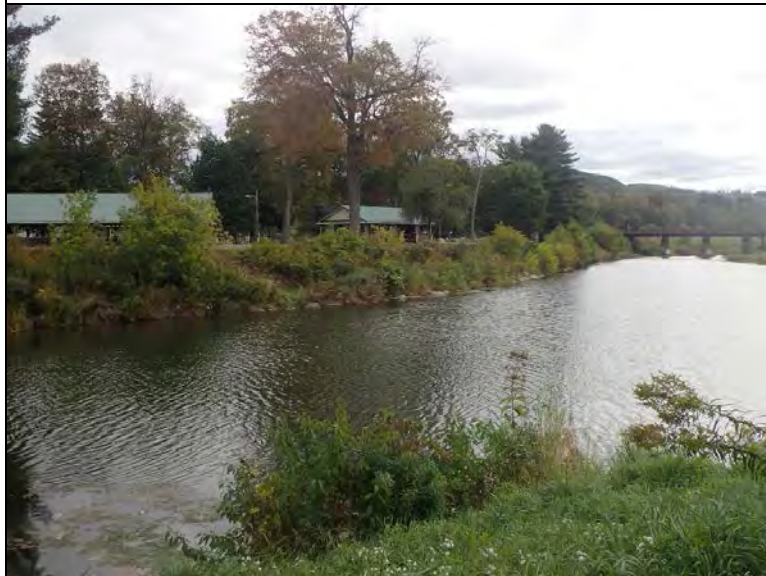
Inspect ID: N21L_2017_p_0095 **Title:** USACE_CELRB_N21L_2017_p_0095_2.jpg
Rated Item: 1. Vegetation and Obstructions **Caption:** Rating: Minimally Acceptable;
Remarks: Soft vegetation on right bank from Island Park to 500 feet upstream of Island Park pedestrian bridge.; **Action:** Remove soft vegetation.; **Station_1:** 29+00; **Station_2:** 11+00

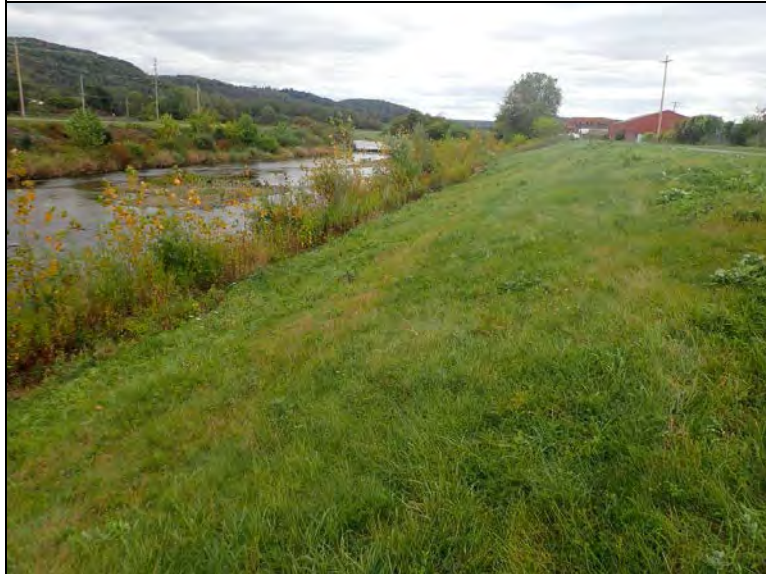
Inspect ID: N21L_2017_p_0119 **Title:** USACE_CELRB_N21L_2017_p_0119_1.jpg
Rated Item: 1. Vegetation and Obstructions **Caption:** Rating: Minimally Acceptable;
Remarks: Unwanted woody vegetation in riprap on left bank starting 550' downstream of barrier levee weir up to barrier levee weir.; **Action:** Remove unwanted woody vegetation.; **Station_1:** 6+00; **Station_2:** 0+00

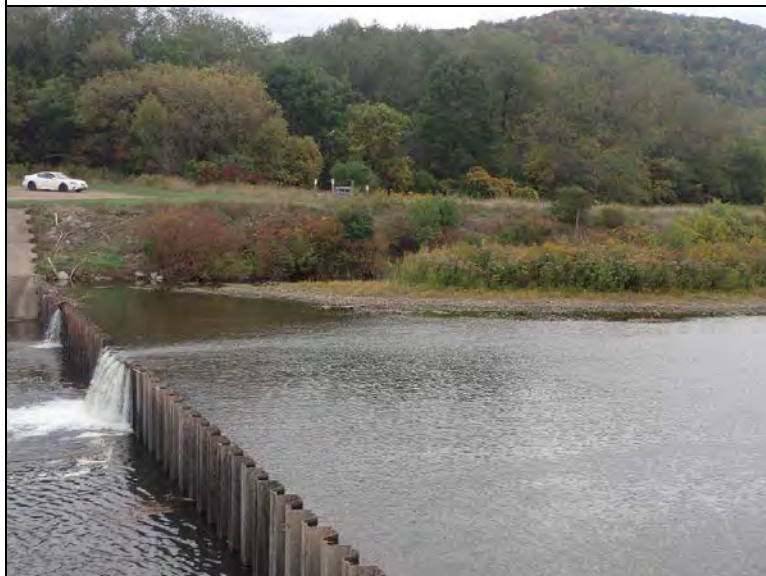
Inspect ID: N21L_2017_p_0129 **Title:** USACE_CELRB_N21L_2017_p_0129_1.jpg
Rated Item: 1. Vegetation and Obstructions **Caption:** Rating: Unacceptable; **Remarks:** Significant vegetation in riprap on right bank from upstream limit weir to 350' upstream of upstream limit weir.; **Action:** Remove vegetation from riprap.; **Station_1:** 0+00; **Station_2:** 0+00

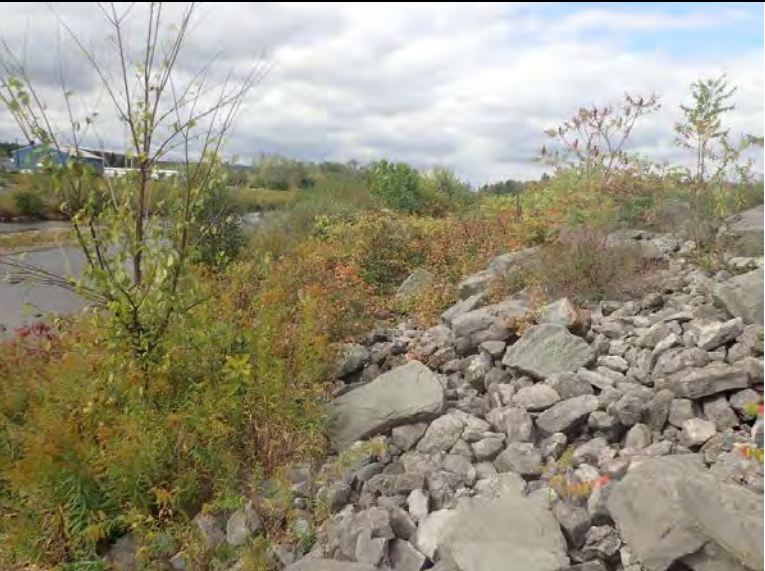
<p>Inspect ID: N21L_2017_p_0133 Title: USACE_CELRB_N21L_2017_p_0133_1.jpg Rated Item: 1. Vegetation and Obstructions Caption: Rating: Unacceptable; Remarks: Significant vegetation in riprap on right bank from 400' downstream of upstream limit weir to barrier levee weir.; Action: Remove vegetation from riprap.; Station_1: 4+00; Station_2: 0+00</p>

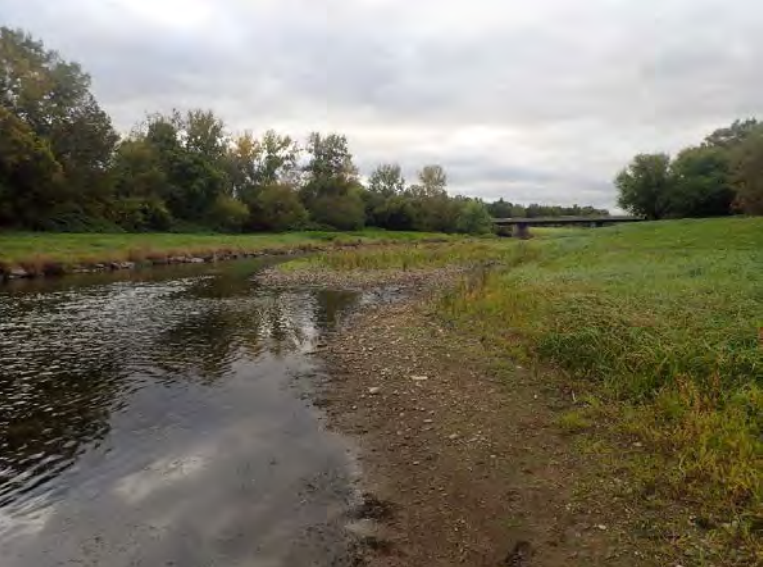
<p>Inspect ID: N21L_2017_p_0005 Title: USACE_CELRB_N21L_2017_p_0005_2.jpg Rated Item: 2. Shoaling (sediment deposition) Caption: Rating: Minimally Acceptable; Remarks: Four alternating vegetated shoals (S-2, S-3, S-4, S-5) on both banks from green golf course pedestrian bridge to Bolivar Road bridge.; Action: Remove shoals.; Station_1: 103+00; Station_2: 92+00</p>

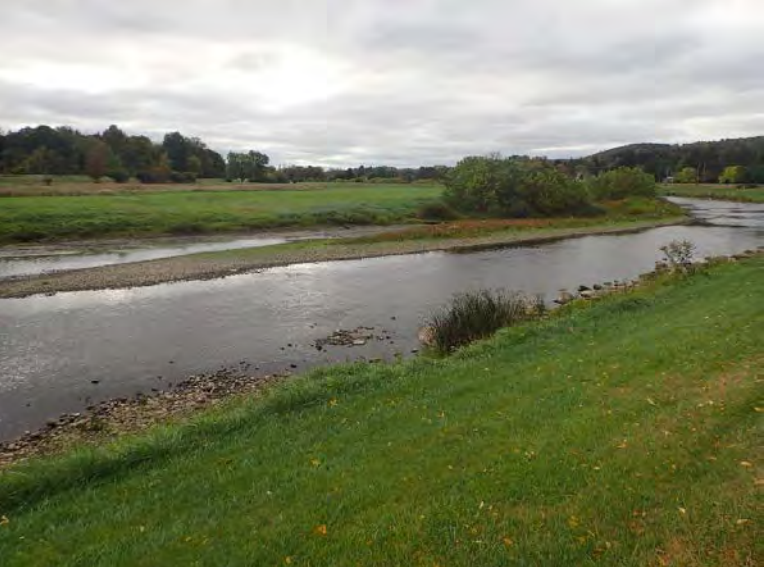
<p>Inspect ID: N21L_2017_p_0021 Title: USACE_CELRB_N21L_2017_p_0021_1.jpg Rated Item: 2. Shoaling (sediment deposition) Caption: Rating: Minimally Acceptable; Remarks: Shoaling (S-6) along right bank from 750' to 1,300' upstream of Bolivar Road bridge (near K-mart Plaza).; Action: Remove shoaling.; Station_1: 83+00; Station_2: 78+00</p>

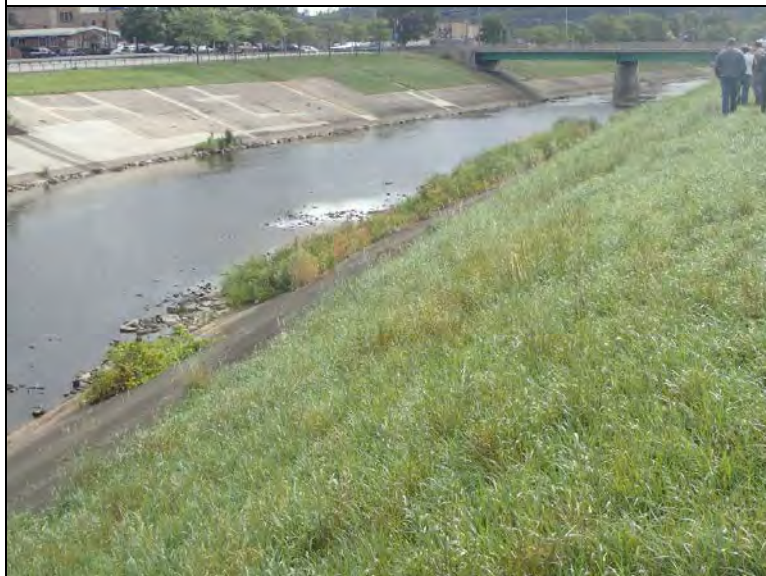
Inspect ID: N21L_2017_p_0072 **Title:** USACE_CELRB_N21L_2017_p_0072_1.jpg
Rated Item: 2. Shoaling (sediment deposition) **Caption:** Rating: Minimally Acceptable;
Remarks: Minor shoaling (S-8) on left bank from 600' downstream of Madison Street (Stevens Street) bridge to State Street bridge.; **Action:** Remove shoaling.; Station_1: 49+00; Station_2: 0+00

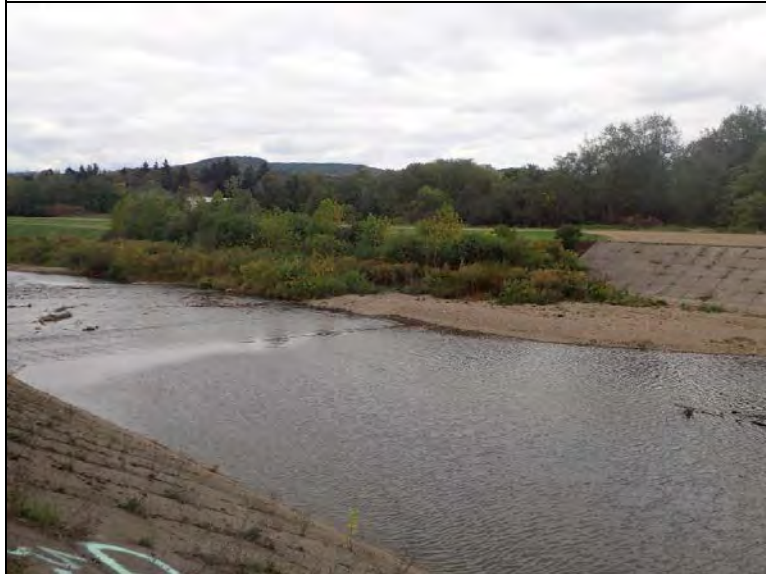
Inspect ID: N21L_2017_p_0127 **Title:** USACE_CELRB_N21L_2017_p_0127_1.jpg
Rated Item: 2. Shoaling (sediment deposition) **Caption:** Rating: Unacceptable;
Remarks: Significant vegetated shoal (S-11) and trees in channel on right bank from 100'-
700' downstream of upstream limit weir.; **Action:** Remove shoaling.; **Station_1:** 0+00

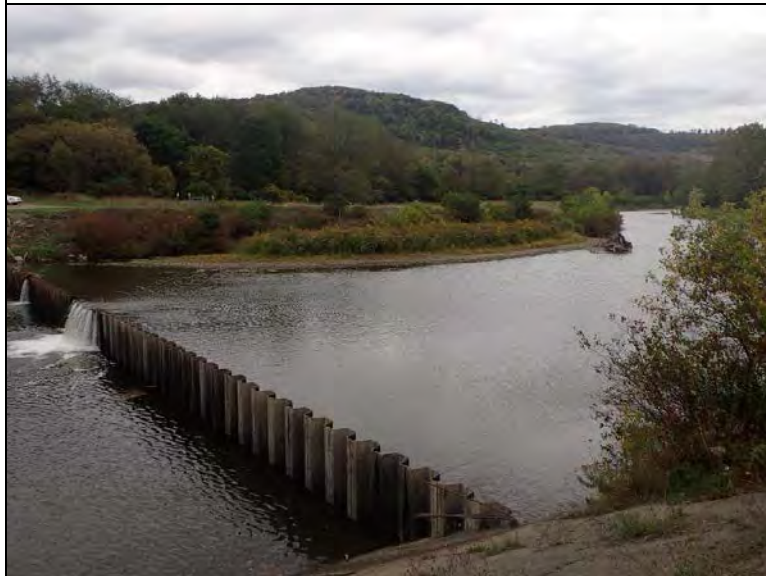
Inspect ID: N21L_2017_p_0128 **Title:** USACE_CELRB_N21L_2017_p_0128_1.jpg
Rated Item: 2. Shoaling (sediment deposition) **Caption:** Rating: Unacceptable;
Remarks: Significant vegetated shoaling (S-12) on right bank from 50' to 225' upstream of upstream limit weir.; **Action:** Remove shoaling.; **Station_1:** 0+00; **Station_2:** 0+00

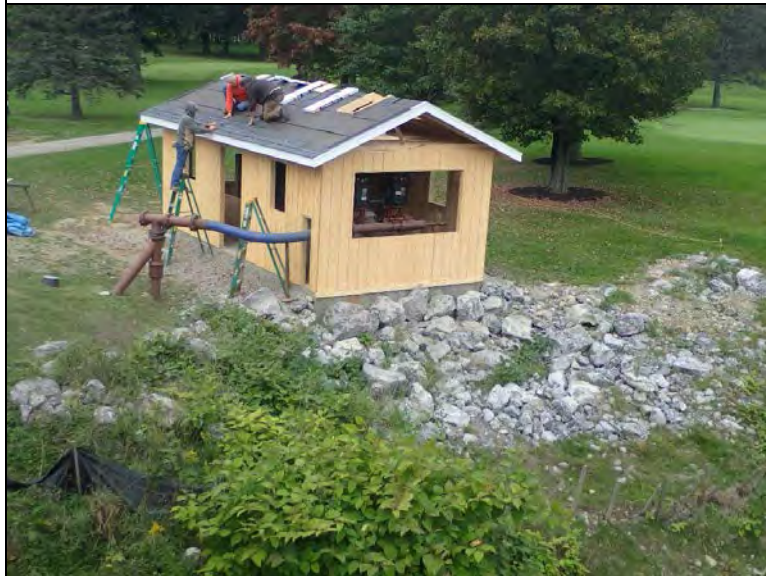
Inspect ID: N21L_2017_p_0003 **Title:** USACE_CELRB_N21L_2017_p_0003_1.jpg
Rated Item: 3. Encroachments **Caption:** Rating: Minimally Acceptable; **Remarks:** Unauthorized Alteration (A-1) - New pump station building, riprap, intake pipe to pump station, and feeder pipes for golf course water just downstream of pedestrian bridge.; **Action:** Submit Section 408 Alteration Request to USACE or remove unauthorized alteration.; **Station_1:** 104+00

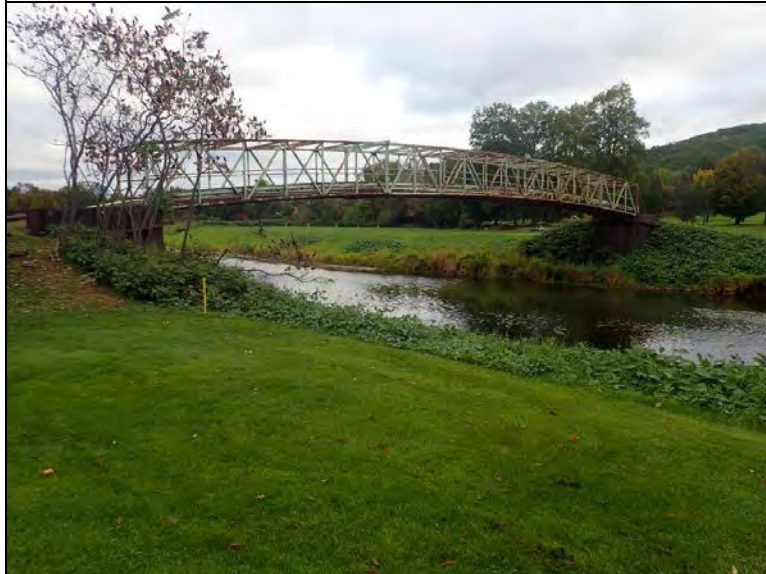
Inspect ID: N21L_2017_p_0004 **Title:** USACE_CELRB_N21L_2017_p_0004_1.jpg
Rated Item: 3. Encroachments **Caption:** Rating: Minimally Acceptable; Remarks: Unauthorized Alteration (A-2) - Green golf course pedestrian bridge 1,250' downstream of Boliver Road bridge. NYSDEC says permitted (need to verify).; Action: Submit Section 408 Alteration Request to USACE or remove unauthorized alteration.; Station_1: 104+00

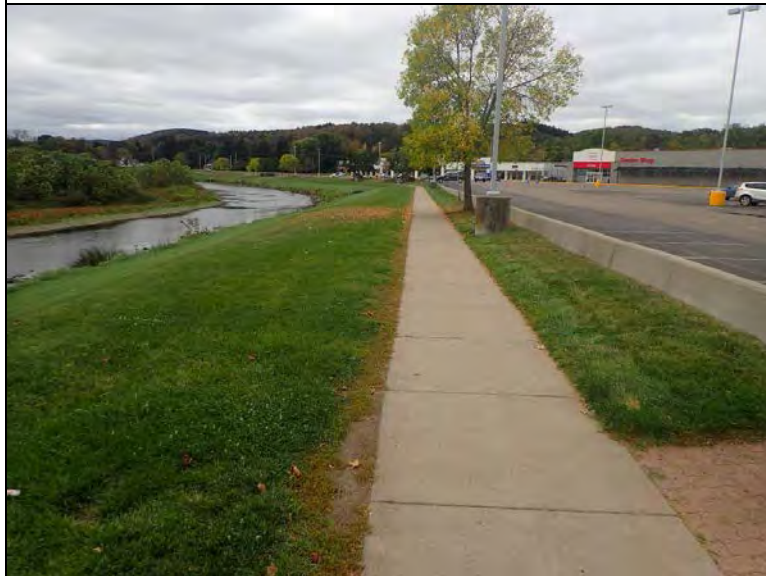
Inspect ID: N21L_2017_p_0018 **Title:** USACE_CELRB_N21L_2017_p_0018_2.jpg
Rated Item: 3. Encroachments **Caption:** Rating: Minimally Acceptable; Remarks: Unauthorized Alteration (A-4) - Sidewalk encroachment (benches and lightposts are not encroachments) along left bank from Bolivar road bridge to 1,775 feet upstream of Bolivar Road bridge.; Action: Submit Section 408 Alteration Request to USACE or remove unauthorized alteration.; Station_1: 90+00; Station_2: 76+00

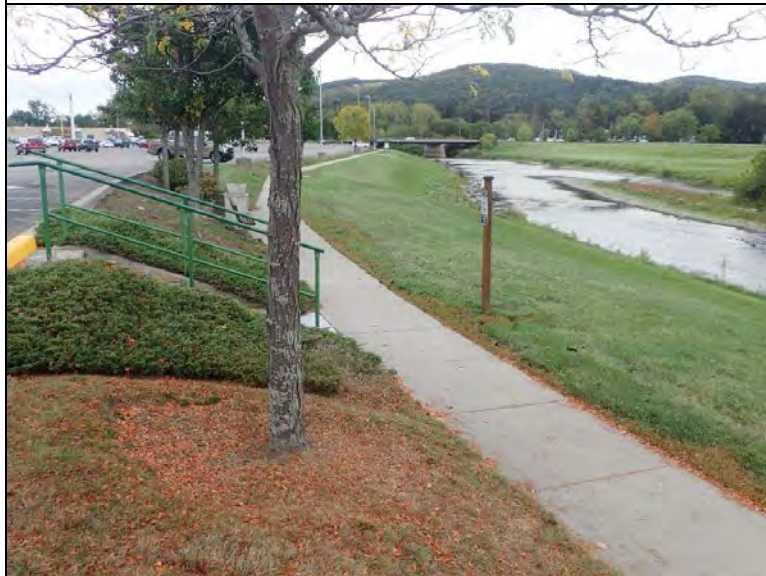
Inspect ID: N21L_2017_p_0027 **Title:** USACE_CELRB_N21L_2017_p_0027_1.jpg
Rated Item: 3. Encroachments **Caption:** Rating: Minimally Acceptable; Remarks: Unauthorized Alteration (A-8) - Pet sign and post encroachment on left bank channel crest.; Action: Submit Section 408 Alteration Request to USACE or remove unauthorized alteration.; Station_1: 77+00

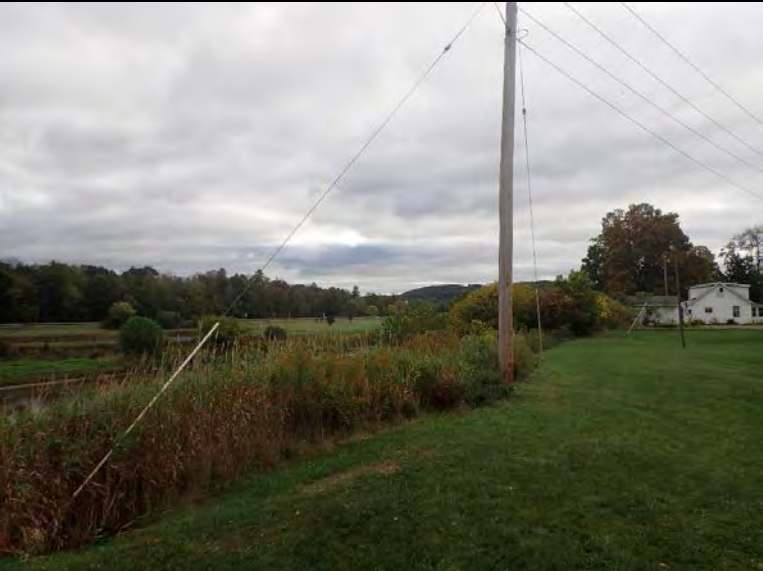
<p>Inspect ID: N21L_2017_p_0031 Title: USACE_CELRB_N21L_2017_p_0031_1.jpg Rated Item: 3. Encroachments Caption: Rating: Minimally Acceptable; Remarks: Unauthorized Alteration (A-11) - Utility pole and 2 guy wires on left bank channel crest 1,700' upstream of Boliver Road bridge (just upstream of asphalt drive).; Action: Submit Section 408 Alteration Request to USACE or remove unauthorized alteration.; Station_1: 74+00</p>

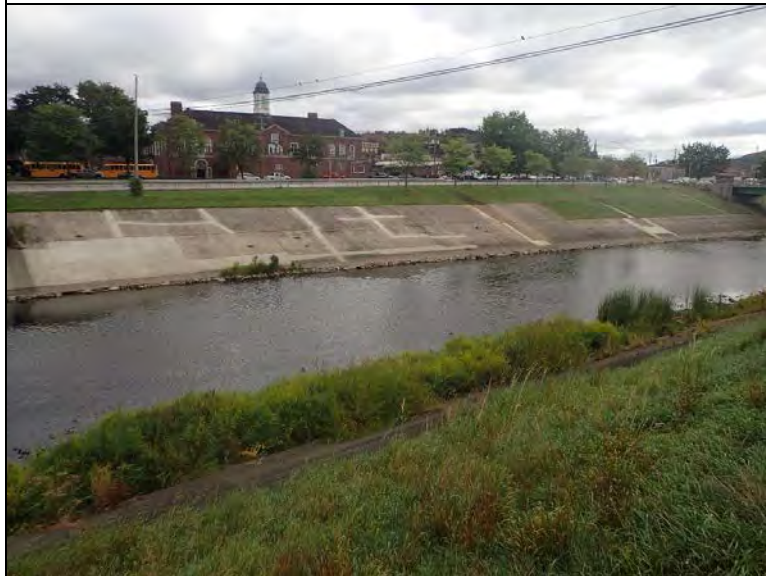
Inspect ID: N21L_2017_p_0075 **Title:** USACE_CELRB_N21L_2017_p_0075_1.jpg
Rated Item: 3. Encroachments **Caption:** Rating: Minimally Acceptable; Remarks:
Unauthorized Alteration (A-27) - Pipe Line bridge just downstream of Steven Street
bridge.; Action: Submit Section 408 Alteration Request to USACE.; Station_1: 46+00

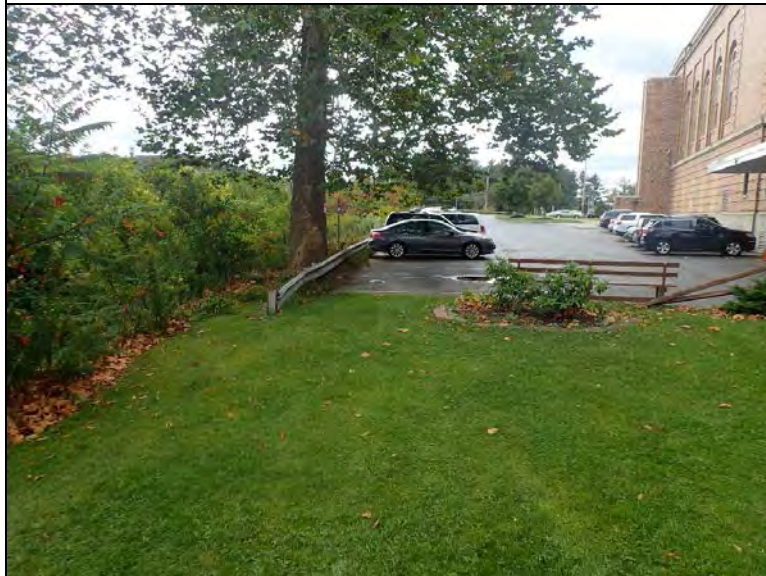
Inspect ID: N21L_2017_p_0086 **Title:** USACE_CELRB_N21L_2017_p_0086_1.jpg
Rated Item: 3. Encroachments **Caption:** Rating: Minimally Acceptable; Remarks: Unauthorized Alteration (A-33) - Wellsville High School rail, parking lot, and 2 signs on left bank levee downstream of State Street bridge. Blocks O&M access, per NYSDEC.; Action: Submit Section 408 Alteration Request Form to USACE.; Station_1: 37+00

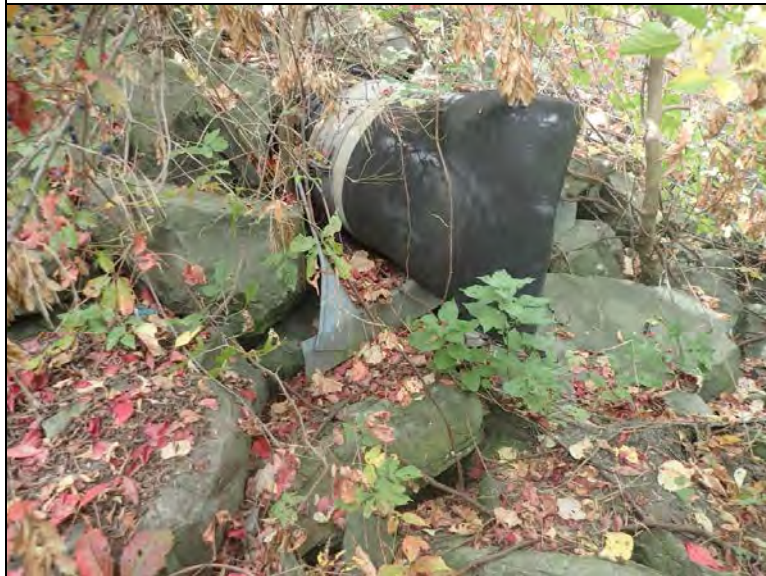
Inspect ID: N21L_2017_p_0089 **Title:** USACE_CELRB_N21L_2017_p_0089_1.jpg
Rated Item: 3. Encroachments **Caption:** Rating: Minimally Acceptable; Remarks: Unauthorized Alteration (A-36) - 18" HDPE outfall and duck bill valve on left bank side slope just downstream of State Street bridge owned by NYSDOT. (NYSDEC says permitted); Action: Submit Section 408 Alteration Request to USACE; Station_1: 34+00

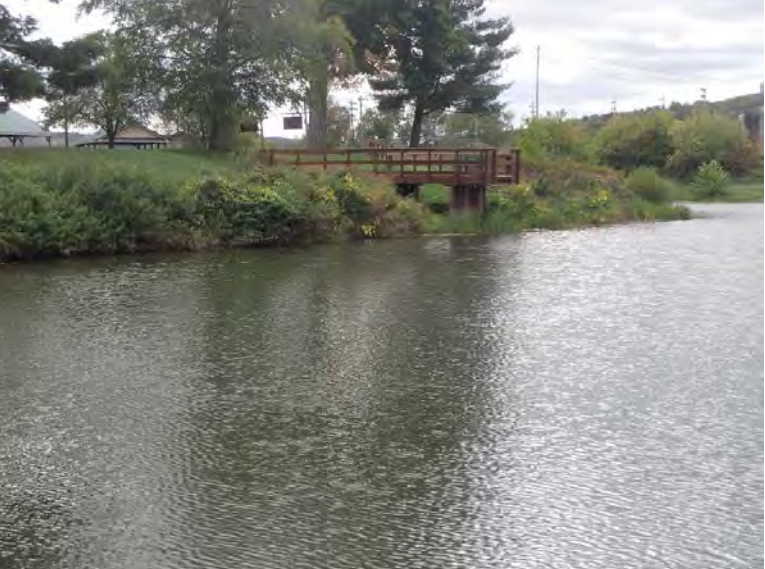
<p>Inspect ID: N21L_2017_p_0099 Title: USACE_CELRB_N21L_2017_p_0099_1.jpg Rated Item: 3. Encroachments Caption: Rating: Minimally Acceptable; Remarks: Unauthorized Alteration (A-41) - Wooden observation platform and fence on right bank 200' upstream of Steel Sheet Pile Weir.; Action: Submit Section 408 Alteration Request to USACE or remove unauthorized alteration.; Station_1: 25+00</p>

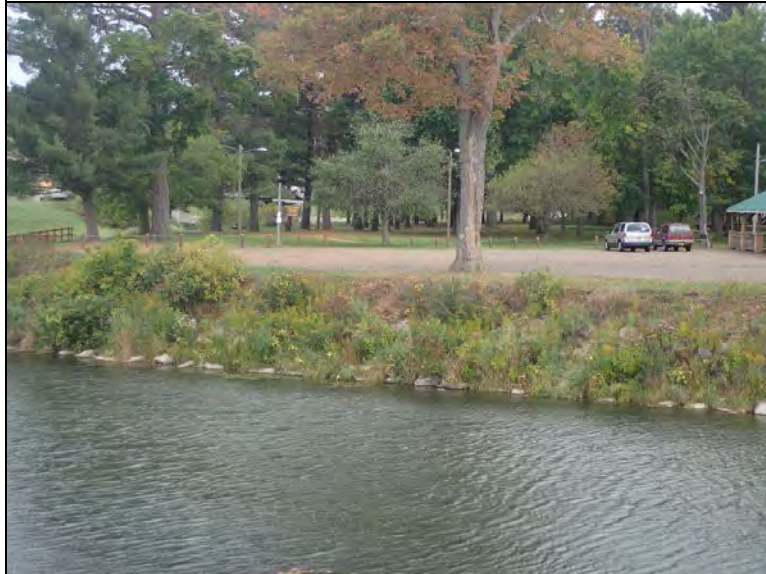
Inspect ID: N21L_2017_p_0109 **Title:** USACE_CELRB_N21L_2017_p_0109_1.jpg
Rated Item: 3. Encroachments **Caption:** Rating: Minimally Acceptable; Remarks: Unauthorized Alteration (A-43) - Parking lot and wooden post barrier on right bank in Island Park 500' upstream of Steel Sheet Pile Weir. Posts and wire rope restrict access.; Action: Submit Section 408 Alteration Request to USACE or remove unauthorized alteration.; Station_1: 22+00

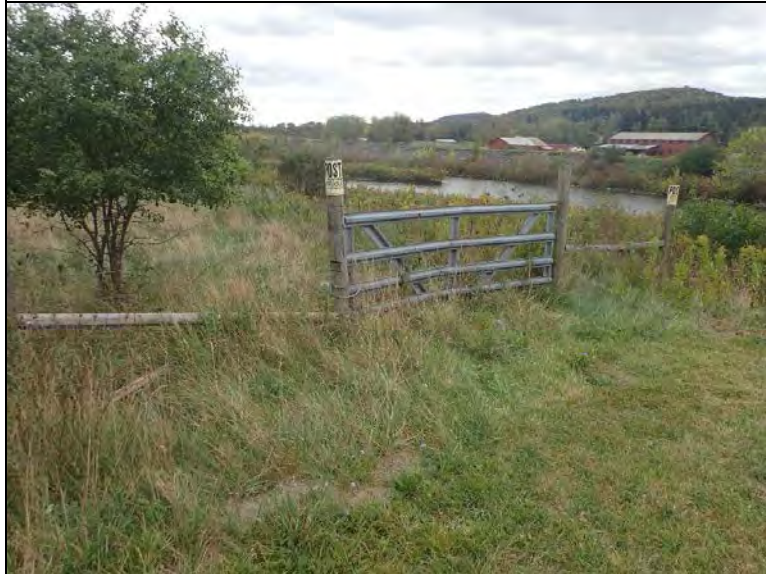
Inspect ID: N21L_2017_p_0136 **Title:** USACE_CELRB_N21L_2017_p_0136_1.jpg
Rated Item: 3. Encroachments **Caption:** Rating: Minimally Acceptable; Remarks: Unauthorized Alteration (A-47) - Barbed wire fence and metal gate on right bank at upstream limit weir.; Action: Submit Section 408 Alteration Request to USACE or remove unauthorized alteration.; Station_1: 0+00

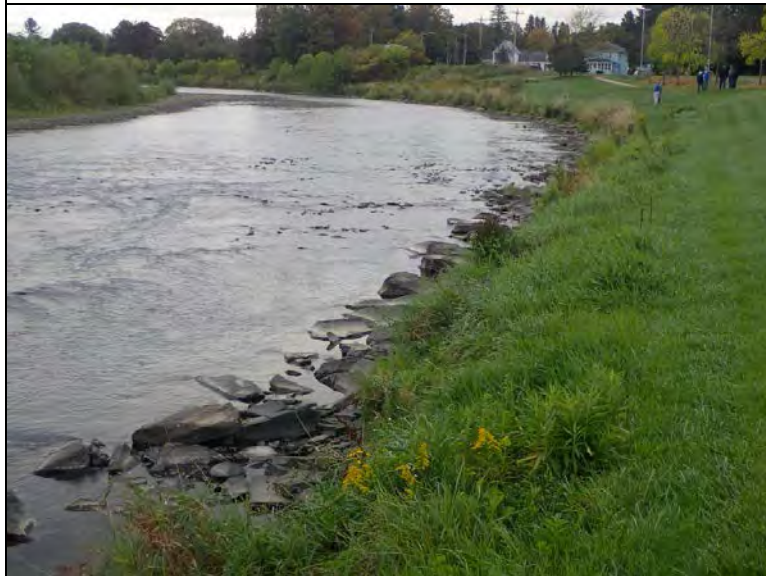
Inspect ID: N21L_2017_p_0141 **Title:** USACE_CELRB_N21L_2017_p_0141_2.jpg
Rated Item: 3. Encroachments **Caption:** Rating: Minimally Acceptable; Remarks: Unauthorized Alteration (A-NEW) - Riprap added to left bank channel toe.; Action: Submit Section 408 Alteration Request to USACE or remove unauthorized alteration.; Station_1: 84+00; Station_2: 68+00
