DEPARTMENT OF THE ARMY

SUBJECT: FY17 Periodic Inspection of Completed Works, Flood Risk Management Project,
Genesee River, Wellsville, New York (09/27/17)

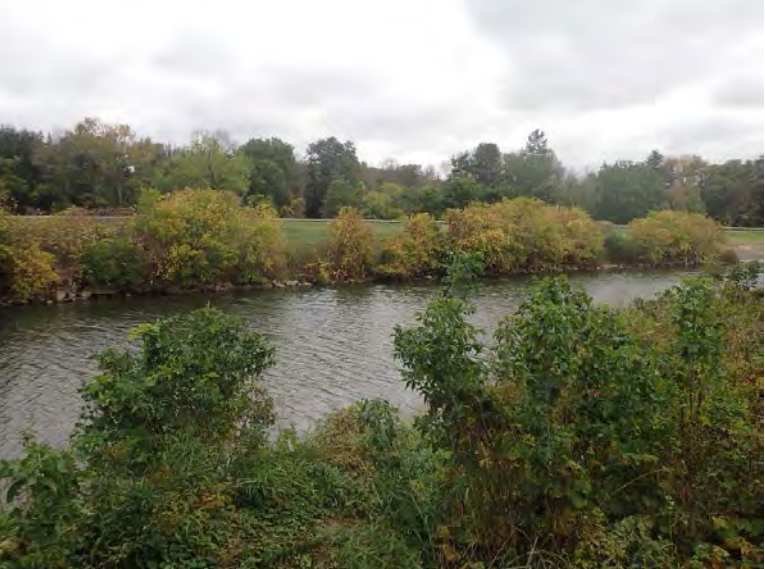
<p>Inspect ID: N21L_2017_p_0052 Title: USACE_CELRB_N21L_2017_p_0052_1.jpg Rated Item: 10. Riprap Revetments & Banks Caption: Rating: Minimally Acceptable; Remarks: Vegetation in riprap on right bank from 1,600' to 1,300' downstream of Madison Street (Stevens Street) bridge.; Action: Remove vegetation from riprap.; Station_1: 59+00; Station_2: 56+00</p>

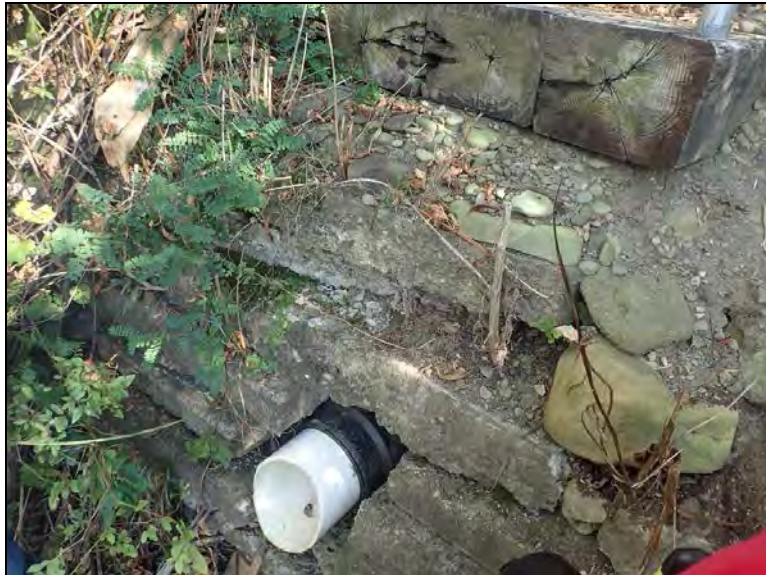
Inspect ID: N21R_2017_p_0028 **Title:** USACE_CELRB_N21R_2017_p_0028_1.jpg
Rated Item: 9. Culverts/ Discharge Pipes **Caption:** Rating: Acceptable; Remarks: 8" PVC outfall on left bank channel sideslope, 125' downstream of Railroad bridge. On As-builts.; Action: NA; Station_1: D 21+00

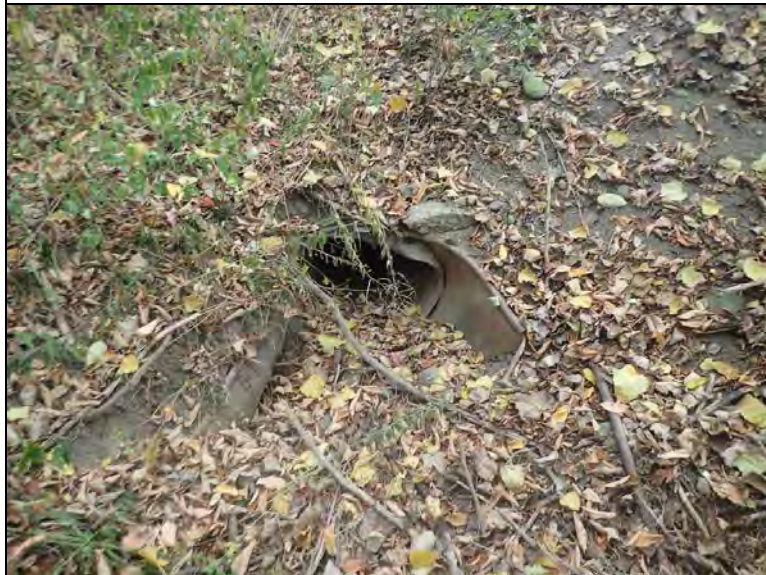
Inspect ID: N21R_2017_p_0049 **Title:** USACE_CELRB_N21R_2017_p_0049_1.jpg
Rated Item: 9. Culverts/ Discharge Pipes **Caption:** Rating: Minimally Acceptable; Remarks: 24" CMP at east end of right bank barrier levee is ~80% obstructed by sediment. (Right Bank); Action: Clear obstructed outfall.; Station_1: 0+00

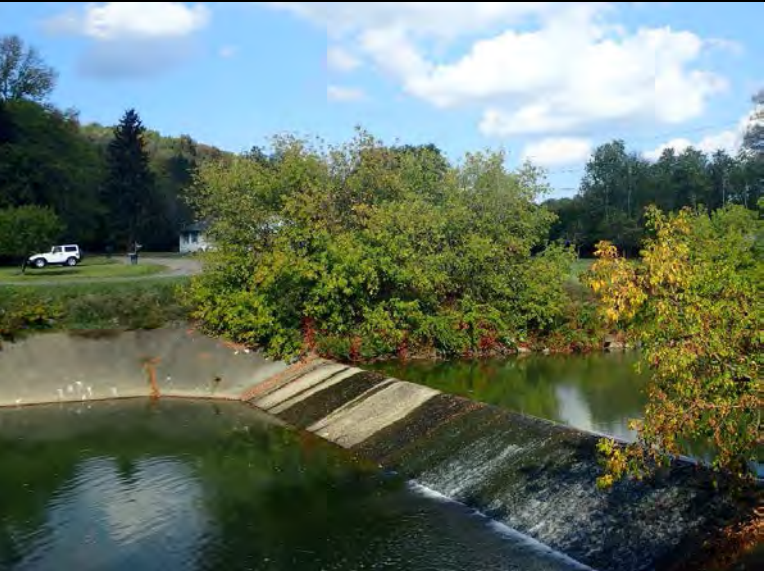
<p>Inspect ID: N21R_2017_p_0008 Title: USACE_CELRB_N21R_2017_p_0008_1.jpg Rated Item: 1. Vegetation and Obstructions Caption: Rating: Minimally Acceptable; Remarks: Significant vegetation and trees on right bank upstream of drop structure. (Dyke Creek); Action: Remove vegetation and trees.; Station_1: 35+00</p>

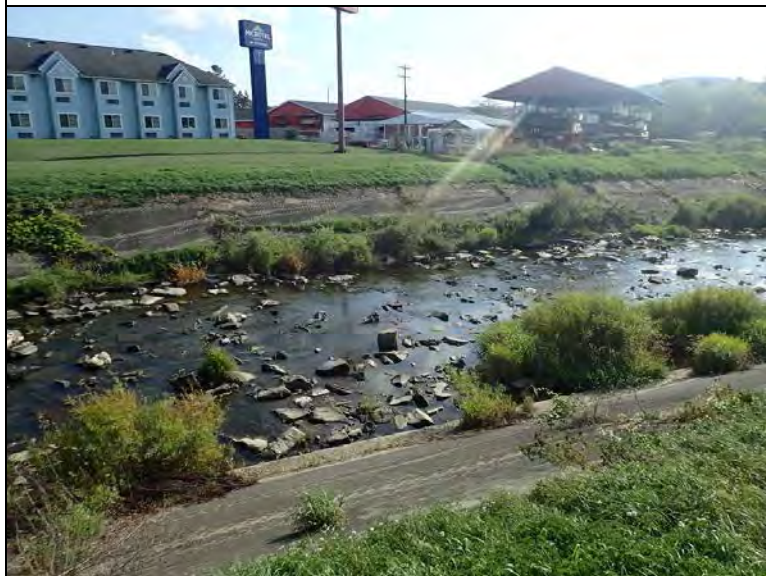
Inspect ID: N21R_2017_p_0039 **Title:** USACE_CELRB_N21R_2017_p_0039_1.jpg
Rated Item: 1. Vegetation and Obstructions **Caption:** Rating: Minimally Acceptable;
 Remarks: Unwanted vegetation in left and right bank concrete channel sideslopes.;
 Action: Remove unwanted vegetation from concrete channel sideslopes.; Station_1: D 18+00; Station_2: D 12+00

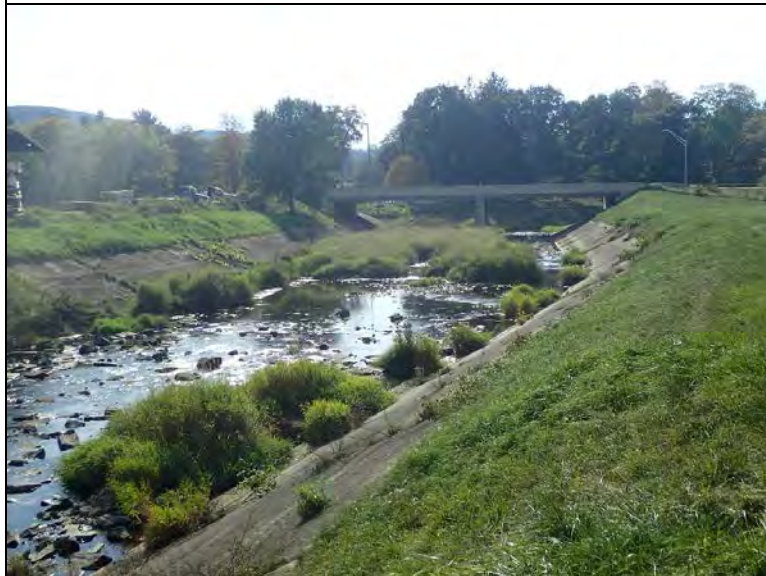
Inspect ID: N21R_2017_p_0039 **Title:** USACE_CELRB_N21R_2017_p_0039_3.jpg
Rated Item: 1. Vegetation and Obstructions **Caption:** Rating: Minimally Acceptable;
Remarks: Unwanted vegetation in left and right bank concrete channel sideslopes.;
Action: Remove unwanted vegetation from concrete channel sideslopes.; **Station_1:** D 18+00; **Station_2:** D 12+00

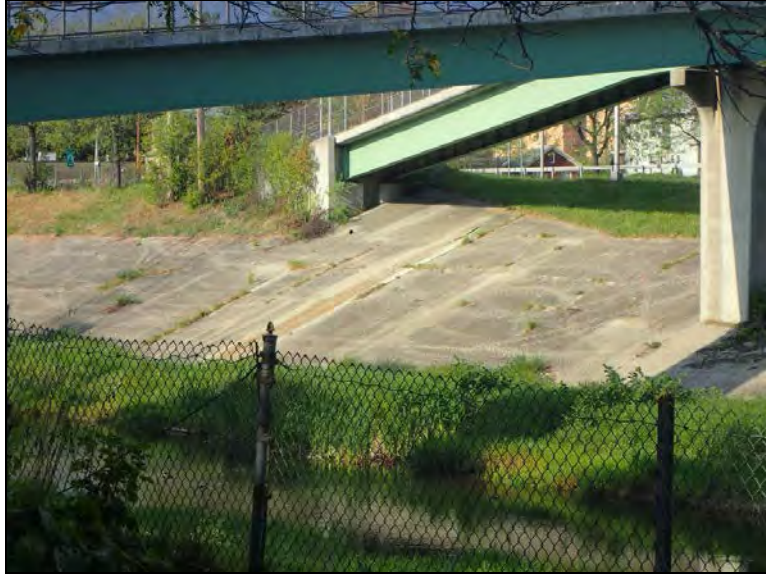
Inspect ID: N21R_2017_p_0042 **Title:** USACE_CELRB_N21R_2017_p_0042_1.jpg
Rated Item: 1. Vegetation and Obstructions **Caption:** Rating: Minimally Acceptable;
Remarks: Unwanted vegetation in left and right bank concrete channel sideslopes.;
Action: Remove unwanted vegetation from concrete channel sideslopes.; Station_1: D 11+00; Station_2: D 2+00

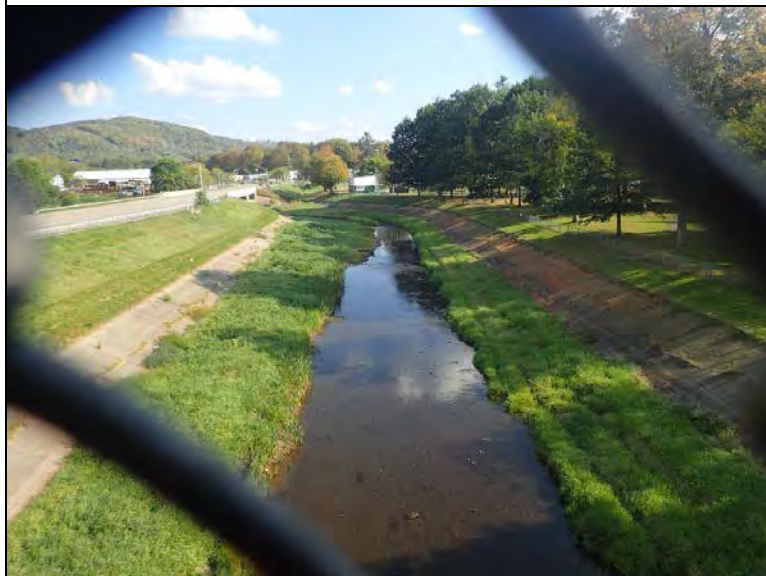
Inspect ID: N21R_2017_p_0042 **Title:** USACE_CELRB_N21R_2017_p_0042_2.jpg
Rated Item: 1. Vegetation and Obstructions **Caption:** Rating: Minimally Acceptable;
Remarks: Unwanted vegetation in left and right bank concrete channel sideslopes.;
Action: Remove unwanted vegetation from concrete channel sideslopes.; Station_1: D 11+00; Station_2: D 2+00

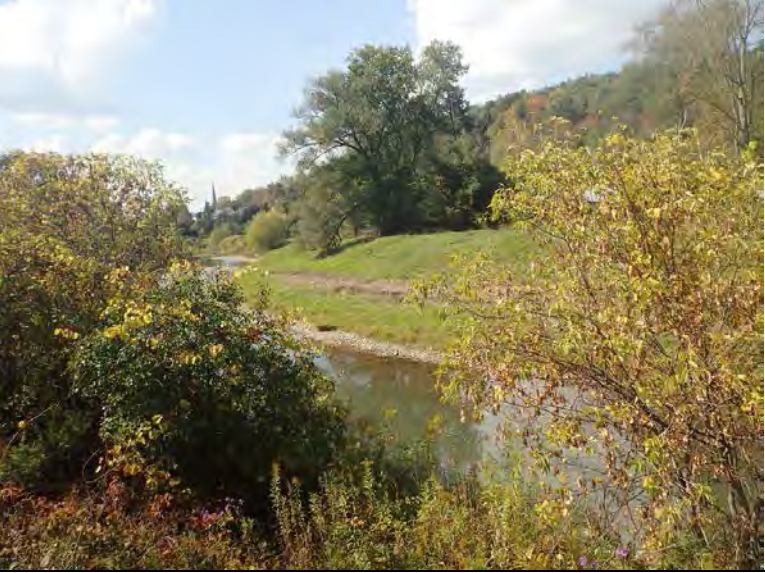
<p>Inspect ID: N21R_2017_p_0005 Title: USACE_CELRB_N21R_2017_p_0005_1.jpg Rated Item: 2. Shoaling (sediment deposition) Caption: Rating: Minimally Acceptable; Remarks: Shoaling (S-14) on right bank from 200' upstream of drop structure to upstream project limit. (Dyke Creek).; Action: Remove shoaling.; Station_1: 35+00; Station_2: 35+00</p>

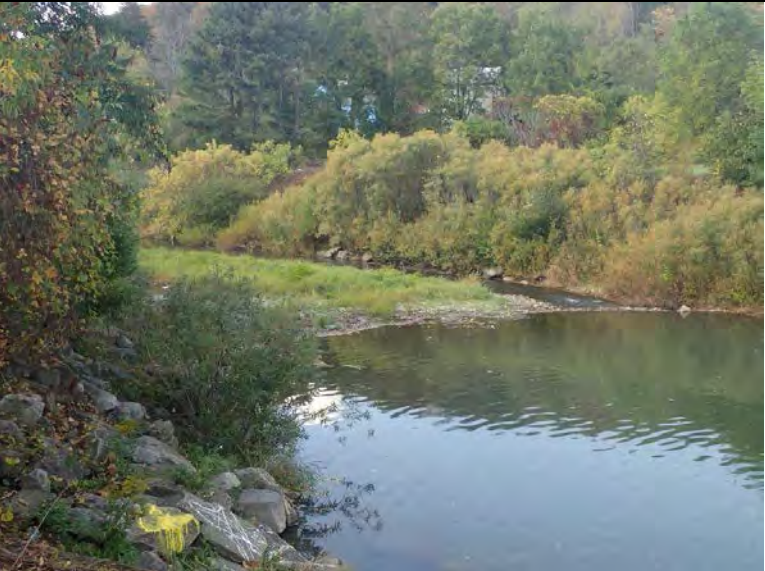
<p>Inspect ID: N21R_2017_p_0015 Title: USACE_CELRB_N21R_2017_p_0015_1.jpg Rated Item: 2. Shoaling (sediment deposition) Caption: Rating: Minimally Acceptable; Remarks: Minor shoal (S-15) in center of channel 100' downstream of drop structure to 200' downstream of drop structure. (Dyke Creek); Action: Remove shoal.; Station_1: 34+00</p>

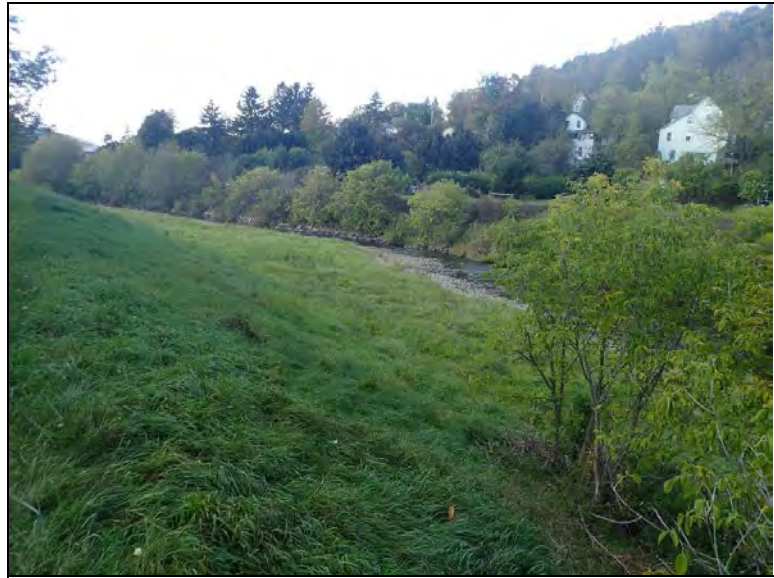
<p>Inspect ID: N21R_2017_p_0017 Title: USACE_CELRB_N21R_2017_p_0017_1.jpg Rated Item: 2. Shoaling (sediment deposition) Caption: Rating: Minimally Acceptable; Remarks: Shoaling (S-16) on left bank and in center of channel from drop structure to Broadway Street bridge. (Dyke Creek); Action: Remove shoal.; Station_1: 24+00; Station_2: 33+00</p>

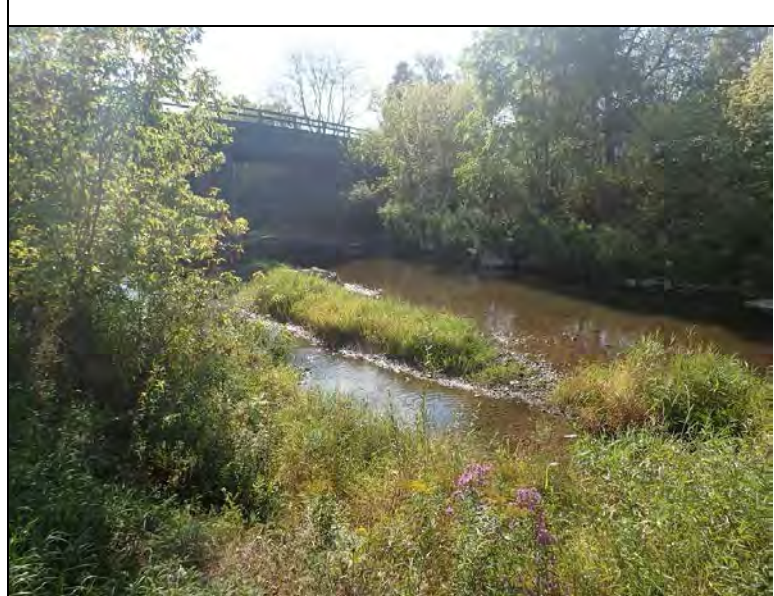
<p>Inspect ID: N21R_2017_p_0017 Title: USACE_CELRB_N21R_2017_p_0017_2.jpg Rated Item: 2. Shoaling (sediment deposition) Caption: Rating: Minimally Acceptable; Remarks: Shoaling (S-16) on left bank and in center of channel from drop structure to Broadway Street bridge. (Dyke Creek); Action: Remove shoal.; Station_1: 24+00; Station_2: 33+00</p>

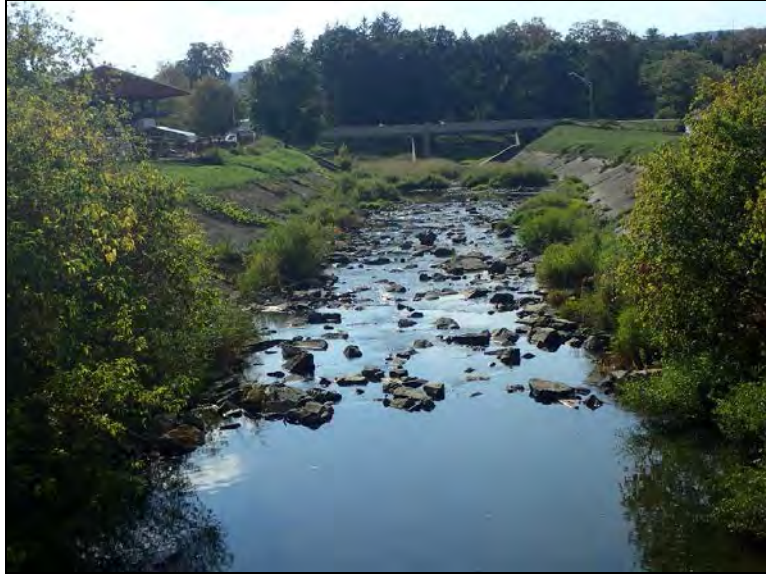
Inspect ID: N21R_2017_p_0036 **Title:** USACE_CELRB_N21R_2017_p_0036_1.jpg
Rated Item: 2. Shoaling (sediment deposition) **Caption:** Rating: Minimally Acceptable;
Remarks: Vegetated shoals (S-17) on concrete sideslopes on both banks and in channel from State Route 417 bridge to Main Street bridge. (Dyke Creek); **Action:** Remove vegetation from concrete.; Station_1: 12+00; Station_2: 18+00

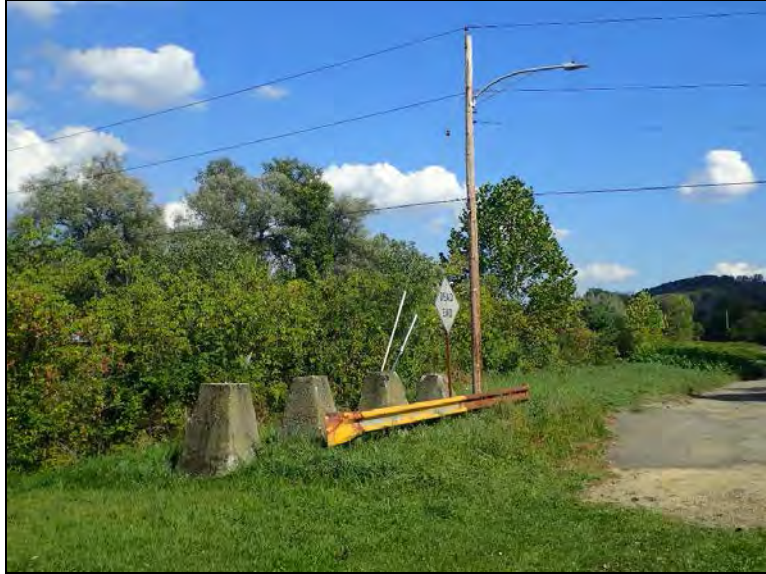
Inspect ID: N21R_2017_p_0009 **Title:** USACE_CELRB_N21R_2017_p_0009_1.jpg
Rated Item: 3. Encroachments **Caption:** Rating: Minimally Acceptable; Remarks: Unauthorized Alteration (A-50) - Concrete blocks, guardrail, utility pole, guy wire, and dead end sign encroachments on left bank at end of Miller Street just upstream of drop structure. (Dyke Creek); Action: Submit Section 408 Alteration Request to USACE or remove unauthorized alteration.; Station_1: 35+00

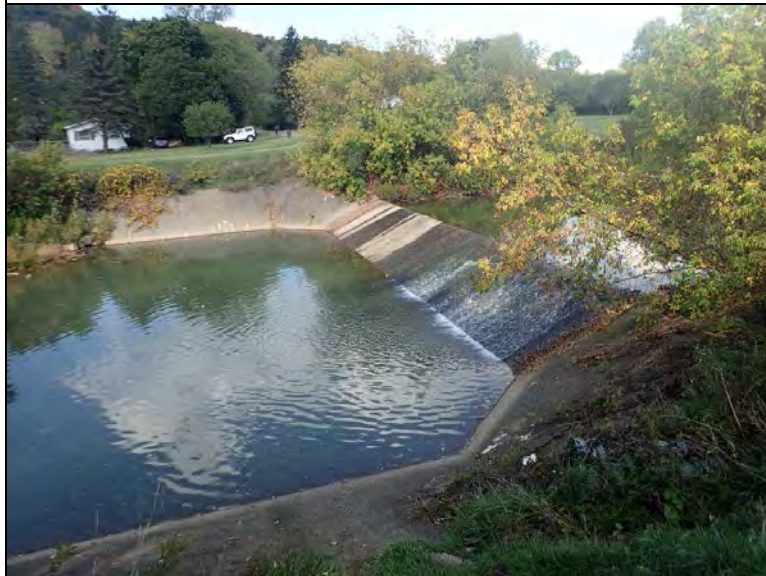
Inspect ID: N21R_2017_p_0013 **Title:** USACE_CELRB_N21R_2017_p_0013_1.jpg
Rated Item: 3. Encroachments **Caption:** Rating: Acceptable; Remarks: Drop Structure in acceptable condition. (Dyke Creek); Action: NA; Station_1: 35+00

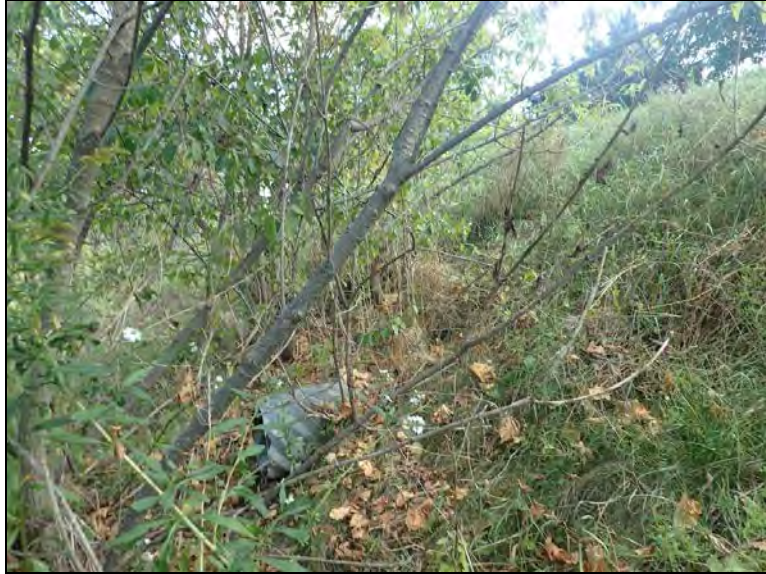
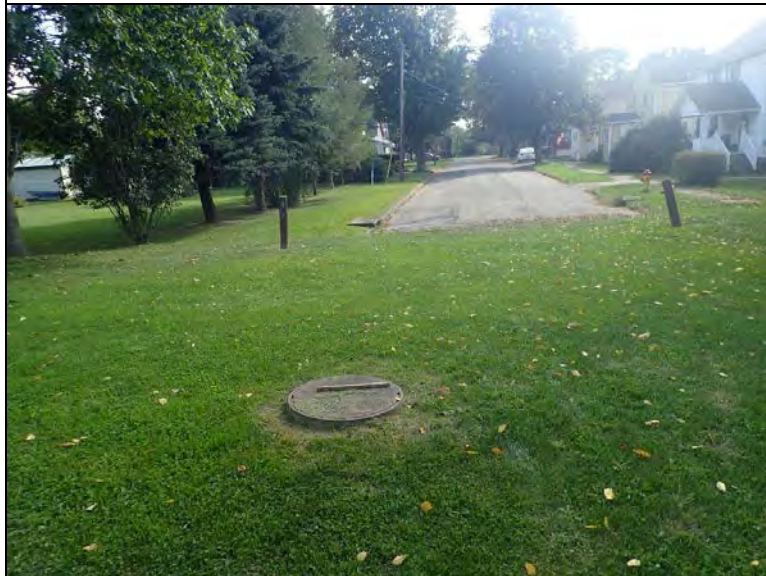
Inspect ID: N21R_2017_p_0018 **Title:** USACE_CELRB_N21R_2017_p_0018_1.jpg
Rated Item: 3. Encroachments **Caption:** Rating: Minimally Acceptable; Remarks: Unauthorized Alteration (NEW) - 18" CMP on left bank channel sideslope at Loring Ave.; Action: Submit Section 408 Alteration Request to USACE or remove unauthorized alteration.; Station_1: D 32+00

Inspect ID: N21R_2017_p_0018 **Title:** USACE_CELRB_N21R_2017_p_0018_2.jpg
Rated Item: 3. Encroachments **Caption:** Rating: Minimally Acceptable; Remarks: Unauthorized Alteration (NEW) - 18" CMP on left bank channel sideslope at Loring Ave.; Action: Submit Section 408 Alteration Request to USACE or remove unauthorized alteration.; Station_1: D 32+00

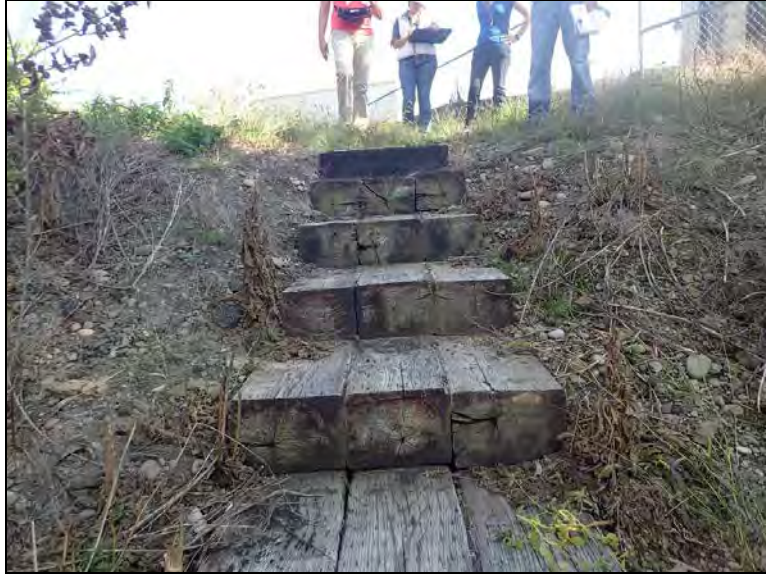
Inspect ID: N21R_2017_p_0024 **Title:** USACE_CELRB_N21R_2017_p_0024_1.jpg
Rated Item: 3. Encroachments **Caption:** Rating: Minimally Acceptable; Remarks: Unauthorized Alteration (A-51) - wood stairs on left bank channel slope just downstream of railroad bridge. (Dyke Creek); Action: Submit Section 408 Alteration Request to USACE or remove unauthorized alteration.; Station_1: 21+00

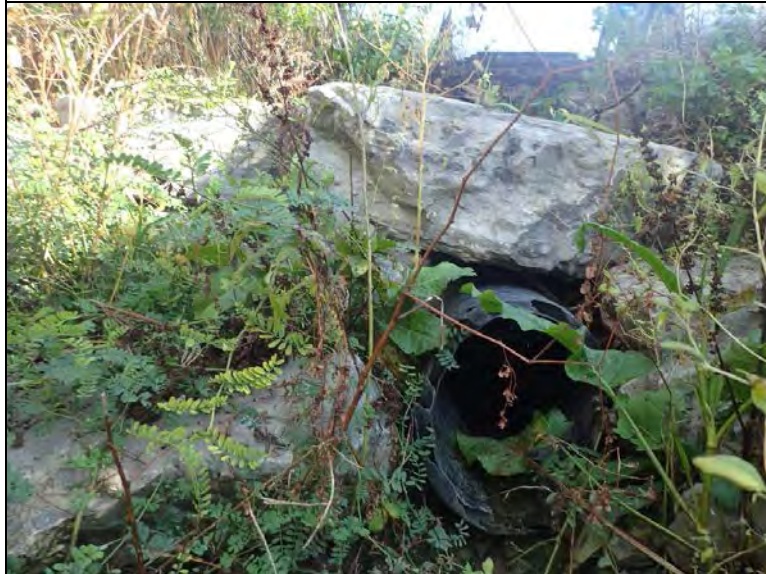
Inspect ID: N21R_2017_p_0026 **Title:** USACE_CELRB_N21R_2017_p_0026_1.jpg
Rated Item: 3. Encroachments **Caption:** Rating: Minimally Acceptable; Remarks: Unauthorized Alteration (NEW) - 12" HDPE outfall on left bank channel sideslope, 50' downstream of Railroad bridge; Action: Submit Section 408 Alteration Request to USACE or remove unauthorized alteration.; Station_1: D 22+00

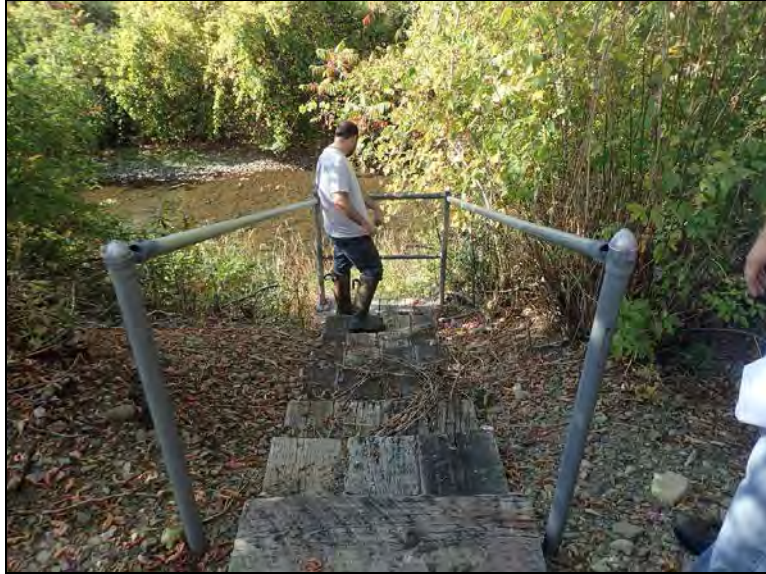
Inspect ID: N21R_2017_p_0027 **Title:** USACE_CELRB_N21R_2017_p_0027_1.jpg
Rated Item: 3. Encroachments **Caption:** Rating: Minimally Acceptable; Remarks: Unauthorized Alteration (A-52) - wooden stairs and railing encroachments on left bank channel slope just downstream of railroad bridge. (Dyke Creek); Action: Submit Section 408 Alteration Request to USACE or remove unauthorized alteration.; Station_1: 21+00

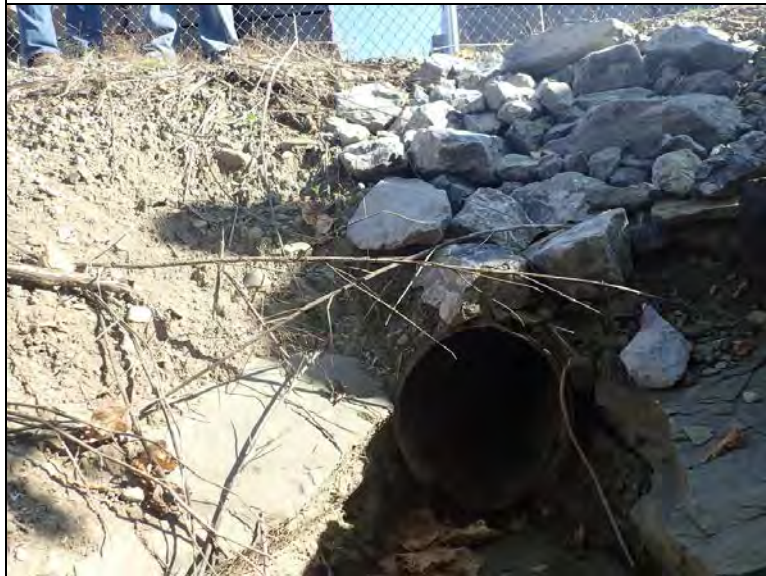
Inspect ID: N21R_2017_p_0030 **Title:** USACE_CELRB_N21R_2017_p_0030_1.jpg
Rated Item: 3. Encroachments **Caption:** Rating: Minimally Acceptable; Remarks: Unauthorized Alteration (A-54) - 12' metal outfall pipe with riprap apron on left bank channel slope just upstream of Main Street bridge. (Dyke Creek); Action: Submit Section 408 Alteration Request to USACE or remove unauthorized alteration.; Station_1: D 20+00; on asdbuilt; ;

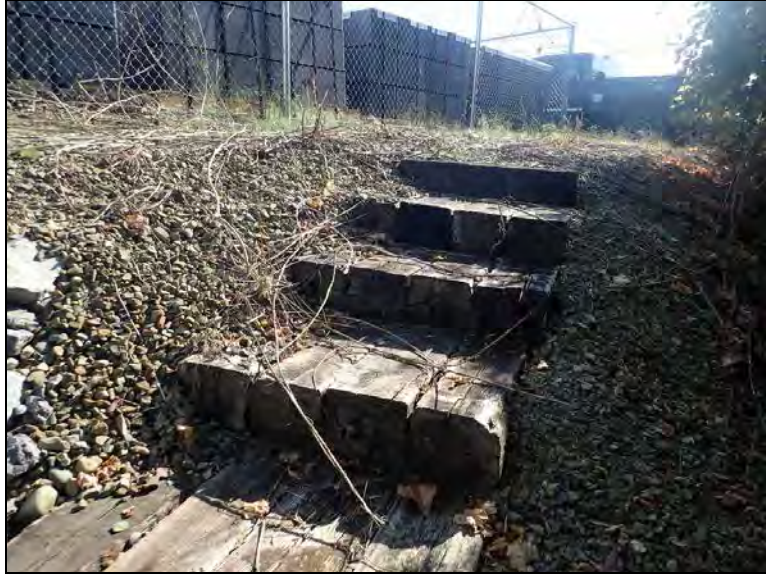
Inspect ID: N21R_2017_p_0031 **Title:** USACE_CELRB_N21R_2017_p_0031_1.jpg
Rated Item: 3. Encroachments **Caption:** Rating: Minimally Acceptable; Remarks: Unauthorized alteration (A-53) - wood stairs left bank channel slope. (Dyke Creek); Action: Submit Section 408 Alteration Request to USACE or remove unauthorized alteration.; Station_1: 20+00

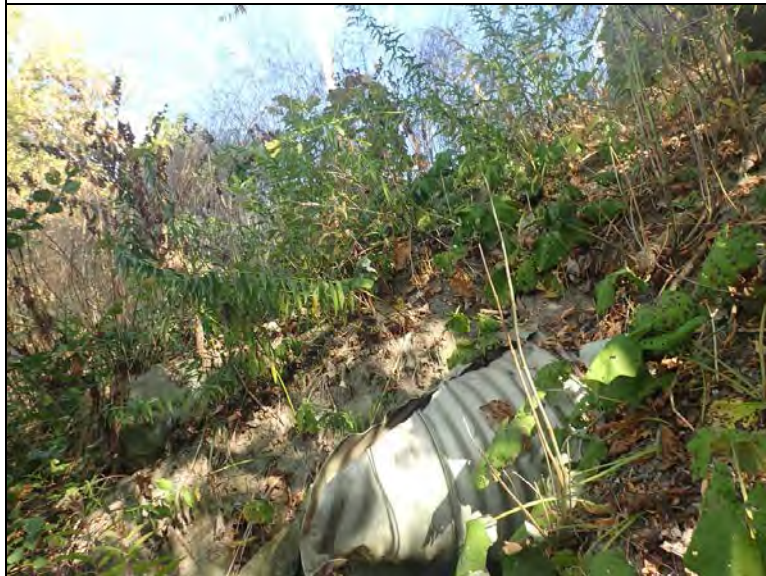
Inspect ID: N21R_2017_p_0033 **Title:** USACE_CELRB_N21R_2017_p_0033_1.jpg
Rated Item: 3. Encroachments **Caption:** Rated Item: 1. Public Sponsor (A or U only); Rating: Acceptable; Remarks: Unauthorized Alteration (NEW) - 24" CMP outfall on left bank channel sideslope, 50' upstream of Main Street bridge.; Action: Submit Section 408 Alteration Request to USACE or remove unauthorized alteration.; Station_1: D 19+00

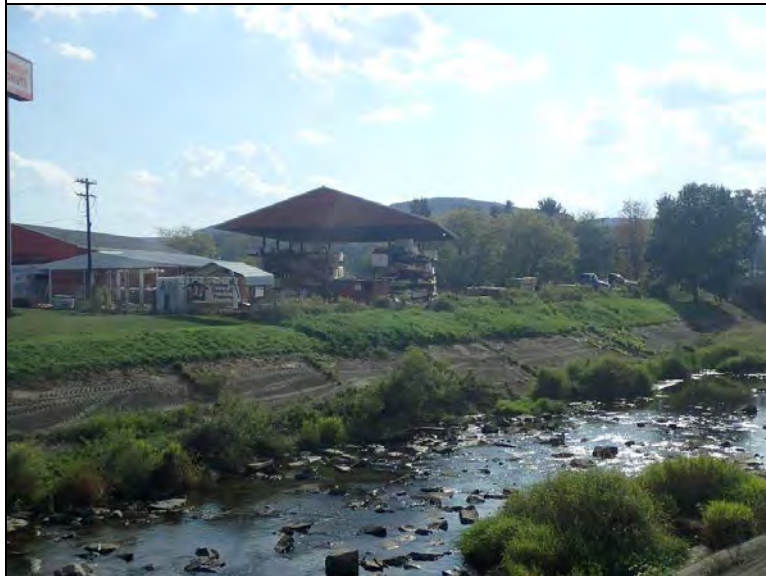
Inspect ID: N21R_2017_p_0038 **Title:** USACE_CELRB_N21R_2017_p_0038_1.jpg
Rated Item: 3. Encroachments **Caption:** Rating: Minimally Acceptable; Remarks:
 Unauthorized Alteration (A-55) - Heating, electrical, and plumbing yard on Dyke Creek
 left bank just upstream of State Route 417 bridge. (Dyke Creek); Action: Submit Section
 408 Alteration Request to USACE or remove unauthorized alteration.; Station_1: 15+00;
 Station_2: 13+00

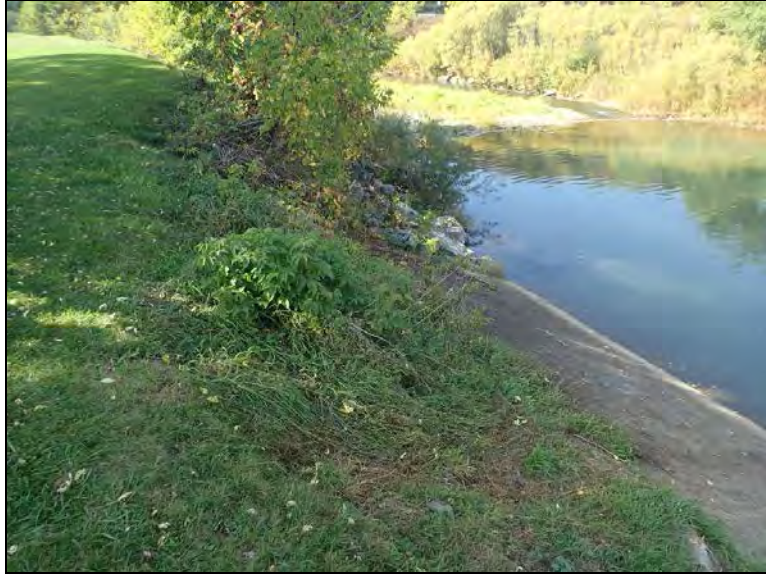
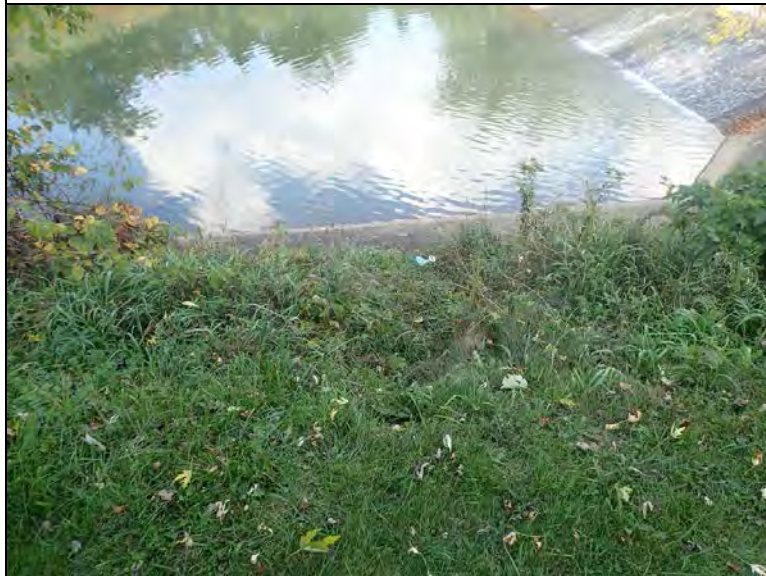
Inspect ID: N21R_2017_p_0012 **Title:** USACE_CELRB_N21R_2017_p_0012_1.jpg
Rated Item: 4. Erosion **Caption:** Rating: Minimally Acceptable; Remarks: Erosion on left bank channel sideslope just downstream of Drop Structure.; Action: Repair erosion; Station_1: D 35+00

Inspect ID: N21R_2017_p_0012 **Title:** USACE_CELRB_N21R_2017_p_0012_2.jpg
Rated Item: 4. Erosion **Caption:** Rating: Minimally Acceptable; Remarks: Erosion on left bank channel sideslope just downstream of Drop Structure.; Action: Repair erosion; Station_1: D 35+00

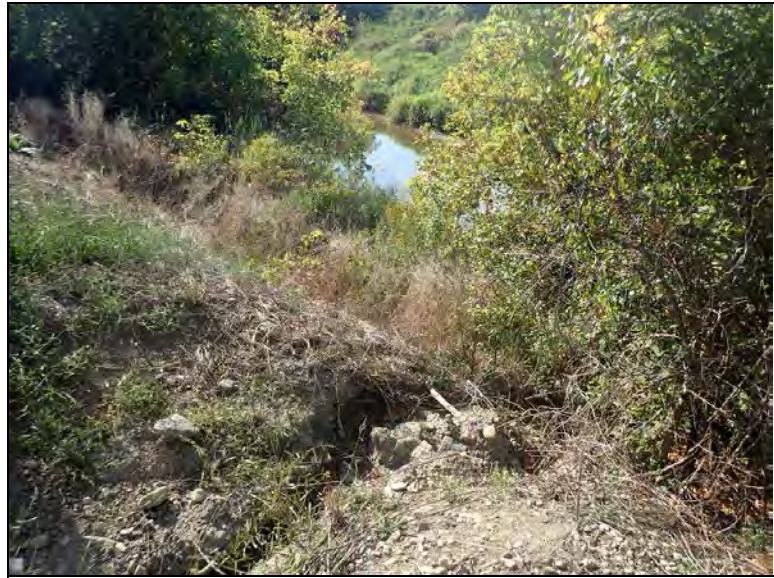
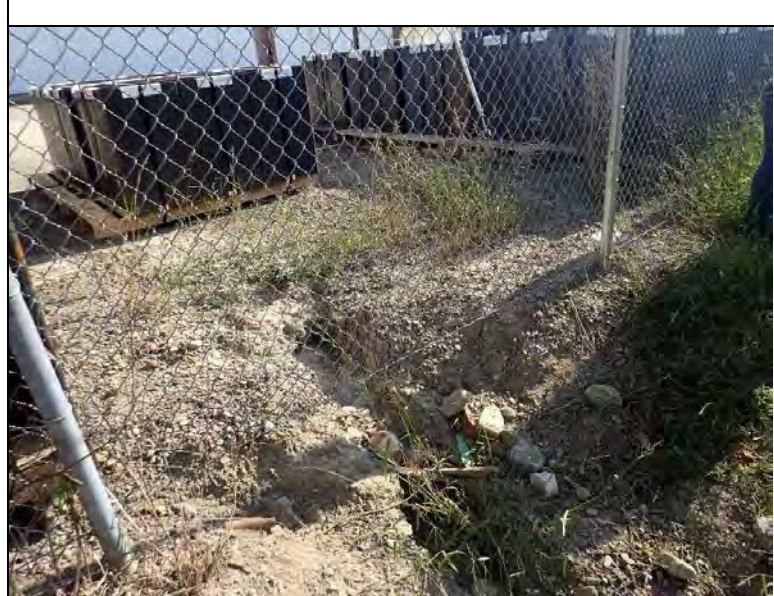
<p>Inspect ID: N21R_2017_p_0029 Title: USACE_CELRB_N21R_2017_p_0029_1.jpg Rated Item: 4. Erosion Caption: Rating: Minimally Acceptable; Remarks: Erosion on left bank channel sideslope 175' upstream of Main St. bridge.; Action: Repair erosion.; Station_1: D 20+00</p>

<p>Inspect ID: N21R_2017_p_0029 Title: USACE_CELRB_N21R_2017_p_0029_2.jpg Rated Item: 4. Erosion Caption: Rating: Minimally Acceptable; Remarks: Erosion on left bank channel sideslope 175' upstream of Main St. bridge.; Action: Repair erosion.; Station_1: D 20+00</p>

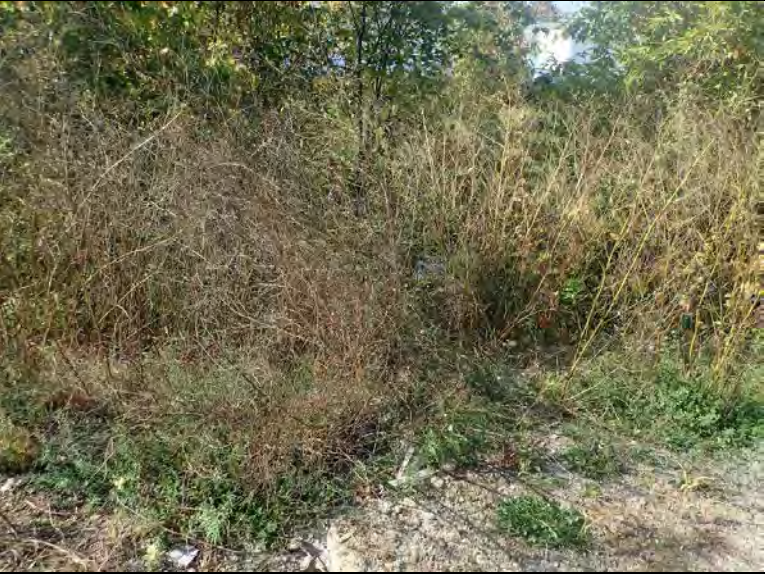
<p>Inspect ID: N21R_2017_p_0032 Title: USACE_CELRB_N21R_2017_p_0032_1.jpg Rated Item: 4. Erosion Caption: Rating: Minimally Acceptable; Remarks: Erosion on left bank upstream of Main Street. (Dyke Creek); Action: Repair erosion.; Station_1: 19+00</p>

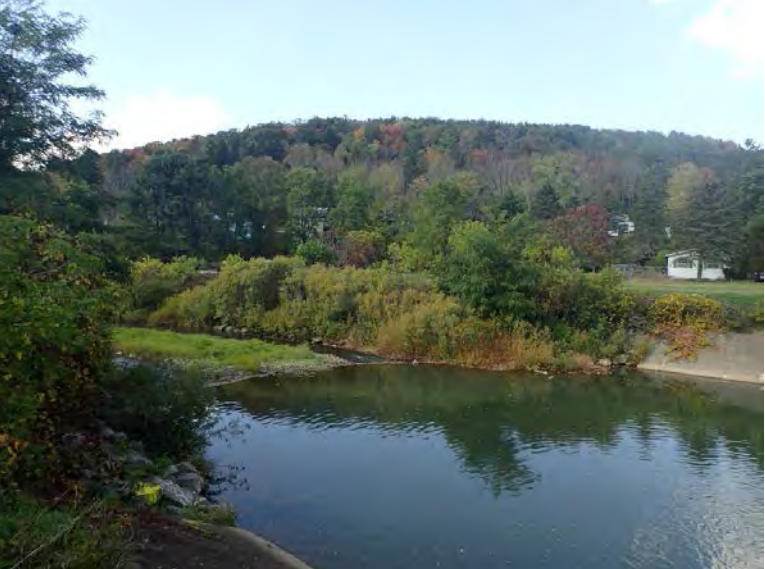
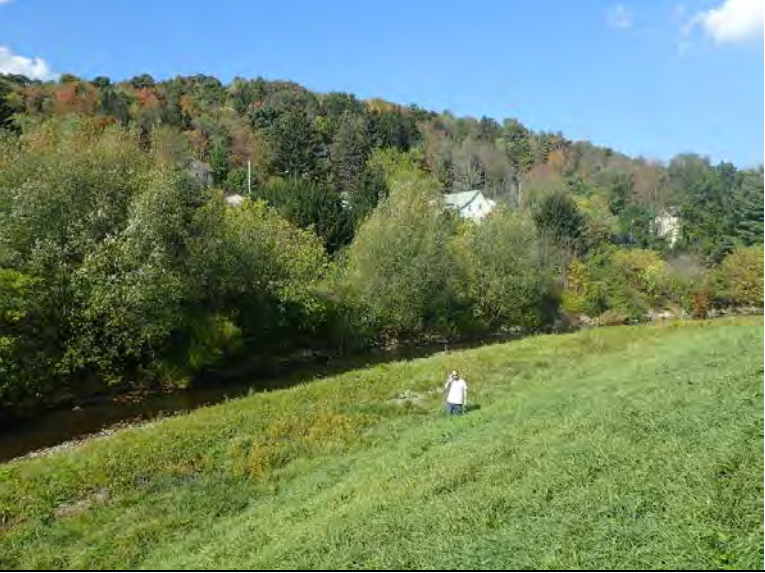
10. Riprap Revetments & Banks	U	A	No riprap displacement or stone degradation that could pose an immediate threat to the integrity of channel bank. Riprap intact with no woody vegetation present.	N21R_2017_p_0014: Station_1 35+00: Station_2 28+00: Trees and unwanted vegetation in riprap on right bank from Broad Street bridge to Drop Structure. (Dyke Creek): Remove unwanted vegetation. (U) N21R_2017_p_0022: Station_1 24+00: Station_2 22+00: Significant unwanted vegetation and trees in riprap on both banks between Railroad bridge and Broad Street bridge. (Dyke Creek): Remove unwanted vegetation. (U) N21R_2017_p_0025: Station_1 22+00: Station_2 18+00: Significant trees and heavy unwanted vegetation in riprap on both banks between Main Street bridge and Railroad bridge. (Dyke Creek): Remove trees and unwanted vegetation. (U) N21R_2017_p_0035: Station_1 17+00: Significant trees and vegetation in riprap on both banks just downstream of Main Street bridge. (Dyke Creek): Remove trees and vegetation from riprap. (U)

<p>Inspect ID: N21R_2017_p_0014 Title: USACE_CELRB_N21R_2017_p_0014_1.jpg Rated Item: 10. Riprap Revetments & Banks Caption: Rating: Unacceptable; Remarks: Trees and unwanted vegetation in riprap on right bank from Broad Street bridge to Drop Structure. (Dyke Creek); Action: Remove unwanted vegetation.; Station_1: 35+00; Station_2: 28+00</p>

<p>Inspect ID: N21R_2017_p_0014 Title: USACE_CELRB_N21R_2017_p_0014_2.jpg Rated Item: 10. Riprap Revetments & Banks Caption: Rating: Unacceptable; Remarks: Trees and unwanted vegetation in riprap on right bank from Broad Street bridge to Drop Structure. (Dyke Creek); Action: Remove unwanted vegetation.; Station_1: 35+00; Station_2: 28+00</p>

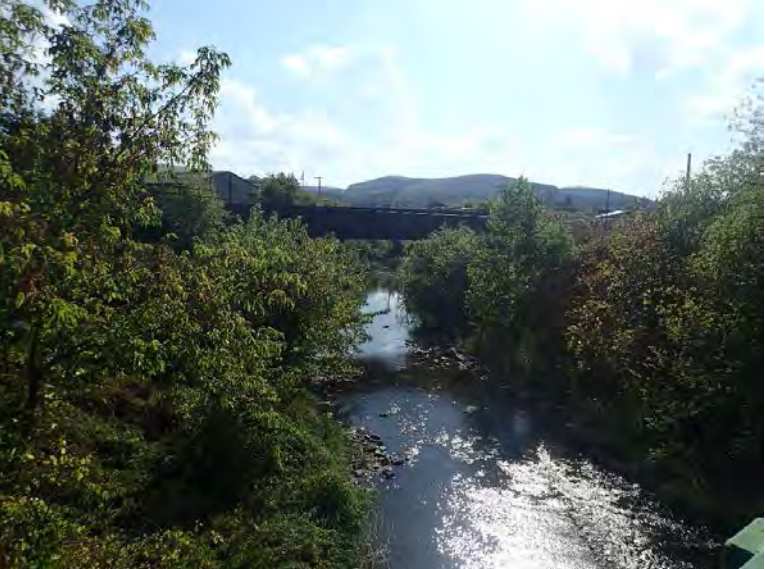
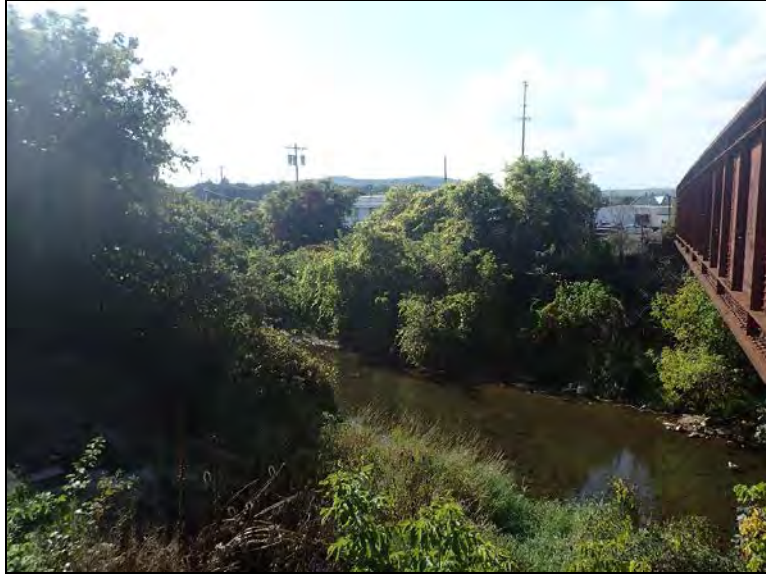
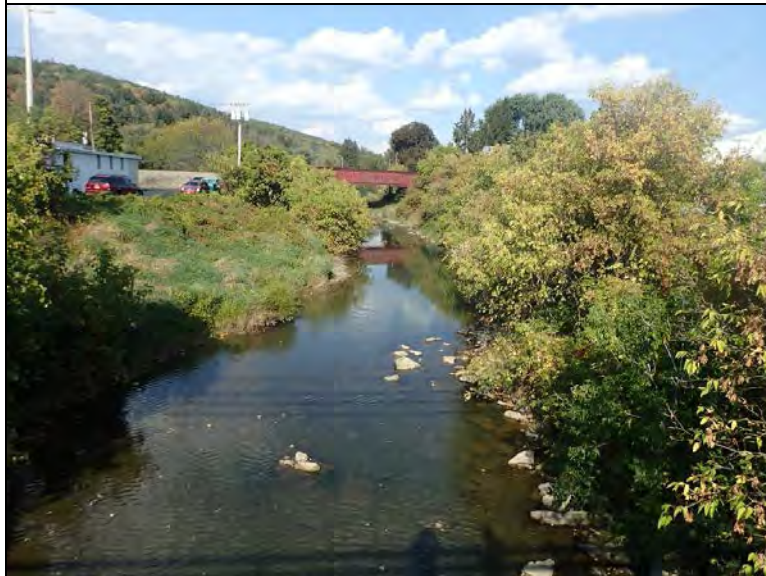
<p>Inspect ID: N21R_2017_p_0022 Title: USACE_CELRB_N21R_2017_p_0022_1.jpg Rated Item: 10. Riprap Revetments & Banks Caption: Rating: Unacceptable; Remarks: Significant unwanted vegetation and trees in riprap on both banks between Railroad bridge and Broad Street bridge. (Dyke Creek); Action: Remove unwanted vegetation.; Station_1: 24+00; Station_2: 22+00</p>

Inspect ID: N21R_2017_p_0022 **Title:** USACE_CELRB_N21R_2017_p_0022_2.jpg
Rated Item: 10. Riprap Revetments & Banks **Caption:** Rating: Unacceptable; Remarks: Significant unwanted vegetation and trees in riprap on both banks between Railroad bridge and Broad Street bridge. (Dyke Creek); Action: Remove unwanted vegetation.; Station_1: 24+00; Station_2: 22+00

Inspect ID: N21R_2017_p_0022 **Title:** USACE_CELRB_N21R_2017_p_0022_3.jpg
Rated Item: 10. Riprap Revetments & Banks **Caption:** Rating: Unacceptable; Remarks: Significant unwanted vegetation and trees in riprap on both banks between Railroad bridge and Broad Street bridge. (Dyke Creek); Action: Remove unwanted vegetation.; Station_1: 24+00; Station_2: 22+00

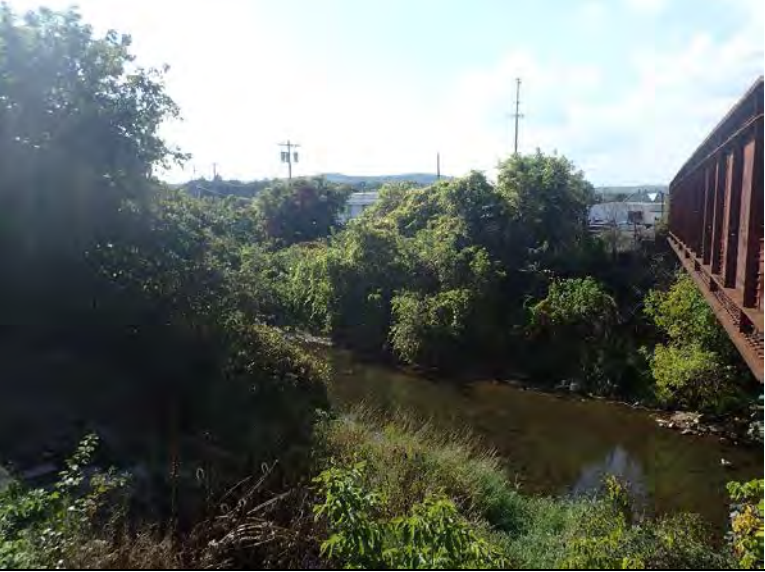
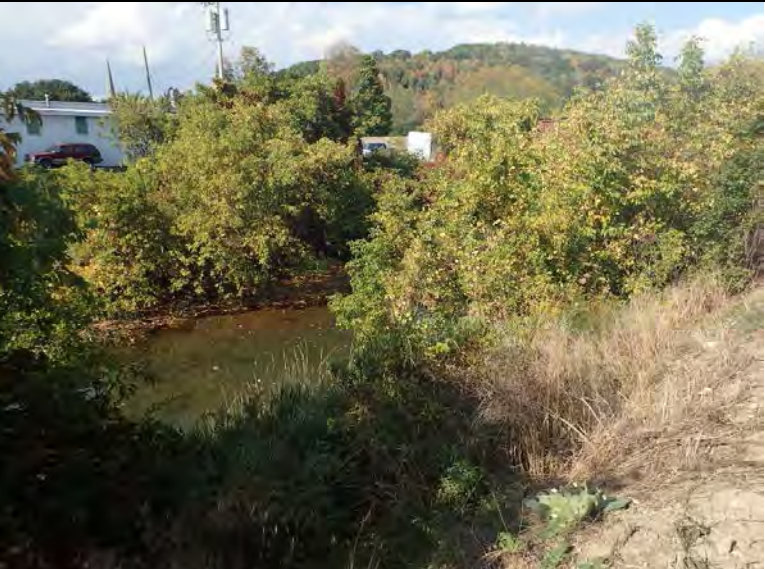
<p>Inspect ID: N21R_2017_p_0025 Title: USACE_CELRB_N21R_2017_p_0025_1.jpg Rated Item: 10. Riprap Revetments & Banks Caption: Rating: Unacceptable; Remarks: Significant trees and heavy unwanted vegetation in riprap on both banks between Main Street bridge and Railroad bridge. (Dyke Creek); Action: Remove trees and unwanted vegetation.; Station_1: 22+00; Station_2: 18+00</p>

<p>Inspect ID: N21R_2017_p_0025 Title: USACE_CELRB_N21R_2017_p_0025_2.jpg Rated Item: 10. Riprap Revetments & Banks Caption: Rating: Unacceptable; Remarks: Significant trees and heavy unwanted vegetation in riprap on both banks between Main Street bridge and Railroad bridge. (Dyke Creek); Action: Remove trees and unwanted vegetation.; Station_1: 22+00; Station_2: 18+00</p>

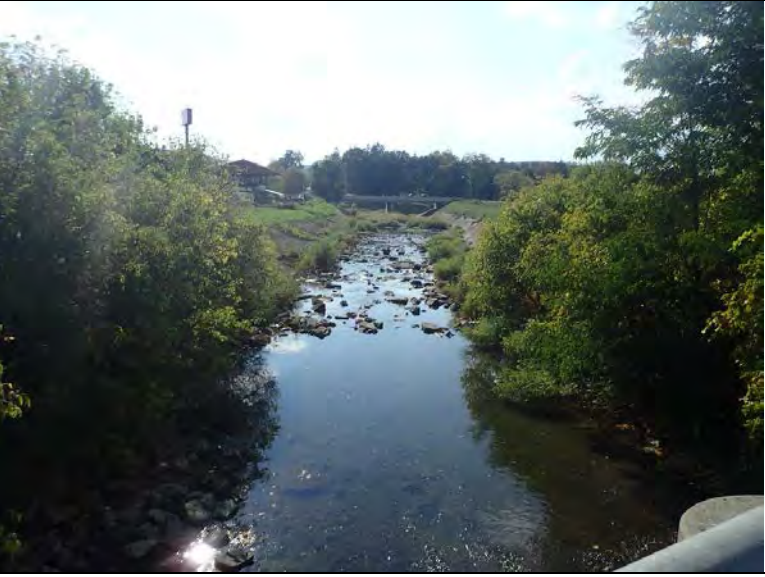
<p>Inspect ID: N21R_2017_p_0035 Title: USACE_CELRB_N21R_2017_p_0035_1.jpg Rated Item: 10. Riprap Revetments & Banks Caption: Rating: Unacceptable; Remarks: Significant trees and vegetation in riprap on both banks just downstream of Main Street bridge. (Dyke Creek); Action: Remove trees and vegetation from riprap.; Station_1: 17+00</p>
