Wellsville, New York  
Genesee River  
Right Bank Levee and Dyke Creek  
Flood Damage Reduction Project  
Levee Periodic Inspection 2010  
System 12 of 13  
Contract No. W912QR-10-D-0003  
Task Order No. DN01

February 16, 2011

**FOR OFFICIAL USE ONLY**  
**Wellsville, New York**  
**Genesee River**  
**Right Bank Levee and Dyke Creek**  
**Flood Damage Reduction Project**  
**Levee Periodic Inspection 2010**  
**System 12 of 13**  
**Contract No. W912QR-10-D-0003**  
**Task Order No. DN01**

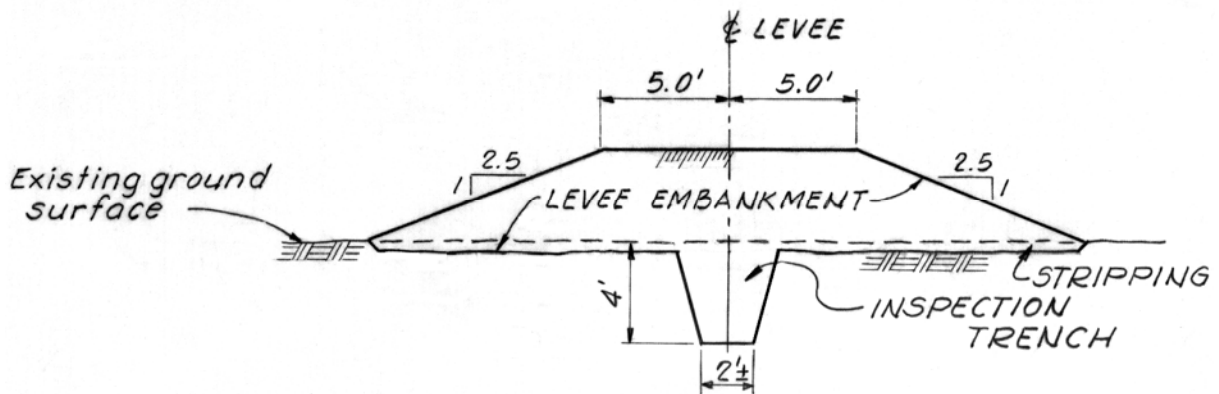
Figure 1. Typical Section of Right Bank Levee

Levees have been constructed along numerous reaches of the Genesee River and Dyke Creek, consisting of a 10 foot crest width and 1 foot vertical on 2-1/2 foot horizontal side slopes, unless otherwise stated. A levee is located on the right bank of the Genesee River starting at the concrete drop structure and extending upstream approximately 1,350 feet to about West Genesee Street. The levee is generally six feet in height, constructed to prevent high stream flows from bypassing the drop structure. A small levee, generally two feet or less in height, was constructed along the right bank of the river immediately upstream of the former W.A. & G. Bridge, extending 620 feet upstream to prevent flooding of a low area in Island Park. A barrier levee was constructed on the right bank, approximately perpendicular to the channel and parallel to the steel sheet pile weir located approximately 1,300 feet upstream of the former W.A. & G. Bridge. The levee extends approximately 670 feet to existing ground, constructed to prevent flood flows from bypassing the weir drop structure. See figure 1 for a typical section of levee at Wellsville FDRP. (USACE, O&M Manual, 2000)

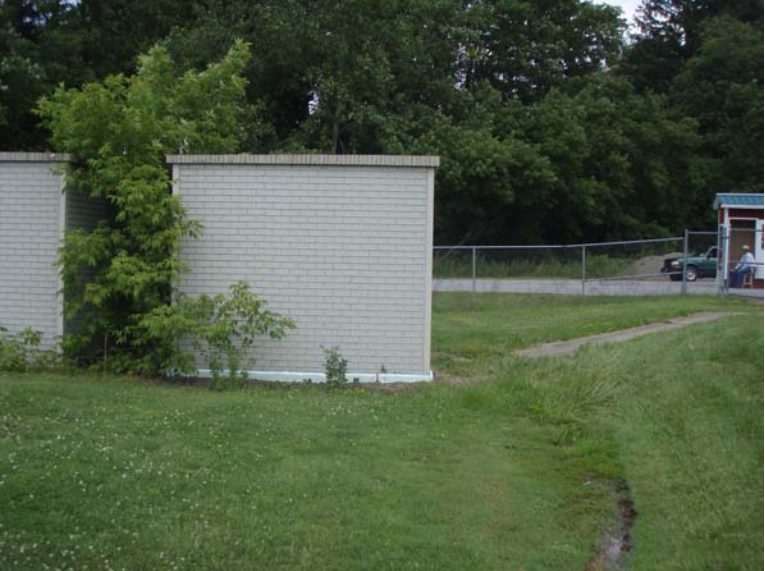
<p><b>Inspect ID:</b> N21R_2010_a_0009 <b>Title:</b> USACE_CELRB_N21R_2010_a_0009_1.jpg <b>Caption:</b> 15' x 3' depression, ponding L/S</p>

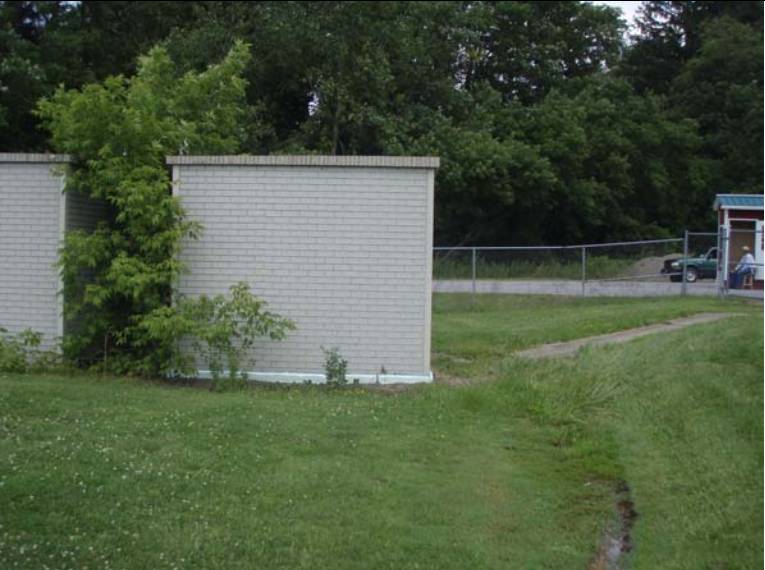
Numerous encroachments were documented along the limits of the levee embankment. Encroachments documented during the inspection included fencing, roadways, utility lines, utility poles, buildings, residential storage sheds, guardrails, traffic signs, and general debris from residential, commercial and industrial areas. Overall encroachments observed are Unacceptable and will inhibit operations and maintenance. See photographs USACE\_CELRB\_N21R\_2010\_a\_0006\_1 and USACE\_CELRB\_N21R\_2010\_a\_0010\_1 for an example of a fence encroachment and a building respectively.

<p><b>Inspect ID:</b> N21R_2010_a_0010 <b>Title:</b> USACE_CELRB_N21R_2010_a_0010_1.jpg <b>Caption:</b> Building along levee L/S</p>

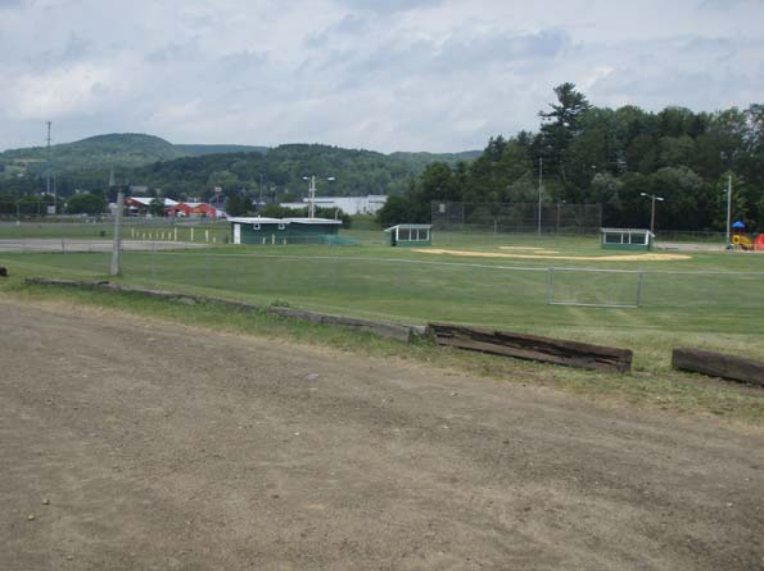
<p><b>Inspect ID:</b> N21R_2010_a_0015   <b>Title:</b> USACE_CELRB_N21R_2010_a_0015_1.jpg <b>Caption:</b> Railroad ties</p>

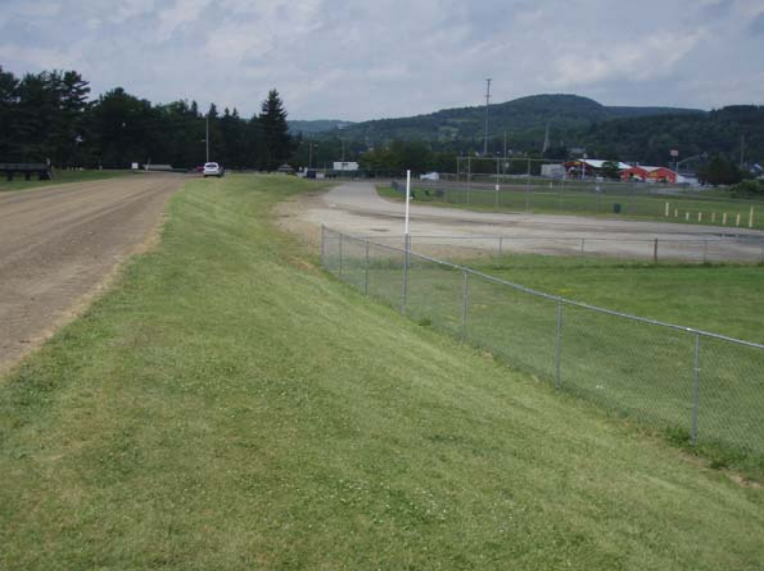
<p><b>Inspect ID:</b> N21R_2010_a_0017 <b>Title:</b> USACE_CELRB_N21R_2010_a_0017_1.jpg <b>Caption:</b> Fence from baseball field L/S</p>

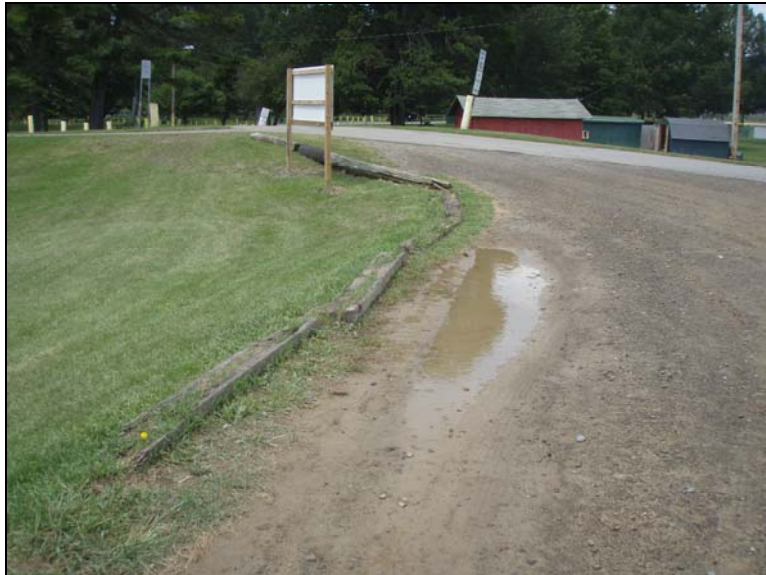
**Inspect ID:** N21R\_2010\_a\_0023 **Title:** USACE\_CELRB\_N21R\_2010\_a\_0023\_1.jpg  
**Caption:** Railroad ties along edge of drive Levee Crown Only

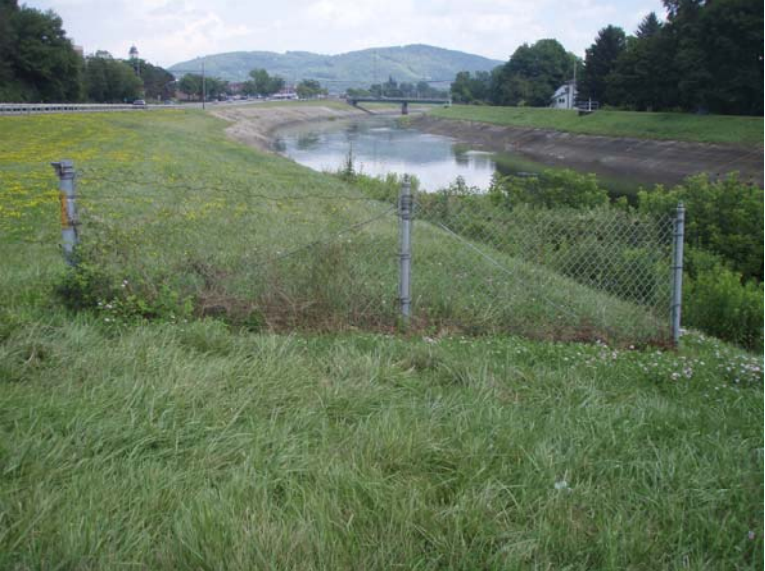
<p><b>Inspect ID:</b> N21R_2010_a_0037 <b>Title:</b> USACE_CELRB_N21R_2010_a_0037_1.jpg <b>Caption:</b> Fence R/S</p>

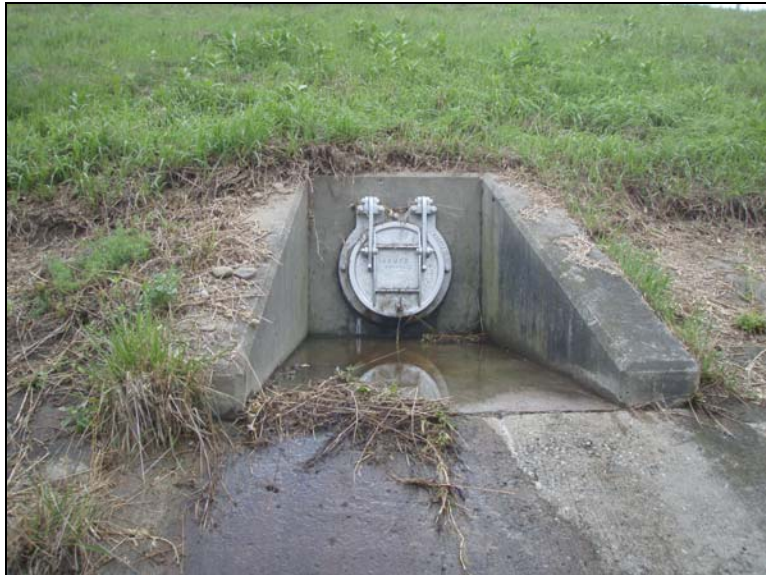
Gravity discharge pipes must have provisions for emergency closure in the event of inoperable flap valves on the creek side. Existing flap gates are damaged and need to be repaired. See example photo USACE\_CELRB\_N21R\_2010\_a\_0044\_1. The overall rating is Minimally Acceptable.

**Inspect ID:** N21R\_2010\_a\_0044 **Title:** USACE\_CELRB\_N21R\_2010\_a\_0044\_1.jpg  
**Caption:** 18" CMP flap gate & pipe separated

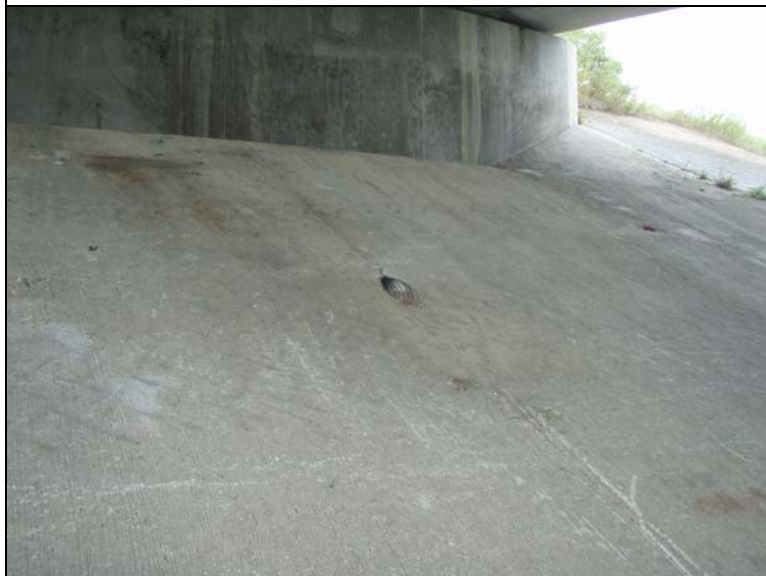
Based on historic reliability issues corrugated metal pipe (CMP) should not be used for gravity drains. The USACE has since changed the minimum standard to reinforced concrete pipe for new construction of gravity drains. It is noted in the O&M manual that CMP and other types of pipe are used in the levee system. This does not meet current design criteria.

**Inspect ID:** N21R\_2010\_a\_0049 **Title:** USACE\_CELRB\_N21R\_2010\_a\_0049\_1.jpg  
**Caption:** Two 6" CMP drainage pipes

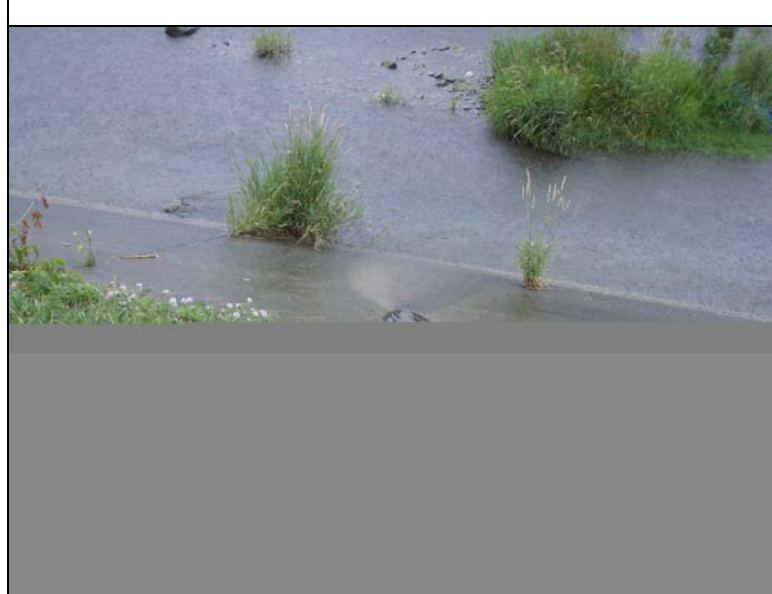
<p><b>Inspect ID:</b> N21R_2010_a_0053 <b>Title:</b> USACE_CELRB_N21R_2010_a_0053_1.jpg <b>Caption:</b> 12" CMP drainage pipe</p>

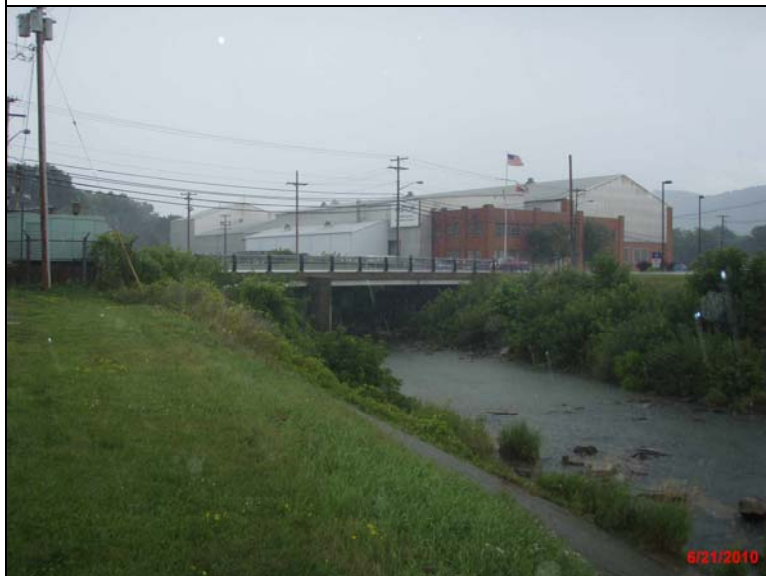
**Inspect ID:** N21R\_2010\_a\_0057 **Title:** USACE\_CELRB\_N21R\_2010\_a\_0057\_1.jpg  
**Caption:** Vegetation in riprap

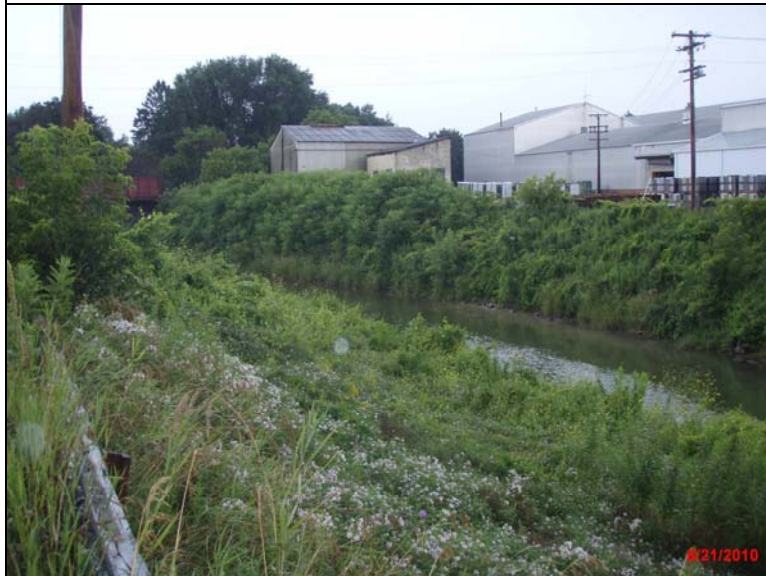
**Inspect ID:** N21R\_2010\_a\_0059 **Title:** USACE\_CELRB\_N21R\_2010\_a\_0059\_1.jpg  
**Caption:** Utility pole, guy wire, generator, buildings

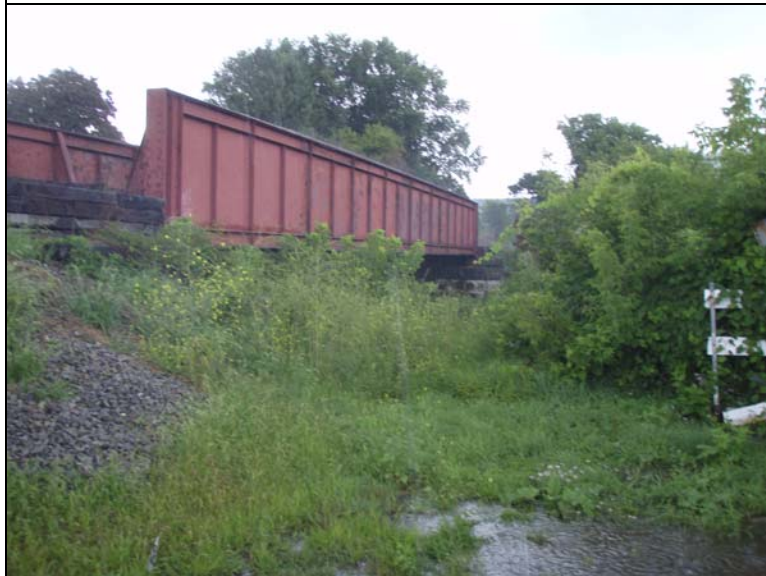
During the inspection, multiple encroachments along the Dyke Creek FDRP flood damage reduction channel was noted including a railroad bridge. An example of an encroachment is shown on photo USACE\_CELRB\_N21R\_2010\_a\_0063\_1. The overall rating of encroachments was Unacceptable.

**Inspect ID:** N21R\_2010\_a\_0063 **Title:** USACE\_CELRB\_N21R\_2010\_a\_0063\_1.jpg  
**Caption:** Railroad bridge over channel

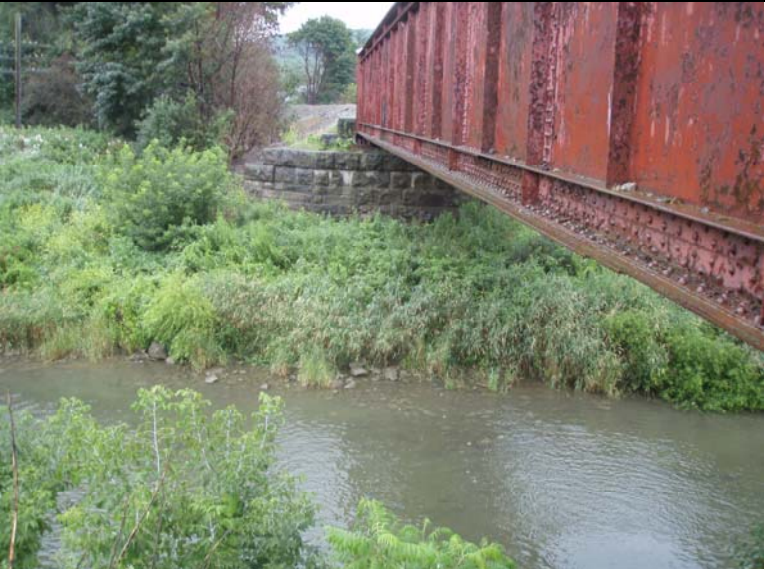
<p><b>Inspect ID:</b> N21R_2010_a_0068 <b>Title:</b> USACE_CELRB_N21R_2010_a_0068_1.jpg <b>Caption:</b> Lack of rip rap</p>

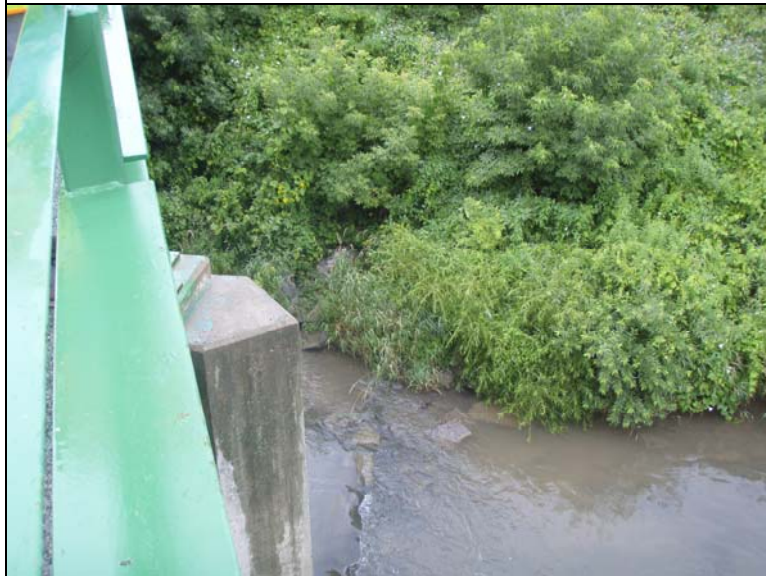
**Inspect ID:** N21R\_2010\_a\_0074 **Title:** USACE\_CELRB\_N21R\_2010\_a\_0074\_1.jpg  
**Caption:** Outfall covered with vegetation

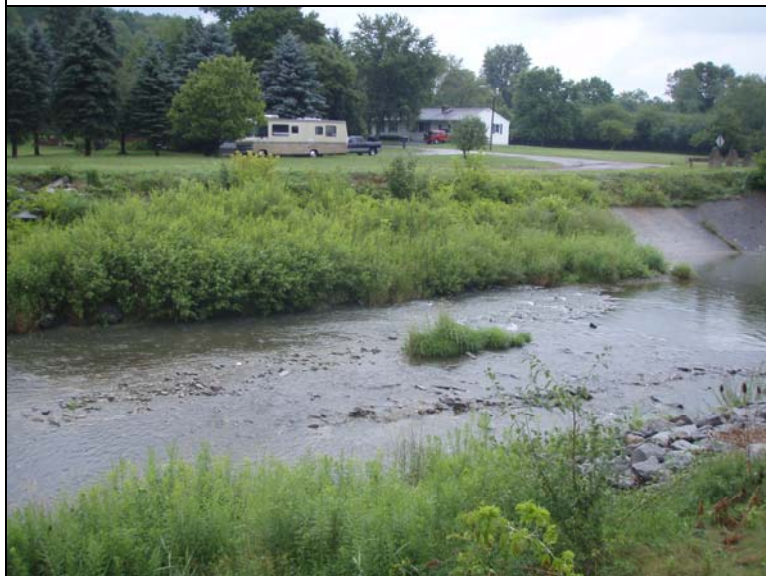
The condition of the channel during the inspection was considered to be Unacceptable due to the amounts of vegetation lining the channel. An example is shown in photo USACE\_CELRB\_N21R\_2010\_a\_0077\_1. Vegetation and Obstructions is rated as Unacceptable due to obstructions impairing the channel.

**Inspect ID:** N21R\_2010\_a\_0077 **Title:** USACE\_CELRB\_N21R\_2010\_a\_0077\_1.jpg  
**Caption:** Vegetation on bank

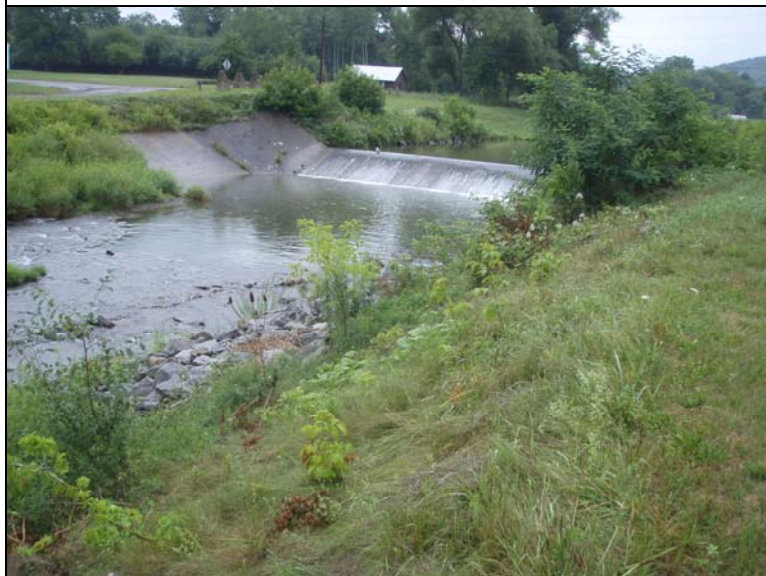
**Inspect ID:** N21R\_2010\_a\_0080 **Title:** USACE\_CELRB\_N21R\_2010\_a\_0080\_1.jpg  
**Caption:** Vegetation in riprap

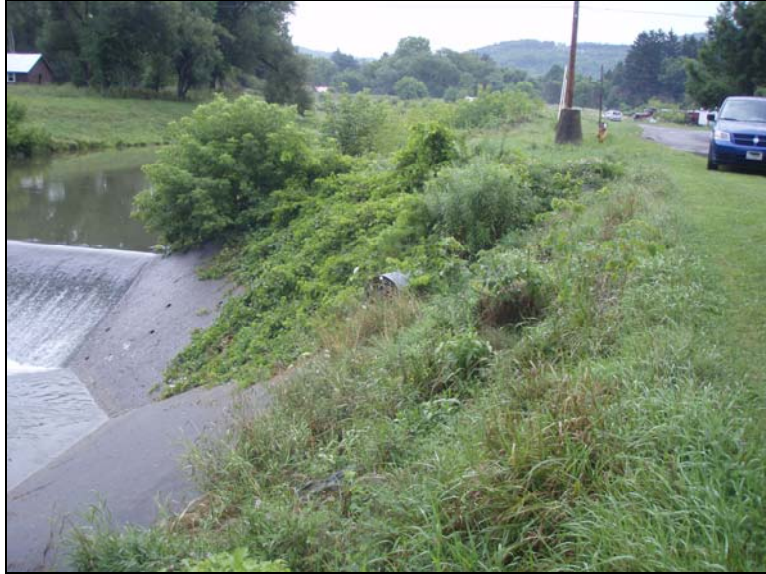
**Inspect ID:** N21R\_2010\_a\_0081 **Title:** USACE\_CELRB\_N21R\_2010\_a\_0081\_1.jpg  
**Caption:** 24" CMP drainage pipe

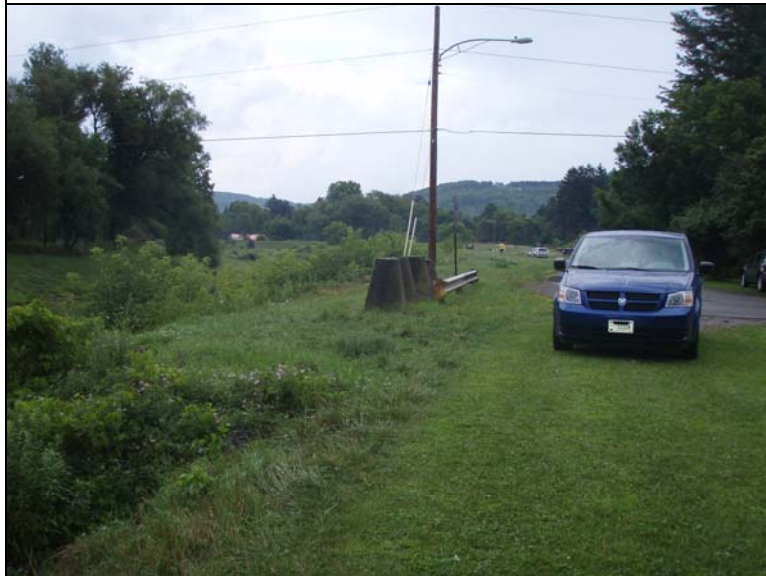
**Inspect ID:** N21R\_2010\_a\_0082 **Title:** USACE\_CELRB\_N21R\_2010\_a\_0082\_1.jpg  
**Caption:** Concrete barriers, utility pole, sign

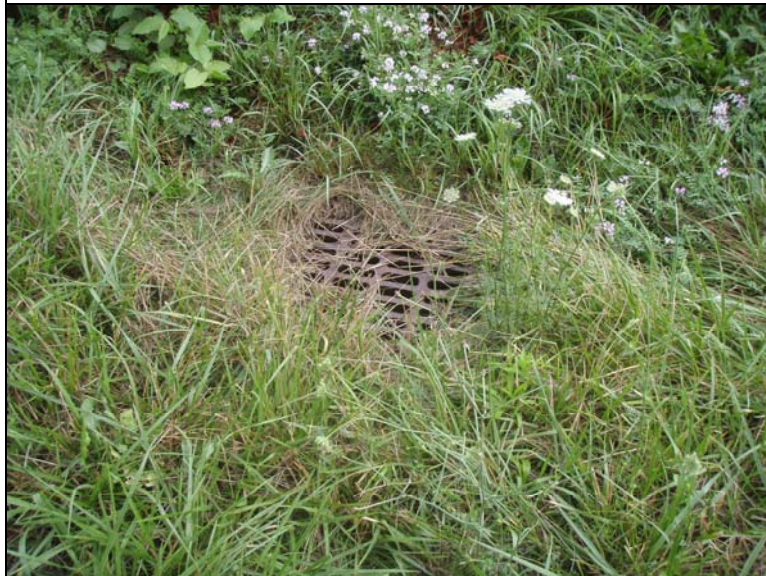
**Inspect ID:** N21R\_2010\_a\_0084 **Title:** USACE\_CELRB\_N21R\_2010\_a\_0084\_1.jpg  
**Caption:** 24" x 24" drainage inlet

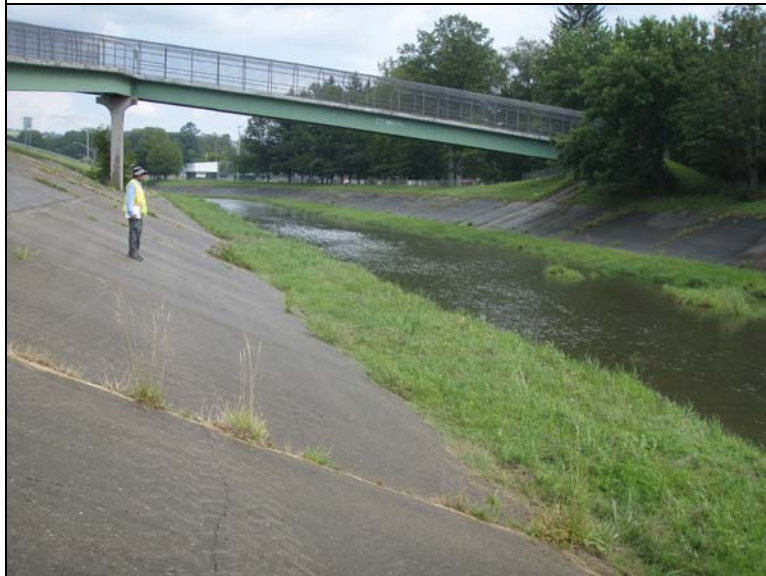
**Inspect ID:** N21R\_2010\_a\_0098 **Title:** USACE\_CELRB\_N21R\_2010\_a\_0098\_1.jpg  
**Caption:** Shoaling at both sides of channel

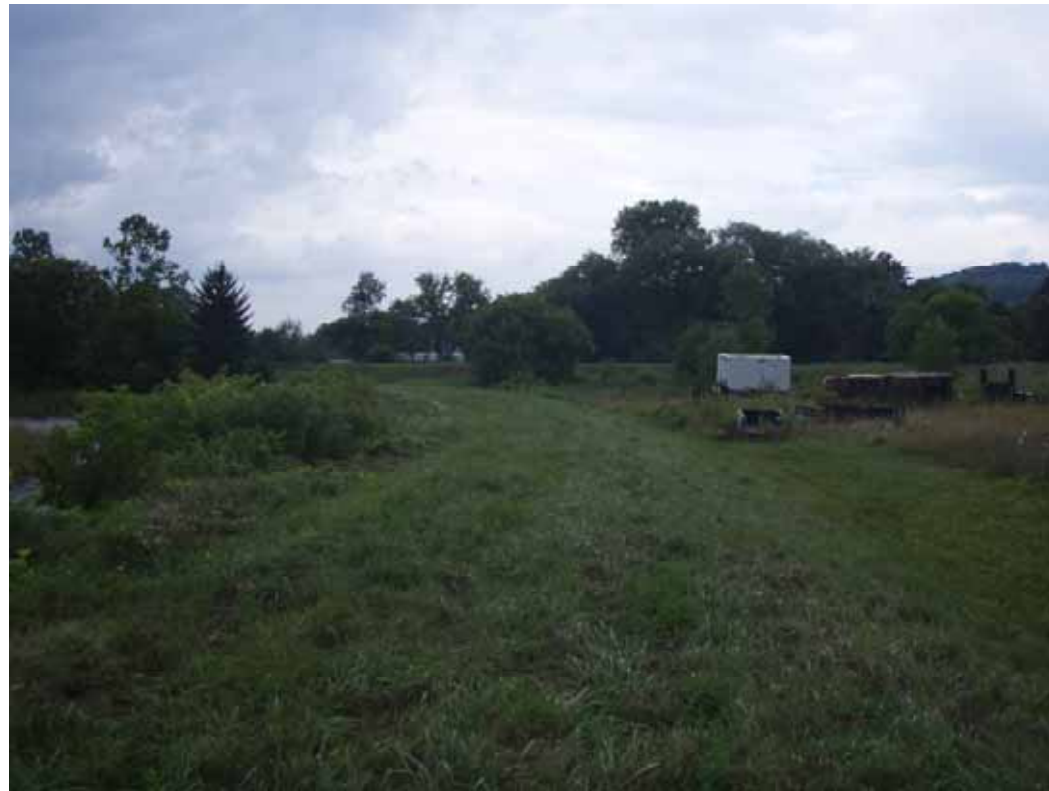
## 1. Unwanted Vegetation Growth

- 0089: Dense vegetation noted within 15 feet of Landside toe: remove vegetation (U)
- Near Sta. 35+00

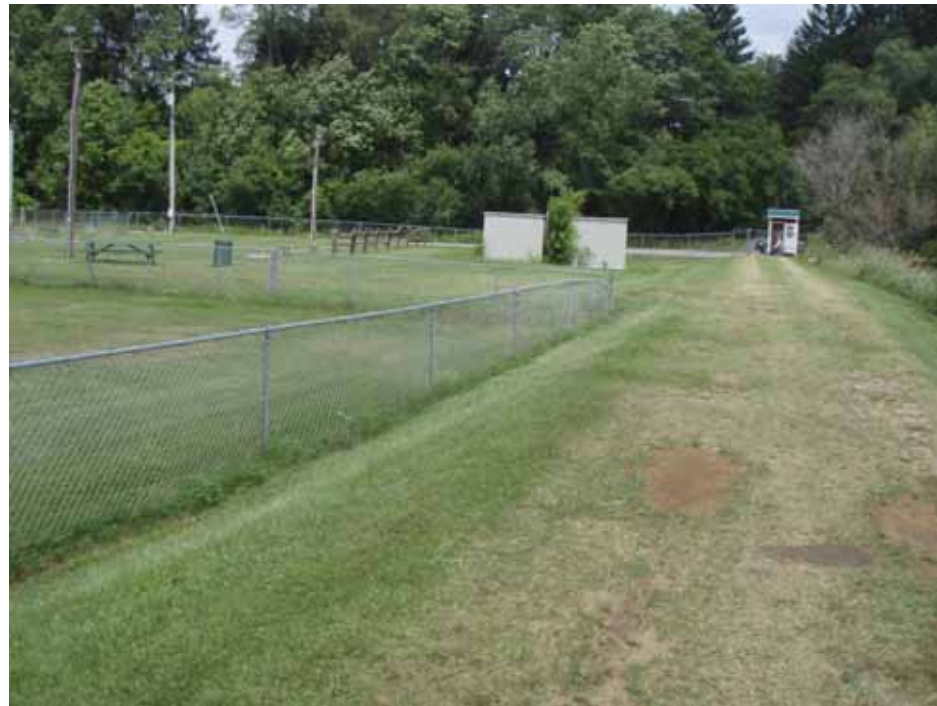
## 3. Encroachments

- 0006: encroachments : fence, maintenance building (U)
- Near Sta. 0+00

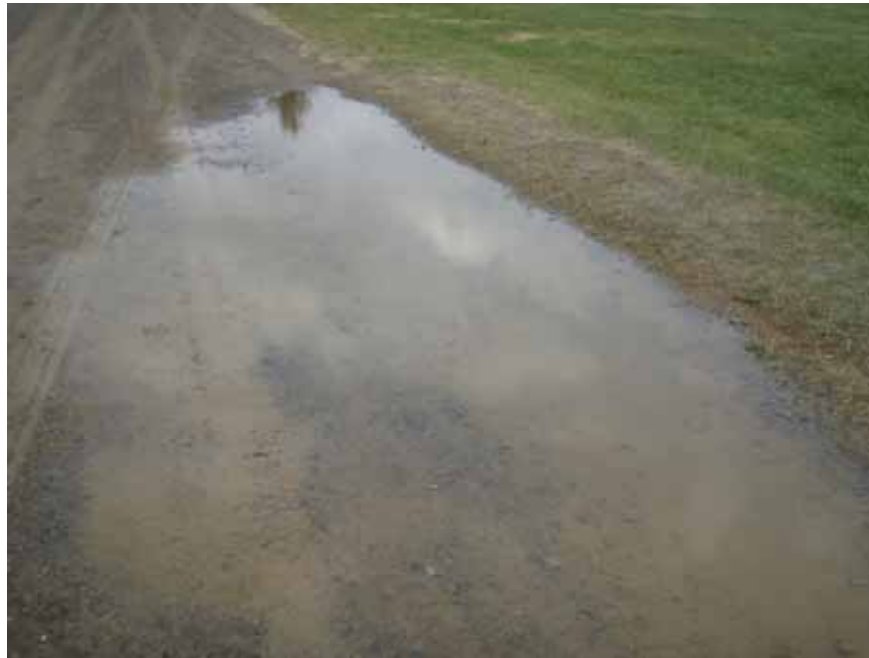
- 0021: Depression/Ponding area noted (M)
- Near Sta. 14+00

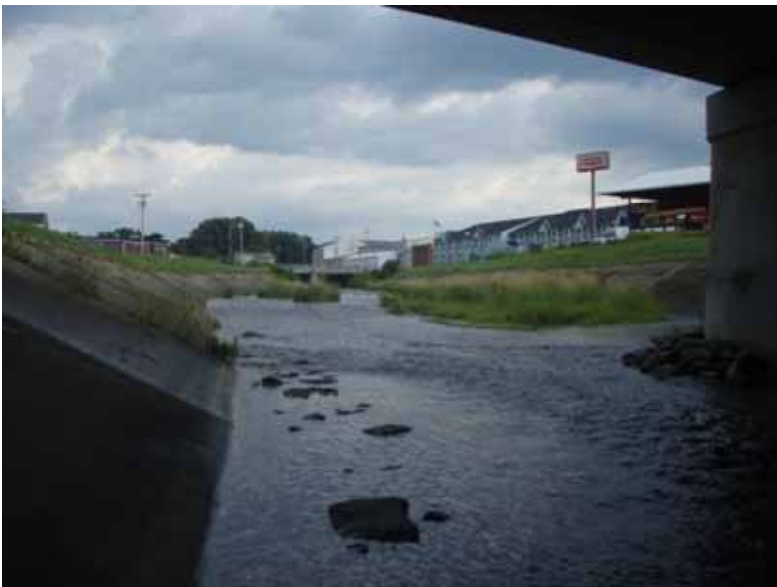
- **2. Shoaling**

- Channel flow capacity is reduced

- 0046: Shoaling is well established (U)
- Near Sta. 10+00
