## DEPARTMENT OF THE ARMY

BUFFALO DISTRICT, CORPS OF ENGINEERS  
1776 NIAGARA STREET  
BUFFALO, NEW YORK 14207-3199

September 19, 2017

SUBJECT: FY16 Joint Routine Inspection of Completed Works, Flood Risk Management Project, Genesee River and Dyke Creek, Wellsville, New York (09/23/16)

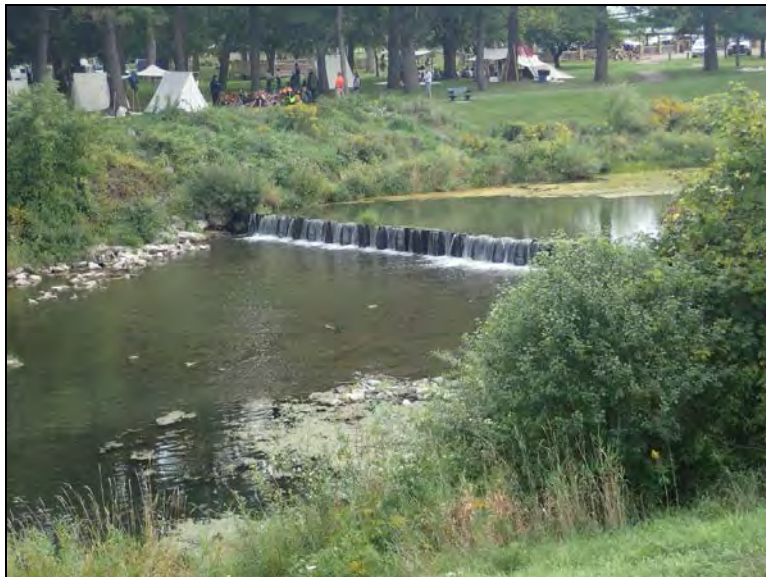
**Inspect ID:** N21L\_2016\_r\_0090 **Title:** USACE\_CELRB\_N21L\_2016\_r\_0090\_1.jpg  
**Rated Item:** 3. Encroachments **Caption:** Rating: Acceptable; Remarks: 1974 Steel Sheet Pile Weir by Others - shown on AS-CONSTRUCTED drawing 189-WEL-2/4 (approved by USACE).; Action: NA; Station\_1: 27+00

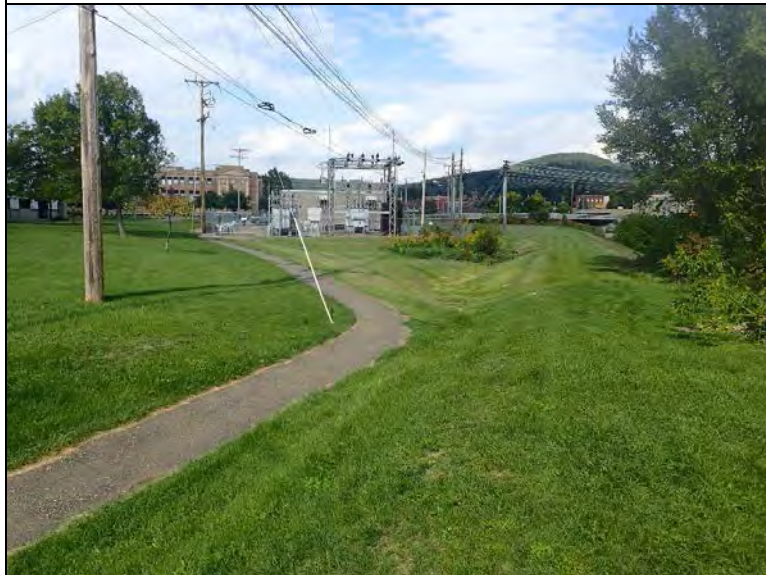
**Inspect ID:** N21L\_2016\_r\_0093 **Title:** USACE\_CELRB\_N21L\_2016\_r\_0093\_1.jpg  
**Rated Item:** 3. Encroachments **Caption:** Rating: Minimally Acceptable; Remarks: Unauthorized Alteration (A-41) - Asphalt sidewalk and guy wire at left bank levee landside toe.; Action: Submit Section 408 Alteration Request to USACE or remove unauthorized alteration.; Station\_1: 24+00; Station\_2: 28+00

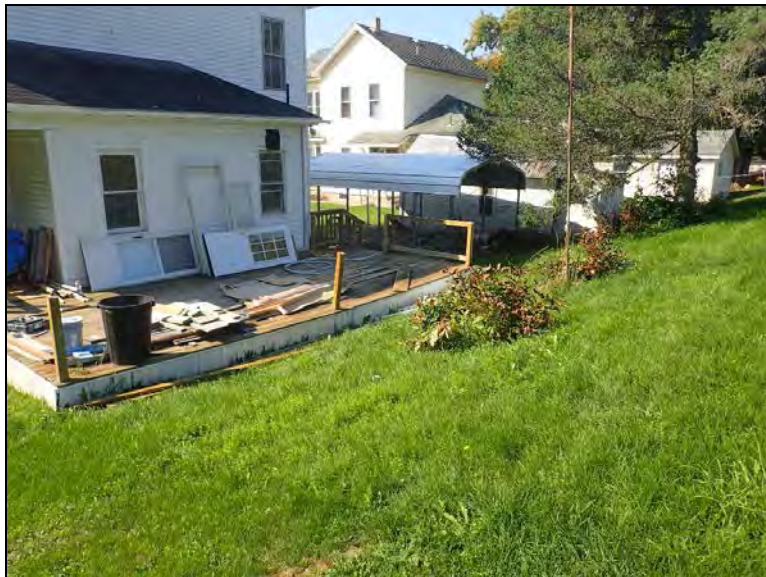
**Inspect ID:** N21L\_2016\_r\_0139 **Title:** USACE\_CELRB\_N21L\_2016\_r\_0139\_2.jpg  
**Rated Item:** 3. Encroachments **Caption:** Rating: Minimally Acceptable; Remarks:  
Unauthorized Alteration (A-22) - Dilapidated white garage and shed and patio deck at left  
bank levee landside toe; clothesline and pole on landside slope at 38 Seneca Street. Note:  
levee is overbuilt at this location (approx. 42 feet wide).; Action: Submit Section 408  
Alteration Request to USACE or remove unauthorized alteration.; Station\_1: 55+00

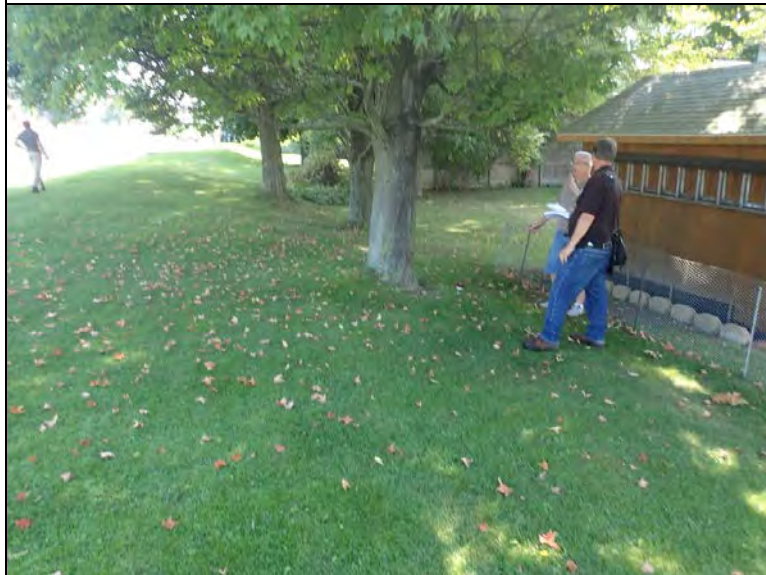
**Inspect ID:** N21L\_2016\_r\_0140 **Title:** USACE\_CELRB\_N21L\_2016\_r\_0140\_1.jpg  
**Rated Item:** 3. Encroachments **Caption:** Rating: Minimally Acceptable; Remarks:  
Unauthorized Alteration (U-23) - Chicken wire fence on left bank levee landside toe and  
rope fence on waterside crest at 20 Chamberlain Street. Note: levee is overbuilt at this  
location (approx. 42 feet wide).; Action: Submit Section 408 Alteration Request to  
USACE or remove unauthorized alteration.; Station\_1: 55+00

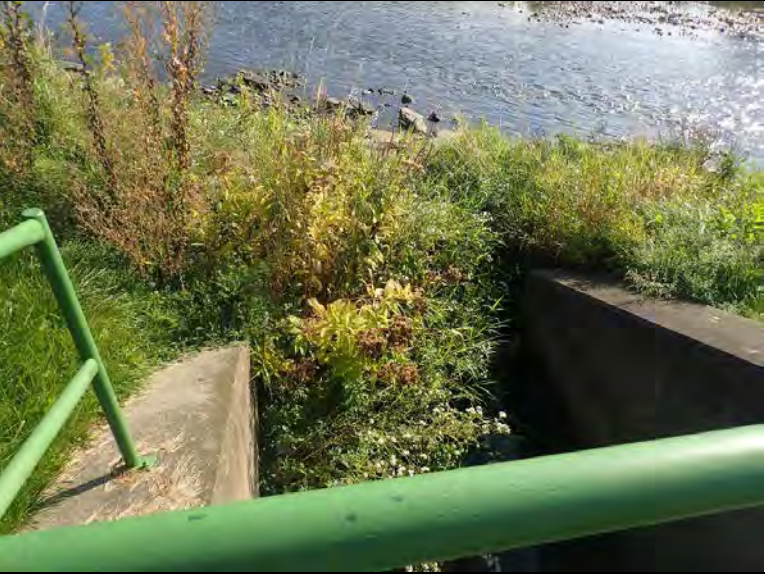
<p><b>Inspect ID:</b> N21L_2016_r_0026 <b>Title:</b> USACE_CELRB_N21L_2016_r_0026_1.jpg <b>Rated Item:</b> 1. Vegetation and Obstructions <b>Caption:</b> Rating: Minimally Acceptable; <b>Remarks:</b> Soft unwanted vegetation obstructing outfall on left bank 900' upstream of Bolivar Road bridge.; <b>Action:</b> Remove unwanted vegetation.; <b>Station_1:</b> 82+00</p>

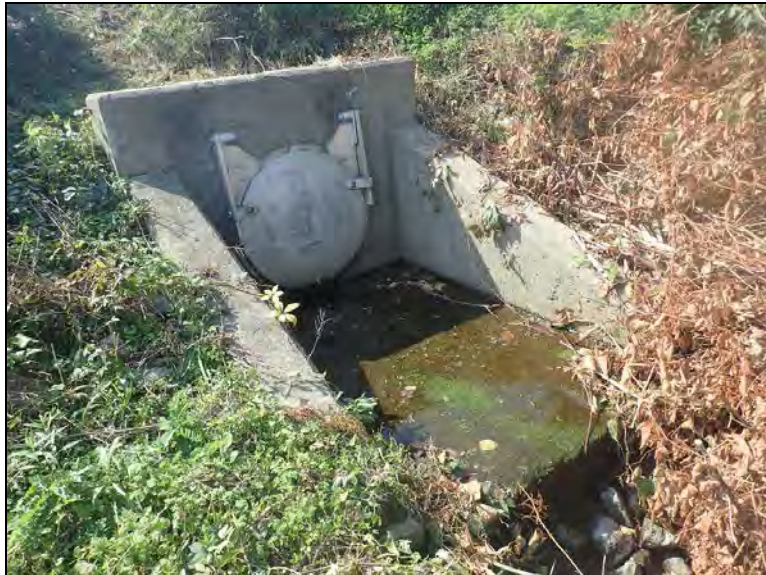
**Inspect ID:** N21L\_2016\_r\_0096 **Title:** USACE\_CELRB\_N21L\_2016\_r\_0096\_1.jpg  
**Rated Item:** 9. Culverts/ Discharge Pipes **Caption:** Rating: Acceptable; Remarks: 36" CMP on left bank 475' upstream of Steel Sheet Pile Weir (rated A in NYSDEC 19DEC13 pipe inspection).; Action: Maintain pipe and videotape inspect by 19DEC18.; Station\_1: 23+00

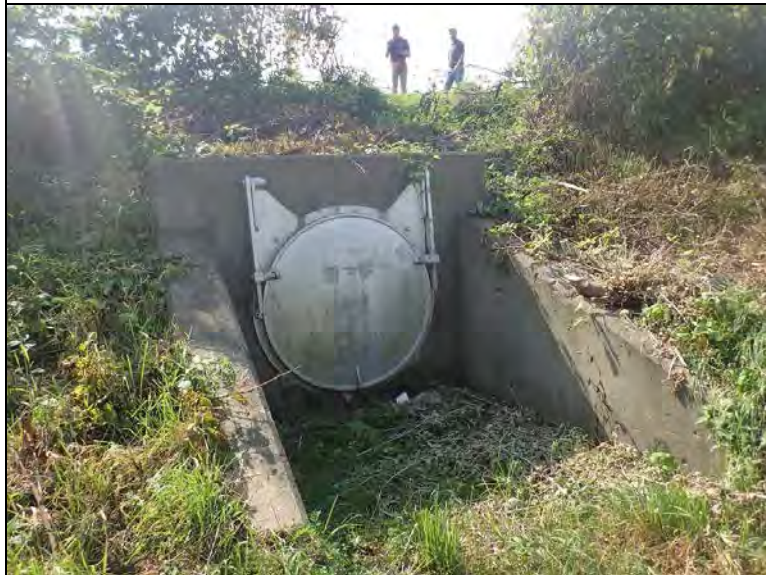
**Inspect ID:** N21L\_2016\_r\_0097 **Title:** USACE\_CELRB\_N21L\_2016\_r\_0097\_1.jpg  
**Rated Item:** 9. Culverts/ Discharge Pipes **Caption:** Rating: Acceptable; Remarks: 48" CMP outlet on left bank riverside slope 515' upstream of Steel Sheet Pile Weir (rated A in NYSDEC 19DEC13 pipe inspection).; Action: Maintain pipe and videotape inspect by 19DEC18.; Station\_1: 23+00

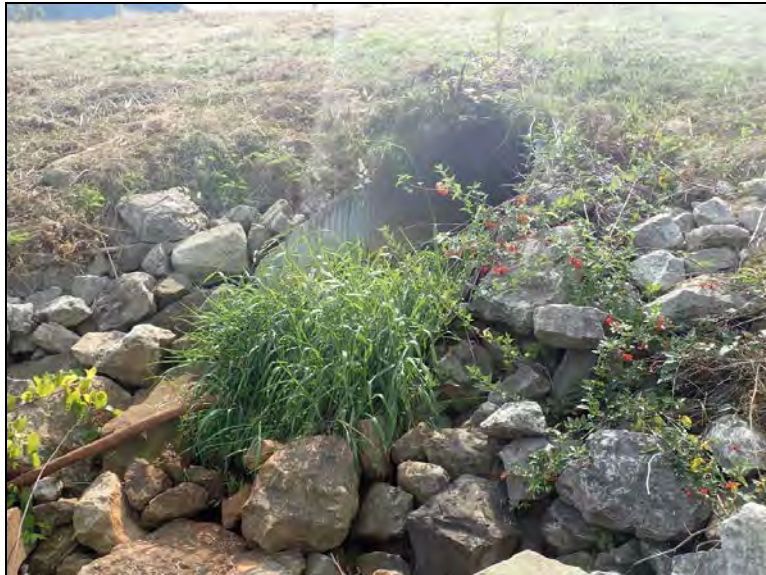
**Inspect ID:** N21L\_2016\_r\_0113 **Title:** USACE\_CELRB\_N21L\_2016\_r\_0113\_1.jpg  
**Rated Item:** 9. Culverts/ Discharge Pipes **Caption:** Rating: Acceptable; Remarks: 36 inch CMP outfall on left bank just upstream of Wellsville, Addison, & Galetton Railroad railway rocks obstructing access.; Action: NA; Station\_1: 5+00

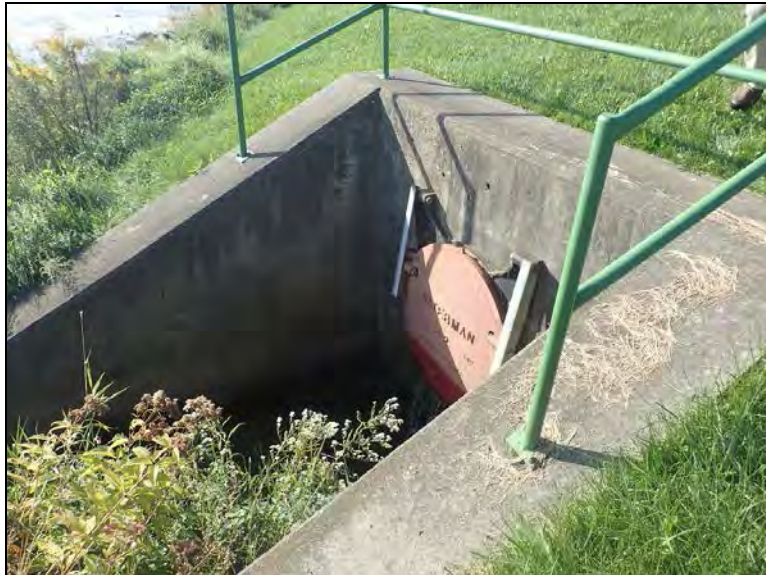
**Inspect ID:** N21L\_2016\_r\_0024 **Title:** USACE\_CELRB\_N21L\_2016\_r\_0024\_1.jpg  
**Rated Item:** 11. Flap Gates/ Flap Valves/ Pinch Valves **Caption:** Rating: Acceptable;  
Remarks: 42" flap gate on left bank 900' upstream of Bolivar Road bridge exercised.;  
Action: NA; Station\_1: 82+00

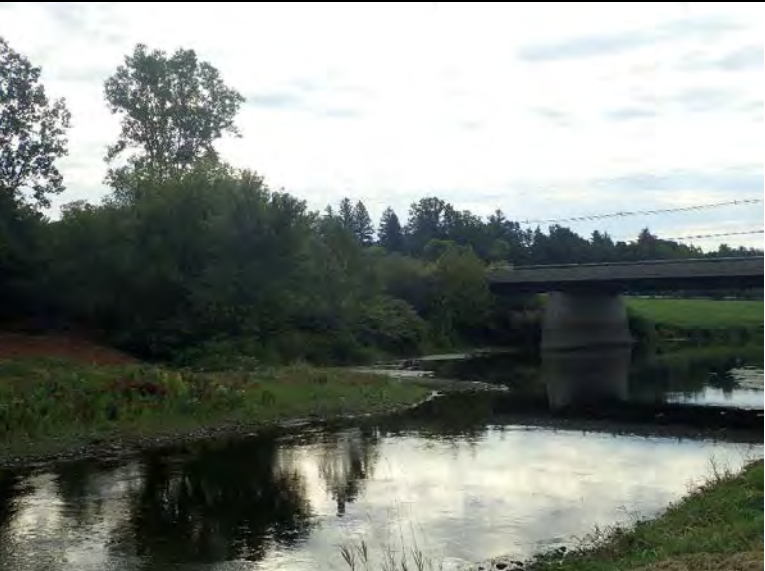
<p><b>Inspect ID:</b> N21L_2016_r_0013 <b>Title:</b> USACE_CELRB_N21L_2016_r_0013_1.jpg <b>Rated Item:</b> 1. Vegetation and Obstructions <b>Caption:</b> Rating: Minimally Acceptable; <b>Remarks:</b> Unwanted heavy woody vegetation on both banks around Bolivar Road bridge.; <b>Action:</b> Remove vegetation.; <b>Station_1:</b> 91+00</p>

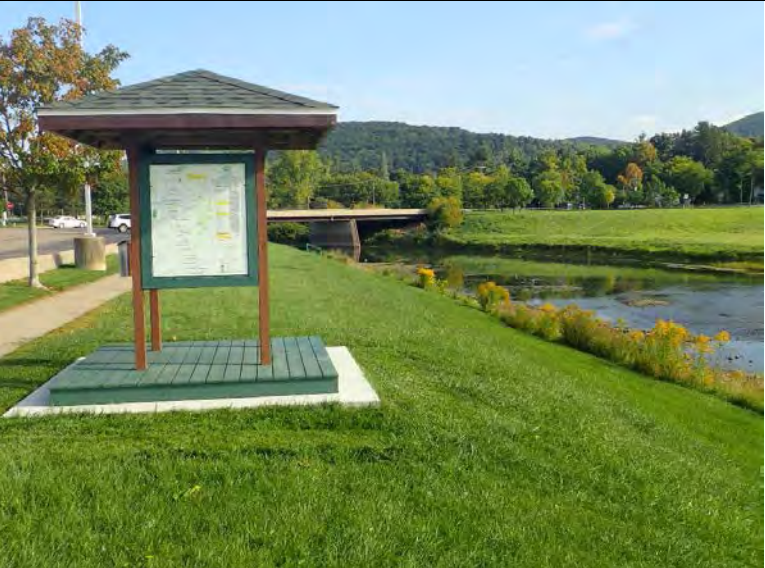
<p><b>Inspect ID:</b> N21L_2016_r_0018 <b>Title:</b> USACE_CELRB_N21L_2016_r_0018_1.jpg <b>Rated Item:</b> 1. Vegetation and Obstructions <b>Caption:</b> Rating: Minimally Acceptable; <b>Remarks:</b> Unauthorized Alteration (A-5) - Riverwalk kiosk on left bank channel crest.; <b>Action:</b> Submit Section 408 Alteration Request to USACE or remove unauthorized alteration.; <b>Station_1:</b> 85+00</p>

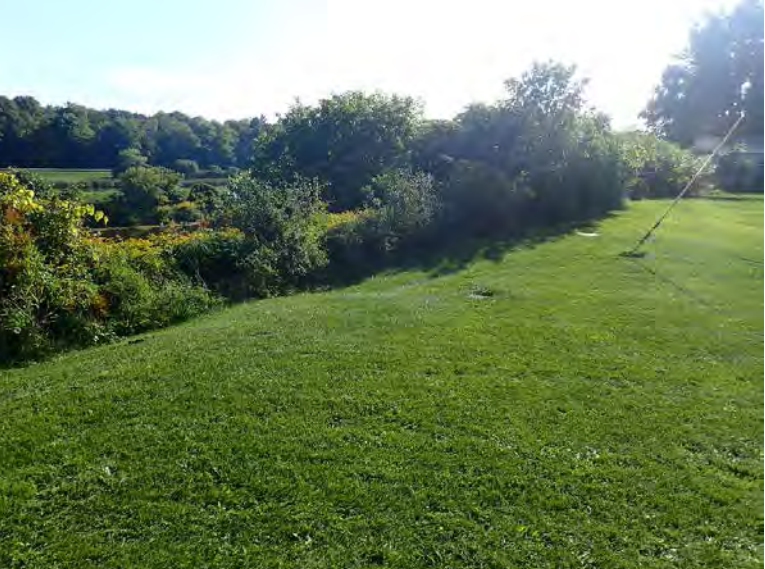
<p><b>Inspect ID:</b> N21L_2016_r_0023 <b>Title:</b> USACE_CELRB_N21L_2016_r_0023_2.jpg <b>Rated Item:</b> 1. Vegetation and Obstructions <b>Caption:</b> Rating: Minimally Acceptable; <b>Remarks:</b> Unwanted vegetation on both bank sideslopes from 750' upstream of Bolivar Road bridge to Madison Street bridge.; <b>Action:</b> Remove unwanted vegetation.; <b>Station_1:</b> 84+00; <b>Station_2:</b> 44+00</p>

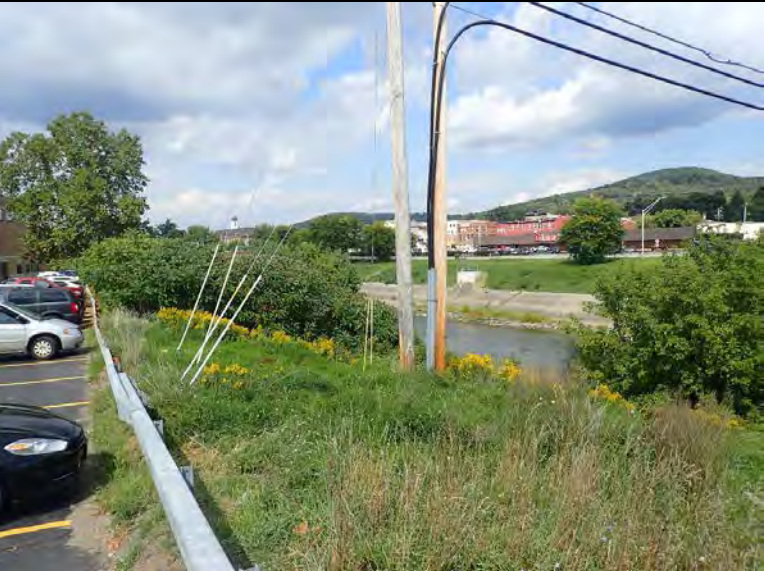
<p><b>Inspect ID:</b> N21L_2016_r_0080 <b>Title:</b> USACE_CELRB_N21L_2016_r_0080_1.jpg <b>Rated Item:</b> 1. Vegetation and Obstructions <b>Caption:</b> Rating: Unacceptable; <b>Remarks:</b> Significant unwanted vegetation and trees on left bank 400' downstream of State Street bridge.; <b>Action:</b> Remove unwanted vegetation and trees.; <b>Station_1:</b> 37+00</p>

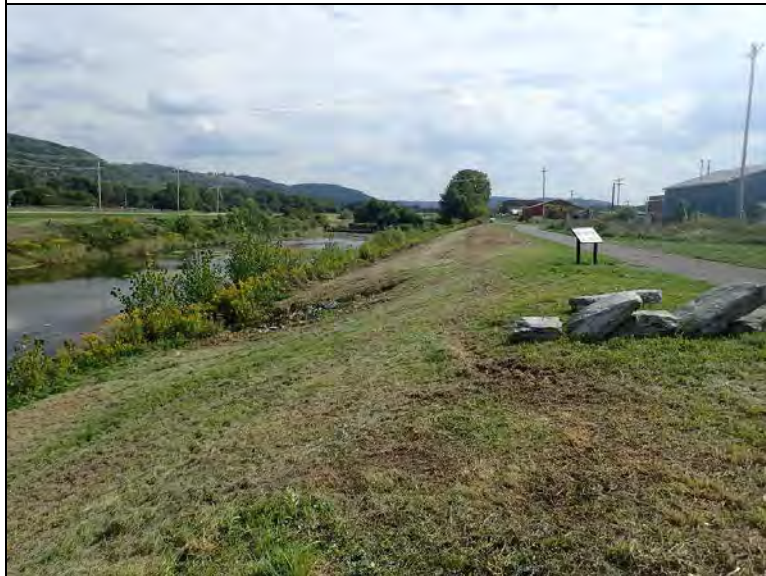
**Inspect ID:** N21L\_2016\_r\_0112 **Title:** USACE\_CELRB\_N21L\_2016\_r\_0112\_1.jpg  
**Rated Item:** 1. Vegetation and Obstructions **Caption:** Rating: Unacceptable; Remarks: Significant vegetation in riprap on right bank from 400' downstream of upstream limit weir to barrier levee weir.; Action: Remove vegetation from riprap.; Station\_1: 4+00; Station\_2: 0+00

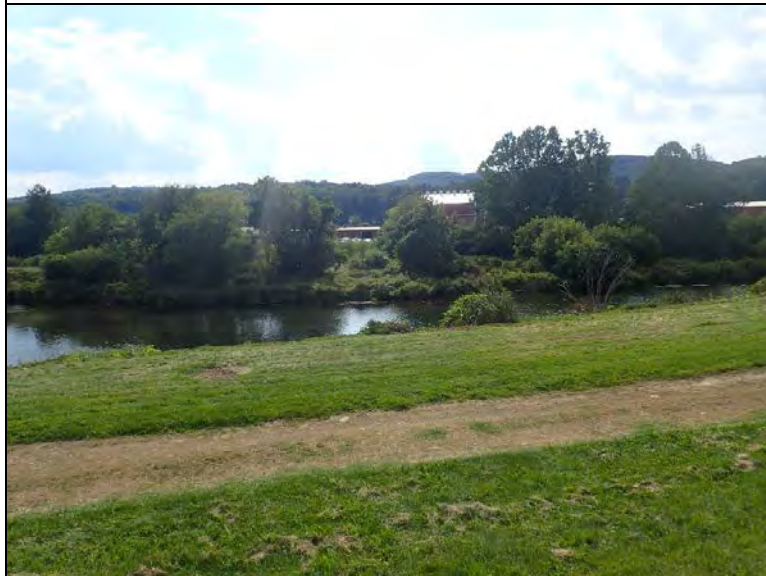
**Inspect ID:** N21L\_2016\_r\_0116 **Title:** USACE\_CELRB\_N21L\_2016\_r\_0116\_1.jpg  
**Rated Item:** 1. Vegetation and Obstructions **Caption:** Rating: Unacceptable; Remarks: Significant unwanted vegetation and trees on left bank 175' upstream of barrier levee weir.; Action: Remove unwanted vegetation.; Station\_1: 0+00

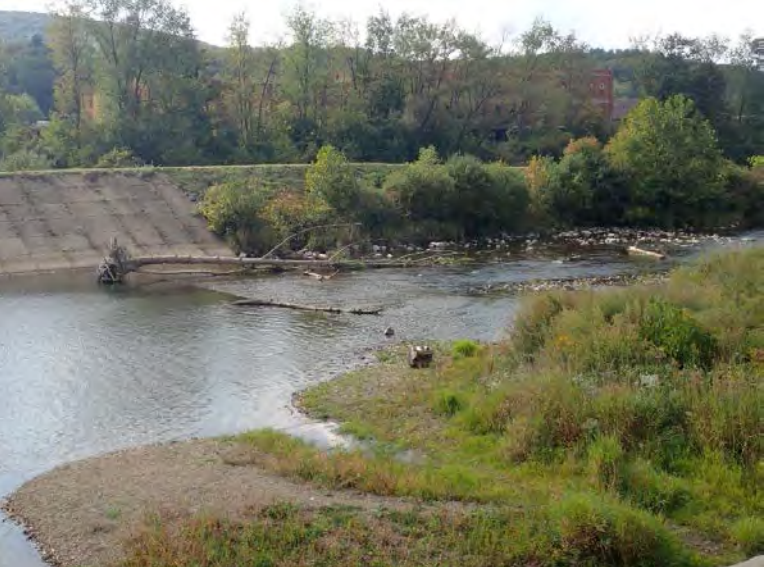
<p><b>Inspect ID:</b> N21L_2016_r_0124 <b>Title:</b> USACE_CELRB_N21L_2016_r_0124_1.jpg <b>Rated Item:</b> 1. Vegetation and Obstructions <b>Caption:</b> Rating: Minimally Acceptable; <b>Remarks:</b> Large tree debris in channel just downstream of weir; <b>Action:</b> Remove tree debris.; <b>Station_1:</b> 0+00</p>

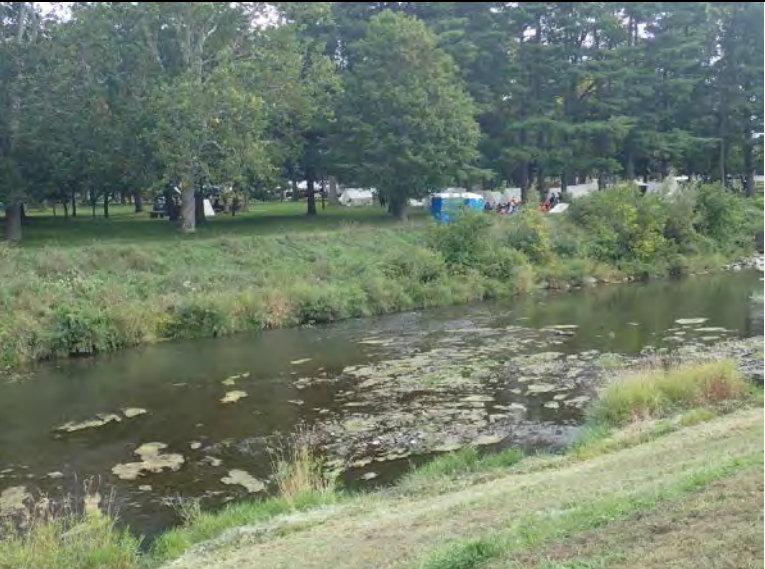
<p><b>Inspect ID:</b> N21L_2016_r_0132 <b>Title:</b> USACE_CELRB_N21L_2016_r_0132_1.jpg <b>Rated Item:</b> 1. Vegetation and Obstructions <b>Caption:</b> Rating: Minimally Acceptable; Remarks: Soft vegetation on right bank from Island Park to 500 feet upstream of Island Park pedestrian bridge.; Action: Remove soft vegetation.; Station_1: 29+00; Station_2: 11+00</p>

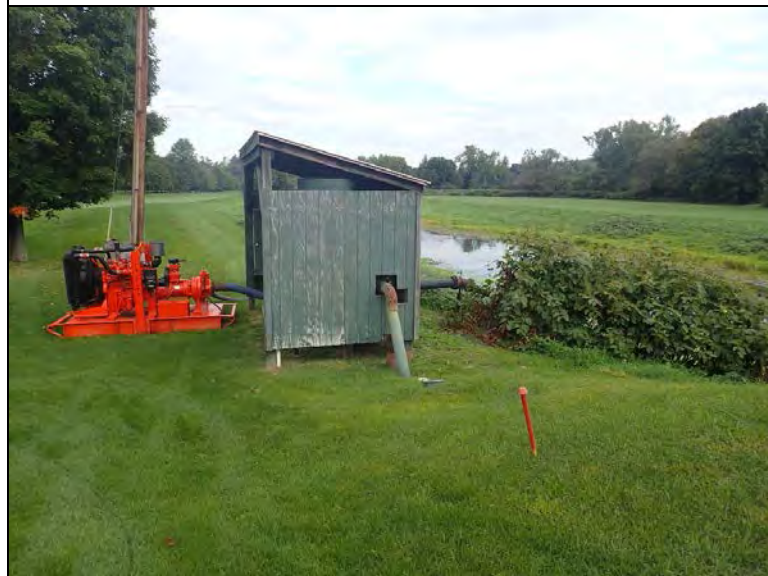
**Inspect ID:** N21L\_2016\_r\_0003 **Title:** USACE\_CELRB\_N21L\_2016\_r\_0003\_1.jpg  
**Rated Item:** 3. Encroachments **Caption:** Rating: Minimally Acceptable; **Remarks:** Unauthorized Alteration (A-1) - Pump station, intake pipe to pump station, and feeder pipes for golf course water.; **Action:** Submit Section 408 Alteration Request to USACE or remove unauthorized alteration.; **Station\_1:** 104+00

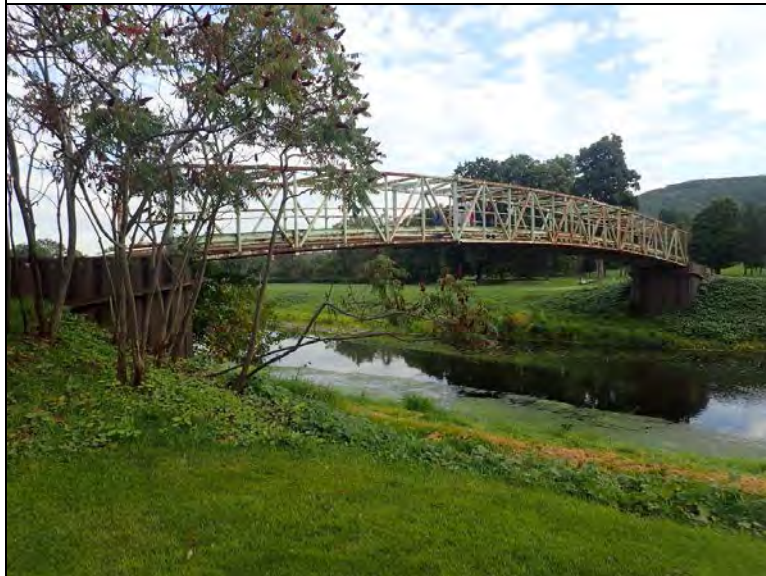
**Inspect ID:** N21L\_2016\_r\_0004 **Title:** USACE\_CELRB\_N21L\_2016\_r\_0004\_1.jpg  
**Rated Item:** 3. Encroachments **Caption:** Rating: Minimally Acceptable; Remarks: Unauthorized Alteration (A-2) - Green golf course pedestrian bridge 1,250' downstream of Boliver Road bridge. NYSDEC says permitted (need to verify).; Action: Submit Section 408 Alteration Request to USACE or remove unauthorized alteration.; Station\_1: 104+00

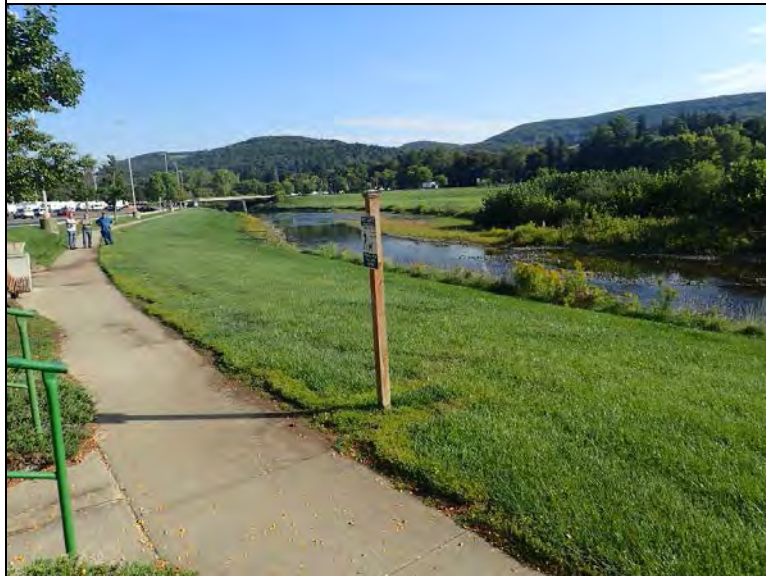
**Inspect ID:** N21L\_2016\_r\_0027 **Title:** USACE\_CELRB\_N21L\_2016\_r\_0027\_1.jpg  
**Rated Item:** 3. Encroachments **Caption:** Rating: Minimally Acceptable; Remarks:  
Unauthorized Alteration (A-8) - pet sign and post encroachment on left bank channel  
crest.; Action: Submit Section 408 Alteration Request to USACE or remove unauthorized  
alteration.; Station\_1: 77+00

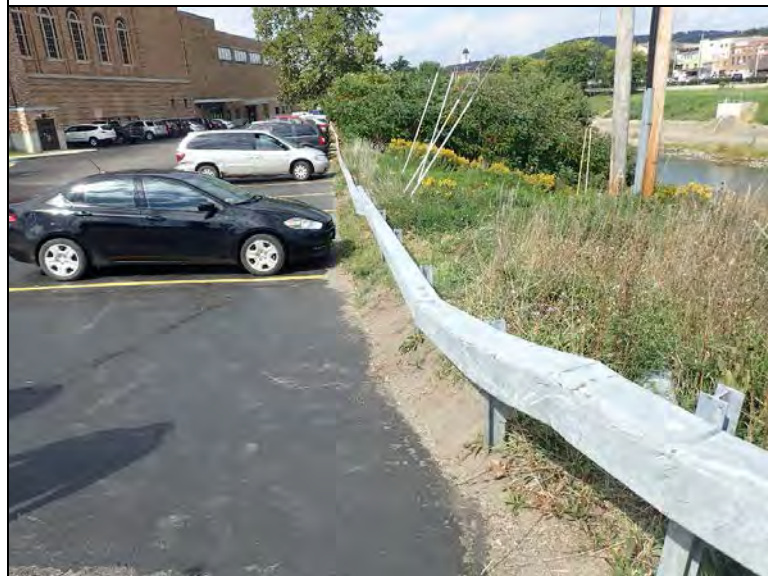
**Inspect ID:** N21L\_2016\_r\_0079 **Title:** USACE\_CELRB\_N21L\_2016\_r\_0079\_2.jpg  
**Rated Item:** 3. Encroachments **Caption:** Rating: Minimally Acceptable; Remarks: Unauthorized Alteration (A-33) - Wellsville High School rail, parking lot, and 2 signs on left bank levee downstream of State Street bridge.; Action: Submit Section 408 Alteration Request Form to USACE.; Station\_1: 37+00

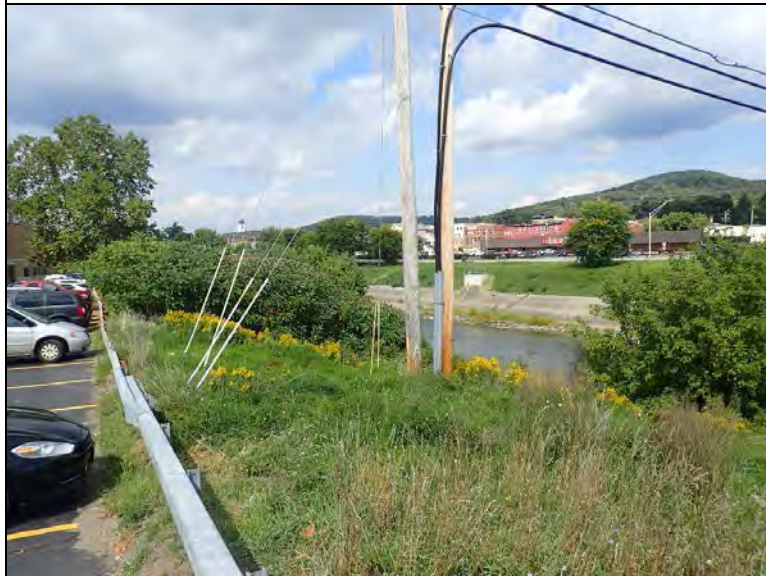
**Inspect ID:** N21L\_2016\_r\_0082 **Title:** USACE\_CELRB\_N21L\_2016\_r\_0082\_1.jpg  
**Rated Item:** 3. Encroachments **Caption:** Rating: Minimally Acceptable; Remarks: Unauthorized Alteration (A-34) - 2 utility poles 6 guy wires 75' downstream of State Street bridge (NYSDEC says permitted).; Action: Submit Section 408 Alteration Request to USACE or remove unauthorized alteration.; Station\_1: 35+00

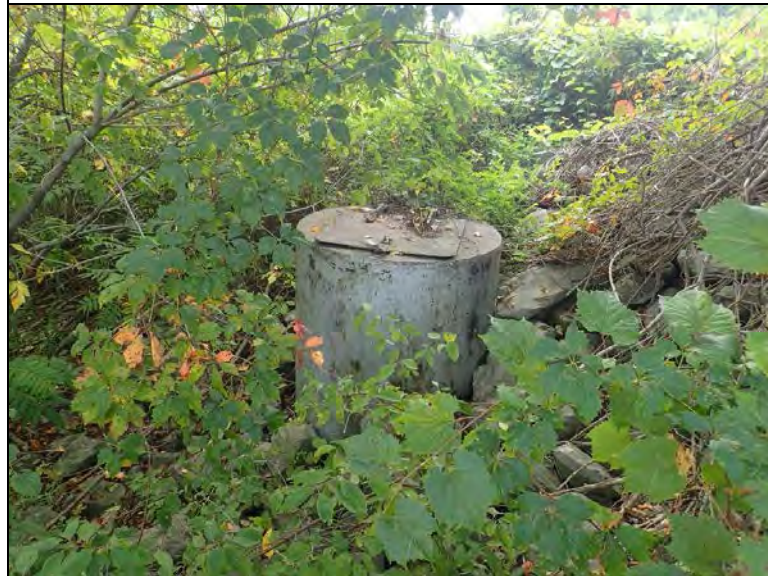
**Inspect ID:** N21L\_2016\_r\_0092 **Title:** USACE\_CELRB\_N21L\_2016\_r\_0092\_1.jpg  
**Rated Item:** 3. Encroachments **Caption:** Rating: Minimally Acceptable; Remarks: Unauthorized Alteration (A-40) - Unidentified drainage structure on channel side slope on left bank.; Action: Submit Section 408 Alteration Request to USACE or remove unauthorized alteration.; Station\_1: 26+00

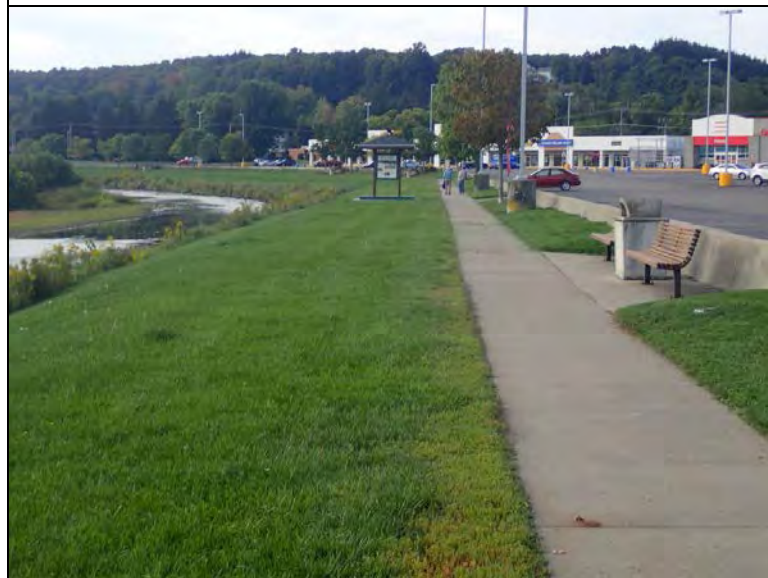
**Inspect ID:** N21L\_2016\_r\_0131 **Title:** USACE\_CELRB\_N21L\_2016\_r\_0131\_1.jpg  
**Rated Item:** 3. Encroachments **Caption:** Rating: Minimally Acceptable; Remarks: Unauthorized Alteration (A-4) - Sidewalk encroachment (benches and lightposts are not encroachments) along left bank from Bolivar road bridge to 1,775 feet upstream of Bolivar Road bridge.; Action: Submit Section 408 Alteration Request to USACE or remove unauthorized alteration.; Station\_1: 90+00; Station\_2: 76+00

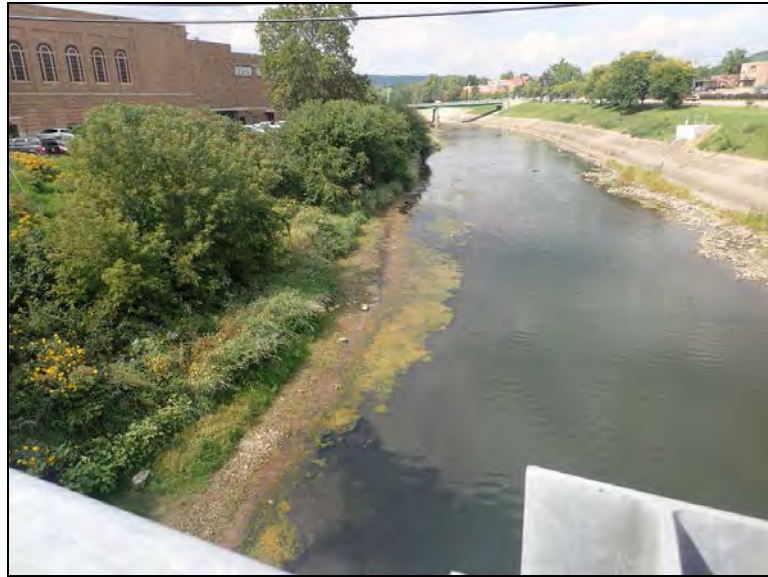
**Inspect ID:** N21L\_2016\_r\_0141 **Title:** USACE\_CELRB\_N21L\_2016\_r\_0141\_1.jpg  
**Rated Item:** 3. Encroachments **Caption:** Rating: Minimally Acceptable; Remarks:  
Unauthorized Alteration (A-35) - Concrete siphon gate well on right bank channel  
sideslope (across from school). NYSDEC says permitted.; Action: Submit Section 408  
Alteration Request to USACE.; Station\_1: 36+00

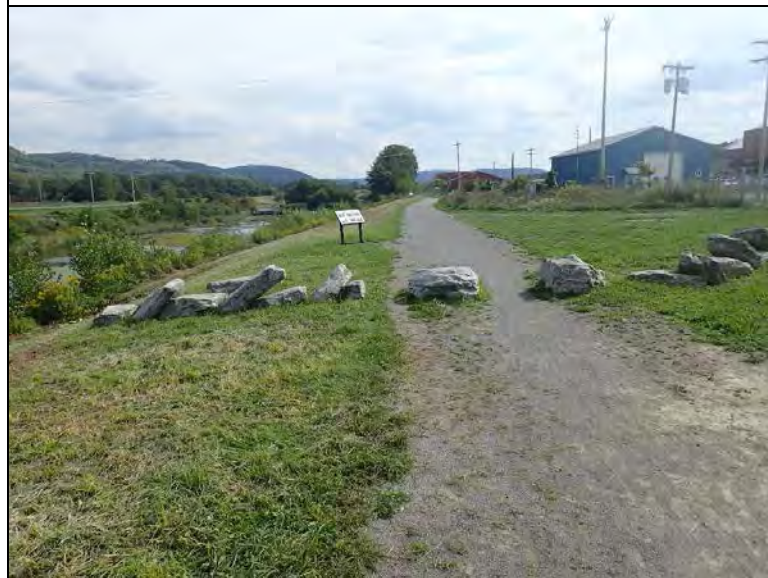
**Inspect ID:** N21L\_2016\_r\_0143 **Title:** USACE\_CELRB\_N21L\_2016\_r\_0143\_1.jpg  
**Rated Item:** 3. Encroachments **Caption:** Rating: Minimally Acceptable; Remarks:  
Unauthorized Alteration (A-45) - Wellsville, Addison, & Galetton Railroad railway (from  
Island Park pedestrian bridge to barrier levee weir) and signs on left bank near boulders  
blocking trail on channel crest.; Action: Submit Section 408 Alteration Request to  
USACE or remove unauthorized alteration.; Station\_1: 0+00; Station\_2: 13+00

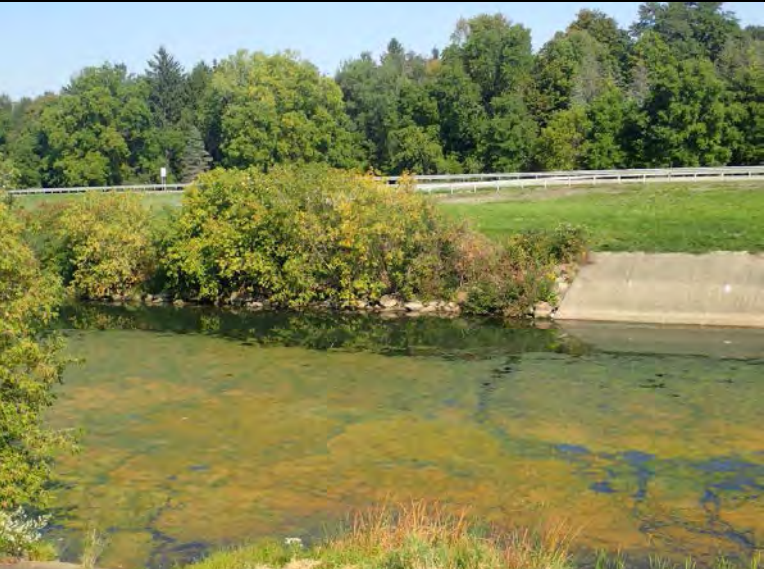
<p><b>Inspect ID:</b> N21L_2016_r_0050 <b>Title:</b> USACE_CELRB_N21L_2016_r_0050_1.jpg <b>Rated Item:</b> 10. Riprap Revetments &amp; Banks <b>Caption:</b> Rating: Minimally Acceptable; Remarks: Vegetation in riprap on right bank from 1,600' to 1,300' downstream of Madison Street (Stevens Street) bridge.; Action: Remove vegetation from riprap.; Station_1: 59+00; Station_2: 56+00</p>

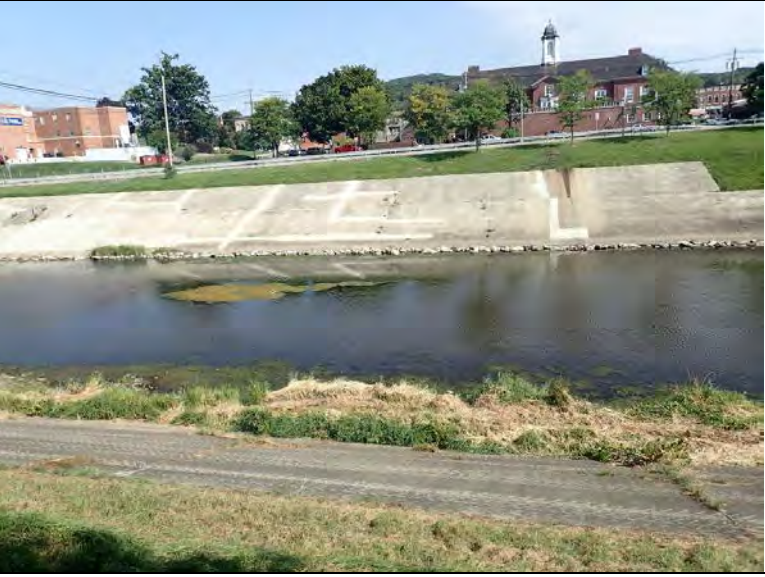
<p><b>Inspect ID:</b> N21L_2016_r_0062 <b>Title:</b> USACE_CELRB_N21L_2016_r_0062_1.jpg <b>Rated Item:</b> 11. Revetments other than Riprap <b>Caption:</b> Rating: Acceptable; Remarks: Cracking in concrete sideslope repaired on right bank 250' downstream of Madison Street (Stevens Street) bridge.; Action: NA; Station_1: 45+00</p>

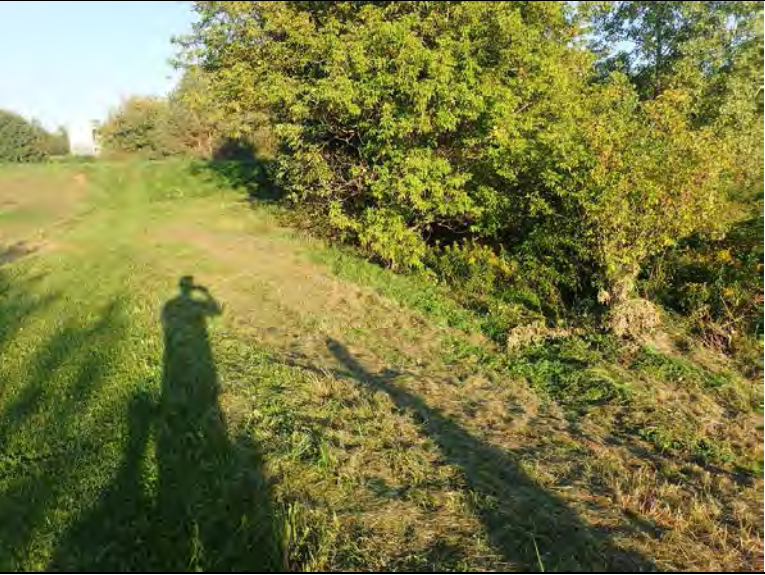
<p><b>Inspect ID:</b> N21R_2016_r_0001 <b>Title:</b> USACE_CELRB_N21R_2016_r_0001_1.jpg  <b>Rated Item:</b> 1. Unwanted Vegetation Growth <b>Caption:</b> Rating: Unacceptable; Remarks: Trees on left bank levee landside slope 700' upstream of Drop Structure. (Dyke Creek); Action: Remove trees.; Station_1: 35+00</p>

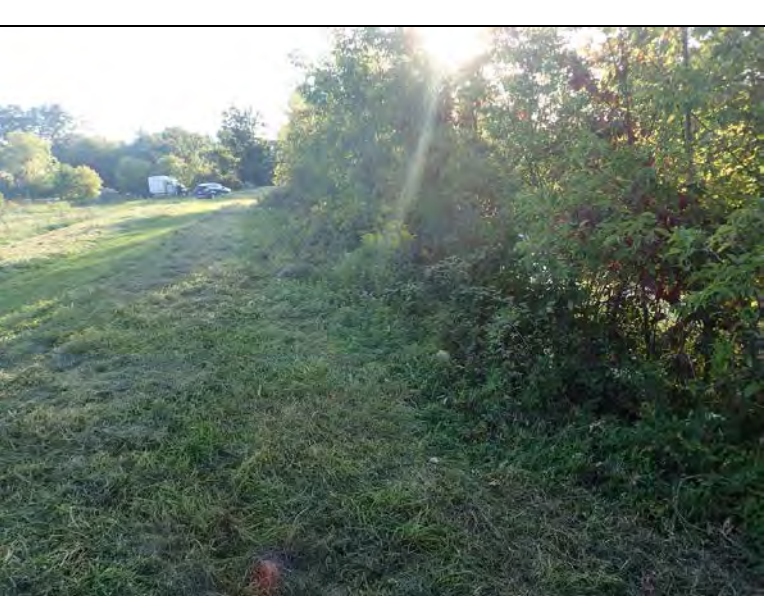
<p><b>Inspect ID:</b> N21R_2016_r_0003 <b>Title:</b> USACE_CELRB_N21R_2016_r_0003_1.jpg  <b>Rated Item:</b> 1. Unwanted Vegetation Growth <b>Caption:</b> Rating: Unacceptable; Remarks: Significant trees and unwanted vegetation on left bank from levee upstream limit to just upstream of the Drop Structure. (Dyke Creek); Action: Remove trees and unwanted vegetation.; Station_1: 35+00; Station_2: 35+00</p>

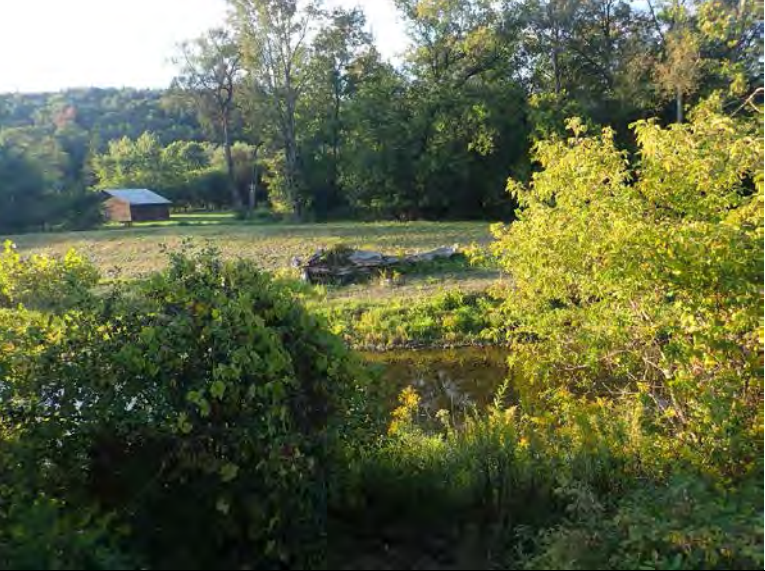
<p><b>Inspect ID:</b> N21R_2016_r_0004 <b>Title:</b> USACE_CELRB_N21R_2016_r_0004_1.jpg <b>Rated Item:</b> 1. Vegetation and Obstructions <b>Caption:</b> Rating: Minimally Acceptable; <b>Remarks:</b> Log debris in channel on right bank shoal 500' upstream of drop structure. (Dyke Creek); <b>Action:</b> Remove debris.; <b>Station_1:</b> 35+00</p>

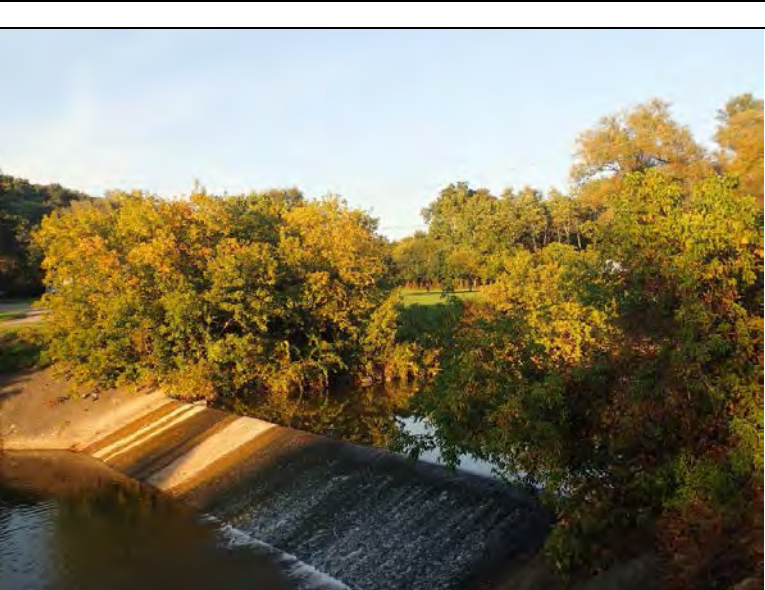
<p><b>Inspect ID:</b> N21R_2016_r_0013 <b>Title:</b> USACE_CELRB_N21R_2016_r_0013_1.jpg <b>Rated Item:</b> 1. Vegetation and Obstructions <b>Caption:</b> Rating: Minimally Acceptable; <b>Remarks:</b> Significant vegetation and trees on right bank upstream of drop structure. (Dyke Creek); <b>Action:</b> Remove vegetation and trees.; <b>Station_1:</b> 35+00</p>

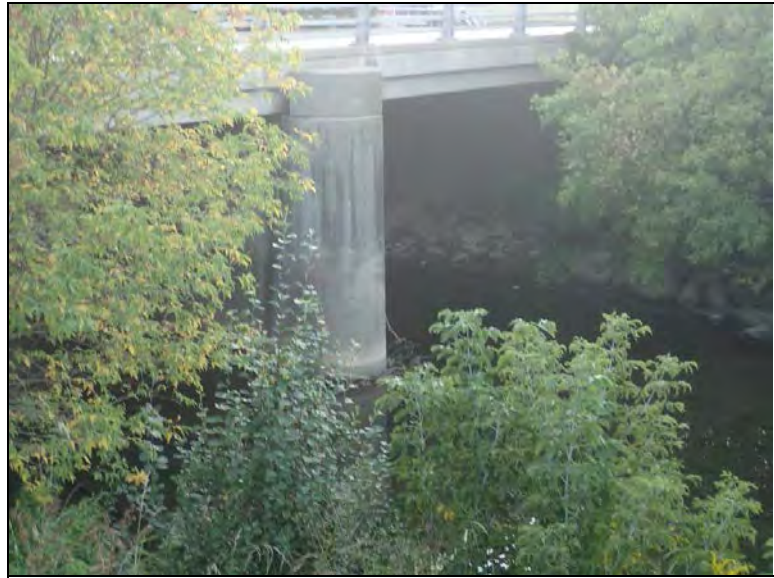
<p><b>Inspect ID:</b> N21R_2016_r_0028 <b>Title:</b> USACE_CELRB_N21R_2016_r_0028_1.jpg <b>Rated Item:</b> 1. Vegetation and Obstructions <b>Caption:</b> Rating: Minimally Acceptable; <b>Remarks:</b> Debris on upstream face of Main Street bridge abutment. (Dyke Creek); <b>Action:</b> Remove debris.; Station_1: 18+00</p>

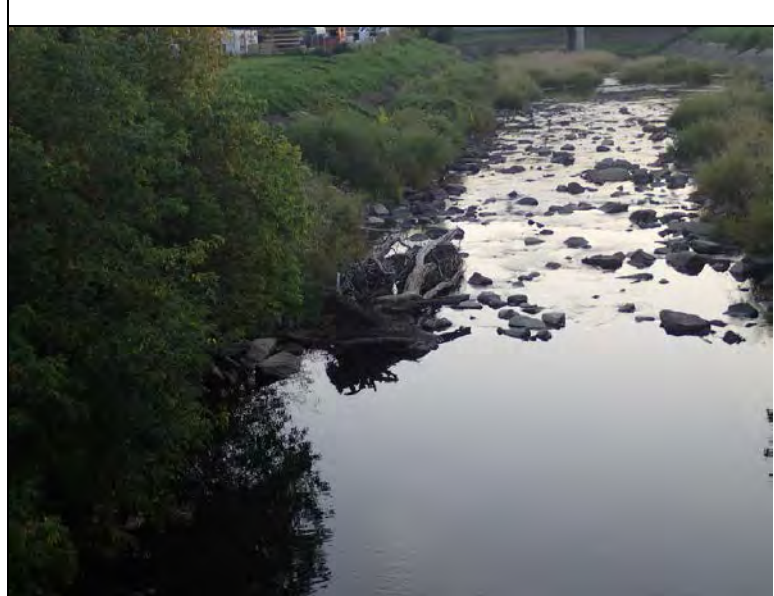
<p><b>Inspect ID:</b> N21R_2016_r_0031 <b>Title:</b> USACE_CELRB_N21R_2016_r_0031_1.jpg <b>Rated Item:</b> 1. Vegetation and Obstructions <b>Caption:</b> Rating: Minimally Acceptable; <b>Remarks:</b> Tree debris in channel downstream of Main Street bridge. (Dyke Creek); <b>Action:</b> Remove tree debris.; Station_1: 17+00</p>

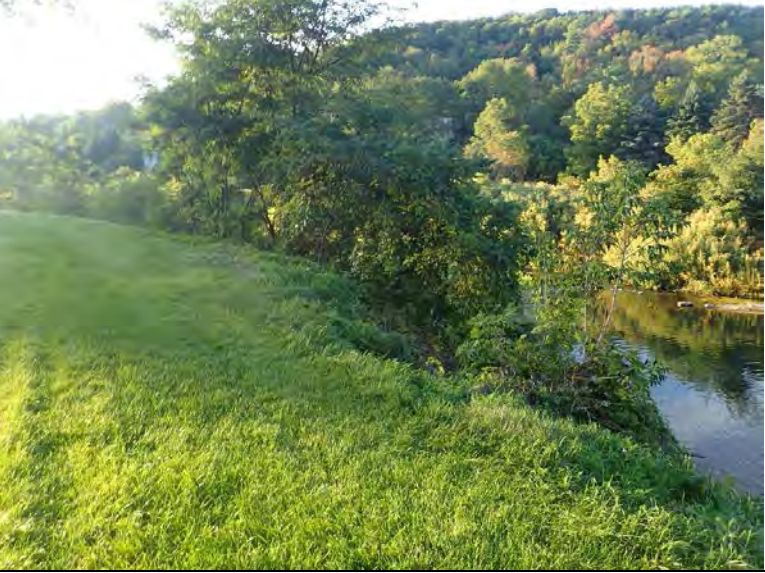
<p><b>Inspect ID:</b> N21R_2016_r_0045 <b>Title:</b> USACE_CELRB_N21R_2016_r_0045_1.jpg <b>Rated Item:</b> 1. Vegetation and Obstructions <b>Caption:</b> Rating: Unacceptable; Remarks: Significant unwanted vegetation on left bank from Broad Street bridge to Drop Structure. (Dyke Creek); Action: Remove unwanted vegetation.; Station_1: 35+00; Station_2: 24+00</p>

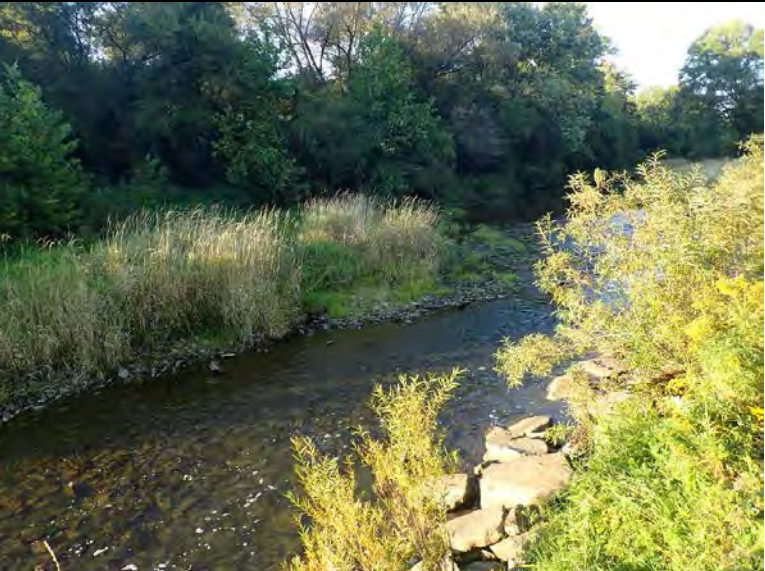
<p><b>Inspect ID:</b> N21R_2016_r_0005 <b>Title:</b> USACE_CELRB_N21R_2016_r_0005_1.jpg <b>Rated Item:</b> 2. Shoaling (sediment deposition) <b>Caption:</b> Rating: Minimally Acceptable; Remarks: Shoaling (S-14) on right bank from 200' upstream of drop structure to upstream project limit. (Dyke Creek); Action: Remove shoaling.; Station_1: 35+00; Station_2: 35+00</p>

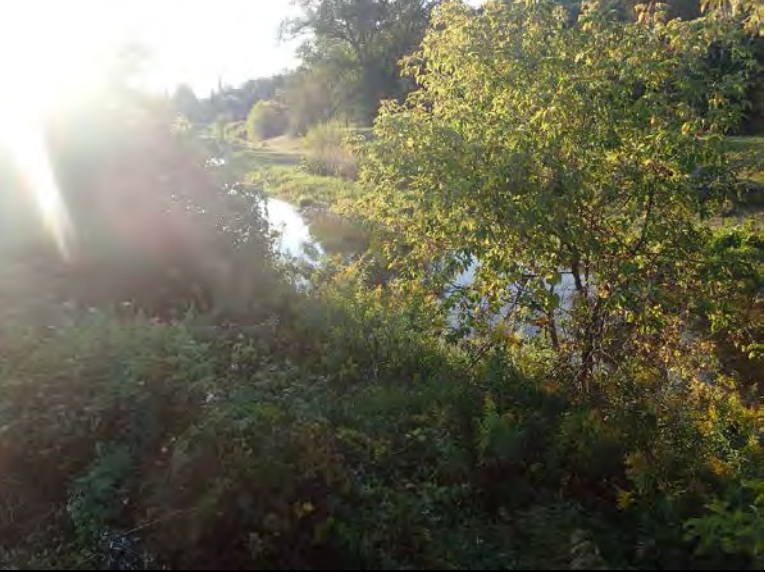
<p><b>Inspect ID:</b> N21R_2016_r_0005 <b>Title:</b> USACE_CELRB_N21R_2016_r_0005_2.jpg <b>Rated Item:</b> 2. Shoaling (sediment deposition) <b>Caption:</b> Rating: Minimally Acceptable; <b>Remarks:</b> Shoaling (S-14) on right bank from 200' upstream of drop structure to upstream project limit. (Dyke Creek); <b>Action:</b> Remove shoaling.; <b>Station_1:</b> 35+00; <b>Station_2:</b> 35+00</p>

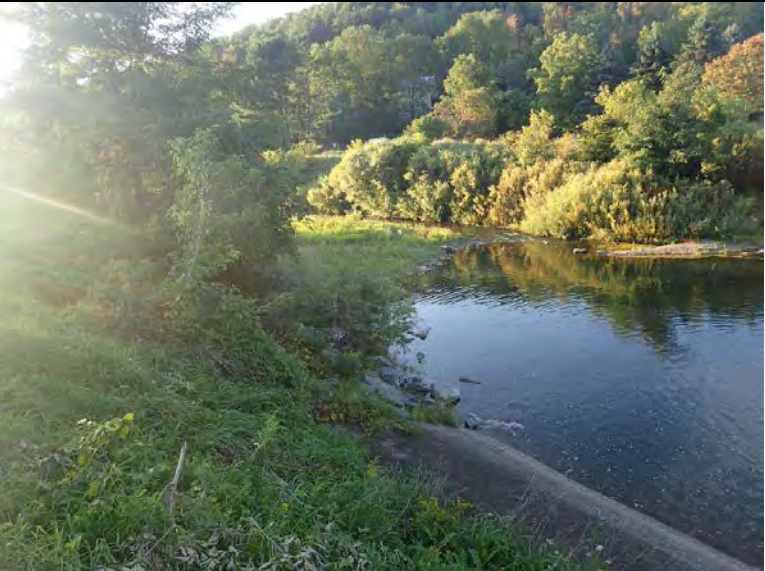
<p><b>Inspect ID:</b> N21R_2016_r_0014 <b>Title:</b> USACE_CELRB_N21R_2016_r_0014_1.jpg <b>Rated Item:</b> 2. Shoaling (sediment deposition) <b>Caption:</b> Rating: Minimally Acceptable; <b>Remarks:</b> Minor shoal (S-15) in center of channel 100' downstream of drop structure to 200' downstream of drop structure. (Dyke Creek); <b>Action:</b> Remove shoal.; <b>Station_1:</b> 34+00</p>

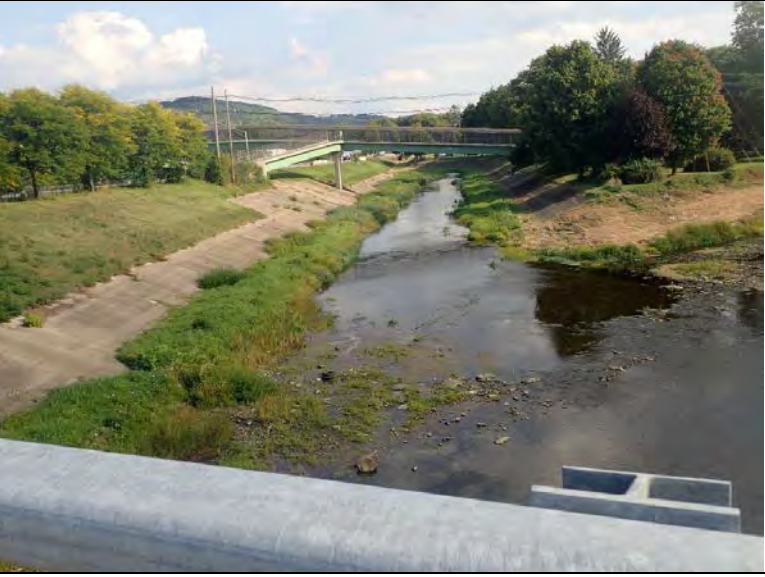
<p><b>Inspect ID:</b> N21R_2016_r_0043 <b>Title:</b> USACE_CELRB_N21R_2016_r_0043_1.jpg <b>Rated Item:</b> 2. Shoaling (sediment deposition) <b>Caption:</b> Rating: Minimally Acceptable; <b>Remarks:</b> Vegetated shoaling (S-18) on both banks from convergence of Dyke Creek to the State Route 417 bridge.; <b>Action:</b> Remove shoaling.; <b>Station_1:</b> 11+00; <b>Station_2:</b> 2+00</p>

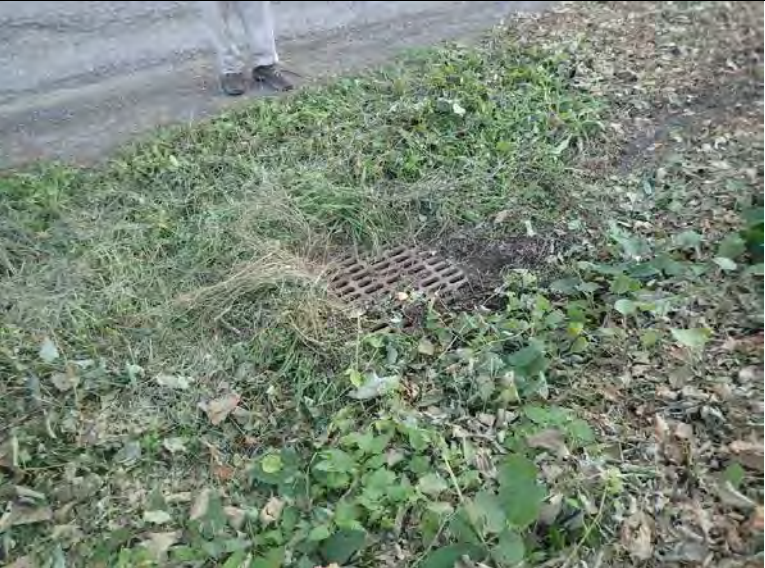
<p><b>Inspect ID:</b> N21R_2016_r_0006 <b>Title:</b> USACE_CELRB_N21R_2016_r_0006_1.jpg <b>Rated Item:</b> 3. Encroachments <b>Caption:</b> Rating: Acceptable; <b>Remarks:</b> 24" CMP drainage inlet on left bank 175' upstream of Drop Structure is not an encroachment, part of existing drainage prior to project. (Dyke Creek); <b>Action:</b> NA; <b>Station_1:</b> 35+00</p>

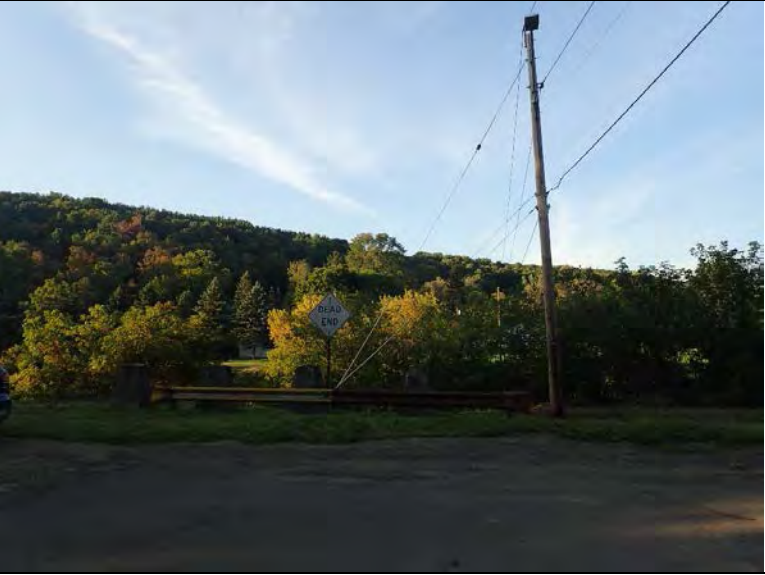
<p><b>Inspect ID:</b> N21R_2016_r_0011 <b>Title:</b> USACE_CELRB_N21R_2016_r_0011_2.jpg <b>Rated Item:</b> 3. Encroachments <b>Caption:</b> Rating: Minimally Acceptable; Remarks: Unauthorized Alteration (A-50) - Concrete blocks, guardrail, utility pole, guy wire, and dead end sign encroachments on left bank at end of Miller Street just upstream of drop structure. (Dyke Creek); Action: Submit Section 408 Alteration Request to USACE or remove unauthorized alteration.; Station_1: 35+00</p>
