## DEPARTMENT OF THE ARMY

BUFFALO DISTRICT, CORPS OF ENGINEERS  
1776 NIAGARA STREET  
BUFFALO, NEW YORK 14207-3199

September 19, 2017

SUBJECT: FY16 Joint Routine Inspection of Completed Works, Flood Risk Management Project, Genesee River and Dyke Creek, Wellsville, New York (09/23/16)

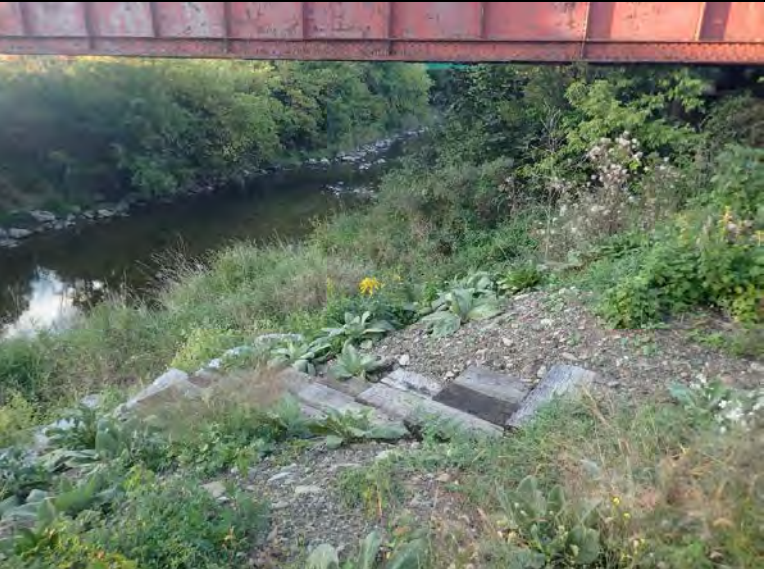
<p><b>Inspect ID:</b> N21R_2016_r_0024 <b>Title:</b> USACE_CELRB_N21R_2016_r_0024_1.jpg <b>Rated Item:</b> 3. Encroachments <b>Caption:</b> Rating: Minimally Acceptable; Remarks: Unauthorized Alteration (A-51) - wood stairs on left bank channel slope just downstream of railroad bridge. (Dyke Creek); Action: Submit Section 408 Alteration Request to USACE or remove unauthorized alteration.; Station_1: 21+00</p>

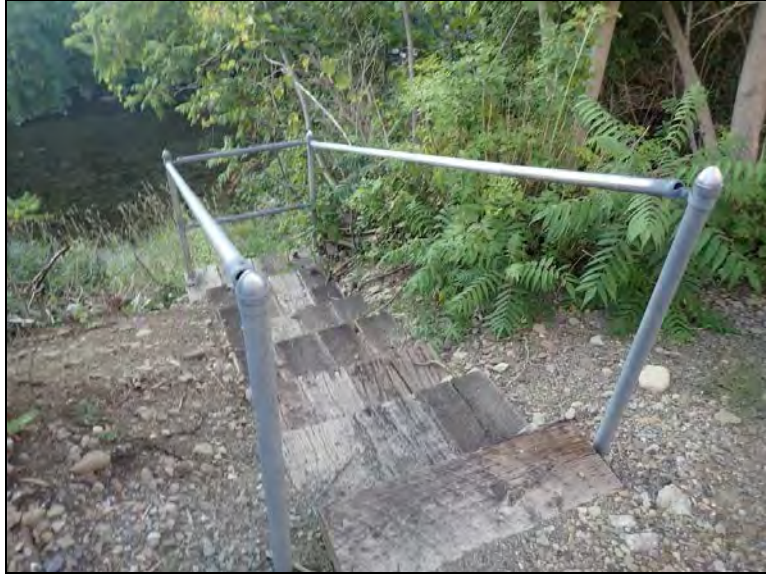
**Inspect ID:** N21R\_2016\_r\_0025 **Title:** USACE\_CELRB\_N21R\_2016\_r\_0025\_1.jpg  
**Rated Item:** 3. Encroachments **Caption:** Rating: Minimally Acceptable; Remarks:  
 Unauthorized Alteration (A-52) - wood stairs and railing encroachments on left bank  
 channel slope just downstream of railroad bridge. (Dyke Creek); Action: Submit Section  
 408 Alteration Request to USACE or remove unauthorized alteration.; Station\_1: 21+00

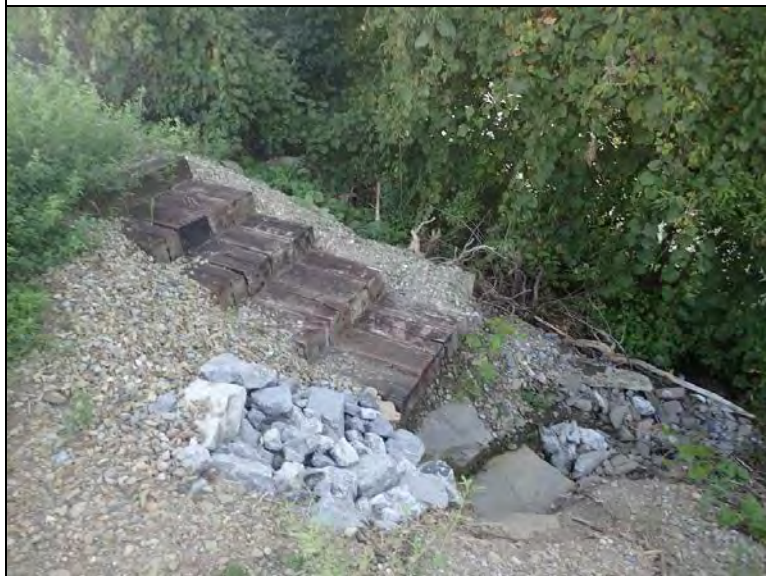
**Inspect ID:** N21R\_2016\_r\_0026 **Title:** USACE\_CELRB\_N21R\_2016\_r\_0026\_1.jpg  
**Rated Item:** 3. Encroachments **Caption:** Rating: Minimally Acceptable; Remarks:  
 Unauthorized alteration (A-53) - wood stairs left bank channel slope. (Dyke Creek);  
 Action: Submit Section 408 Alteration Request to USACE or remove unauthorized  
 alteration.; Station\_1: 20+00

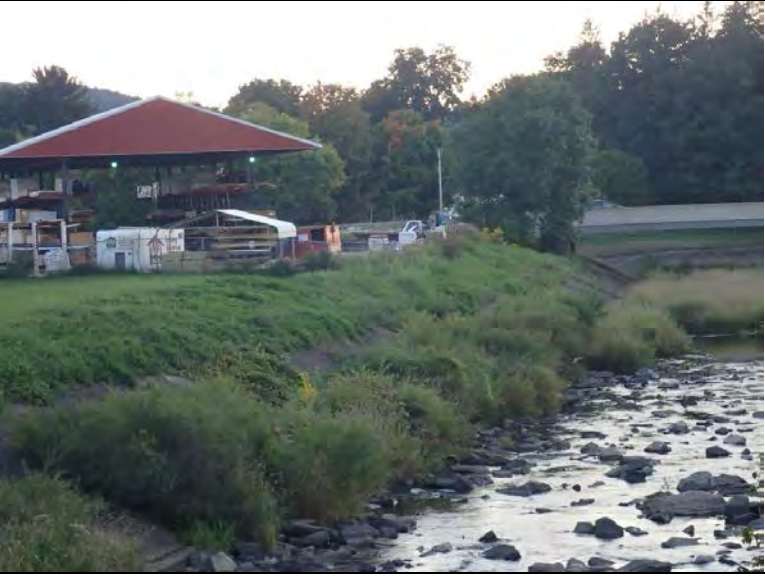
<p><b>Inspect ID:</b> N21R_2016_r_0033 <b>Title:</b> USACE_CELRB_N21R_2016_r_0033_1.jpg <b>Rated Item:</b> 3. Encroachments <b>Caption:</b> Rating: Minimally Acceptable; Remarks: Unauthorized Alteration(A-55) - Heating, electrical, and plumbing yard on Dyke Creek left bank just upstream of State Route 417 bridge. (Dyke Creek); Action: Submit Section 408 Alteration Request to USACE or remove unauthorized alteration.; Station_1: 15+00; Station_2: 13+00</p>

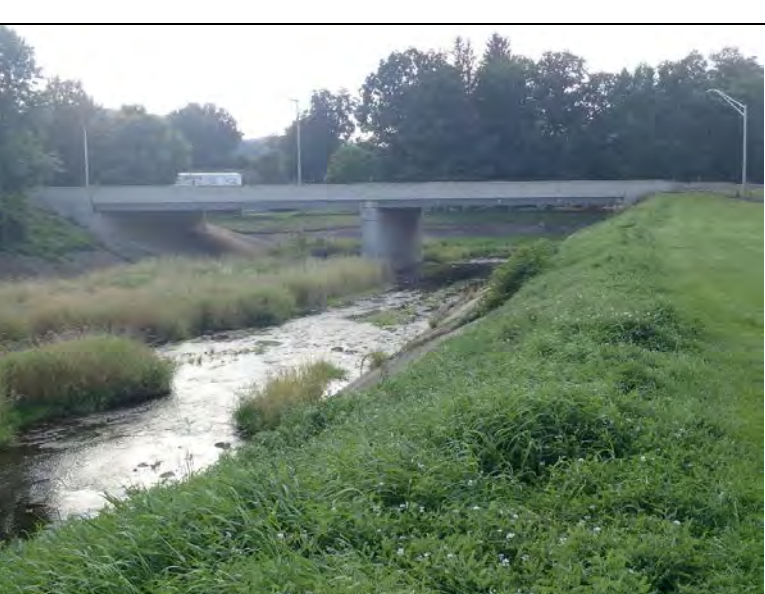
<p><b>Inspect ID:</b> N21R_2016_r_0042 <b>Title:</b> USACE_CELRB_N21R_2016_r_0042_1.jpg <b>Rated Item:</b> 3. Encroachments <b>Caption:</b> Rating: Acceptable; Remarks: Approved Alteration - State Route 417 bridge replacement over Dyke Creek.; Action: NA; Station_1: 11+00</p>

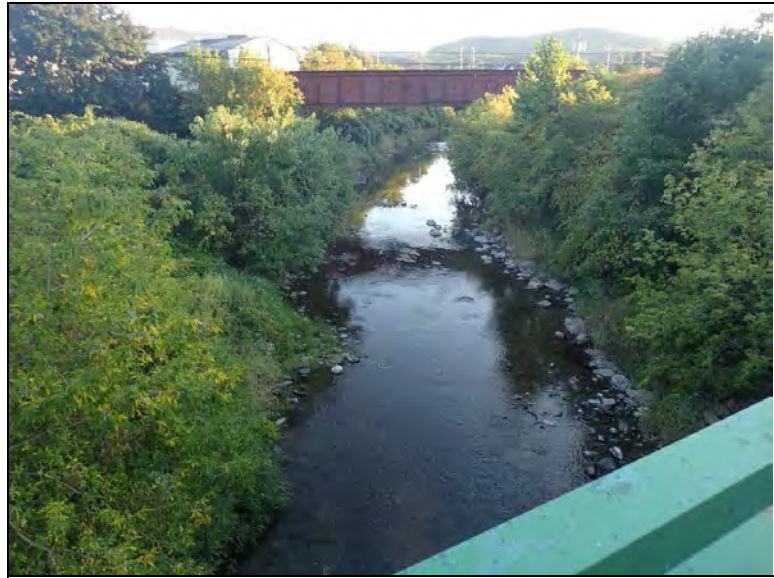
<p><b>Inspect ID:</b> N21R_2016_r_0022 <b>Title:</b> USACE_CELRB_N21R_2016_r_0022_1.jpg <b>Rated Item:</b> 10. Riprap Revetments &amp; Banks <b>Caption:</b> Rating: Unacceptable; Remarks: Significant unwanted vegetation and trees in riprap on both banks between Railroad bridge and Broad Street bridge. (Dyke Creek); Action: Remove unwanted vegetation.; Station_1: 24+00; Station_2: 22+00</p>

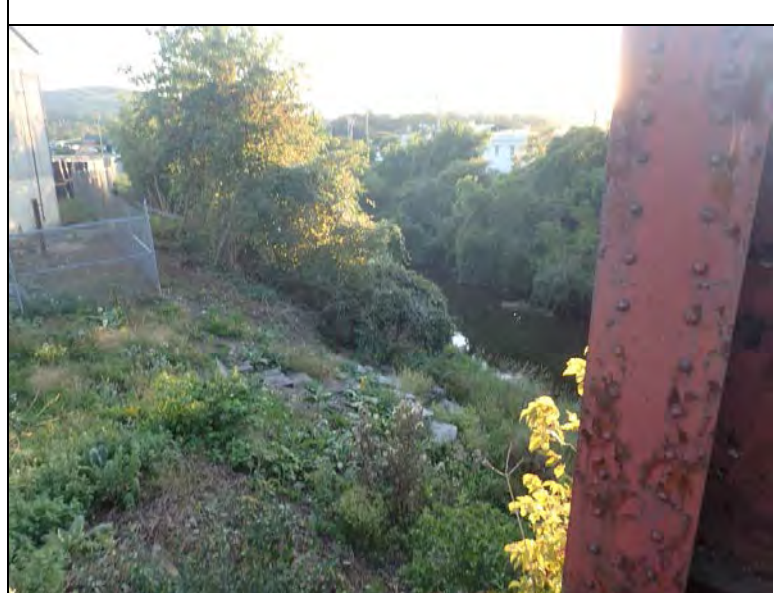
<p><b>Inspect ID:</b> N21R_2016_r_0023 <b>Title:</b> USACE_CELRB_N21R_2016_r_0023_1.jpg <b>Rated Item:</b> 10. Riprap Revetments &amp; Banks <b>Caption:</b> Rating: Unacceptable; Remarks: Significant trees and heavy unwanted vegetation in riprap on both banks between Main Street bridge and Railroad bridge. (Dyke Creek); Action: Remove trees and unwanted vegetation.; Station_1: 22+00; Station_2: 18+00</p>

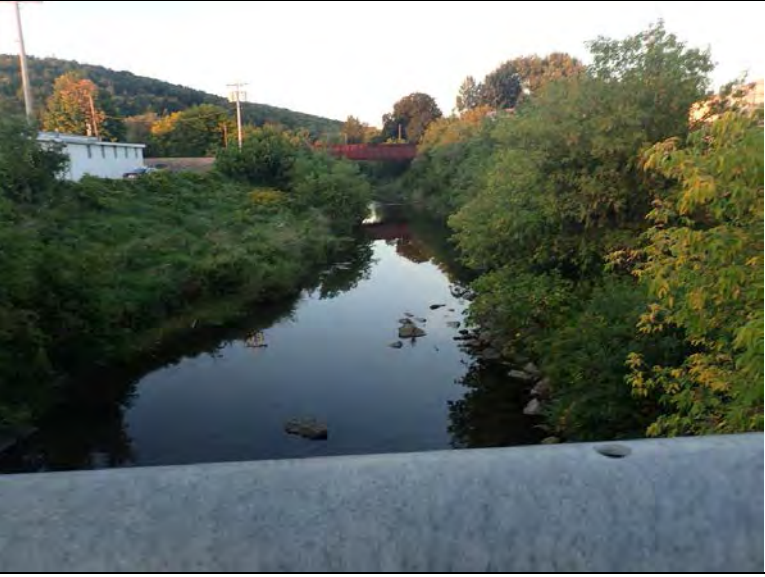
<p><b>Inspect ID:</b> N21R_2016_r_0023 <b>Title:</b> USACE_CELRB_N21R_2016_r_0023_2.jpg <b>Rated Item:</b> 10. Riprap Revetments &amp; Banks <b>Caption:</b> Rating: Unacceptable; Remarks: Significant trees and heavy unwanted vegetation in riprap on both banks between Main Street bridge and Railroad bridge. (Dyke Creek); Action: Remove trees and unwanted vegetation.; Station_1: 22+00; Station_2: 18+00</p>

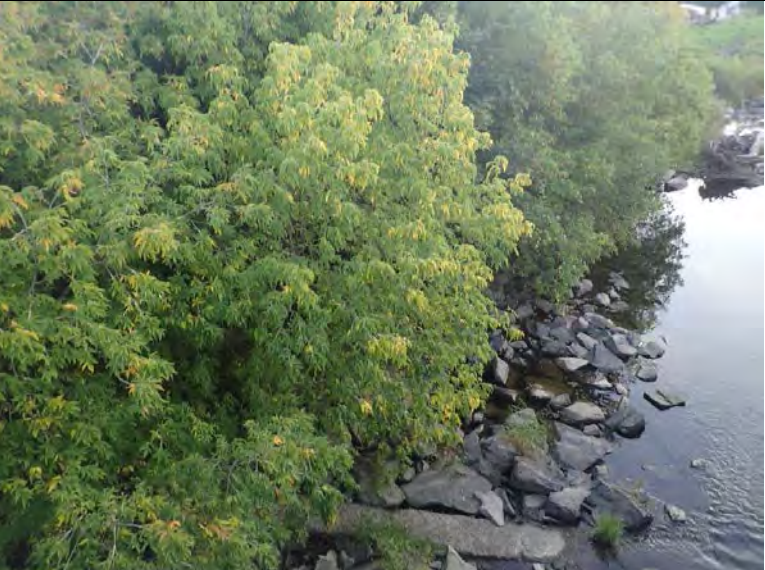
<p><b>Inspect ID:</b> N21R_2016_r_0029 <b>Title:</b> USACE_CELRB_N21R_2016_r_0029_1.jpg <b>Rated Item:</b> 10. Riprap Revetments &amp; Banks <b>Caption:</b> Rating: Unacceptable; Remarks: Significant trees and vegetation in riprap on both banks just downstream of Main Street bridge. (Dyke Creek); Action: Remove trees and vegetation from riprap.; Station_1: 17+00</p>

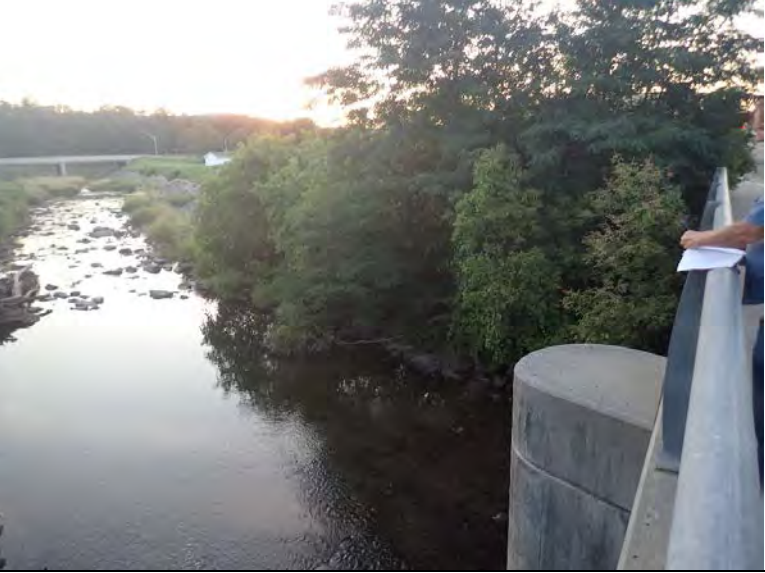
<p><b>Inspect ID:</b> N21R_2016_r_0029 <b>Title:</b> USACE_CELRB_N21R_2016_r_0029_2.jpg <b>Rated Item:</b> 10. Riprap Revetments &amp; Banks <b>Caption:</b> Rating: Unacceptable; Remarks: Significant trees and vegetation in riprap on both banks just downstream of Main Street bridge. (Dyke Creek); Action: Remove trees and vegetation from riprap.; Station_1: 17+00</p>
