## DEPARTMENT OF THE ARMY

BUFFALO DISTRICT, CORPS OF ENGINEERS  
1776 NIAGARA STREET  
BUFFALO, NEW YORK 14207-3199

SUBJECT: FY18 Joint Routine Inspection of Completed Works, Flood Risk Management Project, Genesee River and Dyke Creek, Wellsville, New York (09/24/18)

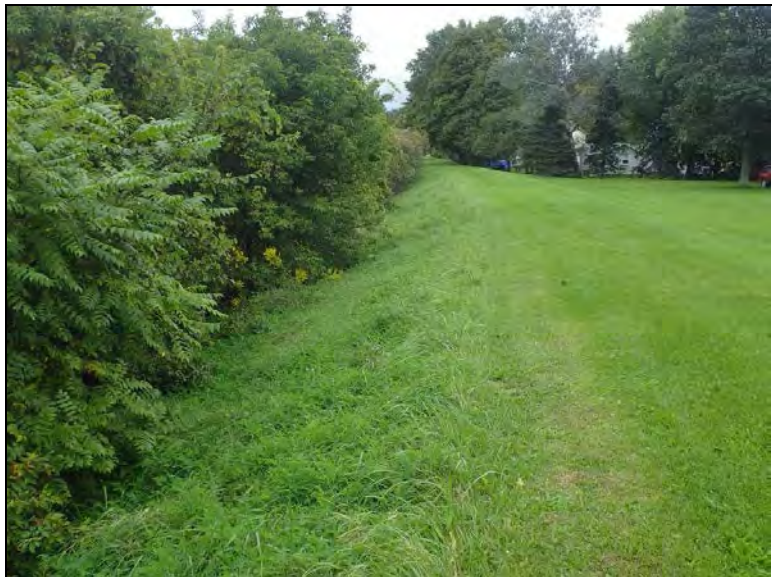
<p><b>Inspect ID:</b> N21L_2018_r_0049 <b>Title:</b> USACE_CELRB_N21L_2018_r_0049_2.jpg <b>Rated Item:</b> 1. Unwanted Vegetation Growth <b>Caption:</b> Rating: Minimally Acceptable; Remarks: Vegetation in excess of 12" on left bank levee waterside slope from Chamberland Street drainage channel to Madison Street bridge.; Action: Mow vegetation to 3"-6" height.; Station_1: 67+00; Station_2: 66+00</p>

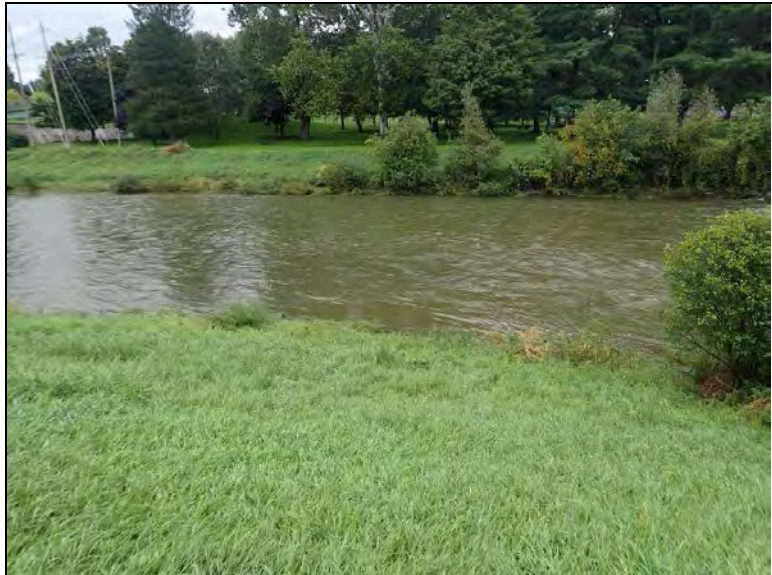
<p><b>Inspect ID:</b> N21L_2018_r_0111 <b>Title:</b> USACE_CELRB_N21L_2018_r_0111_1.jpg <b>Rated Item:</b> 3. Encroachments <b>Caption:</b> Rating: Minimally Acceptable; Remarks: Unauthorized alteration (E-37a): 6" cast iron pipe on left bank levee waterside slope 450' upstream of State Street bridge.; Action: Remove or submit Section 408 Alteration Request to USACE.; Station_1: 29+00</p>
 	<p><b>Inspect ID:</b> N21L_2018_r_0115 <b>Title:</b> USACE_CELRB_N21L_2018_r_0115_1.jpg <b>Rated Item:</b> 3. Encroachments <b>Caption:</b> Rating: Minimally Acceptable; Remarks: Unauthorized alteration (E-38): Green metal stairs and concrete pad for access to Water Intake Unit in left bank riverside slope at Steel Sheet Pile Weir (Water Intake Unit is part of project as shown on As-Constructed drawing 189-WEL-2/4).; Action: Remove or submit Section 408 Alteration Request to USACE.; Station_1: 27+00</p>

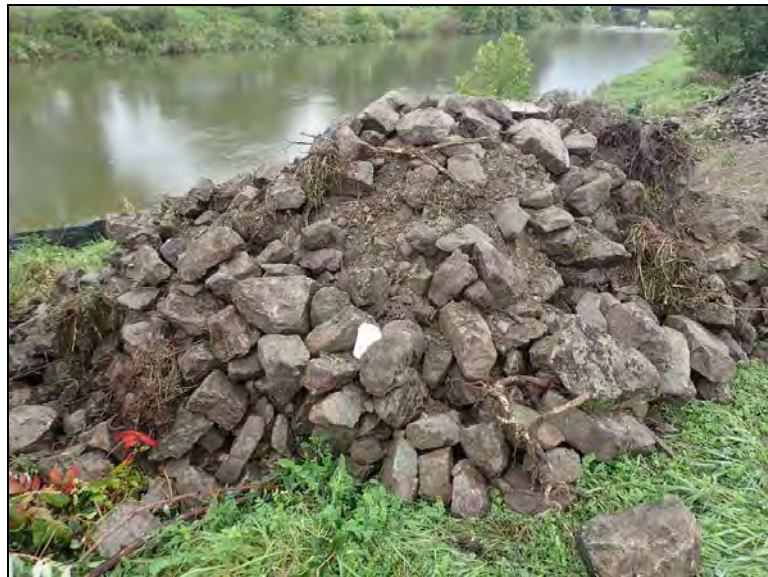
**Inspect ID:** N21L\_2018\_r\_0168 **Title:** USACE\_CELRB\_N21L\_2018\_r\_0168\_2.jpg  
**Rated Item:** 3. Encroachments **Caption:** Rating: Acceptable; Remarks: Authorized alteration: gateway installation for 48" CMP on left bank, 515' upstream of Steel Sheet Pile Weir.; Action: NA; Station\_1: 23+00

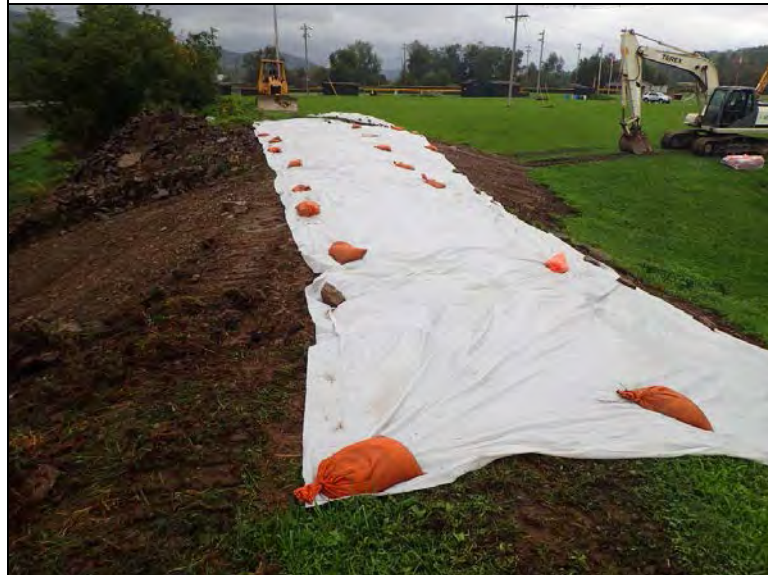
**Inspect ID:** N21L\_2018\_r\_0168 **Title:** USACE\_CELRB\_N21L\_2018\_r\_0168\_3.jpg  
**Rated Item:** 3. Encroachments **Caption:** Rating: Acceptable; Remarks: Authorized alteration: gateway installation for 48" CMP on left bank, 515' upstream of Steel Sheet Pile Weir.; Action: NA; Station\_1: 23+00

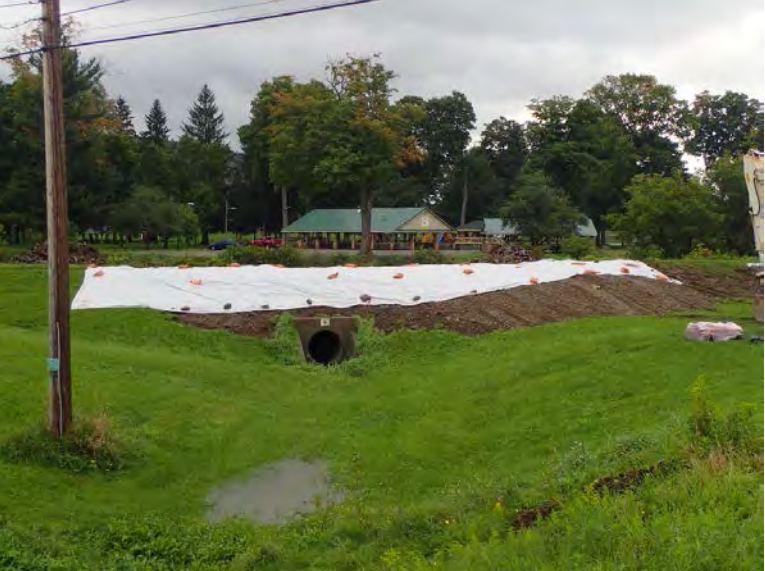
<p><b>Inspect ID:</b> N21L_2018_r_0168 <b>Title:</b> USACE_CELRB_N21L_2018_r_0168_6.jpg  <b>Rated Item:</b> 3. Encroachments <b>Caption:</b> Rating: Acceptable; Remarks: Authorized alteration: gatewell installation for 48" CMP on left bank, 515' upstream of Steel Sheet Pile Weir.; Action: NA; Station_1: 23+00</p>

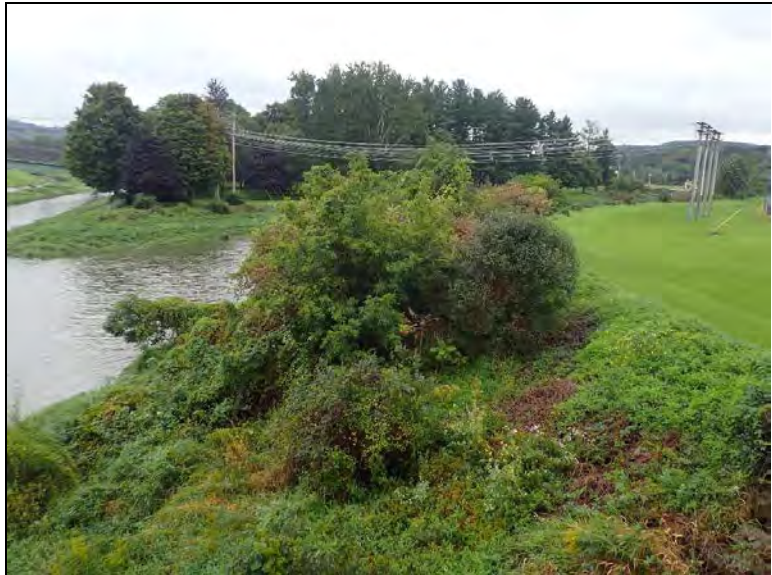
<p><b>Inspect ID:</b> N21L_2018_r_0107 <b>Title:</b> USACE_CELRB_N21L_2018_r_0107_1.jpg <b>Rated Item:</b> 12. Riprap Revetments &amp; Bank Protection <b>Caption:</b> Rated Item: 1. Unwanted Vegetation Growth; Rating: Unacceptable; Remarks: Trees and vegetation in riprap on left bank channel side slope from State Street bridge to 1,250' upstream.; Action: Remove trees and vegetation from riprap.; Station_1: 33+00; Station_2: 24+00</p>

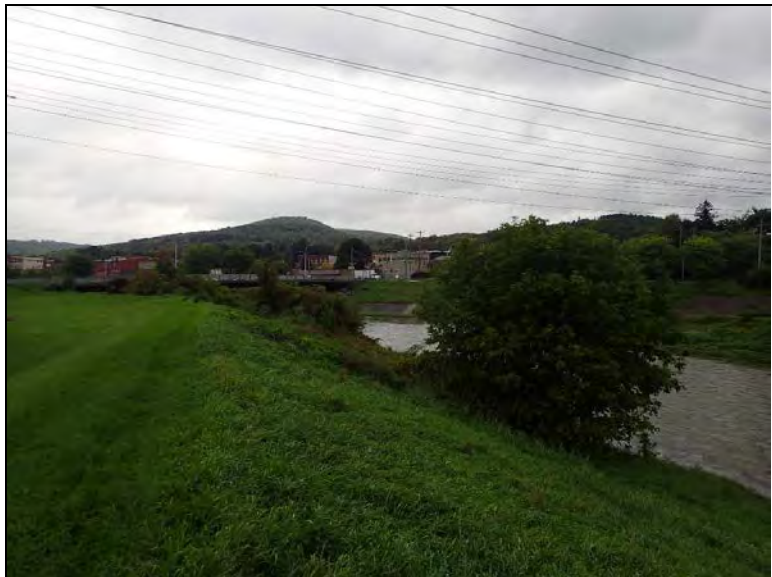
<p><b>Inspect ID:</b> N21L_2018_r_0107 <b>Title:</b> USACE_CELRB_N21L_2018_r_0107_3.jpg  <b>Rated Item:</b> 12. Riprap Revetments &amp; Bank Protection <b>Caption:</b> Rated Item: 1.  Unwanted Vegetation Growth; Rating: Unacceptable; Remarks: Trees and vegetation in riprap on left bank channel side slope from State Street bridge to 1,250' upstream.;  Action: Remove trees and vegetation from riprap.; Station_1: 33+00; Station_2: 24+00</p>

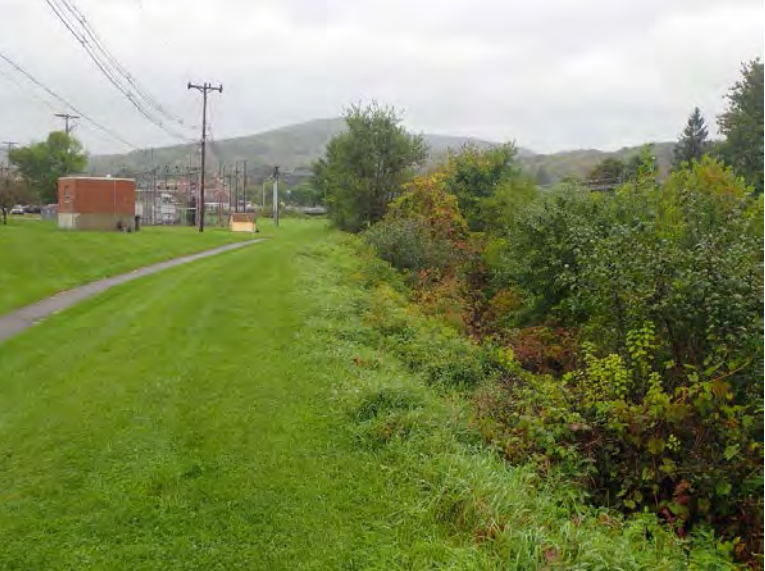
<p><b>Inspect ID:</b> N21L_2018_r_0107 <b>Title:</b> USACE_CELRB_N21L_2018_r_0107_5.jpg <b>Rated Item:</b> 12. Riprap Revetments &amp; Bank Protection <b>Caption:</b> Rated Item: 1. Unwanted Vegetation Growth; Rating: Unacceptable; Remarks: Trees and vegetation in riprap on left bank channel side slope from State Street bridge to 1,250' upstream.; Action: Remove trees and vegetation from riprap.; Station_1: 33+00; Station_2: 24+00</p>

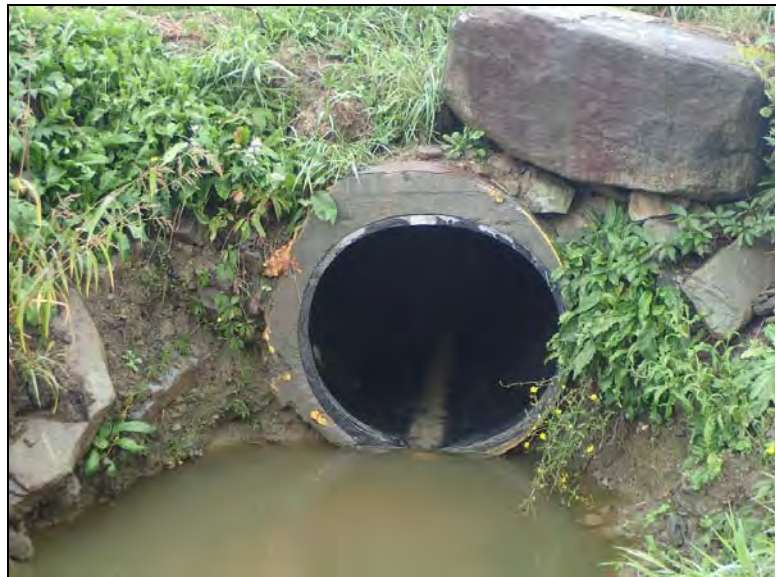
<p><b>Inspect ID:</b> N21L_2018_r_0124 <b>Title:</b> USACE_CELRB_N21L_2018_r_0124_1.jpg <b>Rated Item:</b> 2. Encroachments <b>Caption:</b> Rating: Acceptable; Remarks: Approved alteration: HDPE slipline inserted into 48" CMP under Dyke Street access road on left bank.; Action: NA; Station_1: 23+00</p>

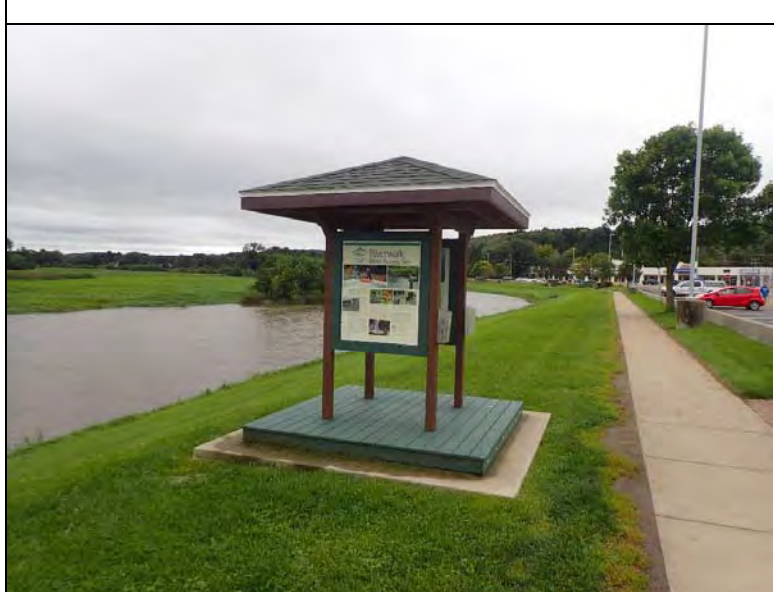
<p><b>Inspect ID:</b> N21L_2018_r_0027 <b>Title:</b> USACE_CELRB_N21L_2018_r_0027_1.jpg <b>Rated Item:</b> 1. Vegetation and Obstructions <b>Caption:</b> Rating: Minimally Acceptable; <b>Remarks:</b> Unauthorized alteration (E-5): Riverwalk kiosk on left bank channel crest.; <b>Action:</b> Submit Section 408 Alteration Request to USACE.; <b>Station_1:</b> 85+00</p>

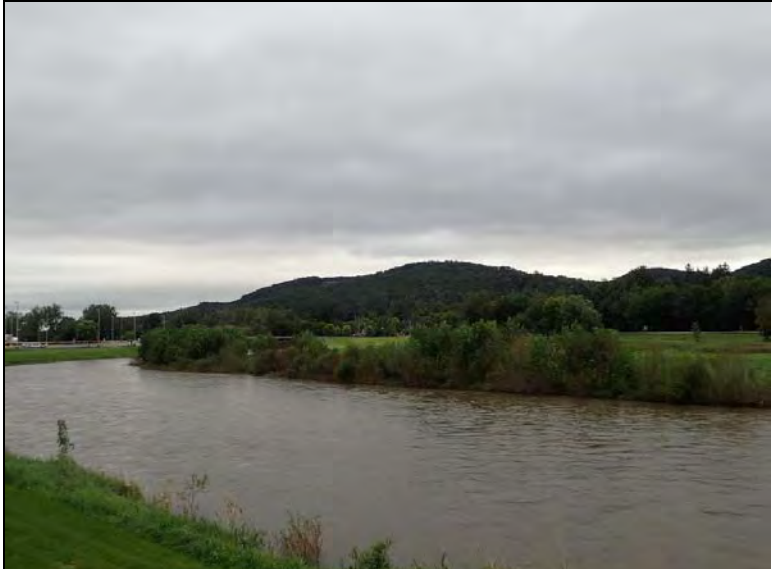
<p><b>Inspect ID:</b> N21L_2018_r_0030 <b>Title:</b> USACE_CELRB_N21L_2018_r_0030_2.jpg <b>Rated Item:</b> 1. Vegetation and Obstructions <b>Caption:</b> Rating: Minimally Acceptable; <b>Remarks:</b> Unwanted vegetation on both bank sideslopes from 750' upstream of Bolivar Road bridge to Madison Street bridge.; <b>Action:</b> Remove unwanted vegetation.; <b>Station_1:</b> 84+00; <b>Station_2:</b> 44+00</p>

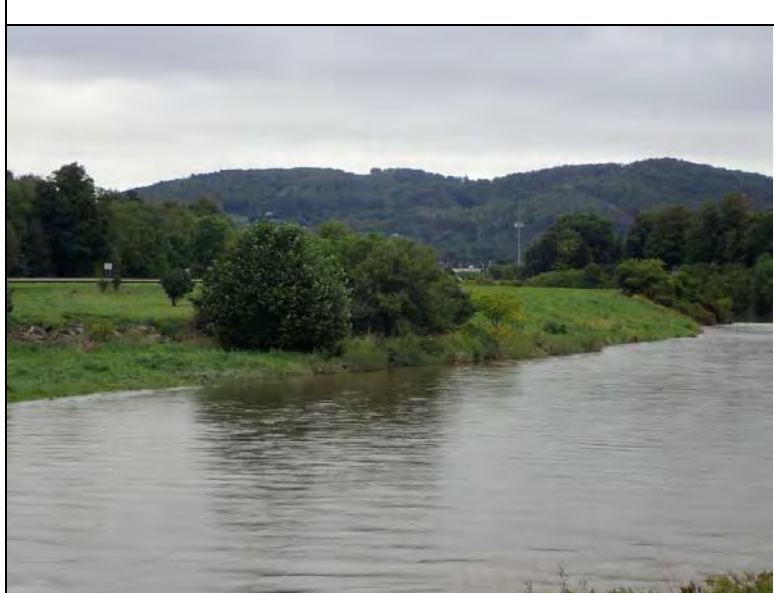
<p><b>Inspect ID:</b> N21L_2018_r_0030 <b>Title:</b> USACE_CELRB_N21L_2018_r_0030_4.jpg <b>Rated Item:</b> 1. Vegetation and Obstructions <b>Caption:</b> Rating: Minimally Acceptable; <b>Remarks:</b> Unwanted vegetation on both bank sideslopes from 750' upstream of Bolivar Road bridge to Madison Street bridge.; <b>Action:</b> Remove unwanted vegetation.; <b>Station_1:</b> 84+00; <b>Station_2:</b> 44+00</p>

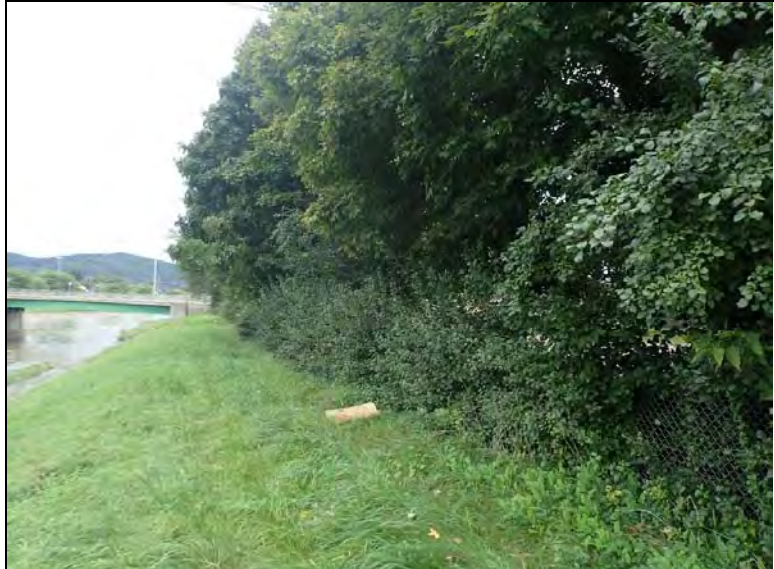
<p><b>Inspect ID:</b> N21L_2018_r_0094 <b>Title:</b> USACE_CELRB_N21L_2018_r_0094_1.jpg <b>Rated Item:</b> 1. Vegetation and Obstructions <b>Caption:</b> Rating: Minimally Acceptable; Remarks: Trees on left bank channel crest from 250' downstream of Madison Street (Stevens Street) bridge to Madison Street bridge.; Action: Remove trees.; Station_1: 46+00; Station_2: 44+00</p>

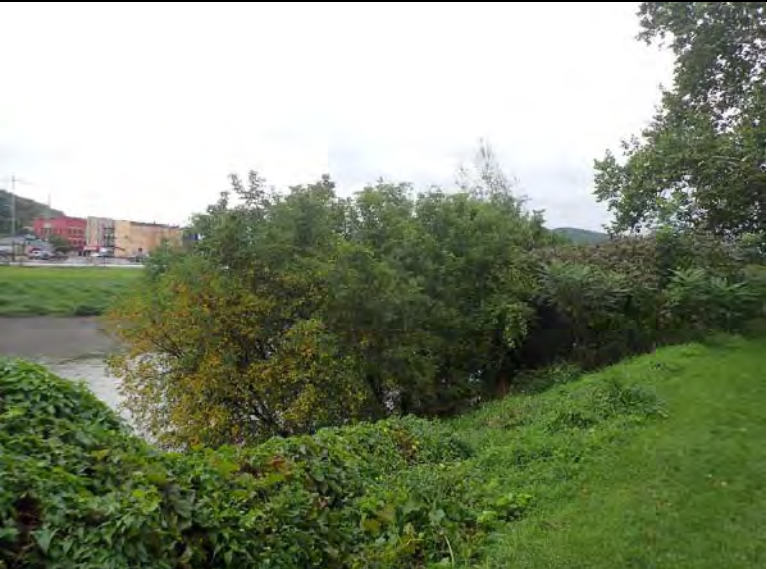
<p><b>Inspect ID:</b> N21L_2018_r_0104 <b>Title:</b> USACE_CELRB_N21L_2018_r_0104_2.jpg <b>Rated Item:</b> 1. Vegetation and Obstructions <b>Caption:</b> Rating: Unacceptable; Remarks: Unwanted vegetation and trees on left bank 400' downstream of State Street bridge.; <b>Action:</b> Remove unwanted vegetation and trees.; Station_1: 37+00</p>

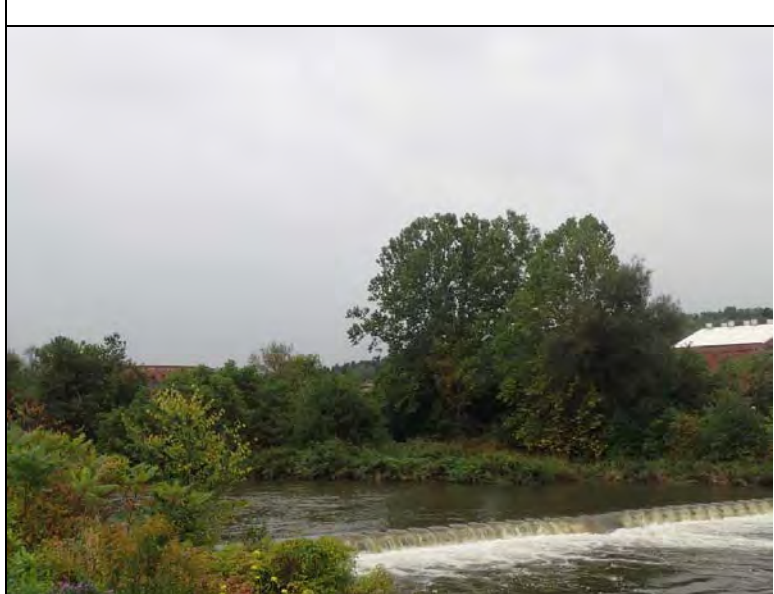
<p><b>Inspect ID:</b> N21L_2018_r_0140 <b>Title:</b> USACE_CELRB_N21L_2018_r_0140_1.jpg <b>Rated Item:</b> 1. Vegetation and Obstructions <b>Caption:</b> Rating: Unacceptable; <b>Remarks:</b> Trees and vegetation on left bank 175' upstream of barrier levee weir.; <b>Action:</b> Remove unwanted vegetation.; <b>Station_1:</b> 0+00</p>

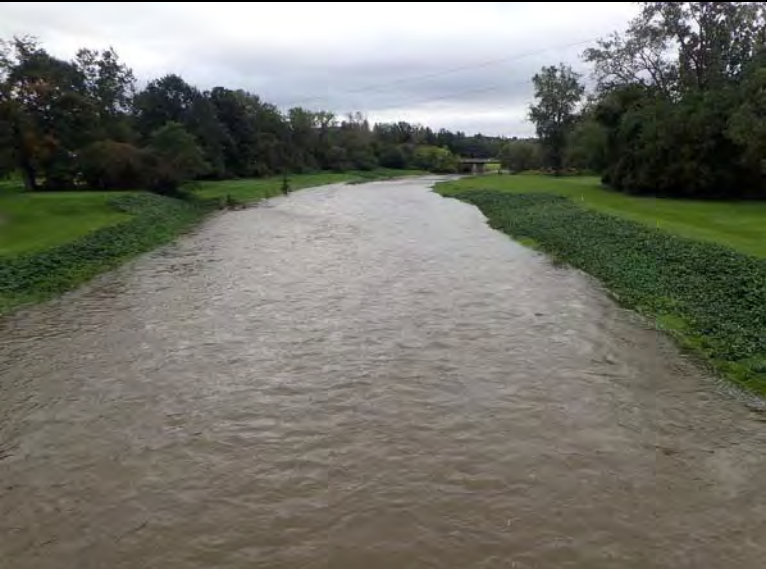
<p><b>Inspect ID:</b> N21L_2018_r_0008 <b>Title:</b> USACE_CELRB_N21L_2018_r_0008_1.jpg <b>Rated Item:</b> 2. Shoaling (sediment deposition) <b>Caption:</b> Rating: Minimally Acceptable; Remarks: Four alternating vegetated shoals (S-2, S-3, S-4, S-5) on both banks from green golf course pedestrian bridge to Bolivar Road bridge.; Action: Remove shoals.; Station_1: 103+00; Station_2: 92+00</p>

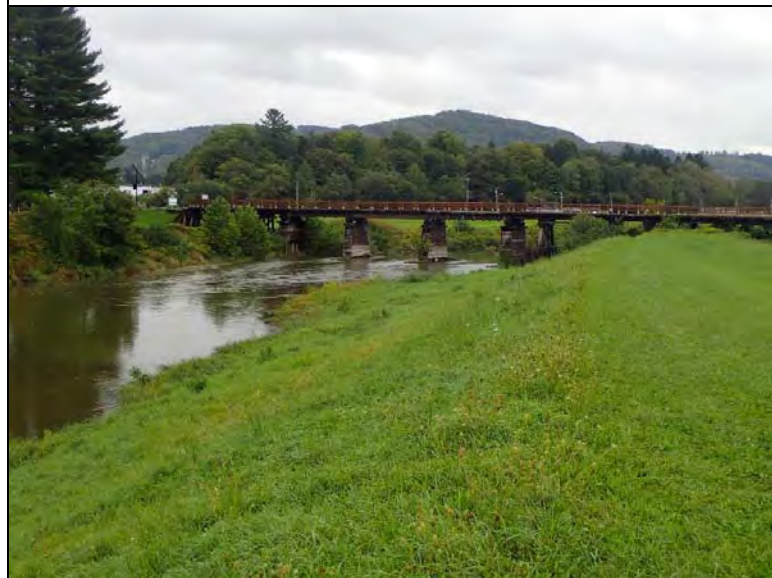
**Inspect ID:** N21L\_2018\_r\_0126 **Title:** USACE\_CELRB\_N21L\_2018\_r\_0126\_1.jpg  
**Rated Item:** 2. Shoaling (sediment deposition) **Caption:** Rating: Minimally Acceptable;  
**Remarks:** Shoal (S-9) along left bank toe from 450' downstream of Island Park pedestrian  
walkway bridge to Island Park Pedestrian Walkway Bridge.; **Action:** Remove shoaling.;  
**Station\_1:** 17+00; **Station\_2:** 21+00

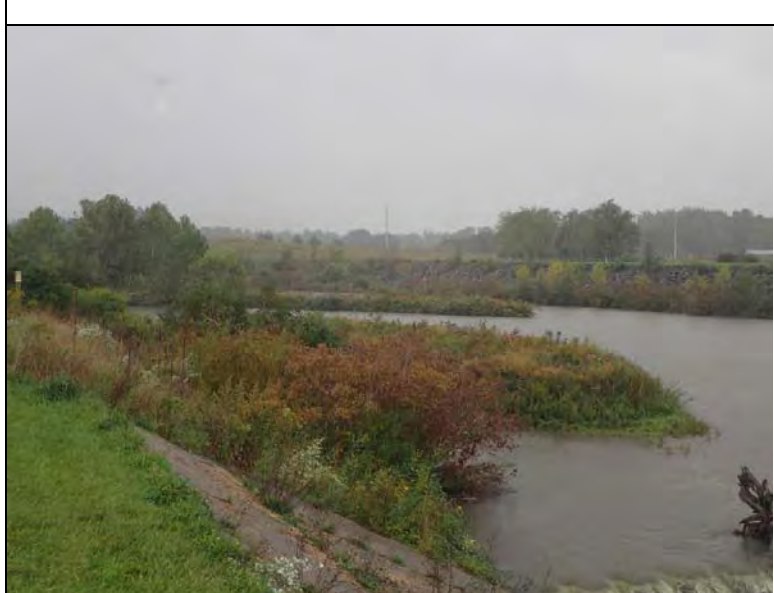
<p><b>Inspect ID:</b> N21L_2018_r_0146 <b>Title:</b> USACE_CELRB_N21L_2018_r_0146_1.jpg <b>Rated Item:</b> 2. Shoaling (sediment deposition) <b>Caption:</b> Rating: Unacceptable; <b>Remarks:</b> Significant vegetated shoaling (S-12) on right bank from 50' to 225' upstream of upstream limit weir.; <b>Action:</b> Remove shoaling.; <b>Station_1:</b> 0+00; <b>Station_2:</b> 0+00</p>

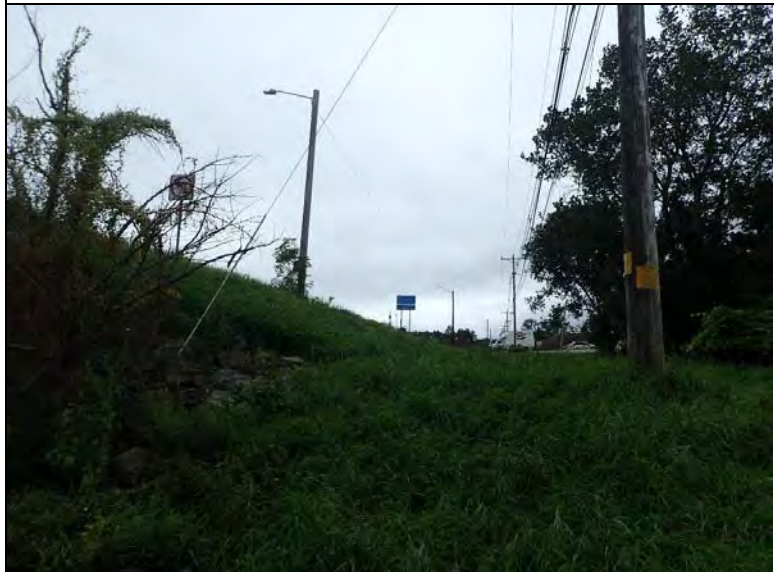
<p><b>Inspect ID:</b> N21L_2018_r_0018 <b>Title:</b> USACE_CELRB_N21L_2018_r_0018_2.jpg <b>Rated Item:</b> 3. Encroachments <b>Caption:</b> Rating: Acceptable; Remarks: Pending alteration: proposed recreational trail on right bank under bridge connecting Riverwalk trail to Bolivar Road. Currently processing Section 408 paperwork (as of 2/28/18); Action: USACE is processing Section 408 Alteration Request.; Station_1: 92+00</p>

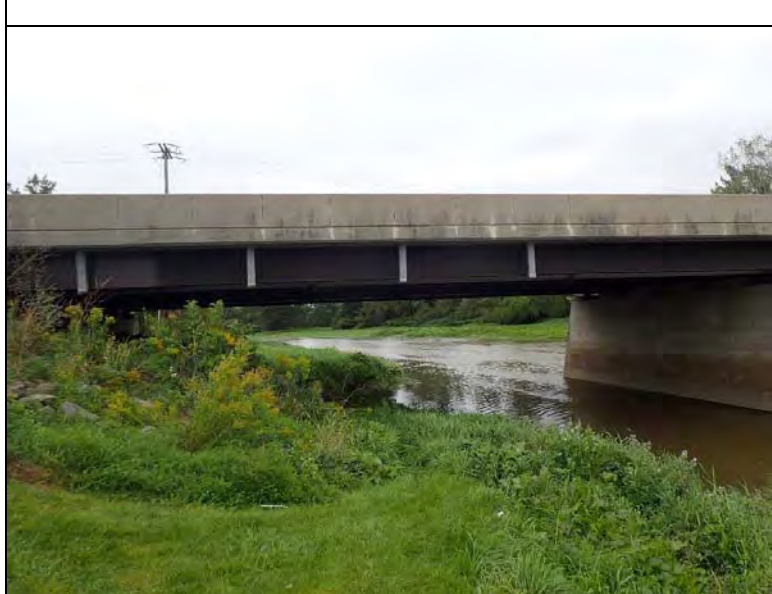
<p><b>Inspect ID:</b> N21L_2018_r_0018 <b>Title:</b> USACE_CELRB_N21L_2018_r_0018_4.jpg <b>Rated Item:</b> 3. Encroachments <b>Caption:</b> Rating: Acceptable; Remarks: Pending alteration: proposed recreational trail on right bank under bridge connecting Riverwalk trail to Bolivar Road. Currently processing Section 408 paperwork (as of 2/28/18); Action: USACE is processing Section 408 Alteration Request.; Station_1: 92+00</p>

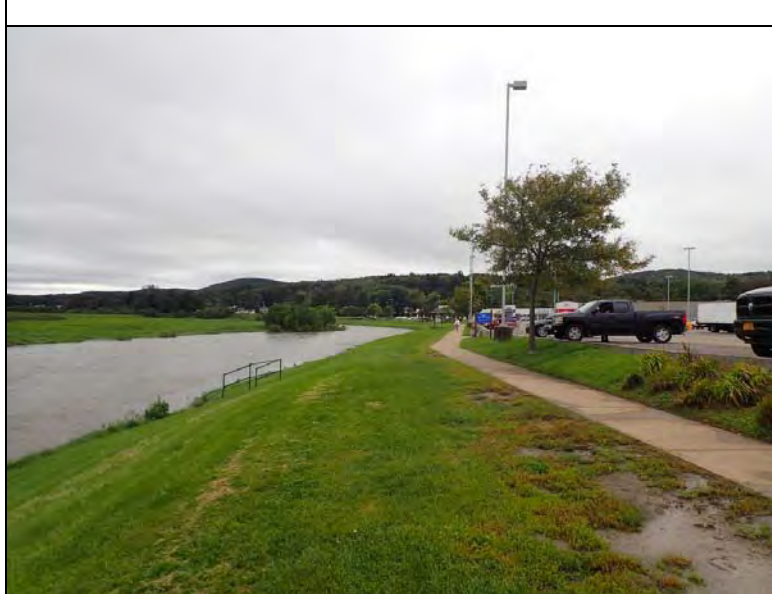
<p><b>Inspect ID:</b> N21L_2018_r_0023 <b>Title:</b> USACE_CELRB_N21L_2018_r_0023_1.jpg <b>Rated Item:</b> 3. Encroachments <b>Caption:</b> Rating: Minimally Acceptable; Remarks: Unauthorized alteration (E-4): Riverwalk encroachment (benches and lightposts are not encroachments) along left bank from Bolivar road bridge to 1,775 feet upstream of Bolivar Road bridge.; Action: Submit Section 408 Alteration Request to USACE.; Station_1: 90+00; Station_2: 76+00</p>

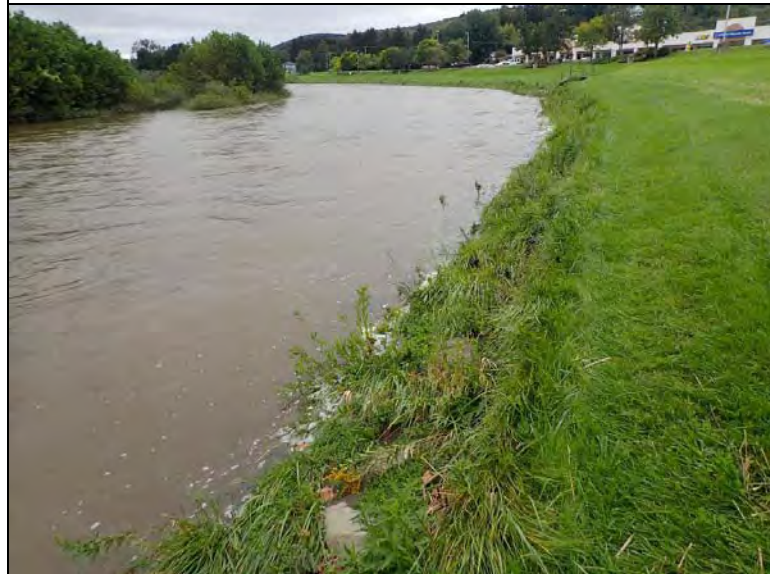
**Inspect ID:** N21L\_2018\_r\_0029 **Title:** USACE\_CELRB\_N21L\_2018\_r\_0029\_1.jpg  
**Rated Item:** 3. Encroachments **Caption:** Rating: Minimally Acceptable; Remarks:  
Unauthorized alteration (E-47a): Riprap added to left bank channel toe.; Action: Submit  
Section 408 Alteration Request to USACE.; Station\_1: 84+00; Station\_2: 68+00

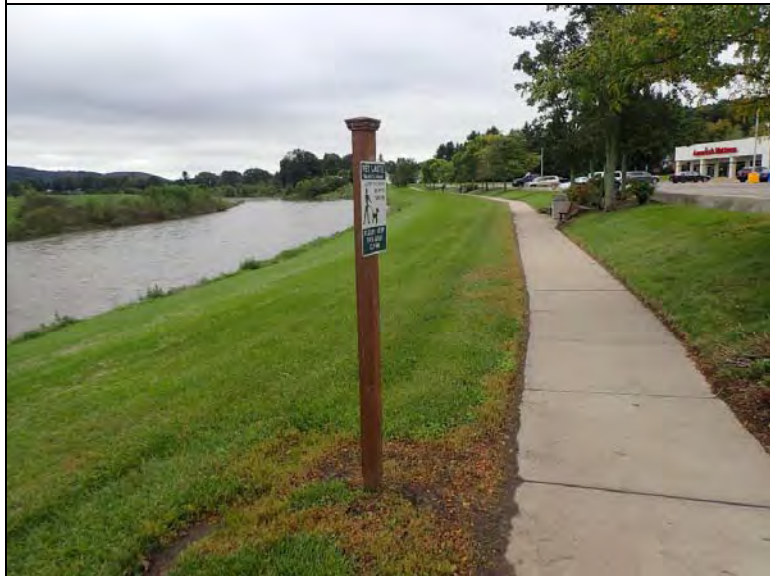
**Inspect ID:** N21L\_2018\_r\_0035 **Title:** USACE\_CELRB\_N21L\_2018\_r\_0035\_1.jpg  
**Rated Item:** 3. Encroachments **Caption:** Rating: Minimally Acceptable; Remarks:  
Unauthorized alteration (E-8): Pet sign and post encroachment on left bank channel crest.;  
Action: Remove or submit Section 408 Alteration Request to USACE.; Station\_1: 77+00

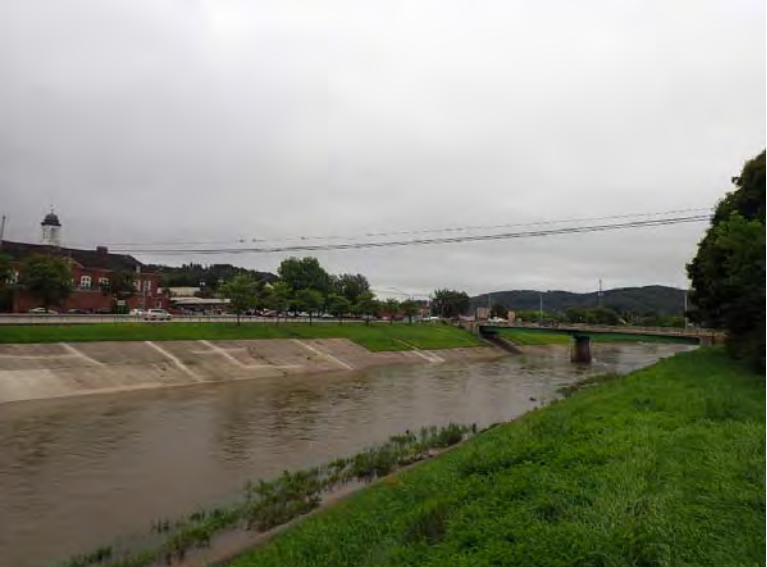
<p><b>Inspect ID:</b> N21L_2018_r_0090 <b>Title:</b> USACE_CELRB_N21L_2018_r_0090_1.jpg <b>Rated Item:</b> 3. Encroachments <b>Caption:</b> Rating: Minimally Acceptable; Remarks: Unauthorized alteration (E-27): Pipe Line bridge just downstream of Steven Street bridge has been removed.; Action: Submit Section 408 Alteration Request to USACE.; Station_1: 46+00</p>

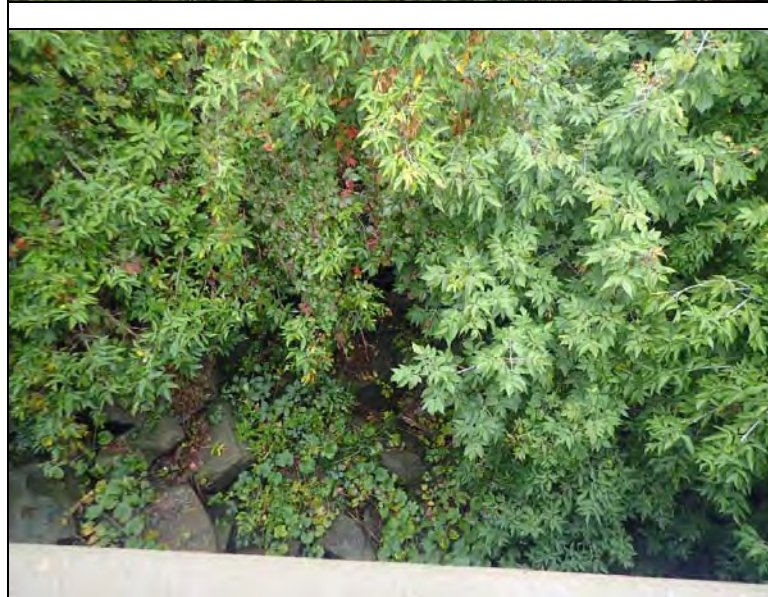
<p><b>Inspect ID:</b> N21L_2018_r_0106 <b>Title:</b> USACE_CELRB_N21L_2018_r_0106_1.jpg  <b>Rated Item:</b> 3. Encroachments <b>Caption:</b> Rating: Minimally Acceptable; Remarks:  Unauthorized alteration (E-36): 18" HDPE outfall and duck bill valve on left bank side  slope just downstream of State Street bridge owned by NYSDOT. (NYSDEC says  permitted); Action: Submit Section 408 Alteration Request to USACE.; Station_1: 34+00</p>

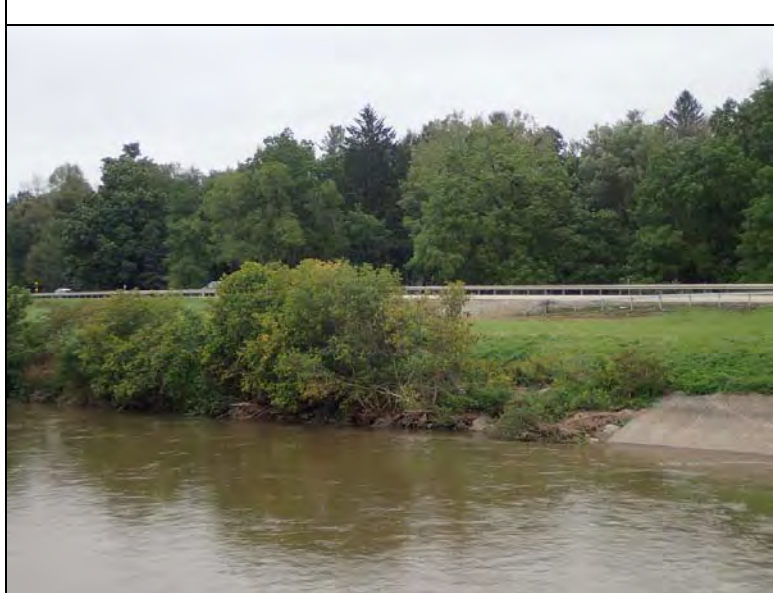
<p><b>Inspect ID:</b> N21L_2018_r_0072 <b>Title:</b> USACE_CELRB_N21L_2018_r_0072_1.jpg  <b>Rated Item:</b> 10. Riprap Revetments &amp; Banks <b>Caption:</b> Rating: Minimally Acceptable; Remarks: Trees and vegetation in riprap on right bank from 1,600' to 1,300' downstream of Madison Street (Stevens Street) bridge.; Action: Remove trees and vegetation from riprap.; Station_1: 59+00; Station_2: 56+00</p>

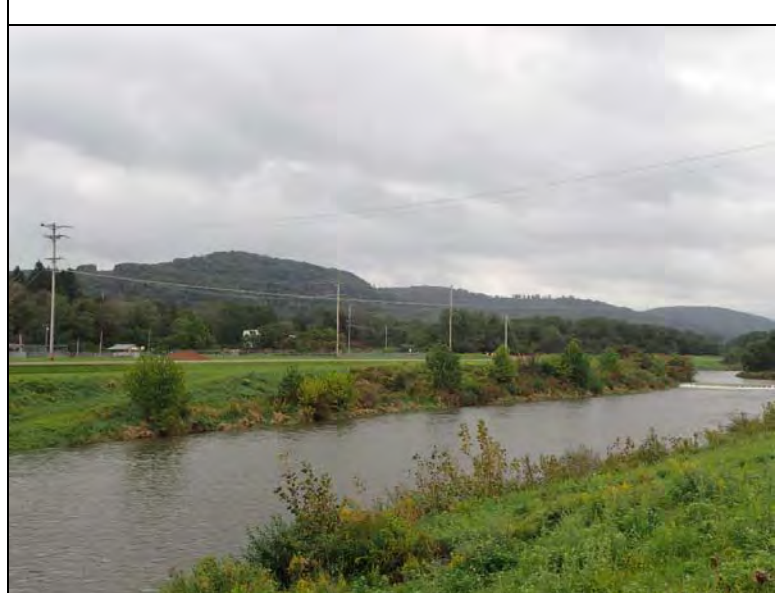
<p><b>Inspect ID:</b> N21L_2018_r_0135 <b>Title:</b> USACE_CELRB_N21L_2018_r_0135_1.jpg <b>Rated Item:</b> 10. Riprap Revetments &amp; Banks <b>Caption:</b> Rated Item: 1. Vegetation and Obstructions; Rating: Unacceptable; Remarks: Vegetation in riprap on right bank from 400' downstream of upstream limit weir to barrier levee weir.; Action: Remove vegetation from riprap.; Station_1: 4+00; Station_2: 0+00</p>

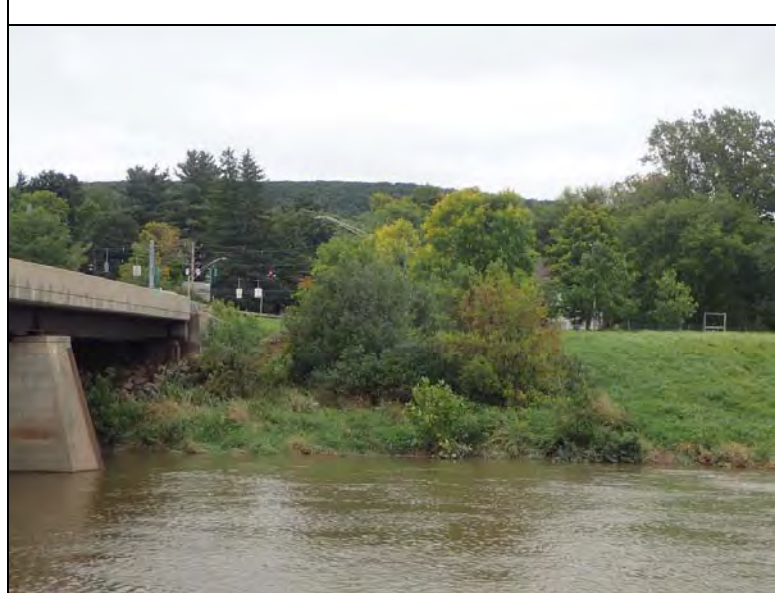
<p><b>Inspect ID:</b> N21L_2018_r_0153 <b>Title:</b> USACE_CELRB_N21L_2018_r_0153_2.jpg <b>Rated Item:</b> 10. Riprap Revetments &amp; Banks <b>Caption:</b> Rating: Minimally Acceptable; Remarks: Trees and vegetation in riprap on right bank around both sides of Bolivar Road bridge.; Action: Remove trees and vegetation from riprap.; Station_1: 91+00; Station_2: 91+00</p>

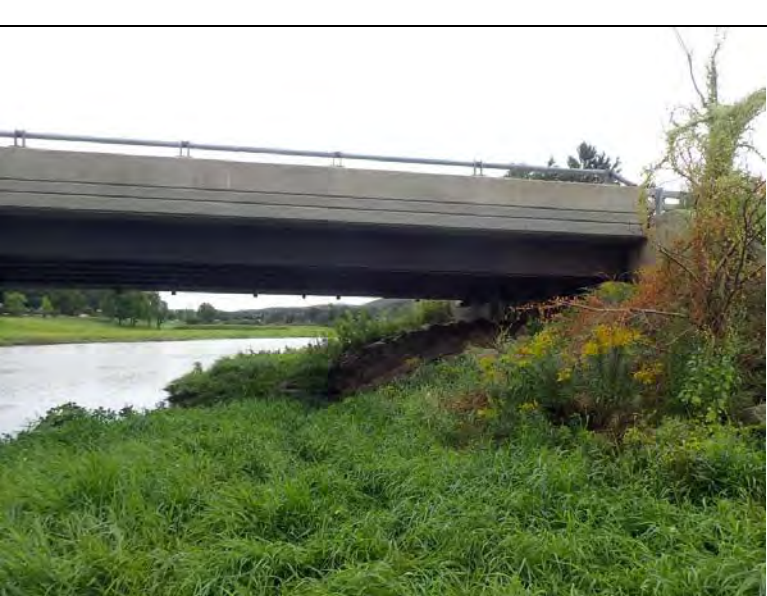
<p><b>Inspect ID:</b> N21L_2018_r_0154 <b>Title:</b> USACE_CELRB_N21L_2018_r_0154_2.jpg <b>Rated Item:</b> 10. Riprap Revetments &amp; Banks <b>Caption:</b> Rating: Minimally Acceptable; <b>Remarks:</b> Vegetation in unauthorized riprap on left bank around both sides of Bolivar Road bridge.; <b>Action:</b> Remove vegetation from riprap.; <b>Station_1:</b> 92+00; <b>Station_2:</b> 91+00</p>

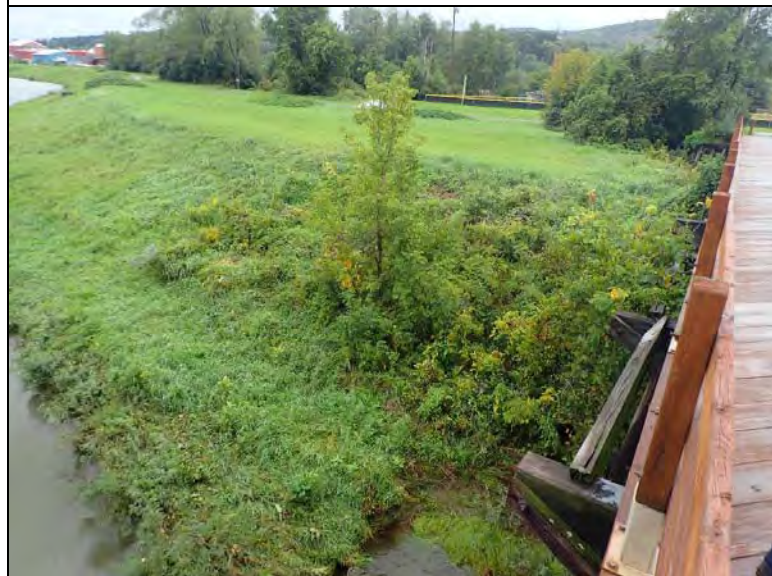
**Inspect ID:** N21L\_2018\_r\_0165 **Title:** USACE\_CELRB\_N21L\_2018\_r\_0165\_2.jpg  
**Rated Item:** 10. Riprap Revetments & Banks **Caption:** Rating: Minimally Acceptable;  
Remarks: Trees and vegetation in riprap on left bank around both sides of Island Park  
Pedestrian Walkway Bridge; Action: Remove trees and vegetation from riprap.;  
Station\_1: 17+00; Station\_2: 16+00

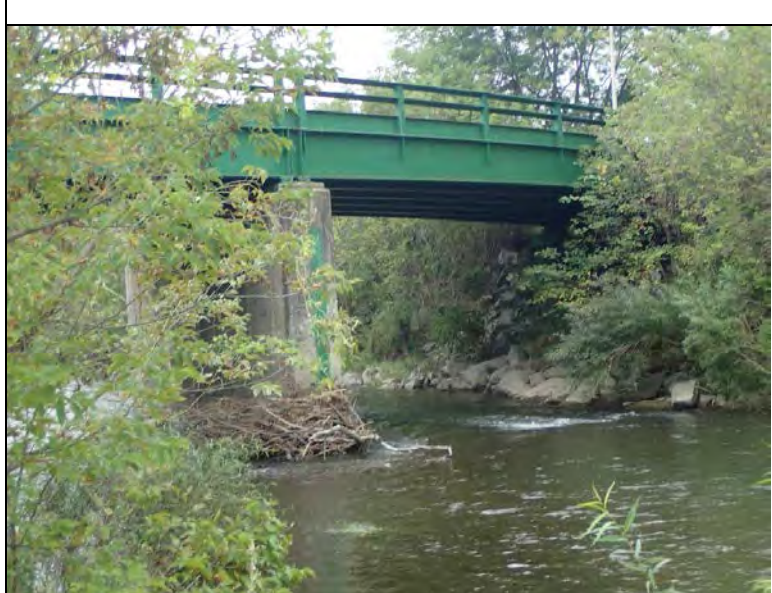
<p><b>Inspect ID:</b> N21R_2018_r_0020 <b>Title:</b> USACE_CELRB_N21R_2018_r_0020_1.jpg <b>Rated Item:</b> 1. Vegetation and Obstructions <b>Caption:</b> Rating: Minimally Acceptable; Remarks: Tree debris in channel on pier of Broad Street bridge. (Dyke Creek); Action: Remove tree debris.; Station_1: D 24+00</p>

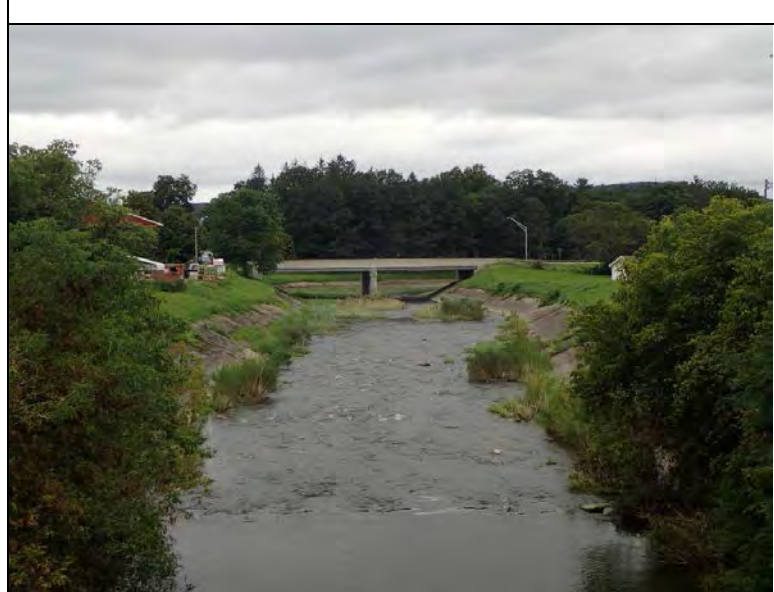
<p><b>Inspect ID:</b> N21R_2018_r_0034 <b>Title:</b> USACE_CELRB_N21R_2018_r_0034_1.jpg <b>Rated Item:</b> 1. Vegetation and Obstructions <b>Caption:</b> Rating: Minimally Acceptable; <b>Remarks:</b> Unwanted vegetation in left and right bank concrete channel sideslopes.; <b>Action:</b> Remove unwanted vegetation from concrete channel sideslopes.; <b>Station_1:</b> D 18+00; <b>Station_2:</b> D 12+00</p>

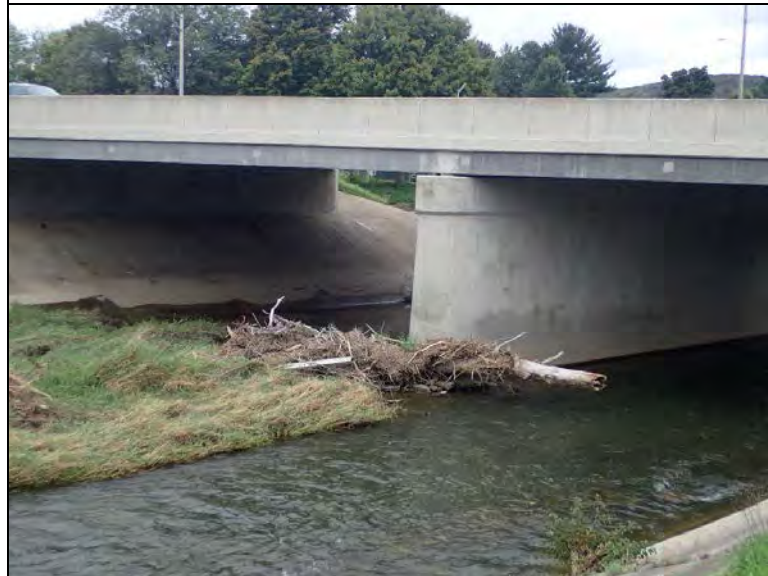
**Inspect ID:** N21R\_2018\_r\_0037 **Title:** USACE\_CELRB\_N21R\_2018\_r\_0037\_1.jpg  
**Rated Item:** 1. Vegetation and Obstructions **Caption:** Rating: Minimally Acceptable;  
Remarks: Tree debris in channel on pier of State Route 417 bridge.; Action: Remove tree  
debris.; Station\_1: D 12+00

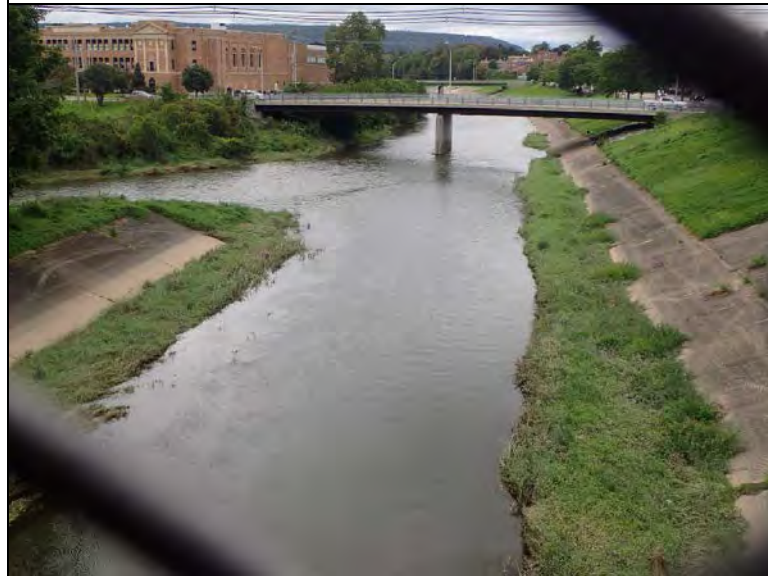
**Inspect ID:** N21R\_2018\_r\_0039 **Title:** USACE\_CELRB\_N21R\_2018\_r\_0039\_2.jpg  
**Rated Item:** 1. Vegetation and Obstructions **Caption:** Rating: Minimally Acceptable;  
**Remarks:** Unwanted vegetation in left and right bank concrete channel sideslopes.;  
**Action:** Remove unwanted vegetation from concrete channel sideslopes.; **Station\_1:** D  
11+00; **Station\_2:** D 2+00

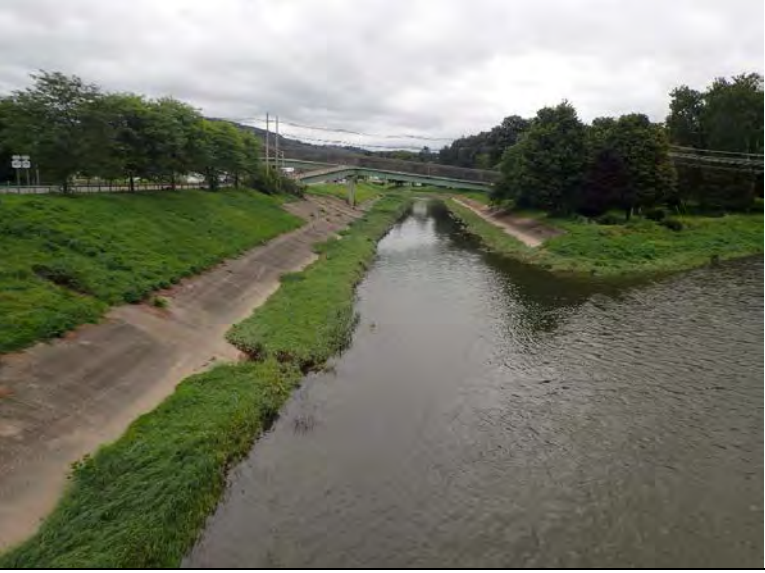
<p><b>Inspect ID:</b> N21R_2018_r_0039 <b>Title:</b> USACE_CELRB_N21R_2018_r_0039_3.jpg <b>Rated Item:</b> 1. Vegetation and Obstructions <b>Caption:</b> Rating: Minimally Acceptable; <b>Remarks:</b> Unwanted vegetation in left and right bank concrete channel sideslopes.; <b>Action:</b> Remove unwanted vegetation from concrete channel sideslopes.; Station_1: D 11+00; Station_2: D 2+00</p>

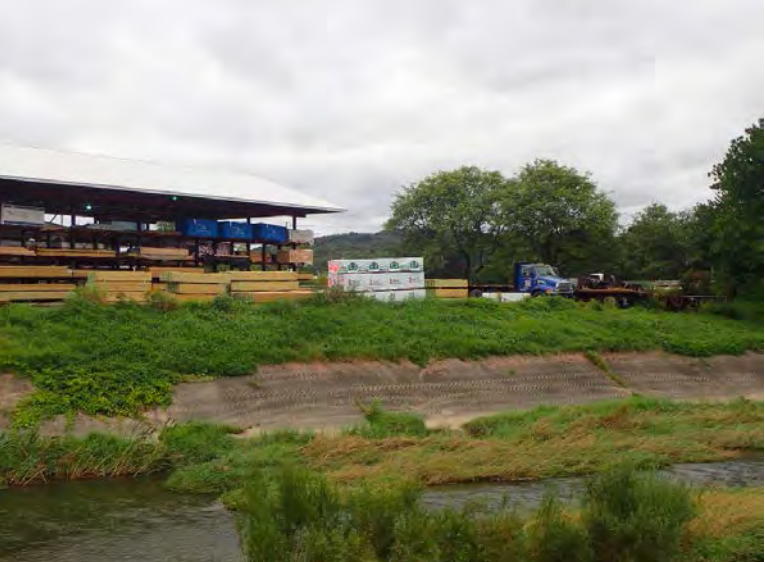
<p><b>Inspect ID:</b> N21R_2018_r_0049 <b>Title:</b> USACE_CELRB_N21R_2018_r_0049_1.jpg <b>Rated Item:</b> 1. Vegetation and Obstructions <b>Caption:</b> Rating: Minimally Acceptable; <b>Remarks:</b> Vegetation in excess of 12" on both banks of channel from State Route 417 bridge to Main Street bridge. ; <b>Action:</b> Mow vegetation to 3"-6" height.; Station_1: D 17+00; Station_2: D 11+00; ; ;</p>

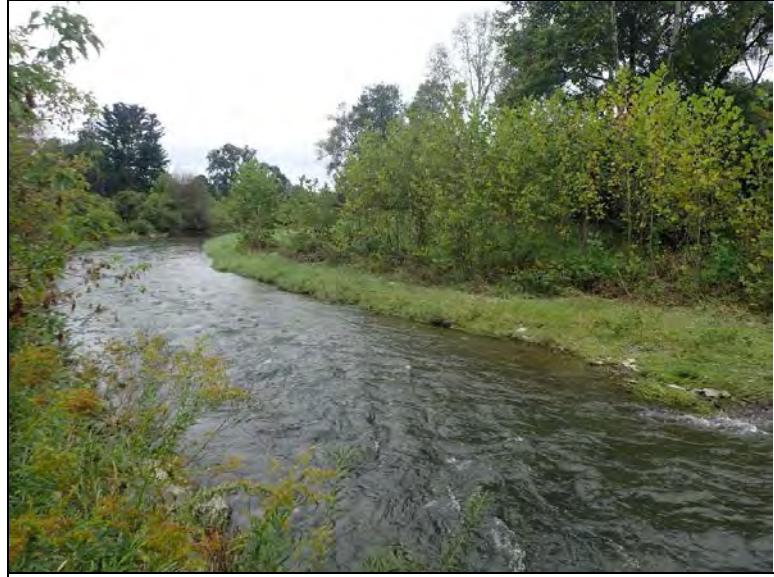
<p><b>Inspect ID:</b> N21R_2018_r_0004 <b>Title:</b> USACE_CELRB_N21R_2018_r_0004_2.jpg <b>Rated Item:</b> 2. Shoaling (sediment deposition) <b>Caption:</b> Rating: Minimally Acceptable; <b>Remarks:</b> Shoaling (S-14) on right bank from 200' upstream of drop structure to upstream project limit. (Dyke Creek).; <b>Action:</b> Remove shoaling.; <b>Station_1:</b> 35+00; <b>Station_2:</b> 35+00</p>
 	<p><b>Inspect ID:</b> N21R_2018_r_0004 <b>Title:</b> USACE_CELRB_N21R_2018_r_0004_3.jpg <b>Rated Item:</b> 2. Shoaling (sediment deposition) <b>Caption:</b> Rating: Minimally Acceptable; <b>Remarks:</b> Shoaling (S-14) on right bank from 200' upstream of drop structure to upstream project limit. (Dyke Creek).; <b>Action:</b> Remove shoaling.; <b>Station_1:</b> 35+00; <b>Station_2:</b> 35+00</p>

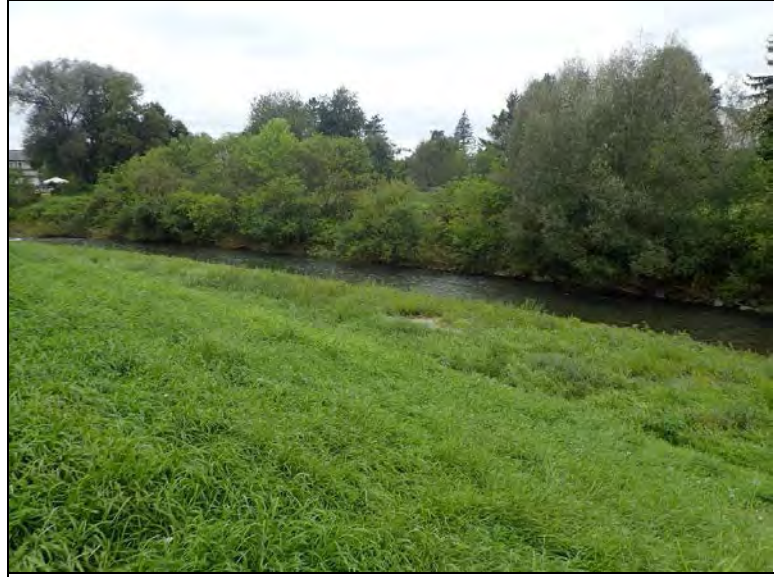
<p><b>Inspect ID:</b> N21R_2018_r_0017 <b>Title:</b> USACE_CELRB_N21R_2018_r_0017_2.jpg <b>Rated Item:</b> 2. Shoaling (sediment deposition) <b>Caption:</b> Rating: Minimally Acceptable; <b>Remarks:</b> Shoaling (S-16) on left bank and in center of channel from drop structure to Broadway Street bridge. (Dyke Creek); <b>Action:</b> Remove shoal.; <b>Station_1:</b> 24+00; <b>Station_2:</b> 33+00</p>

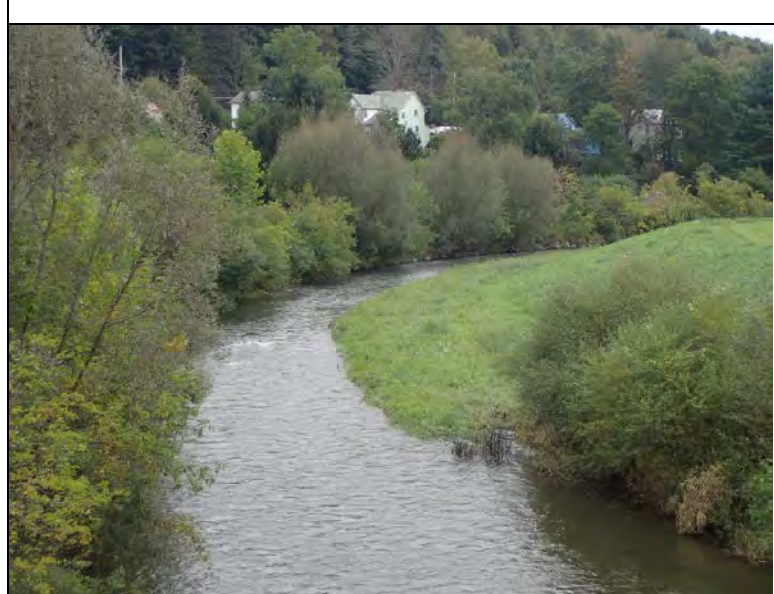
<p><b>Inspect ID:</b> N21R_2018_r_0017 <b>Title:</b> USACE_CELRB_N21R_2018_r_0017_3.jpg <b>Rated Item:</b> 2. Shoaling (sediment deposition) <b>Caption:</b> Rating: Minimally Acceptable; <b>Remarks:</b> Shoaling (S-16) on left bank and in center of channel from drop structure to Broadway Street bridge. (Dyke Creek); <b>Action:</b> Remove shoal.; <b>Station_1:</b> 24+00; <b>Station_2:</b> 33+00</p>
