## DEPARTMENT OF THE ARMY

BUFFALO DISTRICT, CORPS OF ENGINEERS  
1776 NIAGARA STREET  
BUFFALO, NEW YORK 14207-3199

SUBJECT: FY18 Joint Routine Inspection of Completed Works, Flood Risk Management Project, Genesee River and Dyke Creek, Wellsville, New York (09/24/18)

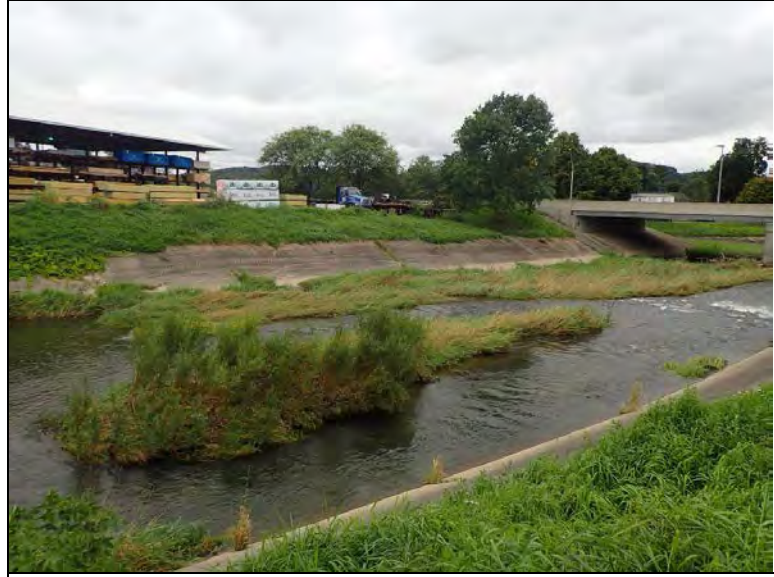
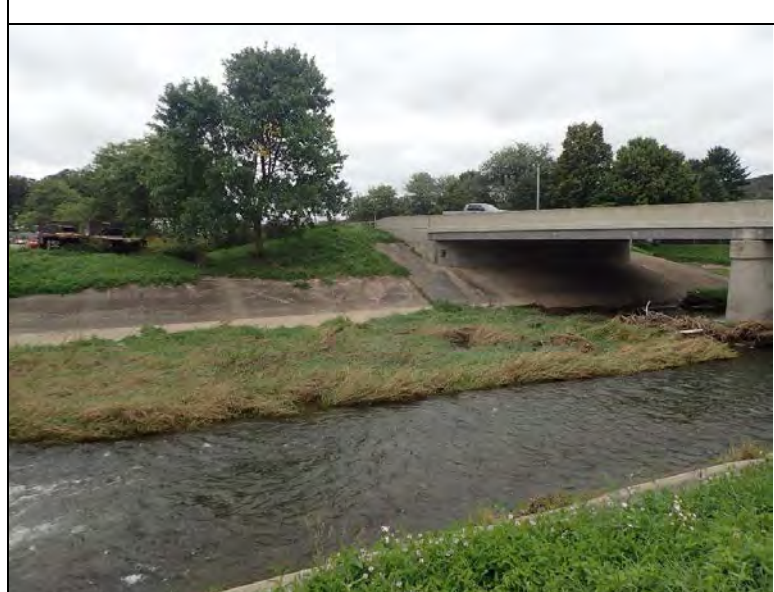
<p><b>Inspect ID:</b> N21R_2018_r_0036 <b>Title:</b> USACE_CELRB_N21R_2018_r_0036_1.jpg <b>Rated Item:</b> 2. Shoaling (sediment deposition) <b>Caption:</b> Rating: Minimally Acceptable; <b>Remarks:</b> Vegetated shoals (S-17) on concrete sideslopes on both banks and in channel from State Route 417 bridge to Main Street bridge. (Dyke Creek); <b>Action:</b> Remove vegetation from concrete.; Station_1: 12+00; Station_2: 18+00</p>

<p><b>Inspect ID:</b> N21R_2018_r_0036 <b>Title:</b> USACE_CELRB_N21R_2018_r_0036_2.jpg <b>Rated Item:</b> 2. Shoaling (sediment deposition) <b>Caption:</b> Rating: Minimally Acceptable; <b>Remarks:</b> Vegetated shoals (S-17) on concrete sideslopes on both banks and in channel from State Route 417 bridge to Main Street bridge. (Dyke Creek); <b>Action:</b> Remove vegetation from concrete.; Station_1: 12+00; Station_2: 18+00</p>

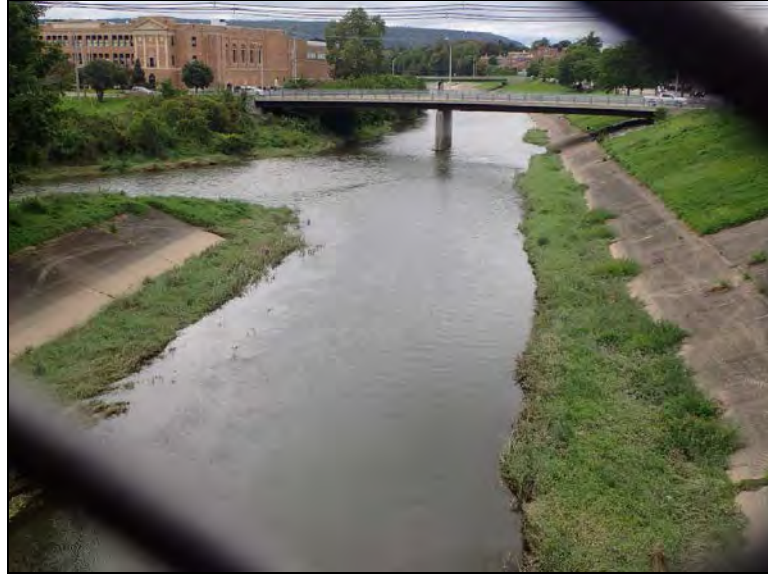
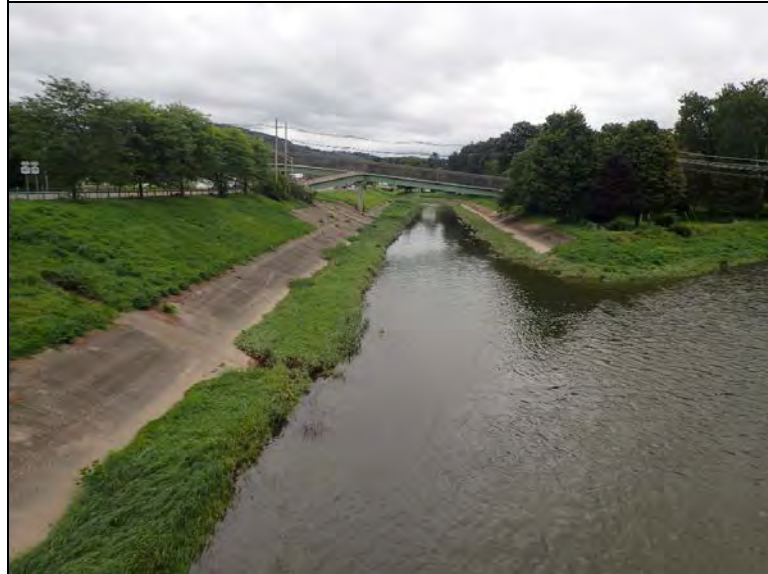
**Inspect ID:** N21R\_2018\_r\_0040 **Title:** USACE\_CELRB\_N21R\_2018\_r\_0040\_3.jpg  
**Rated Item:** 2. Shoaling (sediment deposition) **Caption:** Rating: Unacceptable;  
Remarks: Vegetated shoaling (S-18) on both banks from convergence of Dyke Creek to the State Route 417 bridge.; Action: Remove shoaling.; Station\_1: 11+00; Station\_2: 2+00

**Inspect ID:** N21R\_2018\_r\_0040 **Title:** USACE\_CELRB\_N21R\_2018\_r\_0040\_4.jpg  
**Rated Item:** 2. Shoaling (sediment deposition) **Caption:** Rating: Unacceptable;  
Remarks: Vegetated shoaling (S-18) on both banks from convergence of Dyke Creek to the State Route 417 bridge.; Action: Remove shoaling.; Station\_1: 11+00; Station\_2: 2+00

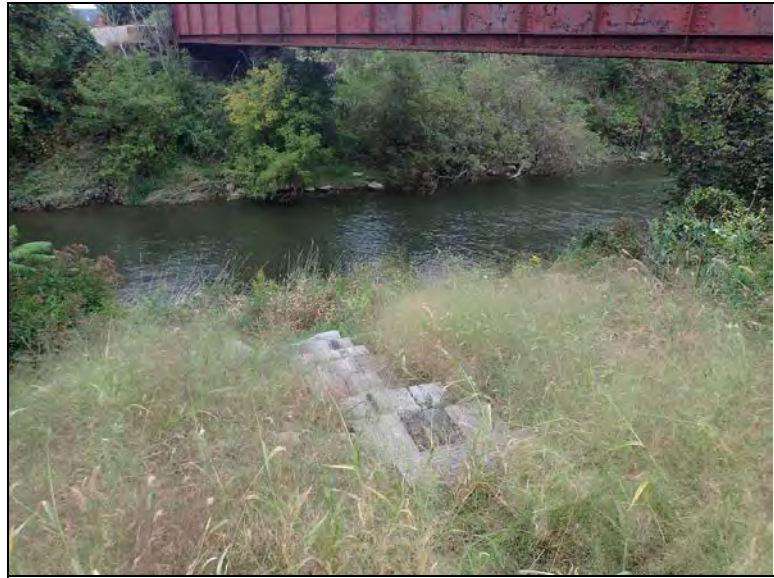
<p><b>Inspect ID:</b> N21R_2018_r_0022 <b>Title:</b> USACE_CELRB_N21R_2018_r_0022_1.jpg <b>Rated Item:</b> 3. Encroachments <b>Caption:</b> Rating: Minimally Acceptable; Remarks: Unauthorized alteration (E-51): wood stairs on left bank channel slope just downstream of railroad bridge. (Dyke Creek); Action: Submit Section 408 Alteration Request to USACE.; Station_1: 21+00</p>

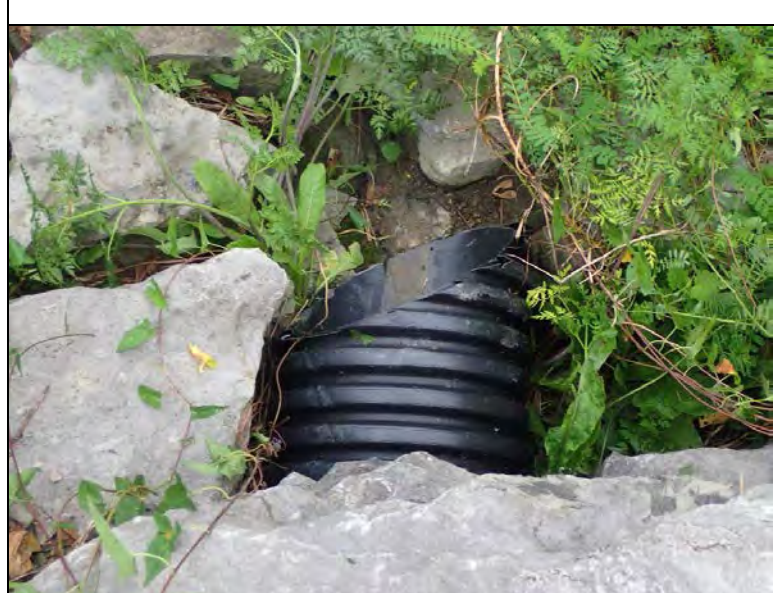
<p><b>Inspect ID:</b> N21R_2018_r_0023 <b>Title:</b> USACE_CELRB_N21R_2018_r_0023_1.jpg <b>Rated Item:</b> 3. Encroachments <b>Caption:</b> Rating: Acceptable; Remarks: 12" HDPE encroachment on left bank, 50' downstream of Railroad bridge.; Action: No alteration request needed for channel pipes less than or equal to 12"; Station_1: D 22+00</p>

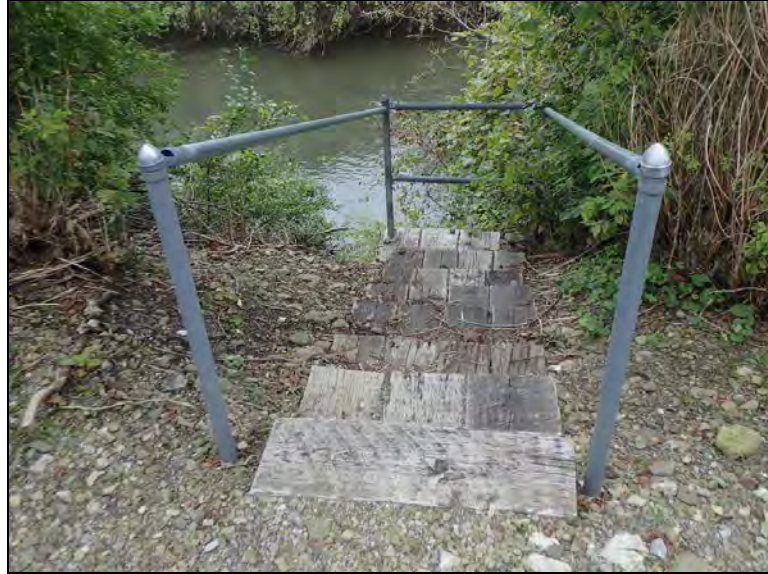
**Inspect ID:** N21R\_2018\_r\_0025 **Title:** USACE\_CELRB\_N21R\_2018\_r\_0025\_1.jpg  
**Rated Item:** 3. Encroachments **Caption:** Rating: Minimally Acceptable; Remarks:  
Unauthorized alteration (E-52): wooden stairs and railing encroachments on left bank  
channel slope just downstream of railroad bridge. (Dyke Creek); Action: Remove or  
submit Section 408 Alteration Request to USACE.; Station\_1: 21+00

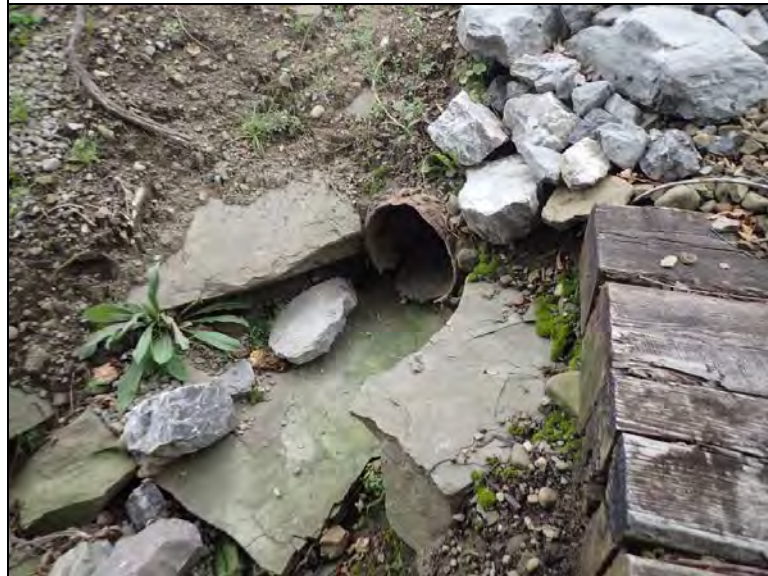
**Inspect ID:** N21R\_2018\_r\_0028 **Title:** USACE\_CELRB\_N21R\_2018\_r\_0028\_1.jpg  
**Rated Item:** 3. Encroachments **Caption:** Rating: Acceptable; Remarks: 12' metal outfall  
encroachment on left bank, just upstream of Main Street bridge. (Dyke Creek); Action:  
No alteration request needed for channel pipes less than or equal to 12".; Station\_1: D  
20+00

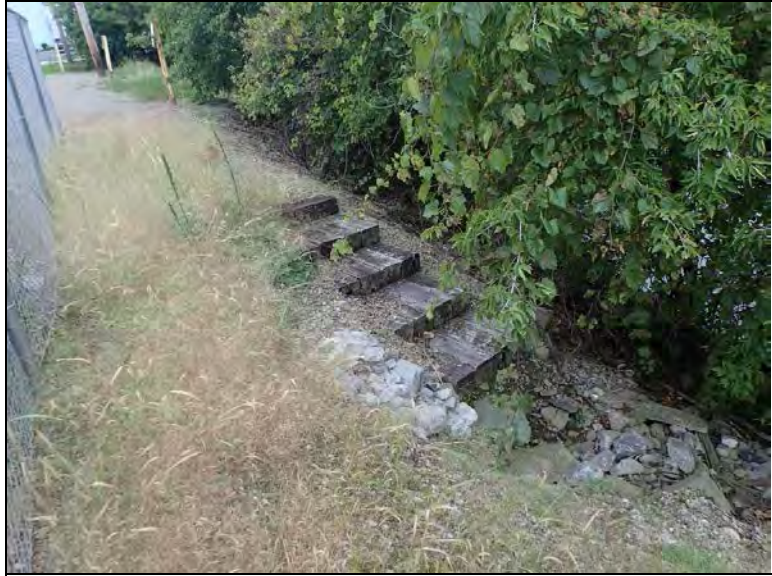
<p><b>Inspect ID:</b> N21R_2018_r_0029 <b>Title:</b> USACE_CELRB_N21R_2018_r_0029_1.jpg <b>Rated Item:</b> 3. Encroachments <b>Caption:</b> Rating: Minimally Acceptable; Remarks: Unauthorized alteration (E-53): wood stairs left bank channel slope. (Dyke Creek); Action: Remove or submit Section 408 Alteration Request to USACE.; Station_1: 20+00</p>

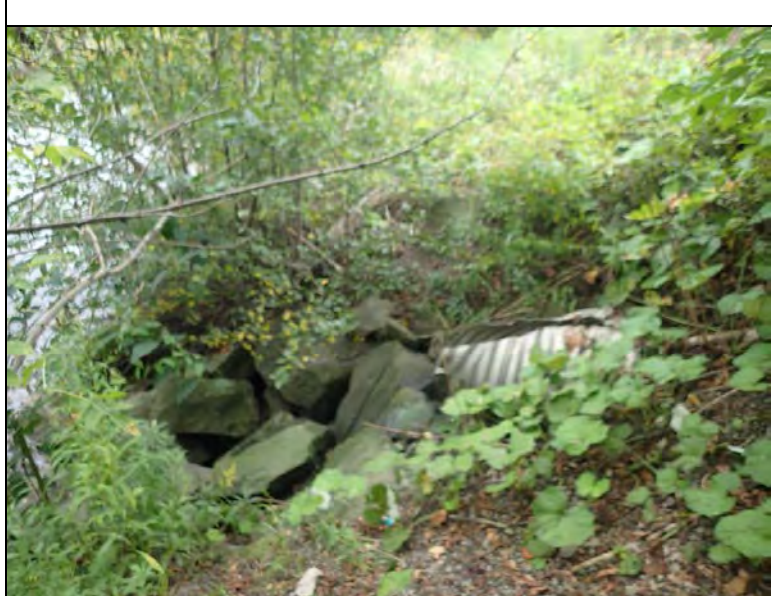
<p><b>Inspect ID:</b> N21R_2018_r_0031 <b>Title:</b> USACE_CELRB_N21R_2018_r_0031_1.jpg <b>Rated Item:</b> 3. Encroachments <b>Caption:</b> Rating: Minimally Acceptable; Remarks: Unauthorized alteration (E-53a): 24" CMP outfall on left bank channel sideslope, 50' upstream of Main Street bridge.; Action: Remove or submit Section 408 Alteration Request to USACE.; Station_1: D 19+00</p>

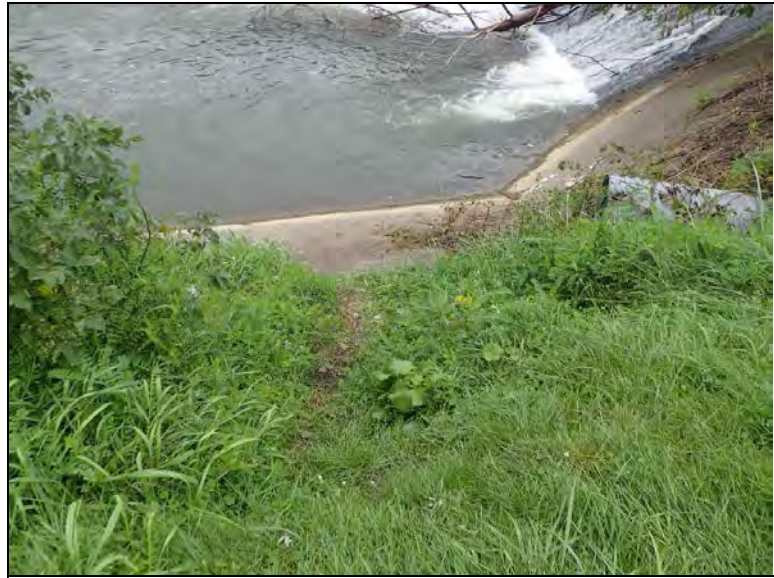
<p><b>Inspect ID:</b> N21R_2018_r_0014 <b>Title:</b> USACE_CELRB_N21R_2018_r_0014_1.jpg <b>Rated Item:</b> 4. Erosion <b>Caption:</b> Rating: Minimally Acceptable; Remarks: Erosion on left bank channel sideslope just downstream of drop structure.; Action: Repair erosion.; Station_1: D 35+00</p>

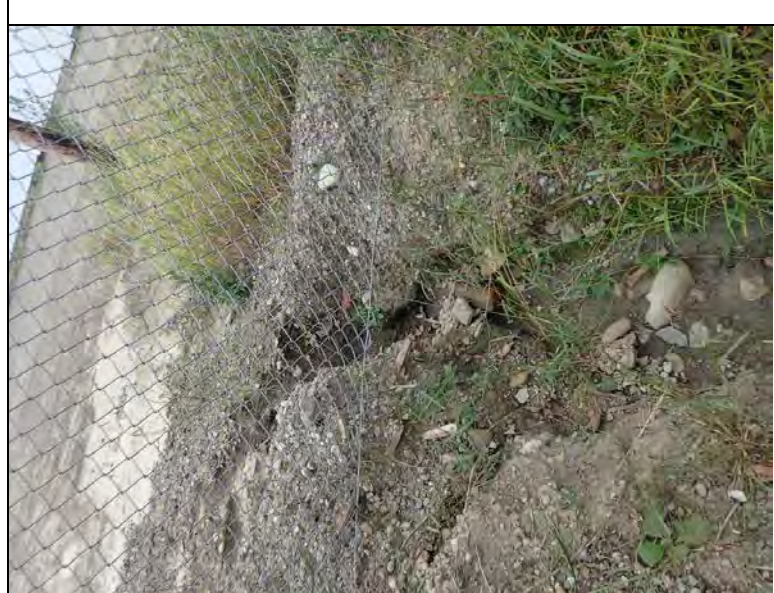
<p><b>Inspect ID:</b> N21R_2018_r_0027 <b>Title:</b> USACE_CELRB_N21R_2018_r_0027_1.jpg <b>Rated Item:</b> 4. Erosion <b>Caption:</b> Rating: Minimally Acceptable; Remarks: Erosion on left bank channel sideslope 175' upstream of Main St. bridge, caused by parking lot drainage; Action: Repair erosion.; Station_1: D 20+00</p>

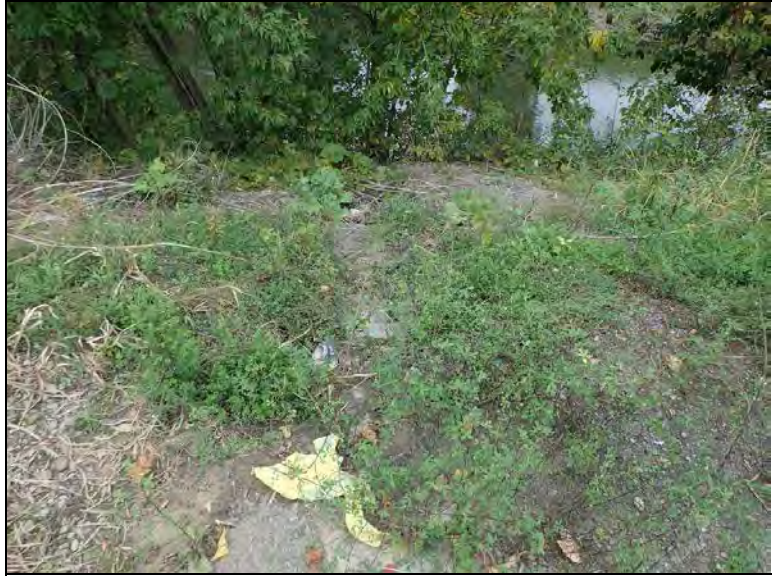
<p><b>Inspect ID:</b> N21R_2018_r_0030 <b>Title:</b> USACE_CELRB_N21R_2018_r_0030_1.jpg <b>Rated Item:</b> 4. Erosion <b>Caption:</b> Rating: Minimally Acceptable; Remarks: Erosion on left bank upstream of Main Street. (Dyke Creek); Action: Repair erosion.; Station_1: 19+00</p>

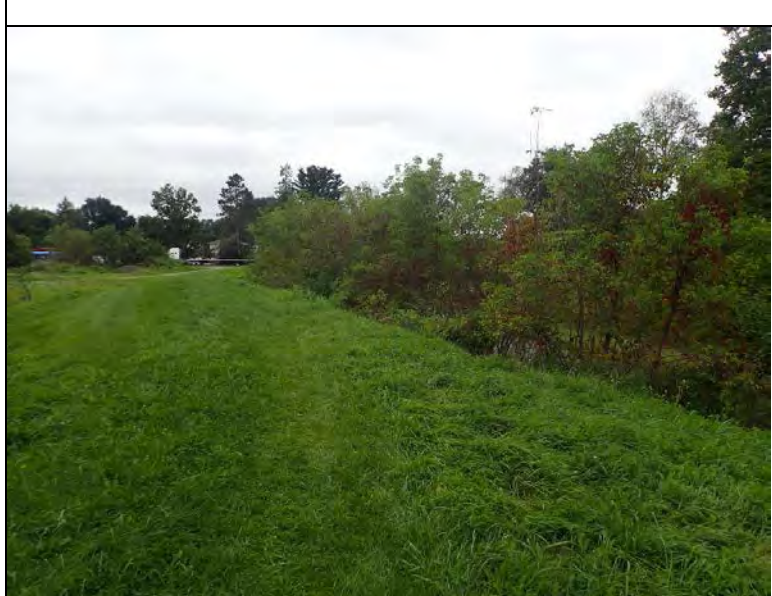
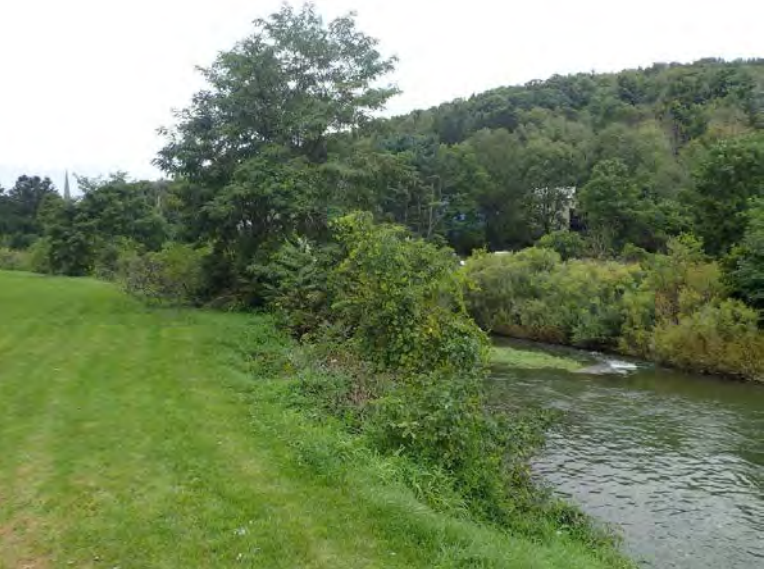
10. Riprap Revetments & Banks	<b>U</b>	<b>A</b>	No riprap displacement or stone degradation that could pose an immediate threat to the integrity of channel bank. Riprap intact with no woody vegetation present.	N21R_2018_r_0003: Station_1 35+00: Station_2 35+00: Trees and unwanted vegetation in riprap on left bank river side slope from upstream limit of Dyke Creek to 300' downstream of the Drop Structure. (Dyke Creek): Remove trees and unwanted vegetation. (U) N21R_2018_r_0012: Station_1 35+00: Trees and vegetation in riprap on right bank upstream of drop structure. (Dyke Creek): Remove vegetation and trees. (U) N21R_2018_r_0013: Station_1 35+00: Station_2 28+00: Trees and vegetation in riprap on right bank from Broad Street bridge to drop structure. (Dyke Creek): Remove unwanted vegetation. (U) N21R_2018_r_0021: Station_1 24+00: Station_2 22+00: Significant unwanted vegetation and trees in riprap on both banks between Railroad bridge and Broad Street bridge. (Dyke Creek): Remove unwanted vegetation. (U) N21R_2018_r_0024: Station_1 22+00: Station_2 18+00: Trees and heavy unwanted vegetation in riprap on both banks between Main Street bridge and Railroad bridge. (Dyke Creek): Remove trees and unwanted vegetation. (U) N21R_2018_r_0032: Station_1 17+00: Significant trees and vegetation in riprap on both banks just 100' of bridgedownstream of Main Street bridge. (Dyke Creek): Remove trees and vegetation from riprap. (U)

<p><b>Inspect ID:</b> N21R_2018_r_0003 <b>Title:</b> USACE_CELRB_N21R_2018_r_0003_1.jpg <b>Rated Item:</b> 10. Riprap Revetments &amp; Banks <b>Caption:</b> Rating: Unacceptable; Remarks: Trees and unwanted vegetation in riprap on left bank river side slope from upstream limit of Dyke Creek to 300' downstream of the Drop Structure. (Dyke Creek).; Action: Remove trees and unwanted vegetation.; Station_1: 35+00; Station_2: 35+00</p>

<p><b>Inspect ID:</b> N21R_2018_r_0003 <b>Title:</b> USACE_CELRB_N21R_2018_r_0003_2.jpg <b>Rated Item:</b> 10. Riprap Revetments &amp; Banks <b>Caption:</b> Rating: Unacceptable; Remarks: Trees and unwanted vegetation in riprap on left bank river side slope from upstream limit of Dyke Creek to 300' downstream of the Drop Structure. (Dyke Creek).; Action: Remove trees and unwanted vegetation.; Station_1: 35+00; Station_2: 35+00</p>

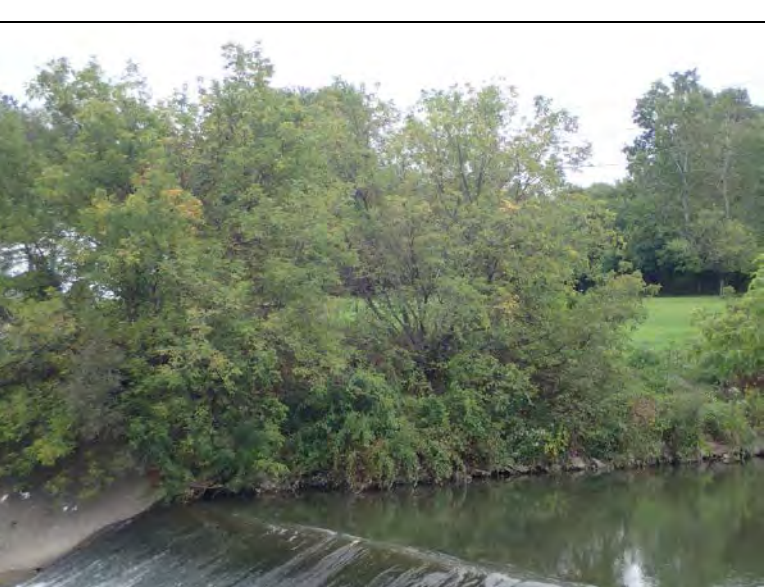
<p><b>Inspect ID:</b> N21R_2018_r_0012 <b>Title:</b> USACE_CELRB_N21R_2018_r_0012_1.jpg <b>Rated Item:</b> 10. Riprap Revetments &amp; Banks <b>Caption:</b> Rating: Unacceptable; Remarks: Trees and vegetation in riprap on right bank upstream of drop structure. (Dyke Creek); Action: Remove vegetation and trees.; Station_1: 35+00</p>

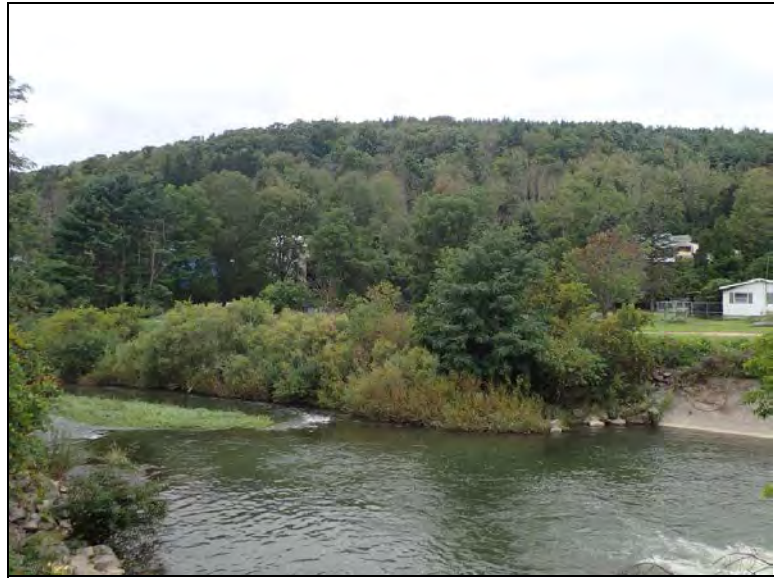
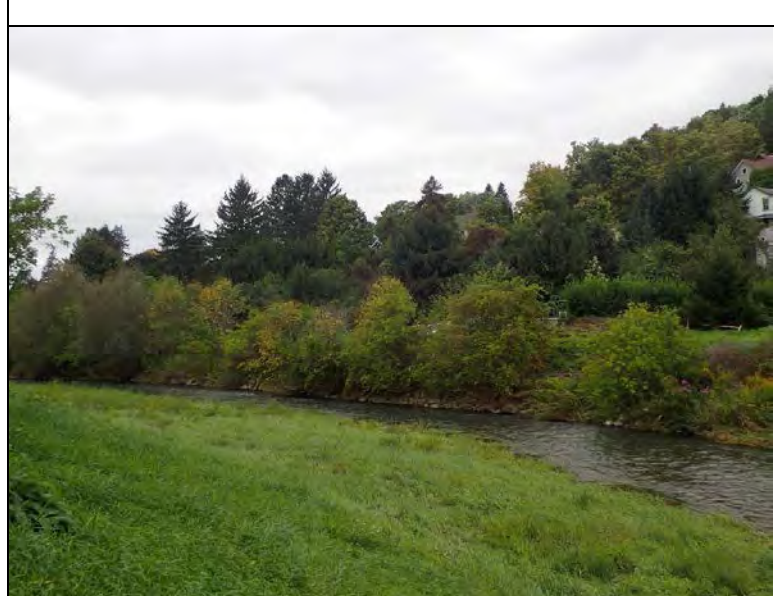
<p><b>Inspect ID:</b> N21R_2018_r_0013 <b>Title:</b> USACE_CELRB_N21R_2018_r_0013_1.jpg <b>Rated Item:</b> 10. Riprap Revetments &amp; Banks <b>Caption:</b> Rating: Unacceptable; Remarks: Trees and vegetation in riprap on right bank from Broad Street bridge to drop structure. (Dyke Creek); Action: Remove unwanted vegetation.; Station_1: 35+00; Station_2: 28+00</p>

<p><b>Inspect ID:</b> N21R_2018_r_0013 <b>Title:</b> USACE_CELRB_N21R_2018_r_0013_2.jpg <b>Rated Item:</b> 10. Riprap Revetments &amp; Banks <b>Caption:</b> Rating: Unacceptable; Remarks: Trees and vegetation in riprap on right bank from Broad Street bridge to drop structure. (Dyke Creek); Action: Remove unwanted vegetation.; Station_1: 35+00; Station_2: 28+00</p>

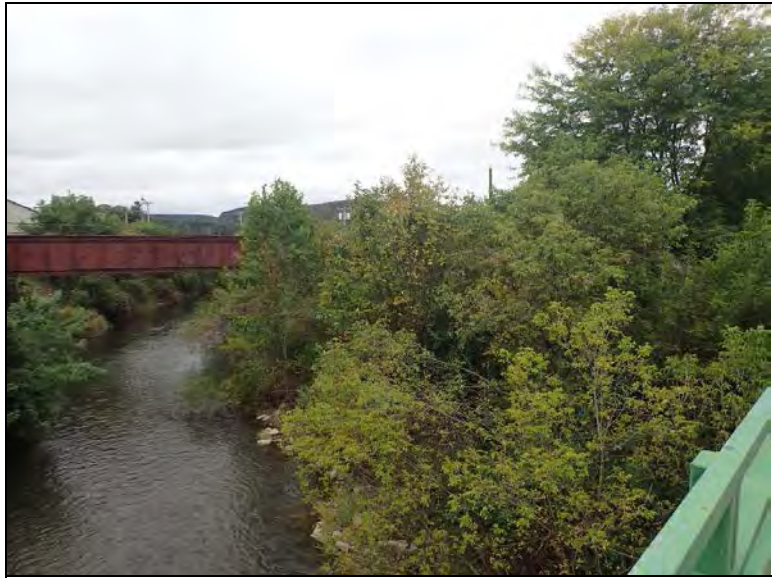
<p><b>Inspect ID:</b> N21R_2018_r_0021 <b>Title:</b> USACE_CELRB_N21R_2018_r_0021_2.jpg <b>Rated Item:</b> 10. Riprap Revetments &amp; Banks <b>Caption:</b> Rating: Unacceptable; Remarks: Significant unwanted vegetation and trees in riprap on both banks between Railroad bridge and Broad Street bridge. (Dyke Creek); Action: Remove unwanted vegetation.; Station_1: 24+00; Station_2: 22+00</p>

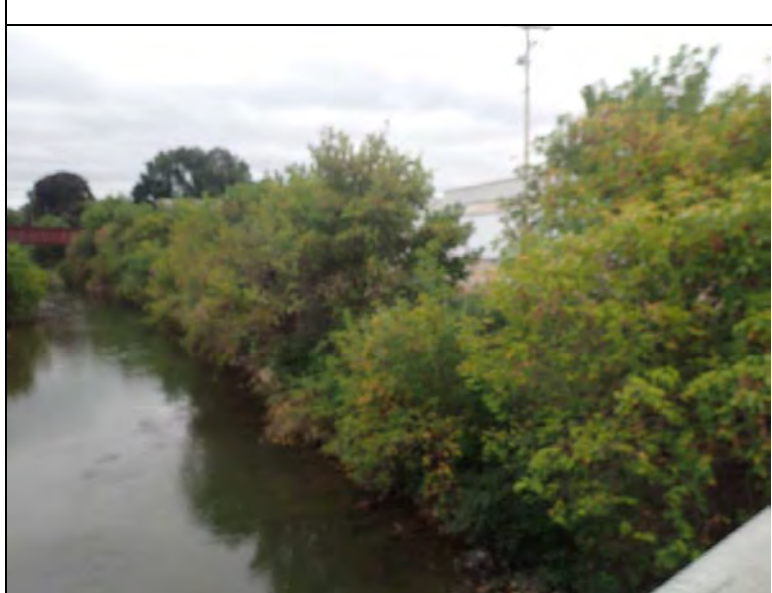
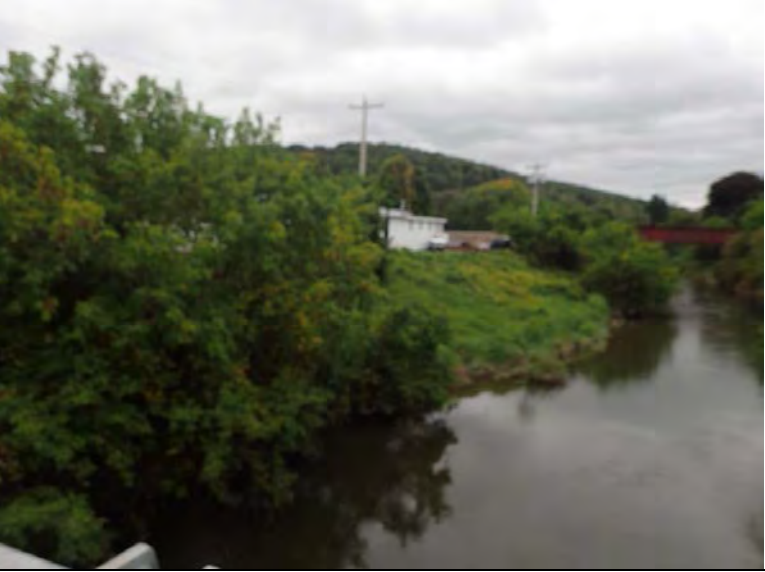
<p><b>Inspect ID:</b> N21R_2018_r_0024 <b>Title:</b> USACE_CELRB_N21R_2018_r_0024_1.jpg <b>Rated Item:</b> 10. Riprap Revetments &amp; Banks <b>Caption:</b> Rating: Unacceptable; Remarks: Trees and heavy unwanted vegetation in riprap on both banks between Main Street bridge and Railroad bridge. (Dyke Creek); Action: Remove trees and unwanted vegetation.; Station_1: 22+00; Station_2: 18+00</p>

<p><b>Inspect ID:</b> N21R_2018_r_0024 <b>Title:</b> USACE_CELRB_N21R_2018_r_0024_2.jpg <b>Rated Item:</b> 10. Riprap Revetments &amp; Banks <b>Caption:</b> Rating: Unacceptable; Remarks: Trees and heavy unwanted vegetation in riprap on both banks between Main Street bridge and Railroad bridge. (Dyke Creek); Action: Remove trees and unwanted vegetation.; Station_1: 22+00; Station_2: 18+00</p>

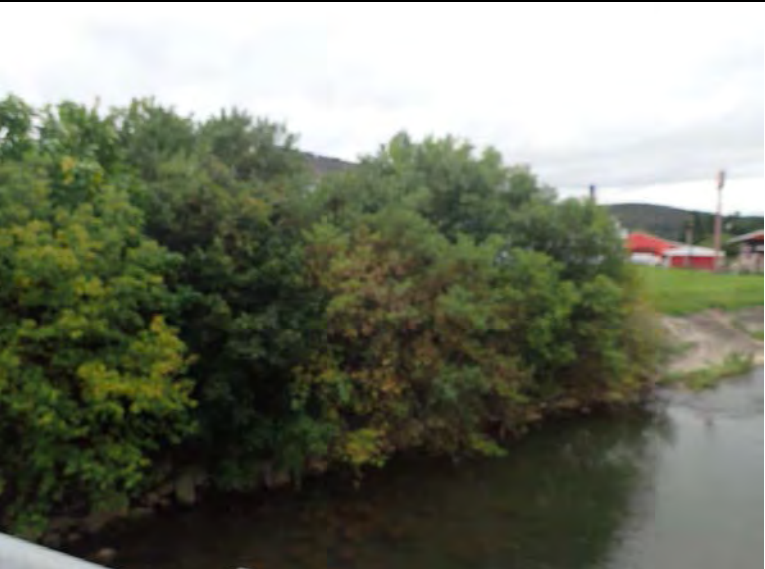
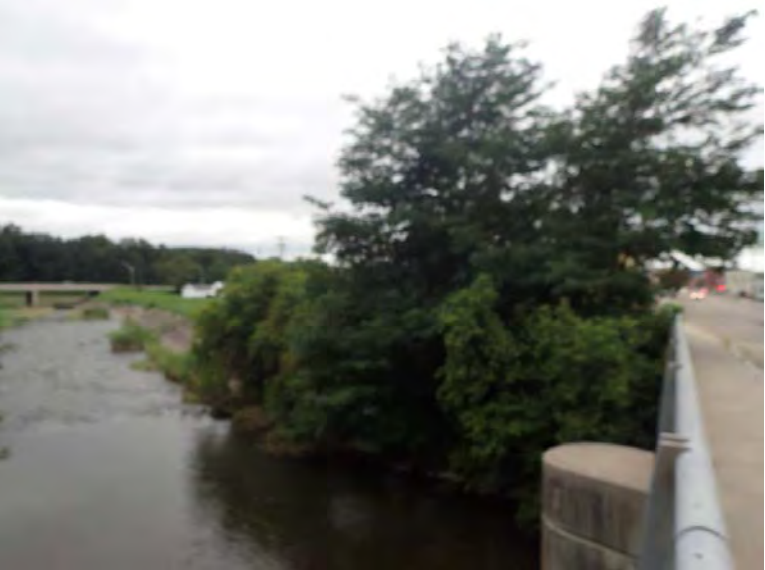
<p><b>Inspect ID:</b> N21R_2018_r_0032 <b>Title:</b> USACE_CELRB_N21R_2018_r_0032_1.jpg <b>Rated Item:</b> 10. Riprap Revetments &amp; Banks <b>Caption:</b> Rating: Unacceptable; Remarks: Significant trees and vegetation in riprap on both banks just 100' of bridgedownstream of Main Street bridge. (Dyke Creek); Action: Remove trees and vegetation from riprap.; Station_1: 17+00</p>

<p><b>Inspect ID:</b> N21R_2018_r_0032 <b>Title:</b> USACE_CELRB_N21R_2018_r_0032_2.jpg <b>Rated Item:</b> 10. Riprap Revetments &amp; Banks <b>Caption:</b> Rating: Unacceptable; Remarks: Significant trees and vegetation in riprap on both banks just 100' of bridgedownstream of Main Street bridge. (Dyke Creek); Action: Remove trees and vegetation from riprap.; Station_1: 17+00</p>
