Levee Analysis and Mapping Plan Portugués and Bucaná Rivers Project

Municipality of Ponce, Puerto Rico

May 2020

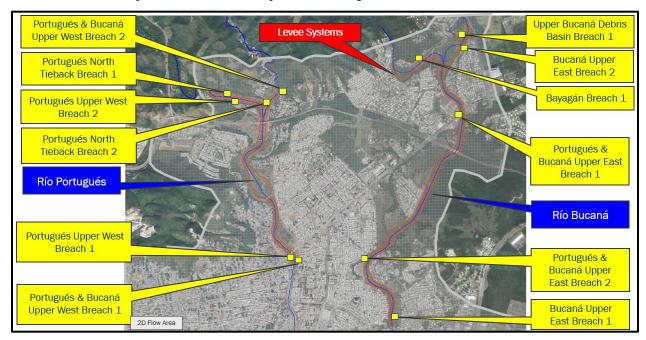
Figure 7: Breach Location Map

For the Structural-Based Inundation Procedure, hypothetical breach analyses were completed at 12 independent locations along the levee reaches. Each breach was analyzed individually using HEC-RAS 5.0.7 (2-D, unsteady flow). The breach analyses were performed at four locations along the Portugués and Bucaná Levee System; at two locations along the Portugués Upper West, Portugués

North Tieback, and Bucaná East Levee Systems; and at one location on the Bayagán North and Upper Bucaná Debris Basin Levee Systems. The breach widths ranged from 140 feet to 400 feet. The breach locations were developed for analysis purposes only and are not intended to indicate historic or future breach development. All 1-percent-annual-chance inundation breach areas were composited to develop the final visual depiction of the Structural-Based Inundation Procedure results. Breach locations developed for this model are presented in Figure 7.

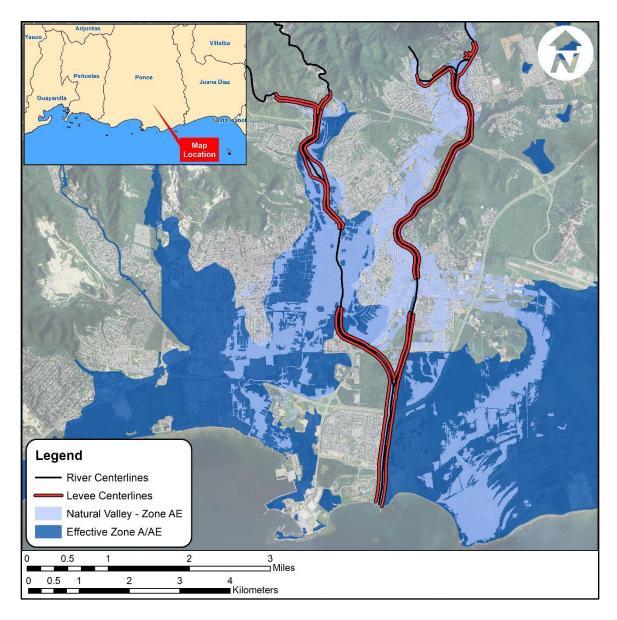
Figure 8: Natural Valley Procedure

The results of the Natural Valley procedure identify the potential flood risk if the levee systems were not providing flood hazard reduction during the base flood event. As described in Section 5.2 of this report, the inundation map represents the composite result of independent Natural Valley Procedures. Figure 8 illustrates the approximate inundation area for the 1-percent-annual-chance flood, using the Natural Valley Procedure within the levee-impacted areas. Figure 9 shows the approximate depth grid using the Natural Valley Procedure within the levee-impacted areas.

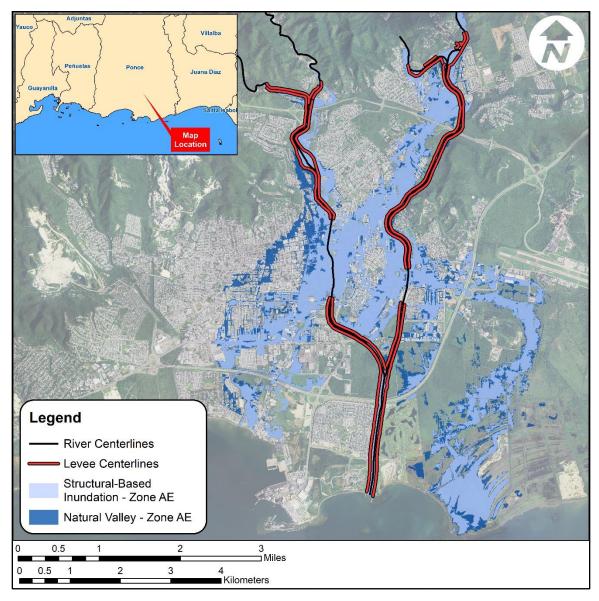
Figure 10: Structural-Based Inundation Procedure

The composite results of the Structural-Based Inundation Procedure, shown in Figure 10 and Figure 11, yield an inundation area in the levee-impacted areas similar to that of the Natural Valley Procedure. The Structural-Based Inundation Procedure yielded a slightly decreased inundation area than the Natural Valley Procedure. Since there have been no historical breaches in any of the studied levee systems in the Portugués and Bucaná Rivers Project the Natural Valley Procedure would be used to map the levee flood hazard if incomplete or no additional data is provided for the levee systems.

Community officials and emergency managers can use the results of the Structural-Based Inundation Procedure to inform emergency action planning and outreach to residents living and working within the levee-impacted area. The Structural-Based Inundation Procedure is an important reminder that if a breach of a levee system occurs, areas along or near a breach are potentially at increased risk to higher velocity flow and inundation, which could happen with little or no warning.
