Areas for Further Review

Township of Hainesport, Burlington County, NJ

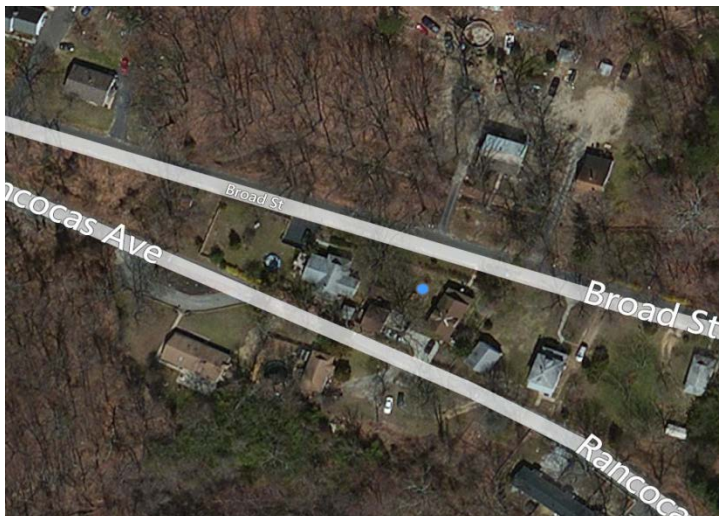
1. South Branch Rancocas Creek: As per County

There are concerns about the ditch extends off of the South Branch Rancocas Creek floodplain and is located on effective panel 3400990005A/preliminary panel 34005C0252F. The floodplain mapping shows the stream centerline running through a homeowner's house; however, a closer look at aerial imagery reveals that it was mapped incorrectly for the effective and same issue exists for the preliminary.
