Levee Analysis and Mapping Procedures (LAMP) for Non-accredited Levees

Town of Vestal
Broome County, NY

February 16, 2017

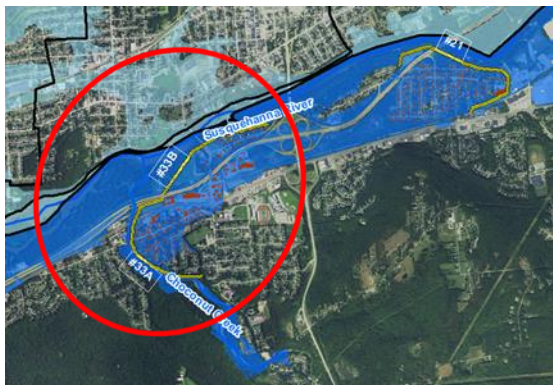
First Pass Results Natural Valley Analysis

- Approximately 490 Structures impacted
