Wellsville, New York

Genesee River

Left Bank Levee and Entire
Channel

Levee Periodic Inspection 2010

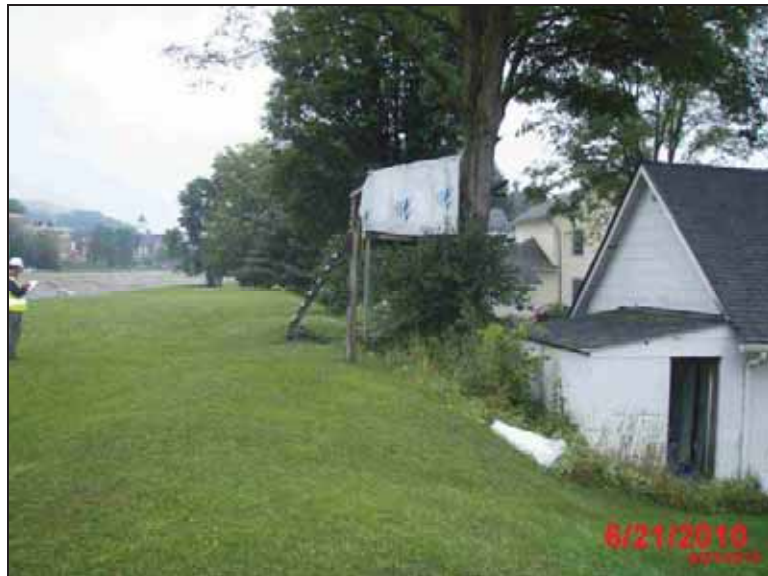
Inspect ID: N21L_2010_a_0084 **Title:** USACE_CELRB_N21L_2010_a_0084_1.jpg
Caption: Multiple trees, crowns over levee

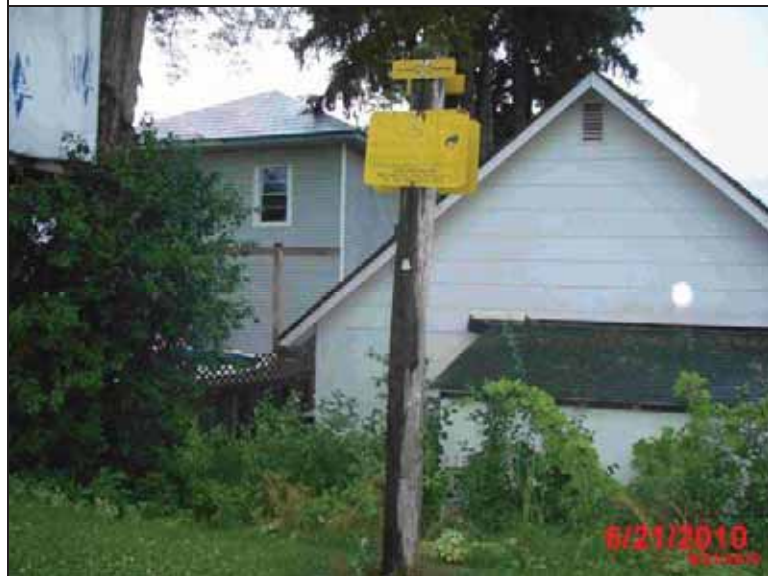
Inspect ID: N21L_2010_a_0085 **Title:** USACE_CELRB_N21L_2010_a_0085_1.jpg
Caption: Underground telephone cable

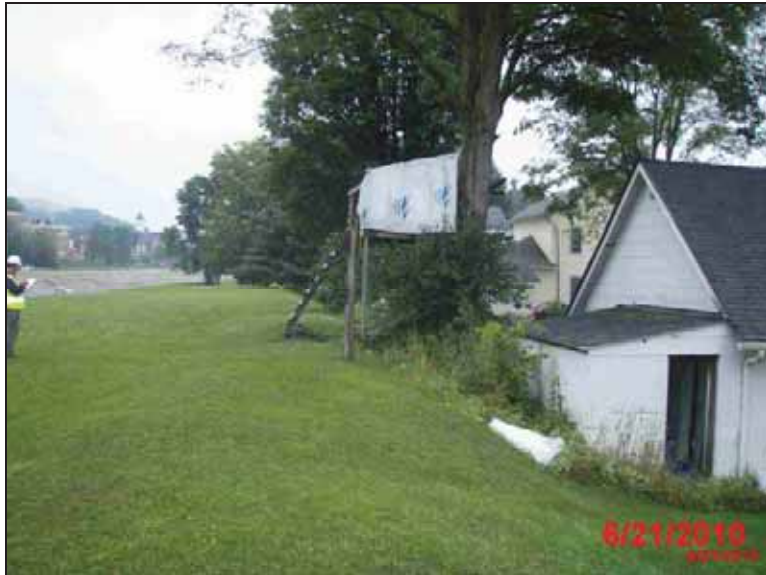
Inspect ID: N21L_2010_a_0086 **Title:** USACE_CELRB_N21L_2010_a_0086_1.jpg
Caption: Miscellaneous encroachments, sheds, tree house, deck

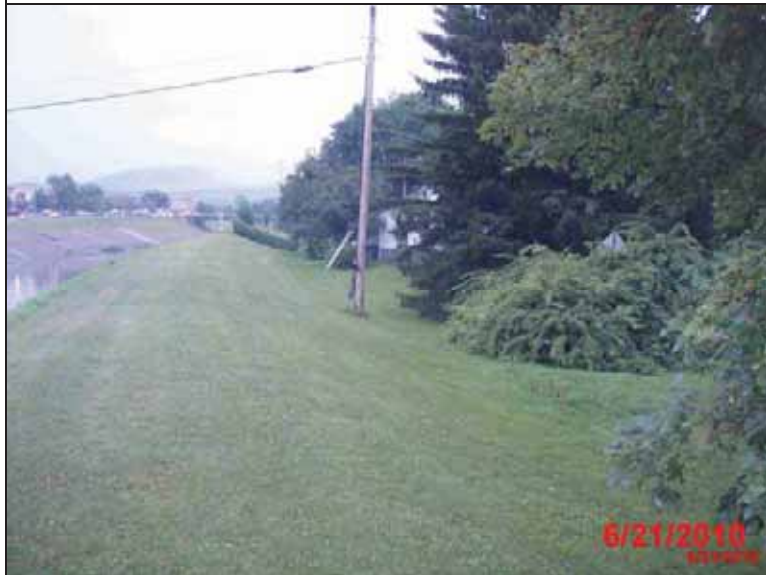
Inspect ID: N21L_2010_a_0090 **Title:** USACE_CELRB_N21L_2010_a_0090_1.jpg
Caption: Vegetation along levee

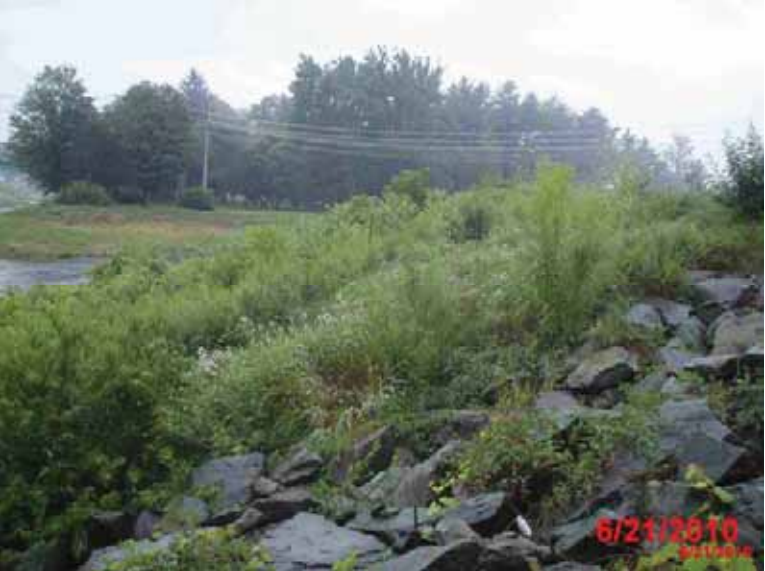
A photograph showing a close-up view of a riprap area. The foreground is filled with dark, irregularly shaped stones. Behind the stones, there is a dense growth of green vegetation, including tall grasses and small shrubs. In the background, a line of trees is visible under a cloudy sky. A red date stamp "6/21/2010" is visible in the bottom right corner of the image.	<p>Inspect ID: N21L_2010_a_0127 Title: USACE_CELRB_N21L_2010_a_0127_1.jpg</p> <p>Caption: Vegetation in riprap</p>

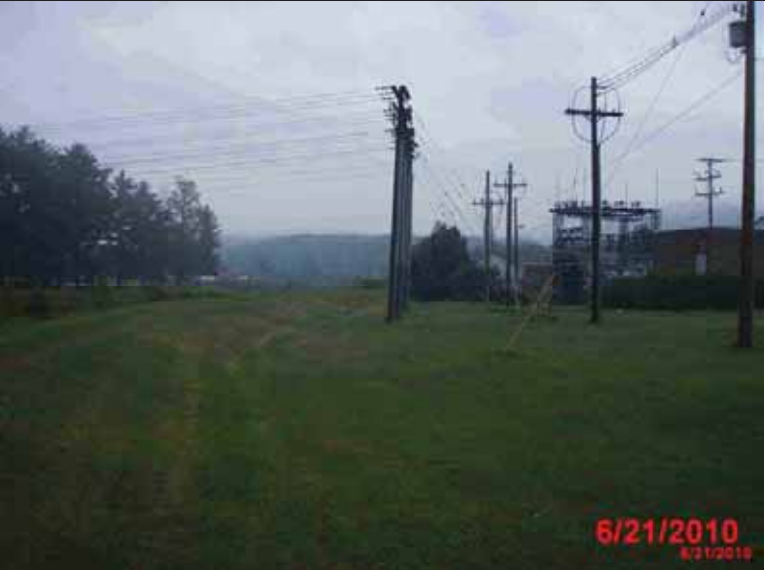
A photograph showing a grassy field with several utility poles and power lines. The poles are made of wood and have cross-arms with wires. In the background, there is a large industrial structure, possibly a water treatment plant or a power station, with a crane-like structure on top. The sky is overcast. A red date stamp "6/21/2010" is visible in the bottom right corner of the image.	<p>Inspect ID: N21L_2010_a_0128 Title: USACE_CELRB_N21L_2010_a_0128_1.jpg</p> <p>Caption: Utility pole</p>

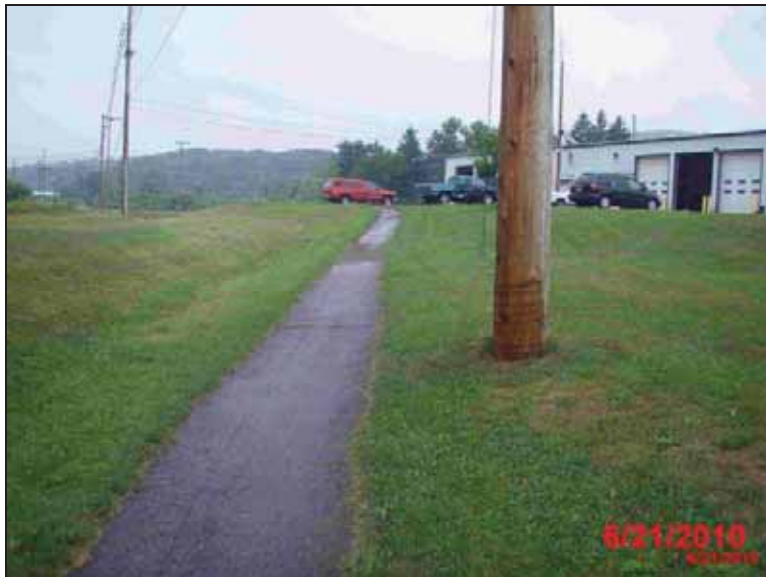
Inspect ID: N21L_2010_a_0141 **Title:** USACE_CELRB_N21L_2010_a_0141_1.jpg
Caption: Utility pole

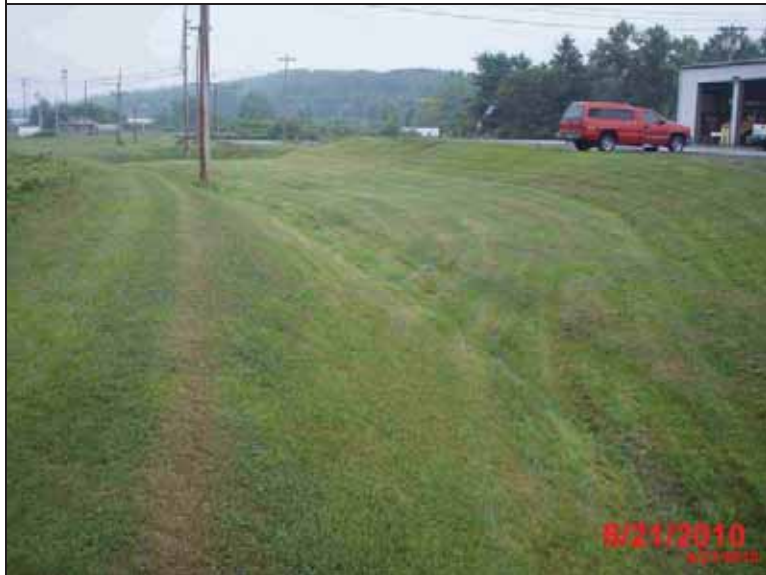
Inspect ID: N21L_2010_a_0142 **Title:** USACE_CELRB_N21L_2010_a_0142_1.jpg
Caption: Drainage channel along levee

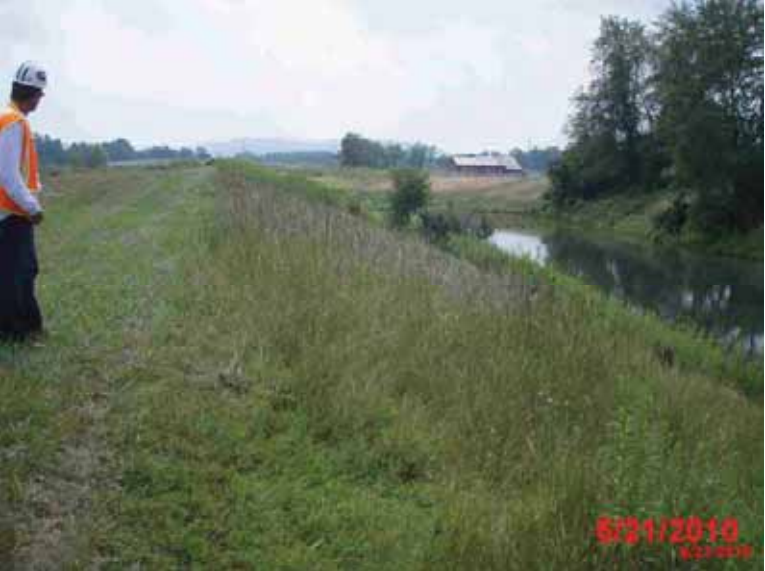
<p>Inspect ID: N21L_2010_a_0198 Title: USACE_CELRB_N21L_2010_a_0198_1.jpg Caption: Vegetation on bank</p>

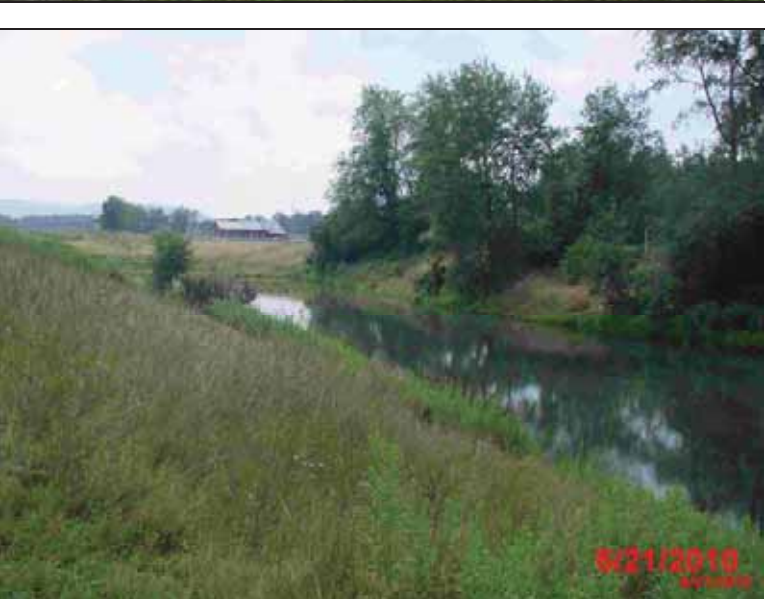
<p>Inspect ID: N21L_2010_a_0199 Title: USACE_CELRB_N21L_2010_a_0199_1.jpg Caption: Water at toe (lagoon)</p>

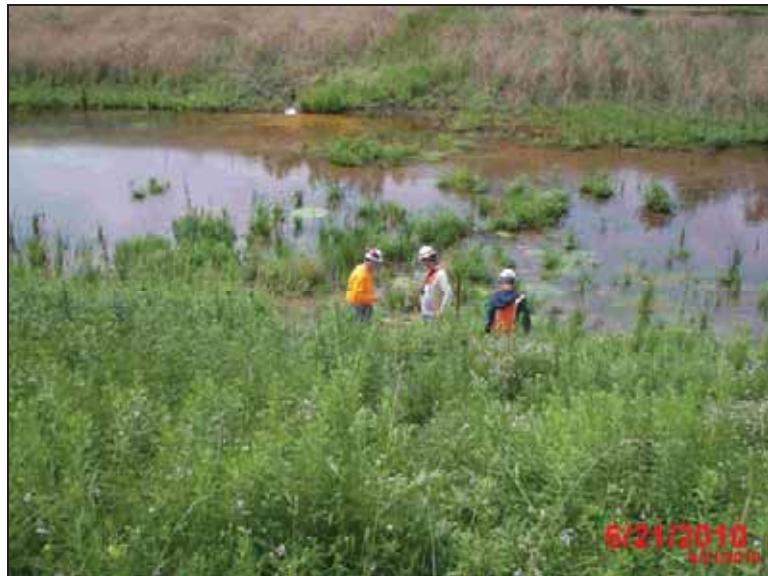
During the Wellsville FDRP inspection, isolated seepage was noted within the earthen levee embankments at the toe of the levee at the south end of project adjacent to BP remediation

Inspect ID: N21L_2010_a_0202 **Title:** USACE_CELRB_N21L_2010_a_0202_1.jpg
Caption: Seepage at toe

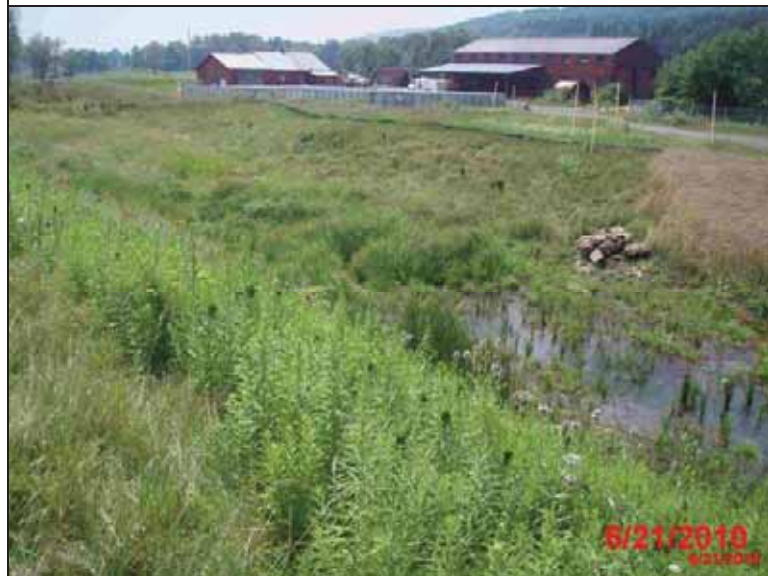
Inspect ID: N21L_2010_a_0203 **Title:** USACE_CELRB_N21L_2010_a_0203_1.jpg
Caption: Running water into lagoon

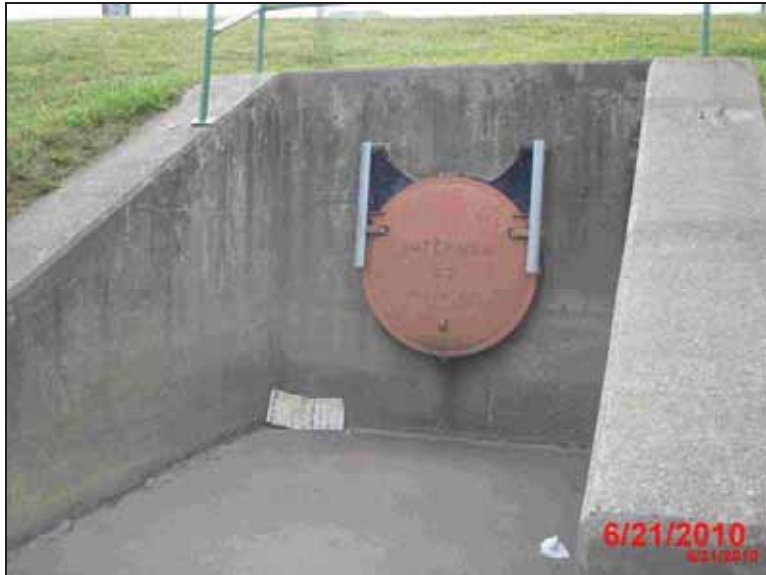
Inspect ID: N21L_2010_a_0040 **Title:** USACE_CELRB_N21L_2010_a_0040_1.jpg
Caption: 42" CMP drainage pipe, flap gate

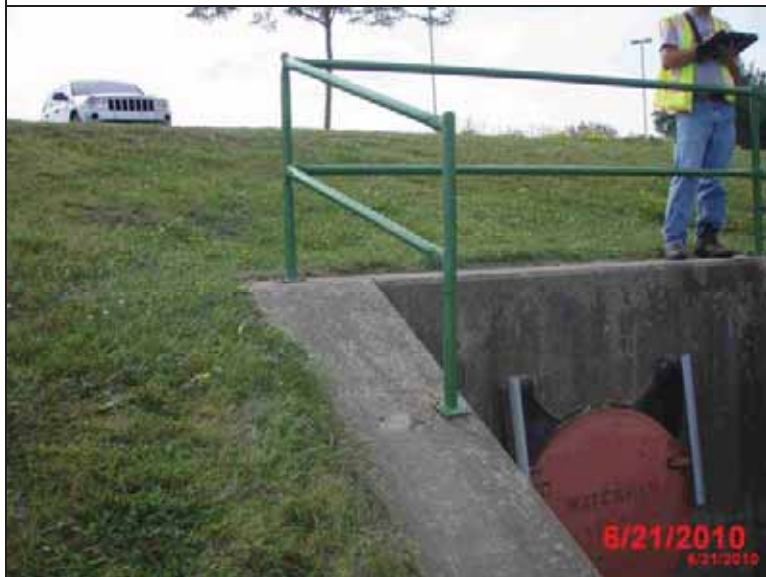
Fencing is damaged at headwall. Repair is needed to fence per photo USACE_CELRB_N21L_2010_a_0042_1. Based upon this item the fencing and gates for the Wellsville FDRP were considered Unacceptable.

Inspect ID: N21L_2010_a_0042 **Title:** USACE_CELRB_N21L_2010_a_0042_1.jpg
Caption: Fence on head wall is dislodged at both ends

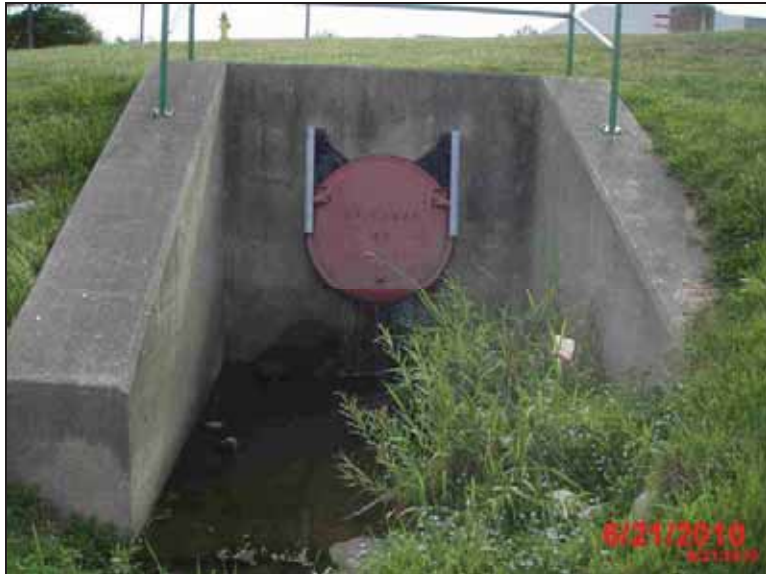
Inspect ID: N21L_2010_a_0049 **Title:** USACE_CELRB_N21L_2010_a_0049_1.jpg
Caption: 42" Flap gate, vegetation

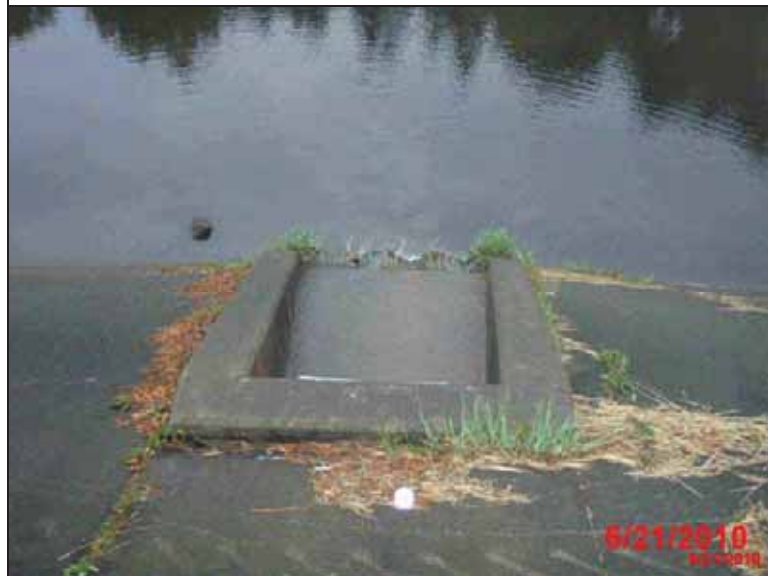
Inspect ID: N21L_2010_a_0088 **Title:** USACE_CELRB_N21L_2010_a_0088_1.jpg
Caption: 24" CMP drainage pipe, flap gate

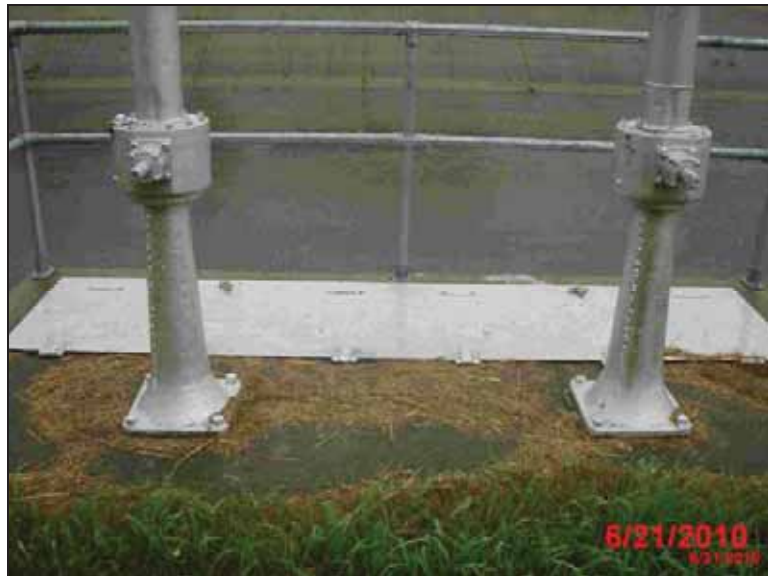
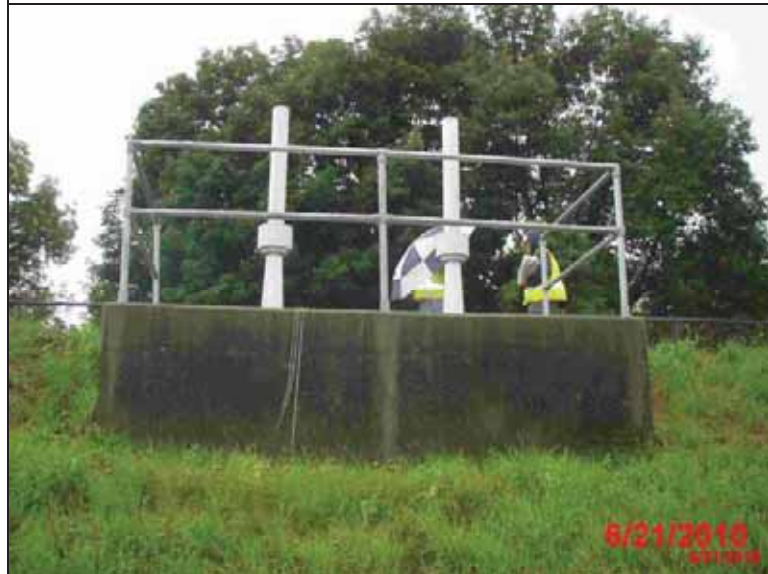
Inspect ID: N21L_2010_a_0099 **Title:** USACE_CELRB_N21L_2010_a_0099_1.jpg
Caption: Exterior good condition

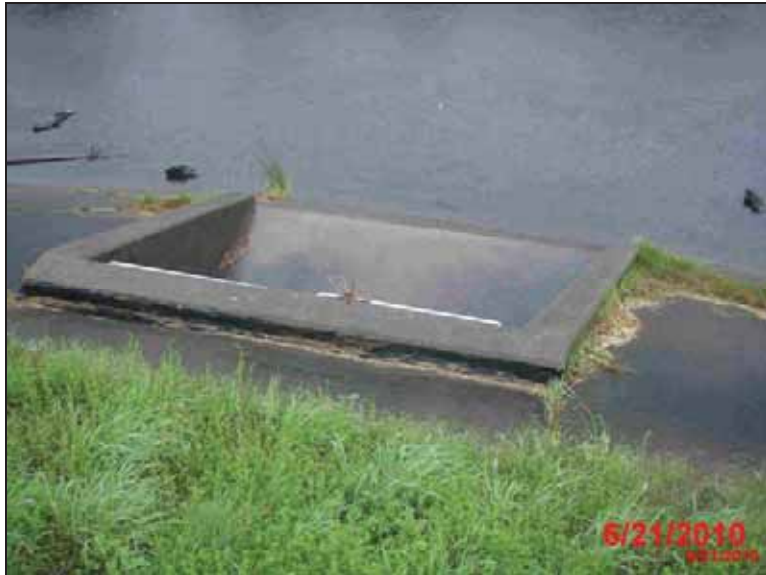
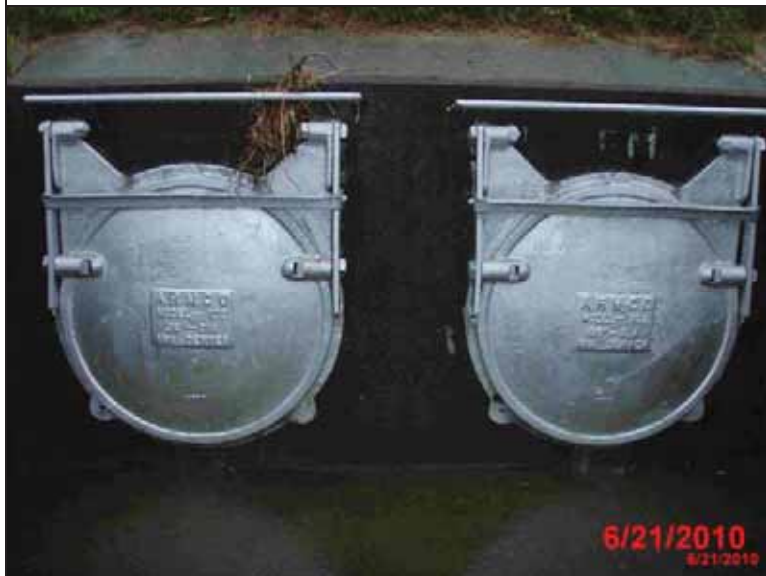
Inspect ID: N21L_2010_a_0100 **Title:** USACE_CELRB_N21L_2010_a_0100_1.jpg
Caption: Two 36" RCP drainage pipes, flap gates

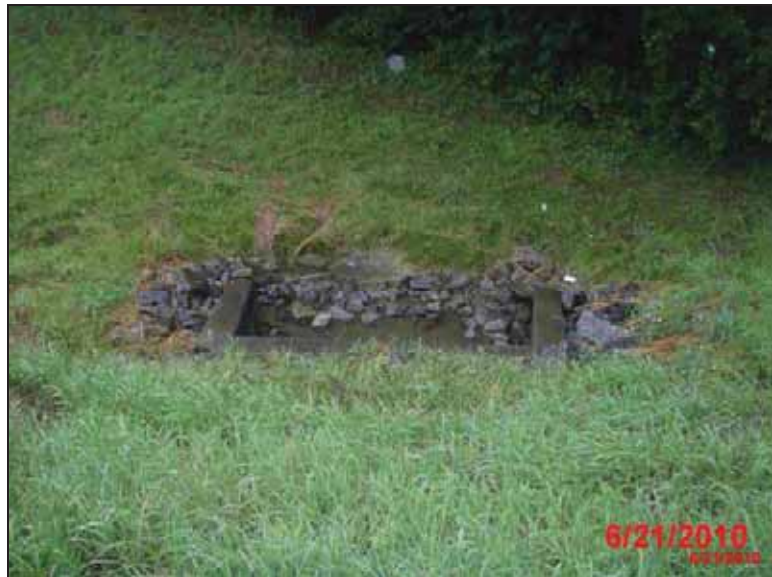
Obstructions including, vegetation, debris and sediment have impaired the channel flow capacity and have blocked more than 10% of a culvert opening at several locations. Sediment and vegetation removal are required to reestablish flow capacity. Overall the vegetation and obstructions observed are Unacceptable due to the blockages. See photo USACE_CELRB_N21L_2010_a_0101_2 for an example of vegetation and obstructions.

<p>Inspect ID: N21L_2010_a_0101 Title: USACE_CELRB_N21L_2010_a_0101_1.jpg Caption: Asphat lined RCP, 25% riprap in pipe</p>
 	<p>Inspect ID: N21L_2010_a_0101 Title: USACE_CELRB_N21L_2010_a_0101_2.jpg Caption: Asphat lined RCP, 25% riprap in pipe</p>

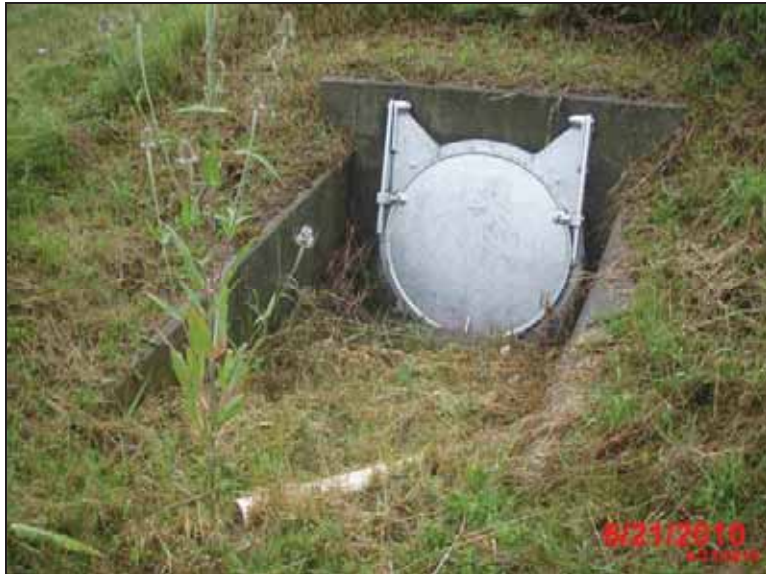
Inspect ID: N21L_2010_a_0148 **Title:** USACE_CELRB_N21L_2010_a_0148_1.jpg
Caption: 48" CMP drainage pipe, flap gate, vegetation in front of flap gate

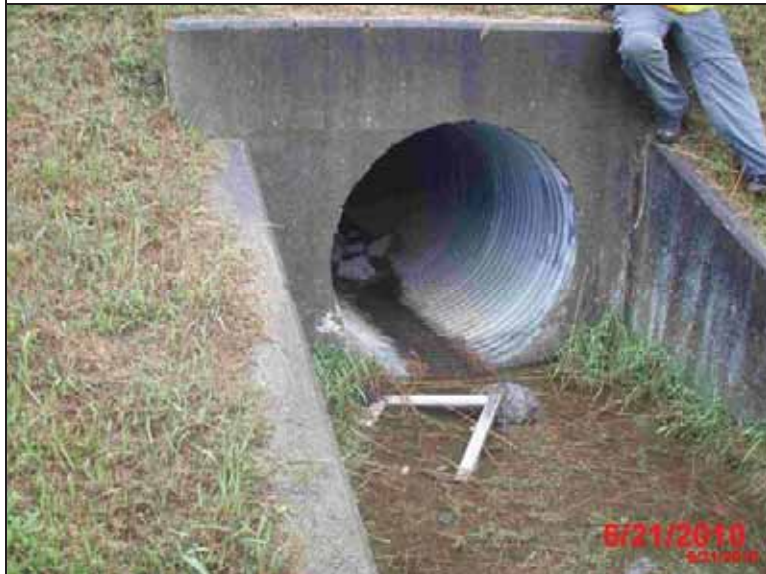
Inspect ID: N21L_2010_a_0149 **Title:** USACE_CELRB_N21L_2010_a_0149_1.jpg
Caption: 48" CMP intake, rip rap in pipe

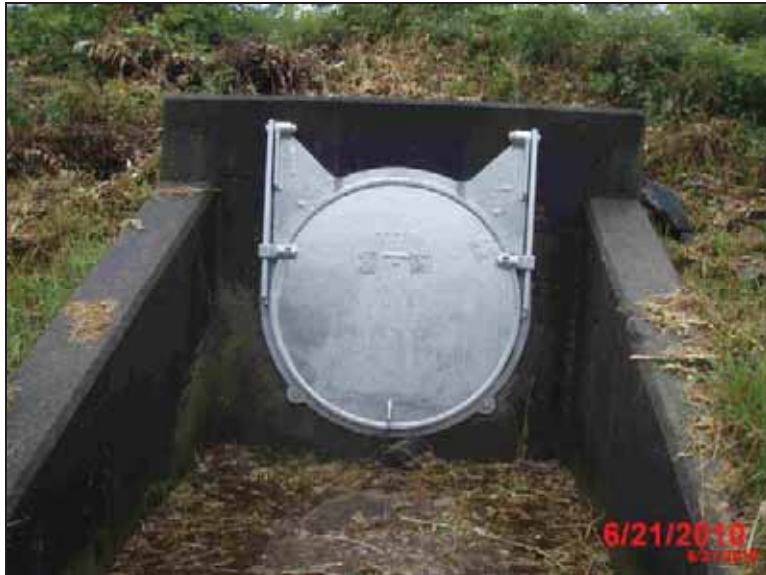
Minor riprap displacement, exposure of bedding and stone degradation was observed. Scour activity is undercutting banks, eroding embankments and impairing channel flows by causing turbulence. Rock protection is hidden by dense brush, trees and grasses. The rating for riprap revetments of inlet/discharge areas is Minimally Acceptable. See photo USACE_CELRB_N21L_2010_a_0150_1 for example.

Inspect ID: N21L_2010_a_0150 **Title:** USACE_CELRB_N21L_2010_a_0150_1.jpg
Caption: 48" CMP drainage pipe, flap gate, lack of riprap, not greased

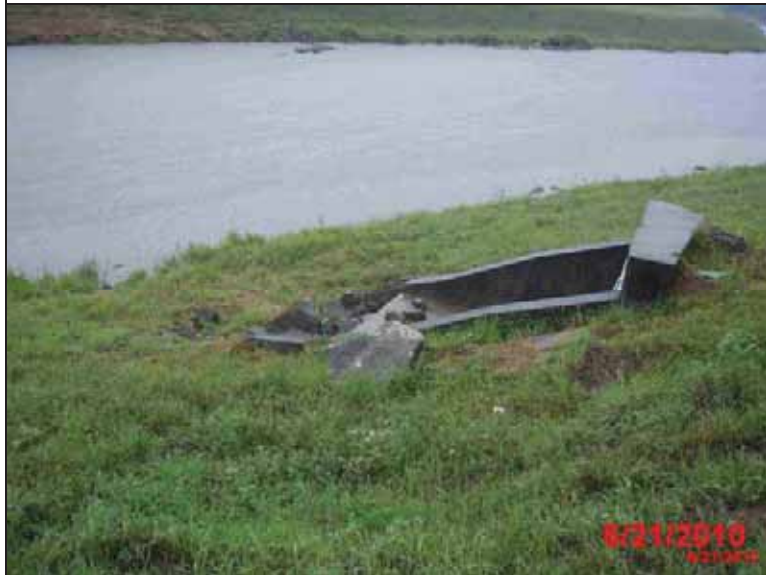
Inspect ID: N21L_2010_a_0158 **Title:** USACE_CELRB_N21L_2010_a_0158_1.jpg
Caption: 42" CMP drainage pipe, flap gate, not greased

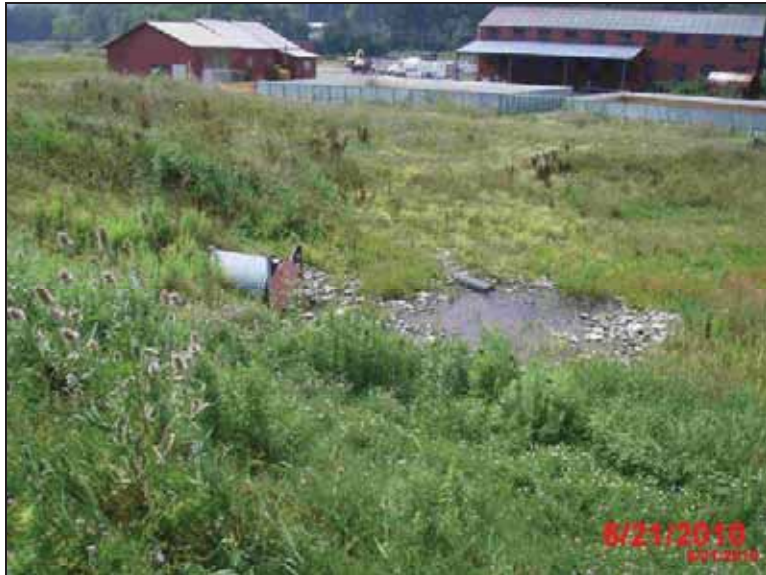
Inspect ID: N21L_2010_a_0204 **Title:** USACE_CELRB_N21L_2010_a_0204_1.jpg
Caption: 42" CMP, flap gate & 12" HDPE

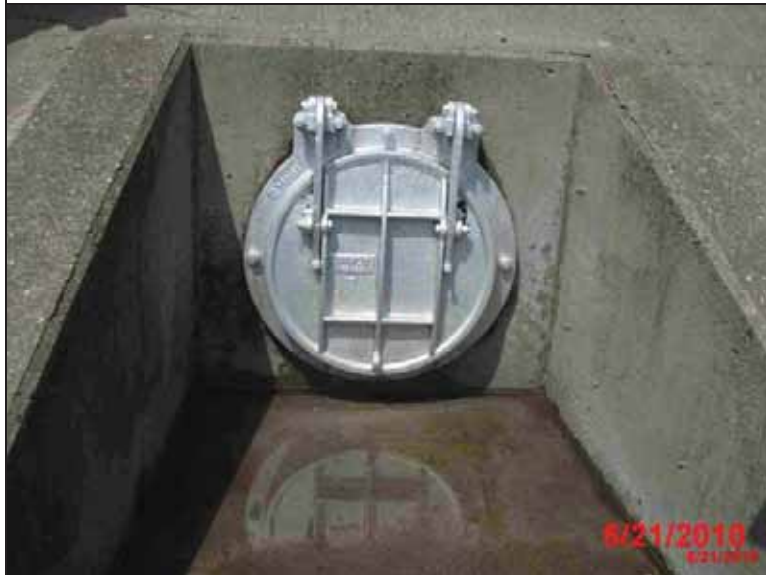
Gravity discharge pipes must have provisions for emergency closure in the event of inoperable flap valves on the creek side. Existing flap gates are damaged and need to be replaced. See example photo USACE_CELRB_N21L_2010_a_0218_1. The overall rating is Unacceptable.

Inspect ID: N21L_2010_a_0218 **Title:** USACE_CELRB_N21L_2010_a_0218_1.jpg
Caption: 24" CMP drainage pipe, flap gate is separated from headwall and pipe

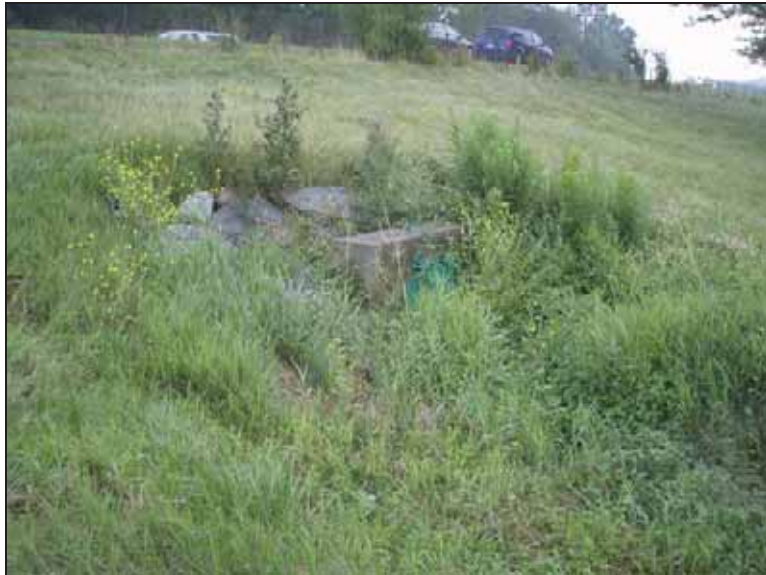
Inspect ID: N21L_2010_a_0253 **Title:** USACE_CELRB_N21L_2010_a_0253_1.jpg
Caption: 24" drainage pipe, flap gate

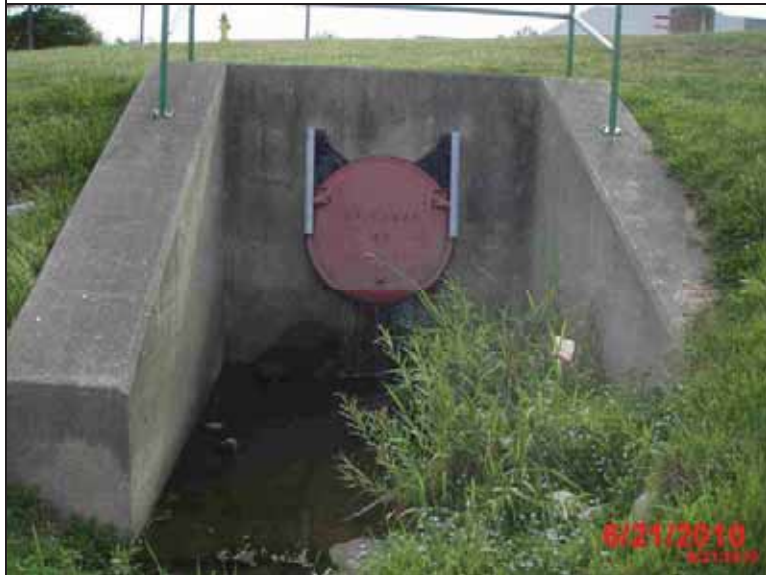
Inspect ID: N21L_2010_a_0255 **Title:** USACE_CELRB_N21L_2010_a_0255_1.jpg
Caption: Vegetation at outfall structure

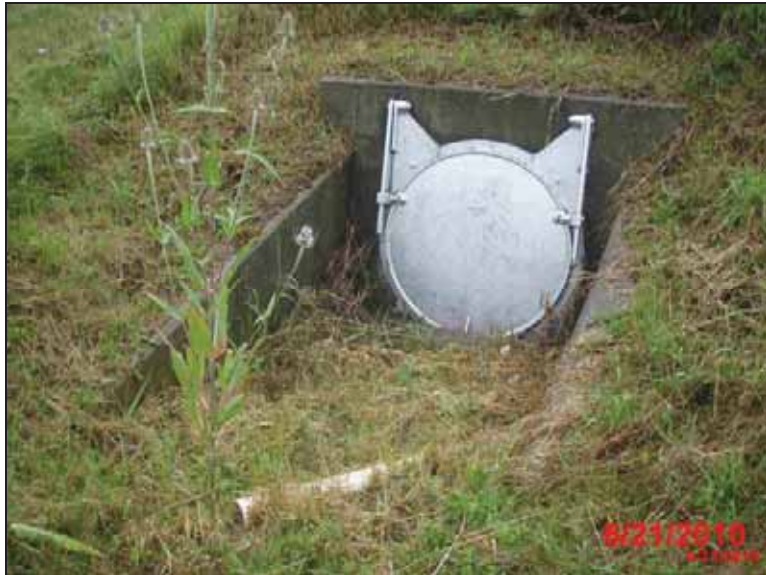
Inspect ID: N21L_2010_a_0256 **Title:** USACE_CELRB_N21L_2010_a_0256_1.jpg
Caption: Vegetation in front of flap gate

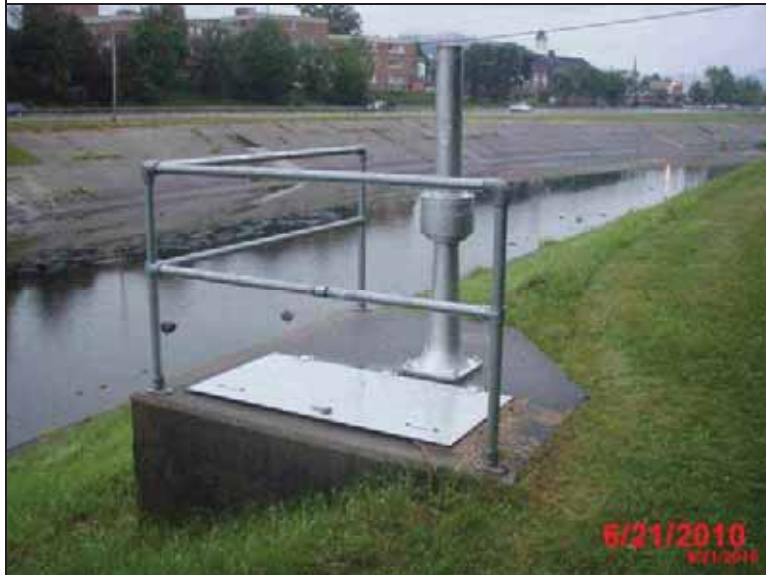
Inspect ID: N21L_2010_a_0257 **Title:** USACE_CELRB_N21L_2010_a_0257_1.jpg
Caption: Railing in good condition

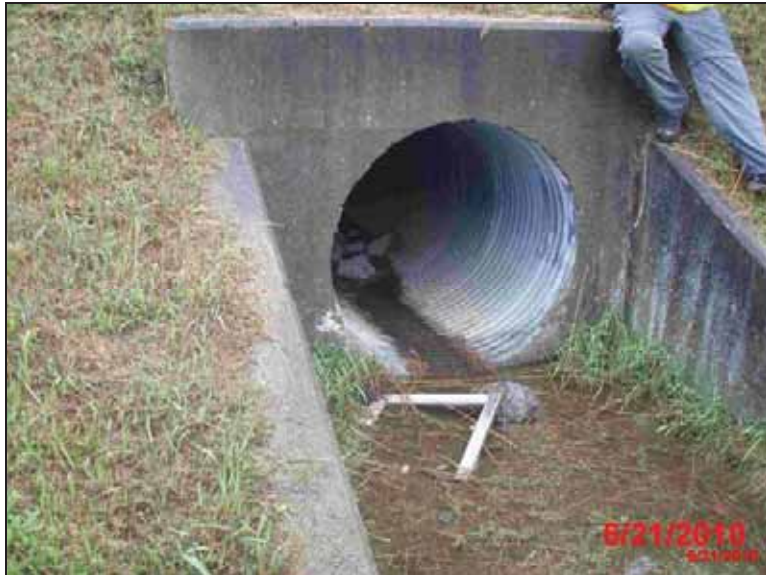
Inspect ID: N21L_2010_a_0258 **Title:** USACE_CELRB_N21L_2010_a_0258_1.jpg
Caption: Riprap in pipe

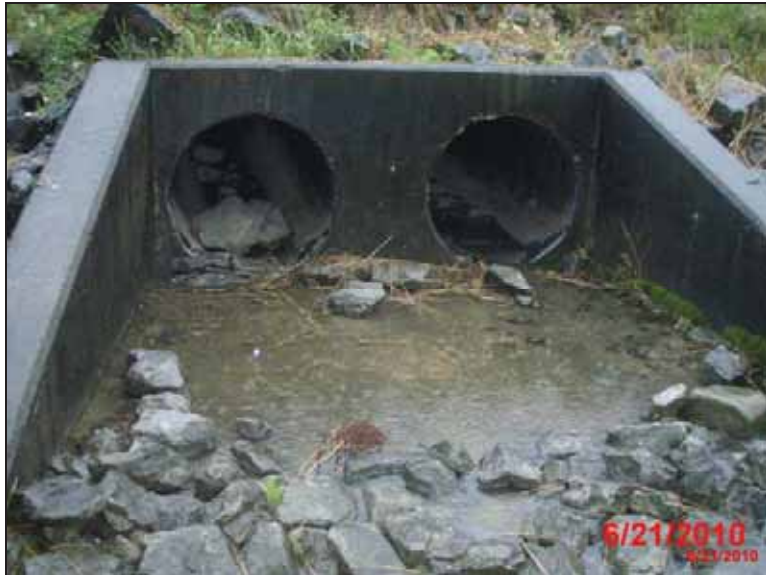
Inspect ID: N21L_2010_a_0260 **Title:** USACE_CELRB_N21L_2010_a_0260_1.jpg
Caption: Riprap displacement

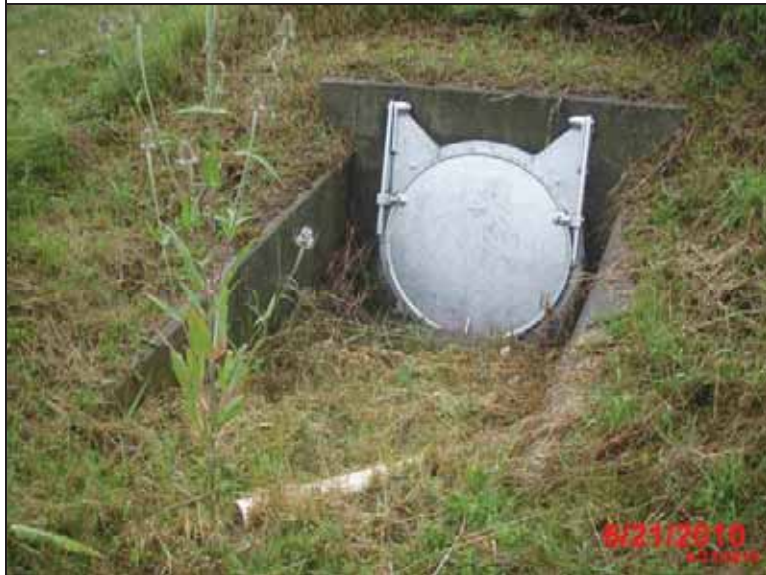
Inspect ID: N21L_2010_a_0261 **Title:** USACE_CELRB_N21L_2010_a_0261_1.jpg
Caption: Lack of riprap

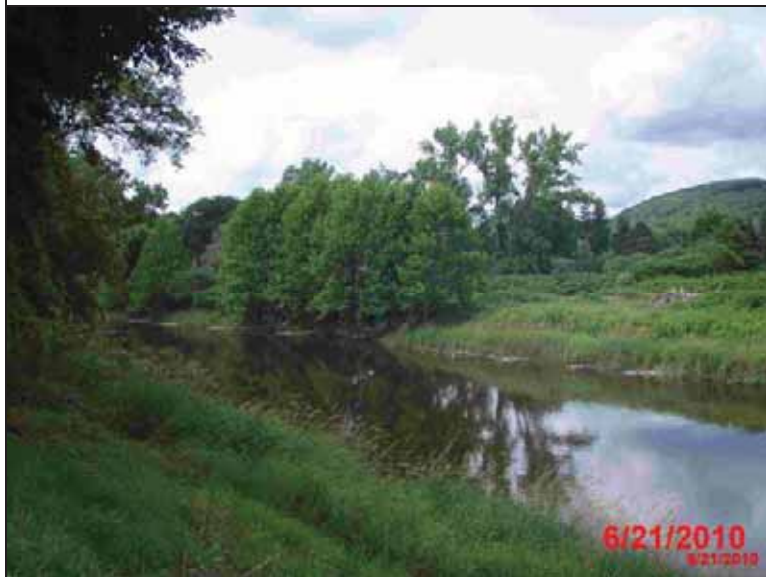
Inspect ID: N21L_2010_a_0001 **Title:** USACE_CELRB_N21L_2010_a_0001_2.jpg
Caption: Vegetation, trees along both banks

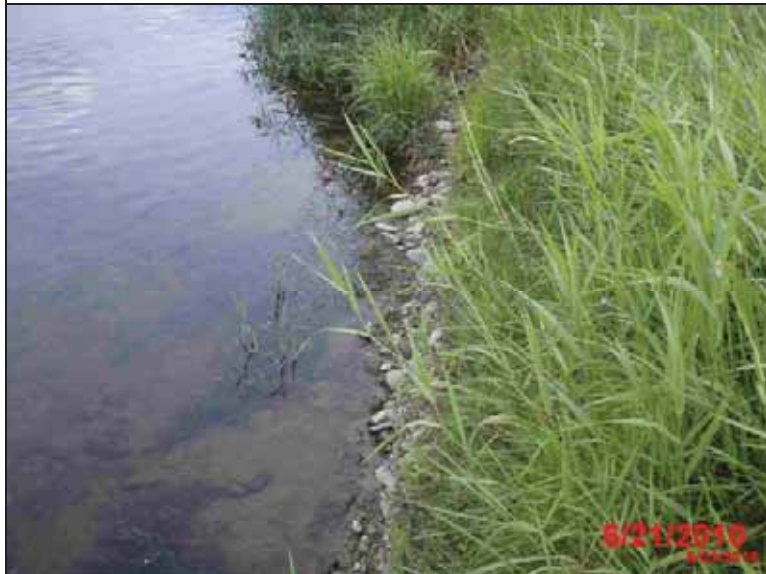
4. Erosion	U	A	No head cutting or horizontal deviation observed.	N21L_2010_a_0006: Erosion along bank: Backfill erosion with engineered fill, re-establish appropriate sod cover (U)
		M	Head cutting and horizontal deviation evident, but is less than 1 foot from the designed grade or cross section.	N21L_2010_a_0012: Erosion along bank: Backfill erosion with engineered fill, re-establish appropriate sod cover (U)
		U	Head cutting and horizontal deviation of more than 1 foot from the designed grade or cross section. Corrective actions required to stop or slow erosion.	N21L_2010_a_0019: Erosion along bank: Backfill erosion with engineered fill, re-establish appropriate sod cover (U) N21L_2010_a_0026: Erosion in drainage ditch to channel: Backfill erosion with engineered fill, re-establish appropriate sod cover (M) N21L_2010_a_0033: Erosion on bank under bridge: Backfill

Inspect ID: N21L_2010_a_0006 **Title:** USACE_CELRB_N21L_2010_a_0006_1.jpg
Caption: Erosion along bank

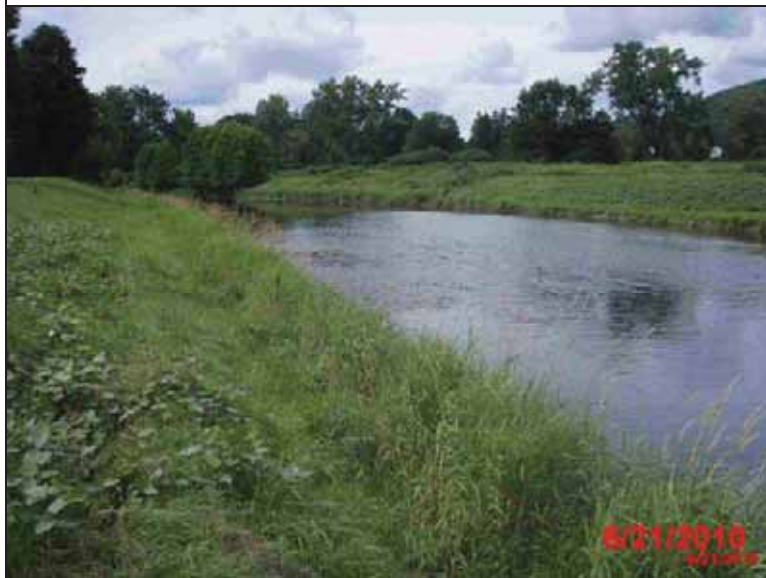
Inspect ID: N21L_2010_a_0008 **Title:** USACE_CELRB_N21L_2010_a_0008_1.jpg
Caption: Vegetation at edge of channel

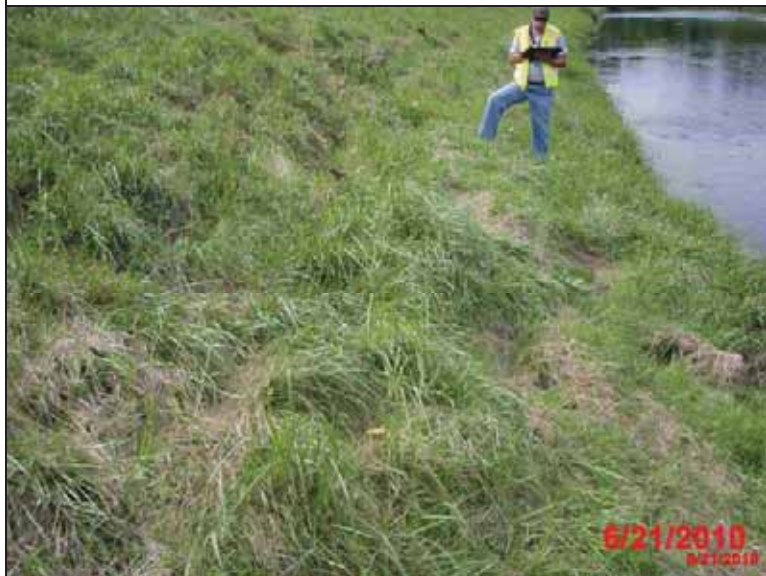
Inspect ID: N21L_2010_a_0010 **Title:** USACE_CELRB_N21L_2010_a_0010_1.jpg
Caption: Rutting along bank

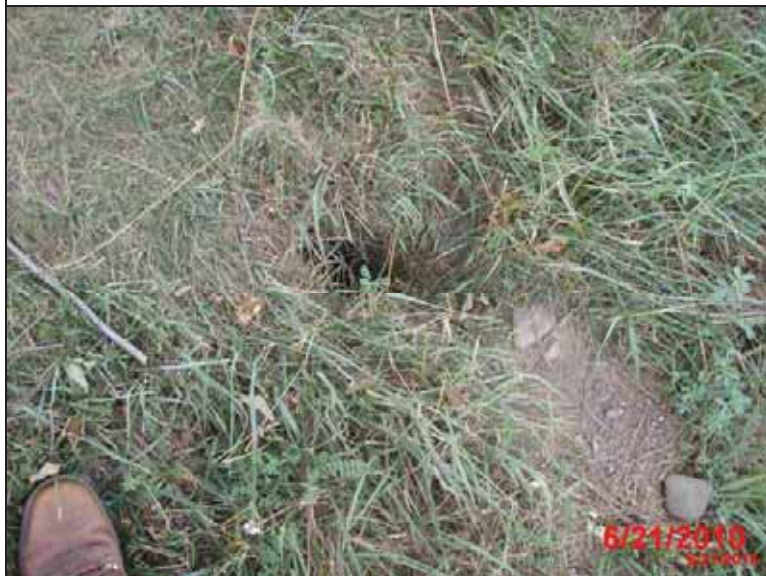
Inspect ID: N21L_2010_a_0011 **Title:** USACE_CELRB_N21L_2010_a_0011_2.jpg
Caption: Multiple burrow holes along bank

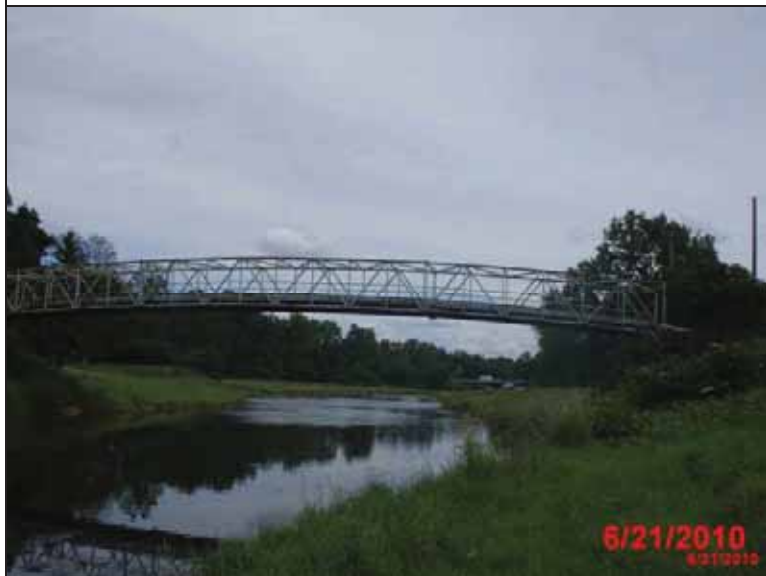
Inspect ID: N21L_2010_a_0013 **Title:** USACE_CELRB_N21L_2010_a_0013_1.jpg
Caption: Pedestrian bridge

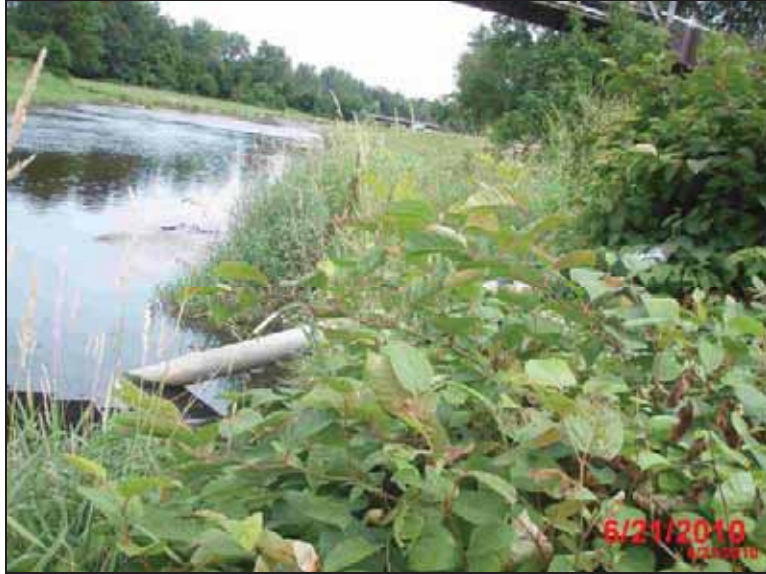
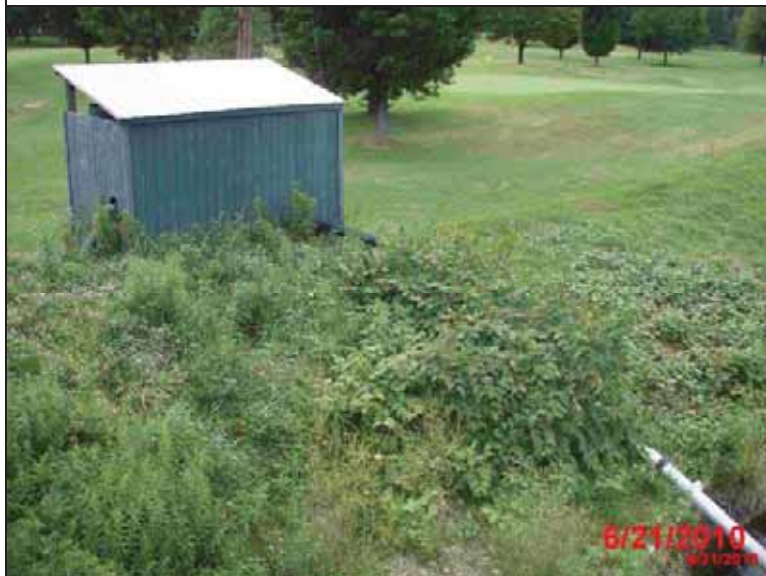
Inspect ID: N21L_2010_a_0014 **Title:** USACE_CELRB_N21L_2010_a_0014_1.jpg
Caption: Intake pipe to water pump station for golf course

Inspect ID: N21L_2010_a_0014 **Title:** USACE_CELRB_N21L_2010_a_0014_2.jpg
Caption: Intake pipe to water pump station for golf course

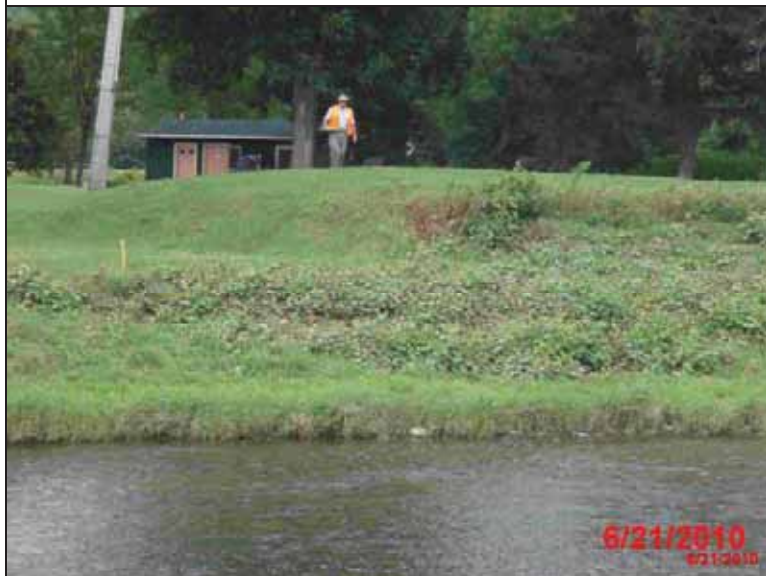
Inspect ID: N21L_2010_a_0019 **Title:** USACE_CELRB_N21L_2010_a_0019_1.jpg
Caption: Erosion along bank

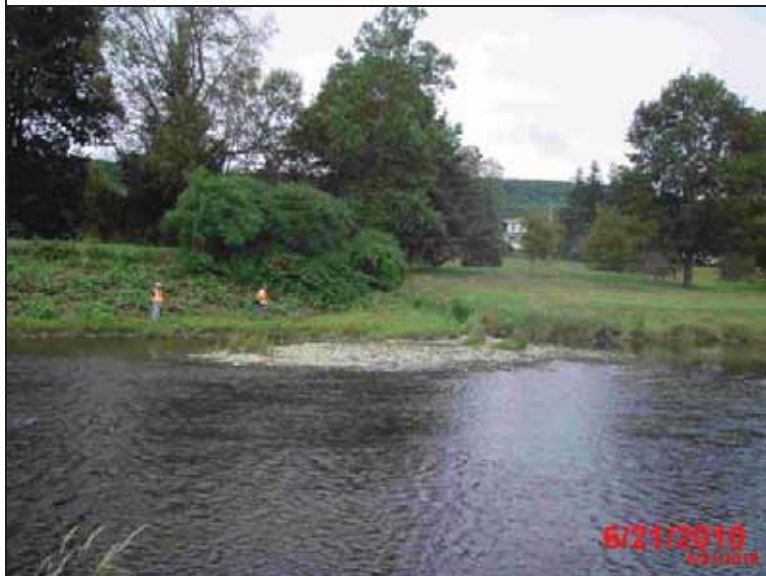
Inspect ID: N21L_2010_a_0021 **Title:** USACE_CELRB_N21L_2010_a_0021_1.jpg
Caption: Drainage ditch to channel

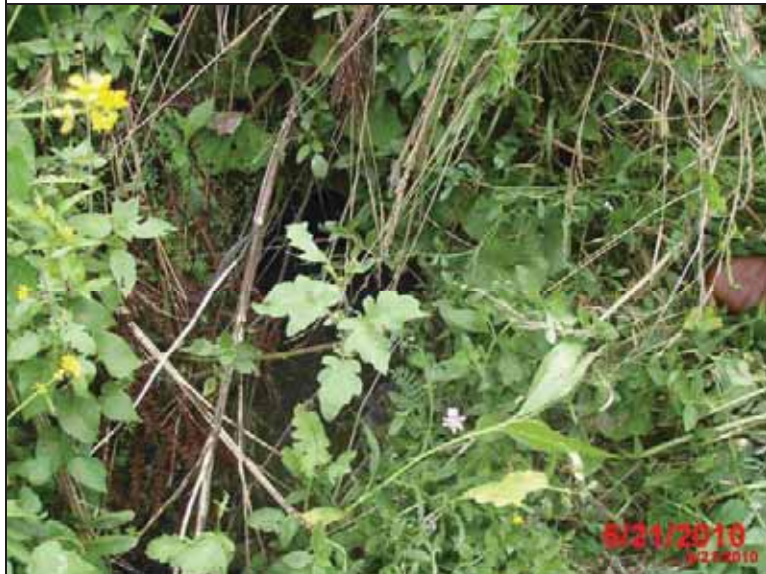
Rated Item	Rating	Rating Guidelines	Location/Remarks/Recommendations
			<p>N21L_2010_a_0025: 24" CMP drainage pipe 25% silted: Sediment and debris removal is recommended (U)</p> <p>N21L_2010_a_0039: Depression on bank: Coordinate with USACE to determine if slope change is occurring or if conditions are as-built (U)</p> <p>N21L_2010_a_0044: Drainage ditch to channel: Document encroachments in accordance with USACE guidance (M)</p> <p>N21L_2010_a_0047: Drainage ditch to channel: Document encroachments in accordance with USACE guidance (M)</p> <p>N21L_2010_a_0051: Rutting from mover: Backfill rutting with engineered fill, re-establish appropriate sod cover (M)</p> <p>N21L_2010_a_0054: 30" CMP drainage pipe, 20% silted: Sediment and debris removal is recommended (U)</p> <p>N21L_2010_a_0058: Burrow hole: Establish animal control program (U)</p> <p>N21L_2010_a_0060: Miscellaneous encroachments, gardens bushes: Document encroachments in accordance with USACE guidance (U)</p> <p>N21L_2010_a_0066: Gage house: Document encroachments in accordance with USACE guidance (M)</p> <p>N21L_2010_a_0067: Drop structure: Document encroachments in accordance with USACE guidance (A)</p> <p>N21L_2010_a_0079: Access ramp: Document encroachments in accordance with USACE guidance (M)</p> <p>N21L_2010_a_0103: Utility pole: Document encroachments in accordance with USACE guidance (U)</p> <p>N21L_2010_a_0106: Bridge, road: Document encroachments in accordance with USACE guidance (M)</p> <p>N21L_2010_a_0107: 6" drain pipe: Document encroachments in accordance with USACE guidance (U)</p> <p>N21L_2010_a_0108: 4" clay tile relief pipe: Clean drainage inlet/outlet to ensure adequate flow (A)</p> <p>N21L_2010_a_0111: Fence: Document encroachments in accordance with USACE guidance (U)</p> <p>N21L_2010_a_0112: Utility pole: Document encroachments in accordance with USACE guidance (M)</p> <p>N21L_2010_a_0115: Manhole: Document encroachments in accordance with USACE guidance (U)</p> <p>N21L_2010_a_0116: Brick building: Document encroachments in accordance with USACE guidance (U)</p> <p>N21L_2010_a_0117: Fence, vegetation: Document encroachments in accordance with USACE guidance (U)</p> <p>N21L_2010_a_0121: Guide rail, fence: Document</p>

Inspect ID: N21L_2010_a_0025 **Title:** USACE_CELRB_N21L_2010_a_0025_1.jpg
Caption: 24" CMP drainage pipe 25% silted
