Wellsville, New York

Genesee River

Left Bank Levee and Entire
Channel

Levee Periodic Inspection 2010

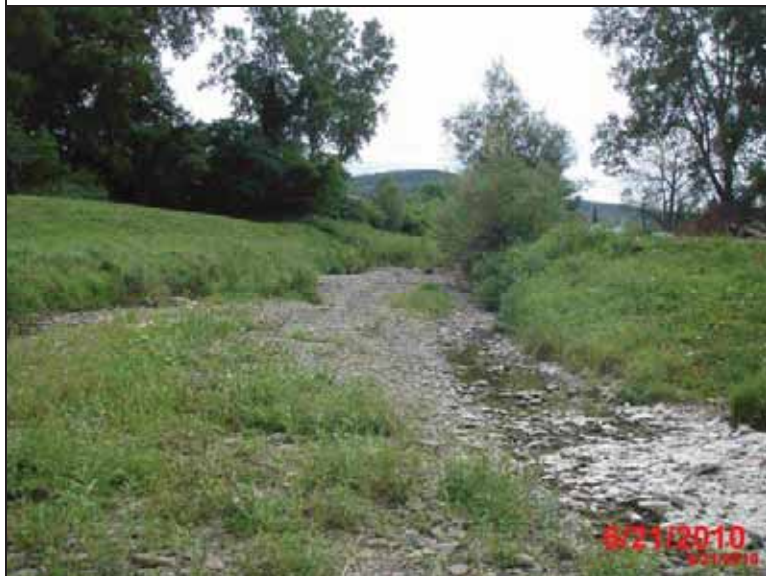
Inspect ID: N21L_2010_a_0029 **Title:** USACE_CELRB_N21L_2010_a_0029_1.jpg
Caption: Shoaling in drainage channel to river

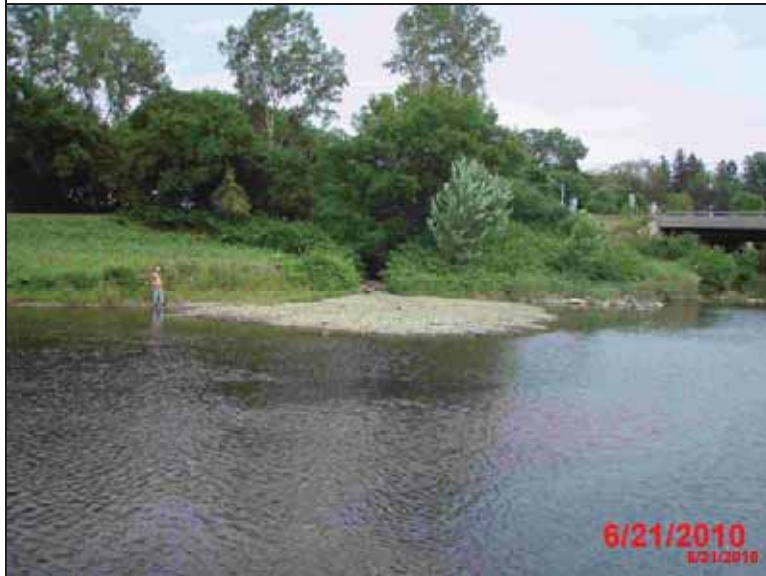
Inspect ID: N21L_2010_a_0031 **Title:** USACE_CELRB_N21L_2010_a_0031_1.jpg
Caption: Shoaling from drainage channel into river

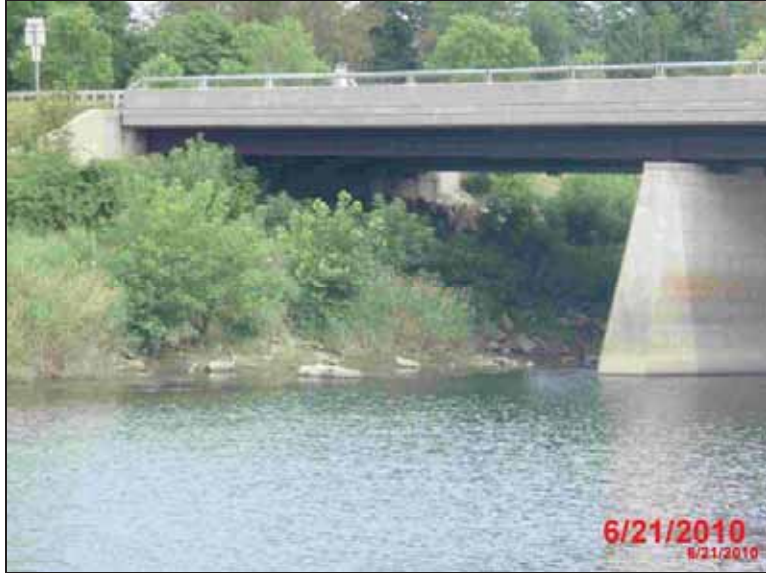
Inspect ID: N21L_2010_a_0032 **Title:** USACE_CELRB_N21L_2010_a_0032_1.jpg
Caption: Vegetation in riprap

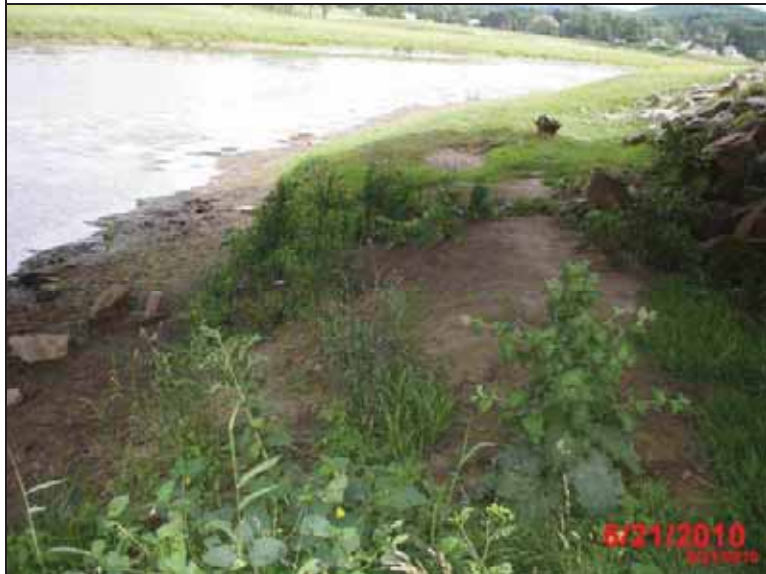
4. Erosion	U	A	No head cutting or horizontal deviation observed.	N21L_2010_a_0006: Erosion along bank: Backfill erosion with engineered fill, re-establish appropriate sod cover (U)
		M	Head cutting and horizontal deviation evident, but is less than 1 foot from the designed grade or cross section.	N21L_2010_a_0012: Erosion along bank: Backfill erosion with engineered fill, re-establish appropriate sod cover (U)
		U	Head cutting and horizontal deviation of more than 1 foot from the designed grade or cross section. Corrective actions required to stop or slow erosion.	N21L_2010_a_0019: Erosion along bank: Backfill erosion with engineered fill, re-establish appropriate sod cover (U) N21L_2010_a_0026: Erosion in drainage ditch to channel: Backfill erosion with engineered fill, re-establish appropriate sod cover (M) N21L_2010_a_0033: Erosion on bank under bridge: Backfill

Inspect ID: N21L_2010_a_0033 **Title:** USACE_CELRB_N21L_2010_a_0033_1.jpg
Caption: Erosion on bank under bridge

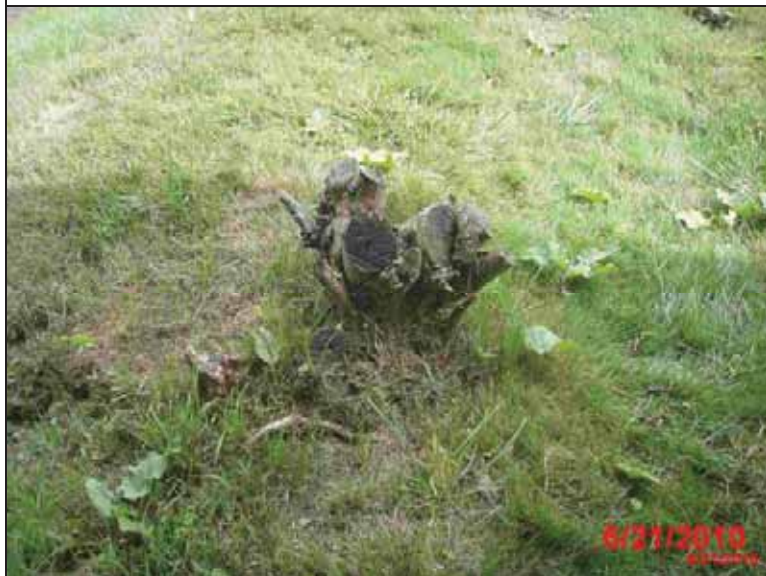
Inspect ID: N21L_2010_a_0035 **Title:** USACE_CELRB_N21L_2010_a_0035_1.jpg
Caption: 12" tree stump on bank

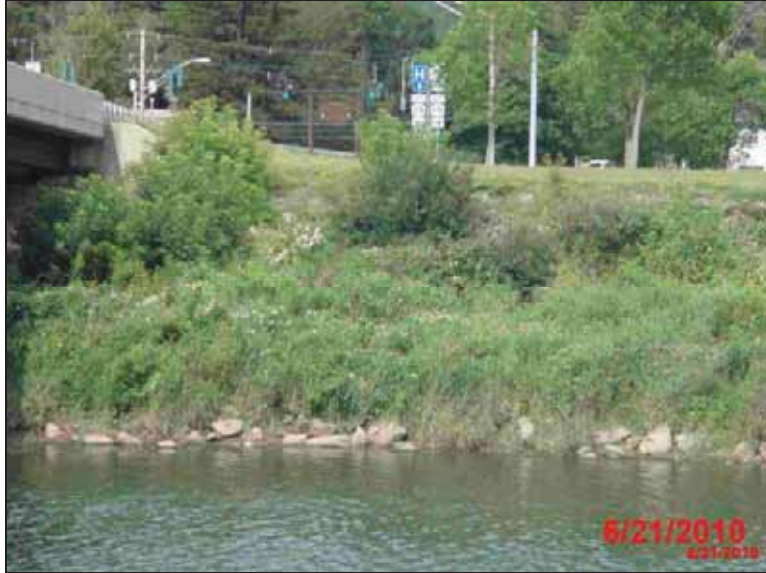
Inspect ID: N21L_2010_a_0036 **Title:** USACE_CELRB_N21L_2010_a_0036_1.jpg
Caption: Vegetation on bank

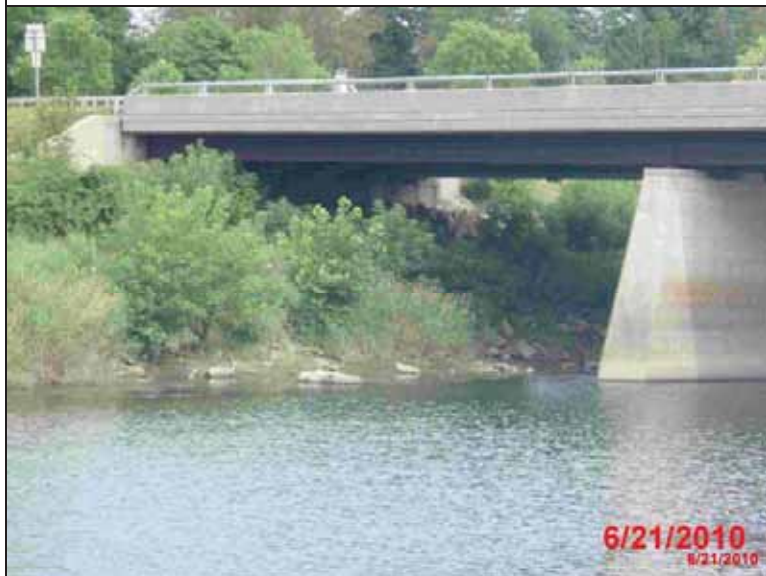
Inspect ID: N21L_2010_a_0037 **Title:** USACE_CELRB_N21L_2010_a_0037_1.jpg
Caption: Shoaling under bridge

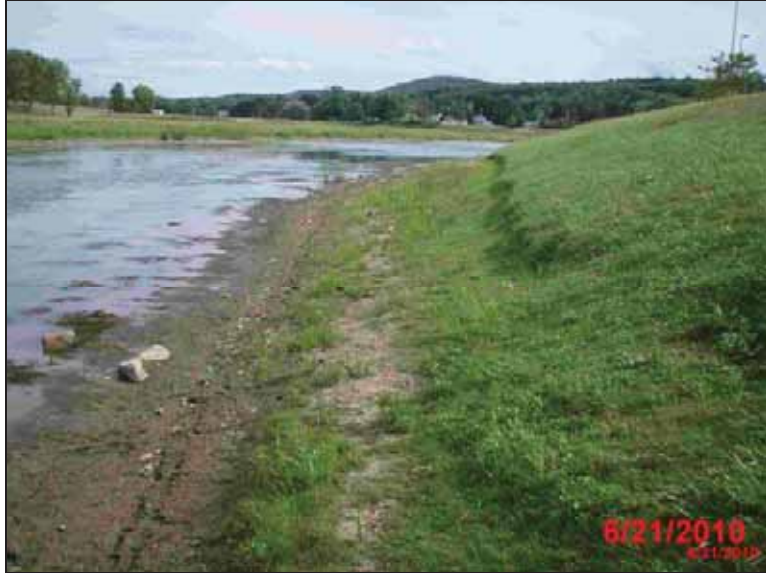
Rated Item	Rating	Rating Guidelines		Location/Remarks/Recommendations
				erosion with engineered fill, re-establish appropriate sod cover (U) N21L_2010_a_0038: Erosion edge of bank: Backfill erosion with engineered fill, re-establish appropriate sod cover (U) N21L_2010_a_0046: Erosion along bank: Backfill erosion with engineered fill, re-establish appropriate sod cover (U) N21L_2010_a_0050: Erosion along bank: Backfill erosion with engineered fill, re-establish appropriate sod cover; survey for future failure (U) N21L_2010_a_0208: Erosion on bank: Backfill erosion with engineered fill, re-establish appropriate sod cover (U) N21L_2010_a_0212: Seepage: Backfill erosion with engineered fill, re-establish appropriate sod cover (U) N21L_2010_a_0231: 15' x 3' erosion: Backfill erosion with engineered fill, re-establish appropriate sod cover (U)

Inspect ID: N21L_2010_a_0038 **Title:** USACE_CELRB_N21L_2010_a_0038_1.jpg
Caption: Erosion edge of bank

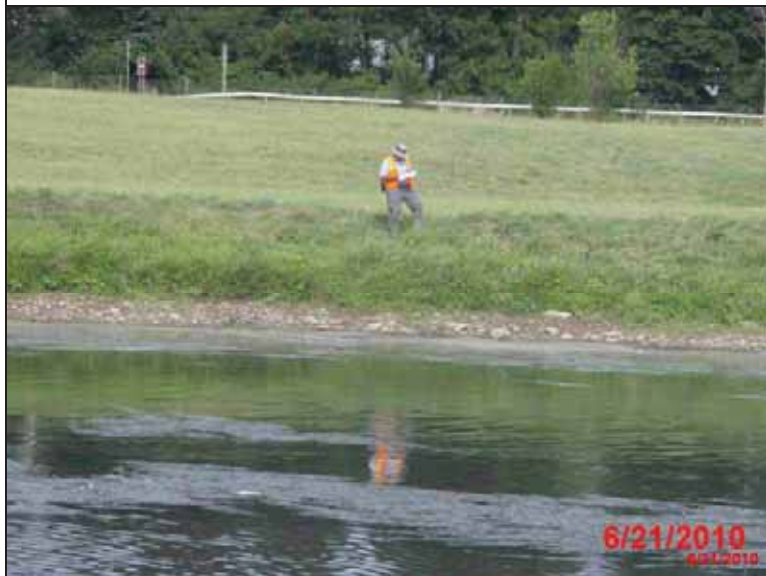
Rated Item	Rating	Rating Guidelines	Location/Remarks/Recommendations
			<p>N21L_2010_a_0025: 24" CMP drainage pipe 25% silted: Sediment and debris removal is recommended (U)</p> <p>N21L_2010_a_0039: Depression on bank: Coordinate with USACE to determine if slope change is occurring or if conditions are as-built (U)</p> <p>N21L_2010_a_0044: Drainage ditch to channel: Document encroachments in accordance with USACE guidance (M)</p> <p>N21L_2010_a_0047: Drainage ditch to channel: Document encroachments in accordance with USACE guidance (M)</p> <p>N21L_2010_a_0051: Rutting from mover: Backfill rutting with engineered fill, re-establish appropriate sod cover (M)</p> <p>N21L_2010_a_0054: 30" CMP drainage pipe, 20% silted: Sediment and debris removal is recommended (U)</p> <p>N21L_2010_a_0058: Burrow hole: Establish animal control program (U)</p> <p>N21L_2010_a_0060: Miscellaneous encroachments, gardens bushes: Document encroachments in accordance with USACE guidance (U)</p> <p>N21L_2010_a_0066: Gage house: Document encroachments in accordance with USACE guidance (M)</p> <p>N21L_2010_a_0067: Drop structure: Document encroachments in accordance with USACE guidance (A)</p> <p>N21L_2010_a_0079: Access ramp: Document encroachments in accordance with USACE guidance (M)</p> <p>N21L_2010_a_0103: Utility pole: Document encroachments in accordance with USACE guidance (U)</p> <p>N21L_2010_a_0106: Bridge, road: Document encroachments in accordance with USACE guidance (M)</p> <p>N21L_2010_a_0107: 6" drain pipe: Document encroachments in accordance with USACE guidance (U)</p> <p>N21L_2010_a_0108: 4" clay tile relief pipe: Clean drainage inlet/outlet to ensure adequate flow (A)</p> <p>N21L_2010_a_0111: Fence: Document encroachments in accordance with USACE guidance (U)</p> <p>N21L_2010_a_0112: Utility pole: Document encroachments in accordance with USACE guidance (M)</p> <p>N21L_2010_a_0115: Manhole: Document encroachments in accordance with USACE guidance (U)</p> <p>N21L_2010_a_0116: Brick building: Document encroachments in accordance with USACE guidance (U)</p> <p>N21L_2010_a_0117: Fence, vegetation: Document encroachments in accordance with USACE guidance (U)</p> <p>N21L_2010_a_0121: Guide rail, fence: Document</p>

Inspect ID: N21L_2010_a_0039 **Title:** USACE_CELRB_N21L_2010_a_0039_1.jpg
Caption: Depression on bank

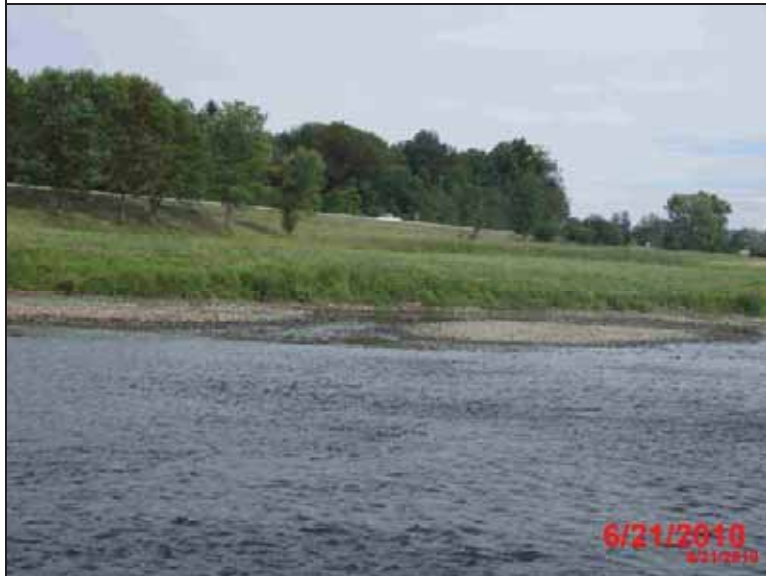
Inspect ID: N21L_2010_a_0043 **Title:** USACE_CELRB_N21L_2010_a_0043_1.jpg
Caption: Shoaling in channel

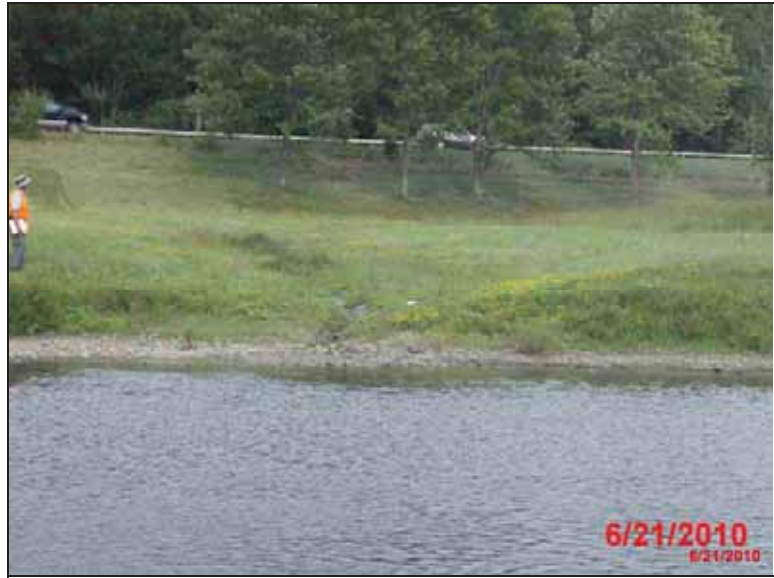
<p>Inspect ID: N21L_2010_a_0044 Title: USACE_CELRB_N21L_2010_a_0044_1.jpg Caption: Drainage ditch to channel</p>

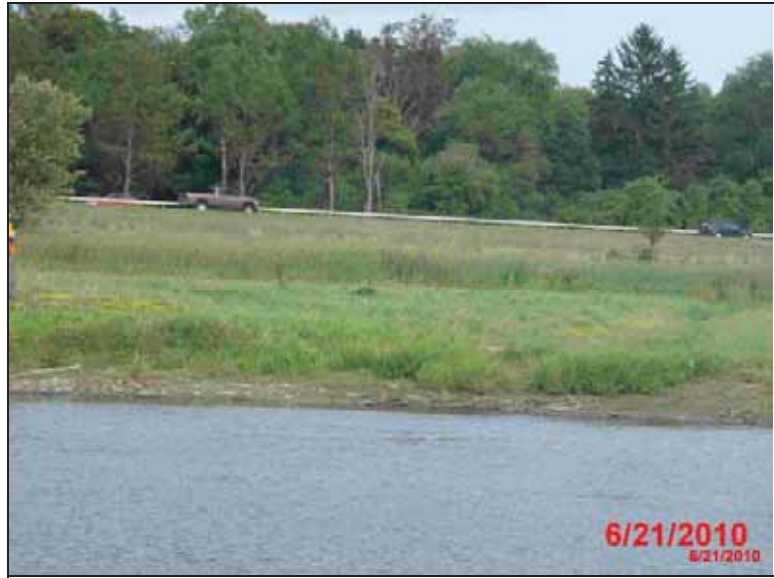
<p>Inspect ID: N21L_2010_a_0047 Title: USACE_CELRB_N21L_2010_a_0047_1.jpg Caption: Drainage ditch to channel</p>

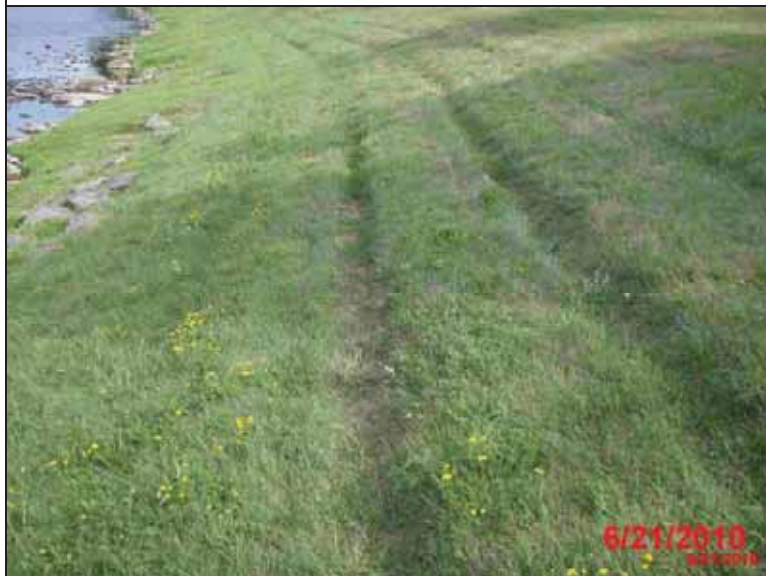
Inspect ID: N21L_2010_a_0051 **Title:** USACE_CELRB_N21L_2010_a_0051_1.jpg
Caption: Rutting from mover

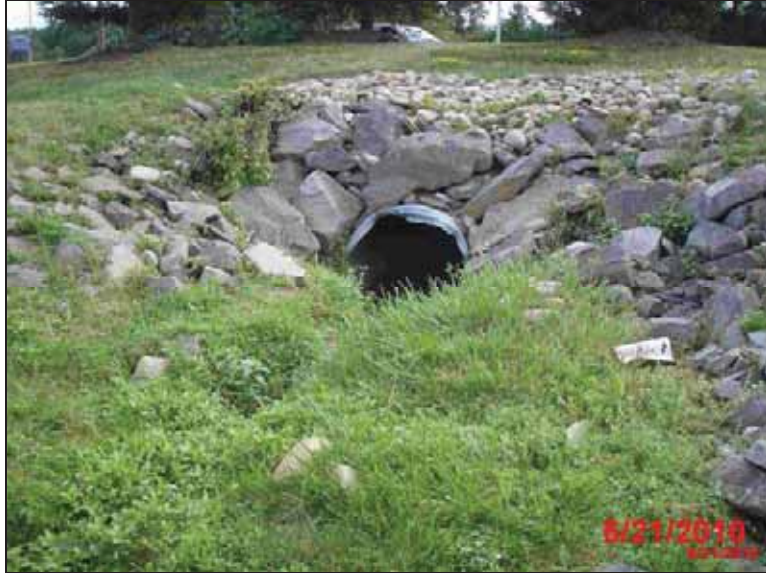
Inspect ID: N21L_2010_a_0054 **Title:** USACE_CELRB_N21L_2010_a_0054_1.jpg
Caption: 30" CMP drainage pipe, 20% silted

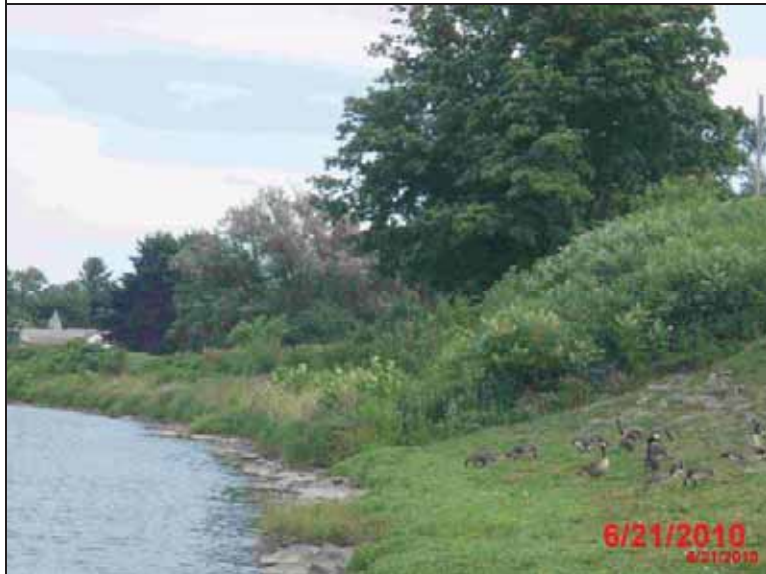
Inspect ID: N21L_2010_a_0055 **Title:** USACE_CELRB_N21L_2010_a_0055_1.jpg
Caption: Vegetation in riprap

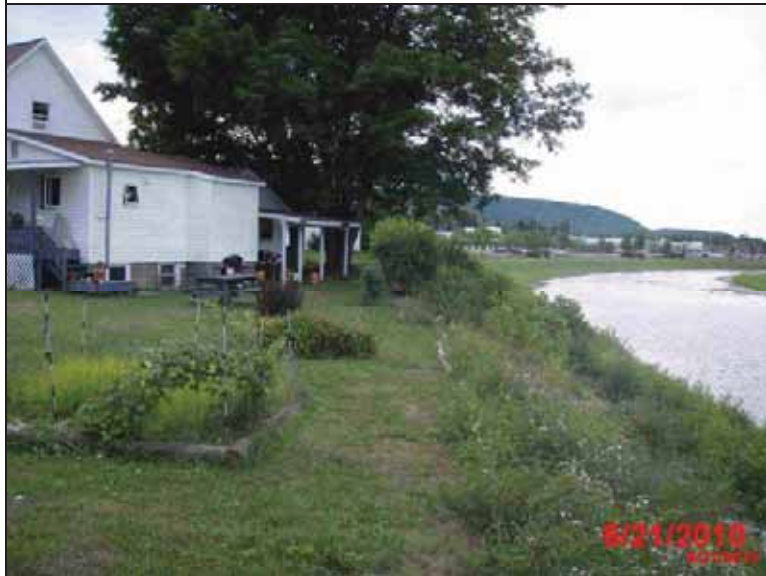
Inspect ID: N21L_2010_a_0060 **Title:** USACE_CELRB_N21L_2010_a_0060_1.jpg
Caption: Miscellaneous encroachments, gardens bushes

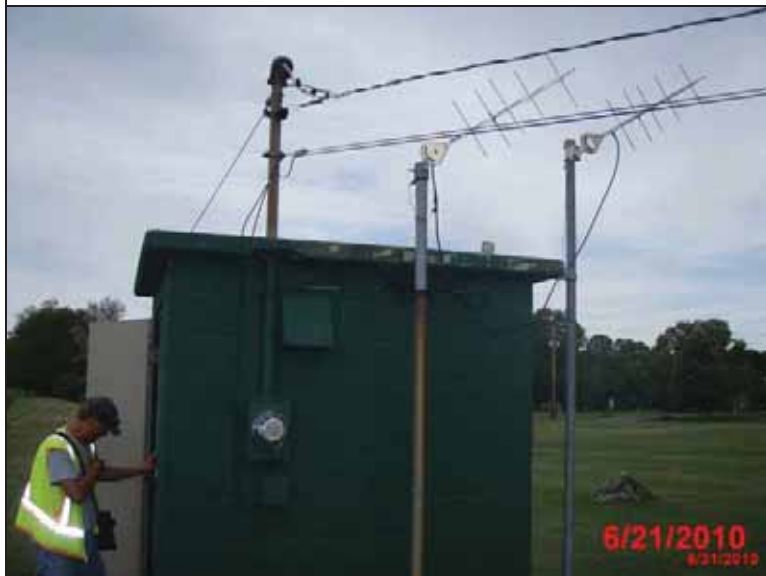
Inspect ID: N21L_2010_a_0066 **Title:** USACE_CELRB_N21L_2010_a_0066_1.jpg
Caption: Gage house

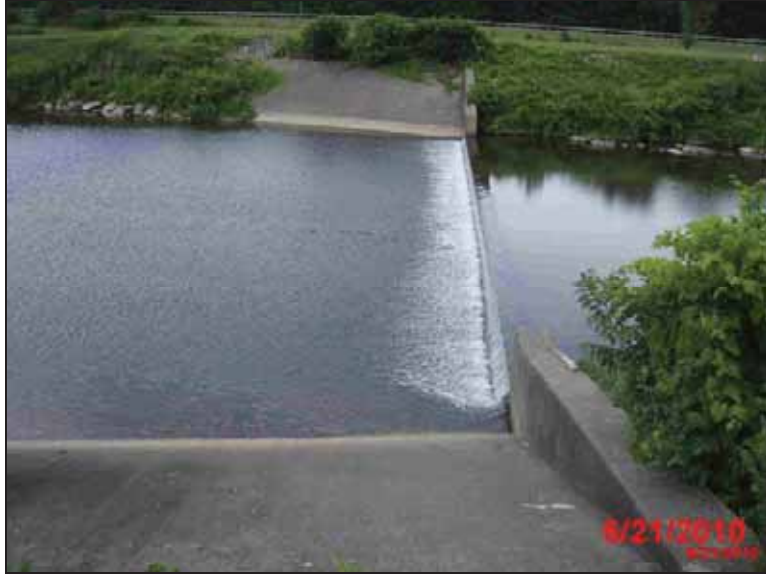
Inspect ID: N21L_2010_a_0067 **Title:** USACE_CELRB_N21L_2010_a_0067_1.jpg
Caption: Drop structure

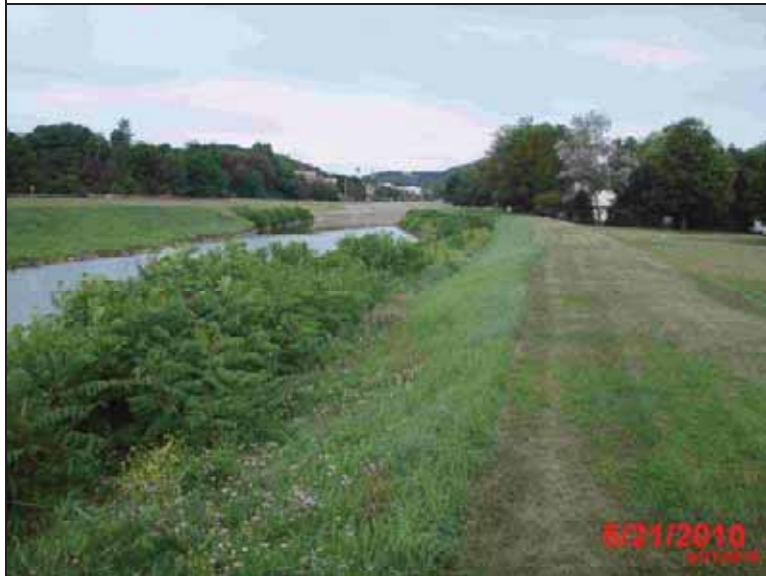
Inspect ID: N21L_2010_a_0069 **Title:** USACE_CELRB_N21L_2010_a_0069_1.jpg
Caption: Vegetation on bank in riprap

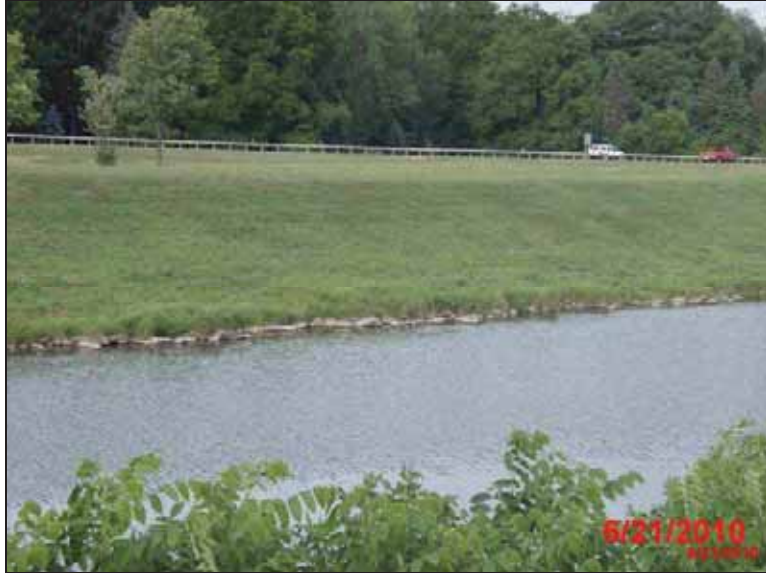
Inspect ID: N21L_2010_a_0070 **Title:** USACE_CELRB_N21L_2010_a_0070_1.jpg
Caption: Shoaling along bank

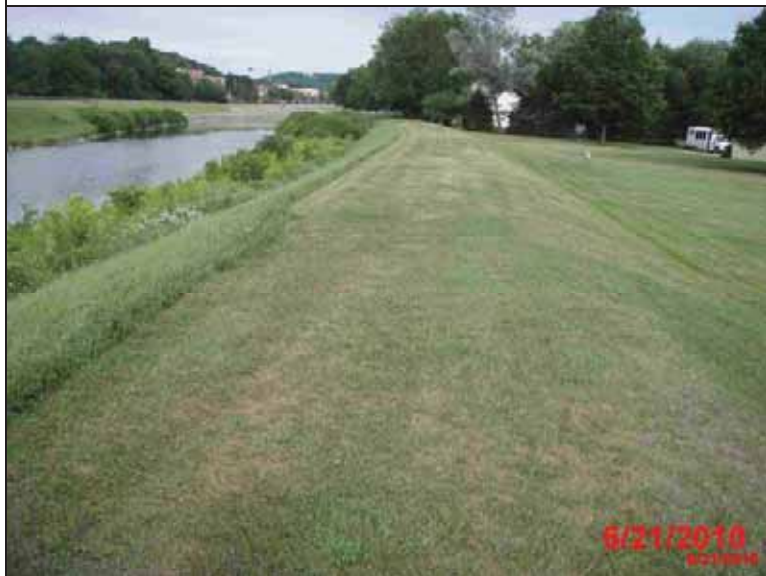
Inspect ID: N21L_2010_a_0072 **Title:** USACE_CELRB_N21L_2010_a_0072_1.jpg
Caption: Shoaling in channel

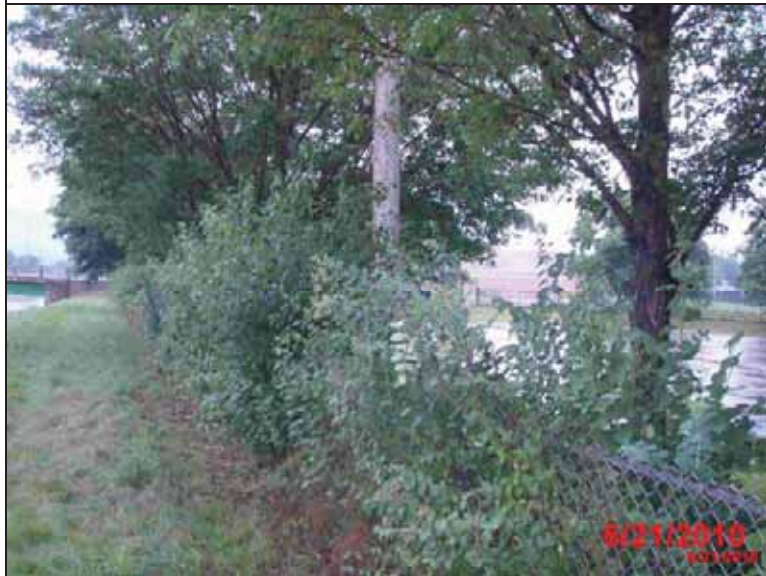
Inspect ID: N21L_2010_a_0103 **Title:** USACE_CELRB_N21L_2010_a_0103_1.jpg
Caption: Utility pole

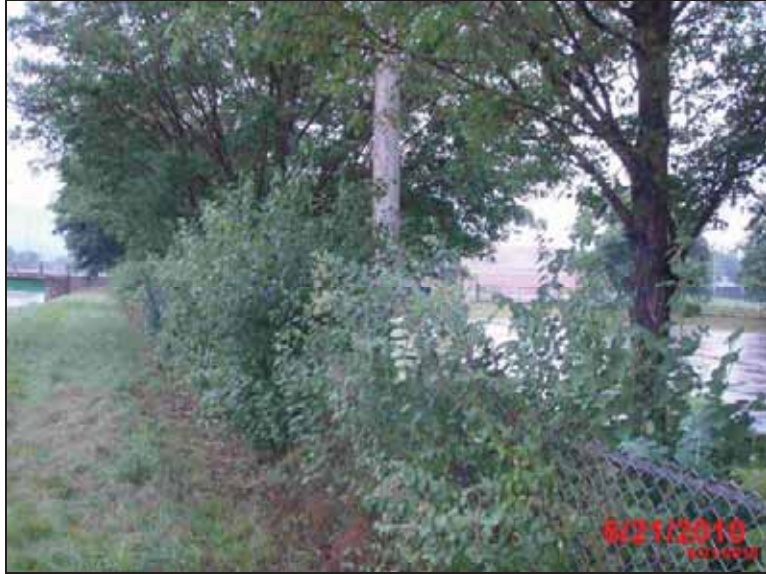
Inspect ID: N21L_2010_a_0104 **Title:** USACE_CELRB_N21L_2010_a_0104_1.jpg
Caption: Trees along fence

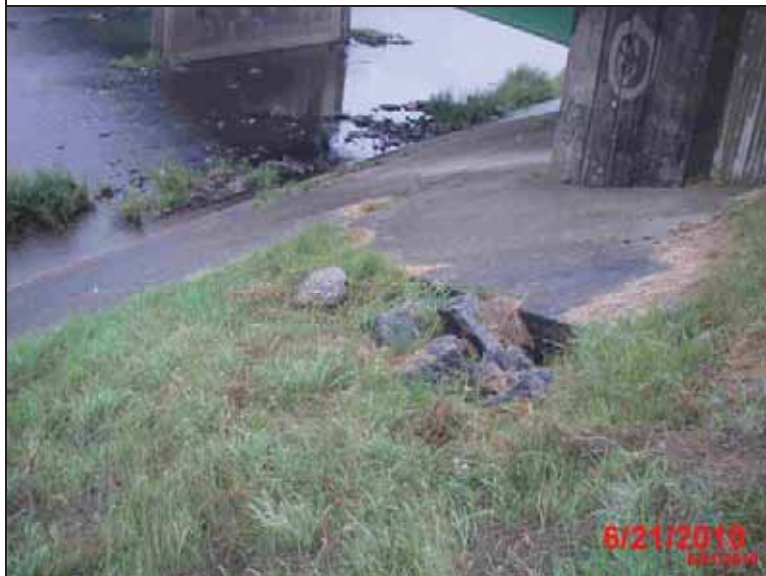
Inspect ID: N21L_2010_a_0105 **Title:** USACE_CELRB_N21L_2010_a_0105_1.jpg
Caption: Erosion in riprap along concrete

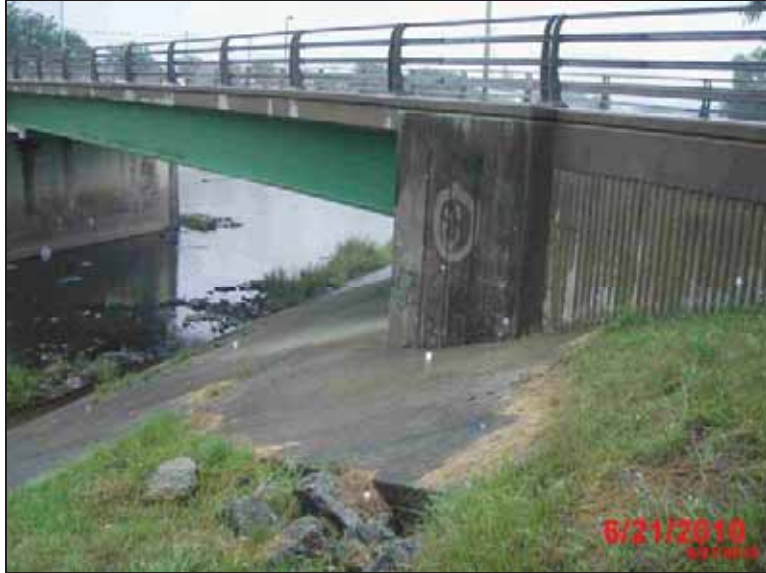
Inspect ID: N21L_2010_a_0106 **Title:** USACE_CELRB_N21L_2010_a_0106_1.jpg
Caption: Bridge, road

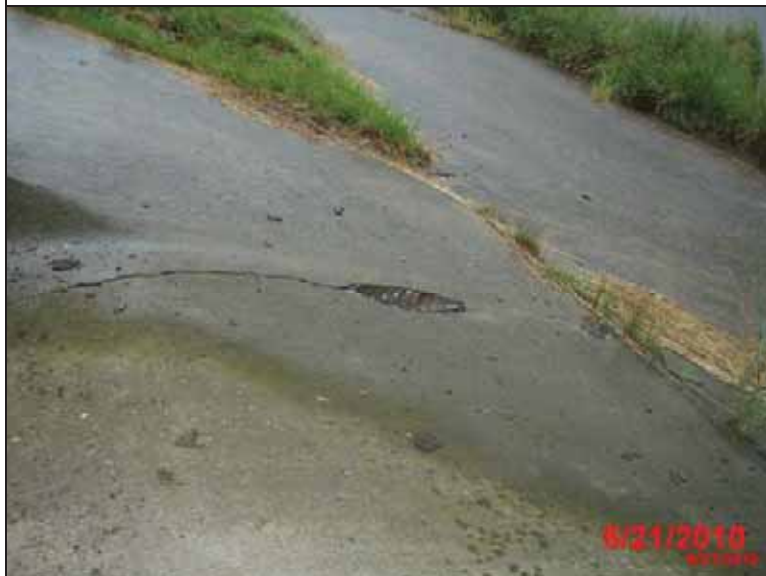
Inspect ID: N21L_2010_a_0107 **Title:** USACE_CELRB_N21L_2010_a_0107_1.jpg
Caption: 6" drainage pipe

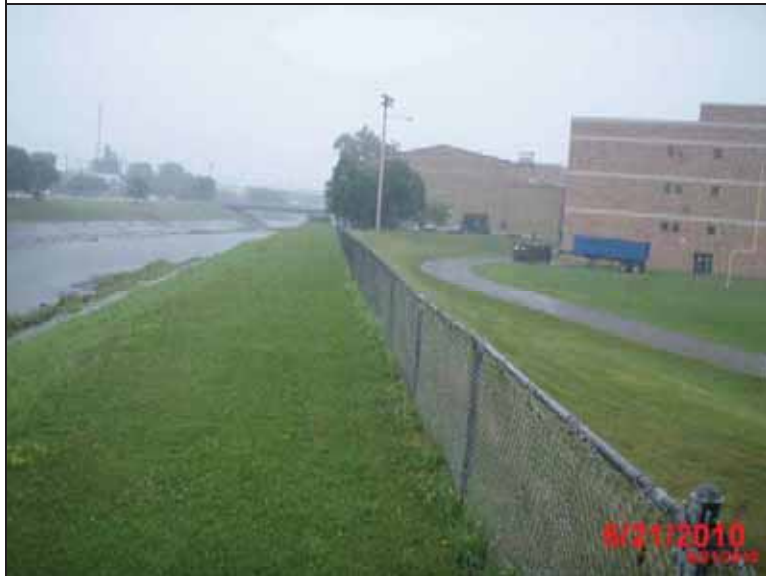
Inspect ID: N21L_2010_a_0111 **Title:** USACE_CELRB_N21L_2010_a_0111_1.jpg
Caption: Fence

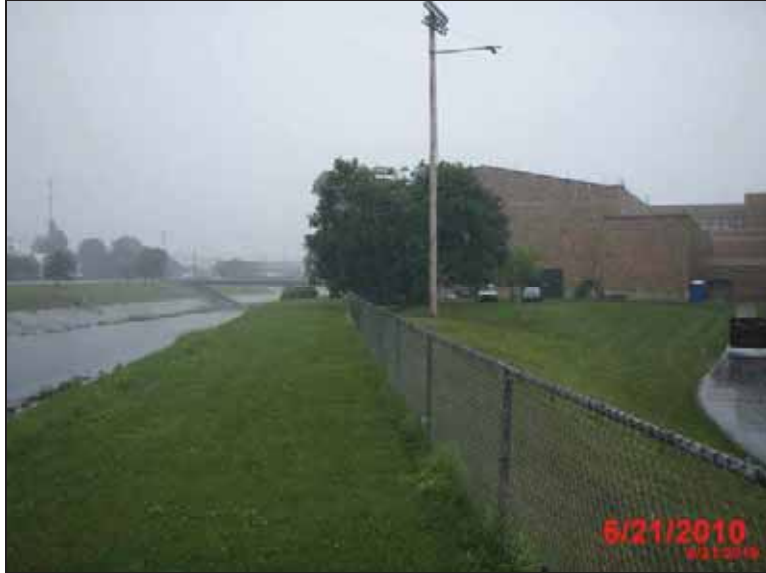
Inspect ID: N21L_2010_a_0112 **Title:** USACE_CELRB_N21L_2010_a_0112_1.jpg
Caption: Utility pole

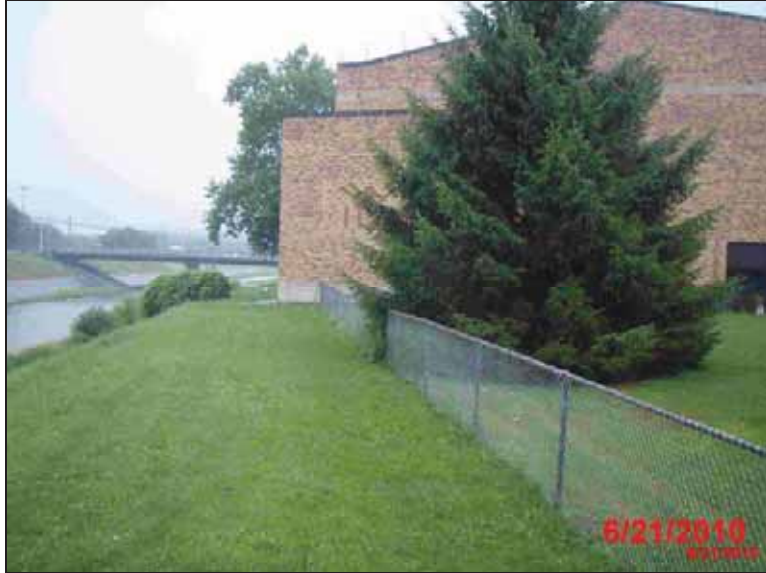
Inspect ID: N21L_2010_a_0114 **Title:** USACE_CELRB_N21L_2010_a_0114_1.jpg
Caption: Tree

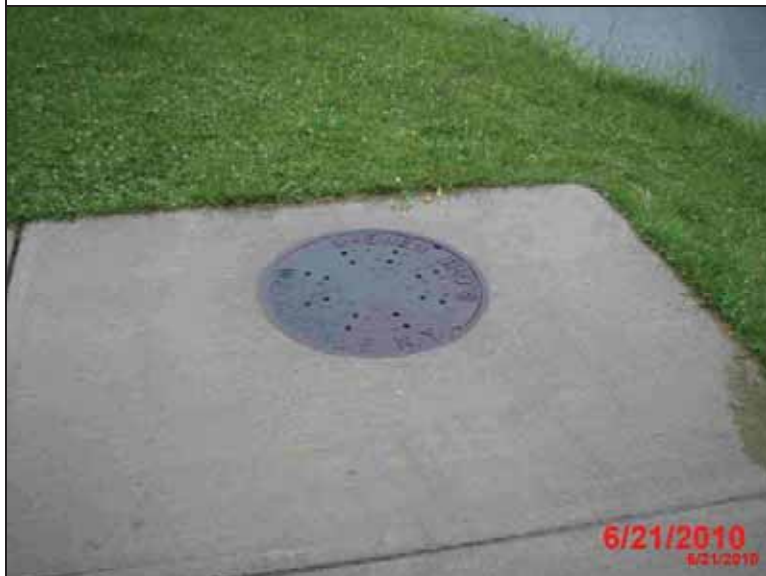
Inspect ID: N21L_2010_a_0115 **Title:** USACE_CELRB_N21L_2010_a_0115_1.jpg
Caption: Manhole

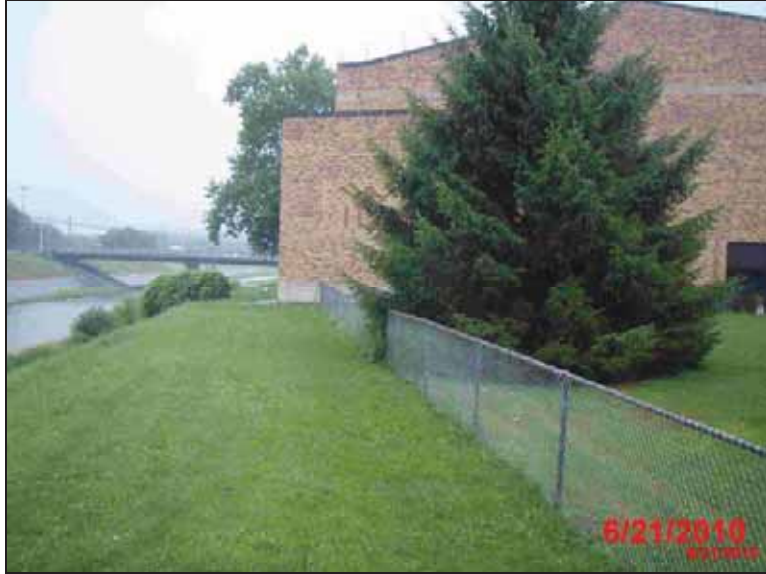
Inspect ID: N21L_2010_a_0116 **Title:** USACE_CELRB_N21L_2010_a_0116_1.jpg
Caption: Brick building

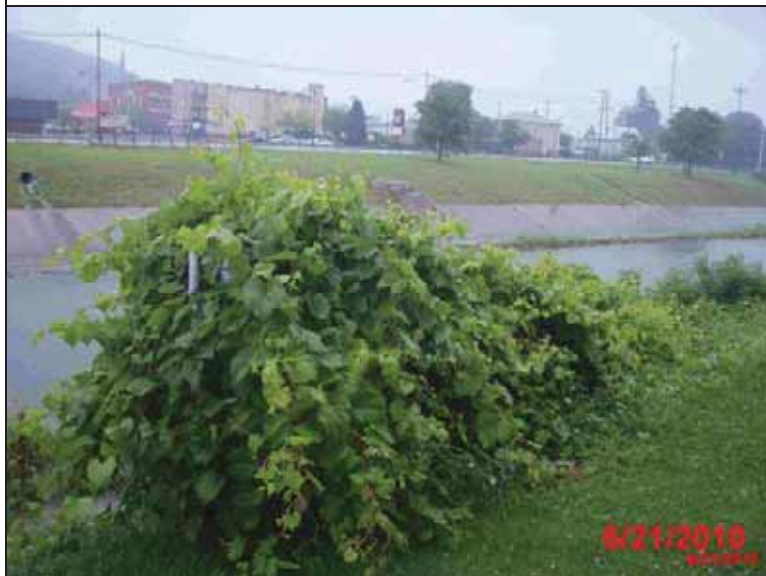
Inspect ID: N21L_2010_a_0117 **Title:** USACE_CELRB_N21L_2010_a_0117_1.jpg
Caption: Fence, vegetation

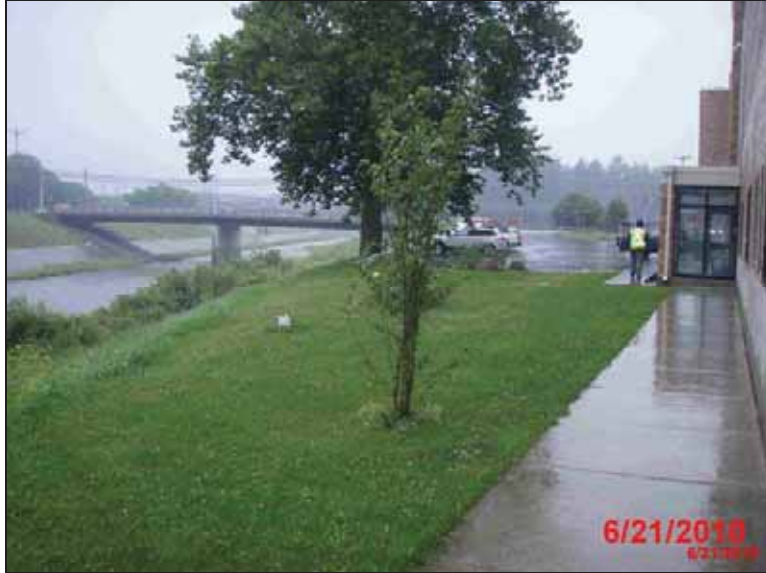
Inspect ID: N21L_2010_a_0118 **Title:** USACE_CELRB_N21L_2010_a_0118_1.jpg
Caption: Trees

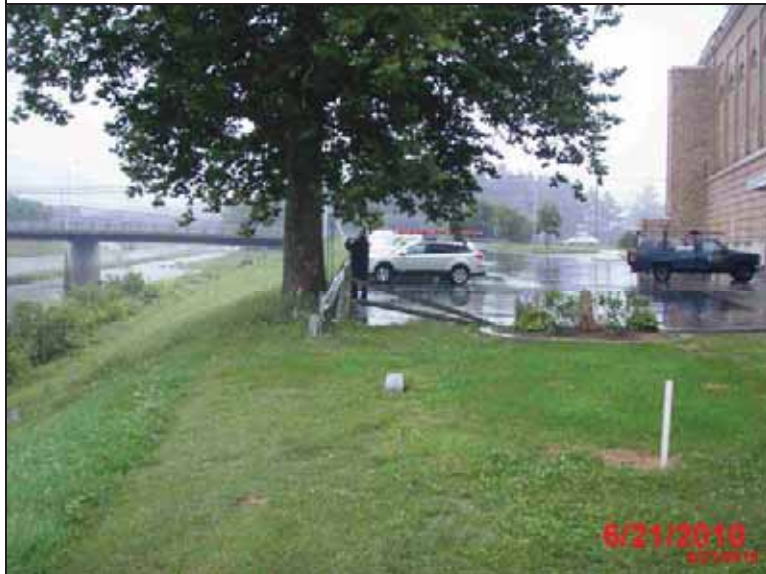
Inspect ID: N21L_2010_a_0119 **Title:** USACE_CELRB_N21L_2010_a_0119_1.jpg
Caption: Tree

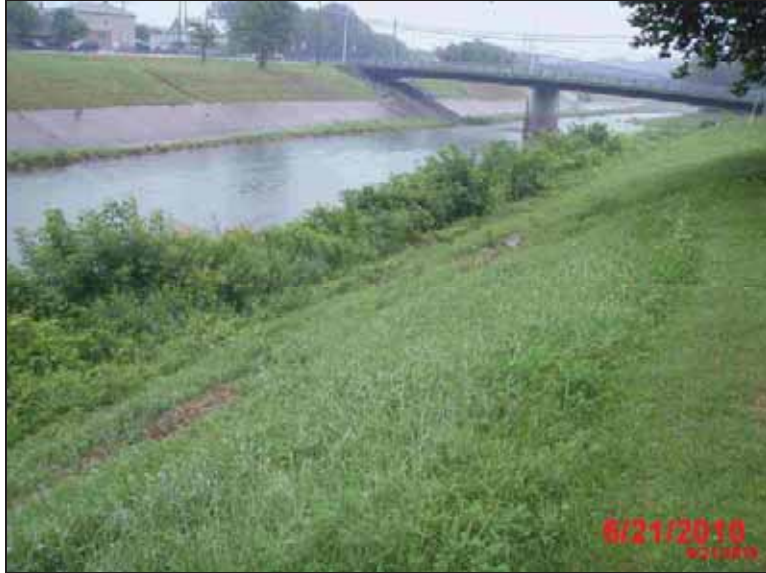
Inspect ID: N21L_2010_a_0120 **Title:** USACE_CELRB_N21L_2010_a_0120_1.jpg
Caption: Shoaling, vegetation

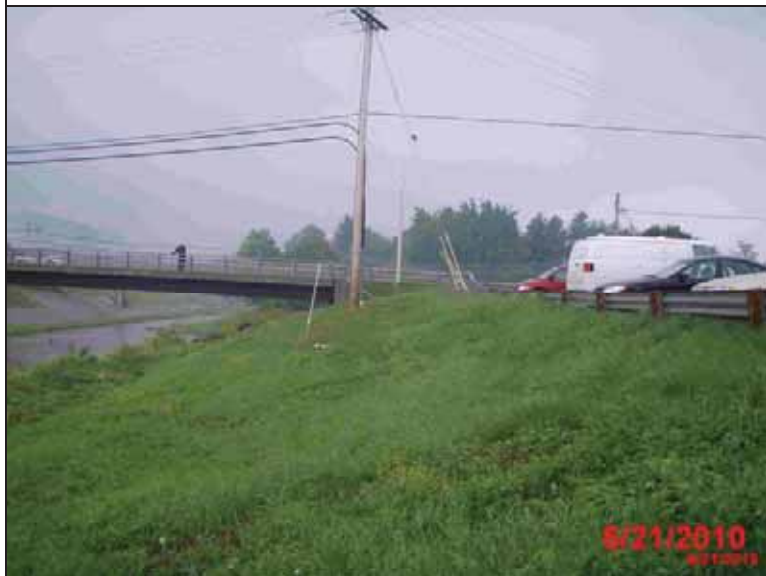
Inspect ID: N21L_2010_a_0121 **Title:** USACE_CELRB_N21L_2010_a_0121_1.jpg
Caption: Guide rail, fence

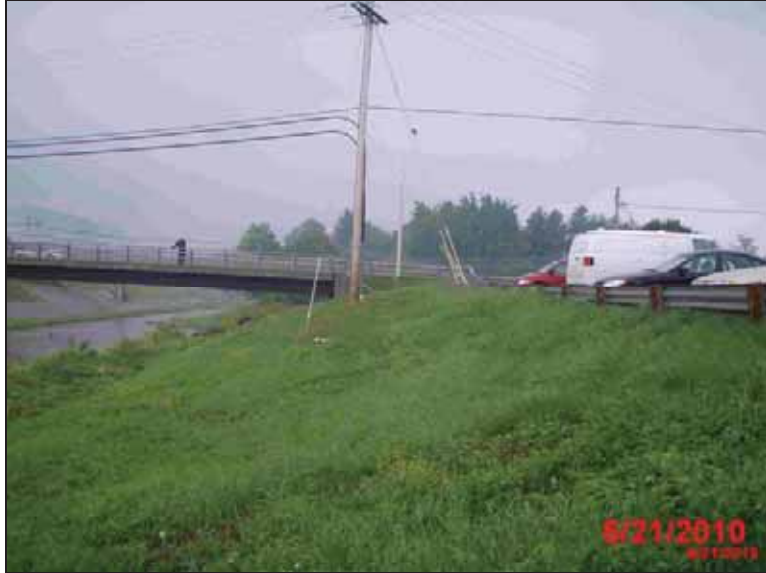
Inspect ID: N21L_2010_a_0122 **Title:** USACE_CELRB_N21L_2010_a_0122_1.jpg
Caption: Utility pole, guy wire light pole

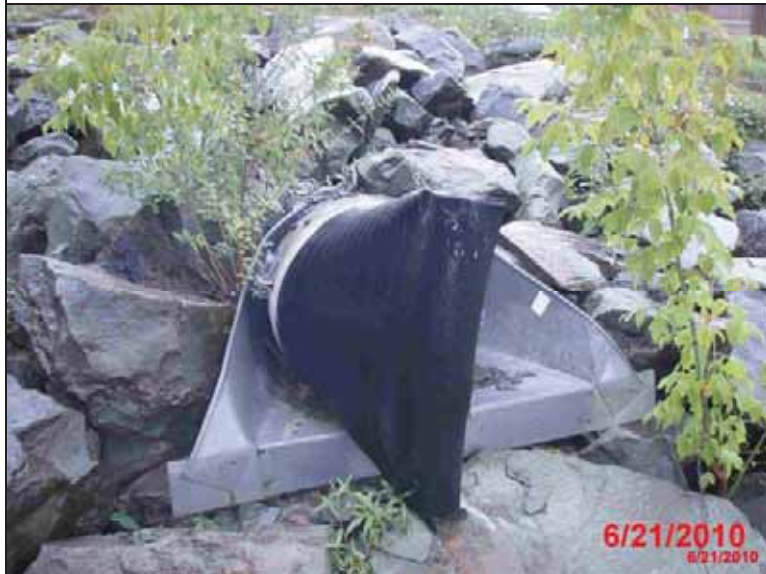
Inspect ID: N21L_2010_a_0123 **Title:** USACE_CELRB_N21L_2010_a_0123_1.jpg
Caption: 18" HDPE drainage pipe, Tideflex valve

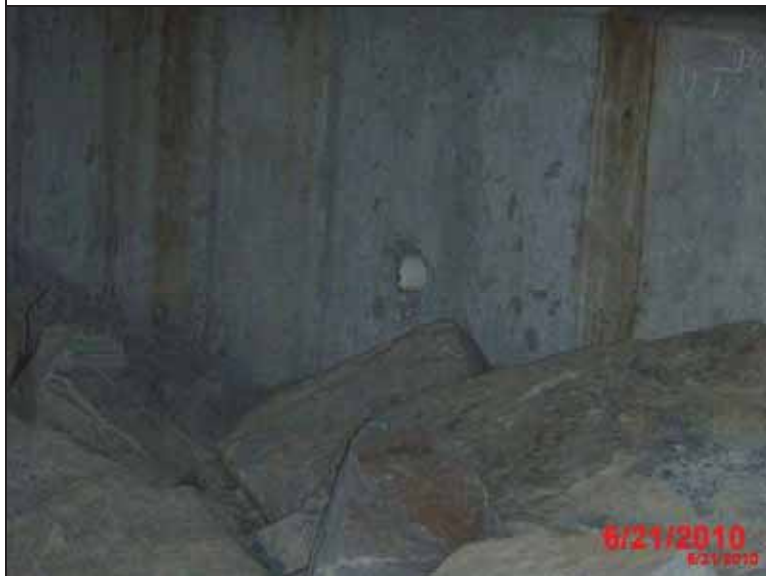
Inspect ID: N21L_2010_a_0126 **Title:** USACE_CELRB_N21L_2010_a_0126_1.jpg
Caption: Three 8" PVC drainage pipes

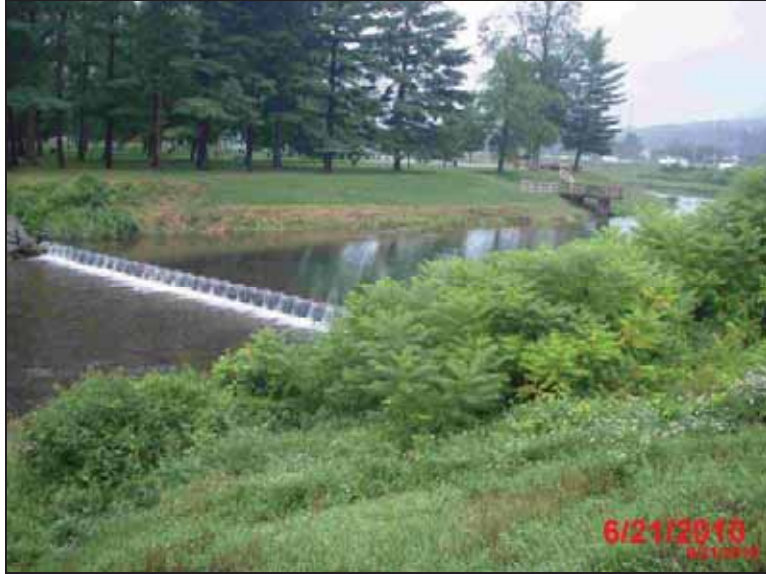
Inspect ID: N21L_2010_a_0137 **Title:** USACE_CELRB_N21L_2010_a_0137_1.jpg
Caption: Weir approved by corps

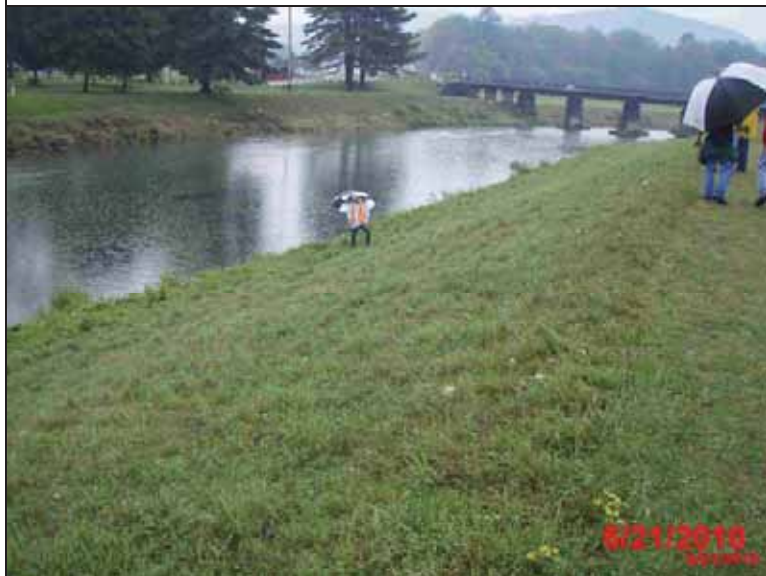
Inspect ID: N21L_2010_a_0152 **Title:** USACE_CELRB_N21L_2010_a_0152_1.jpg
Caption: Shoaling along toe

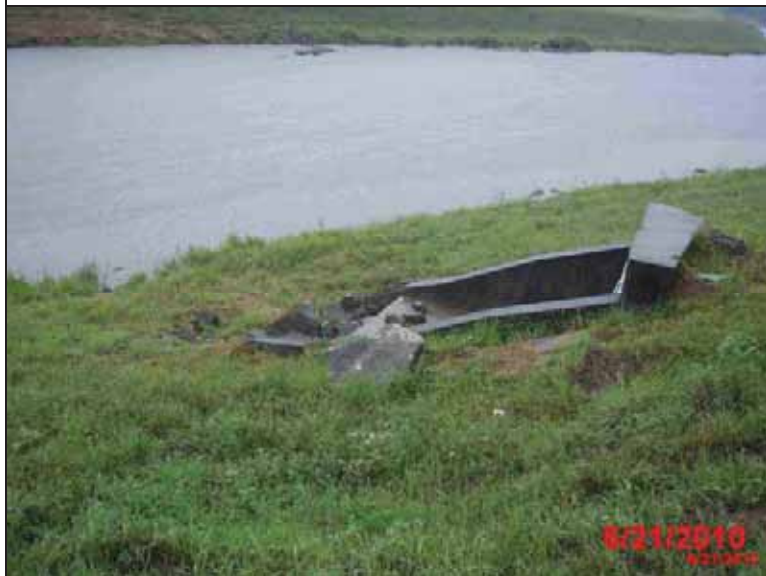
Inspect ID: N21L_2010_a_0159 **Title:** USACE_CELRB_N21L_2010_a_0159_1.jpg
Caption: Displaced riprap in channel from 42" CMP

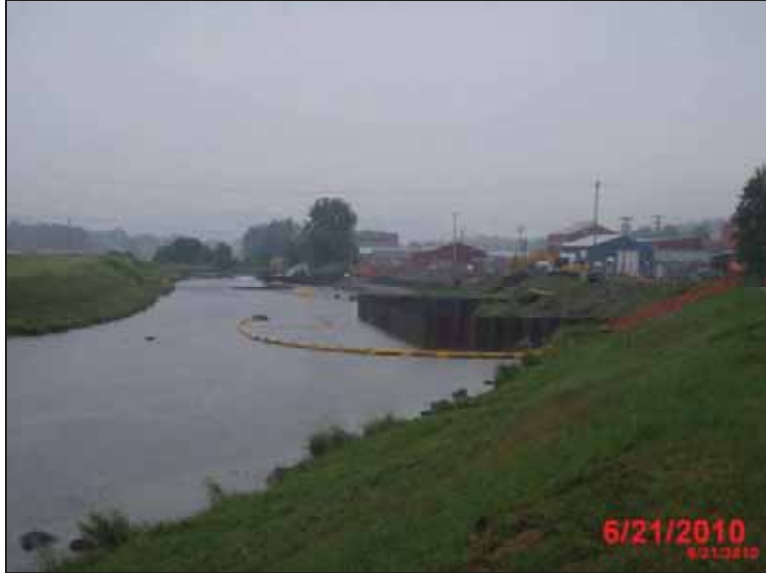
Inspect ID: N21L_2010_a_0161 **Title:** USACE_CELRB_N21L_2010_a_0161_1.jpg
Caption: Embankment under construction by BP

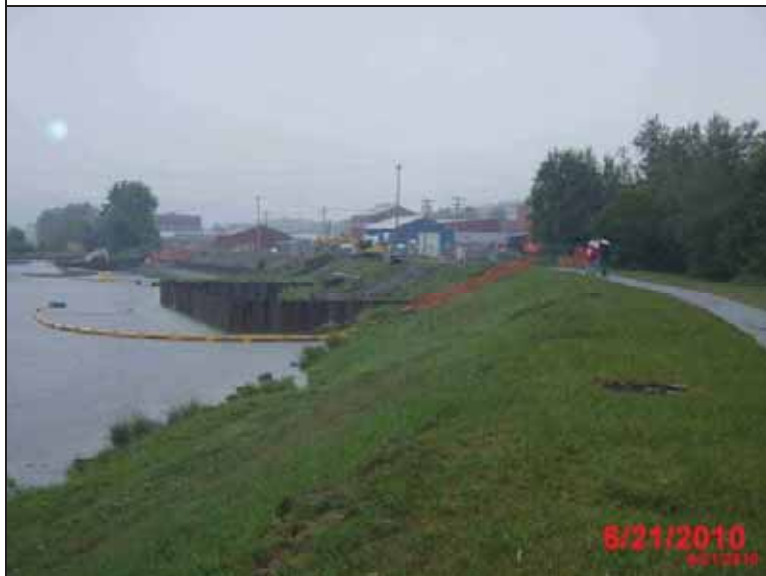
Inspect ID: N21L_2010_a_0161 **Title:** USACE_CELRB_N21L_2010_a_0161_2.jpg
Caption: Embankment under construction by BP

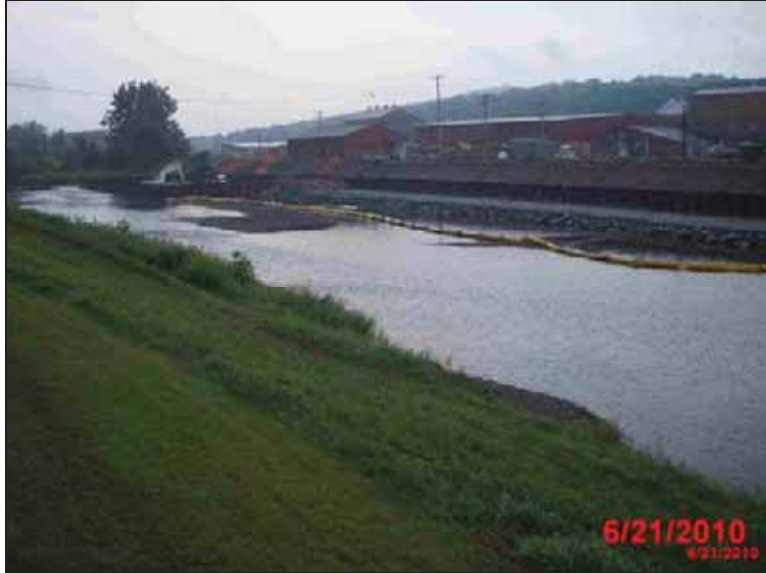
Inspect ID: N21L_2010_a_0169 **Title:** USACE_CELRB_N21L_2010_a_0169_1.jpg
Caption: Shoaling in channel

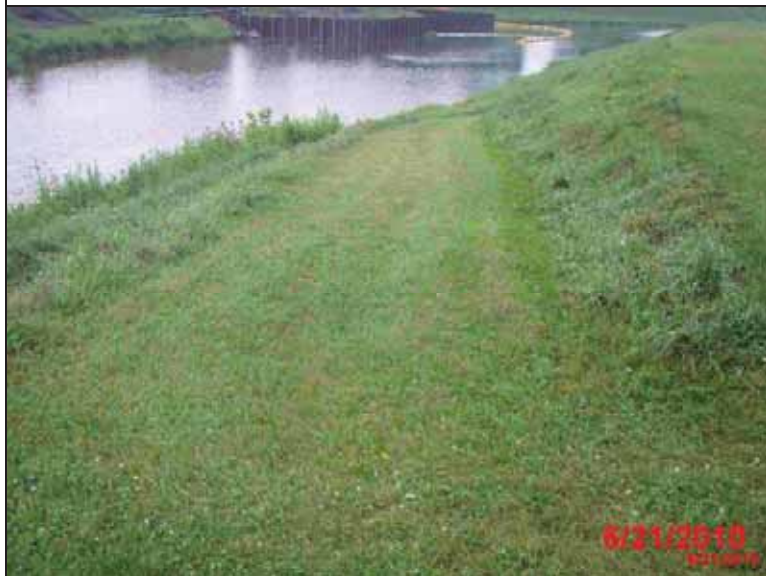
Inspect ID: N21L_2010_a_0170 **Title:** USACE_CELRB_N21L_2010_a_0170_1.jpg
Caption: Access ramp
