Wellsville, New York

Genesee River

Left Bank Levee and Entire
Channel

Levee Periodic Inspection 2010

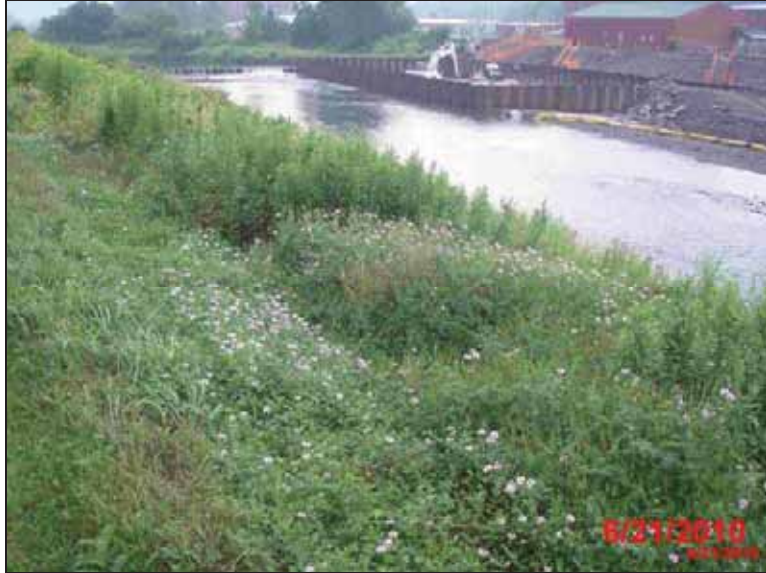
Inspect ID: N21L_2010_a_0171 **Title:** USACE_CELRB_N21L_2010_a_0171_1.jpg
Caption: Vegetation in riprap

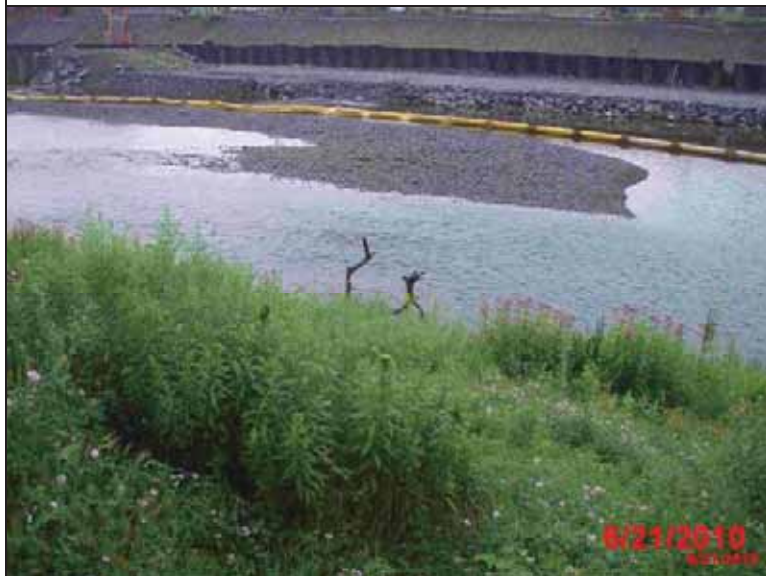
Inspect ID: N21L_2010_a_0172 **Title:** USACE_CELRB_N21L_2010_a_0172_1.jpg
Caption: Debris in channel near bank

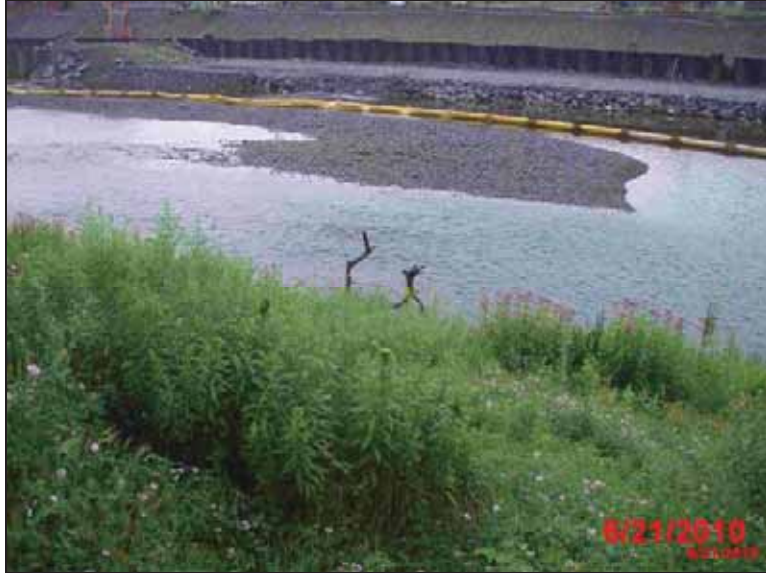
Inspect ID: N21L_2010_a_0173 **Title:** USACE_CELRB_N21L_2010_a_0173_1.jpg
Caption: Shoaling in channel

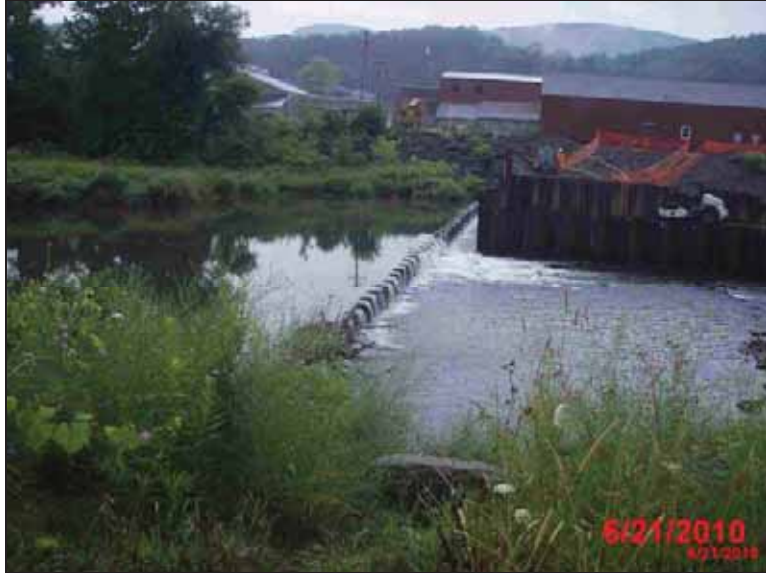
Inspect ID: N21L_2010_a_0174 **Title:** USACE_CELRB_N21L_2010_a_0174_1.jpg
Caption: Debris on Weir

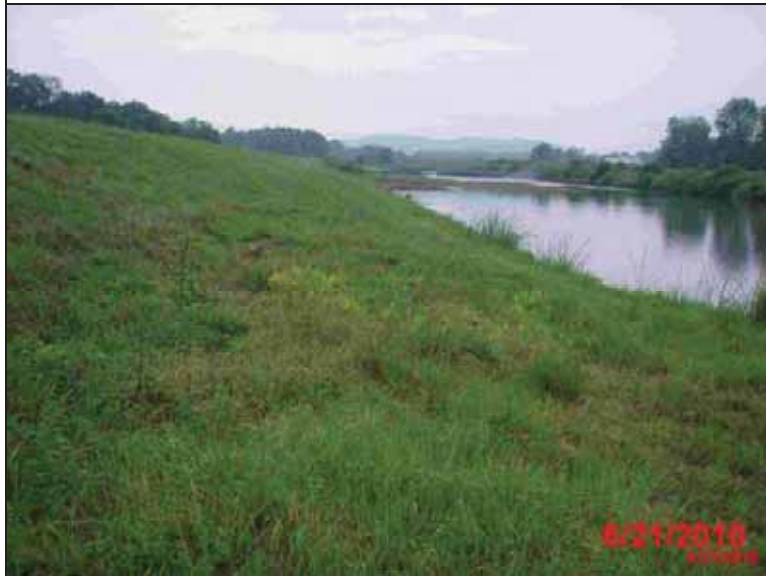
Inspect ID: N21L_2010_a_0179 **Title:** USACE_CELRB_N21L_2010_a_0179_1.jpg
Caption: Shoaling near bank

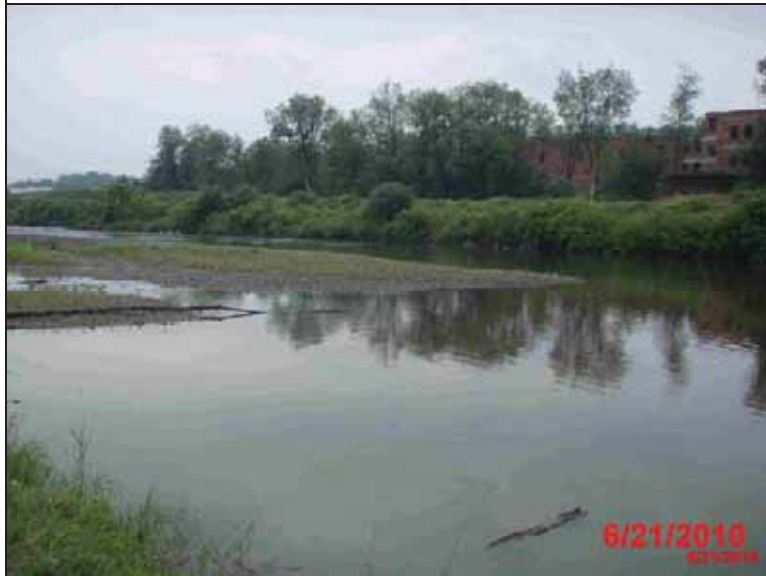
Inspect ID: N21L_2010_a_0181 **Title:** USACE_CELRB_N21L_2010_a_0181_1.jpg
Caption: Shoaling

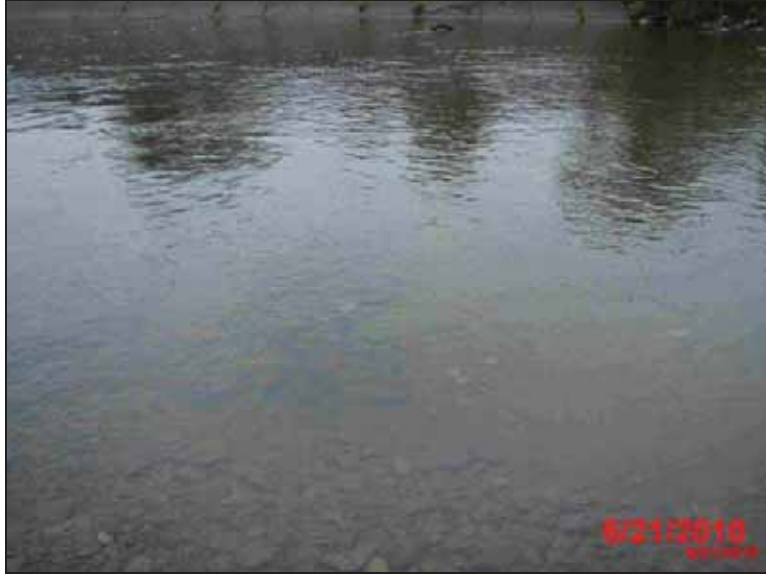
Inspect ID: N21L_2010_a_0189 **Title:** USACE_CELRB_N21L_2010_a_0189_1.jpg
Caption: Lower weir

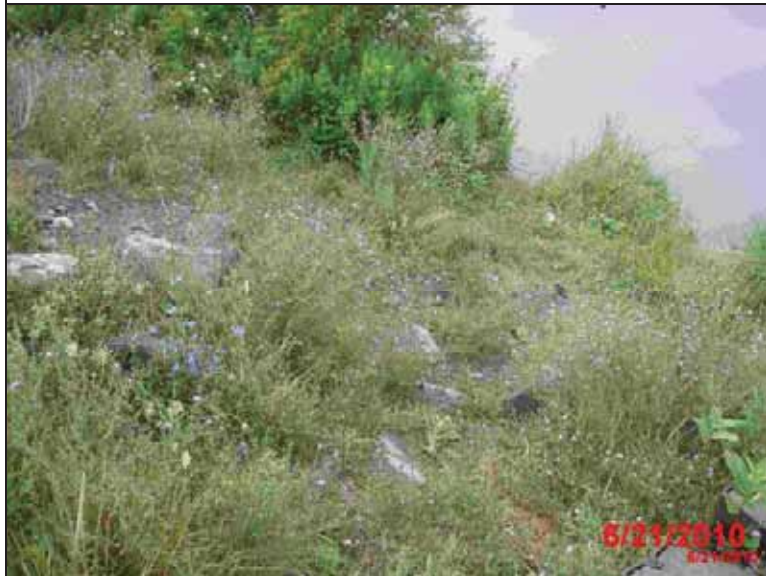
Inspect ID: N21L_2010_a_0192 **Title:** USACE_CELRB_N21L_2010_a_0192_1.jpg
Caption: Displacement of riprap along concrete

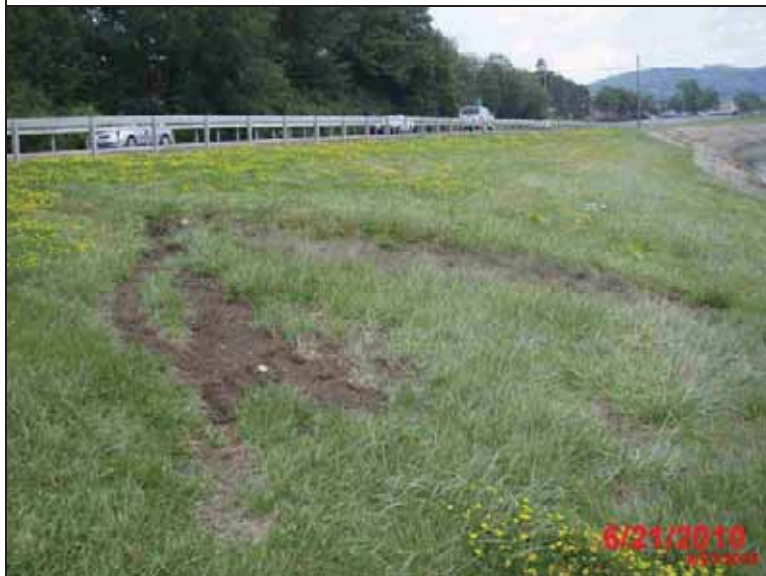
Inspect ID: N21L_2010_a_0208 **Title:** USACE_CELRB_N21L_2010_a_0208_1.jpg
Caption: Erosion on bank

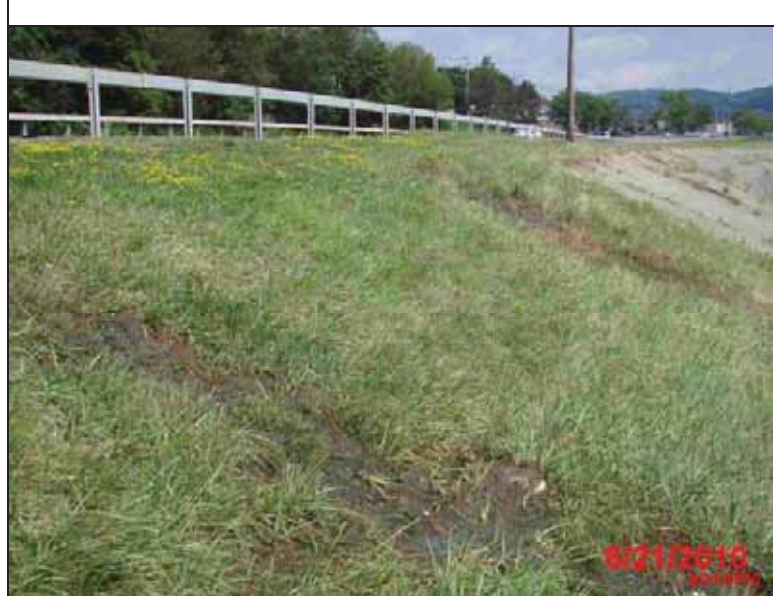
<p>Inspect ID: N21L_2010_a_0211 Title: USACE_CELRB_N21L_2010_a_0211_1.jpg Caption: 4" perforated drainage pipe</p>

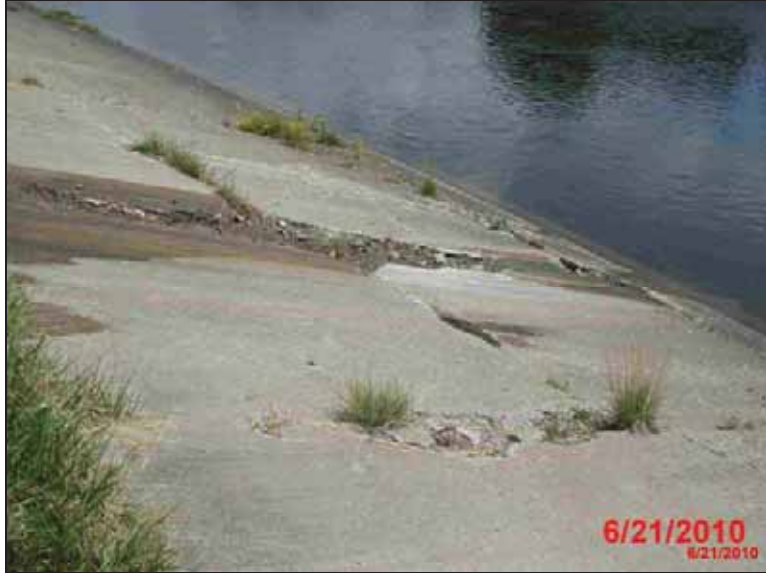
Inspect ID: N21L_2010_a_0214 **Title:** USACE_CELRB_N21L_2010_a_0214_1.jpg
Caption: 15' x 3' concrete spalling

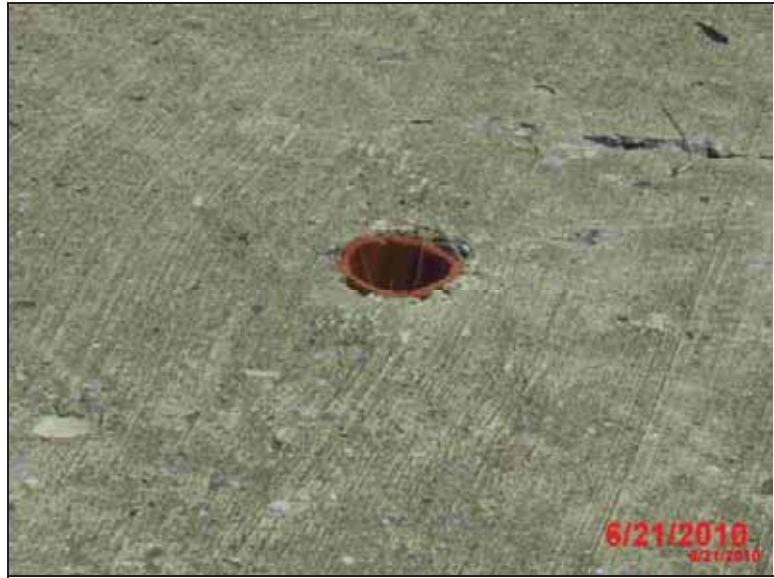
<p>Inspect ID: N21L_2010_a_0216 Title: USACE_CELRB_N21L_2010_a_0216_1.jpg Caption: 4" drainage tile</p>
 	<p>Inspect ID: N21L_2010_a_0217 Title: USACE_CELRB_N21L_2010_a_0217_1.jpg Caption: Typical spalling</p>

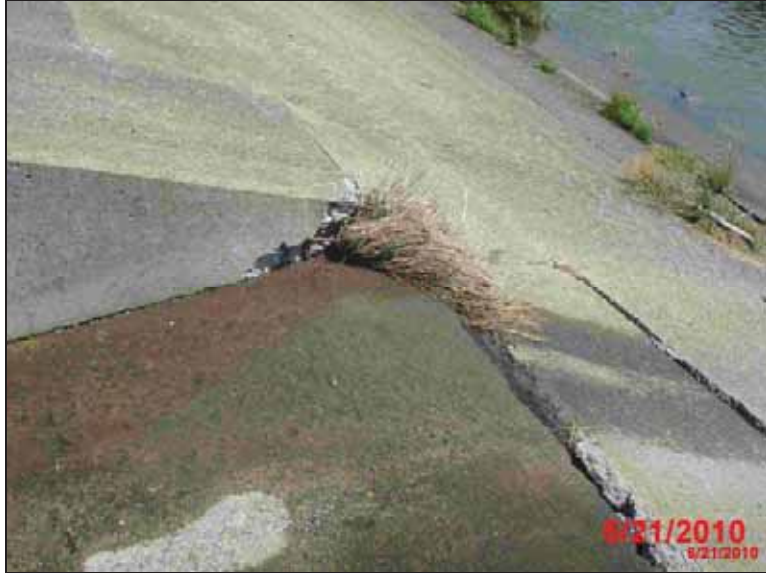
Inspect ID: N21L_2010_a_0225 **Title:** USACE_CELRB_N21L_2010_a_0225_1.jpg
Caption: Headwall spalling, rebar exposed

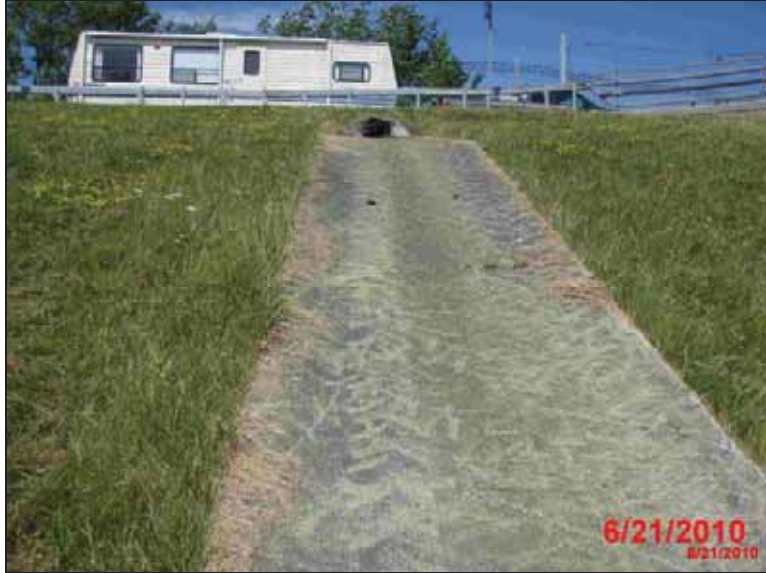
Inspect ID: N21L_2010_a_0232 **Title:** USACE_CELRB_N21L_2010_a_0232_1.jpg
Caption: 18" CMP drainage pipe

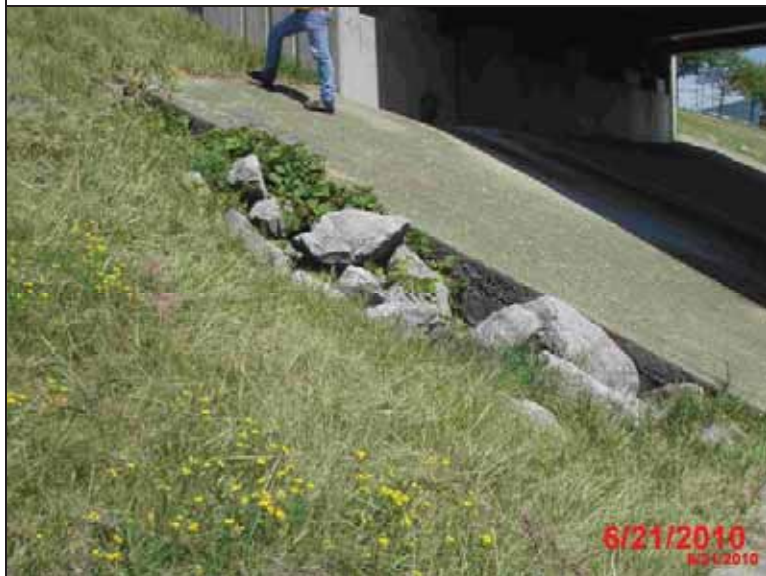
Inspect ID: N21L_2010_a_0233 **Title:** USACE_CELRB_N21L_2010_a_0233_1.jpg
Caption: Erosion in riprap along concrete

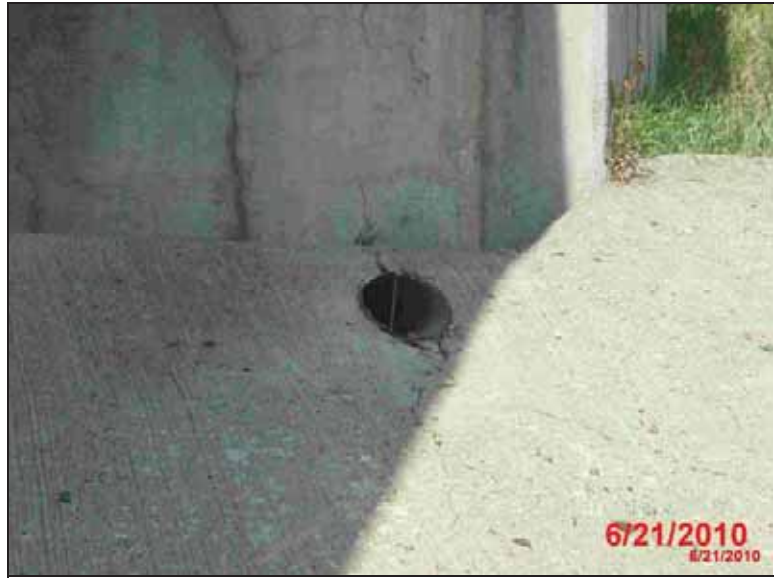
<p>Inspect ID: N21L_2010_a_0234 Title: USACE_CELRB_N21L_2010_a_0234_1.jpg Caption: Two 6" CMP drainage pipe, either side of bridge</p>

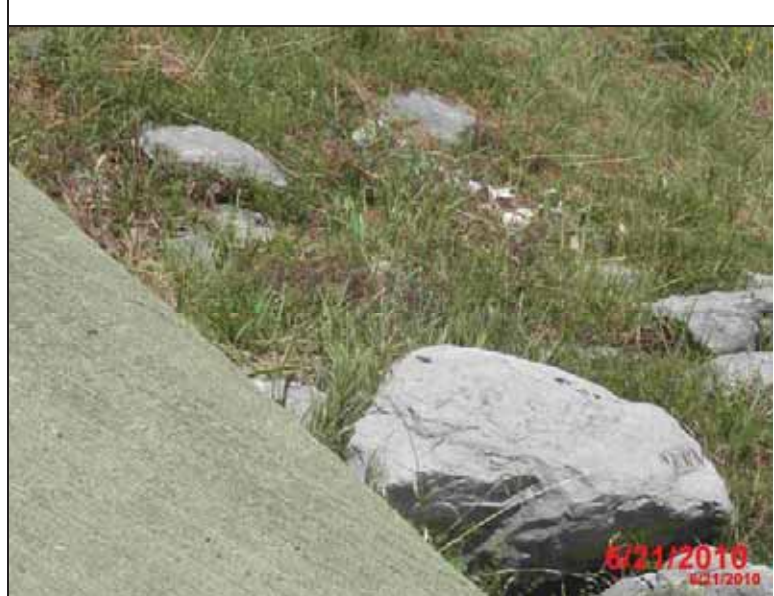
<p>Inspect ID: N21L_2010_a_0235 Title: USACE_CELRB_N21L_2010_a_0235_1.jpg Caption: Erosion in riprap along concrete</p>

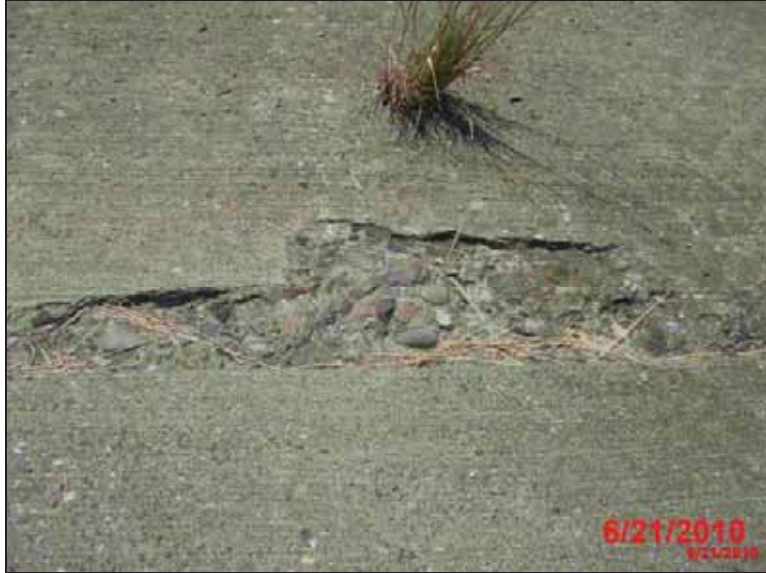
Inspect ID: N21L_2010_a_0238 **Title:** USACE_CELRB_N21L_2010_a_0238_1.jpg
Caption: Spalling on bank

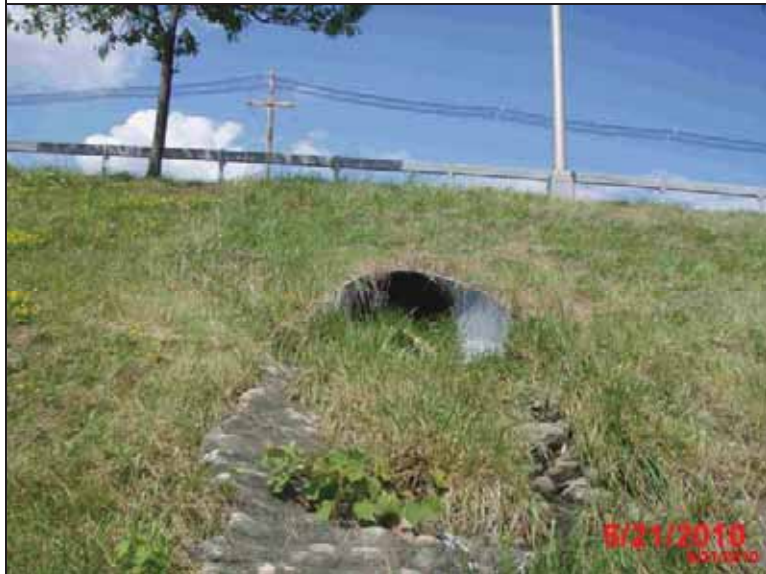
Inspect ID: N21L_2010_a_0239 **Title:** USACE_CELRB_N21L_2010_a_0239_1.jpg
Caption: 36" CMP drainage pipe

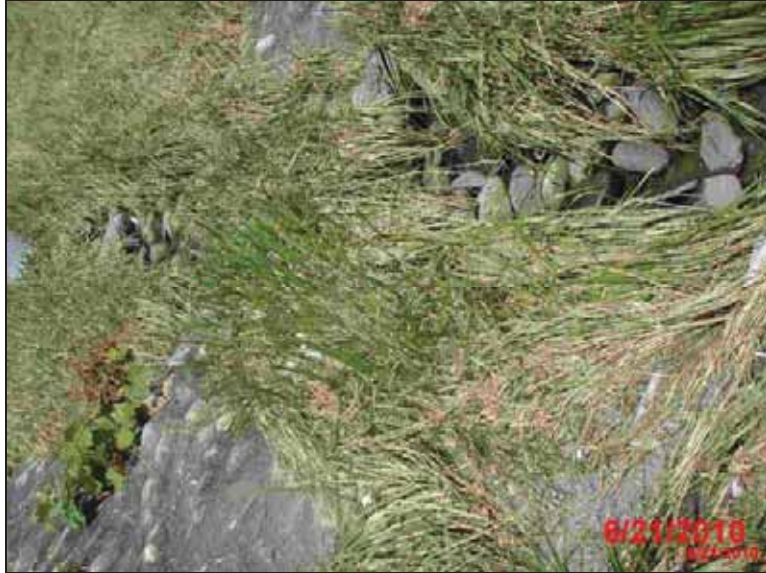
Inspect ID: N21L_2010_a_0240 **Title:** USACE_CELRB_N21L_2010_a_0240_1.jpg
Caption: Erosion, lack of riprap

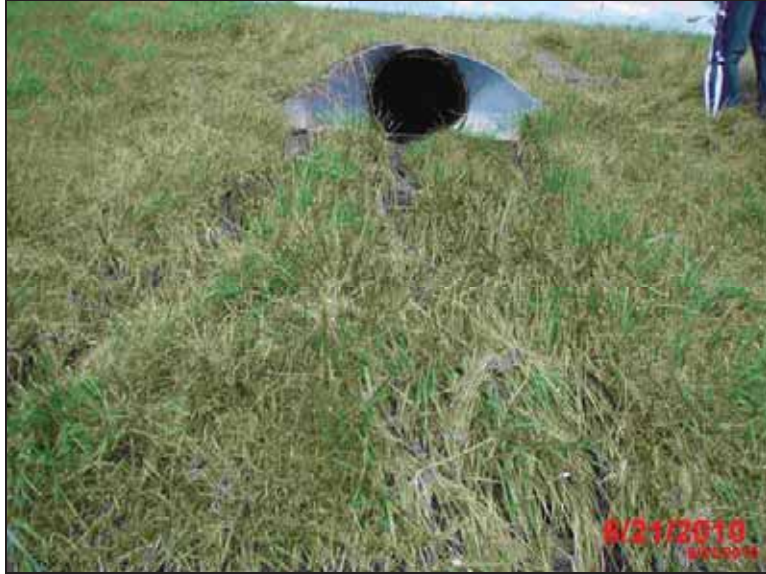
Inspect ID: N21L_2010_a_0243 **Title:** USACE_CELRB_N21L_2010_a_0243_1.jpg
Caption: 36" CMP drainage pipe

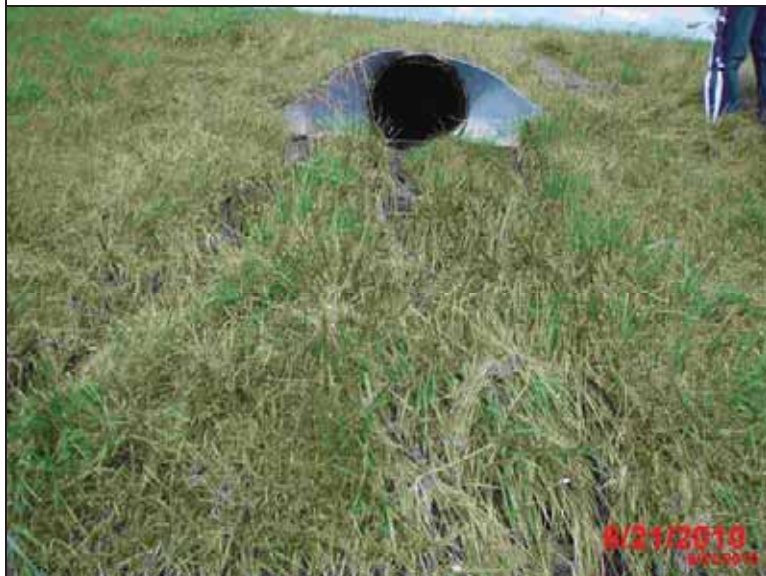
Inspect ID: N21L_2010_a_0244 **Title:** USACE_CELRB_N21L_2010_a_0244_1.jpg
Caption: Erosion, lack of riprap

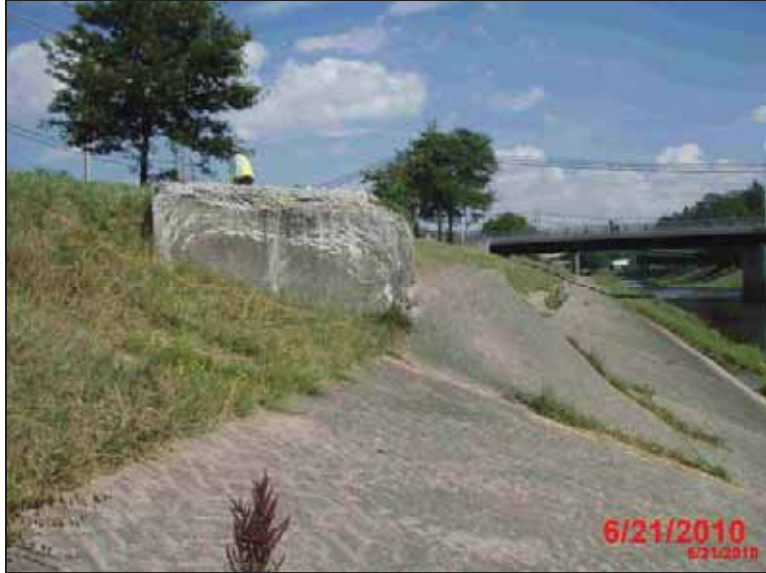
Inspect ID: N21L_2010_a_0245 **Title:** USACE_CELRB_N21L_2010_a_0245_1.jpg
Caption: Sanitary sewer structure, severely damaged

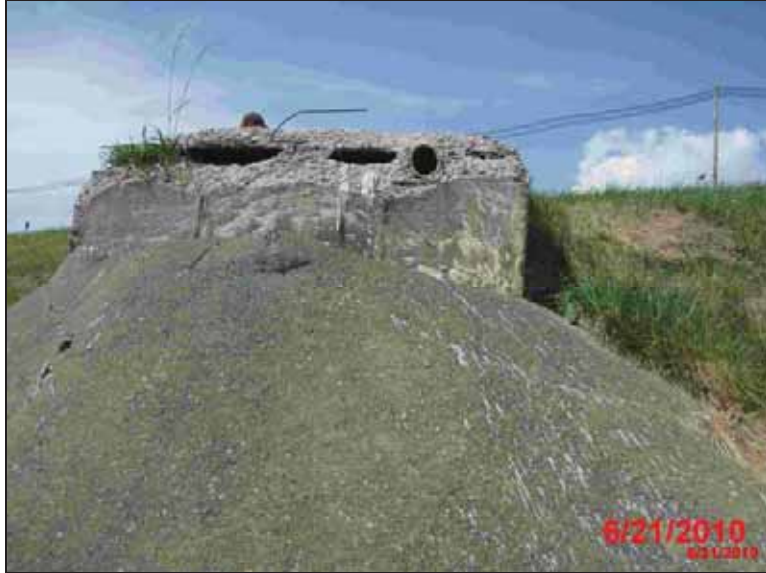
Inspect ID: N21L_2010_a_0245 **Title:** USACE_CELRB_N21L_2010_a_0245_3.jpg
Caption: Sanitary sewer structure, severely damaged

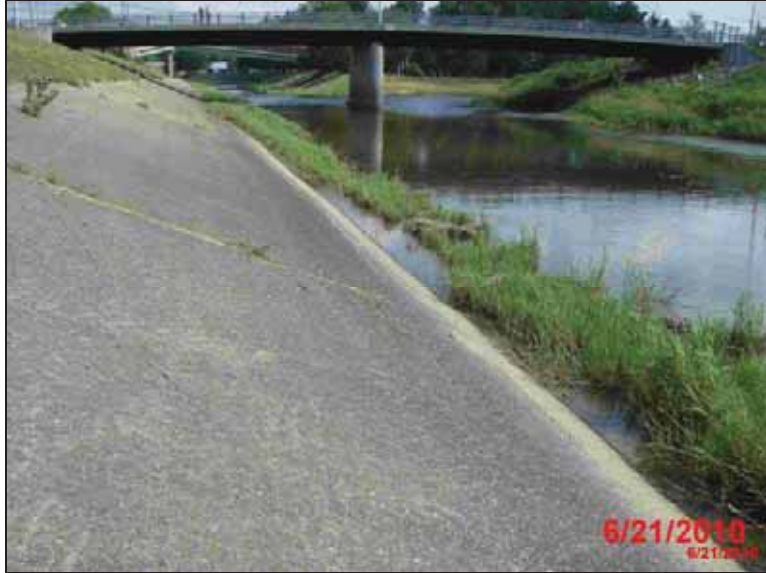
Inspect ID: N21L_2010_a_0247 **Title:** USACE_CELRB_N21L_2010_a_0247_1.jpg
Caption: Shoaling at bank

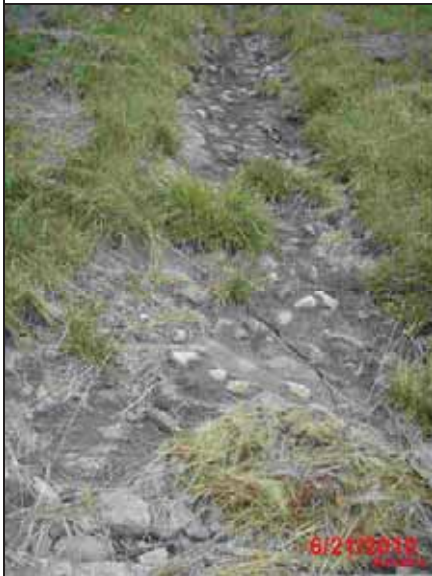
Inspect ID: N21L_2010_a_0248 **Title:** USACE_CELRB_N21L_2010_a_0248_1.jpg
Caption: Spalling, vegetation

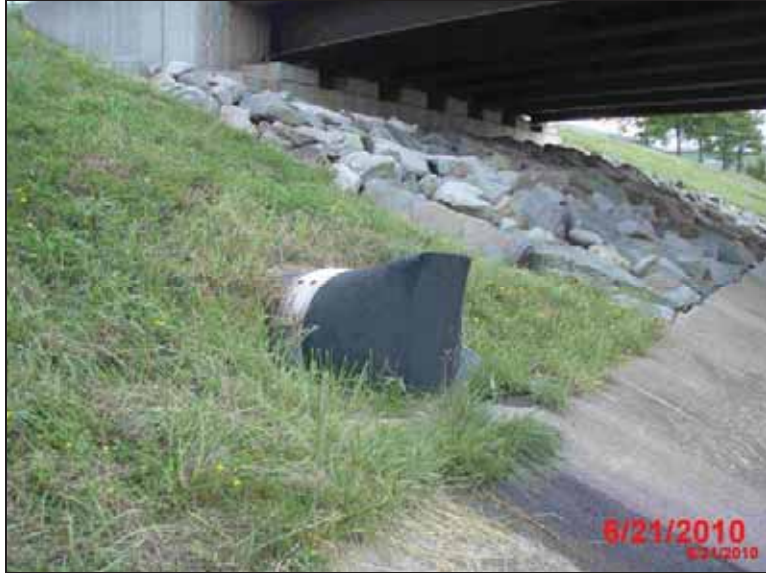
Inspect ID: N21L_2010_a_0249 **Title:** USACE_CELRB_N21L_2010_a_0249_1.jpg
Caption: 18" HDPE Tideflex gate

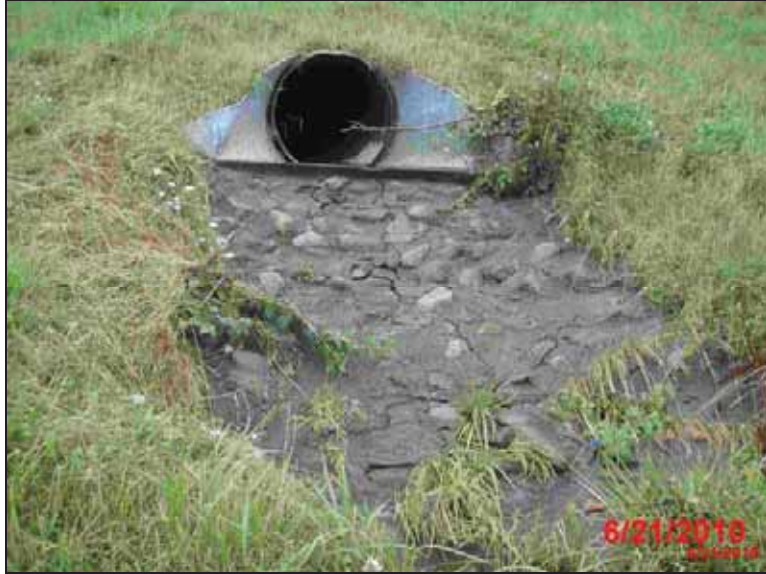
Inspect ID: N21L_2010_a_0251 **Title:** USACE_CELRB_N21L_2010_a_0251_1.jpg
Caption: 30" CMP drainage pipe

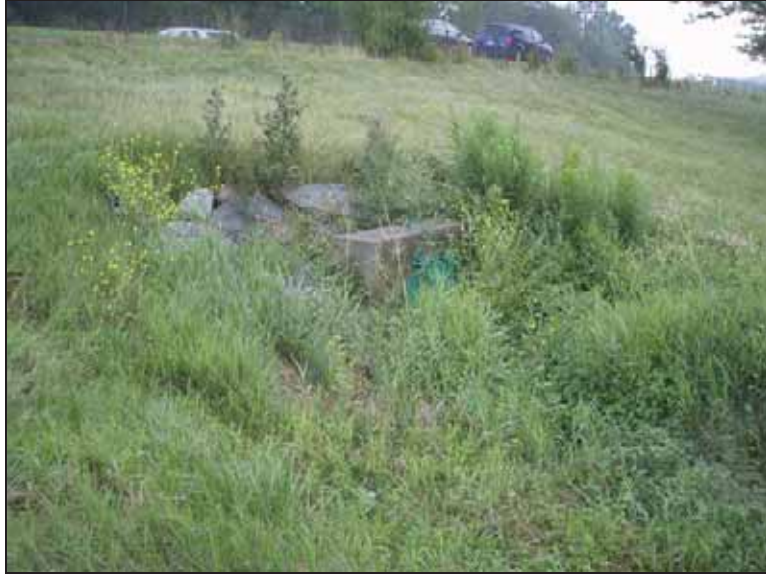
Inspect ID: N21L_2010_a_0254 **Title:** USACE_CELRB_N21L_2010_a_0254_1.jpg
Caption: Drainage channel from 24" flap gate to river

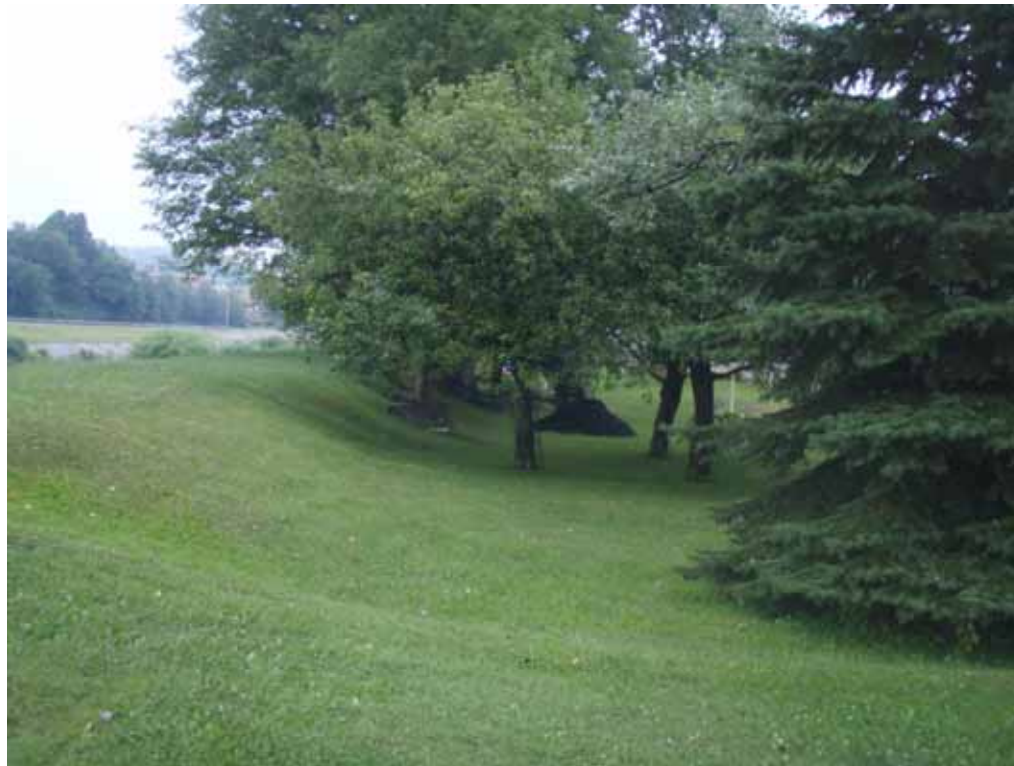
- 0078: Dense vegetation noted within 15 feet of Landside toe: remove vegetation (U)
- Near Sta. 59+00

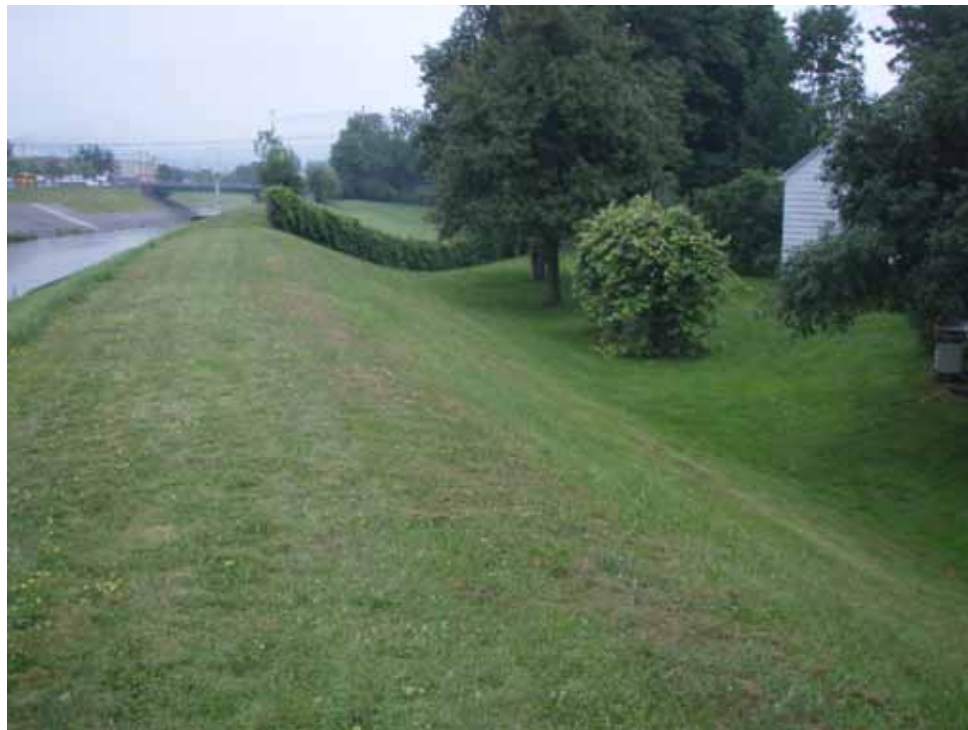
- 0095: encroachments : fence on levee (U)
- Near Sta. 49+00

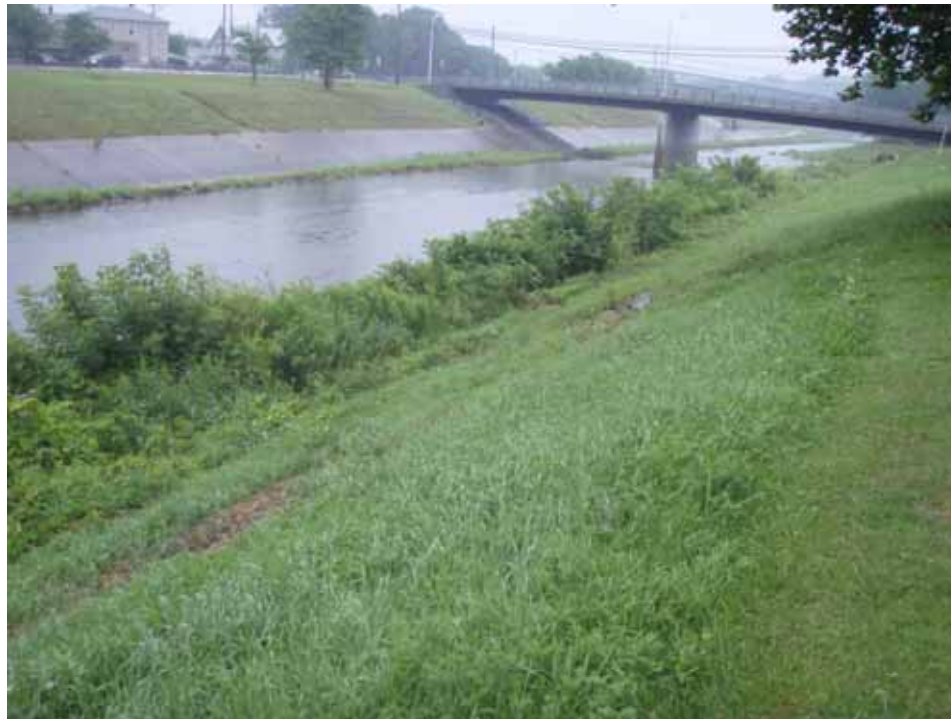
- 0156: Rutting area noted (M)
- Near Sta. 14+00

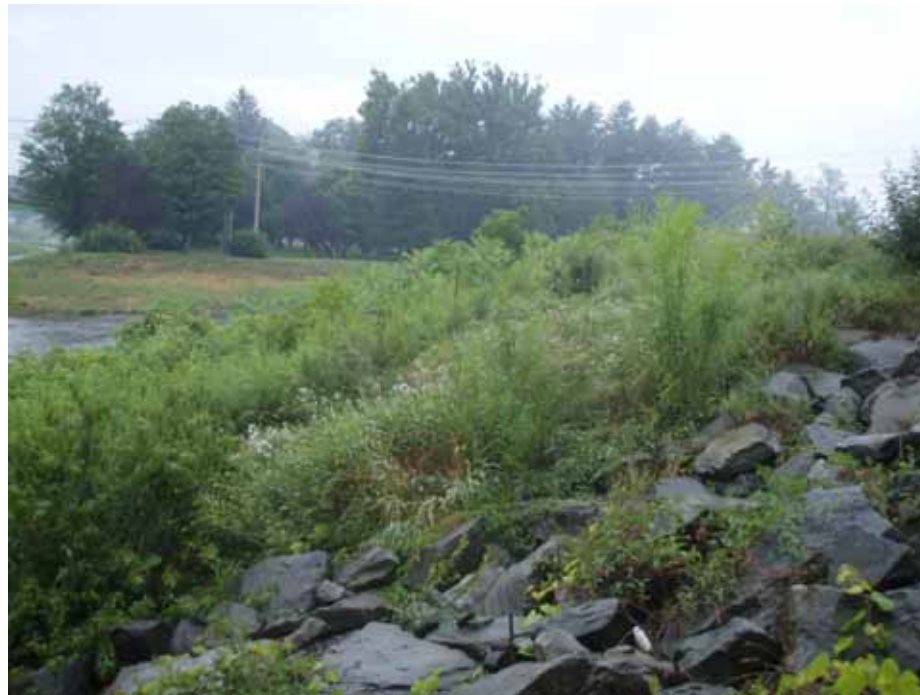
- 0196: Rock protection hidden by dense vegetation (U)
- Near Sta. 0+00

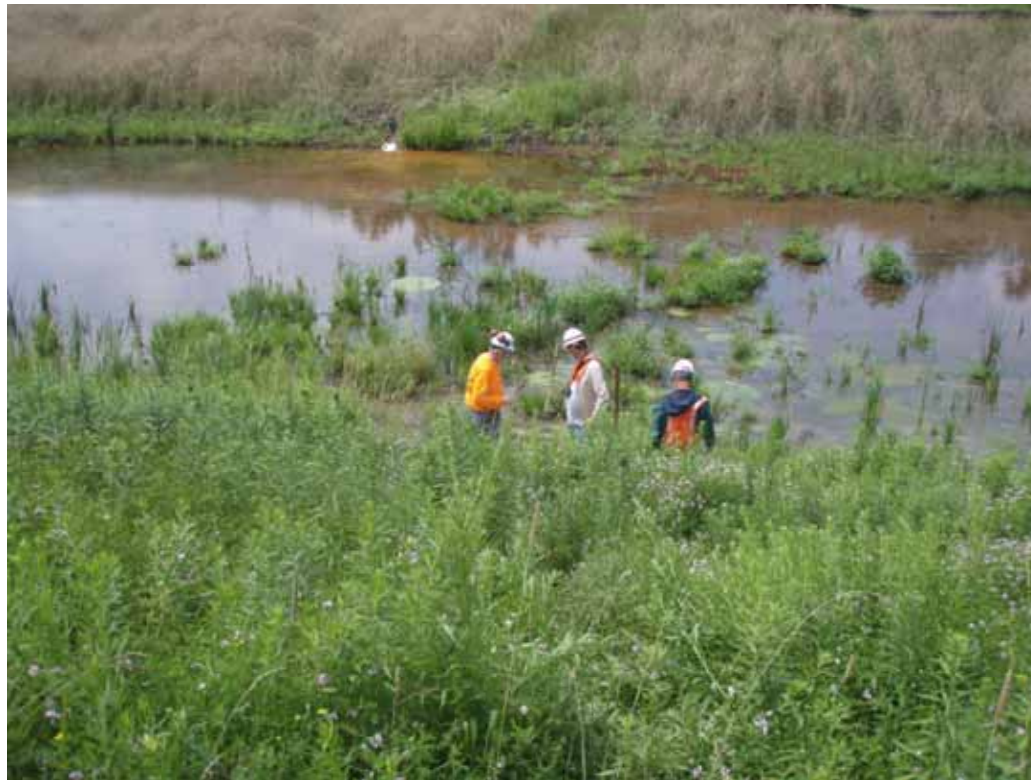
- 0202: Seepage at toe of slope of levee (U)
- Near Sta. 0+00

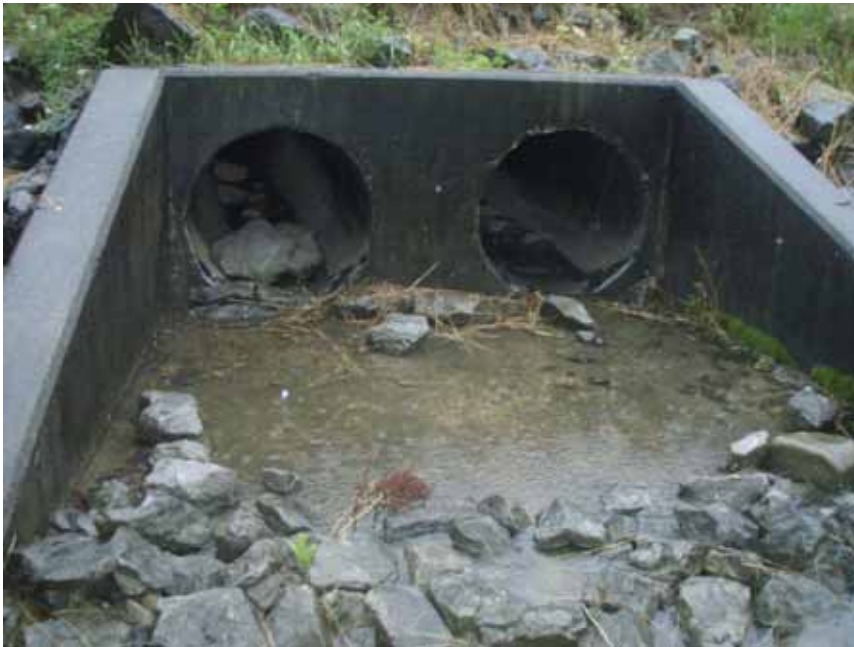
- Areas of sediment, debris and vegetation

- 0101: Unwanted obstruction in pipe: remove debris (U)
- Near Sta. 49+00

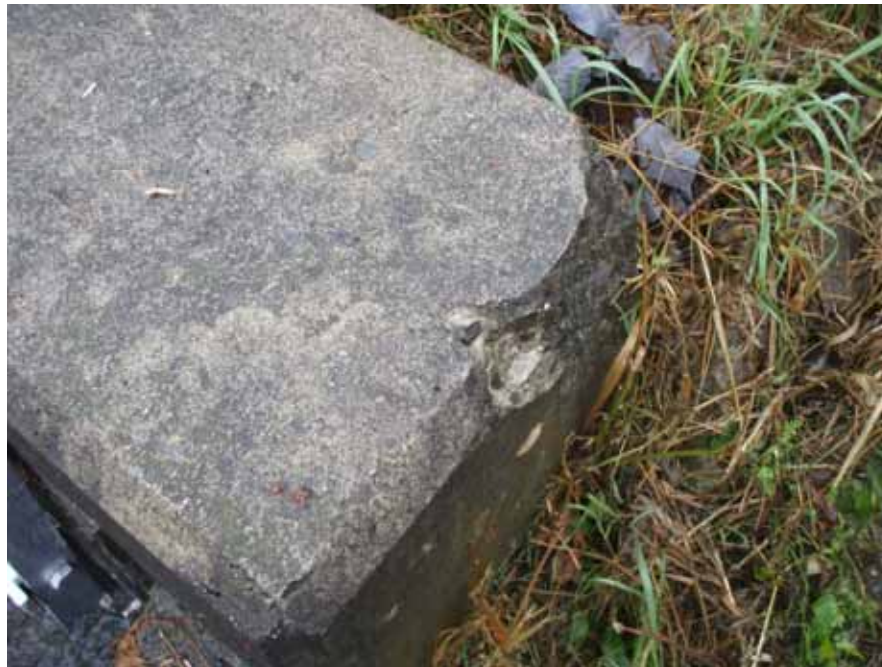
- 0144: Spalling, cracking of concrete (U)
- Near Sta. 24+00

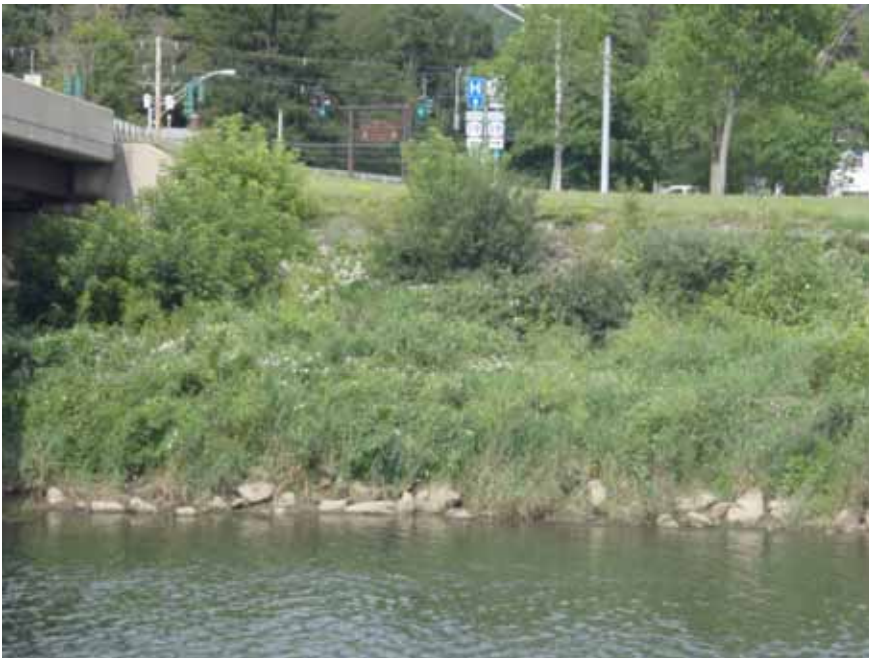
- Areas of sediment, debris and vegetation lining channel

- 0036: Unwanted vegetation along channel : remove vegetation (U)
- Near Sta. 91+00

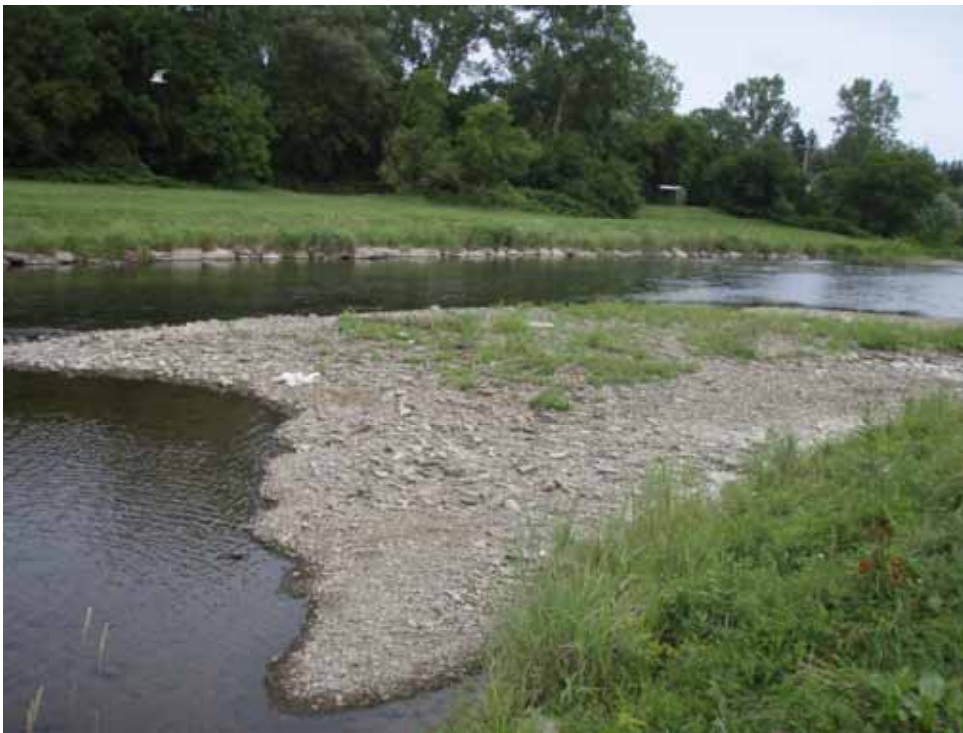
- Channel flow capacity is reduced

- 0181: Shoaling is well established (U)
- Near Sta. 0+00

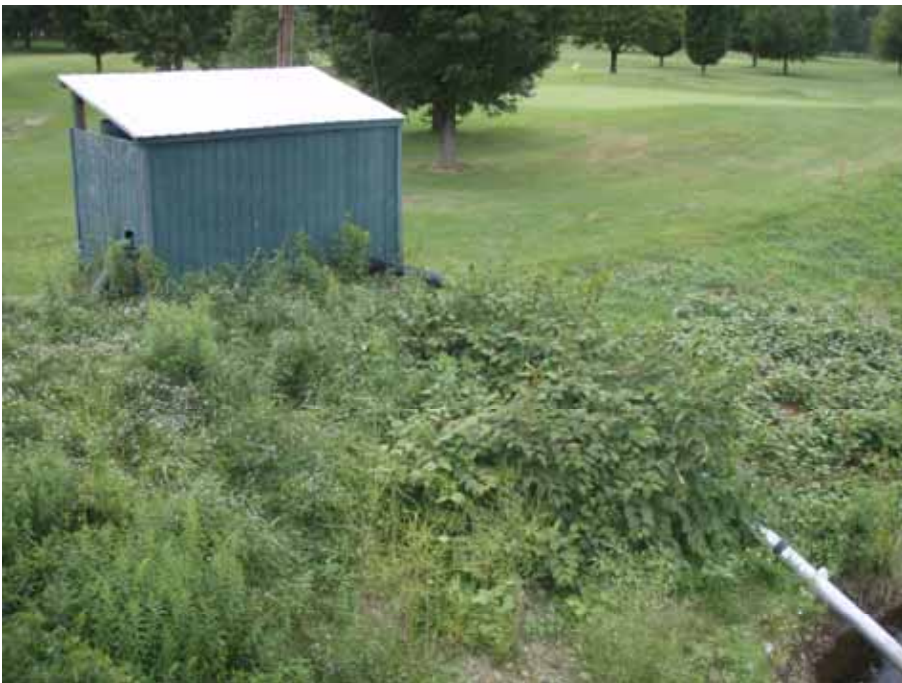
- **3. Encroachments**
 - Multiple encroachments along channel

- 0014: Multiple encroachments (U)
- Near Sta. 104+00

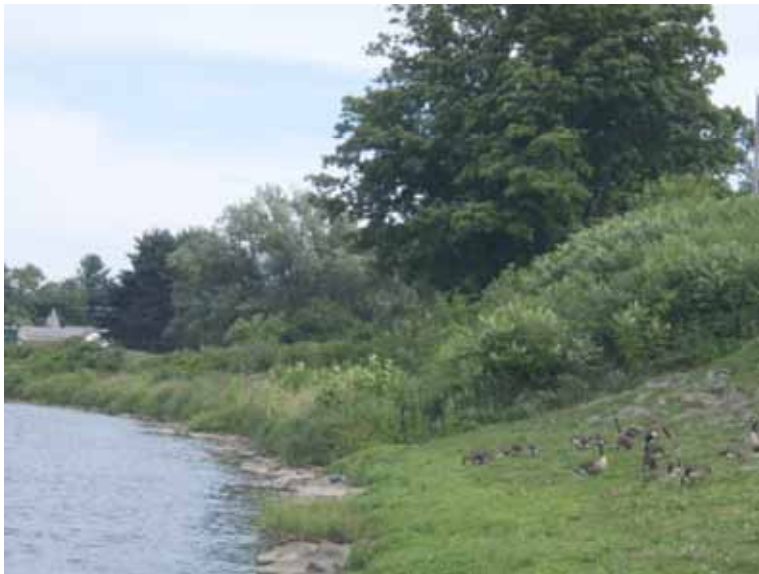
- Vegetation in riprap has occurred

- 0177: Vegetation in riprap noted: (U)
- Near Sta. 1+00
